Childs-Irving Hydroelectric Project

Closeout Report – Reach 9 Sally Mae Siphon

Childs/Irving Hydroelectric Project Facilities Decommissioning

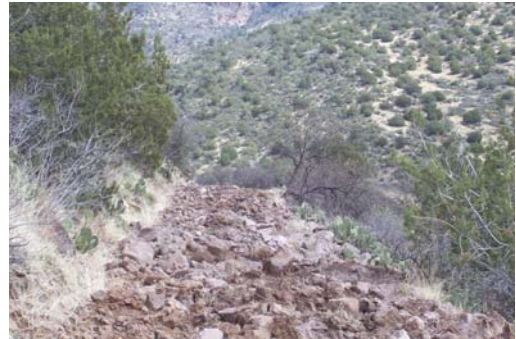
2.1 Concrete / Steel Flume on Bench

The concrete / steel flume has been removed. All concrete and steel materials have been removed for disposal off site. The bench area has been re-seeded. A portion of the flume approaching the intake structure remains for historical interpretation.

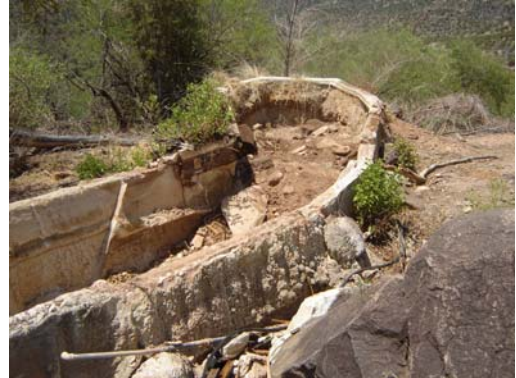
2.2 Sally Mae Siphon Intake

The metal structure, trash rake, grating, gate and wooden plank platforms have been removed and all materials disposed off site. The concrete intake structure remains as a historical reference point.

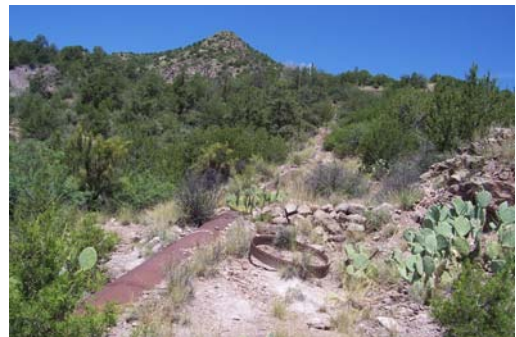
2.3 Exposed Siphon Pipe

The exposed siphon pipe (48", 45" 42" diameter) sections remain in place, except pipe bridges. The siphon pipe was sealed at both ends. All vent pipes have been removed and welded shut. Manways into the pipe have been welded shut and concealed to prevent access.

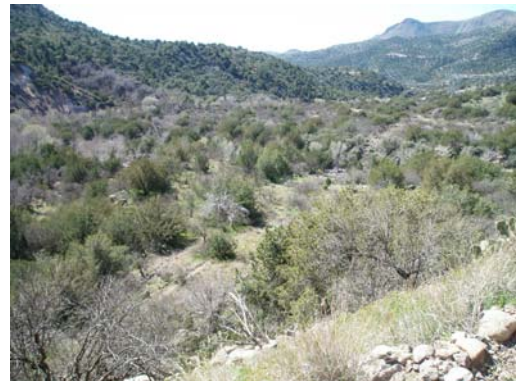
Bridge No. 8 (230' steel truss bridge) has been removed. All metal support structures have been removed to the tops of the foundations. The exposed ends of the siphon pipe have been welded shut.

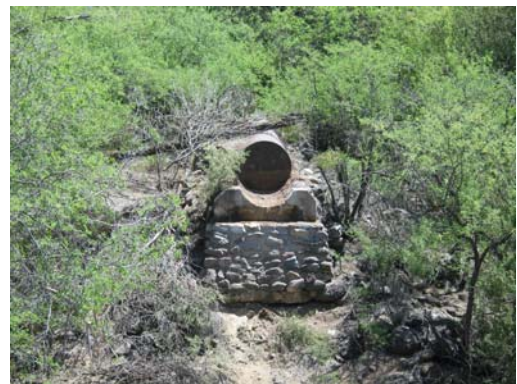
Bridge No. 7 (98' steel truss bridge) has been removed. All metal support structures have been removed to the tops of the foundations. The exposed ends of the siphon pipe have been welded shut.

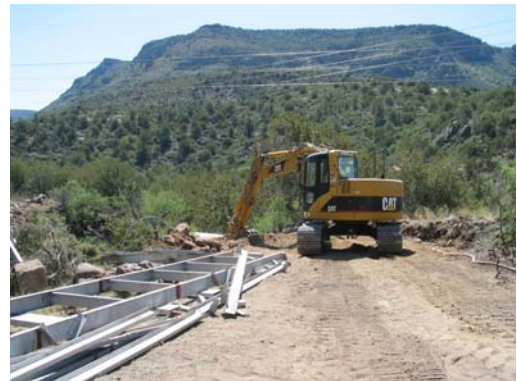
Bridge No. 6 (80' steel truss bridge) has been removed. All metal support structures have been removed to the tops of the foundations. The exposed ends of the siphon pipe have been welded shut.

All steel materials for these bridges have been removed from the site and hauled off site for disposal. Areas around the bridges used for staging of equipment has been ripped and re-seeded.
