CHOLLA POWER PLANT Fly Ash Dam, Bottom Ash Dam, Sedimentation Pond, and Bottom Ash Monofill

Annual CCR Impoundment and Landfill Inspection Report

2018

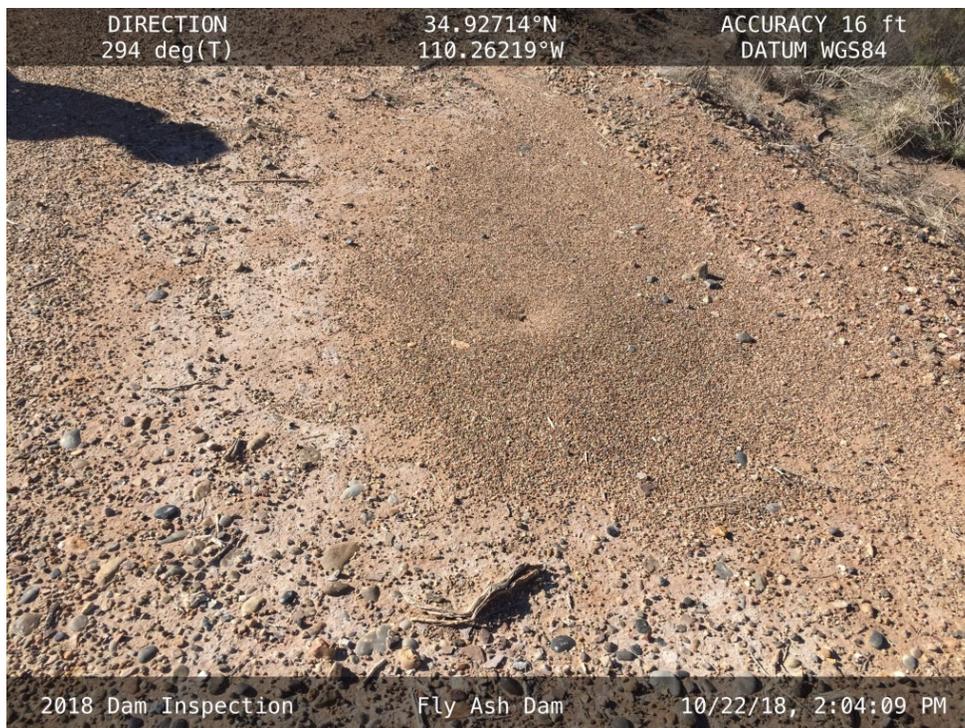
20181022 – IMG_0453

DAM EMBANKMENT CHECKLIST											
3	DAM CREST										
a	Settlements, slides, depressions?										
b	Misalignment?										
c	Longitudinal/Transverse cracking?										
d	Animal burrows? Ant hills were observed at various locations across the crest (Photo IMG_0453).				X	X	X				
e	Adverse vegetation?										
f	Erosion?										
4	UPSTREAM SLOPE										
a	Erosion? Minor erosion and soil wasting observed along the upstream slope. See comment ii.				X	X					
b	Inadequate ground cover?										
c	Adverse vegetation? Continue removing adverse vegetation.				X		X				
d	Longitudinal/Transverse cracking?										
e	Inadequate riprap?										
f	Stone deterioration? Minor wasting observed. See comment iii.				X	X					
g	Settlements, slides, depressions, bulges?										
h	Animal burrows? None observed. Continue to monitor.				X		X

Ant hill in the crest of the South Embankment along the upstream slope.

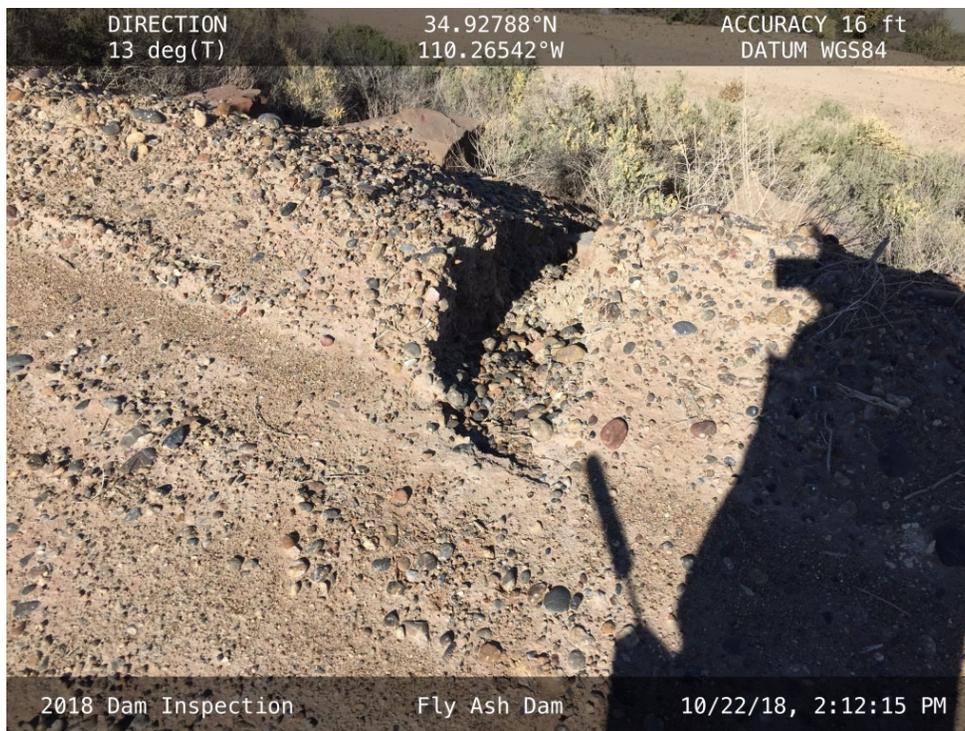
- ii. Minor erosion was observed along the upstream slope of the southern 1/8th of the West Embankment (Photo IMG_0463). The erosion observed during this inspection is in the same vicinity as erosion observed during the 2017 inspection. The erosion does not appear to be significantly worse since the 2017 inspection, but should be monitored. Additionally, minor soil wasting was observed along the upstream slope near the Northwest Abutment (Photo IMG_0499). The soil wasting should be monitored and repaired if it continues.

20181022 – IMG_0463
 Minor erosion along the upstream slope of the West Embankment.

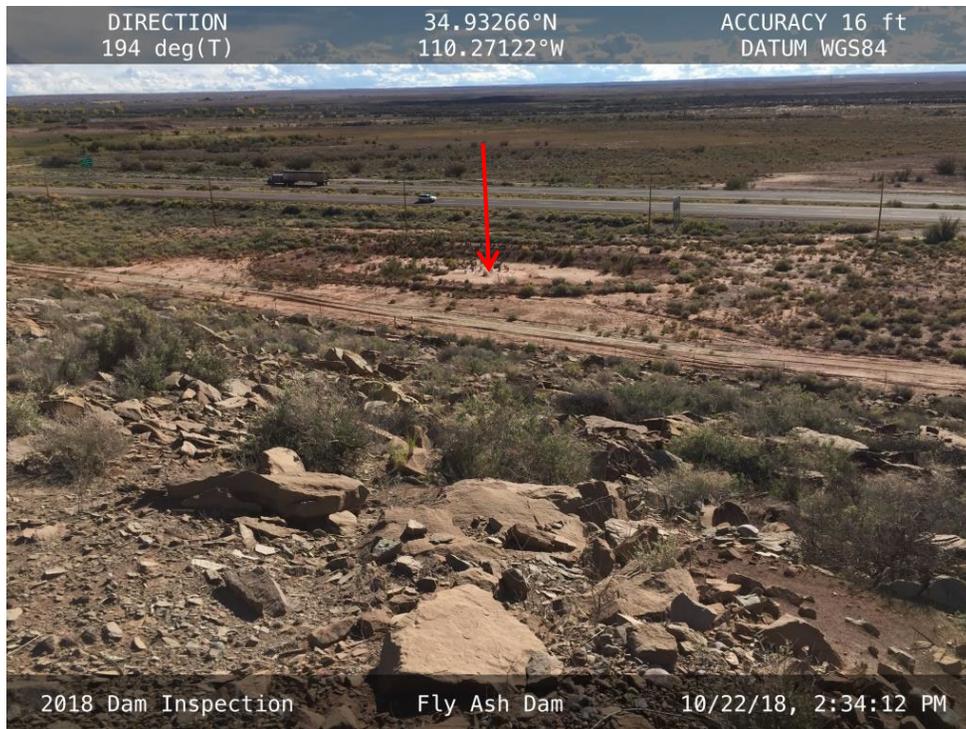
20181022 – IMG_0493
 Area of historic seepage, currently in a dry condition.

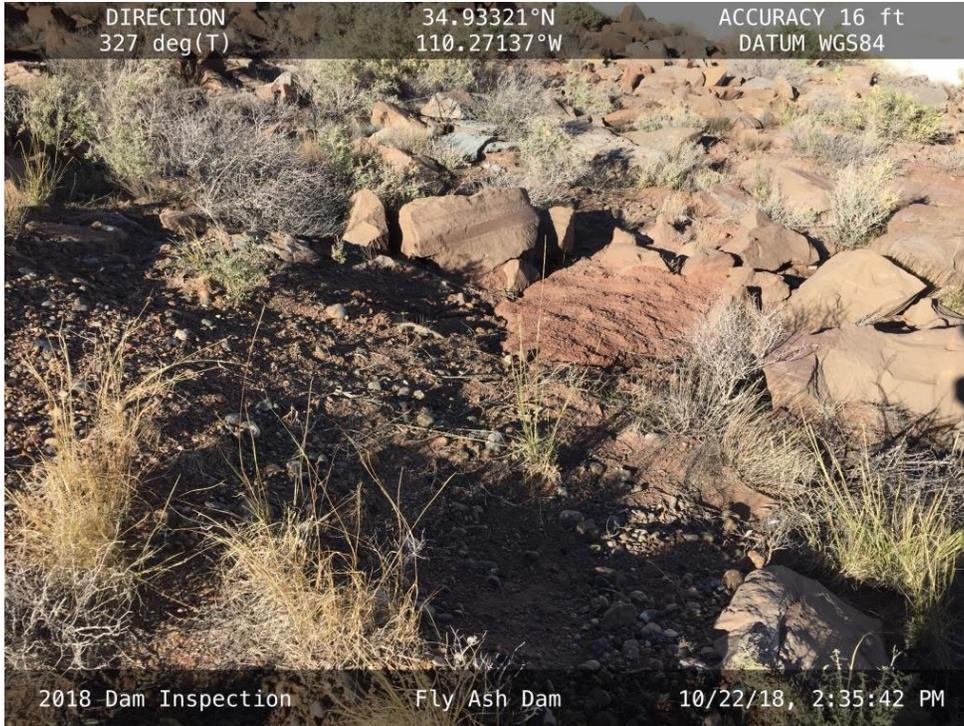
20181022 – IMG_0499
Minor soil wasting along the upstream slope.

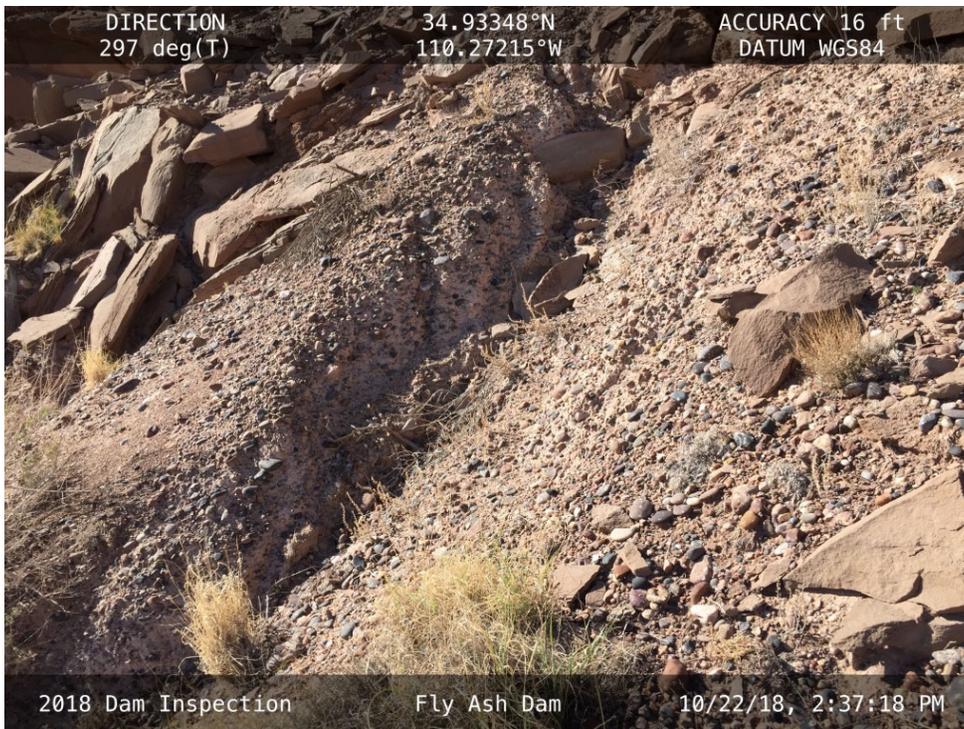
- iii. Minor stone deterioration was also observed during previous inspections.
- iv. Minor erosion was observed at the Northwest Abutment contact (Photos IMG_0502 and IMG_0542). The erosion should be monitored and repaired if the depth exceeds 1 foot.

20181022 – IMG_0502
Minor erosion at the Northwest Abutment contact.

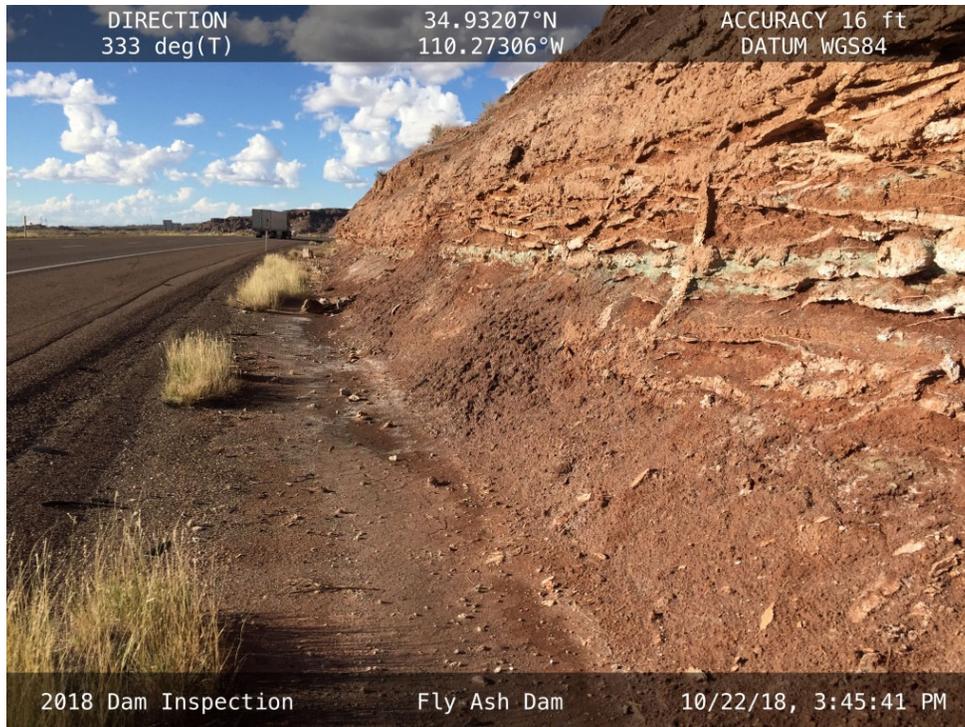
- v. Seepage has historically been observed at the Geronimo seep, the Hunt seep, the I-40 seep, and in areas of relatively lower elevation along the downstream toe. The Geronimo and Hunt Sumps were active during the inspection; however, the I-40 seep and historic seepage areas downstream of the West Embankment were dry. The I-40 seep was drier during this inspection than it had been during previous inspections (Photo IMG_0553).

20181022 – IMG_0553
The I-40 seep in a dry condition.

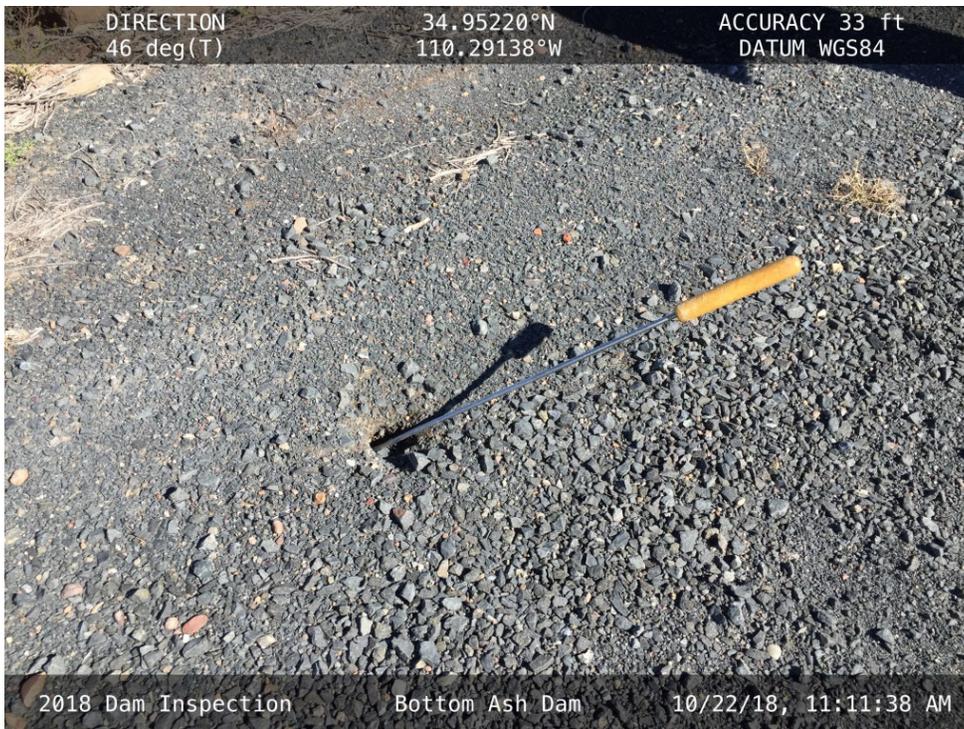
20181022 – IMG_0281

- i. Several erosion holes were observed in the crest of both the South and East Embankments. Erosion holes in the South Embankment and southeast corner crest are scattered (Photos IMG_0281, IMG_0294, IMG_0304, and IMG_0325) while erosion holes in the East Embankment crest (Photos IMG_0341 and IMG_0343) are clustered near settlement monument M-16. However, settlement monuments M-15, M-16, and PI do not indicate abnormal or sudden movement over the previous 12 months. The erosion holes should be repaired and the area should be monitored for additional erosion.

Shallow erosion hole on the South Embankment crest.

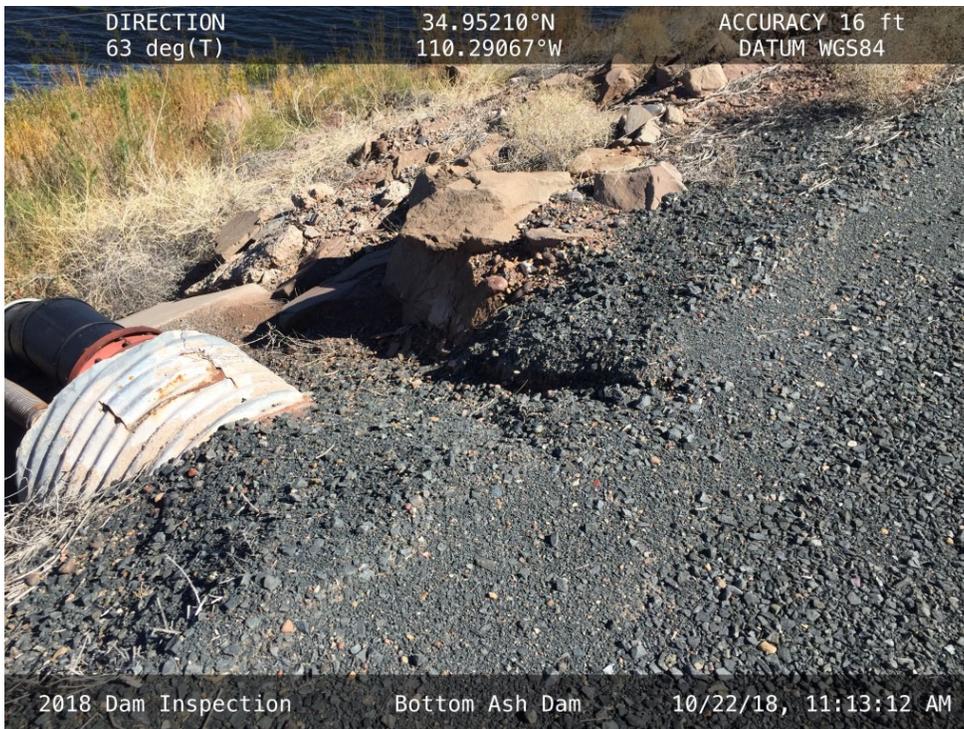
20181022 – IMG_0283

- ii. Shallow erosion rills were observed in isolated locations along the South Embankment crest (Photos IMG_0280 and IMG_0283). These areas should be monitored and repaired if they are observed to exceed a depth of 1 foot.

Shallow erosion on the upstream slope and crest near the western siphon line.

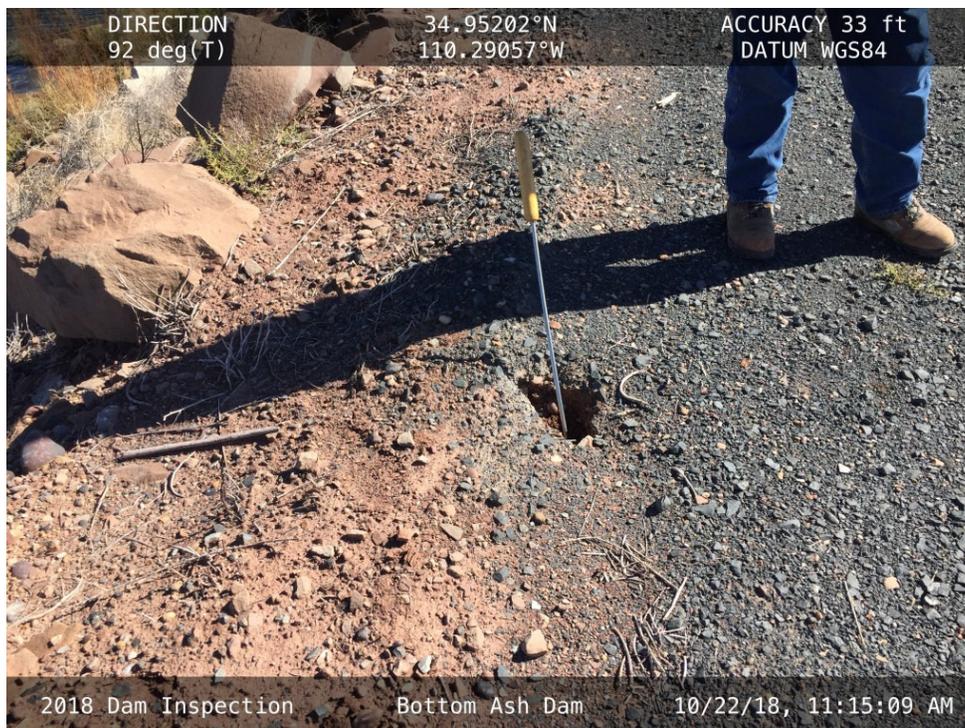
20181022 – IMG_0294

Erosion hole on the downstream side of the South Embankment crest.

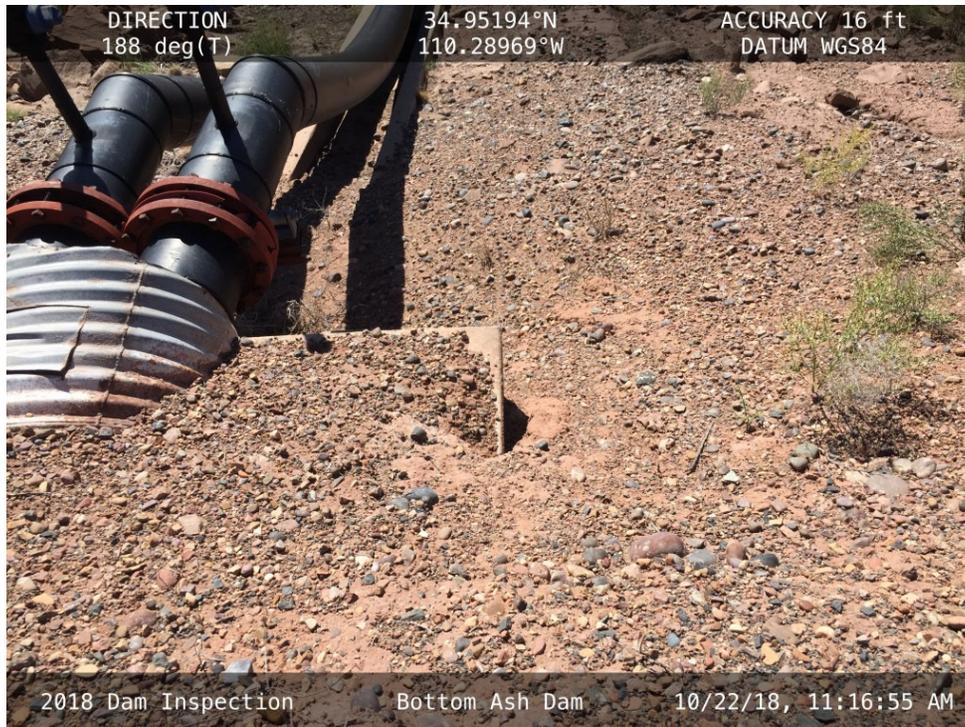
20181022 – IMG_0296

- iii. Minor erosion, soil wasting, and erosion gullies were observed:
 - a. Minor erosion was observed on the downstream slope around the concrete encasement for the central siphon lines (Photo IMG_0296).

Minor erosion around the concrete encasement for the central siphon lines, facing downstream.

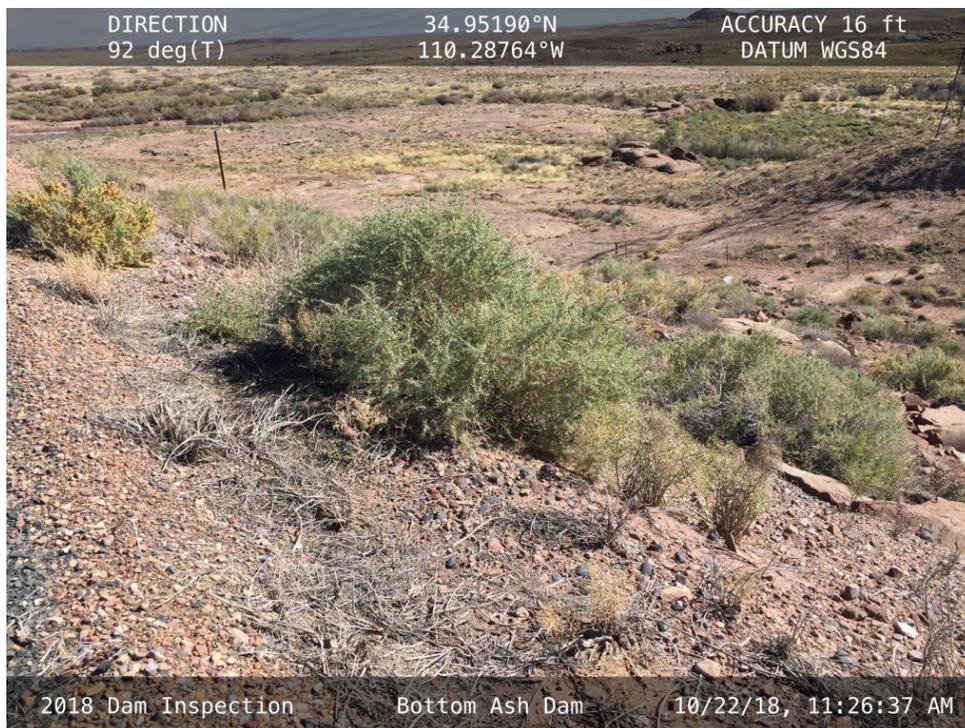
20181022 – IMG_0318

Bottom Ash Dam		SID: 09.27		N/A	No	Yes	Mon	Rep	Inv
5	DOWNSTREAM SLOPE								
a	Erosion?	See comment iii.			X	X			X
b	Inadequate ground cover?			X					
c	Adverse vegetation?	Several large bushes were observed on the downstream slope (Photo IMG_0318).			X			X	
d	Longitudinal/Transverse cracking?			X					
e	Inadequate riprap?			X					
f	Stone deterioration?	Riprap deterioration does not appear to have accelerated since the previous inspection.			X	X			
g	Settlements, slides, depressions, bulges?			X					
h	Soft spots or boggy areas?	See comment iv.			X	X			
i	Movement at or beyond toe?			X					
j	Animal burrows?	None observed. Continue to monitor.		X		X			
6	ABUTMENT CONTACTS								
a	Erosion?			X					
b	Differential movement?			X					
c	Cracks?			X					
d	Settlements, slides, depressions, bulges?			X					
e	Seepage?	Yes. Measured approximately 2 gpm at the West Abutment Weir during the inspection. Continue to monitor.			X	X

Vegetation on the downstream slope along the southeast corner of the Bottom Ash Dam.

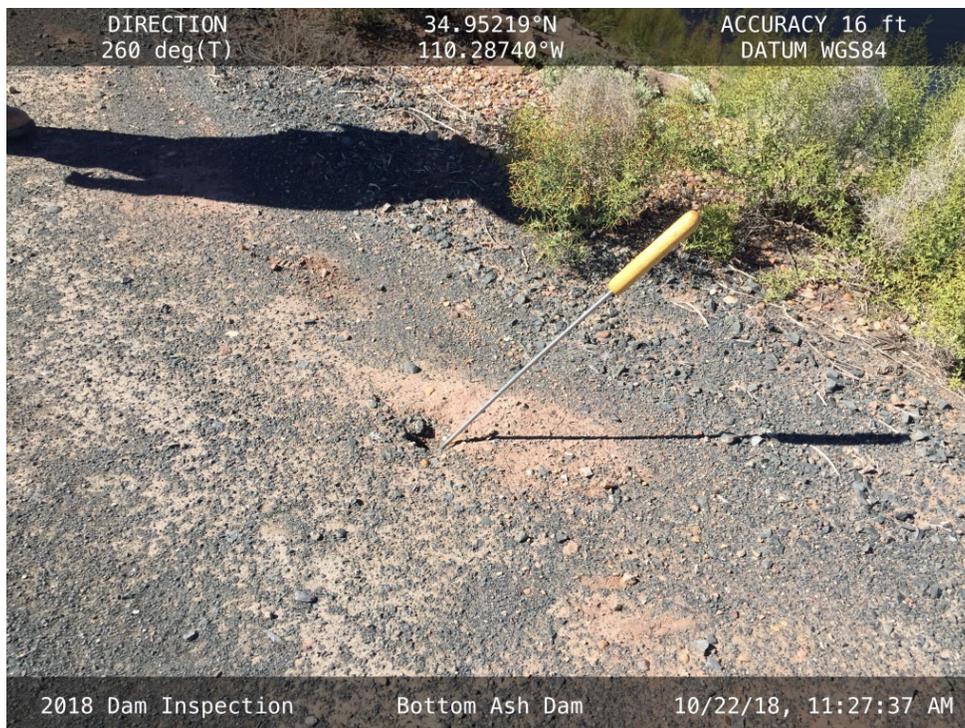
20181022 – IMG_0325

An erosion hole in the crest at the southeast corner of the Bottom Ash Dam.

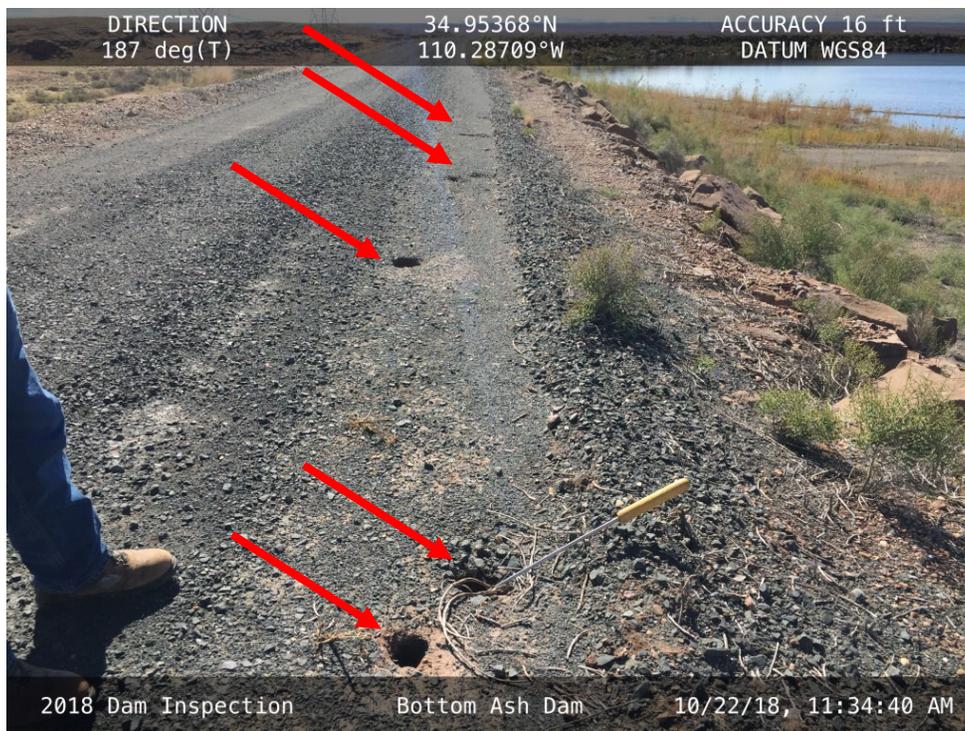
20181022 – IMG_0341
 A series of erosion holes on the upstream shoulder of the crest near settlement monument M-16.

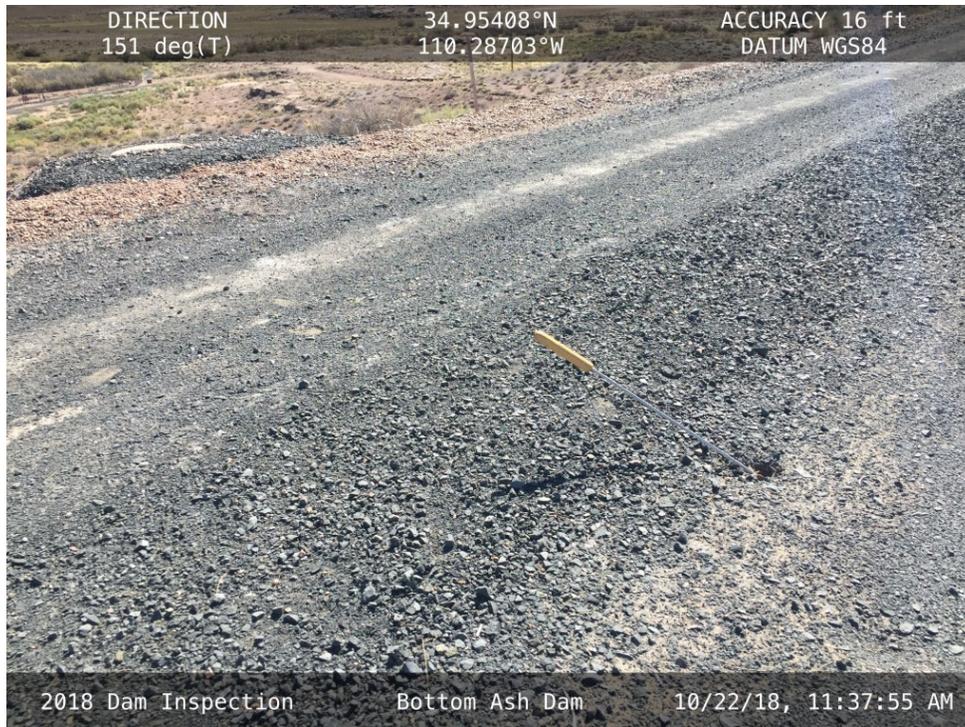
20181022 – IMG_0343
 Additional erosion hole near settlement monument M-16.

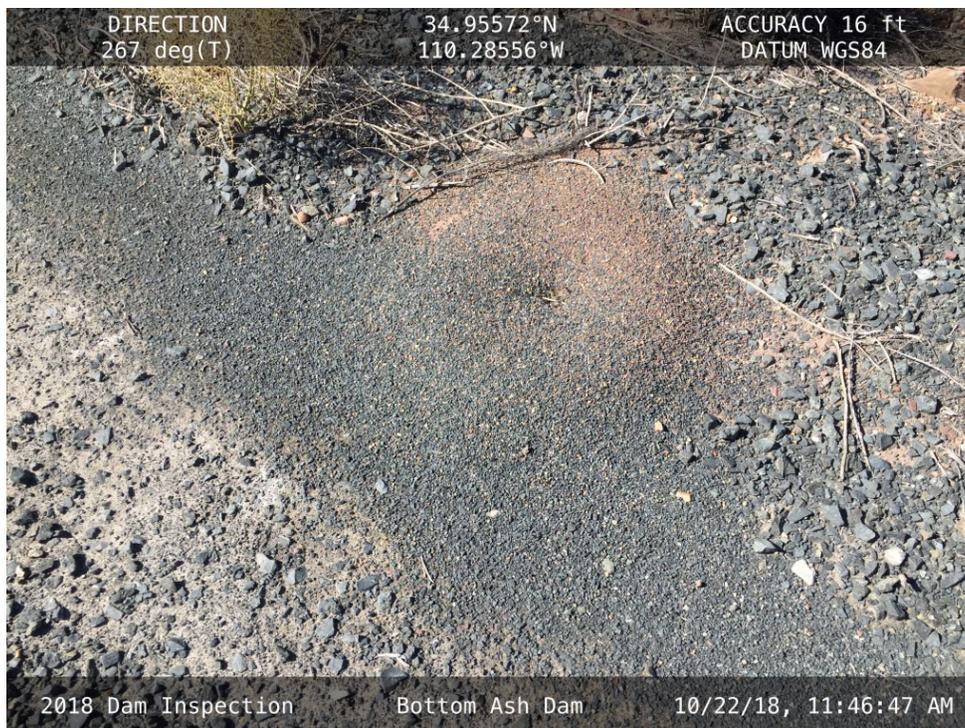
DAM EMBANKMENT CHECKLIST											
3	DAM CREST										
a	Settlements, slides, depressions?										
b	Misalignment?										
c	Longitudinal/Transverse cracking?										
d	Animal burrows? Scattered ant hills were observed (Photo IMG_0362). Monitor and remove.										
e	Adverse vegetation?										
f	Erosion? See comment i.										
4	UPSTREAM SLOPE										
a	Erosion? Minor erosion near the crest observed. See comment ii.										
b	Inadequate ground cover?										
c	Adverse vegetation? There is vegetation in the pond near the West Abutment (Photo IMG_0275).										
d	Longitudinal/Transverse cracking?										
e	Inadequate riprap?										
f	Stone deterioration?										
g	Settlements, slides, depressions, bulges?										
h	Animal burrows? None observed. Continue to monitor.

20181022 – IMG_0362
An ant hill along the crest in the northern half of the East Embankment.

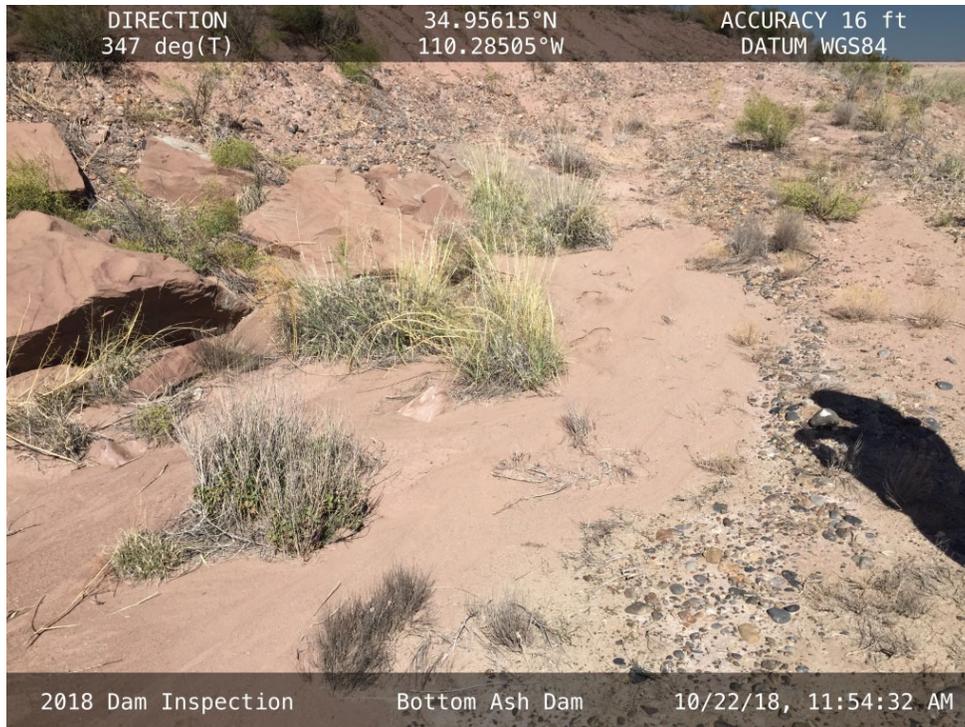
20181022 – IMG_0373

- b. Soil erosion was observed along the downstream slope of the East Embankment, near piezometer B-215 and settlement monument M-18 (Photo IMG_0373). The sediment is collecting in a diversion ditch between the access road and the embankment. The source of the sediment (crest, slope, riprap decomposition) should be investigated and repaired if it is determined that the erosion would affect the integrity of the embankment.

Soil erosion on the downstream slope of the East Embankment near the North Abutment.

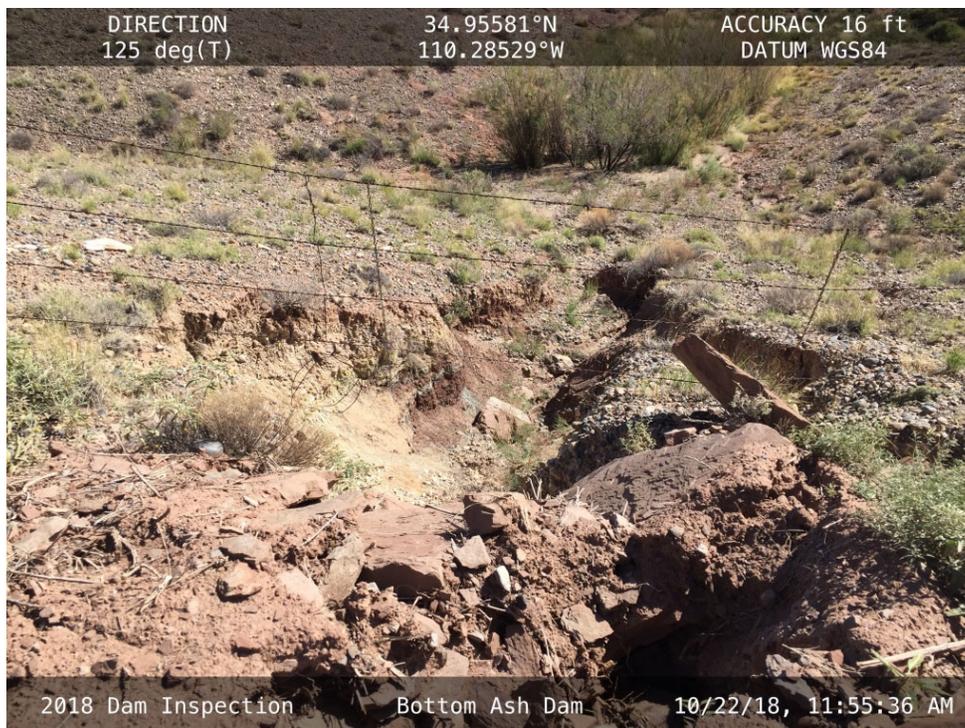
20181022 – IMG_0376

- c. Two erosion gullies were observed on the downstream slope along the northern half of the East Embankment. The northern erosion gully (Photo IMG_0376) did not appear to be significantly deeper or more extensive compared to previous inspections. The southern erosion gully (Photo IMG_0381) had not been observed during previous inspections. Both locations should be repaired.

An erosion gully on the downstream slope along the northern half of the East Embankment.

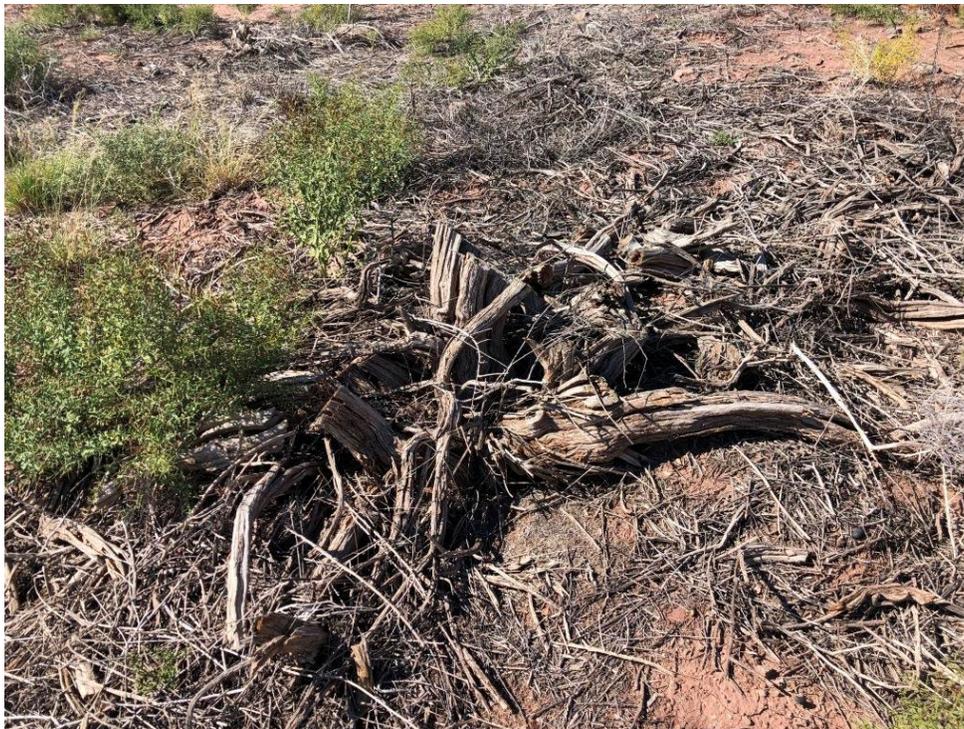
20181022 – IMG_0727

The stump of a tree left over after vegetation removal activities (to be removed).

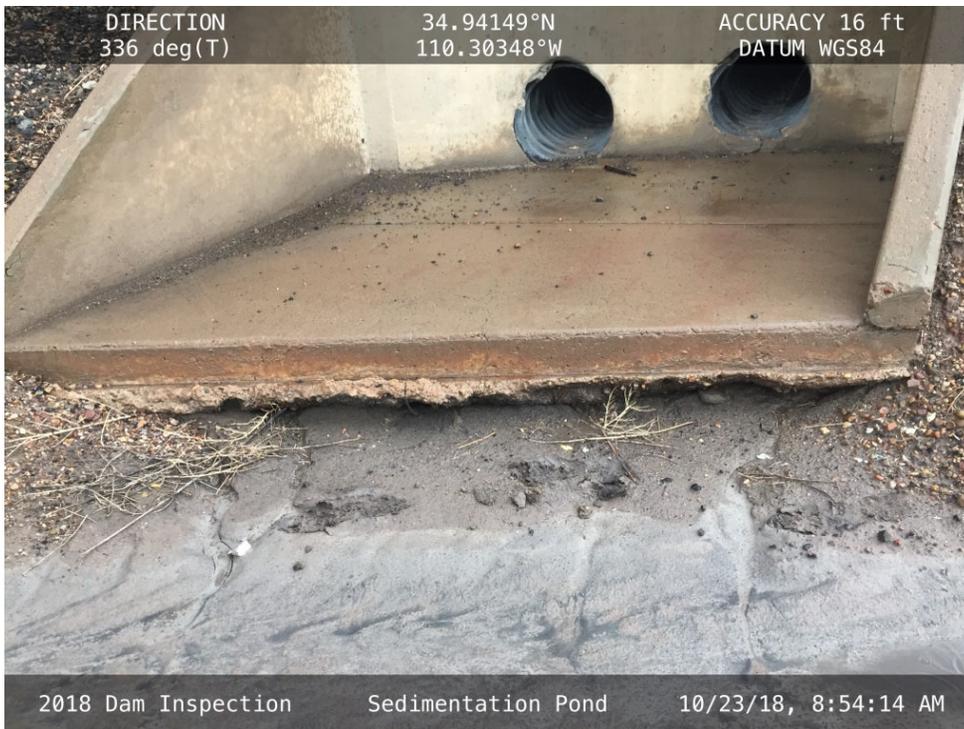
20181023 – IMG_0659

Sedimentation Pond		SID: N/A		N/A	No	Yes	Mon	Rep	Inv
5	DOWNSTREAM SLOPE								
a	Erosion?	Minor erosion around the outlet structure.							
b	Inadequate ground cover?		X			X			
c	Adverse vegetation?		X						
d	Longitudinal/Transverse cracking?		X						
e	Inadequate riprap?		X						
f	Stone deterioration?		X						
g	Settlements, slides, depressions, bulges?		X						
h	Soft spots or boggy areas?		X						
i	Movement at or beyond toe?		X						
j	Animal burrows?		X						
6	ABUTMENT CONTACTS								
Abutments are not defined due to general grading in the area.									
a	Erosion?		X						
b	Differential movement?		X						
c	Cracks?		X						
d	Settlements, slides, depressions, bulges?		X						
e	Seepage?		X						
f	Animal burrows?		X						
7	SEEPAGE/PIPING CONTROL DESIGN FEATURE(S)								
a	Describe:	None.							
b	Internal drains flowing?		X						
c	Seepage at or beyond toe?			X					
d	If so, does seepage contain fines?		X

Erosion under the concrete spillway on the downstream side of the south embankment.

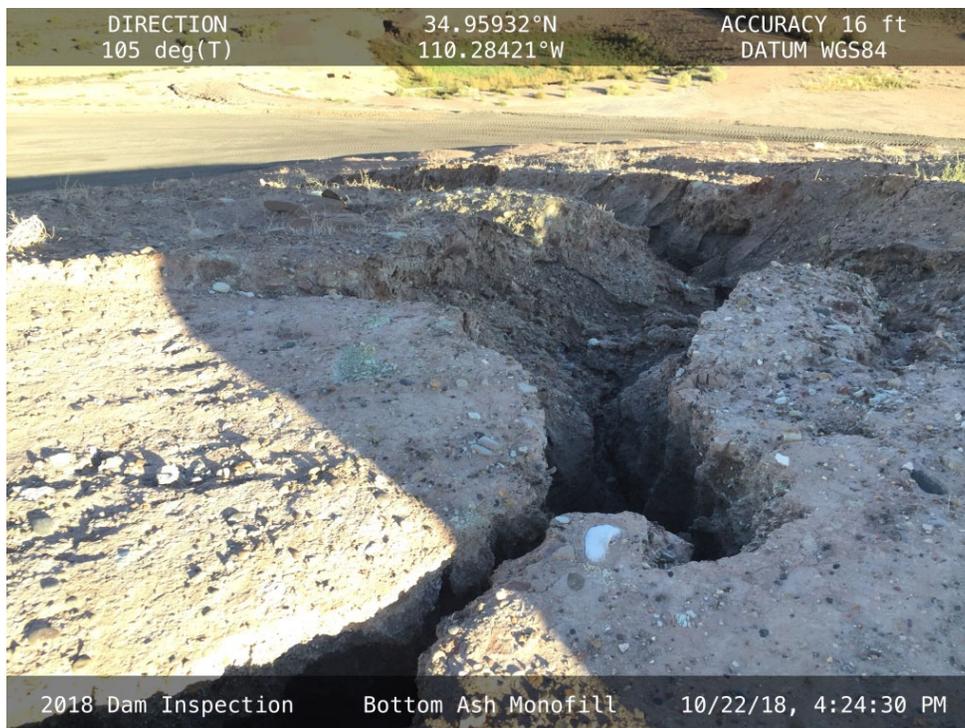
20181022 – IMG_0565
An erosion gully on the east side of the Bottom Ash Monofill requiring repair.

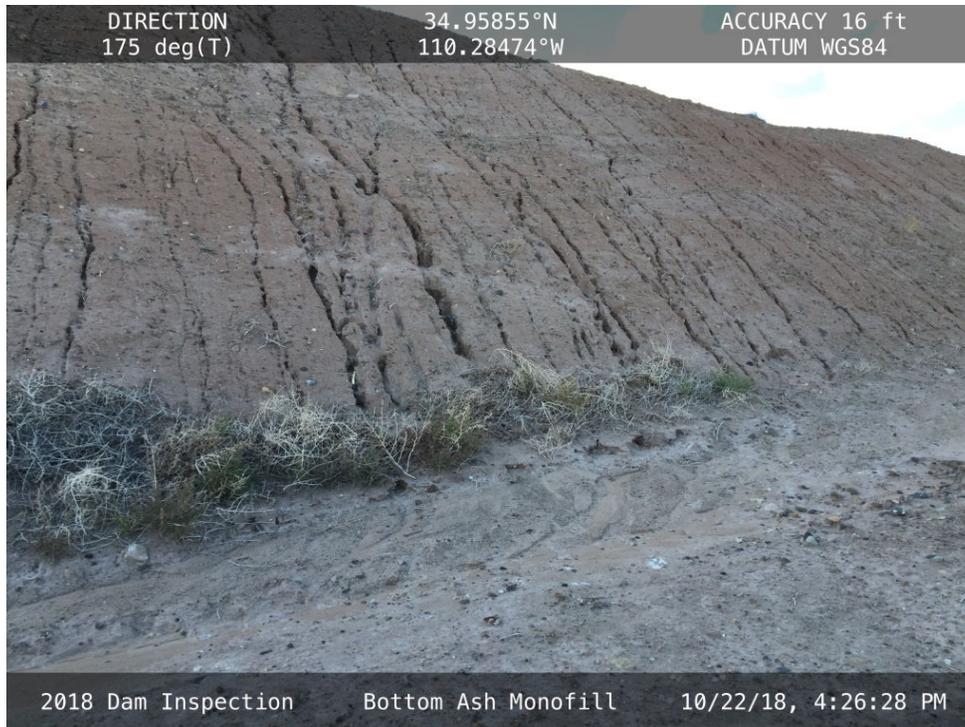
20181022 – IMG_0575
 Minor erosion rills on the south side of the Bottom Ash Monofill.

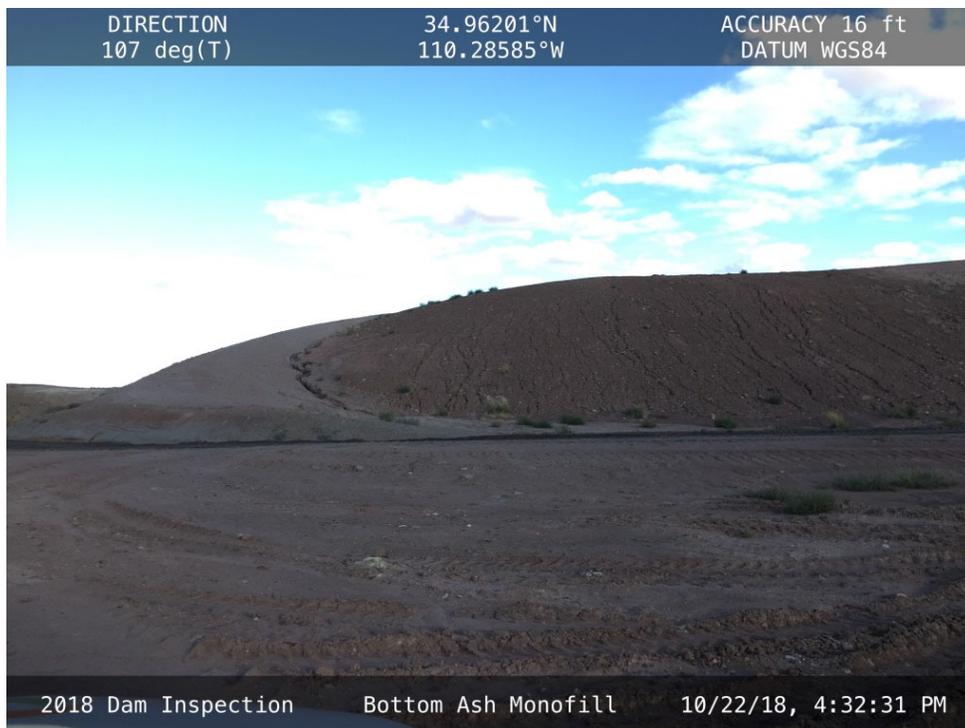
20181022 – IMG_0595

Erosion on the north side of the western slope, facing east.

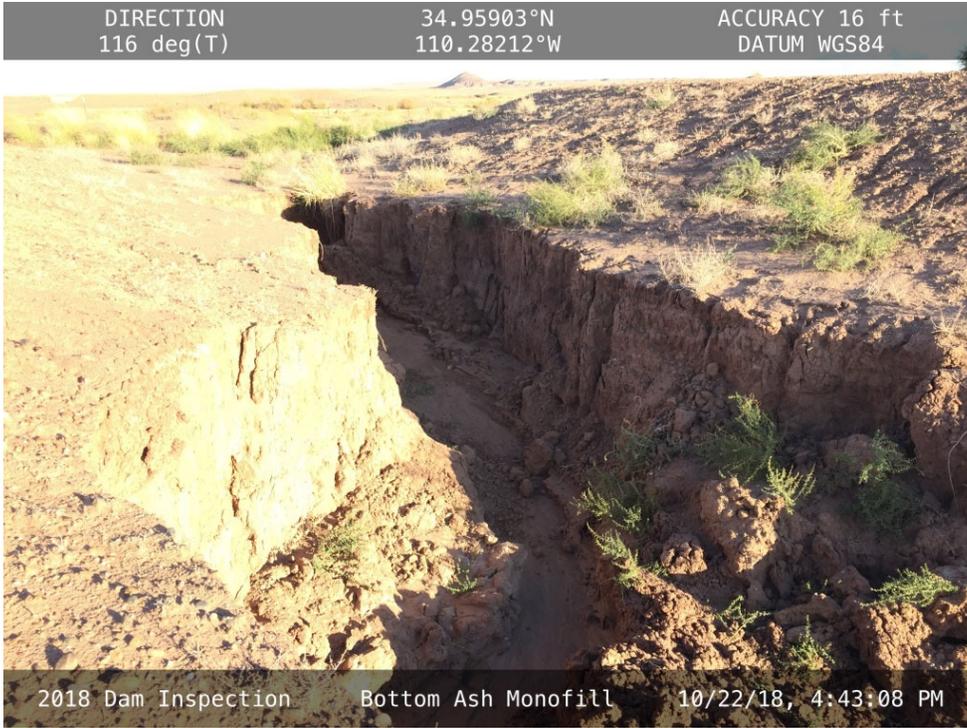
20181022 – IMG_0620

Headcutting on the east side of the Stormwater Detention Basin, facing east.

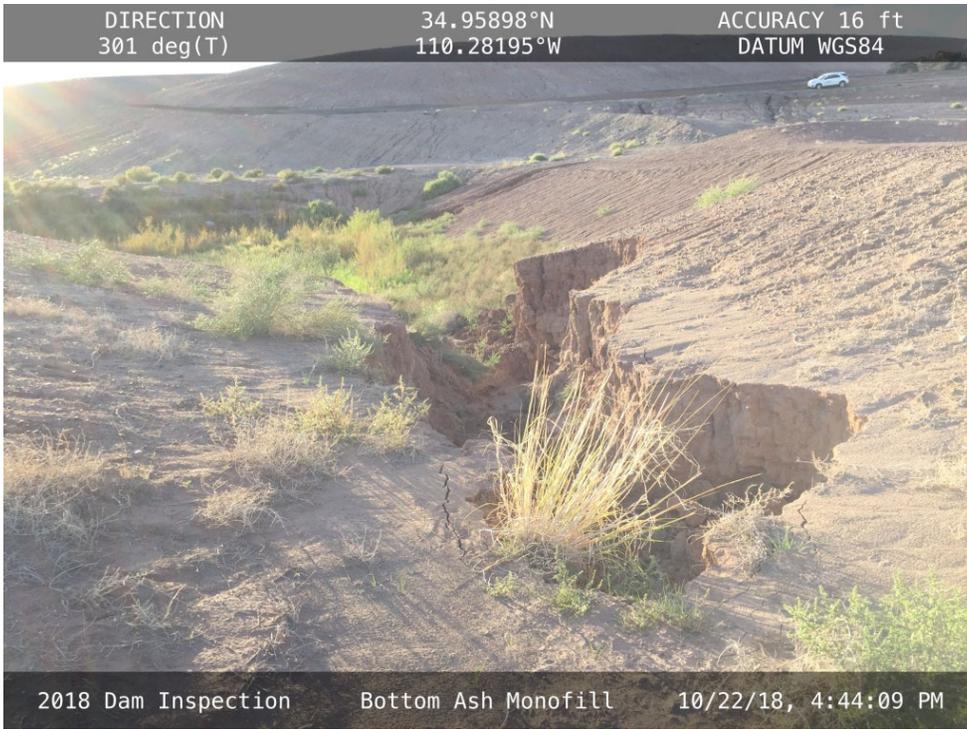
20181022 – IMG_0626

Headcutting on the east side of the Stormwater Detention Basin, facing west.
