CHOLLA POWER PLANT Fly Ash Dam, Bottom Ash Dam, and Bottom Ash Monofill

Annual CCR Impoundment and Landfill Inspection Report 2021

GENERATION ENGINEERING
Design Engineering
P.O. BOX 53999
PHOENIX, ARIZONA 85072

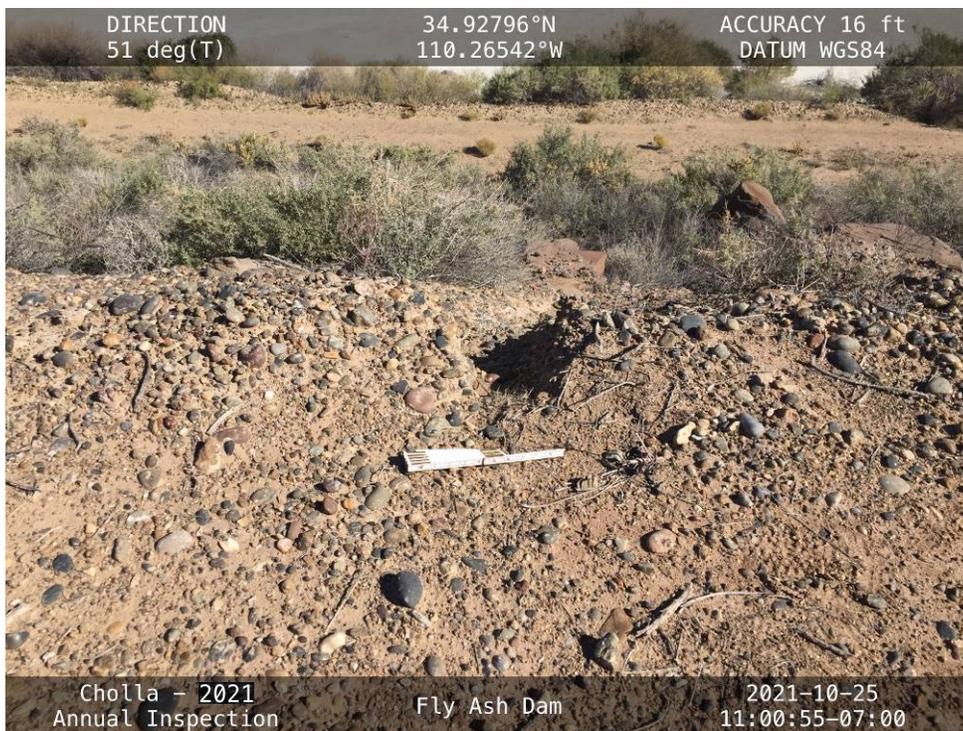
20211025-IMG_6786

- iii. Minor erosion was observed along the upstream slope near the piezometers screened in the dam core (Photos IMG_6786, IMG_6787, IMG_6793, and IMG_6794). The eroded portion was observed to be slightly wider during this inspection compared to the 2020 inspection (comparing 2020 Photo IMG_2344 with 2021 Photo IMG_6793) and the erosion locations appeared more numerous compared to the 2020 inspection. The affected portion of the upstream slope is part of the dam crest widening constructed in early 2000 to accommodate piezometer installation activities. The crest is approximately 40 feet wide in this area (compared to the design crest width of 24 feet). The erosion appears to be in the extended portion and is not affecting the original crest.

Minor erosion on the upstream side of the crest in an area where the crest is wider.

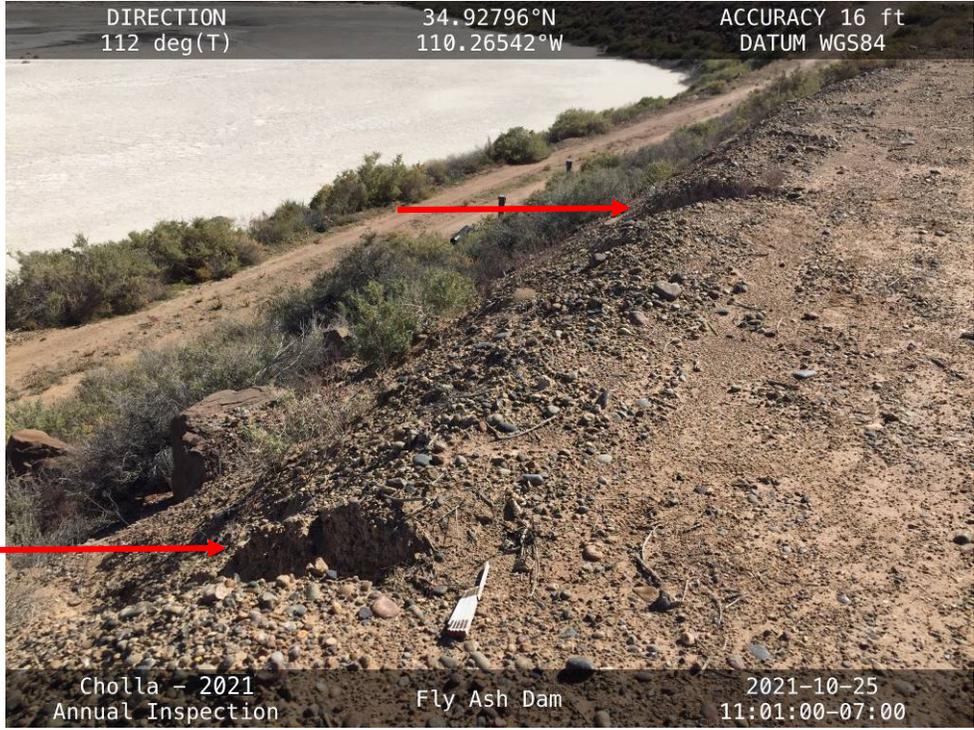
20211025-IMG_6787

The 6-foot-long crack observed in the wider portion of the upstream shoulder south of Piezometer F-124 during the 2020 inspection was not observed during this inspection (Photo IMG_6787). This crack was near areas of minor erosion on the upstream slope and is in part of the dam crest that was widened in early 2000 to accommodate piezometer installation activities. The area should be monitored during weekly inspections in the event the crack reappears.

Two instances of minor erosion on the upstream side of the crest. No crack observed on the crest.

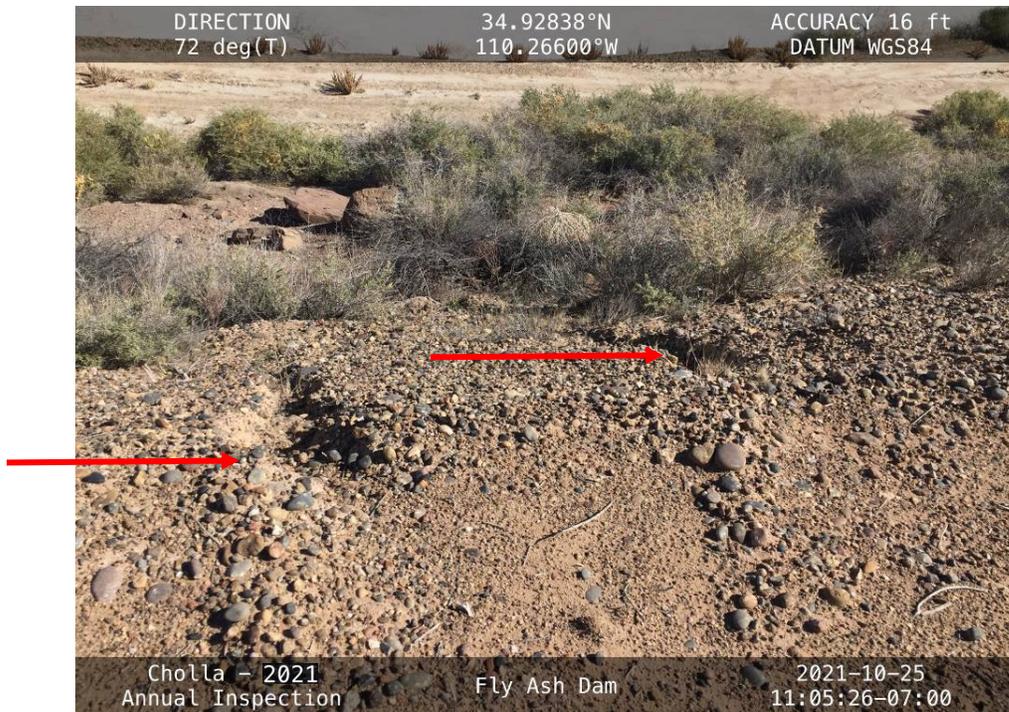
20211025 – IMG_6794

Minor erosion on the upstream side of the crest in an area where the crest is wider.

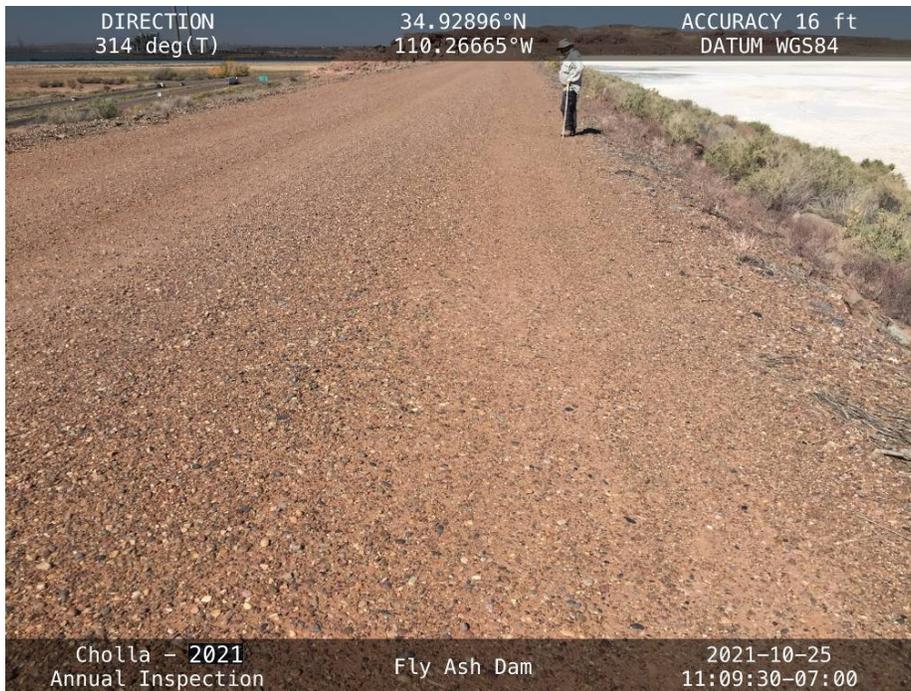
20211025-IMG_6796

- ii. The shallow (up to 2-inches deep), discontinuous, longitudinal crack observed spanning a length of 20 feet along the upstream half of the crest near settlement monument M-5B during the 2020 inspection was not observed during this inspection (Photo IMG_6796). The area should be monitored during weekly inspections in the event the crack reappears.

Location where part of a 20-foot-long discontinuous crack was observed during the 2020 inspection. Not observed during this inspection.

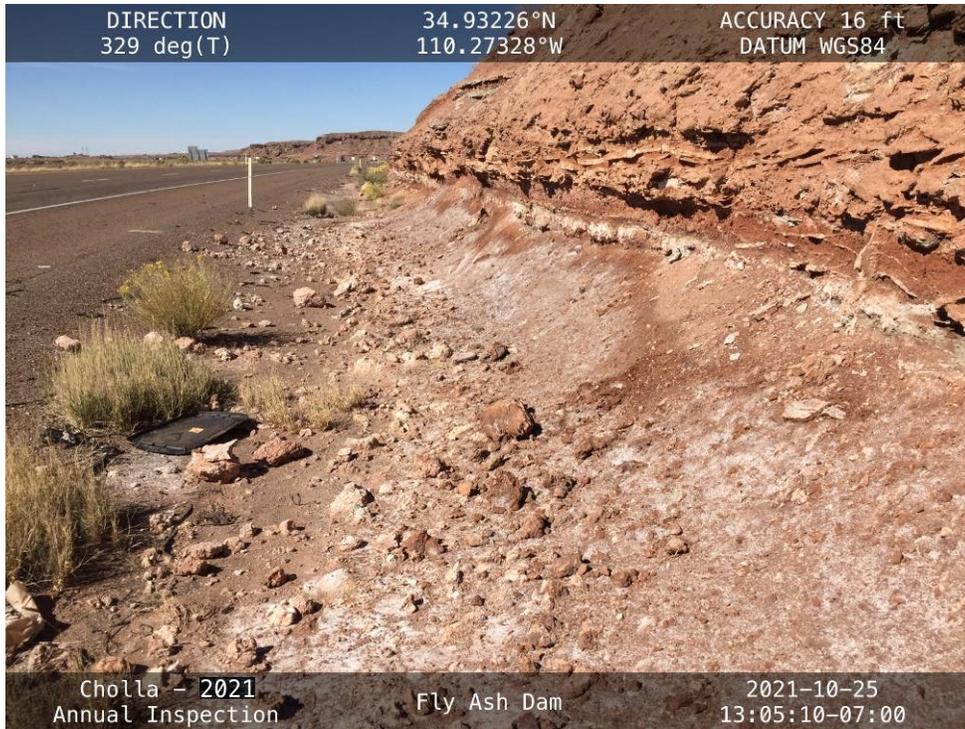
20211025-IMG_6927
The I-40 seep.

The I-40 seep was observed to be relatively drier during this inspection than it was during previous inspections (Photos IMG_6927 and IMG_6928).

20211025-IMG_6928
The I-40 seep.

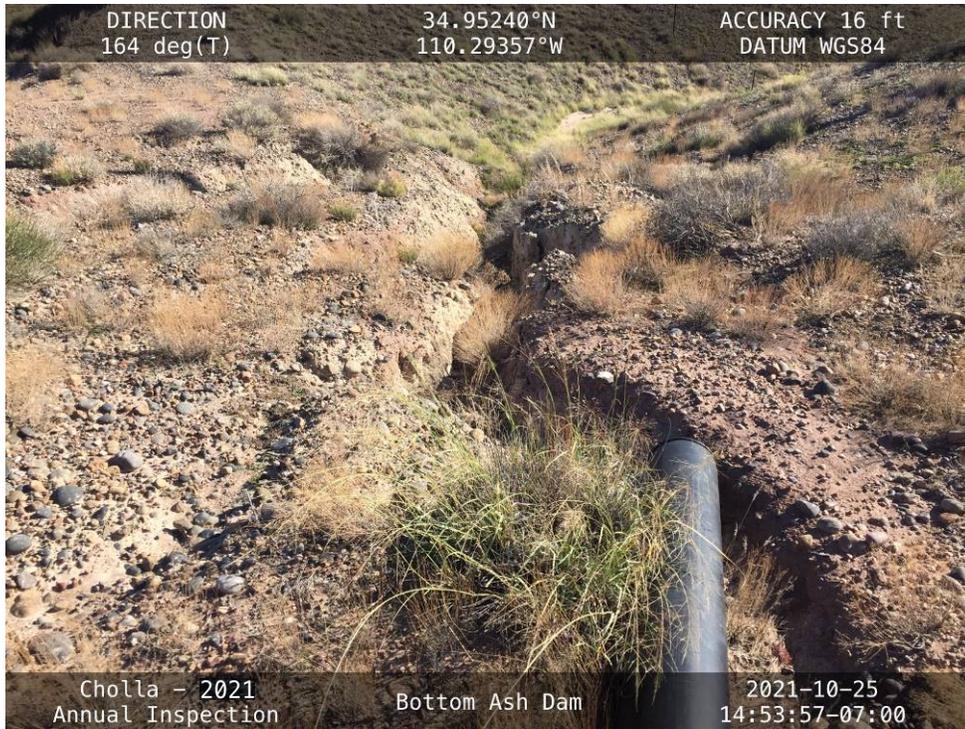
20211025-IMG_6972

6	<i>ABUTMENT CONTACTS</i>							
a	Erosion?	There is erosion in the downstream groin of the Right Abutment (Photo IMG_6972). The erosion is deeper than 1 foot in some sections and should be repaired by placing erosion protection in the eroded section.			X		X	
b	Differential movement?			X				
c	Cracks?			X				
d	Settlements, slides, depressions, bulges?			X				
e	Seepage?	Yes. Measured approximately 1.5 gpm at the West Abutment Weir during the inspection. Continue to monitor.			X	X		
f	Animal burrows?	None observed. Continue to monitor.		X		X		
7	<i>SEEPAGE/PIPING CONTROL DESIGN FEATURE(S)</i>							
a	Describe:	Several monitoring, seepage, and pump back collection systems are located downstream of the dam.						
b	Internal drains flowing?				X			
c	Seepage at or beyond toe?	See comment v.			X	X		
d	If so, does seepage contain fines?	The water in the Bottom Ash Toe Drain Sump was cloudy. See comment v.			X	X

Erosion in the downstream groin of the Right Abutment, facing south from the abutment contact.

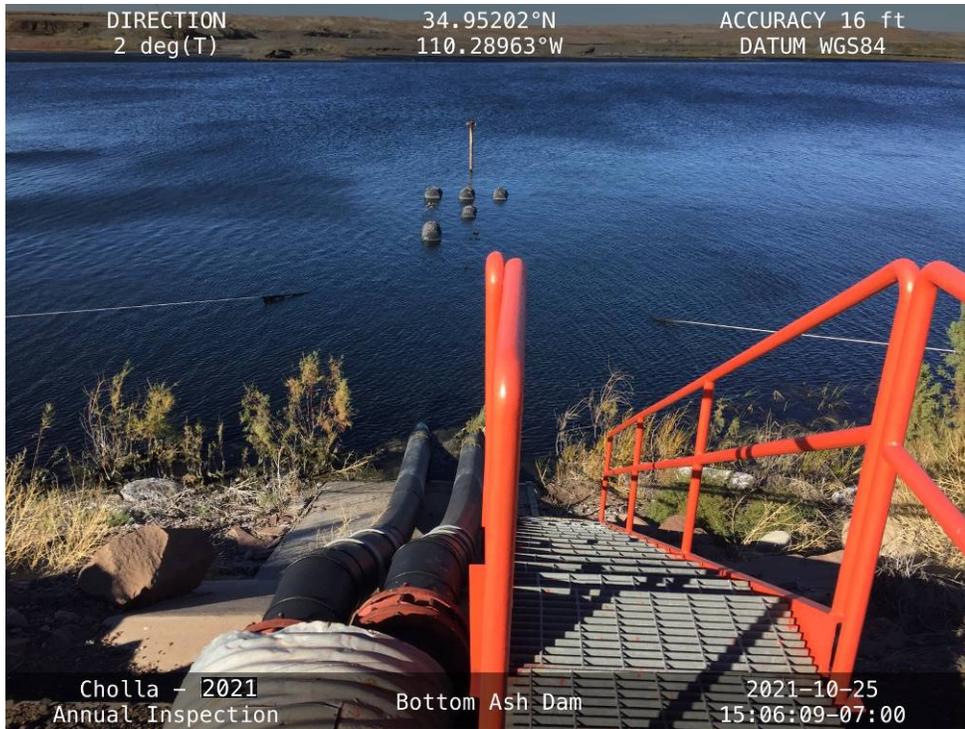
20211025-IMG_7008

The central siphon lines along the upstream slope of the South Embankment.

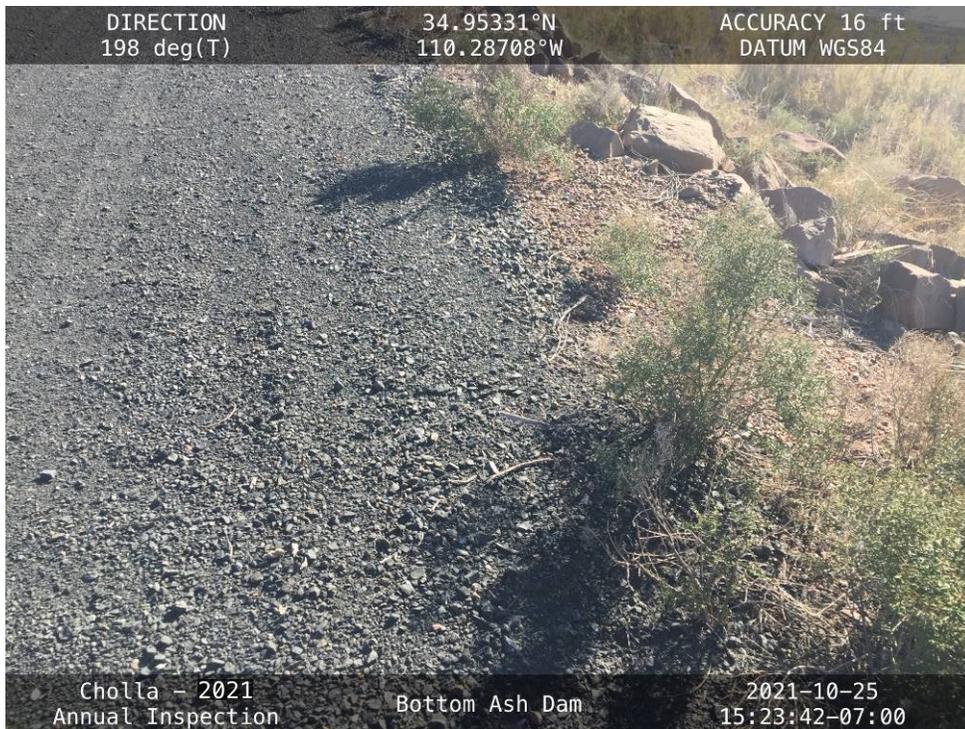
20211025-IMG_7045

Some erosion holes observed on the crest or shoulder during the 2020 inspection were not observed during this inspection (Photos IMG_7045, IMG_7054, and IMG_7083). Several new erosion holes were observed along the crest and shoulders (Photos IMG_7053, IMG_7064, IMG_7073, IMG_7082, IMG_7093, IMG_7095, IMG_7097, IMG_7098, and IMG_7099).

Repaired area where two shallow holes were observed during the 2020 inspection (IMG_2694).

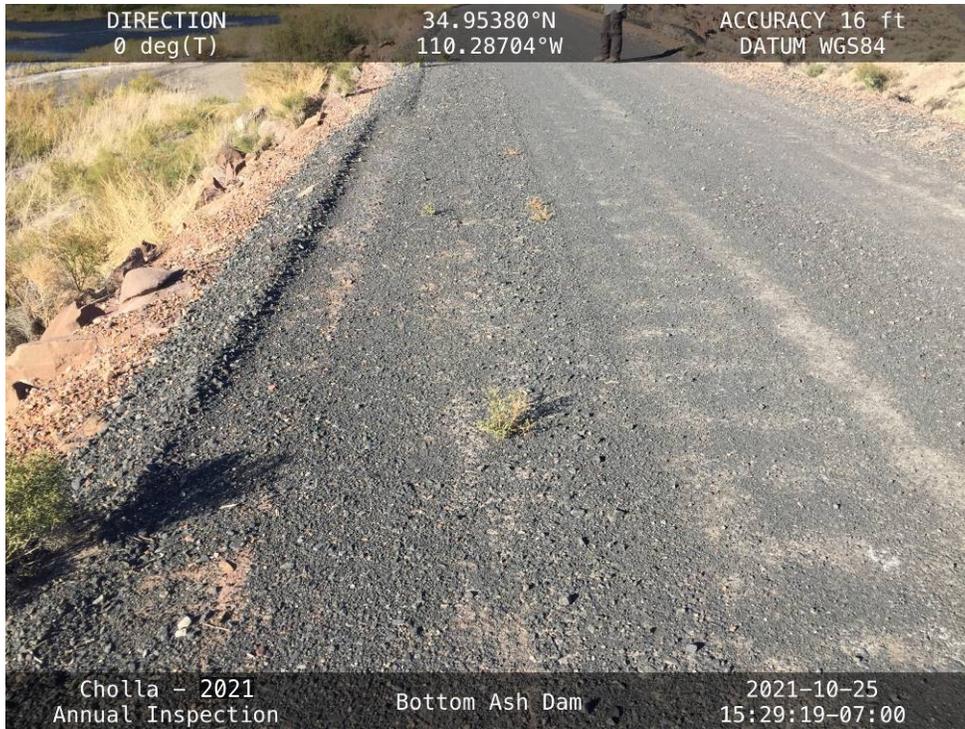
20211025-IMG_7054

Repaired area where a shallow hole was observed during the 2020 inspection (IMG_2695).

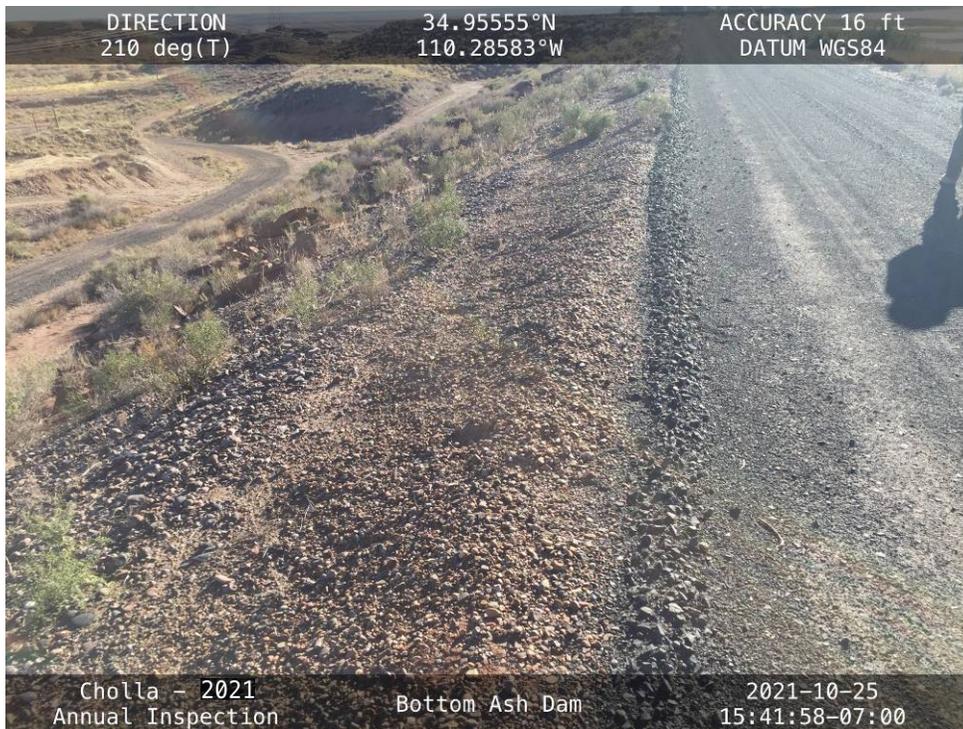
20211025-IMG_7083

Repaired area where a series of holes was observed during the 2020 inspection (IMG_2700).

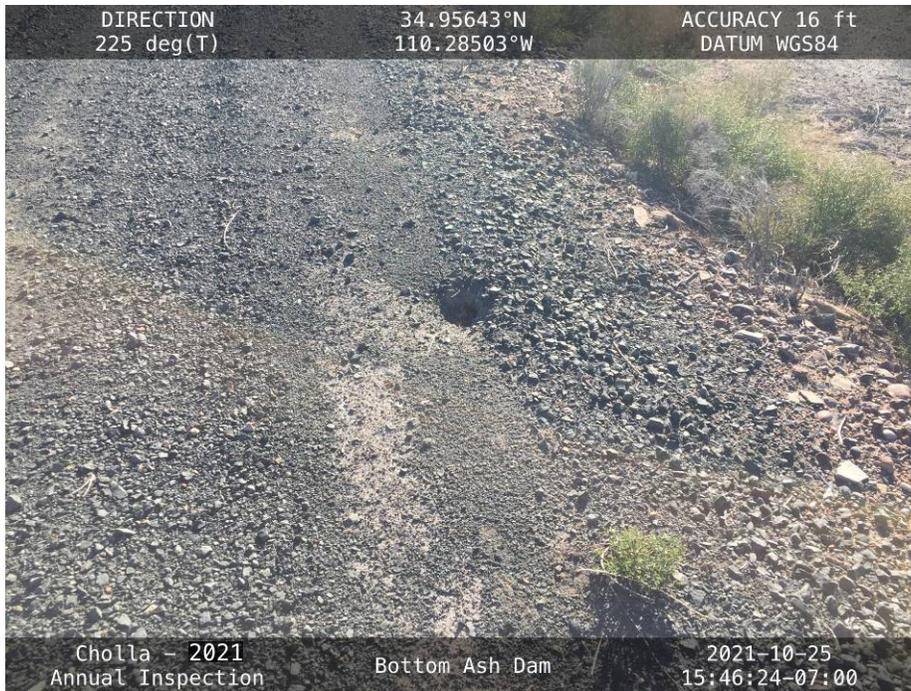
20211025-IMG_7093

A hole on the upstream shoulder of the East Embankment, also observed during the 2020 inspection (IMG_2704).

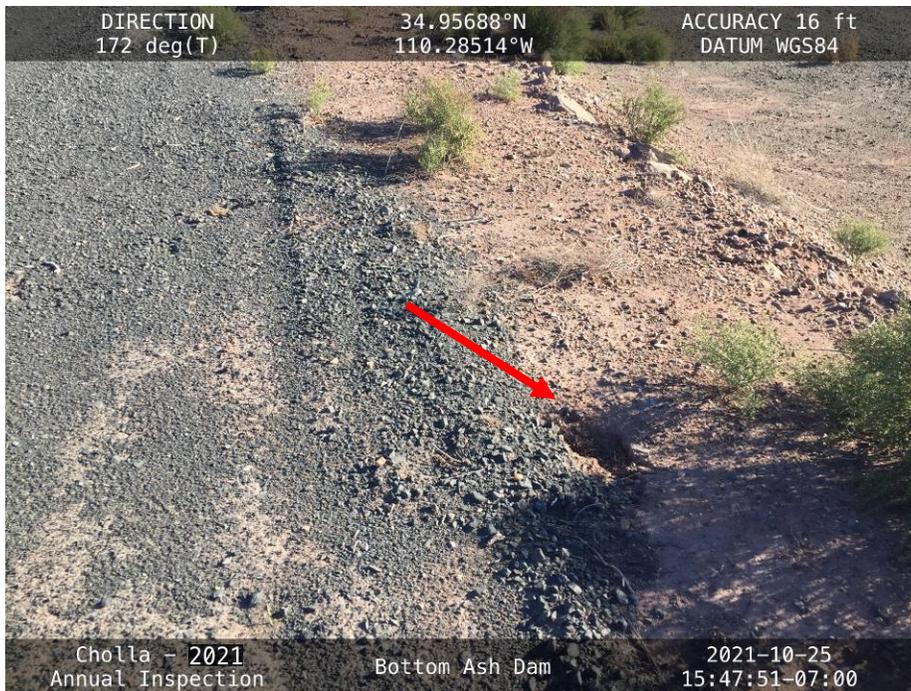
20211025-IMG_7095

New holes observed on the upstream shoulder of the East Embankment, where a hole observed during the 2020 inspection had been repaired (IMG_2718).

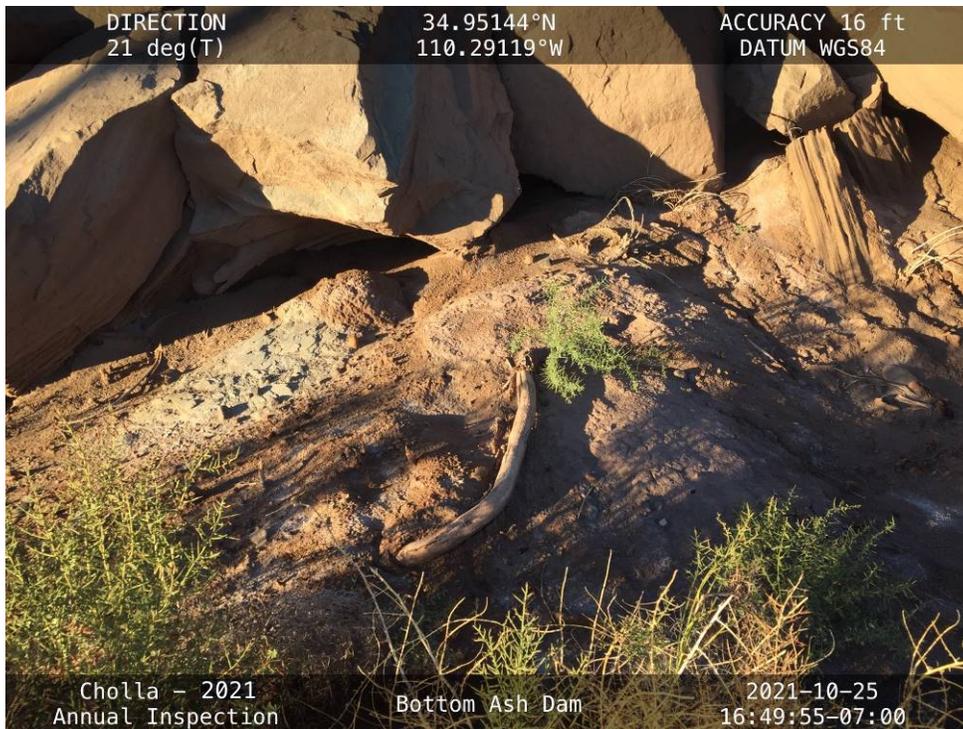
20211025-IMG_7191

Riprap deterioration along the South Embankment toe.

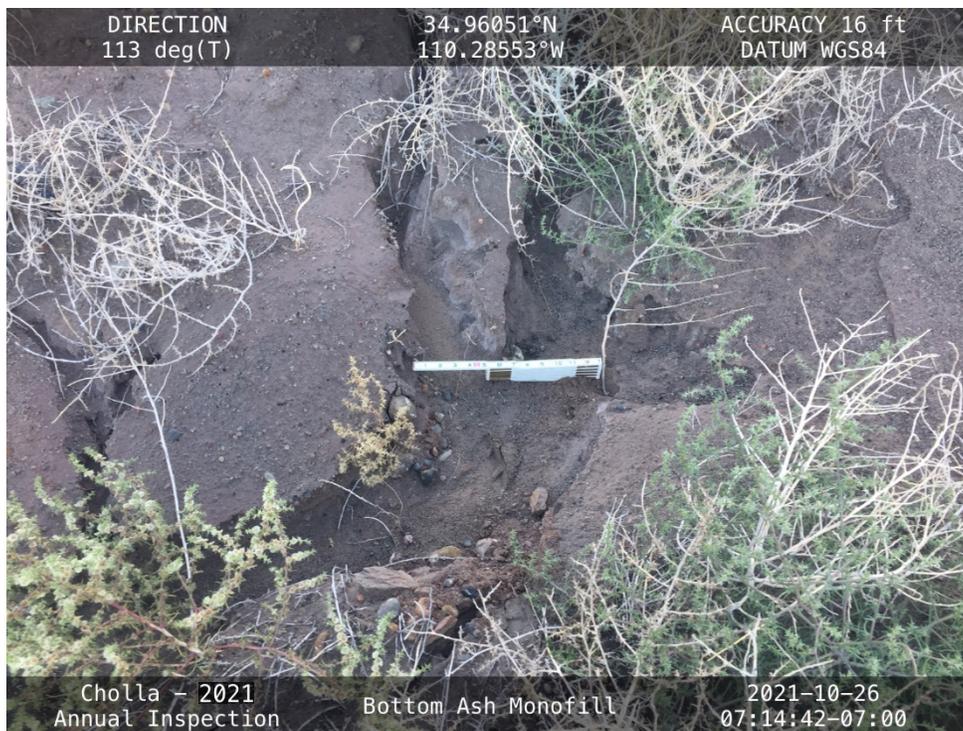
20211026-IMG_7223

Erosion gullies along the western toe of the BAM. The ruler is 13 inches long.

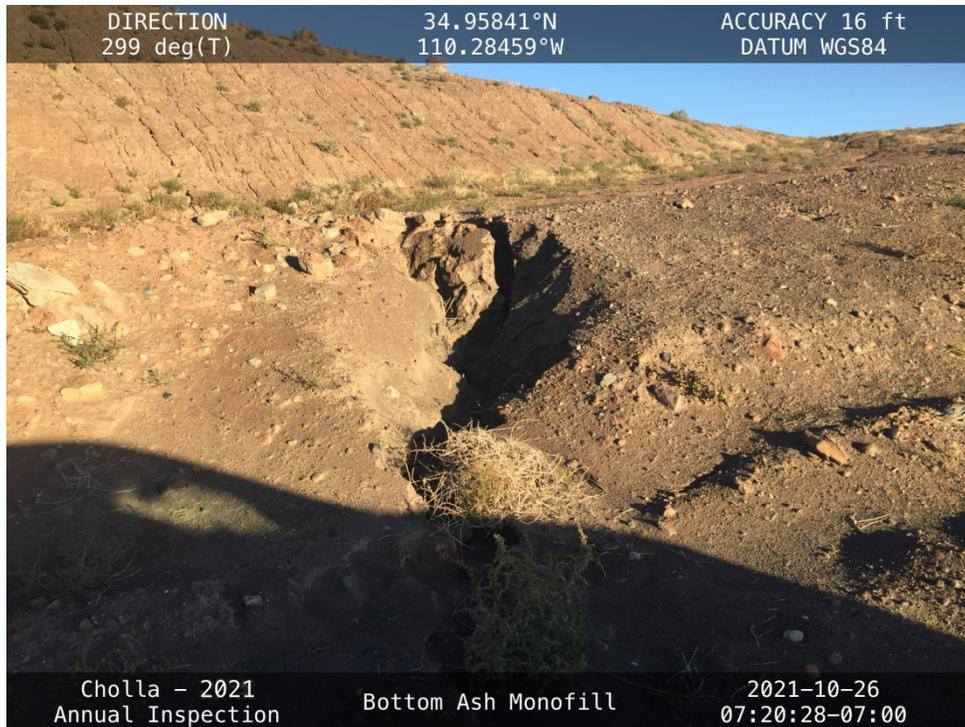
20211026-IMG_7229

An erosion gully on the southeast side of the BAM requiring repair.

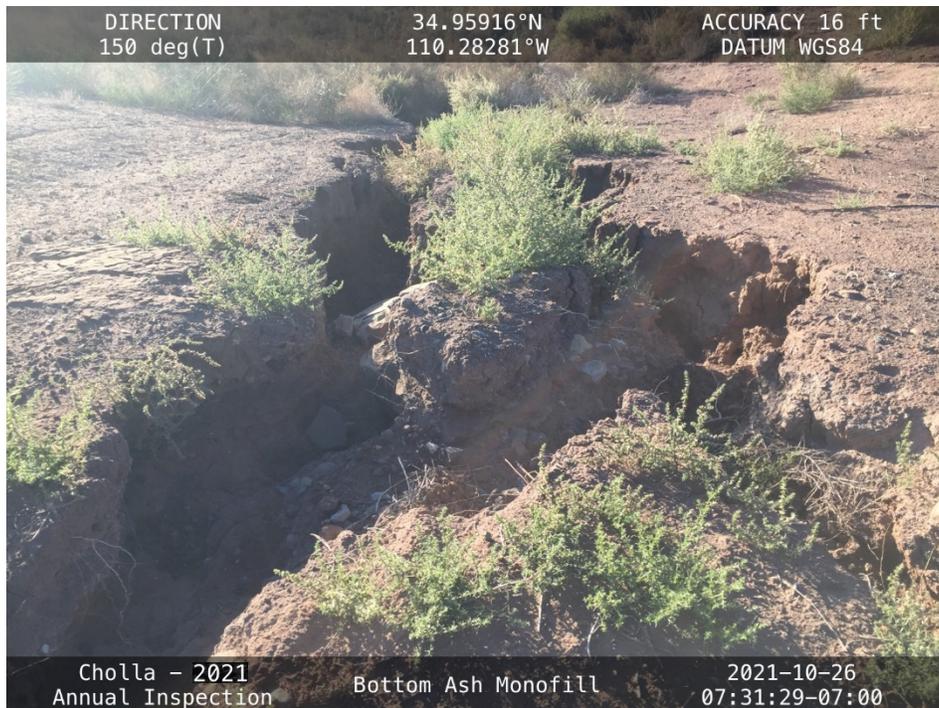
20211026-IMG_7251

New headcutting up to 4.5 feet deep where erosion was previously repaired in the northwest corner of the Stormwater Detention Basin.

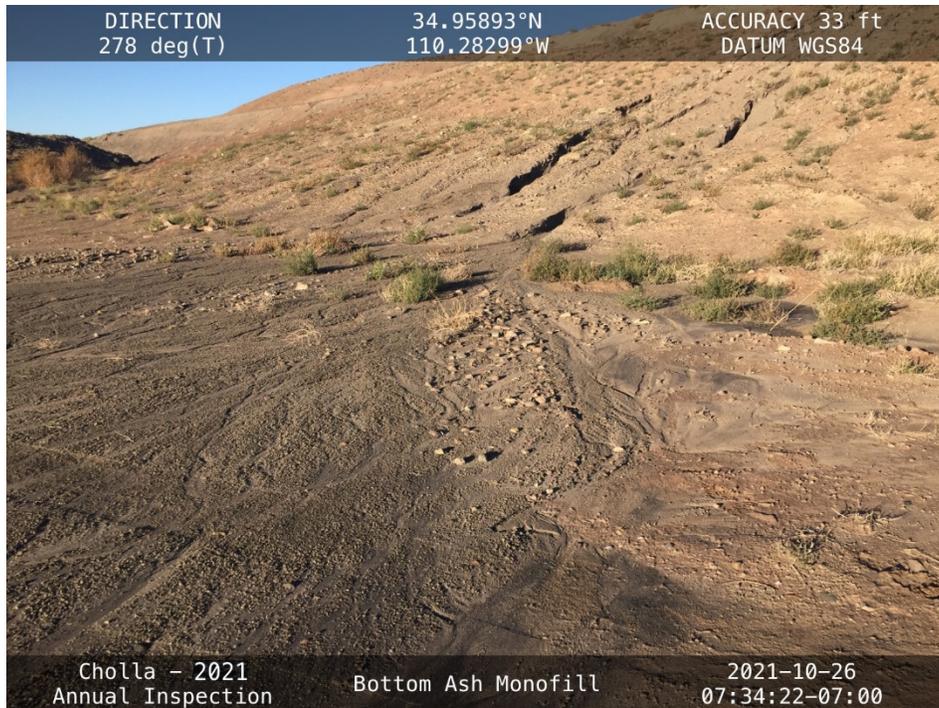
20211026-IMG_7255

Eroded material deposited at the toe of the BAM, west of the Stormwater Detention Basin (approximately 2 feet of erosion in the slope).

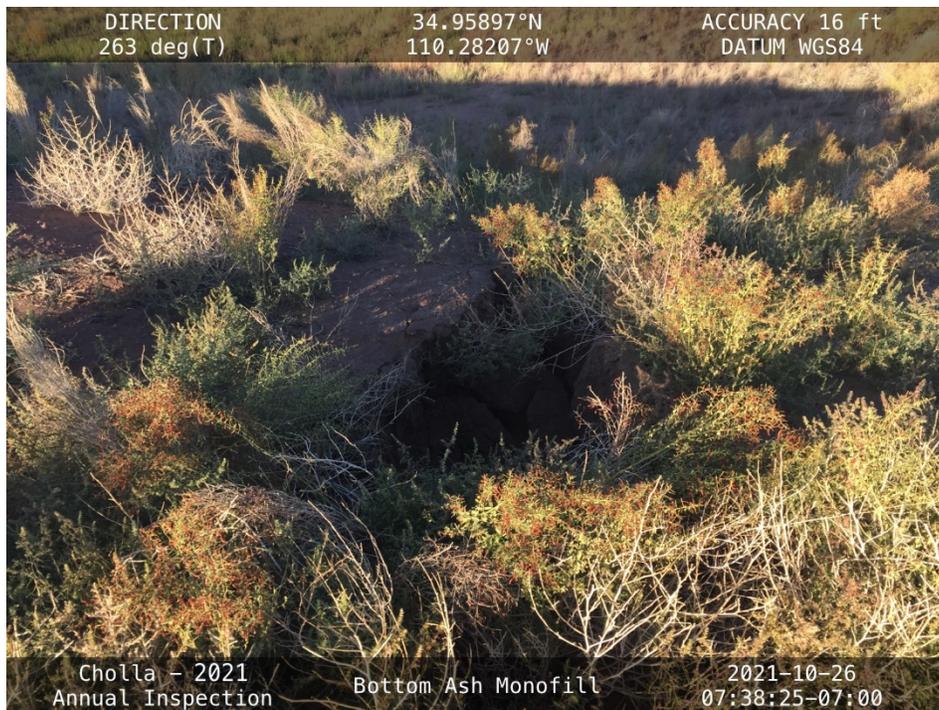
20211026-IMG_7263

Headcutting on the east side of the Stormwater Detention Basin in an area previously repaired.

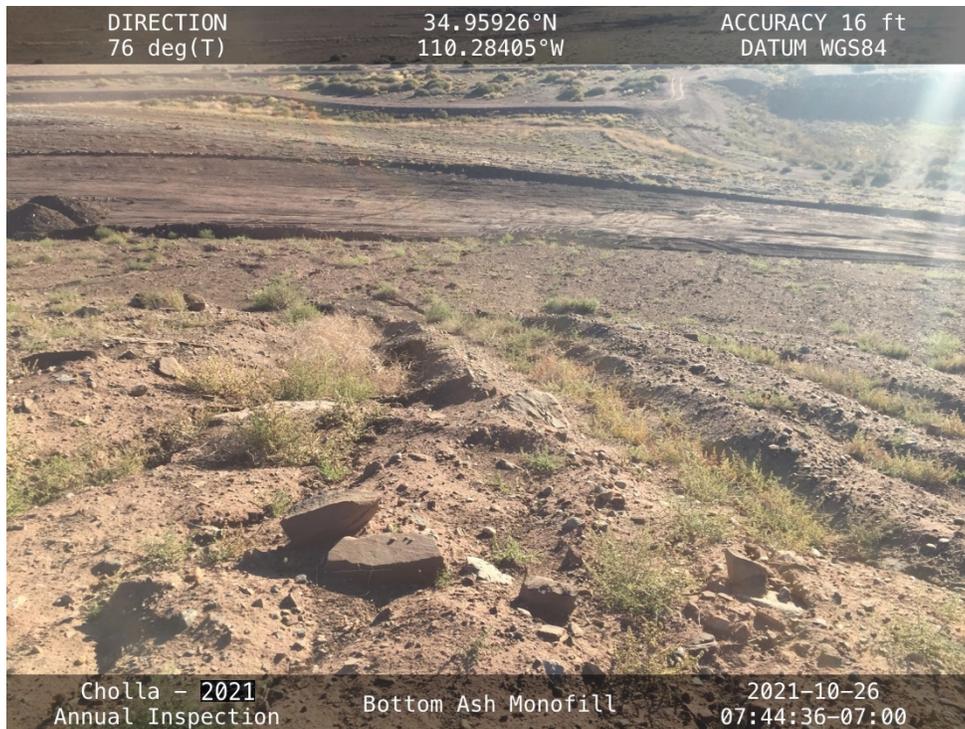
20211026-IMG_7272

An area of a repaired erosion gully from 2018 on the east side of the Bottom Ash Monofill.
