CHOLLA POWER PLANT Fly Ash Dam, Bottom Ash Dam, and Bottom Ash Monofill

Annual CCR Impoundment and Landfill Inspection Report

2023

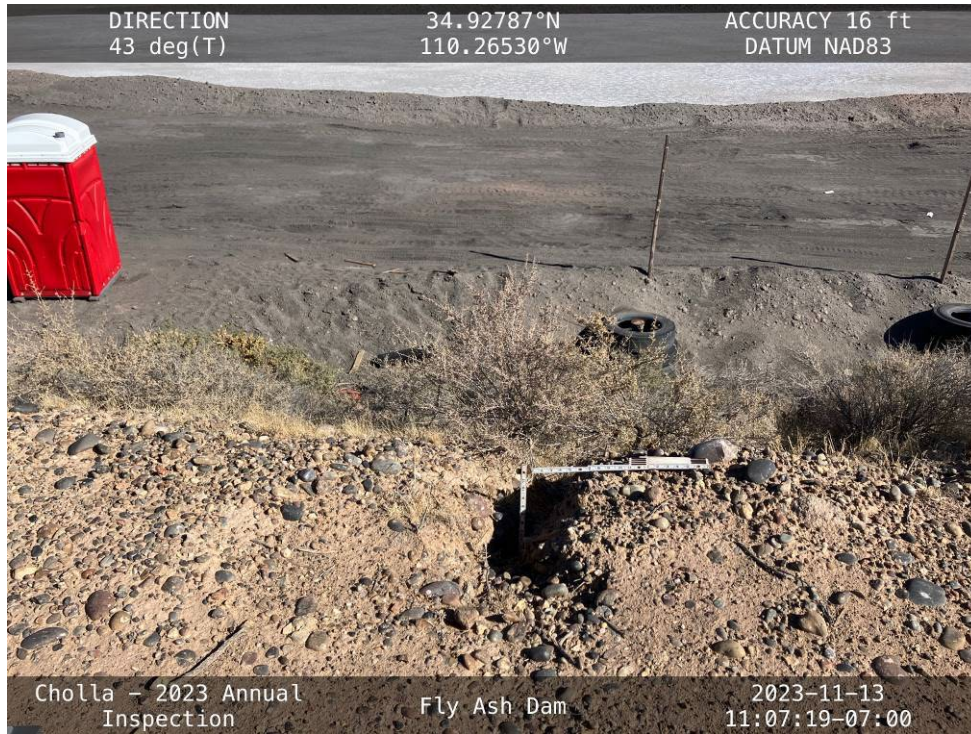
20231113 – IMG_1414

- iii. Erosion was observed along the upstream slope near the piezometers screened in the dam core (Photos IMG_1414, IMG_1417, IMG_1424, and IMG_1429). The eroded portions were observed to be deeper during this inspection compared to the 2022 inspection. The affected portion of the upstream slope is part of the dam crest widening constructed in early 2000 to accommodate piezometer installation activities. The crest is approximately 40 feet wide in this area (compared to the design crest width of 24 feet). The erosion appears to be within the extended portion and is not affecting the original crest.

One foot of erosion on the upstream side of the crest in an area where the crest is wider.

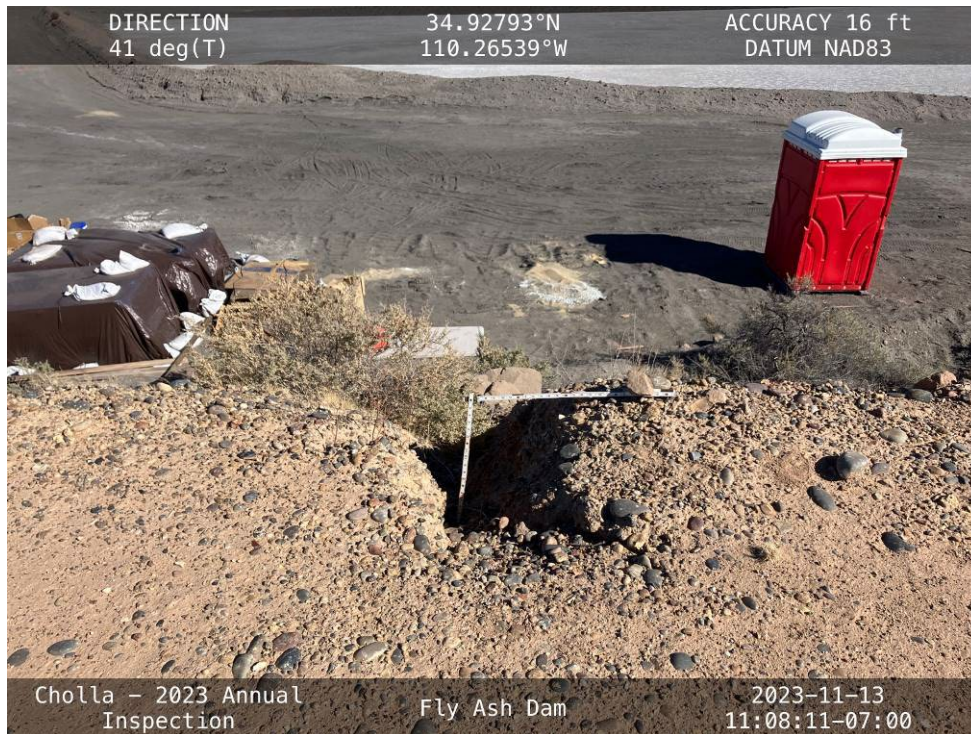
20231113 – IMG_1417

1.5 feet of erosion on the upstream side of the crest in an area where the crest is wider.

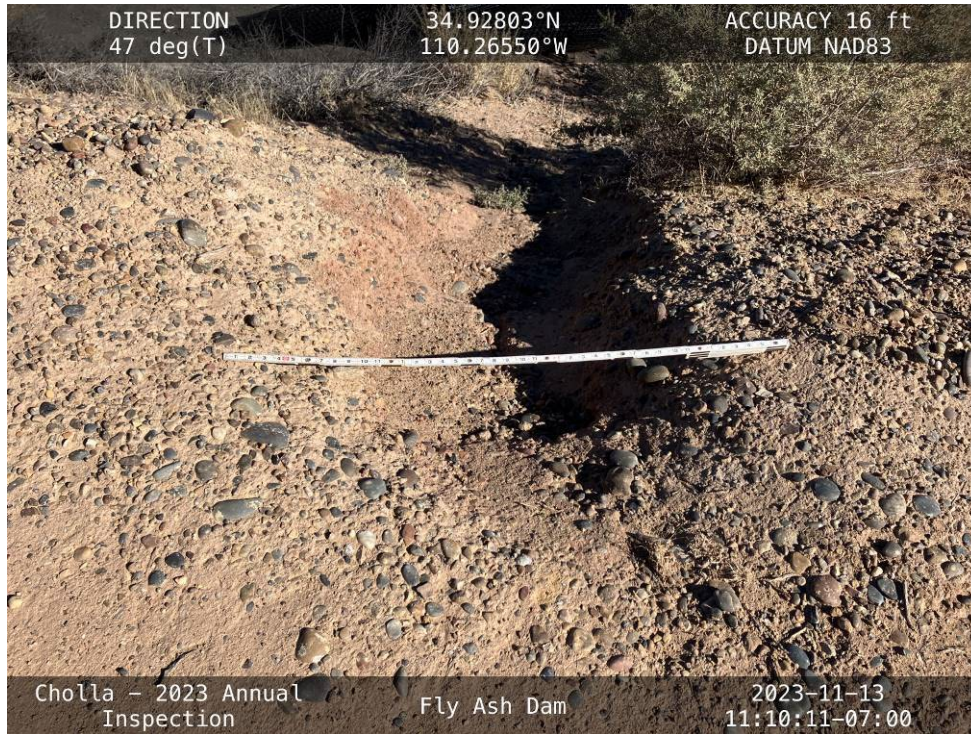
20231113 – IMG_1424

Erosion (2 feet wide, 1 foot deep) on the upstream side of the crest where the crest is wider.

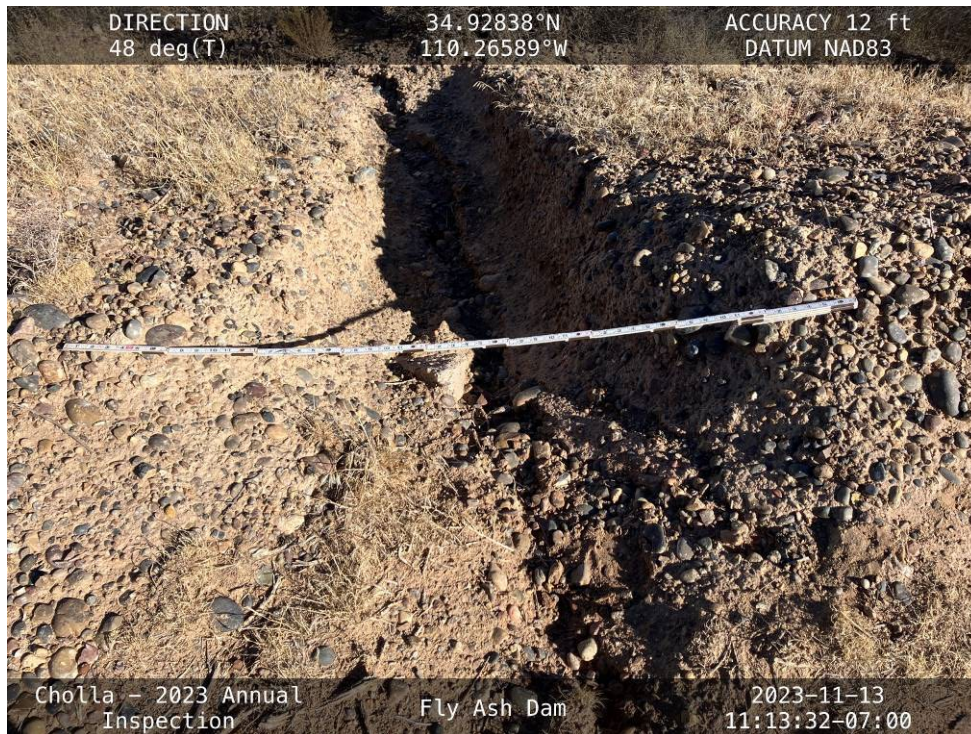
20231113 – IMG_1429

Erosion (3.25 feet wide, 1.5 feet deep) on the upstream side of the crest where the crest is wider.

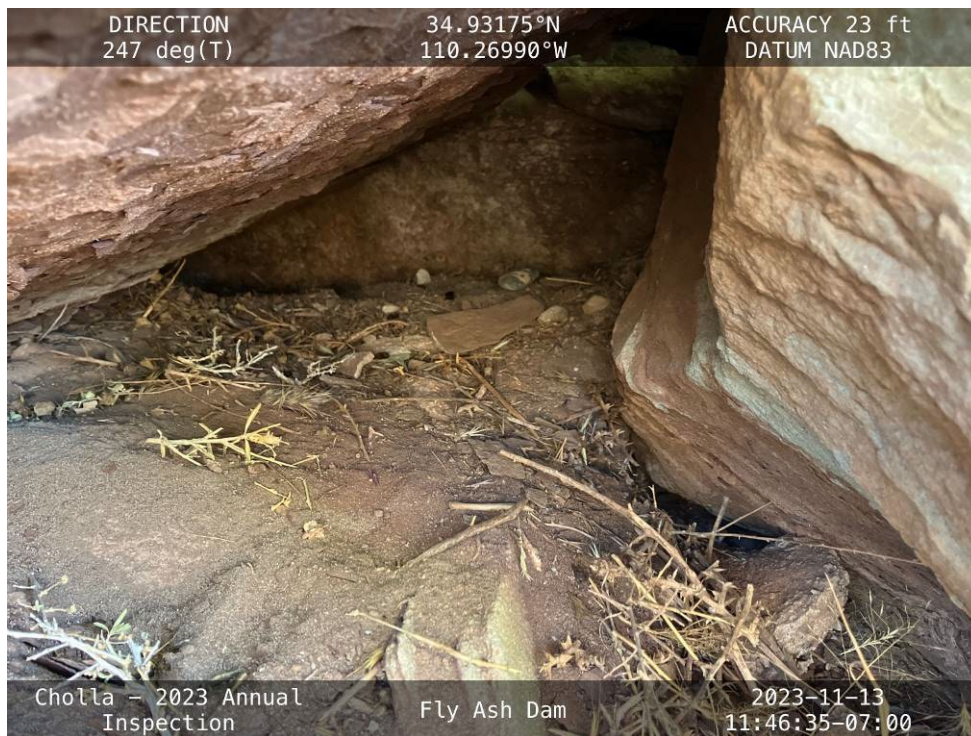
20231113 – IMG_1469
A 1.5-foot-deep gap formed as soil erodes away between riprap on the upstream slope.

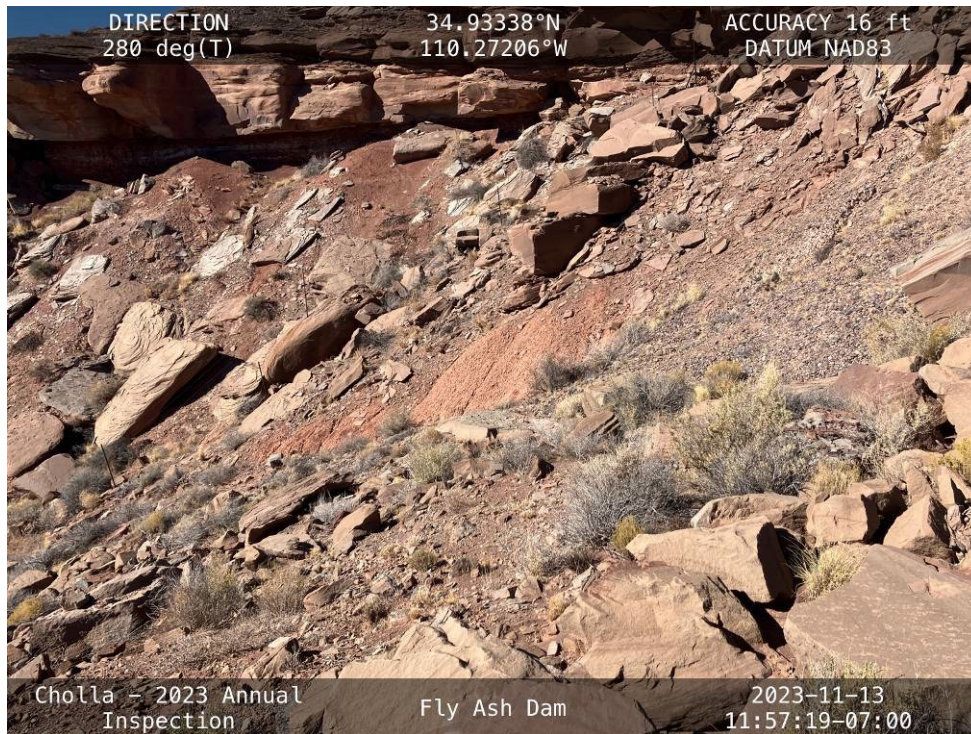
20231113 – IMG_1482

6	ABUTMENT CONTACTS							
a	Erosion?	Approximately 1 foot of erosion observed at the Right Abutment groin. The erosion is in the colluvium at the Right Abutment and along the access road at the toe (Photos IMG_1482, IMG_1485, IMG_1587, and IMG_1589). Continue to monitor.		X		X		
b	Differential movement?			X				
c	Cracks?			X				
d	Settlements, slides, depressions, bulges?			X				
e	Seepage?	Historic seepage has been observed downstream of the Right Abutment during previous inspections. See comment v.		X		X		
f	Animal burrows?	None observed. Continue to monitor.		X		X		
7	SEEPAGE/PIPING CONTROL DESIGN FEATURE(S)							
a	Describe:	1) The Geronimo and Hunt seepage collection and pump back systems are located downstream of the dam near I-40 for fluid interception. See comment v. 2) Discharge from the crest side of the reservoir creates a beach to prevent water from being stored against the upstream face.

Erosion on the downstream side of the Right Abutment contact.

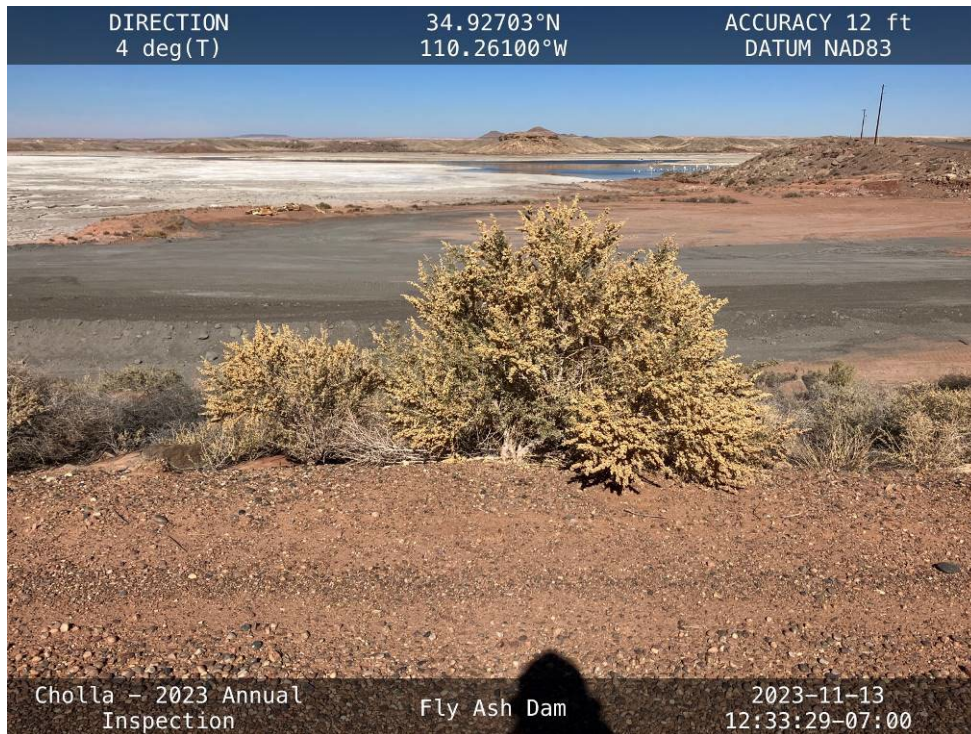
20231113 – IMG_1505

Vegetation to be removed from the South Embankment upstream shoulder.

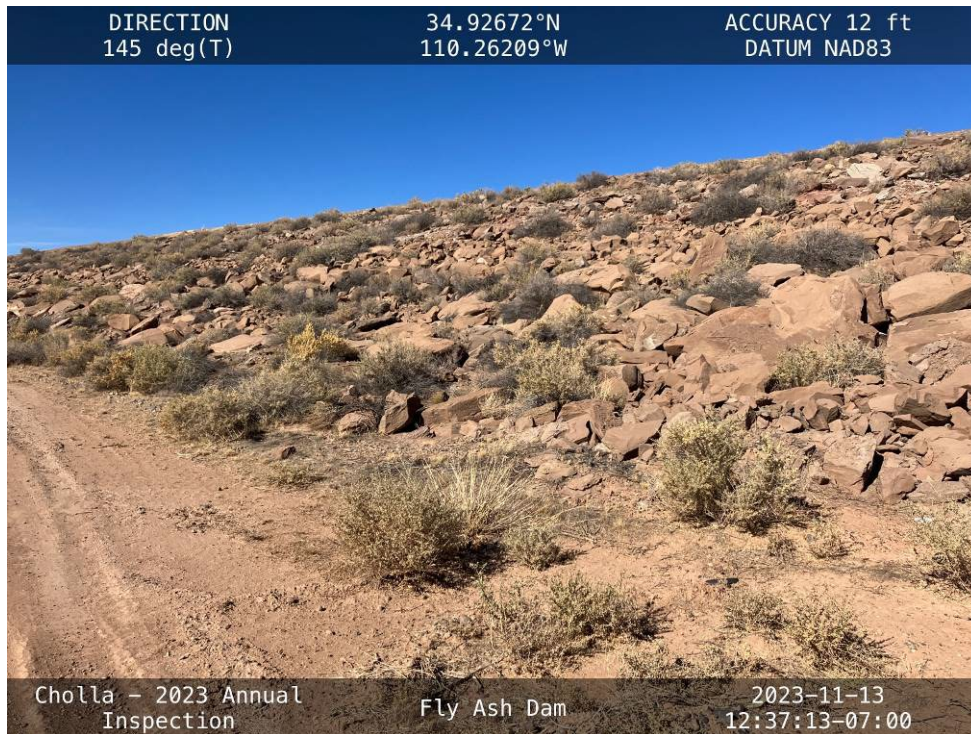
Fly Ash Dam		SID: 09.28	N/A	No	Yes	Mon	Rep	Inv
5	DOWNSTREAM SLOPE							
a	Erosion?	Erosion observed during the previous inspection was not as prominent during this inspection (Photos IMG_1510, IMG_1517, and IMG_1519); however, evidence of soil loss due to erosion at the downstream toe was present near the Geronimo Seep (IMG_1543). Continue to monitor and repair when the eroded depth exceeds 1 foot.			X	X		
b	Inadequate ground cover?			X				
c	Adverse vegetation?	None observed. Continue to monitor.		X		X		
d	Longitudinal/Transverse cracking?			X				
e	Inadequate riprap?			X				
f	Stone deterioration?	Minor deterioration observed. See comment iv.			X	X		
g	Settlements, slides, depressions, bulges?			X				
h	Soft spots or boggy areas?	There is evidence of historic seepage beyond the downstream toe. Continue to monitor.			X	X		
i	Movement at or beyond toe?			X				
j	Animal burrows?	None observed. Continue to monitor.		X		X

20231113 – IMG_1510
The downstream slope and toe of the South Embankment.

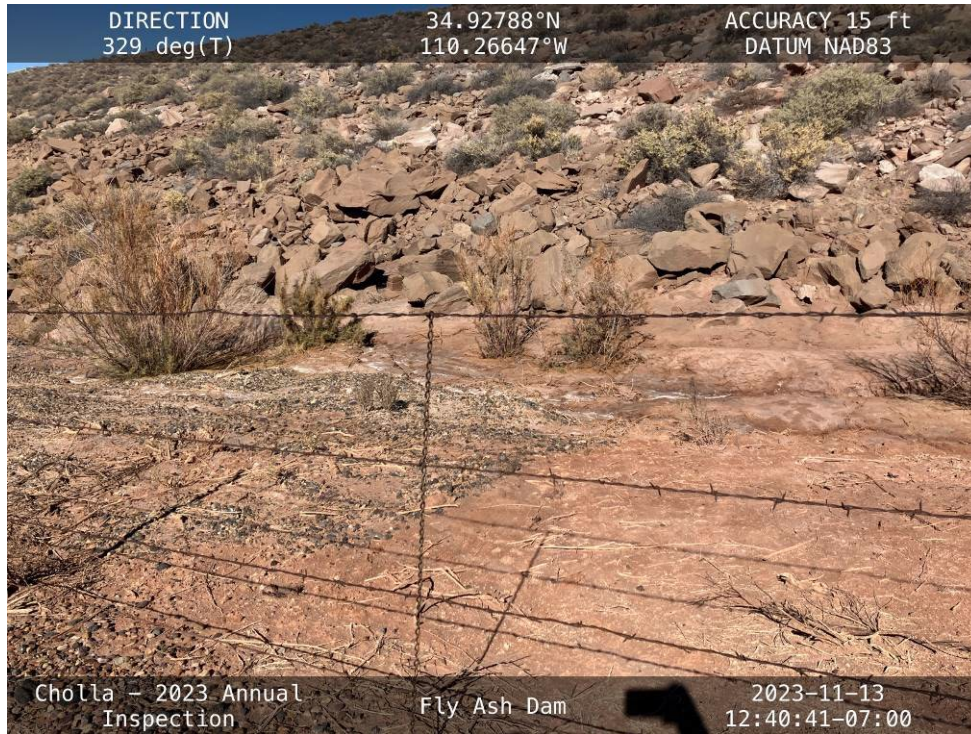
20231113 – IMG_1517
 The downstream slope and toe of the West Embankment.

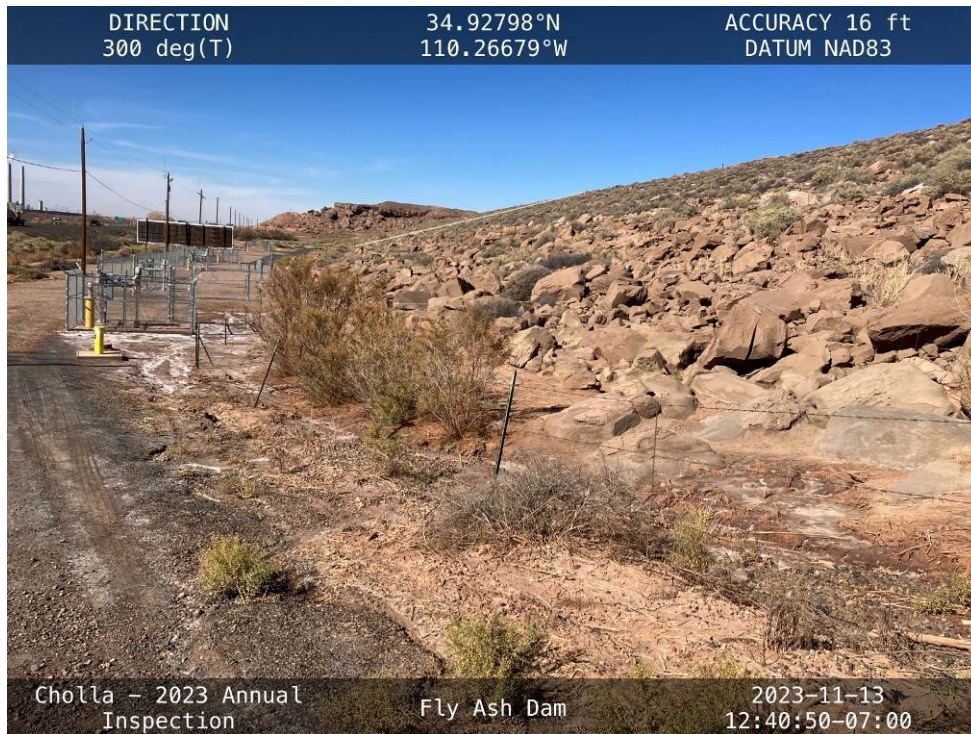
APS completed upgrading the seepage collection system at the Geronimo Seep in January 2023. APS installed four new extraction wells (EW-01 through EW-04) to replace the four Geronimo Seep well pumps (A through D) (Photos IMG_1519, IMG_1525, and IMG_1559). Water in the sumps associated with the new extraction wells appeared to be clear during the inspection. APS monitors the turbidity at Discharge Line “C” (i.e., the

20231113 – IMG_1519
 The Geronimo Seep area, with new monitoring wells, fencing, and extraction wells.

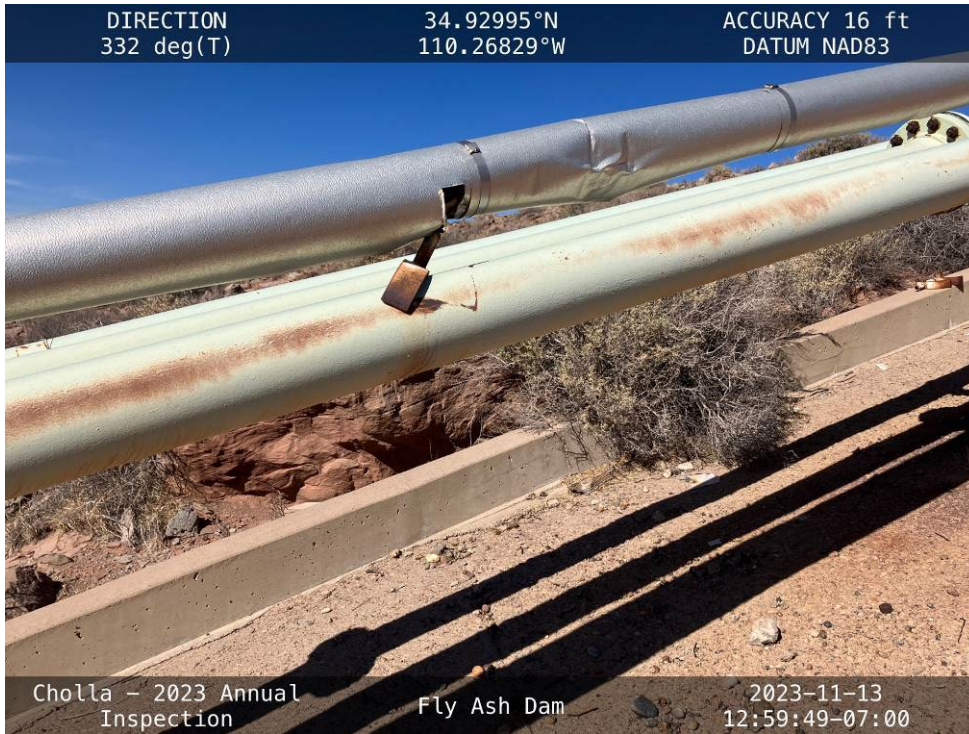
20231113 – IMG_1573
A broken pipe support along the inlet lines.

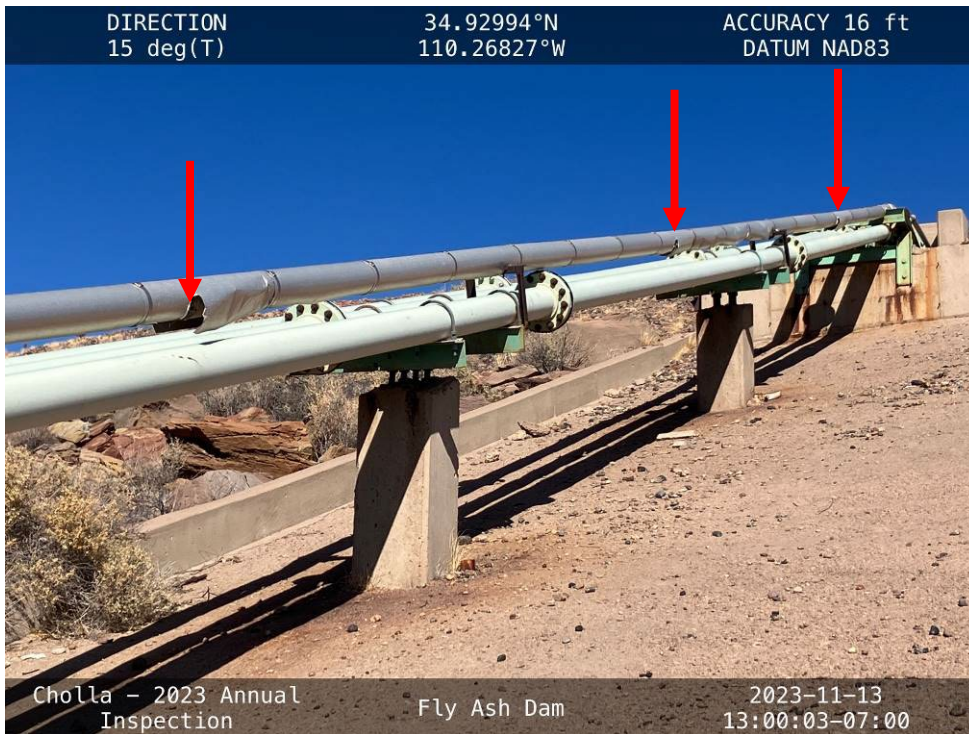
20231113 – IMG_1575
Missing pipe supports along the inlet lines.

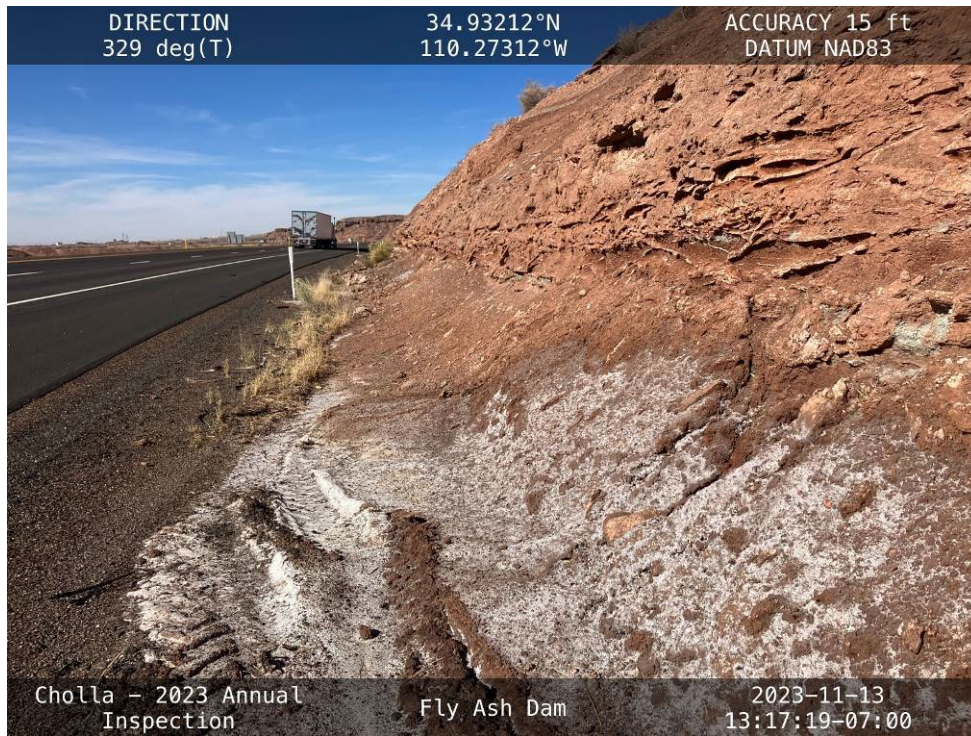
The I-40 seep was observed to be slightly damp during this inspection (Photos IMG_1593, IMG_1594). There had been no precipitation at the site since October 24, 2023. The elevation of the seep is still below the current reservoir level. Continue to monitor the I-40 seep. Any perceived increases in seepage volume, affected area, or perpetual standing water should be reviewed by the APS geotechnical engineer.

20231113 – IMG_1594
 The I-40 seep.

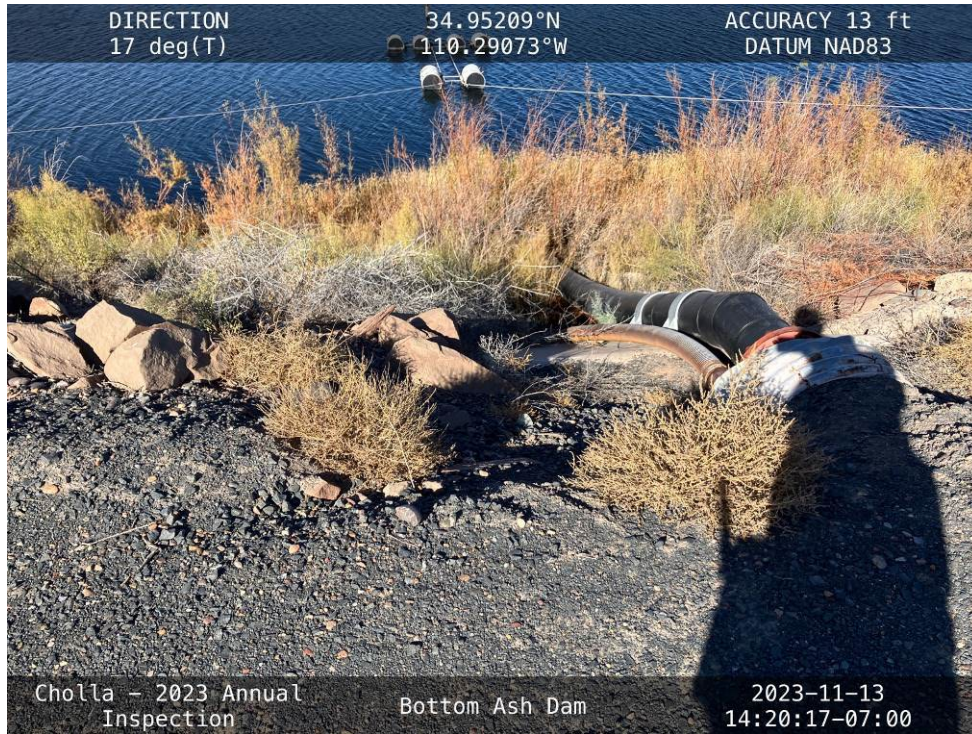
20231113 – IMG_1617

- iii. Continue to monitor the erosion around the siphon line encasements (Photos IMG_1617), soil wasting along the downstream slope of the East Embankment, and erosion gullies (Photos IMG_1723 and IMG_1728) that were also observed during previous inspections. Repair erosion if the eroded depth exceeds 1 foot. Investigate the source of sediment collecting in the diversion ditch between the East Embankment access road and the East Embankment.

Minor erosion around the concrete encasement for the western siphon line, facing upstream.

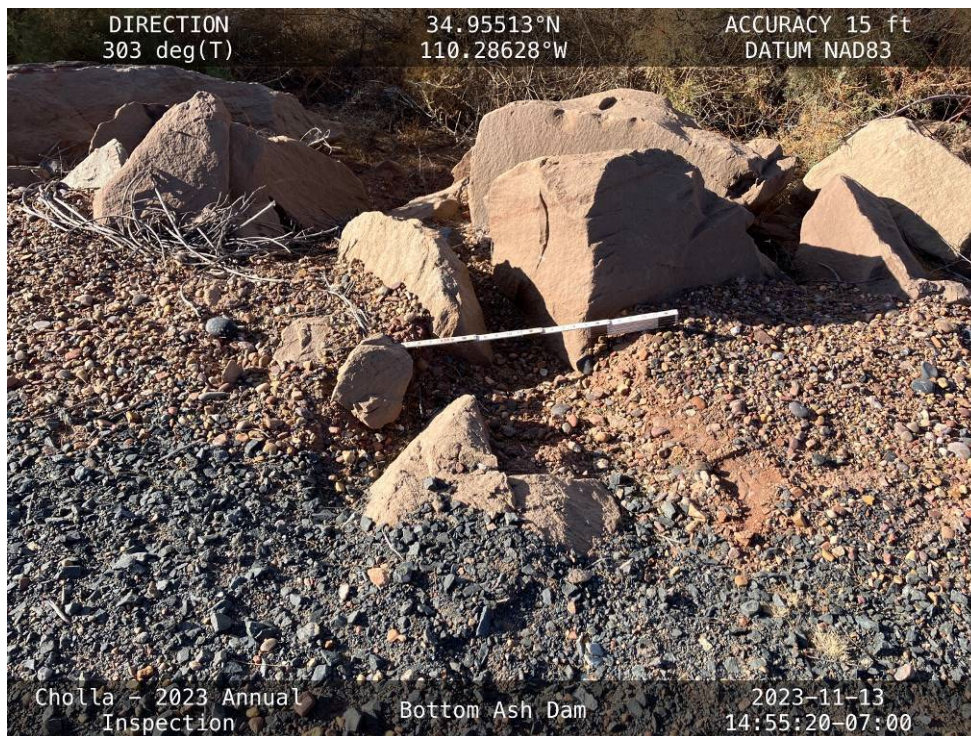
20231113 – IMG_1696

Several erosion rills were observed along the shoulders of the crest (Photos IMG_1611, IMG_1612, IMG_1616, IMG_1696, and IMG_1702). The rills were generally less than 19 inches across and all were no deeper than 12 inches. The erosion should be monitored and repaired once the depth exceeds 12 inches or if it adversely affects the crest or slopes.

Erosion rills on the upstream slope of the East Embankment. The ruler is 22 inches long.

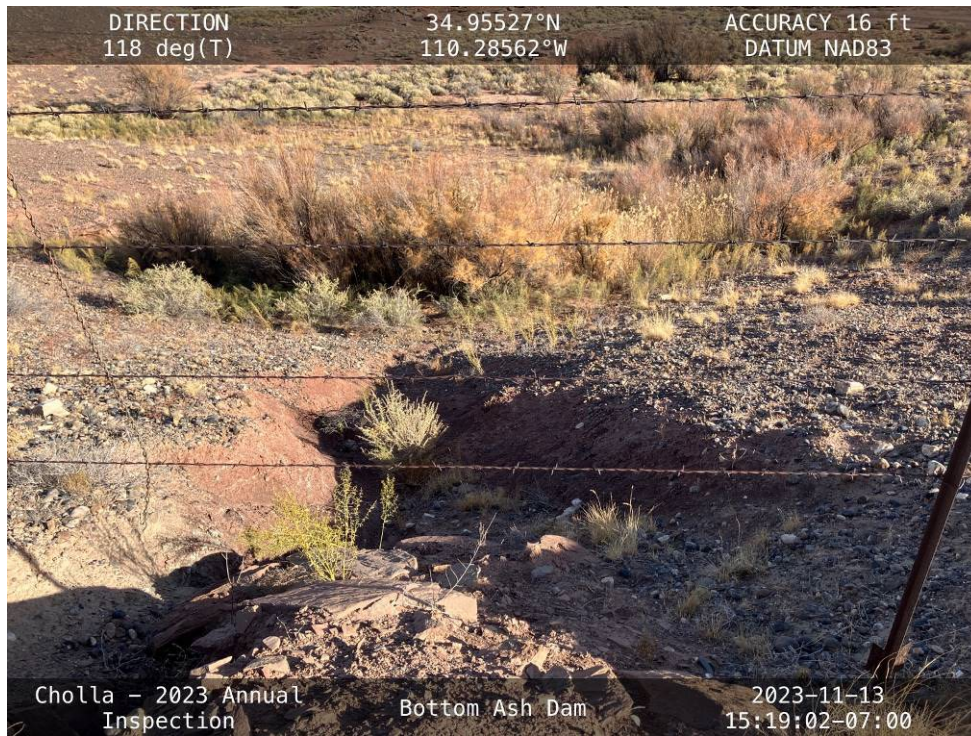
20231113 – IMG_1728

Bottom Ash Dam		SID: 09.27	N/A	No	Yes	Mon	Rep	Inv
5	DOWNSTREAM SLOPE							
a	Erosion?	Erosion gullies at the toe of the East Embankment downstream slope do not appear to be affecting the embankment (Photos IMG_1723 and IMG_1728).			X	X		
b	Inadequate ground cover?			X				
c	Adverse vegetation?	The dense vegetation near the West Abutment Weir is growing back (Photos IMG_1803 and IMG_1805). Woody vegetation remains absent; however, some woody vegetation is beginning to grow along the toe and should be removed. Continue to monitor the area and remove vegetation in accordance with the NMOSE (2011) guidance.			X	X	X	
d	Longitudinal/Transverse cracking?			X				
e	Inadequate riprap?			X				
f	Stone deterioration?	Riprap deterioration does not appear to have accelerated since the previous inspection.			X	X		
g	Settlements, slides, depressions, bulges?			X				
h	Soft spots or boggy areas?	See comment iv.			X	X

An erosion gully on the downstream slope along the northern half of the East Embankment.

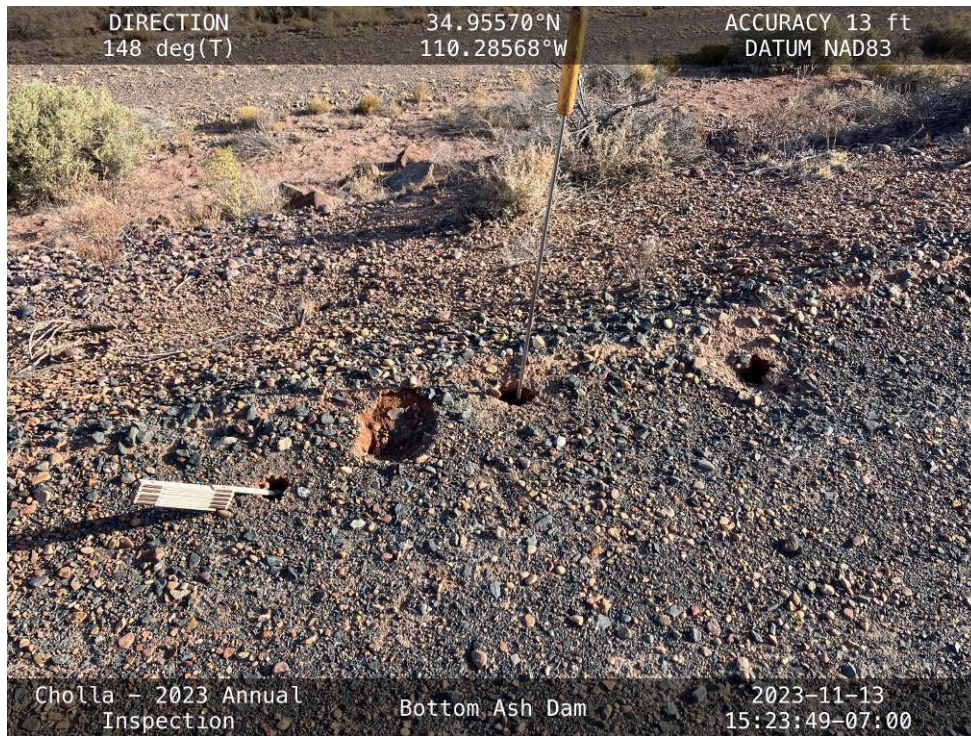
20231113 – IMG_1736

- i. Several new erosion holes were observed (Photos IMG_1611, IMG_1612, IMG_1616, IMG_1617, IMG_1631, IMG_1679, IMG_1695, IMG_1696, IMG_1699, IMG_1702, IMG_1703, IMG_1718, and IMG_1736). The deepest measured erosion hole was at least 22 inches (on the East Embankment; Photo IMG_1703). Although erosion holes are more prevalent in some annual inspections compared to others, most individual erosion holes are not present in consecutive inspections. Holes that are observed in consecutive inspections are typically shallower or nearly filled in during the next annual inspection and are not present during the third annual inspection. The holes on the crest and shoulders should be monitored and repaired if the depth exceeds 1 foot or appears to reach the core.

A 9-inch-deep erosion hole and three shallower holes along the East Embankment downstream shoulder.

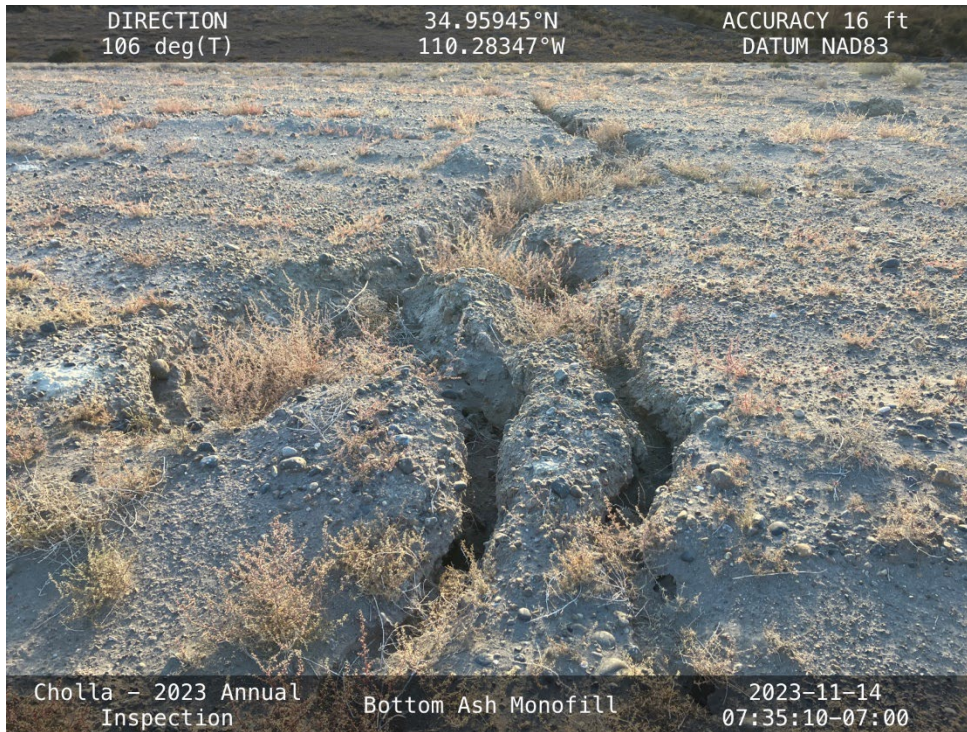
20231114 – IMG_1874

A pair of 2-foot-deep erosion rills on the eastern slope of the lower section, also observed in 2022.

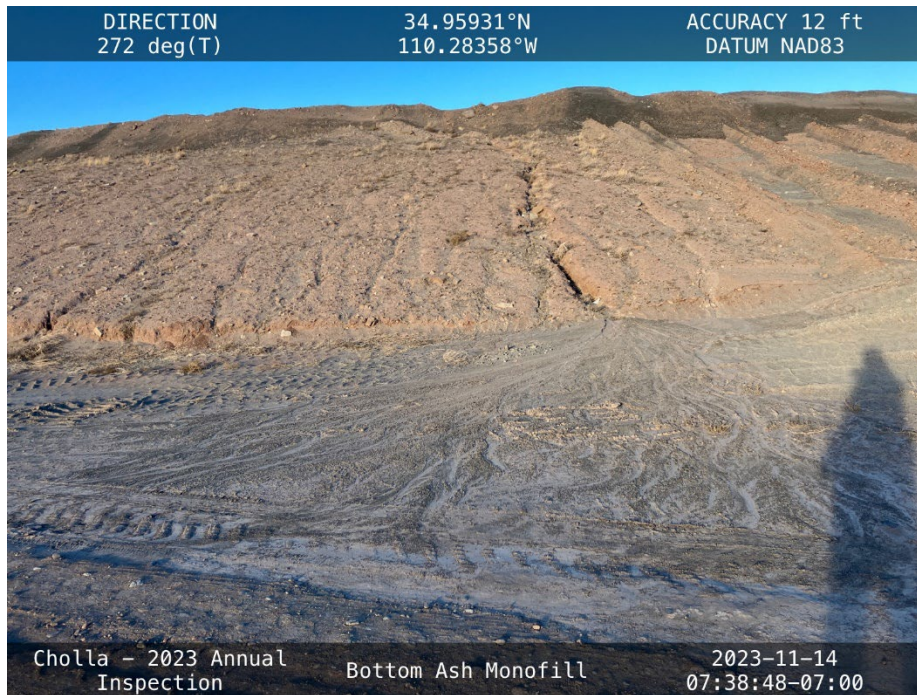
20231114 – IMG_1878

A 1-foot-deep erosion gully (see also IMG_1879) and resulting fan deposit on the southeast slope of the BAM, also observed in 2022.

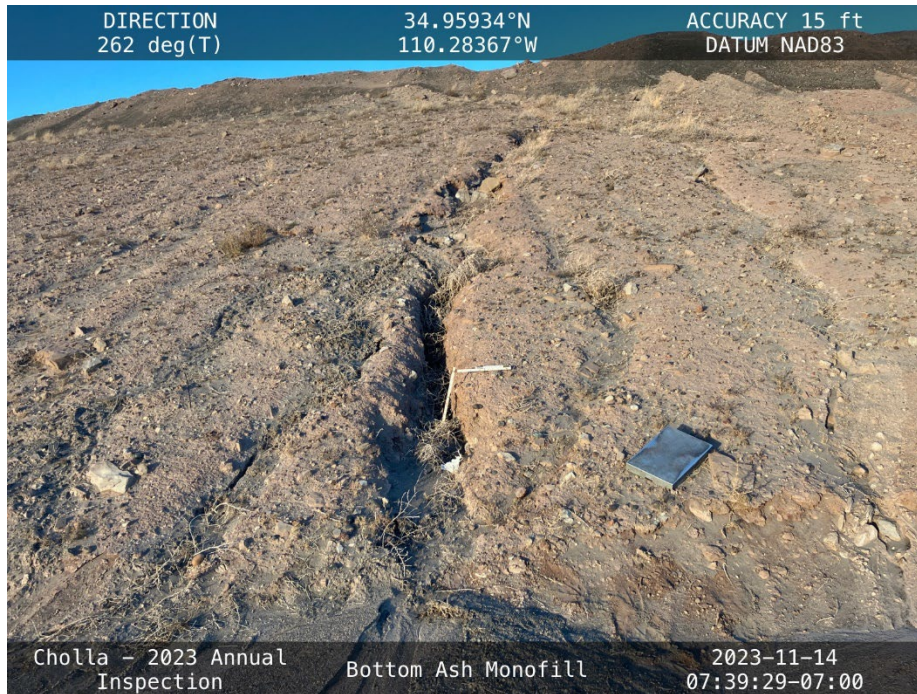
20231114 – IMG_1879

A 1-foot-deep erosion gully (see also IMG_1878) on the southeast slope of the BAM, also observed in 2022.

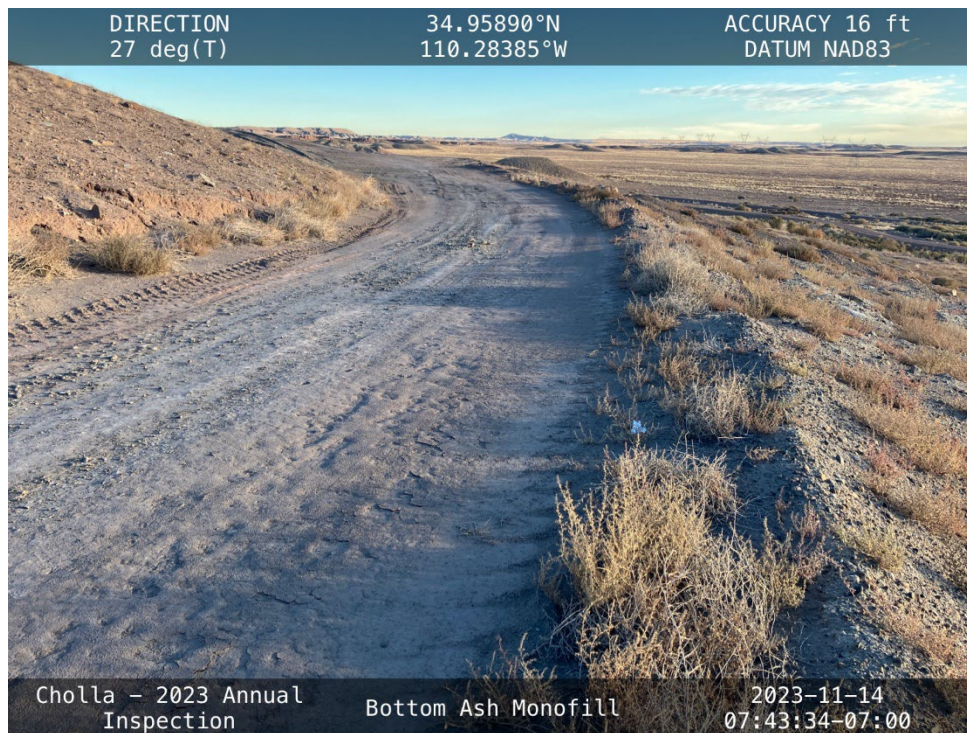
20231114 – IMG_1881

A low spot on the perimeter road, facing north.

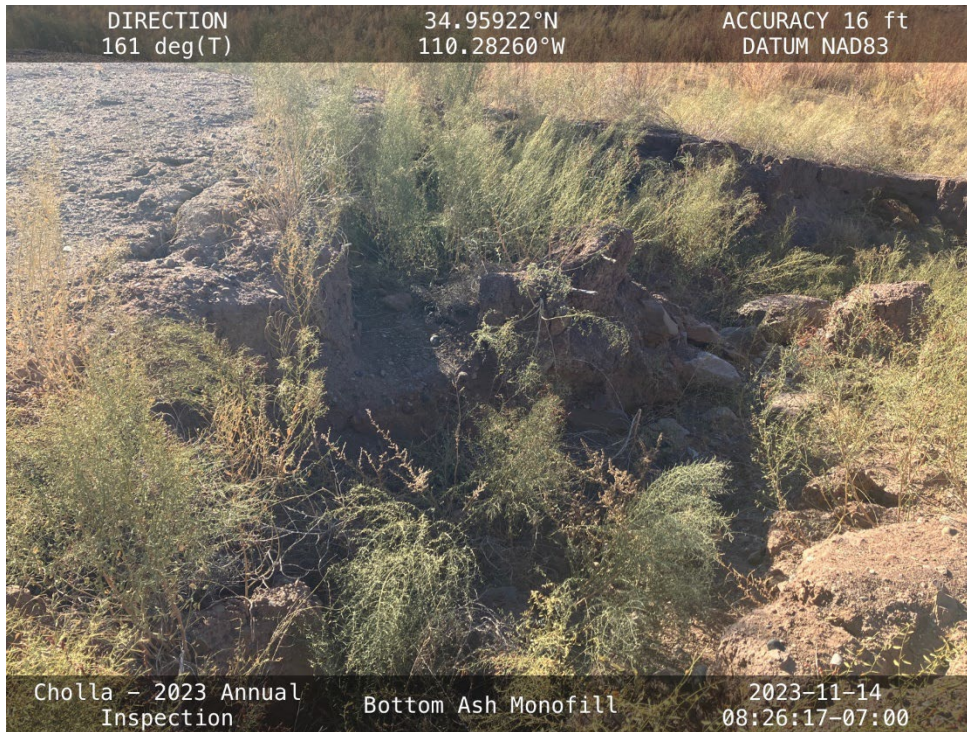
20231114 – IMG_1942

Erosion on the north side of the Stormwater Detention Basin where a tunnel was observed in 2022.

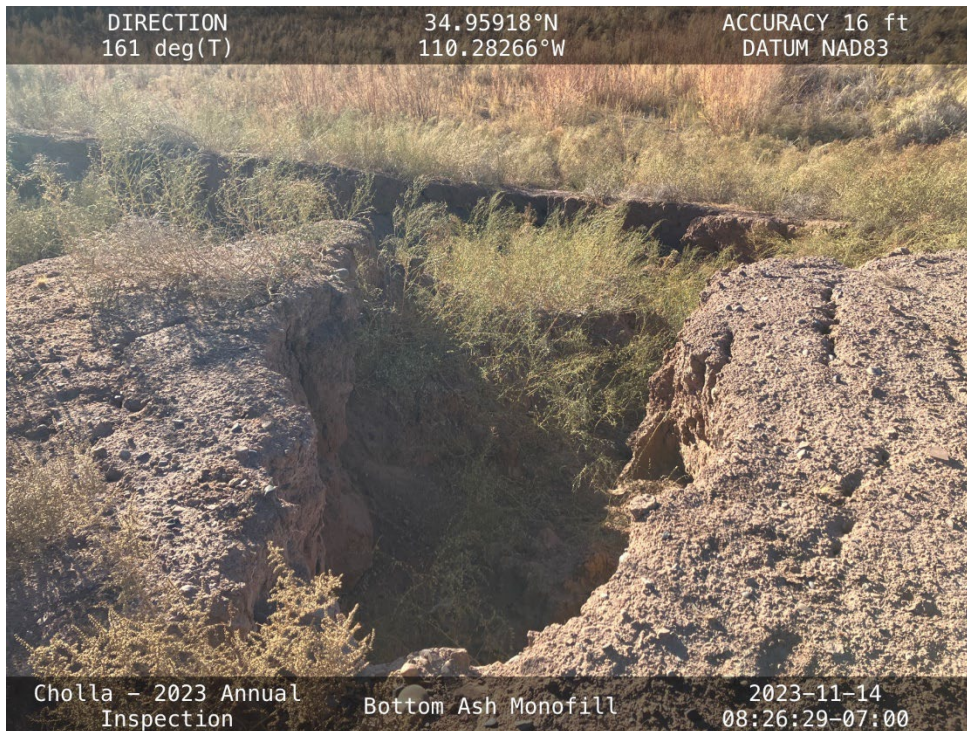
20231114 – IMG_1943

Erosion on the north side of the Stormwater Detention Basin similar to the 2022 inspection.
