# **CHOLLA POWER PLANT Fly Ash Dam, Bottom Ash Dam, Sedimentation Pond, and Bottom Ash Monofill**

## **Annual CCR Impoundment and Landfill Inspection Report 2016**

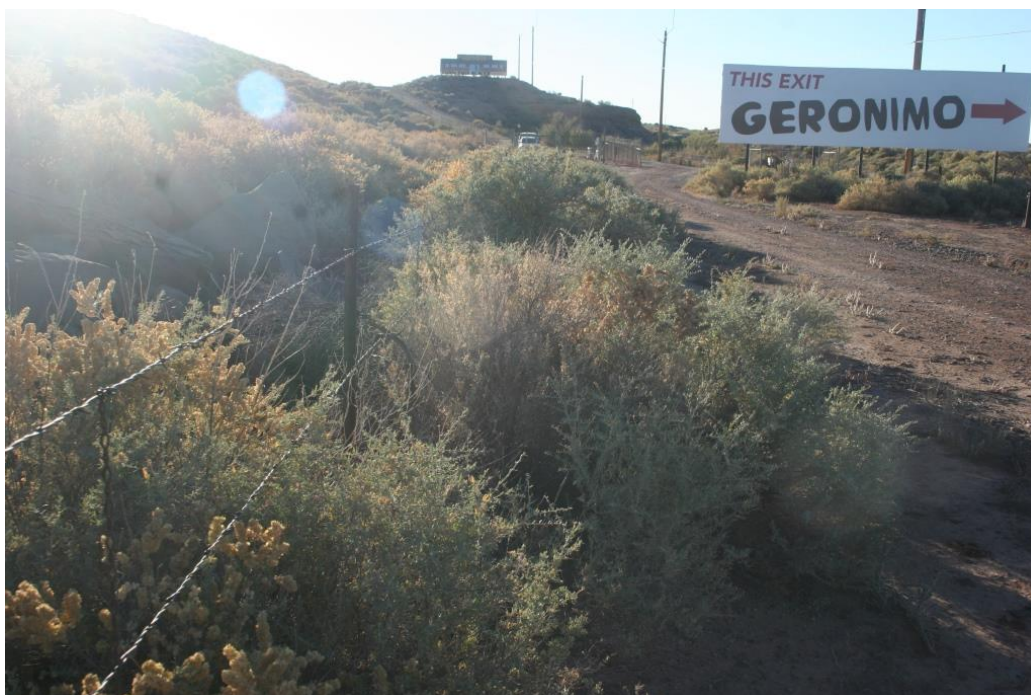
#### 20161020 – IMG\_0364

- i. F-35 is repaired. See photo IMG\_2186.
- ii. Excessive natural vegetation has been removed from the toe of the dam in several locations, but is still thick along the toe and fence line elsewhere (see photos IMG\_0364 and IMG\_2148). Continue clearing along the entire toe of the dam.

Dense vegetation along the toe of the Fly Ash Dam near the fenceline, facing east.

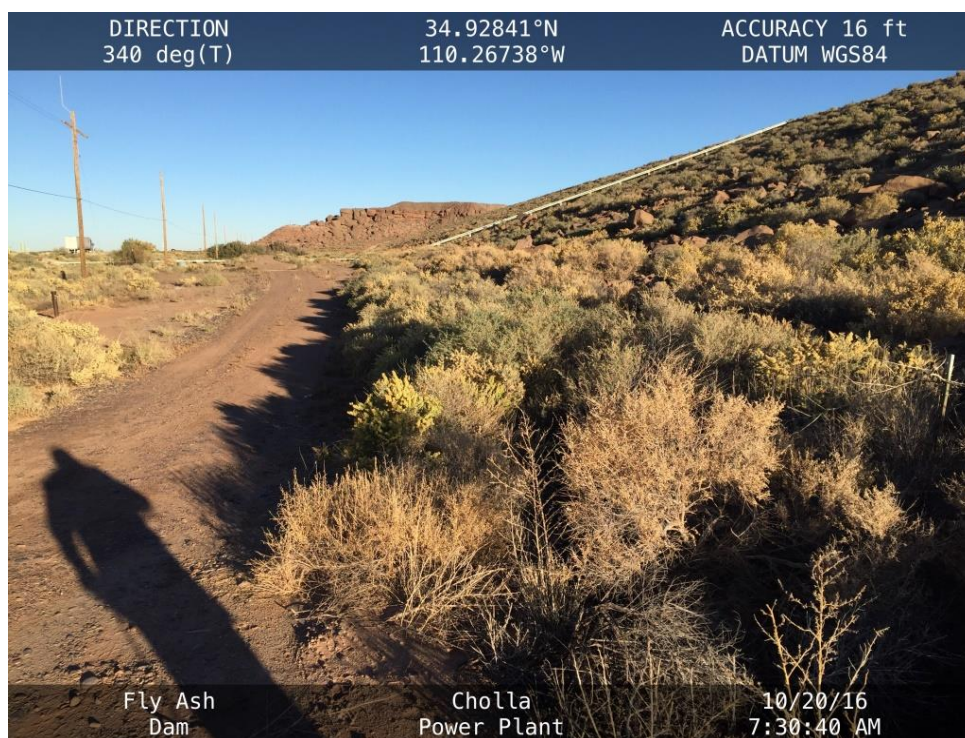
#### 20161020 – IMG\_2148

Dense vegetation along the toe of the Fly Ash Dam near the fenceline, facing west.

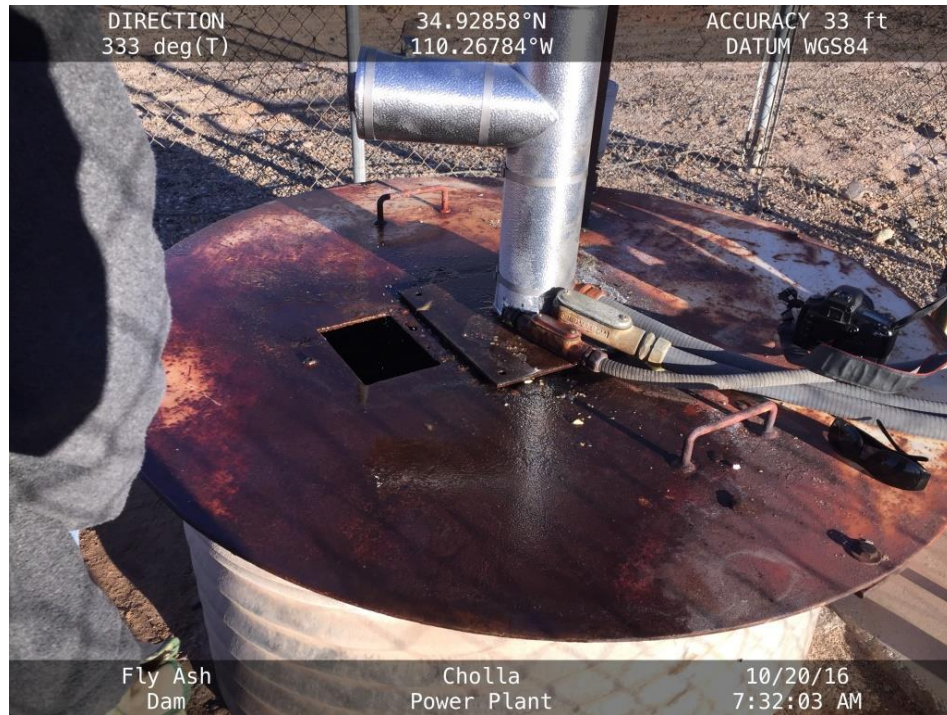
**20161020 – IMG\_2153**  
Water leaking out of the piping in Geronimo Sump D.

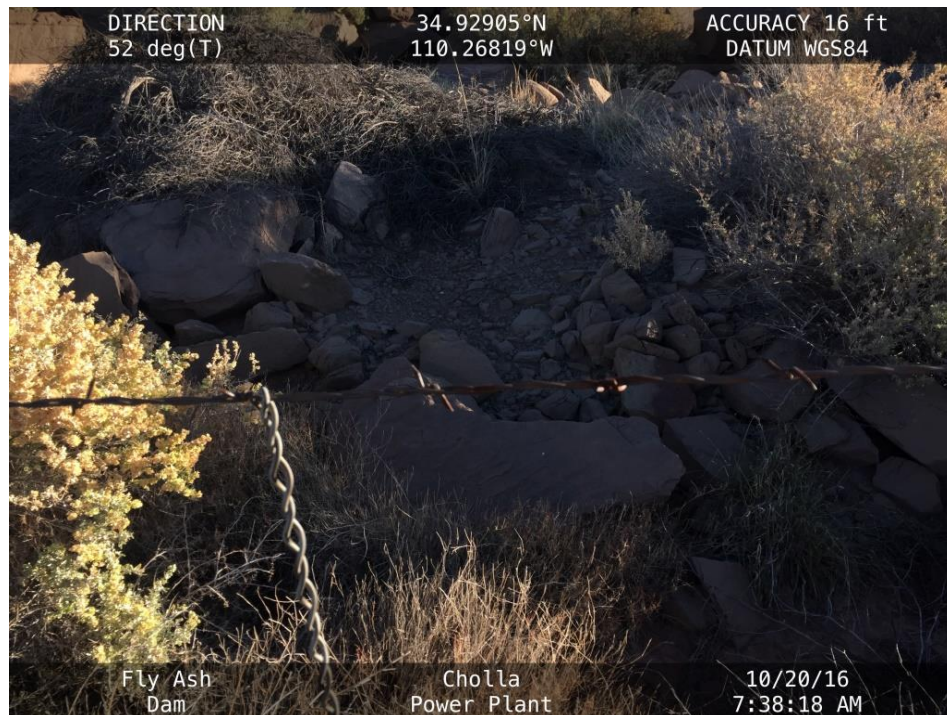
- viii. APS is in the process of updating the Emergency Action Plan before April 17, 2017 to comply with the initial plan requirement of CFR 257.73.
- ix. The riprap in several areas of the downstream slope is deteriorating. The deterioration does not appear to affect the safety of the dam. Continue to monitor the condition of the riprap and replace as necessary.

**20161020 – IMG\_2159**  
Riprap deterioration along the toe of the Fly Ash Dam.

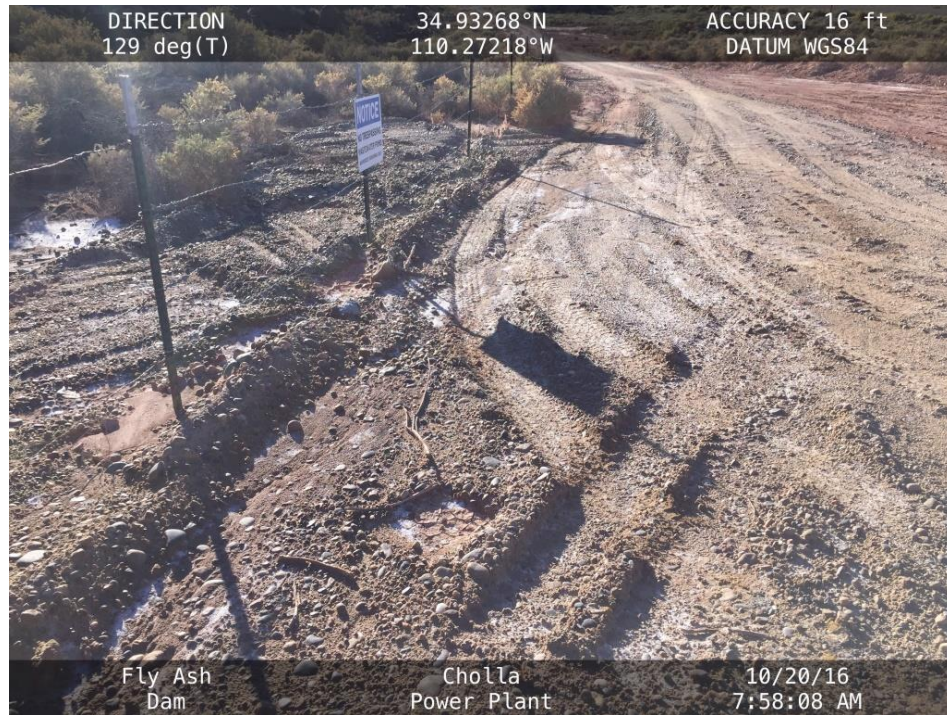
### 20161020 – IMG\_2172

- iii. Erosion due to surface water runoff near the Geronimo Sump and along both sides of the access road has been repaired (see photo IMG\_2181).
- iv. Minor erosion was observed in the downstream groin of the West Abutment (see photo IMG\_2172). Continue to monitor and repair as needed.

Minor erosion in the groin of the West Abutment.

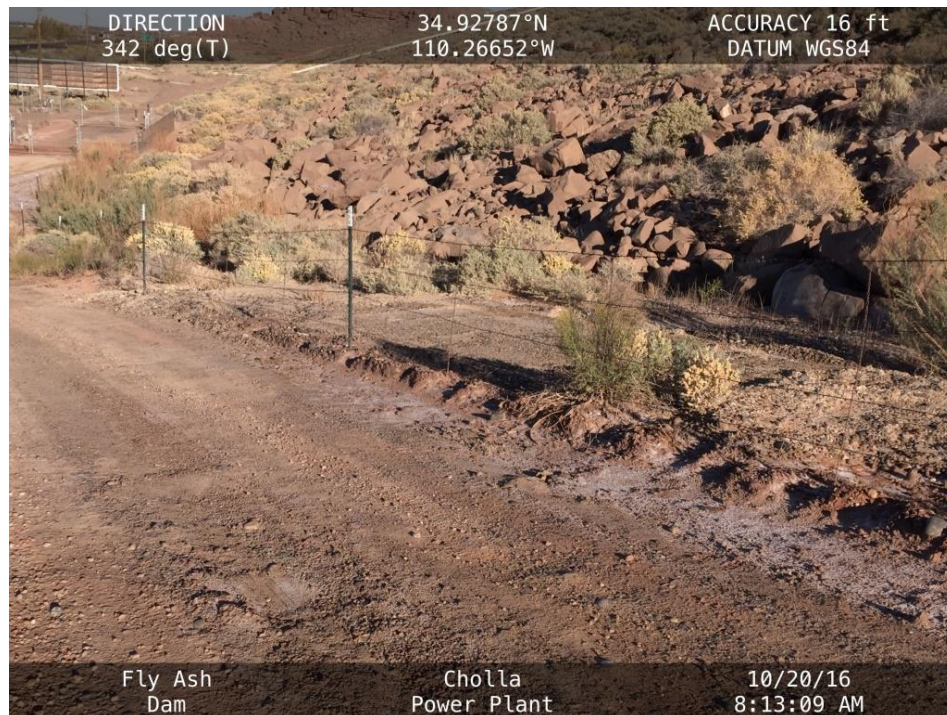
### 20161020 – IMG\_2181

Area of repaired erosion near the Geronimo Sump along the access road, facing west.

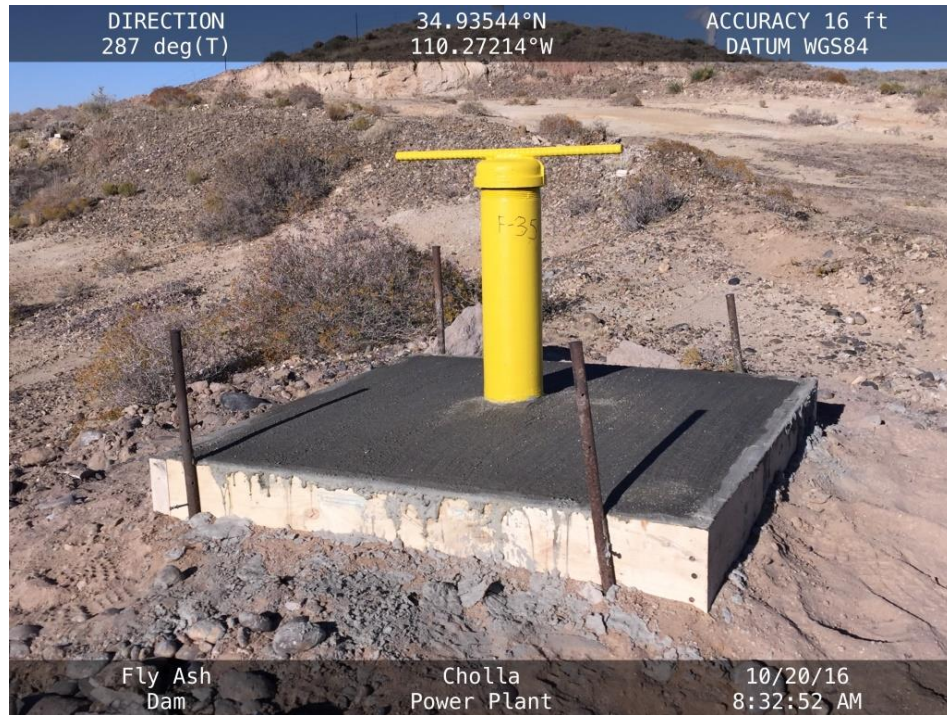
### 20161020 – IMG\_2186

A newly-installed monument around piezometer F-35.

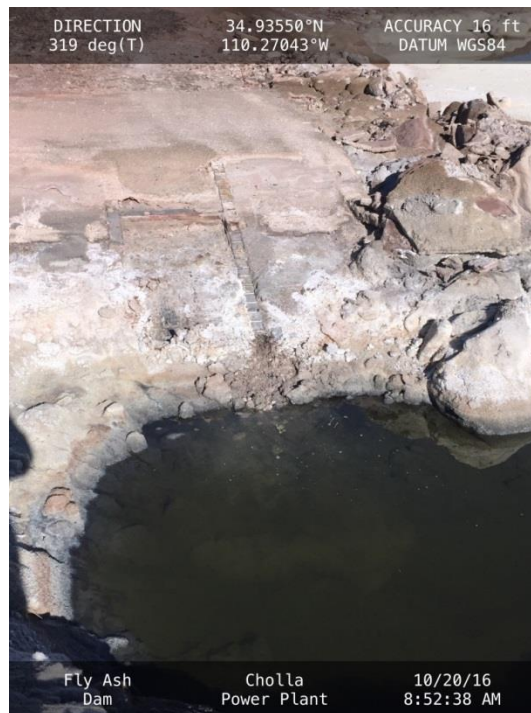
### 20161020 – IMG\_2197

Accumulated sediment on the Fly Ash Pond water level gauge.

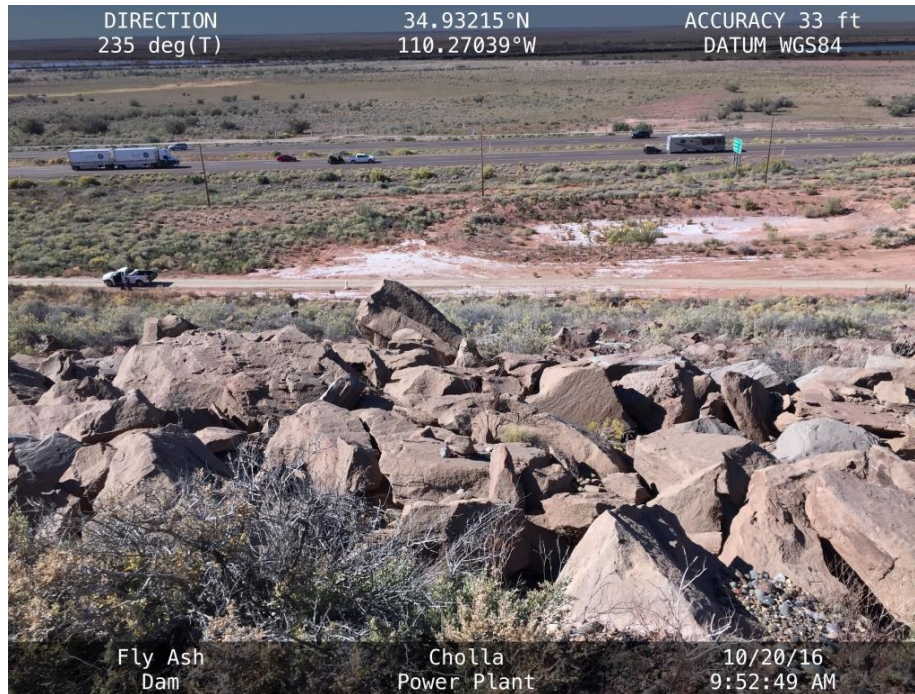
#### 20161020 – IMG\_2229

Evidence of previous seepage (white evaporates) along the downstream toe of the Fly Ash Dam, facing south.

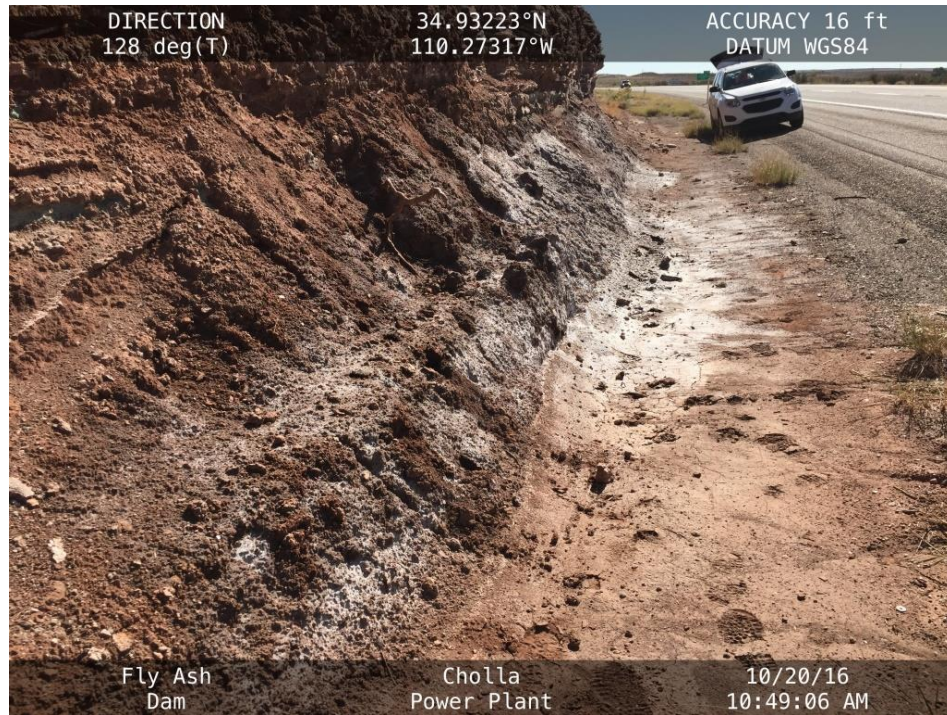
**20161020 – IMG\_2248**  
The I-40 Seep in a relatively soft, but dry condition.

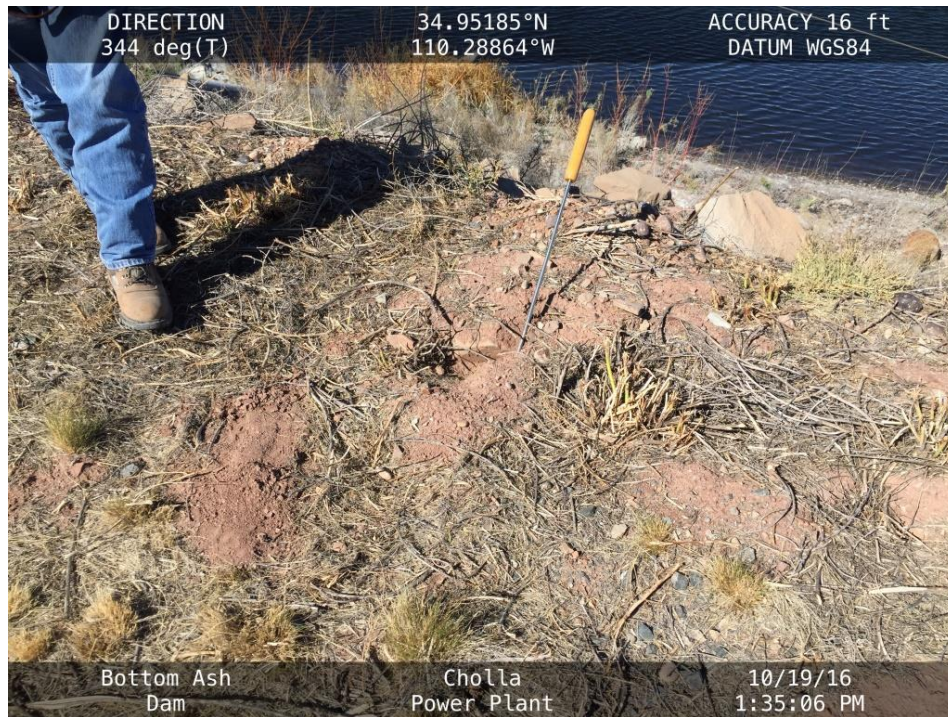
**20161019 – IMG\_2047**

- ii. APS is in the process of updating the Emergency Action Plan before April 17, 2017 to comply with the initial plan requirement of CFR 257.73.
- iii. Relatively fewer animal burrows were observed compared to the 2015 inspection. The majority of animal burrows occurred along the edge of the crest and did not extend beyond a depth of approximately 12 inches. Continue to monitor the frequency of the burrows and implement deterrents if necessary.

An animal burrow in the crest of the South Embankment.

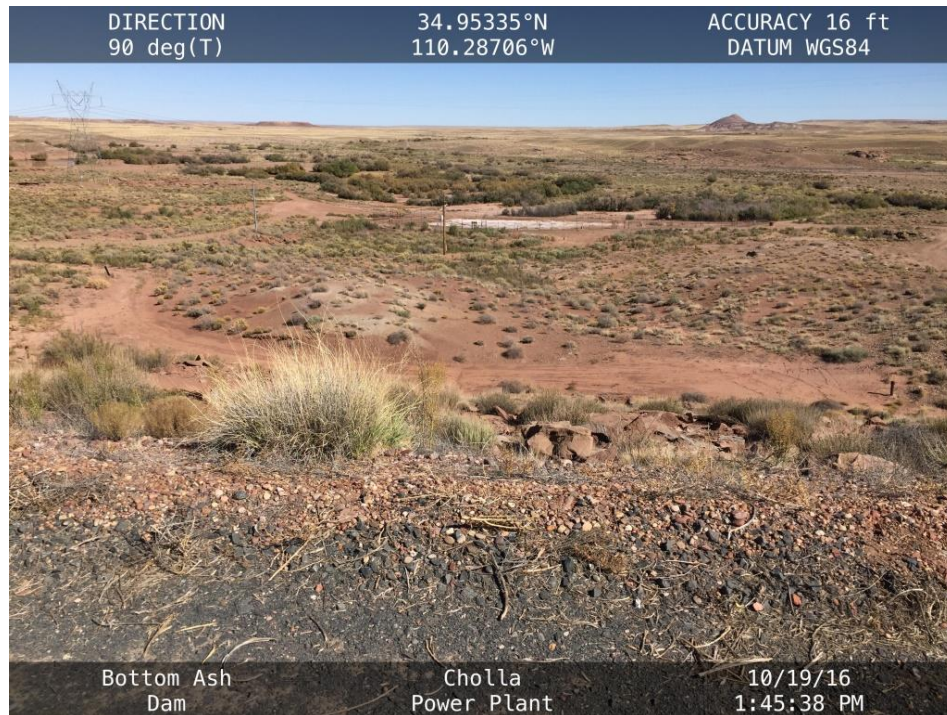
### 20161019 – IMG\_2061

The P-232 seep at the downstream toe of the Bottom Ash Dam, facing east.

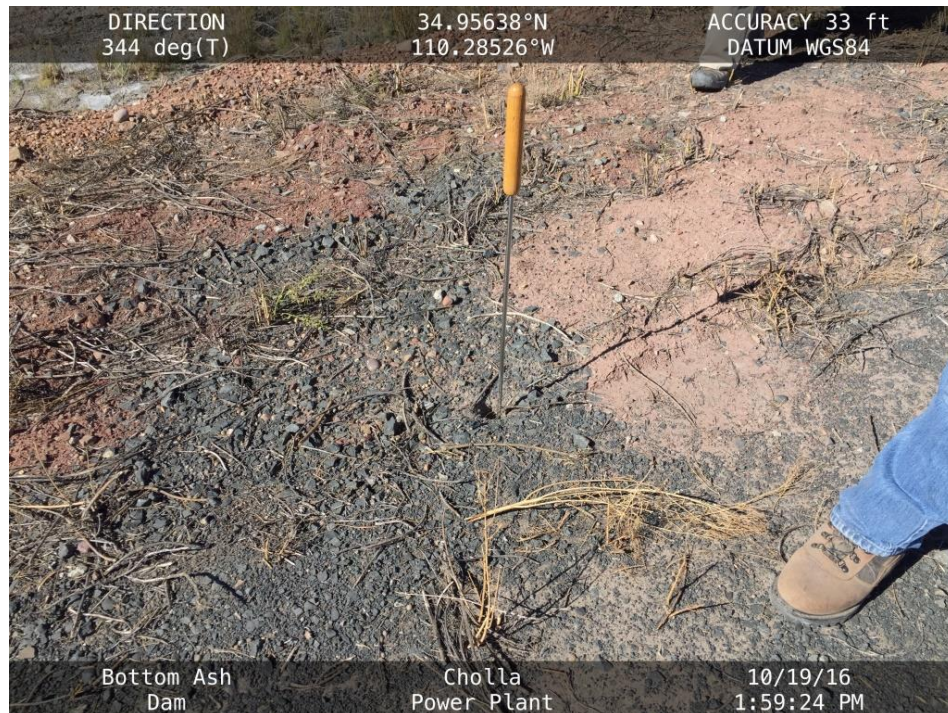
**20161019 – IMG\_2071**

An animal burrow in the crest of the East Embankment.

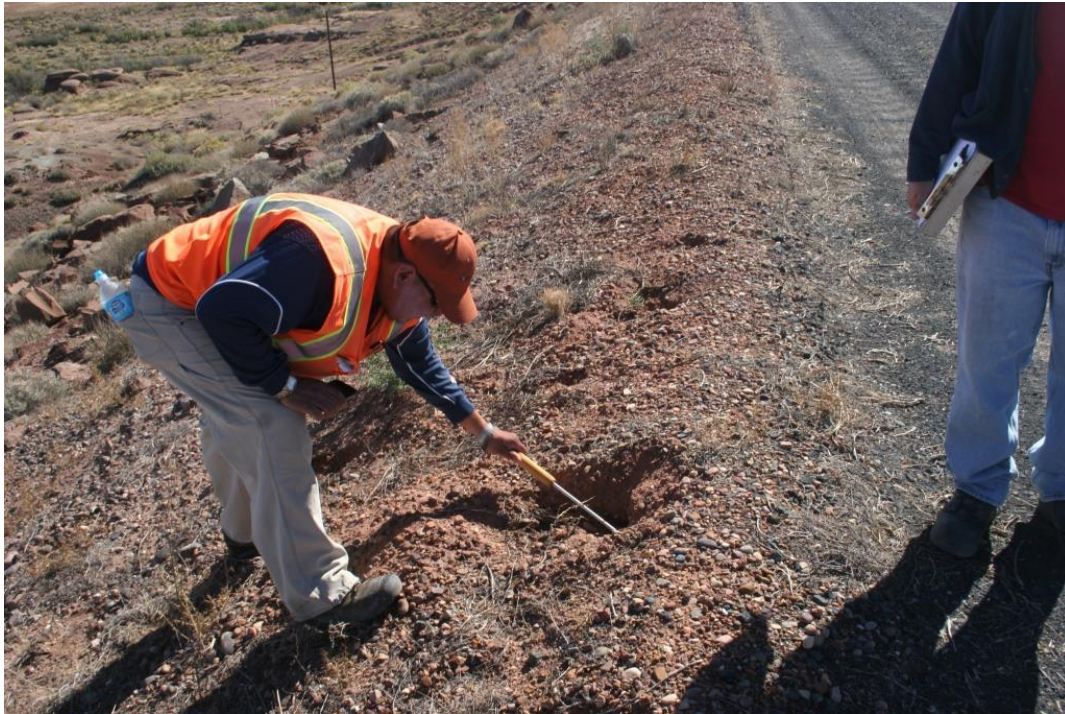
### 20161019 – IMG\_0313

An animal burrow along the downstream slope of the East Embankment.

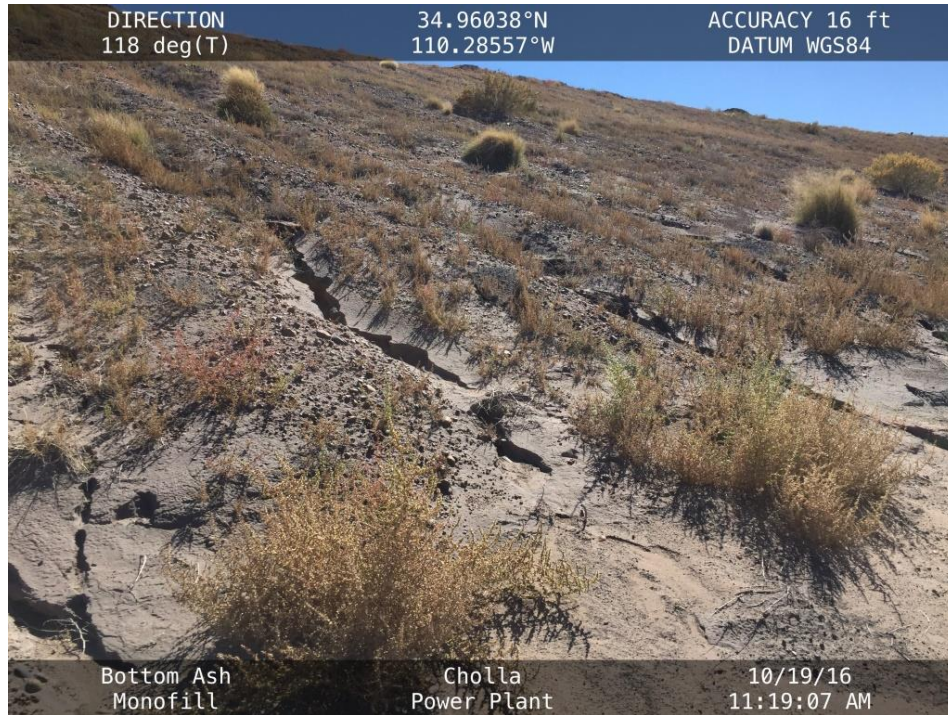
### 20161019 – IMG\_1948

Erosion rills along the western slope of the Bottom Ash Monofill, facing east.

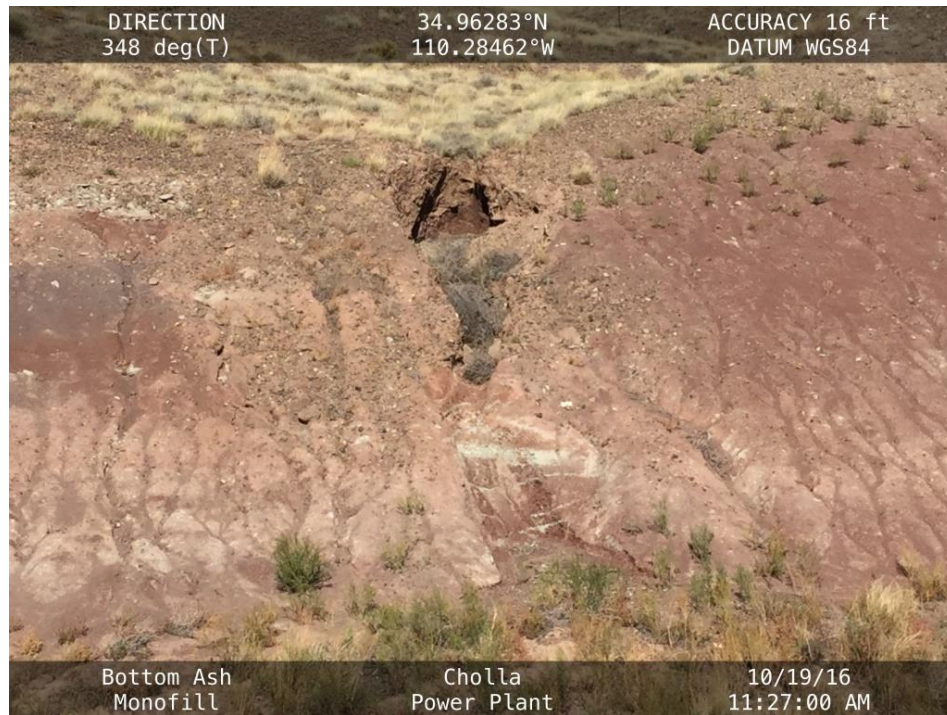
### 20161019 – IMG\_1963

Deep headcutting in the diversion channel along the north side of the Monofill, facing north.

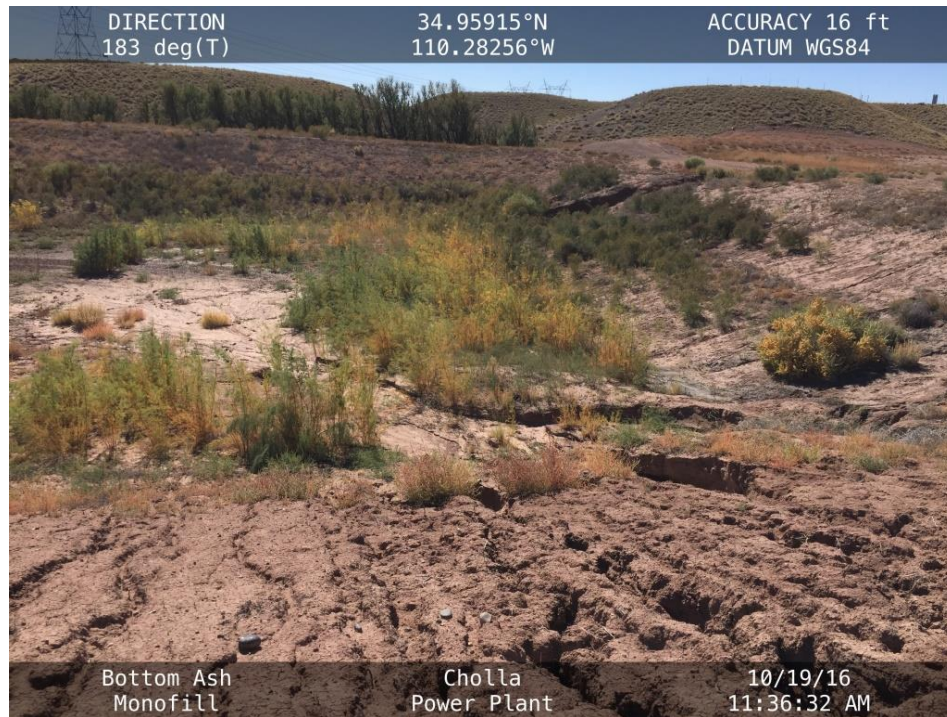
### 20161019 – IMG\_1986

The Stormwater Detention Basin with erosion and vegetation, facing south from the north side.
