CHOLLA POWER PLANT Fly Ash Dam, Bottom Ash Dam, Sedimentation Pond, and Bottom Ash Monofill

Annual CCR Impoundment and Landfill Inspection Report

2017

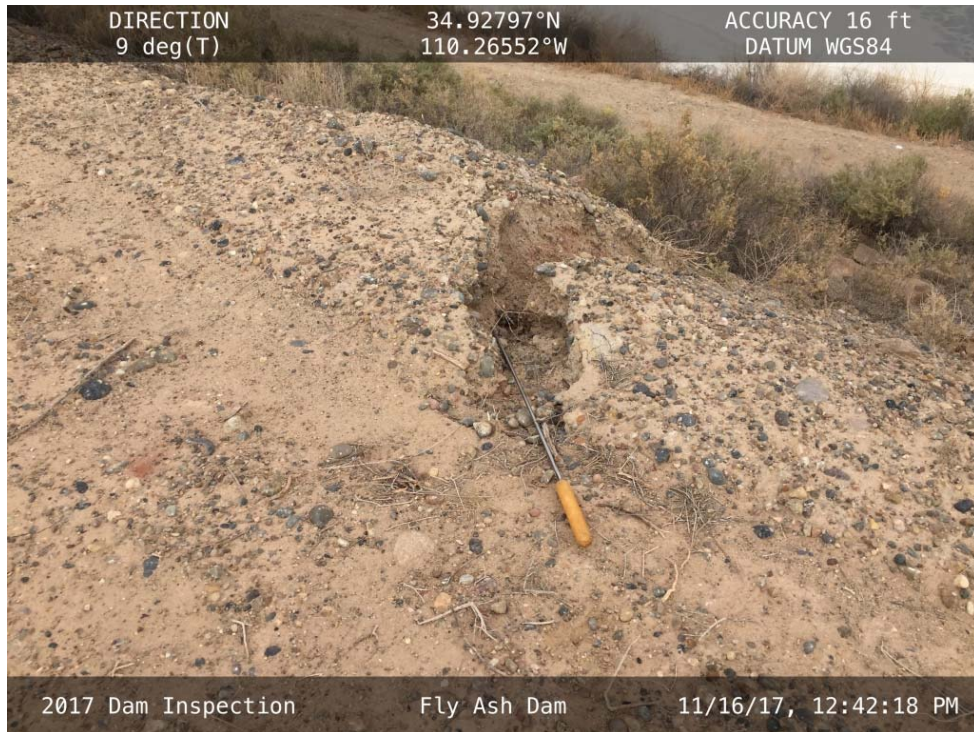
20171116 – IMG_5954
Erosion along the upstream side of the Fly Ash Dam.

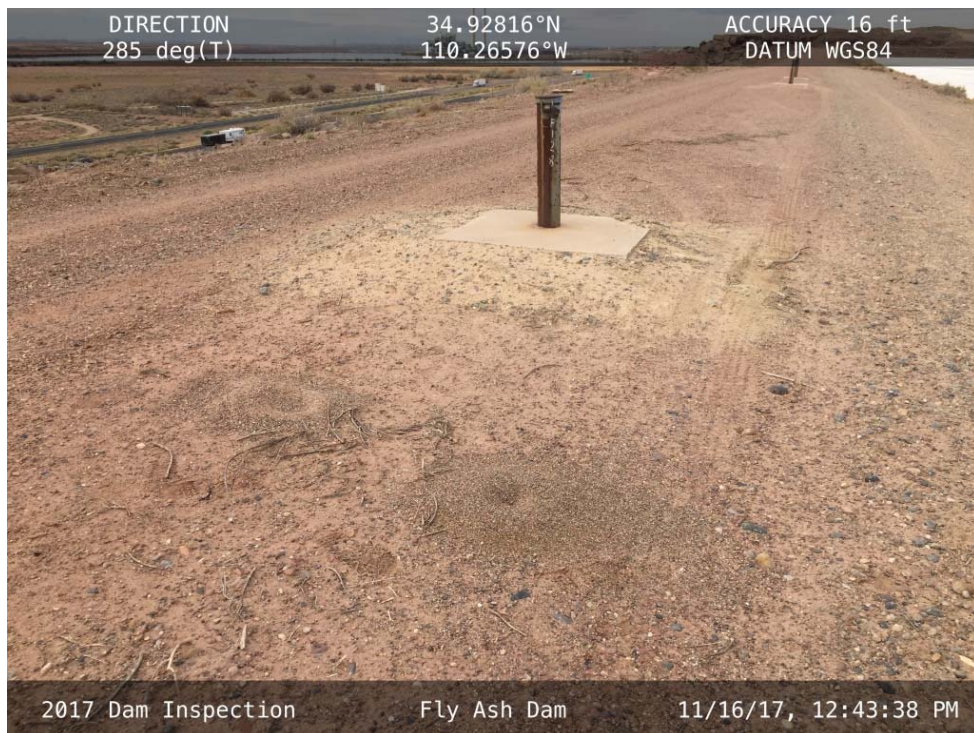
20171116 – IMG_5955
Ant hills in the center of the crest.

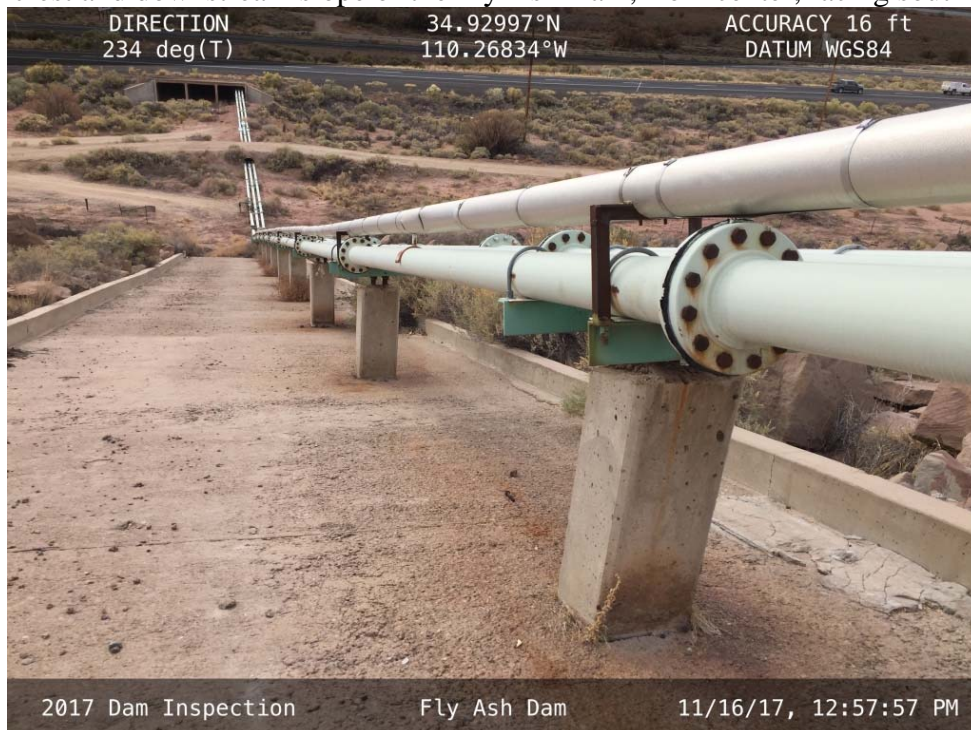
20171116 – IMG_5970

The inlet pipe system with repaired pipe supports.

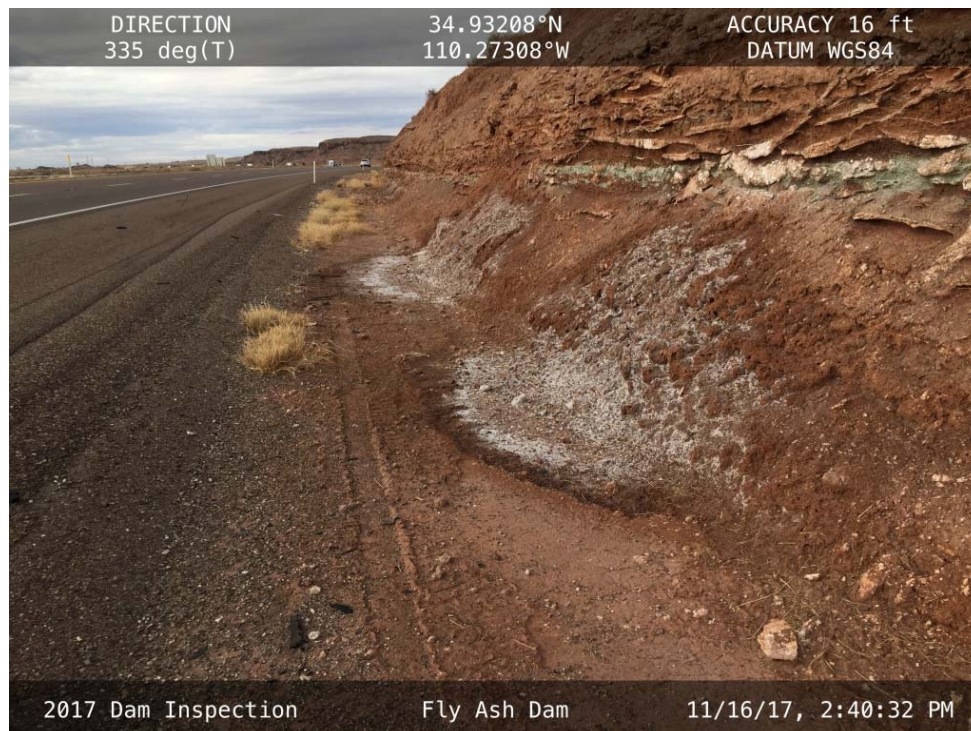
20171116 – IMG_6043

e	Seepage?	Historic seepage near the downstream East Abutment area (I-40 seep) indicated by evaporates and soft ground. Continue to monitor.				X	X		
f	Animal burrows?	None observed. Continue to monitor.		X			X		
7	SEEPAGE/PIPING CONTROL DESIGN FEATURE(S)								
a	Describe:	1) The Geronimo and Hunt seepage collection and pump back systems are located downstream of the dam near I-40 for fluid interception. 2) Discharge from the crest side of the reservoir creates a beach to prevent water from being stored against the upstream face.							
b	Internal drains flowing?					X	X		
c	Seepage at or beyond toe?	Yes.				X	X		
d	If so, does seepage contain fines?	APS measures turbidity of seep water.		X			X		
e	Evidence of sand boils at or beyond toe?			X

The I-40 Seep in a relatively soft, but dry condition.

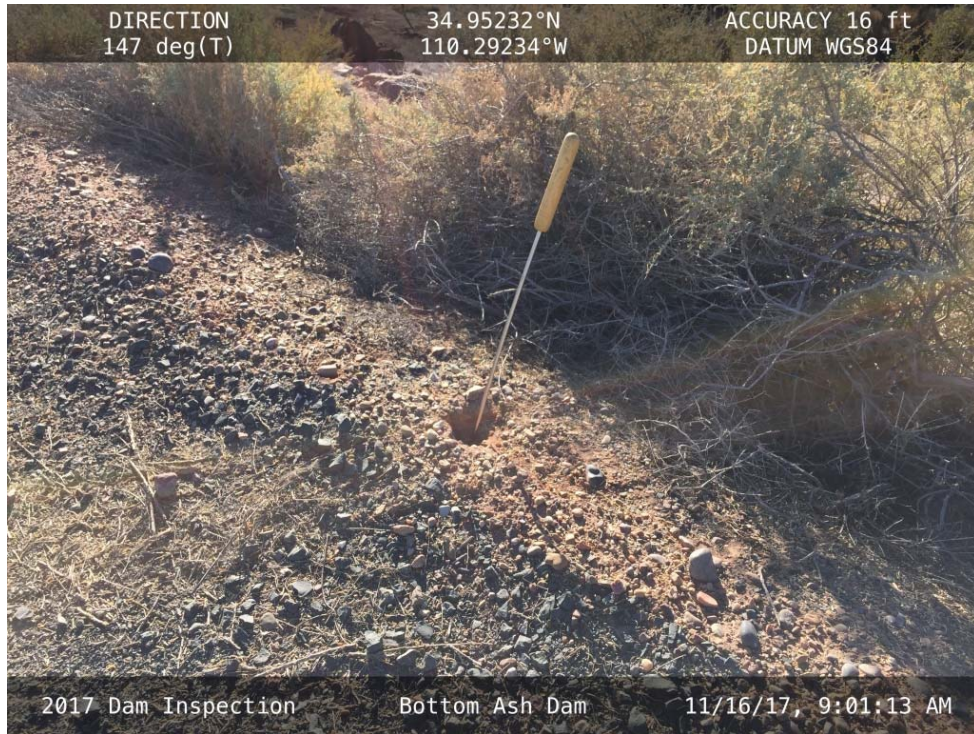
20171116 – IMG_5793

An animal burrow along the crest of the South Embankment.

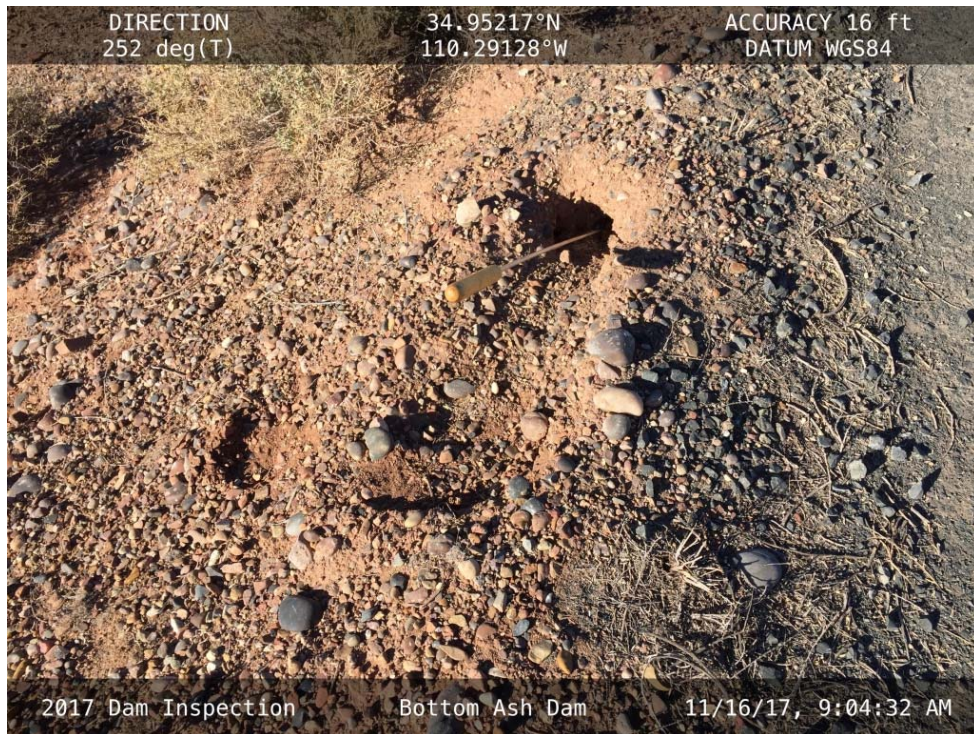
20171116 – IMG_5794

An animal burrow in the crest of the South Embankment.

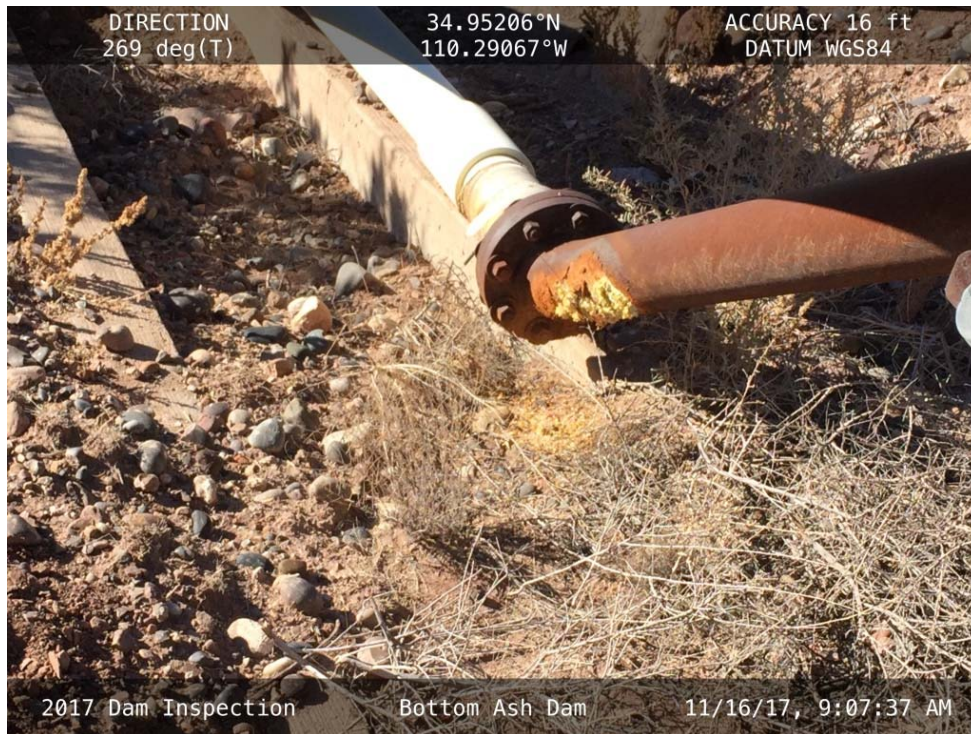
20171116 – IMG_5801

Corrosion on the pipe from Toe Drain Seep at the western siphon line.

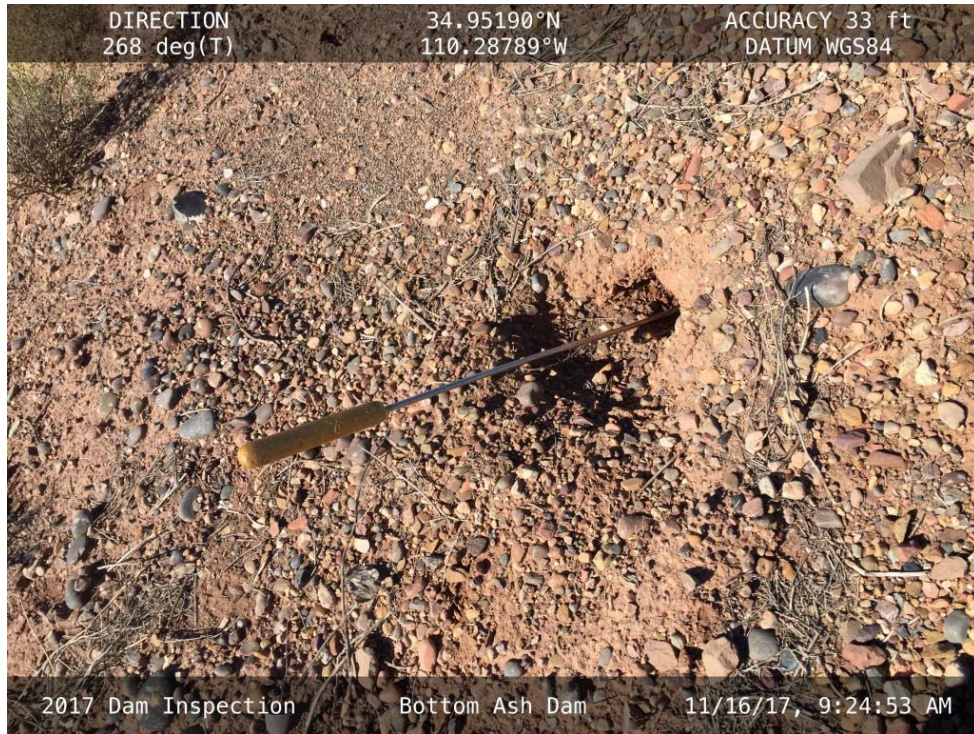
20171116 – IMG_5825

An animal burrow in the downstream slope of the southwest corner.

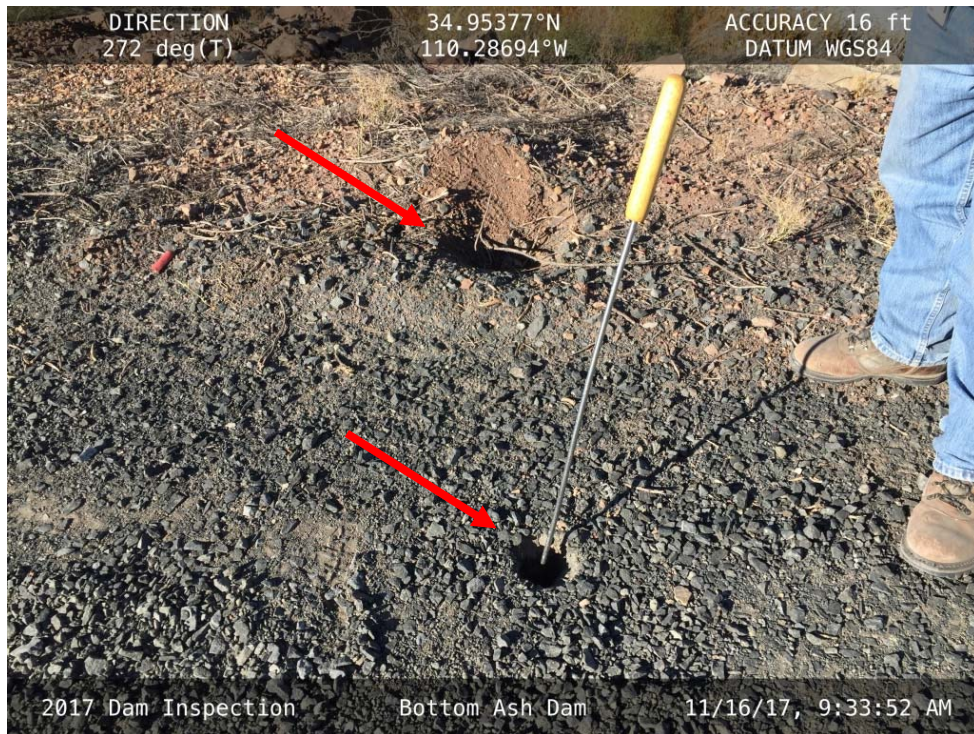
20171116 – IMG_5841

- i. Several erosion holes were observed in the crest and near the edge of the crest (example photos IMG_5841 and IMG_5859). The erosion holes in the crest were generally clustered and were only observed within a few feet of the edge.

Two erosion holes in the crest of the East Embankment.

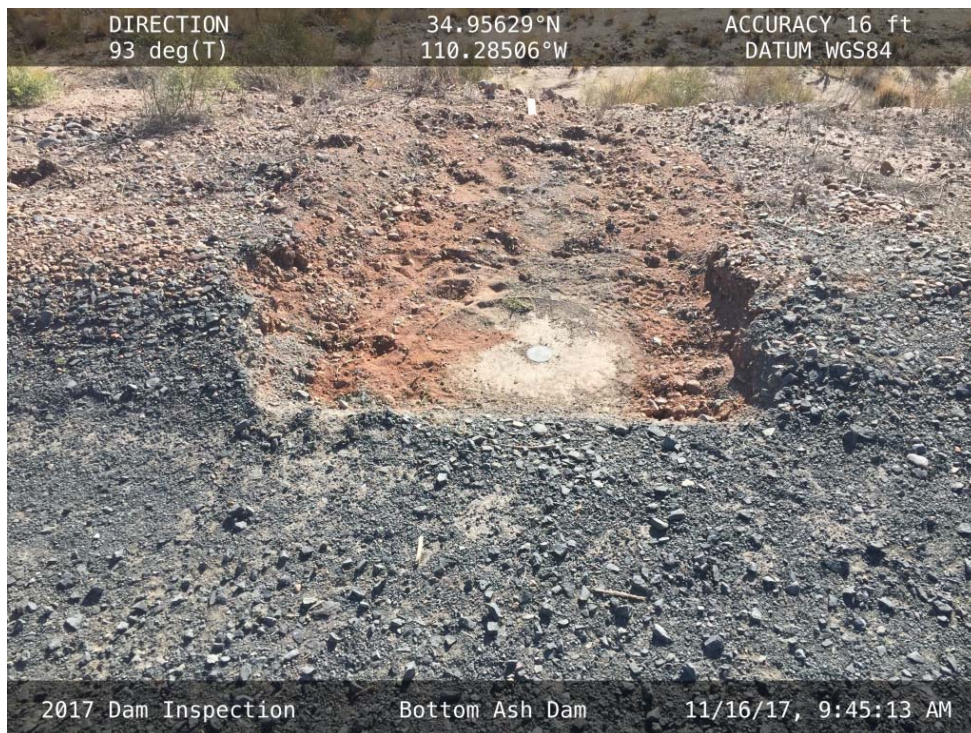
20171116 – IMG_5856
A settlement monument along the East Embankment exposed after crest grading activities.

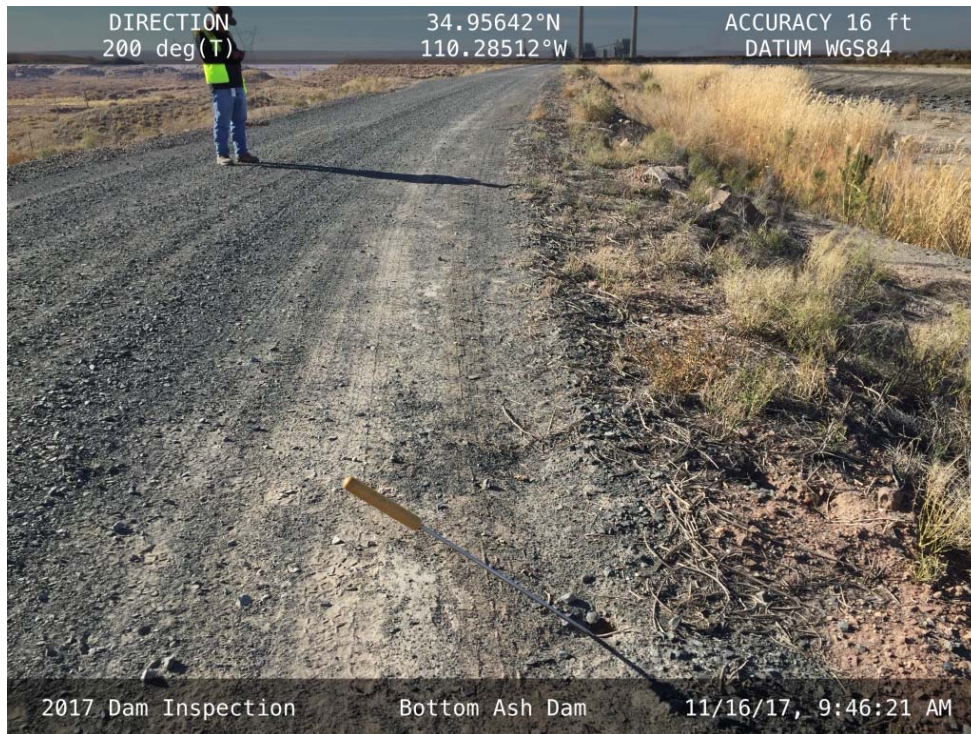
20171116 – IMG_5859

An erosion hole in the crest of the East Embankment.

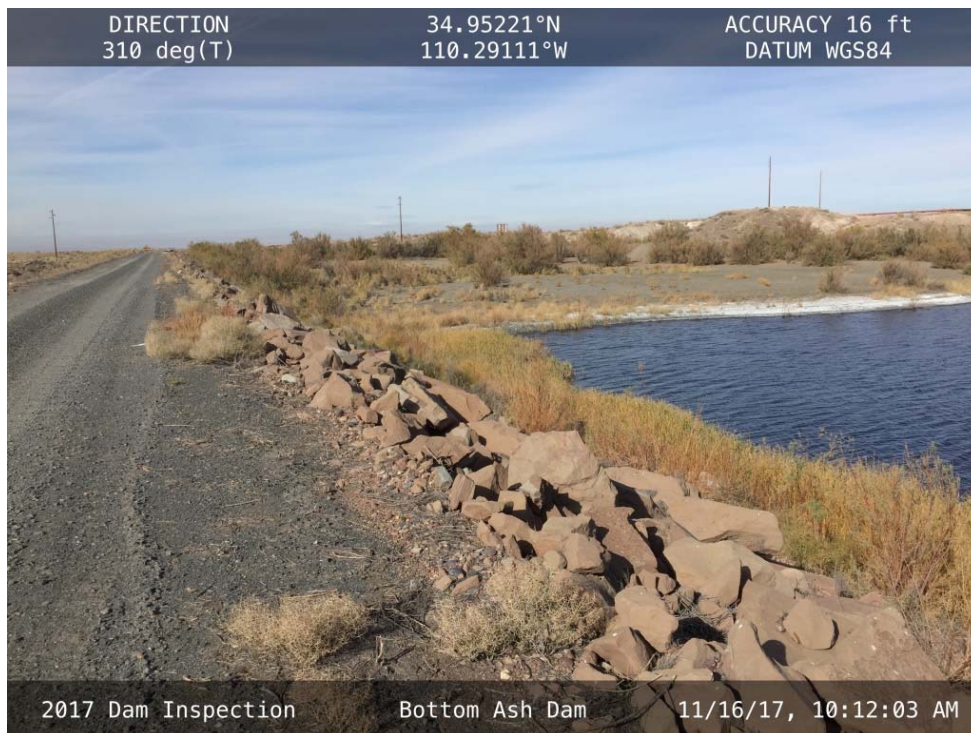
20171116 – IMG_5873

Trees growing in impounded ash at the West Abutment, facing west.

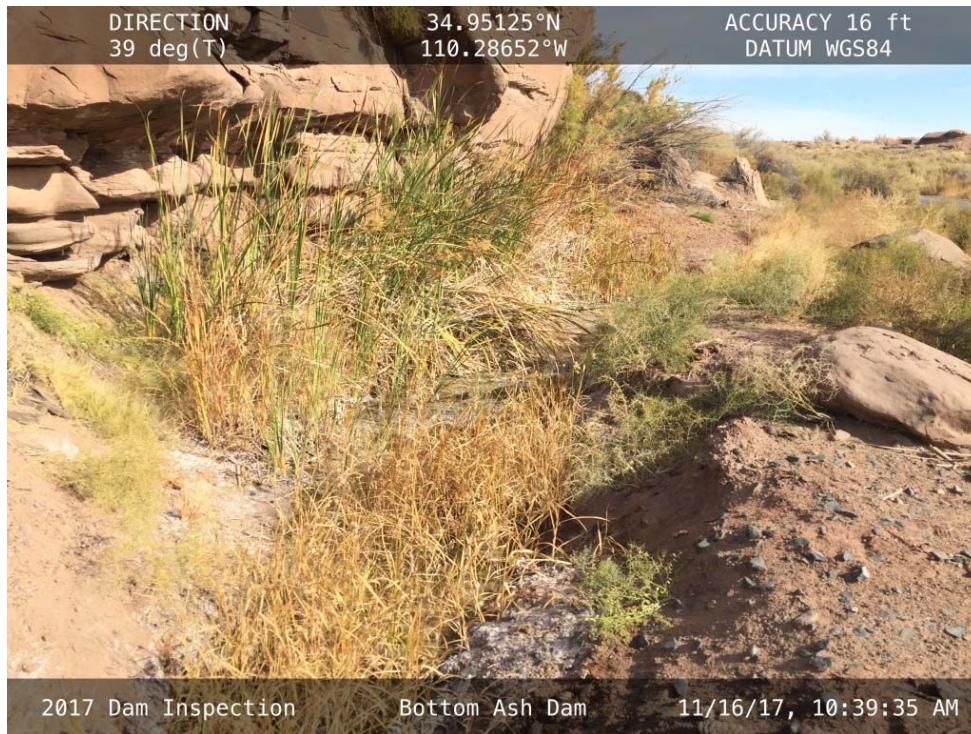
20171116 – IMG_5896
Grassy vegetation growing near the Petroglyph Seep, facing north.

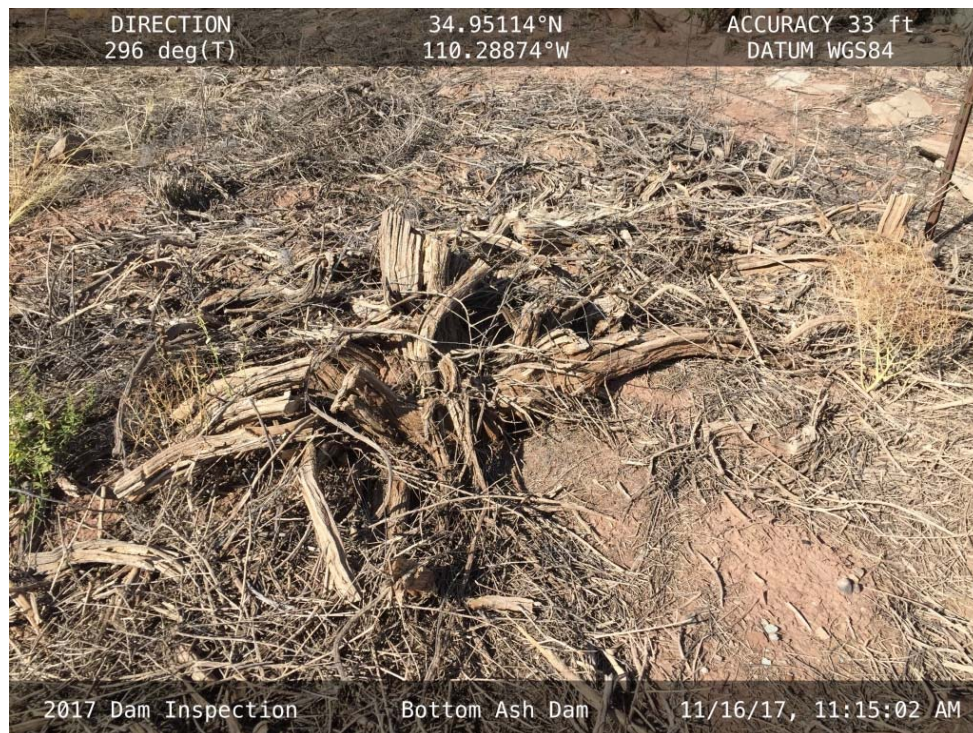
20171116 – IMG_5922

The stump of a tree left over after vegetation removal activities.

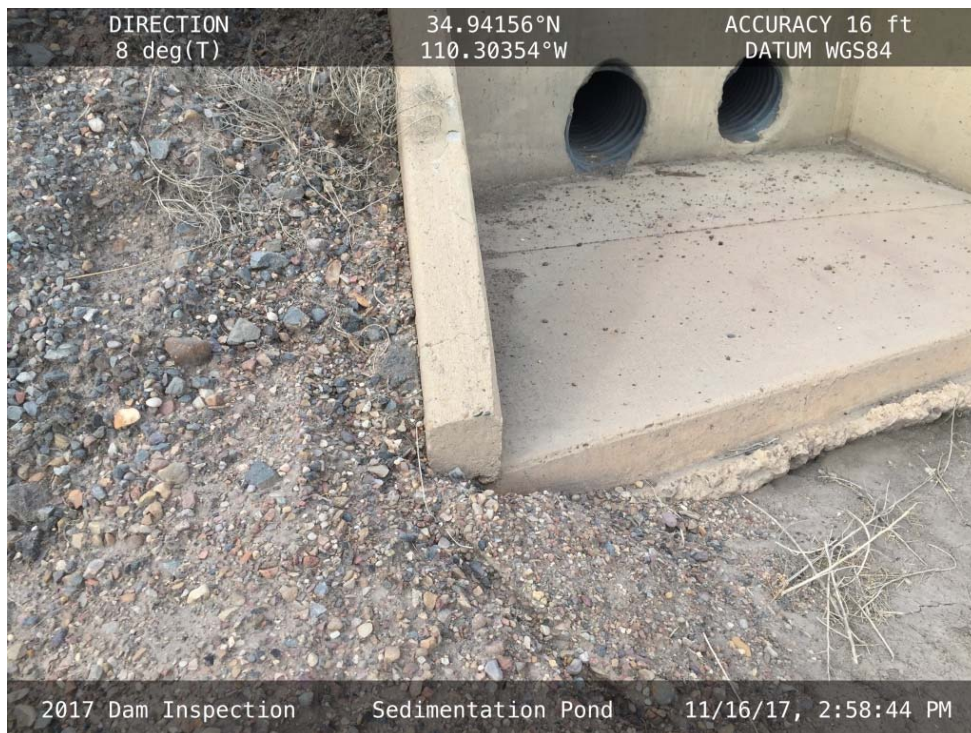
20171116 – IMG_6068

- i. Minor erosion was observed along the edges of the concrete outfall structure (photos IMG_6068, IMG_6070, and IMG_6071).
- ii. The weekly inspection reports for the period between November 8, 2016 and September 30, 2017 do not indicate that there were any appearances of actual or potential structural weakness or other conditions that have the potential to disrupt the operation or safety of the CCR unit.

Erosion around the concrete spillway along the south embankment.

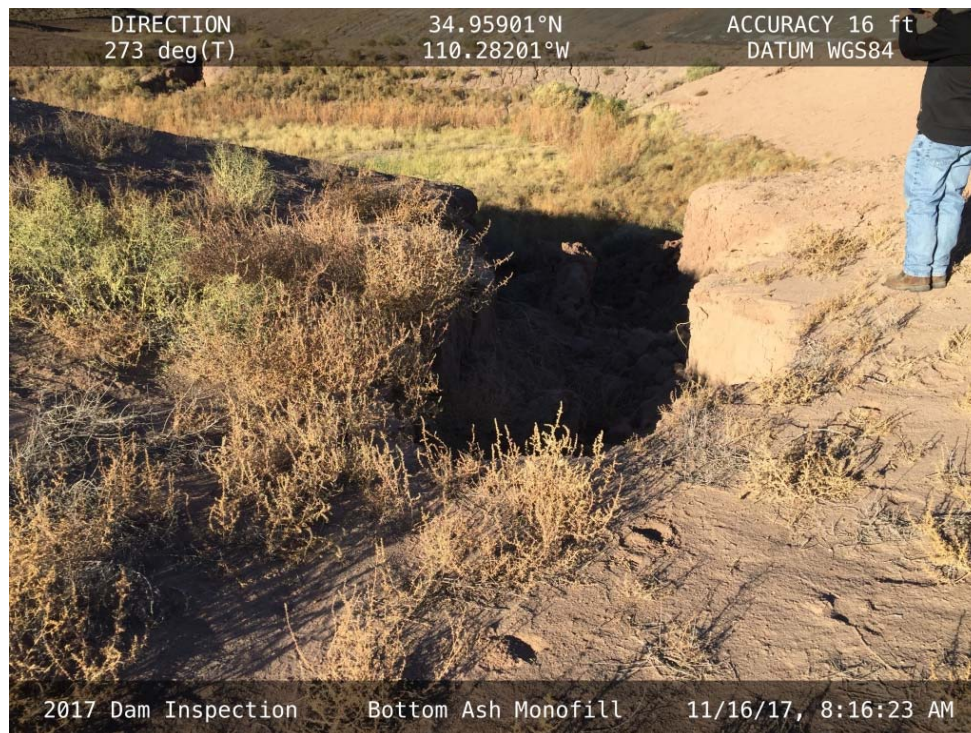
20171116 – IMG_5738

Headcutting on the east side of the Stormwater Detention Basin, facing west.

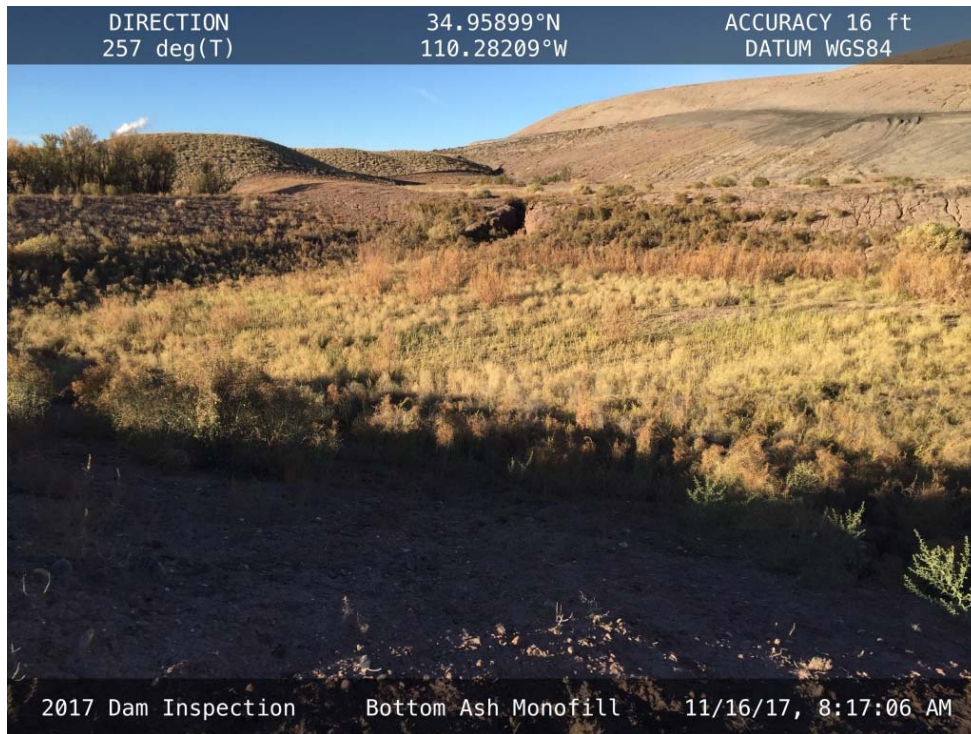
20171116 – IMG_5741

Headcutting on the west side of the Stormwater Detention Basin, facing west.

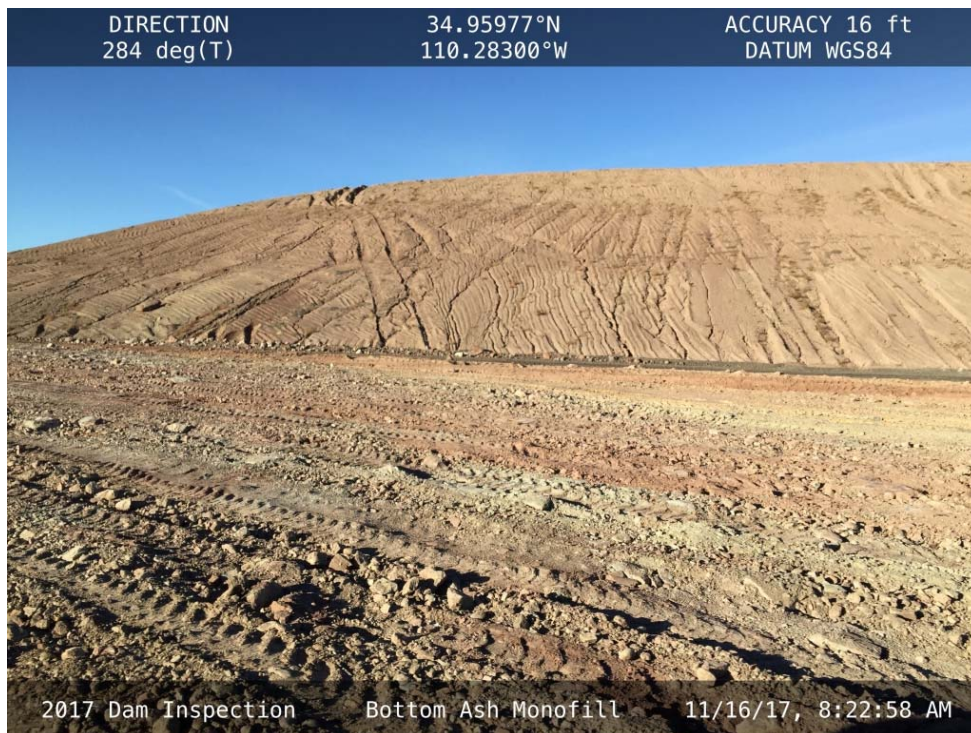
20161019 – IMG_5748

Minor erosion rills along the eastern side of the Bottom Ash Monofill, facing west.
