# CHOLLA POWER PLANT Fly Ash Dam, Bottom Ash Dam, Sedimentation Pond, and Bottom Ash Monofill

## Annual CCR Impoundment and Landfill Inspection Report

2020

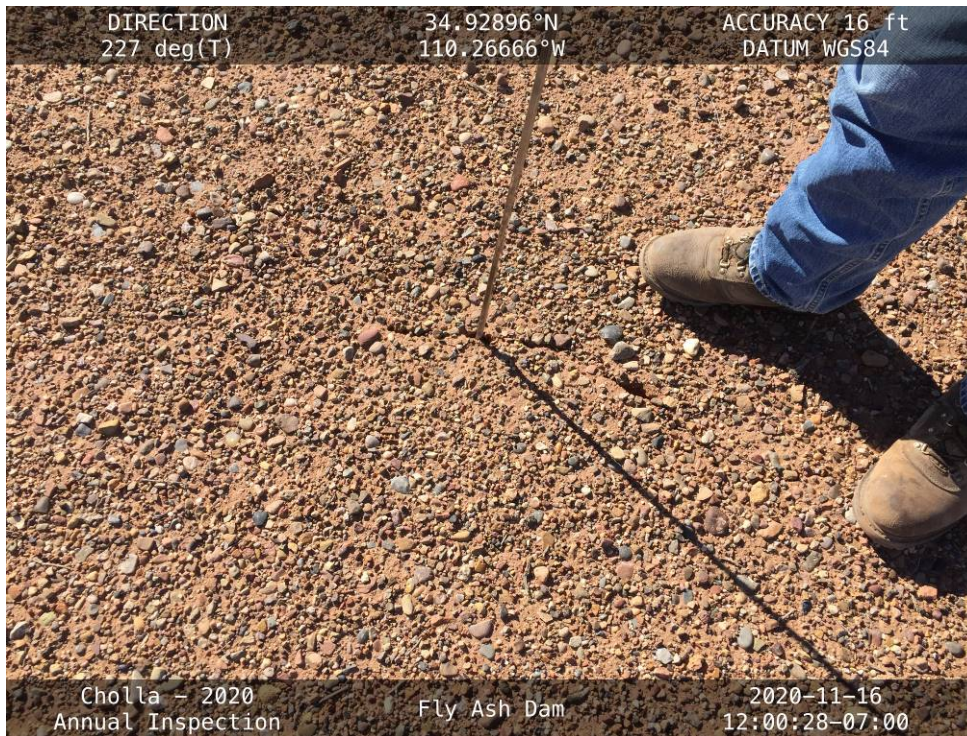
**20201116 – IMG\_2328**

Part of a 20-foot long discontinuous crack near the upstream shoulder on the West Embankment.

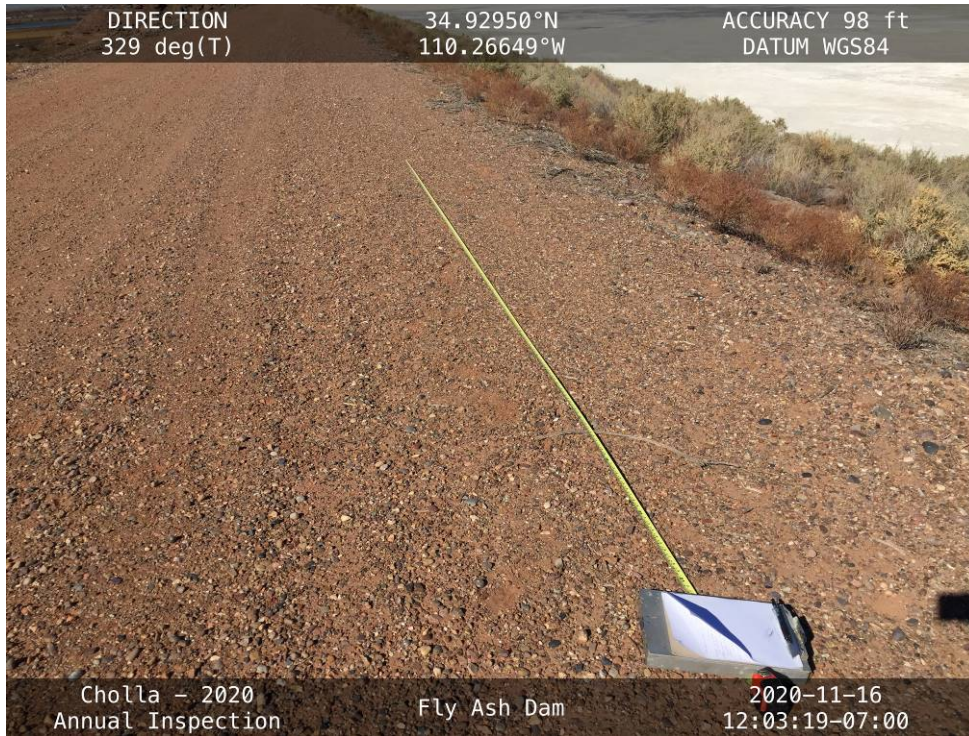
**20201116 – IMG\_2331**

- ii. A shallow (up to 2-inches deep), discontinuous, longitudinal crack was observed spanning a length of 20 feet along the upstream half of the crest near M-5B (Photo IMG\_2331). The deepest portion of the crack spanned approximately 3 feet (Photo IMG\_2328). The crack should be marked and monitored during weekly inspections. If the crack is observed to grow or deepen, it should be repaired and its cause should be investigated.

The 20-foot long discontinuous crack near the upstream shoulder on the West Embankment.

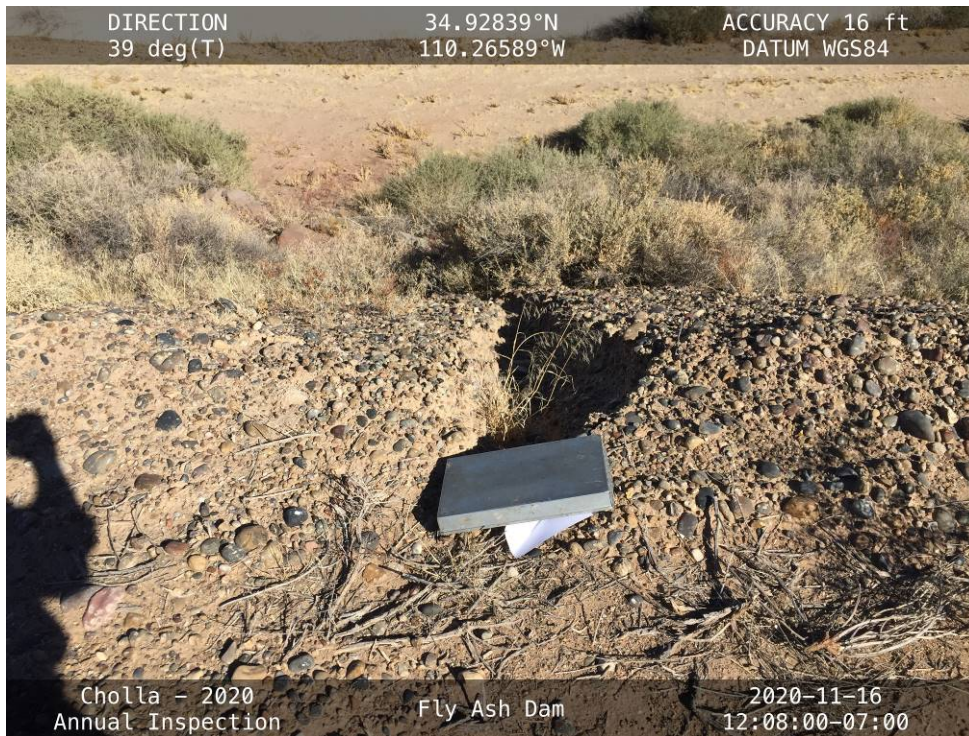
**20201116 – IMG\_2344**

- iii. Minor erosion was observed along the upstream slope near the piezometers screened in the dam core (Photos IMG\_2344 and IMG\_2351). The eroded portion was observed to be relatively unchanged during this inspection compared to the 2019 inspection. The affected portion of the upstream slope is part of the dam crest widening constructed in early 2000 to accommodate piezometer installation activities. The crest is approximately 40 feet wide in this area (compared to the design crest width of 24 feet). The erosion appears to be in the extended portion and is not affecting the original crest.

Minor erosion on the upstream side of the crest in an area where the crest is wider.

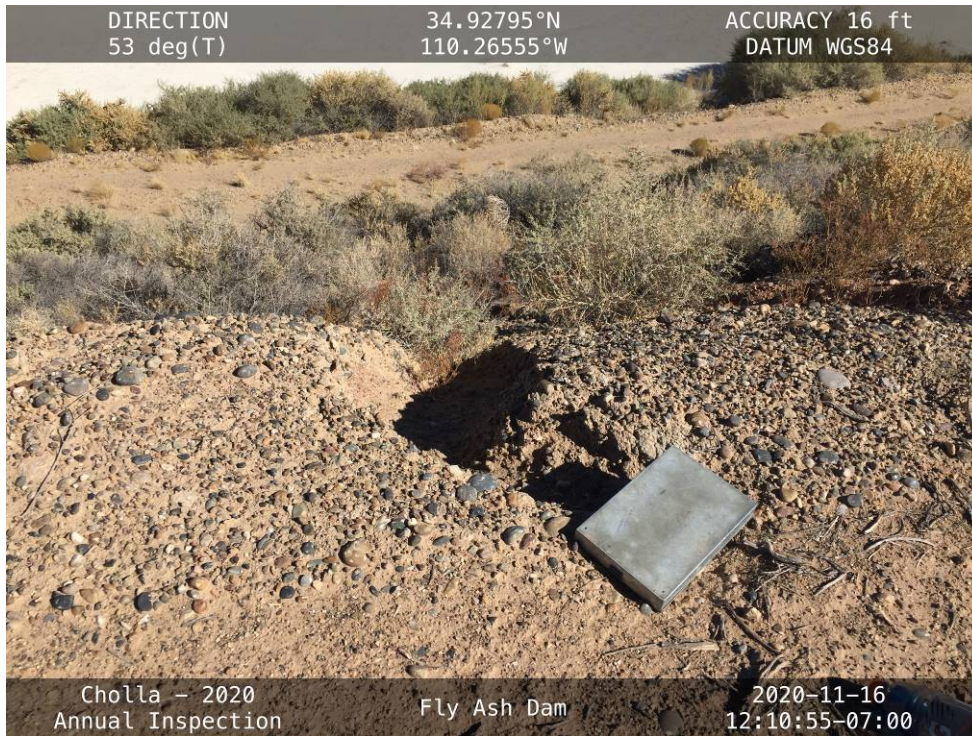
**20201116 – IMG\_2351 – see IMG\_5729 from 2019**

Minor erosion on the upstream side of the crest in an area where the crest is wider.

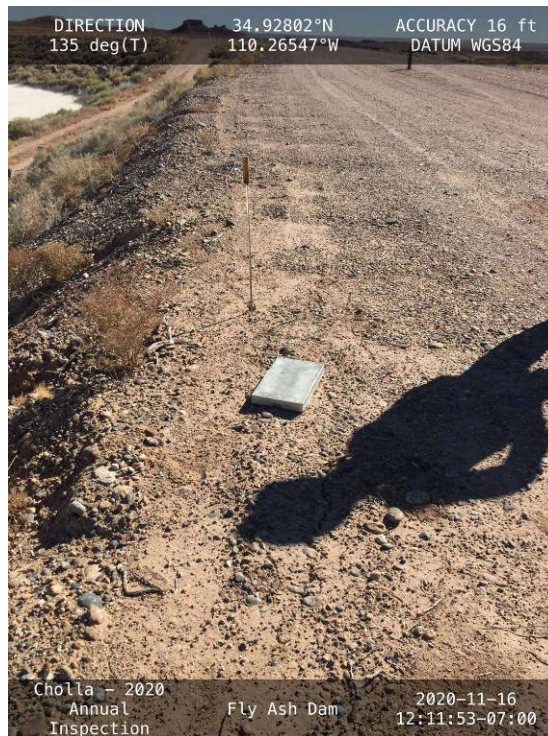
**20201116 – IMG\_2353**

A second 6-foot long crack was observed in the wider portion of the upstream shoulder south of Piezometer F-124 (Photo IMG\_2353). This crack is near areas of minor erosion on the upstream slope and is in part of the dam crest that was widened in early 2000 to accommodate piezometer installation activities. This crack should be marked and monitored during weekly inspections. If the crack is observed to grow or begin to affect the original dam crest, it should be repaired and its cause should be investigated.

A 6-foot long crack along the upstream shoulder on the West Embankment near F-124.

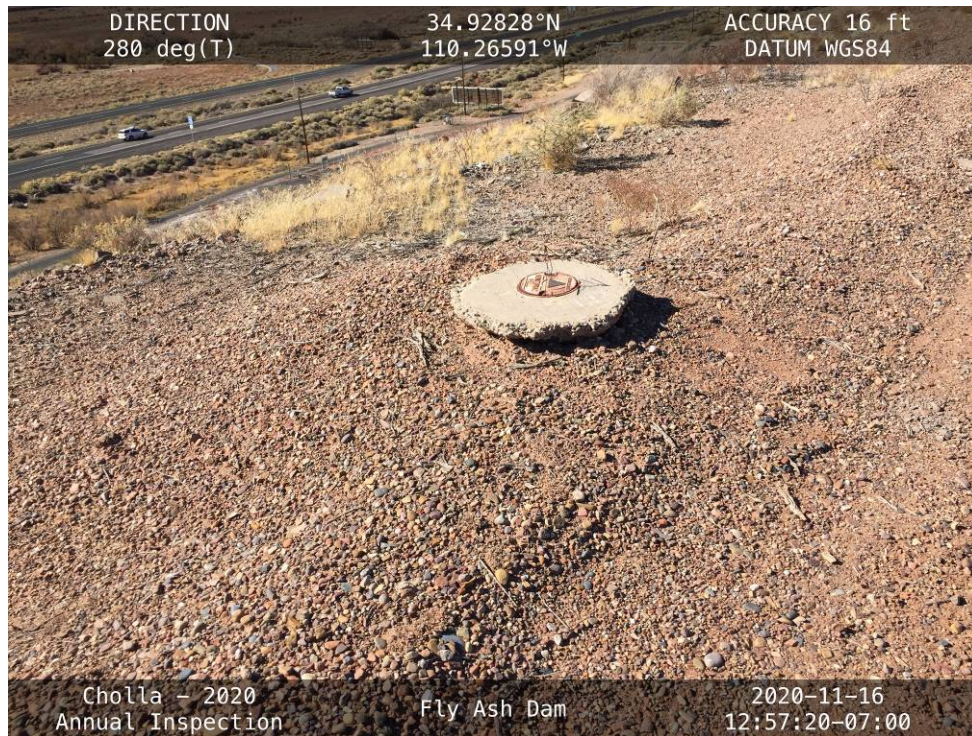
**20201116 – IMG\_2428**

Erosion around a monitoring well on the downstream shoulder of the West Embankment crest.

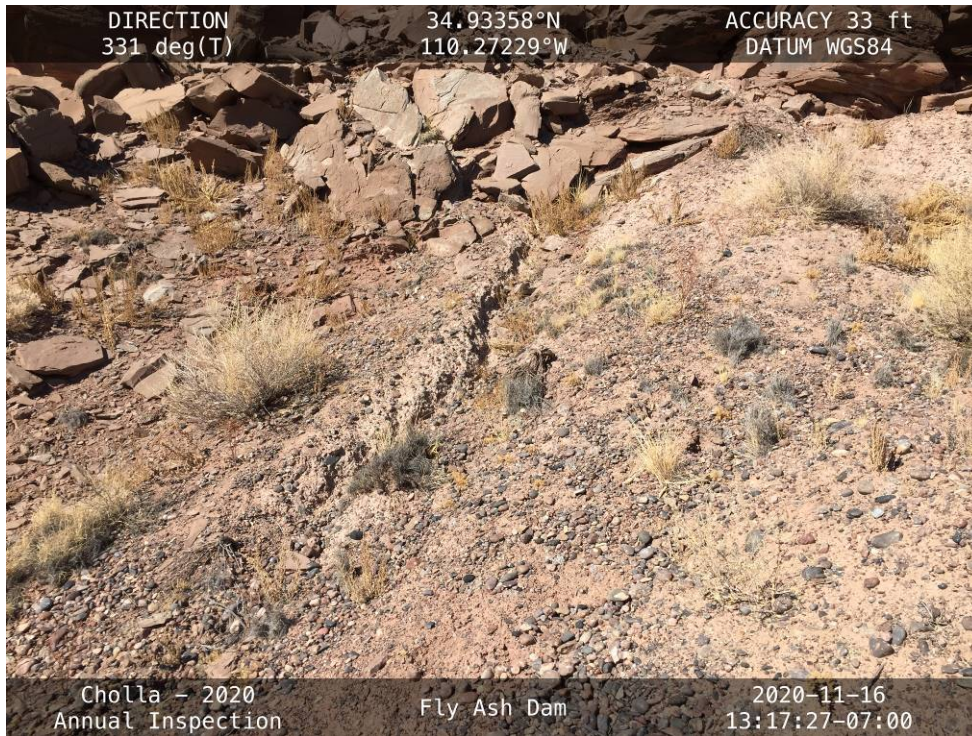
**20201116 – IMG\_2447**

Minor erosion along downstream side of the Northwest Abutment contact.

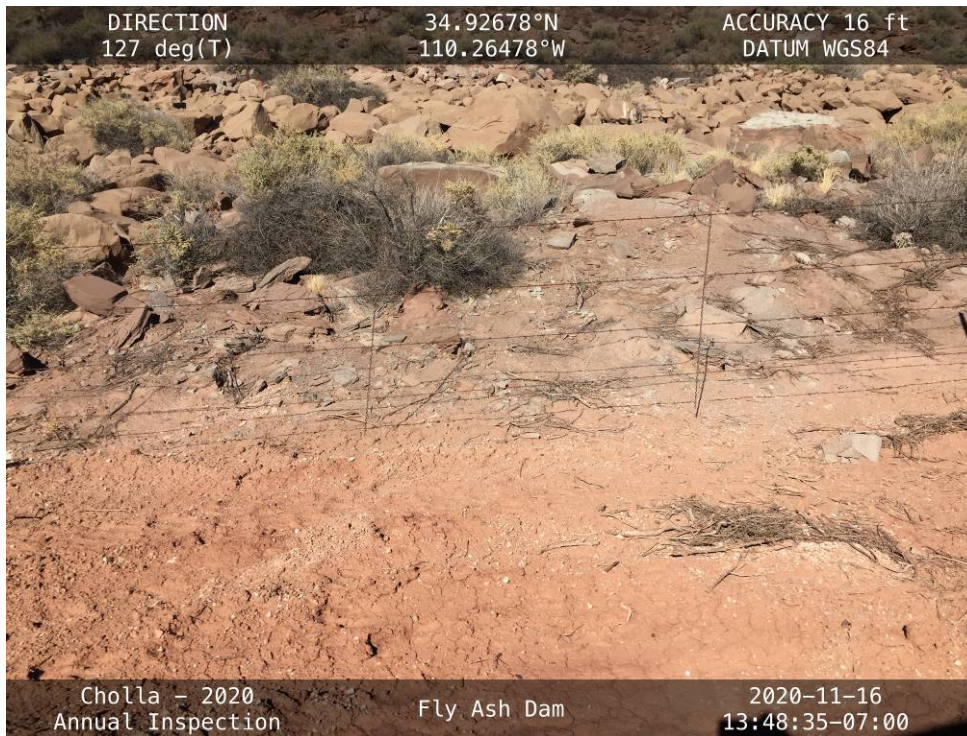
**20201116 – IMG\_2508**

Deteriorating riprap along the downstream toe of the South Emankment.

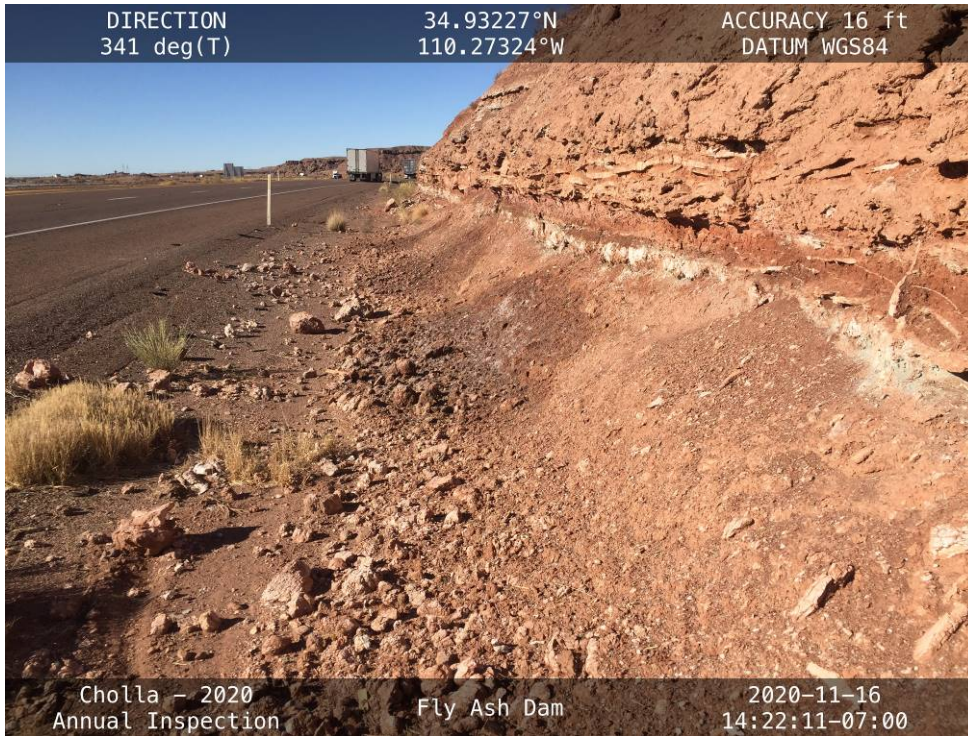
The I-40 seep was observed to be relatively more damp during this inspection than it was during the 2019 inspection (Photos IMG\_2580 and IMG\_2584).

**20201116 – IMG\_2580**  
The I-40 seep.

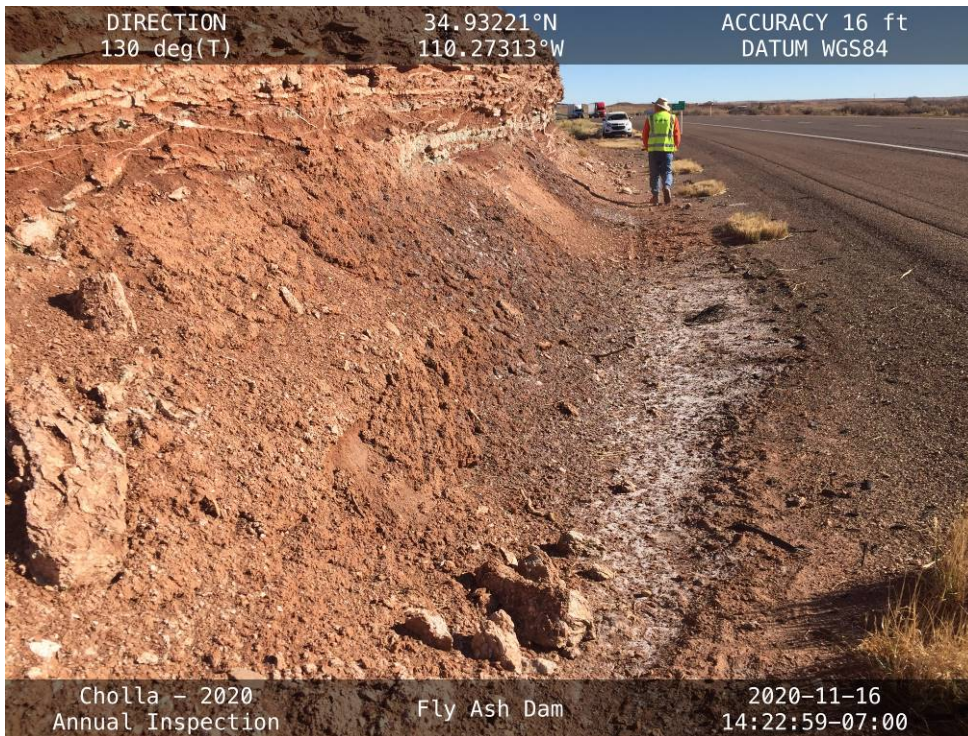
**20201116 – IMG\_2584**  
The I-40 seep.

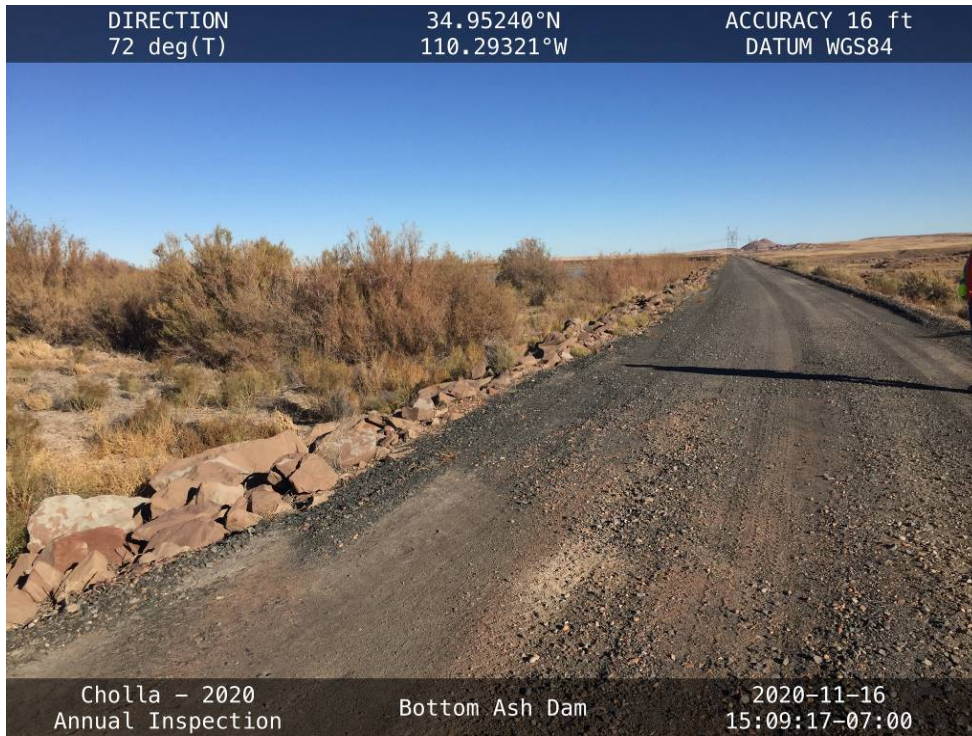
**20201116 – IMG\_2593**

Trees and other woody vegetation to be removed from the South Embankment upstream slope.

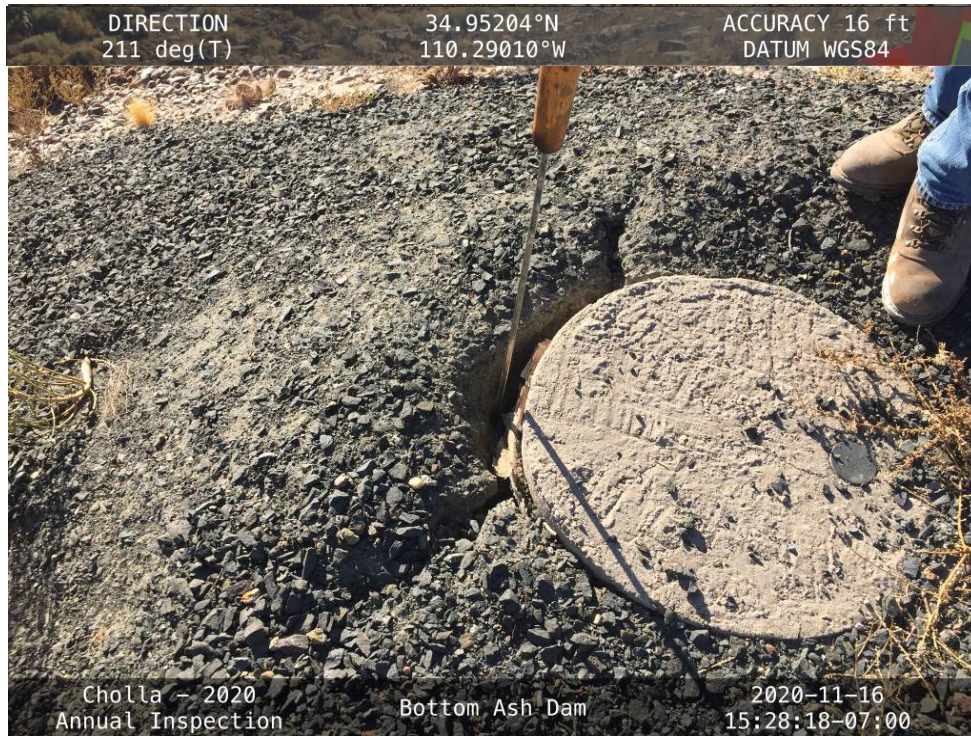
**20201116 – IMG\_2642**

- ii. There is a crack in the support material on the downstream side of settlement monument M-13. The surrounding fill is beginning to separate from the concrete (Photo IMG\_2642). The fill does not affect the structural integrity of the dam, but the crack should be monitored and repaired if abnormal movements are indicated at M-13.

The support material on the downstream side of M-13 starting to separate from the concrete.

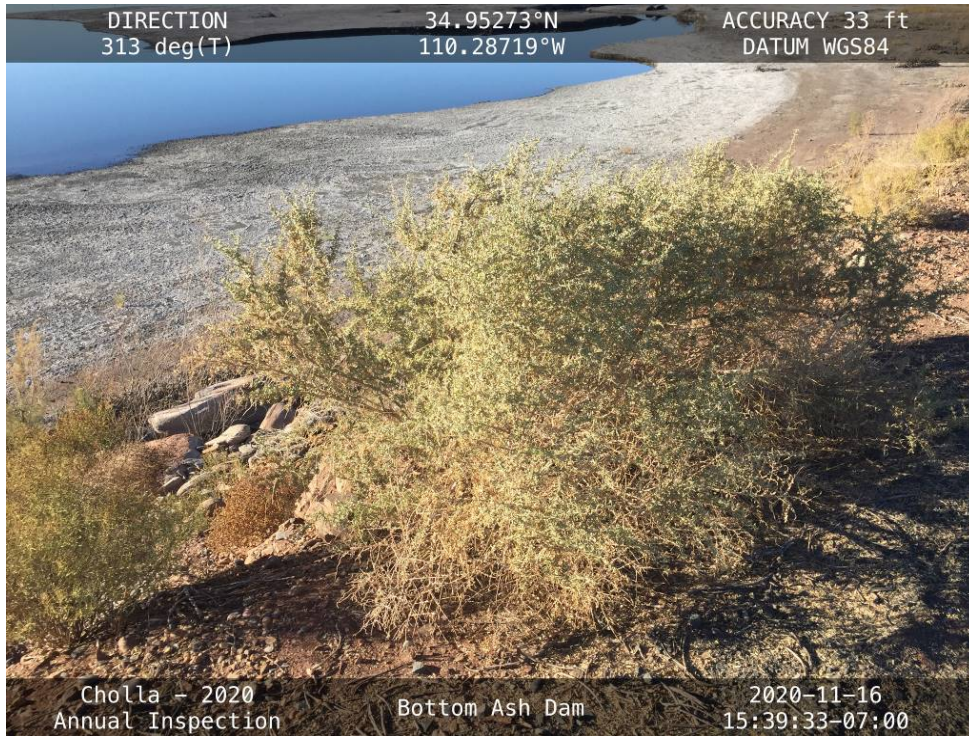
**20201116 – IMG\_2689**

Vegetation to be removed from the upstream slope of the East Embankment.

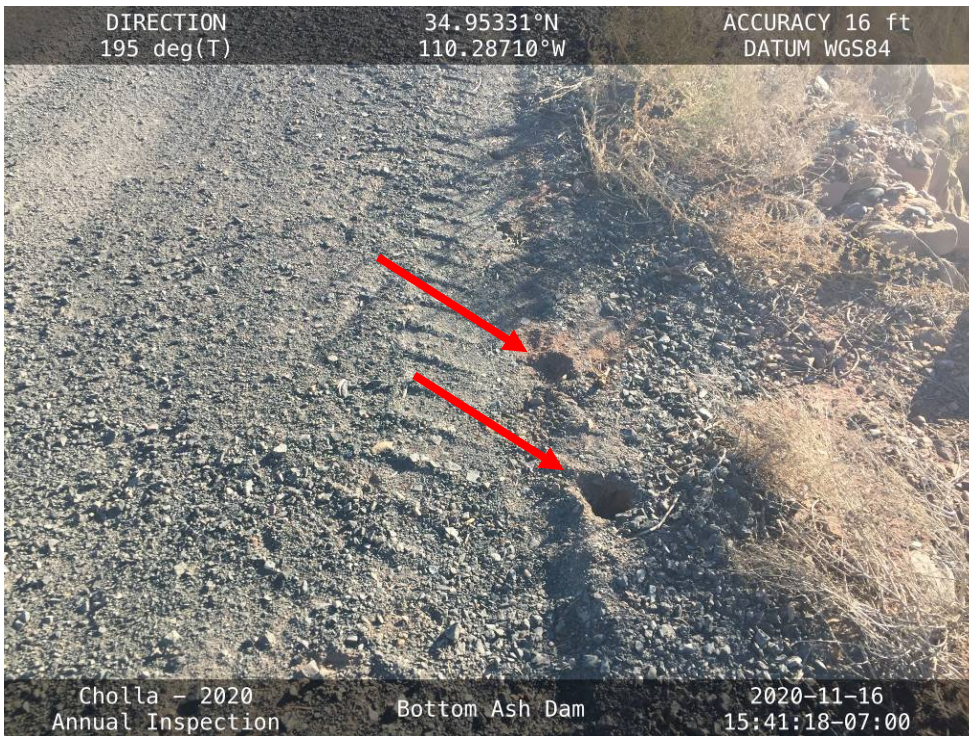
**20201116 – IMG\_2694**

- iii. APS recently bladed the dam crest. As a result, no holes were observed on the South Embankment crest and fewer erosion holes were observed on the East Embankment crest compared to the 2019 inspection (Photos IMG\_2694, IMG\_2695, IMG\_2700, IMG\_2704, and IMG\_2718). None of the holes observed during this inspection appeared to extend deeper than 1 foot.

Two shallow holes along the upstream shoulder of the East Embankment.

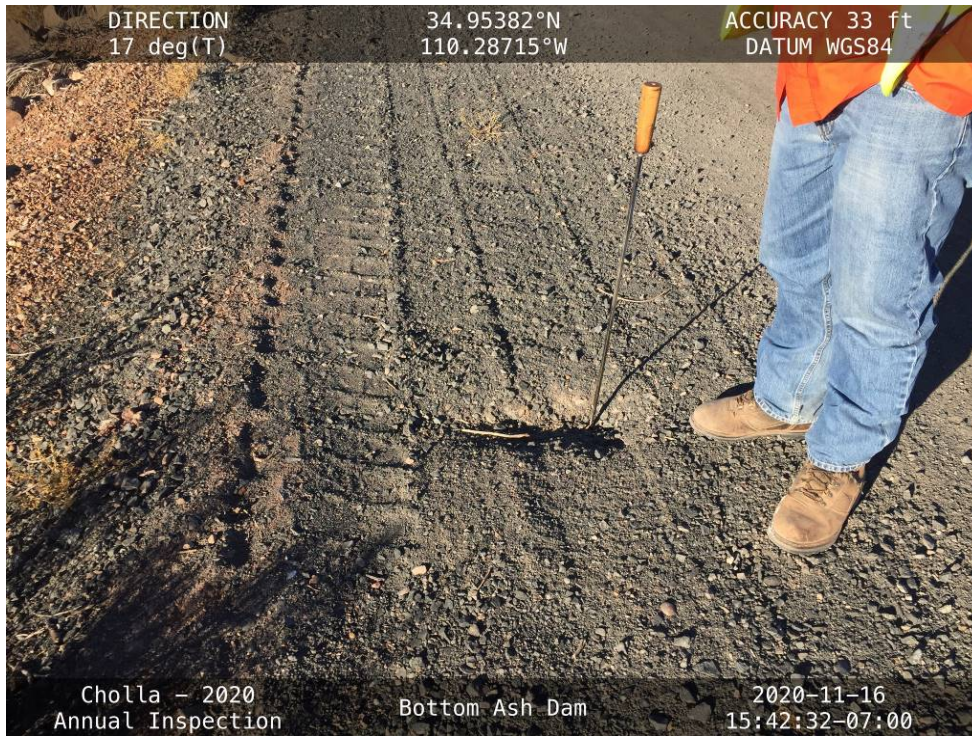
**20201116 – IMG\_2695**

A shallow hole along the upstream shoulder of the East Embankment.

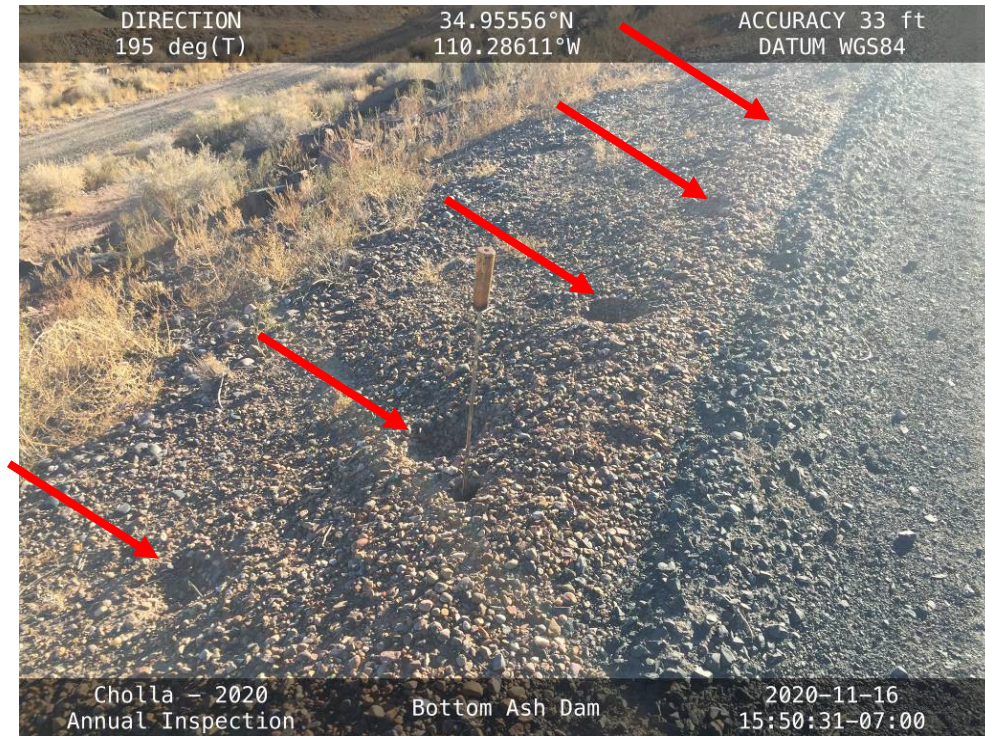
**20201116 – IMG\_2700**

A series of holes on the downstream shoulder of the East Embankment.

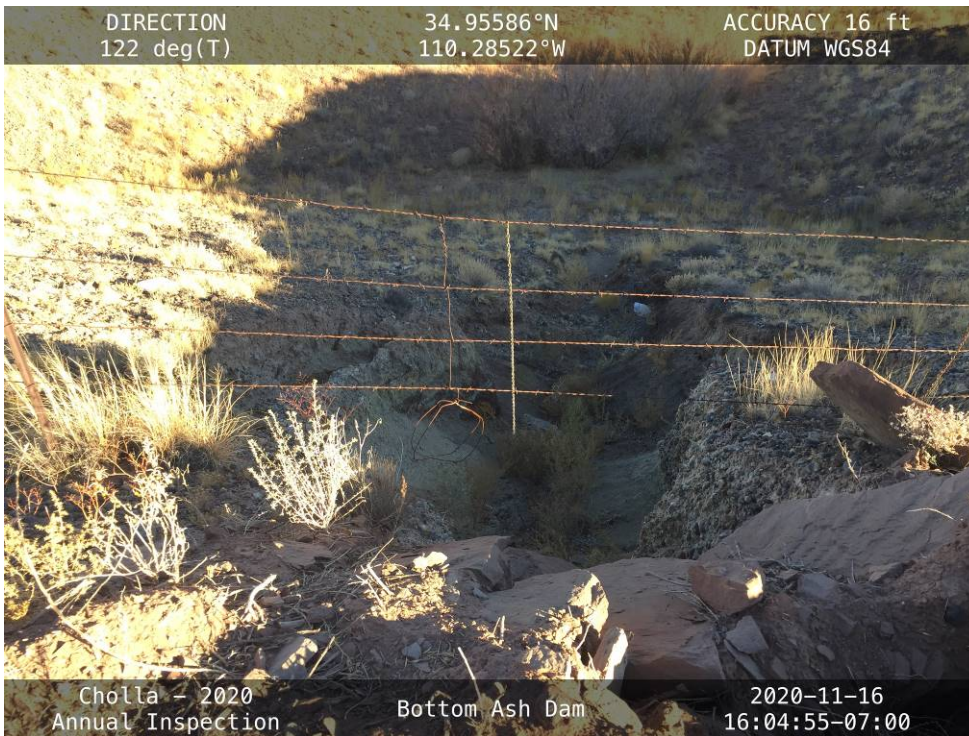
**20201116 – IMG\_2759**

Bottom Ash Dam		SID: 09.27	N/A	No	Yes	Mon	Rep	Inv
<b>5</b>	<b>DOWNSTREAM SLOPE</b>							
a	Erosion?	Erosion gullies at the toe of the East Embankment downstream slope do not appear to be affecting the embankment (Photos IMG 2748 and IMG 2759).		X		X		
b	Inadequate ground cover?			X				
c	Adverse vegetation?	Much of the dense vegetation and all of the woody vegetation observed near the West Abutment Weir during previous inspections has been removed (Photo IMG 2825). Continue to monitor the area and remove vegetation in accordance with the NMOSE (2011) guidance.		X		X		
d	Longitudinal/Transverse cracking?			X				
e	Inadequate riprap?			X				
f	Stone deterioration?	Riprap deterioration does not appear to have accelerated since the previous inspection.			X	X		
g	Settlements, slides, depressions, bulges?				X			
h	Soft spots or boggy areas?	See comment v.			X	X		
i	Movement at or beyond toe?			X				
j	Animal burrows?	None observed. Continue to monitor.		X		X

- iv. Continue to monitor the erosion around the siphon line encasements (Photo IMG\_2646), soil wasting, and erosion gullies (Photos IMG\_2748 and IMG\_2759) observed during the 2018 inspection. Repair erosion if the eroded depth exceeds 1 foot. Investigate the source of sediment collecting in the diversion ditch between the East Embankment access road and the East Embankment.

An erosion gully on the downstream slope along the northern half of the East Embankment.

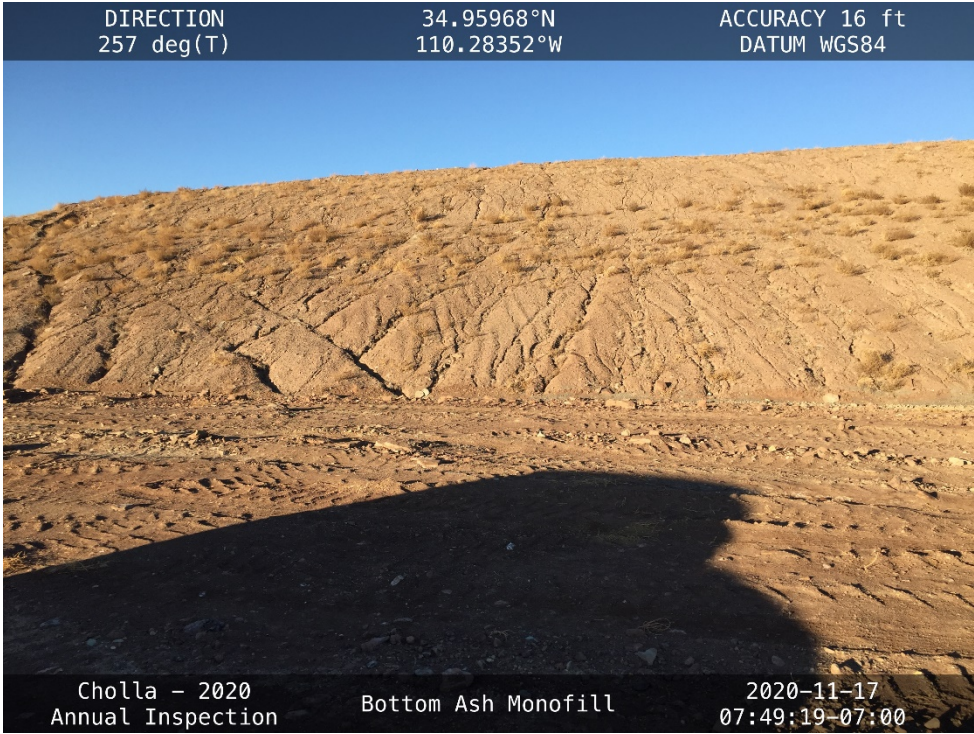
**20201117 – IMG\_2839**

Erosion gullies along the eastern slope of the Bottom Ash Monofill, facing west.

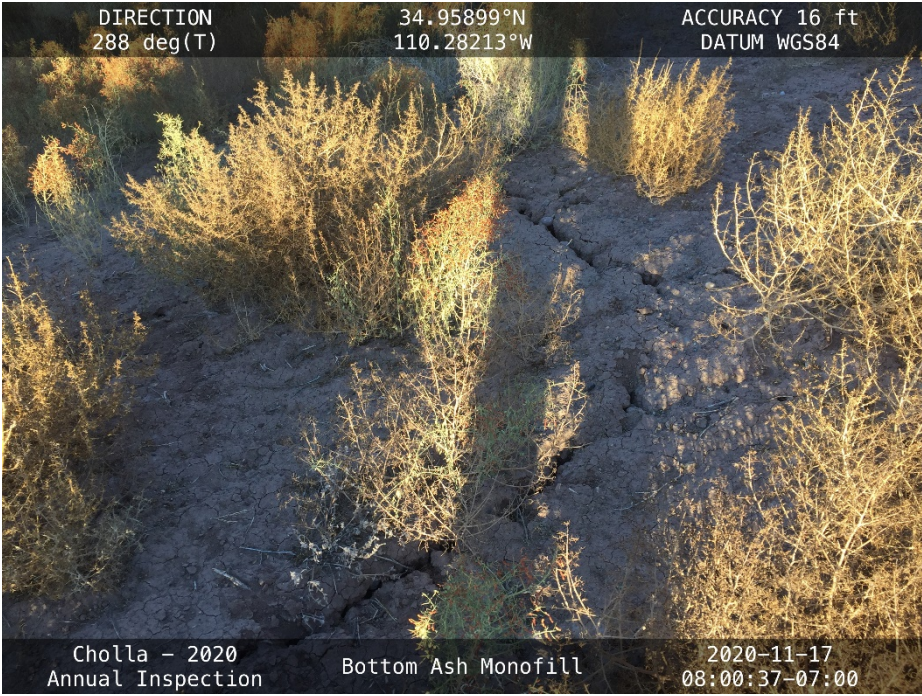
**20201117 – IMG\_2866**  
An incipient erosion rill where erosion was previously repaired in the northeast corner of the Stormwater Detention Basin.

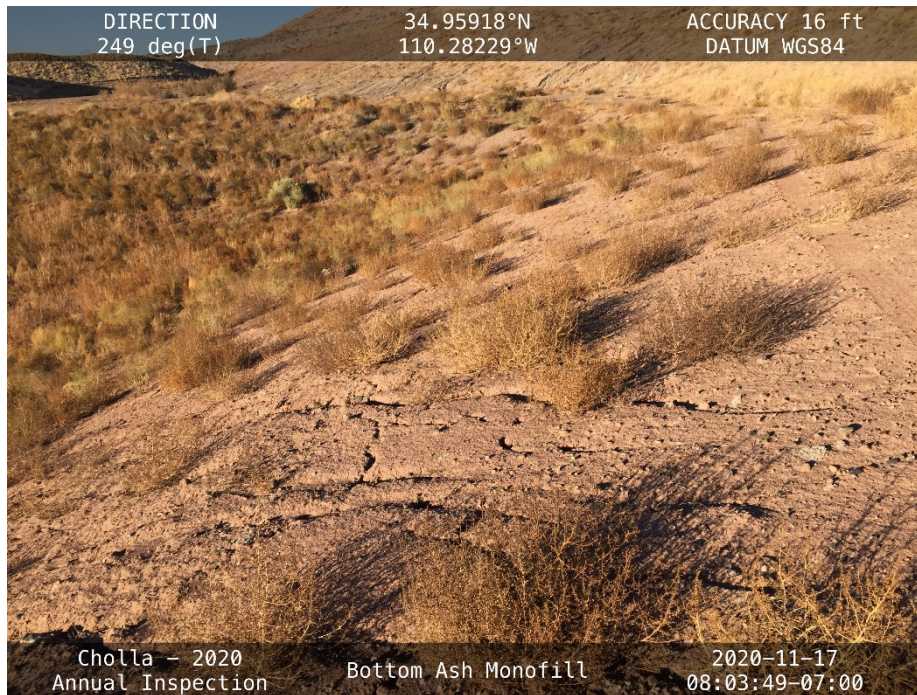
**20201117 – IMG\_2870**

Incipient erosion rills where erosion was previously repaired in the northeast corner of the Stormwater Detention Basin.

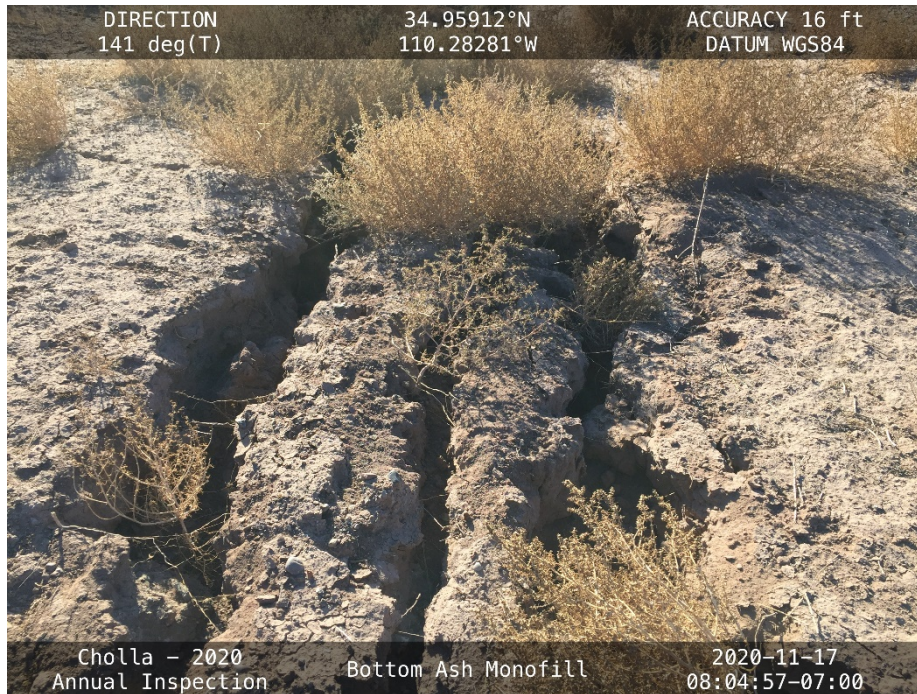
**20201117 – IMG\_2875**

Erosion rills where erosion was previously repaired in the northwest corner of the Stormwater Detention Basin.
