CHOLLA POWER PLANT Fly Ash Dam, Bottom Ash Dam, and Bottom Ash Monofill

Annual CCR Impoundment and Landfill Inspection Report

2022

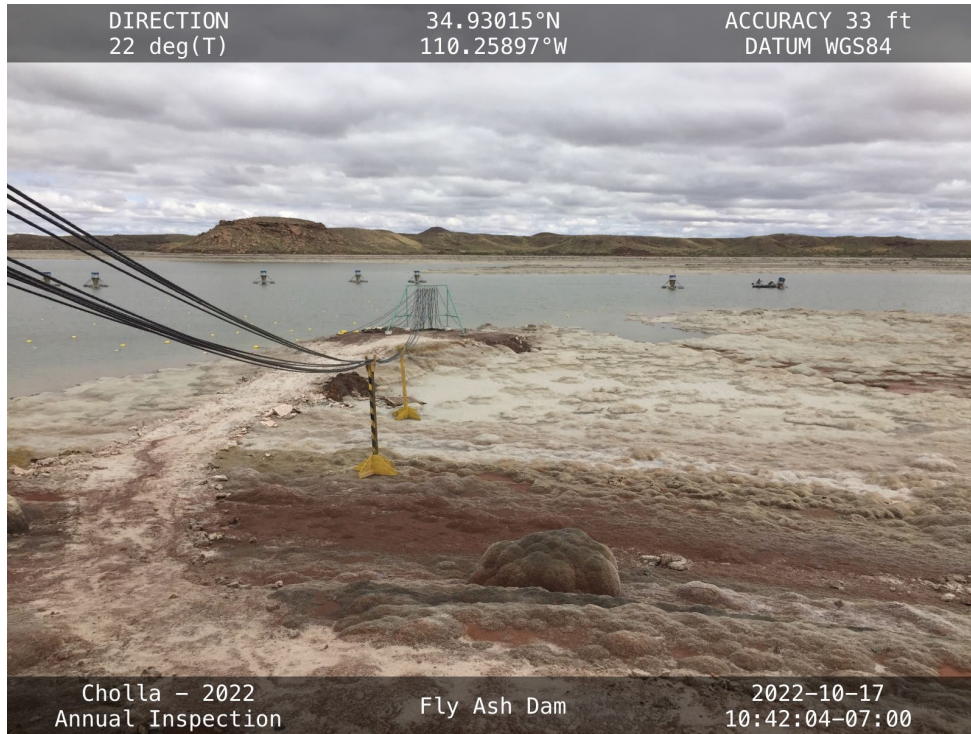
20221017 – IMG_3381

Downdraft evaporators in the Fly Ash Pond. One evaporator being removed for repairs.

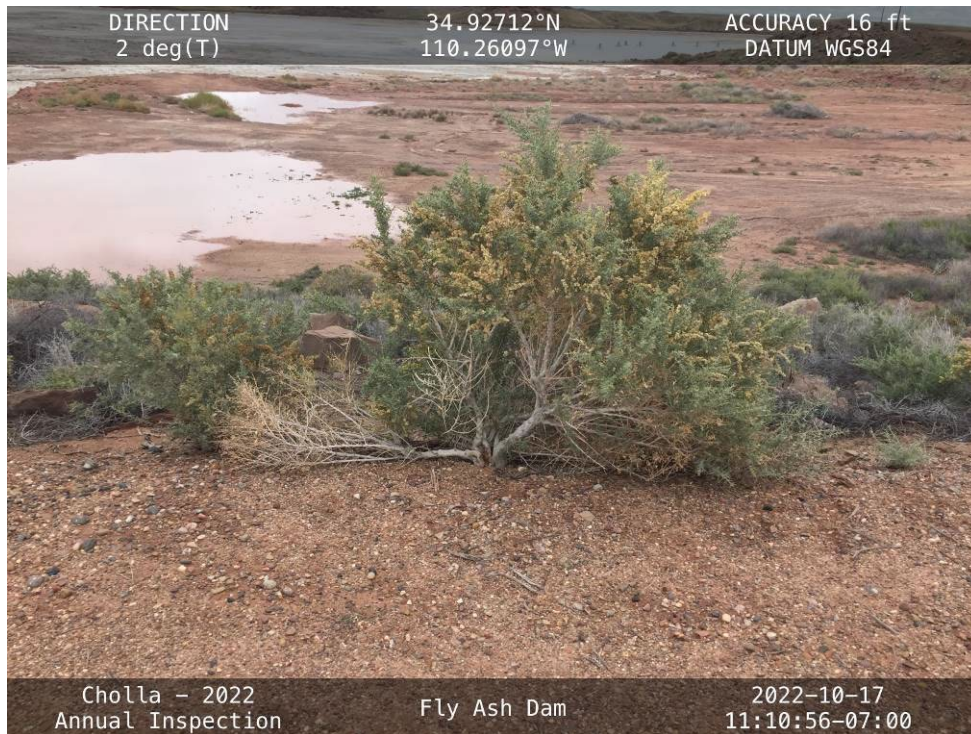
20221017 – IMG_3394

Vegetation to be removed from the upstream shoulder of the South Embankment crest.

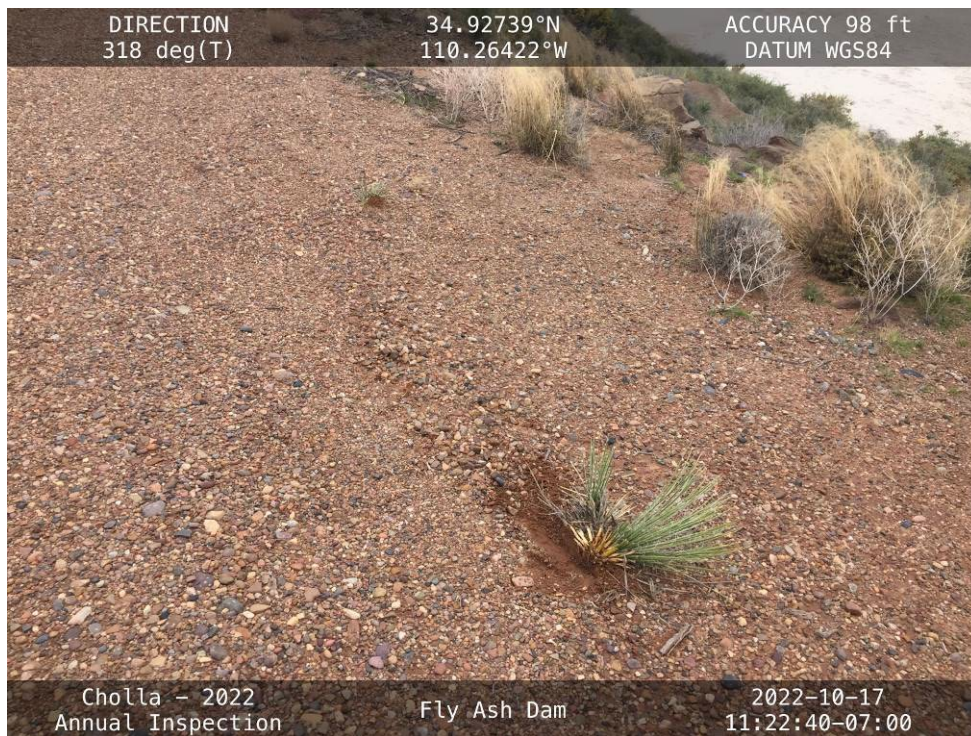
20221017 – IMG_3401

Vegetation growing along the upstream shoulder of the South Embankment.

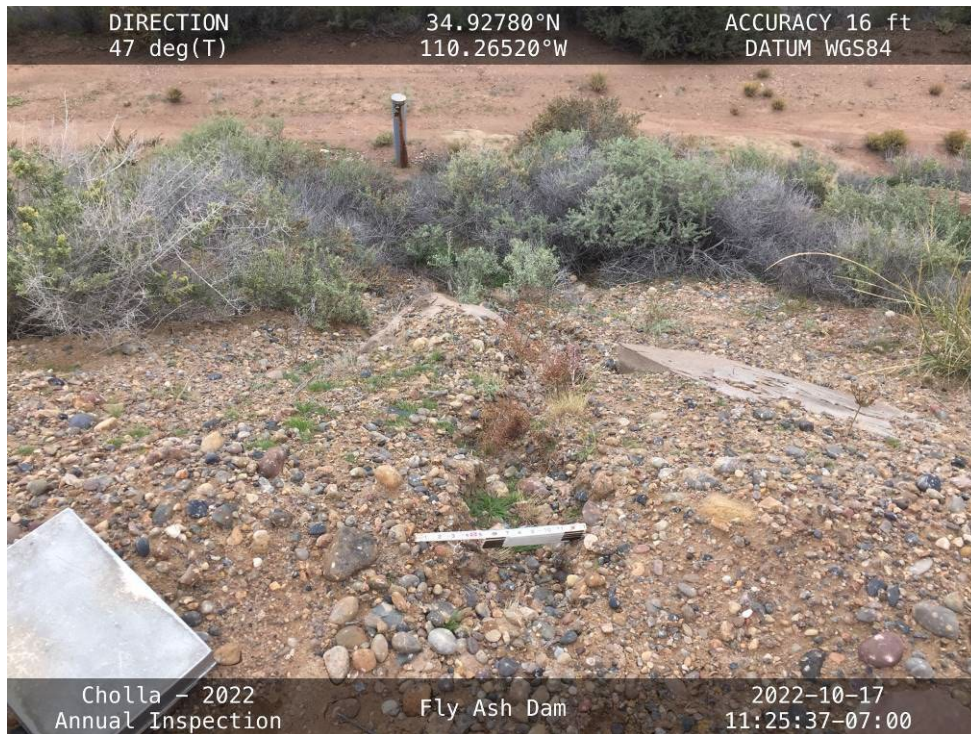
20221017 – IMG_3405

- iii. Minor erosion was observed along the upstream slope near the piezometers screened in the dam core (Photos IMG_3405, IMG_3408, and IMG_3413). The eroded portions were observed to be deeper during this inspection compared to the 2021 inspection. The affected portion of the upstream slope is part of the dam crest widening constructed in early 2000 to accommodate piezometer installation activities. The crest is approximately 40 feet wide in this area (compared to the design crest width of 24 feet). The erosion appears to be within the extended portion and is not affecting the original crest.

Minor erosion on the upstream side of the crest in an area where the crest is wider.

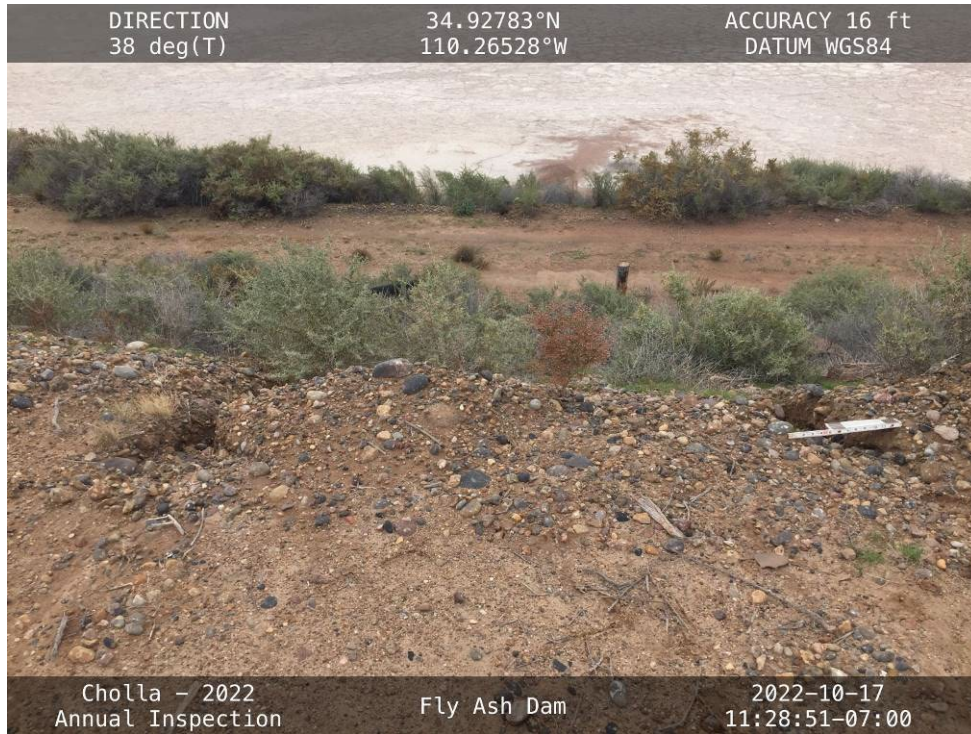
20221017 – IMG_3408

Minor erosion on the upstream side of the crest in an area where the crest is wider.

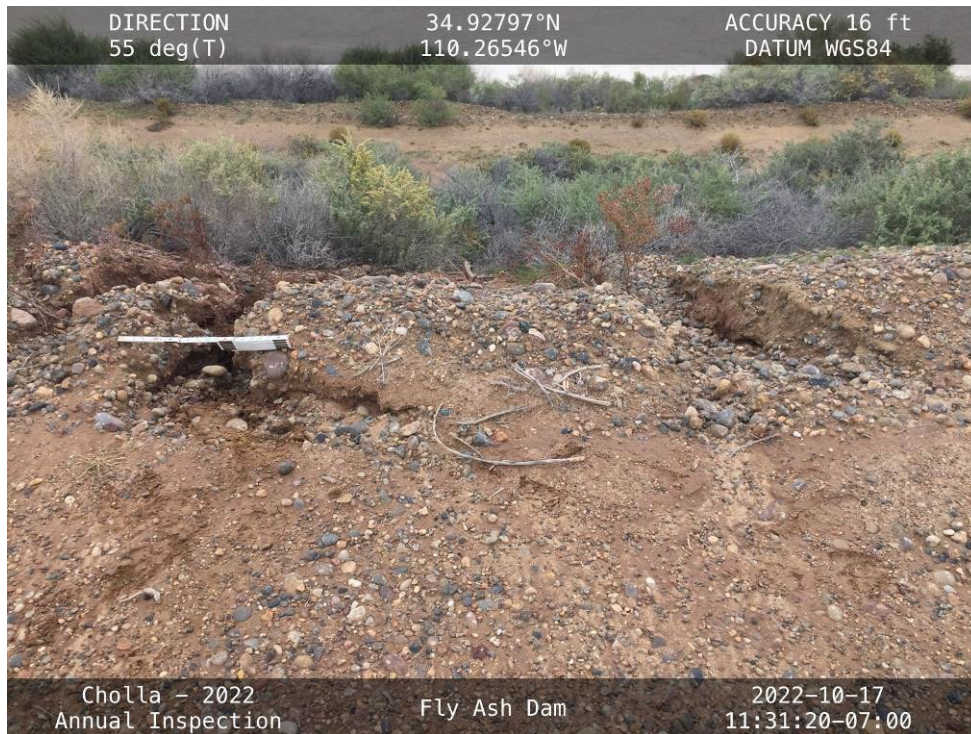
20221017 – IMG_3413

Erosion on the upstream side of the crest in an area where the crest is wider.

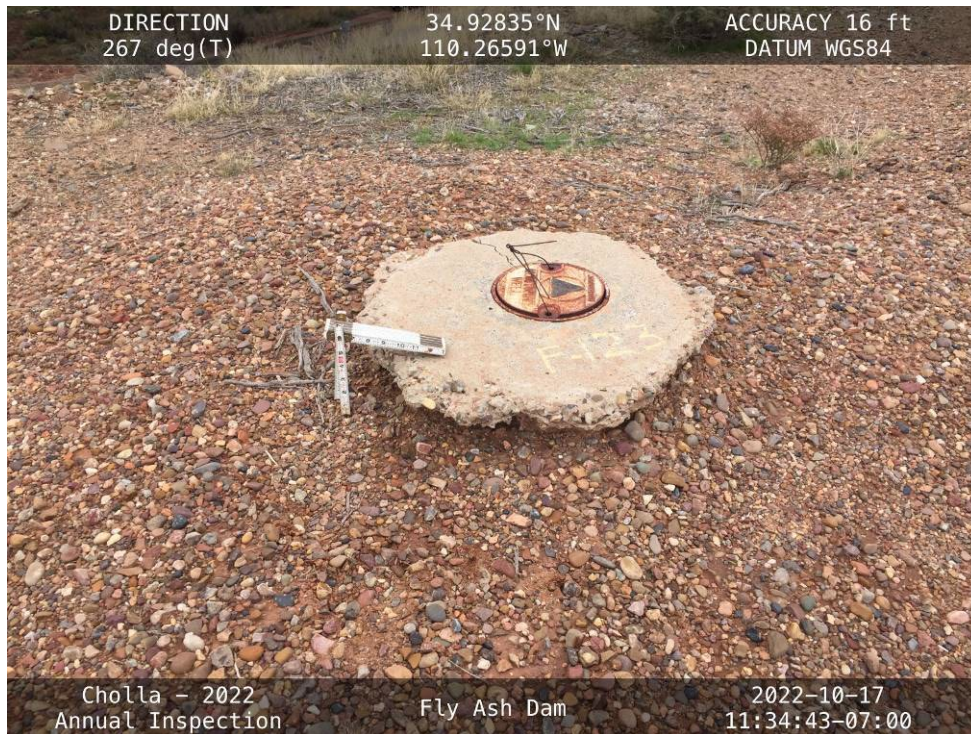
20221017 – IMG_3415

Erosion around piezometer F-123 on the downstream shoulder of the West Embankment crest.

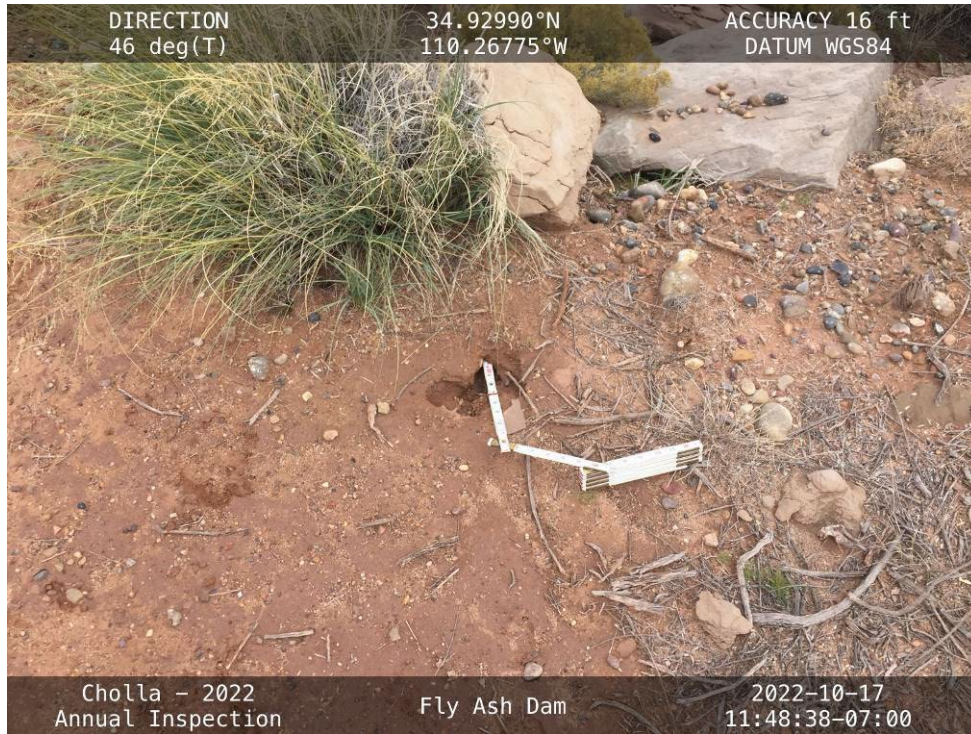
20221017 – IMG_3423

An erosion hole at least 3.5 inches deep along the upstream shoulder of the crest.

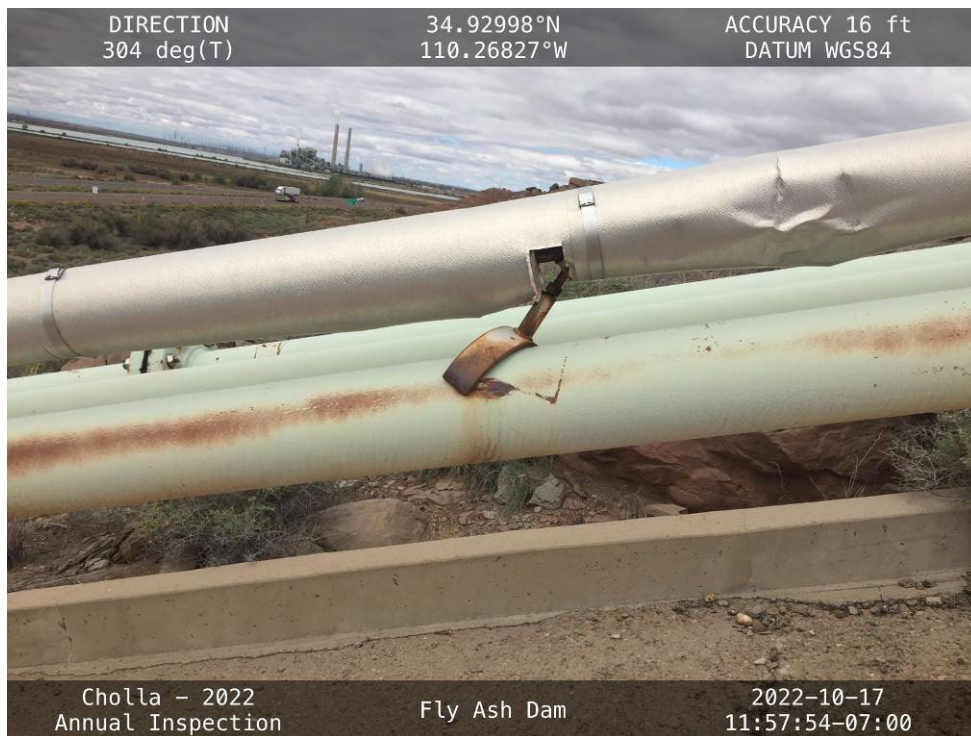
20221017 – IMG_3445

A broken pipe support along the inlet lines.

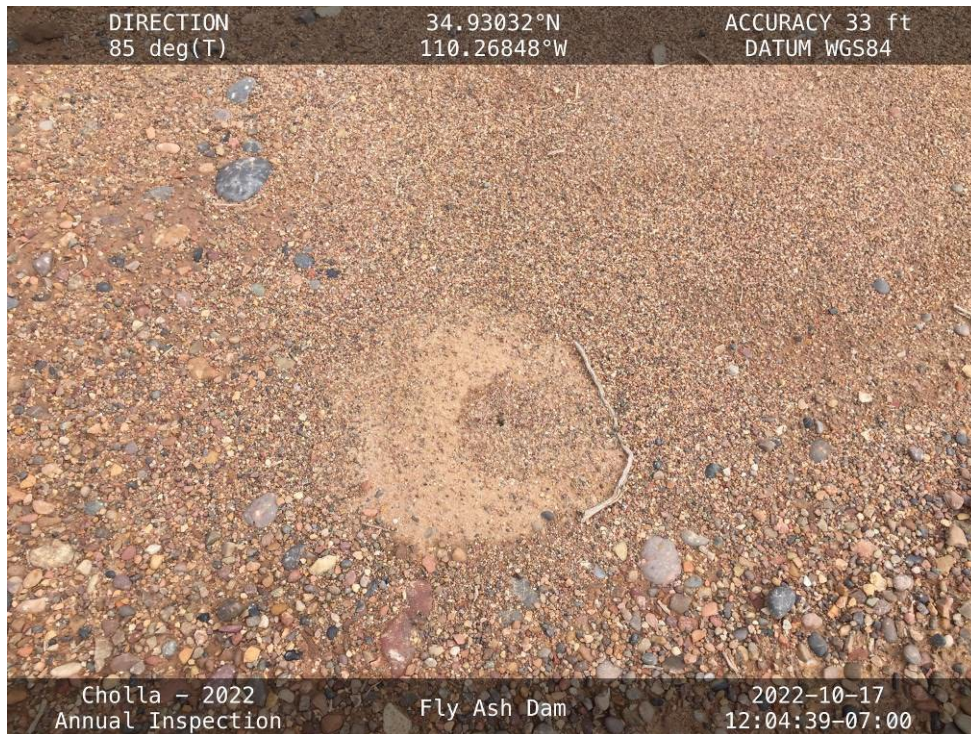
20221017 – IMG_3449
An ant hill on the embankment crest near the inlet lines.

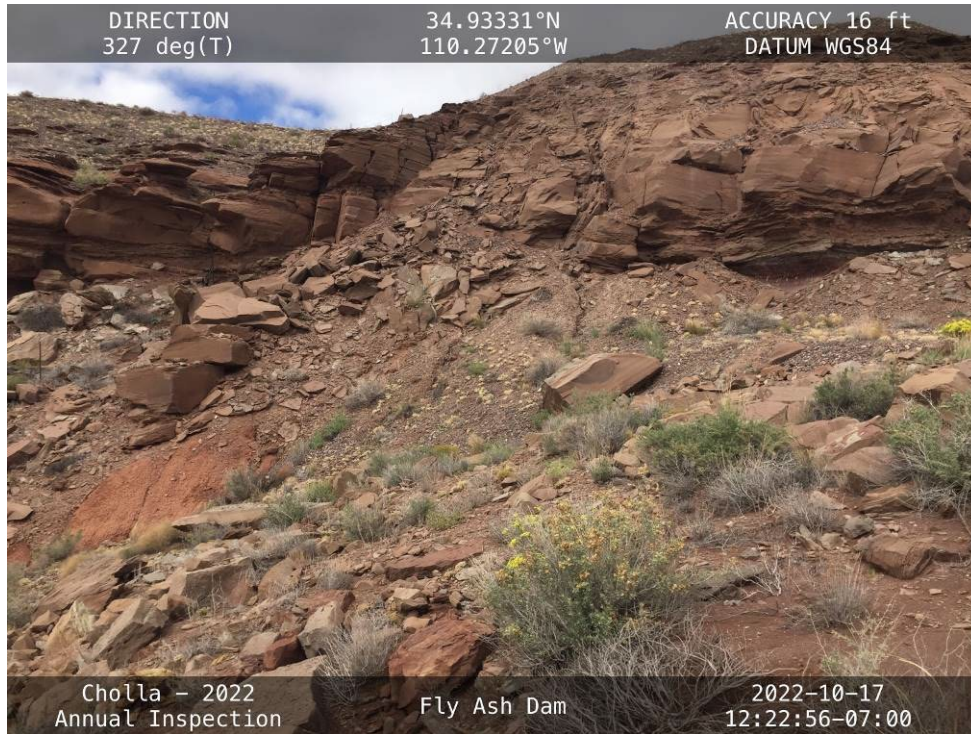
6	ABUTMENT CONTACTS							
a	Erosion?	Approximately 1 foot of erosion observed at the Right Abutment groin. The erosion is in the native rock at the Right Abutment and along the access road at the toe (Photos IMG_3459 and IMG_3492). Continue to monitor.		X		X		
b	Differential movement?			X				
c	Cracks?			X				
d	Settlements, slides, depressions, bulges?			X				
e	Seepage?	Historic seepage has been observed downstream of the Right Abutment during previous inspections. See comment v.		X		X		
f	Animal burrows?	None observed. Continue to monitor.		X		X		
7	SEEPAGE/PIPING CONTROL DESIGN FEATURE(S)							
a	Describe:	1) The Geronimo and Hunt seepage collection and pump back systems are located downstream of the dam near I-40 for fluid interception. See comment v. 2) Discharge from the crest side of the reservoir creates a beach to prevent water from being stored against the upstream face.						
b	Internal drains flowing?				X	X

20221017 – IMG_3459
Erosion on the downstream side of the Right Abutment contact.

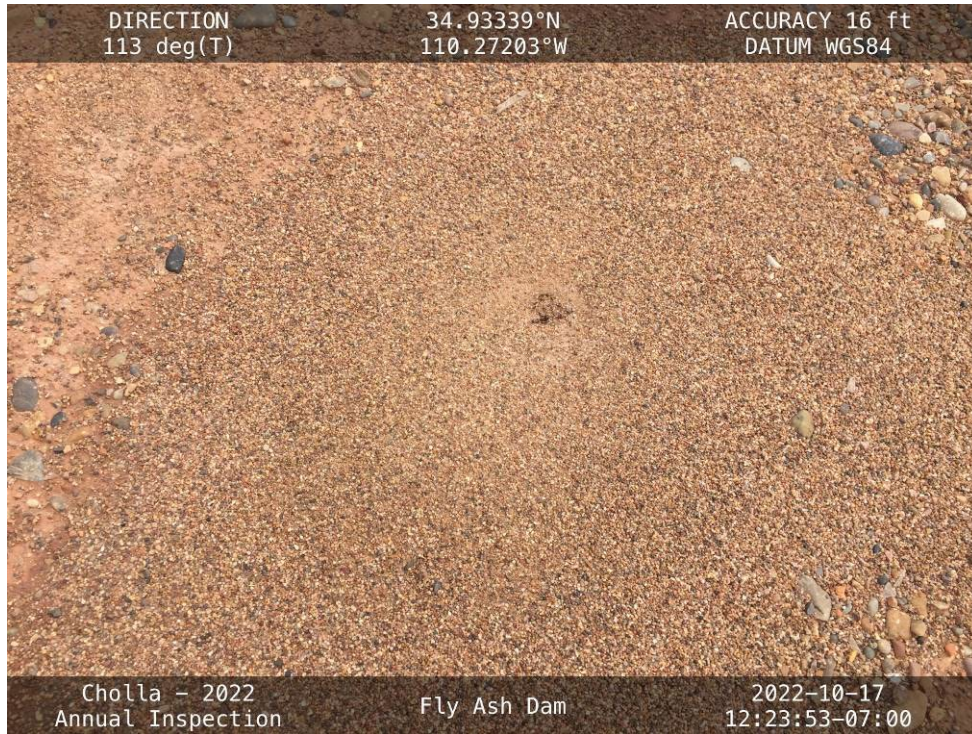
20221017 – IMG_3463
An ant hill on the crest near the Right Abutment.

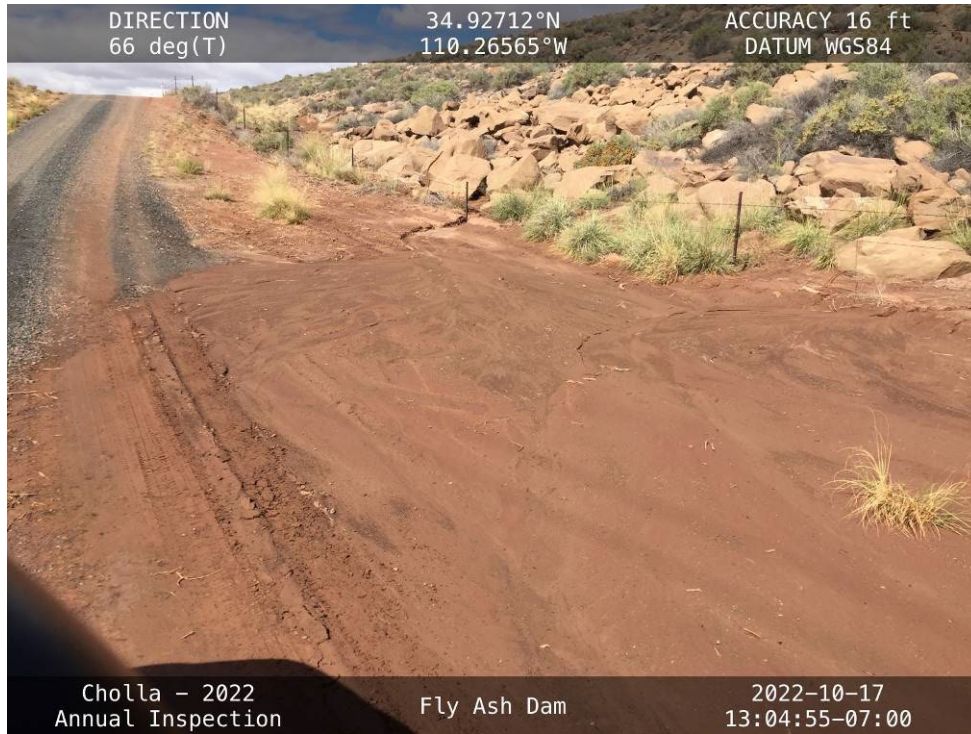
20221017 – IMG_3487

Fly Ash Dam		SID: 09.28	N/A	No	Yes	Mon	Rep	Inv
5	DOWNSTREAM SLOPE							
a	Erosion?	Approximately 1 foot of erosion observed on the ramp near the Geronimo Sump with sediment washed onto the access road (Photo IMG_3487). Sediment deposits at the toe near the Geronimo Sump formed alluvial fans where the sediment originally encountered standing water. Repair and continue to monitor.			X	X	X	
b	Inadequate ground cover?			X				
c	Adverse vegetation?	None observed. Continue to monitor.		X		X		
d	Longitudinal/Transverse cracking?			X				
e	Inadequate riprap?			X				
f	Stone deterioration?	Minor deterioration observed. See comment iv.			X	X		
g	Settlements, slides, depressions, bulges?			X				
h	Soft spots or boggy areas?	There is evidence of historic seepage beyond the downstream toe. Continue to monitor.			X	X		
i	Movement at or beyond toe?			X				
j	Animal burrows?	None observed. Continue to monitor.		X		X

Sediment eroded from the South Embankment slope onto the Geronimo sump access road.

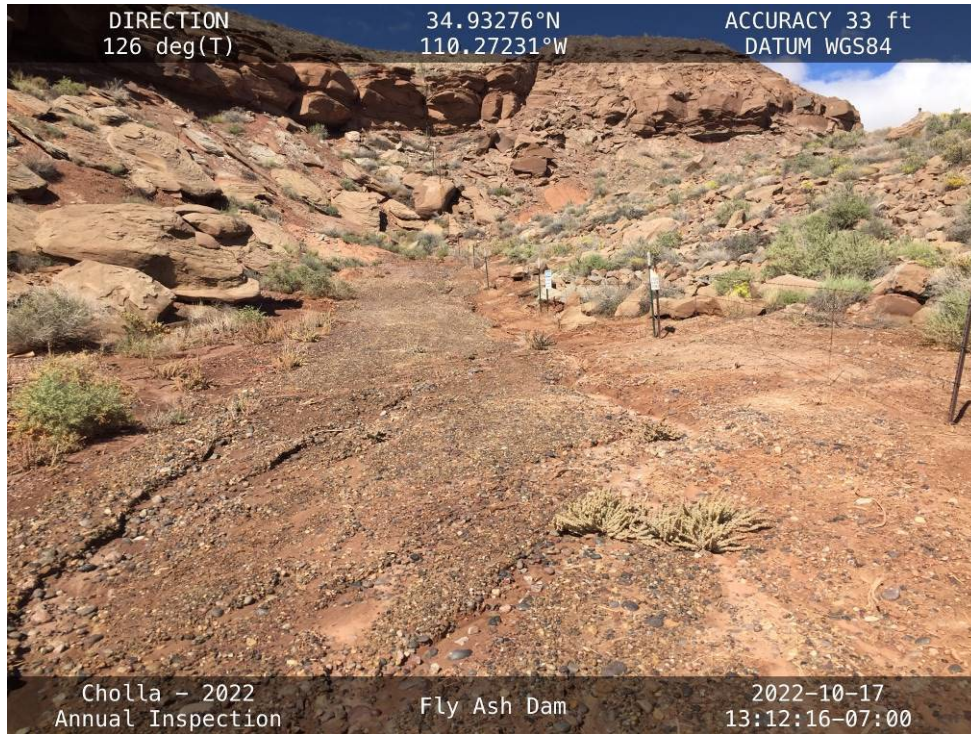
20221017 – IMG_3492

The Right Abutment groin on the downstream slope, facing toward the abutment contact.

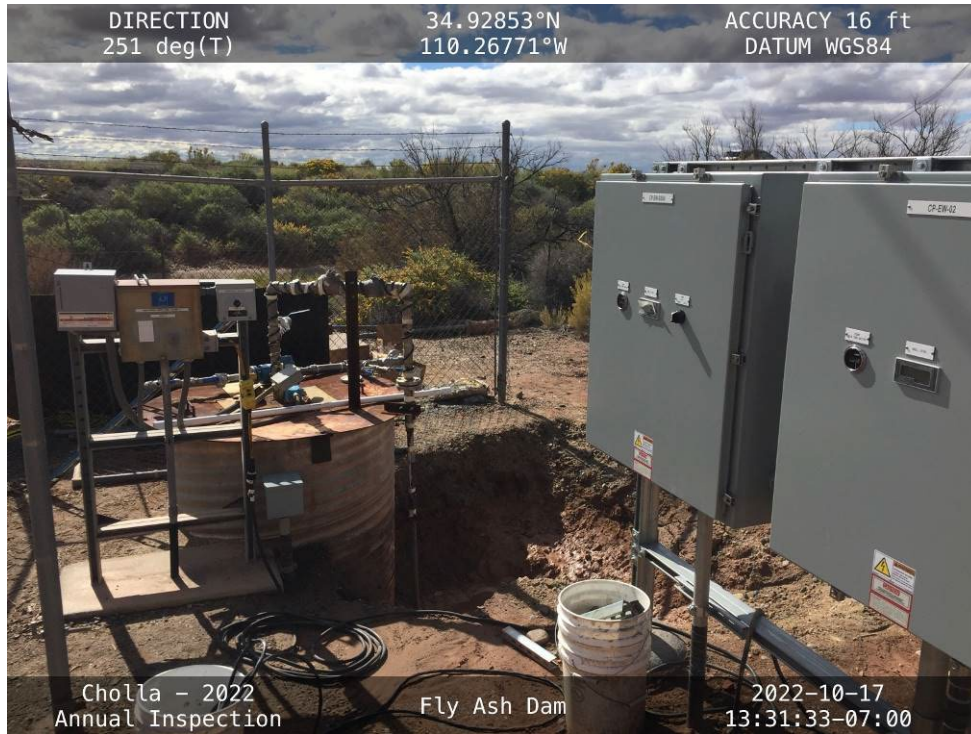
20221017 – IMG_3530
 Geronimo Seep Well Pump D in the process of being replaced.

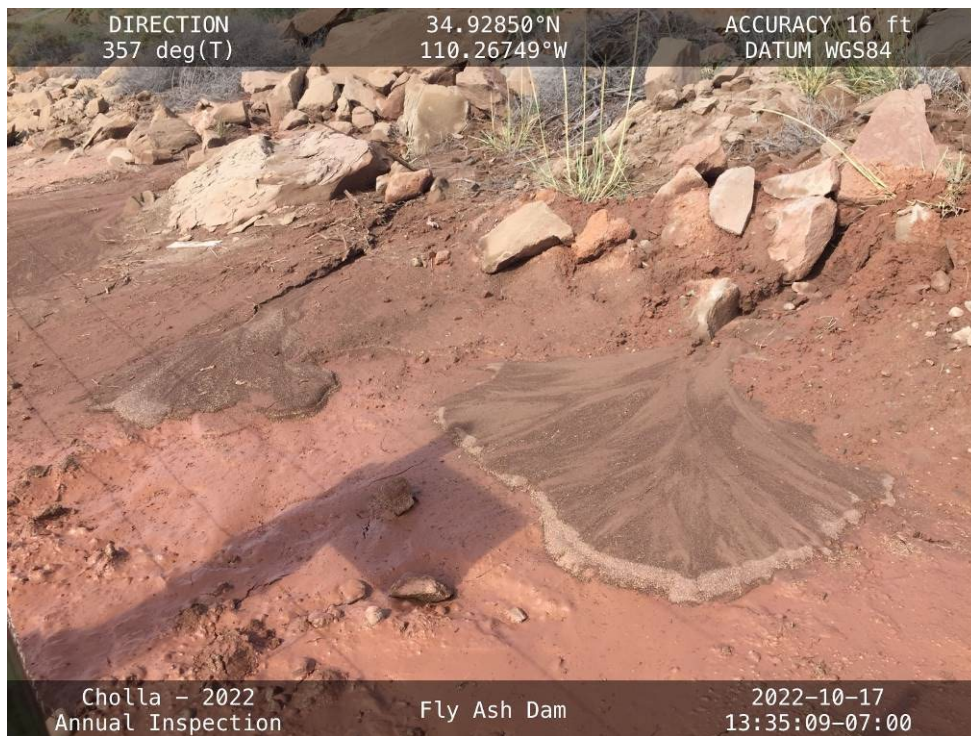
20221017 – IMG_3541
 Two alluvial fans at the toe of the West Embankment.

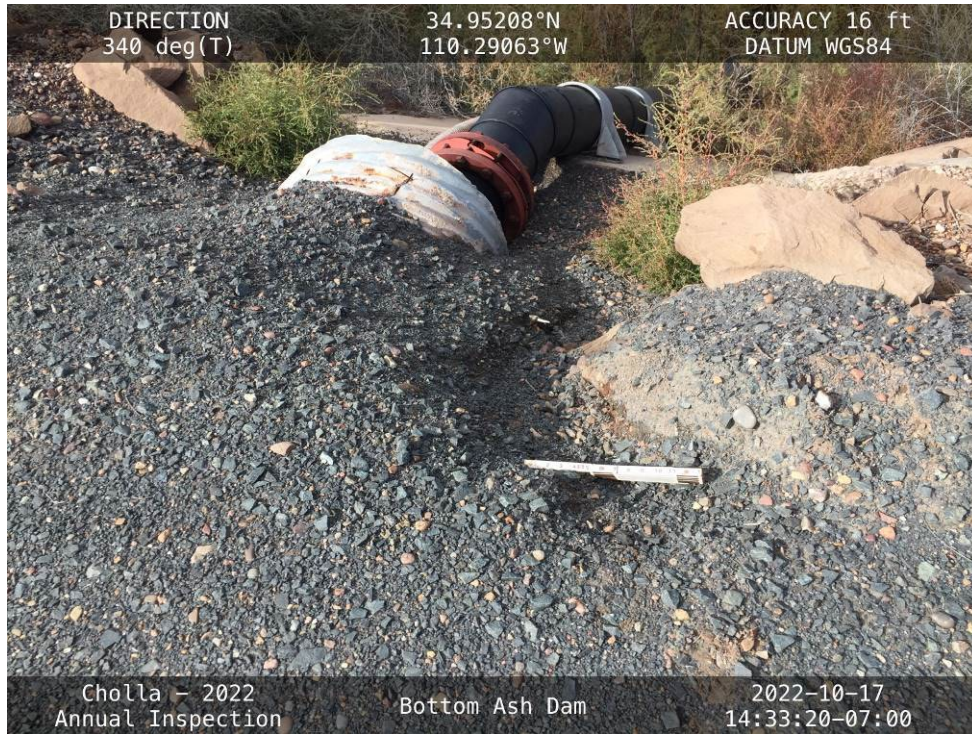
20221017 – IMG_3576

- iv. Continue to monitor the erosion around the siphon line encasements (Photos IMG_3576, IMG_3594), soil wasting along the downstream slope of the East Embankment, and erosion gullies (Photos IMG_3663 and IMG_3665) that were also observed during previous inspections. Repair erosion if the eroded depth exceeds 1 foot. Investigate the source of sediment collecting in the diversion ditch between the East Embankment access road and the East Embankment.

Minor erosion around the concrete encasement for the western siphon line, facing upstream.

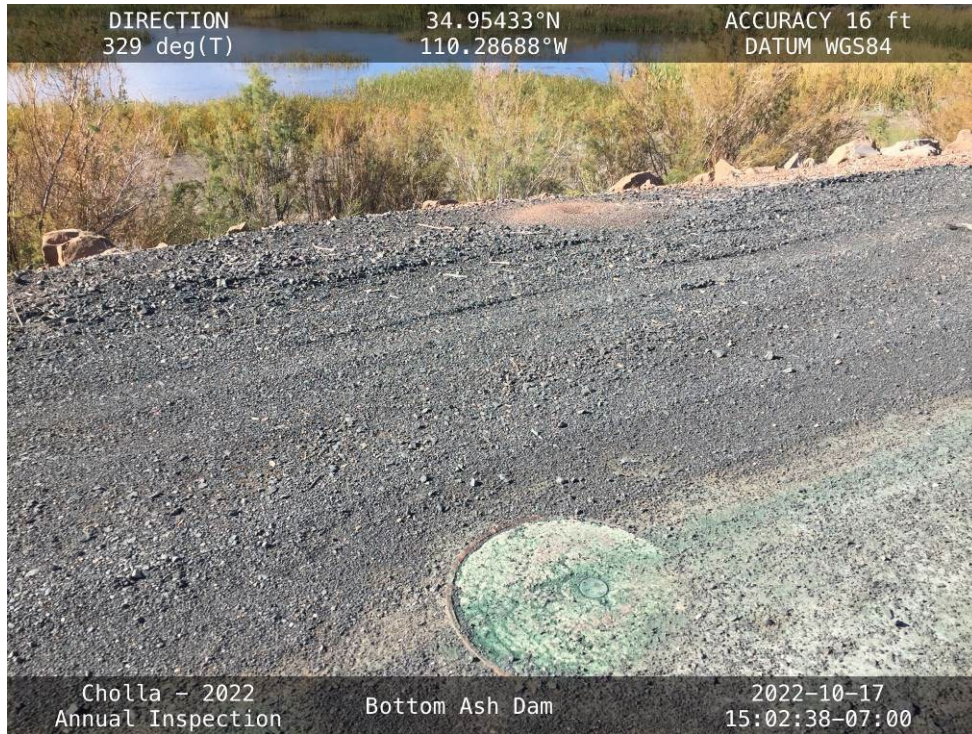
20221017 – IMG_3627
 An ant hill on the upstream shoulder near Monument PI.

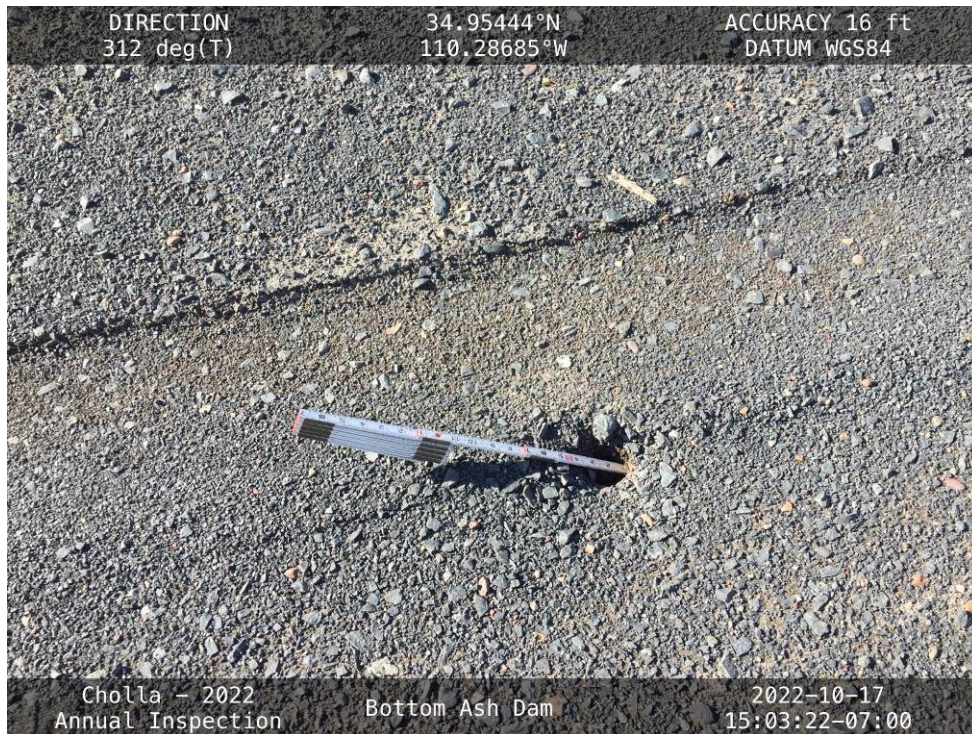
Many of the erosion holes observed along the crest and shoulders during the 2021 inspection were not observed during this inspection; however, several new holes were observed (Photos IMG_3567, IMG_3629, and IMG_3654). The deepest measured erosion hole was at least 10 inches (on the South Embankment). In general, fewer holes were observed during this inspection compared to the 2021 inspection. The holes on the crest and shoulders should be monitored and repaired if the depth exceeds 1 foot or appears to reach the core.

20221017 – IMG_3629
 A hole in the crest of the East Embankment, approximately 4 inches deep.

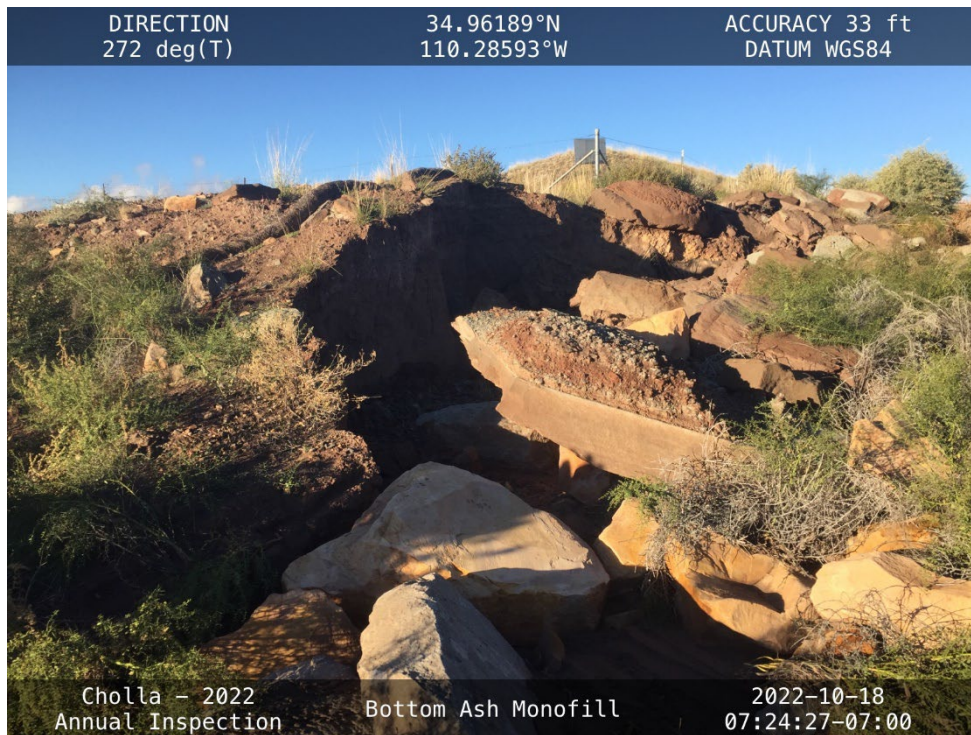
20221018 – IMG_3717

Excessive erosion on the west side of the BAM near the access road to the western stockpile.

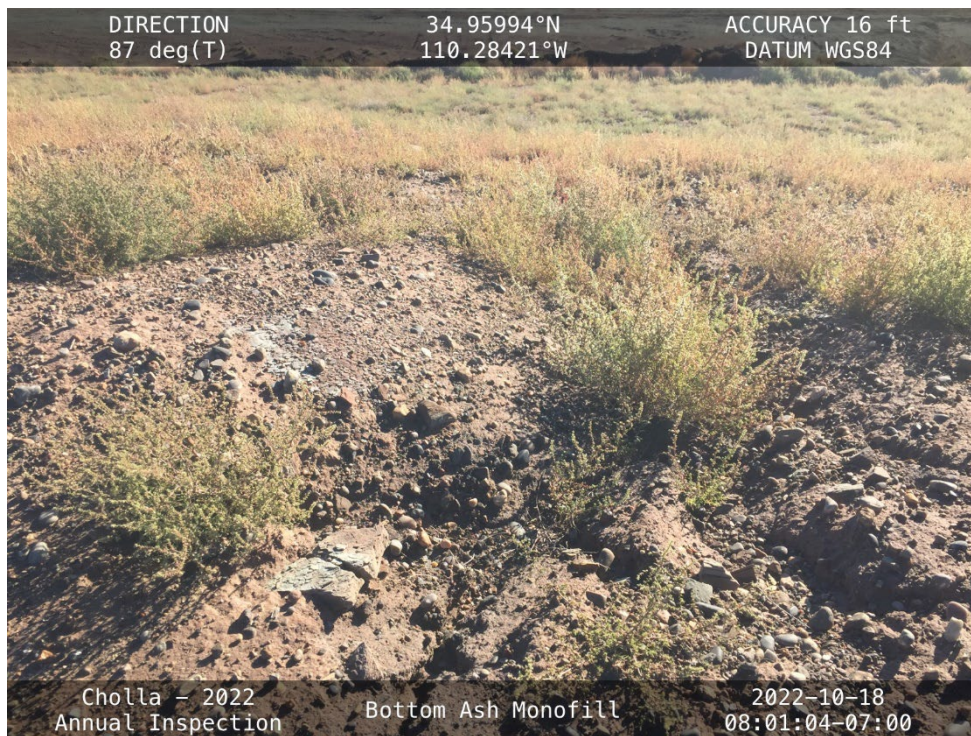
20221018 – IMG_3757

An erosion rill on the eastern slope near the top of the BAM. Slightly deeper compared to 2021.

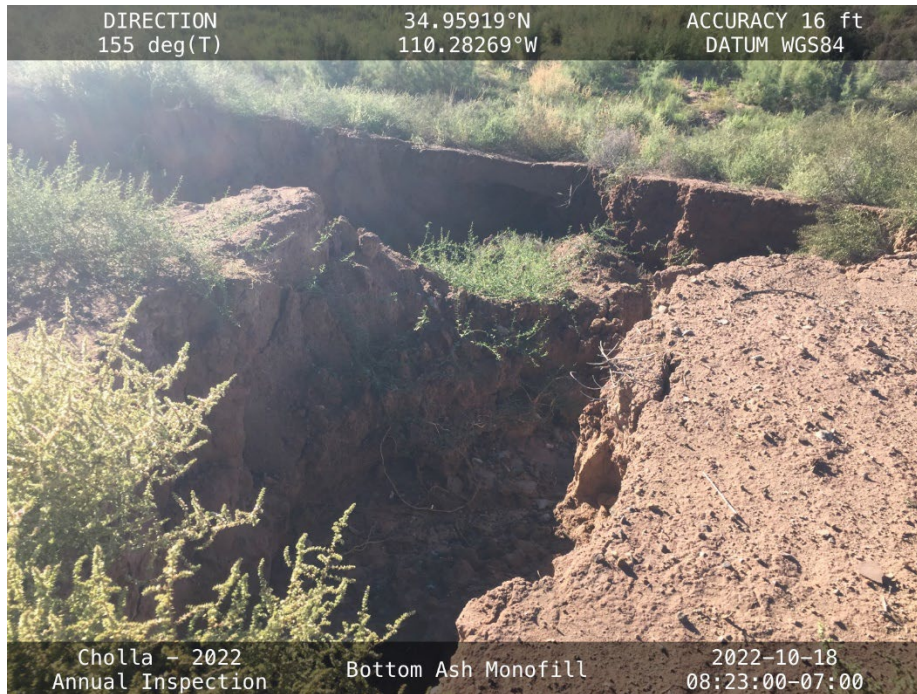
20221018 – IMG_3769

The Stormwater Detention Basin is an incised structure with no offsite conveyance. Over the last few years, APS has repaired erosion damage at the northwest corner, the southwest corner, and the inlet; however, erosion has continued in these areas. APS should assess the gradients entering the Stormwater Detention Basin at these locations and either reduce the entrance slope or place riprap to reduce the erosive potential of the run-on in order to prevent excessive erosion after the Plant closes.
- iii. Shallow erosion rills were observed throughout the CCR unit (see Appendix C). In addition, new, deep erosion was observed in locations of historic erosion at the Stormwater Detention Basin as deep as 2.5 feet (Photos IMG_3769, IMG_3771, and IMG_3776). Continue to monitor these areas and repair erosion where the eroded depth exceeds 1 foot (see comment ii).

Erosion on the north side of the Stormwater Detention Basin where previous repairs had been made (2021 photo IMG_7248).

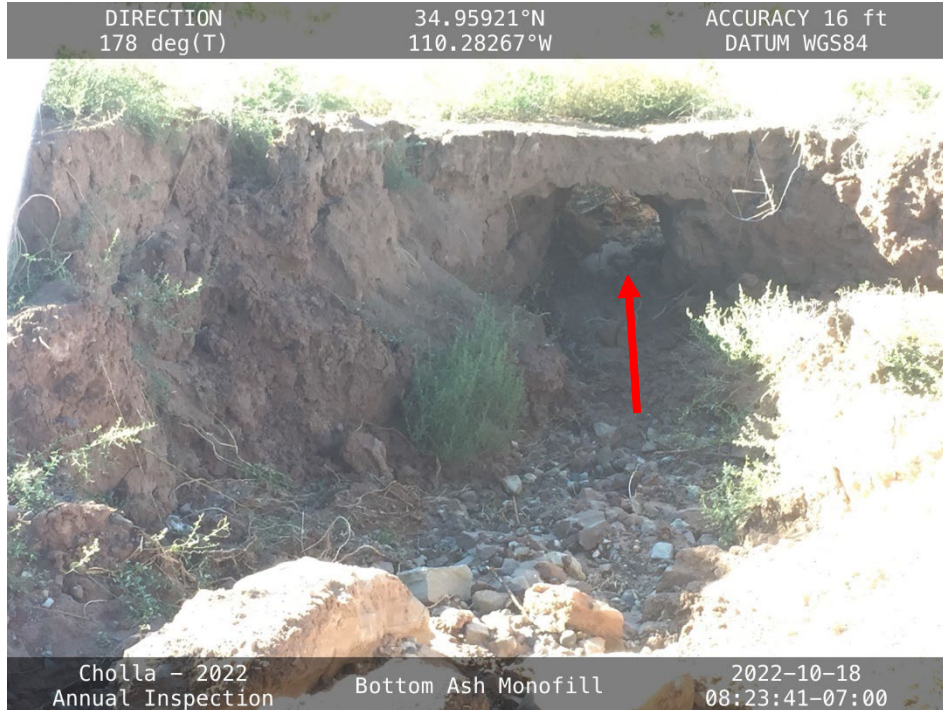
20221018 – IMG_3771

Erosion and a tunnel on the north side of the Stormwater Detention Basin where previous repairs had been made.

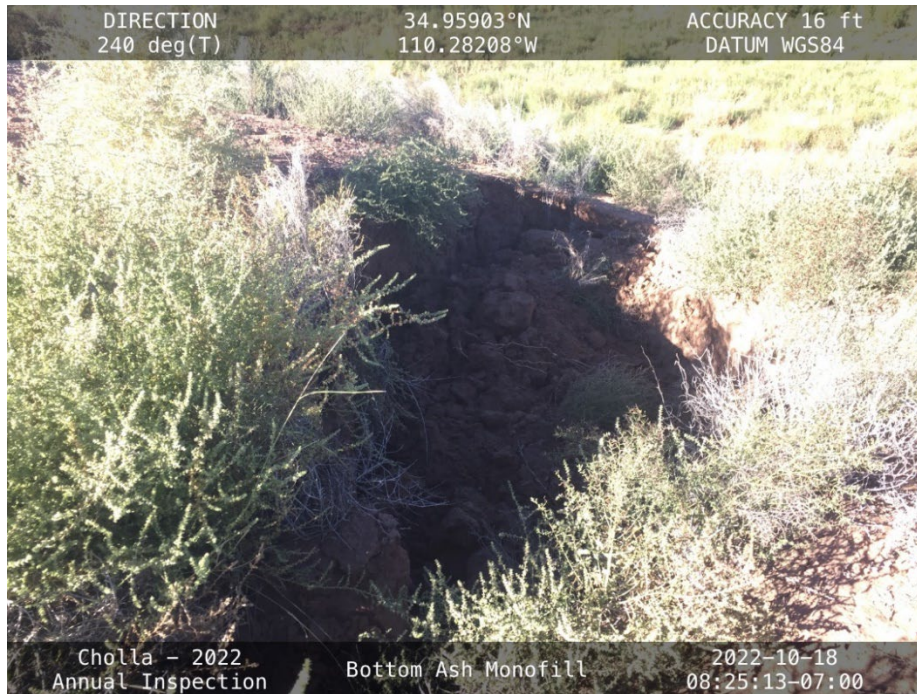
20221018 – IMG_3776

Erosion on the east side of the Stormwater Detention Basin where previous repairs had been made (2021 photo IMG_7263).
