CHOLLA POWER PLANT Fly Ash Dam, Bottom Ash Dam, Sedimentation Pond, and Bottom Ash Monofill

Annual CCR Impoundment and Landfill Inspection Report

2019

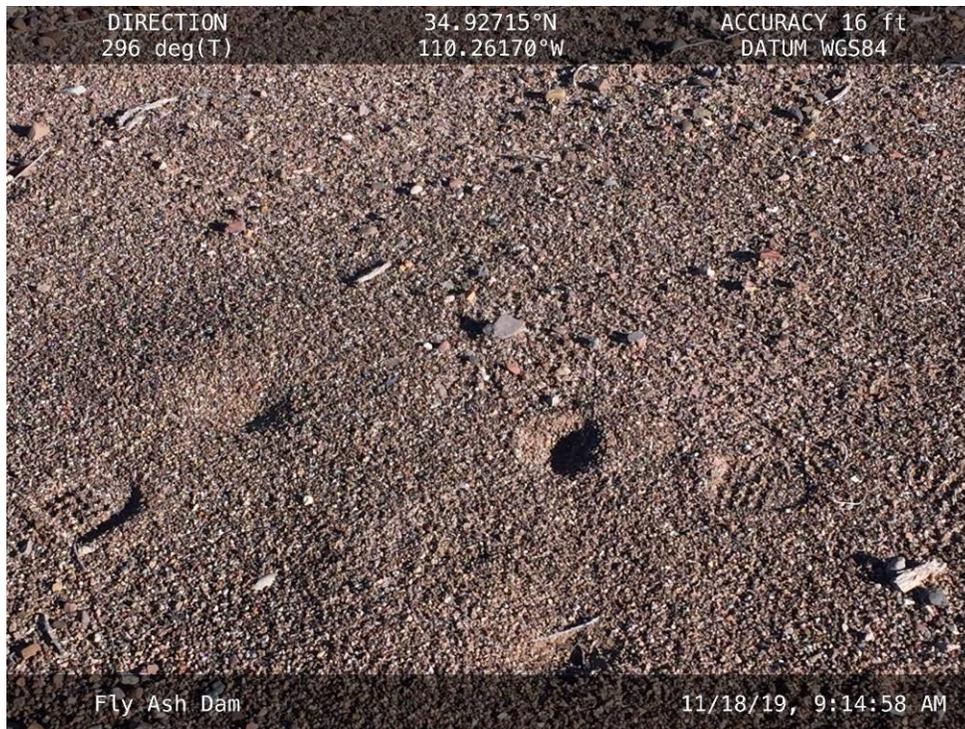
20191118 – IMG_5705

DAM EMBANKMENT CHECKLIST											
3	DAM CREST										
a	Settlements, slides, depressions?										
b	Misalignment?										
c	Longitudinal/Transverse cracking?										
d	Animal burrows?	Ant hills were observed at various locations across the crest (Photo IMG_5705).									
e	Adverse vegetation?										
f	Erosion?										
4	UPSTREAM SLOPE										
a	Erosion?	Minor erosion and soil wasting observed along the upstream slope. See comment ii.									
b	Inadequate ground cover?										
c	Adverse vegetation?	None observed. Continue to monitor vegetation.									
d	Longitudinal/Transverse cracking?										
e	Inadequate riprap?										
f	Stone deterioration?	Minor wasting observed. See comment iii.									
g	Settlements, slides, depressions, bulges?										
h	Animal burrows?	None observed. Continue to monitor.

Ant hill in the crest of the South Embankment.

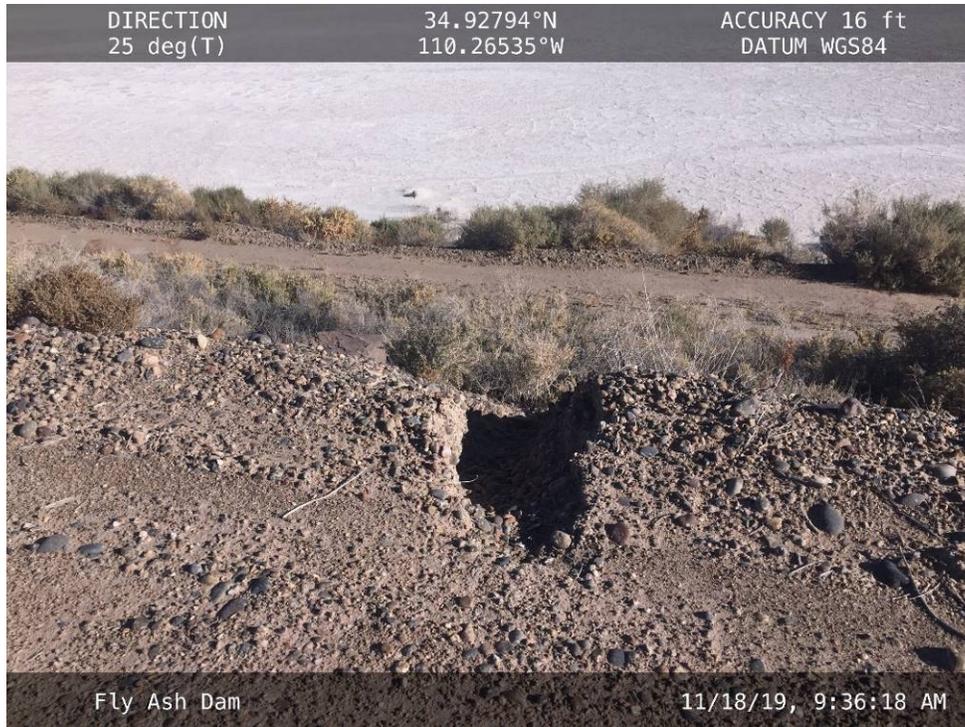
20191118 – IMG_5729

- ii. Minor erosion was observed along the upstream slope near the piezometers screened in the dam core (Photo IMG_5729). The eroded portion was observed to be wider during this inspection compared to the 2018 inspection, but there does not appear to be additional headcutting in this area. The affected portion of the upstream slope is part of the dam crest widening constructed in early 2000 to accommodate piezometer installation activities. The crest is approximately 40 feet wide in this area (compared to the design crest of 24 feet). The erosion appears to be in the extended portion and is not affecting the original crest.

Minor erosion on the upstream side of the crest in an area where the crest is wider.

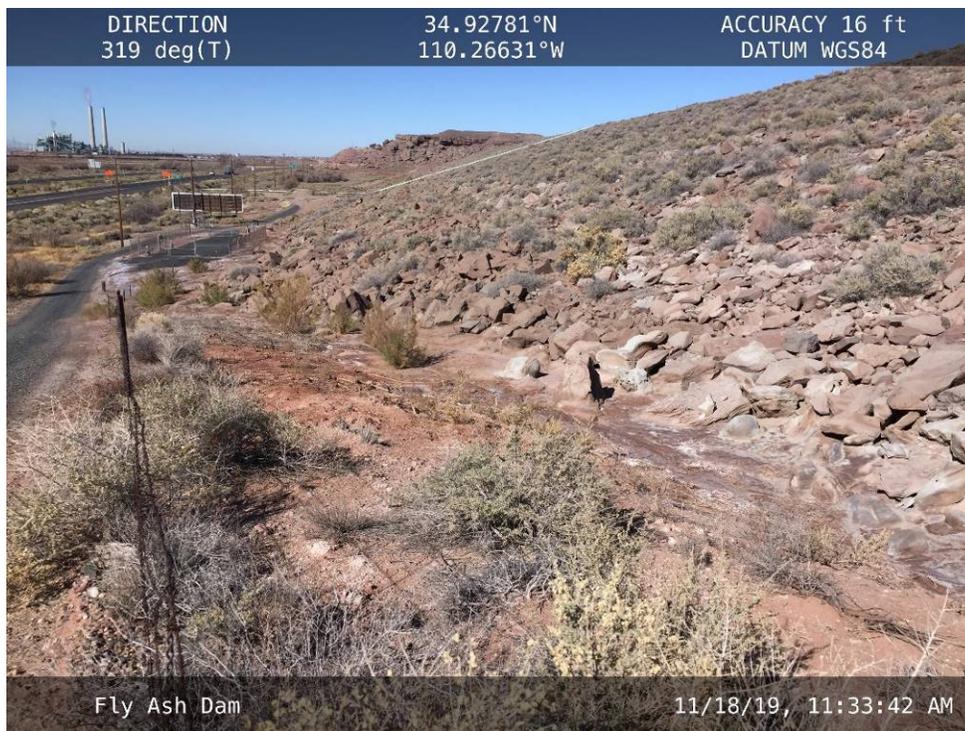
20191118 – IMG_5790

Area of historic erosion along the downstream toe of the West Embankment.

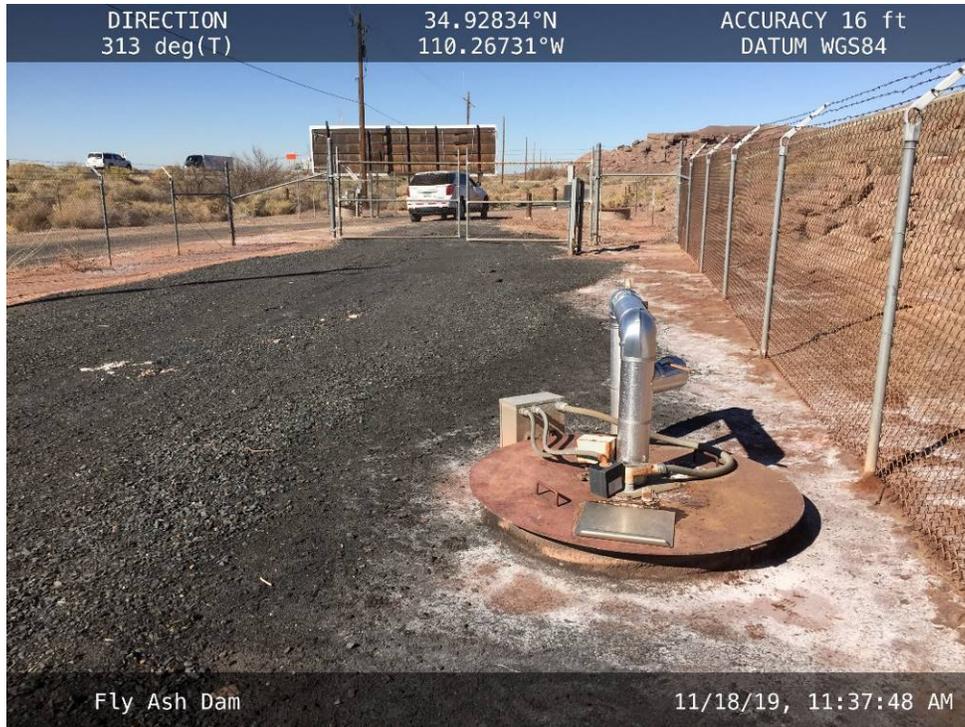
- iii. Minor stone deterioration was also observed during previous inspections. Continue to monitor.
- iv. Seepage has historically been observed at the Geronimo seep, the Hunt seep, the I-40 seep, and in areas of relatively lower elevation along the downstream toe. The Geronimo and Hunt Sumps were active during the inspection; however, the I-40 seep (Photo IMG_5822) and historic seepage areas downstream of the West Embankment were dry. In the 2018 annual inspection report, the I-40 seep was observed to have been drier than it was during previous inspections.

20191118 – IMG_5793
A sump at the Geronimo Seep.

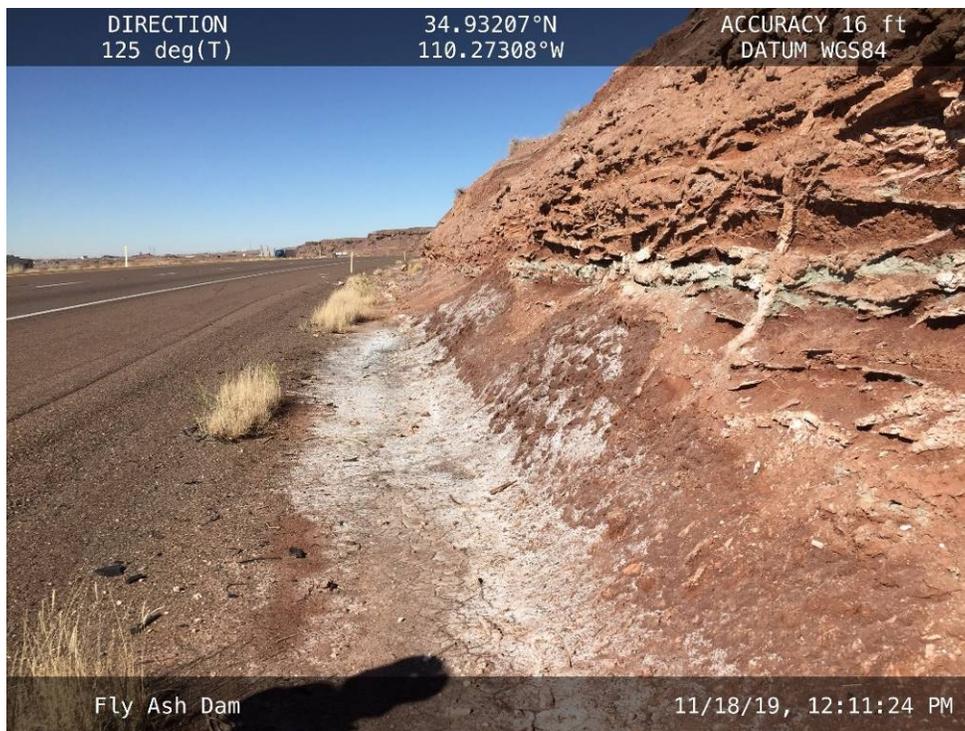
20191118 – IMG_5822

The I-40 seep in a dry condition.

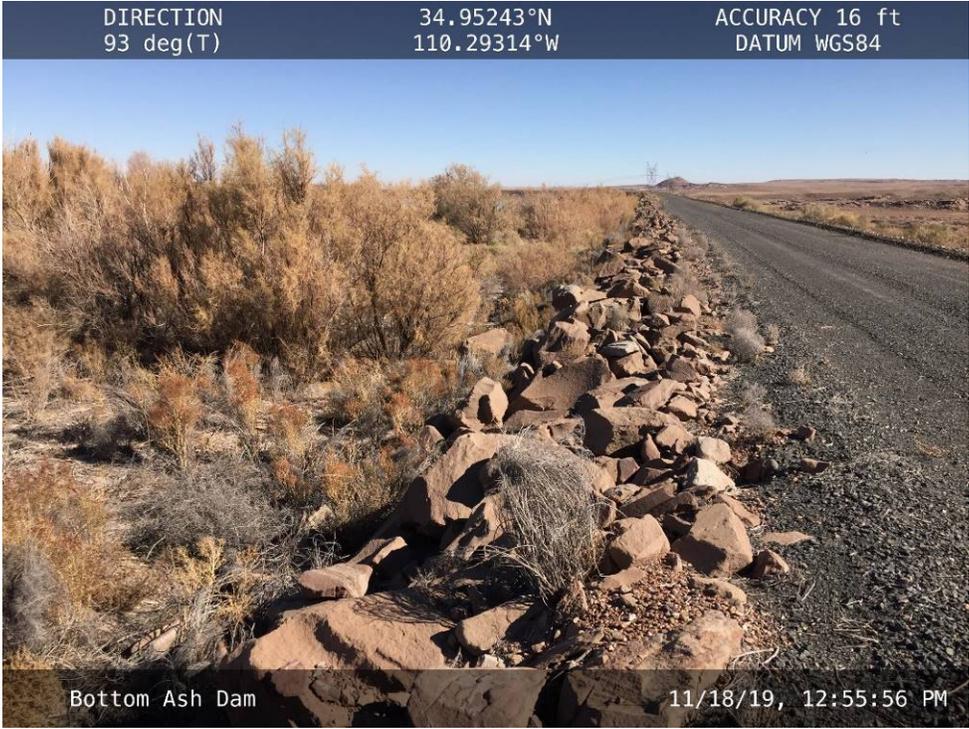
20191118 – IMG_5827
 Trees and other woody vegetation to be removed from the South Embankment upstream slope.

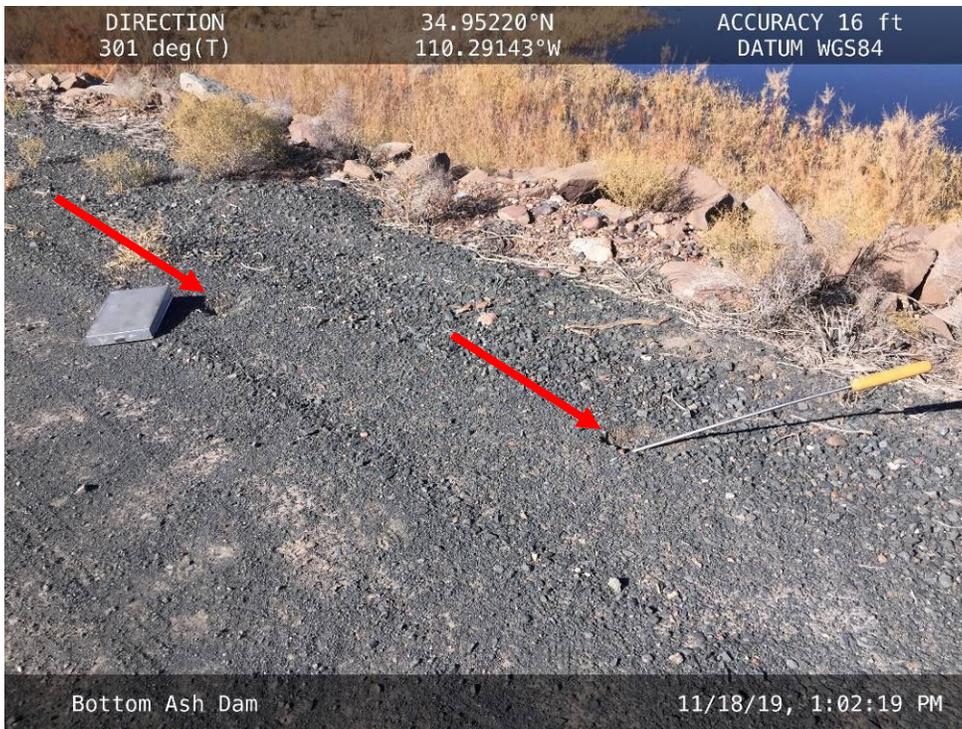
20191118 – IMG_5840

- i. Fewer erosion holes were observed in the South Embankment crest (Photos IMG_5840 and IMG_5857) compared to the 2018 inspection. The series of five erosion holes observed on the East Embankment crest (Photo IMG_5901) during the 2018 inspection manifested as a series of four shallow holes and depressions during this inspection. Other isolated erosion holes (Photos IMG_5871 and IMG_5879) were present on the southern half of the East Embankment. The erosion holes should be repaired and the area should be monitored for additional erosion.

Two shallow erosion holes on the upstream side of the South Embankment crest.

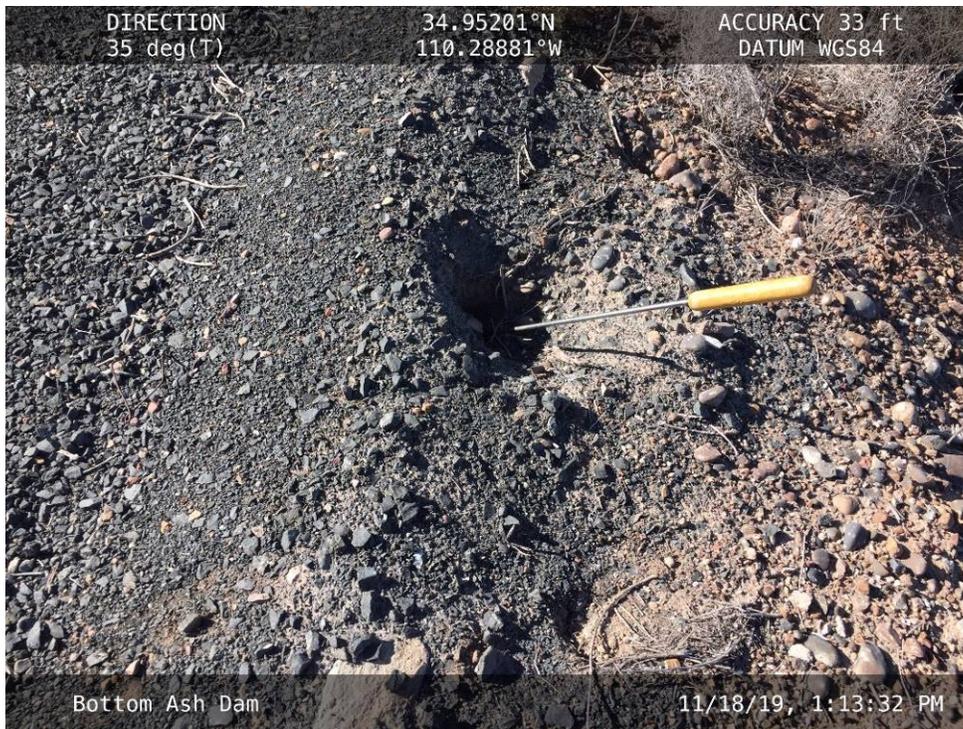
20191118 – IMG_5857

An erosion hole on the upstream side of the South Embankment crest.

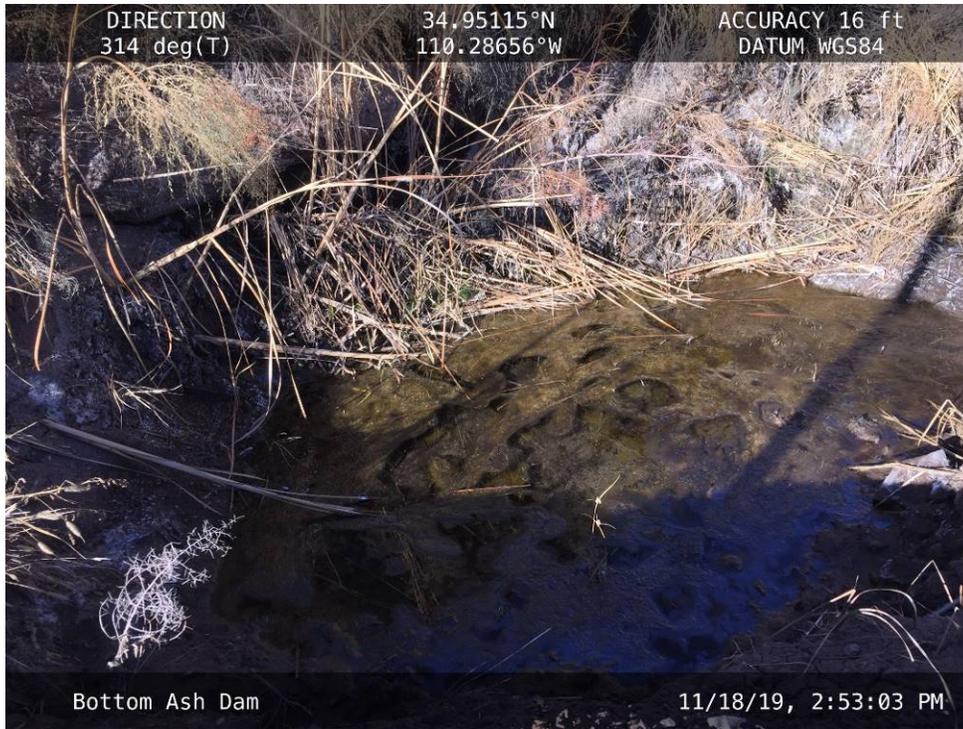
- iii. Seepage and boggy areas were observed along the downstream toe in locations of known and active seepage (e.g. the Petroglyph Seep (Photo IMG_5924), the Tanner Wash seep, the Bottom Ash Toe Drain Sump, the West Abutment Weir (Photo IMG_5912), and the P-232 seepage intercept area). Water in the sumps appeared to be clear during the inspection.

20191118 – IMG_5924
 Water ponding at the Petroglyph Seep.

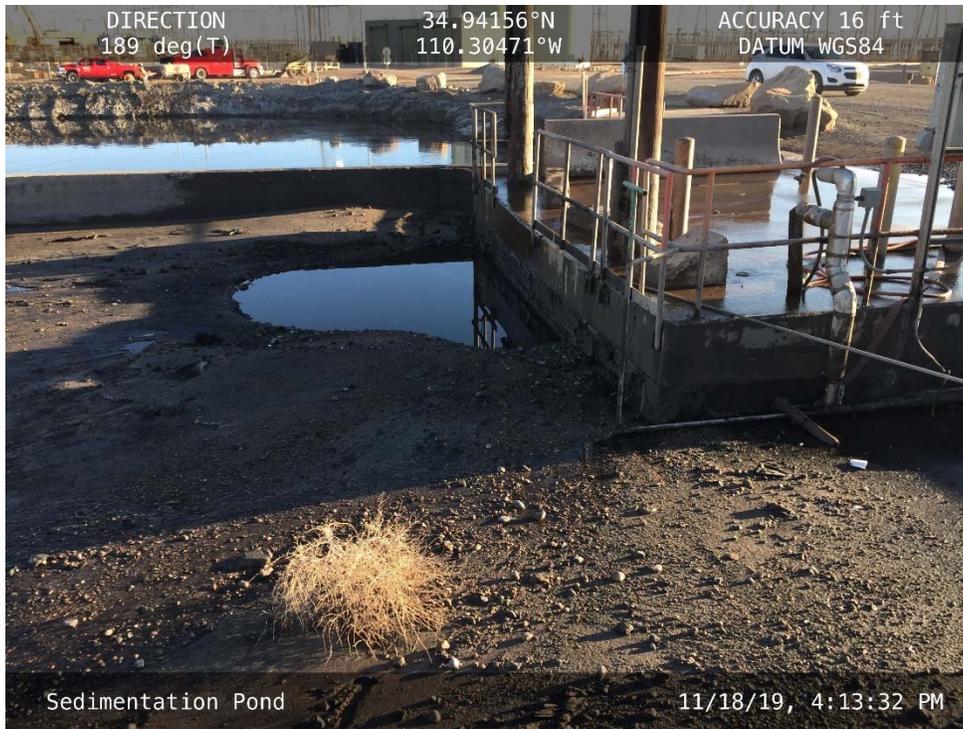
20191118 – IMG_6031
Sediment accumulated in the west side of the North Cell.

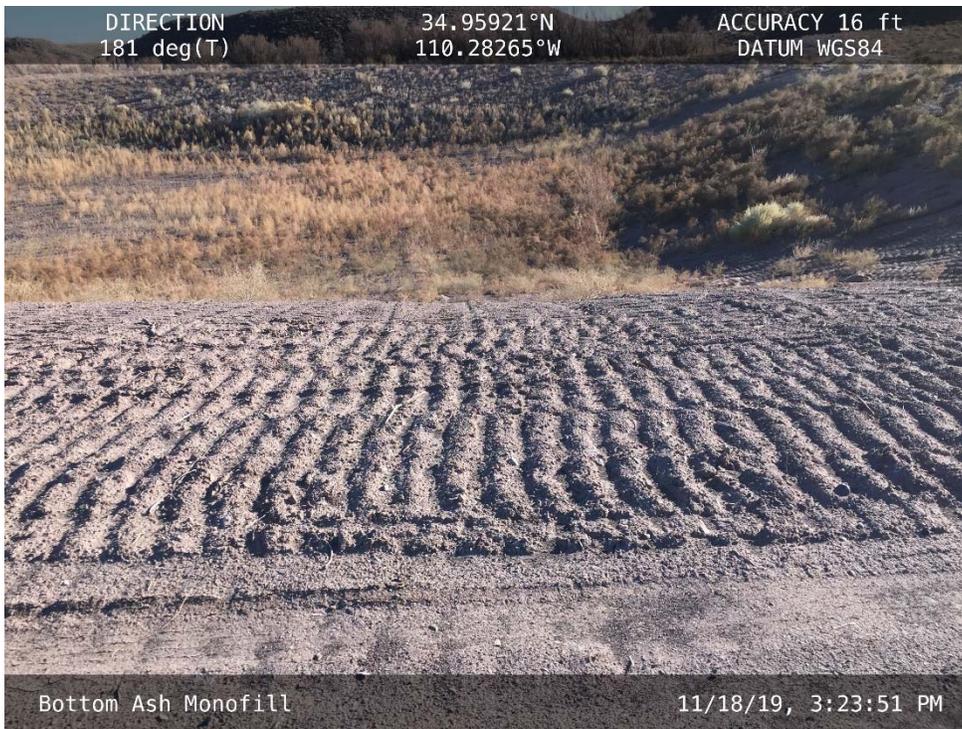
20191118 – IMG_5967
Area of repaired erosion in the northwest corner of the Stormwater Detention Basin.

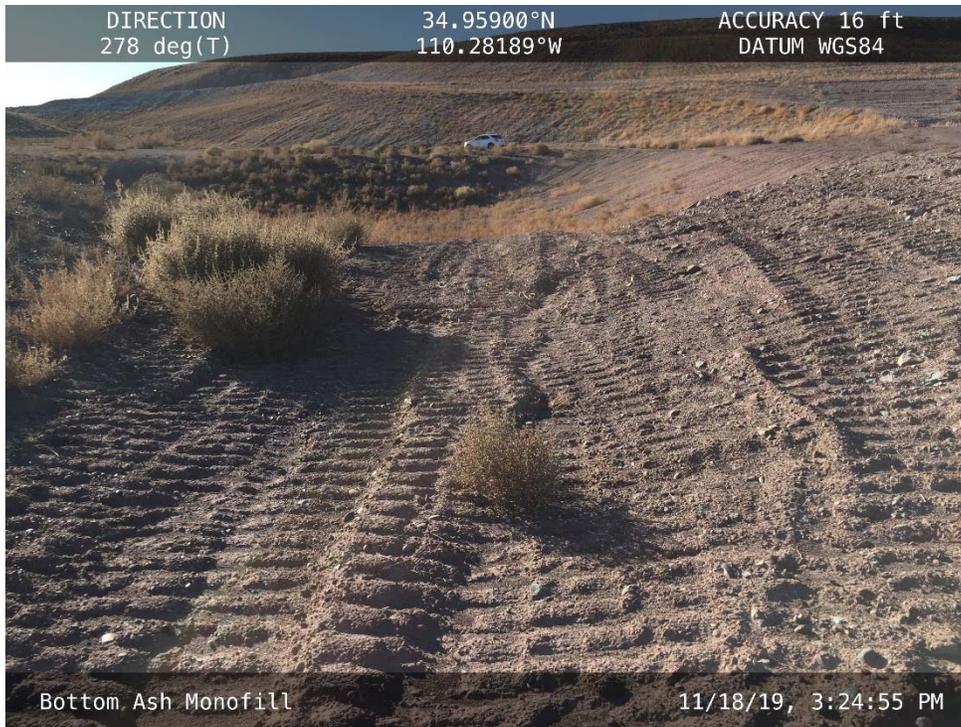
20191118 – IMG_5972

Area of repaired headcutting on the east side of the Stormwater Detention Basin.

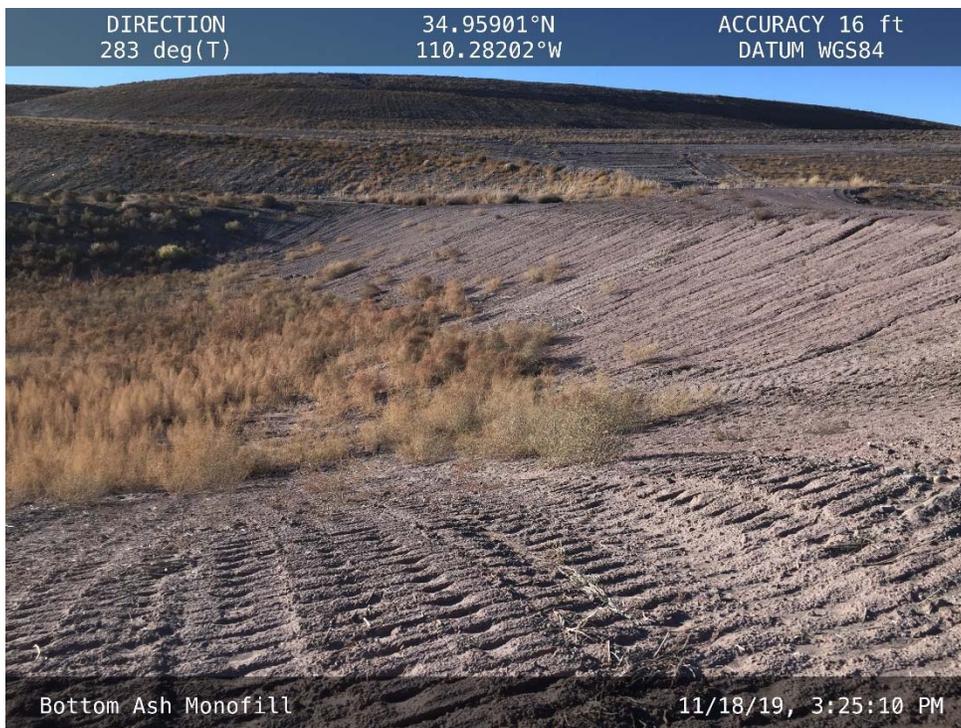
20191118 – IMG_5974

Area of repaired headcutting on the east side of the Stormwater Detention Basin.
