# CHOLLA POWER PLANT Fly Ash Pond, Bottom Ash Pond, Sedimentation Pond and Bottom Ash Monofill

## Annual CCR Impoundment and Landfill Inspection Report

### 2015

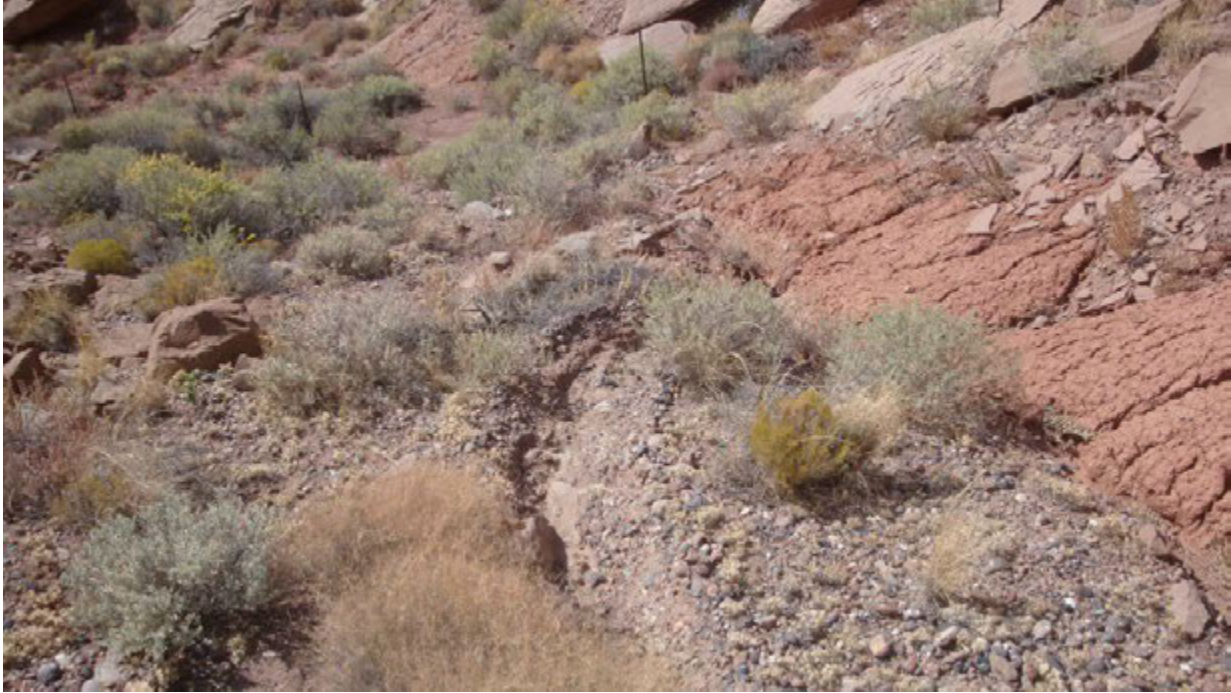
<b>6 ABUTMENT CONTACTS</b>											
a	Erosion?	Minor erosion observed in downstream right abutment groin. See Photo FAP 8.				X		X			
b	Differential movement?			X							
c	Cracks?			X							
d	Settlements, slides, depressions, bulges?			X							
e	Seepage?	Historic seepage near the downstream right abutment area indicated by evaporites. See Photo FAP 36. Continue to monitor.				X		X			
f	Animal burrows?	None observed. Continue to monitor.		X				X			
<b>7 SEEPAGE/PIPING CONTROL DESIGN FEATURE(S)</b>											
a	Describe:	1) The Geronimo and Hunt seepage collection and pump back systems are located downstream of the dam near 1-40 for fluid interception. See Photo FAP 16. 2) Discharge from the crest side of the reservoir creates a beach to prevent water from being stored against the upstream face. See Photo FAP 15.									
b	Internal drains flowing?		X								
c	Seepage at or beyond toe?	See comment 6.e.				X		X

**20151016 – Photo 8**  
Downstream slope, right abutment groin. Erosion at contact.

- Erosion due to surface water runoff was observed near the Geronimo Sump and along both sides of the access road. Continue to monitor and repair as needed.
- Erosion was observed in the downstream groin of the West Abutment. See Photo FAP 8. Continue to monitor and repair as needed.
- Prepare updated Emergency Action Plan before 04/17/2017 to comply with initial plan requirement of CFR 257.73
- Re-establish water level gauge to record higher pond levels.
- Excessive natural vegetation has been removed from toe of dam in several locations (right abutment, see Photo FAP 36). Recommend similar clearing along remainder of the toe of dam to allow visual inspection and identification of seeps.

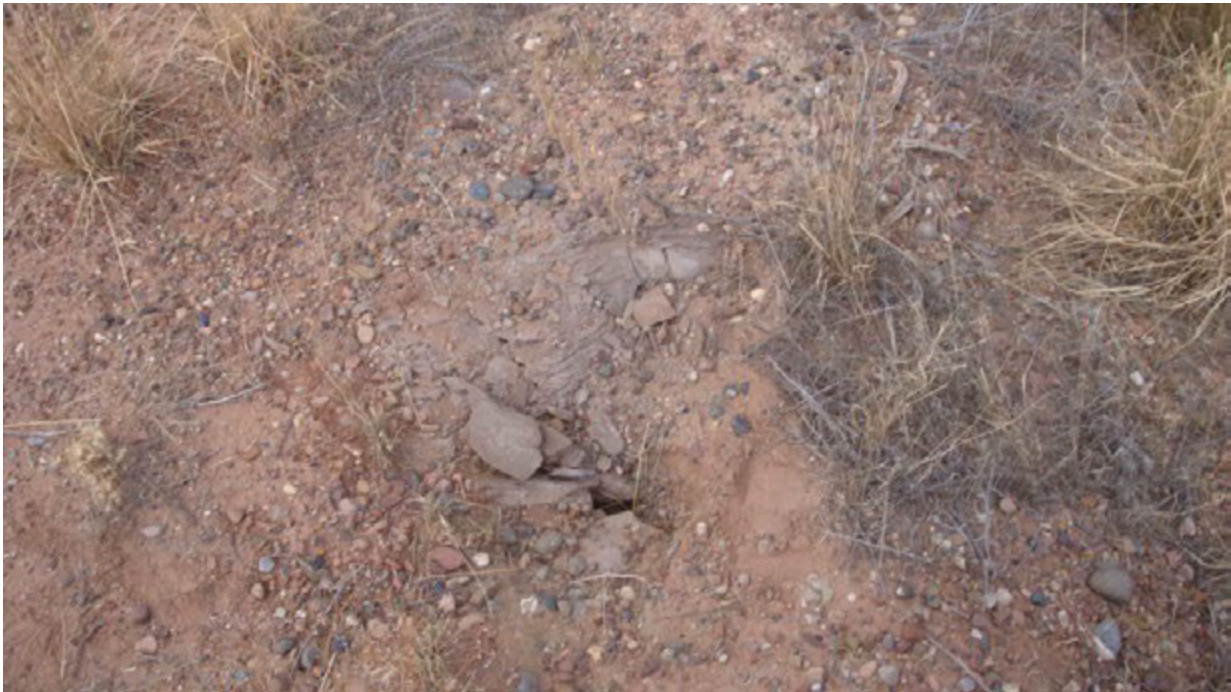
<b>DAM EMBANKMENT CHECKLIST</b>								
<b>3</b>	<b>DAM CREST</b>							
a	Settlements, slides, depressions?			X				
b	Misalignment?			X				
c	Longitudinal/Transverse cracking?			X				
d	Animal burrows? <b>Observed, but at low frequency. See Photos FAP 10, FAP 17, and IMG-2148. Continue to monitor and implement deterrent measures if frequency increases.</b>			X		X		
e	Adverse vegetation?			X				
f	Erosion?			X				
<b>4</b>	<b>UPSTREAM SLOPE</b>							
a	Erosion?			X				
b	Inadequate ground cover?			X				
c	Adverse vegetation? <b>Shrubs and other vegetation observed. See Photo FAP 16 and FAP 22.</b>				X	X		
d	Longitudinal/Transverse cracking?			X				
e	Inadequate riprap?			X				
f	Stone deterioration?			X				
g	Settlements, slides, depressions, bulges?			X

**20151016 – Photo 10**  
Crest. Apparent minor animal burrow.

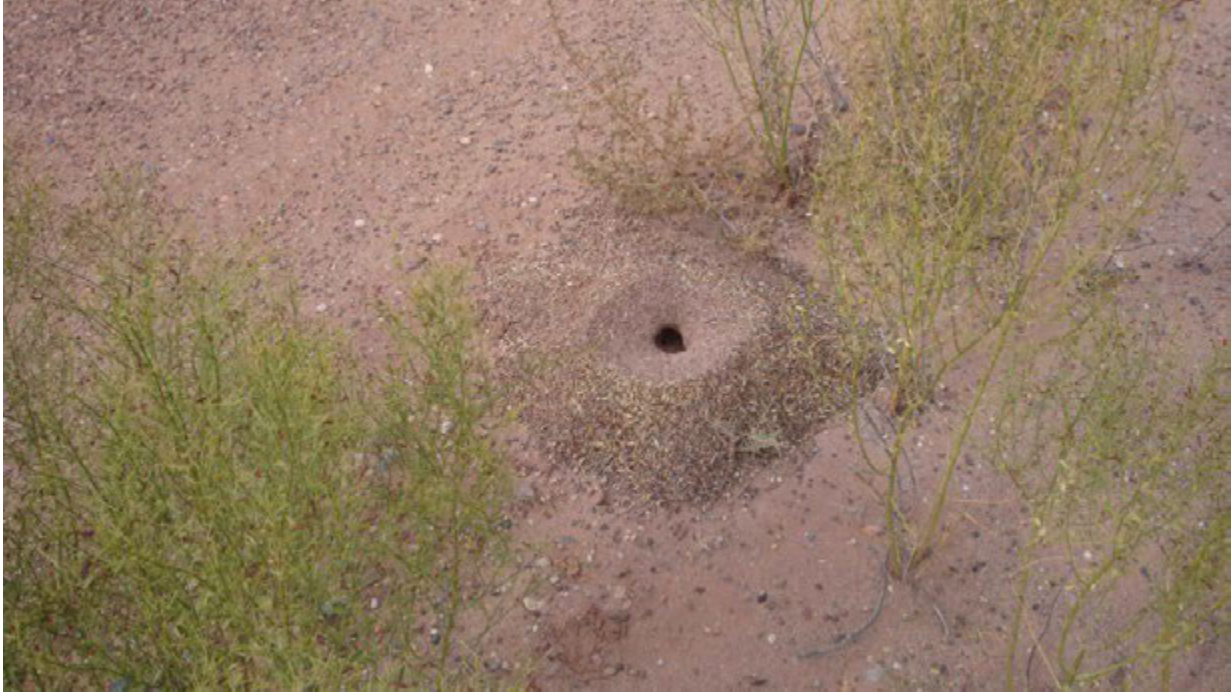
**20151016 – Photo 17**  
Crest. Apparent minor animal burrow.

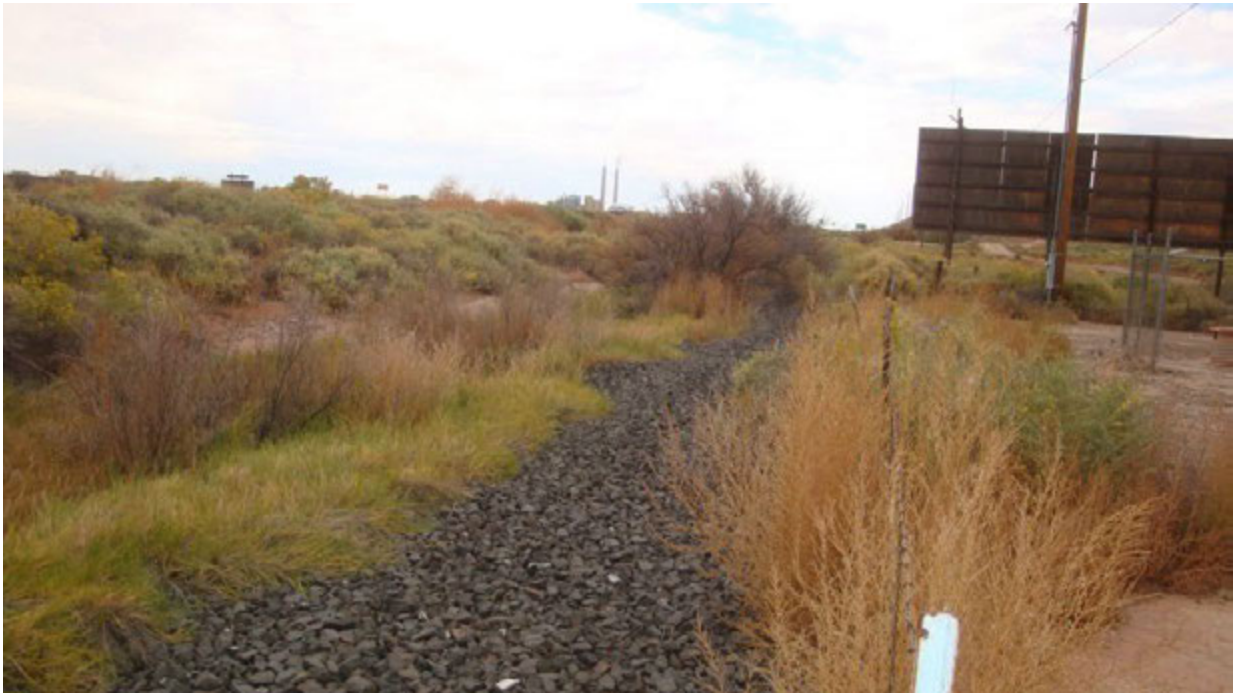
Downstream toe. Geronimo seep area. Note French drain exposed on ground surface.

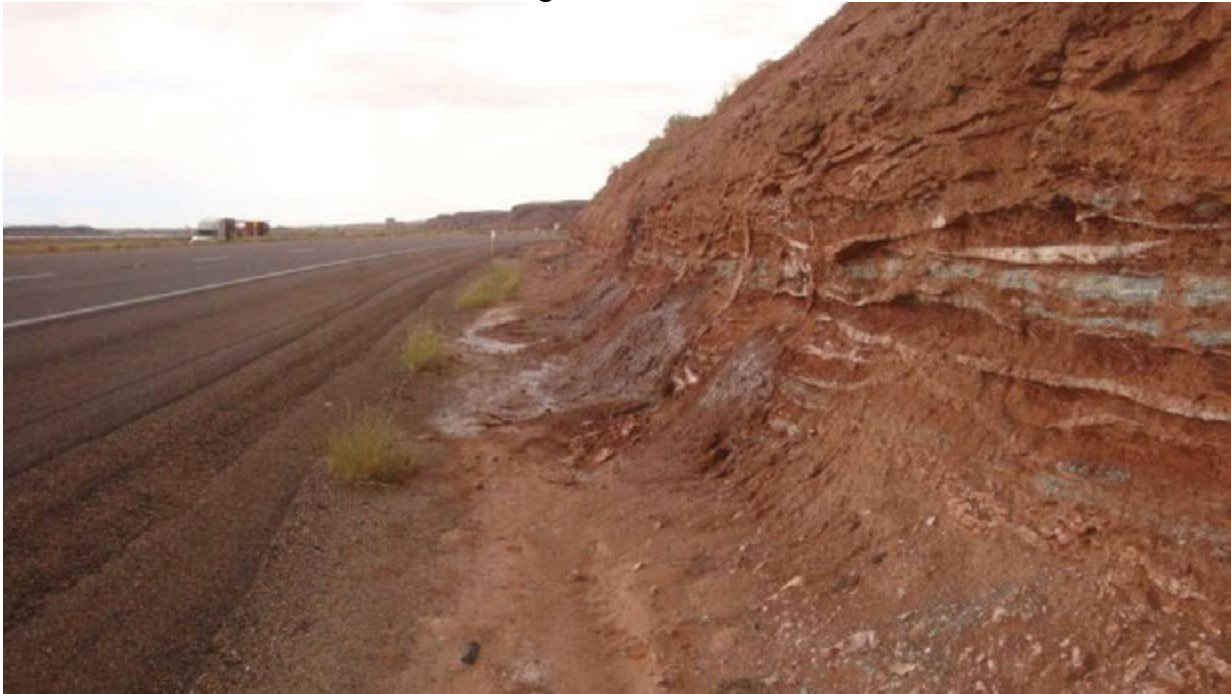
Exposed foundation and seep condition on edge of Interstate 40.

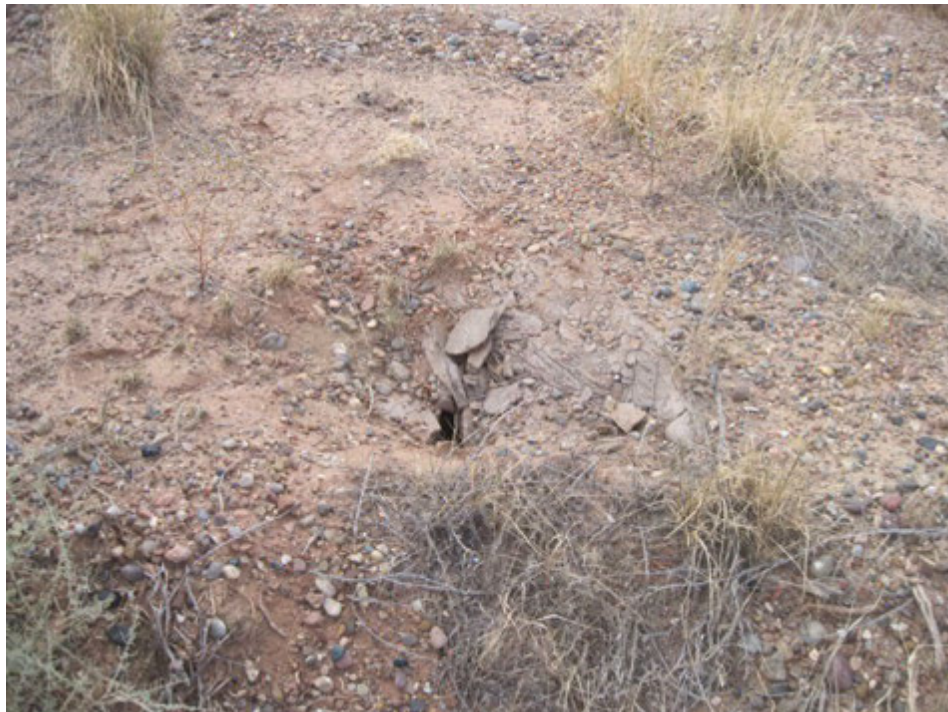
**20151016 – IMG\_2148**  
Crest. Apparent minor animal burrow.

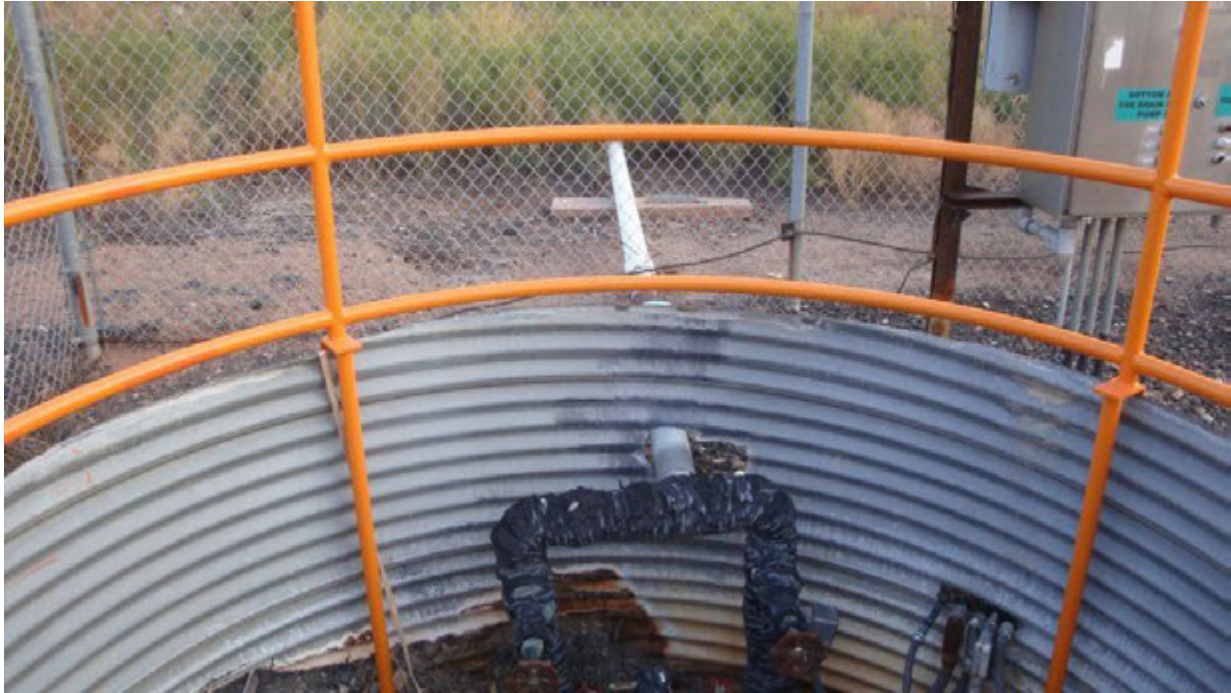
e	Seepage? <b>Yes. Documented in past reports. See Photo BAP 1.</b>				X	X		
f	Animal burrows? <b>None observed. Continue to monitor.</b>		X					
<b>7 SEEPAGE/PIPING CONTROL DESIGN FEATURE(S)</b>								
a	Describe: <b>Several monitoring, seepage, and pump back collection systems are located downstream of the dam. See Photos BAP 1 and BAP 22 (Petroglyph Seep).</b>							
b	Internal drains flowing?		X					
c	Seepage at or beyond toe?				X	X		
d	If so, does seepage contain fines?		X					
e	Evidence of sand boils at or beyond toe?		X

Downstream toe. Right abutment. Seepage collection and pumpback sump.

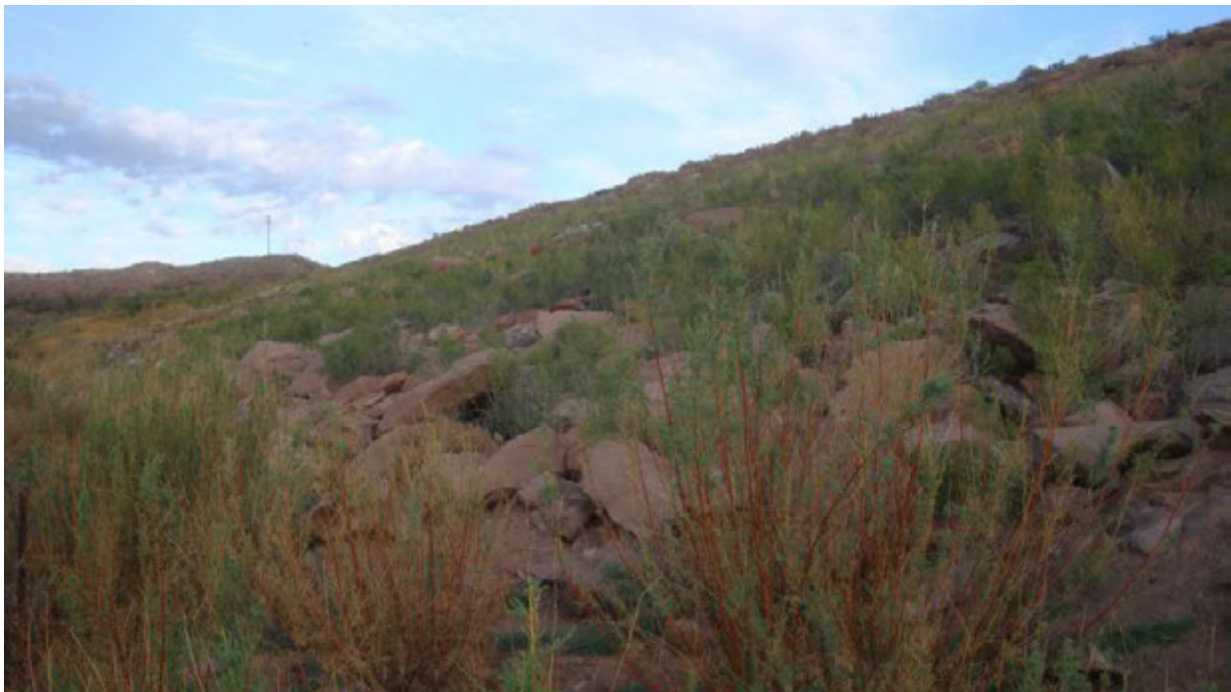
<b>Bottom Ash Dam/Impoundment</b>		<b>SID: 09.27</b>	N/A	No	Yes	Mon	Rep	Inv
c	Adverse vegetation? <b>Yes, need to clear toe and remove bushes taller than 4 feet on slope. See for example, Photos BAP 3, and BAP 17</b>				X		X	
d	Longitudinal/Transverse cracking?		X					
e	Inadequate riprap?		X					
f	Stone deterioration?		X					
g	Settlements, slides, depressions, bulges?		X					
h	Soft spots or boggy areas? <b>Historic seepage at the toe and active seepage (1 gallon/37 seconds) at the right groin area. Continue to monitor.</b>		X			X		
i	Movement at or beyond toe? <b>Yes, minor evidence of soil wasting from below riprap in areas adjacent to downstream toe.</b>				X			
j	Animal burrows? <b>None observed. Continue to monitor.</b>		X					
<b>6 ABUTMENT CONTACTS</b>								
a	Erosion? <b>No. See Photo BAP 31.</b>		X					
b	Differential movement?		X					
c	Cracks?		X					
d	Settlements, slides, depressions, bulges?		X

- Vegetation along the majority of the length of the downstream toe of the embankment is too thick to allow adequate visual inspection. See Photos BAP 3 and BAP 17. Vegetation has been removed by blading in specific locations, apparently for access to drill groundwater monitoring wells (see Photo BAP 20.) Recommend maintenance of all vegetation sufficient to allow thorough inspection of the soil and rip rap conditions on the faces and crests of the embankments. Vegetation removal should be performed along the entire toe of the west and east legs of the embankment in accordance with the NMOSE vegetation maintenance guidelines “*Vegetation Management on Dams*” reference.
- The majority of vegetation on the downstream face of the embankment is considered acceptable ground cover in this environment. Bushes and trees (see Photo BAP 11)

Downstream slope. Note rip rap and vegetation exceeding 3-foot height.

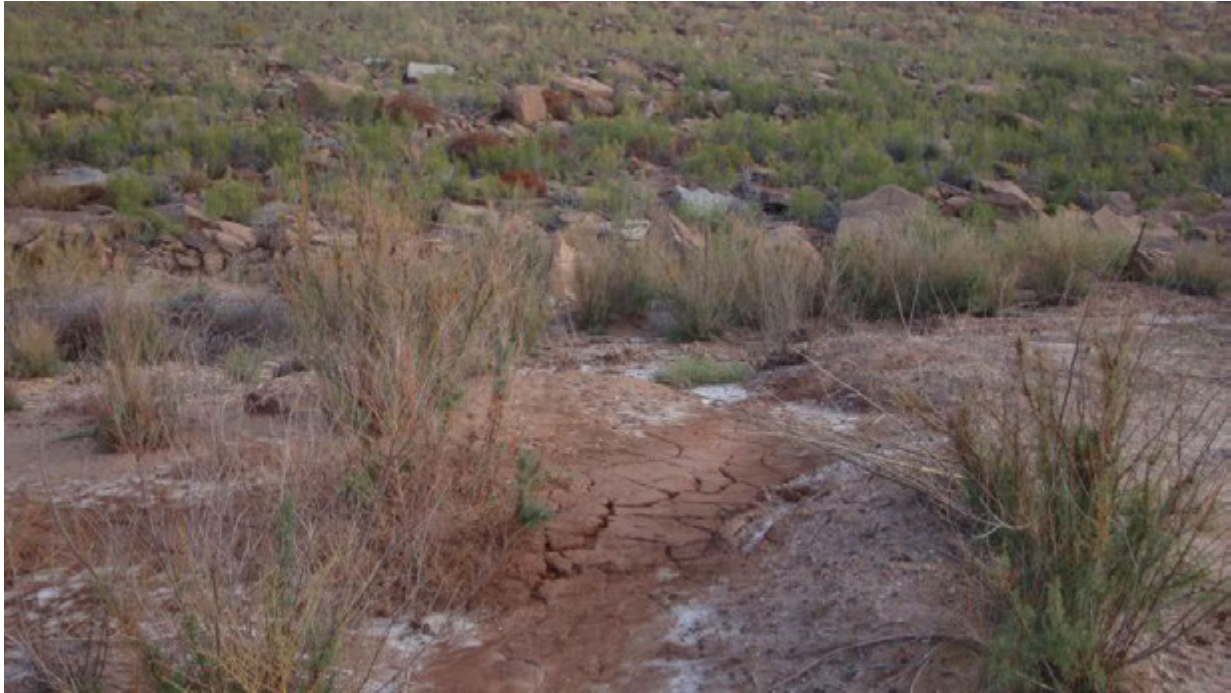
- Identified signs of minor wasting of soil from the downstream toe of the west leg of the embankment, likely from beneath the surface riprap slope covering (see Photo BAP 5.) Accumulated soil will likely be disturbed or removed as a result of recommended removal of vegetation in the vicinity of the toe. Since effect appears to only surficial and worsening limited by riprap layer, condition should be observed after toe cleanup during future annual inspections.

Downstream toe. Accumulation of fine-grained soil, possibly wasting from beneath rip rap slope facing.

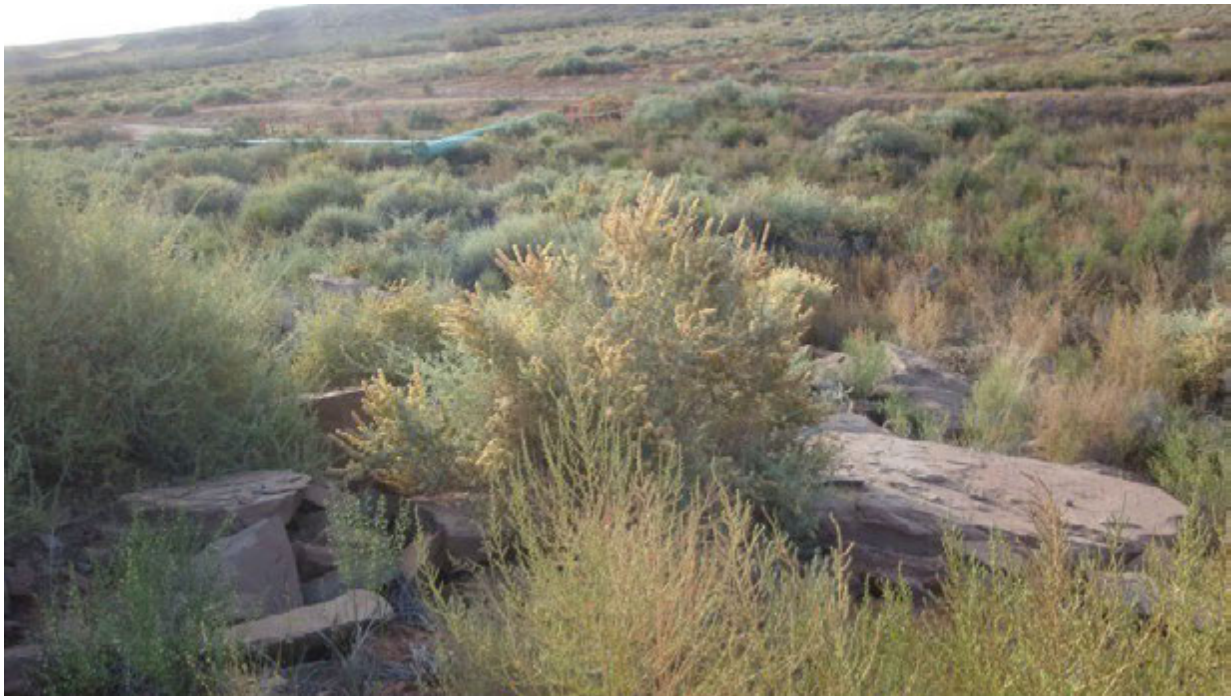
Downstream slope. Example of bush significantly exceeding 3-foot height that should be removed.

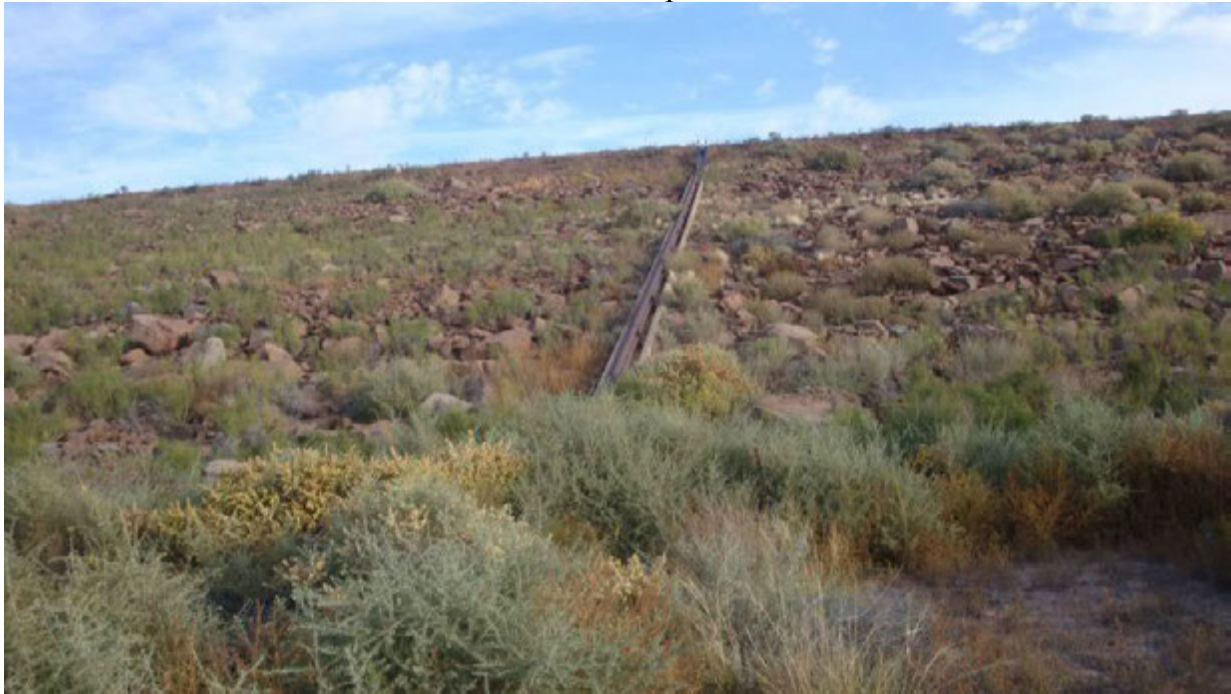
Downstream slope. Vegetation exceeding 3-foot height at toe, generally less than 3 feet on slope. Note BAP decant line on slope.

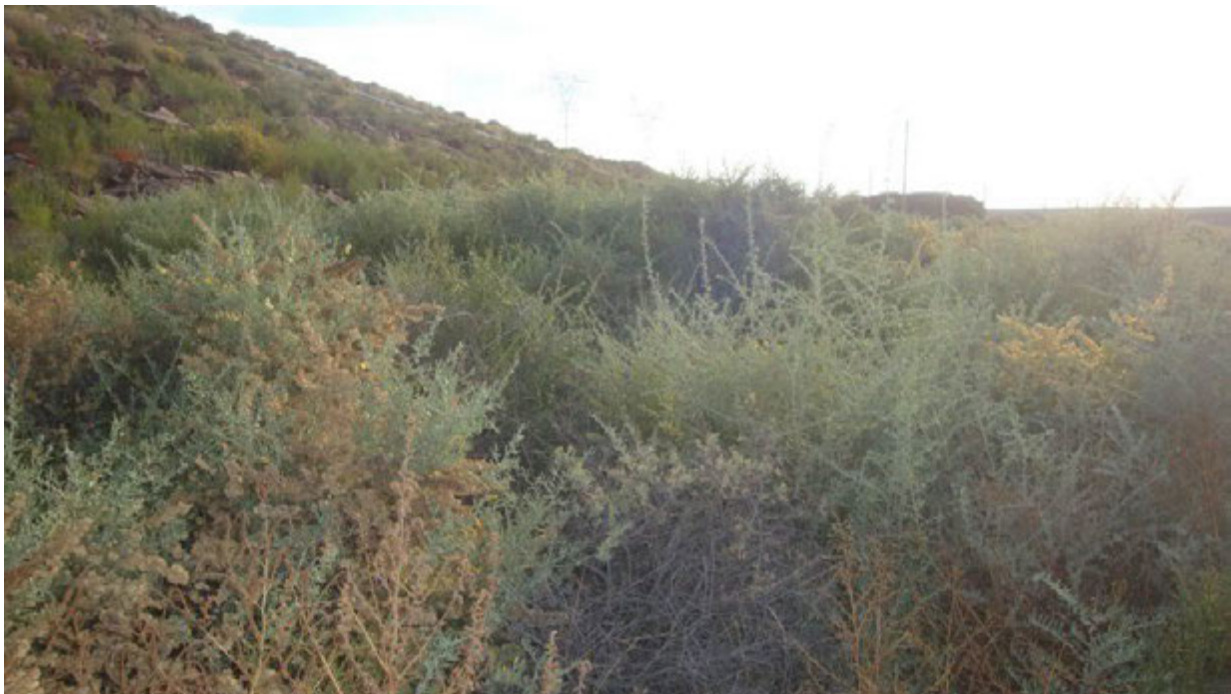
**20151016 – Photo 17**  
Downstream slope. Vegetation exceeding 3-foot height at toe.

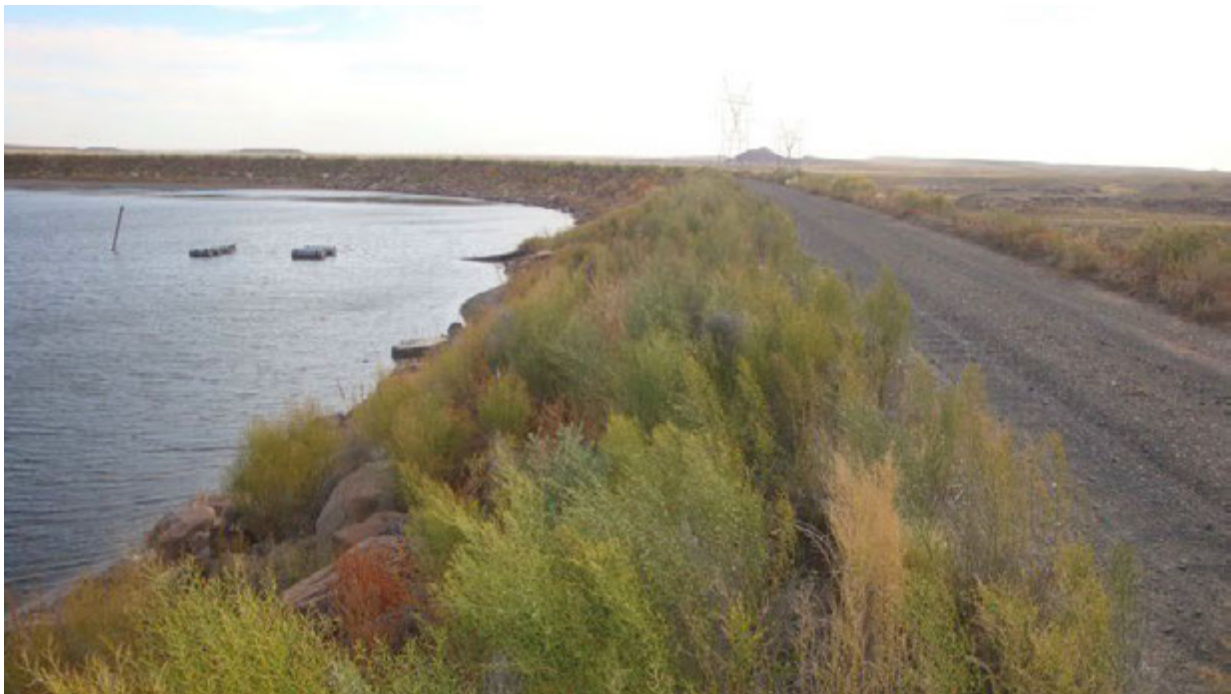
Upstream slope. Vegetation exceeding 3-foot height adjacent to crest.

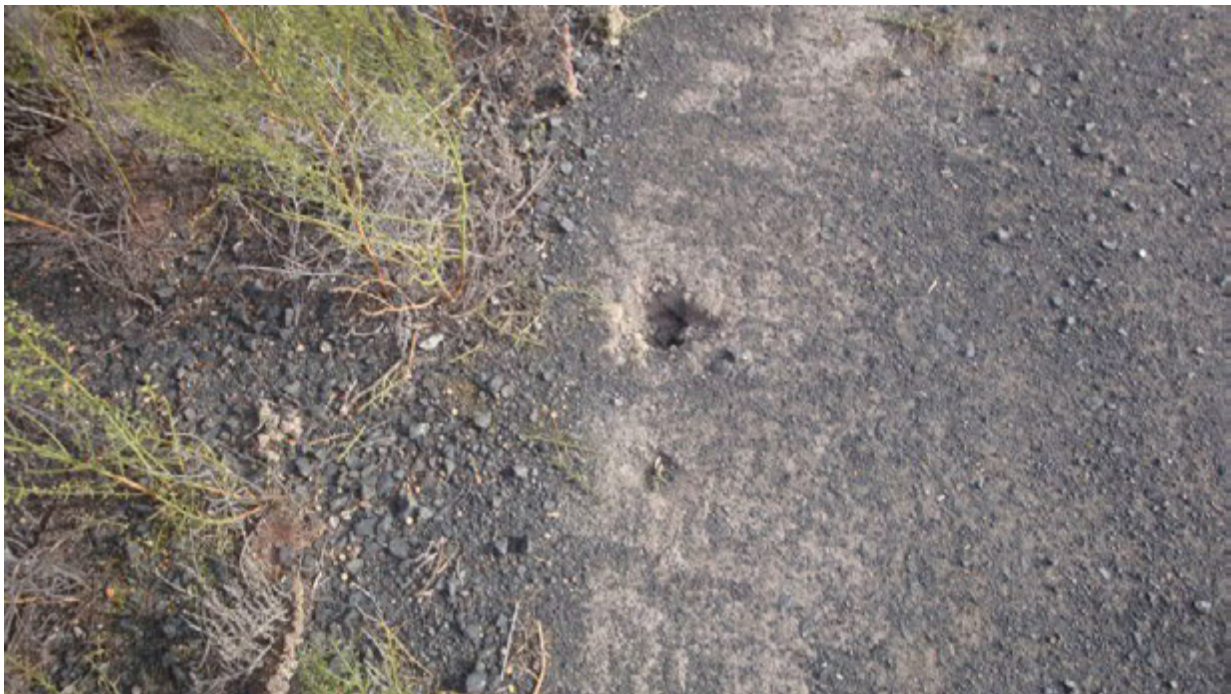
**20151016 – Photo 46**  
Crest. Apparent minor animal burrow.

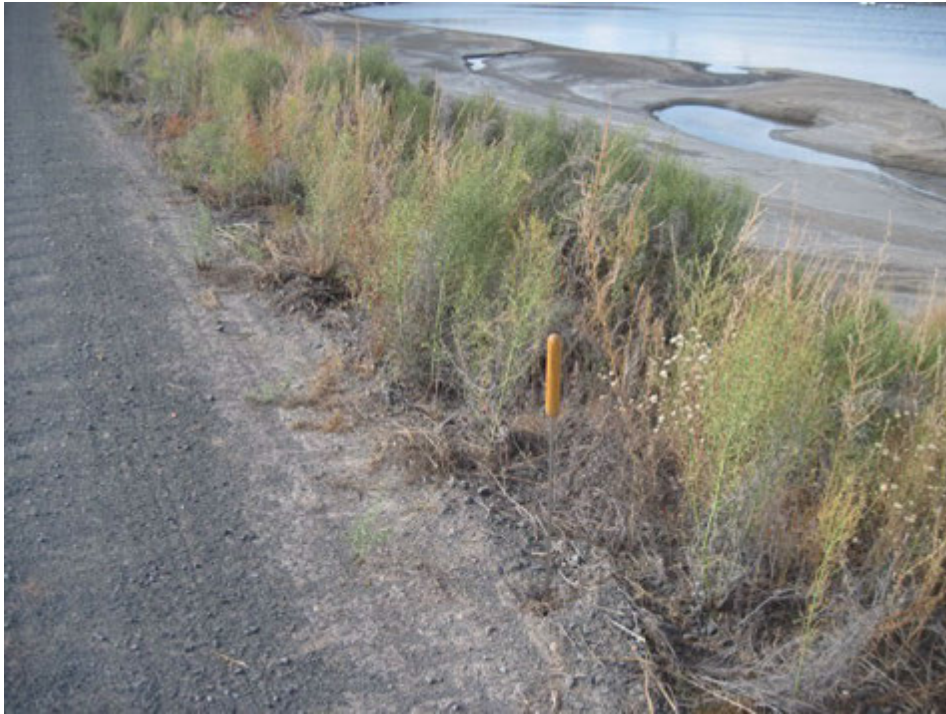
- Prepare Emergency Action Plan before 04/17/2017 to comply with initial plan requirement of CFR 257.73.
- Numerous (less than ten) small animal burrows were identified on the crest of the east leg of the embankment. See Photos IMG\_2132, 2135, and 2137. The inspector (B. Conrad) noted that the frequency and probed depth (6 to 18 inches) of identified burrows appeared less severe than identified during a similar inspection in Spring 2015. Animal species causing burrows unknown. Recommend same measurement of frequency during next annual inspection and, if increased frequency, follow-on installation of bait, traps, poison or other approved control measure to discourage small burrowing pests.

Crest. East leg of embankment. Apparent minor animal burrow.

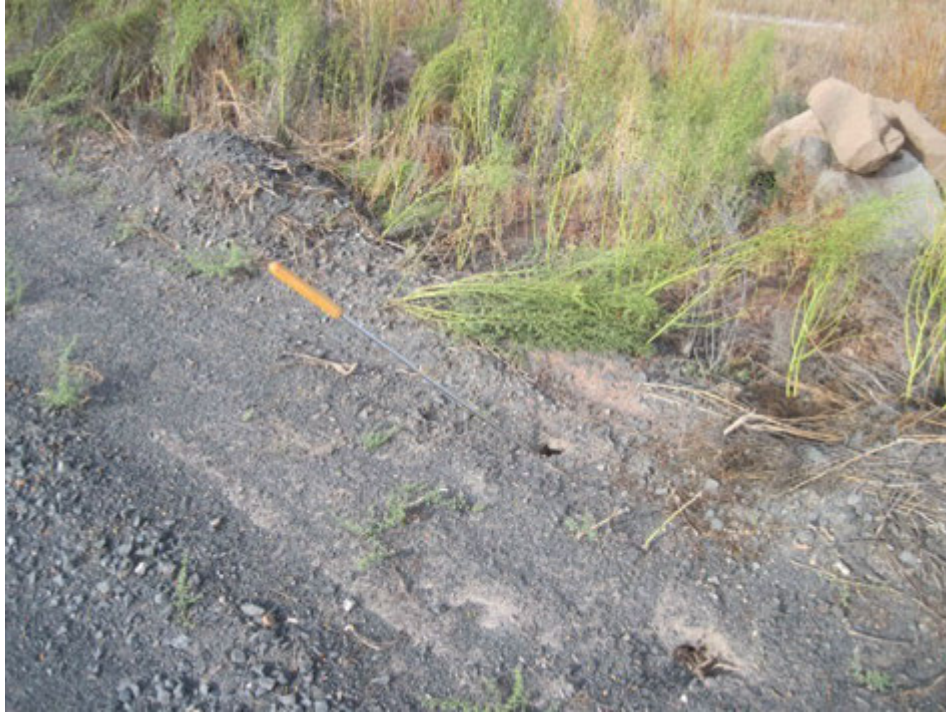
Crest. East leg of embankment. Apparent minor animal burrow.

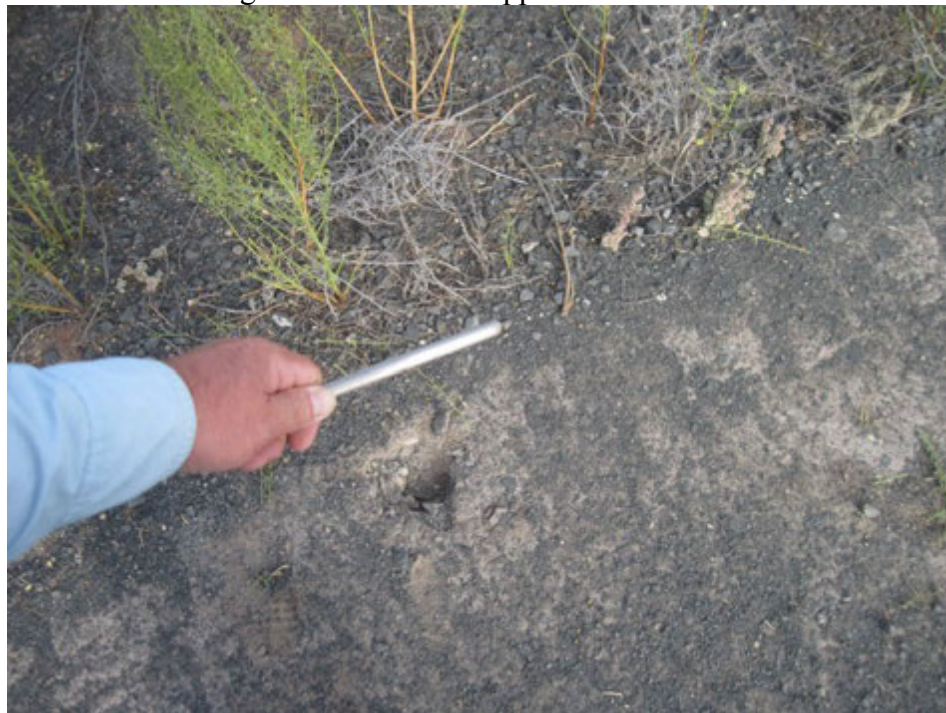
Crest. East leg of embankment. Apparent minor animal burrow.

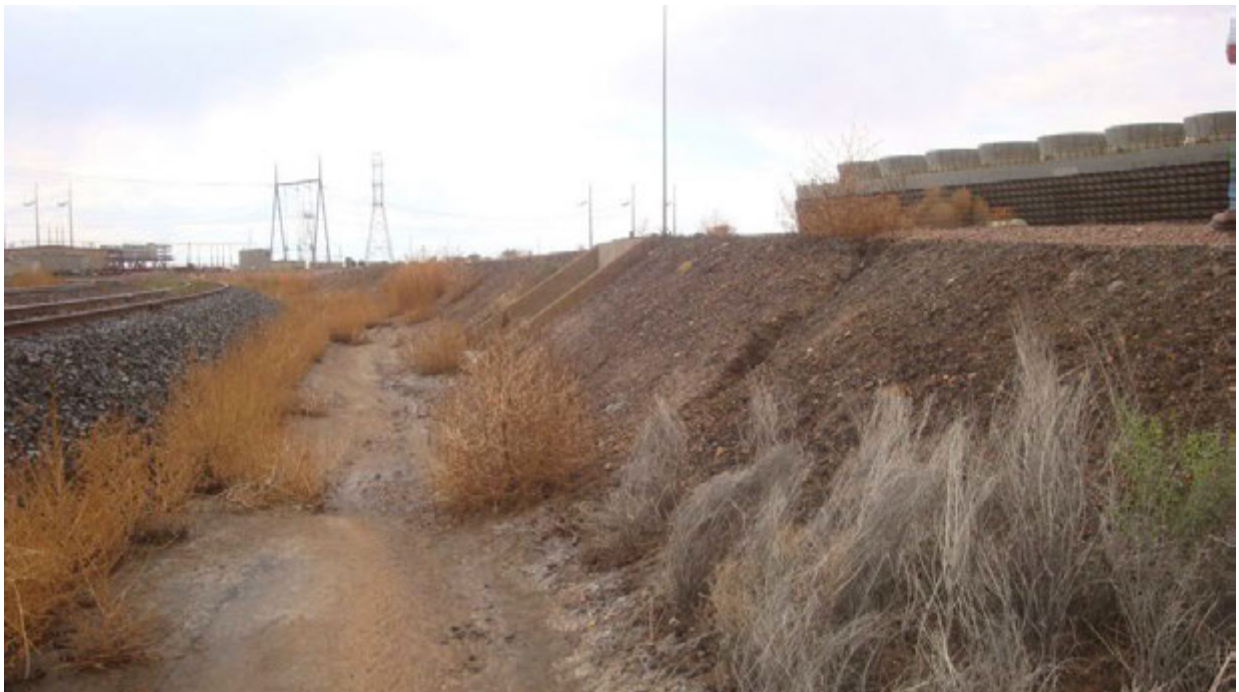
**20151016 – Photo 2**  
West Embankment. Downstream slope. Minor erosion rills.

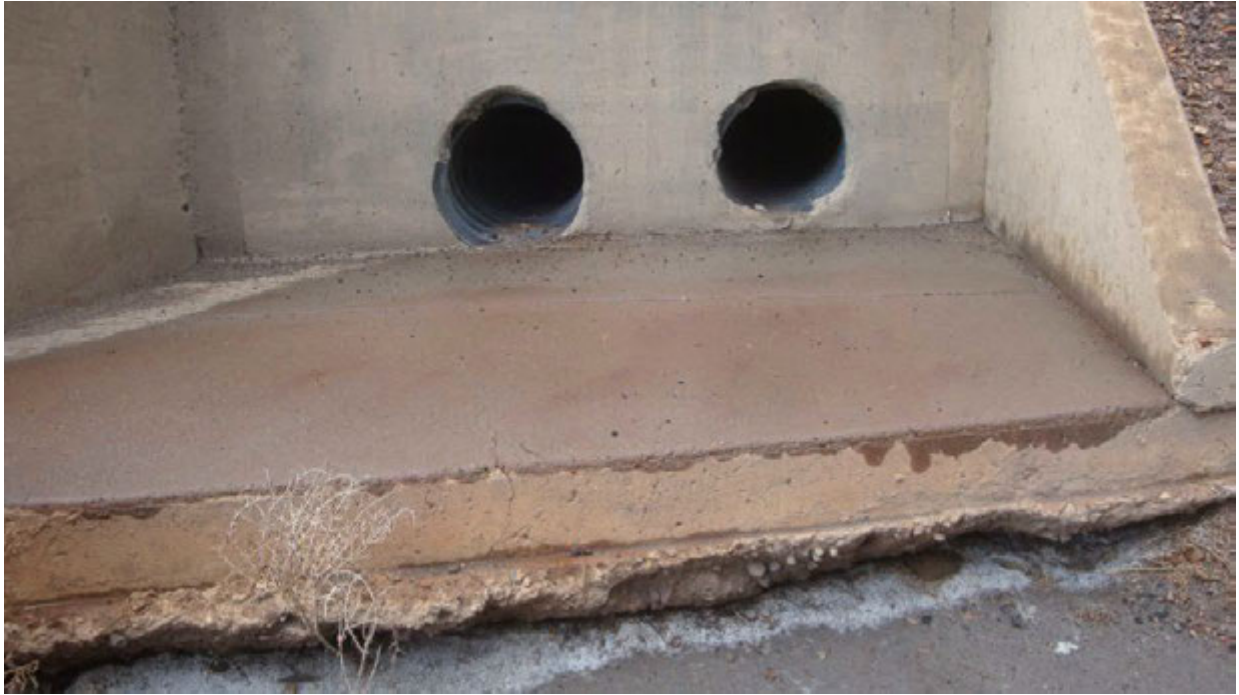
<b>Cholla Sedimentation Pond</b>		SID: N/A		N/A	No	Yes	Mon	Rep	Inv
c	Adverse vegetation?			X					
d	Longitudinal/Transverse cracking?			X					
e	Inadequate riprap?			X					
f	Stone deterioration?			X					
g	Settlements, slides, depressions, bulges?			X					
h	Soft spots or boggy areas?			X					
i	Movement at or beyond toe?			X					
j	Animal burrows?	<b>None observed. Continue to monitor.</b>		X			X		
<b>6 ABUTMENT CONTACTS</b>									
a	Erosion?	<b>Abutments not defined due to general plant grading.</b>			X				
b	Differential movement?				X				
c	Cracks?				X				
d	Settlements, slides, depressions, bulges?				X				
e	Seepage?				X				
f	Animal burrows?	<b>None observed. Continue to monitor.</b>		X			X		
<b>7 SEEPAGE/PIPING CONTROL DESIGN FEATURE(S)</b>									
a	Describe:	<b>None.</b>							
b	Internal drains flowing?			X					
c	Seepage at or beyond toe?	<b>Slight evidence of evaporites in drainage ditch at toe of embankment, may just result from water in channel. See Photo 3.</b>				X	X

**20151016 – Photo 3**  
Downstream slope. Outlet to Tanner Wash.

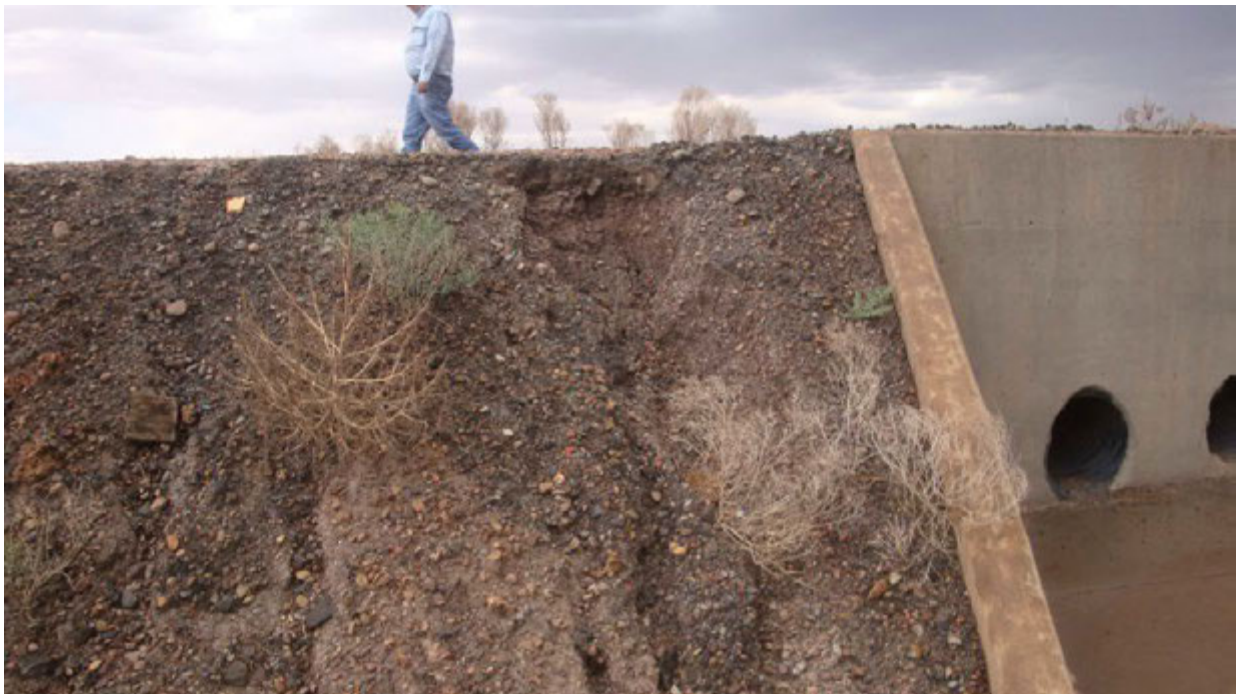
<b>DAM EMBANKMENT CHECKLIST</b>									
<b>3</b>	<b>DAM CREST</b>								
a	Settlements, slides, depressions?		X						
b	Misalignment?		X						
c	Longitudinal/Transverse cracking?		X						
d	Animal burrows? <b>None observed. Continue to monitor.</b>		X		X				
e	Adverse vegetation?		X						
f	Erosion? <b>Indications of concentrated runoff caused by road grading that is causing erosion rills on d/s slope. See Photos Sedi 4 and 5.</b>		X						
<b>4</b>	<b>UPSTREAM SLOPE</b>								
a	Erosion?		X						
b	Inadequate ground cover?		X						
c	Adverse vegetation? <b>Shrubs and other vegetation observed. See Photos Sedi 2 and 11.</b>			X	X				
d	Longitudinal/Transverse cracking?		X						
e	Inadequate riprap?		X						
f	Stone deterioration?		X						
g	Settlements, slides, depressions, bulges?		X						
h	Animal burrows? <b>None observed. Continue to monitor.</b>		X		X				
<b>5</b>	<b>DOWNSTREAM SLOPE</b>								
a	Erosion? <b>Several rills, 1 to 2 feet deep, likely caused by concentrated runoff caused by crest road grading. See Photos Sedi 4 and 5.</b>			X	X

**20151016 – Photo 4**  
Downstream slope. Minor erosion rills.

- Adjust embankment crest road grading to cause runoff to flow into south chamber of impoundment to eliminate erosion on downstream slope of embankment.

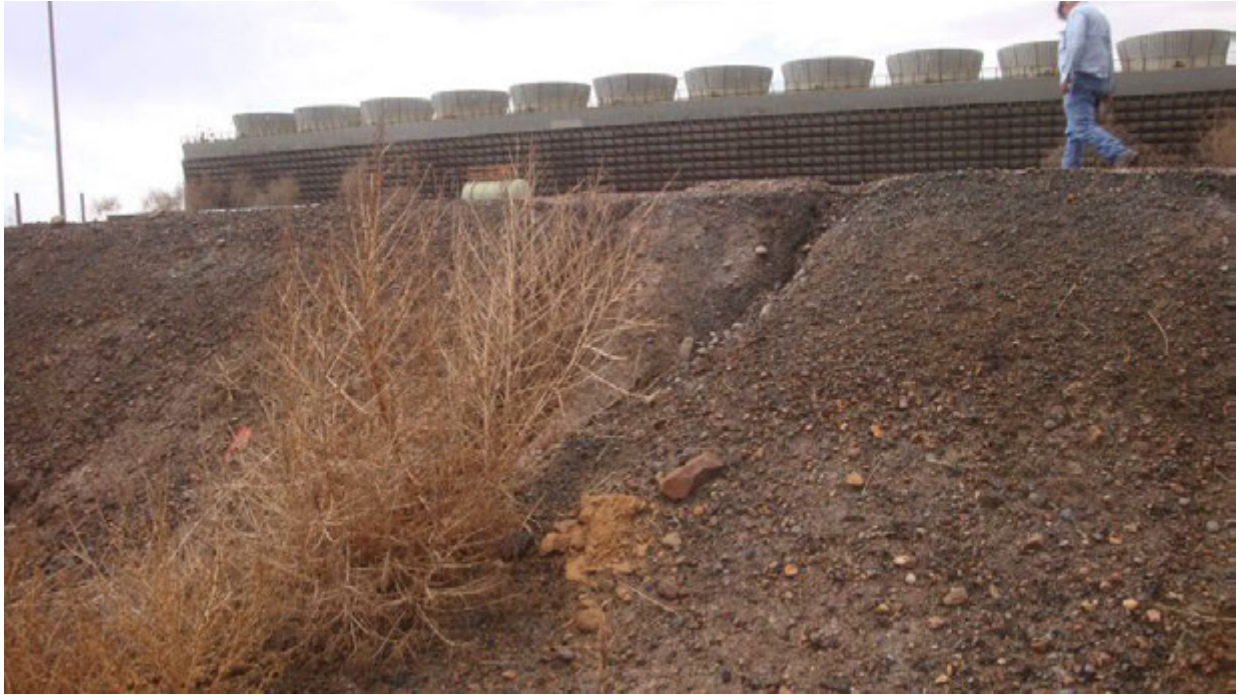
**20151016 – Photo 5**  
Downstream slope. Minor erosion rills.

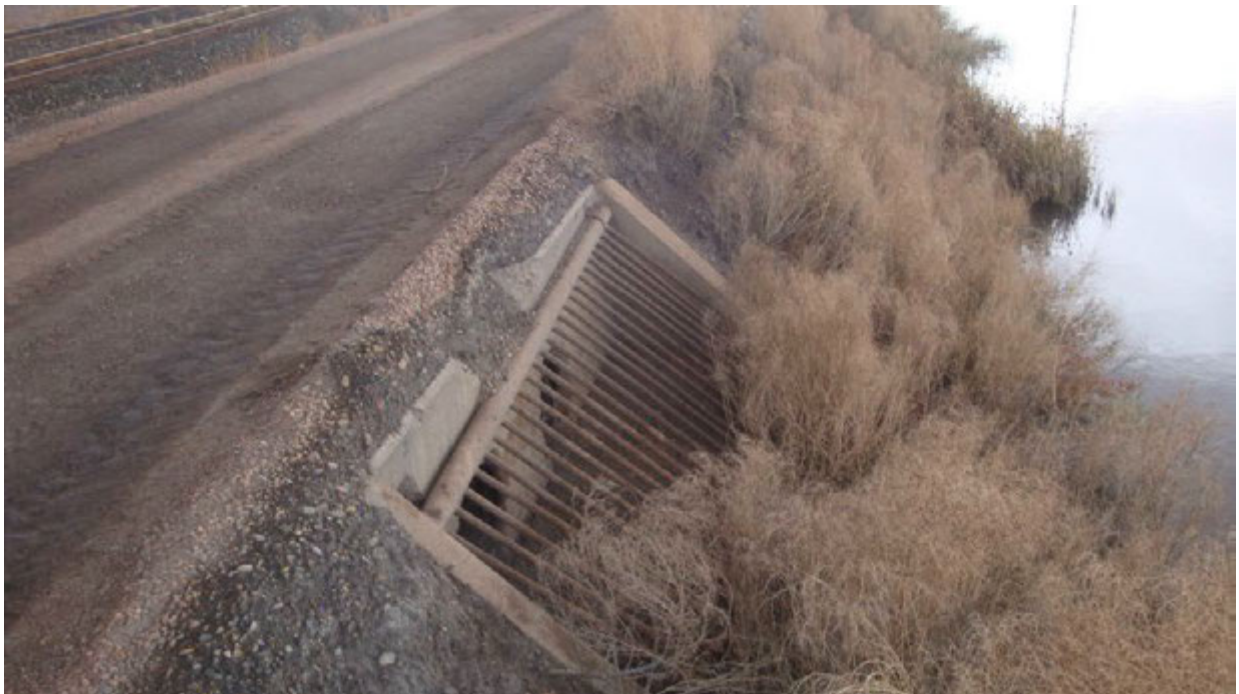
**20151016 – Photo 11**  
Upstream slope. Gated inlet, partially blocked by vegetation.

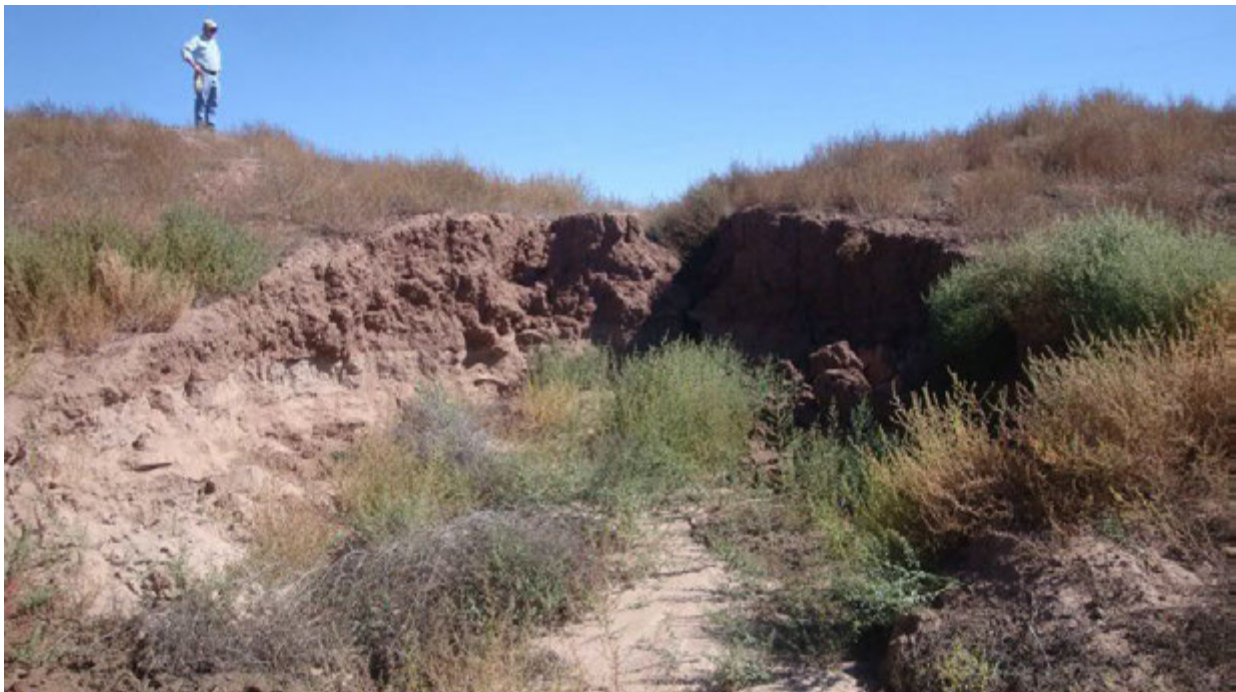
- Evidence of head-cutting in inlet channel to run-on detention basin located in SE corner of landfill. See Photos BAM 12 and 15. Recommend to monitor extent during weekly, next annual inspection and repair if needed. Does not seem to compromise storage or performance of landfill itself.
- Evidence of sediment from side channel blocking run-on channel adjacent to NW corner of landfill. See Photos BAM 21, 22, and 23. If conditions continue, may need excavation of in-filled sediment and placement of riprap or other erosion control measures to control side channel and prevent compromise to function of run-on diversion channel.

**20151016 – Photo 12**  
Run-on detention basin. Head-cutting at inlet.

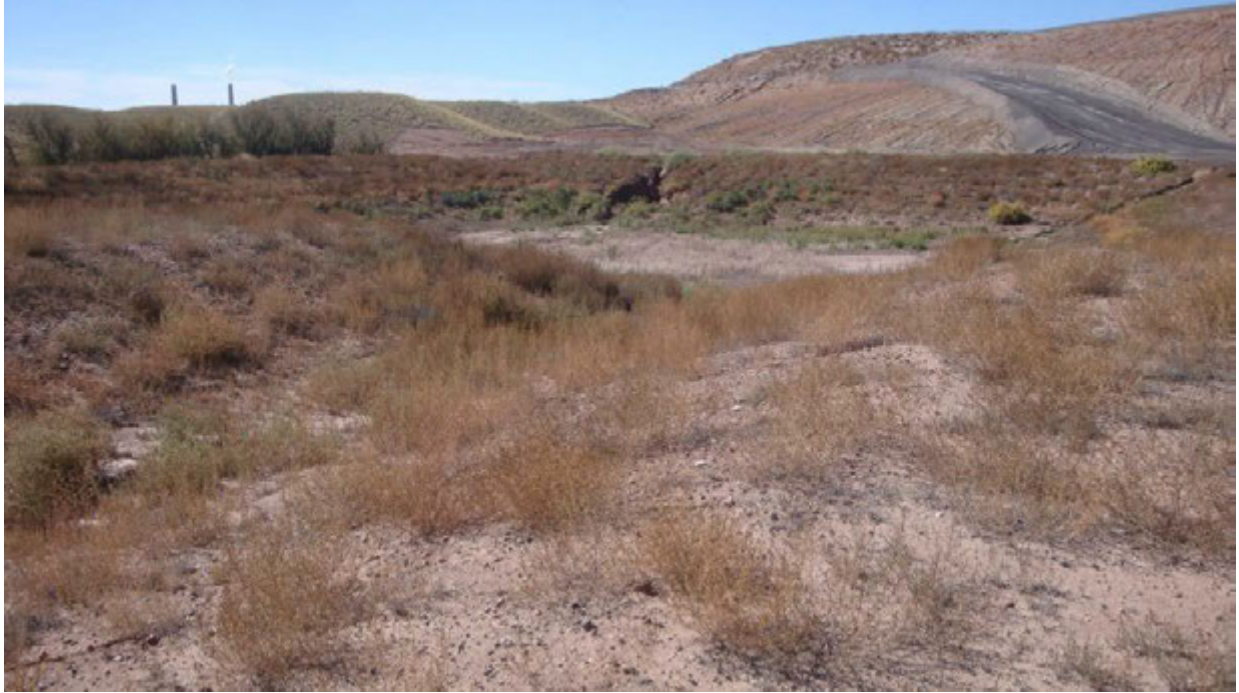
**20151016 – Photo 15**  
Run-on detention basin. General view.
