# CHOLLA POWER PLANT Fly Ash Pond, Bottom Ash Pond, Sedimentation Pond and Bottom Ash Monofill

## Annual CCR Impoundment and Landfill Inspection Report

### 2015

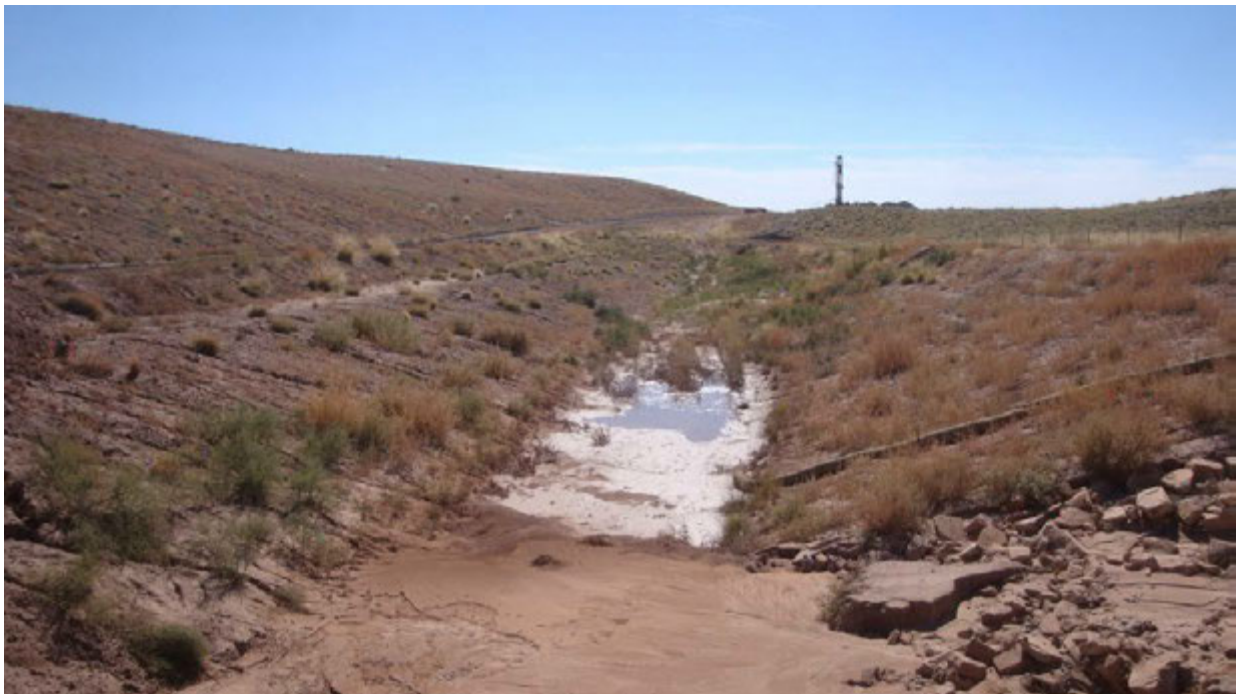
<b>2</b>	<b>CONDITION SUMMARY</b>	<b>Comments</b> Not Applicable, No, Yes, Monitor, Repair, Investigate							
a	Waste placed in good practices?	Waste is placed roughly annually when dredged from Bottom Ash Pond. The eastern portion of the permitted footprint of the landfill had been prepared to receive ash at the time of the inspection and several lifts had been placed although placement was not underway and not observed during the inspection. Waste appeared to have been placed in accordance with good practice. See Photos BAM 4 and 5.			X				
b									
<b>3</b>	<b>LANDFILL CONFIGURATION</b>	<b>Comments</b> Not Applicable, No, Yes, Monitor, Repair, Investigate							
a	Settlements, slides, slope stability?	No, none apparent		X					
b	Cracking? No, None apparent								
c	Run on control?	Yes. Some evidence of head-cutting in inlet to run-on detention basin located in SE corner of landfill. See Photos BAM 12 and 15. Evidence of sediment blocking run-on channel adjacent to NW corner of landfill, may need removal and placement of riprap to prevent erosion into run-on channel. See Photos BAM 21, 22, and 23.			X	X

**20151016 – Photo 21**  
Run-on diversion channel. Looking up-gradient. Partially blocked by debris side drainage.

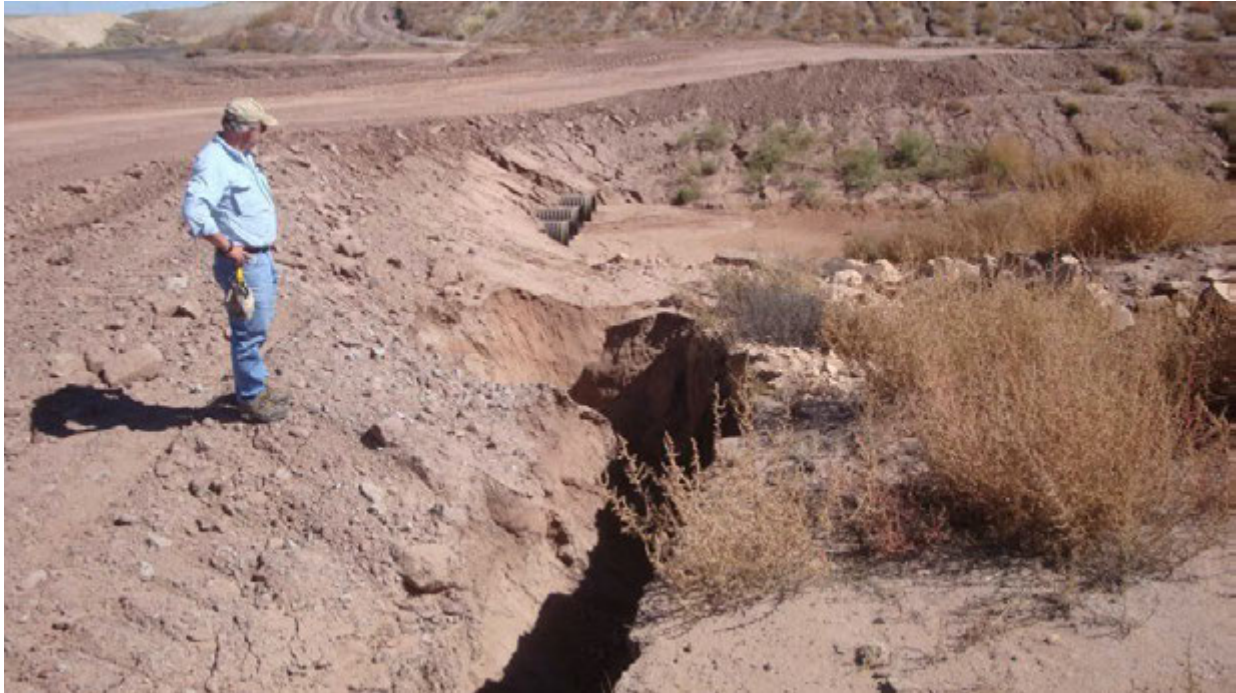
Side drainage to run-on diversion channel. Looking downstream with a deep erosion rill.

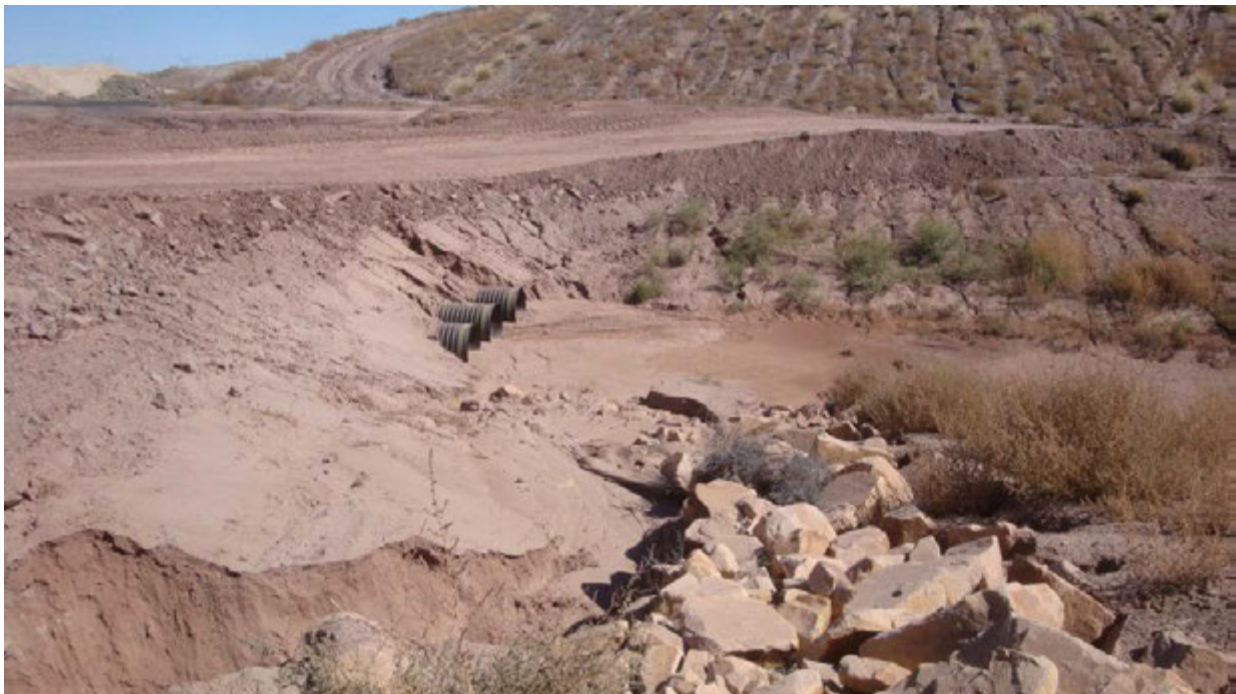
Side drainage to run-on diversion channel. Looking at displaced rip rap protection.
