# CHOLLA POWER PLANT Fly Ash Dam, Bottom Ash Dam, and Bottom Ash Monofill

## Annual CCR Impoundment and Landfill Inspection Report

2024

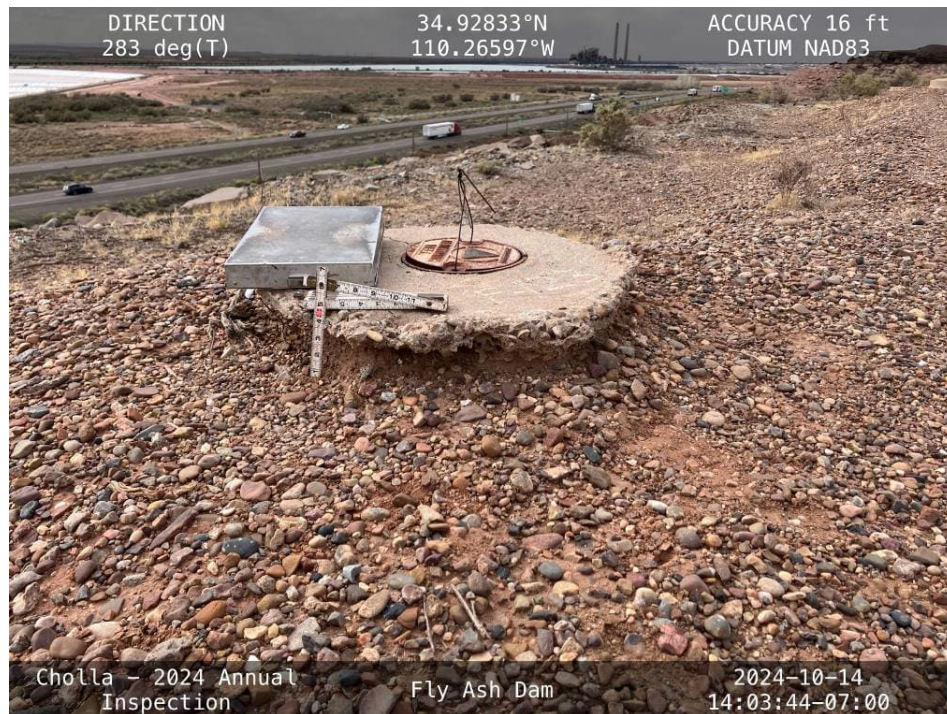
#### 20241014 – IMG\_6456

Location along the upstream slope where erosion 3.25 feet wide and 1.5 feet deep observed during the 2023 inspection has been repaired.

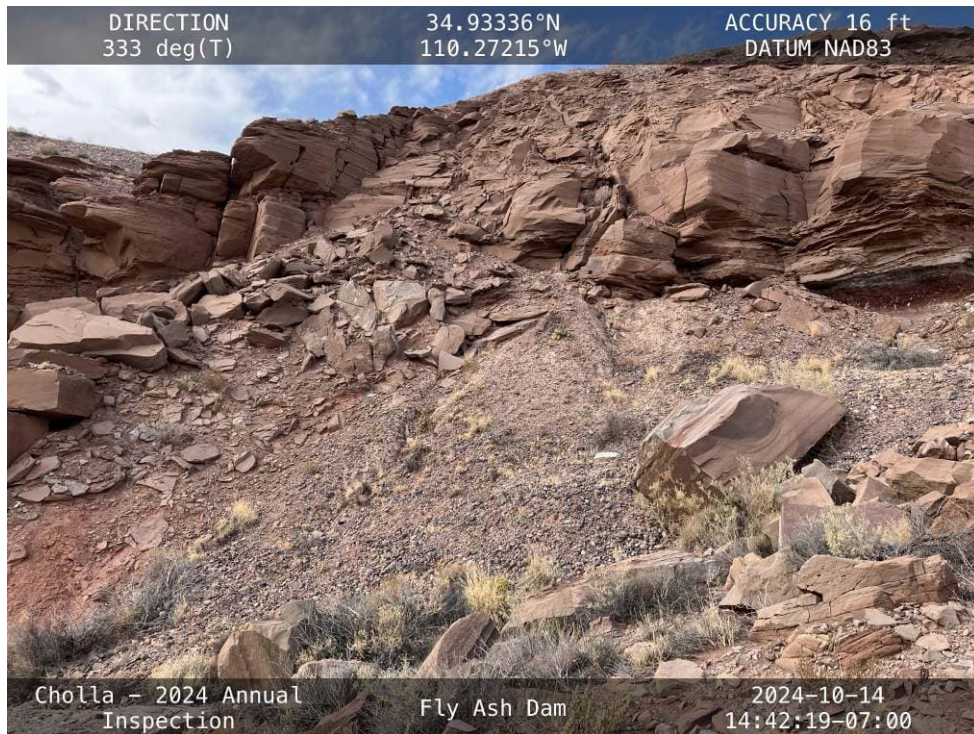
#### 20241014 – IMG\_6506

A 1-foot deep hole was observed within the riprap on the downstream shoulder of the West Embankment crest (Photo IMG\_6473) and a 10-inch deep hole on the upstream shoulder of the West Embankment (Photo IMG\_6506). Continue to monitor the crest for progressive erosion and the appearance of new erosion holes. Repair holes when the depth exceeds 1 foot.

A 10-inch deep hole on the upstream shoulder of the West Embankment.

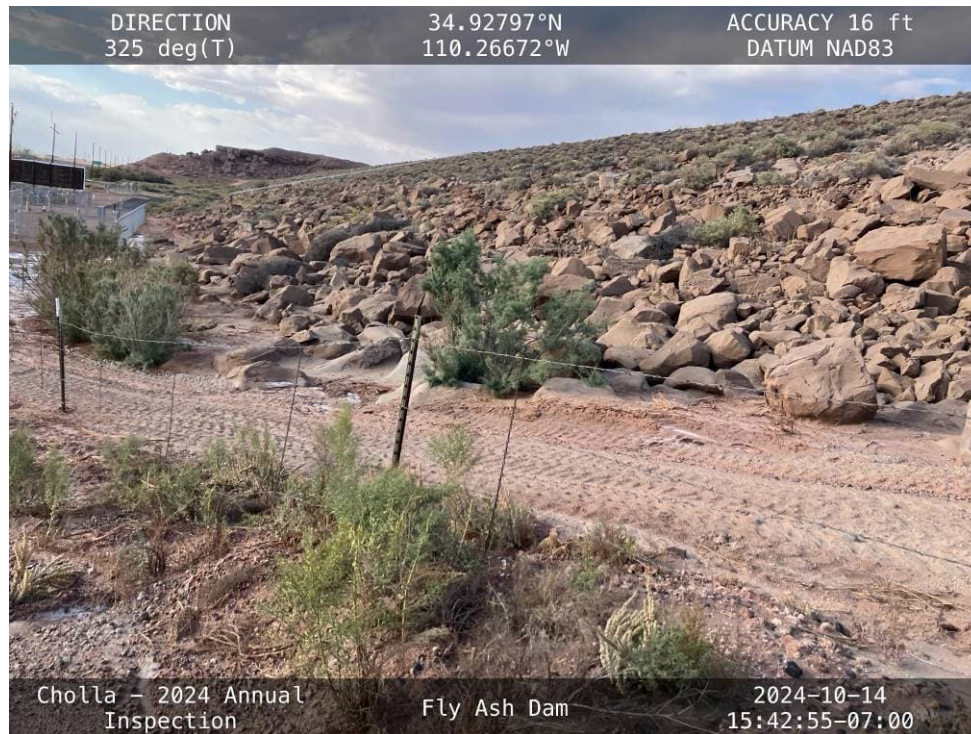
### 20241014 – IMG\_6583

Fly Ash Dam		SID: 09.28	N/A	No	Yes	Mon	Rep	Inv
5	<b>DOWNSTREAM SLOPE</b>							
a	Erosion?	Erosion typically observed along the access road over the Geronimo Knob during previous inspections had been recently repaired (Photos IMG_6583 and IMG_6584); however, evidence of soil loss due to erosion at the downstream toe was present near the Geronimo Seep (IMG_6593). Continue to monitor and repair when the eroded depth exceeds 1 foot.			X	X		
b	Inadequate ground cover?			X				
c	Adverse vegetation?	None observed. Continue to monitor.		X		X		
d	Longitudinal/Transverse cracking?			X				
e	Inadequate riprap?			X				
f	Stone deterioration?	Minor deterioration observed. See comment vi.			X	X		
g	Settlements, slides, depressions, bulges?			X				
h	Soft spots or boggy areas?	There is evidence of historic seepage beyond the downstream toe. Continue to monitor.			X	X		
i	Movement at or beyond toe?			X				
j	Animal burrows?	None observed. Continue to monitor.		X		X

Repaired erosion at the downstream toe, south of the Geronimo Seep area.

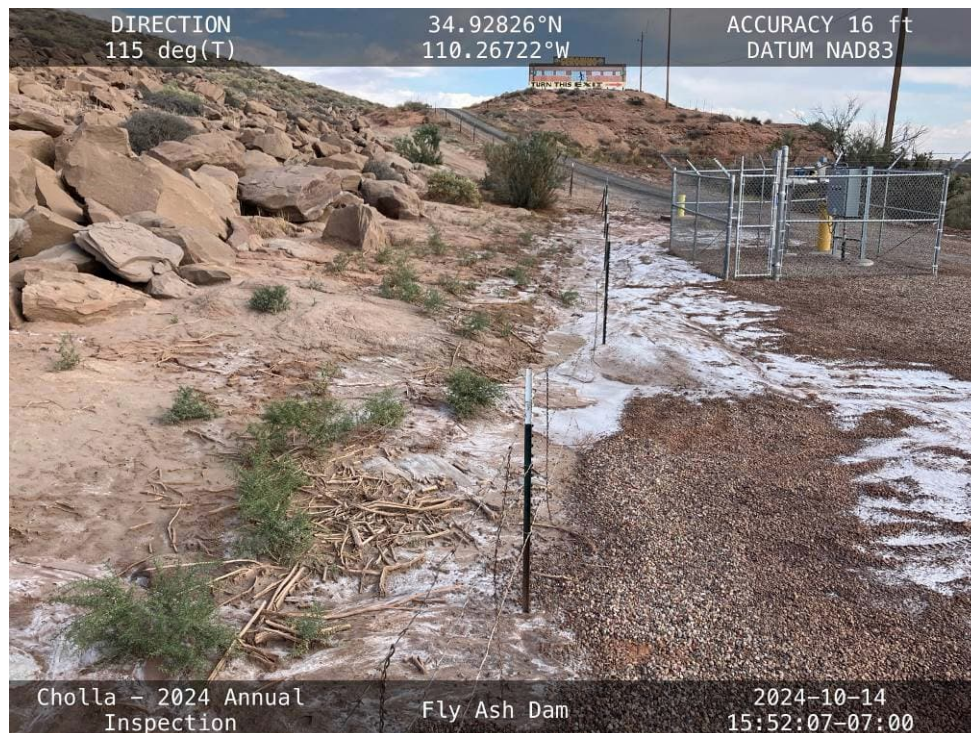
### 20241014 – IMG\_6584

Repaired erosion at the downstream toe, south of the Geronimo Seep area.

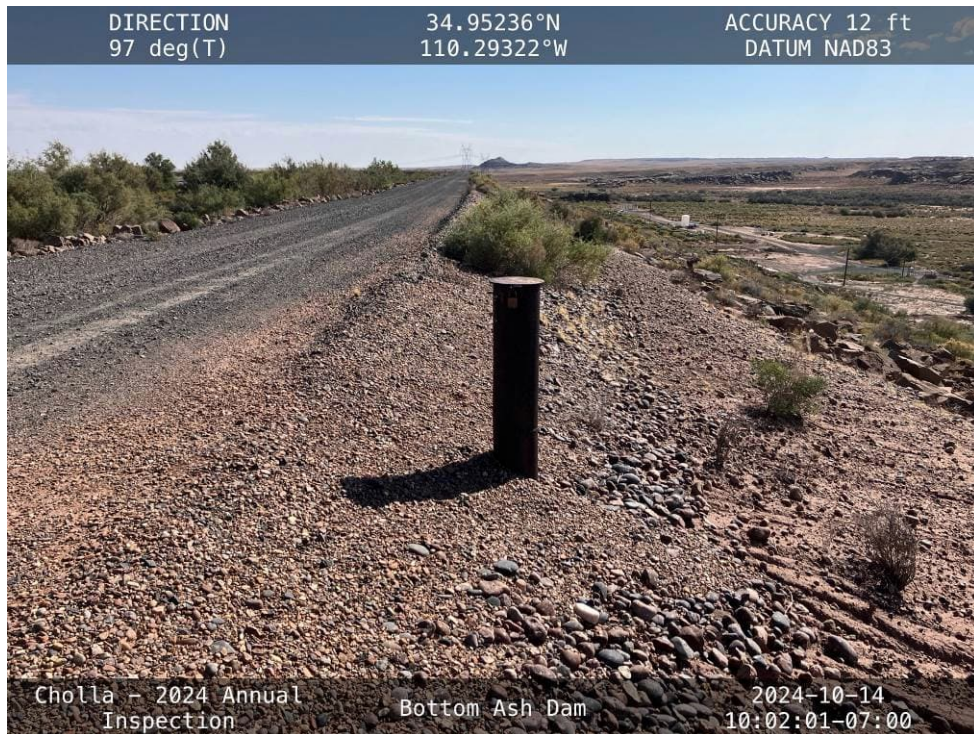
### 20241014 – IMG\_6116

j	Animal burrows?	None observed. Continue to monitor.		X			X		
<b>6</b>	<b>ABUTMENT CONTACTS</b>								
a	Erosion?	APS repaired the erosion in the downstream groin of the Right Abutment (Photo IMG_6116). An erosion gully has since formed in the repaired area and was measured to be 22 inches deep during this inspection. Continue to monitor this area and repair it as directed by the APS geotechnical engineer.				X		X	
b	Differential movement?			X					
c	Cracks?			X					
d	Settlements, slides, depressions, bulges?			X					
e	Seepage?	Yes. See comment v.				X	X		
f	Animal burrows?	None observed. Continue to monitor.		X			X		
<b>7</b>	<b>SEEPAGE/PIPING CONTROL DESIGN FEATURE(S)</b>								
a	Describe:	Several monitoring, seepage, and pump back collection systems are located downstream of the dam. The monitored seeps include the West Abutment Weir, the Toe Drain Seep, the Petroglyph Seep, the Tanner Wash Seep, and the P-226 Seep. The pump back collection system consists of three siphon lines extending from the toe into the reservoir along the South Embankment.

22-inch deep erosion near the downstream groin of the Right Abutment, facing northwest.

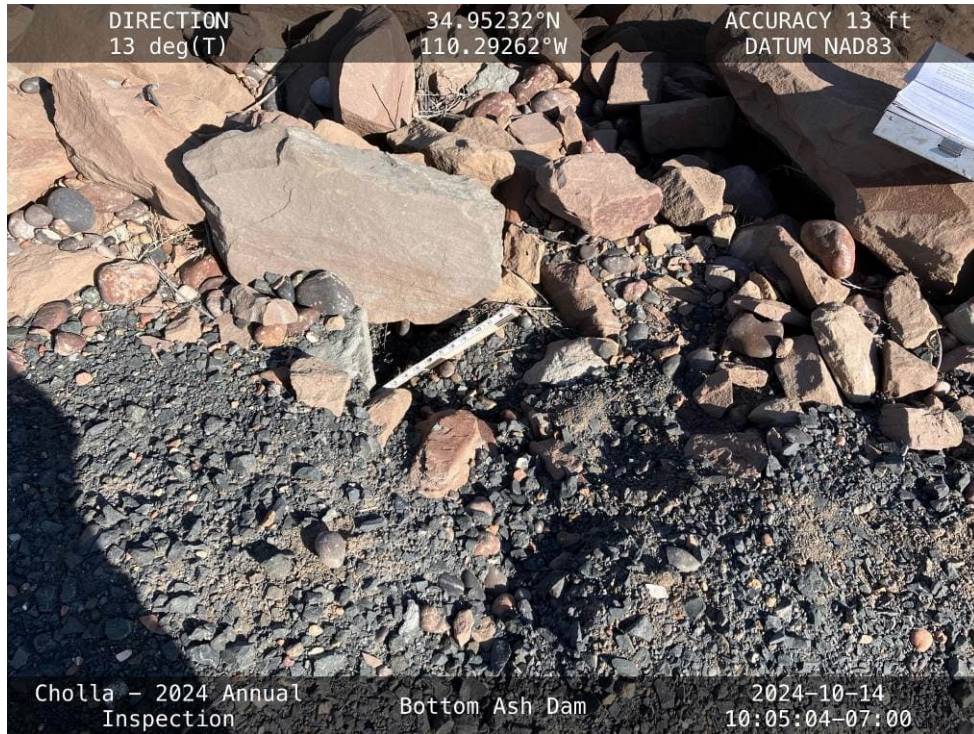
### 20241014 – IMG\_6119

b	Inadequate ground cover?			X					
c	Adverse vegetation?	<b>There is woody vegetation in the pond near the Right Abutment (Photo IMG_6119) and along the upstream slope (Photos IMG_6130, IMG_6156, IMG_6157, IMG_6169, IMG_6177, IMG_6179, and IMG_6185).</b>			X		X		
d	Longitudinal/Transverse cracking?			X					
e	Inadequate riprap?			X					
f	Stone deterioration?			X					
g	Settlements, slides, depressions, bulges?			X					
h	Animal burrows?	<b>None observed. Continue to monitor.</b>		X		X

Trees and other woody vegetation to be removed from the South Embankment upstream slope.

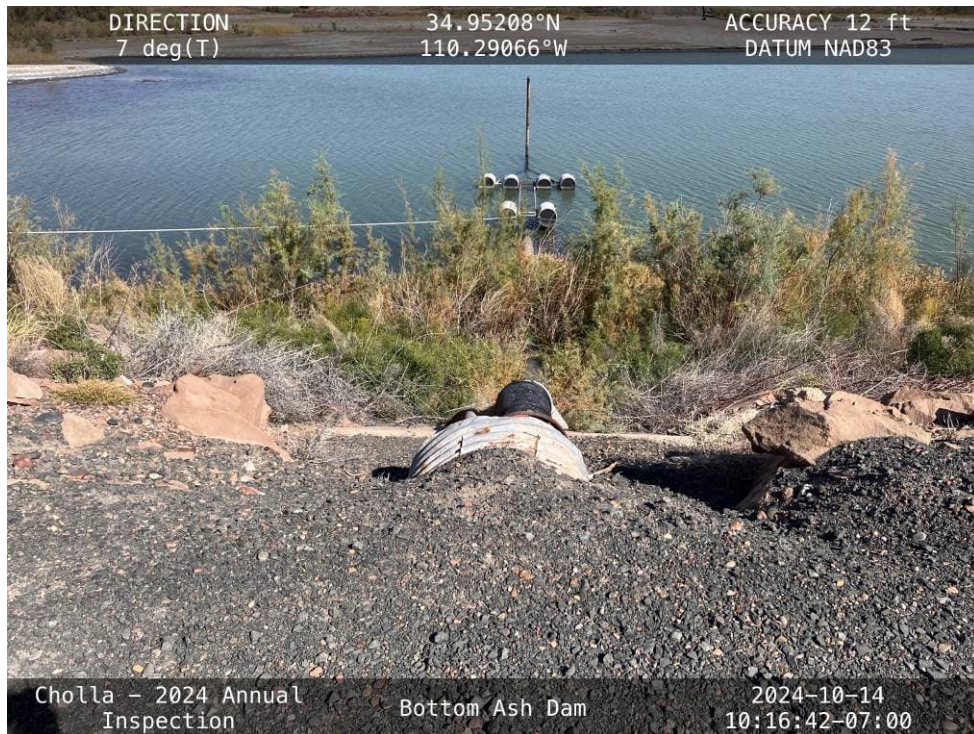
**20241014 – IMG\_6121**

- i. The EAP distribution list should be kept up to date with current personnel.
- ii. Several new erosion holes and rills were observed along the crest and shoulder (Photos IMG\_6121, IMG\_6130, IMG\_6138, IMG\_6188, IMG\_6189, IMG\_6191, IMG\_6206, and IMG\_6211). The deepest measured erosion hole was at least 27 inches (on the South Embankment; Photo IMG\_6121). Although erosion holes are more prevalent in some annual inspections compared to others, most individual erosion holes are not present in consecutive inspections. Holes that are observed in consecutive inspections are typically shallower or nearly filled in during the next annual inspection and are not present during the third annual inspection. The holes on the crest and shoulders should be monitored and repaired if the depth exceeds 1 foot or appears to reach the core.

A 27-inch deep hole under the crest on the upstream side of the South Embankment shoulder.

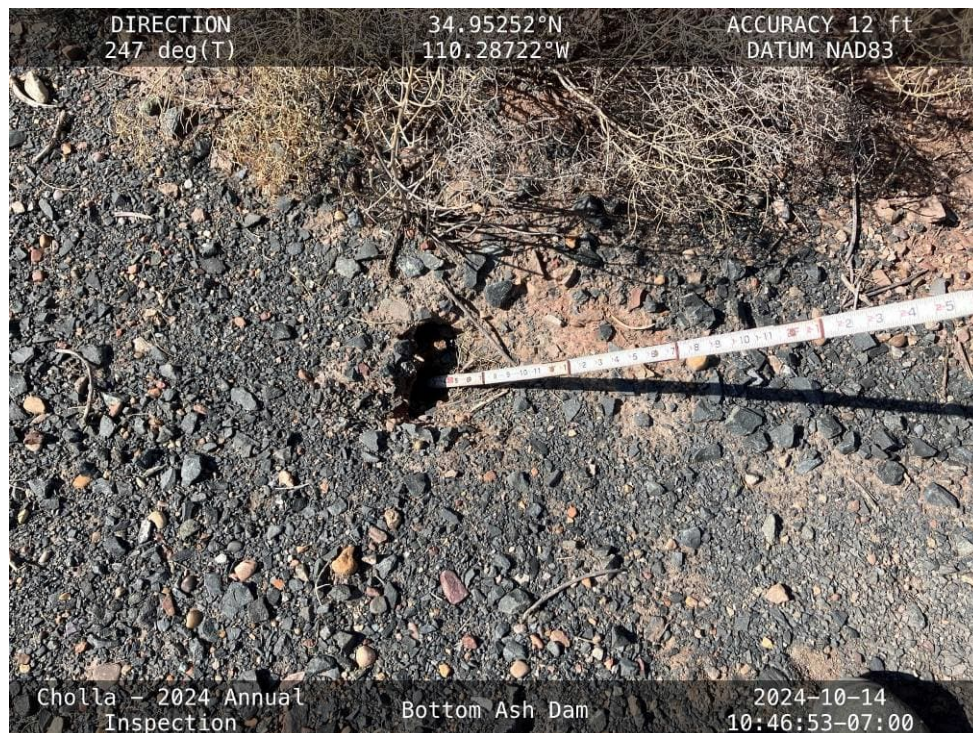
### 20241014 – IMG\_6188

A 5.5-inch deep erosion rill forming along the upstream shoulder of the East Embankment.

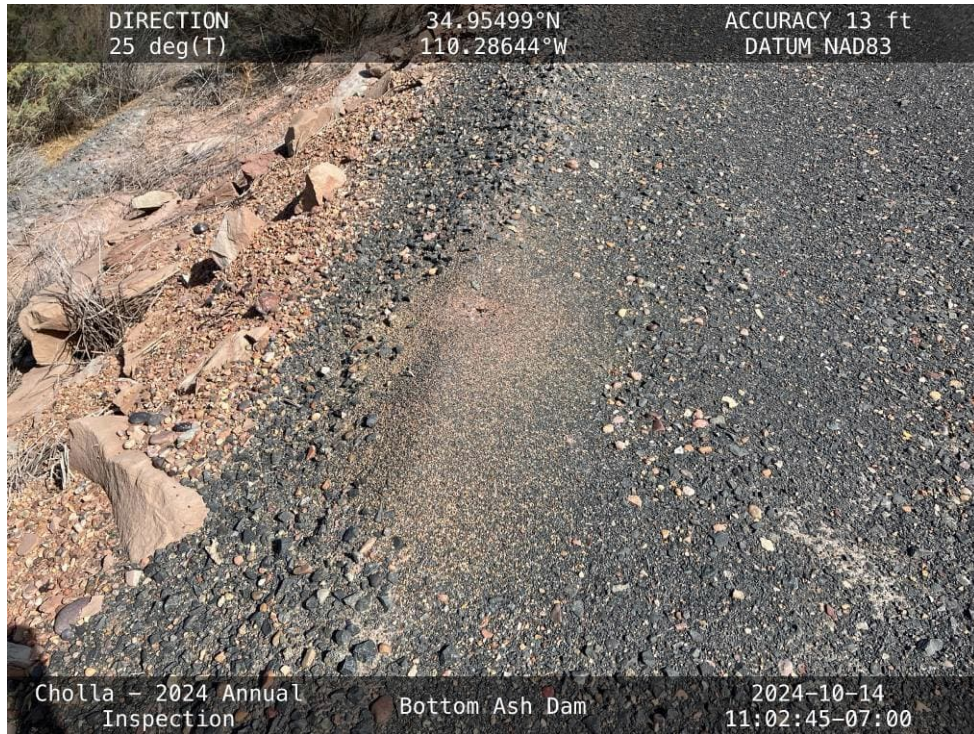
**20241014 – IMG\_6211**

A 6-inch deep hole on the downstream half of the East Embankment crest.

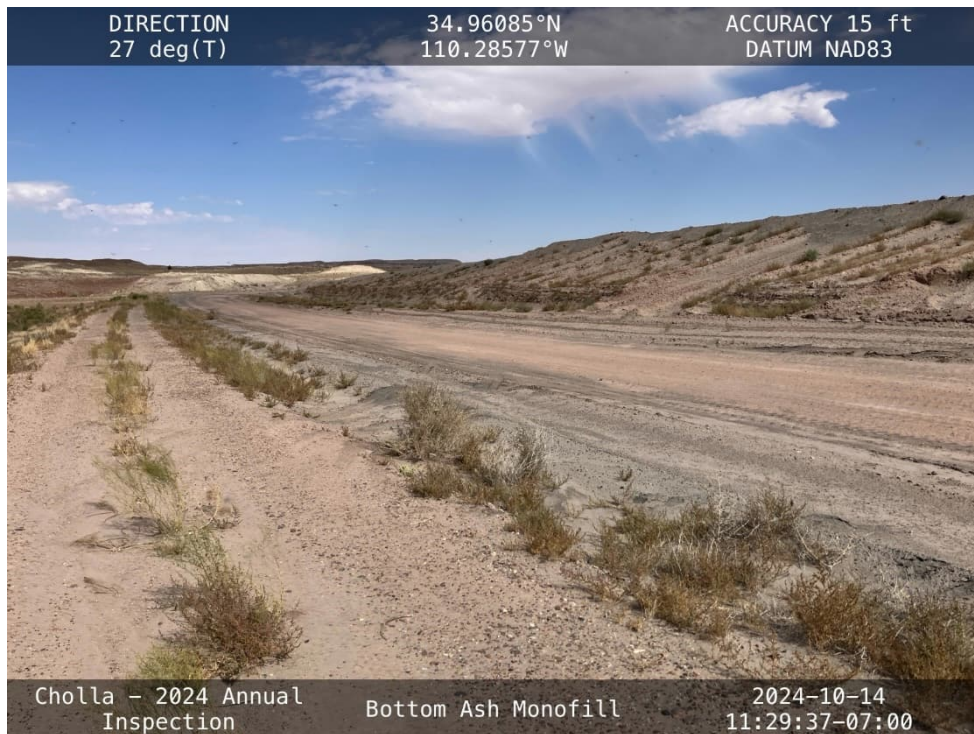
**20241014 – IMG\_6256**  
Erosion gullies and tunnels on the west side of the diversion ditch.

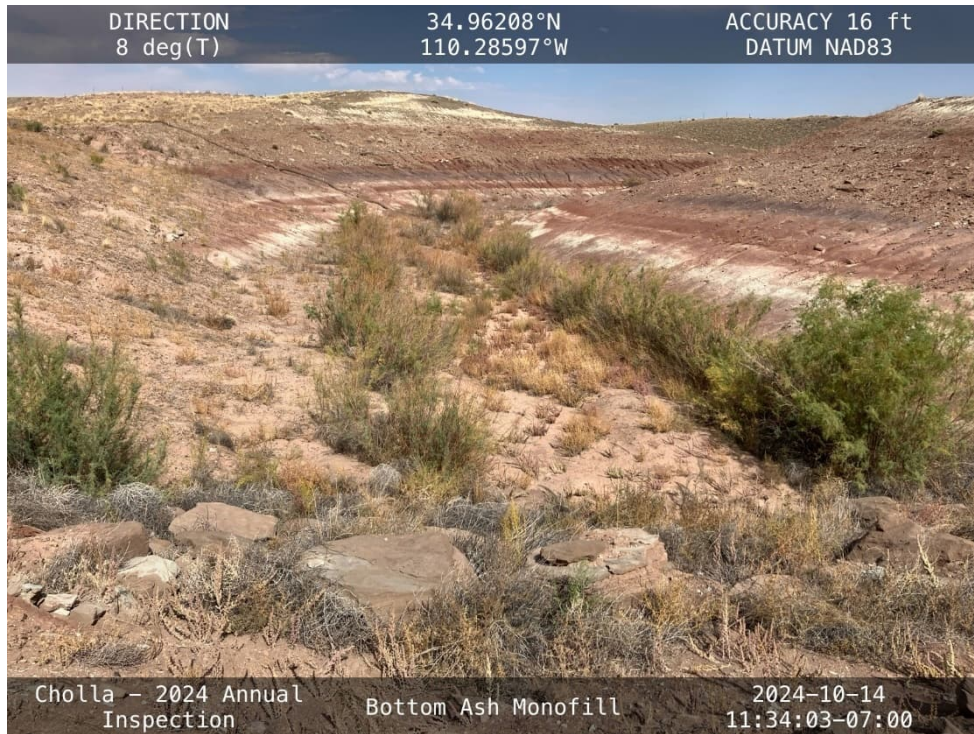
### 20241014 – IMG\_6272

Erosion along the drainage channel on the west side of the BAM, facing west.

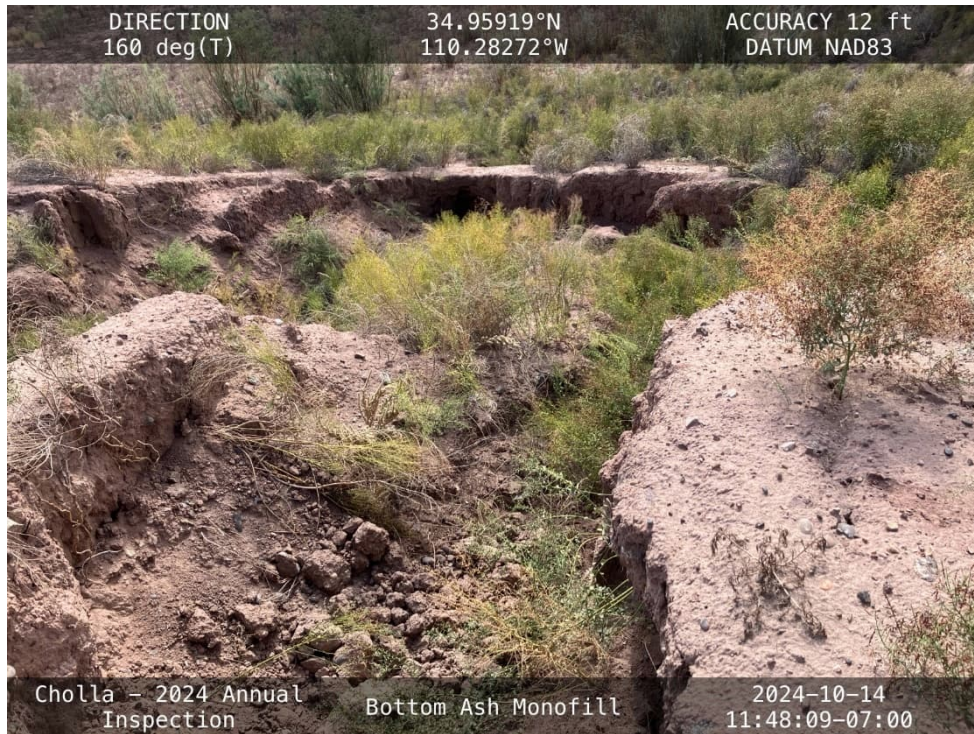
**20241014 – IMG\_6297**  
Erosion on the north side of the Stormwater Detention Basin.
