**FOUR CORNERS POWER PLANT
Lined Ash Impoundment,
Lined Decant Water Pond,
Combined Waste Treatment Pond,
Upper Retention Sump, and
Dry Fly Ash Disposal Area**

**Annual
CCR Impoundment and
Landfill Inspection Report
2018**

**GENERATION ENGINEERING
Design Engineering
P.O. BOX 53999
PHOENIX, ARIZONA 85072**

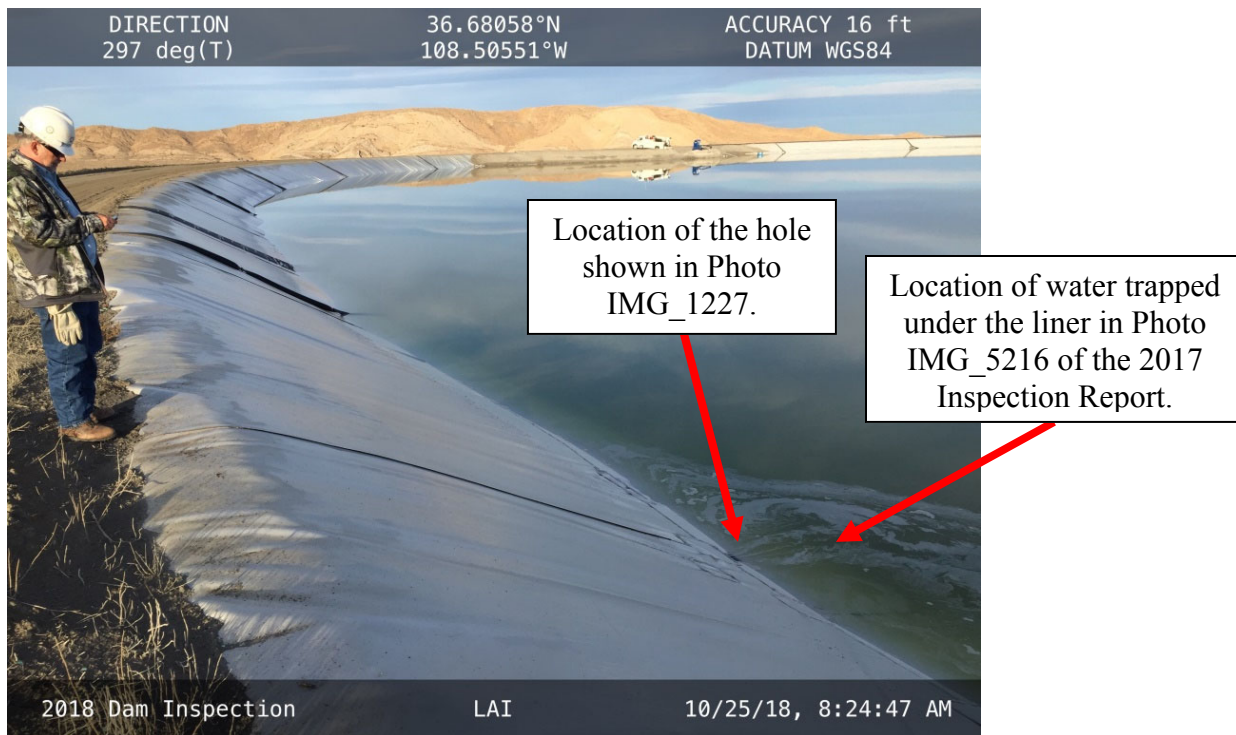
20181025 – IMG_1229

The upstream slope in the Southwest Corner, facing west.

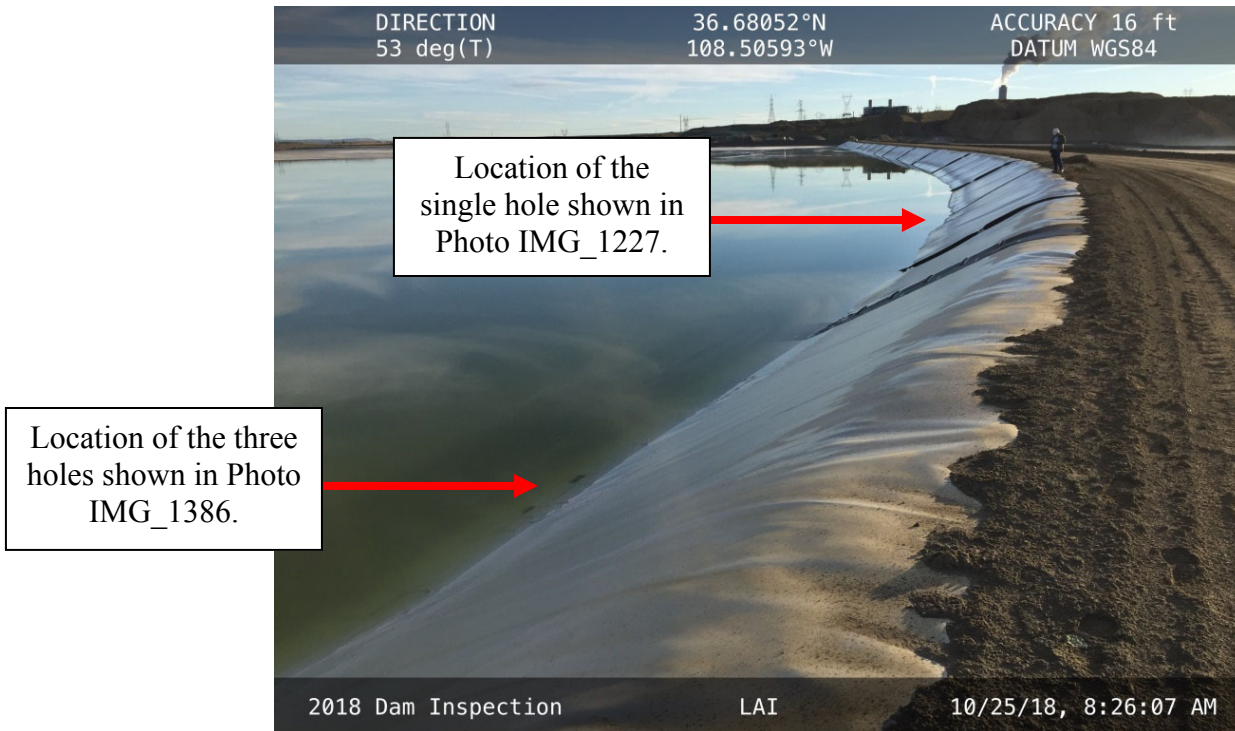
20181025 – IMG_1235

- i. During the inspection, four rectangular holes in the geomembrane liner were observed along the South Embankment below the impounded water level (Photos IMG_1227 and IMG_1386). The straight edges along each hole suggests the holes were cut intentionally (compare Photo IMG_1229 and IMG_1235 in Appendix A of this Inspection Report with Photo IMG_5216 and IMG_5228 in Appendix A of the 2017 Inspection Report). One of the holes appeared to be draining water from underneath the geomembrane liner at the time of the inspection, but the three other holes appeared to be allowing the upstream clay blanket to erode into the impoundment. All of the holes in the geomembrane liner should be repaired as soon as it can be safely done and the purpose for creating the holes should be investigated. The LAI embankment was designed to be stable without the geomembrane liner (URS Corporation 2012); however, the upstream slope and the toe drain along the South Embankment should be monitored for evidence of internal erosion. Evidence could include benching along the upstream slope due to the erosive action of water against the clay and cloudy seepage flowing out of the toe drain. The South Embankment toe drain was dry on the date of this inspection (photo IMG_1415). APS does not believe that the presence of water beneath the liner, nor the damage to the liner itself presents a safety concern since the LAI was designed to be stable without the presence of the liner.

The upstream slope along the South Embankment with holes in the liner annotated, facing east.

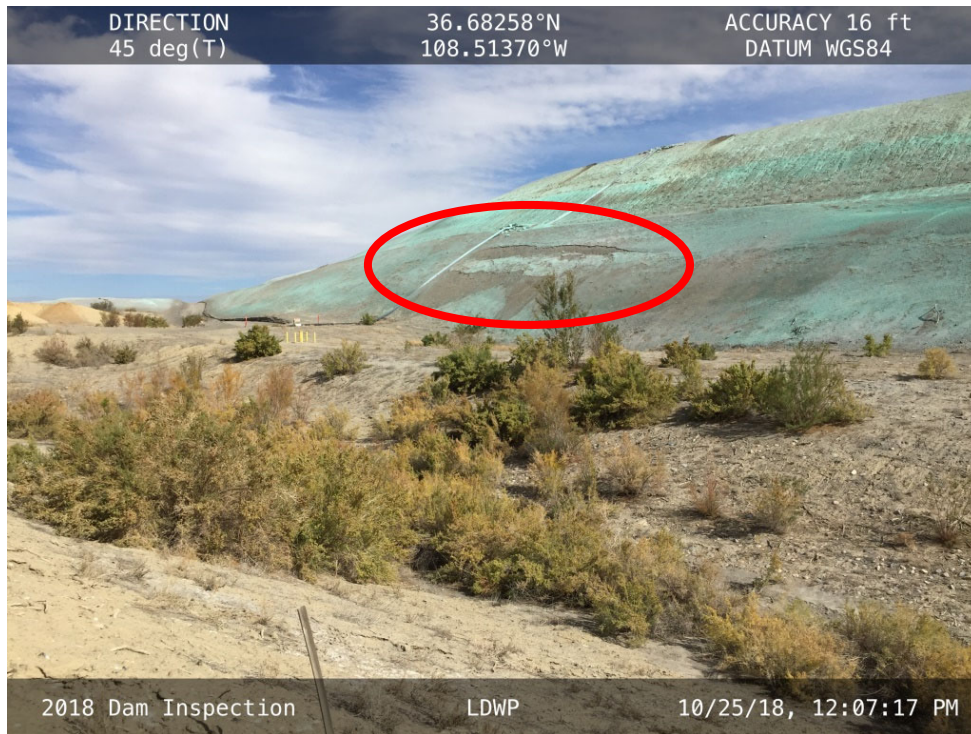
20181025 – IMG_1435

- ii. Two shallow sloughs were observed on the lowermost bench of the West Embankment (Photos IMG_1435 and IMG_1438). The sloughs are laterally extensive and should be repaired.

A shallow surface slough on the lowermost bench of the West Embankment.

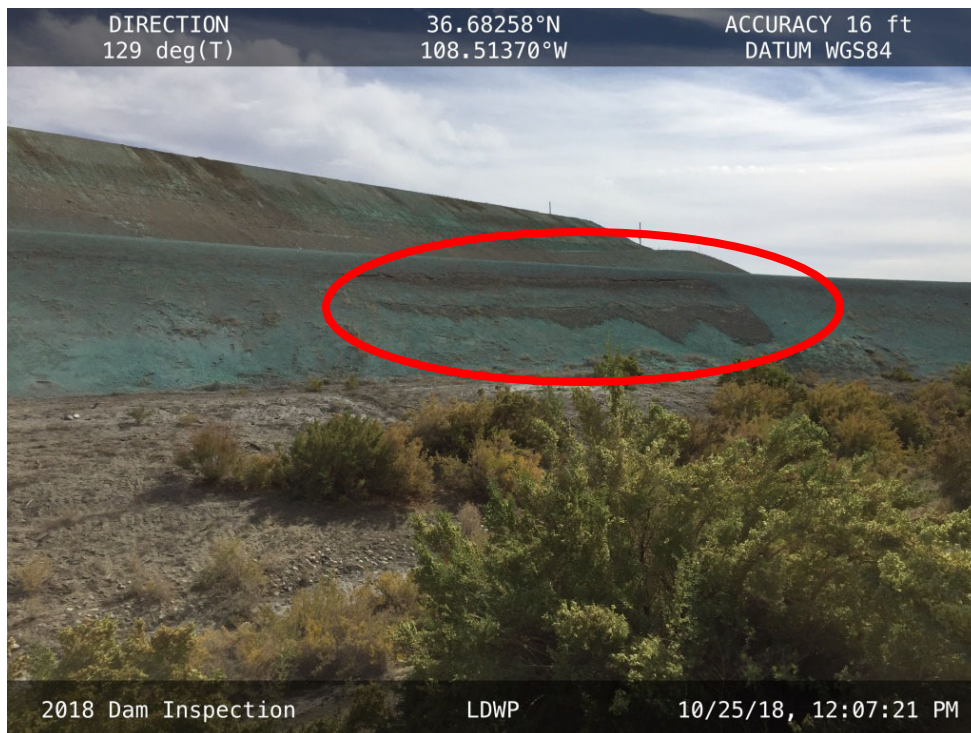
20181025 – IMG_1438

A second shallow surface slough on the lowermost bench of the West Embankment.

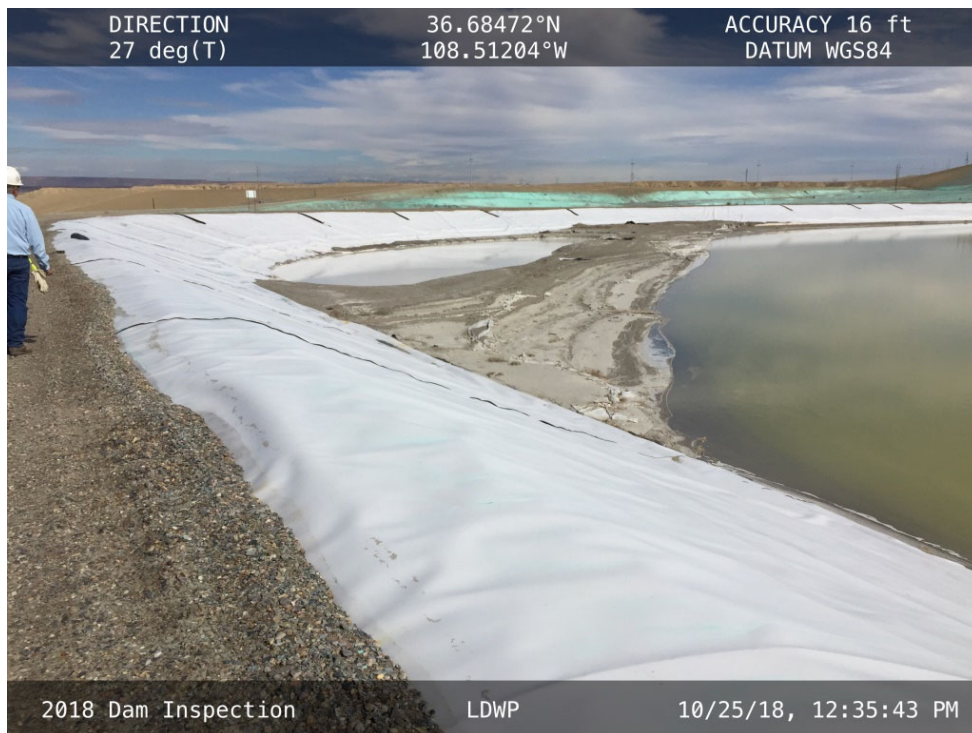
- iv. There were several dents, holes, and tears in the liner along the South, North, and East Embankments (Photos IMG_1521, IMG_1529, IMG_1530, IMG_1571, and IMG_1572). Some of the damaged areas were also observed during the 2017 inspection. Damage to the liner should be repaired and the liner should be monitored for additional tears and cuts.

20181025 – IMG_1521
A shallow dent in the liner in the northwest corner of the LDWP.

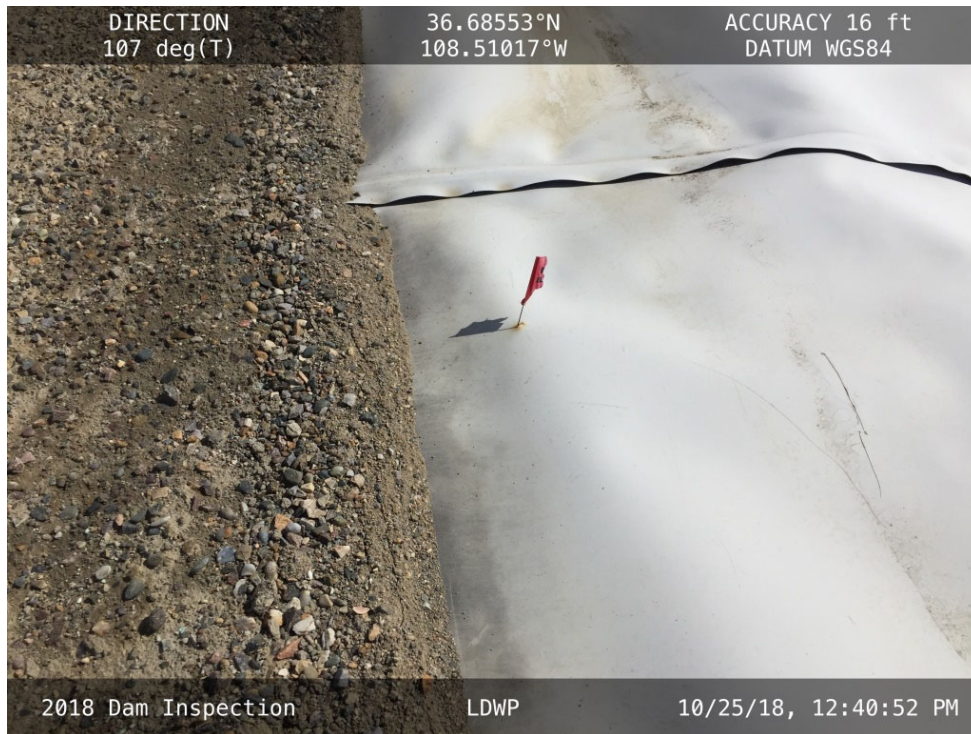
20181025 – IMG_1529
A hole in the liner along the North Embankment already marked with a pin flag.

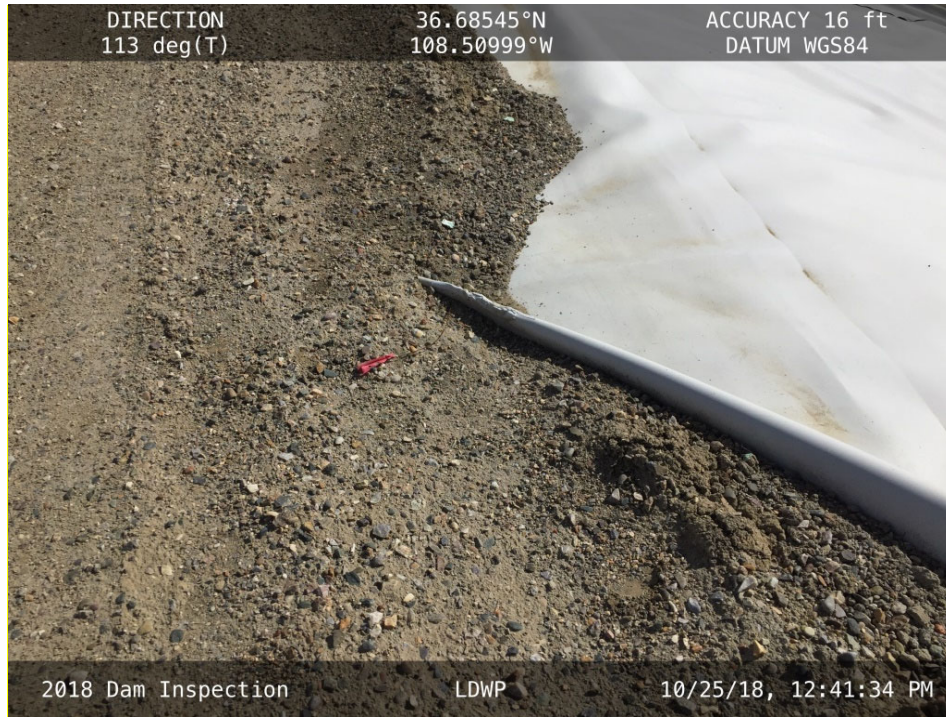
20181025 – IMG_1530

Small tears in the liner along the North Embankment already marked with a pin flag (these were also observed during the 2017 inspection).

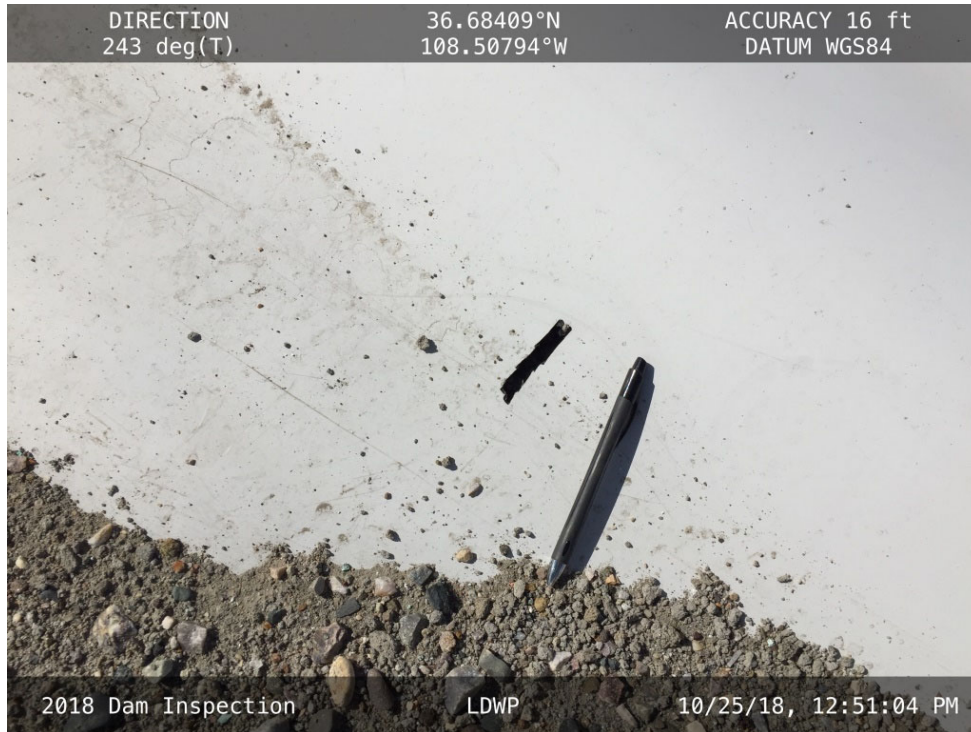
20181025 – IMG_1571
A tear in the liner along the East Embankment (also observed during the 2017 inspection).

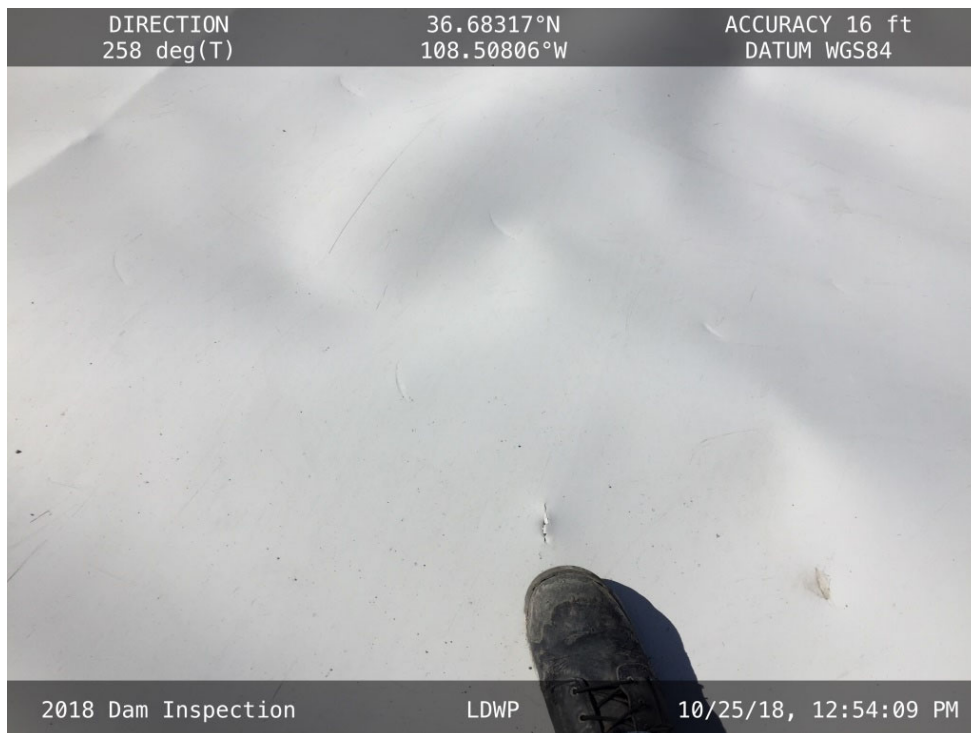
20181025 – IMG_1572
Shallow dents in the liner along the upstream slope of the East Embankment.

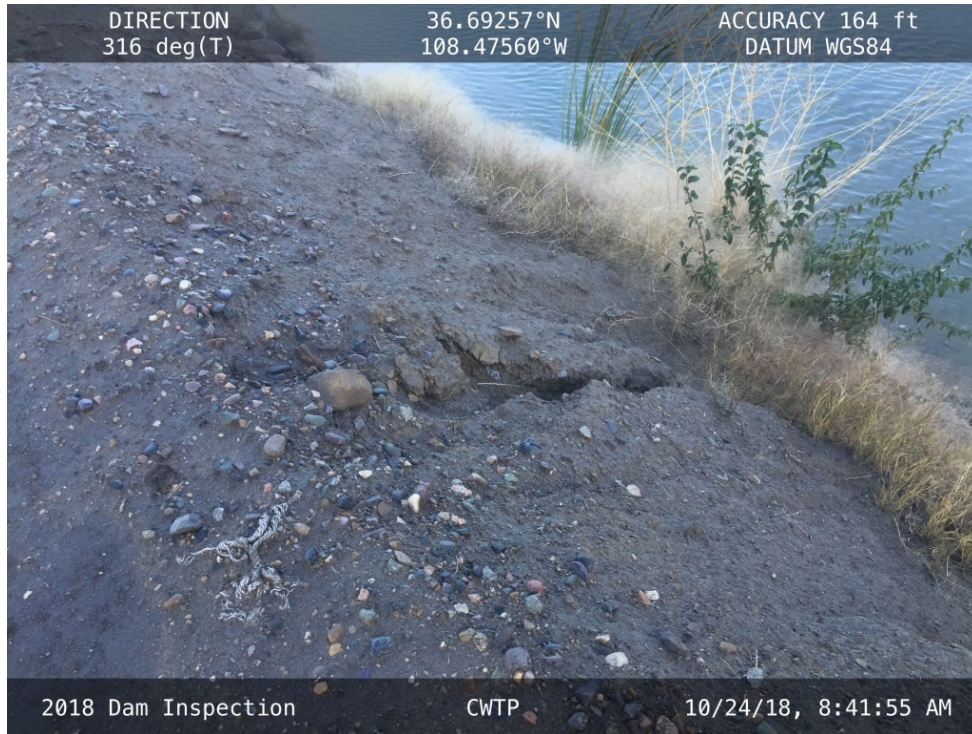
20181024 – IMG_0914

Combined Waste Treatment Pond (CWTP)		SID: N/A		N/A	No	Yes	Mon	Rep	Inv
5	DOWNSTREAM SLOPE								
a	Erosion?	See comment iii.			X	X			
b	Inadequate ground cover?			X					
c	Adverse vegetation?	Isolated instances of adverse vegetation (Photos IMG_0909, IMG_0914, and IMG_0921).			X	X			
d	Longitudinal/Transverse cracking?	See comment iv.			X	X			
e	Inadequate riprap?	See comment v.		X					
f	Stone deterioration?			X					
g	Settlements, slides, depressions, bulges?	See comments iii and iv.			X	X			
h	Soft spots or boggy areas?			X					
i	Movement at or beyond toe?	Cannot observe.	X						
j	Animal burrows?	None observed. Continue to monitor.		X			X		
6	ABUTMENT CONTACTS								
a	Erosion?			X					
b	Differential movement?			X					
c	Cracks?			X					
d	Settlements, slides, depressions, bulges?			X					
e	Seepage?			X					
f	Animal burrows?	None observed. Continue to monitor.		X			X		
7	SEEPAGE/PIPING CONTROL DESIGN FEATURE(S)

Vegetation on the downstream slope of the CWTP embankment.

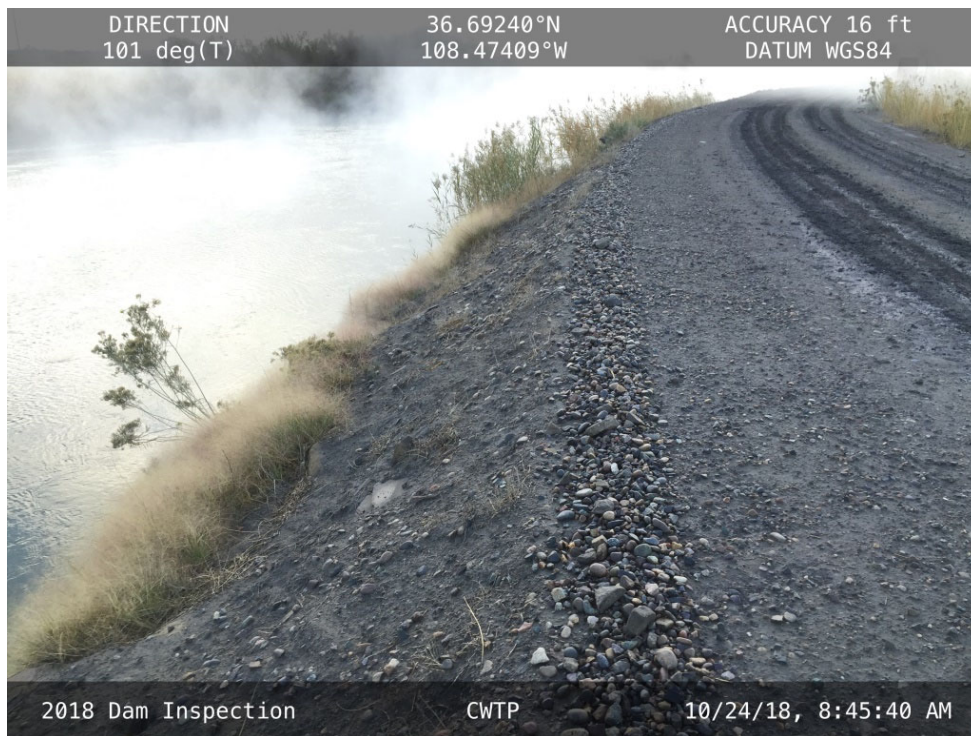
20181024 – IMG_0927
Erosion at the waterline along the downstream slope.

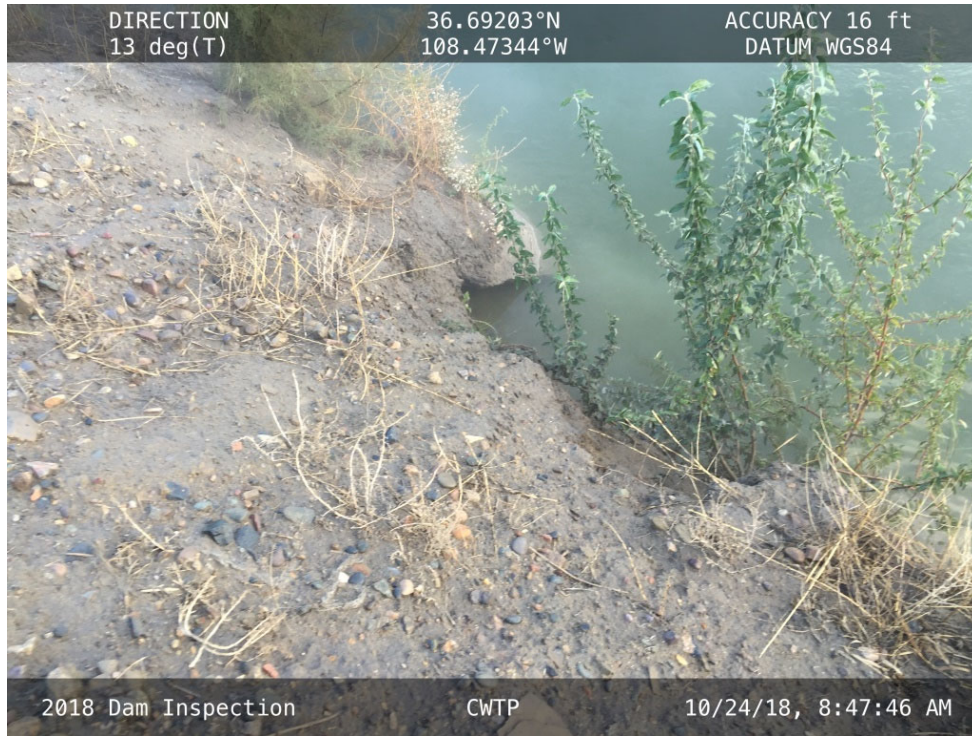
20181024 – IMG_0931
Erosion holes along the downstream shoulder of the crest.

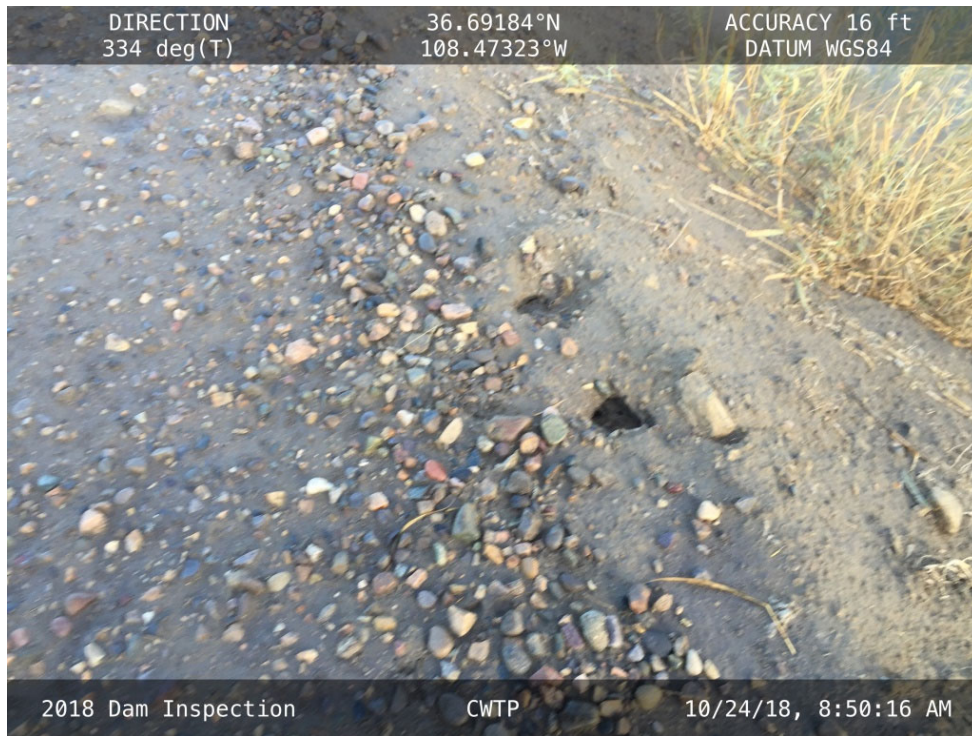
20181024 – IMG_0933
 Longitudinal cracks on the downstream slope of the CWTP embankment.

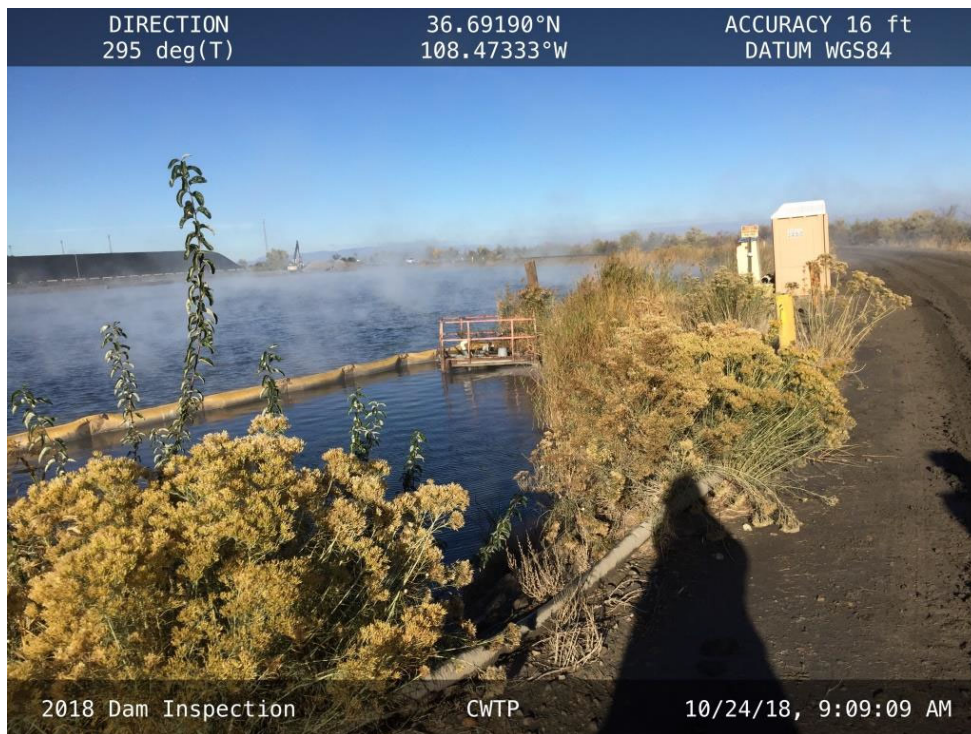
20181024 – IMG_0952

Woody vegetation on the upstream slope near the South Abutment, facing north.

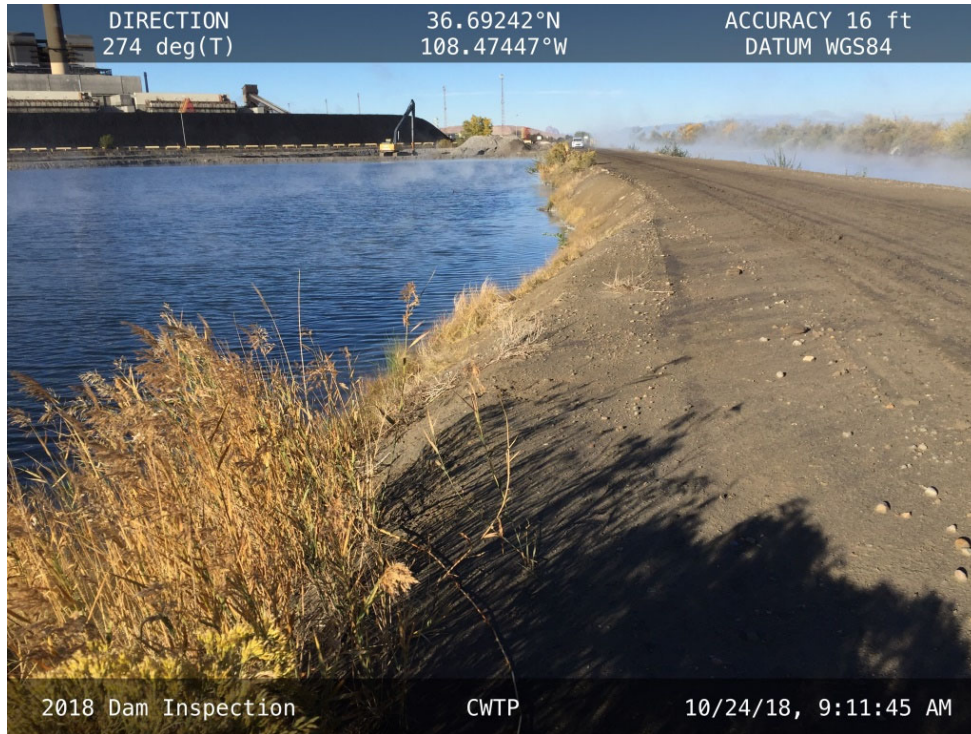
20181024 – IMG_0961

g	Settlements, slides, depressions, bulges?	Portions of the slope are steeper than others (Photo IMG_0961).			X		
h	Animal burrows?	None observed. Continue to monitor.		X		X

The upstream slope along the northern portion of the embankment, facing west.

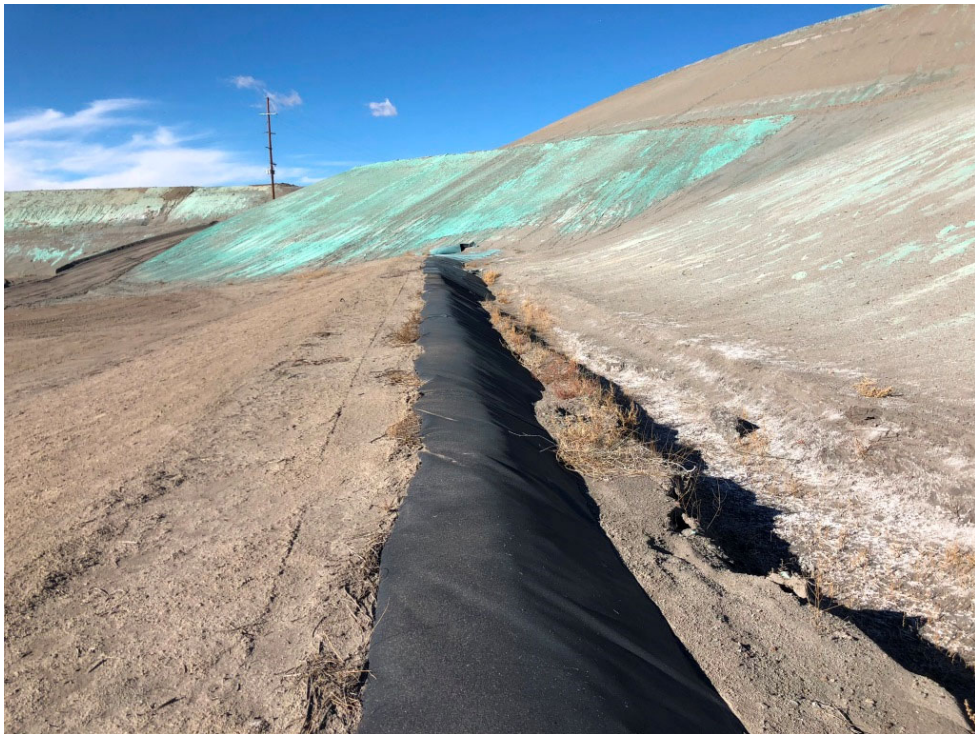
20181024 – IMG_0937
Area of additional erosion along the western toe of Cell 3 north of IMG_0933, facing north.

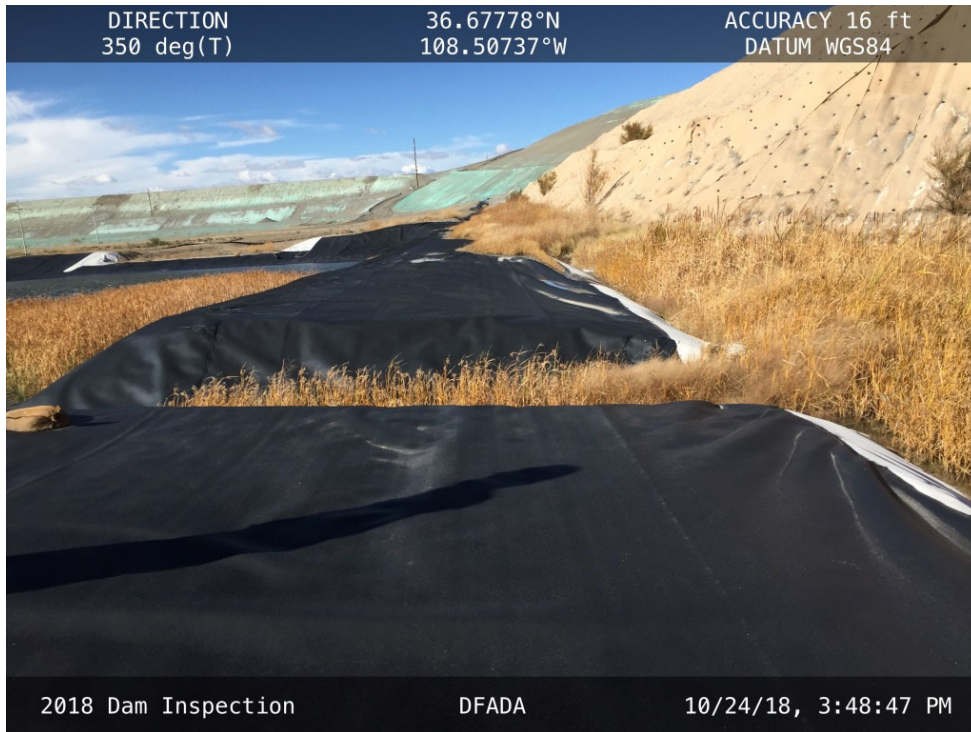
20181024 – IMG_1154

Vegetation growing in the drainage ditch and overflow channel of the leachate collection pond.

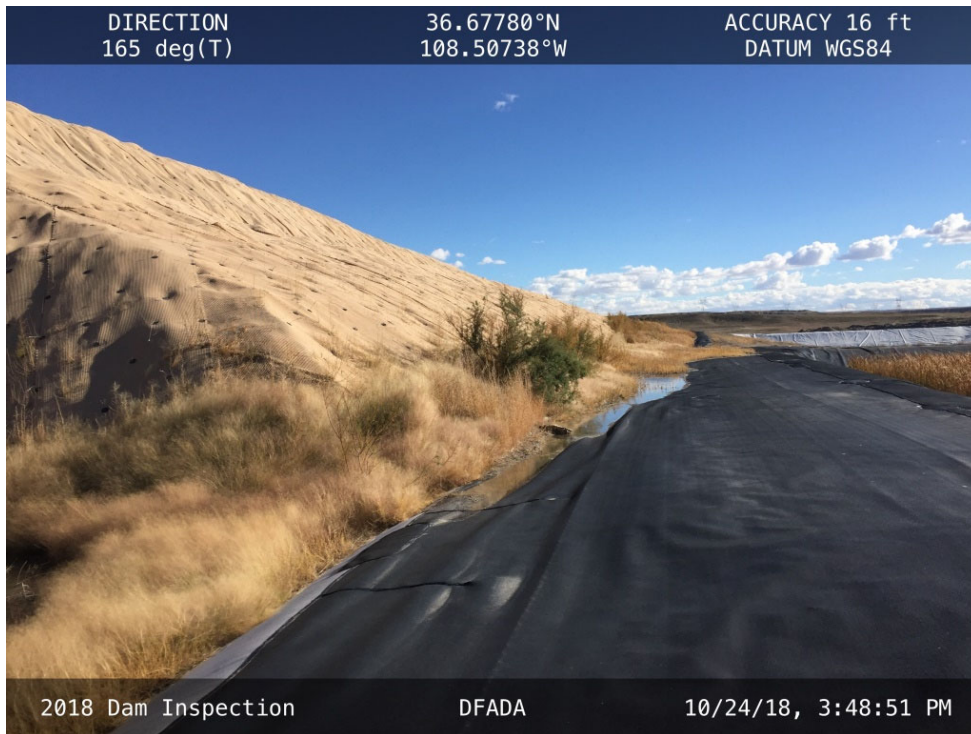
20181024 – IMG_1157

Woody vegetation growing through the Pyramat on the western toe of DFADA Cell 1.

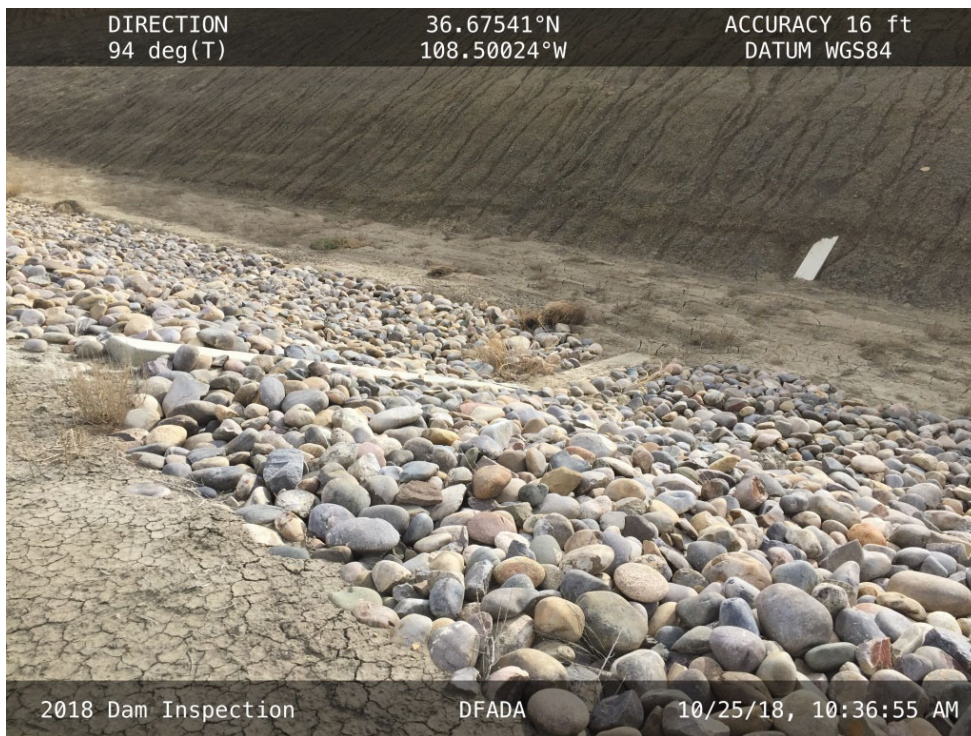
20181025 – IMG_1423
Sediment in the Stormwater Diversion Channel near the outlet.
