**FOUR CORNERS POWER PLANT
Lined Ash Impoundment,
Lined Decant Water Pond,
Combined Waste Treatment Pond,
and Dry Fly Ash Disposal Area**

**Annual
CCR Impoundment and
Landfill Inspection Report
2019**

**GENERATION ENGINEERING
Design Engineering
P.O. BOX 53999
PHOENIX, ARIZONA 85072**

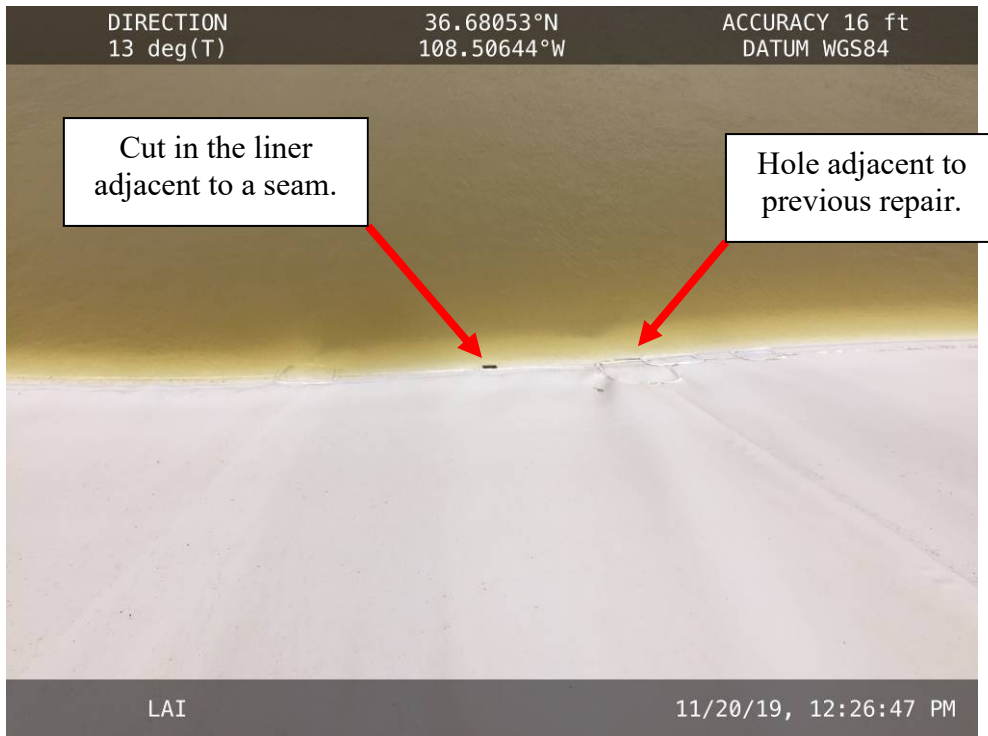
- ii. The geomembrane liner was observed to exhibit uneven depressions and bulges in the Southwest Corner (Photo IMG_6504). These depressions and bulges are in the vicinity of previously observed holes in the upstream liner. In addition, a new cut and a possible new hole in the geomembrane liner were observed during this inspection (Photo IMG_6506). The presence and identified causes of the depressions, bulges, and liner damage should be recorded and any tears should be repaired in accordance with the recommendation of the geotechnical engineer. Repair documentation should be maintained with the operating record.

20191120 – IMG_6504
 Uneven section of the upstream liner along the South Embankment.

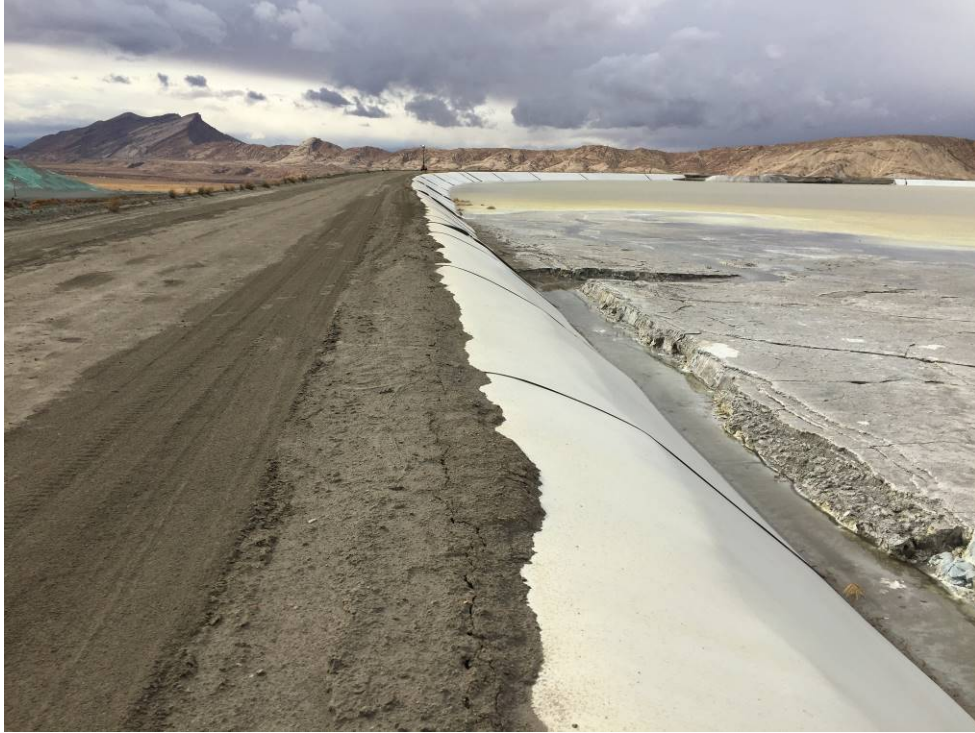
20191120 – IMG_6506
 Two holes in the liner along the upstream slope on the South Embankment.

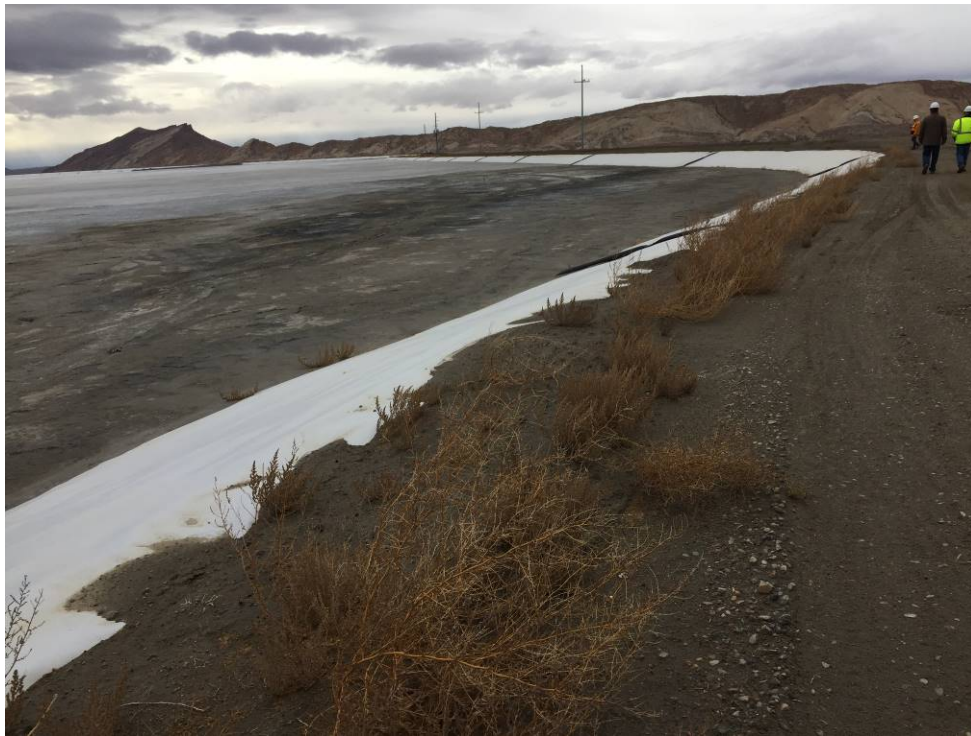
20191120 – IMG_6612

DAM EMBANKMENT CHECKLIST											
3	DAM CREST										
a	Settlements, slides, depressions?				X						
b	Misalignment?				X						
c	Longitudinal/Transverse cracking?	Cracks were observed along portions of the geomembrane liner anchor trench in the Northwest Embankment. See Photos IMG_6612 and IMG_6622.									
d	Animal burrows?				X						
e	Adverse vegetation?				X						
f	Erosion?				X

Longitudinal cracks at the anchor trench along the Northwest Embankment.

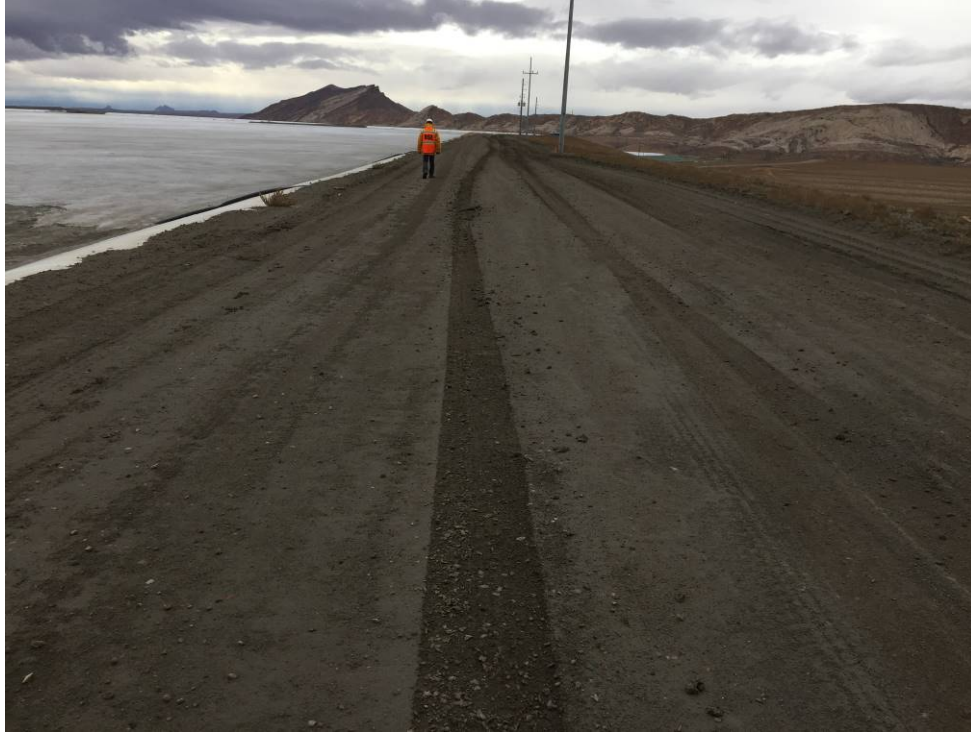
20191120 – IMG_6622
The upstream slope of the Northwest Embankment and a crack in the anchor trench, facing southwest.

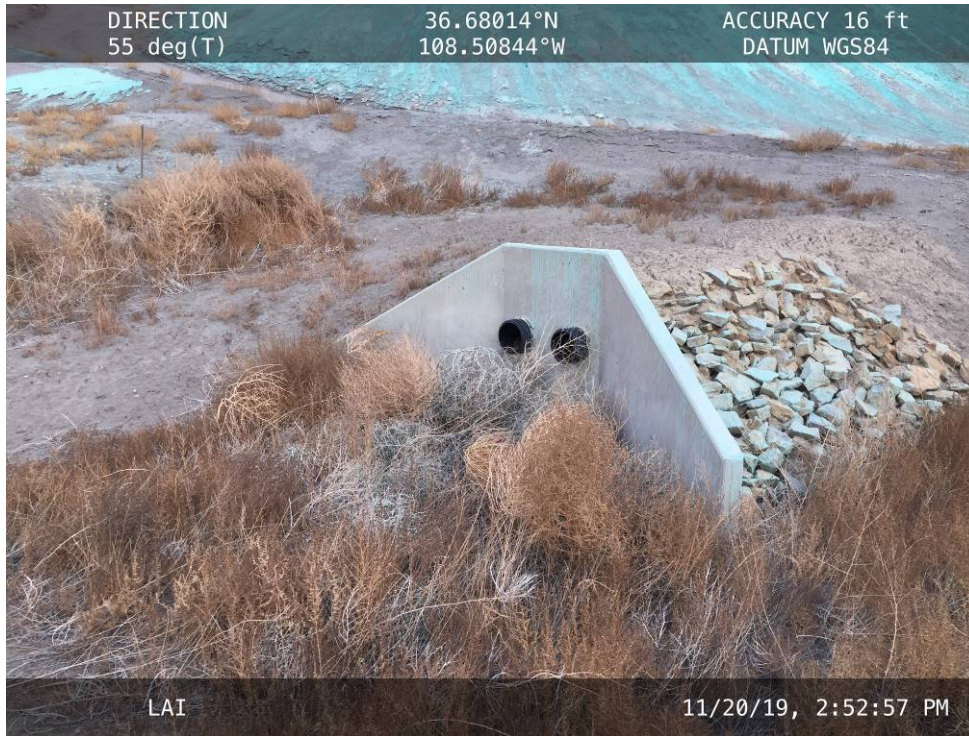
20191120 – IMG_6732

- iii. An 8-inch diameter hole was observed at the toe of the West Embankment where it meets the crest of the LDWP (Photo IMG_6732). Part of the hole appeared to have been made mechanically. The cause of the hole should be investigated under the direction of a geotechnical engineer.

- i. An 8-inch diameter hole was observed at the toe of the LAI West Embankment where it meets the crest of the LDWP (Photo IMG_6732). Part of the hole appeared to have been made mechanically. The cause of the hole should be investigated under the supervision of a geotechnical engineer.

A hole at the downstream toe of the West Embankment.

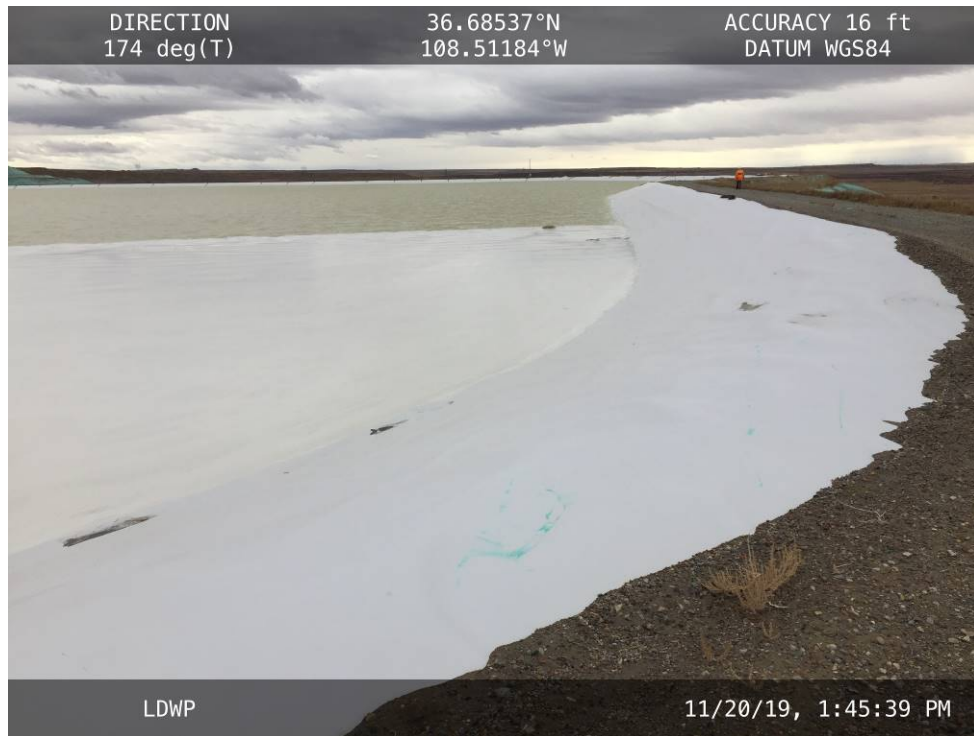
20191120 – IMG_6643

Lined Decant Water Pond (LDWP)		SID: D-635	N/A	No	Yes	Mon	Rep	Inv
5	DOWNSTREAM SLOPE							
a	Erosion?	Minor rilling on the South and West Embankments (Photos IMG_6643, IMG_6648, IMG_6674, IMG_6700, and IMG_6702).			X	X		
b	Inadequate ground cover?	The LDWP South and West Embankment slopes are faced with bottom ash that supports only sporadic and uneven vegetation. A lime-based, white- and turquoise-colored dust suppression agent is applied in accordance with the Plant's Dust Control Plan.		X				
c	Adverse vegetation?			X				
d	Longitudinal/Transverse cracking?			X				
e	Inadequate riprap?		X					
f	Stone deterioration?		X					
g	Settlements, slides, depressions, bulges?	No. See comment iv.		X				
h	Soft spots or boggy areas?			X				
i	Movement at or beyond toe?			X				
j	Animal burrows?			X				
6	ABUTMENT CONTACTS							
a	Erosion?			X				
b	Differential movement?			X				
c	Cracks?			X				
d	Settlements, slides, depressions, bulges?			X

Incipient erosion on the downstream slope in the northwest corner marked for repair.

- iii. Shallow erosion rills observed on the West and South Embankments during the inspection should be monitored and repaired if they are observed to exceed 1 foot in depth.

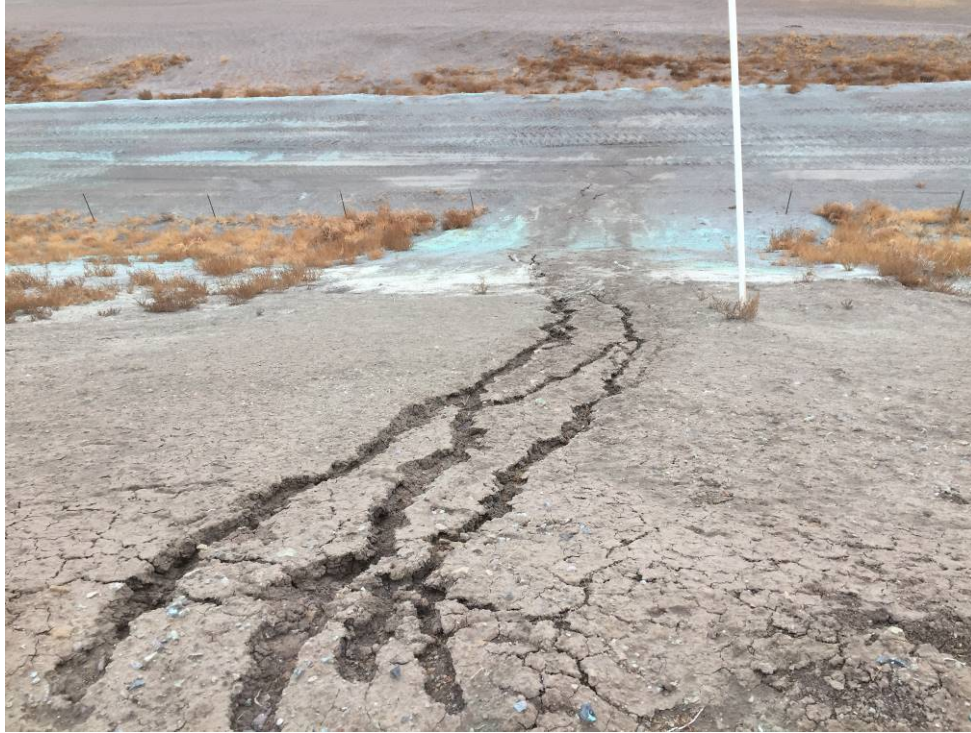
20191120 – IMG_6700
Erosion rills forming in an area of prior repair on the upper half of the South Embankment.

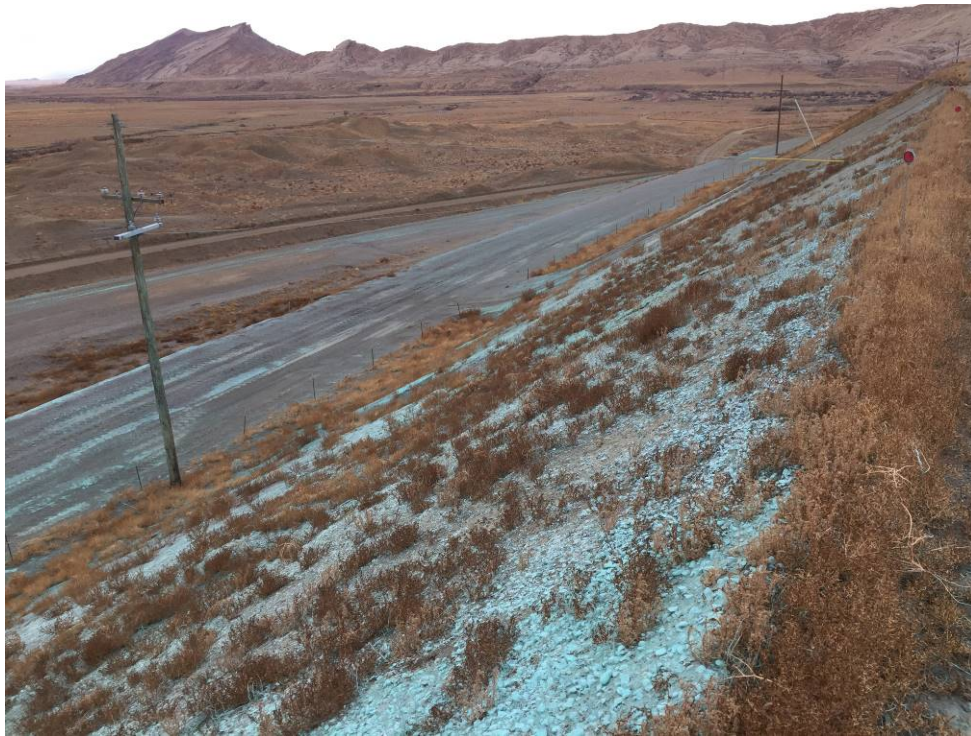
20191120 – IMG_6702

Erosion rills forming in an area of prior repair on the upper half of the South Embankment.

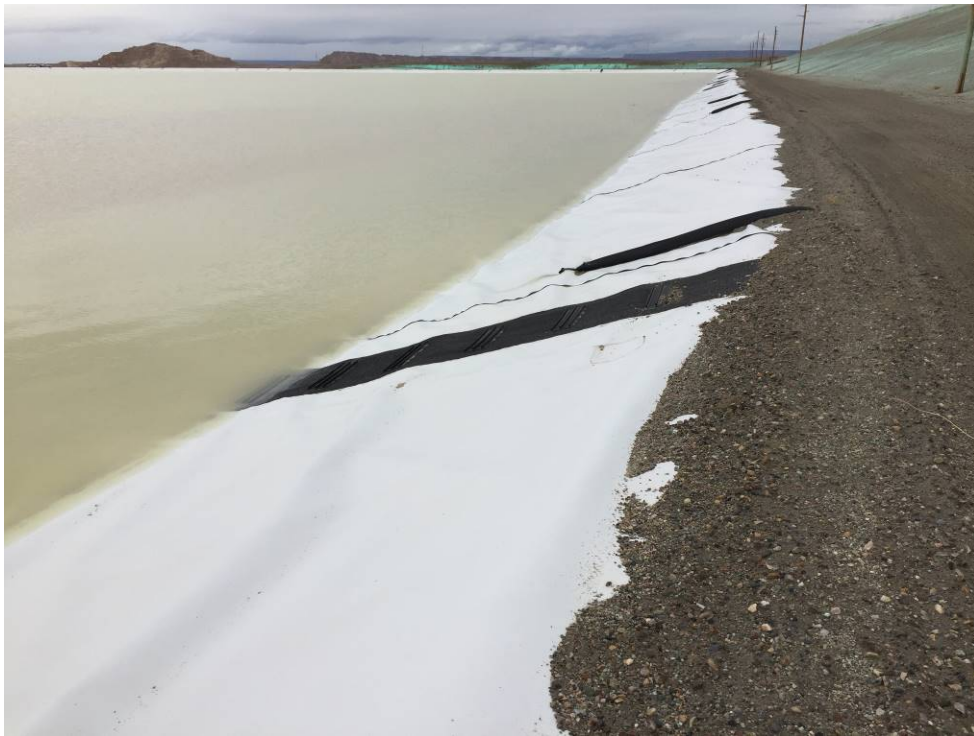
20191120 – IMG_6711

- vii. Water was observed discharging into the LDWP via the Deadpool Pump pipe (LDWP Photo IMG_6711).
- viii. The weekly inspection reports for the period between October 1, 2018 and September 30, 2019 were reviewed and do not indicate that there were any appearances of actual or potential structural weakness or other conditions that have the potential to disrupt the operation or safety of the CCR unit.

Water pumped into the LDWP from the LAI through the Deadpool Pump pipe system.

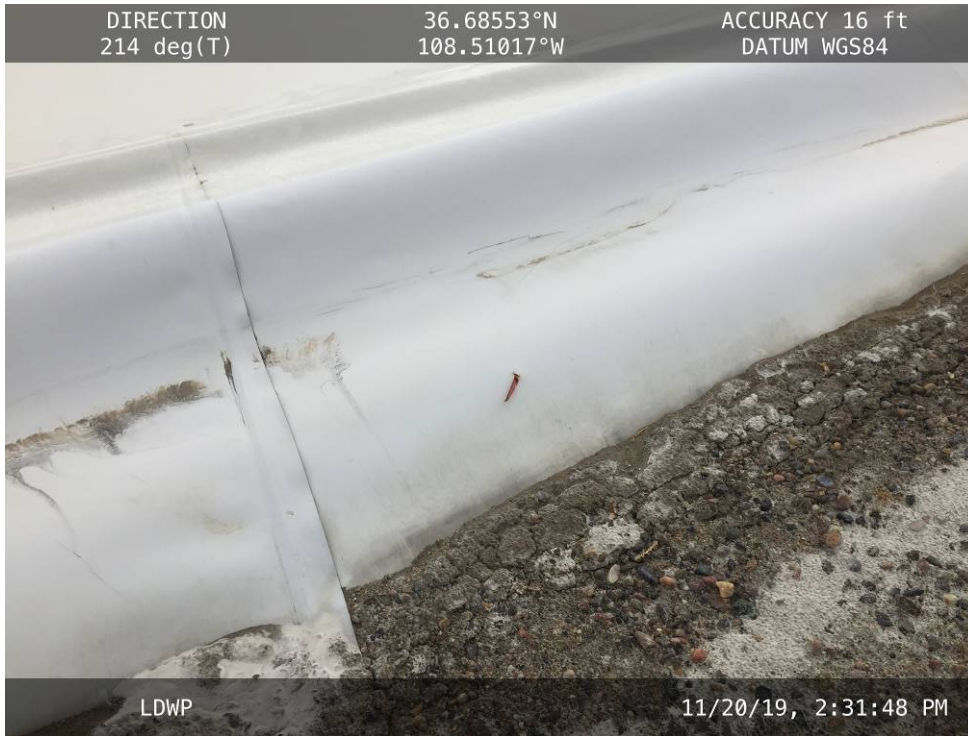
- vi. Only one hole was observed in the liner during this inspection (Photo IMG_6768). One of the locations with damage observed during the 2018 inspection had been repaired prior to this inspection (Photo IMG_6766). Continue to monitor the liner for damage and repair it.

20191120 – IMG_6766
Small tears in the liner along the North Embankment repaired since the 2018 inspection.

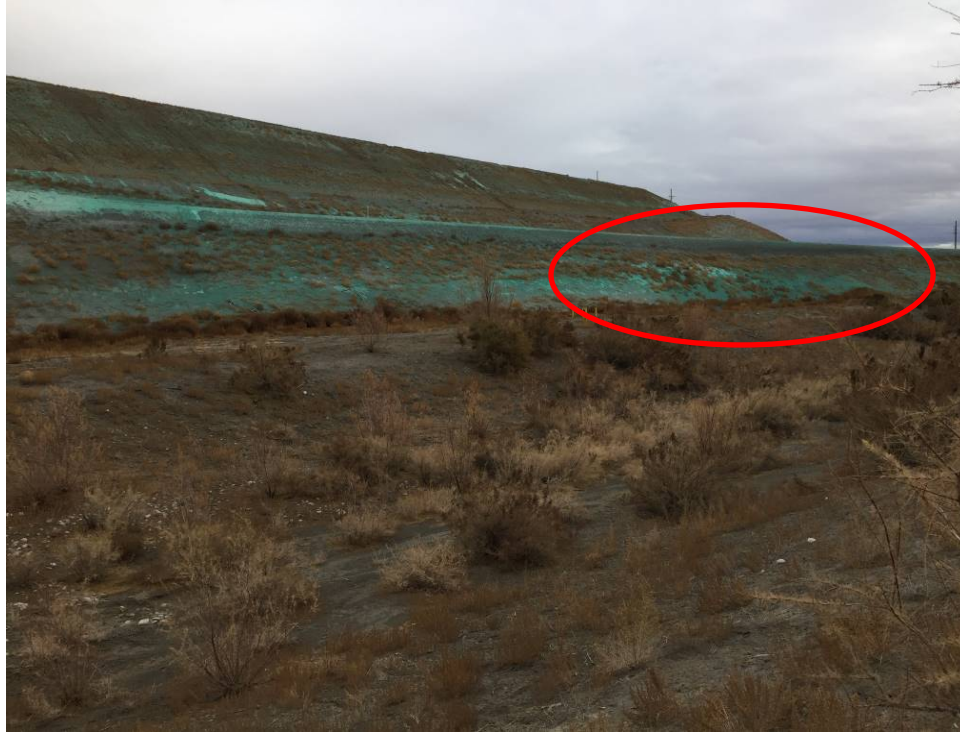
- iv. The two shallow sloughs that were observed on the lower bench of the West Embankment in 2018 have been repaired (Photos IMG_6772 and IMG_6774).
- v. The LDWP interstitial geomembrane leak detection and evacuation pump was not operating at the time of the inspection. Commercially available submersible pumps (Photo IMG_6680) break down on a regular basis due to the water chemistry in the LDWP. APS has determined that regularly replacing the pumps is more economical and feasible than temporarily decommissioning the entire pond and constructing a different access port configuration. Because the pump is replaced on a regular basis, the Plant should maintain an inventory of spares and monitor the system and replace the pump if it is degraded. The pump was placed back in service on November 23.

20191120 – IMG_6772
Repair of surface slough observed during the 2018 inspection (2018 IMG_1435).

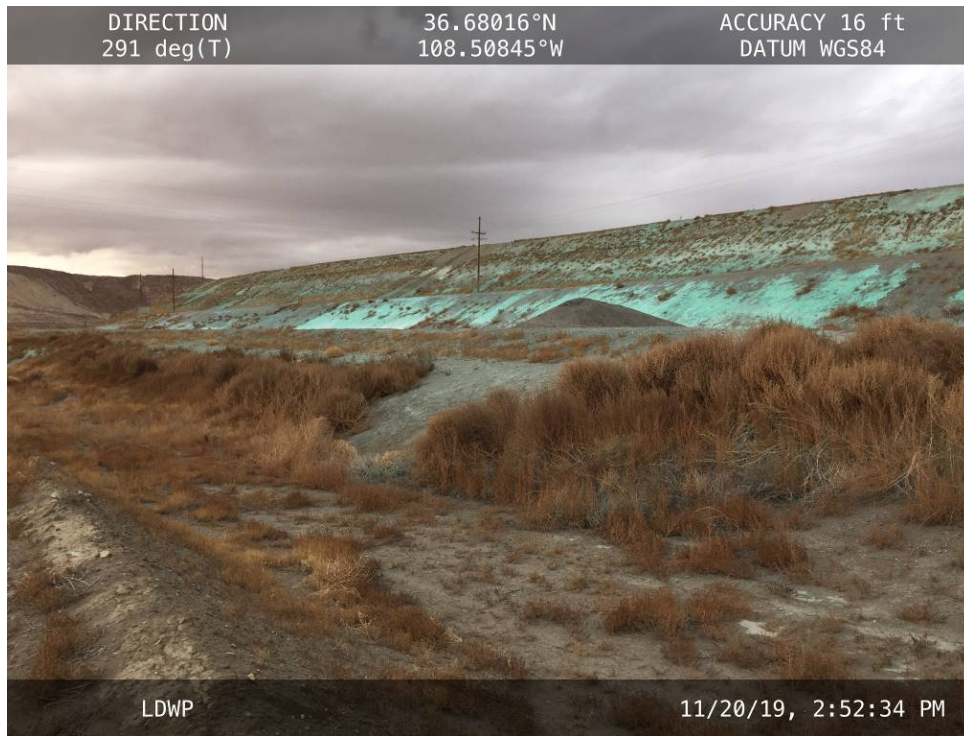
20191120 – IMG_6774

Repair of surface slough observed during the 2018 inspection (2018 IMG_1438).

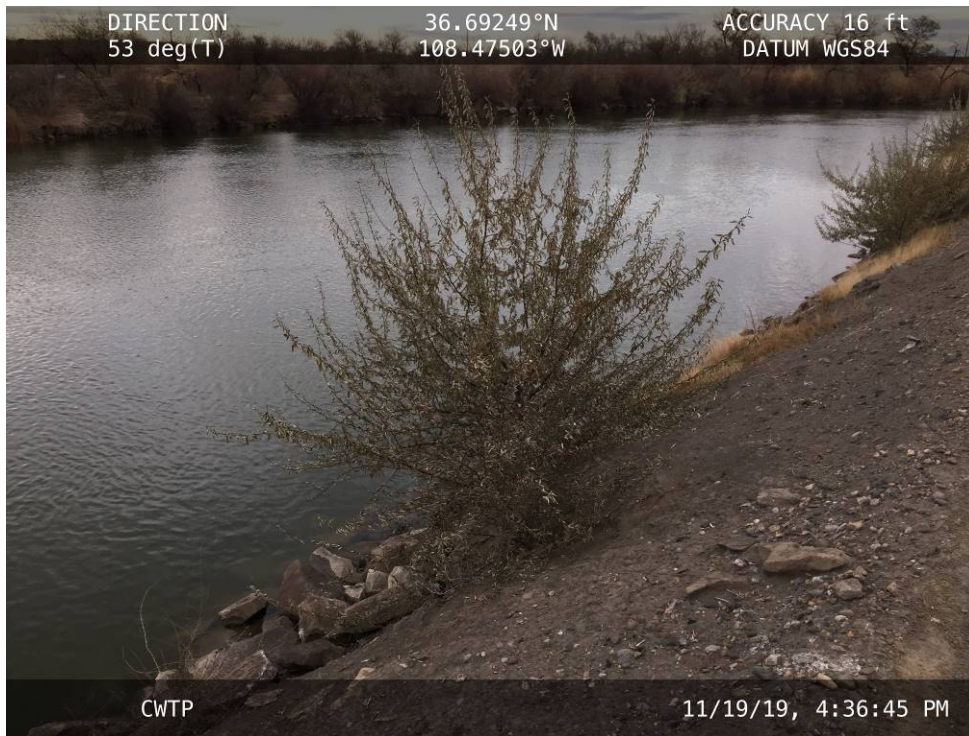
20191119 – IMG_6255

Erosion on the upstream slope along the northern portion of the embankment.

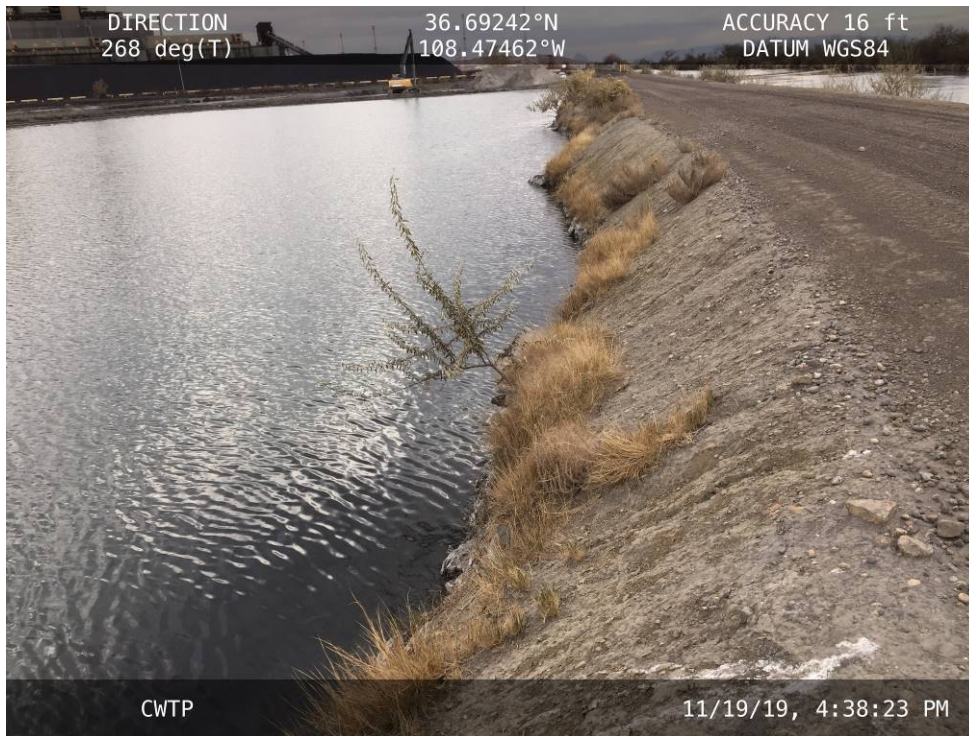
20191119 – IMG_6260

Erosion on the downstream slope along the northern portion of the embankment.

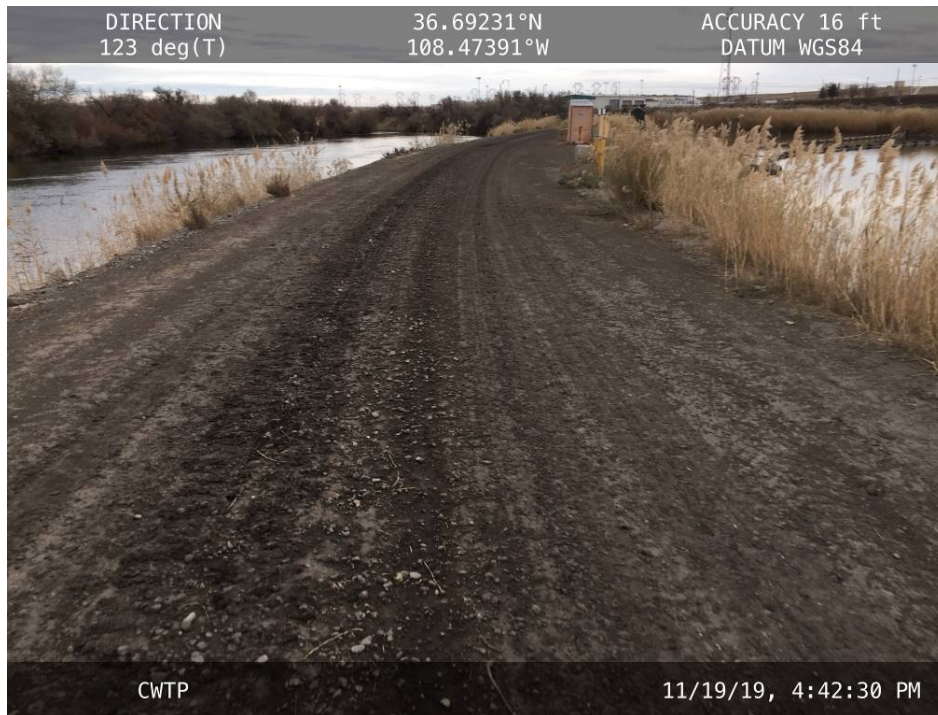
20191119 – IMG_6266

Aligned holes and a possible tension crack on the downstream slope where the embankment transitions from west-east to northwest-southeast.
