**FOUR CORNERS POWER PLANT
Lined Ash Impoundment,
Lined Decant Water Pond,
Combined Waste Treatment Pond,
Dry Fly Ash Disposal Area,
and Return Water Pond**

**Annual
CCR Impoundment and
Landfill Inspection Report
2021**

**GENERATION ENGINEERING
Design Engineering
P.O. BOX 53999
PHOENIX, ARIZONA 85072**

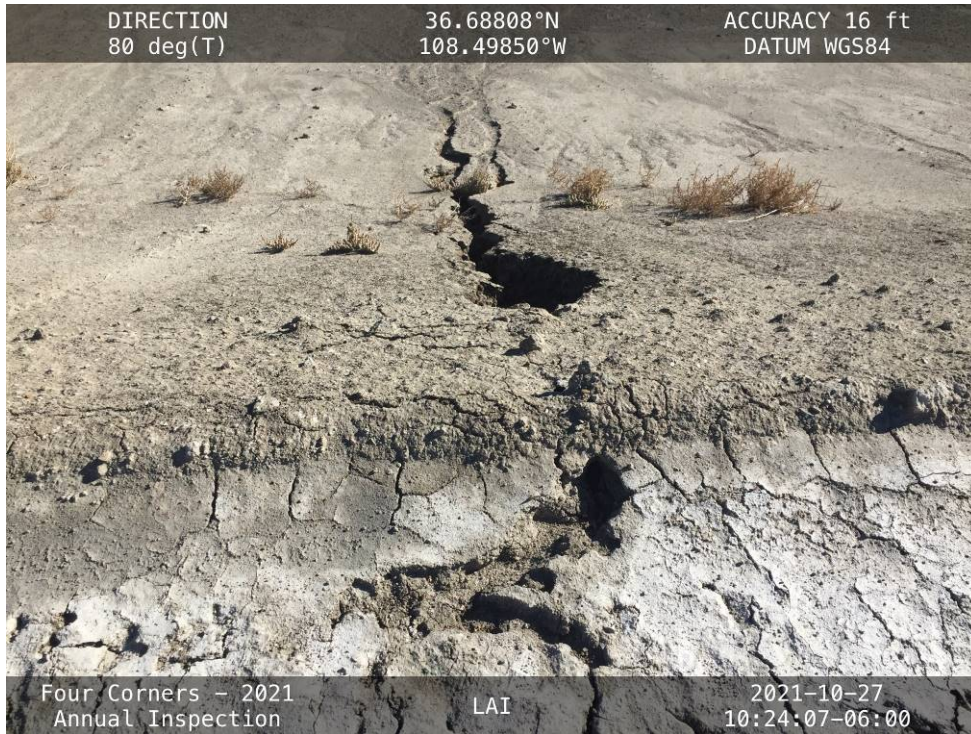
20211027-IMG_7617

The crest of the East Embankment, facing southeast near the north V-ditch.

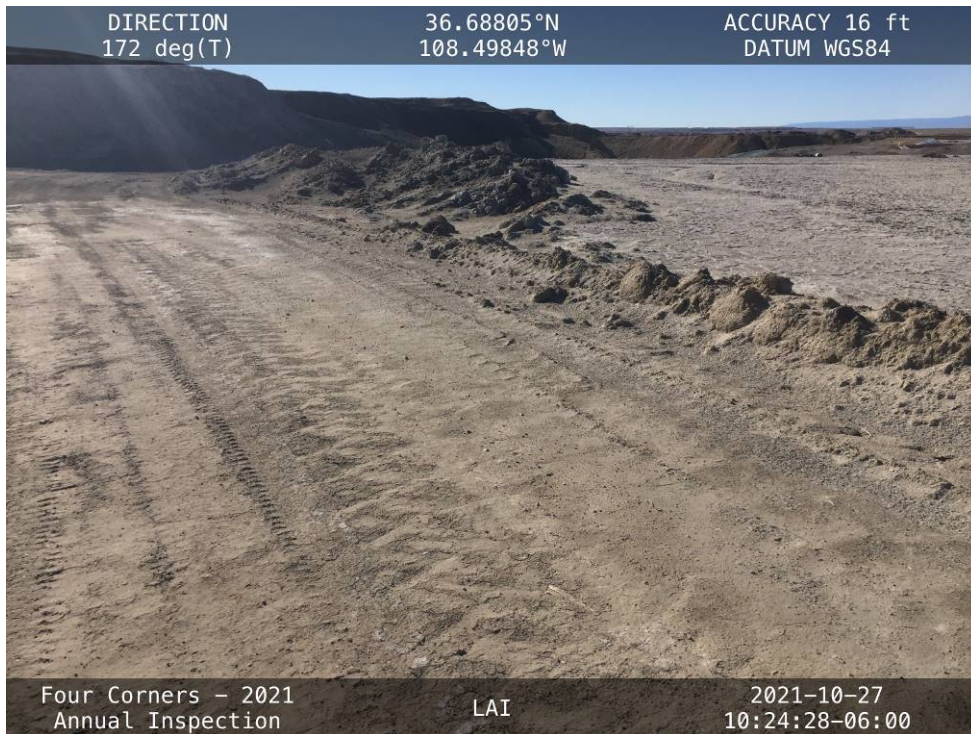
20211027-IMG_7619

Minor erosion on the downstream slope of the East Embankment, near the north V-ditch.

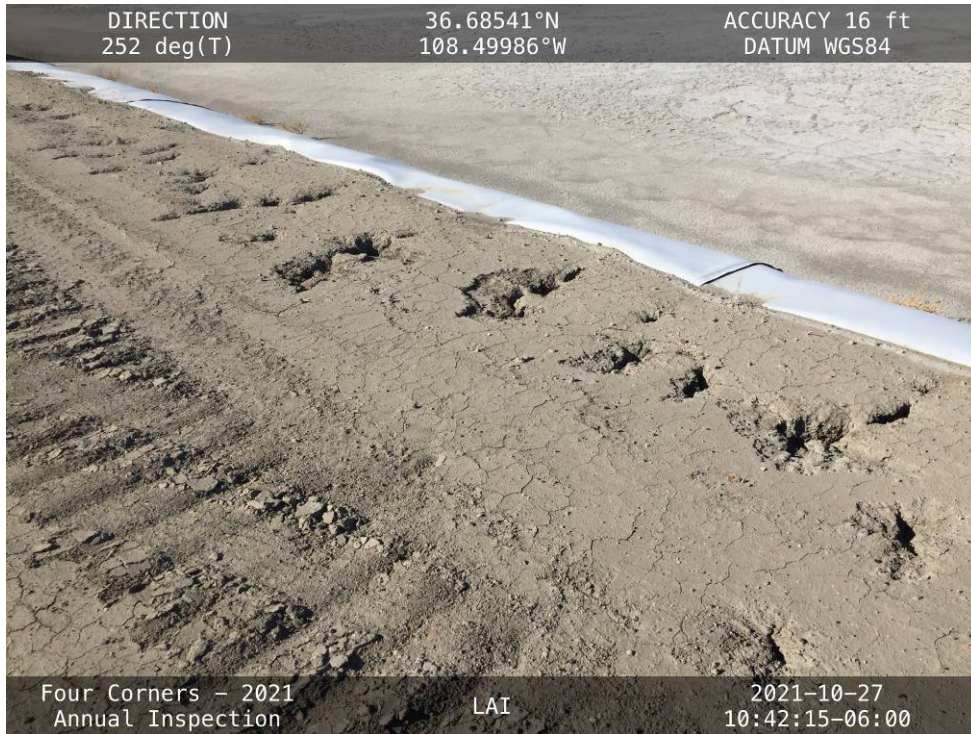
20211027-IMG_7656

- ii. Ruts were observed on the downstream side of the South Embankment crest (Photo IMG_7698) and the downstream side of the East Embankment crest (Photo IMG_7656). These did not appear to be affecting the structural integrity of the dam, but drivers should be instructed to avoid driving through these areas and such depressions should be repaired.

Ruts in the East Embankment crest, facing south.

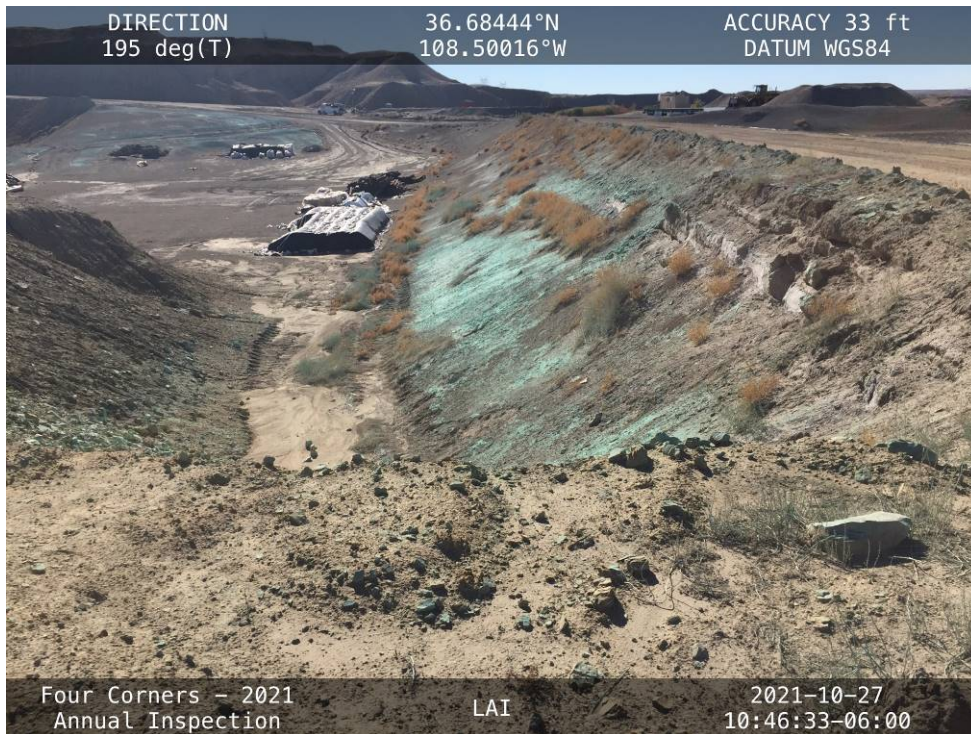
20211027-IMG_7657

Holes at the edge of the anchor trench along the upstream side of the East Embankment.

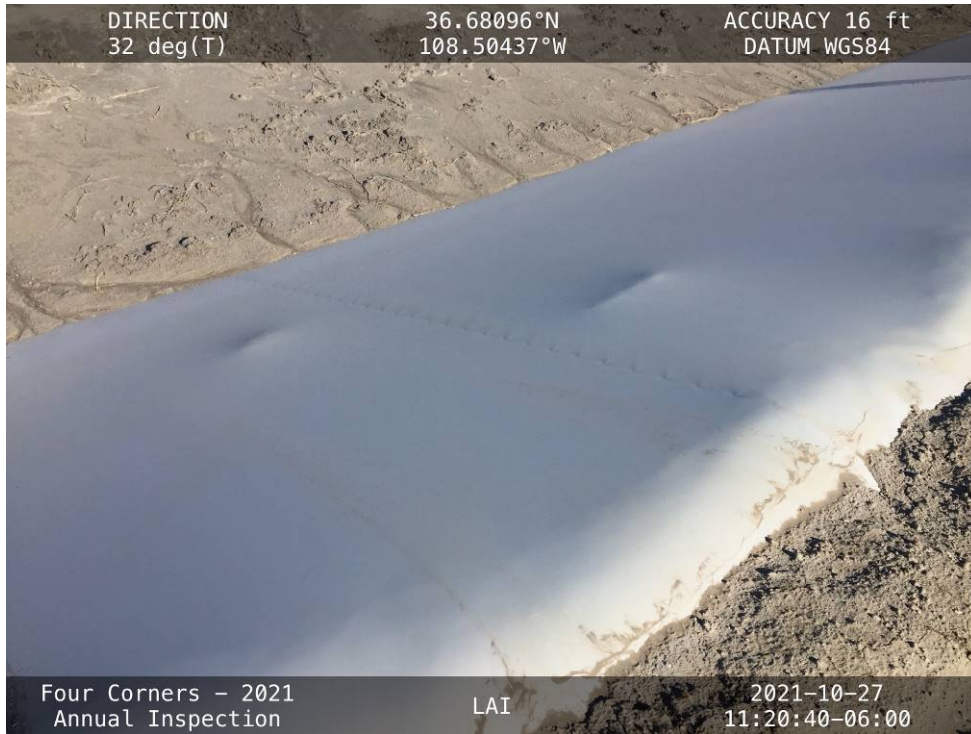
20211027-IMG_7698

A shallow depression on the downstream half of the South Embankment crest.

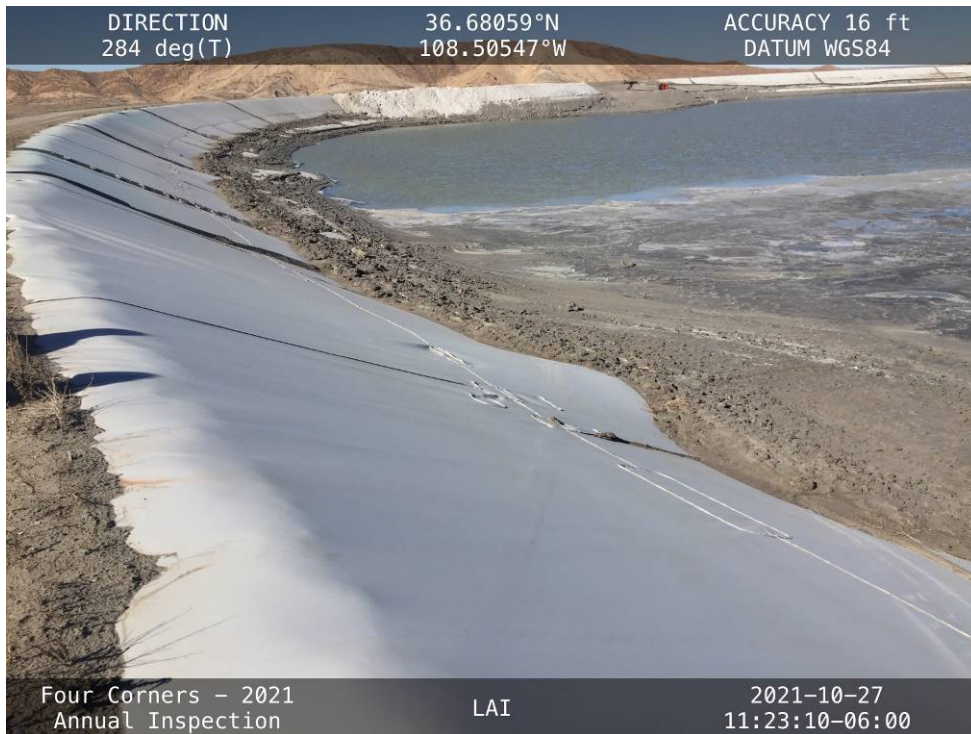
20211027-IMG_7700

Two protrusions were observed beneath the liner on the upstream slope near the midpoint of the South Embankment (Photo IMG_7700). There did not appear to be any damage to the liner in this area. The liner appeared to be tighter, possibly as a result of the lower water level in the reservoir and presumed settlement of the impounded solids. The protrusions should be monitored and the liner should be repaired if it tears.

Two protrusions beneath the liner on the upstream slope of the South Embankment.

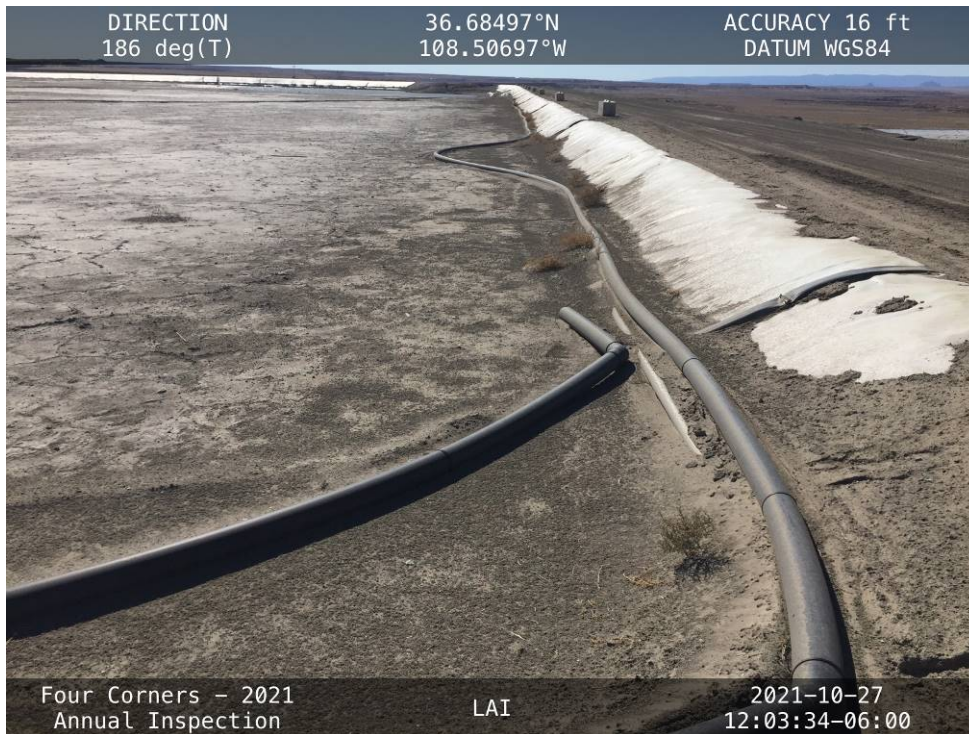
20211027-IMG_7768

A liner mud crack on the upstream side of the West Embankment crest.

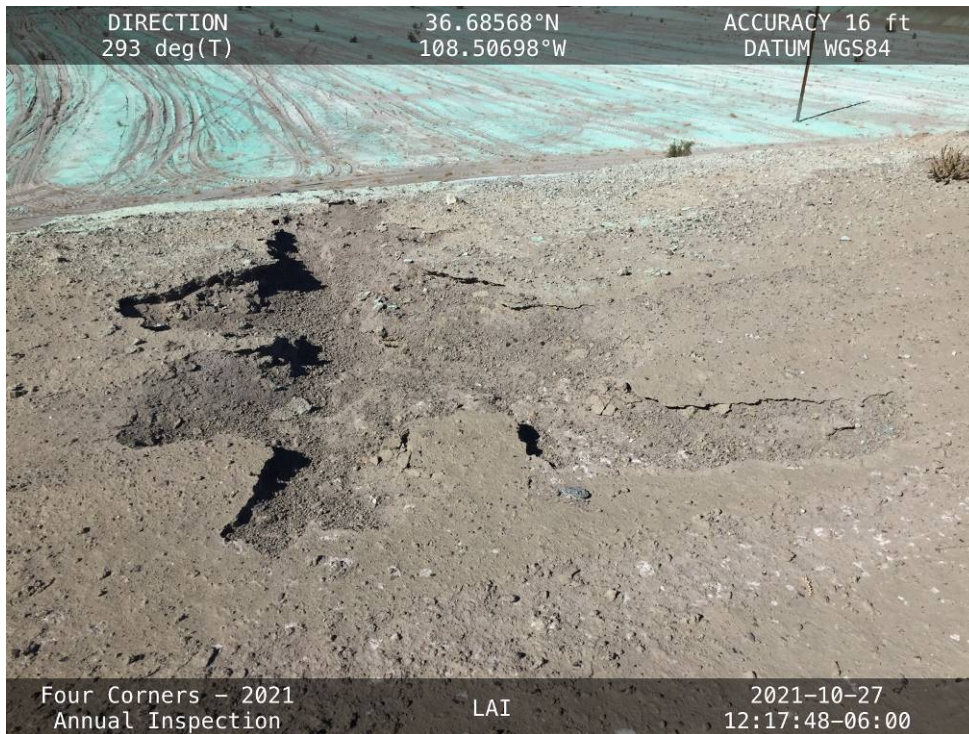
20211027-IMG_7776

Holes in the mud cracks along the anchor trench north of the Drop Inlet Structure.

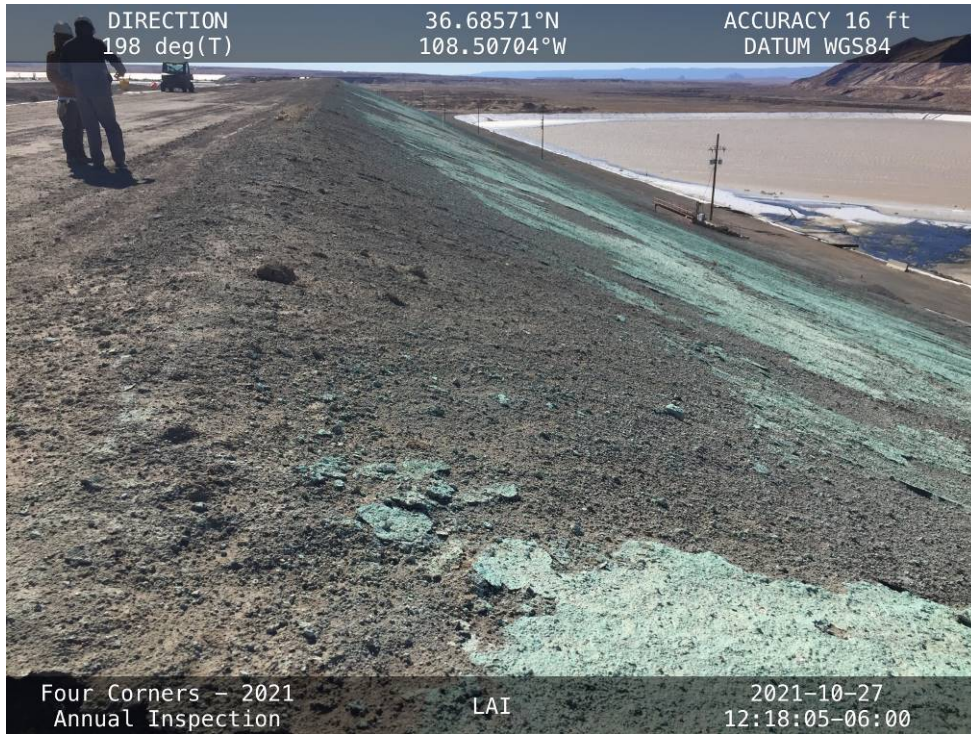
20211027-IMG_7780

Erosion along the upper portion of the West Embankment, facing downstream from the crest.

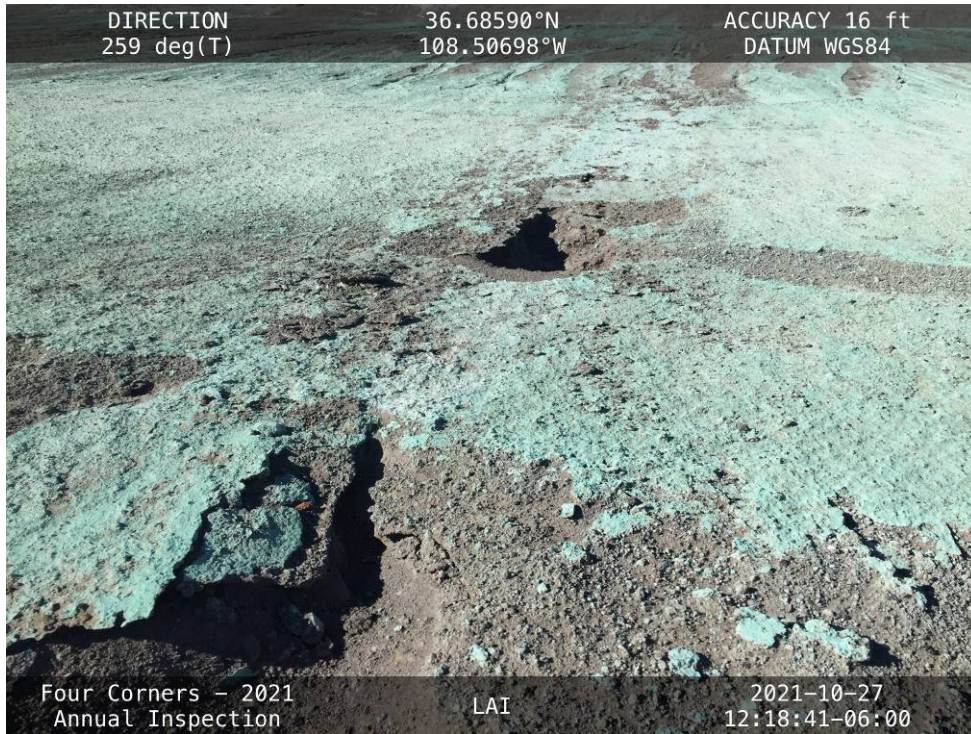
20211027-IMG_7784

Erosion along the upper portion of the West Embankment, facing downstream from the crest.

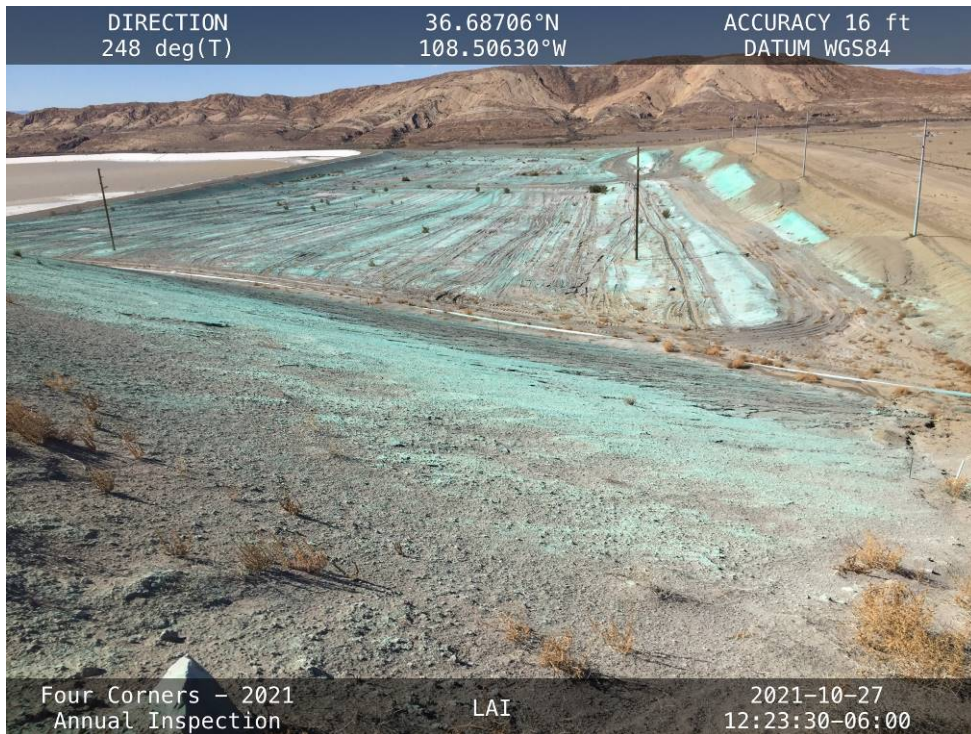
20211027-IMG_7785

Erosion along the upper portion of the West Embankment, facing downstream from the crest.

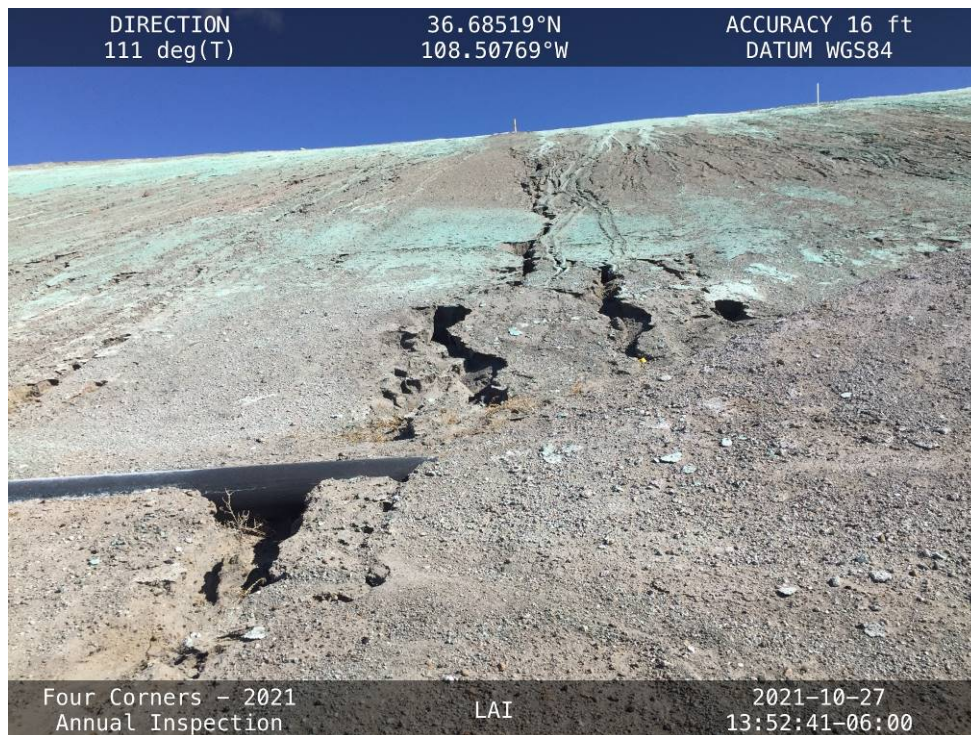
20211027 – IMG_7898

- iv. The 8-inch diameter hole at the toe of the West Embankment first observed during the 2019 inspection was not present during this inspection (Photo IMG_7898). There were no signs of instability in the area observed during this inspection. The hole was observed to be filled with loose ash during the 2020 inspection and may have been further filled via erosion throughout the previous year.
- v. The North Toe Buttress (NTB) was constructed as part of the 5280 Lift of the LAI to provide additional stability in the northern portion of the West Embankment (Photo

The location of a hole previously observed at the toe of the West Embankment, no longer present, facing north.

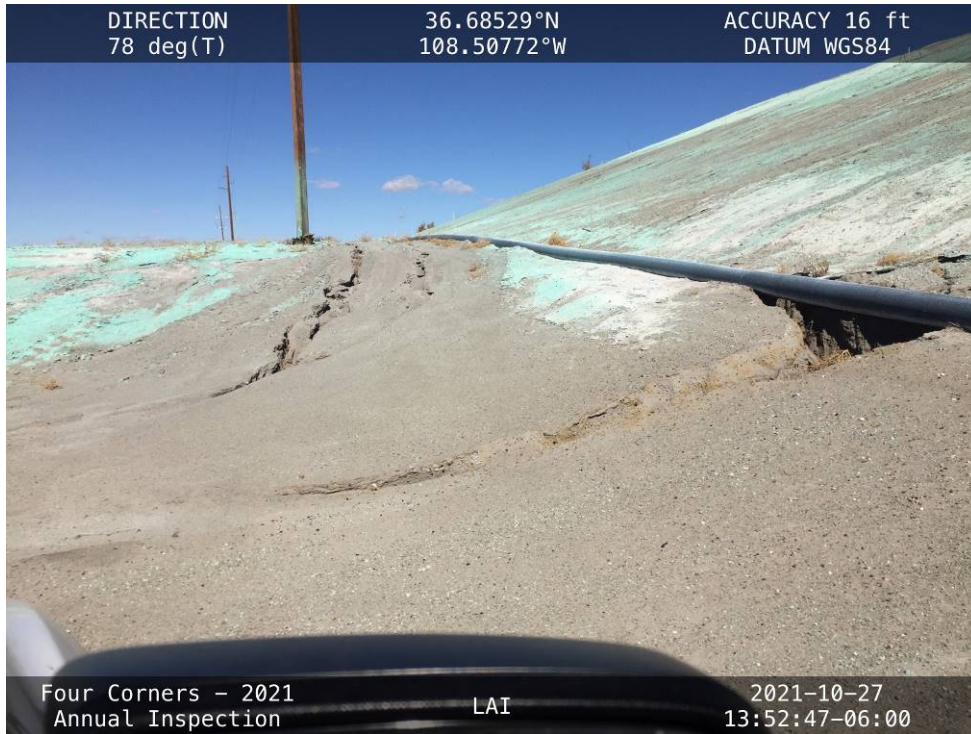
20211027 – IMG_7905

Erosion gullies on the West Embankment near the south end of the North Toe Buttress.

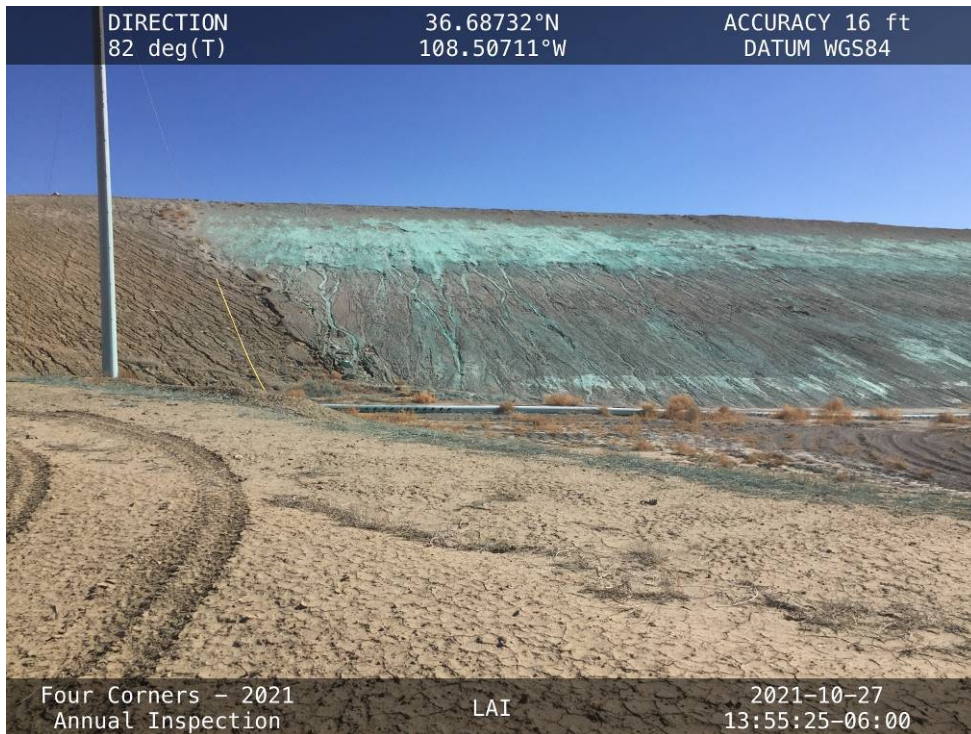
20211027-IMG_7906

Erosion gullies at the toe of the West Embankment near the south end of the North Toe Butress.

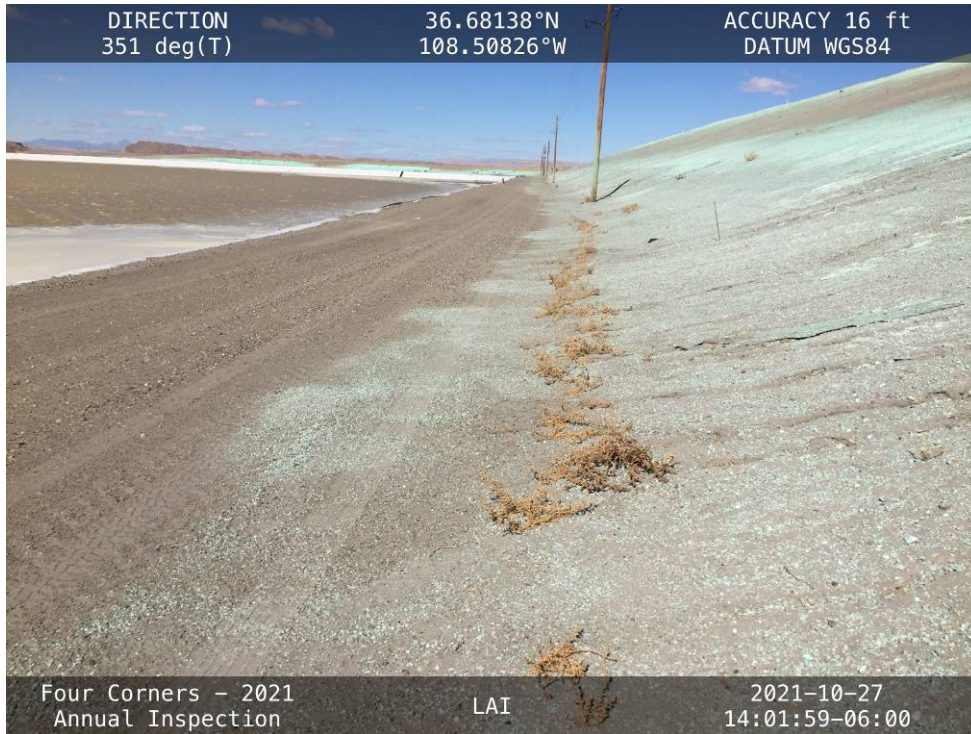
20211027-IMG_7909

An erosion rill at the junction of the Northwest Embankment (soil) and the West Embankment (ash).

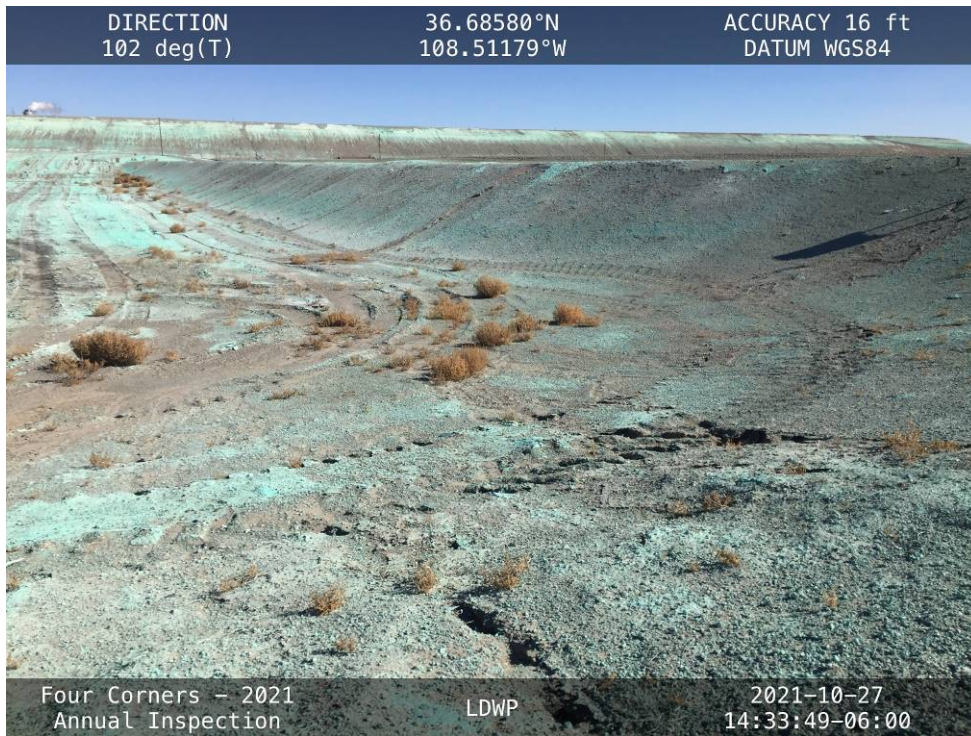
20211027-IMG_7968

An erosion gully on the downstream slope of the North Embankment, near the northwest corner.

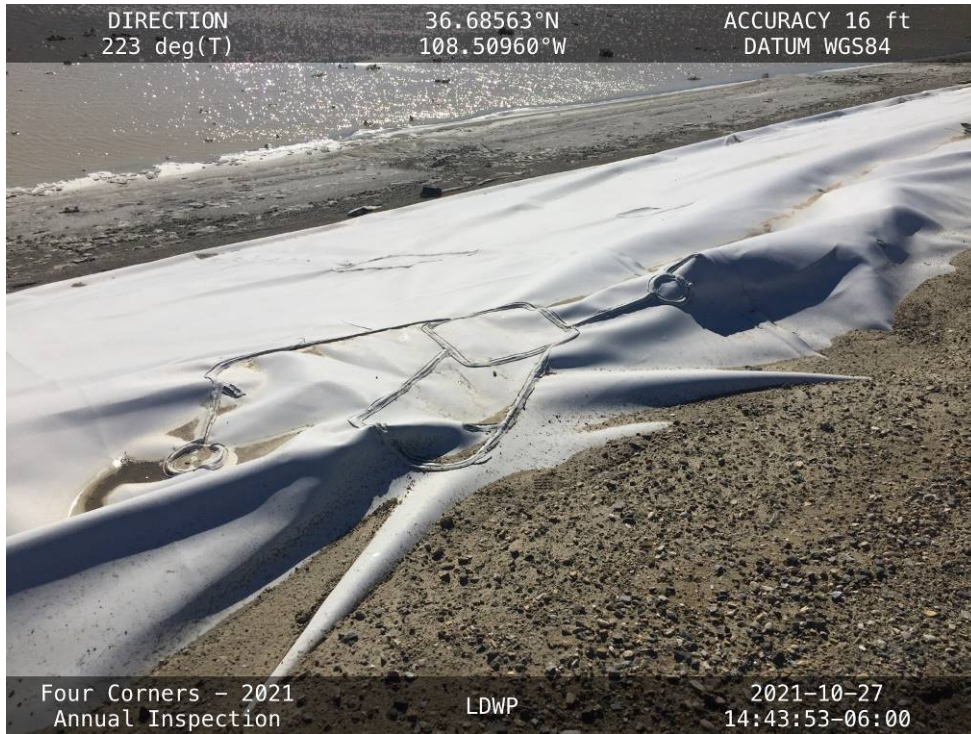
20211027 – IMG_7984

A whaleback on the north side of the reservoir, facing south from the North Embankment crest.

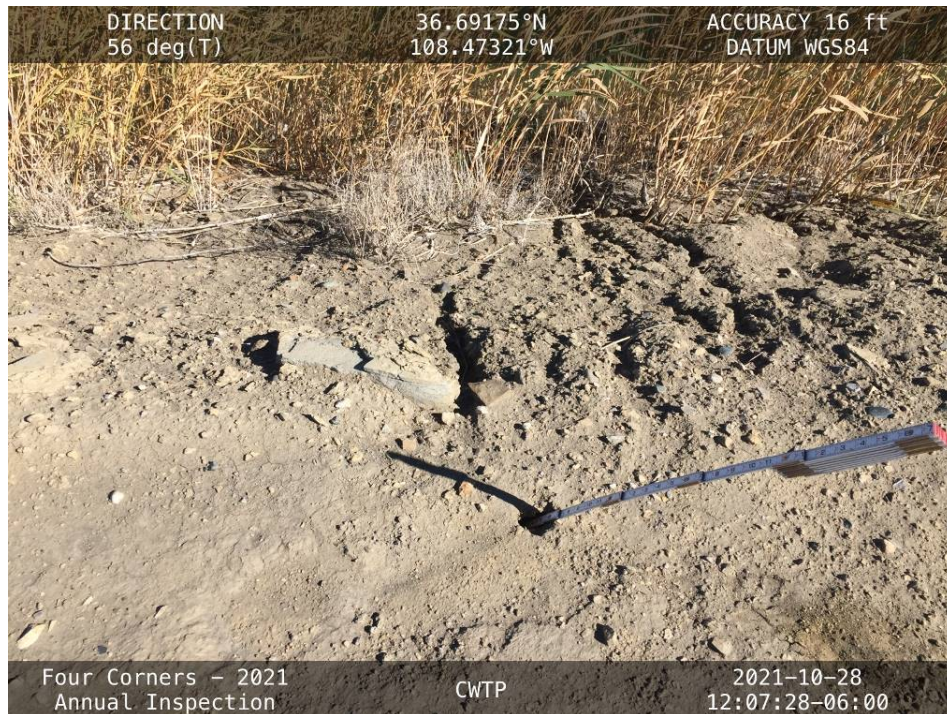
20211028 – IMG_8358

A zone of loose material on the upstream half of the crest also observed during the 2020 inspection (2020 Photo IMG_3273).

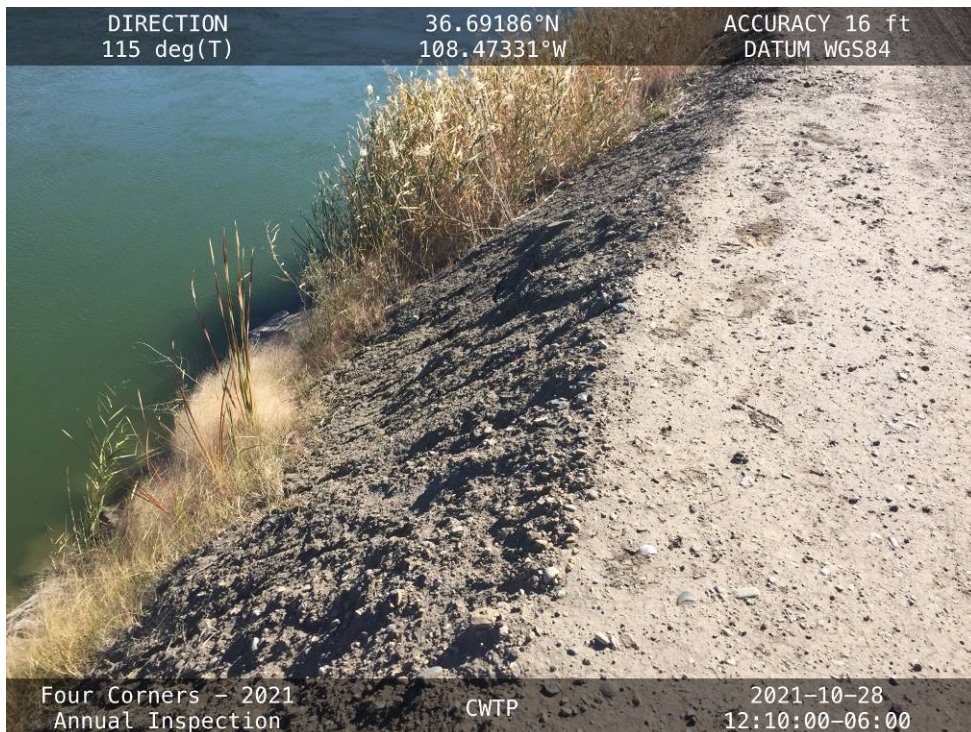
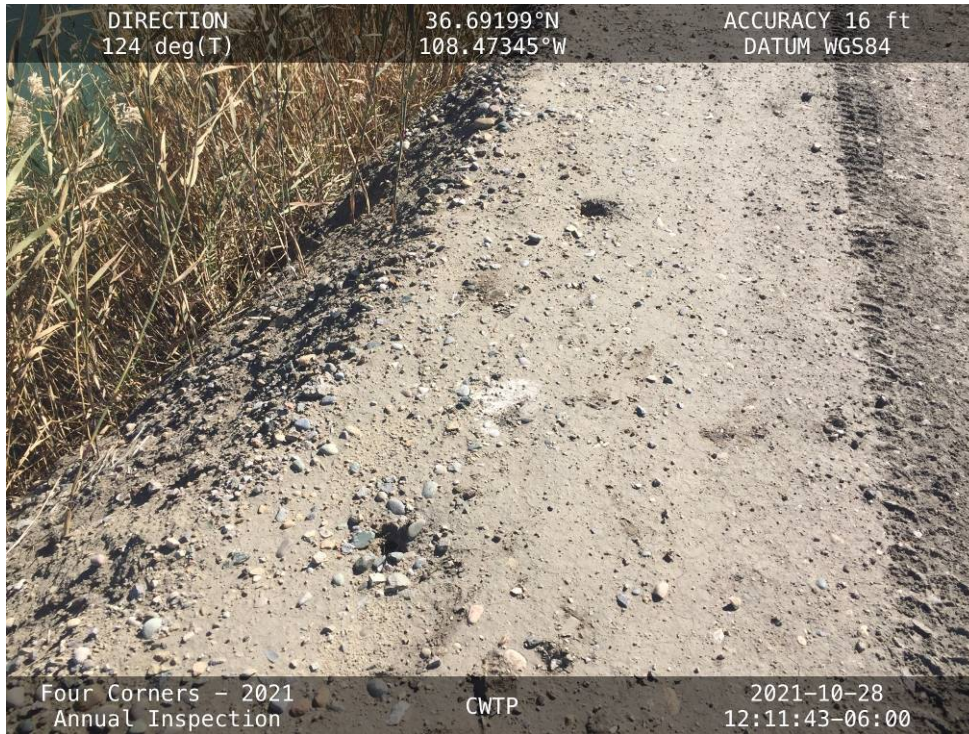
IMG_8361 and IMG_8366: Location of the 11.5-foot long tension crack observed during the 2020 and 2018 inspections. Not observed during this inspection, but the ground appears to be less vegetated; the surficial material may have sloughed into the canal.

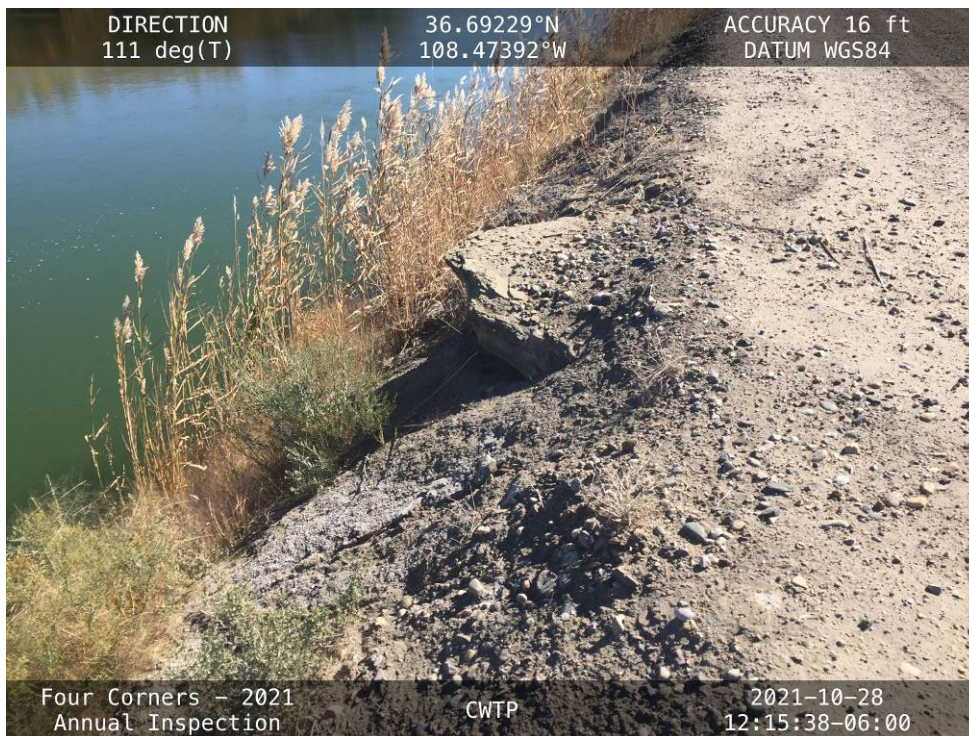
20211028 – IMG_8389
 An incipient erosion rill on the upstream slope of the embankment.

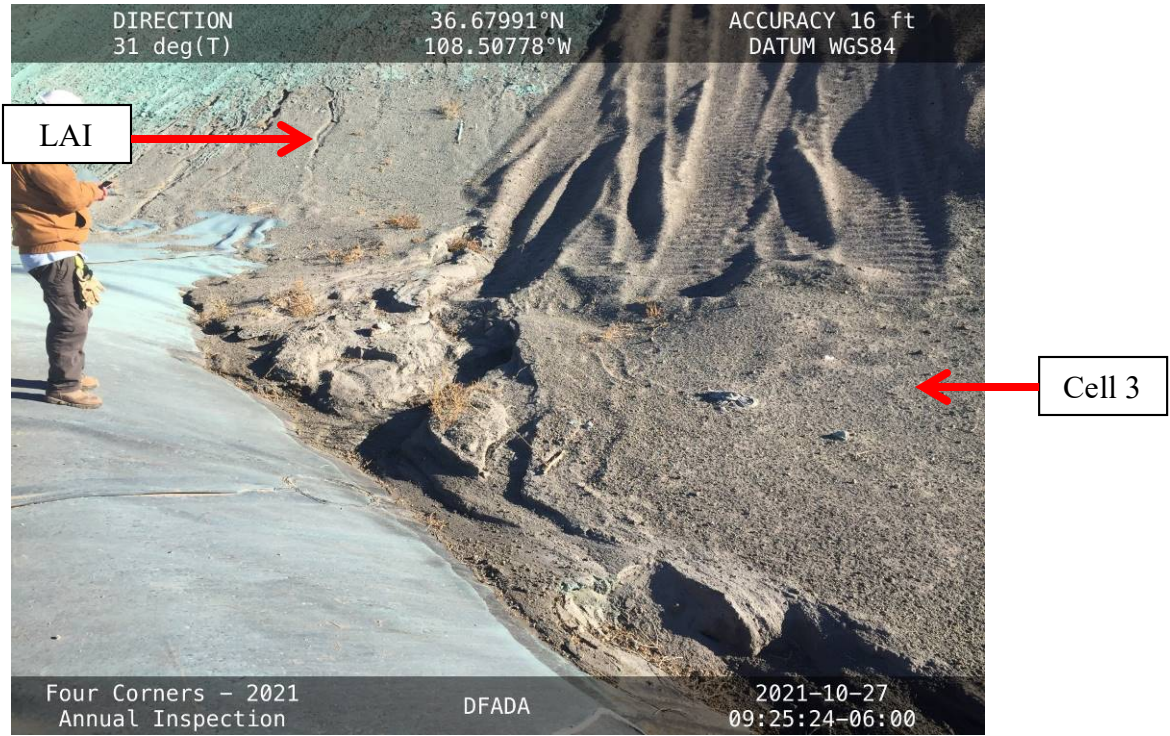
20211027-IMG_7591

Erosion repair at the groin between the LAI and Cell 3, facing east.

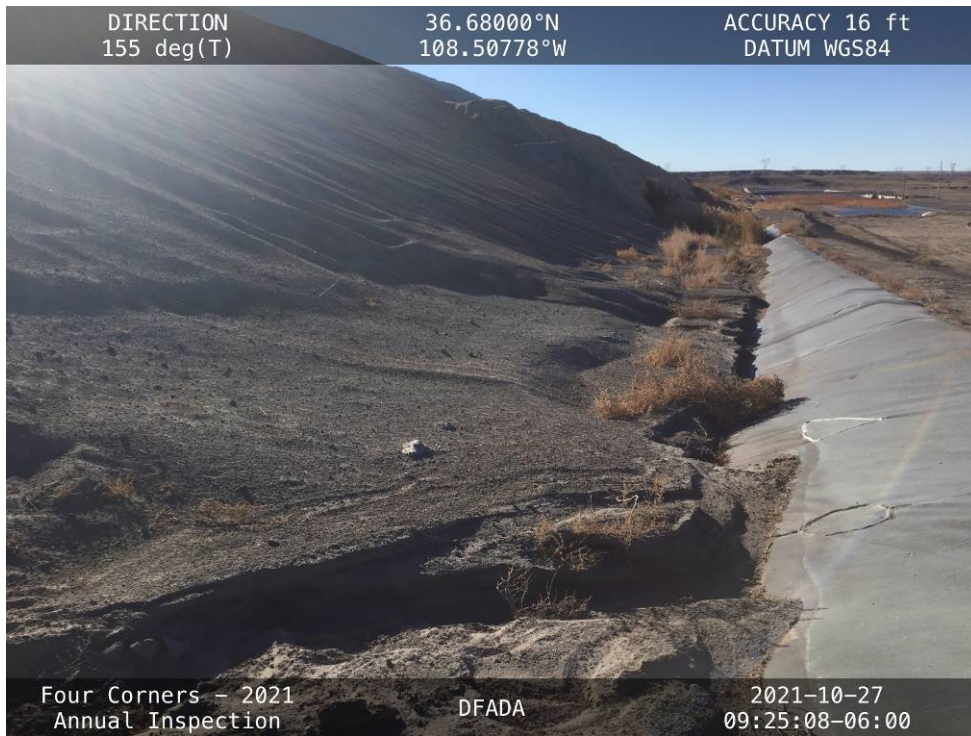
20211027-IMG_7594

Erosion repair at the groin between the LAI and Cell 3, facing north.

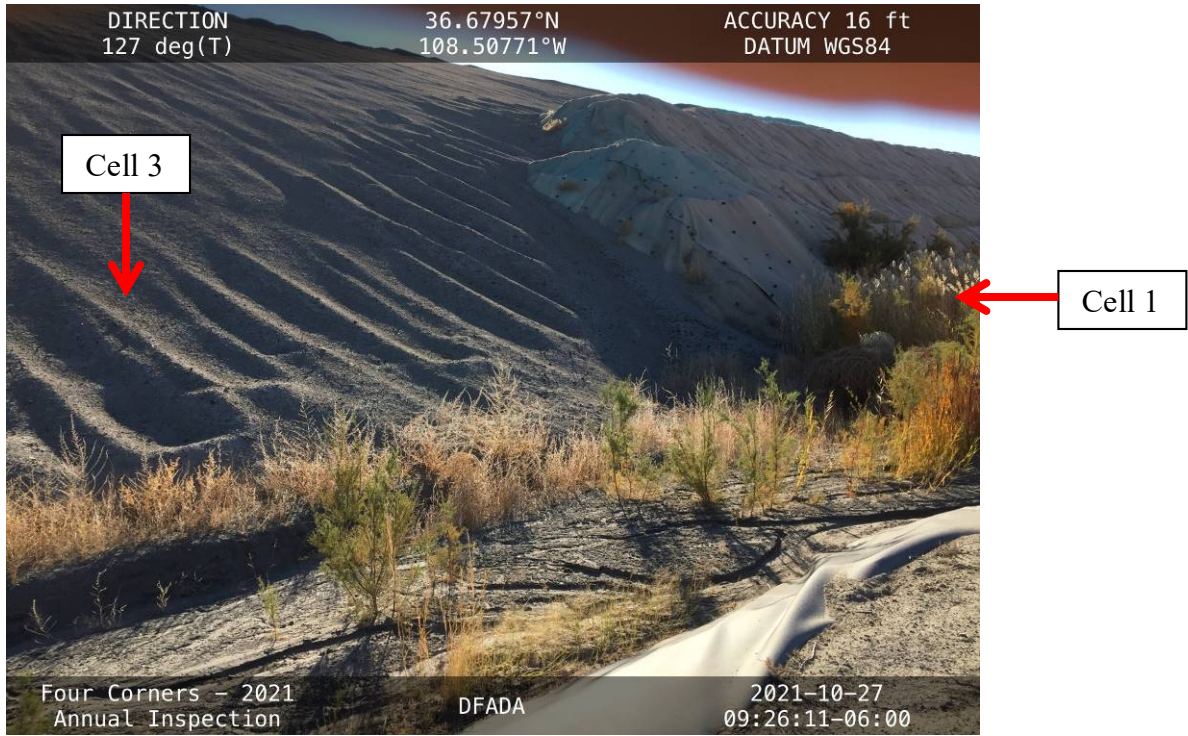
20211027-IMG_7592

Erosion along the liner at the downstream toe of the Cell 3 West Embankment, facing south.

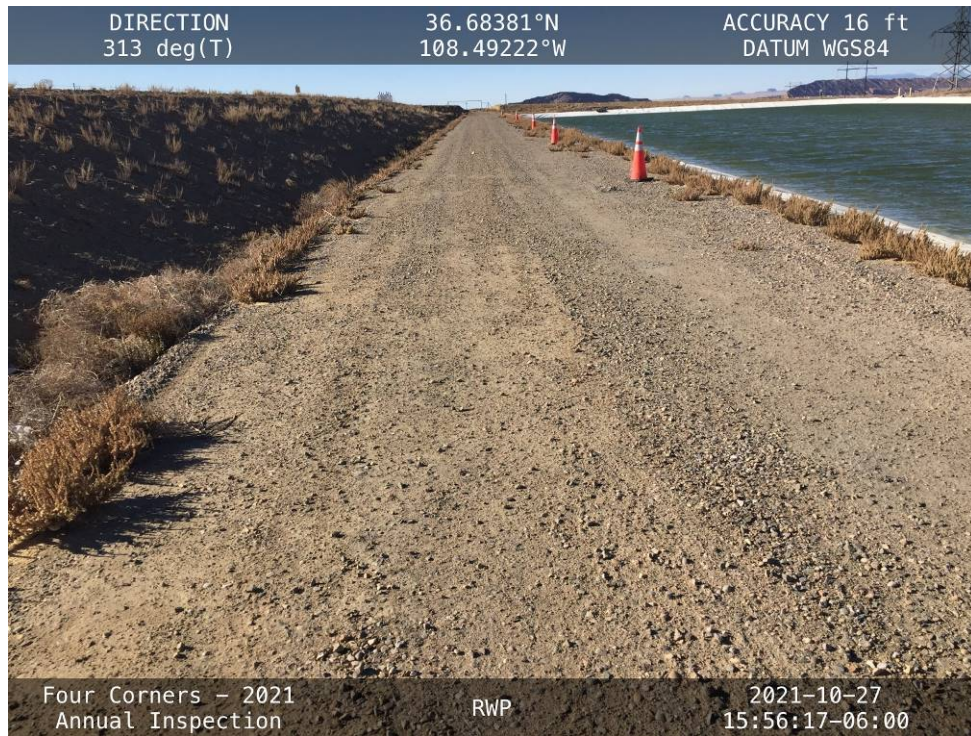
20211027 – IMG_8064

The water in the FGD Pond cell on the verge of overflowing into the RWP cell, facing northwest.

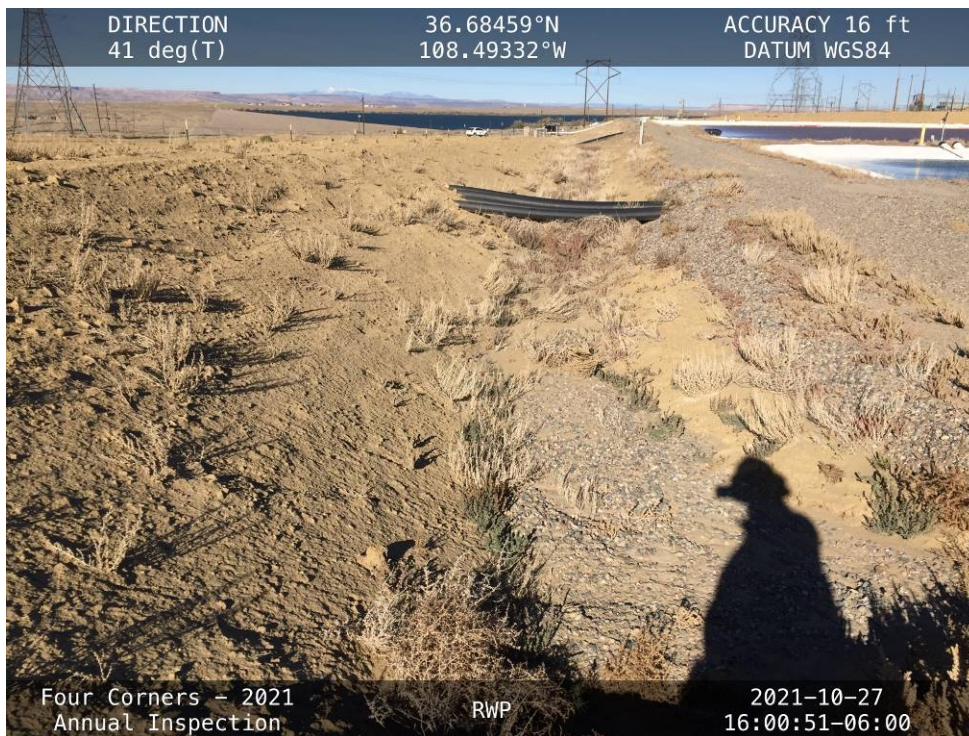
20211027-IMG_8078

Tension cracks forming on the slope of the drainage ditch along the western corner of the pond.
