FOUR CORNERS POWER PLANT COMBINED WASTE TREATMENT POND – Periodic Structural Integrity Assessment

Periodic Hazard Potential Classification Periodic Structural Stability Assessment Periodic Safety Factor Assessment

October 2021 AECOM Project 60664563

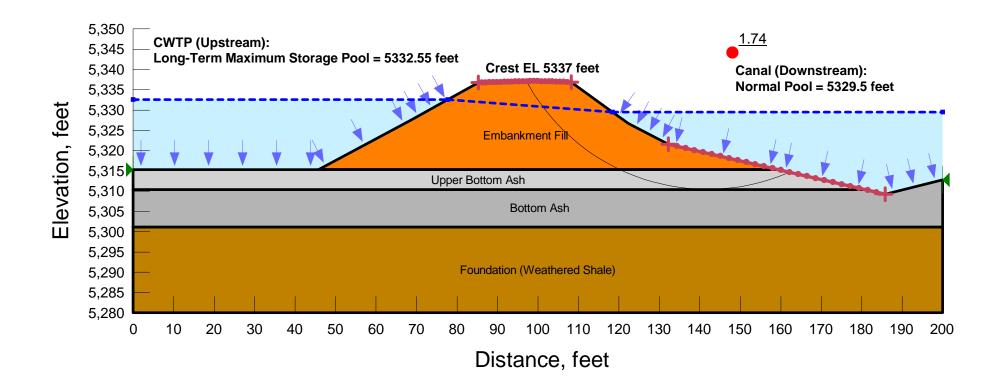
Slope Stability Analysis Section 1 Combined Waste Treatment Pond

Factor of Safety: 1.74

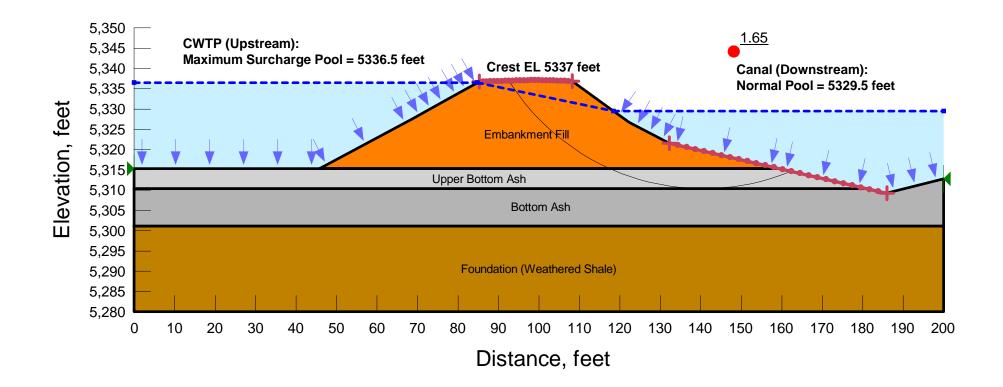
Slope Stability Analysis Section 1 **Combined Waste Treatment Pond**

Factor of Safety: 1.65

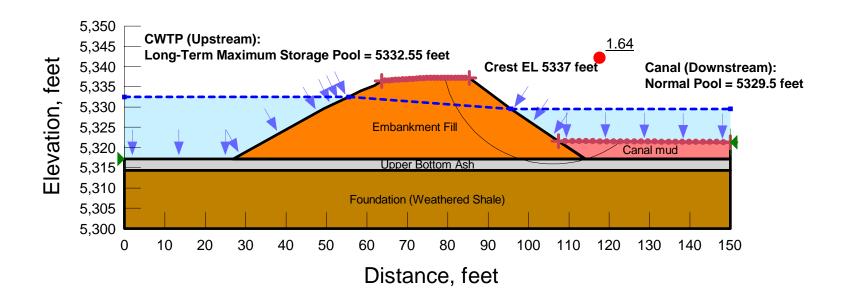
Slope Stability Analysis Section 2 Combined Waste Treatment Pond

Factor of Safety: 1.64

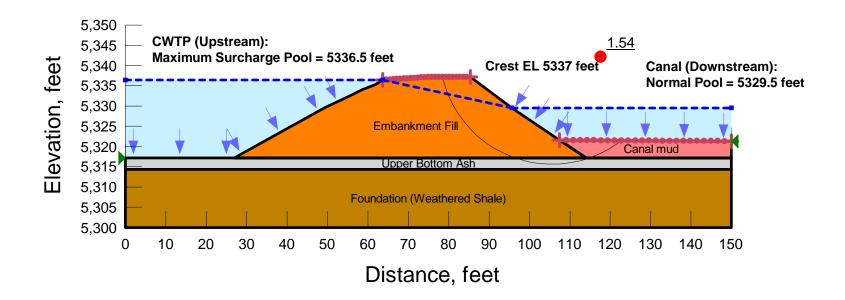
Slope Stability Analysis Section 2 **Combined Waste Treatment Pond**

Factor of Safety: 1.54
