**FOUR CORNERS POWER PLANT
Lined Ash Impoundment, Lined Decant
Water Pond, Combined Waste Treatment
Pond, Upper Retention Sump, and Dry
Fly Ash Disposal Area**

**Annual
CCR Impoundment and
Landfill Inspection Report
2015**

**AECOM
7720 North 16th Street,
Suite 100
PHOENIX, ARIZONA 85020**

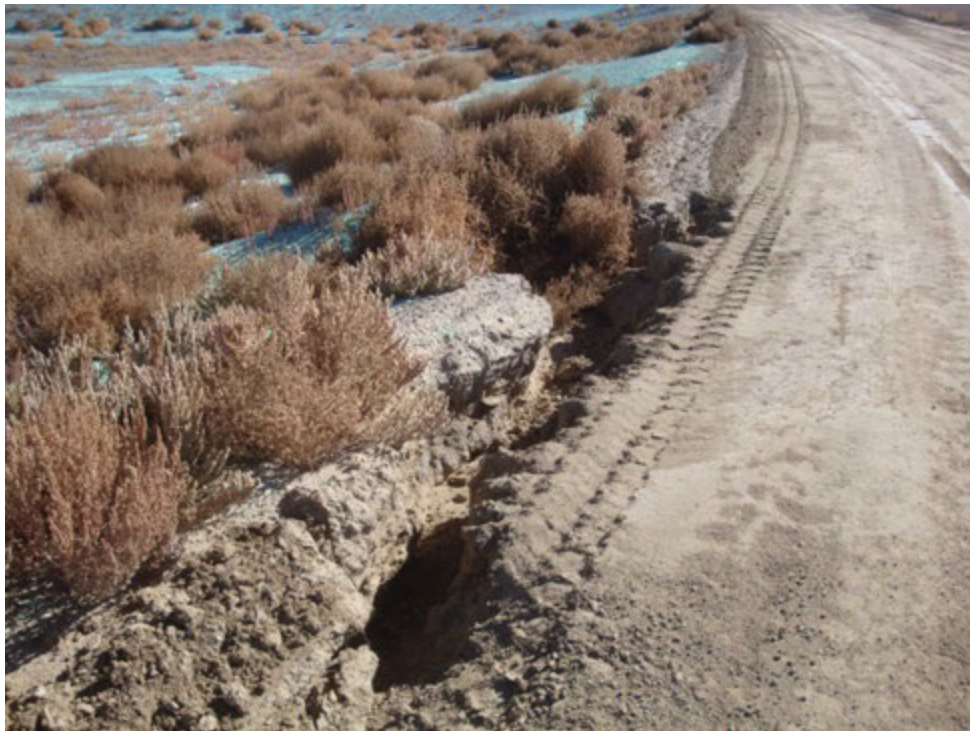
20151014 – Photo 1

Downstream berm of North Toe Buttress (NTB). Erosion caused by road maintenance.

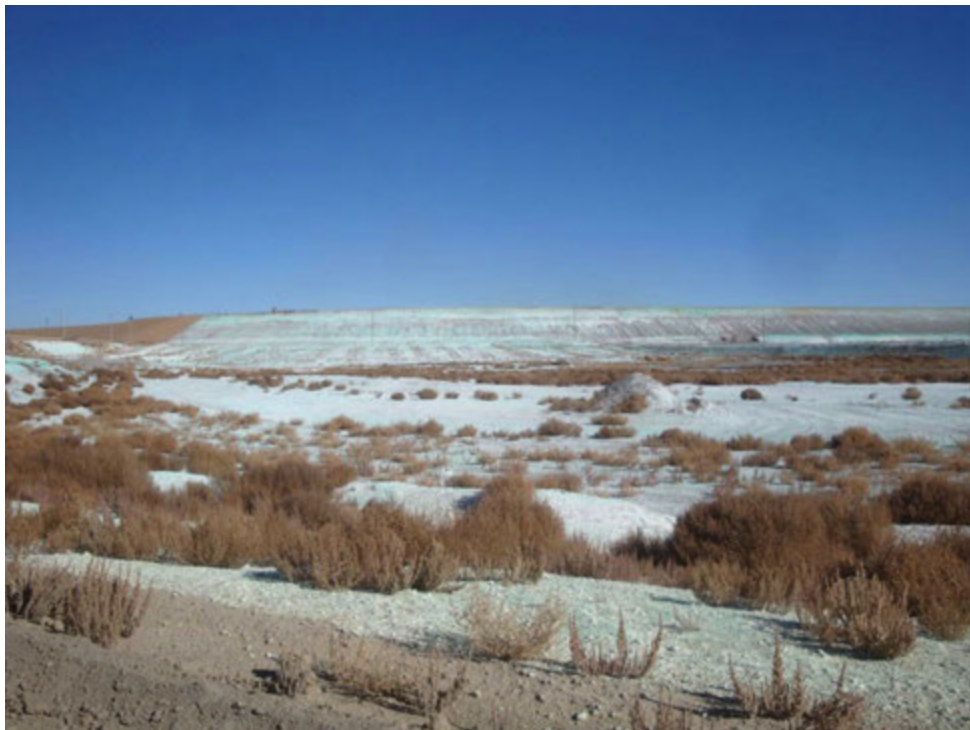
20151014 – Photo 2

- The North Toe Buttress (NTB) was constructed to provide additional stability to the elevation 5280 feet Raise of the LAI West Embankment. The NTB is shown in Photo LAI NTB 2. The physical configuration of the NTB was observed during the inspection to be good. The NTB foundation instrumentation are reviewed monthly and indicate that the NTB is functioning as intended.

NTB. View from west. White color is sprayed dust suppression covering.

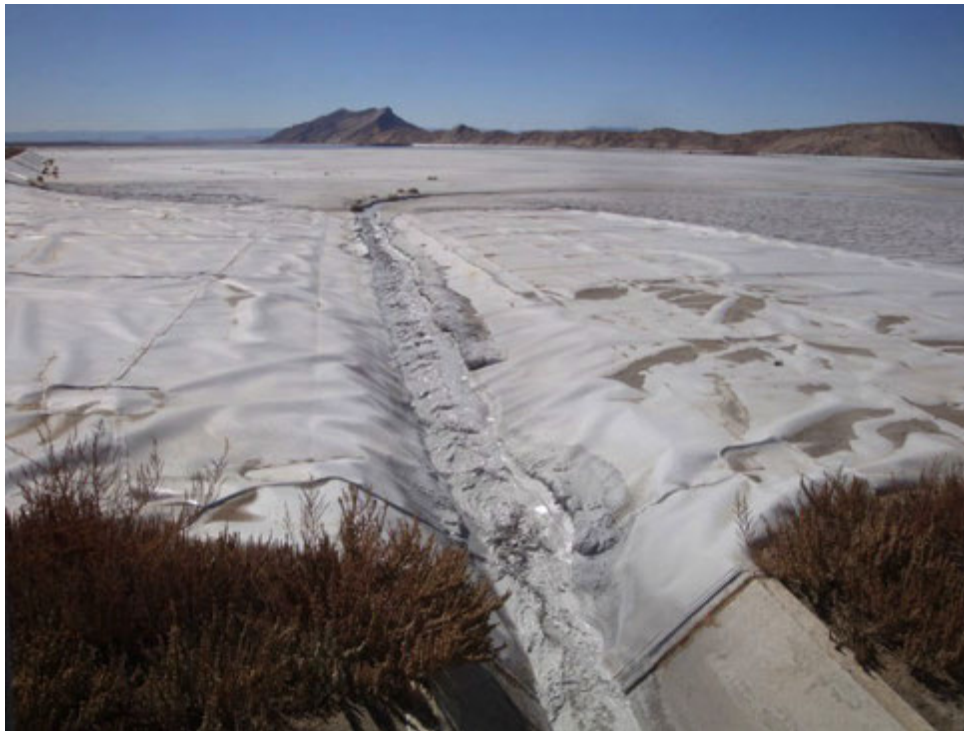
20151014 – Photo 4

LAI. Inflow of FGD waste flow into north side of impoundment.

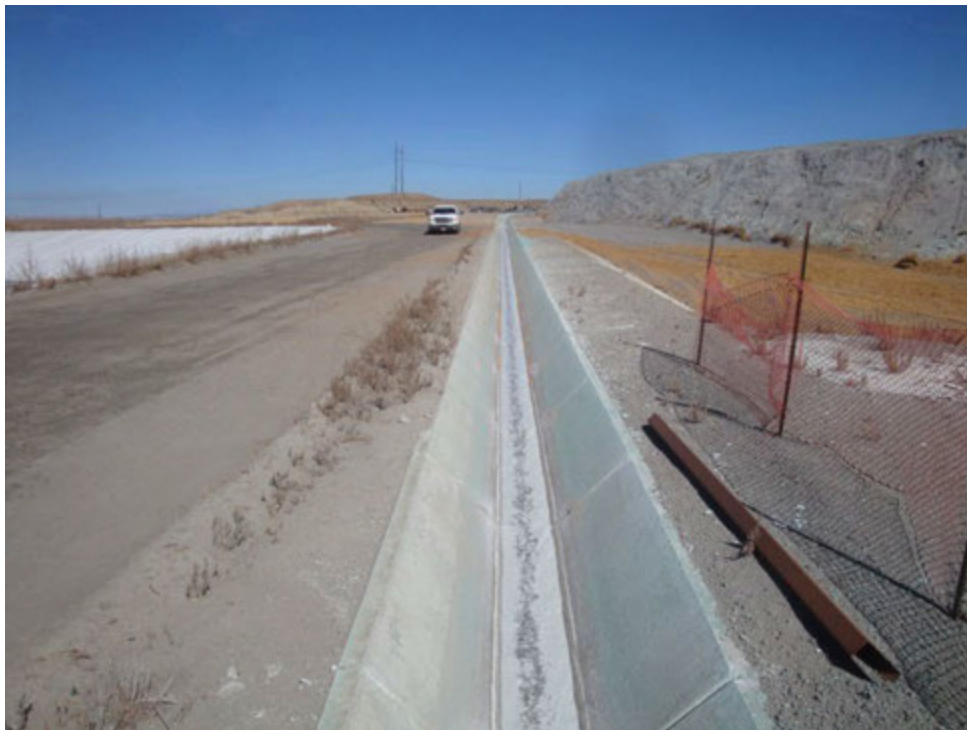
20151014 – Photo 5

LAI. Channel carrying FGD waste flow to impoundment.

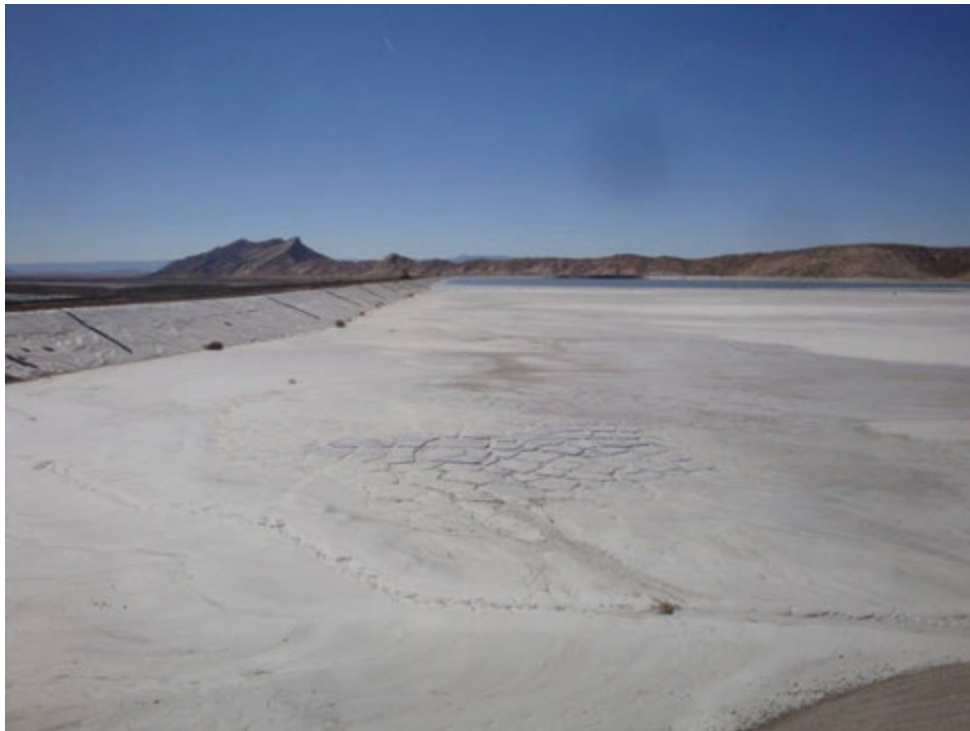
20151014 – Photo 8
Southeast corner of LAI. Impounded ash and FGD waste.

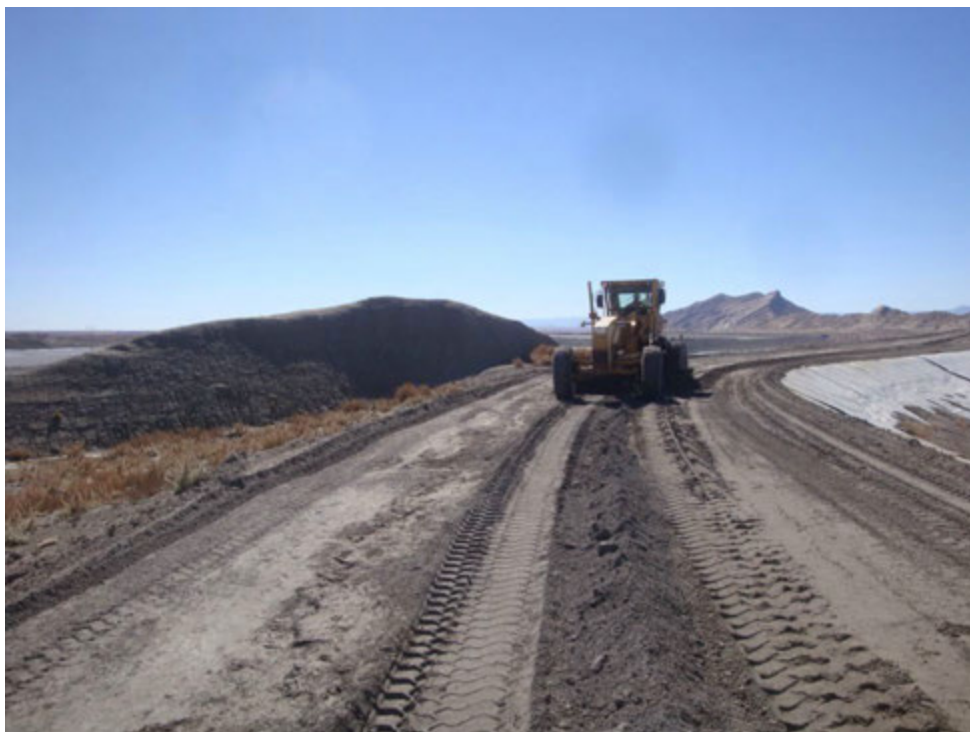
20151014 – Photo 10
Crest. LAI South Embankment. Road maintenance activity ongoing.

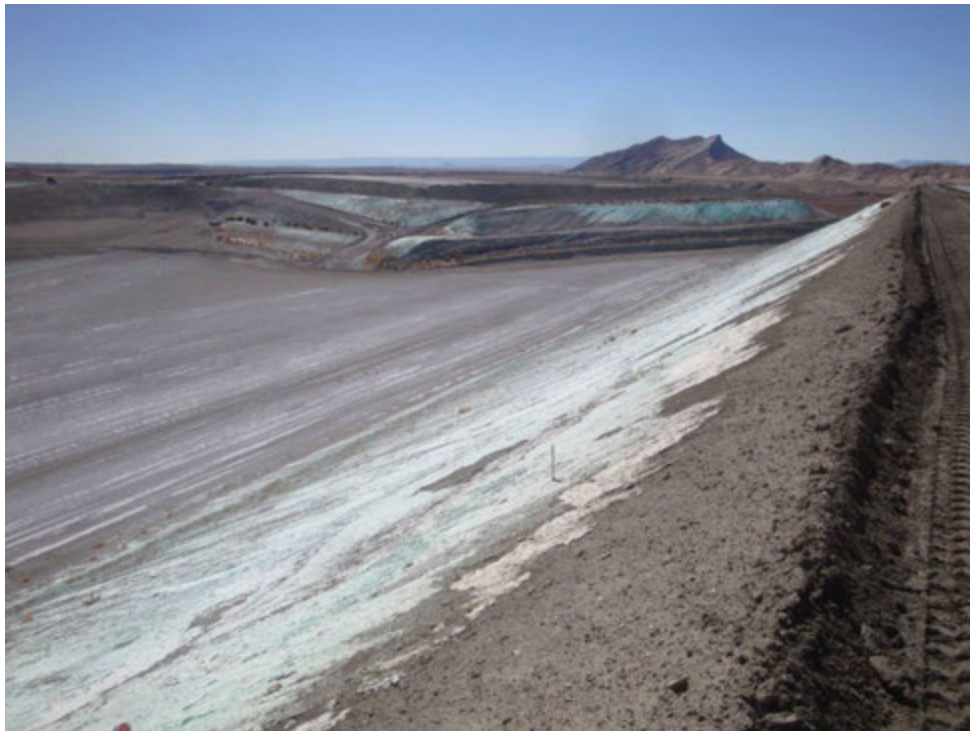
20151014 – Photo 12

LAI South Embankment. White-colored dust suppression covering in foreground. DFADA Cell 3, under construction, in background.

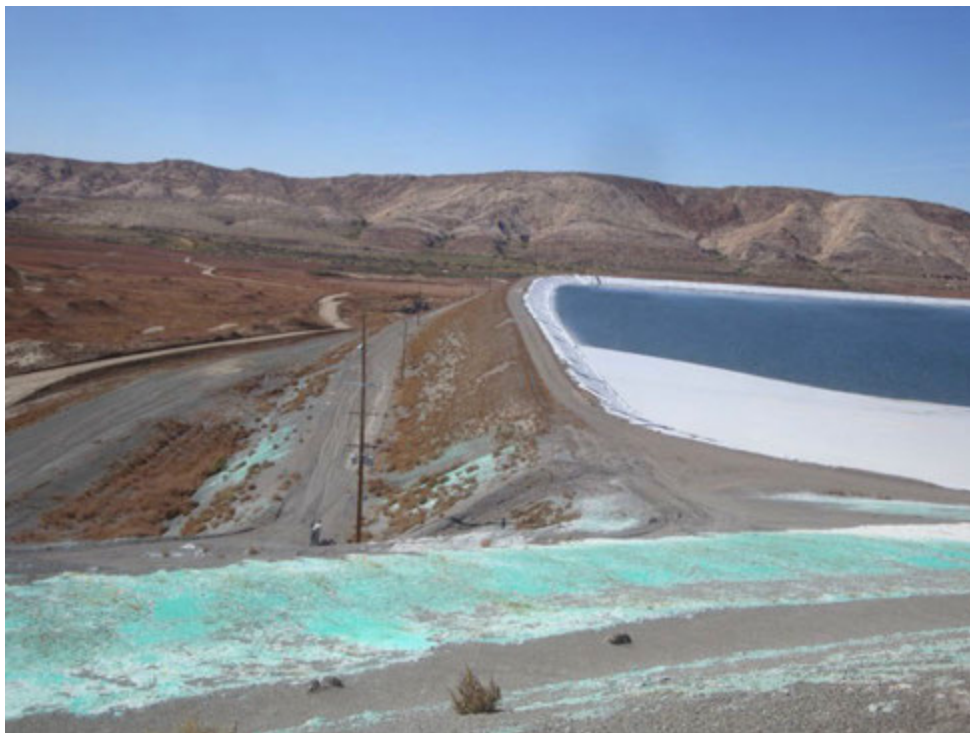
20151014 – Photo 21

Dead Pool Sump Pump Station and LDWP (right). View looking west from southwest corner of LAI crest.

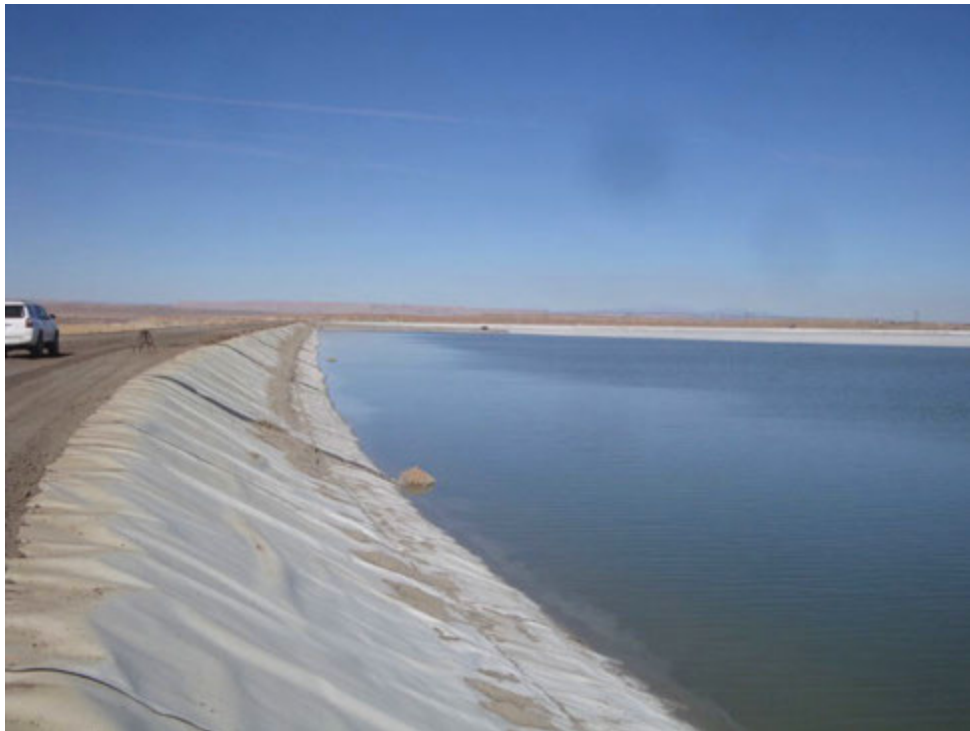
DAM EMBANKMENT CHECKLIST									
3	DAM CREST								
a	Settlements, slides, depressions?		X						
b	Misalignment?		X						
c	Longitudinal/Transverse cracking?		X						
d	Animal burrows?		X						
e	Adverse vegetation?		X						
f	Erosion?		X						
4	UPSTREAM SLOPE								
a	Erosion? Upstream slope is covered by geomembrane. See Photo LAI 22.		X						
b	Inadequate ground cover?		X						
c	Adverse vegetation? None.		X

20151014 – Photo 22
LAI. View from crest of South Embankment.

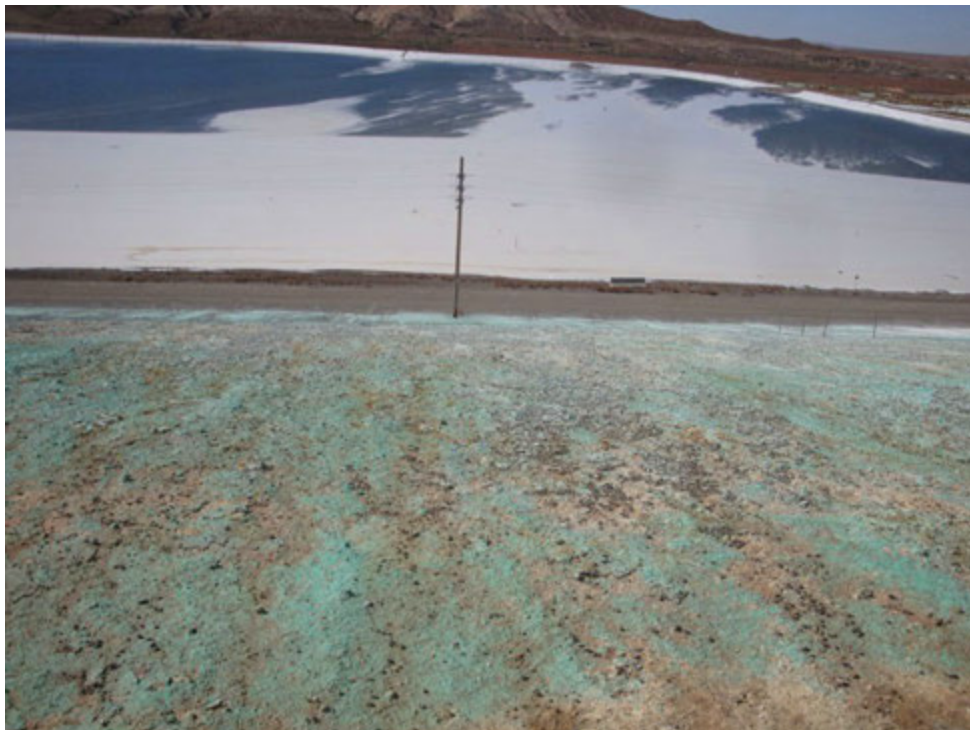
20151014 – Photo 24
LAI West Embankment. View from crest looking west toward LDWP. Note dust suppression coverage on face of West Embankment.

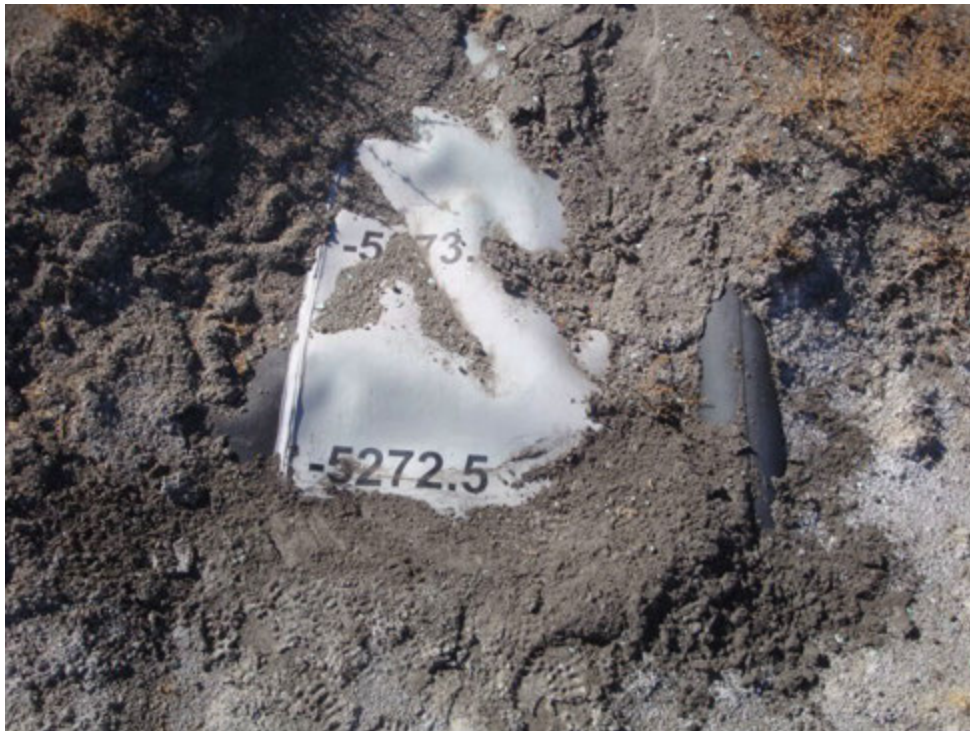
20151014 – Photo 26

LAI. Permanently-installed elevation marker on west side of impoundment.

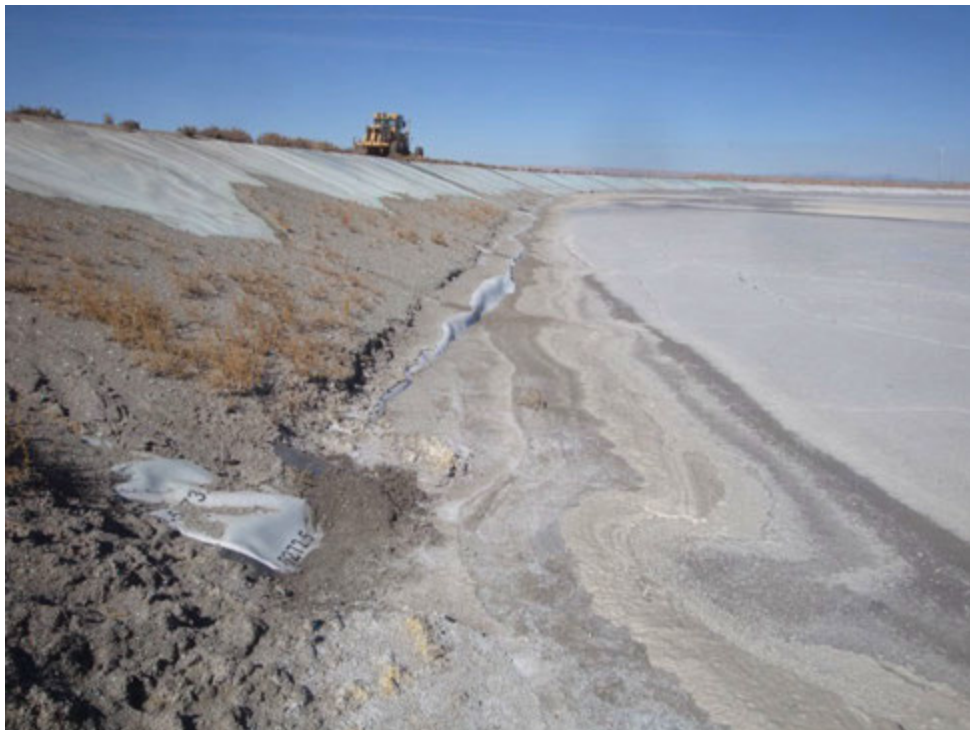
20151014 – Photo 27

LAI. Permanently-installed elevation marker on west side of impoundment.

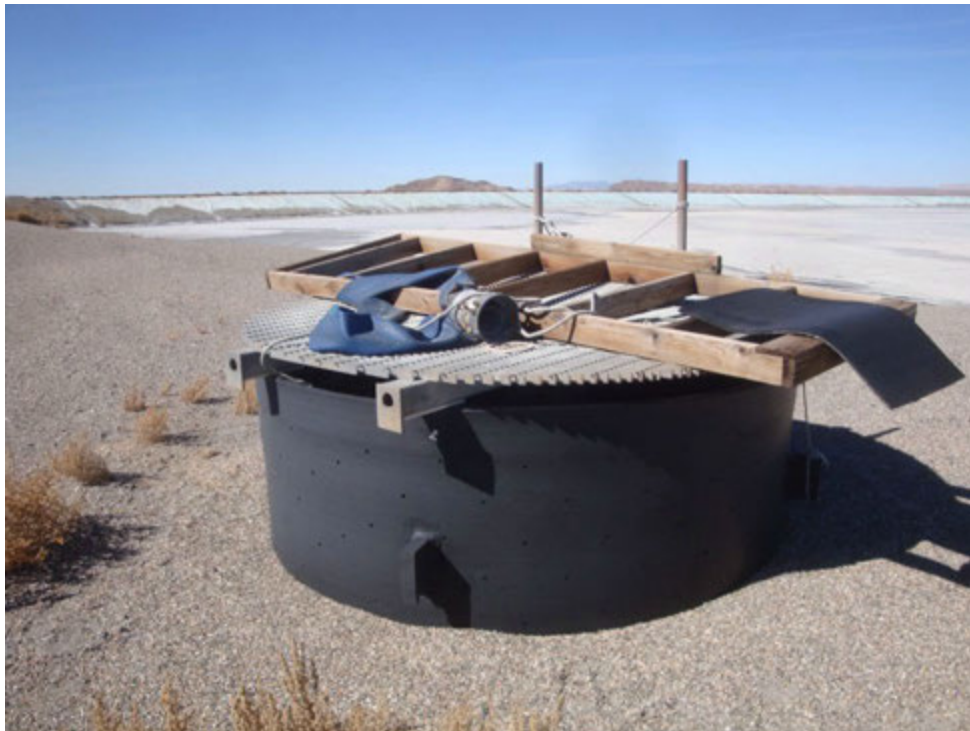
20151014 – Photo 30

- The primary outlet from LAI to LDWP is an 8-foot vertical, perforated HDPE riser (see Photo LAI 30) connected at the bottom to 8-inch and 16-inch diameter HDPE gravity pipe outlets to the LDWP (see Photo LAI 39). The riser was constructed in segments by adding rings with each sequential embankment raise. The riser is surrounded by a select, graded gravel fill zone to allow water, but not solids, to drain from the impounded ash. At the time of inspection, the sound of falling water within the riser could be heard but not observed using flashlight or reflected sunlight. The performance of the riser appeared to be similar to that observed during prior inspections.

Exposed top of LAI Discharge Riser. Insufficient impounded water to inundate.

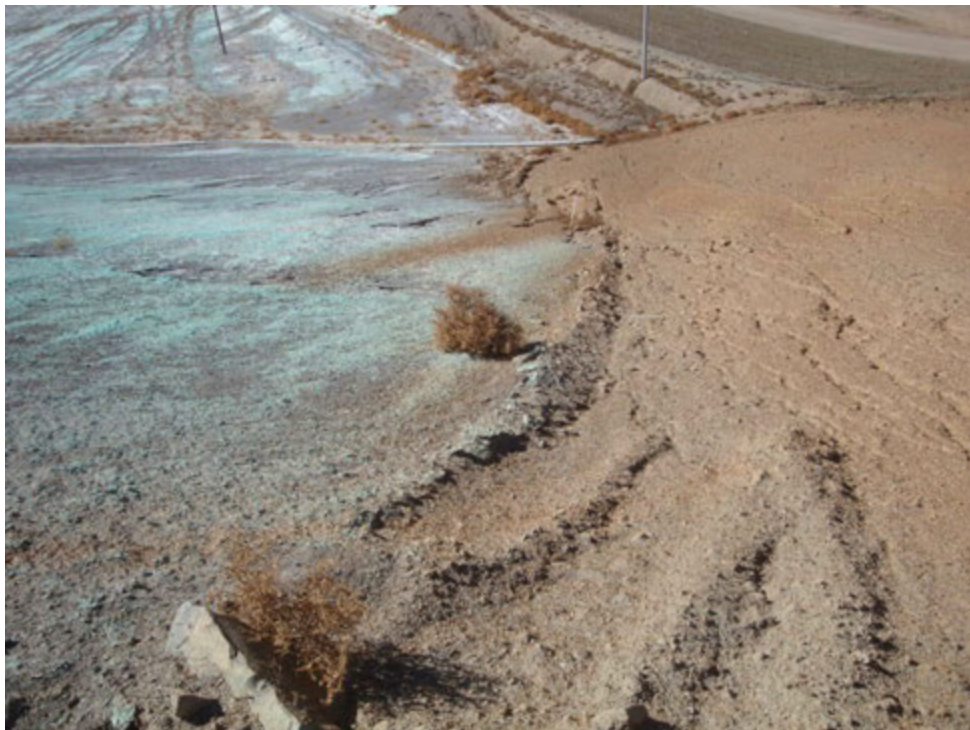
20151014 – Photo 32

West Embankment. Downstream slope. Interface between 3:1 “final constructed” slope of Pond 4 segment and 4:1 “closed” slope of Pond 5 segment.

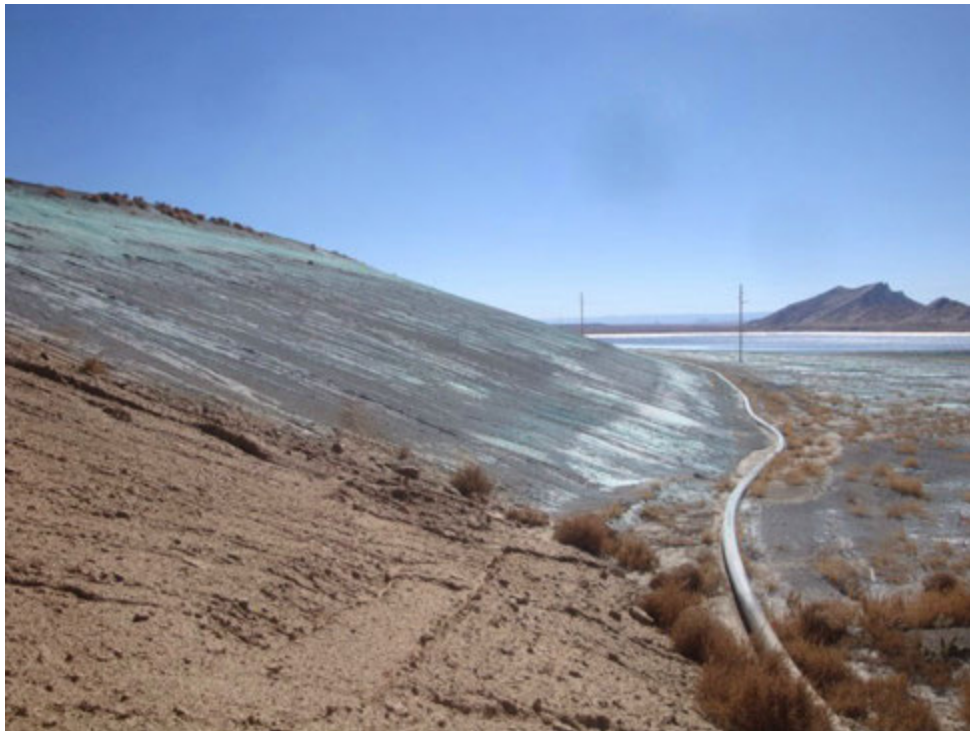
20151014 – Photo 33

West Embankment. Downstream slope. Interface between 3:1 “final constructed” slope of Pond 4 segment and 4:1 “closed” slope of Pond 5 segment.

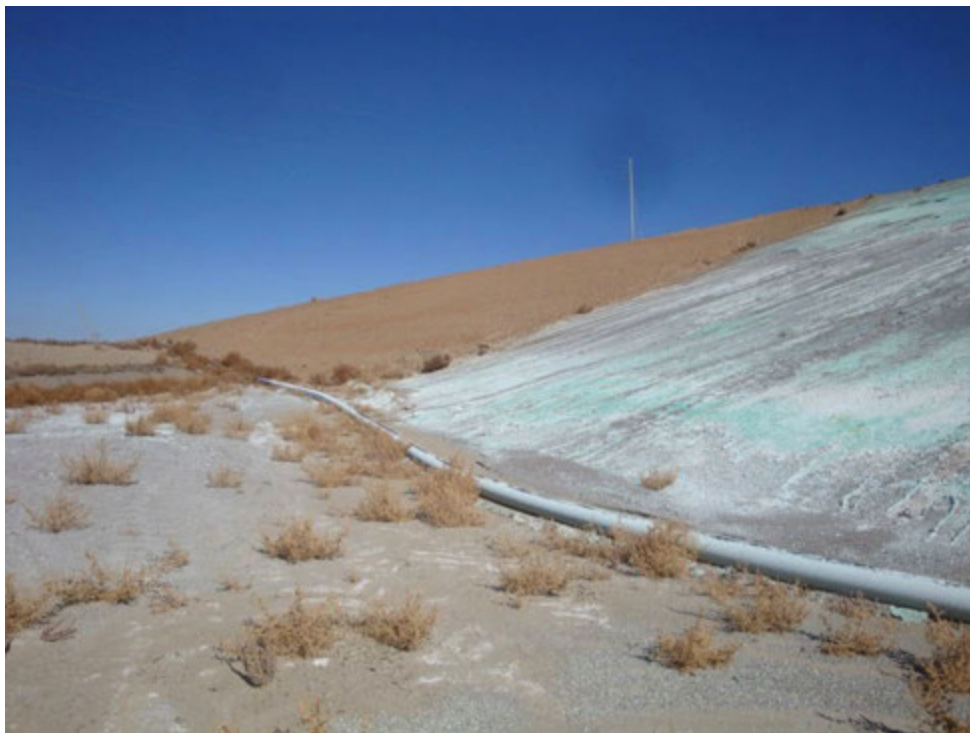
20151014 – Photo 35

West Embankment. Downstream slope. Interface between 3:1 “final constructed” slope of Pond 4 segment and 4:1 “closed” slope of Pond 5 segment.

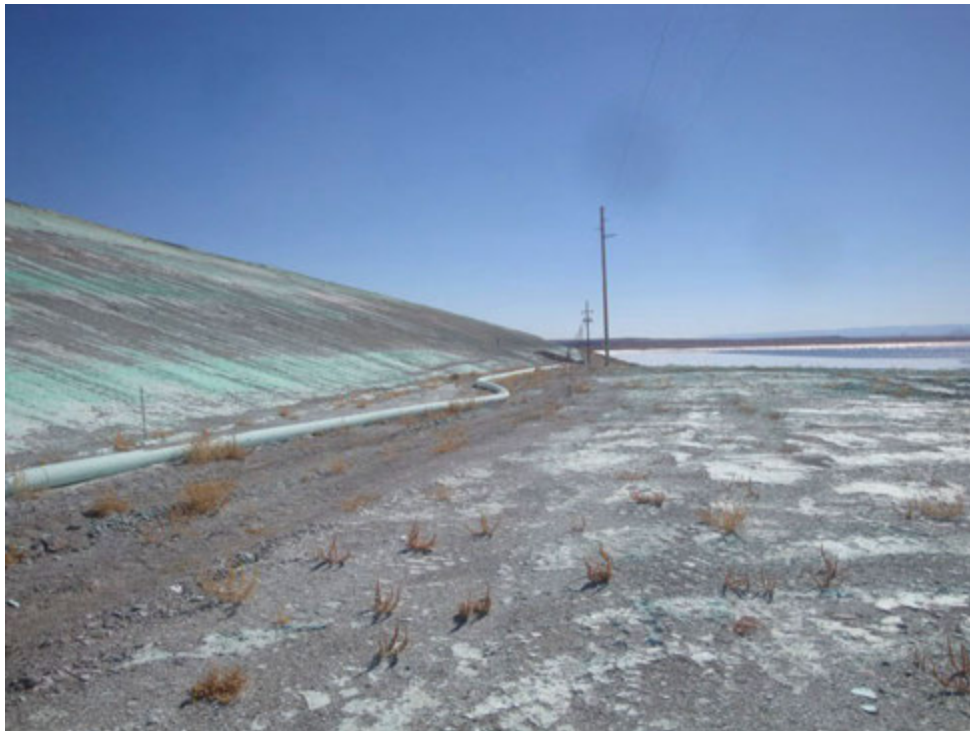
20151014 – Photo 36

West Embankment. Downstream slope. Interface with North Toe Buttress. LDWP in far ground.

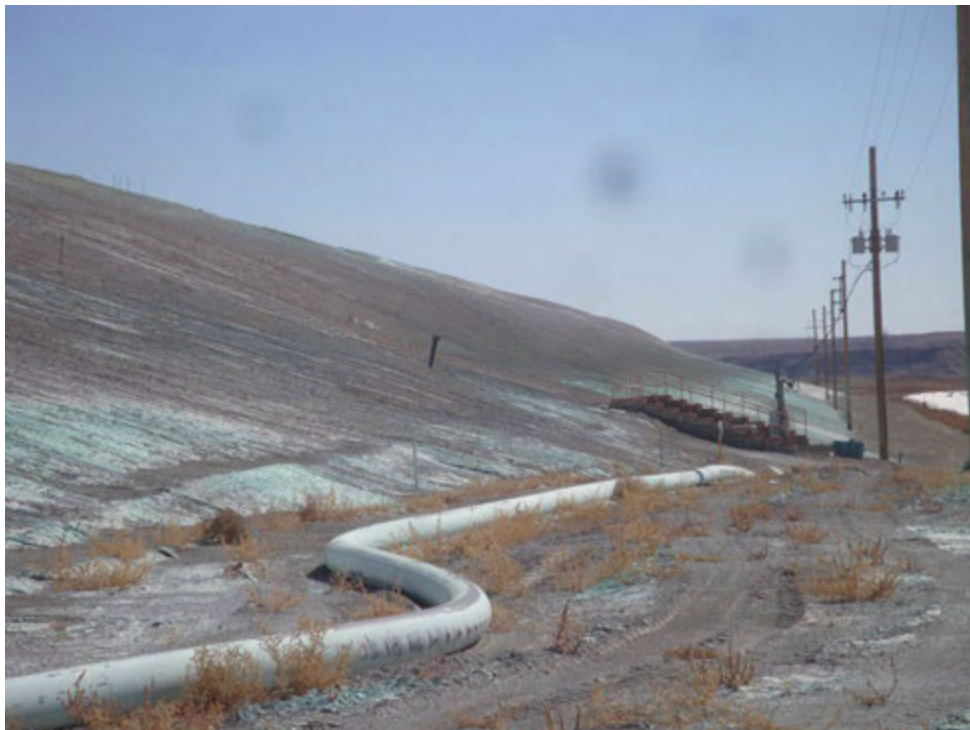
20151014 – Photo 37

West Embankment. Downstream slope. LDWP pump station and double-walled pressure line in foreground.

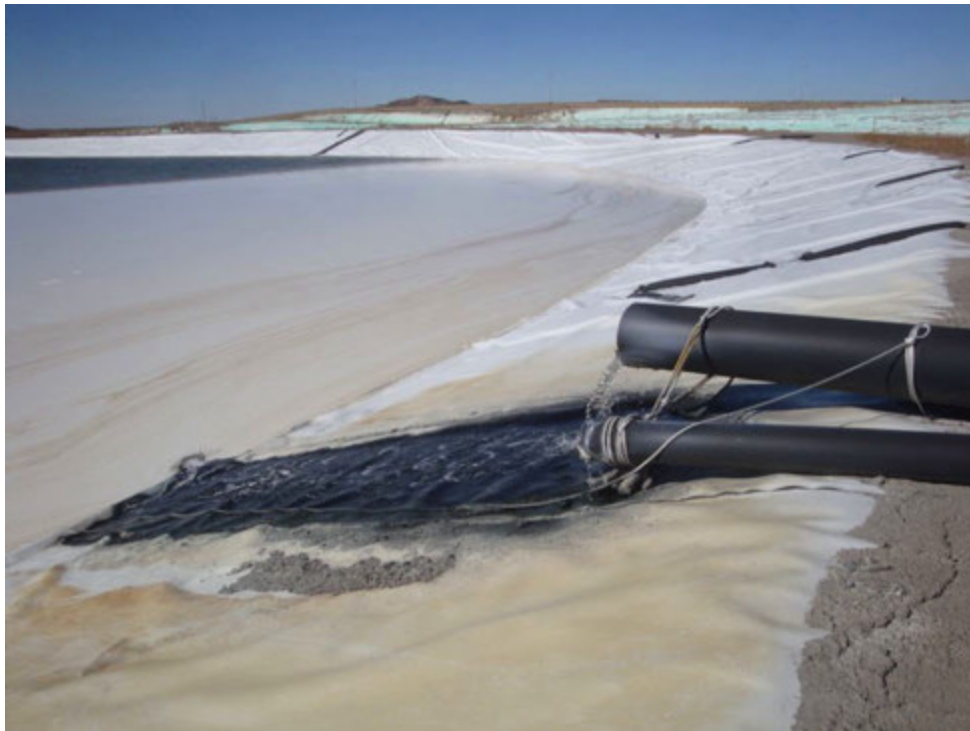
- At the downstream (LDWP) side of the decant structure, discharge flow was observed from both the 8-inch and 16-inch outlet pipes (see Photo LAI 39). Based on the observed low flow from the 8-inch pipe and his prior experience with the engineering and operation of the decant system, Mr. Byron Conrad, P.E., commented that the 8-inch line was probably partially blocked with sediment. A past attempt, in approximately 2013, to clear by “surging” with a water lance was not wholly successful. A subsequent attempt to raise the driving head in the 8-foot diameter riser by raising the discharge end of the 16-inch outlet pipe was partially successful at dislodging accumulated sediment in the 8-inch outlet. We recommend continued monitoring of flow from the 8-inch pipe and, if

20151014 – Photo 39
Discharge by gravity from LAI Riser to LDWP.

warranted, repeating the earlier successful dislodging effort if inadequate flow is reporting to the LDWP from the LAI. The interconnection is not required for flood management purposes since the minimum freeboard of the LAI is sufficient to store the directly-incident PMP

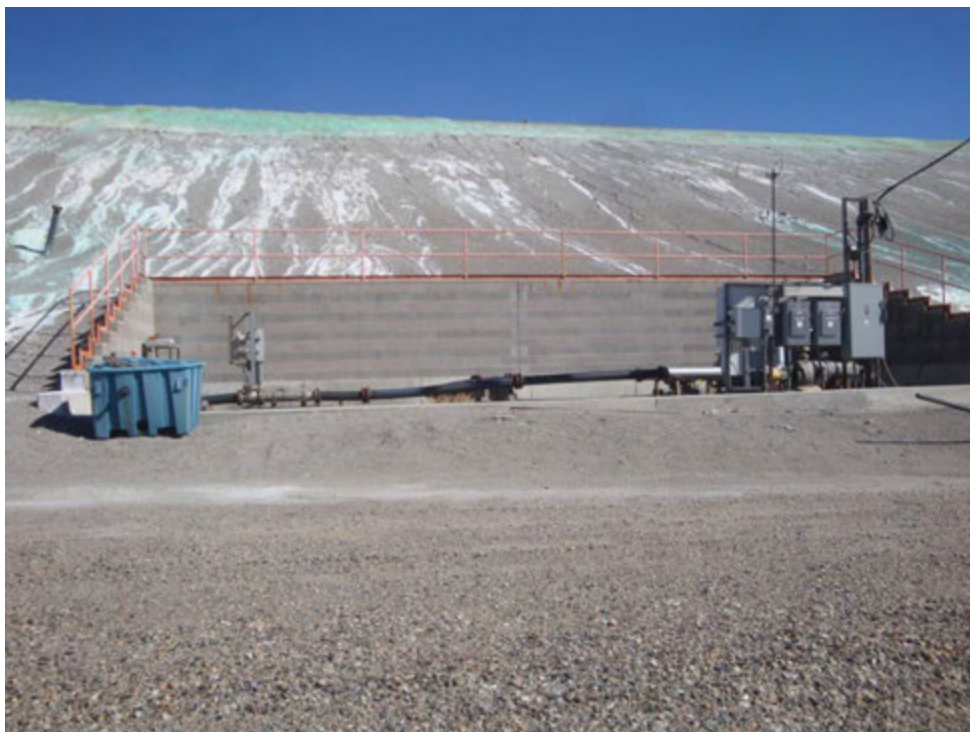
20151014 – Photo 40
West Embankment. LDWP Pump Station.

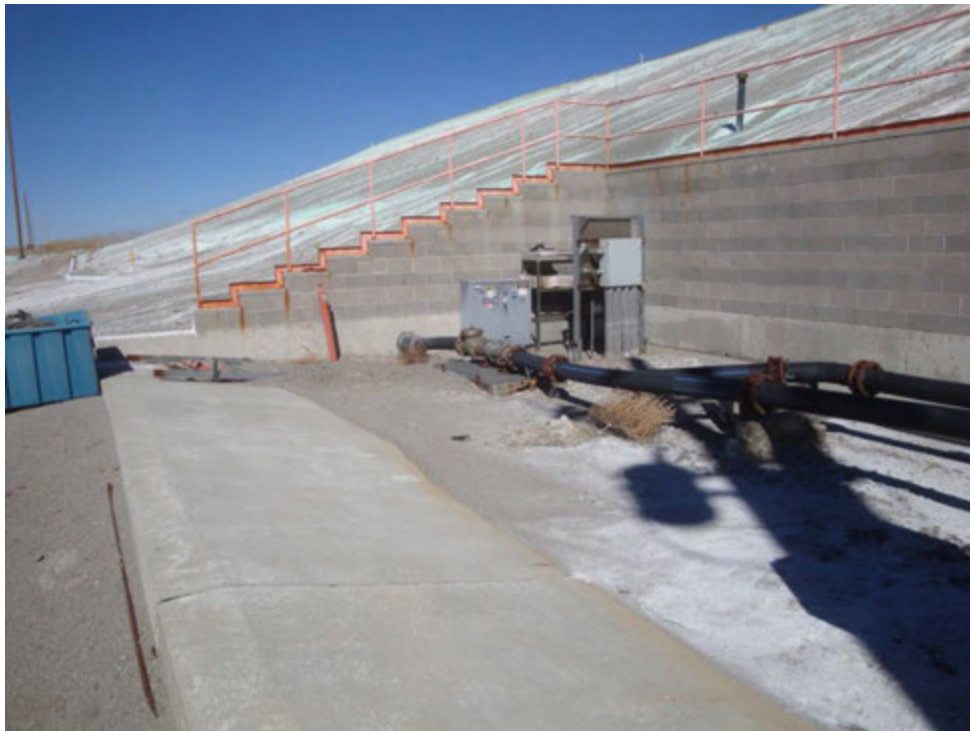
20151014 – Photo 42

- The LDWP pump station is located on the crest of the LDWP, adjacent to on inset within the toe of the West Embankment of the LAI (see Photo LAI 40). The pump station was designed with a sump and gravity drain to allow leaks and other nuisance flows to drain through a pipe to the LDWP rather than flowing in an uncontrolled manner across the crest of the LDWP embankment. At the time of the inspection, it appeared that sufficient dust and sediment had accumulated in the pump station to prevent gravity drainage. See Photo LAI 42. Recommend that sediment and debris be cleaned

West Embankment. LDWP Pump Station. View of accumulated sediment.

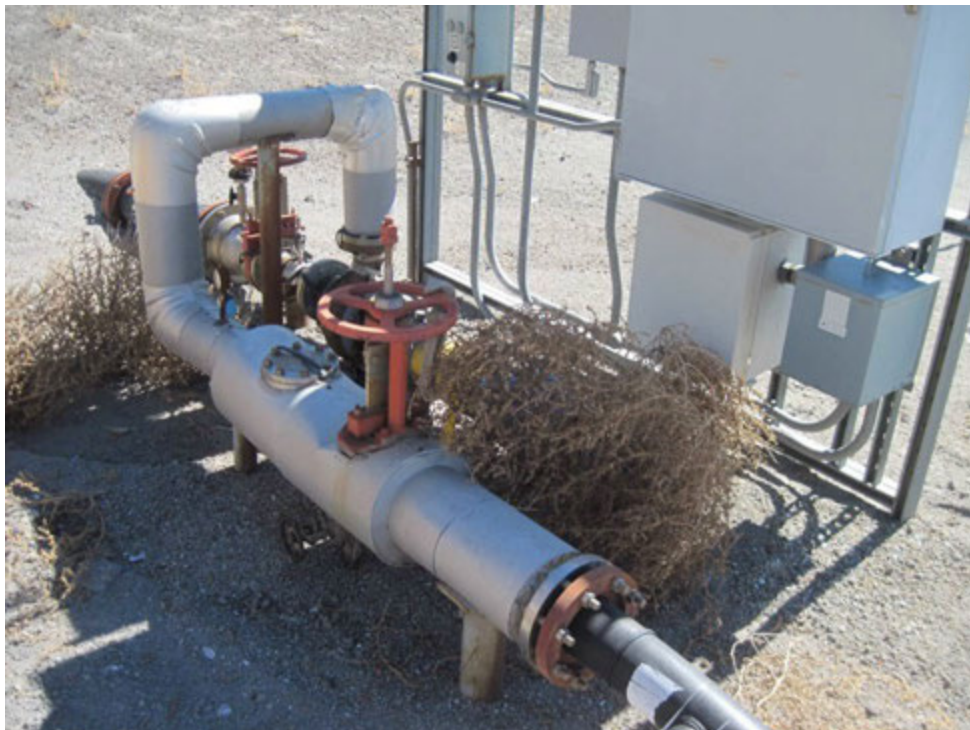
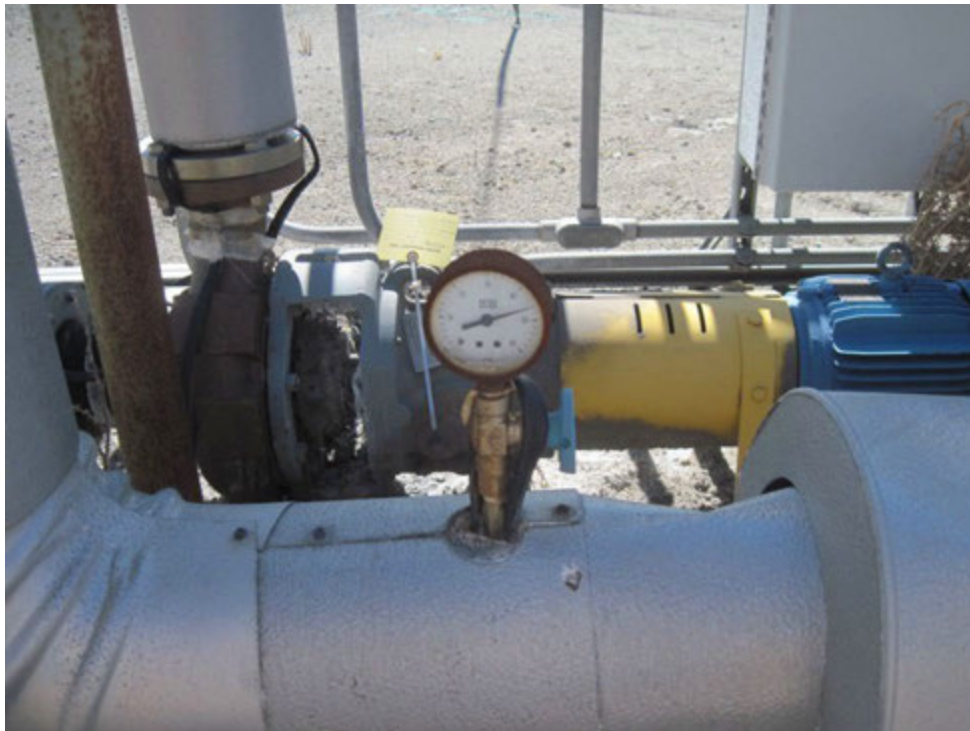
- The Dead Pool Sump and internal toe drain is a means of dewatering impounded ash within the LAI. It is drained by gravity and pumped (see Photo LAI IMG_2118) with a discharge to the LDWP. Its operation is not a requirement for safe operation of the LAI but is encouraged because it assists with dewatering, consolidation, and strengthening of the impounded solids. At the time of inspection, the system was pressurized (see Photo LAI IMG_2119) but not operational. Recommend that a Corrective Action Request (CAR) be issued to re-activate and/or repair the pump system.

Dead Pool Sump Pump Station. Non-operational but pressurized.

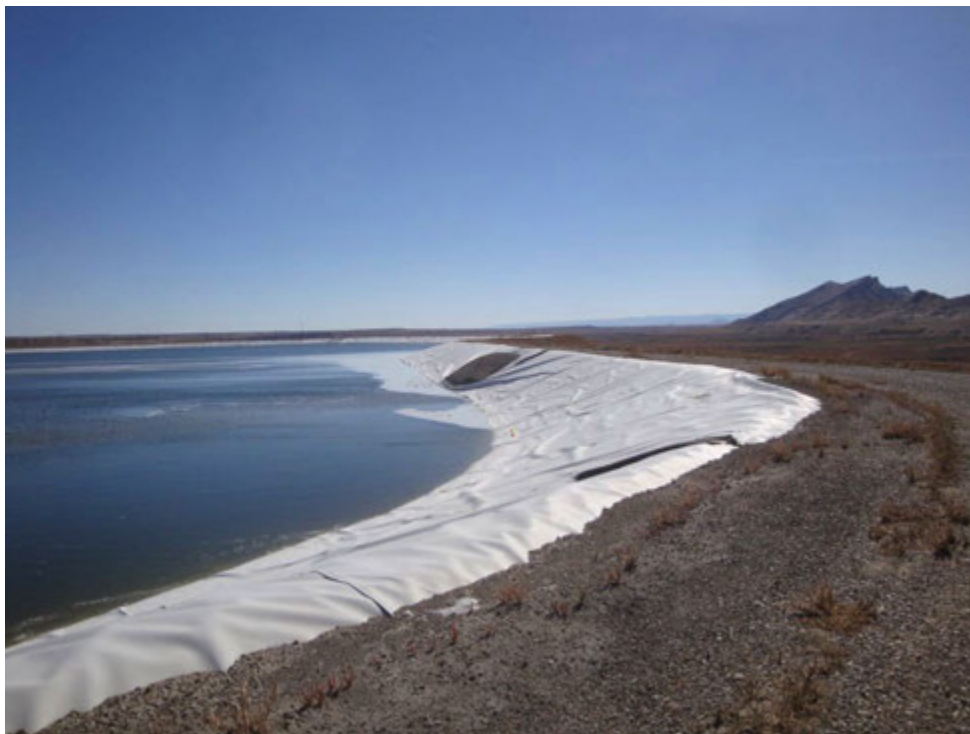
20151014 – Photo 2, Set 1
Impoundment. Northwest corner.

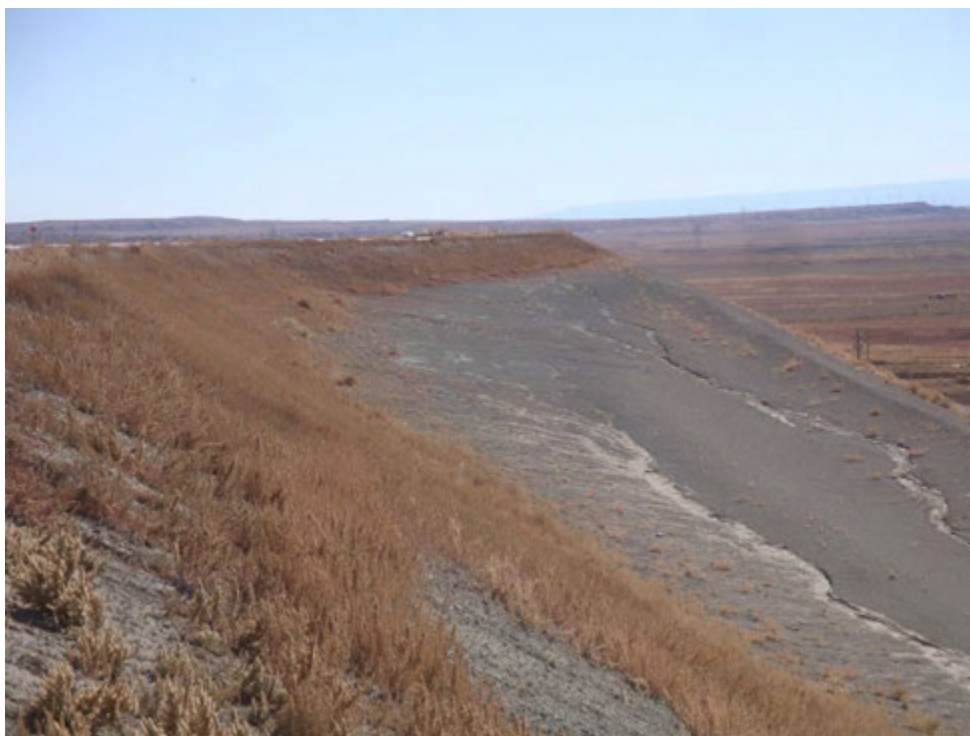
20151014 – Photo 7, Set 1
West Embankment. Erosion rills.

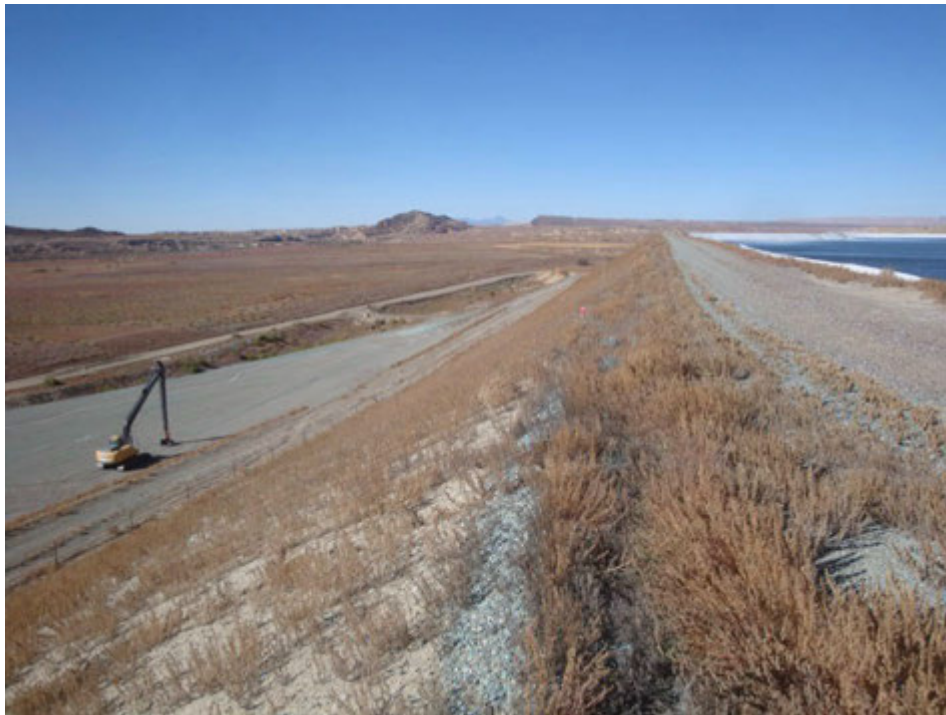
20151014 – Photo 14, Set 1

Downstream Slope. West Embankment.

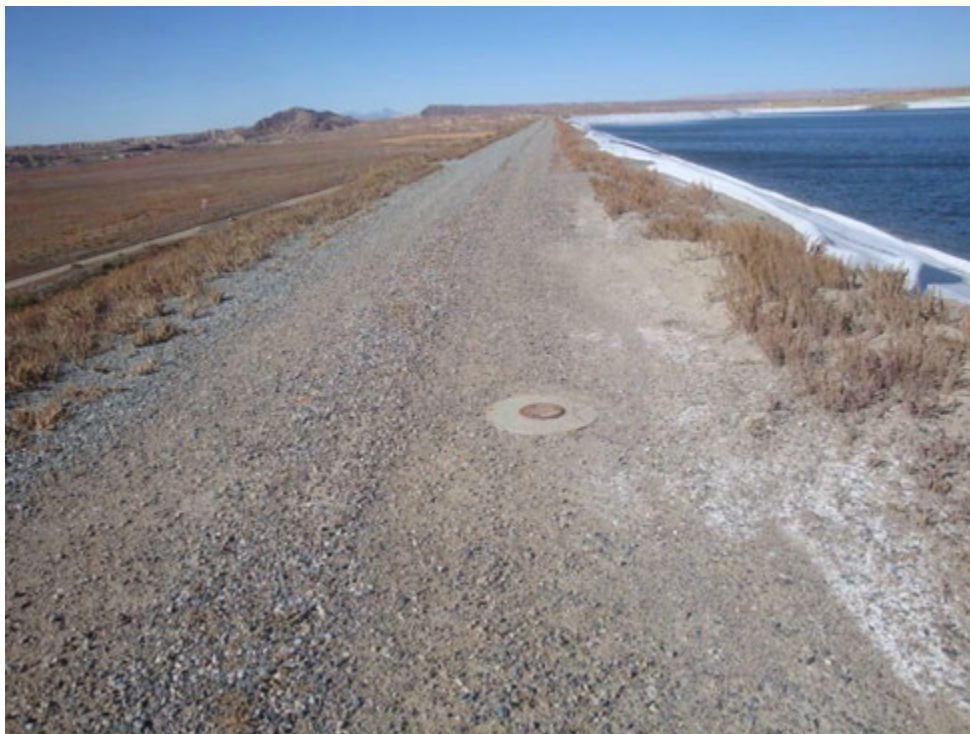
20151014 – Photo 15, Set 1
Crest. West Embankment. Survey monument.

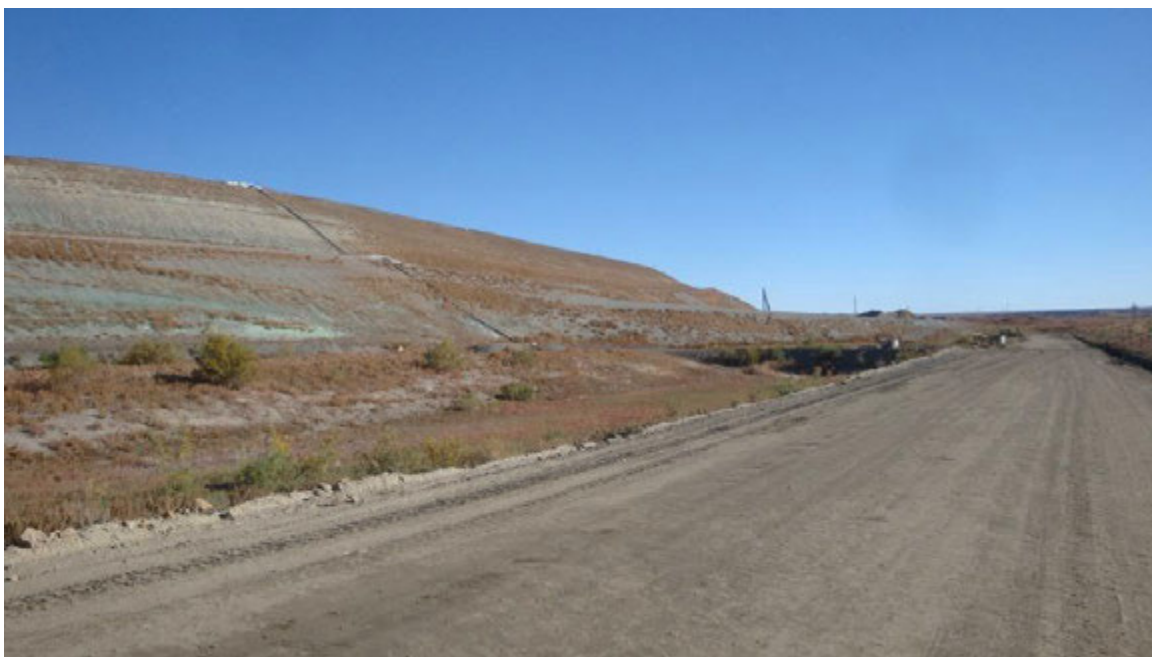
20151014 – Photo 3, Set 2
West Embankment. Note varied, sparse vegetation.

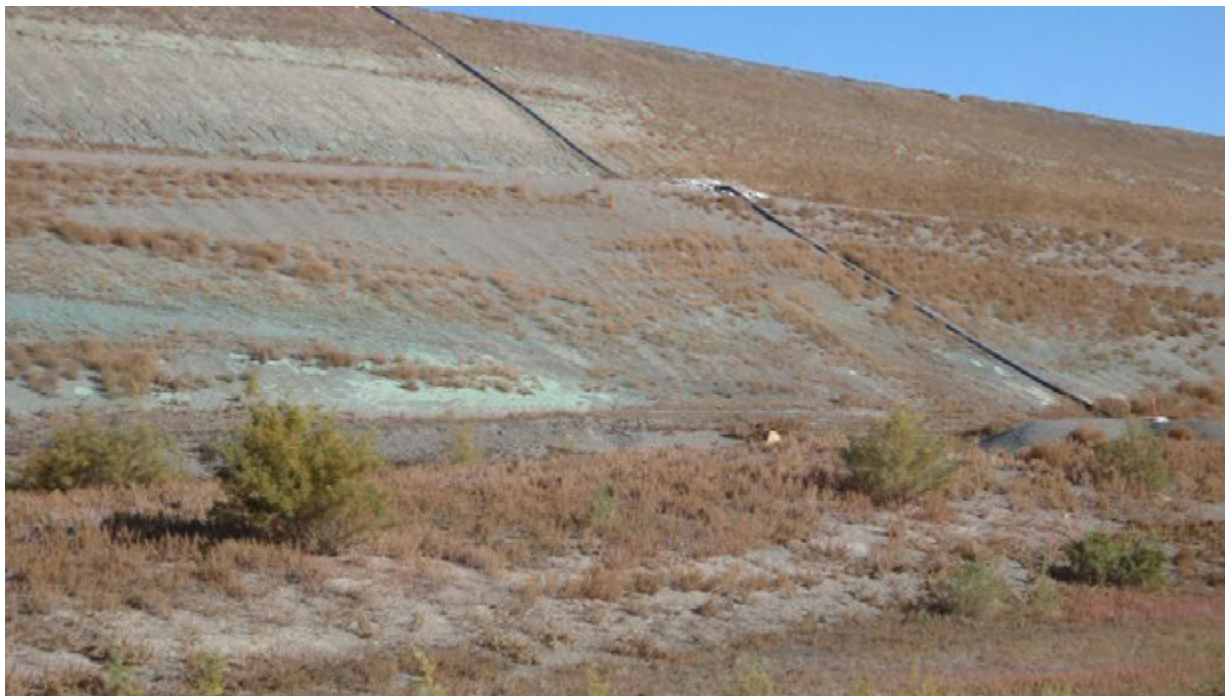
20151014 – Photo 4, Set 2
 West Embankment. Note double-walled pumpback line from Sump 3.
