**FOUR CORNERS POWER PLANT
Lined Ash Impoundment, Lined Decant
Water Pond, Combined Waste Treatment
Pond, Upper Retention Sump, and Dry
Fly Ash Disposal Area**

**Annual
CCR Impoundment and
Landfill Inspection Report
2015**

**AECOM
7720 North 16th Street,
Suite 100
PHOENIX, ARIZONA 85020**

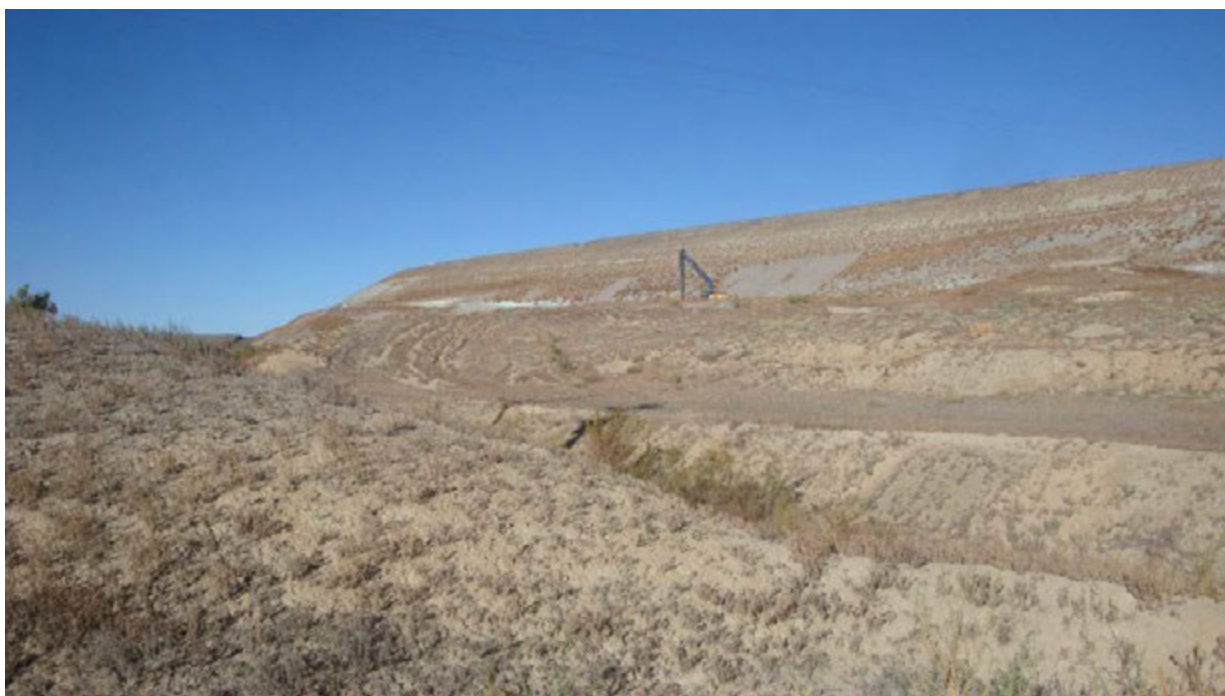
- The external slopes of the embankments show evidence of minor to significant erosion rilling, presumably caused by rainfall runoff. APS has been maintaining affected areas by regrading and recompacting eroded areas. See Photos LDWP Set 2 8 and LDWP Set 2 12. Recommend that program be continued and that rills be repaired if the depth exceeds one foot.

20151014 – Photo 8, Set 2
 West Embankment. Note widely-spaced erosion rills and equipment for ongoing maintenance.

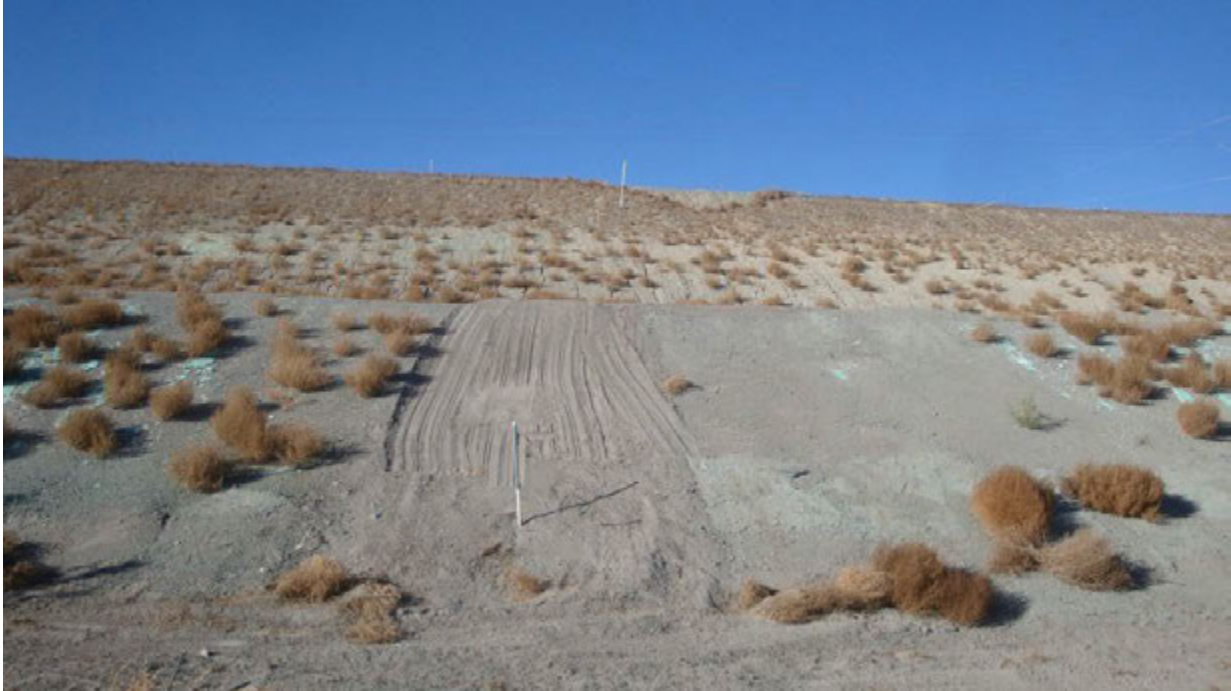
20151014 – Photo 12, Set 2
West Embankment. Note recently-completed erosion maintenance.

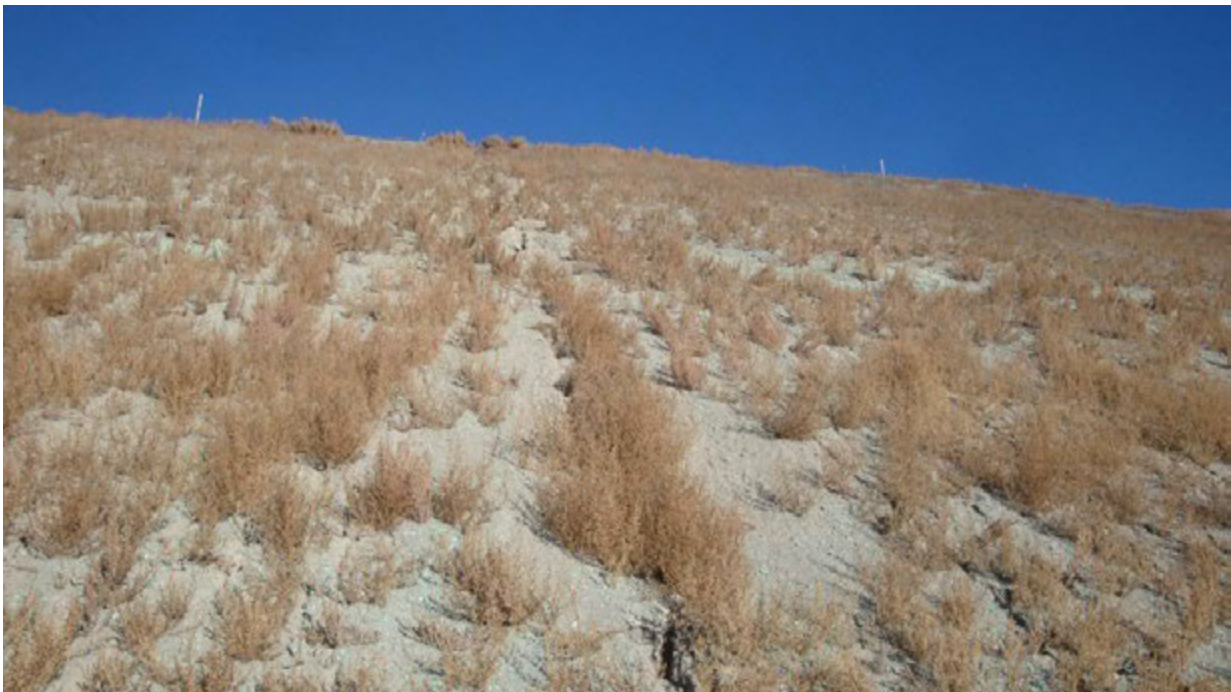
20151014 – Photo 15, Set 2
West Embankment. Note varied, sparse vegetation.

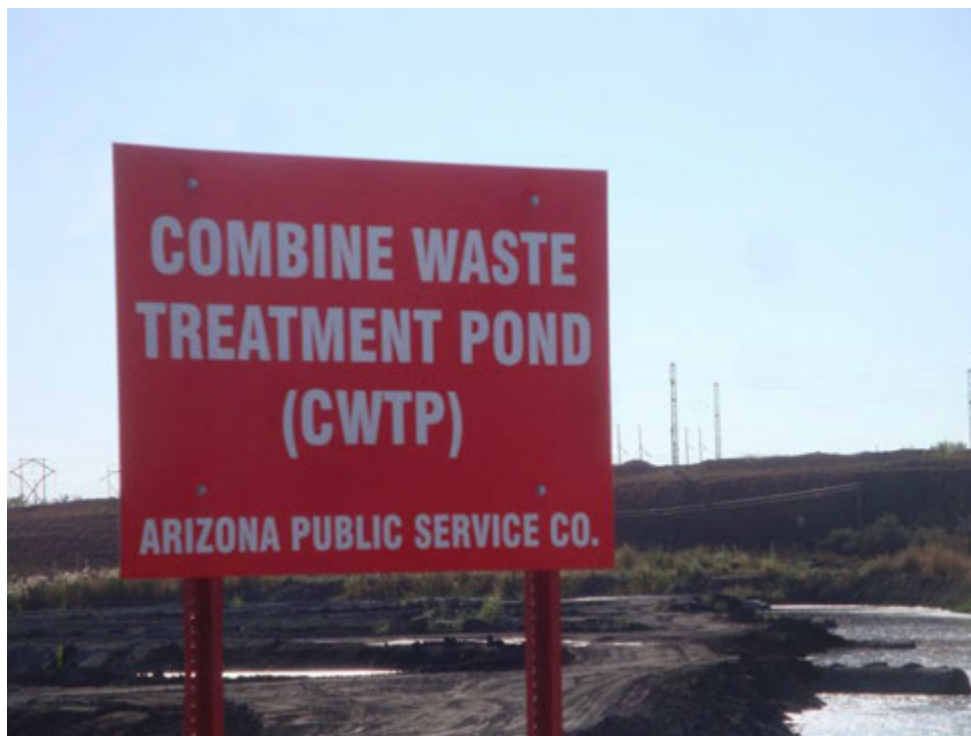
20151014 – Photo 1

Signage for the CWTP, previously also known as Low Volume Waste Water Pond (LVWWP).

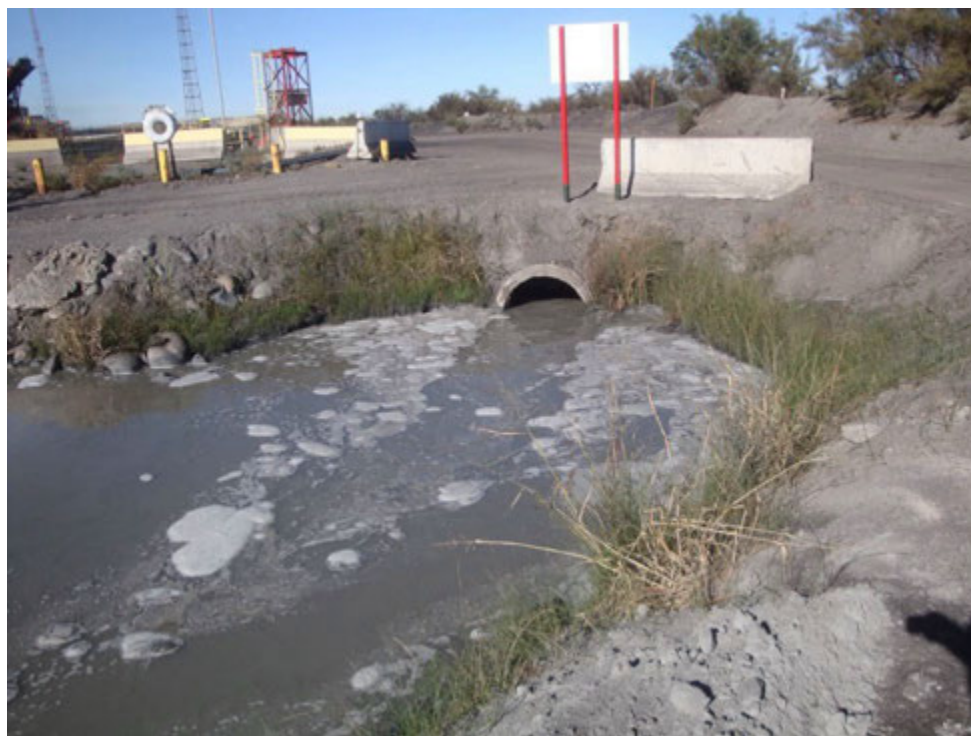
20151014 – Photo 2

Sediment decant cell. Filled.

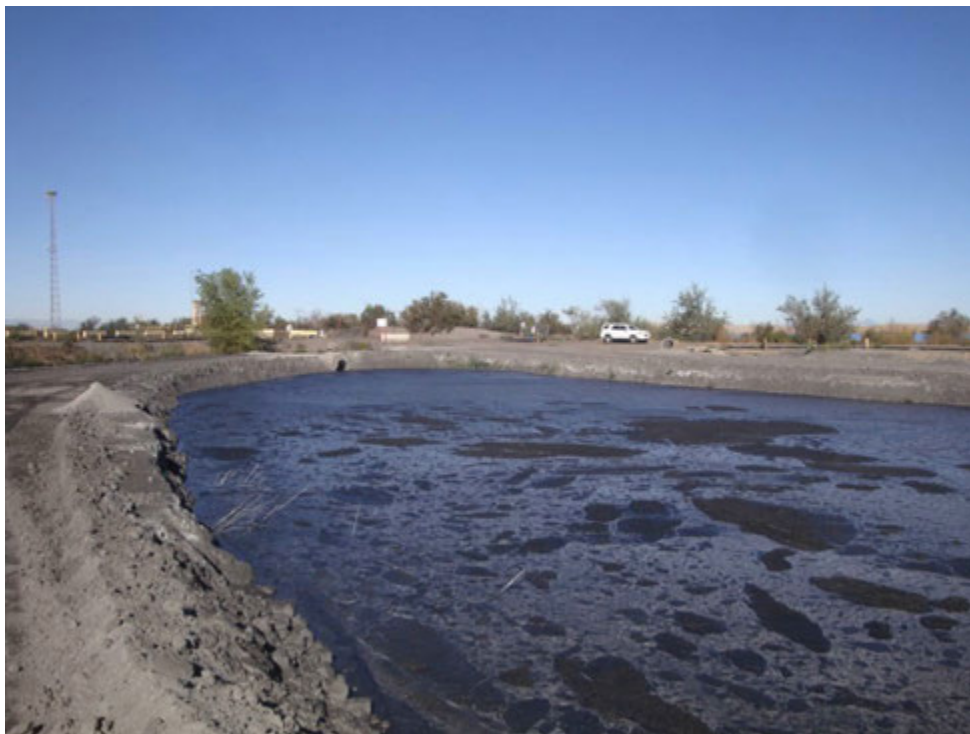
20151014 – Photo 6
Typical sediment decant cell. Seven total.

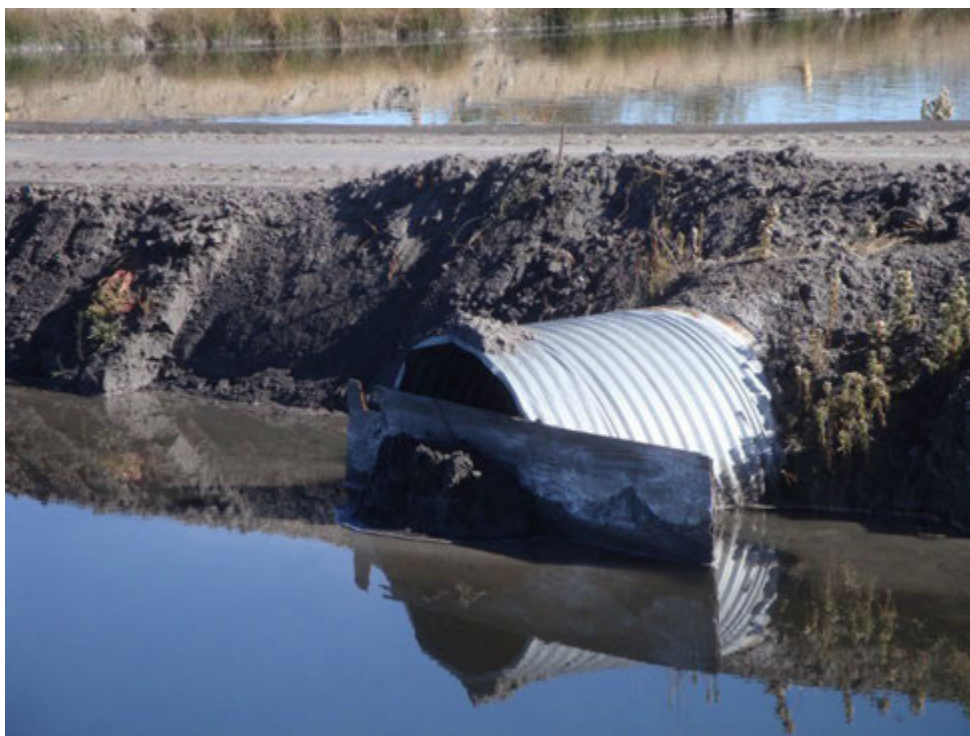
20151014 – Photo 7
Decant cell outlet CMP. Temporarily blocked to increase residence time in decant cell.

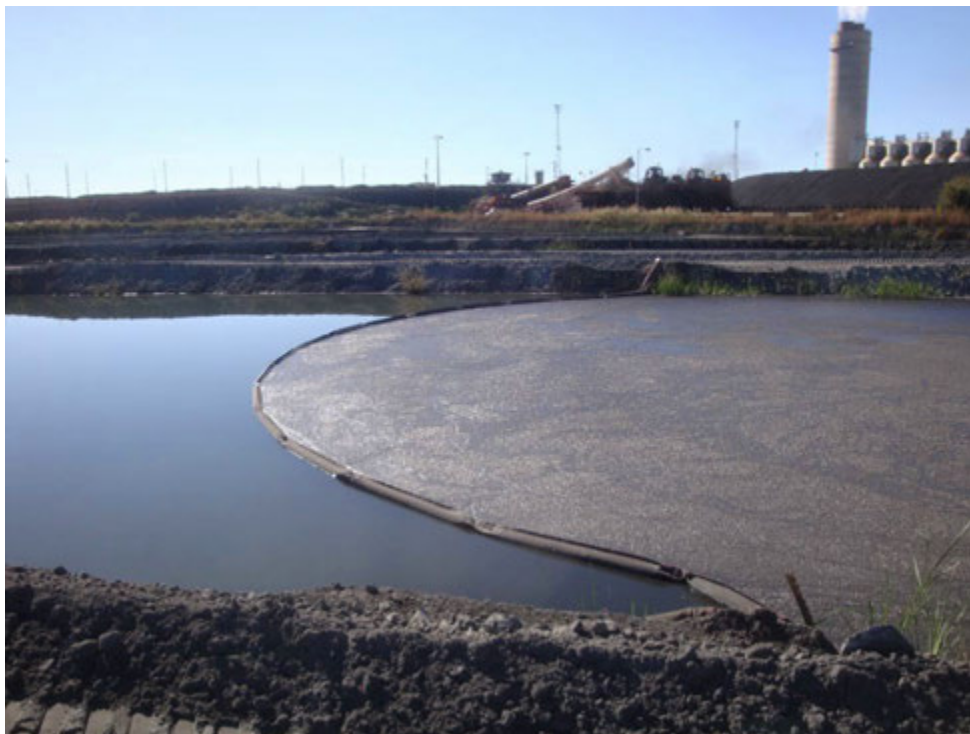
20151014 – Photo 9
Retained floating debris. To be removed before discharge.

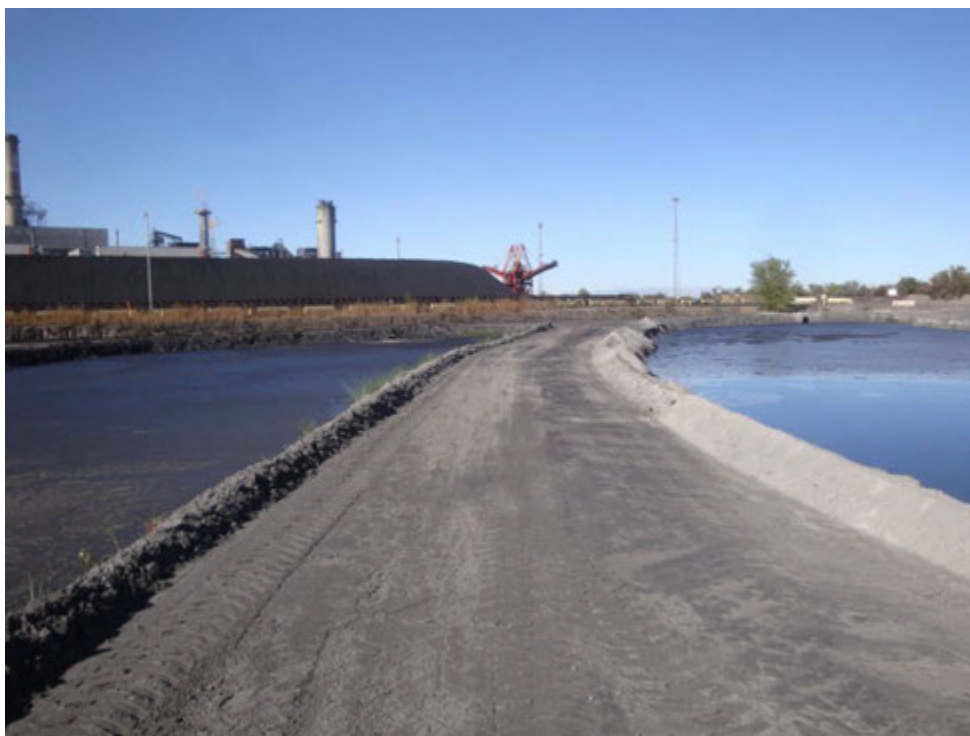
20151014 – Photo 10
Crest of typical interior decant cell divider dike.

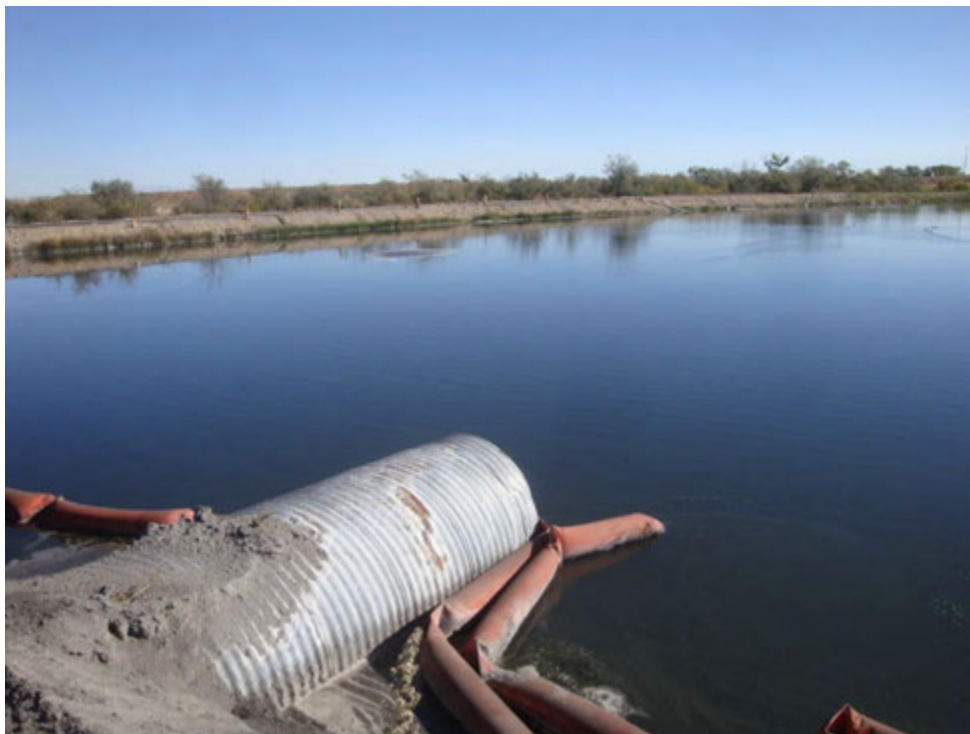
20151014 – Photo 12
Outlet from decant cell to CWTP.

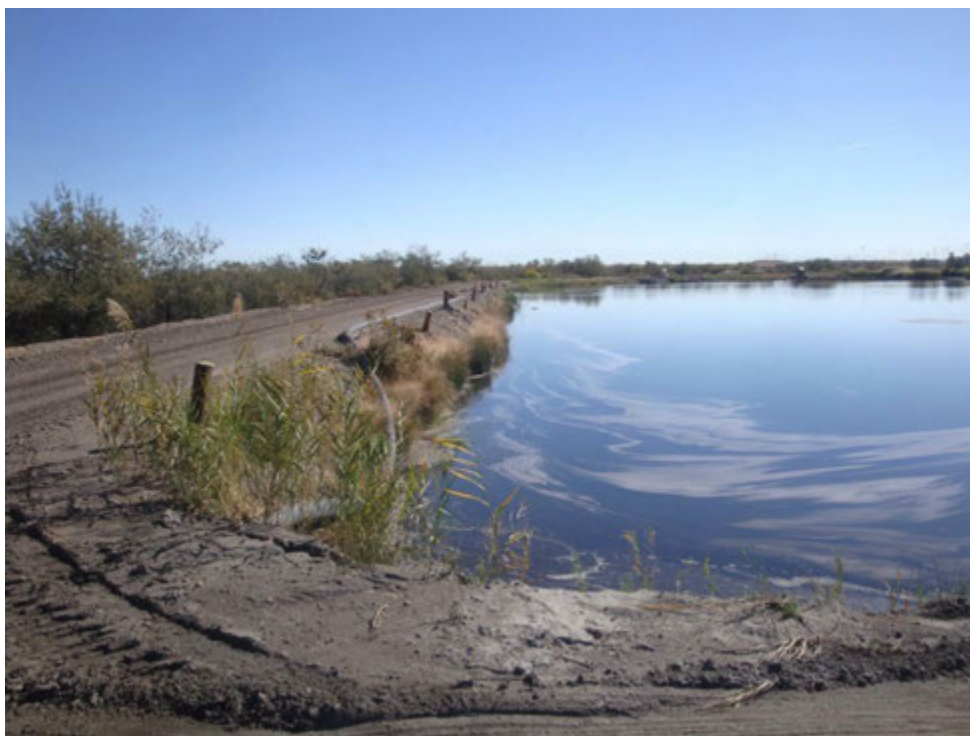
20151014 – Photo 13
Upstream slope of CWTP. Looking east. Note only light vegetation on upstream slope.

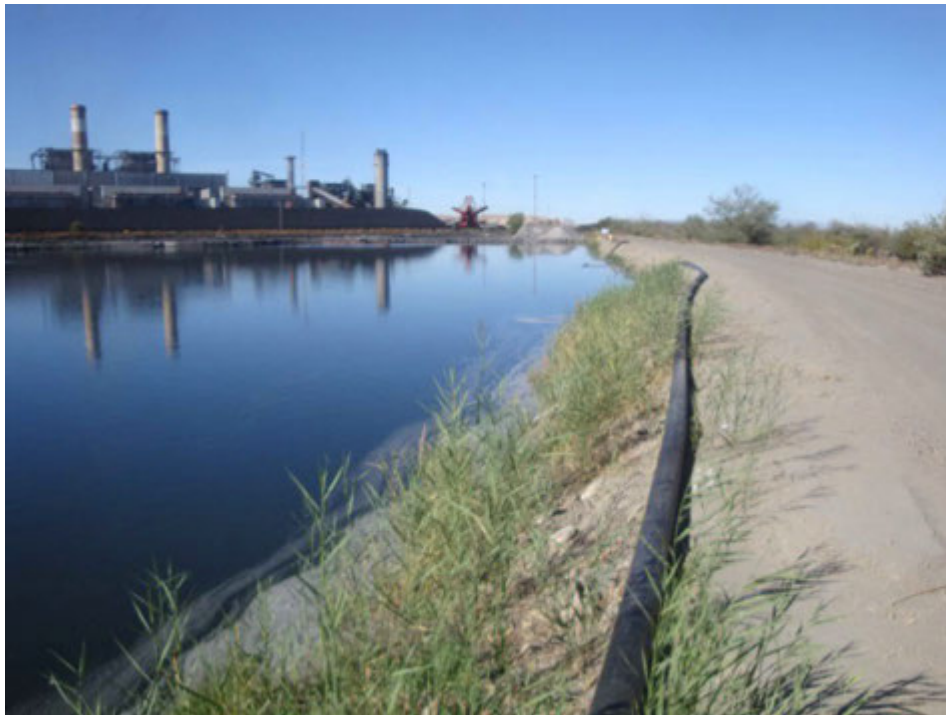
20151014 – Photo 21

Upstream slope of CWTP. Looking west. Note only light vegetation on upstream slope.

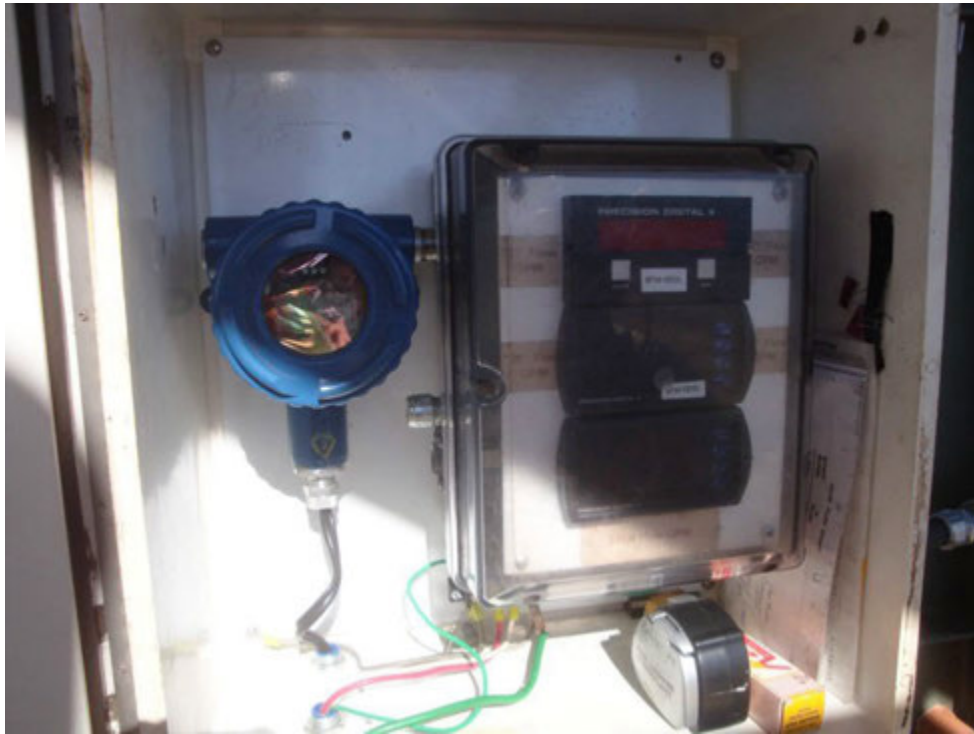
20151014 – Photo 28
Discharge flow measurement and recording instruments.

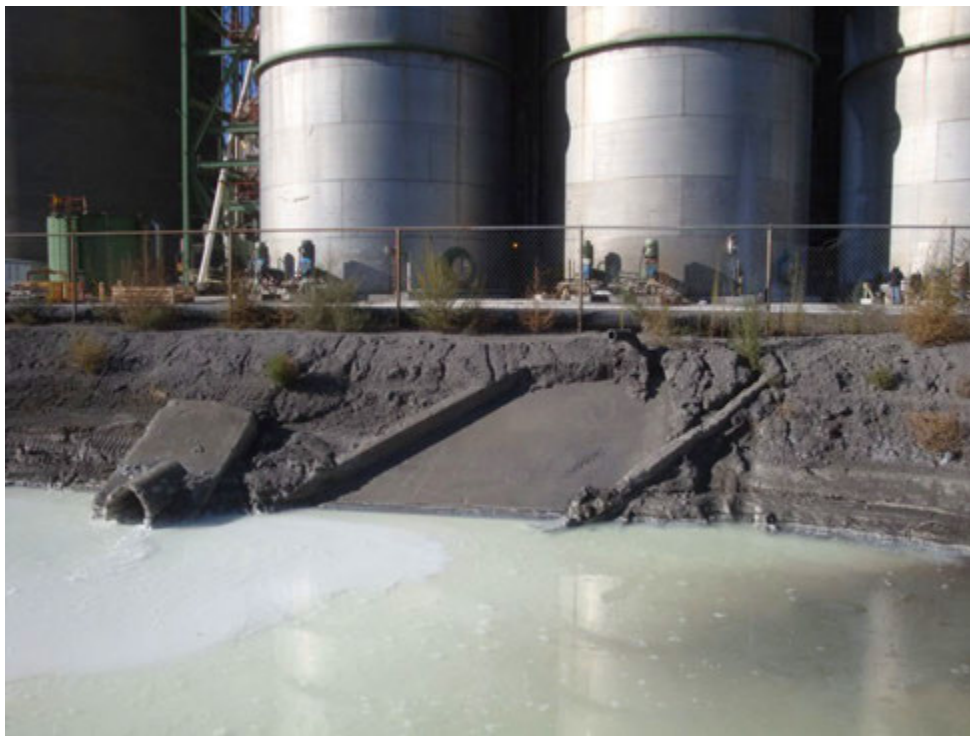
20151014 – Photo 1

Upper Retention Sump. West side. Overflow channel from adjacent FGD vessels and system.

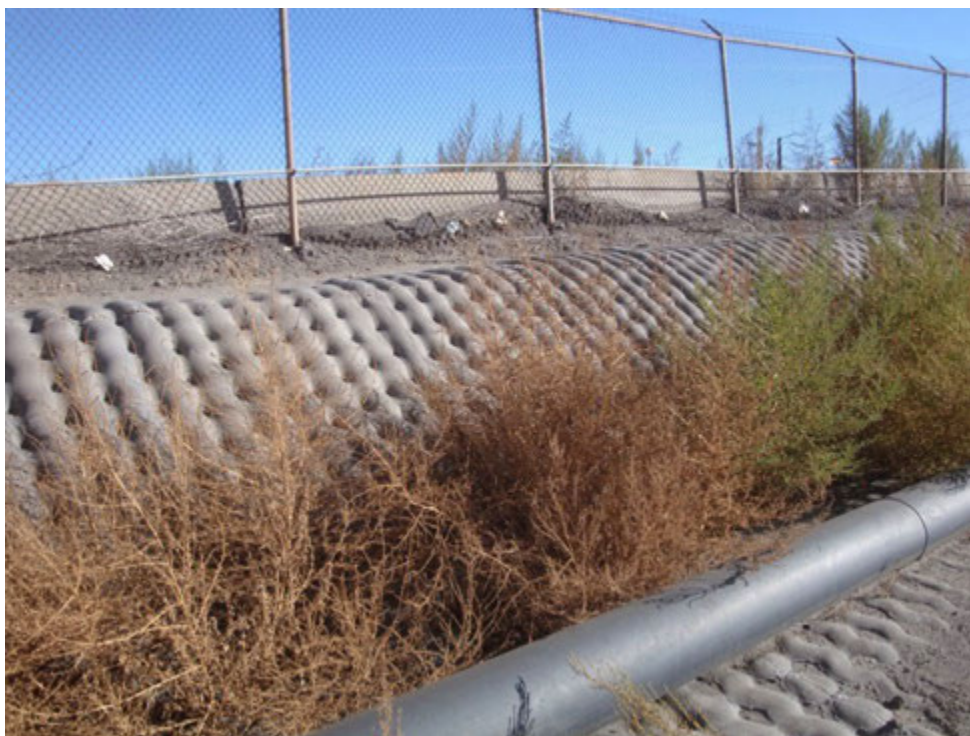
20151014 – Photo 5

Fabriform bank protection. Northwest crest. Ash haul road on other side of fence.

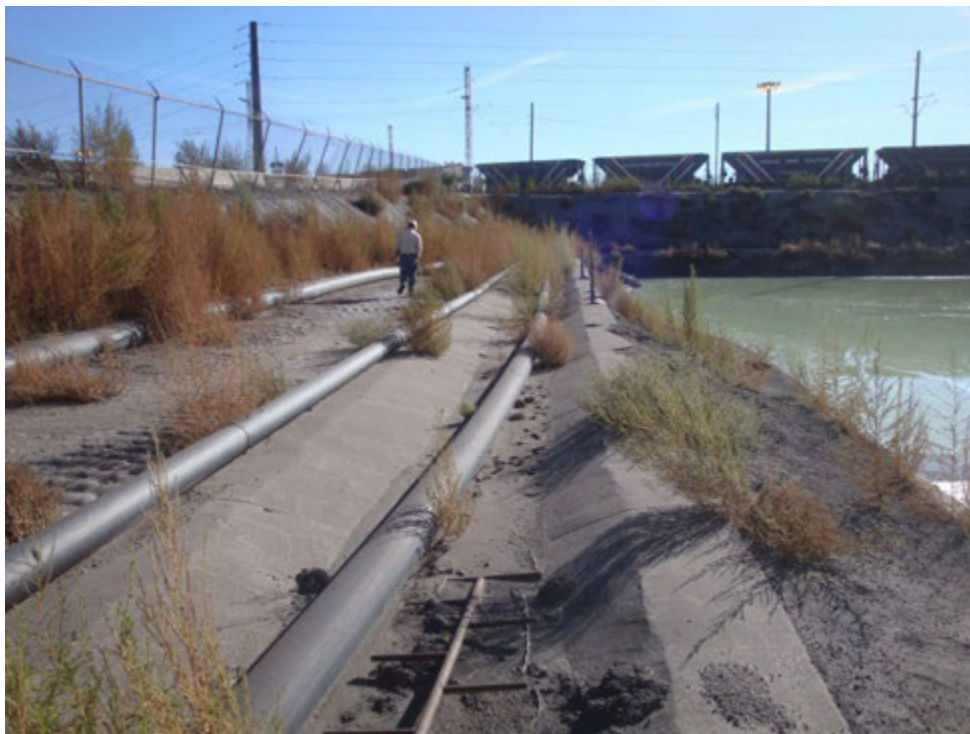
20151014 – Photo 6
 Northwest crest. Note possibly pressurized pipes on crest.

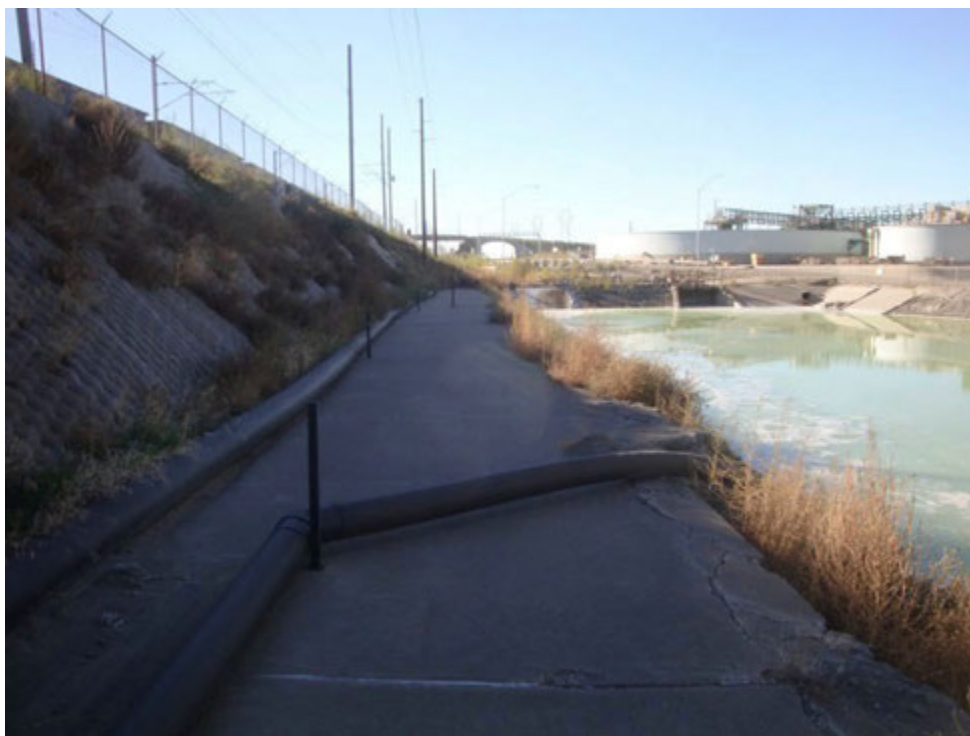
20151014 – Photo 10
 Southeast crest. Concrete slab. Railroad on other side of fence.

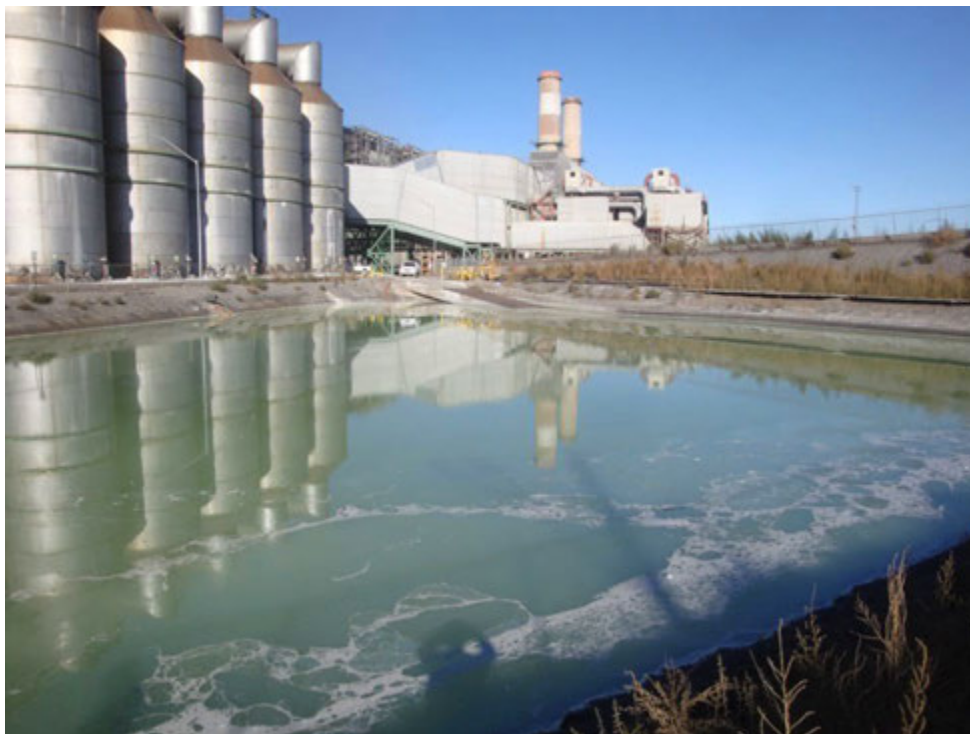
20151014 – Photo 13

Upper Retention Sump. View looking north. Clean out ramp for sump in far ground.

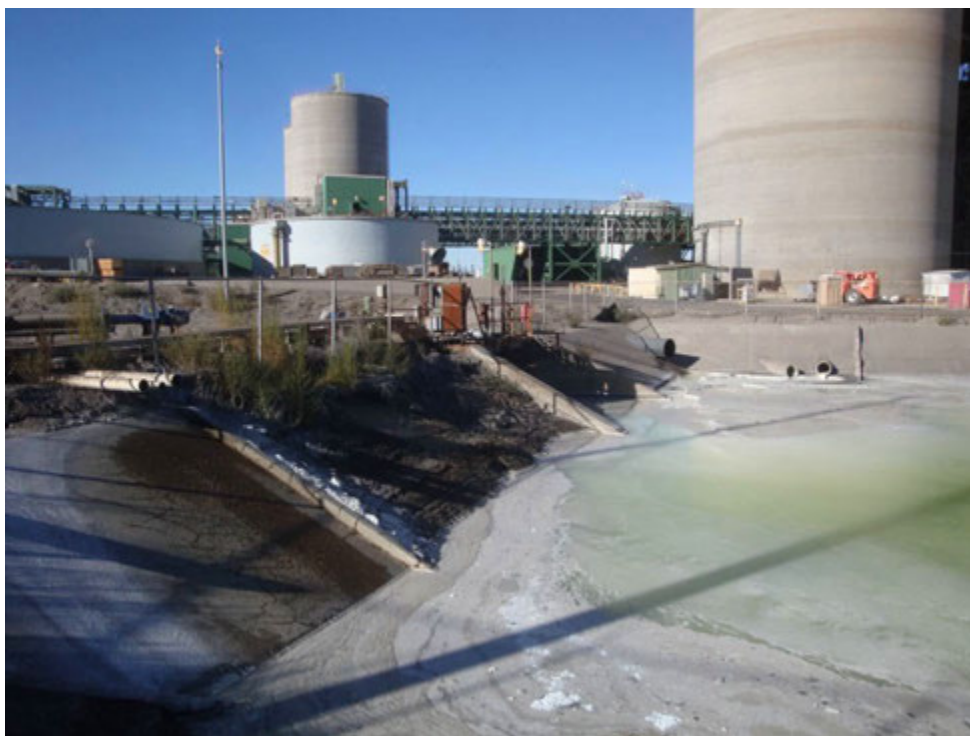
20151014 – Photo 14

Upstream slope. South Embankment.

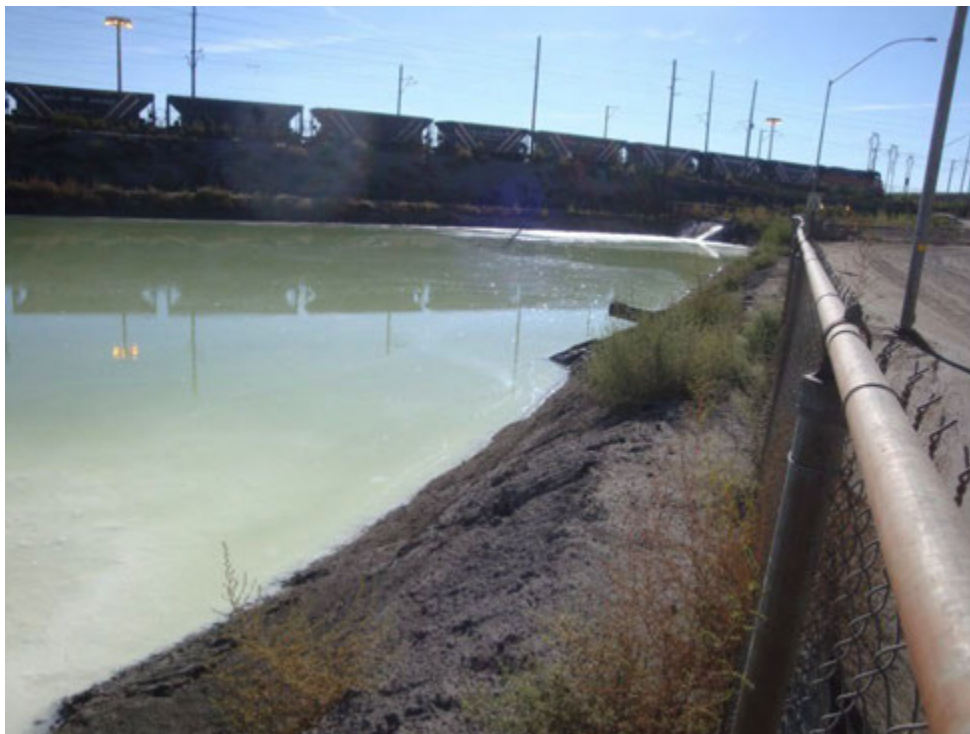
20151014 – Photo 16
Upstream slope. West Embankment. View to the south.

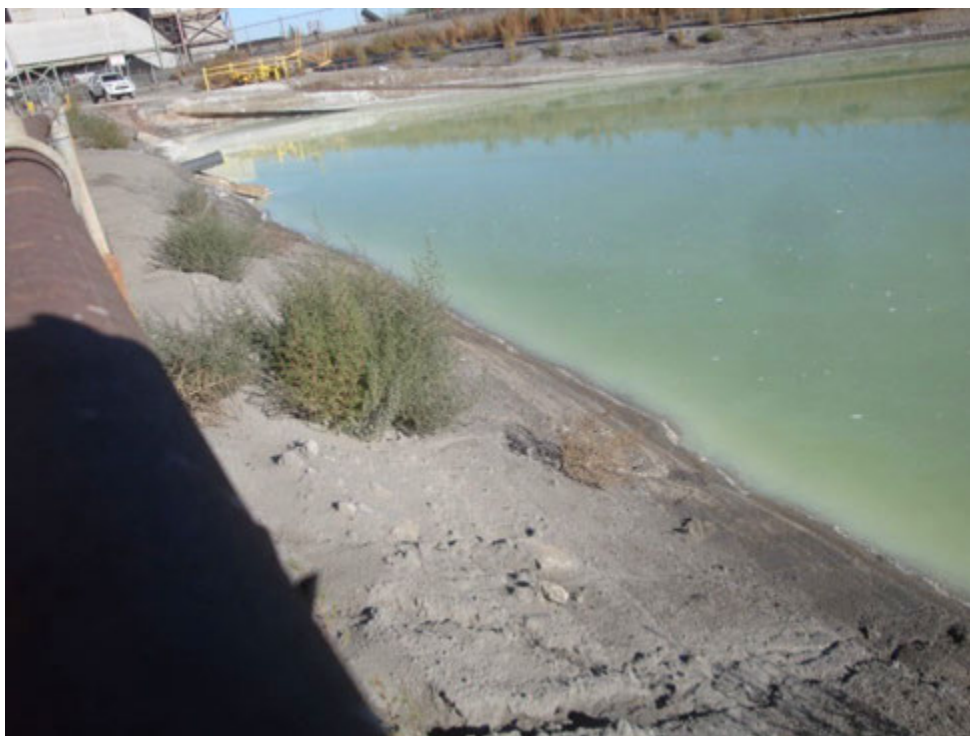
20151014 – Photo 17
Upstream slope. West Embankment. View to the north.

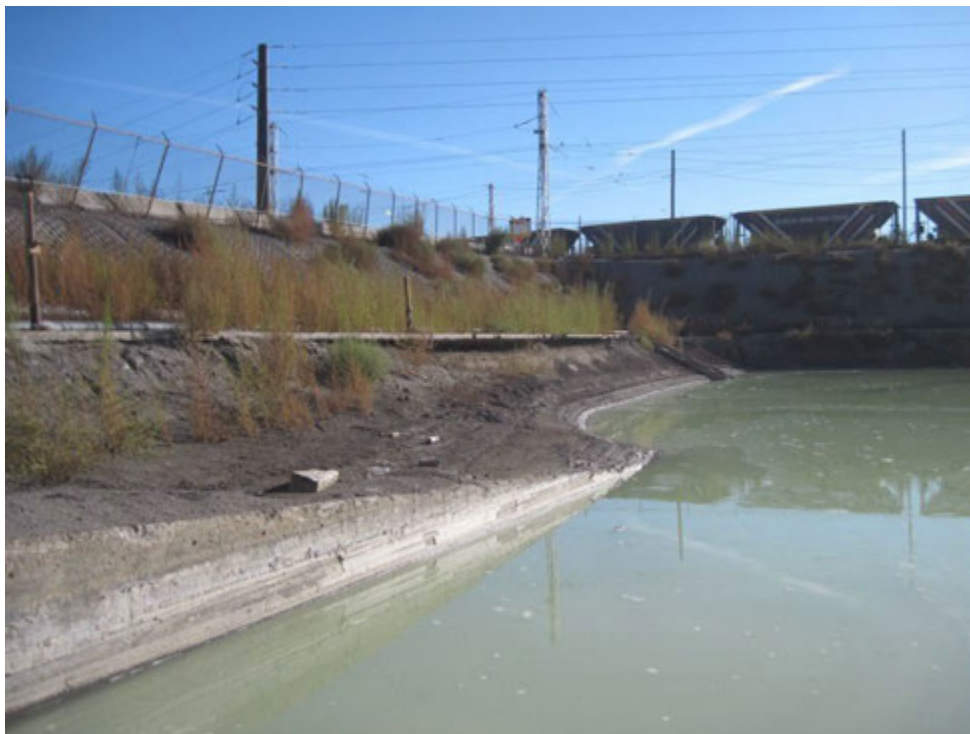
20151014 – IMG_2092

Clean out ramp on upstream slope of northwest embankment.

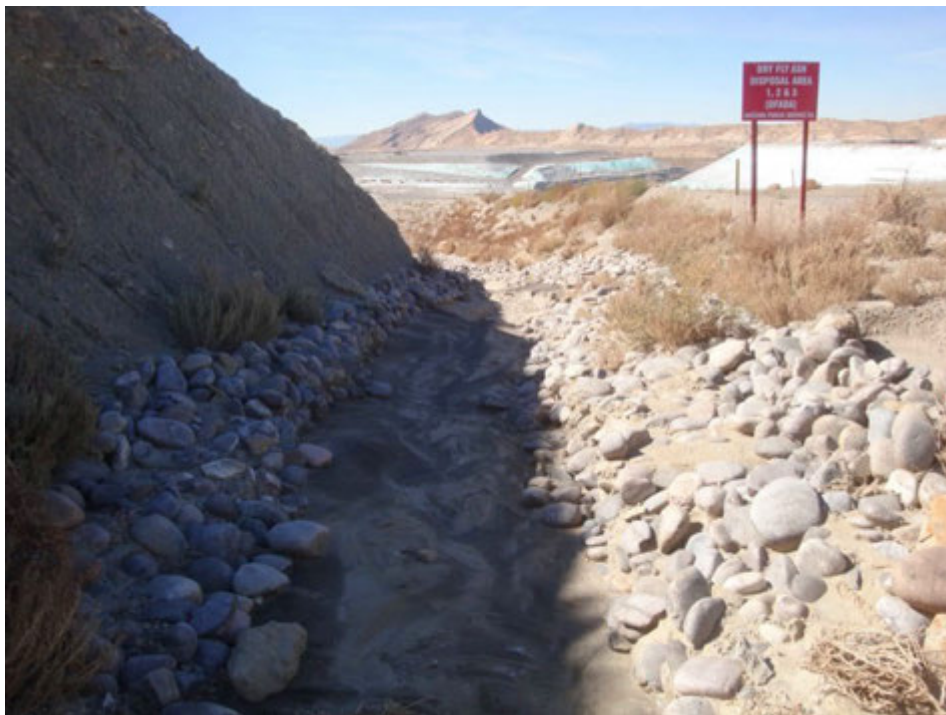
20151014 – Photo 5

Inlet to Storm Water Diversion Channel from ash haul cut. Good condition in this section. Note CCR Rule-required signage for DFADA.

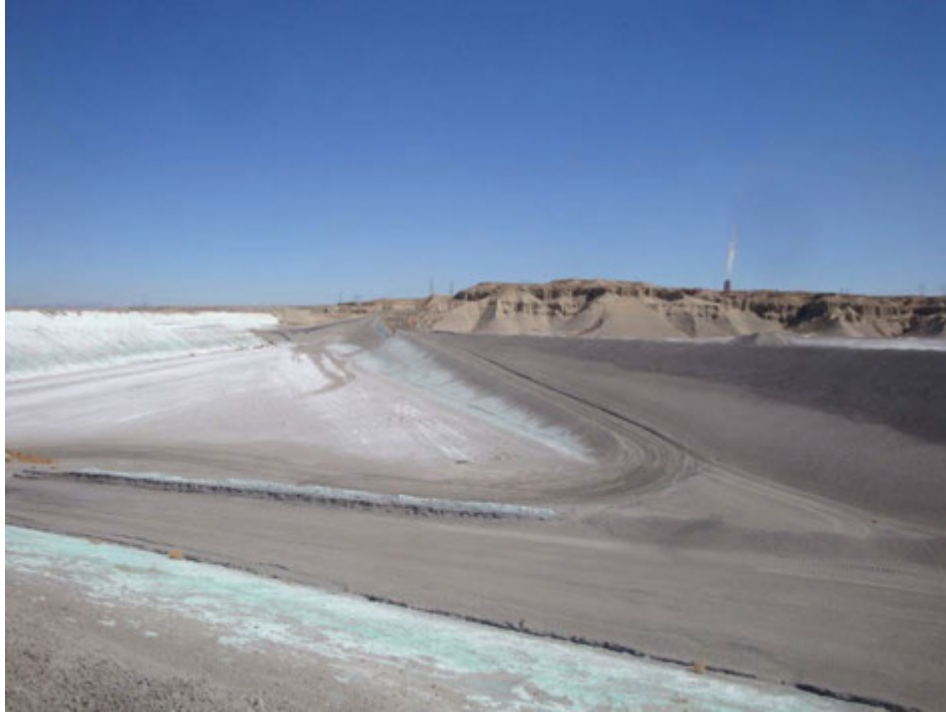
20151014 – Photo 11

View from current crest of DFADA complex. Looking east towards Plant. Standing on Unit 1 with filled Unit 2 on right side and unfilled Unit 3 on left side of view.

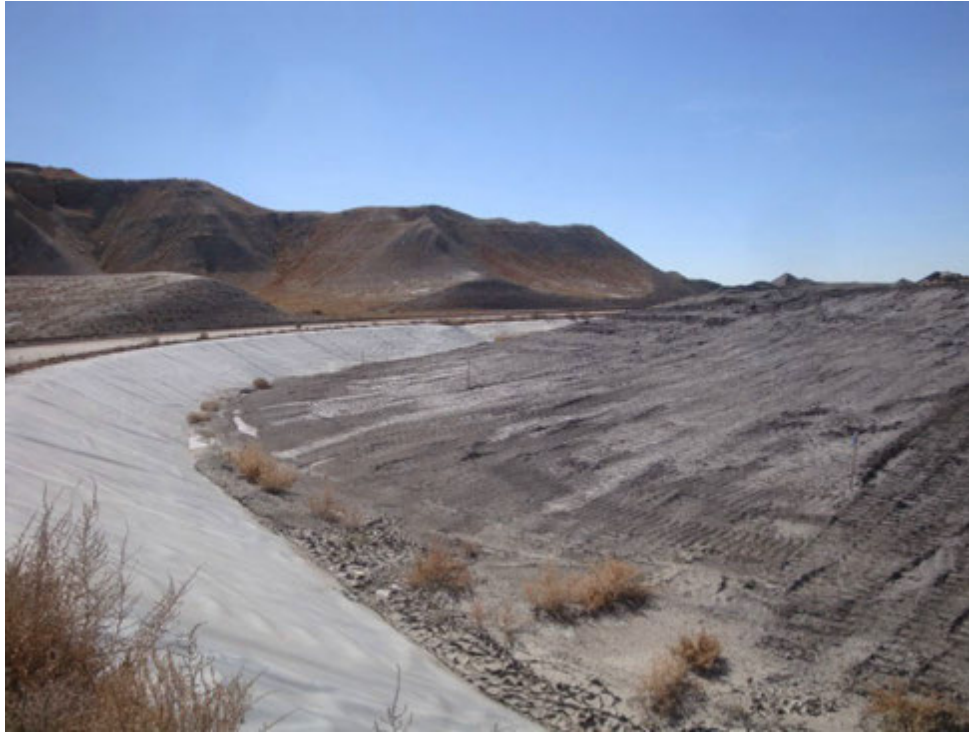
20151014 – Photo 21
DFADA Unit 2. Partially-filled portion of Unit 2.

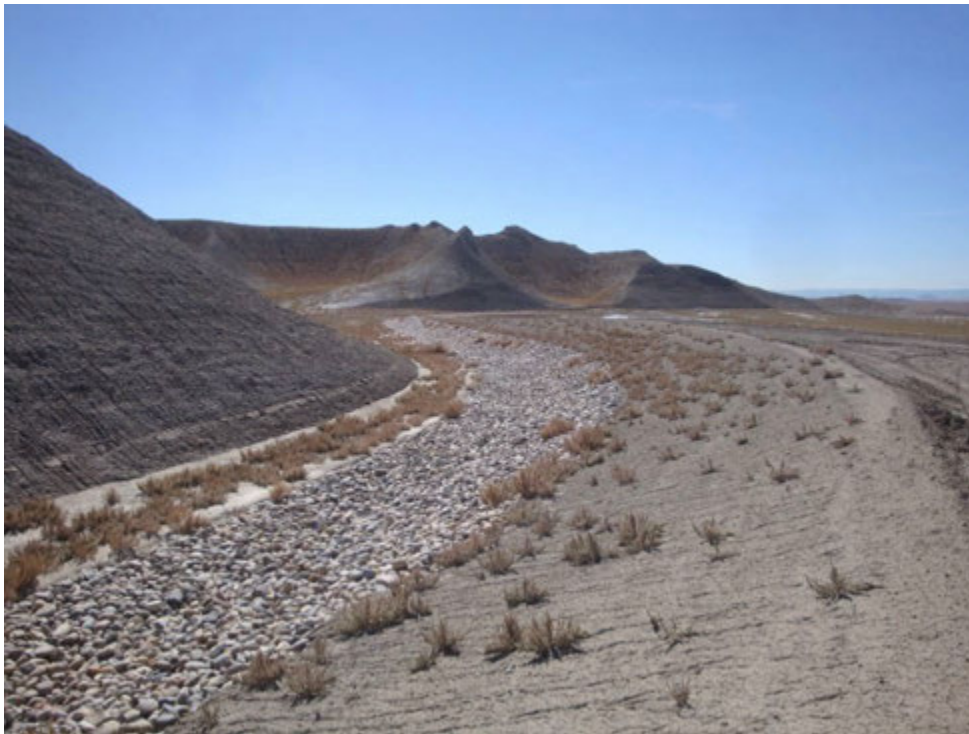
20151014 – Photo 25
Storm water diversion channel. South side of Unit 2.

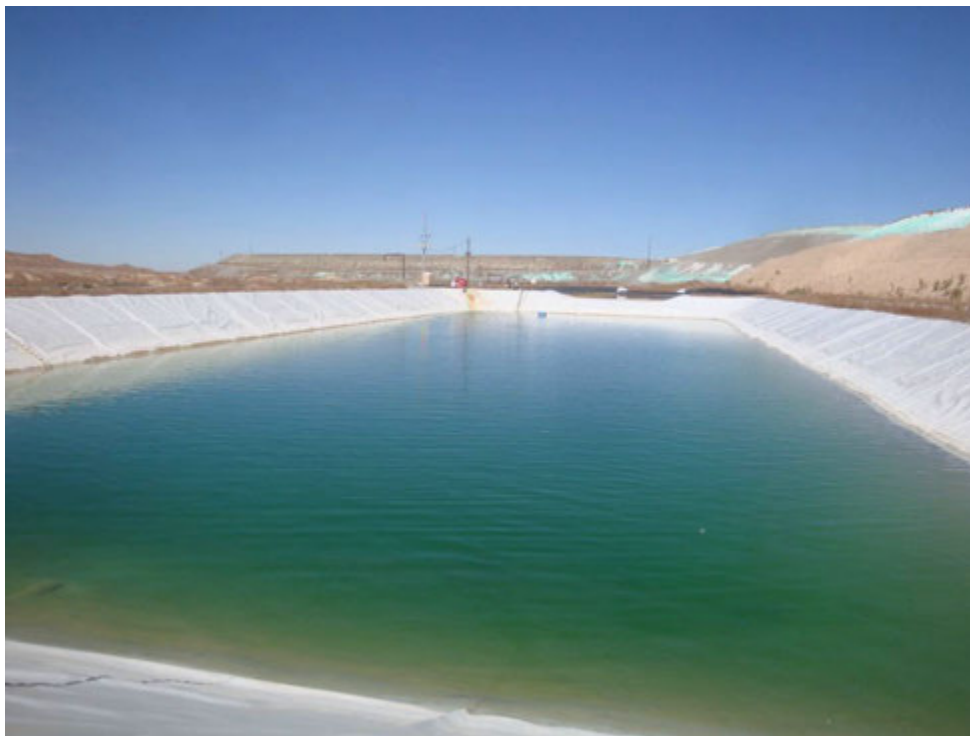
20151014 – Photo 39
Unit 2 leachate and rain runoff collection pond.

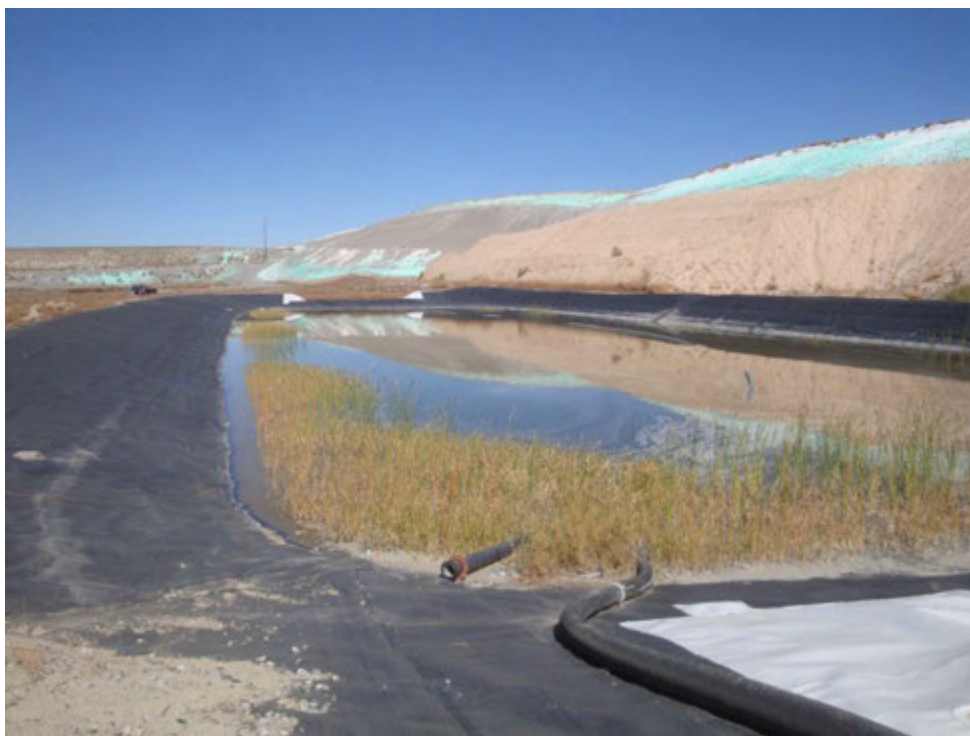
20151014 – Photo 40
Unit 1 leachate and rain runoff collection pond.

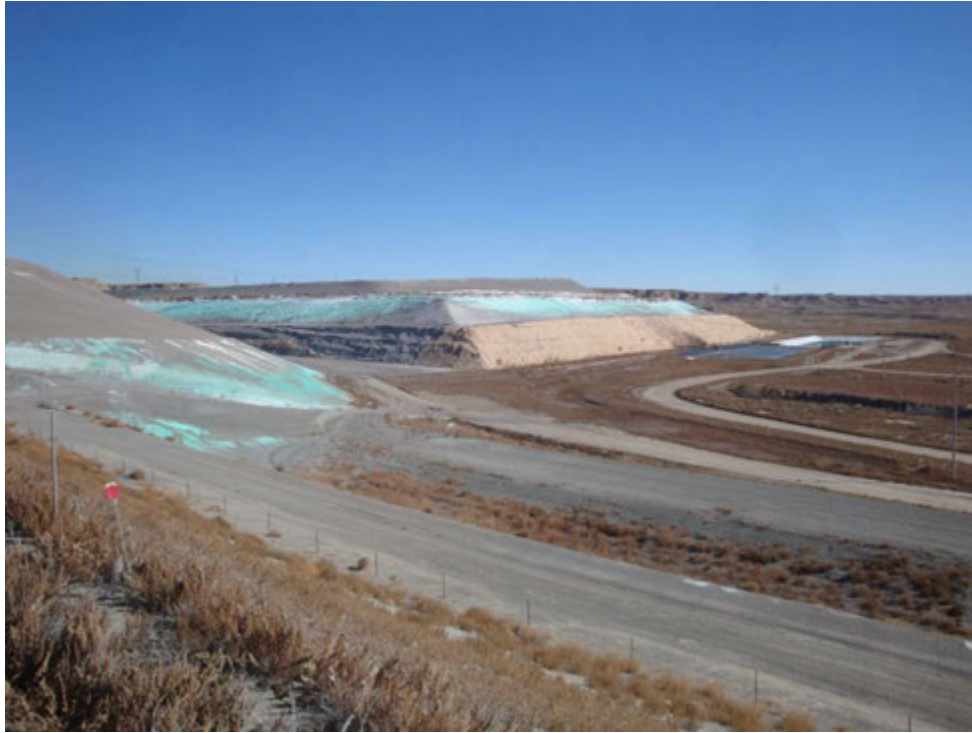
20151014 – Photo 44

Northwest corner of Unit 1. Pyramat on the lower slope portions. Lime-based sprayed dust suppressant on the upper slope portions. Unit 1 and 2 leachate and rain runoff collection ponds at downgradient toe of Unit 1.
