**FOUR CORNERS POWER PLANT
Lined Ash Impoundment,
Lined Decant Water Pond,
Combined Waste Treatment Pond,
Upper Retention Sump, and
Dry Fly Ash Disposal Area**

**Annual
CCR Impoundment and
Landfill Inspection Report
2016**

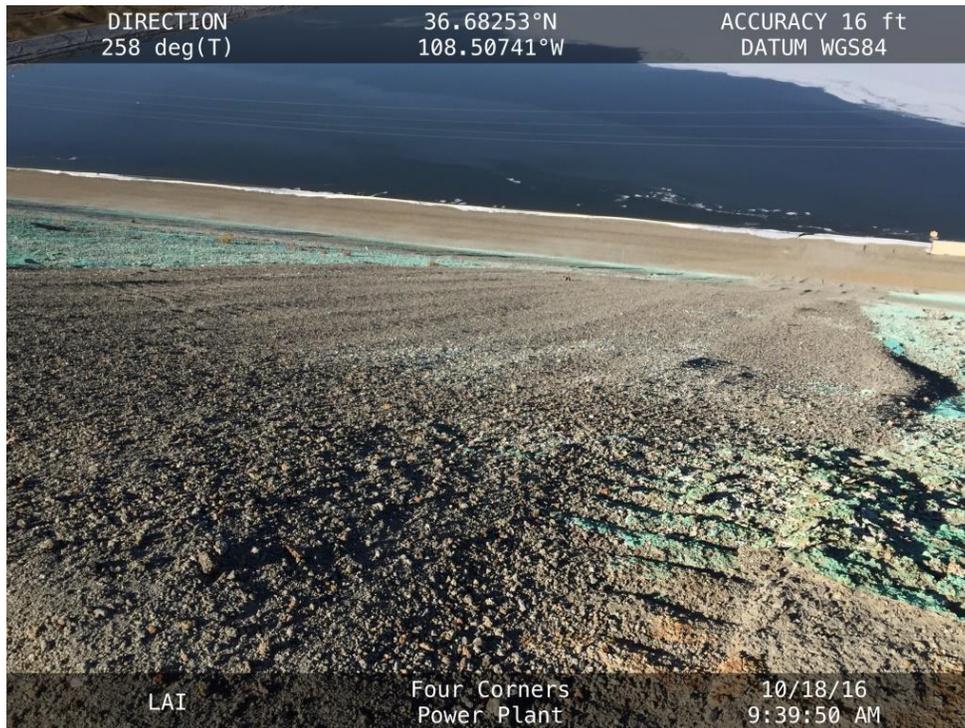
20161018 – IMG_1771

Area of erosion repair along the downstream slope of the West Embankment, facing west from the crest toward the toe and the LDWP.

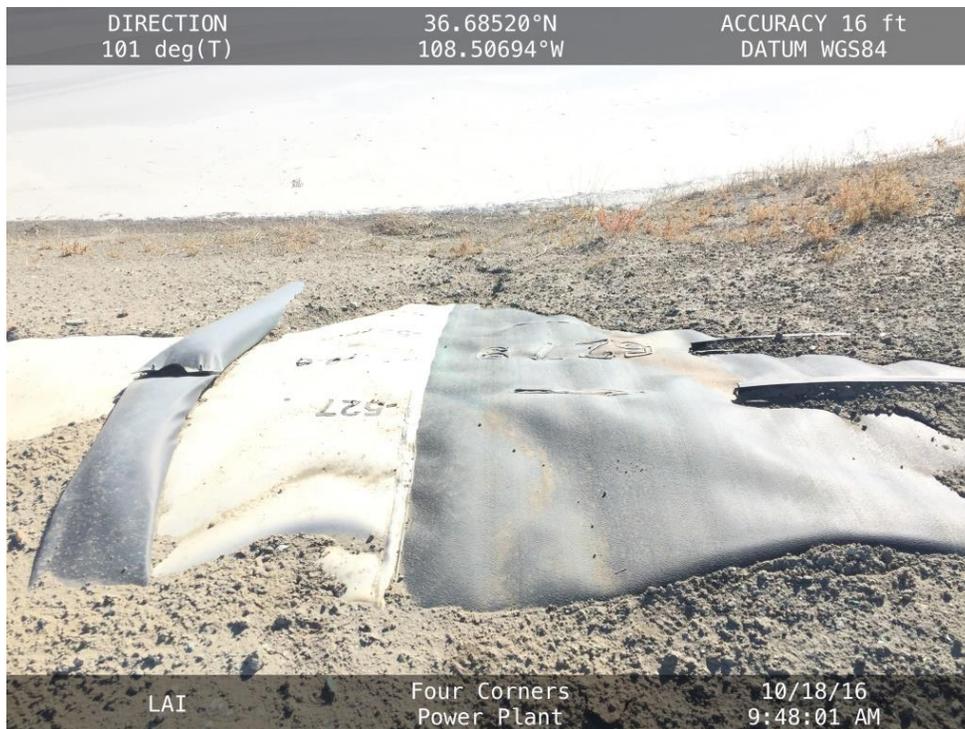
20161018 – IMG_1783

Ash covering the water elevation marker near the Drop Inlet Riser.

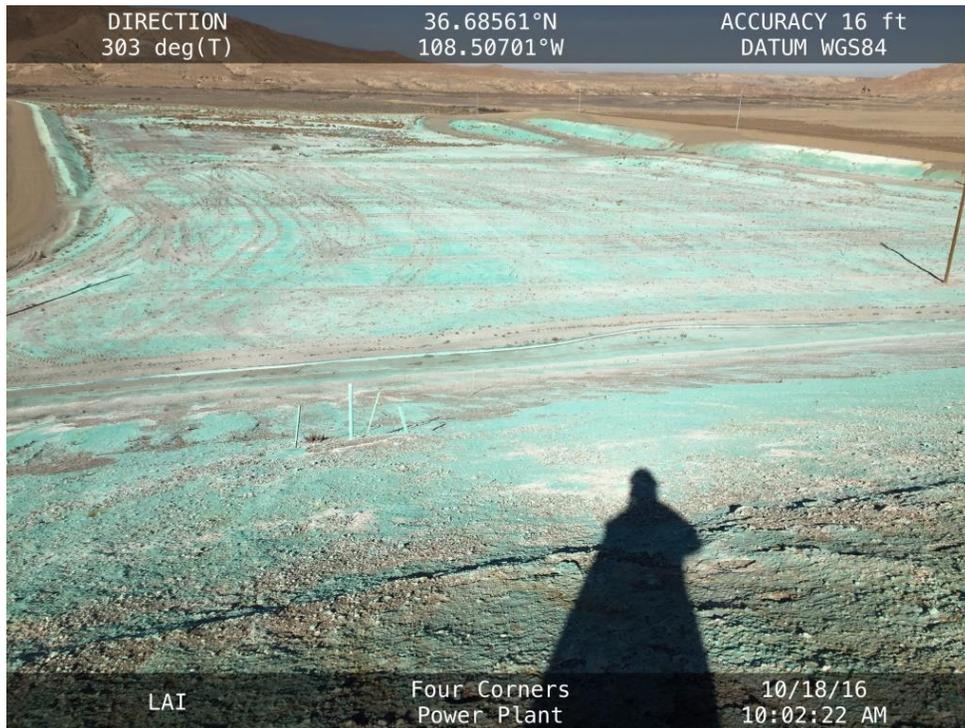
- iii. The North Toe Buttress (NTB) was constructed as part of the 5280 Lift of the LAI to provide additional stability in the northern portion of the West Embankment (see photo IMG_1792). The NTB appeared to be in good condition during the inspection. The NTB foundation instruments are recorded on an interval not to exceed 30 days and indicate normal, expected foundation conditions.

20161018 – IMG_1792
 The NTB as seen from the crest of the LAI, facing west.

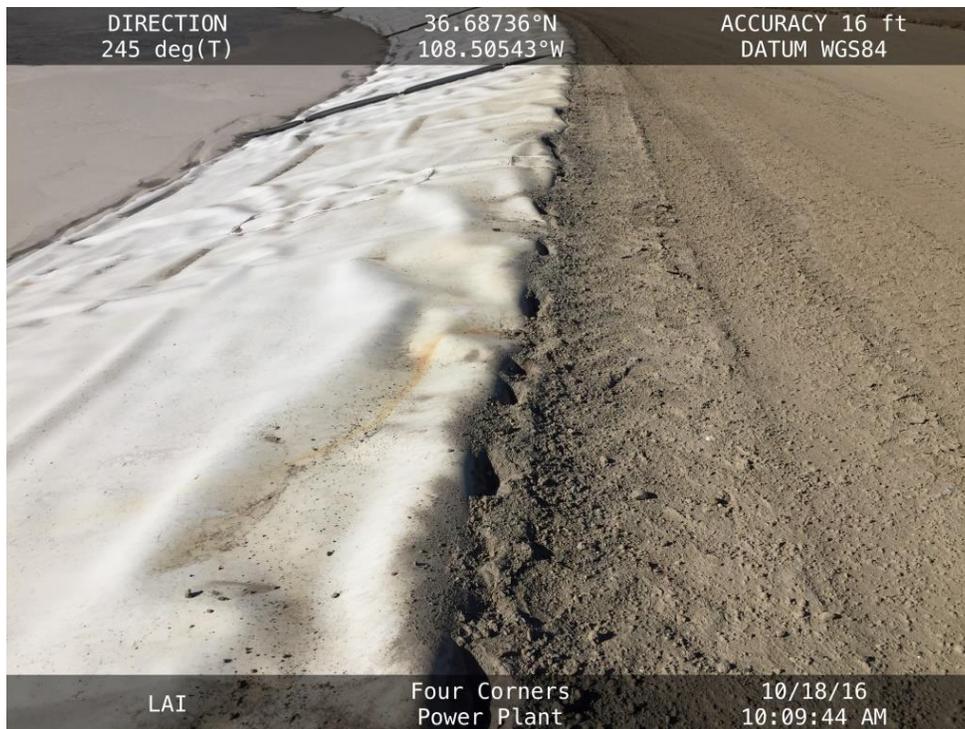
20161018 – IMG_1806

- v. There appear to be a series of small depressions along the edge of the geomembrane liner anchor trench on the Northwest Embankment (see photo IMG_1806). Their cause should be monitored and assessed as to whether or not the anchor trench is properly compacted or if there is piping/internal erosion in this area.

A series of small depressions along the interface between the anchor trench and the geomembrane liner on the Northwest Embankment.

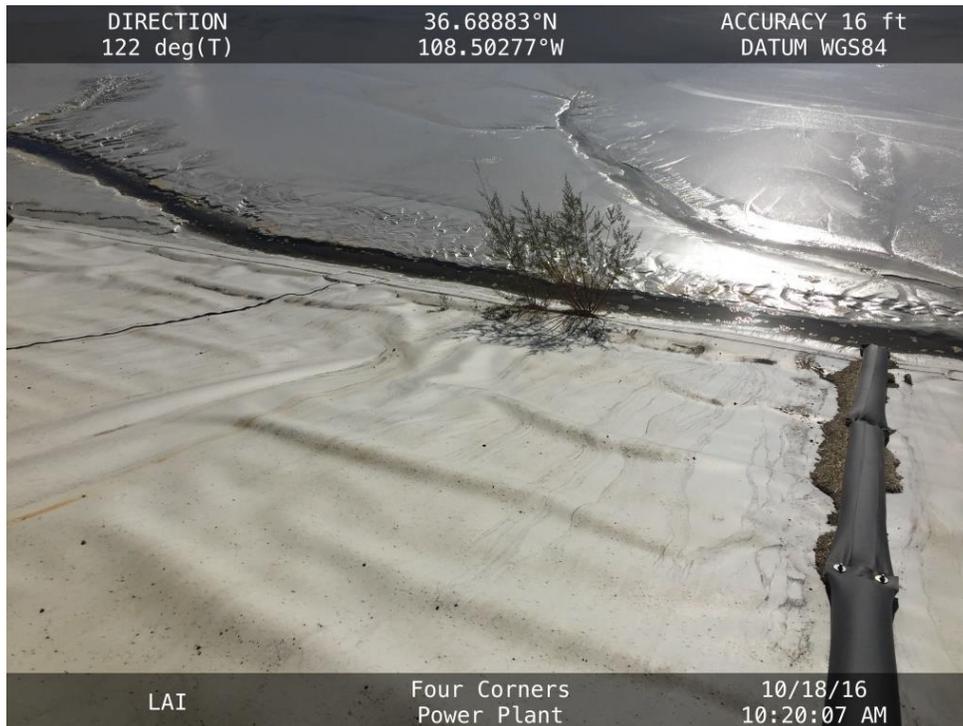
- vi. Two tears/holes were observed in the liner along the Northwest Embankment during the inspection, magnified by the presence of small shrubs taking root in the clay blanket (see photos IMG_1812 and IMG_1813). The shrubs should be removed and the liner should be repaired. The cause of the tears/holes should be investigated.

20161018 – IMG_1812
Vegetation growing in a liner tear along the Northwest Embankment.

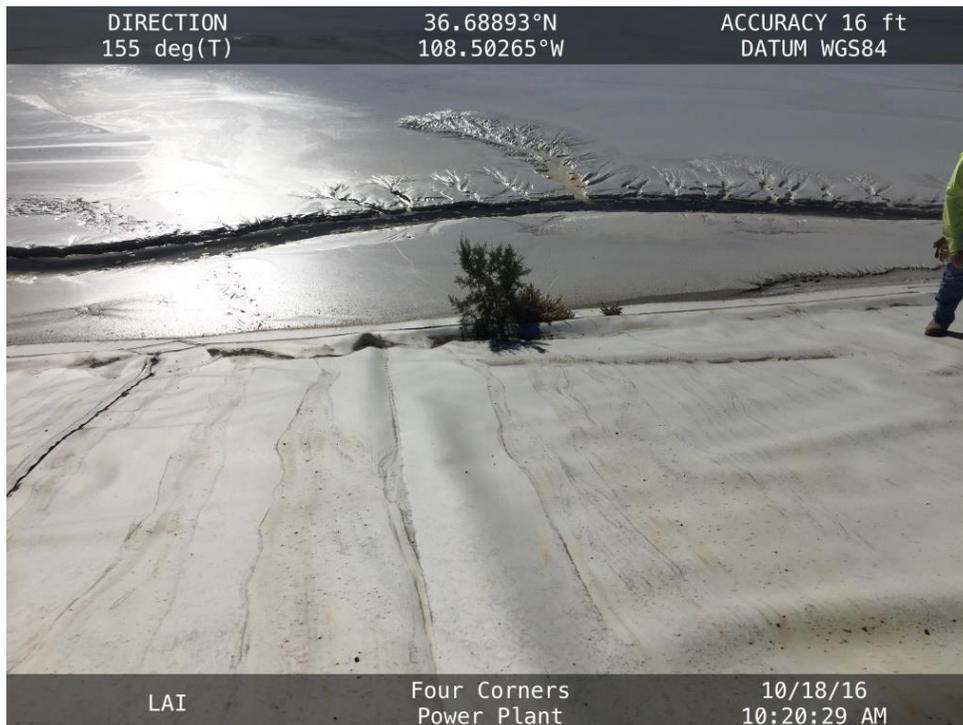
20161018 – IMG_1813
Vegetation growing in a liner tear along the Northwest Embankment.

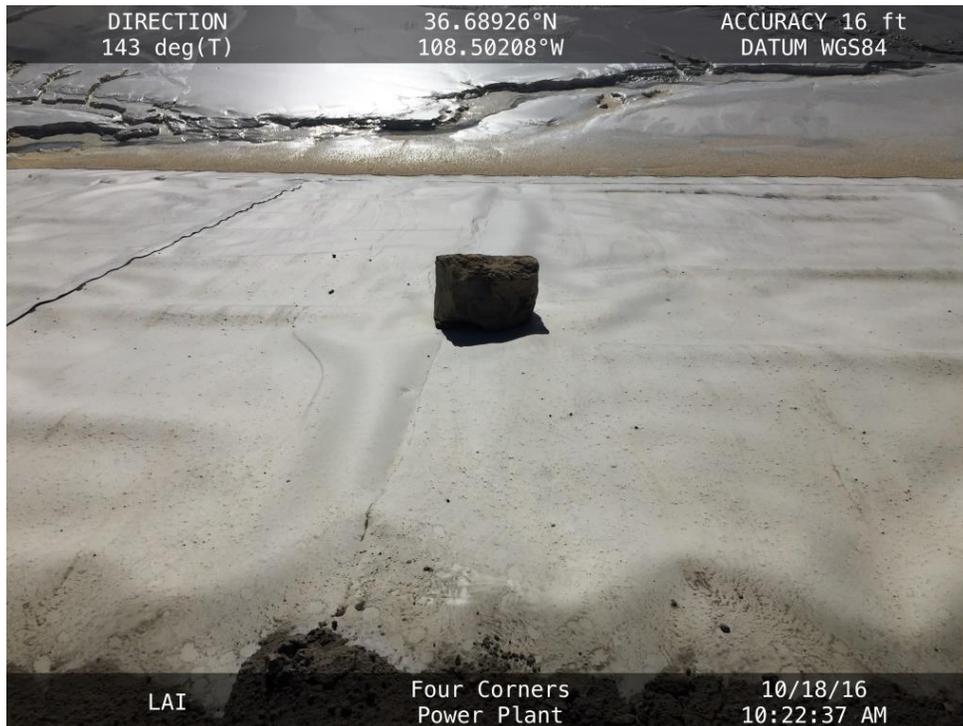
20161018 – IMG_1814

- vii. A block of sandstone was observed sitting on top of the liner along the Northwest Embankment (see photo IMG_1814). The liner did not appear to be torn, but the block of sandstone should be removed, the area should be re-inspected, and necessary repairs should be made.

A block of sandstone on top of the liner along the Northwest Embankment.

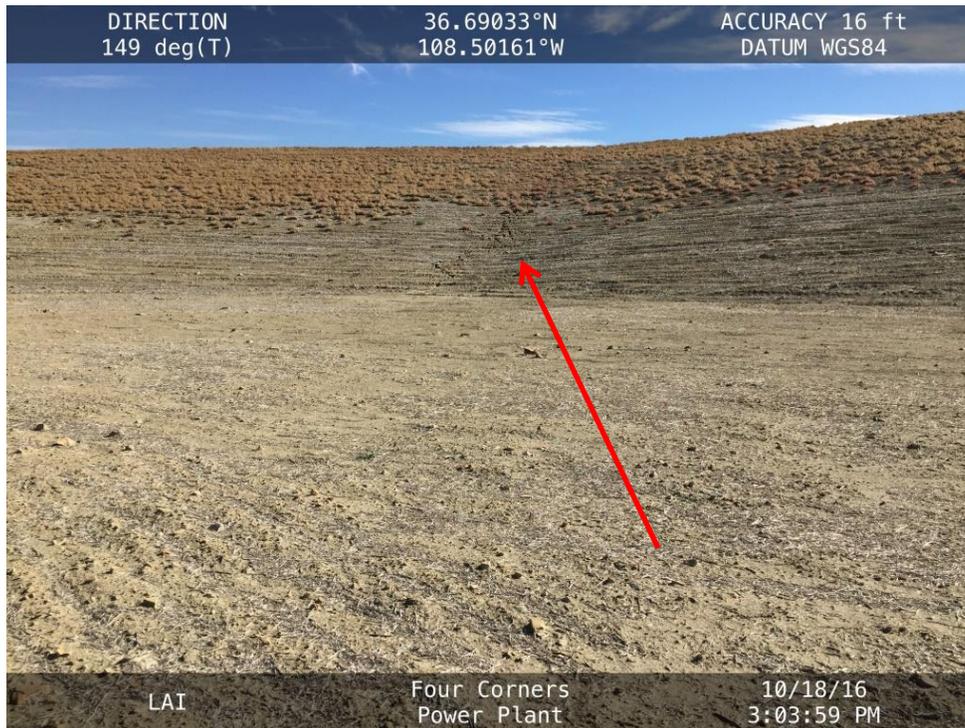
- viii. There was minor erosion in the groin of the Northwest Embankment (see photo IMG_1946). Monitor and repair the erosion as soon as the erosion depth exceeds one foot.

20161018 – IMG_1946
Erosion in the groin of the Northwest Embankment, facing south.

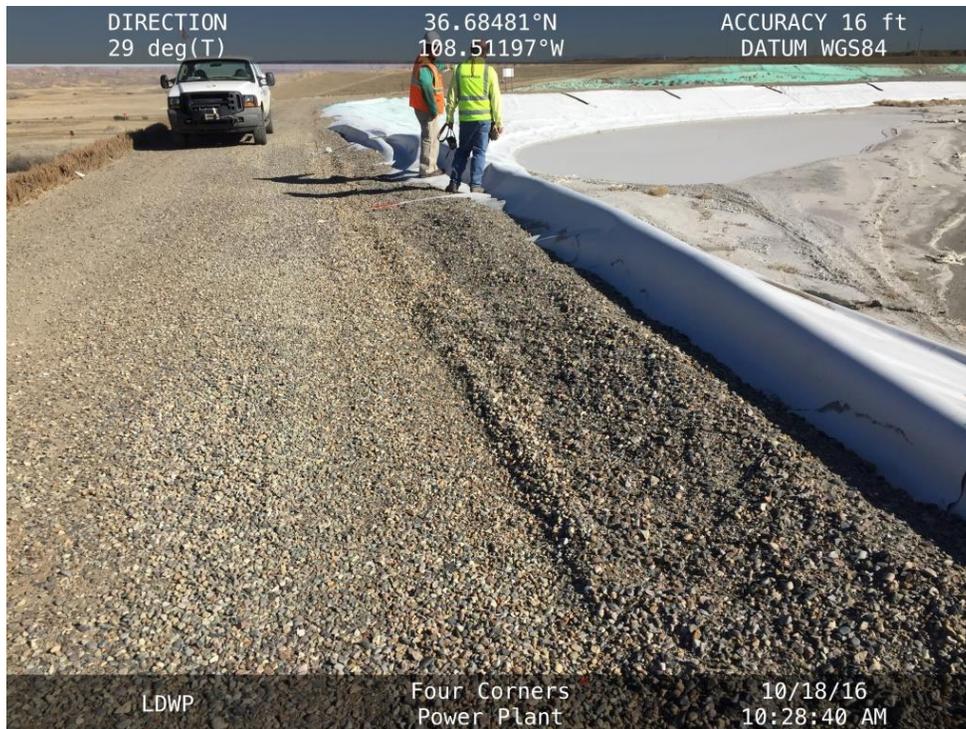
20161018 – IMG_1815
 Anchor trench, liner pulling up in the northwest corner of the LDWP.

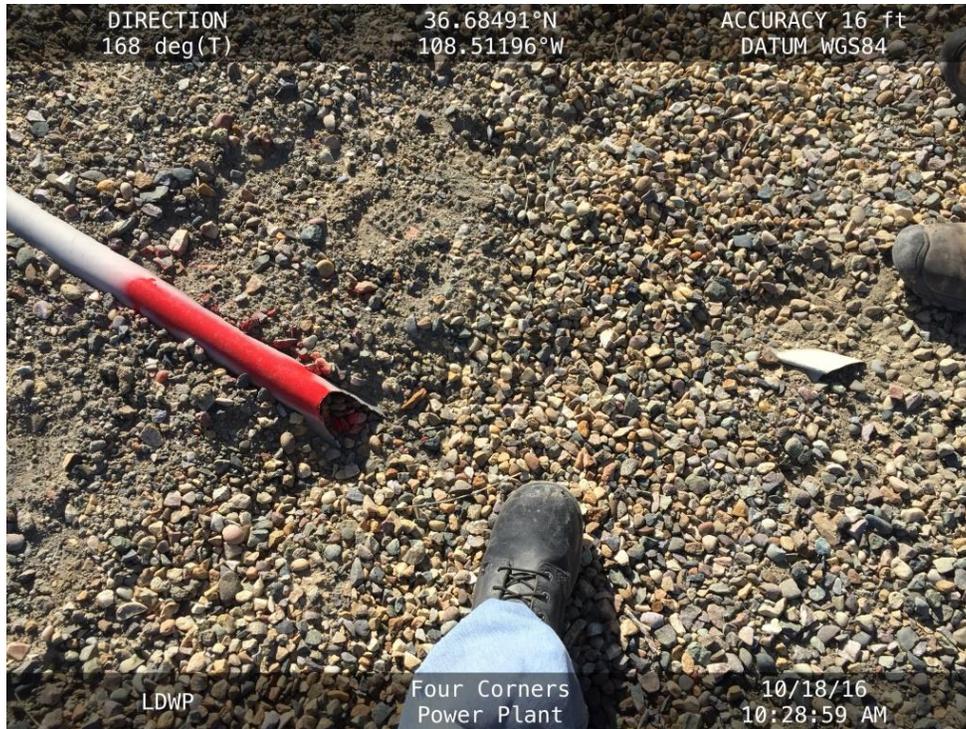
20161018 – IMG_1816

Anchor trench, liner pulling up in the northwest corner of the LDWP.

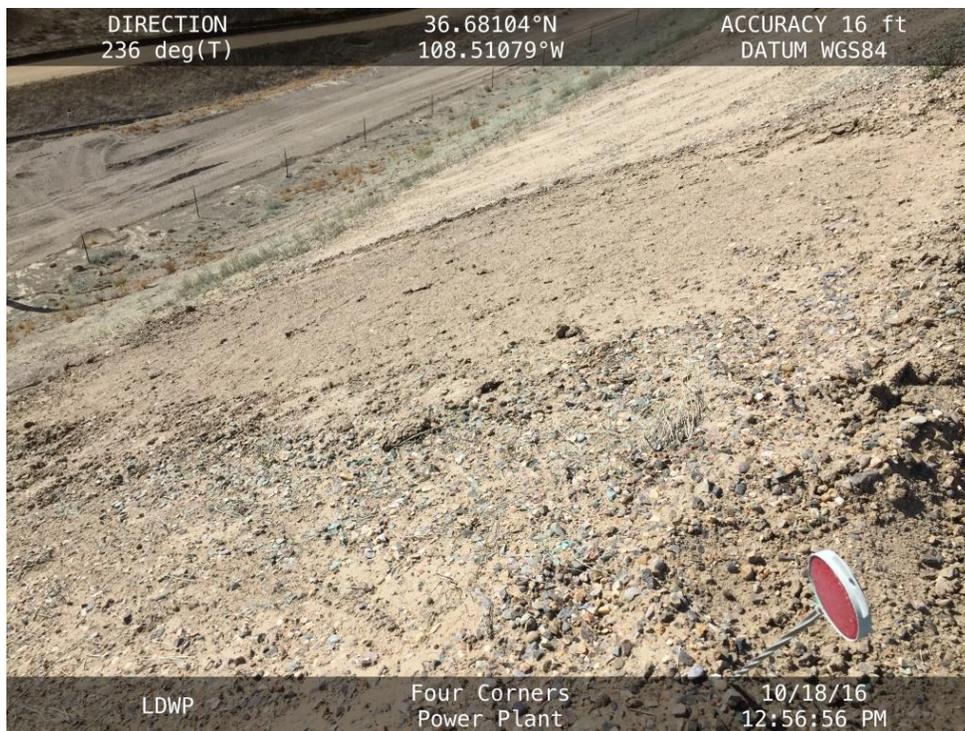
20161018 – IMG_1883

Area of repaired erosion along the South Embankment.

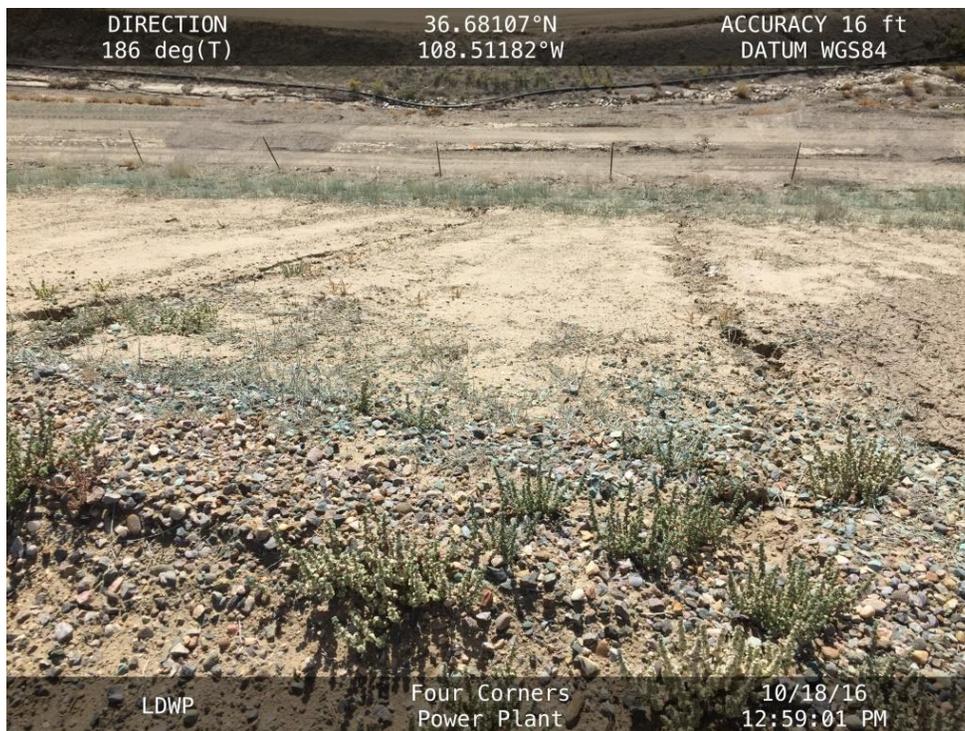
- iii. The external slopes of the embankments show evidence of minor erosion rilling (see photo IMG_1889). APS has been maintaining affected areas by regrading and recompacting eroded areas (see photo IMG_1914). At the time of the inspection, several locations along the South Embankment had recently been repaired. The current program appears to be sufficient and should be continued such that rills are repaired if the erosion depth exceeds one foot.

20161018 – IMG_1889
 Areas of newer erosion rills along the LDWP South Embankment.

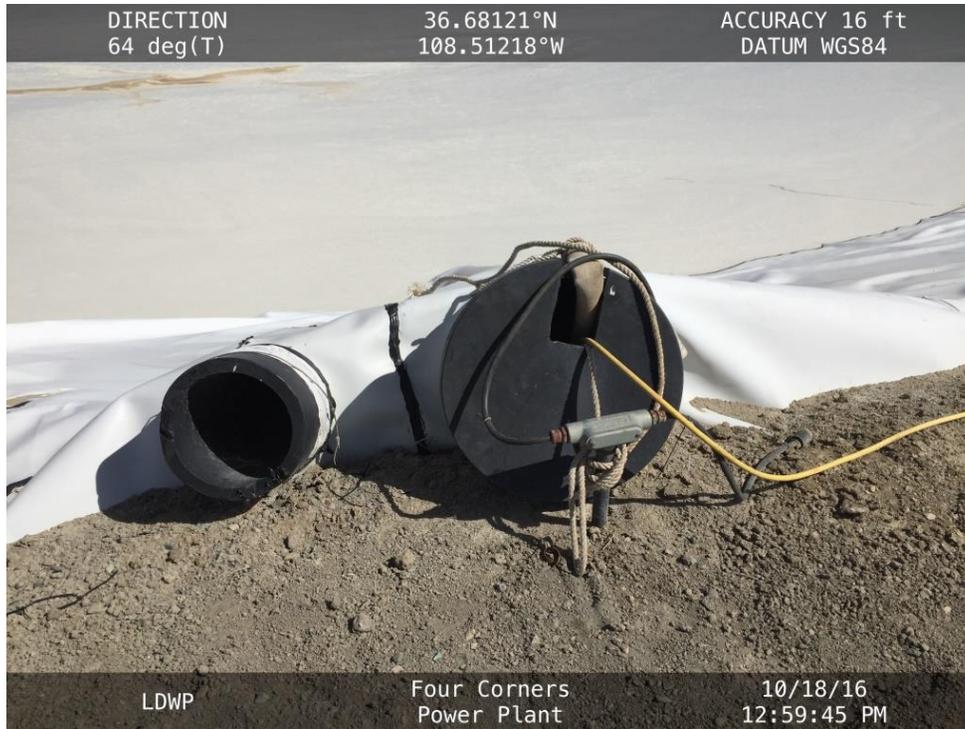
20161018 – IMG_1891

- iv. The LDWP interstitial geomembrane leak detection and evacuation pump was operating at the time of inspection (see photo IMG_1891). Prior investigations indicated that the primary large-diameter access port was blocked and that the type of commercially-available submersible pumps that can be inserted into the secondary small-diameter access port do not last for more than a couple of months in these operating conditions. APS later determined that regularly replacing the pump is more economical and feasible than the other identified alternative, temporarily decommissioning the entire pond and constructing a different access port configuration. Because the pump will be replaced on a regular basis, the Plant should continue to monitor the system for signs the pump has, or is about to, break down.

The interstitial geomembrane leak detection and evacuation pump.

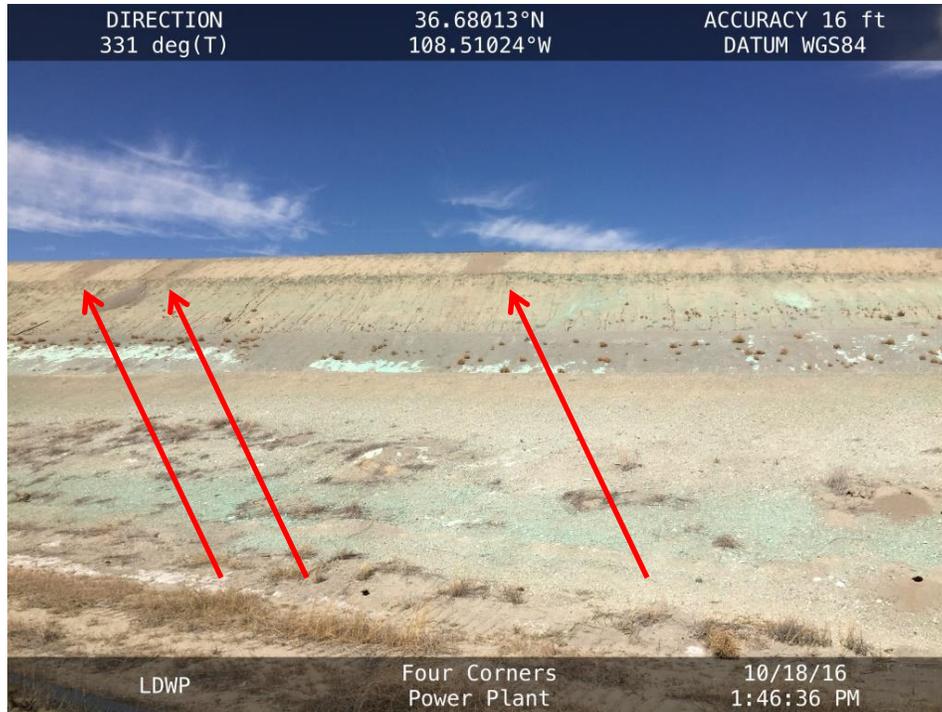
20161018 – IMG_1914

The South Embankment of the LDWP, facing north from the toe. The arrows point to locations where erosion has been repaired.

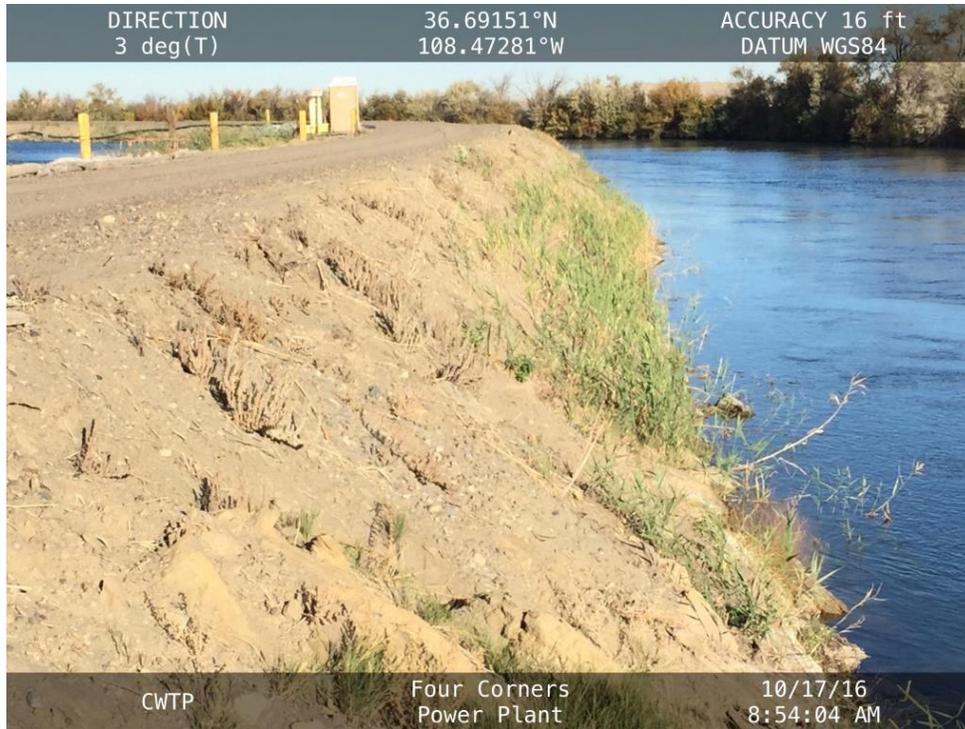
- i. No vegetation (trees and shrubs) was observed on the crest or slopes during this inspection (see photos IMG_1480 and IMG_1506). Trees and shrubs observed on the downstream slope in the 2015 inspection have been removed. Continue removing vegetation in accordance with the NMOSE vegetation maintenance guidelines “*Vegetation Management on Dams*” (2011).

20161017 – IMG_1480
The downstream slope of the CWTP embankment, facing north.

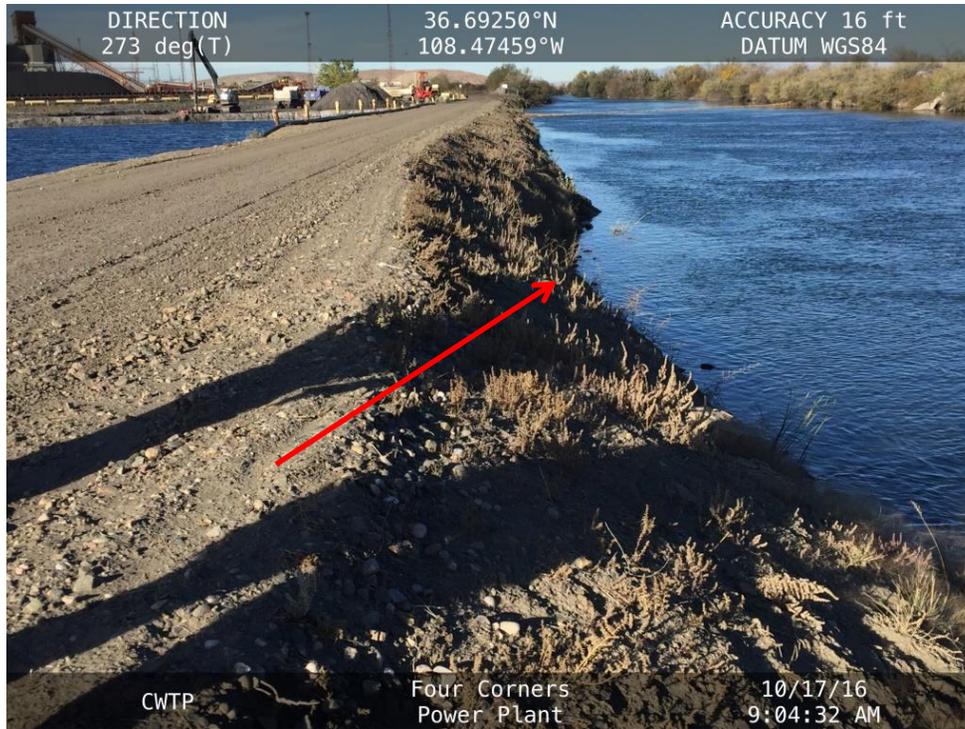
20161017 – IMG_1506

- iii. There appeared to be an over-steepened area in the upstream slope along the northern (east-west) section of the embankment (see photo IMG_1506). This area was heavily vegetated during the 2015 inspection and the irregular slope may have been caused by the vegetation removal activities. APS will monitor the flow in the discharge canal for erosive velocities until riprap is replaced on the slope.

The downstream slope of the CWTP, facing west. The arrow is pointing to an oversteepened portion.

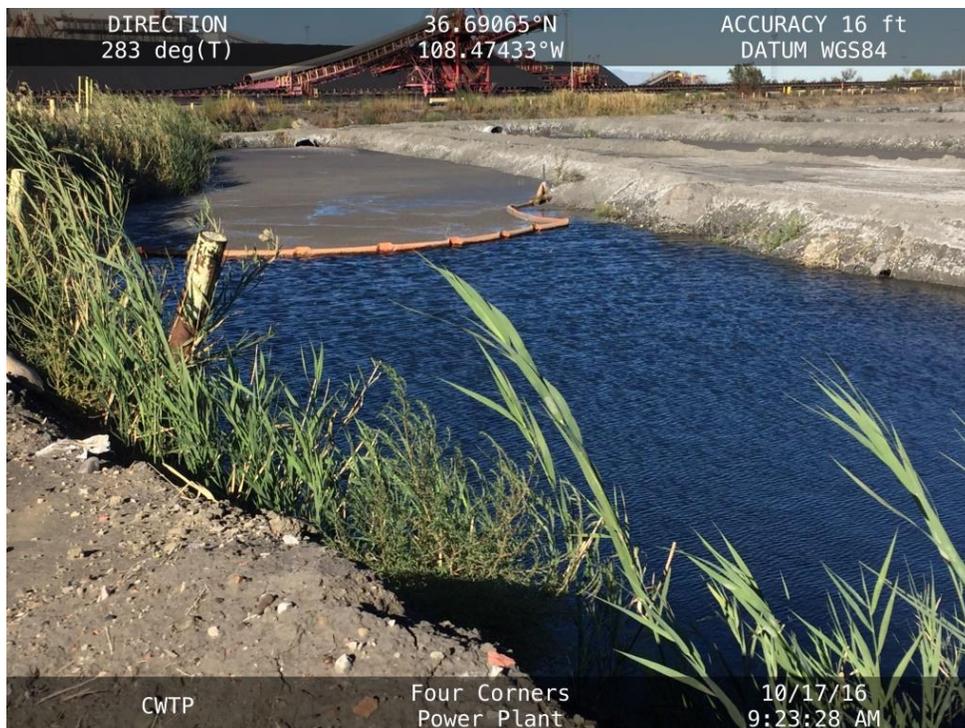
20161017 – IMG_1532

A decant cell in the CWTP partially filled with solids.

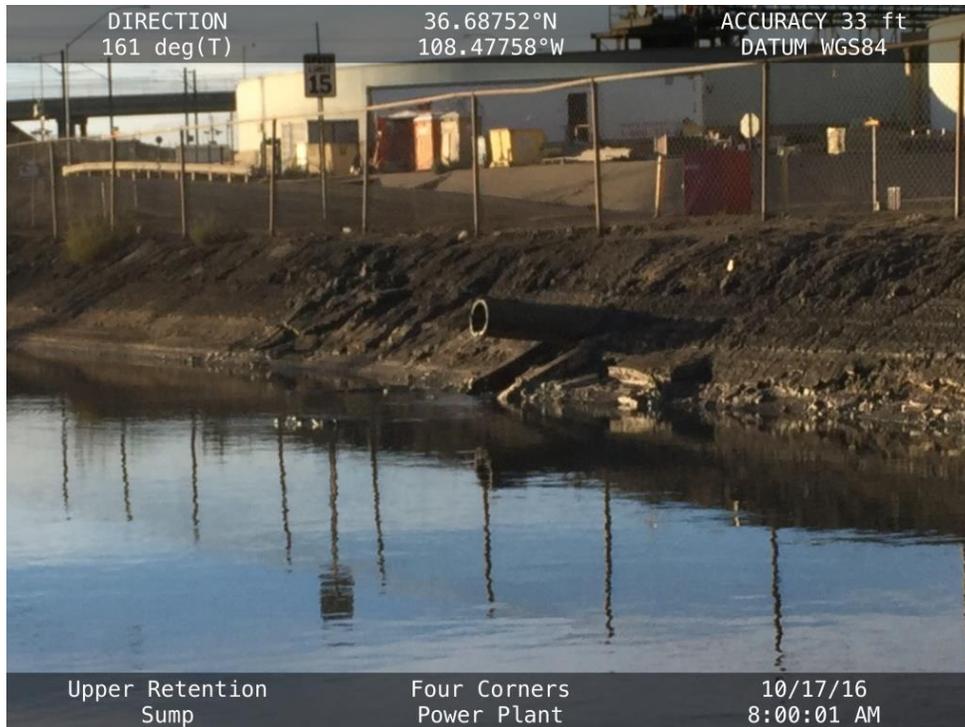
20161017 – IMG_1421

An inlet pipe along the west side of the Upper Retention Sump turned upward at a slight angle.

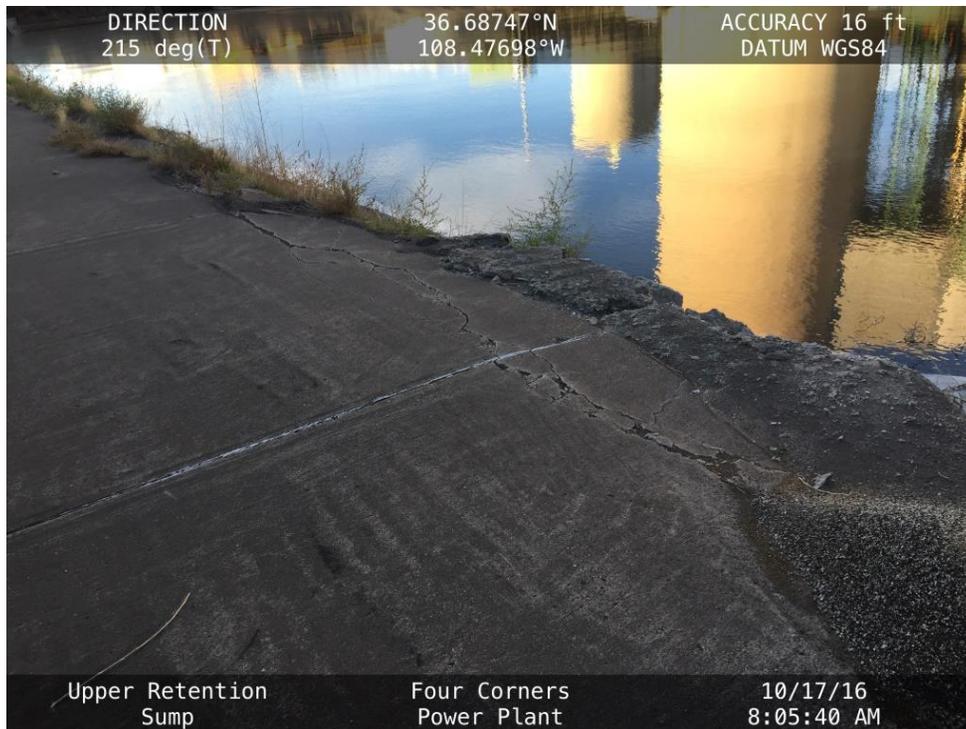
20161017 – IMG_1436

A crack in the cement along the east side of the Upper Retention Sump.

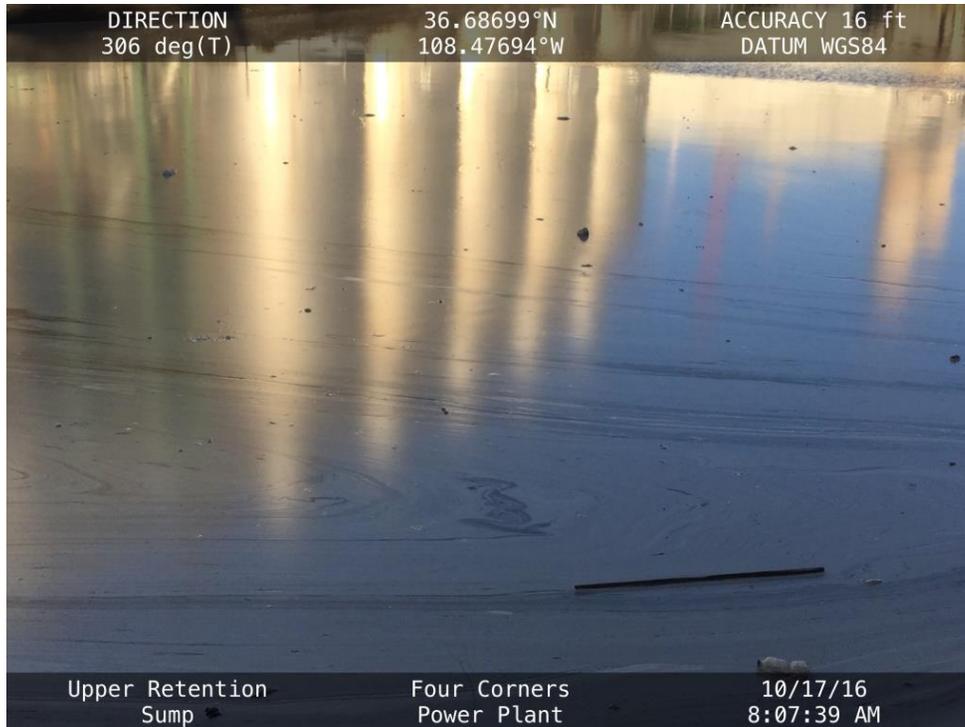
20161017 – IMG_1439
Debris present in the reservoir.

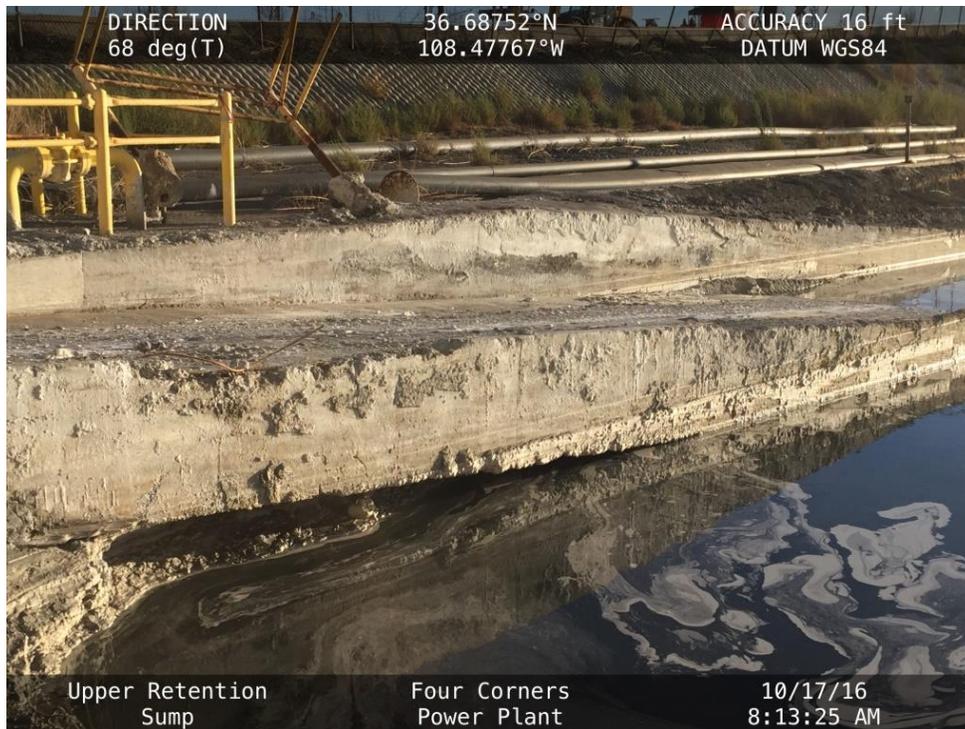
20161017 – IMG_1447

Undermining beneath the concrete ramp in the northwest corner of the Upper Retention Sump.

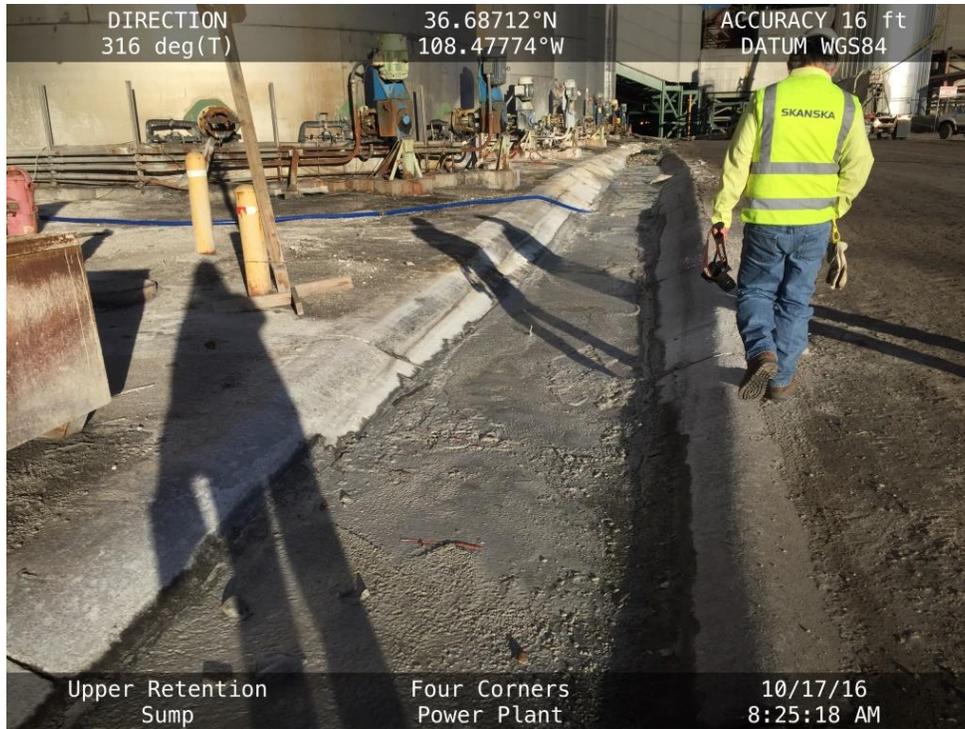
20161017 – IMG_1467

The canal to the west of the Upper Retention Sump filled with solids.

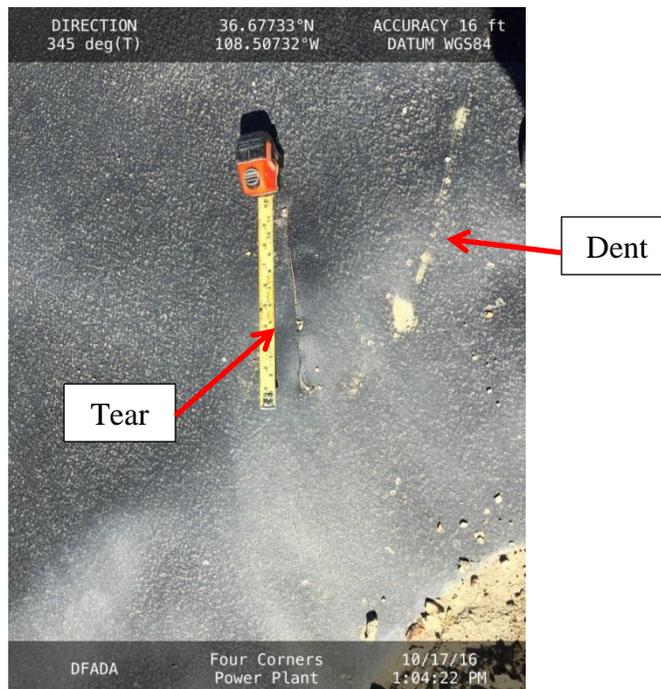
20161017 – IMG_1664
 Damage to the geomembrane along the crest of the Cell 1 collection pond. The measuring tape is 12 inches long.

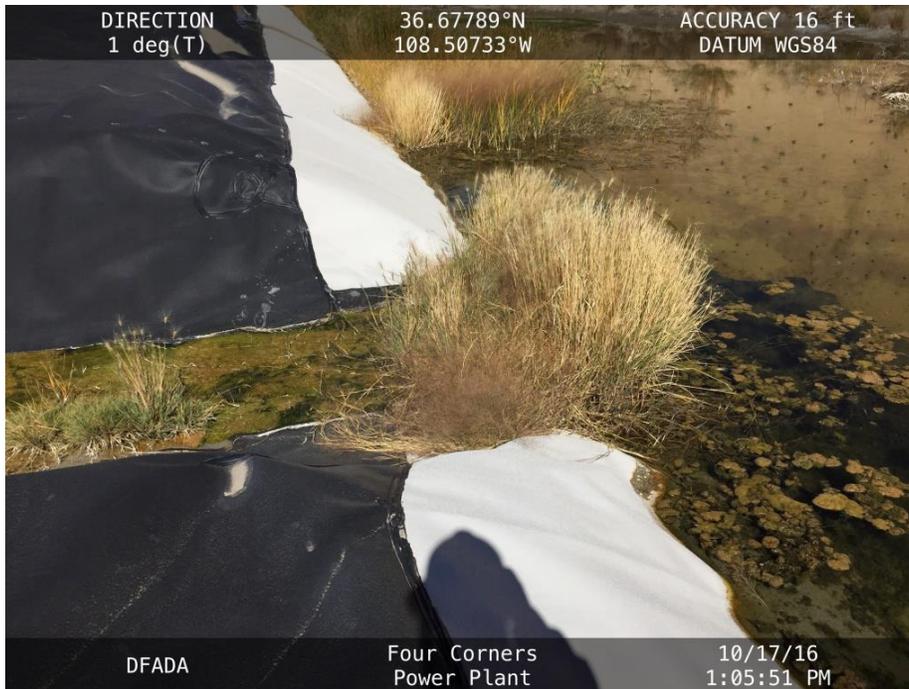
20161017 – IMG_1668

Vegetation and algae growing in drainage ditch between Cell 1 and the collection pond.

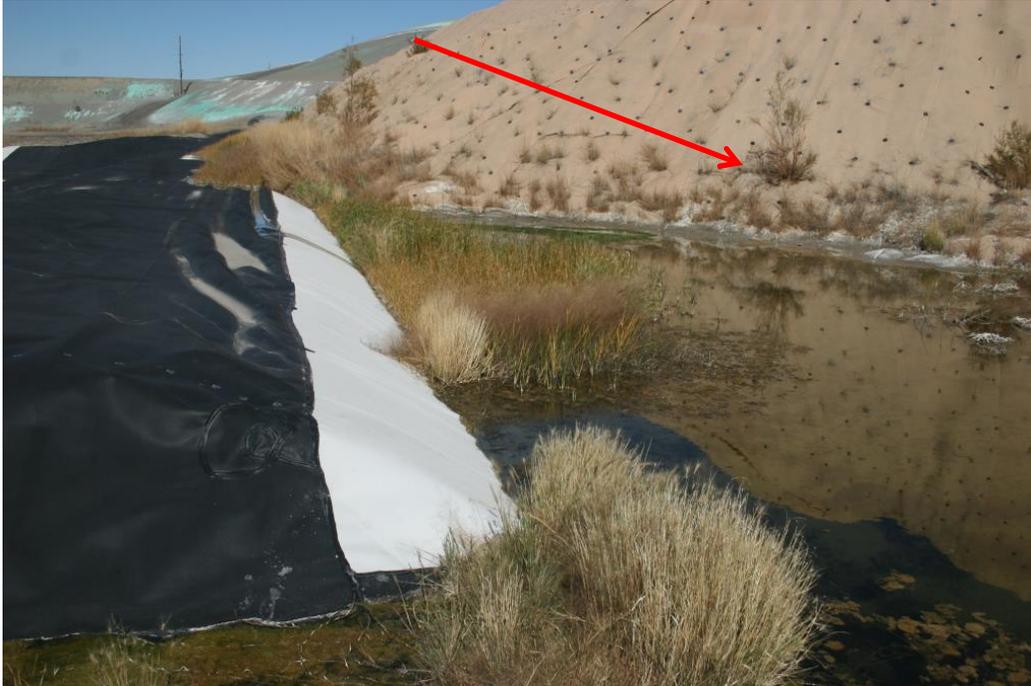
20161017 – IMG_0108

Woody vegetation growing through tears in the Pyramat in the west slope of Cell 1.
