FOUR CORNERS POWER PLANT

**Lined Ash Impoundment,
Lined Decant Water Pond,
Combined Waste Treatment Pond,
Upper Retention Sump, and
Dry Fly Ash Disposal Area**

Annual CCR Impoundment and Landfill Inspection Report 2017

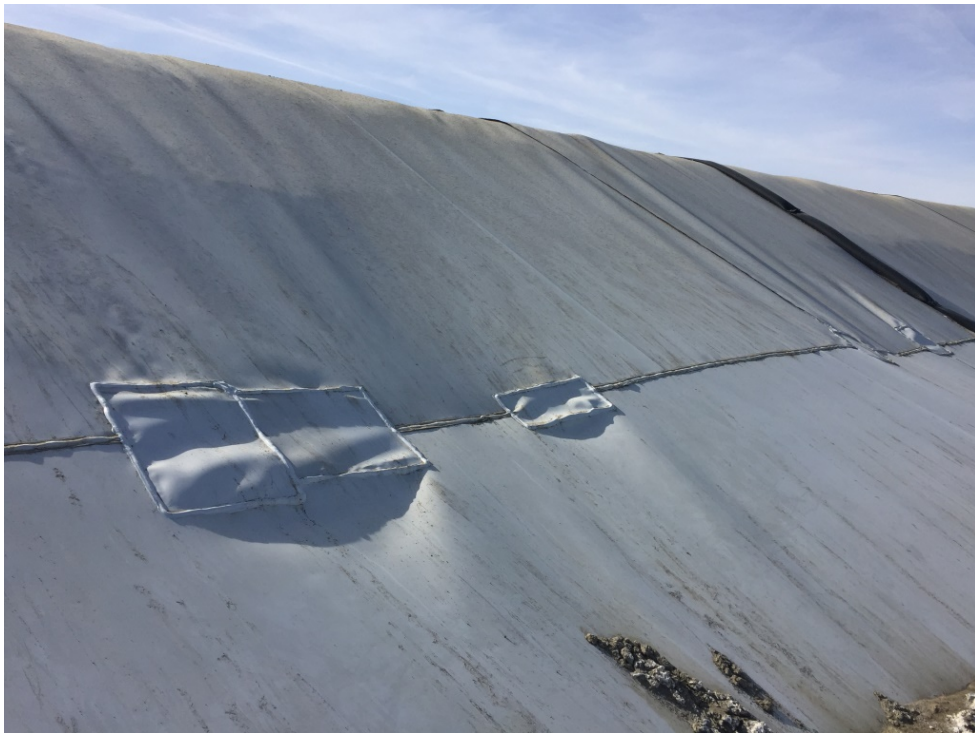
20171113 – IMG_1877

- ii. The liner is bulging along the western portion of the South Embankment. In early summer, APS discovered several tears in the liner when the water level in the LAI was higher. APS repaired the tears in October (photo IMG_1877), but water had already entered the space between the liner and the compacted clay along the upstream slope. The water migrated down the liner/clay contact and lifted the liner along the ponded water level (photos IMG_5216 and IMG_5228). APS has since been drawing down the water level in the LAI. The LAI embankment was designed to be stable without the geomembrane liner (URS 2012); however, the upstream slope and the toe drain along the South Embankment should be monitored for evidence of internal erosion. Evidence could include benching along the upstream slope due to the erosive action of water against the clay and cloudy seepage flowing out of the toe drain. The South Embankment toe drain was dry on the date of this inspection (photo IMG_5353).

Repairs of the geomembrane liner along the western portion of the South Embankment.

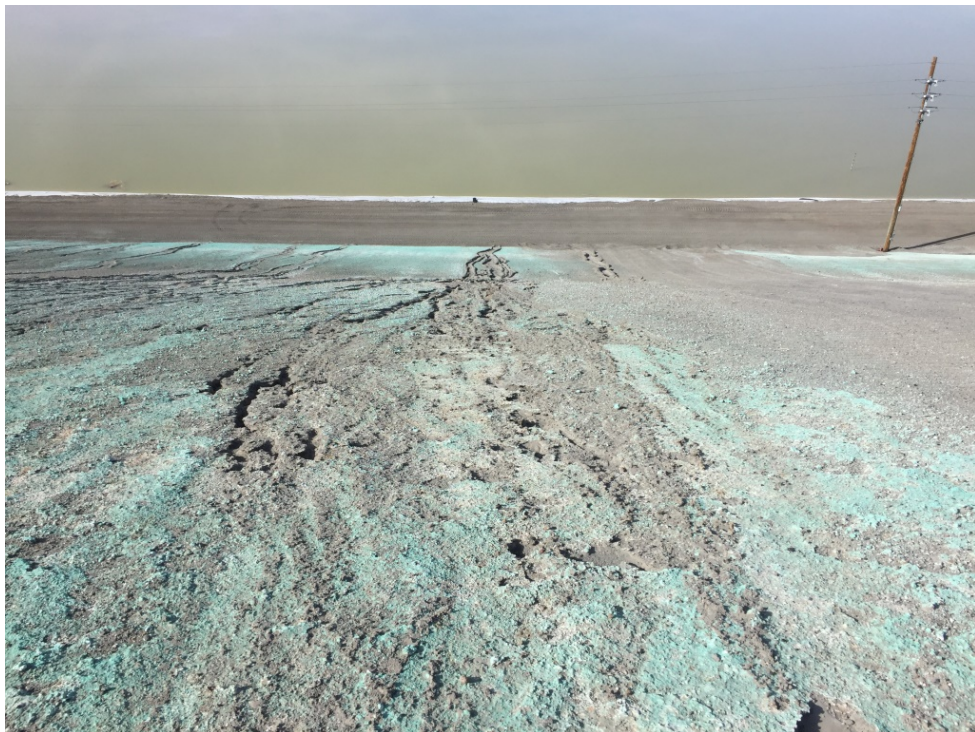
20171113 – IMG_1884

- iv. The downstream slope of the West Embankment had recent erosion repairs (photo IMG_1886) and minor recent erosion rills. These local erosional features may require repair in the future (photos IMG_1884 and IMG_1887) and should be monitored.

Minor erosion rills along the downstream slope of the West Embankment.

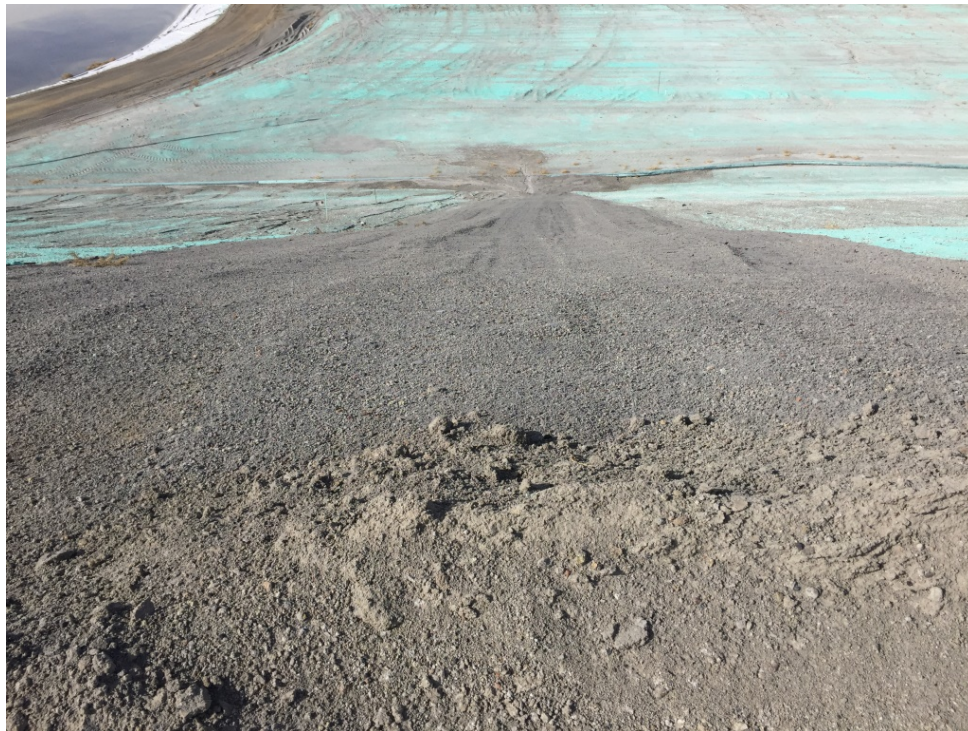
20171113 – IMG_1886

Area of repaired erosion along the downstream slope of the West Embankment.

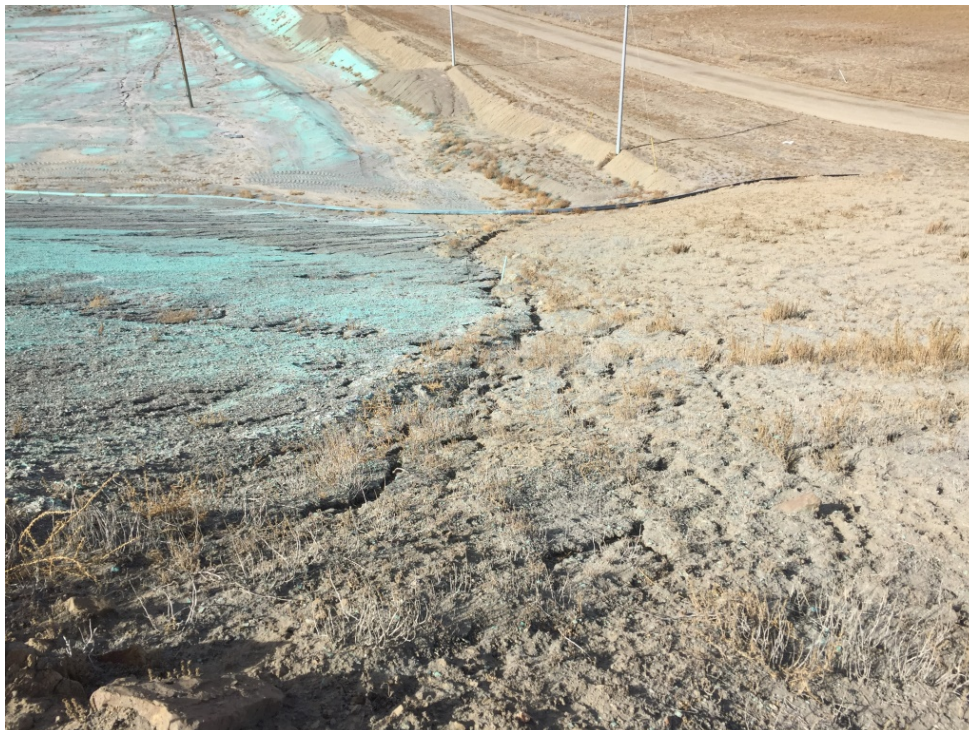
20171113 – IMG_1887

Minor erosion rills along the downstream slope of the West Embankment.

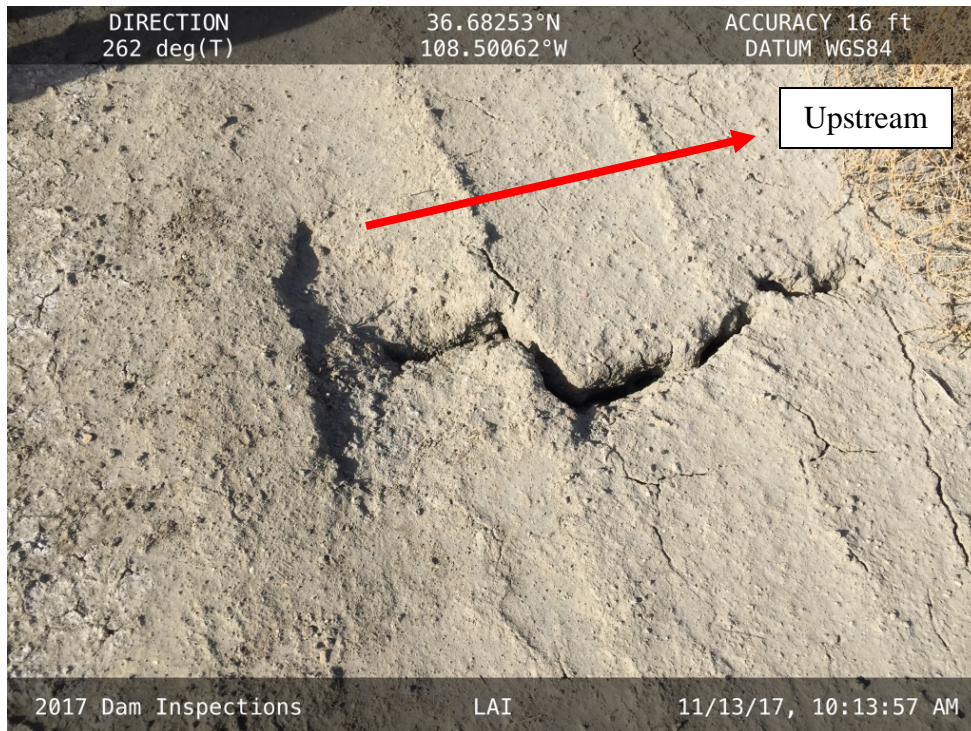
20171113 – IMG_5190

DAM EMBANKMENT CHECKLIST										
3	DAM CREST									
a	Settlements, slides, depressions?			X						
b	Misalignment?			X						
c	Longitudinal/Transverse cracking?	Transverse cracks were observed in the anchor trench in the western half of the South Embankment (photo IMG_5190). See comment i.			X	X				
d	Animal burrows?			X						
e	Adverse vegetation?			X						
f	Erosion?			X

A transverse crack on the crest of the South Embankment extending from the edge of the anchor trench to the upstream slope.

- i. The transverse cracks observed in the anchor trench along the South Embankment (photo IMG_5190) did not appear to be widespread or indicative of adverse conditions along the crest. The area should be monitored and repaired if the cracks become more widespread.

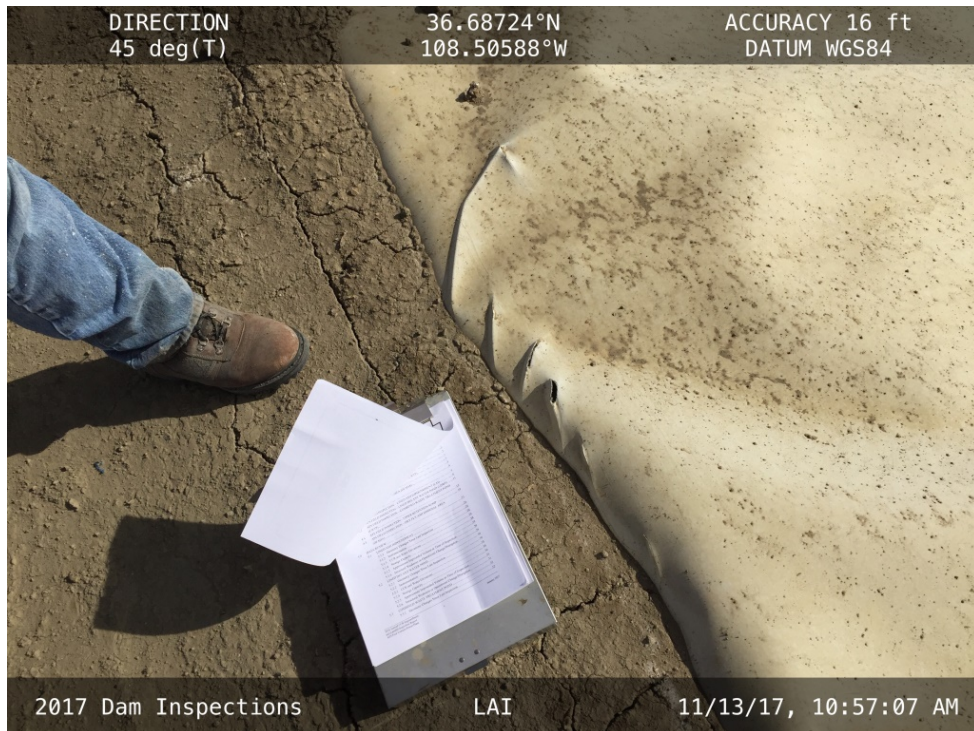
20171113 – IMG_5275
Tears in the liner along the Northwest Embankment.

- v. There are small tears in the liner on the crest of the Northwest Embankment (photo IMG_5275). The tears should be repaired to prevent stormwater or other runoff from entering the space beneath the liner.

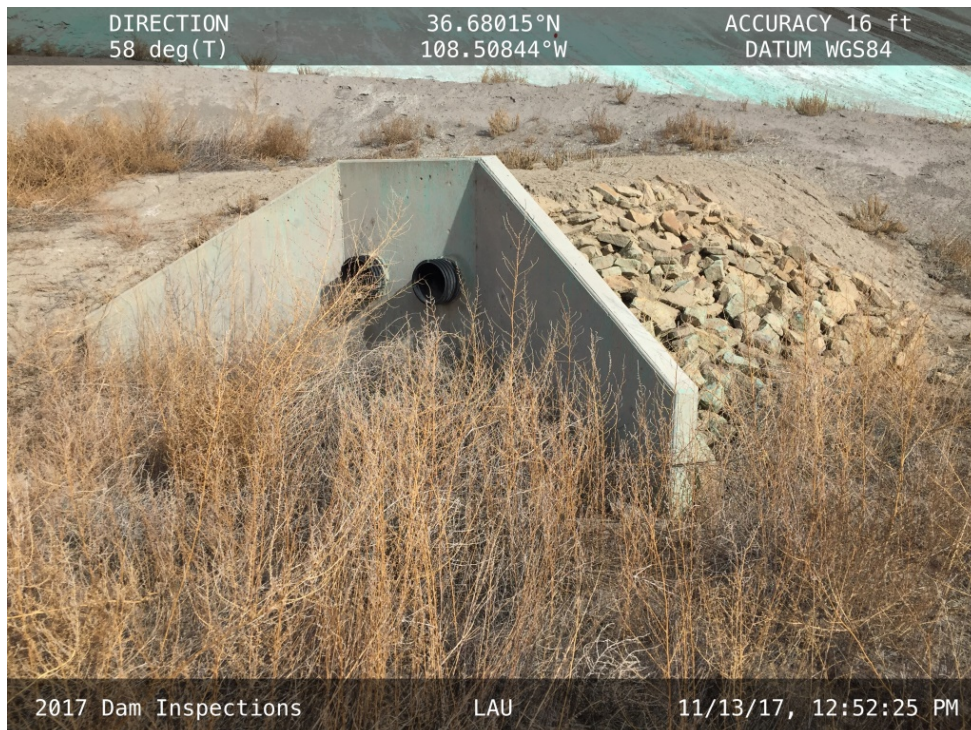
20171113 – IMG_5353
The South Embankment toe drain in a dry condition.

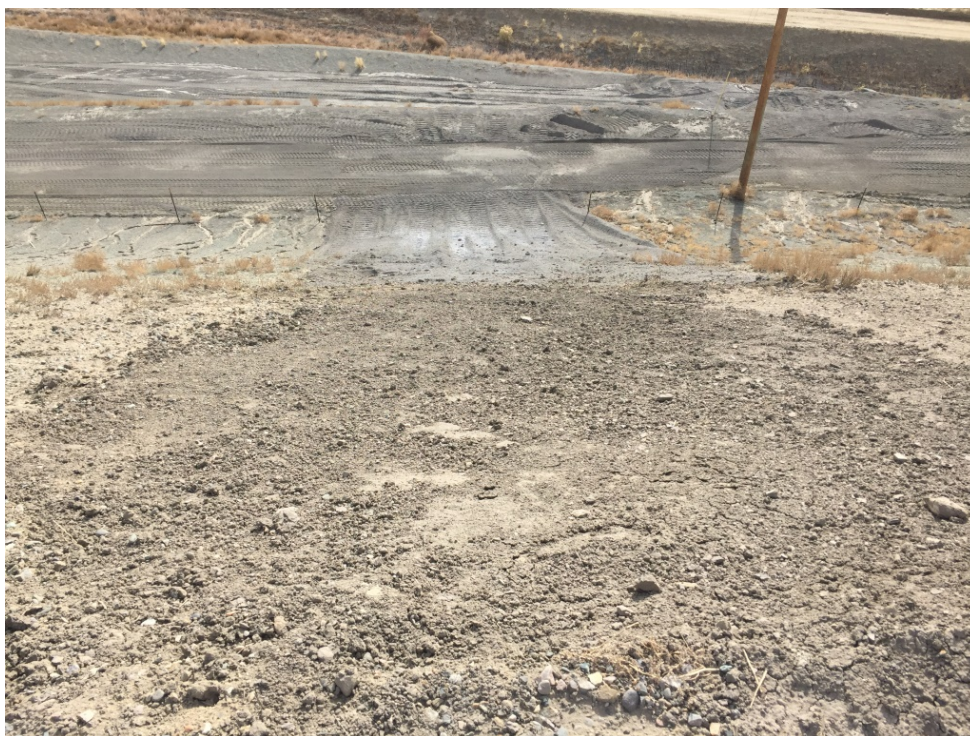
20171113 – IMG_1899

Area of repaired erosion along the downstream slope of the South Embankment.

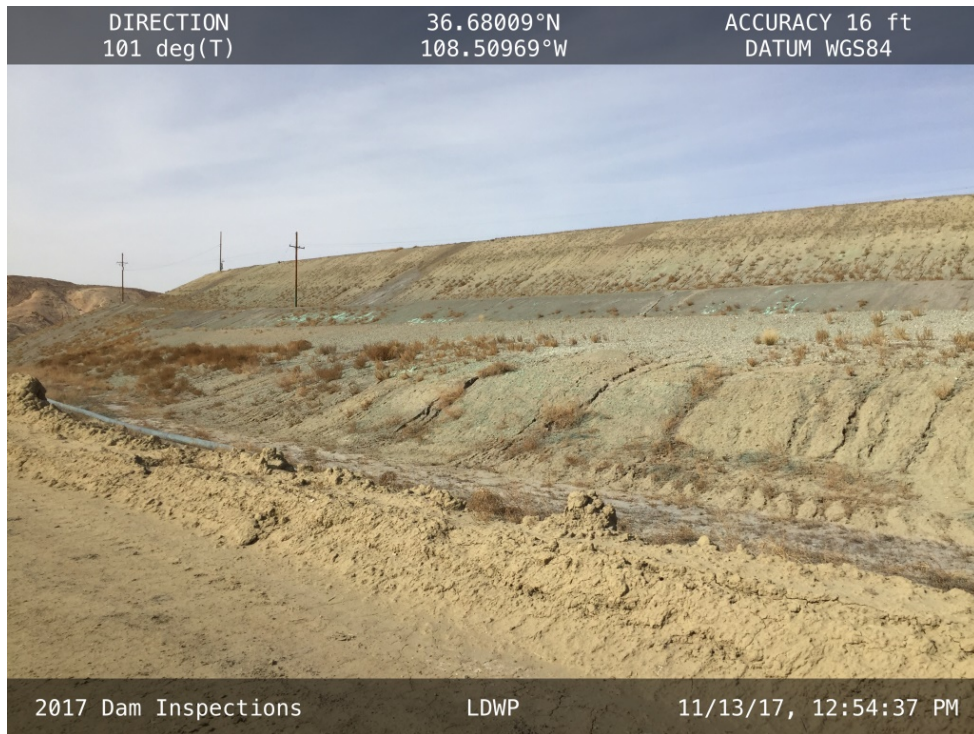
20171113 – IMG_5354

- ii. The external slopes of the embankments show evidence of minor erosion rilling (photos IMG_5354, IMG_5361, and IMG_5425). APS has been maintaining the affected areas by regrading and recompacting eroded areas (photo IMG_5421). At the time of the inspection, several locations along the South, West, and North Embankments had recently been repaired. The current program appears to be sufficient and should be continued such that rills are repaired if the erosion depth exceeds one foot.

The South Embankment of the LDWP and Ash Pond 3, facing northwest from the toe.

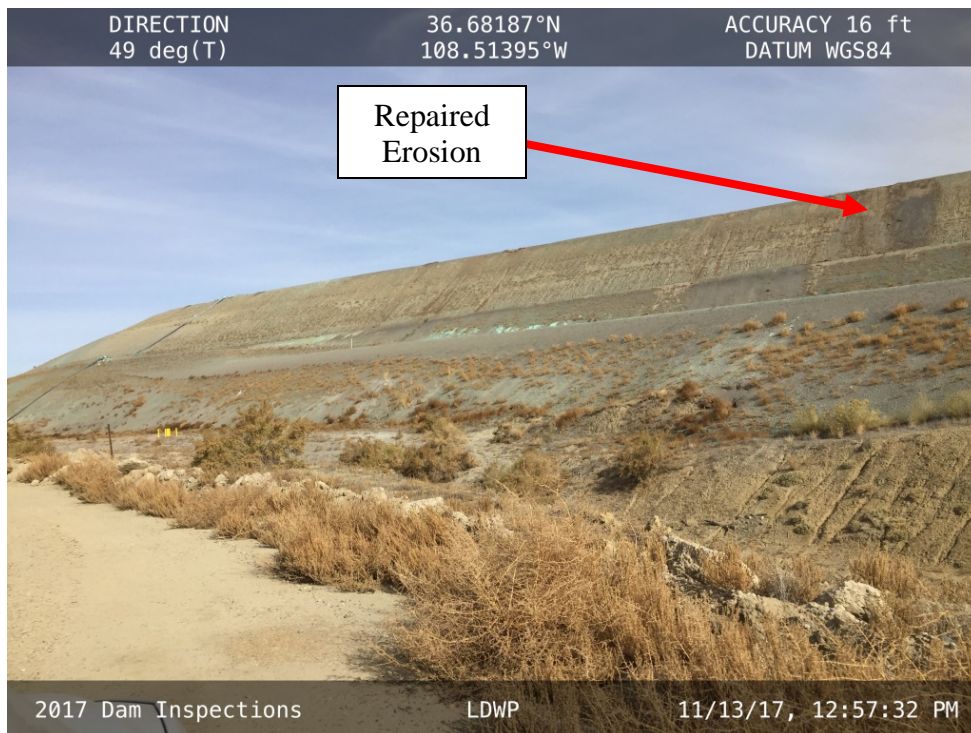
20171113 – IMG_5361

The West Embankment of the LDWP and Pond 3, facing northeast from the toe.

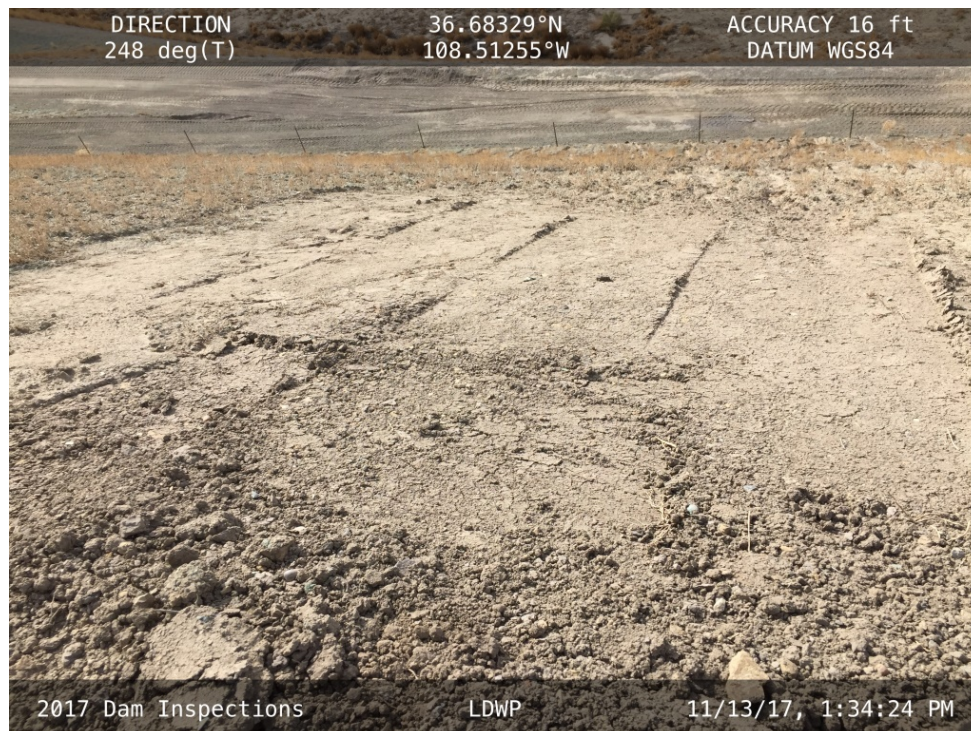
20171113 – IMG_5388
Area of repaired erosion along the West Embankment, facing west toward the toe.

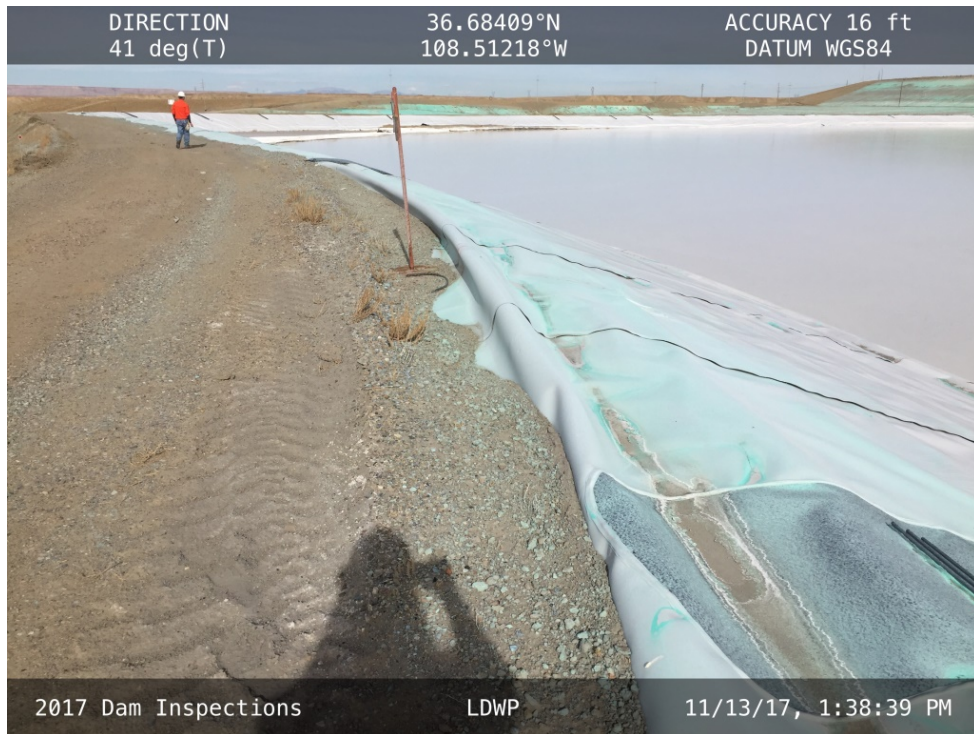
20171113 – IMG_5408

- v. The liner was observed to be pulling out of the anchor trench in isolated areas along the West and East Embankments (photos IMG_5408 and IMG_5435). The area where the liner was observed pulling out of the anchor trench during the 2016 inspection has been repaired (photo IMG_5411).

The liner pulling out of the anchor trench in the northern portion of the West Embankment.

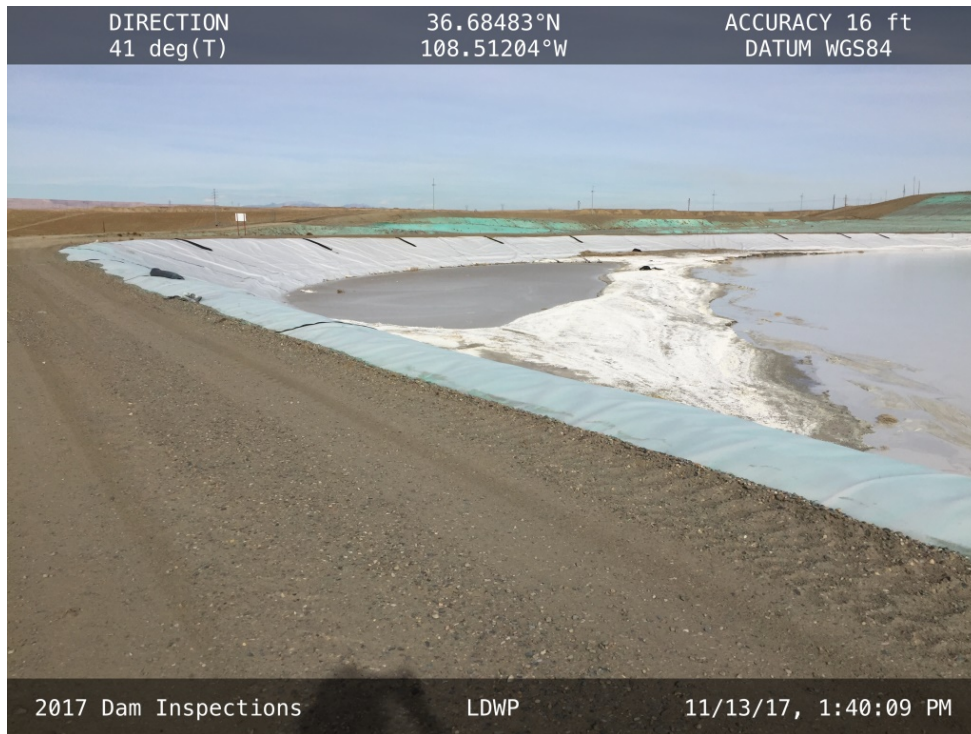
20171113 – IMG_5411

Repaired area of the liner, observed pulling out of the anchor trench during the 2016 inspection.

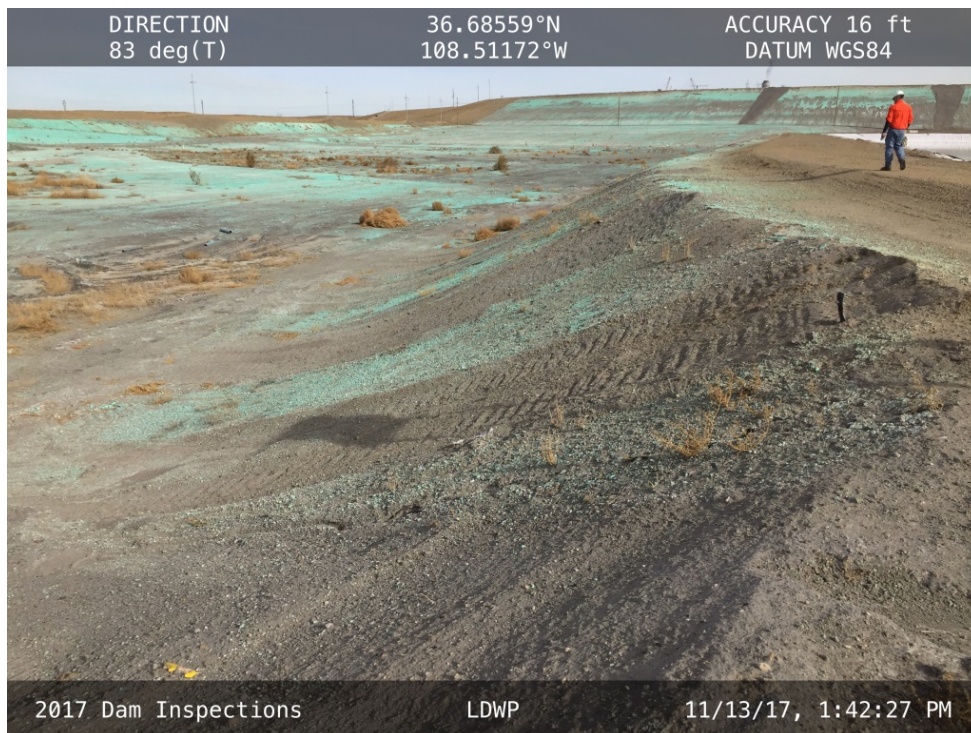
20171113 – IMG_5421

Areas of repaired erosion along the North Embankment, facing east.

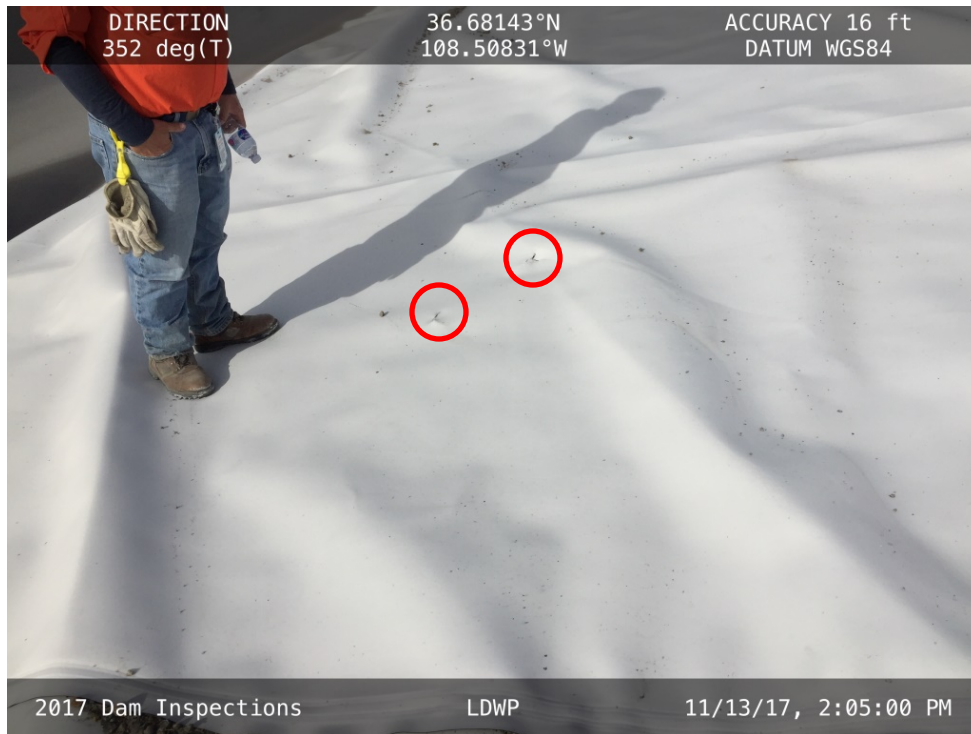
- iv. There were several holes and tears in the liner along the South, North, and East Embankments (photos IMG_5382, IMG_5429, IMG_5438, and IMG_5442). FCPP personnel stated that they were aware of several existing tears and intend to repair them.

20171113 – IMG_5442
Tears in the liner along the East Embankment.

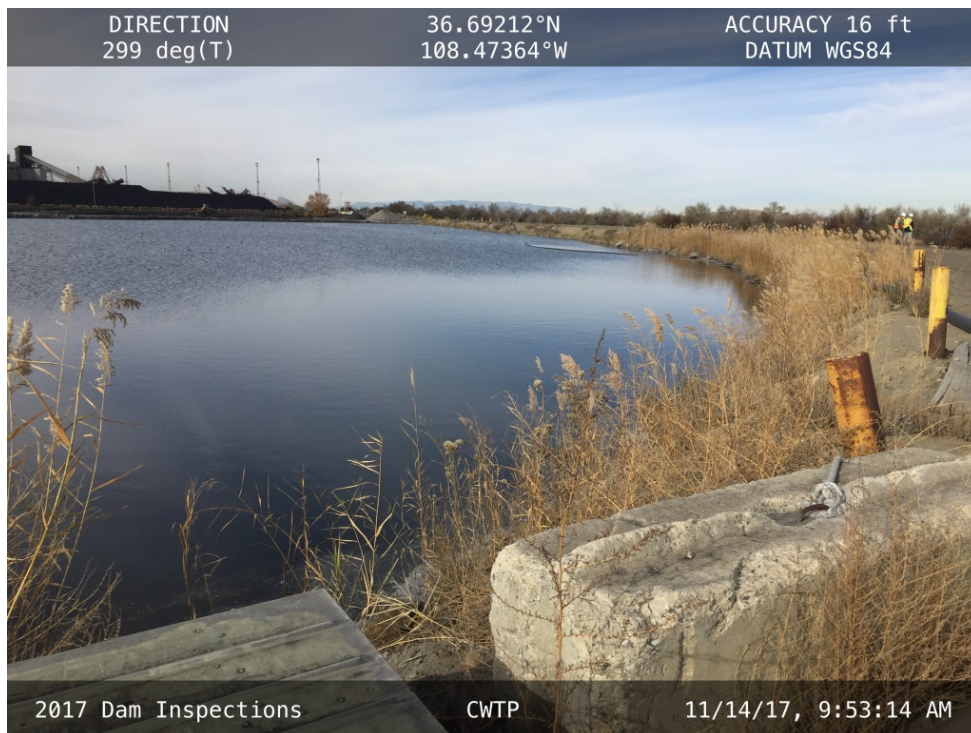
- i. Minor vegetation (grass, small trees, and shrubs) was observed on the slopes during this inspection (photos IMG_1921, IMG_1927, and IMG_5604). Trees and shrubs observed on the downstream slope in the 2015 inspection have been removed. Continue removing vegetation in accordance with the NMOSE vegetation maintenance guidelines “*Vegetation Management on Dams*” (2011). The tall grass on the upstream slope of the embankment is beginning to establish and has grown significantly since the 2016 inspection. The vegetation on the upstream slope should be removed using the same NMOSE vegetation guidelines as the downstream slope to prevent woody vegetation from establishing as well.

20171114 – IMG_5604
The reservoir and vegetation along the upstream slope of the embankment, facing northwest.

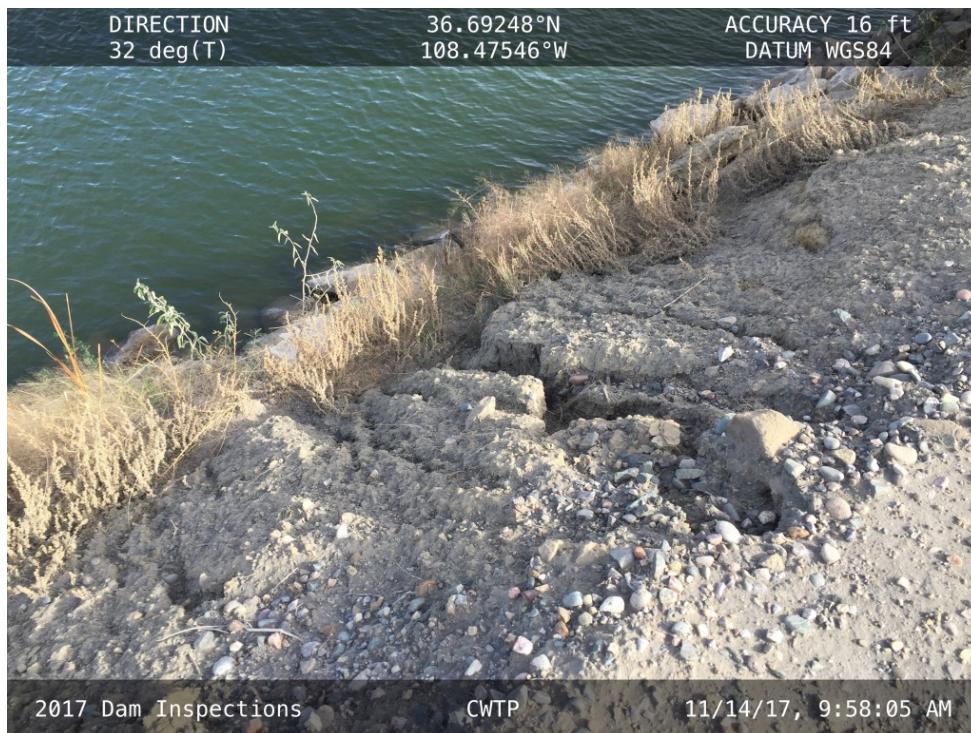
20171114 – IMG_5624

- ii. Several instances of minor erosion were observed on the downstream slope above the riprap (photos IMG_5598 and IMG_5624). These areas should be monitored and repaired if the erosion depth exceeds one foot.

Minor erosion rills forming on the downstream slope.

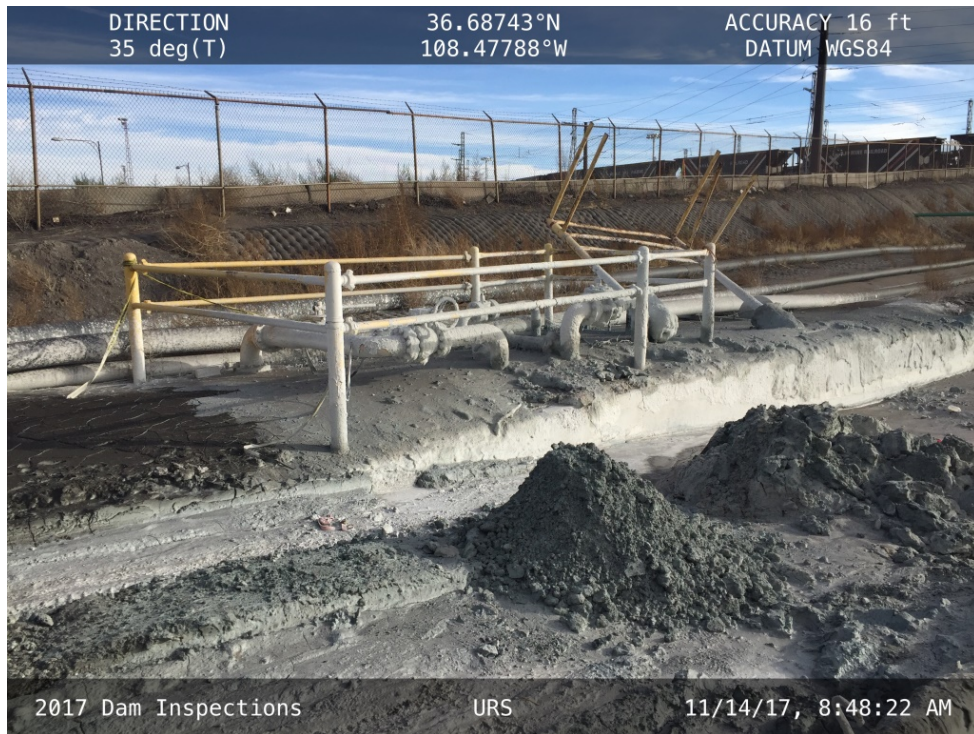
20171114 – IMG_5497

A guardrail and solids dumped on and around the gas connection near the access ramp.

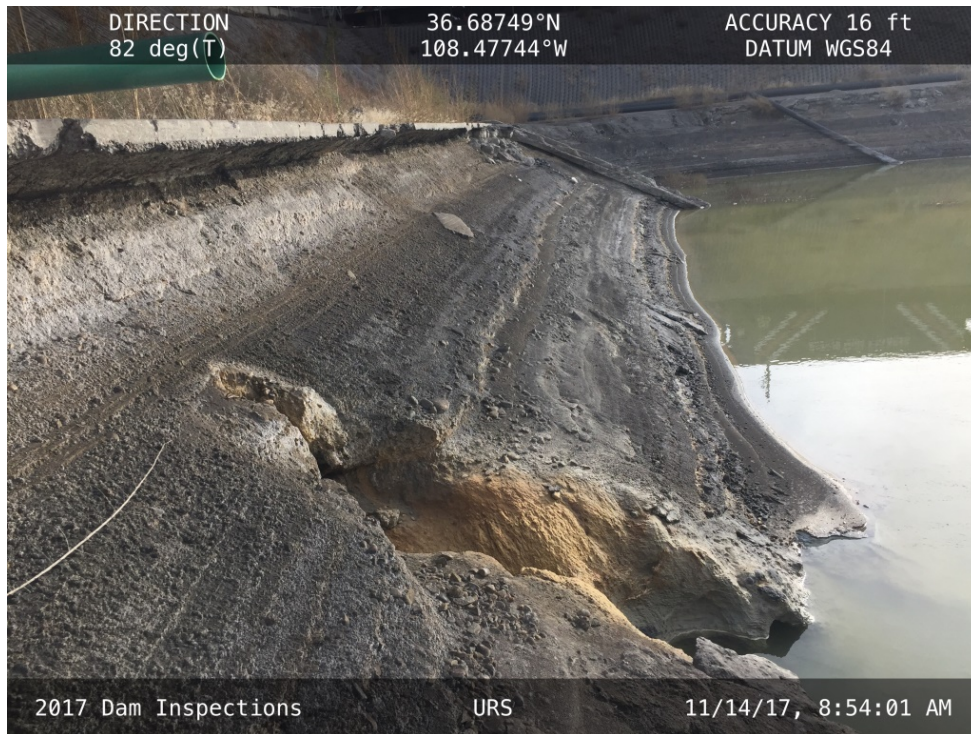
20171114 – IMG_5511
Erosion on the north side of the Upper Retention Sump, facing east.

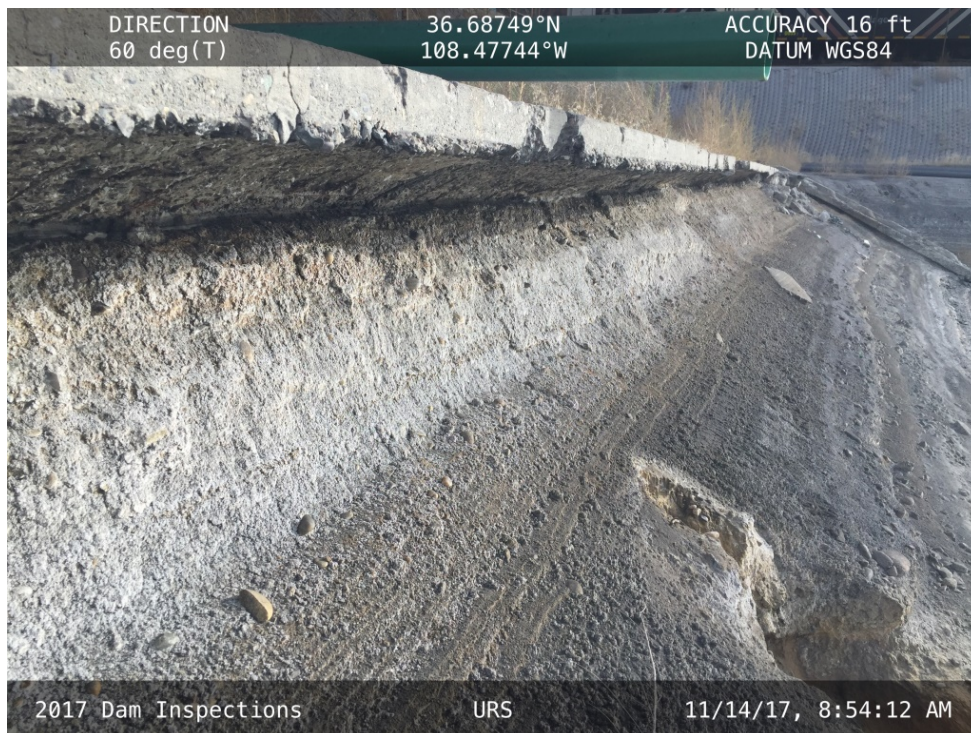
20171114 – IMG_5513
Undermined cement along the north side of the Upper Retention Sump, facing east.

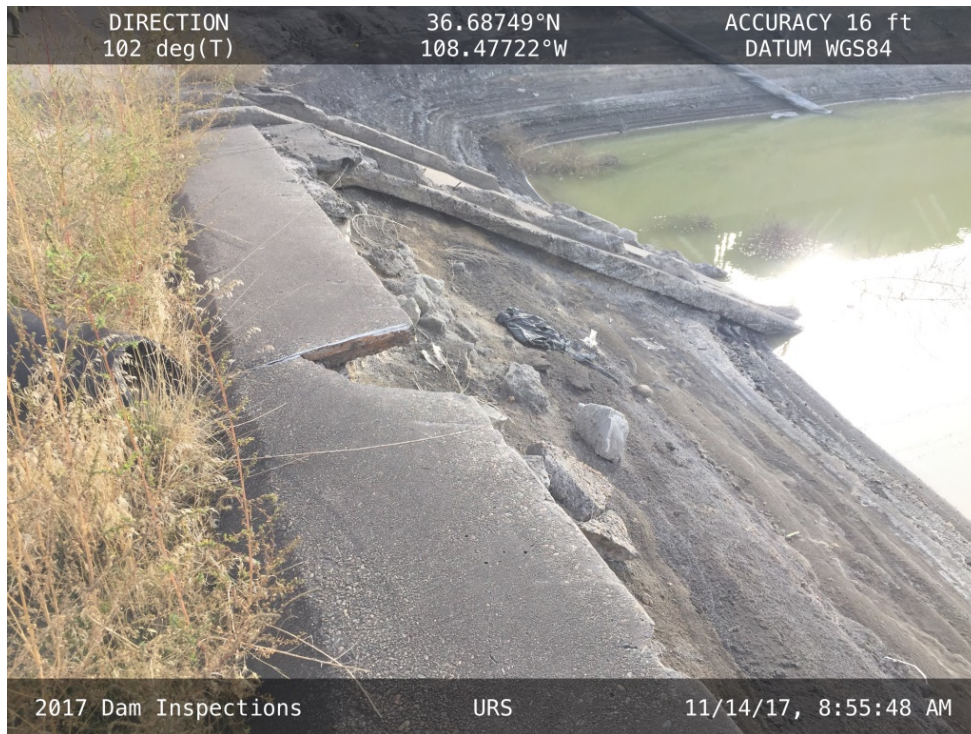
20171114 – IMG_5519

Broken cement along the north side of the Upper Retention Sump, facing east.

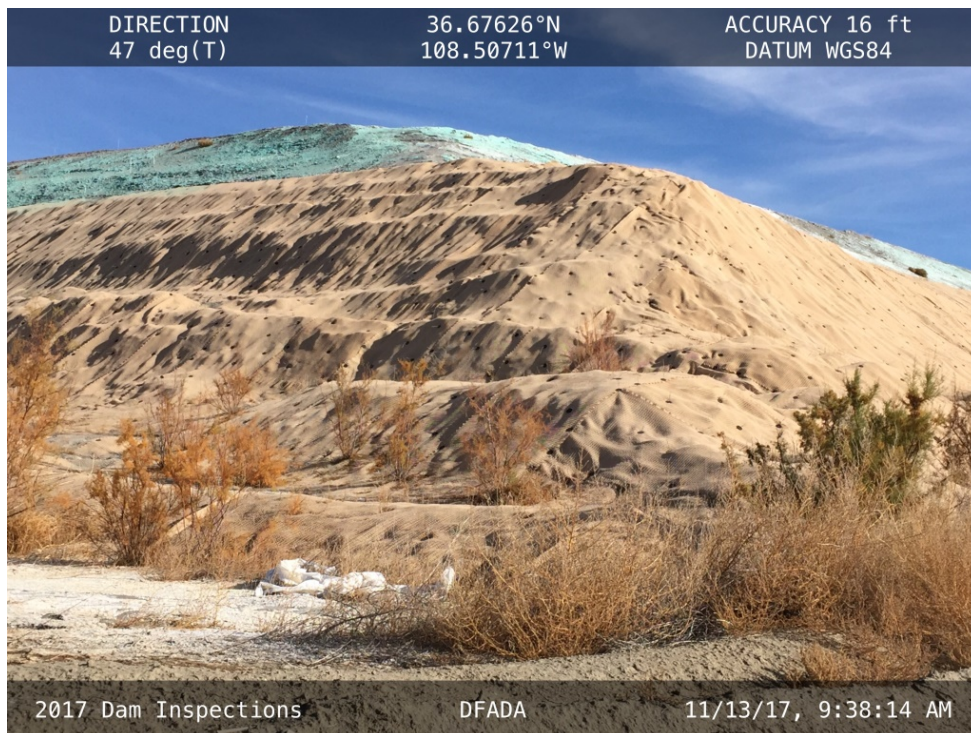
20171113 – IMG_5152
Woody vegetation growing through the Pyramat in the southwest corner of Cell 1.

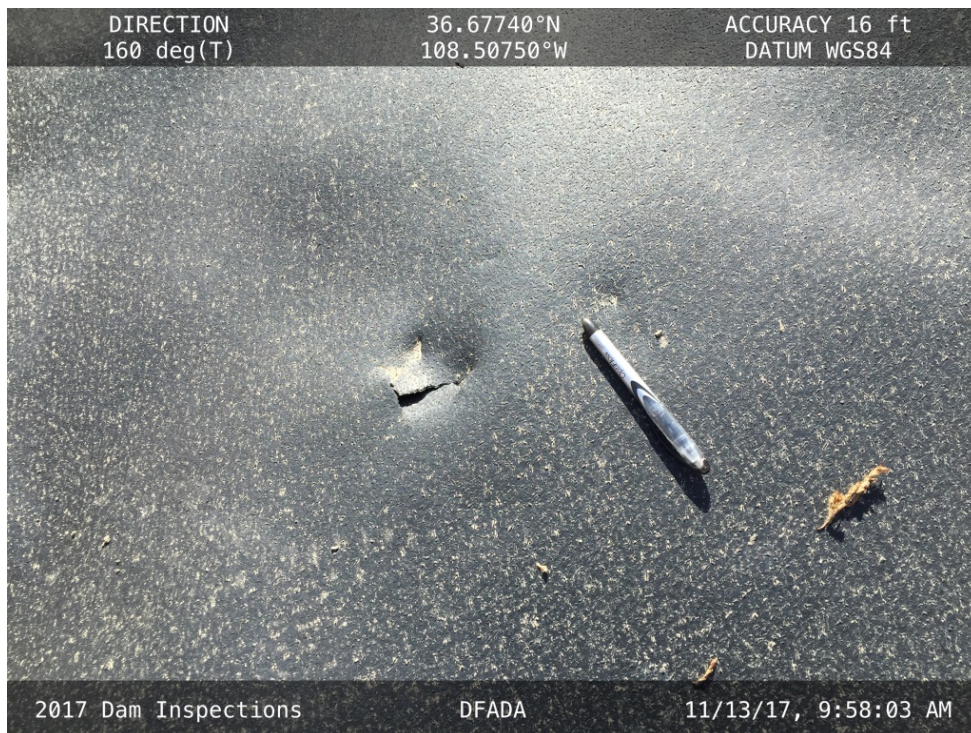
20171113 – IMG_5179
A tear in the geomembrane liner of the Cell 1 collection pond.
