**FOUR CORNERS POWER PLANT
Lined Ash Impoundment,
Lined Decant Water Pond,
Combined Waste Treatment Pond,
Dry Fly Ash Disposal Area,
and Return Water Pond**

**Annual
CCR Impoundment and
Landfill Inspection Report
2022**

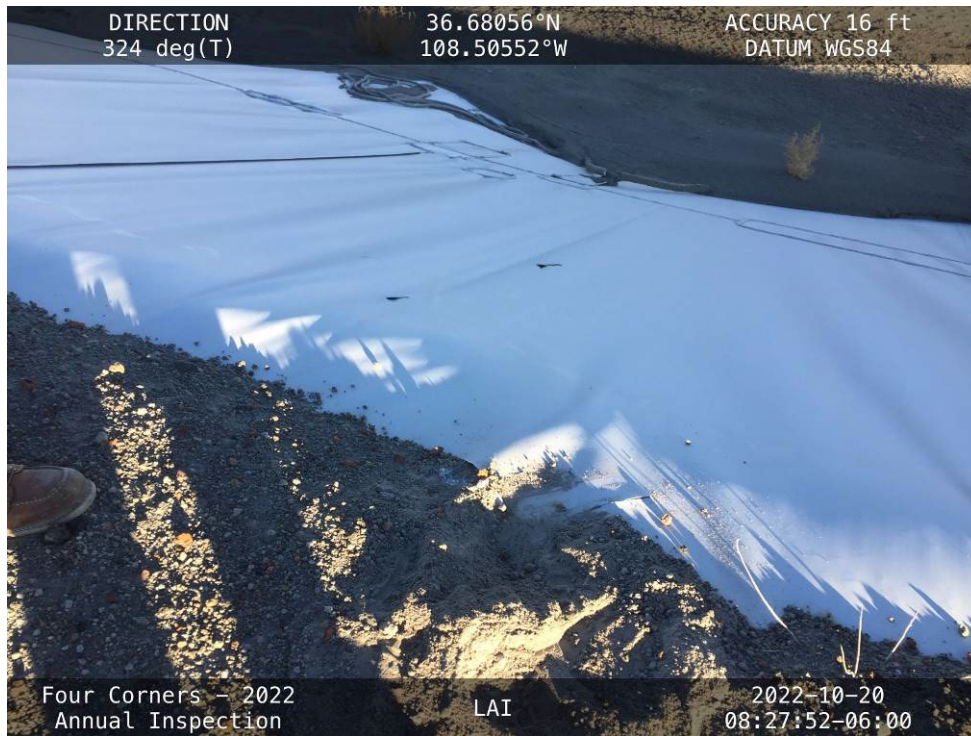
20221020 – IMG_4427

- iv. There are several tears, cuts, and torn seams in the liner along the upstream slope. Two tears and all of the torn seams are on the South Embankment near the Southwest Corner (Photos IMG_4427, IMG_4429, IMG_4443, IMG_4444, IMG_4449, IMG_4450) appear to be due to tension in the liner as they occur along the horizontal seams associated with the last embankment raise. The torn seams were leaking water at the time of the inspection. This is likely the water trapped under the liner observed during previous inspections. The water should be removed and the tension tears should be repaired under the direction of the APS Geotechnical Engineer.

Two tears in the liner in the Southwest Corner, near the staff gauge.

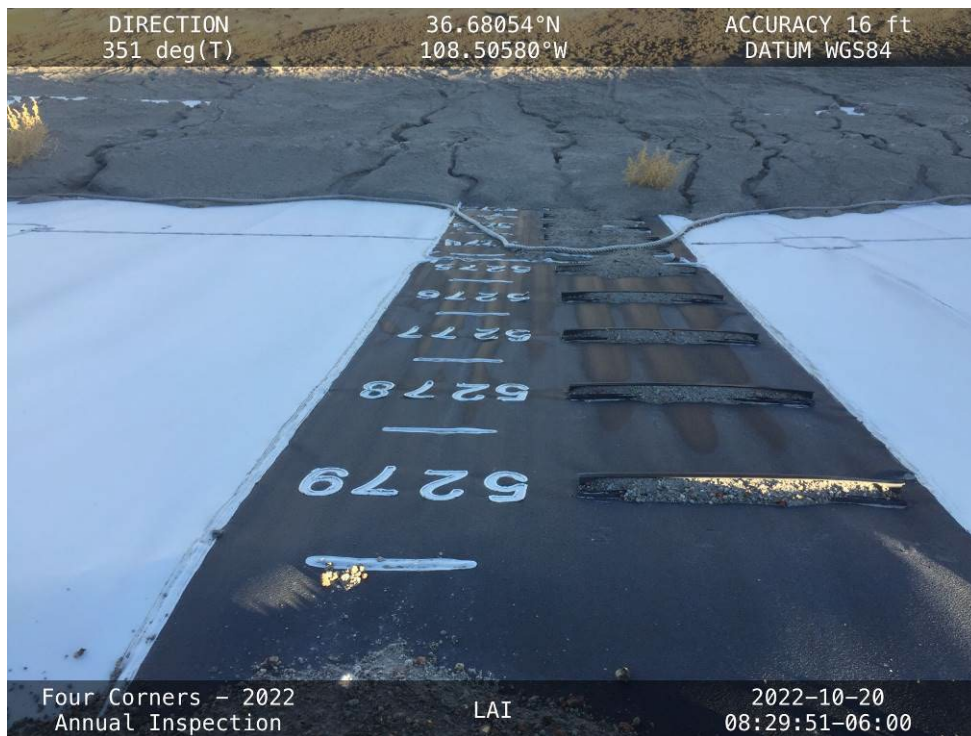
20221020 – IMG_4429
 A tear along the horizontal seam in the liner.

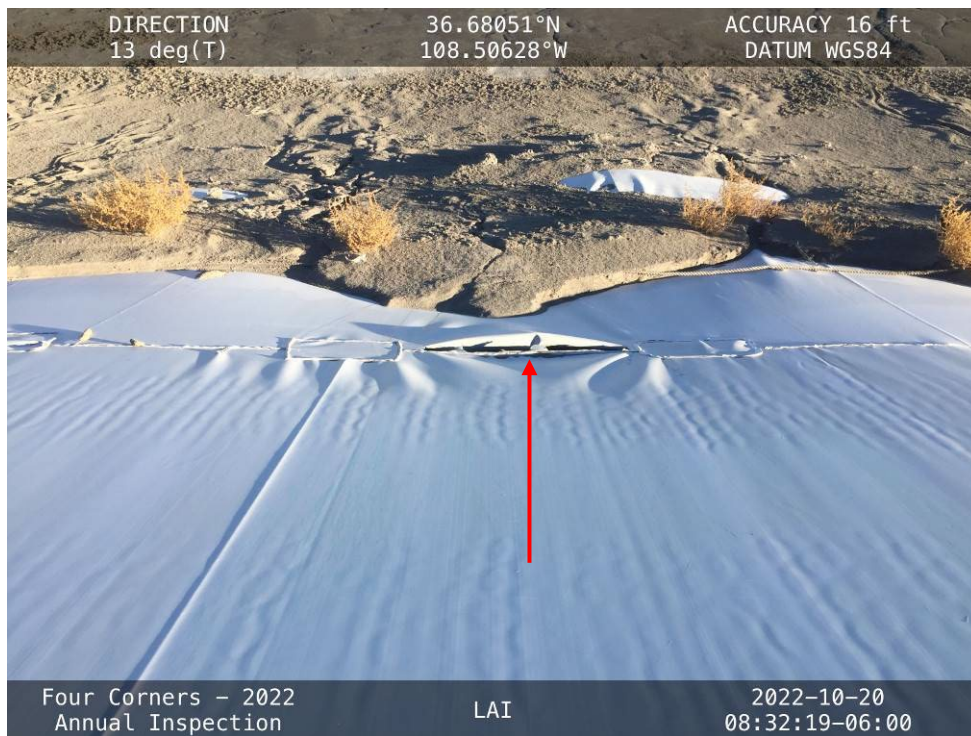
20221020 – IMG_4443

Undulations in the liner and tears along the horizontal seam in the Southwest Corner.

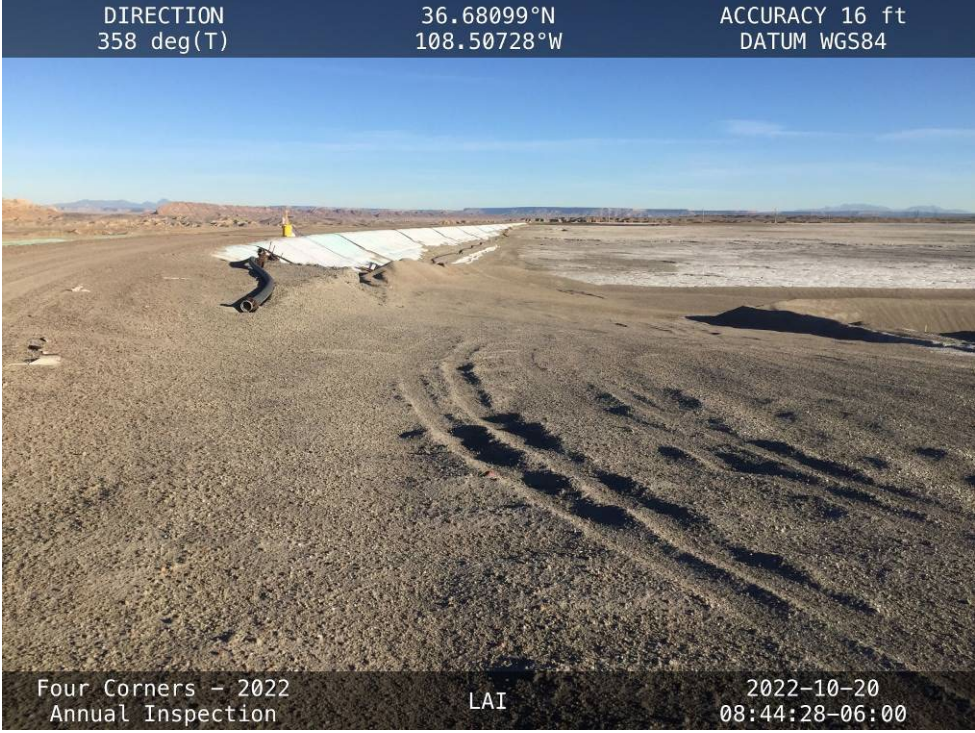
20221020 – IMG_4461

There are tears in the exposed liner at the former cenosphere mining area. The working area for the cenosphere mining operation is built into the reservoir area and the mechanical damage is not affecting the integrity of the embankment (Photo IMG_4461). The area should be monitored.

The cenosphere mining area in the Southwest Corner, facing north.

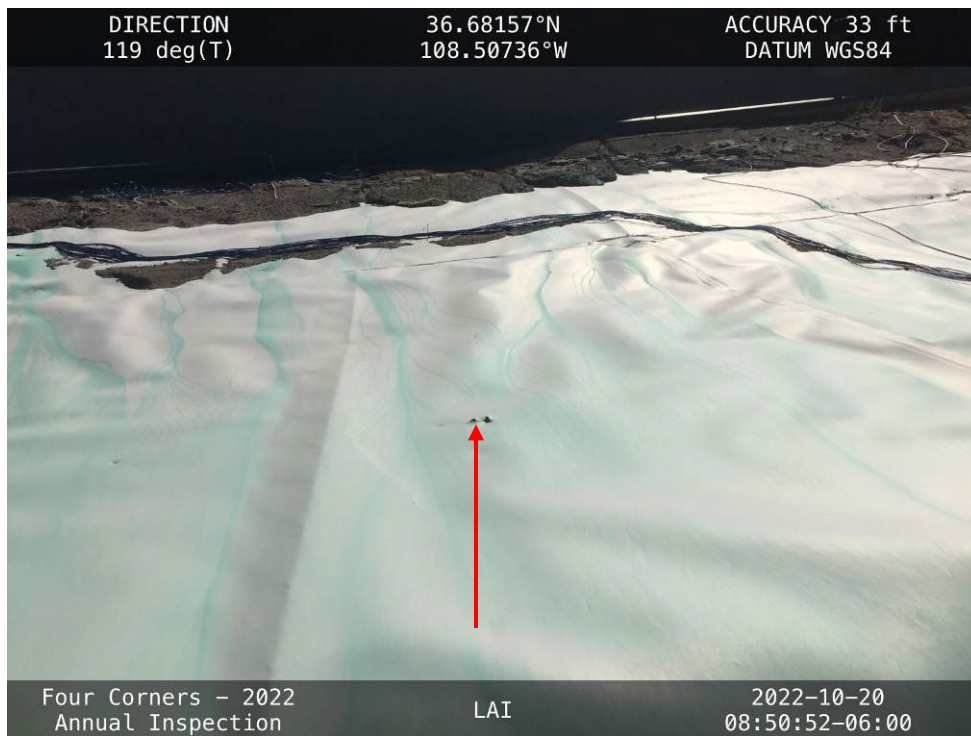
20221020 – IMG_4469

One puncture in the liner was observed on the West Embankment (Photo IMG_4469) and additional tears were observed on the Northwest Embankment along the crest where temporary ash berms were placed to divert flow from the V-ditch (Photo IMG_4518). Repair documentation should be maintained with the operating record.

A hole in the liner on the south end of the West Embankment.

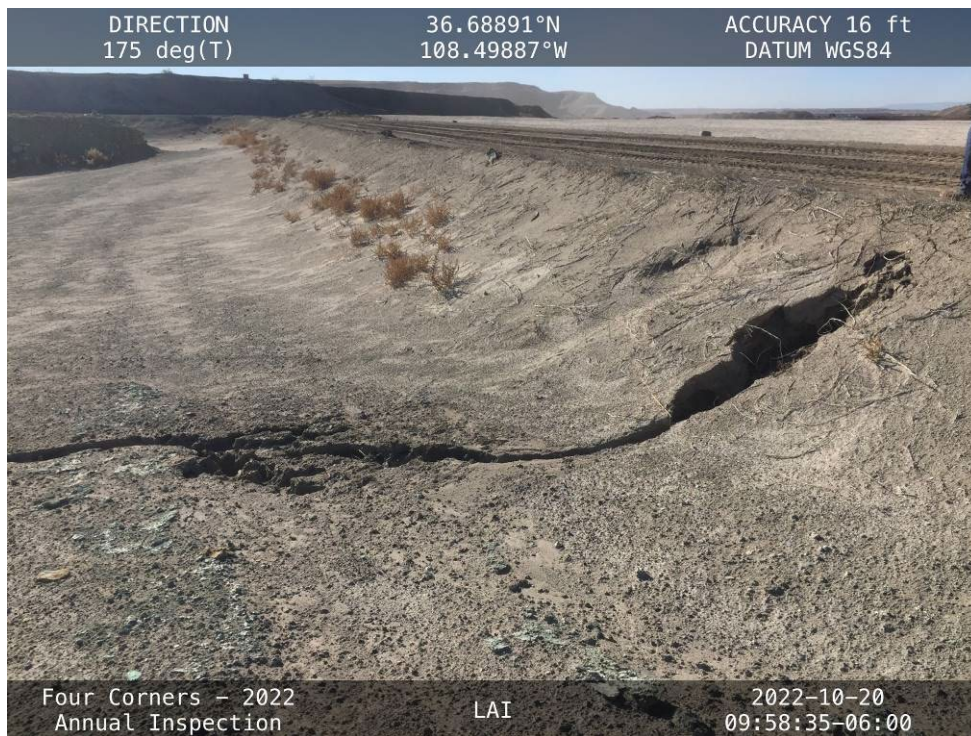
20221020 – IMG_4533

IMG_4533 and IMG_4568) and along the downstream toe of the West Embankment (Photos IMG_4821, IMG_4822, IMG_4874, and IMG_4876). At the toe of the West Embankment, erosion tunnels were forming beneath the dust suppression agent applied on the slope. Repair all erosion that extends deeper than 1 foot.

Erosion on the downstream slope of the East Embankment, facing south.

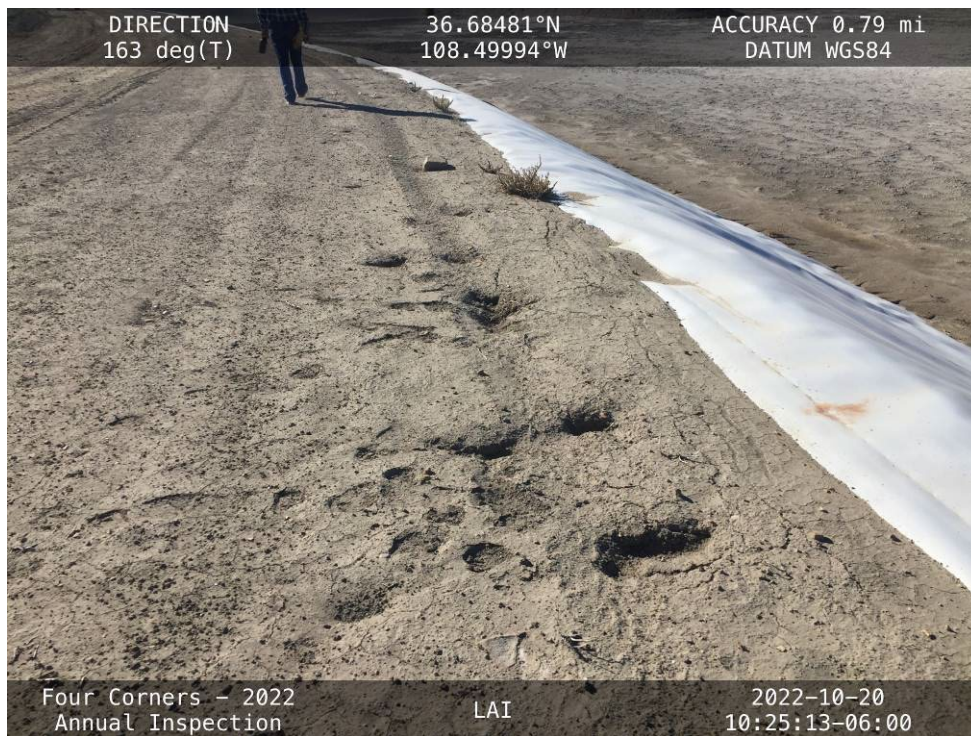
20221020 – IMG_4567

A series of shallow holes in the East Embankment anchor trench, facing south.

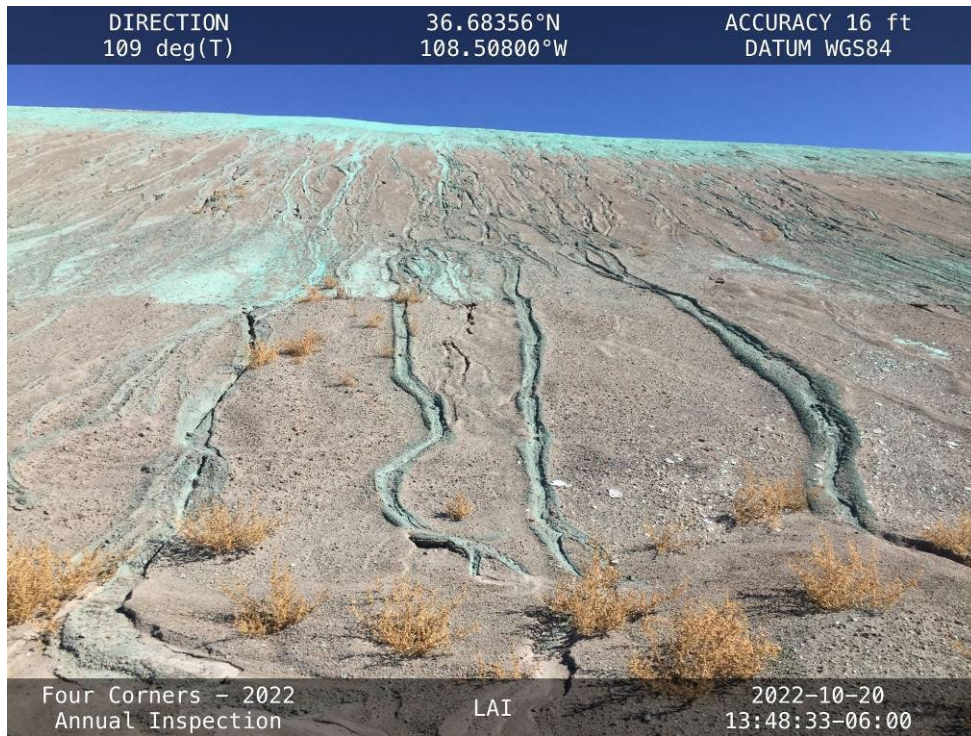
20221020 – IMG_4874
Erosion rills on the West Embankment covered with dust suppressant.

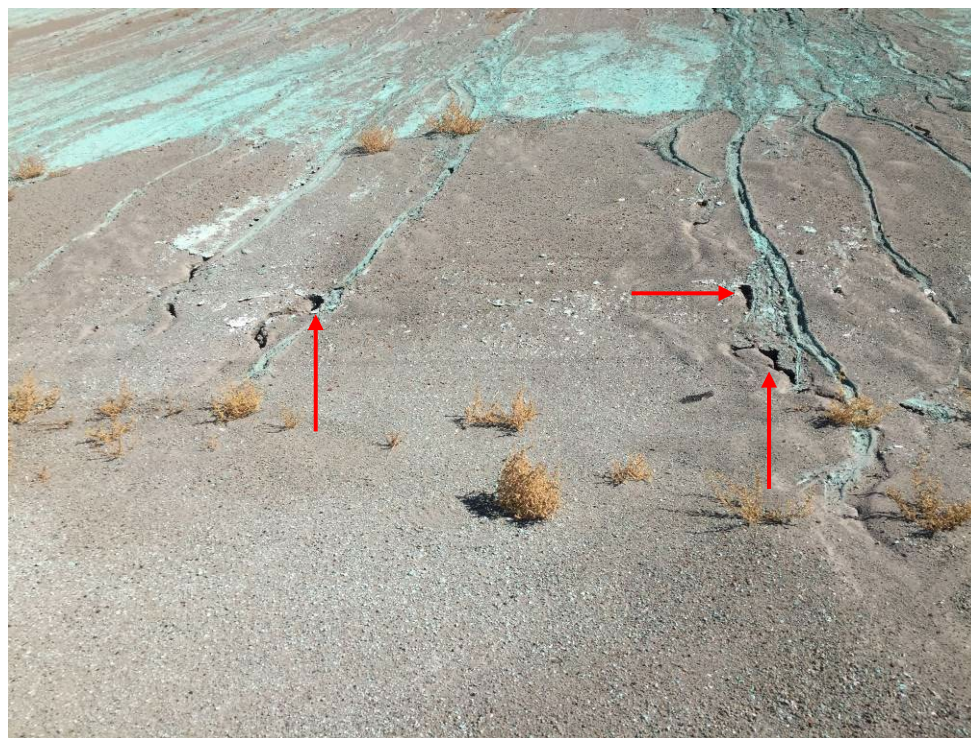
20221020 – IMG_4876
Erosion rills on the West Embankment, undermined beneath the dust suppressant.

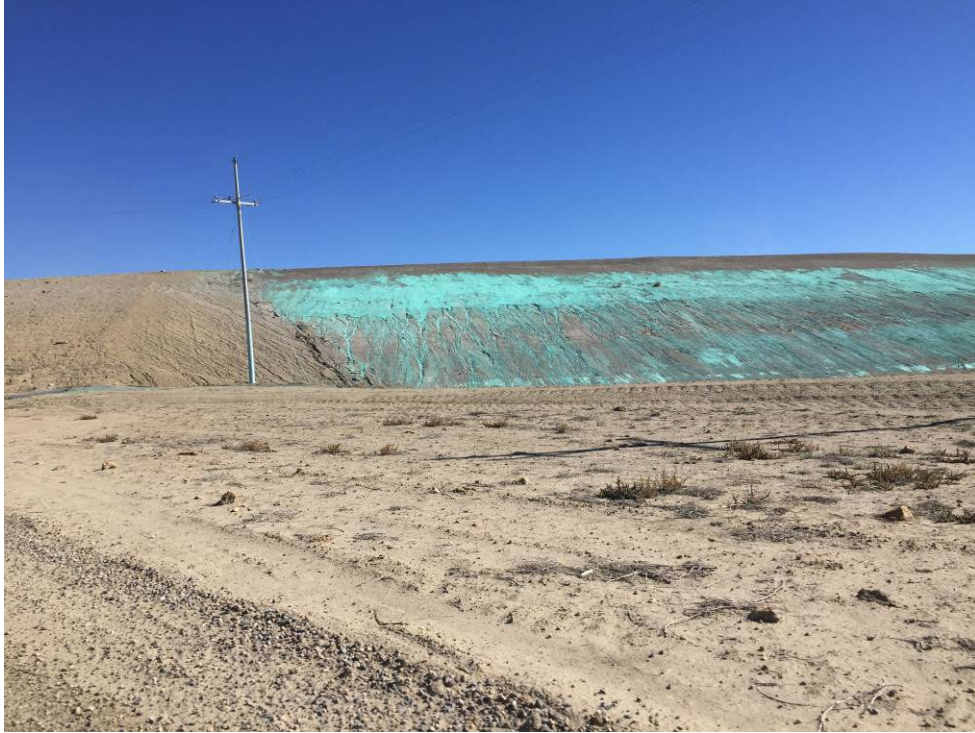
20221020 – IMG_4907

An erosion rill at the junction of the Northwest Embankment (soil) and the West Embankment (ash).

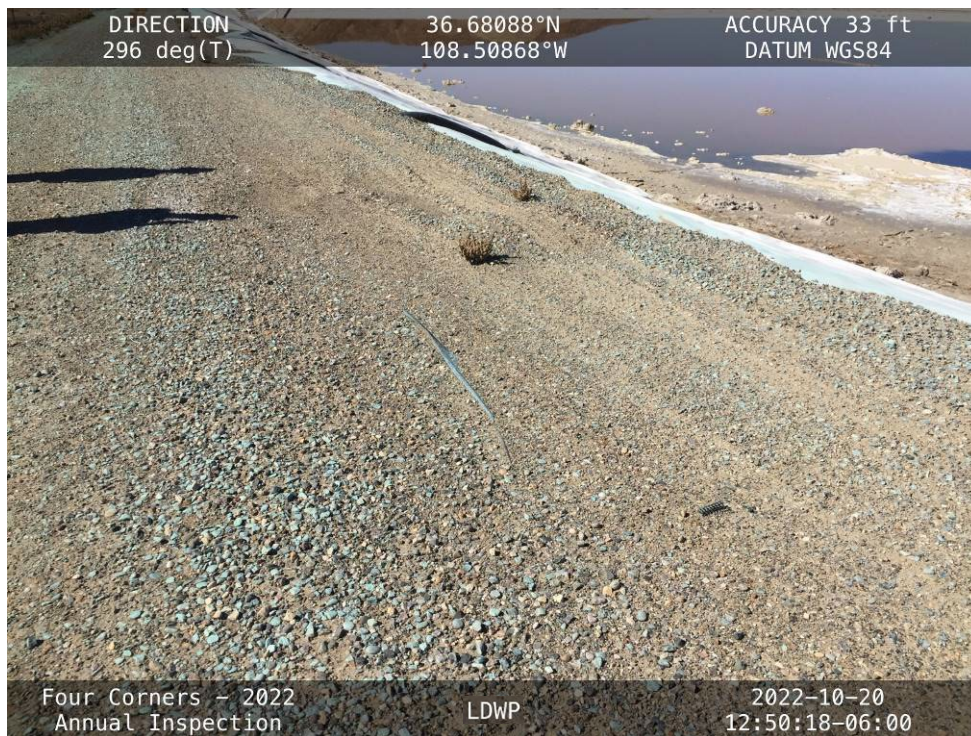
20221020 – IMG_4752

A rut in the crest of the South Embankment.

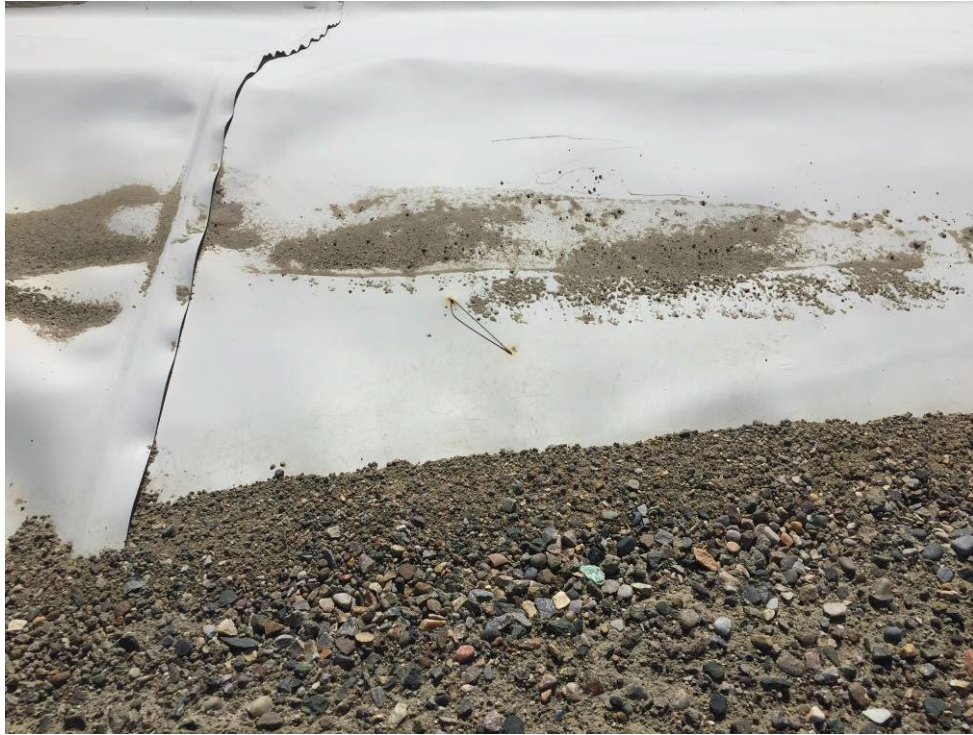
20221020 – IMG_4810

A hole in the liner along the North Embankment marked with a pin flag.

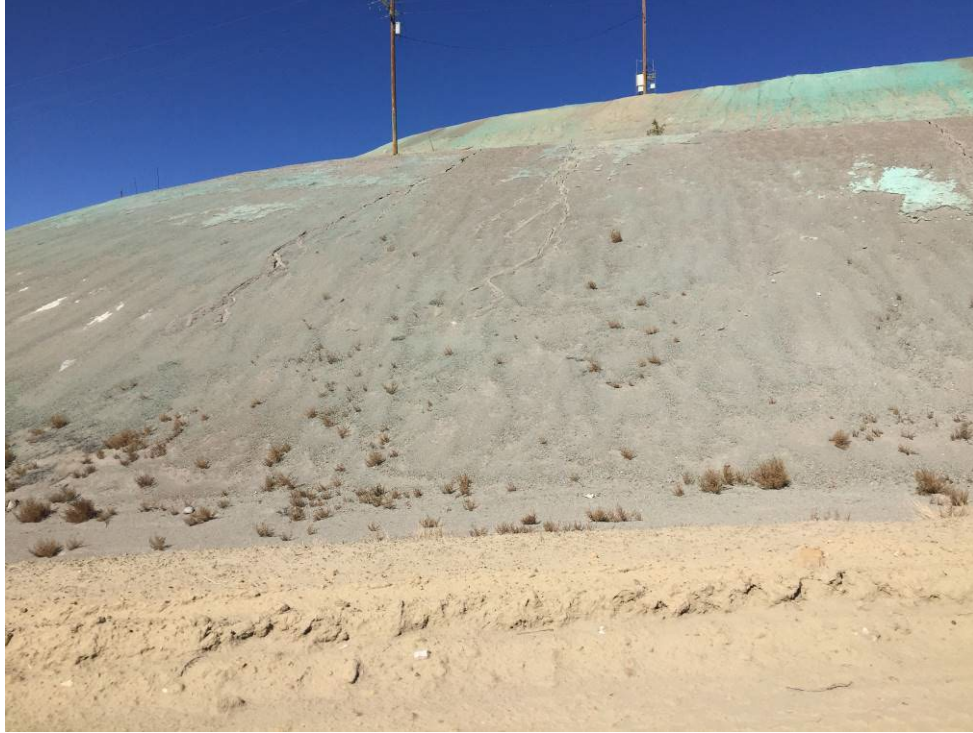
20221020 – IMG_4888

New and repaired erosion on the downstream slope at the western end of the South Embankment.

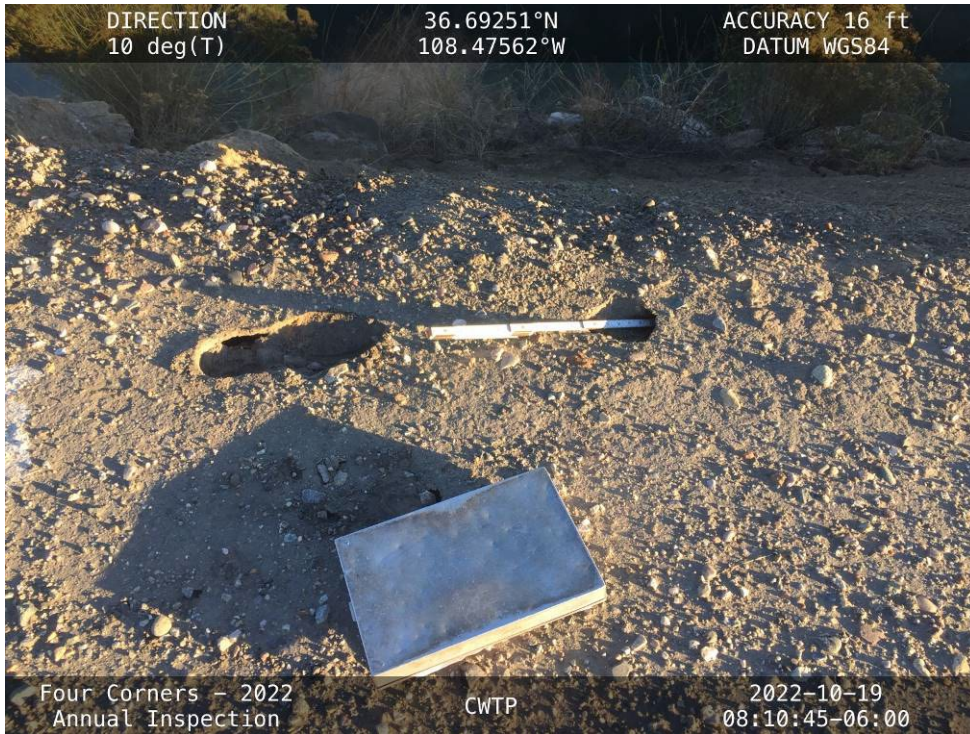
20221019 – IMG_4002

Loose soil and a 6-inch deep erosion hole on the downstream shoulder of the North Embankment.

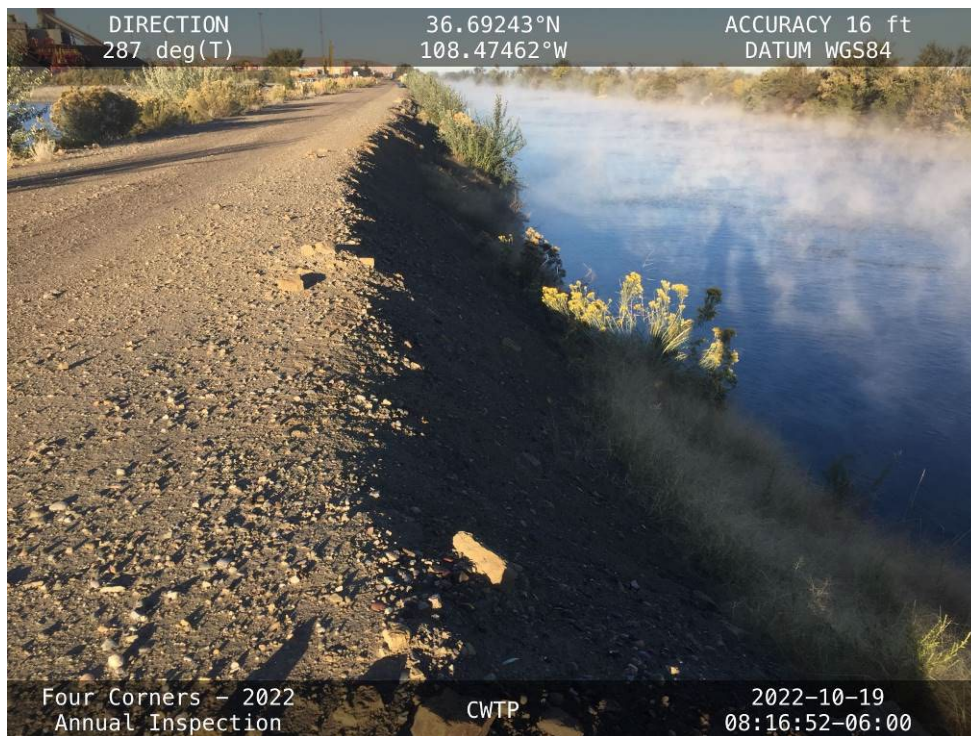
20221019 – IMG_4017
Erosion beneath a riprap boulder on the downstream slope.

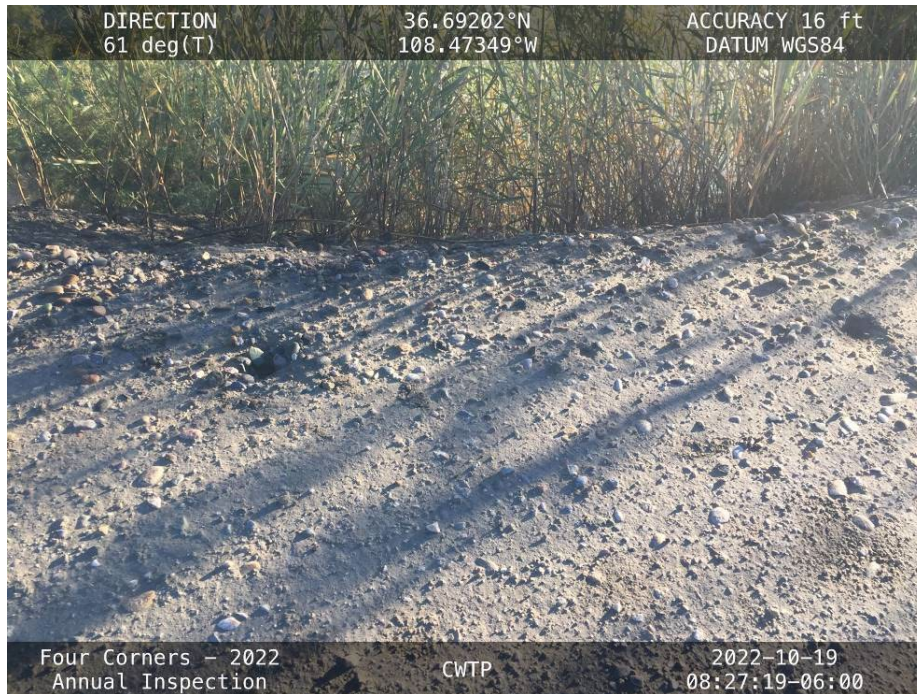
20221019 – IMG_4021

Two small erosion holes on the downstream shoulder of the East Embankment crest. These erosion holes were also observed during the 2021 inspection (2021 Photo IMG_8375).

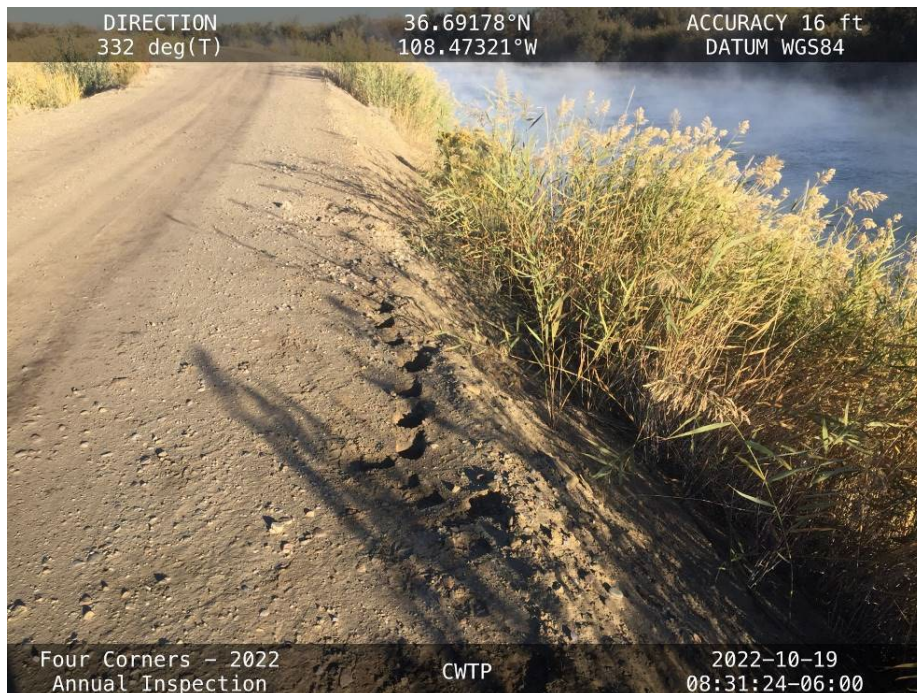
20221019 – IMG_4030

A stretch of loose soil near the 7-inch-deep erosion hole observed in 2021 (2021 IMG_8359) and a previous 11.5-foot-long crack observed in 2018 and 2020.

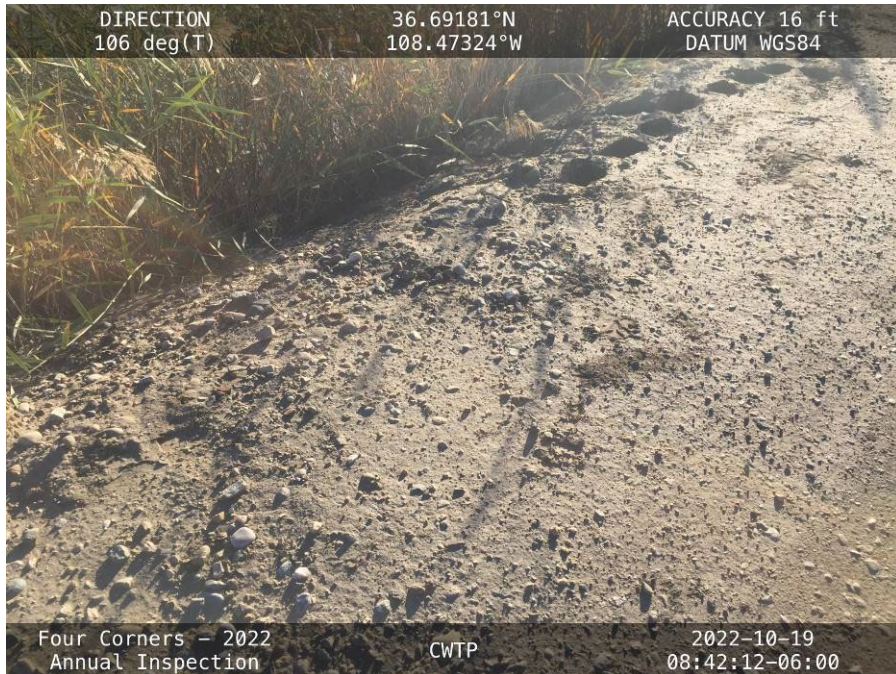
20221019 – IMG_4049

A zone of loose material on the upstream half of the crest also observed during the 2020 and 2021 inspections.

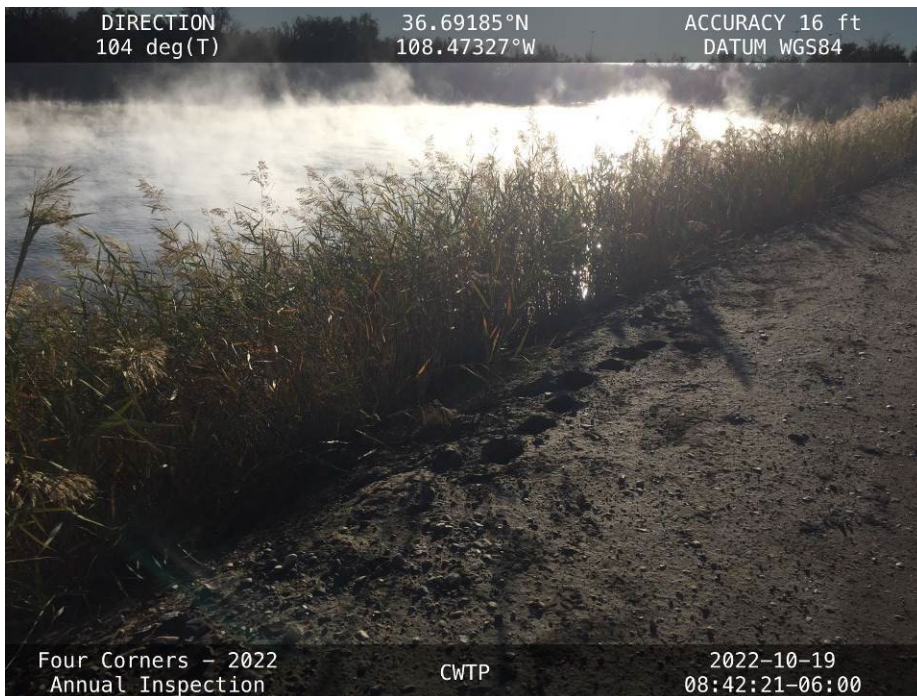
20221019 – IMG_4056

A zone of loose material on the upstream half of the crest also observed during the 2020 and 2021 inspections near the location of the 11.5-foot long tension crack observed during the 2020 and 2018 inspections.

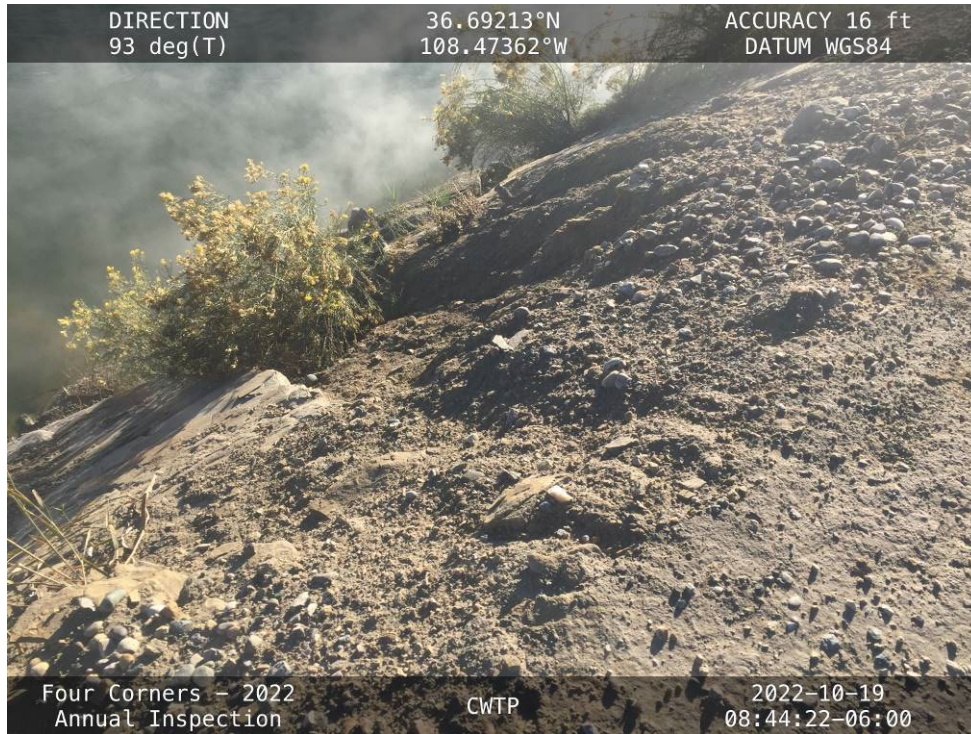
20221019 – IMG_4061

Erosion around riprap boulders along the downstream slope of the East Embankment.

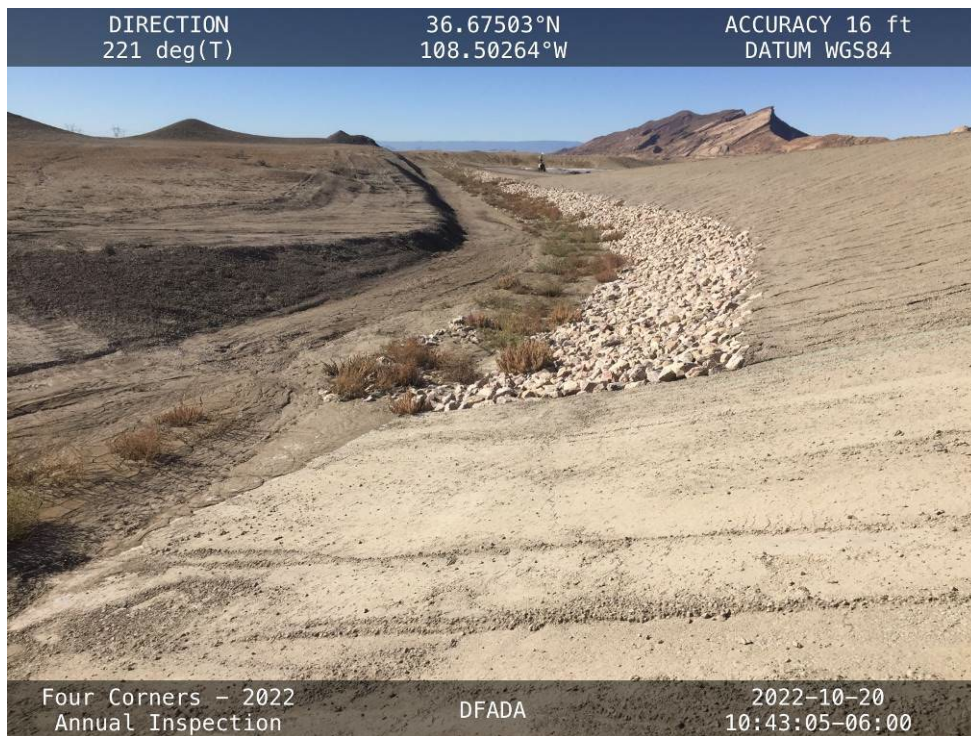
20221020 – IMG_4628
The headwall at the new outlet for the Stormwater Diversion Channel, buried in sediment.

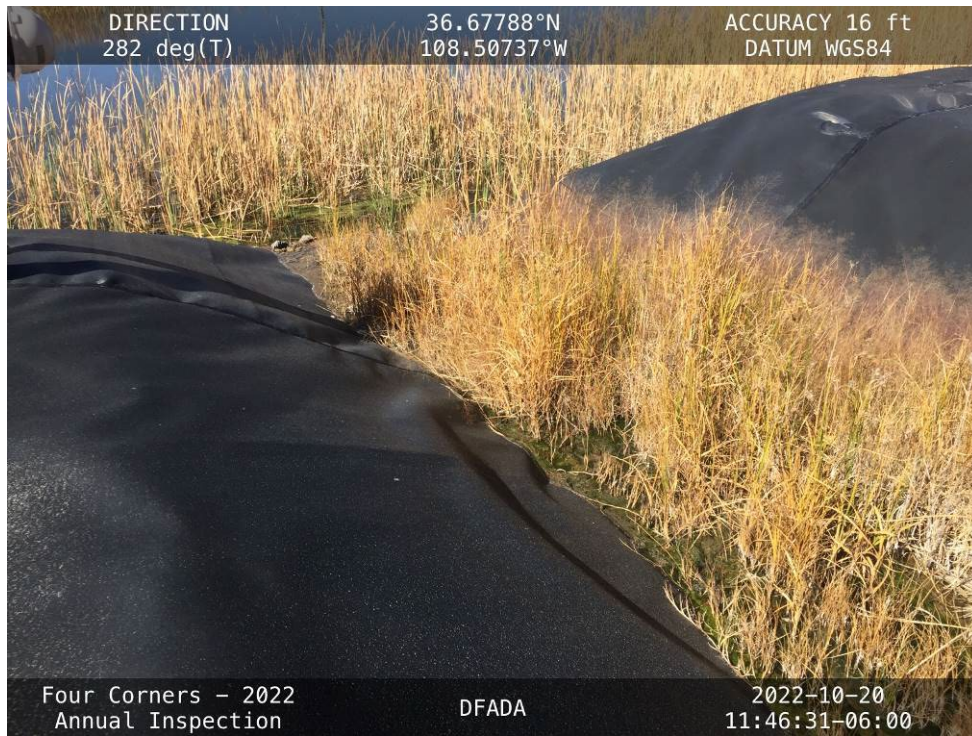
20221020 – IMG_4674

The drainage channel to the Cell 1 leachate collection pond, filled with sediment and grasses.

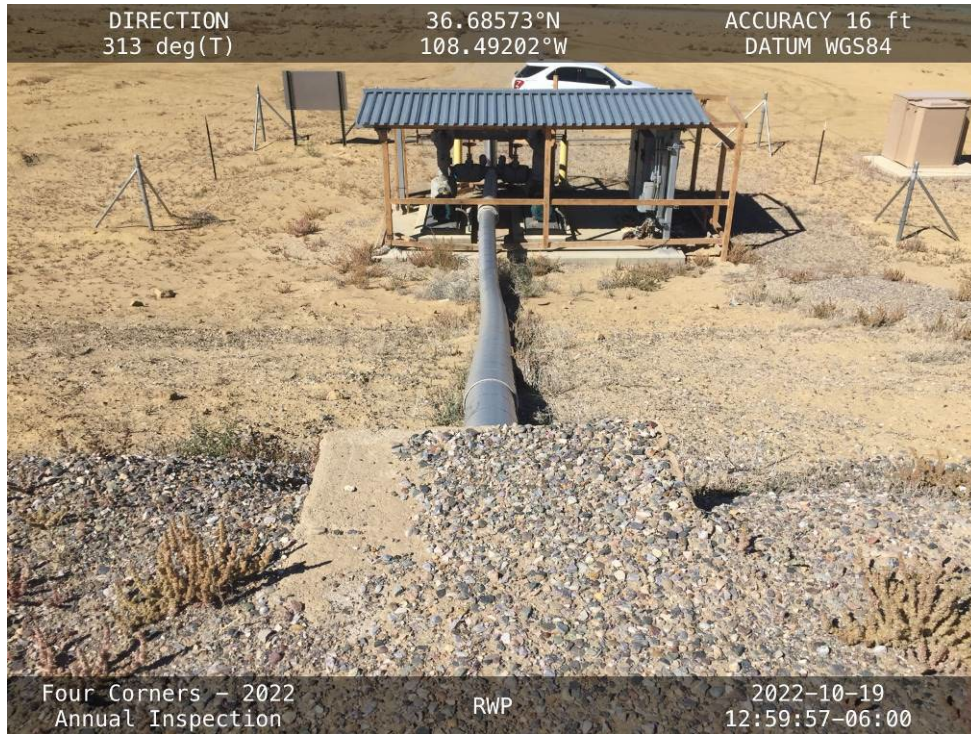
20221019 – IMG_4309

The return water pipe and pumps along the downstream slope of the Northwest Embankment.

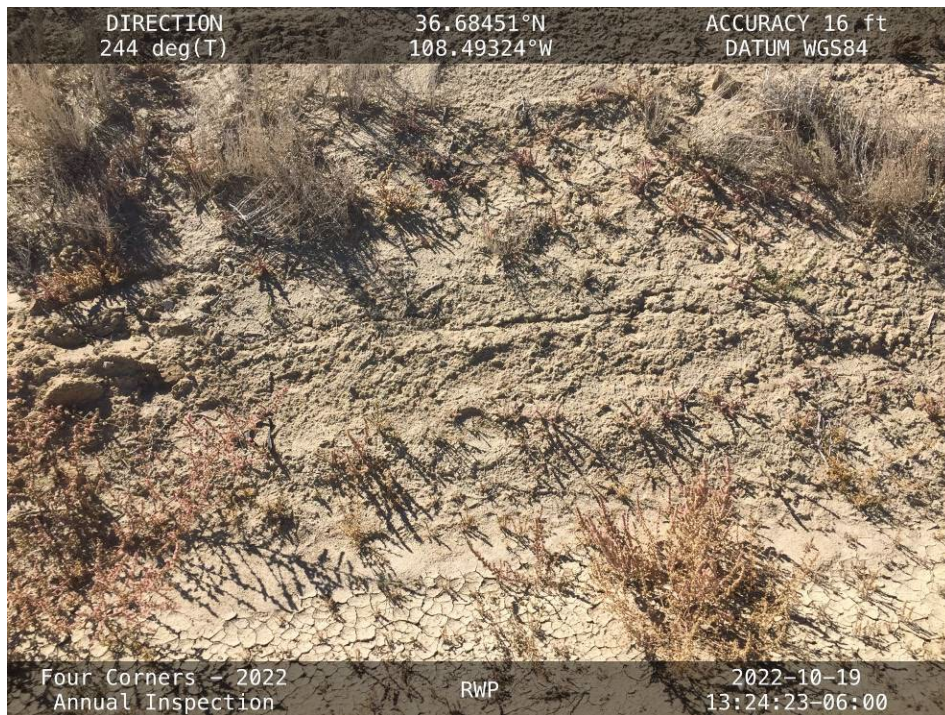
20221019 – IMG_4356

Smaller tension cracks on the slope of the drainage ditch along the western corner of the pond compared to the 2021 inspection.

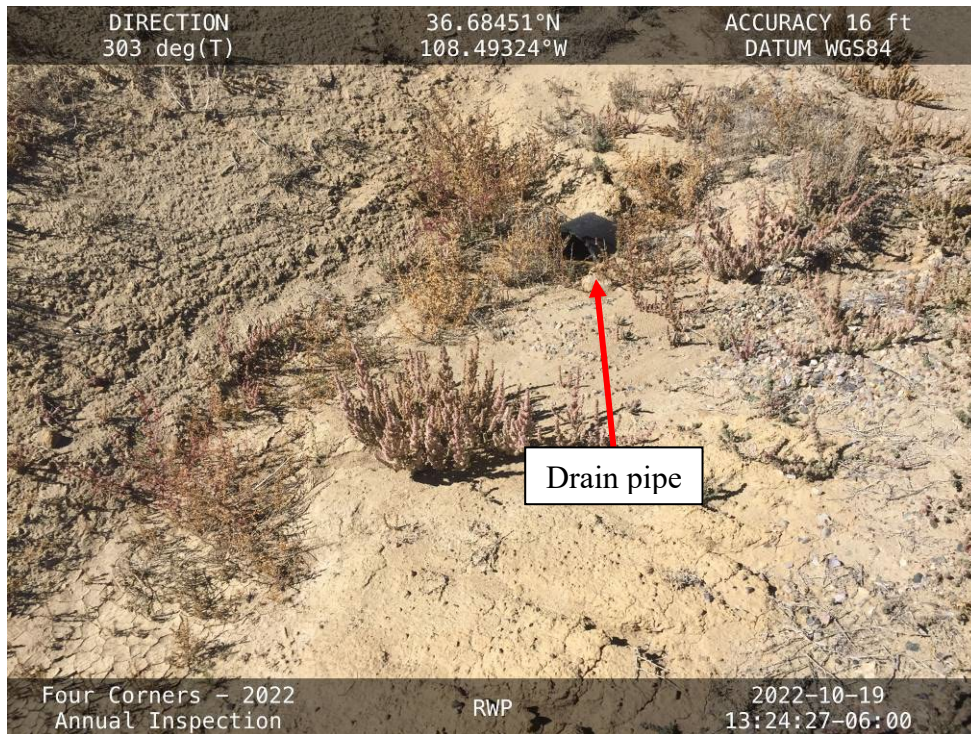
20221019 – IMG_4357
Sediment filling the drainage ditch on the western corner of the RWP.
