**FOUR CORNERS POWER PLANT  
Lined Ash Impoundment,  
Lined Decant Water Pond,  
Combined Waste Treatment Pond,  
Dry Fly Ash Disposal Area,  
and Return Water Pond**

**Annual  
CCR Impoundment and  
Landfill Inspection Report  
2023**

**GENERATION ENGINEERING  
Design Engineering  
P.O. BOX 53999  
PHOENIX, ARIZONA 85072**

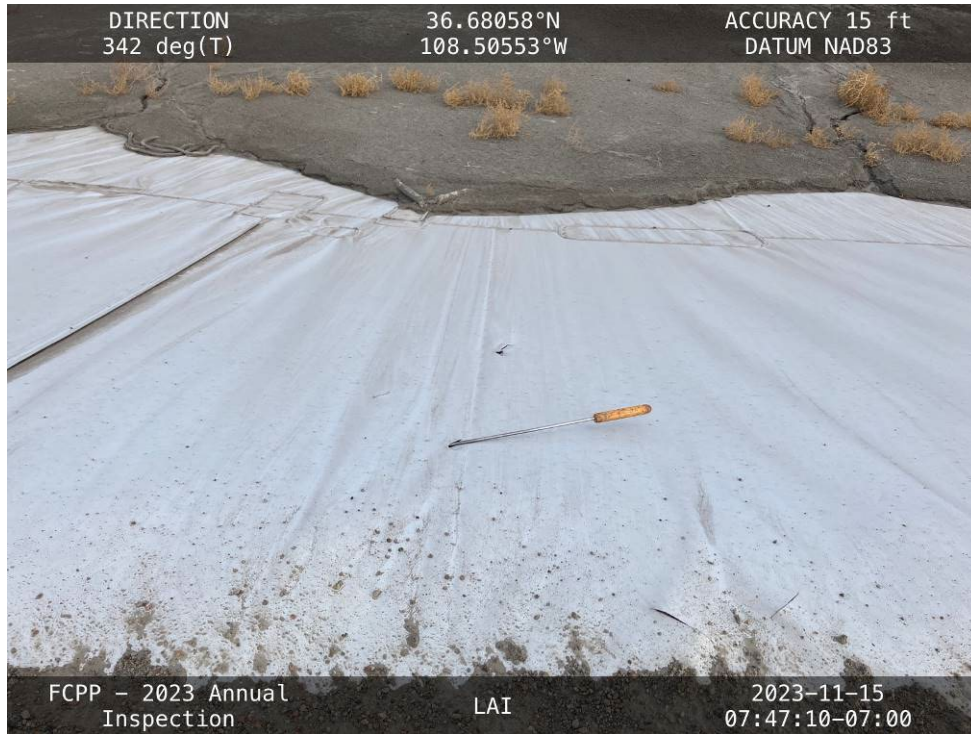
**20231115 – IMG\_2311**

- v. There are several tears, cuts, and torn seams in the liner along the upstream slope. Two tears and all of the torn seams are on the South Embankment near the Southwest Corner (Photos IMG\_2306, IMG\_2311, IMG\_2325, IMG\_2327) appear to be due to tension in the liner as they occur along the horizontal seams associated with the final embankment raise. Unlike the 2022 inspection, the torn seams were not leaking water; however, the liner on the South Embankment is very tight. The tension could be released by excavating the anchor trench, pulling extra liner out to provide slack, and backfilling the trench. Repair the tears to prevent water from infiltrating underneath the line.

Two tears in the liner in the Southwest Corner, near the staff gauge. Also observed during the 2022 inspection.

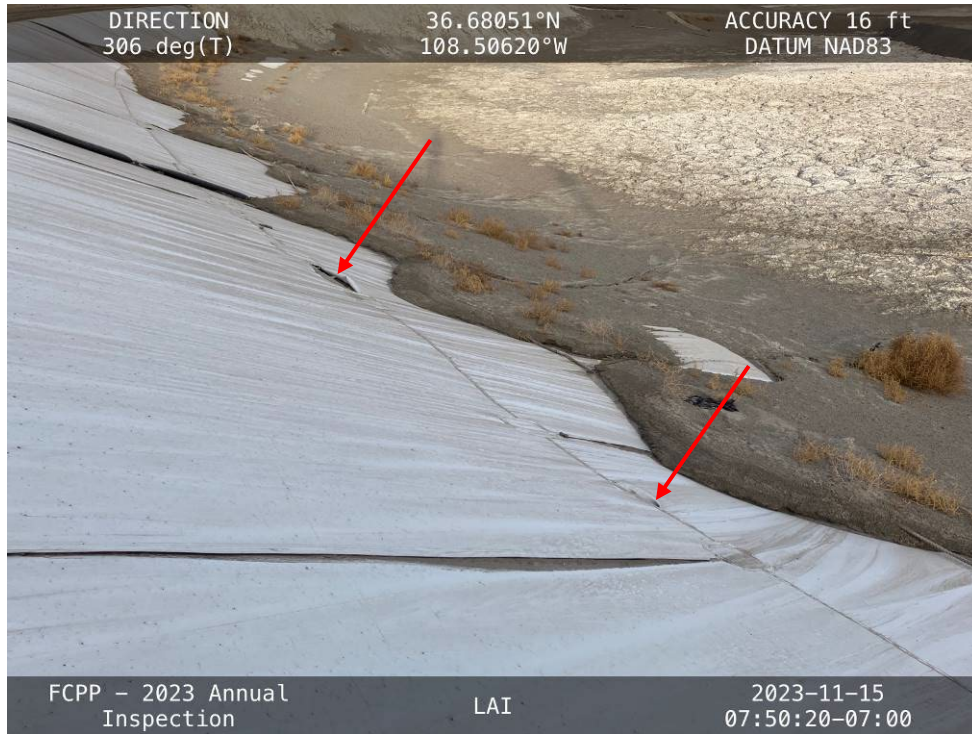
**20231115 – IMG\_2325**

Undulations in the liner and tears along the horizontal seam. Also observed during the 2022 inspection.

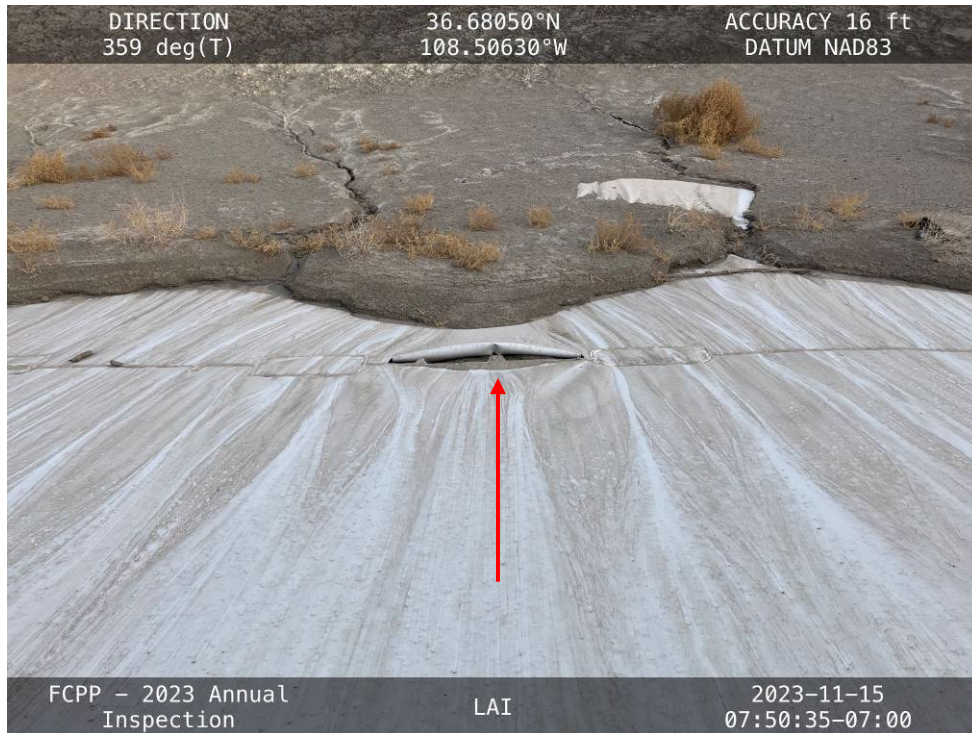
**20231115 – IMG\_2327**

A tear along the horizontal seam in the Southwest Corner. Also observed during the 2022 inspection.

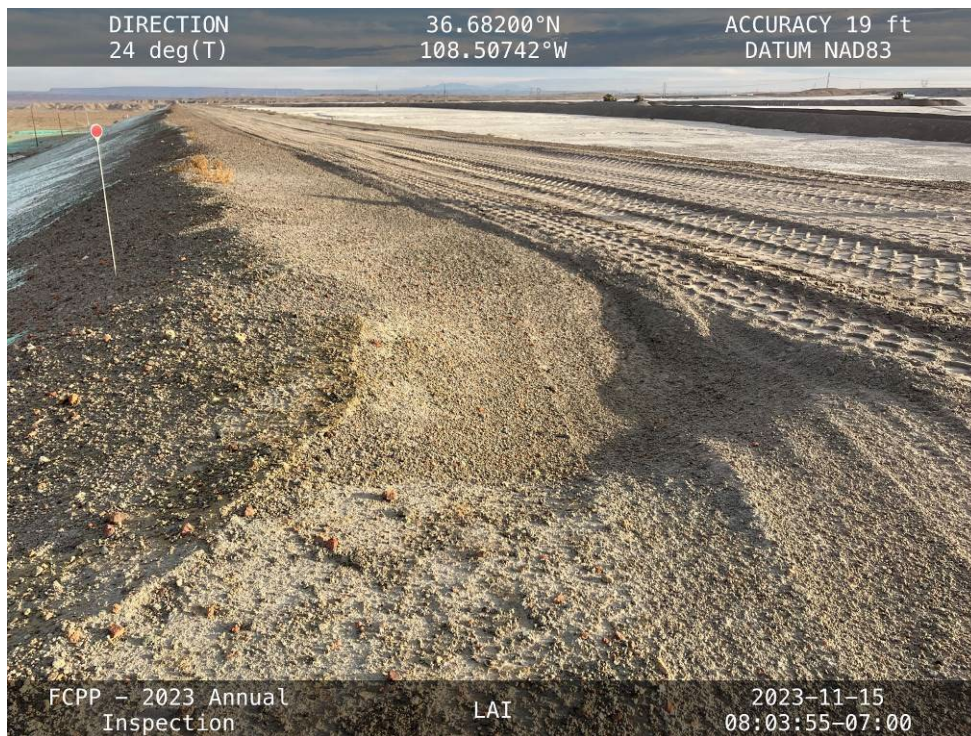
**20231115 – IMG\_2361**

- iv. Ruts and a depression were observed along the West Embankment (Photos IMG\_2361 and IMG\_2376). The rut in the middle of the West Embankment in IMG\_2376 was caused by haul trucks that are taking ash to the impoundment to construct access roads. This rut is in the area of the crest that was reinstated as described in comment i. The depression on the downstream shoulder of the West Embankment near the southern access ramp may be the result of erosion at the ramp/crest interface or the result of trucks driving into a less-compacted zone of ash. Regrade the West Embankment crest and instruct haul truck

A depression on the downstream shoulder of the West Embankment near the southern access ramp.

operators to vary their travel paths to prevent creating ruts. Repair the depression near the southern access ramp.

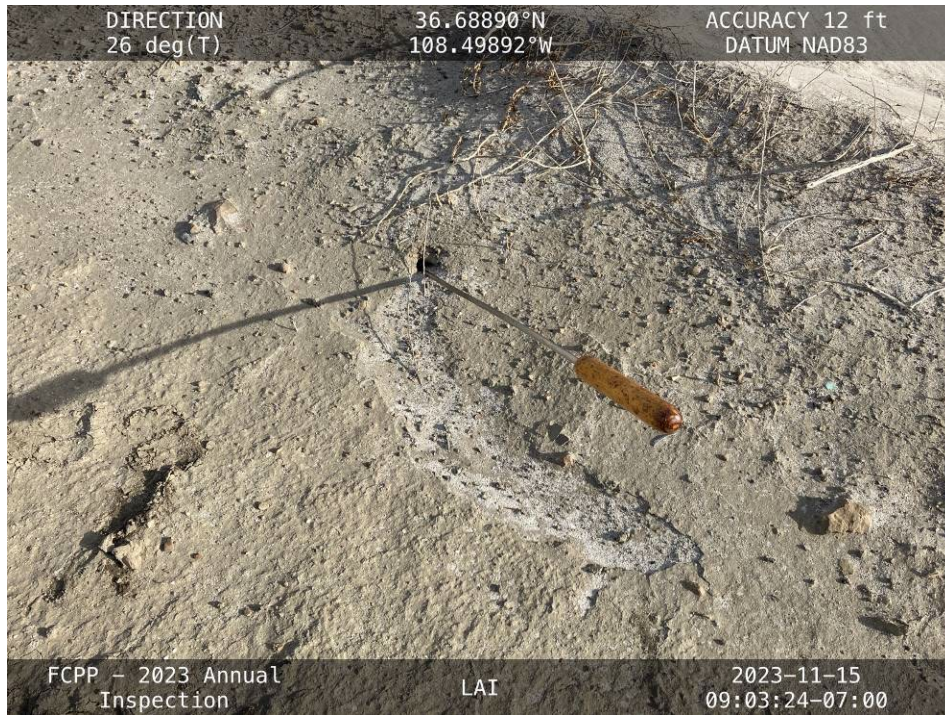
**20231115 – IMG\_2451**

An erosion hole on the downstream shoulder of the East Embankment crest near where erosion was observed during the 2022 inspection.

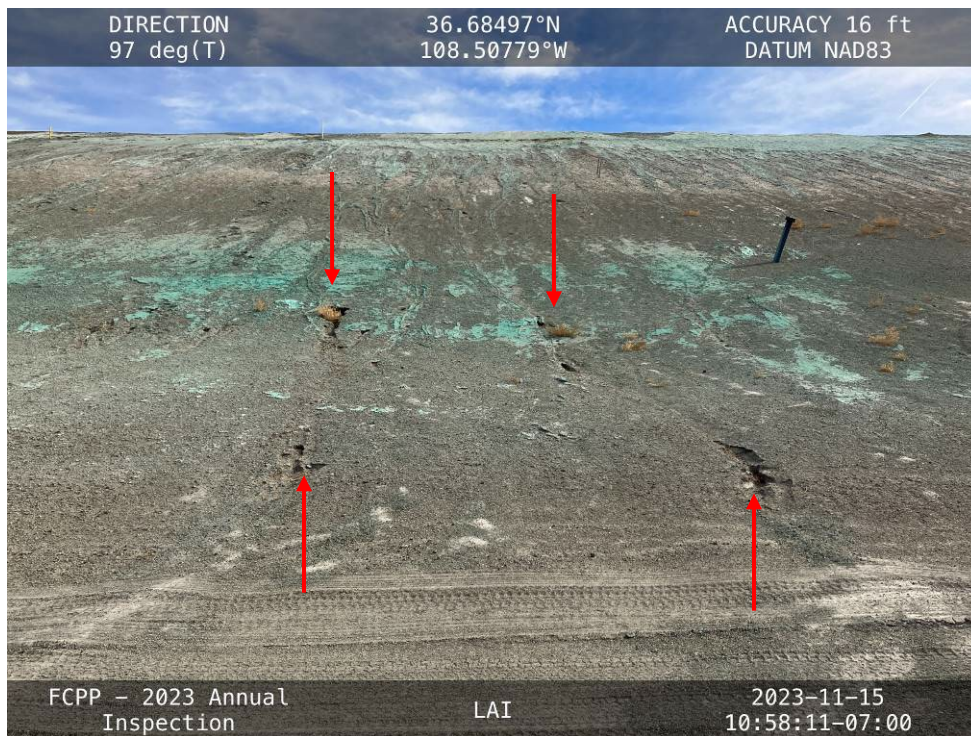
**20231115 – IMG\_2655**

Erosion is present along the downstream toe and the lower portion of the downstream slope of the West Embankment (Photos IMG\_2391, IMG\_2648, IMG\_2655, IMG\_2691, and IMG\_2693) as evidenced by the erosion rills on the slope and ash deposits on the LDWP crest (Appendix B – IMG\_2685). Some of the erosion is forming tunnels beneath the dust suppression agent applied on the slope (IMG\_2693). Repair all erosion that extends deeper than 1 foot.

Erosion forming on the West Embankment.

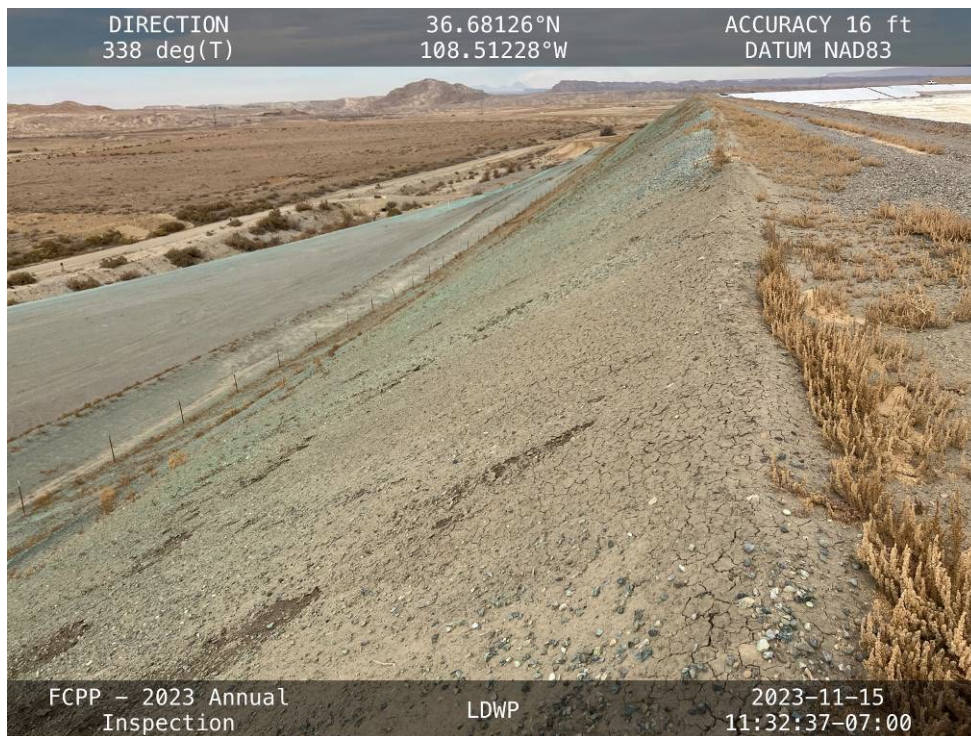
**20231115 – IMG\_2732**

An 11-inch-deep erosion rill on downstream slope of the West Embankment.

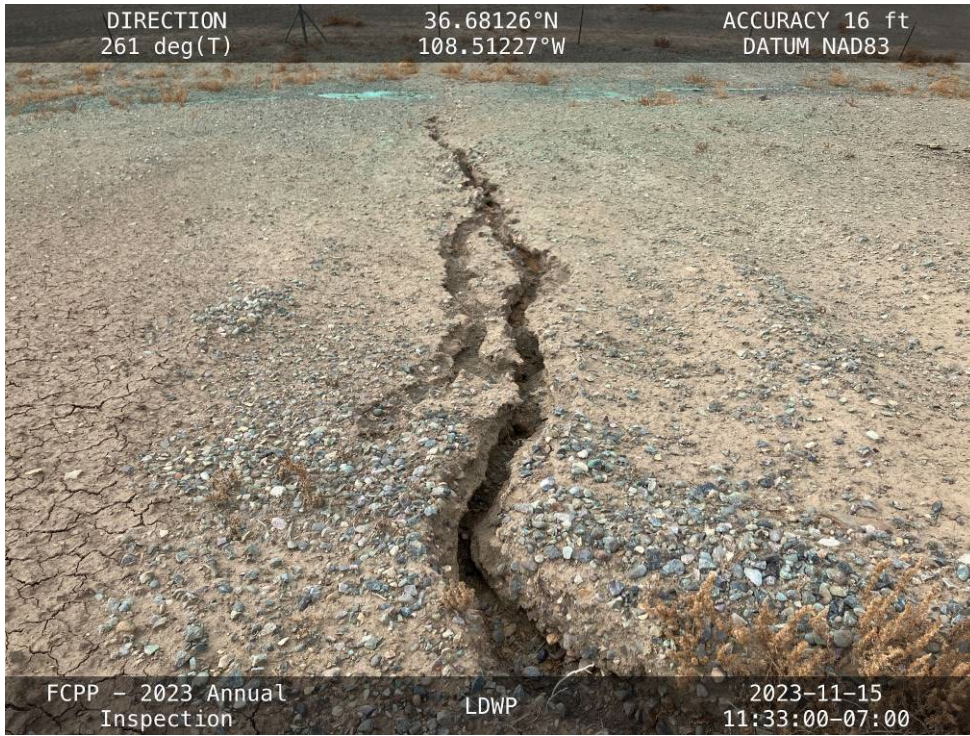
**20231115 – IMG\_2737**

An erosion hole on the downstream shoulder of the West Embankment crest, facing west.

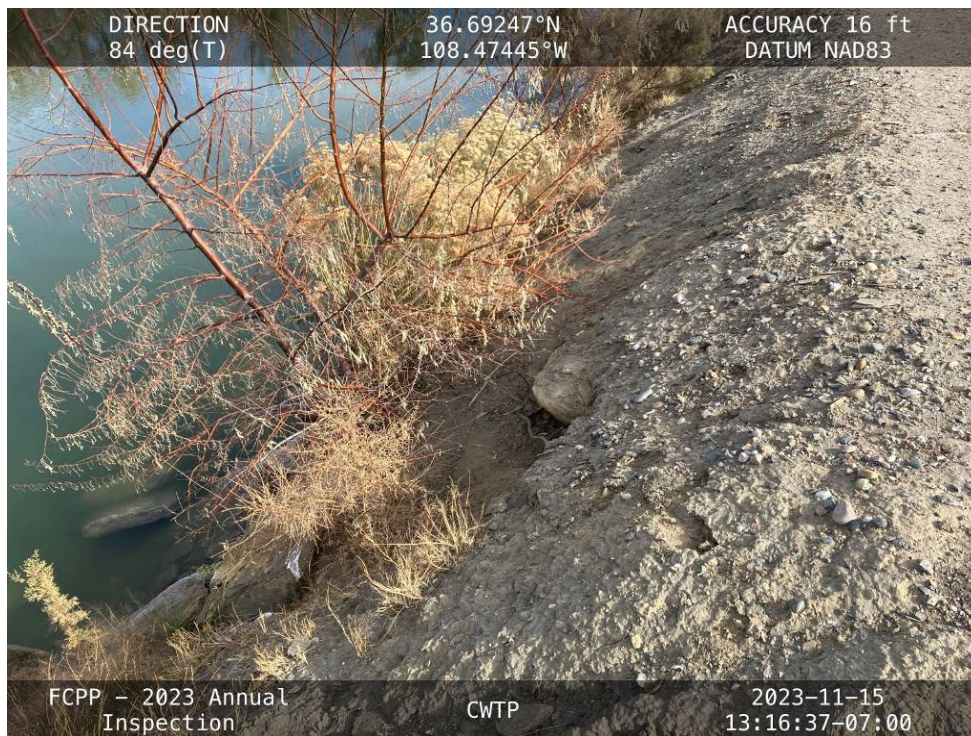
**20231115 – IMG\_2842**

Erosion undermining a riprap boulder on the downstream slope of the North Embankment.

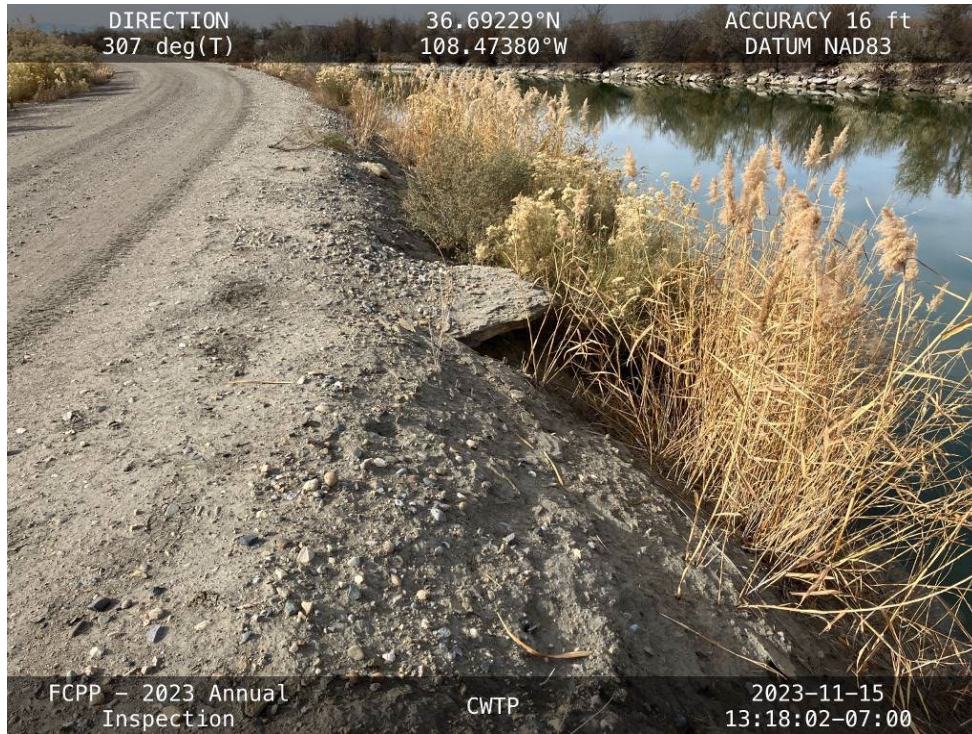
**20231115 – IMG\_2843**

Shallow holes and incipient erosion on the downstream slope of the North Embankment.

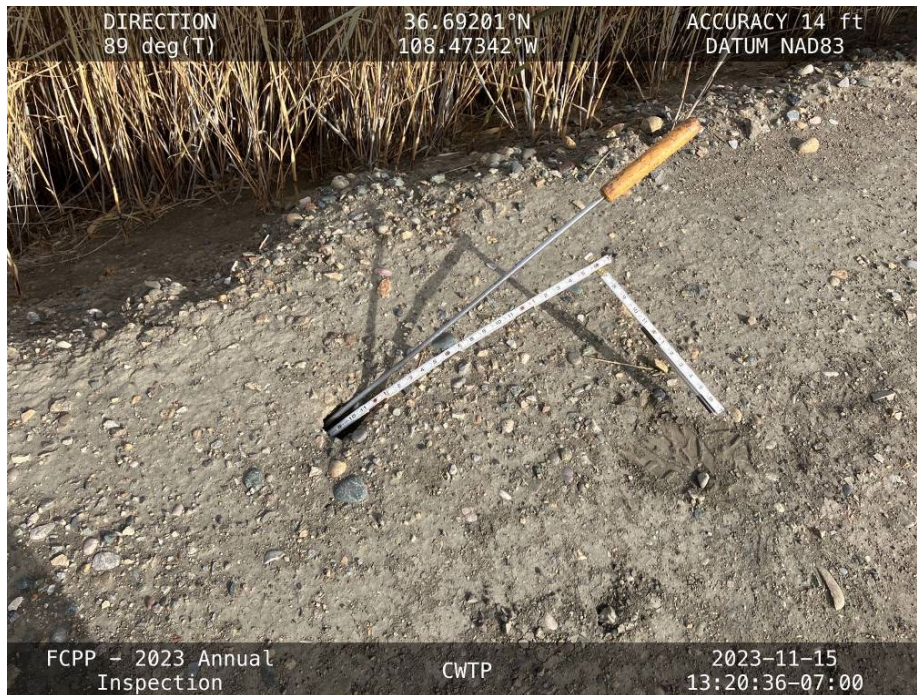
**20231115 – IMG\_2854**

A 1-foot-deep erosion hole on the downstream shoulder of the East Embankment crest.  
Similar erosion holes were also observed during the 2021 and 2022 inspections.

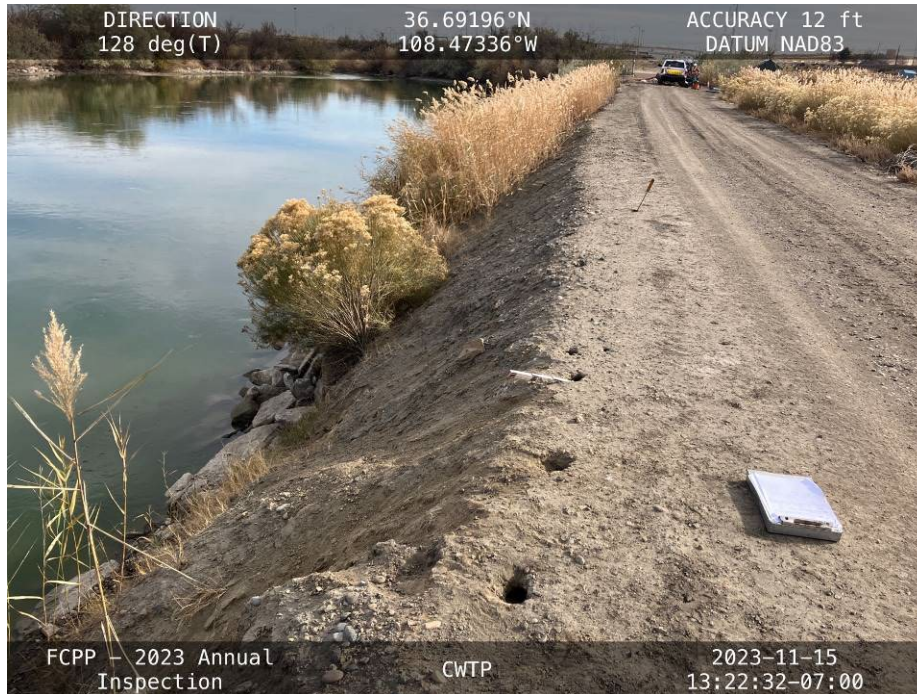
**20231115 – IMG\_2858**

A series of holes up to 1.5 feet deep on the downstream shoulder of the East Embankment crest accompanied by erosion on the downstream slope.

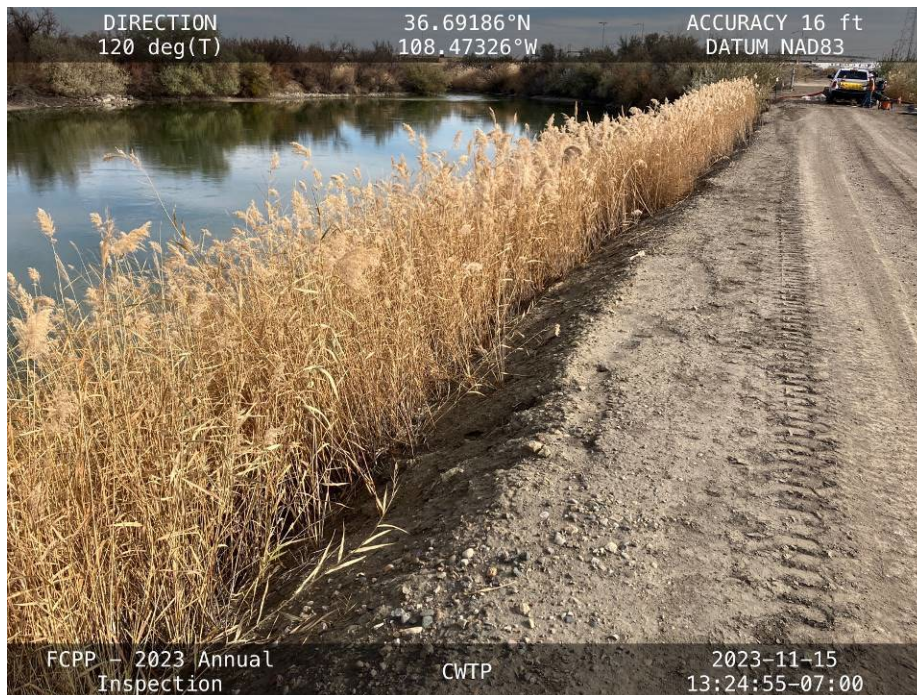
**20231115 – IMG\_2863**

A stretch of loose soil near the 7-inch-deep erosion hole observed in 2021 (2021 IMG\_8359) and a previous 11.5-foot-long crack observed in 2018 and 2020.

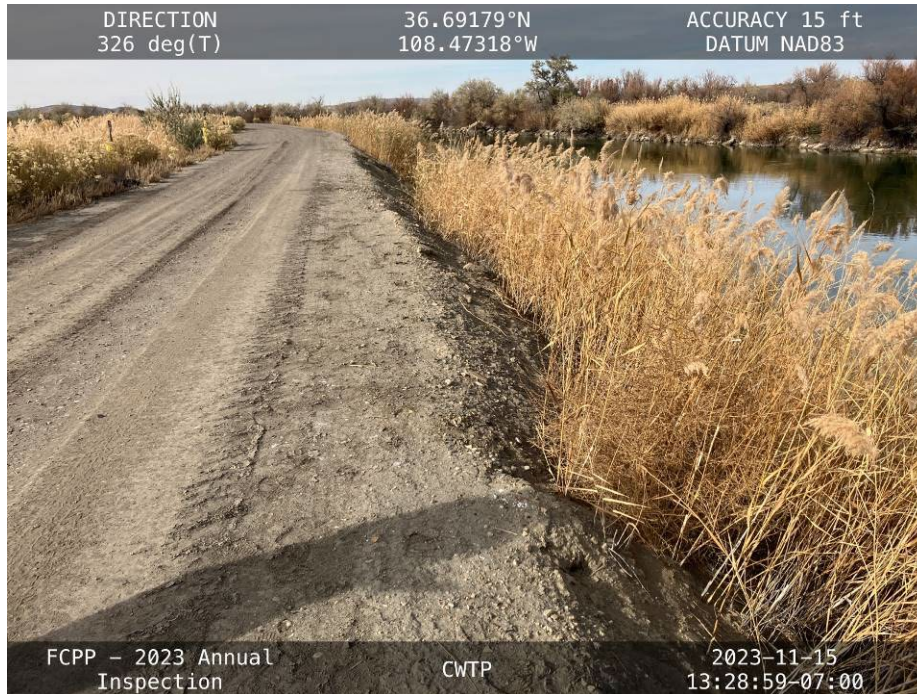
**20231115 – IMG\_2867**

A stretch of loose soil near the 7-inch-deep erosion hole observed in 2021 (2021 IMG\_8359) and a previous 11.5-foot-long crack observed in 2018 and 2020.

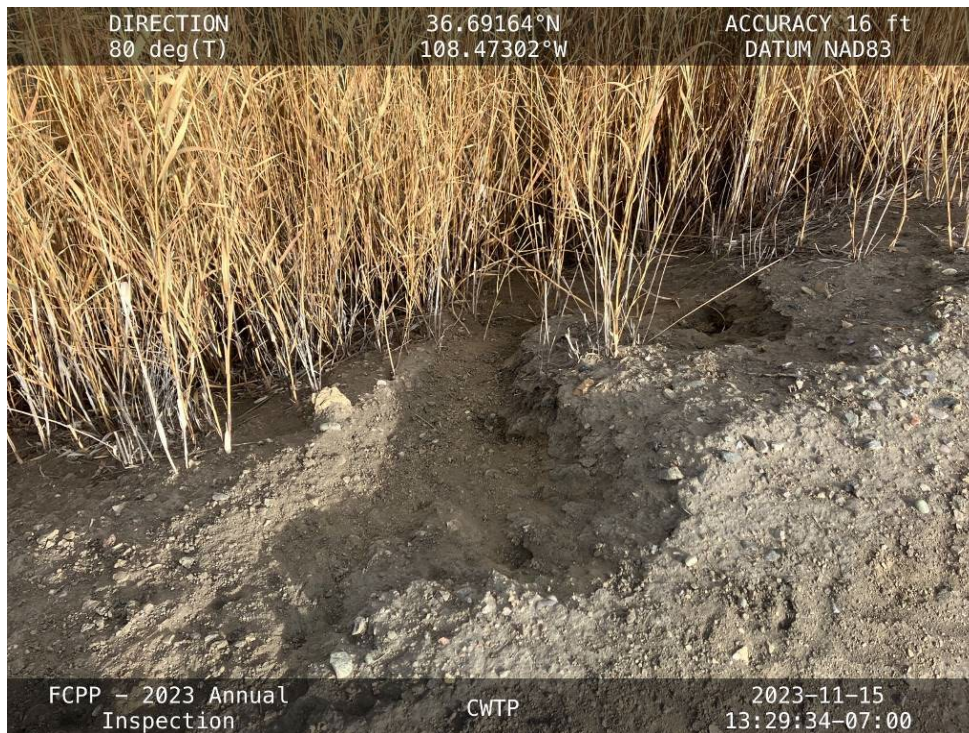
**20231115 – IMG\_2870**

Erosion around reeds growing on the downstream slope of the East Embankment.

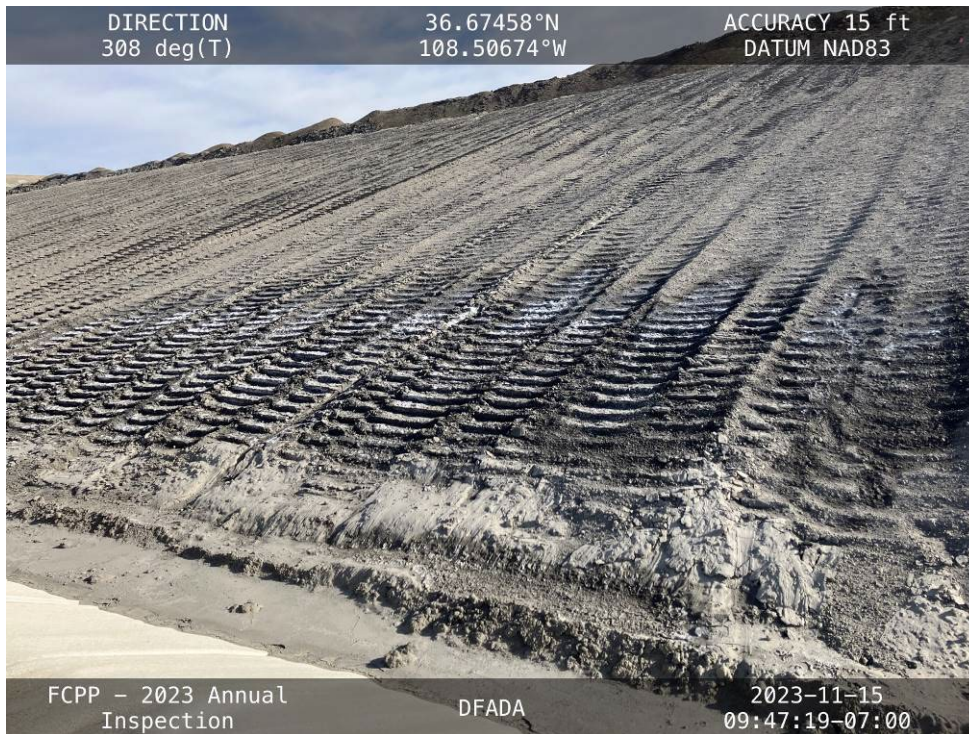
**20231115 – IMG\_2539**

Moisture along the lower portion of the Cell 4 western slope.

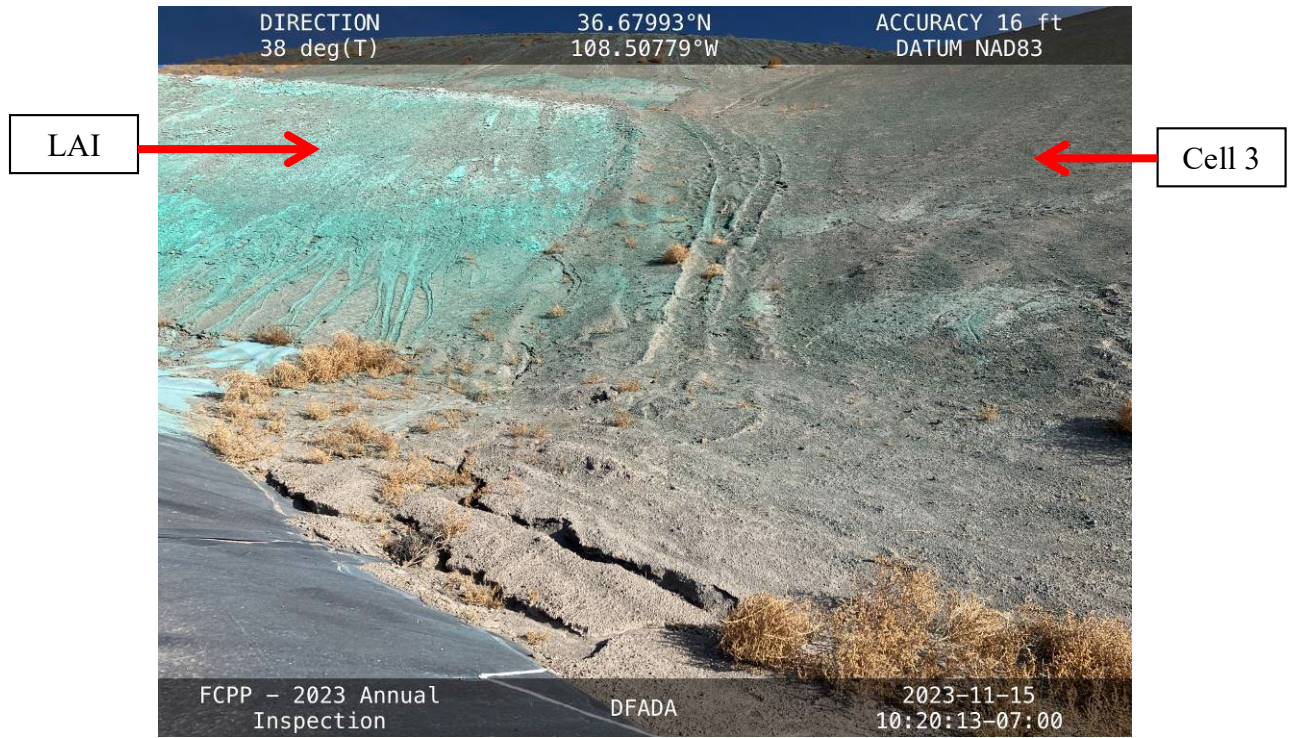
**20231115 – IMG\_2587**

The LAI/Cell 3 groin with evidence of historic erosion on the slope and current erosion at the toe.

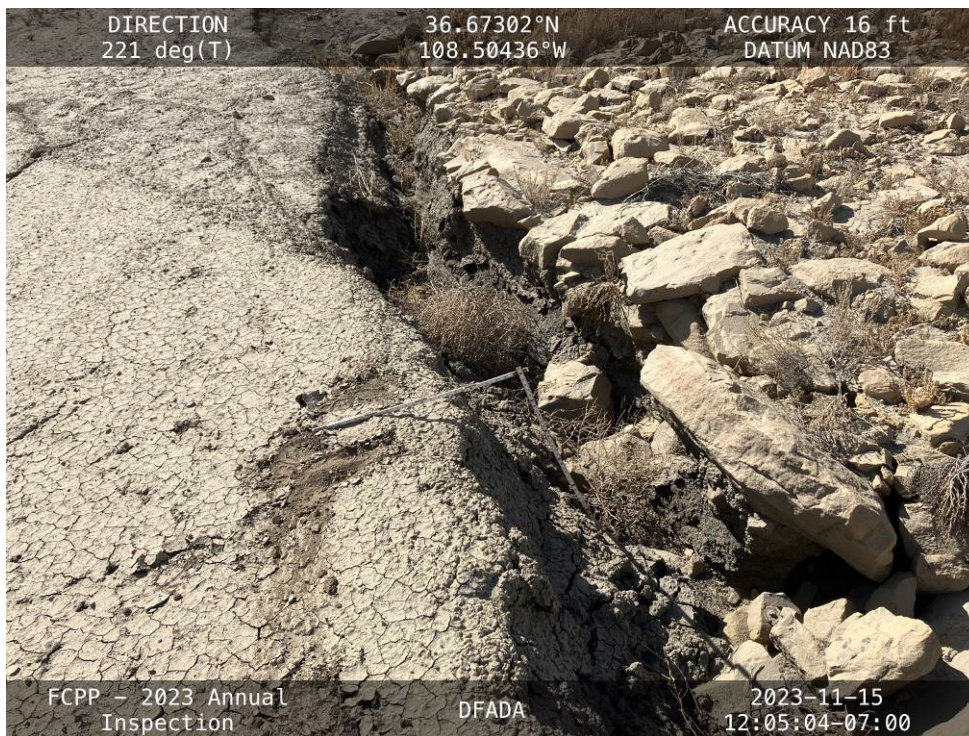
**20231115 – IMG\_2781**  
 3.5 feet of erosion at the outlet for the Stormwater Diversion Channel.

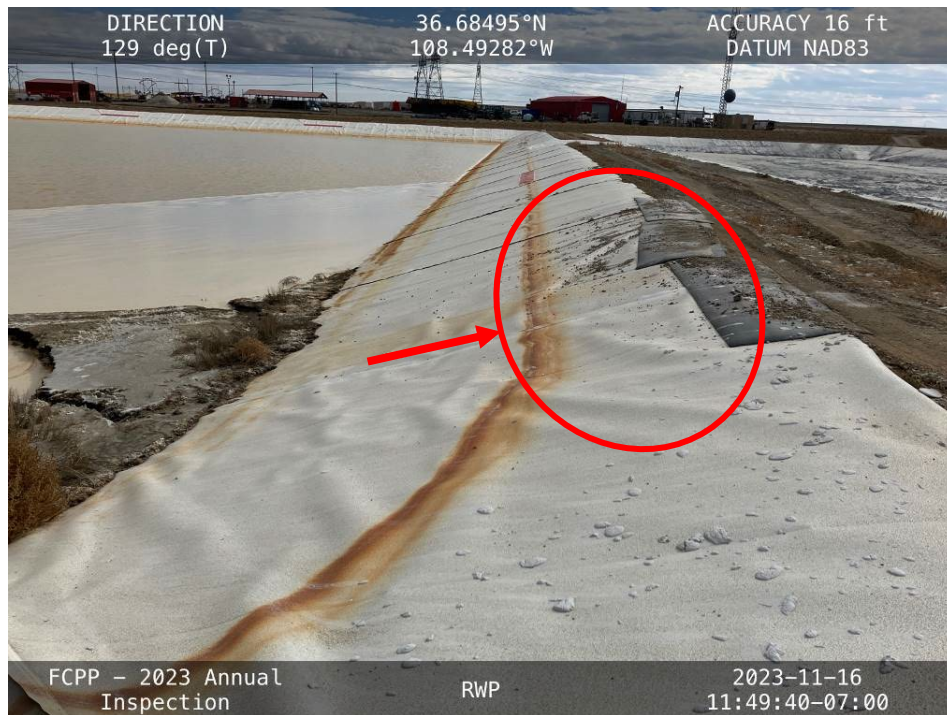
**20231116 – IMG\_3178**

The upstream slope of the RWP Internal Embankment with loose liner where previous construction activity took place (arrow), facing southeast.

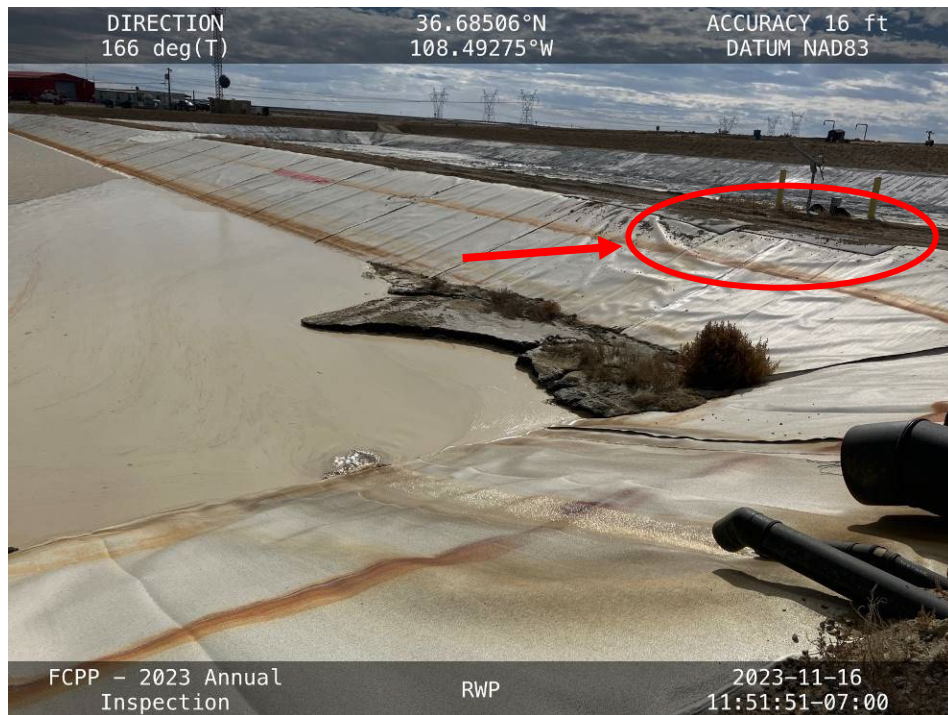
**20231116 – IMG\_3193**  
The western corner of the RWP cell Internal Embankment, with loose liner where previous construction activity took place (arrow).

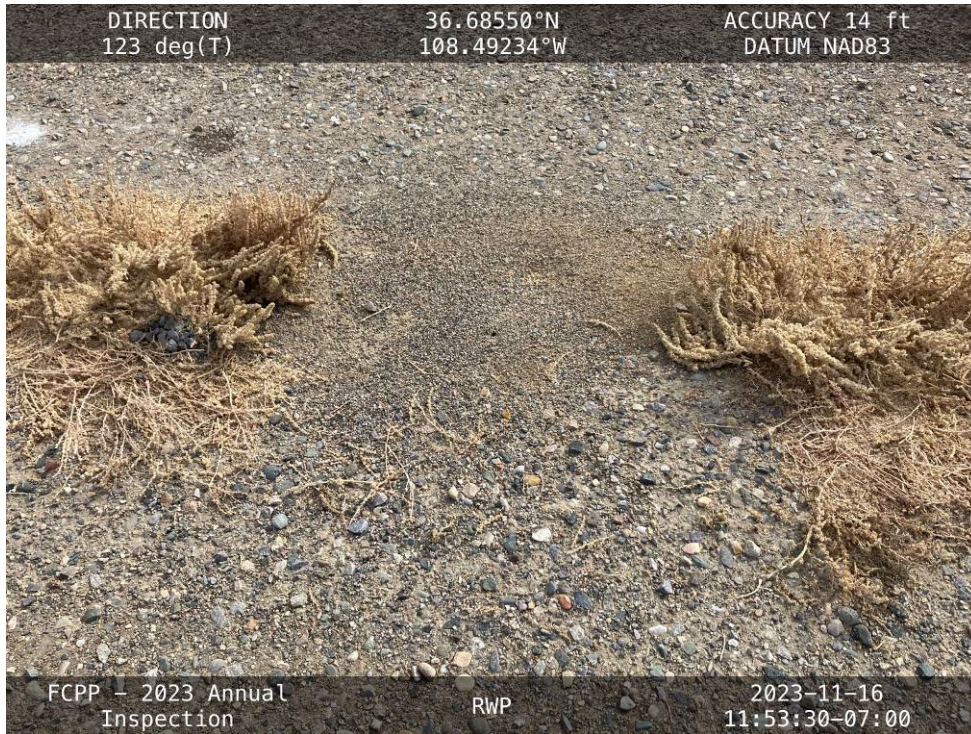
**20231116 – IMG\_3195**  
An ant hill on the RWP Northwest Embankment crest.
