FOUR CORNERS POWER PLANT
Lined Ash Impoundment,
Lined Decant Water Pond,
Combined Waste Treatment Pond,
Dry Fly Ash Disposal Area,
and Return Water Pond

Annual
CCR Impoundment and
Landfill Inspection Report
2024

GENERATION ENGINEERING
Design Engineering
P.O. BOX 53999
PHOENIX, ARIZONA 85072

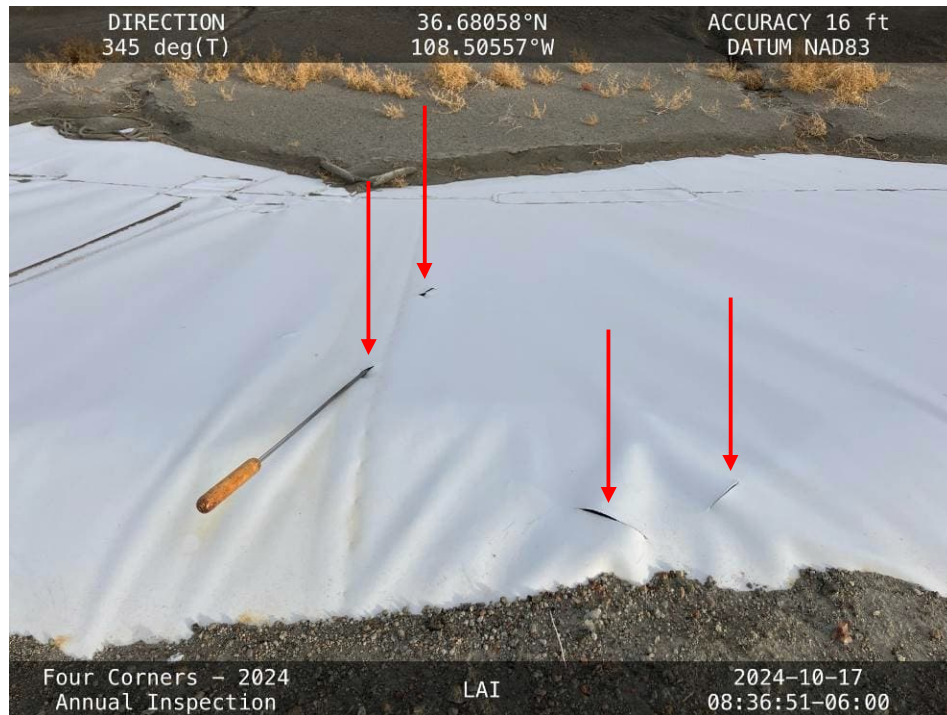
20241017 – IMG_7186

Tears in the liner in the Southwest Corner, near the staff gauge. Also observed during the 2022 and 2023 inspections.

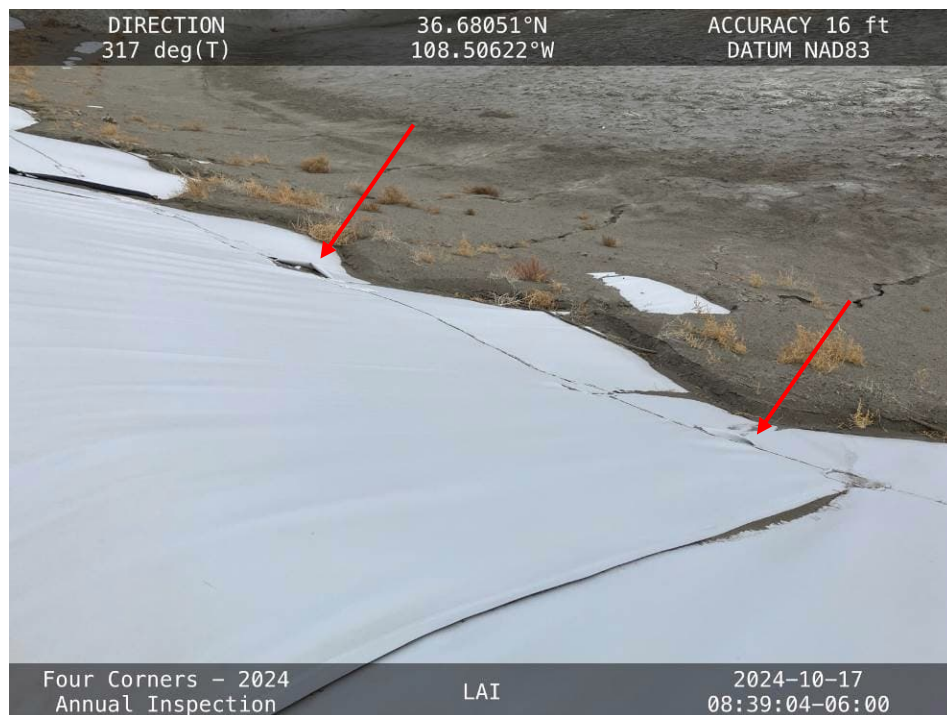
20241017 – IMG_7192

Undulations in the liner and tears along the horizontal seam. Also observed during the 2022 and 2023 inspections.

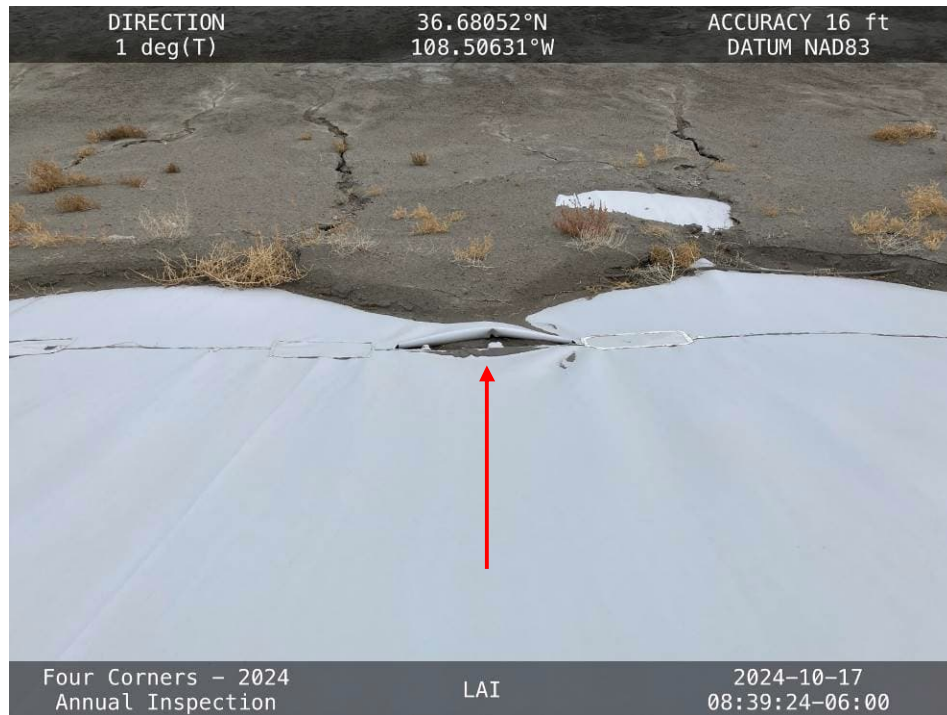
20241017 – IMG_7193

A tear along the horizontal seam in the Southwest Corner. Also observed during the 2022 and 2023 inspections.

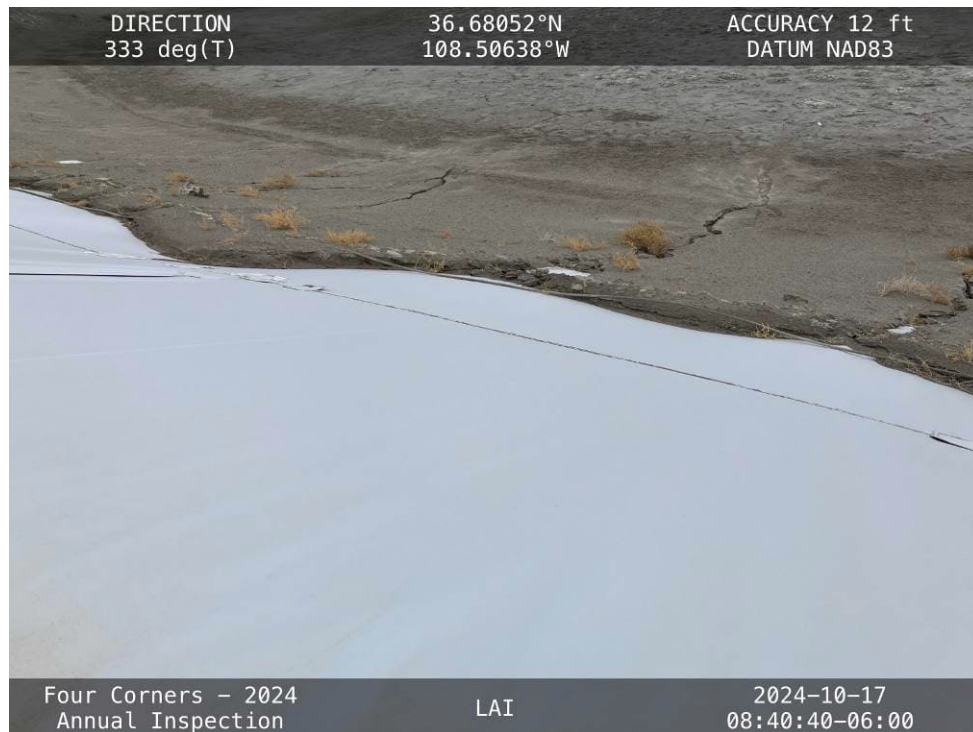
20241017 – IMG_7196

Previous patches along the liner seam separating from the sheet.

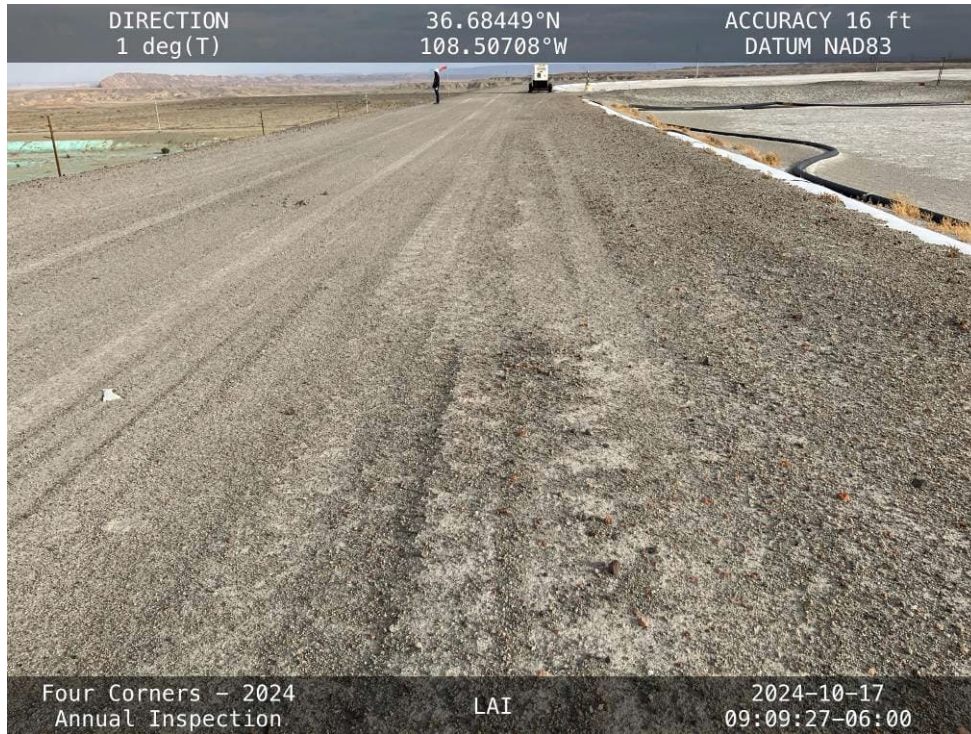
20241017 – IMG_7224

- iv. The ruts and depression observed in the Southwest Corner and along the West Embankment during the 2023 inspection were not present during this inspection (Photo IMG_7224); however, a new 6-inch deep rut was observed along the center of the East Embankment crest (Photo IMG_7309). Continue to monitor the crest for ruts and depressions; repair ruts and depressions that are deeper than 1 foot.
- v. There are several tears, cuts, and torn seams in the liner along the upstream slope (Photos IMG_7186, IMG_7192, IMG_7193) and previously patched locations along the liner seam were observed to be separating from the adjacent sheets (Photo IMG_7196). Two tears and all of the torn seams are on the South Embankment near the Southwest Corner. The liner damage appears to be due to tension in the liner (the liner along the South Embankment is

Area where a 6-inch deep rut in the West Embankment crest was observed during the 2023 inspection.

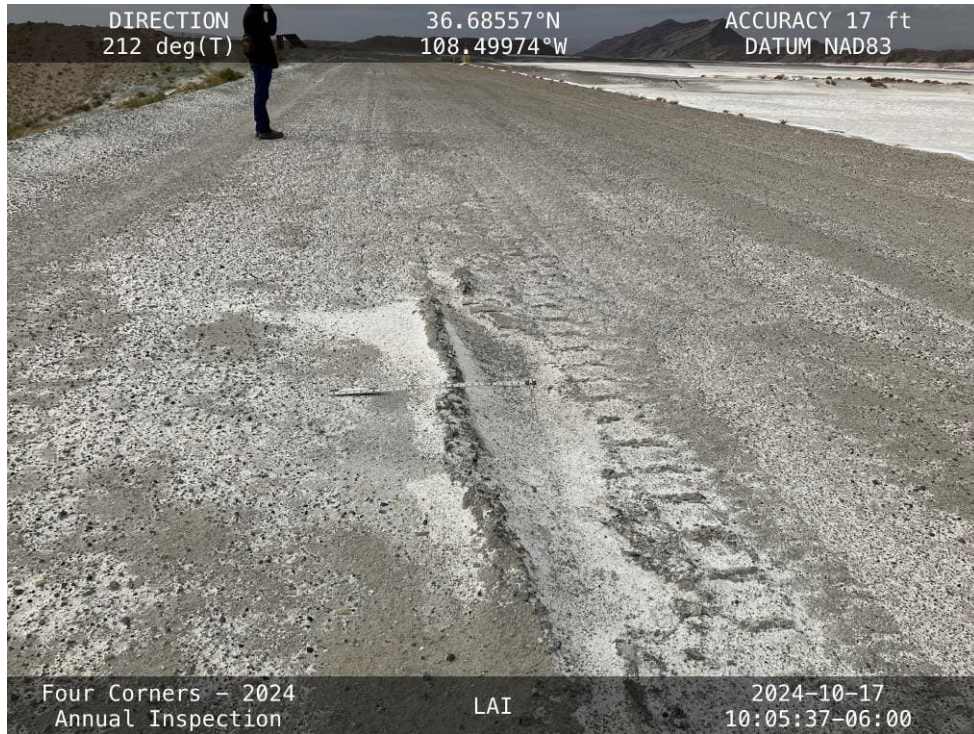
20241017 – IMG_7309
A 6-inch deep rut in the East Embankment crest.

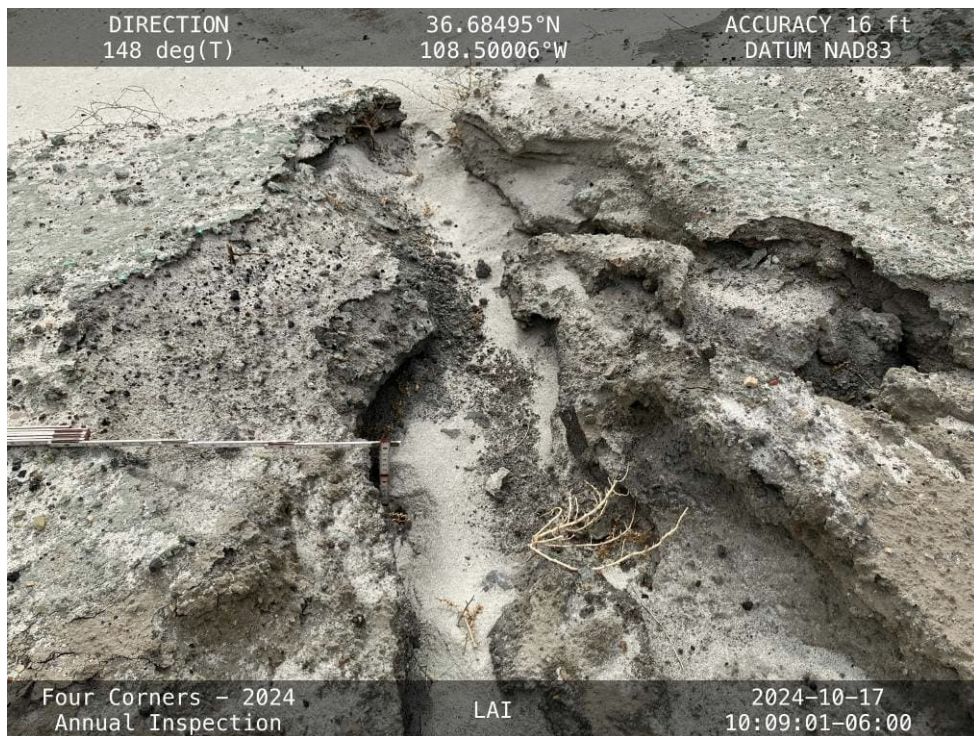
- vi. Erosion was observed on the downstream slopes of the West Embankment (Photo IMG_7242), Northwest Embankment (Photo IMG_7246), and East Embankment (Photos IMG_7280, IMG_7281, IMG_7313, and IMG_7319). The 18-inch deep erosion on the downstream slope of the East Embankment shown in IMG_7313 is more advanced compared to the condition observed in 2023 (2023 Photo IMG_2492). The erosion at each location referenced in this paragraph should be repaired.

20241017 – IMG_7313
Approximately 18 inches of erosion on the downstream slope of the East Embankment shown in IMG_7319.

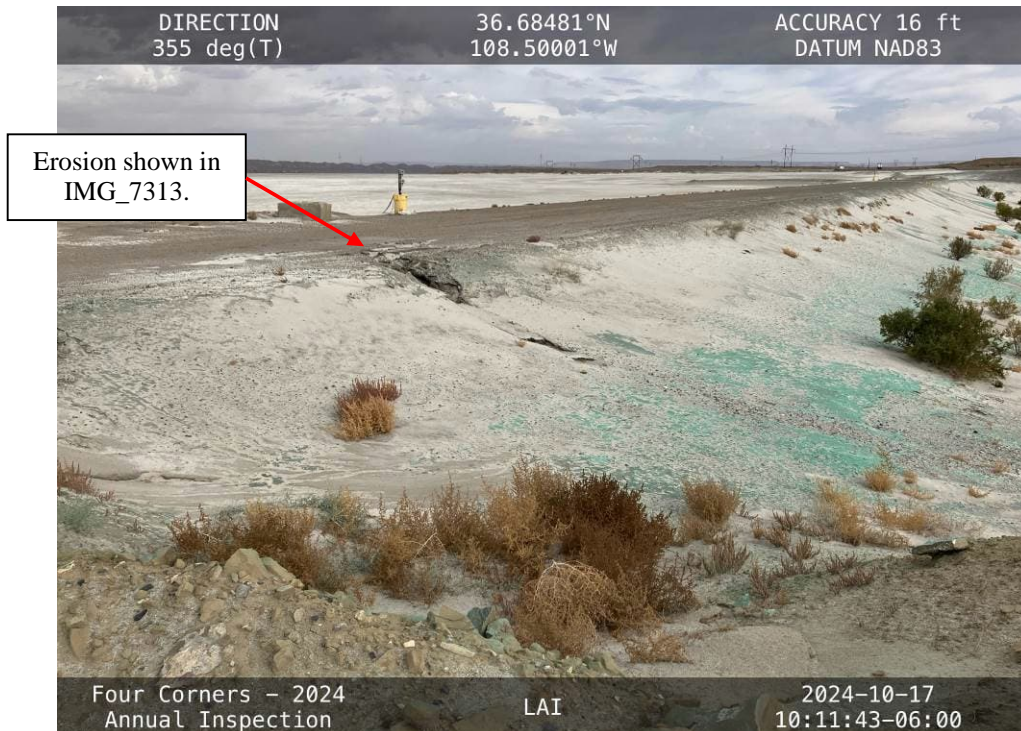
20241017 – IMG_7319

The downstream slope of the East Embankment facing north.

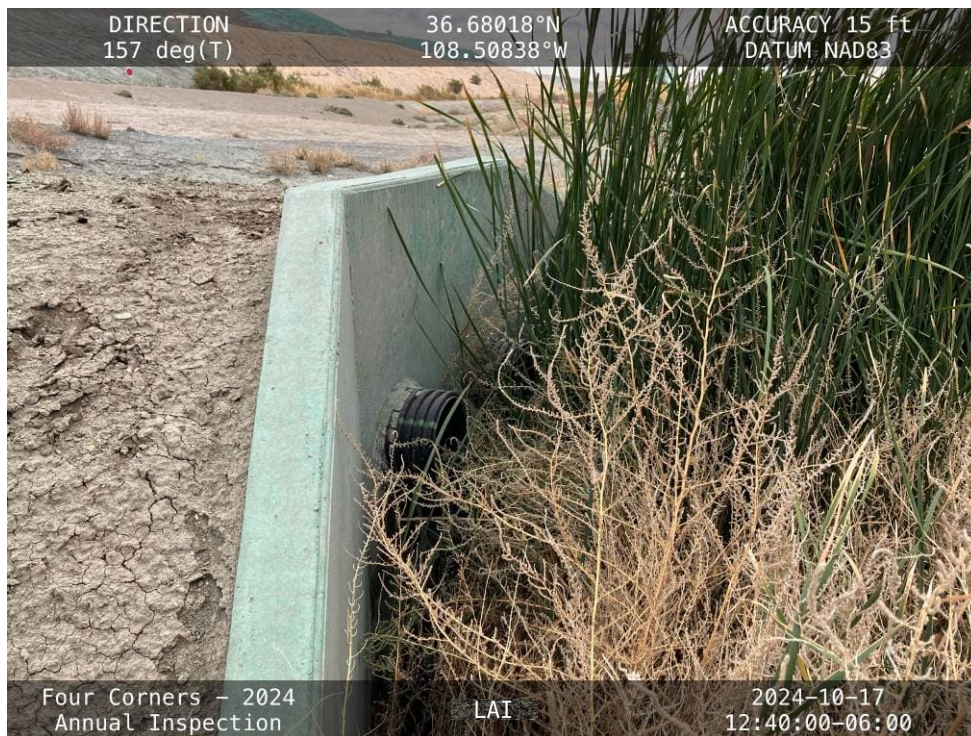
20241017 – IMG_7579

- vii. The seepage exiting the northern conduit in the South Embankment Toe Drain (Photos IMG_7574 and IMG_7579) (first observed in April 2023 after APS began constructing the bottom ash stockpile on top of DFADA Cell 3) was measured to be 0.68 gpm. No substantial flow was observed at the southern conduit. The flowrate during this inspection was less than the flowrate measured during the 2023 inspection (0.83 gpm in the northern conduit and 0.033 gpm in the southern conduit). APS should measure the flowrate on a weekly basis as part of the 7-day CCR inspections and provide the measurements to the APS geotechnical engineer.

The South Embankment toe drain with water flowing out of the conduits.

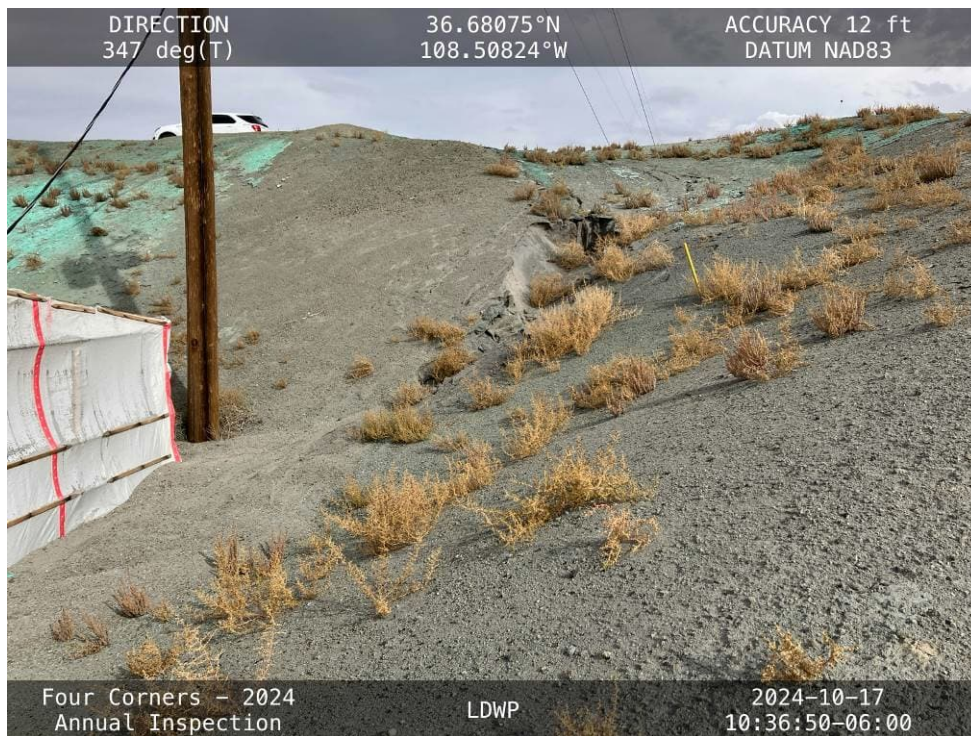
20241017 – IMG_7330

Erosion in the groin of the LDWP/LAI access ramp, facing north.

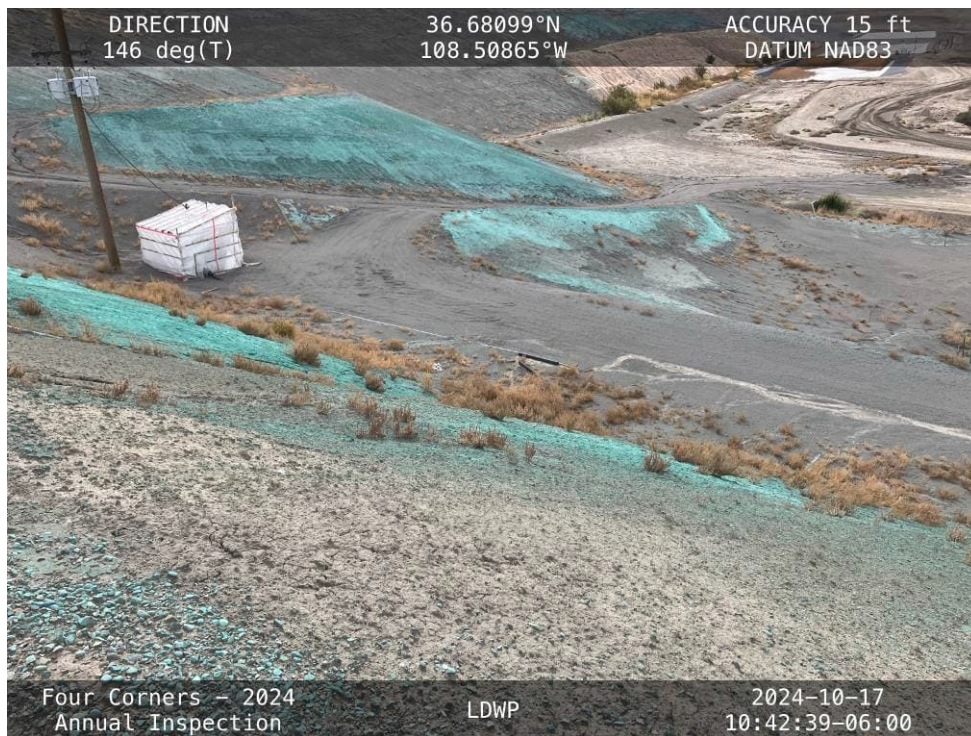
20241017 – IMG_7341

CCR at the toe of the slope where the Deadpool Pump pipe runs along the LDWP South Embankment.

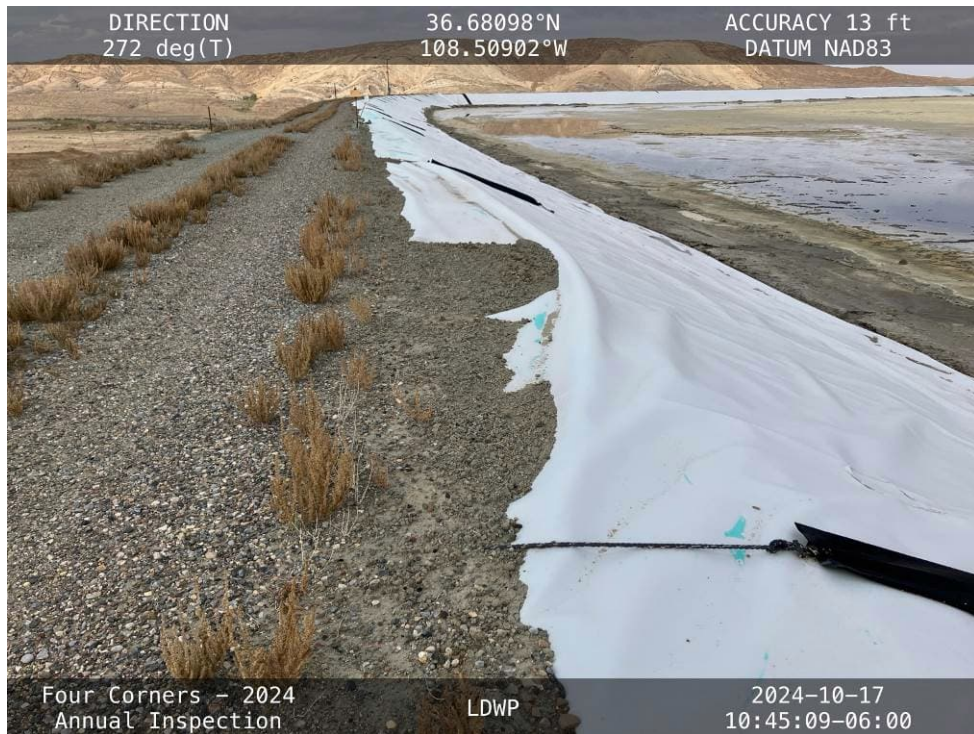
20241017 – IMG_7343

A wrinkle in the liner along the upstream slope of the South Embankment.

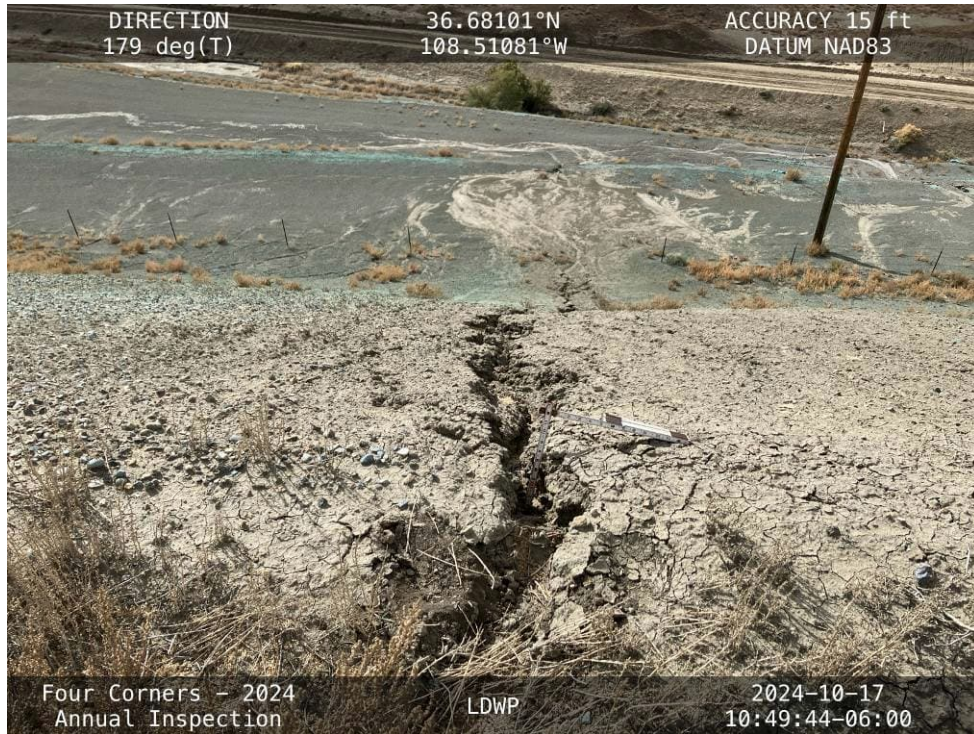
20241017 – IMG_7349

A 9-inch erosion rill on the downstream slope of the South Embankment.

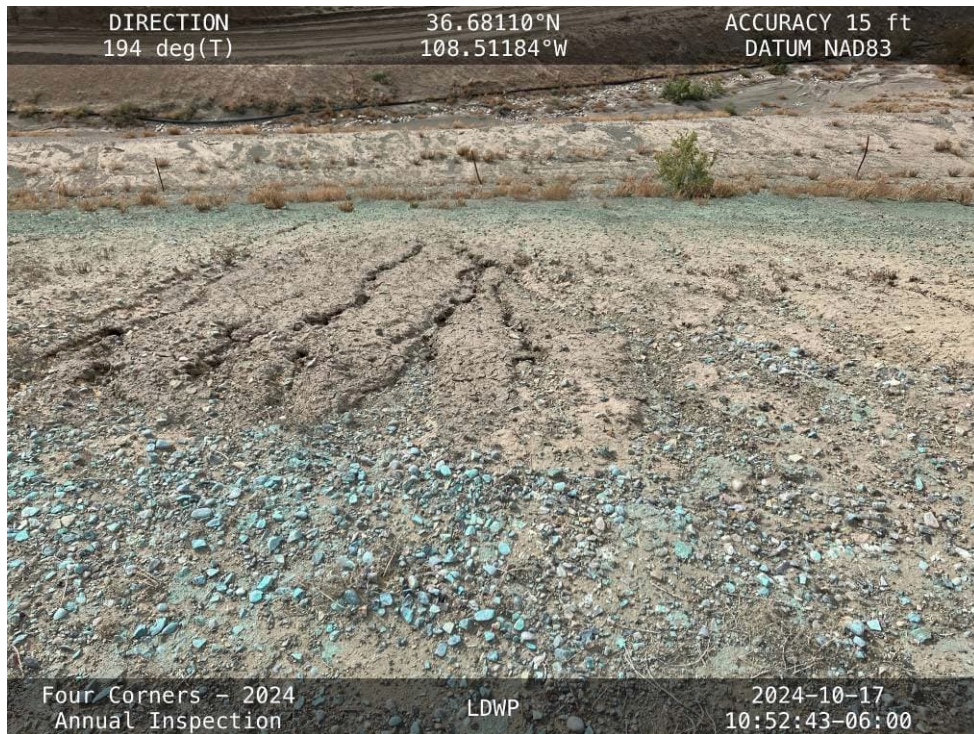
20241017 – IMG_7353

Shallow erosion rills on the downstream slope of the South Embankment.

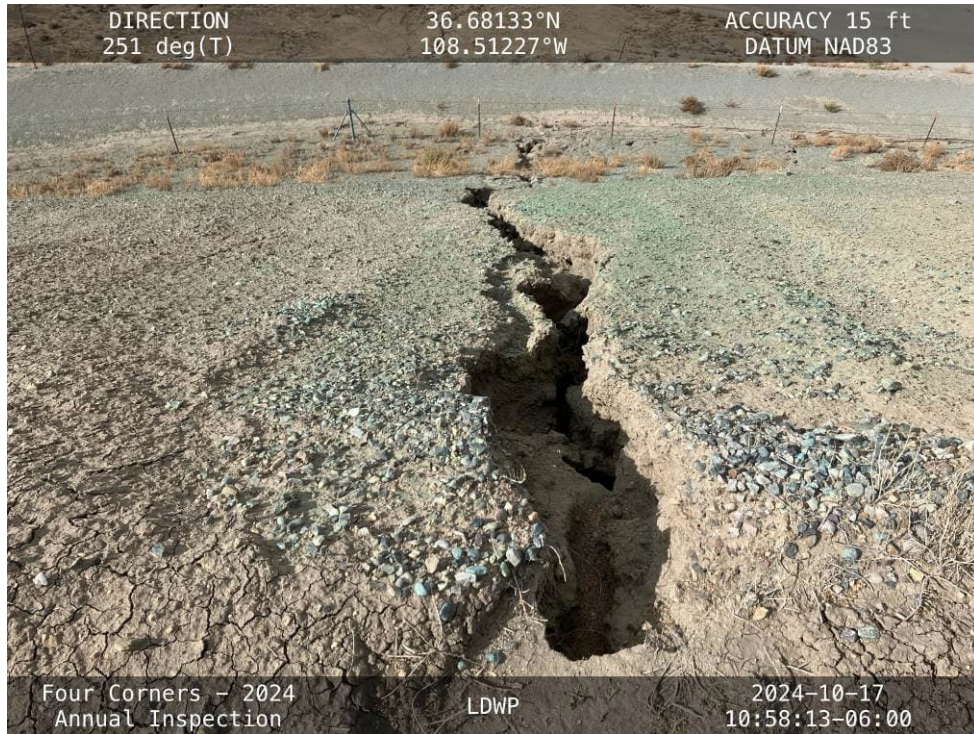
20241017 – IMG_7364

A 2.5-foot deep erosion rill on the downstream slope of the West Embankment.

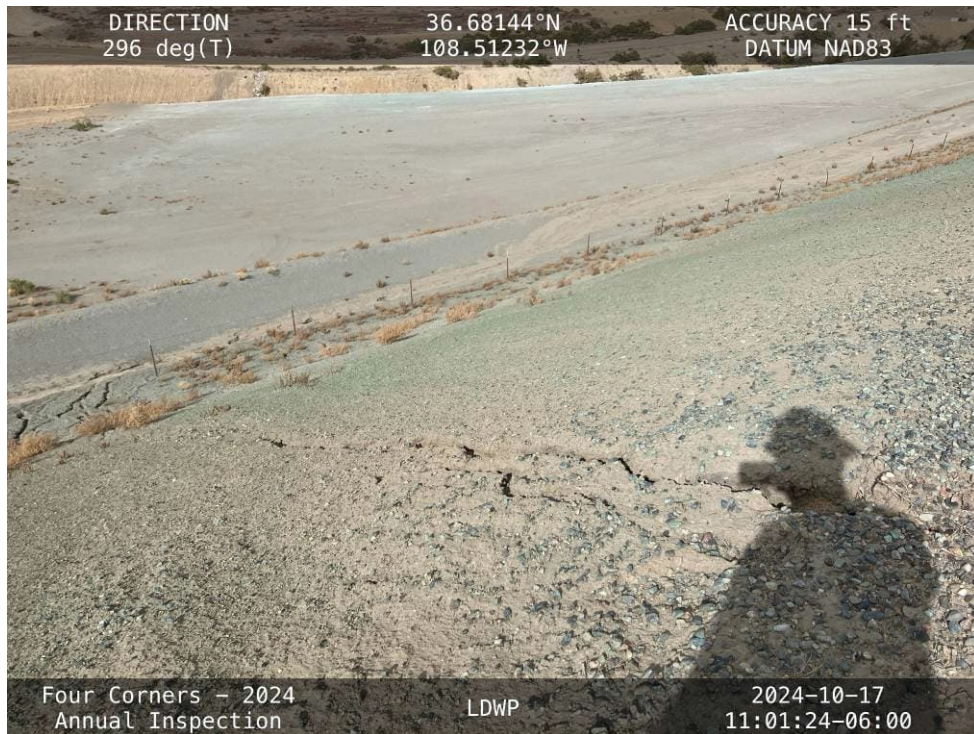
20241017 – IMG_7366

Erosion rills and sediment at the toe of the LDWP West Embankment, facing west.

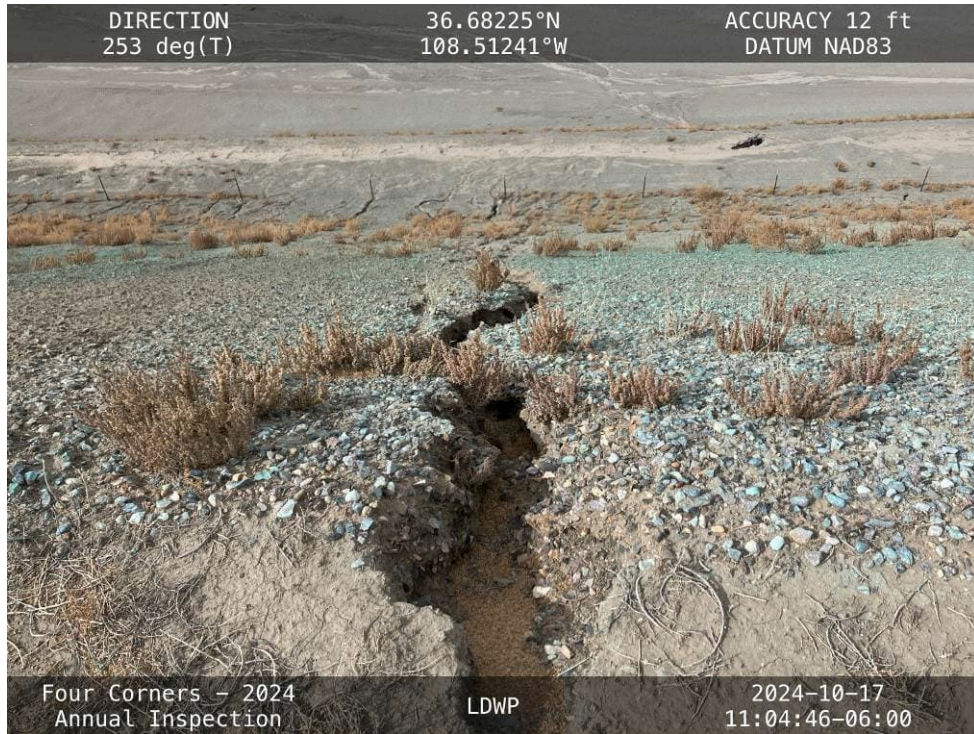
20241017 – IMG_7371

A 10-inch deep erosion rill on the downstream slope of the West Embankment.

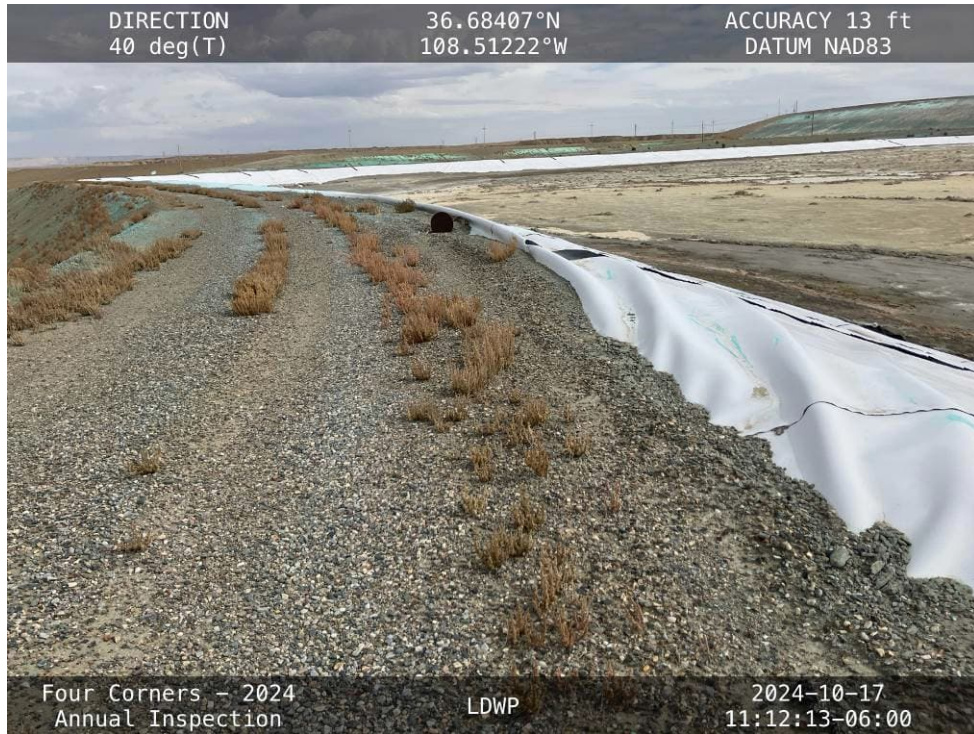
20241017 – IMG_7390

The liner pulling out of the anchor trench in the northern portion of the West Embankment.

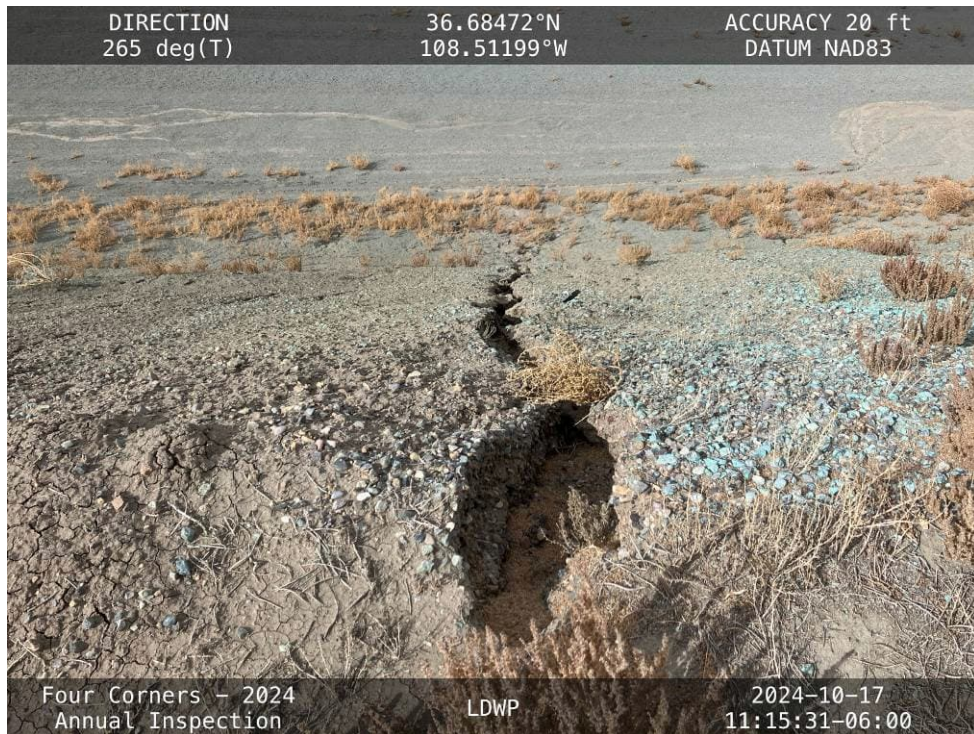
20241017 – IMG_7400

An erosion gully forming on the downstream slope in the northern portion of the West Embankment.

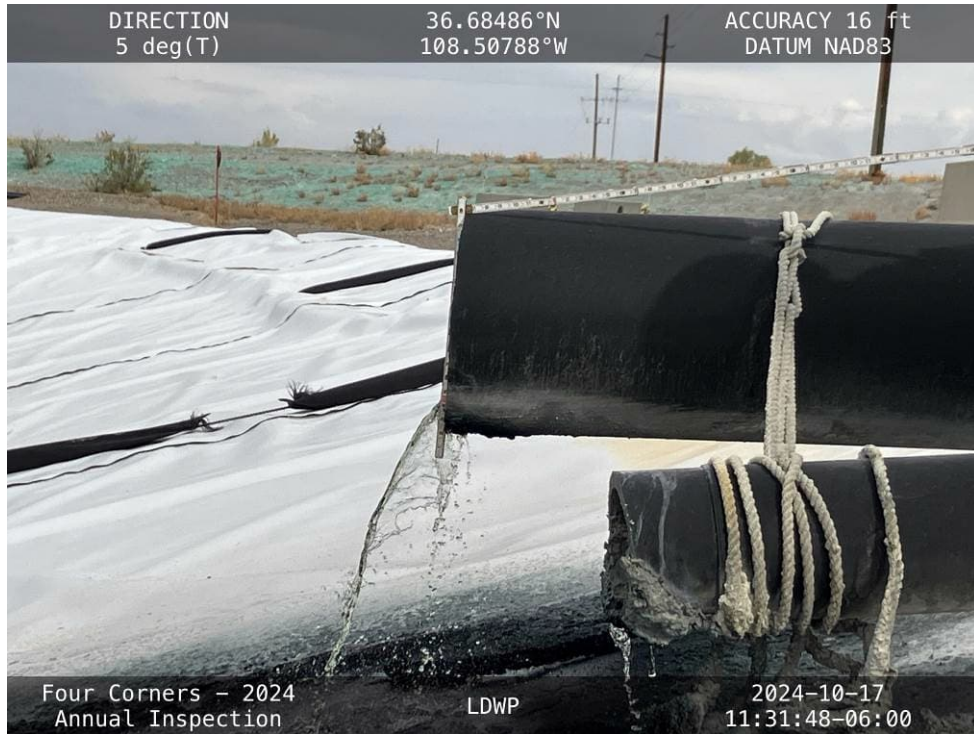
20241017 – IMG_7454

The inspectors observed water trickling out of the 8-inch pipe and water was flowing out of the 16-inch pipe at approximately 7.1 gpm at the time of the inspection (Appendix B – LDWP Photo IMG_7454). The invert elevation of the 16-inch pipe in the Drop Inlet Structure at the LAI is approximately EL 5220 feet. The invert elevation of the 8-inch pipe in the Drop Inlet Structure is approximately EL 5213.5 feet. The flowrate out of the 8-inch pipe was significantly less than the expected flowrate associated with discharge out of the higher 16-inch pipe. APS should clean out the 8-inch pipe to allow free flow from the LAI to the LDWP and inspect the 16-inch pipe for blockages (and remove any observed obstructions). This activity be overseen by a responsible engineer and acceptable jetting pressures should be calculated and monitored to avoid damaging the pipe if the jetting pressure is too high. The Deadpool Sump was discharging intermittently during the inspection.

The 8-inch and 16-inch HDPE outlet pipes conveying decant water from the LAI.

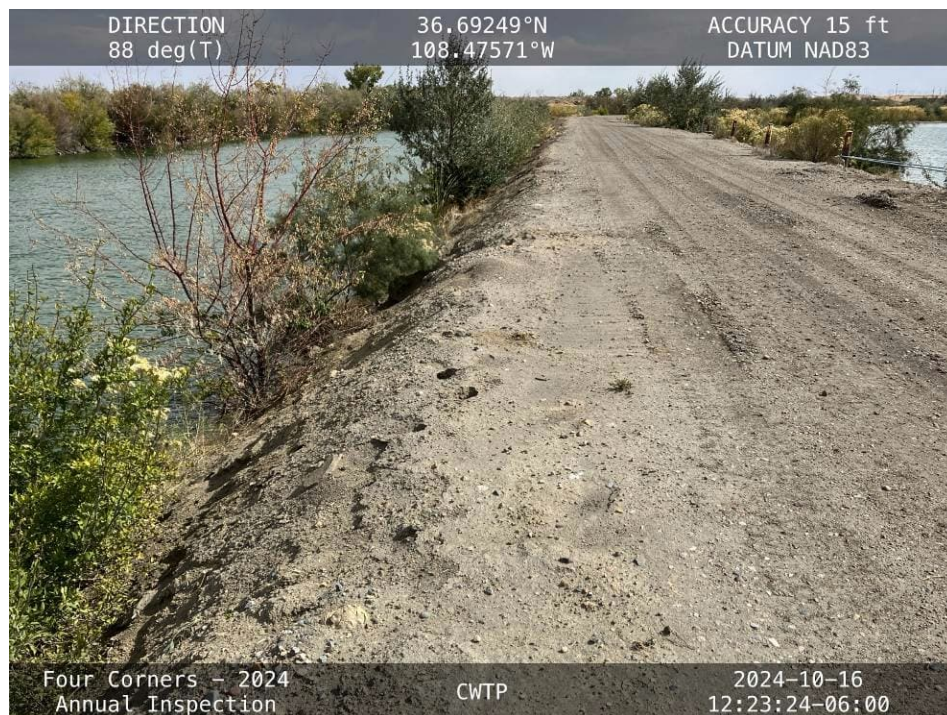
20241016 – IMG_7081
Shallow holes on the downstream shoulder of the North Embankment where depressions have been previously observed.

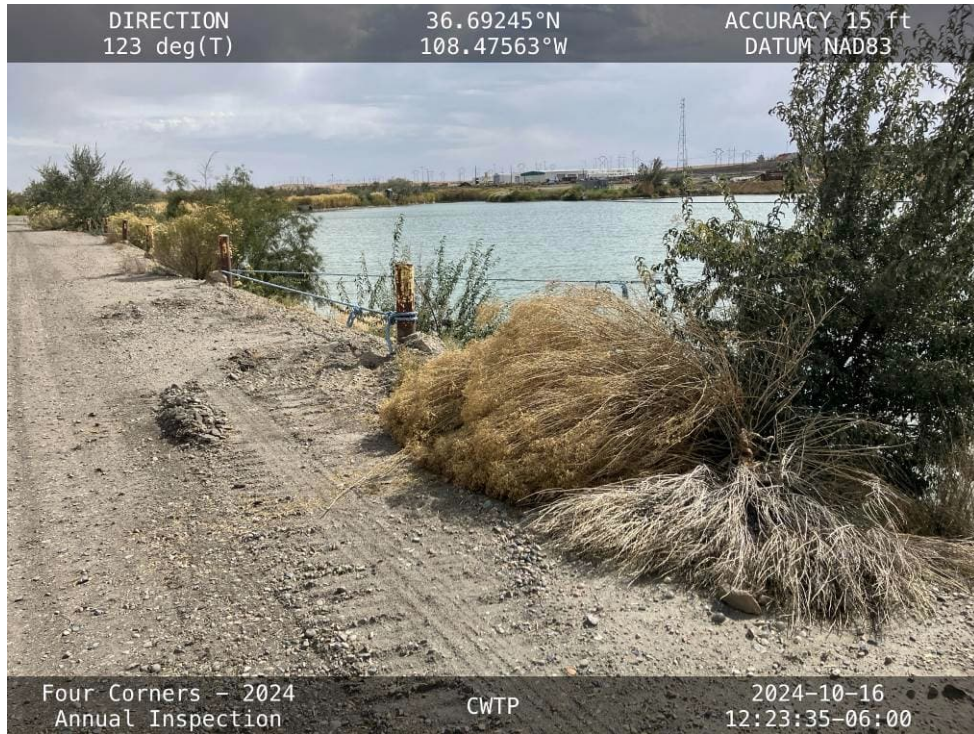
20241016 – IMG_7082
Vegetation to be removed from the upstream slope.

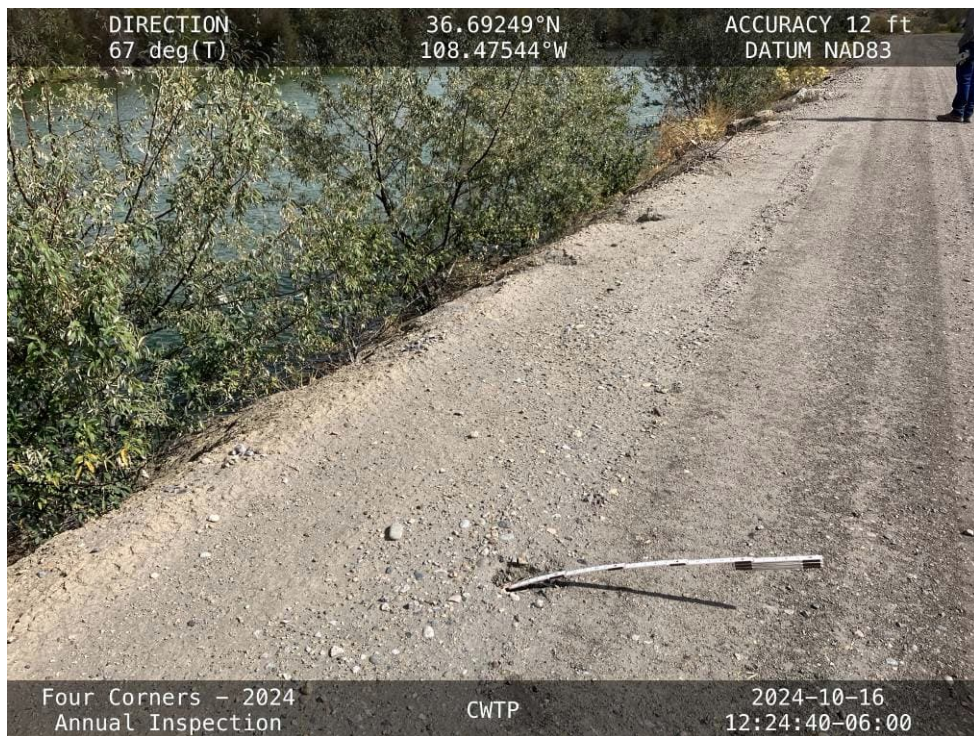
20241016 – IMG_7085
A 1-foot deep hole in the North Embankment crest.

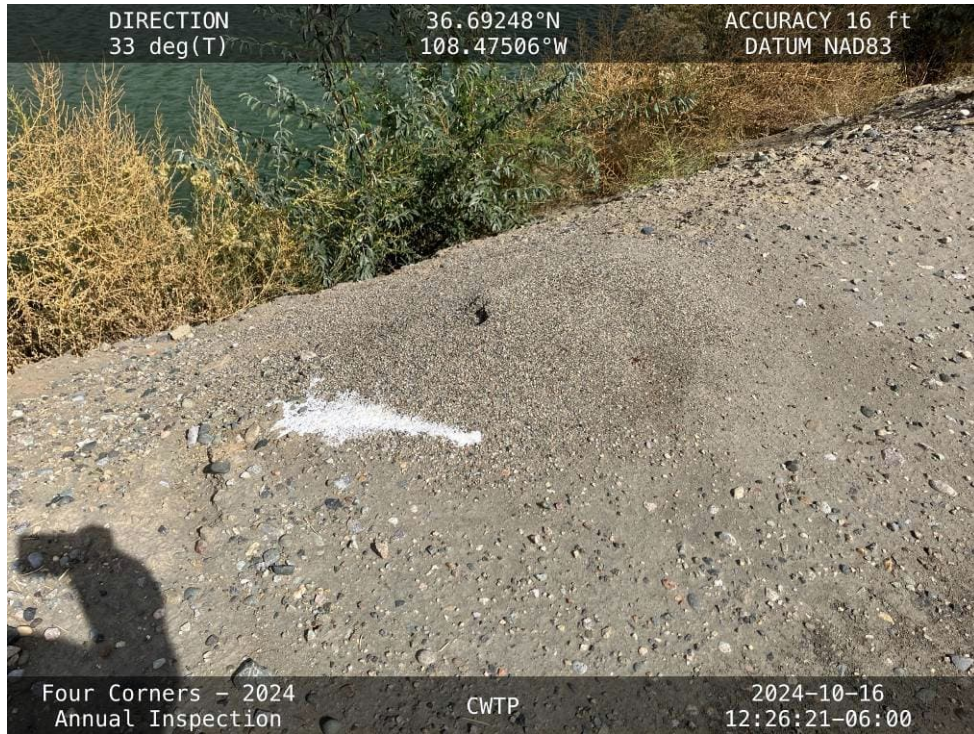
20241016 – IMG_7090

An ant hill on the upstream shoulder of the North Embankment.

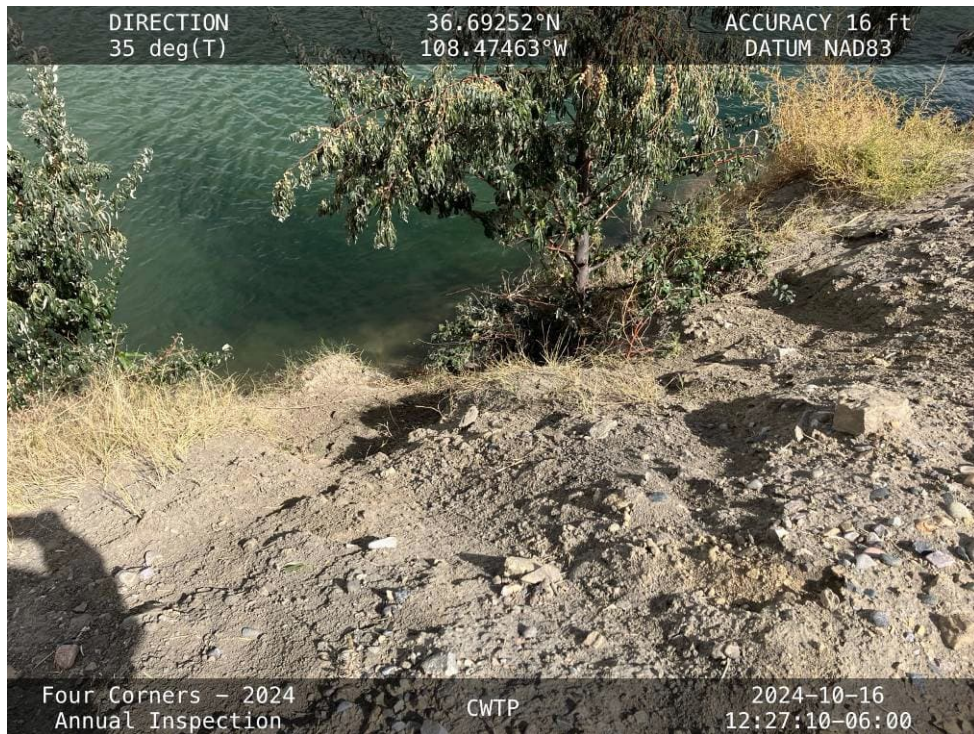
20241016 – IMG_7093

Erosion on the upstream slope of the North Embankment.

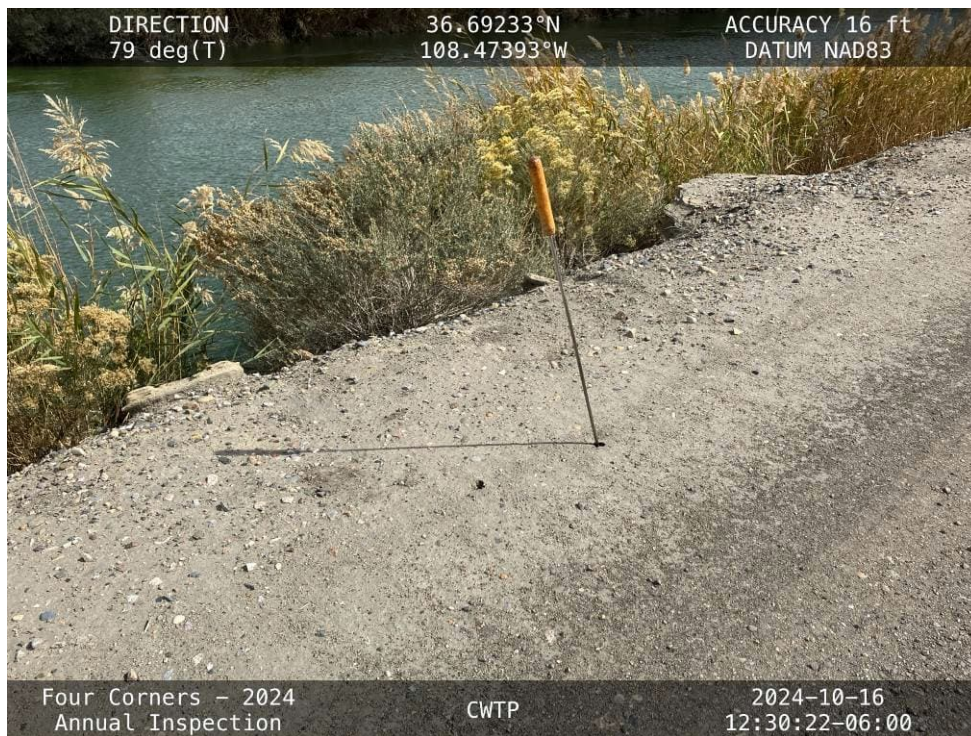
20241016 – IMG_7110

A shallow hole near the riprap slab in IMG_7109.

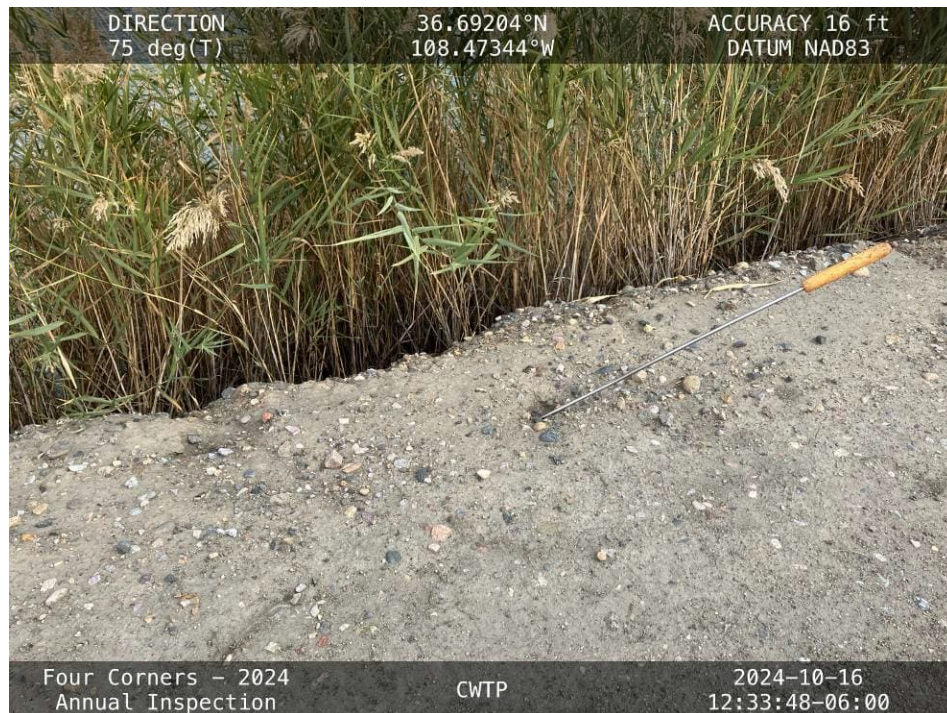
20241016 – IMG_7120

A 1-foot-deep erosion hole on the downstream shoulder of the East Embankment crest. Similar erosion holes were also observed during the 2021, 2022, and 2023 inspections.

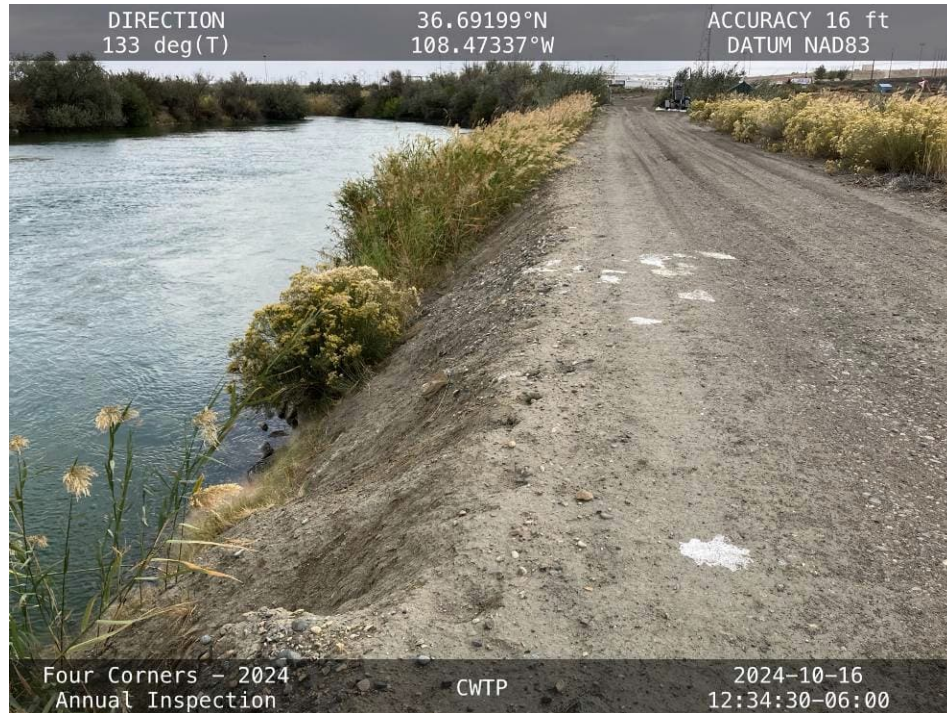
20241016 – IMG_7122

Holes (up to 1 foot deep) on the downstream shoulder of the East Embankment crest where 1.5-foot deep holes were observed in 2023, accompanied by erosion on the downstream slope.

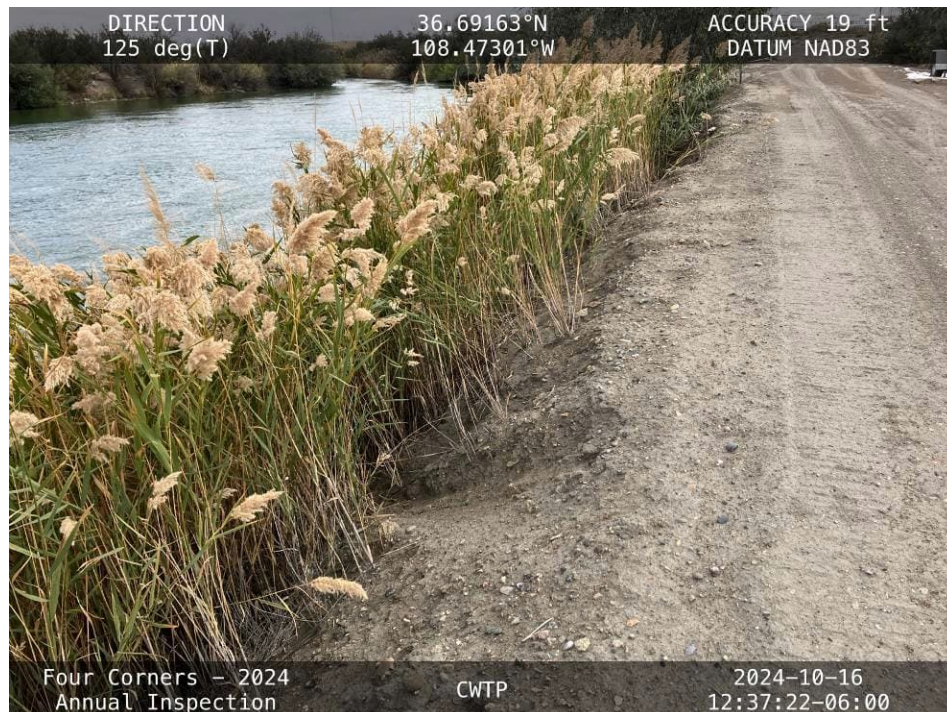
20241016 – IMG_7130

Erosion around reeds growing on the downstream slope of the East Embankment.

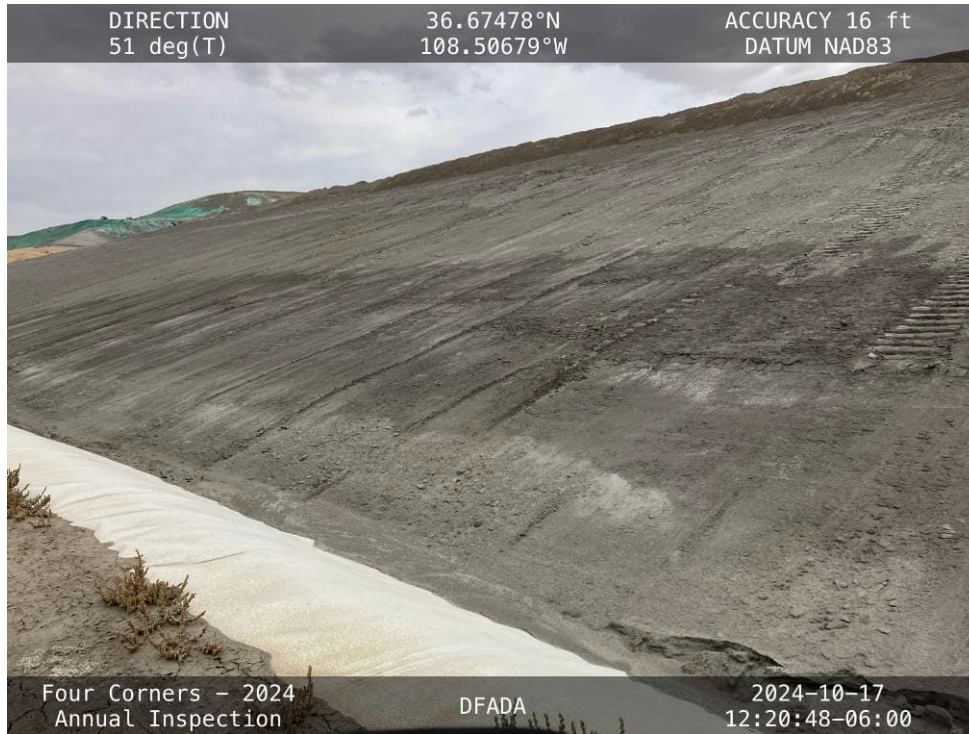
20241017 – IMG_7533
Moisture along the lower portion of the Cell 4 western slope.
