FOUR CORNERS POWER PLANT
Lined Ash Impoundment,
Lined Decant Water Pond,
Combined Waste Treatment Pond,
Dry Fly Ash Disposal Area,
and Return Water Pond

Annual
CCR Impoundment and
Landfill Inspection Report
2024

GENERATION ENGINEERING
Design Engineering
P.O. BOX 53999
PHOENIX, ARIZONA 85072

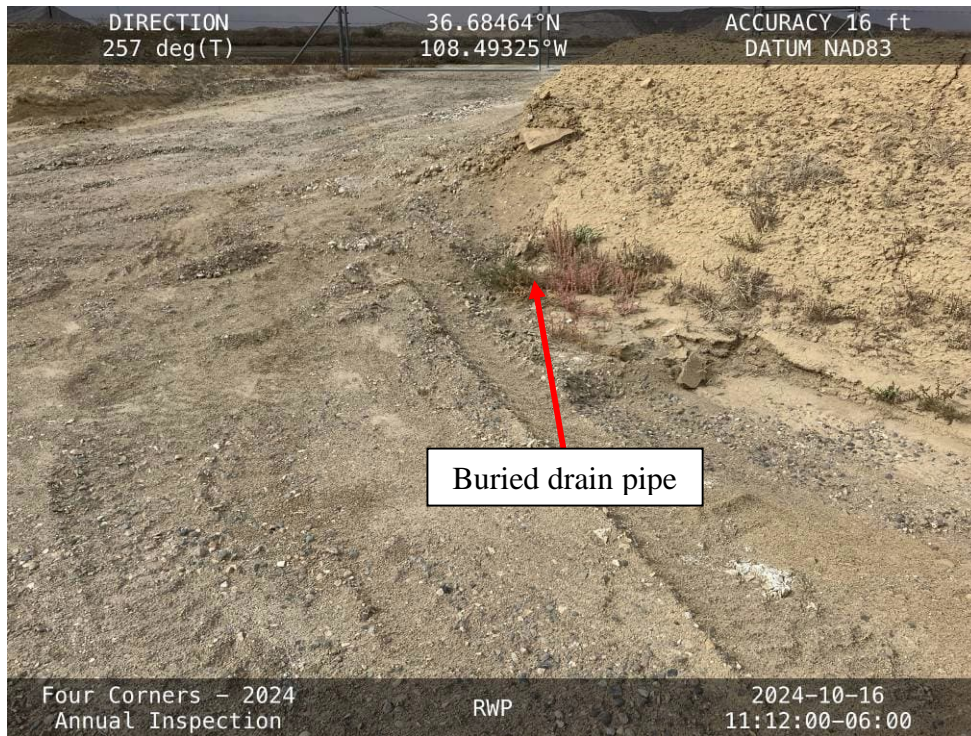
20241016 – IMG_7013

Sediment (to be removed) blocking the drain pipe on the western corner of the RWP.

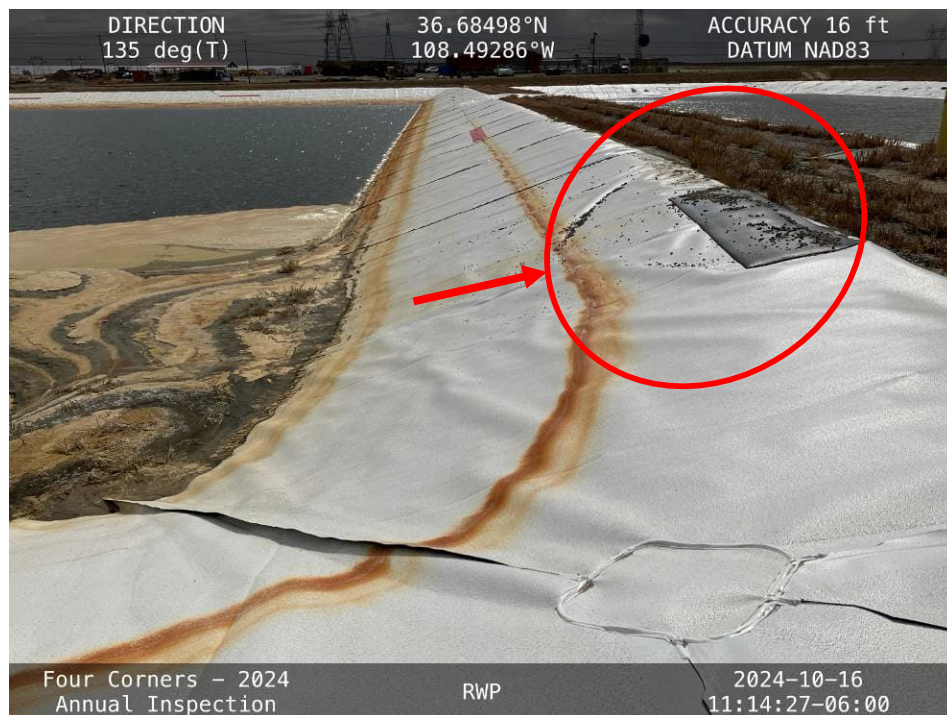
20241016 – IMG_7030

The upstream slope of the Internal Embankment with loose liner where previous construction activity took place (arrow), facing southeast with the RWP cell on the left.
