FOUR CORNERS POWER PLANT LINED DECANT WATER POND - Periodic Structural Integrity Assessment

Periodic Hazard Potential Classification
Periodic Structural Stability Assessment
Periodic Safety Factor Assessment

October 2021
AECOM Project 60664563

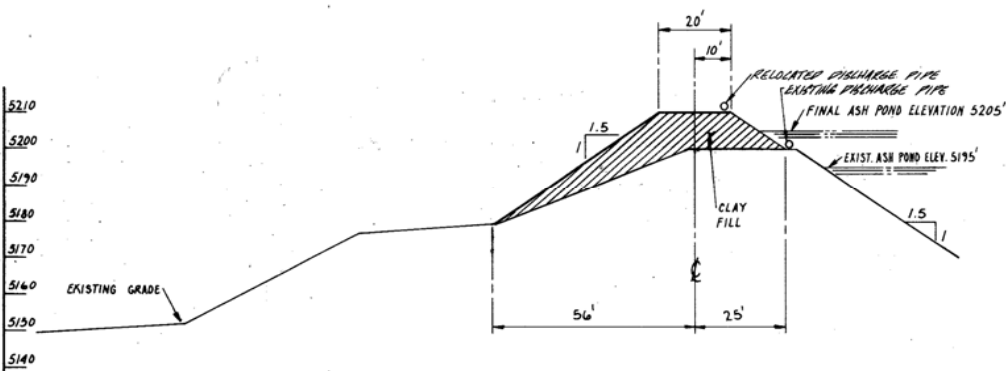
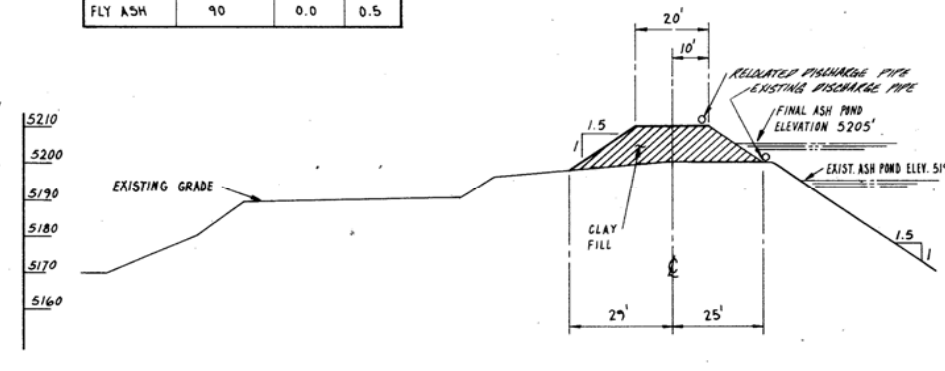
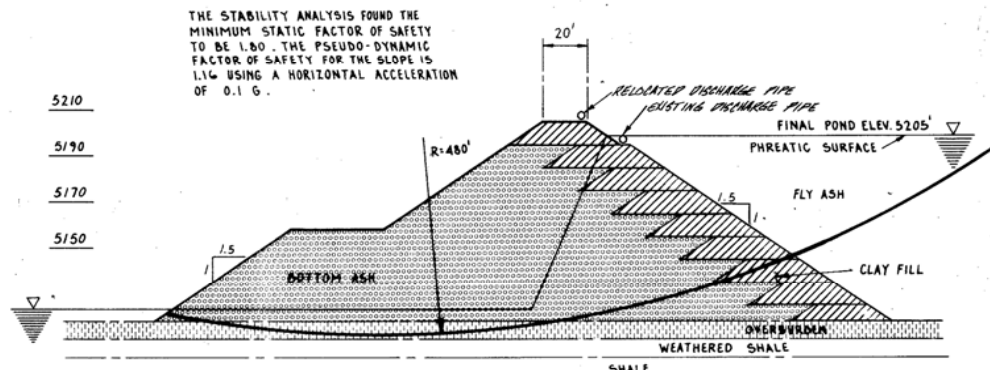
SECTION G G SCALE: 1" = 25'

THE STABILITY ANALYSIS FOUND THE MINIMUM STATIC FACTOR OF SAFETY TO BE 1.00. THE PSEUDO-DYNAMIC FACTOR OF SAFETY FOR THE SLOPE IS 1.14 USING A HORIZONTAL ACCELERATION OF 0.1 G.
