**FOUR CORNERS POWER PLANT
Lined Ash Impoundment,
Lined Decant Water Pond,
Combined Waste Treatment Pond,
Dry Fly Ash Disposal Area,
and Return Water Pond**

**Annual
CCR Impoundment and
Landfill Inspection Report
2020**

**GENERATION ENGINEERING
Design Engineering
P.O. BOX 53999
PHOENIX, ARIZONA 85072**

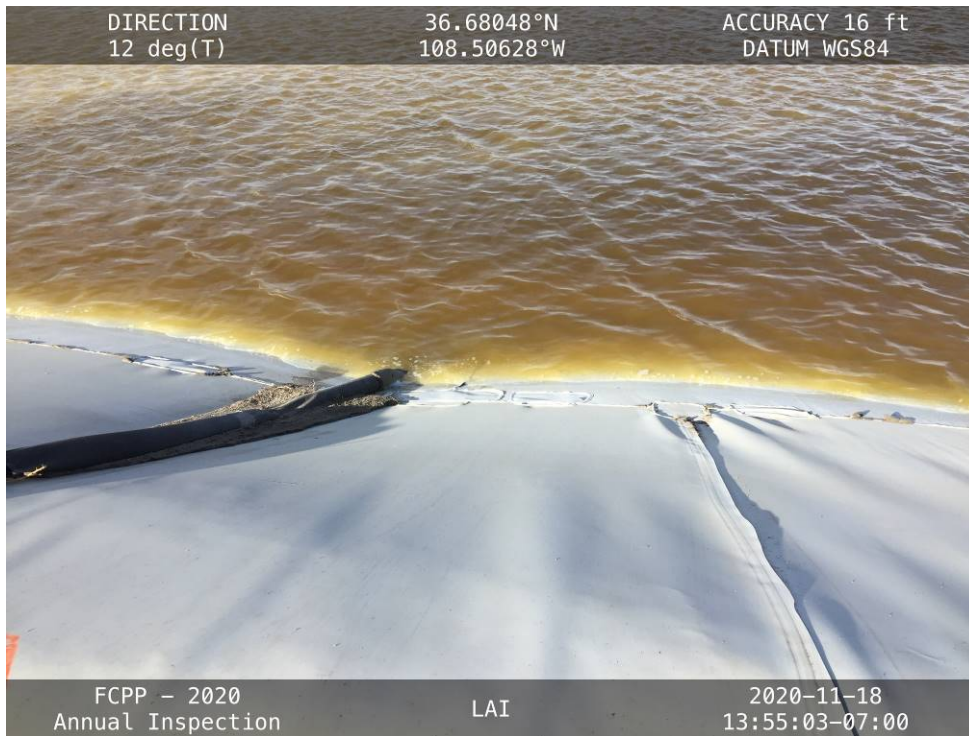
20201118 – IMG_3346

- ii. The geomembrane liner was observed to exhibit uneven depressions and bulges along the South Embankment (Photos IMG_3346 and IMG_3353). These depressions and bulges are in the vicinity of previously observed holes in the upstream liner that were later patched and may be due to the presence of water underneath the liner. The presence and actual causes of the bulges should be recorded, and the geotechnical engineer should be consulted. Repair documentation should be maintained with the operating record.

Uneven section of the upstream liner along the South Embankment.

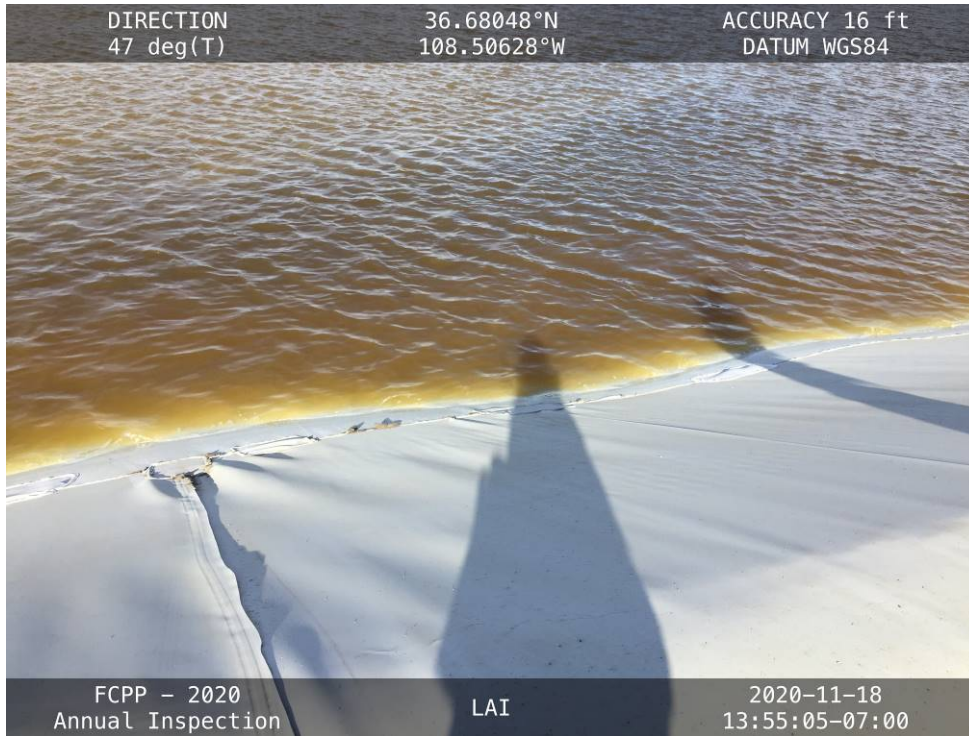
20201118 – IMG_3347

A series of patches at the liner seam along the upstream slope of the South Embankment.

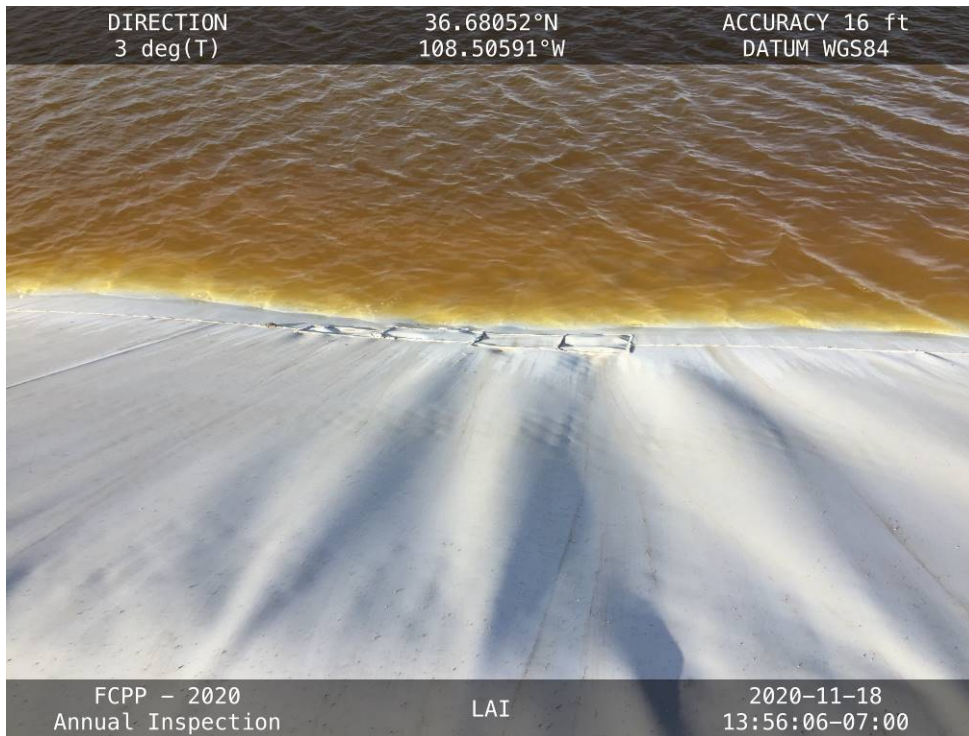
20201118 – IMG_3349

A set of patches at the liner seam along the upstream slope of the South Embankment.

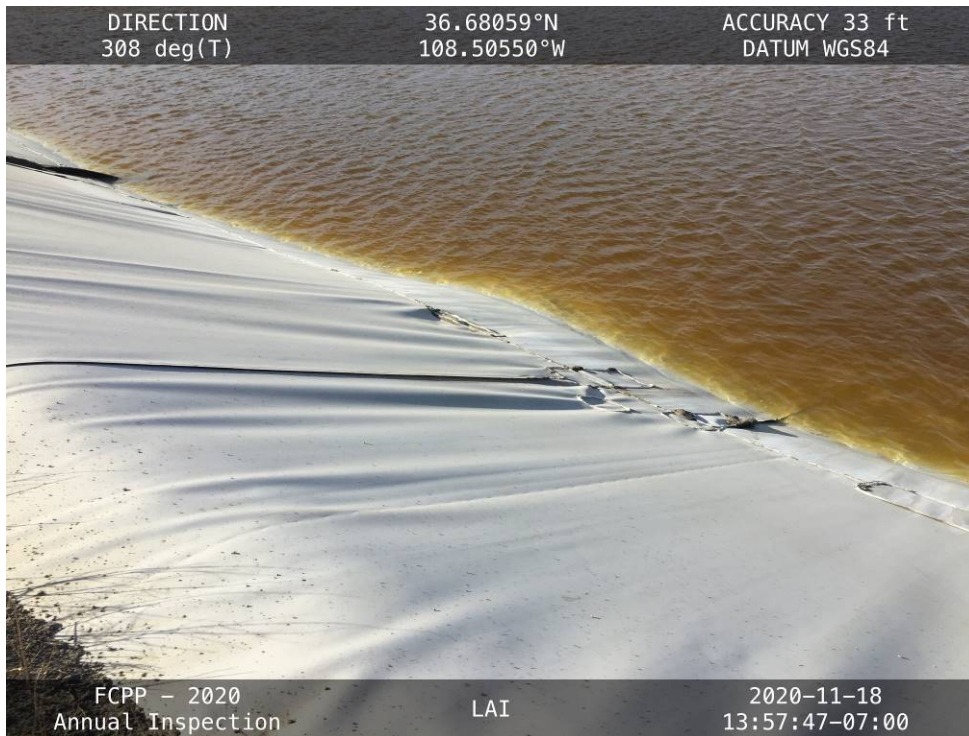
20201118 – IMG_3353

Uneven section of liner along the upstream slope on the South Embankment.

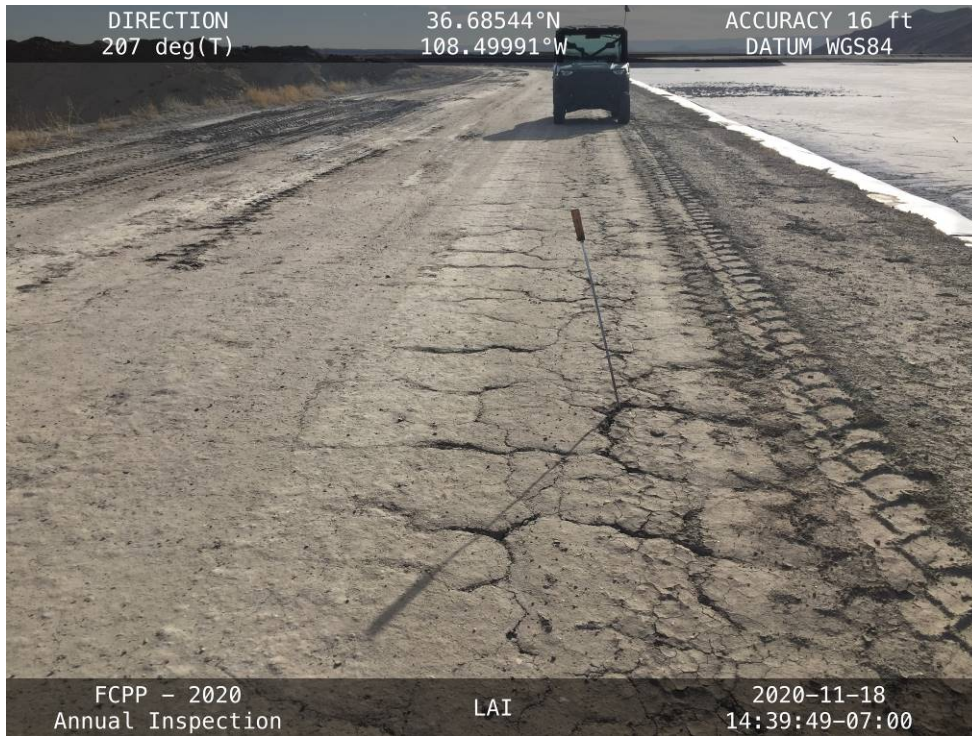
20201118 – IMG_3388

- i. Holes were observed along portions of the geomembrane liner anchor trench in the South and East Embankment (see Photos IMG_3375 and IMG_3384). Mud cracks were observed on the East Embankment crest (see Photo IMG_3388). The holes and cracks all appeared to be superficial. The holes did not extend past the bottom of the anchor trench and the mud cracks were less than 1 inch deep. The holes and mud cracks should be monitored and repaired if they are observed to extend deeper than 1 foot.

Mud cracks on the upstream side of the East Embankment crest, facing south.

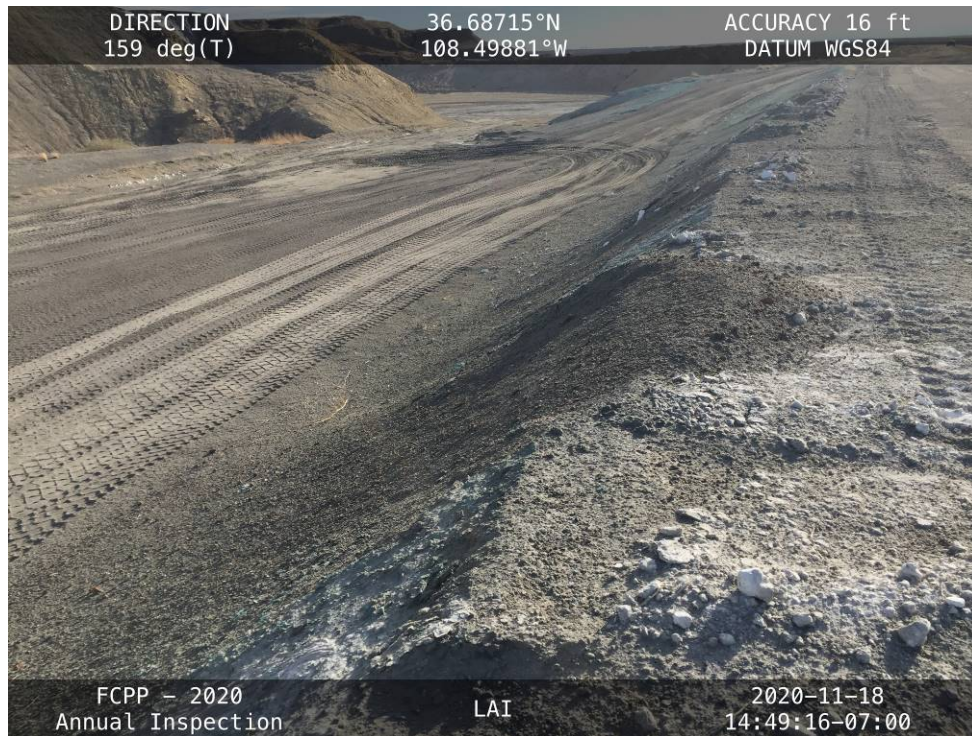
20201118 – IMG_3394

Bottom ash built up near the old V-ditch to contain the reservoir inflow.

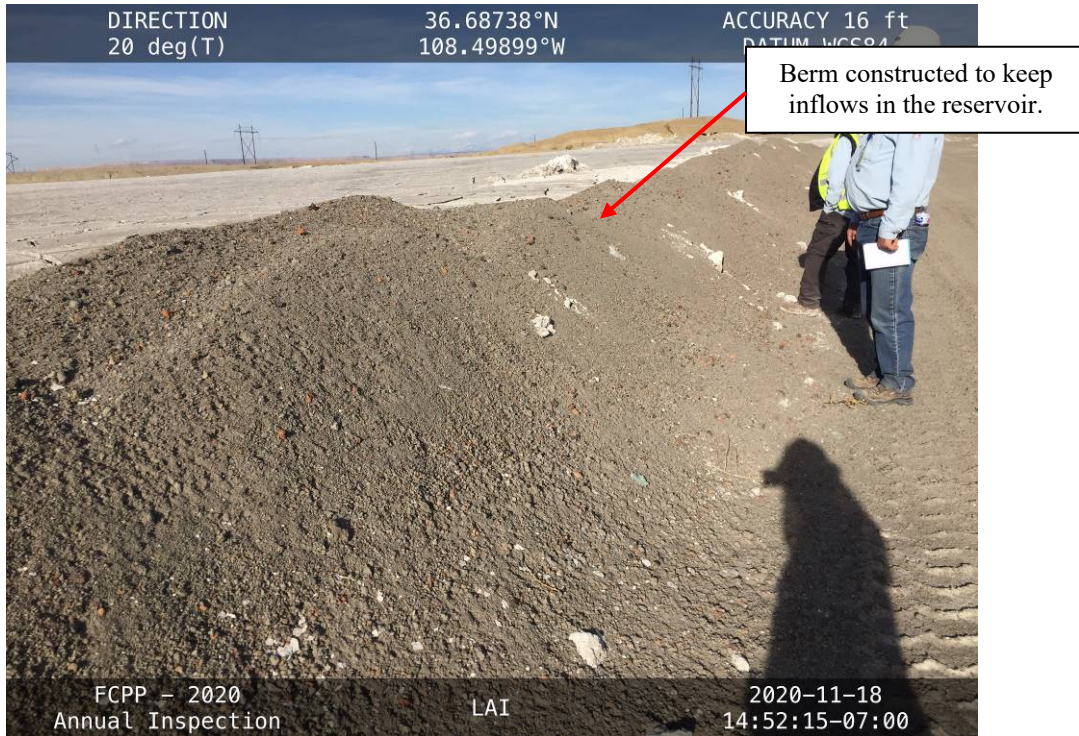
20201118 – IMG_3398

Bottom ash built up on the north side of the old V-ditch to contain the reservoir inflow.

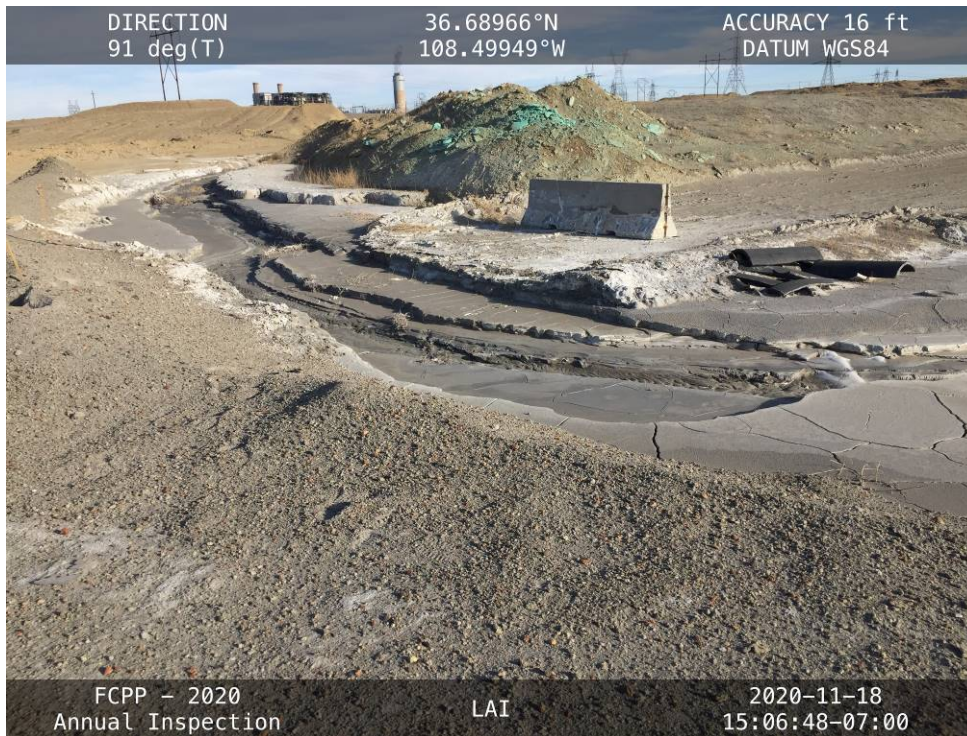
20201118 – IMG_3416

The inflow conditions at the north V-ditch, facing east with the LAI reservoir on the right.

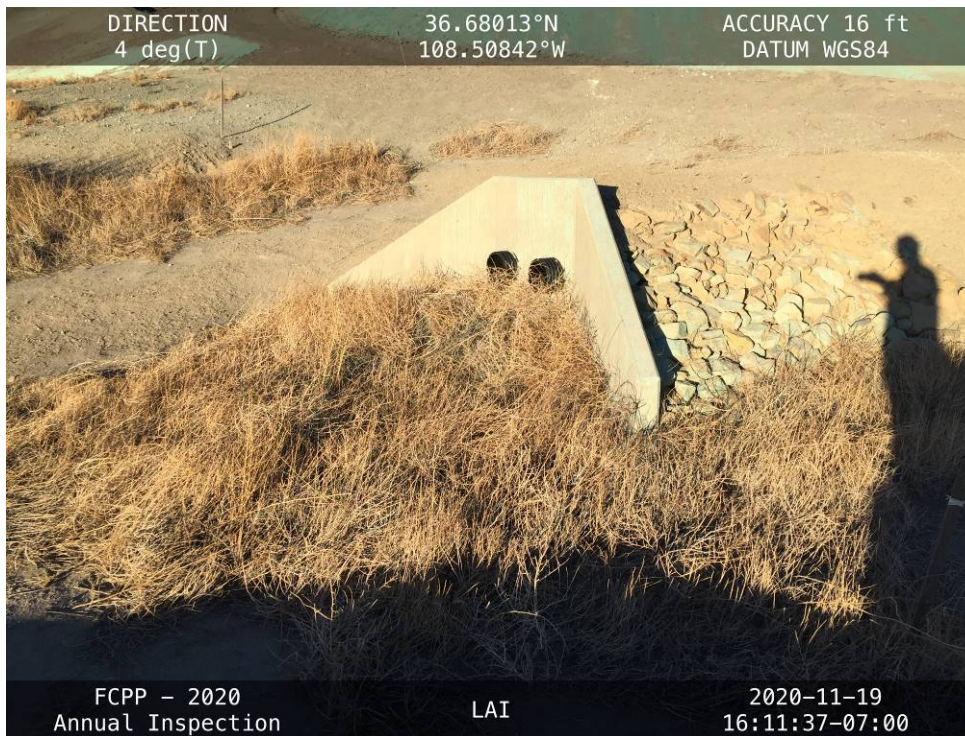
20201119 – IMG_3934

The South Embankment toe drain in a dry condition.

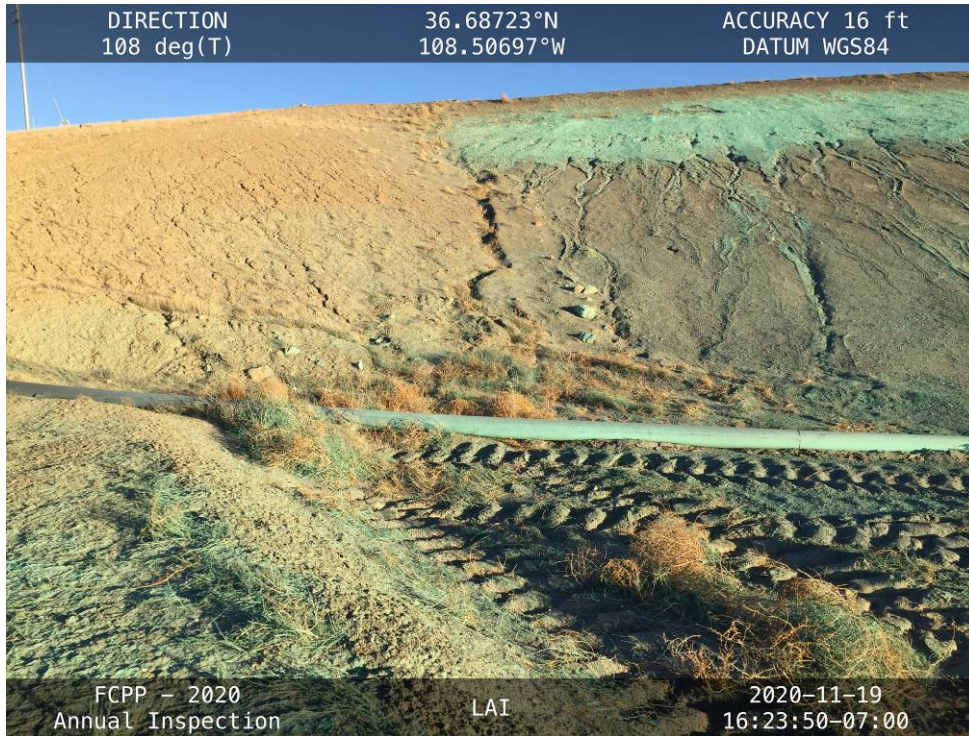
20201119 – IMG_3936

An erosion rill at the junction of the Northwest Embankment (soil) and the West Embankment (ash).

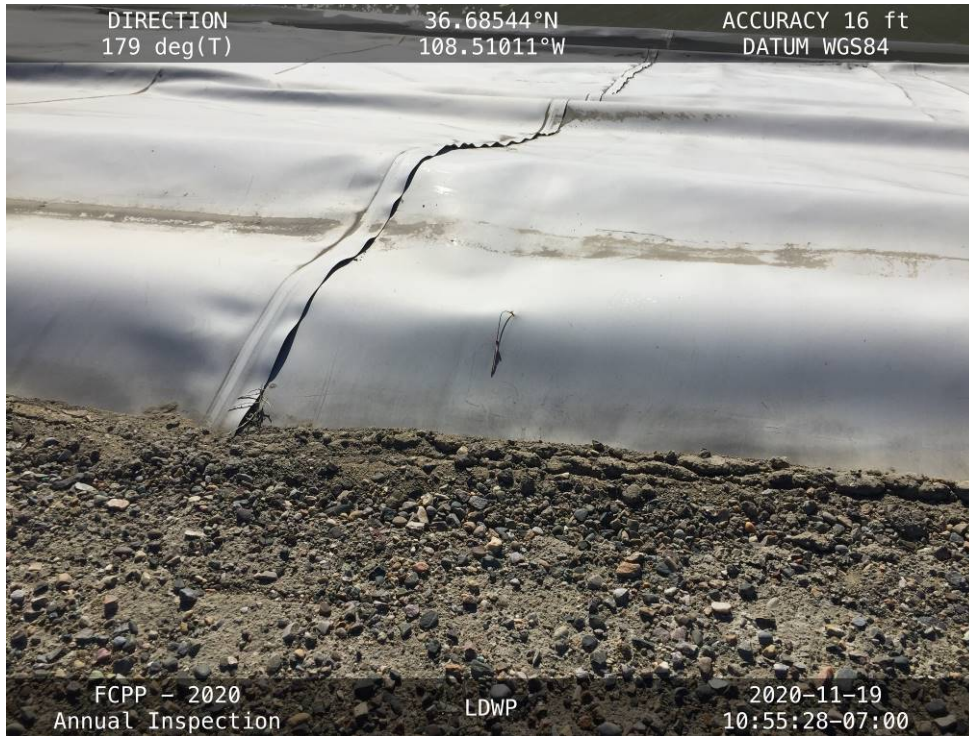
20201119 – IMG_3623

- iii. Two sheets of liner were observed to be separated along the North Embankment (Photo IMG_3619). In addition, the hole in the liner observed during the 2019 inspection is still present (Photo IMG_3623).

A hole in the liner along the North Embankment marked with a pin flag.

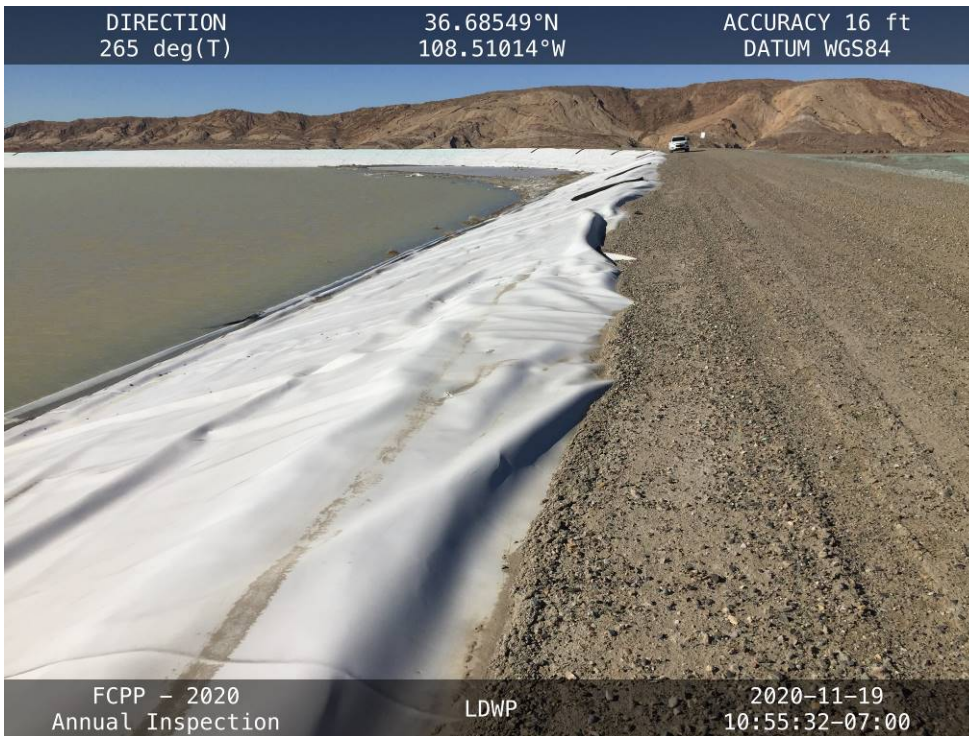
20201119 – IMG_3624

Portions of the North Embankment liner with wrinkles, facing west near the center of the crest.

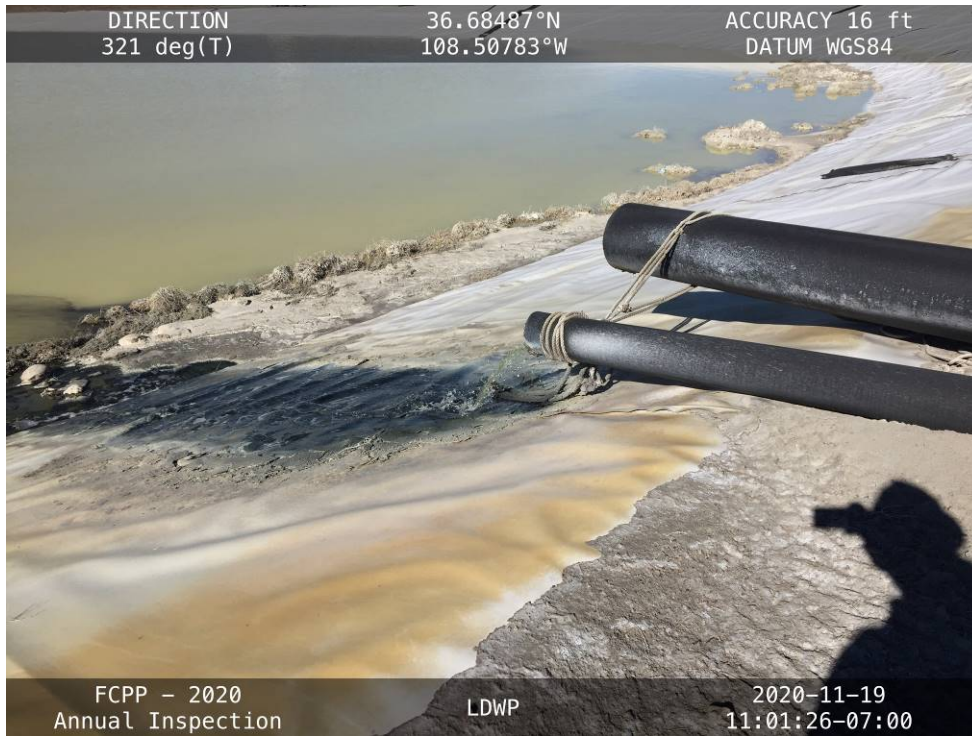
20201119 – IMG_3635

- vii. Water was observed discharging into the LDWP from the LAI via the 8-inch pipe (Appendix B – LDWP Photo IMG_3635).
- viii. The weekly inspection reports for the period between October 1, 2019 and September 30, 2020 were reviewed and indicate the following:

The 8-inch and 16-inch HDPE outlet pipes used to convey decant water from the LAI.

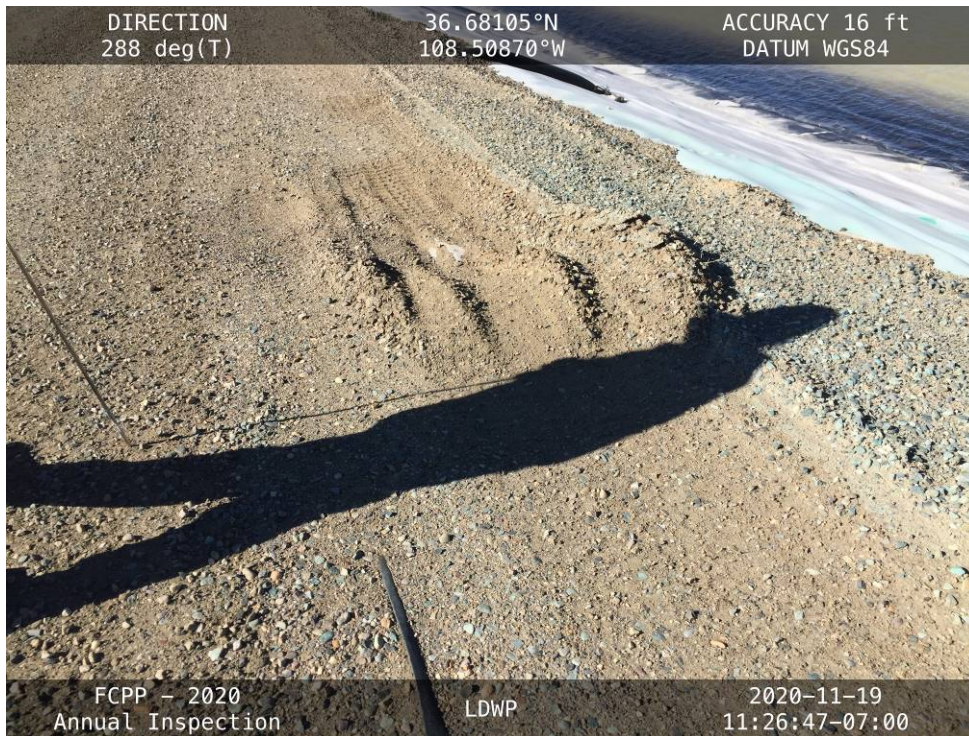
20201119 – IMG_3660

- ii. A rut was observed on the upstream half of the South Embankment crest (Photo IMG_3660). The rut was deep enough to expose the liner. This area should be repaired before the liner is damaged or the rut extends further.

A rut in the crest of the South Embankment.

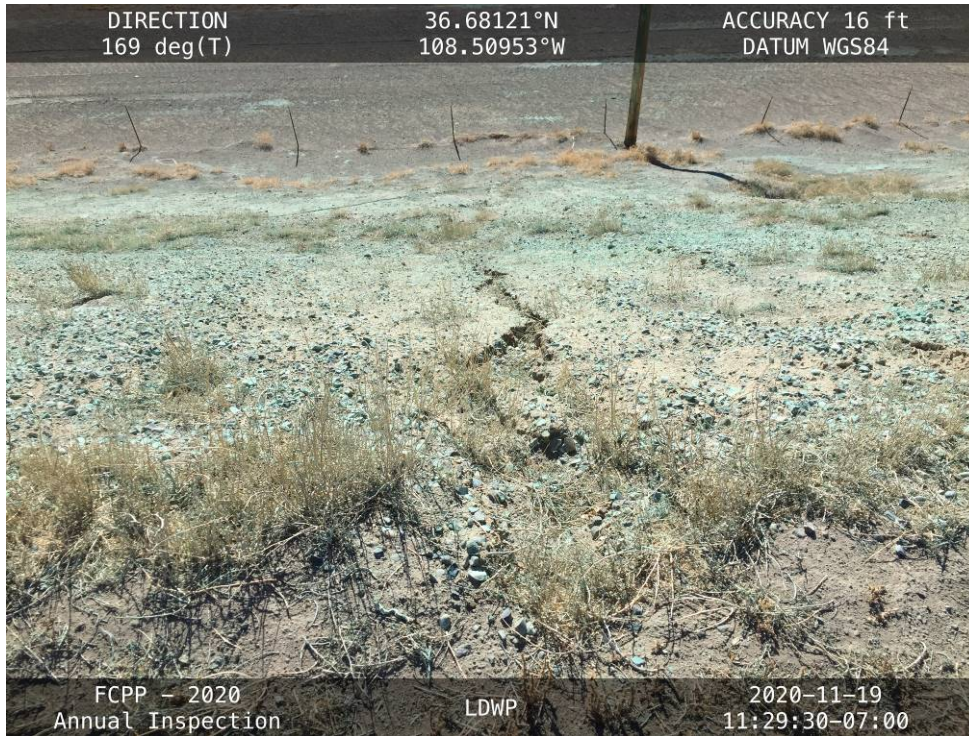
20201119 – IMG_3663

Lined Decant Water Pond (LDWP)		SID: D-635	N/A	No	Yes	Mon	Rep	Inv
5	<i>DOWNSTREAM SLOPE</i>							
a	Erosion?	Minor rilling on the South and West Embankments (Photos IMG_3663, IMG_3668, and IMG_3691). These should be repaired if they exceed 1 foot in depth.			X	X		
b	Inadequate ground cover?	The LDWP South and West Embankment slopes are faced with bottom ash that supports only sporadic and uneven vegetation. A lime-based, white- and turquoise-colored dust suppression agent is applied in accordance with the Plant's Dust Control Plan.		X				
c	Adverse vegetation?			X				
d	Longitudinal/Transverse cracking?			X				
e	Inadequate riprap?		X					
f	Stone deterioration?		X					
g	Settlements, slides, depressions, bulges?			X				
h	Soft spots or boggy areas?			X				
i	Movement at or beyond toe?			X				
j	Animal burrows?			X				
6	<i>ABUTMENT CONTACTS</i>							
a	Erosion?			X				
b	Differential movement?			X

An incipient erosion rill on the downstream slope of the South Embankment, seen from the crest.

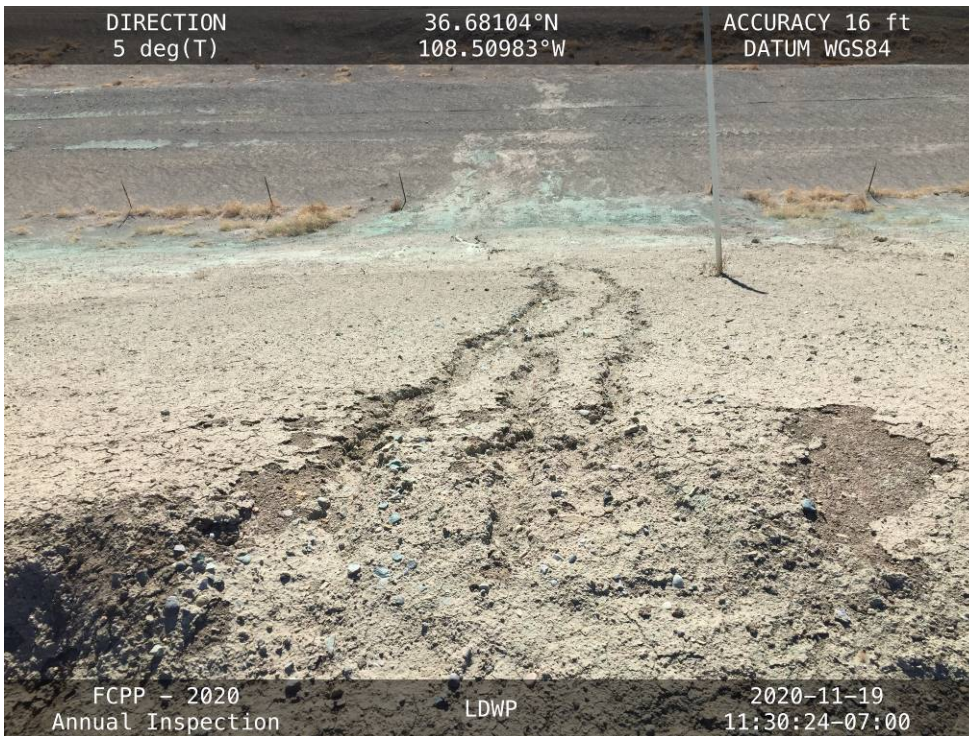
20201119 – IMG_3668

Erosion rills forming in an area of prior repair on the upper half of the South Embankment.

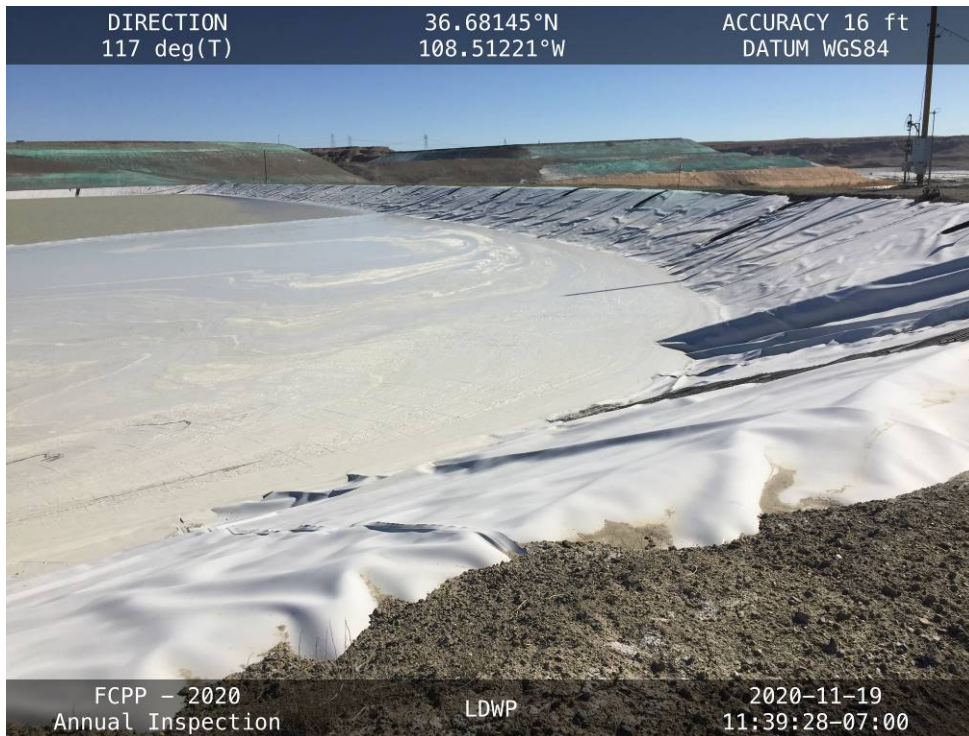
20201119 – IMG_3691

Incipient erosion rills on the downstream slope of the West Embankment, seen from the crest.

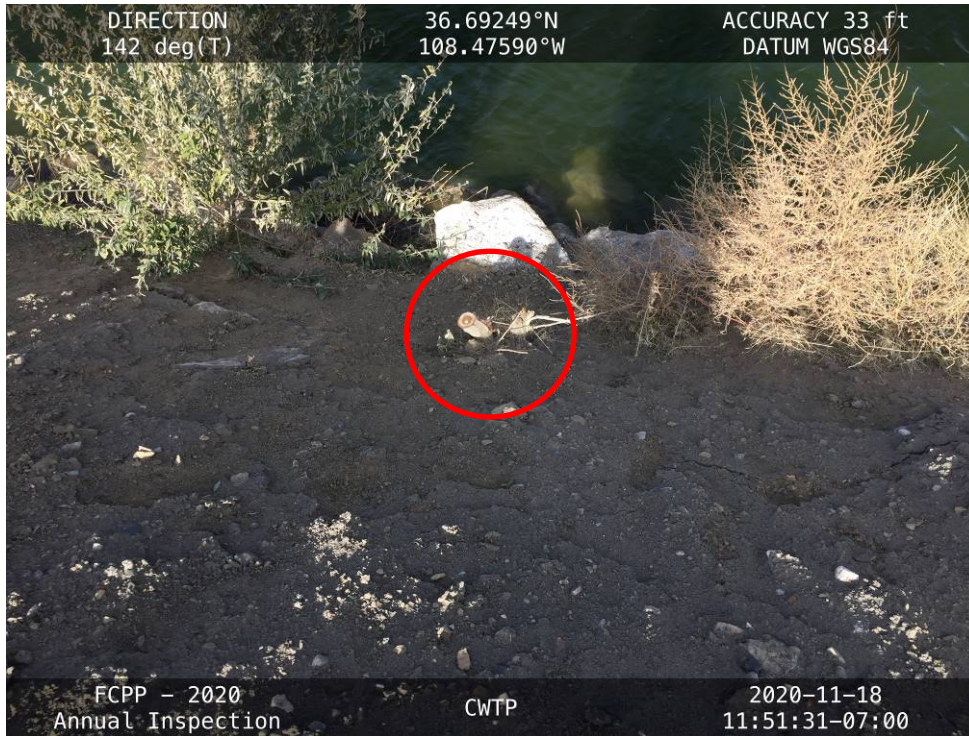
20201118 – IMG_3240
Woody vegetation roots to be removed.

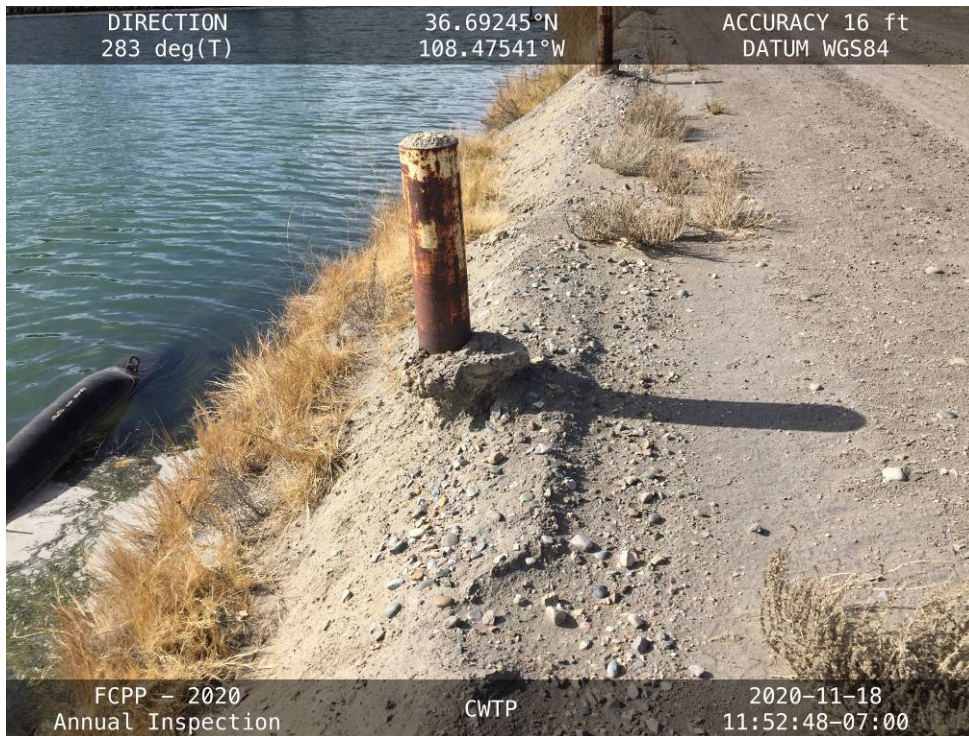
20201118 – IMG_3243
Erosion around the base of a bollard on the upstream slope.

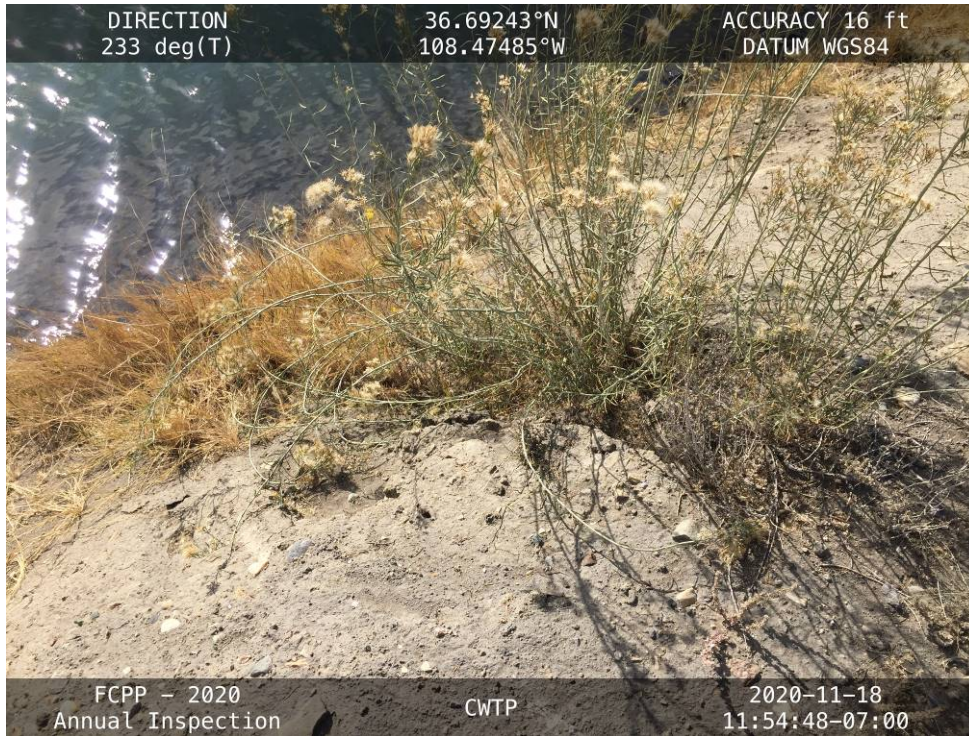
20201118 – IMG_3245

An ant hill on the downstream shoulder of the embankment.

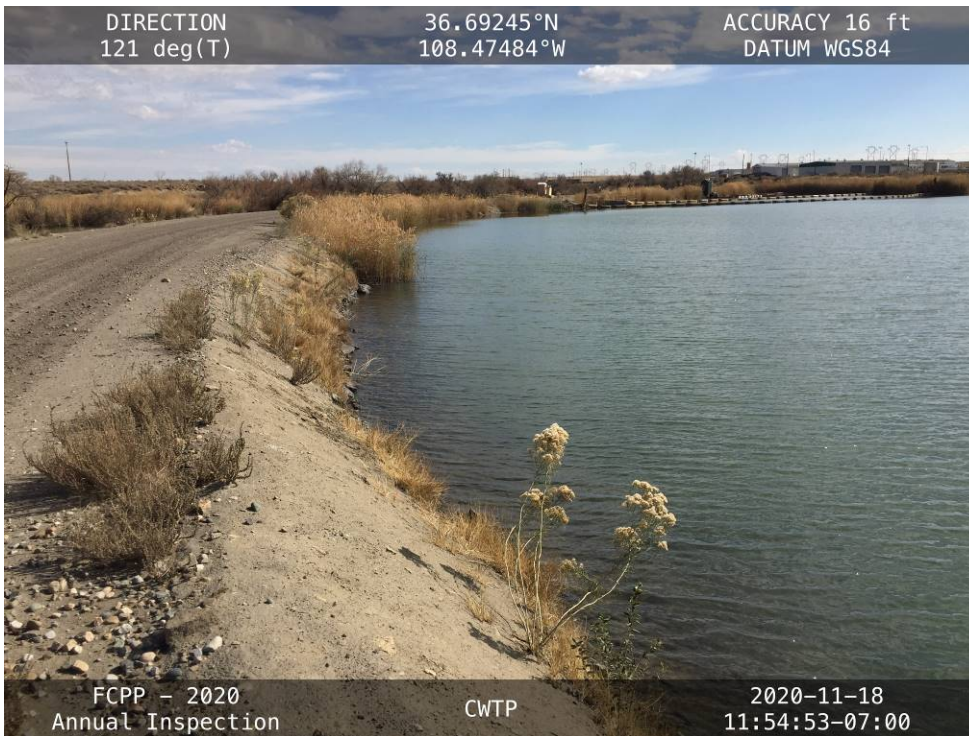
20201118 – IMG_3249

- iv. Instances of minor erosion were observed on the downstream slope (Photos IMG_3249 and IMG_3257). Continue to monitor these areas and repair erosion if it exceeds 1 foot in depth.

Erosion with vegetation on the downstream slope along the northern portion of the embankment.

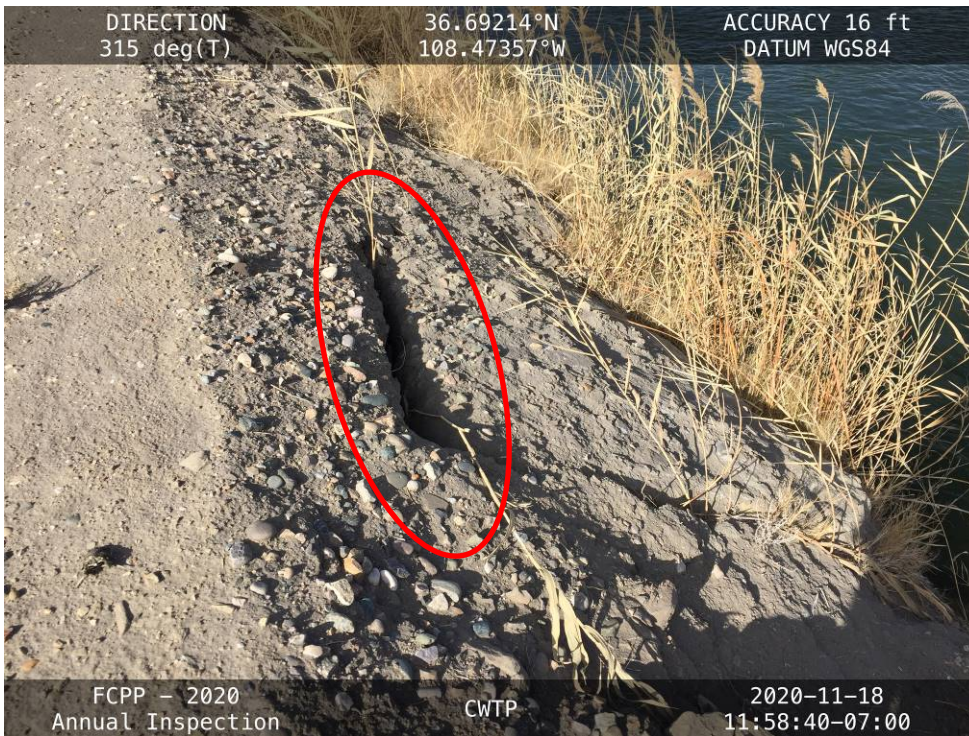
20201118 – IMG_3257
Erosion in a portion of the downstream slope without riprap.

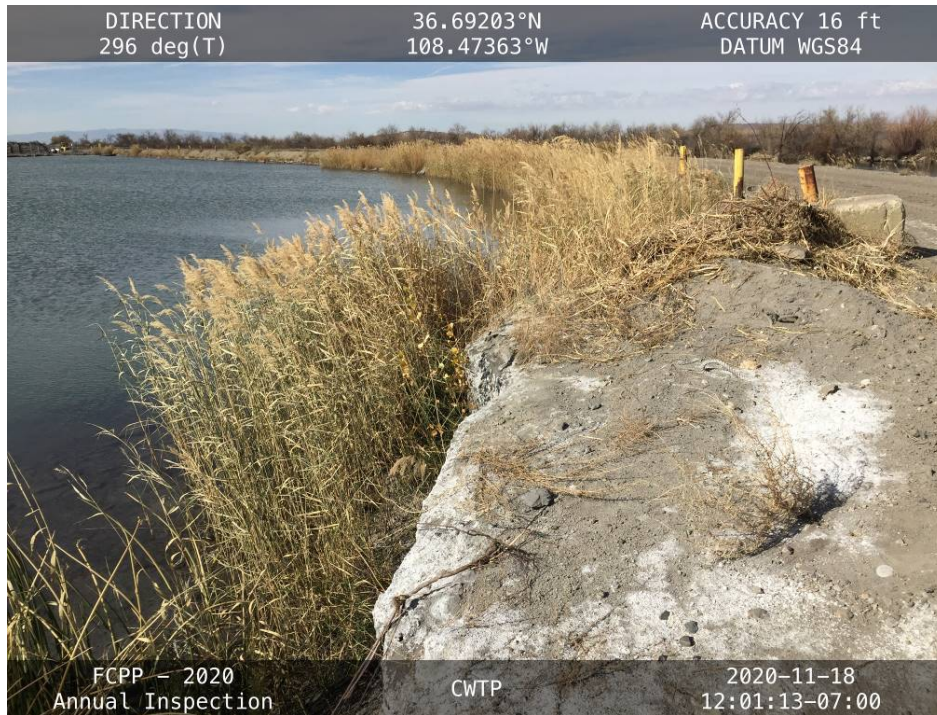
20201118 – IMG_3258
A riprap boulder separating from the rest of the slope, developing a 1-foot deep crack.

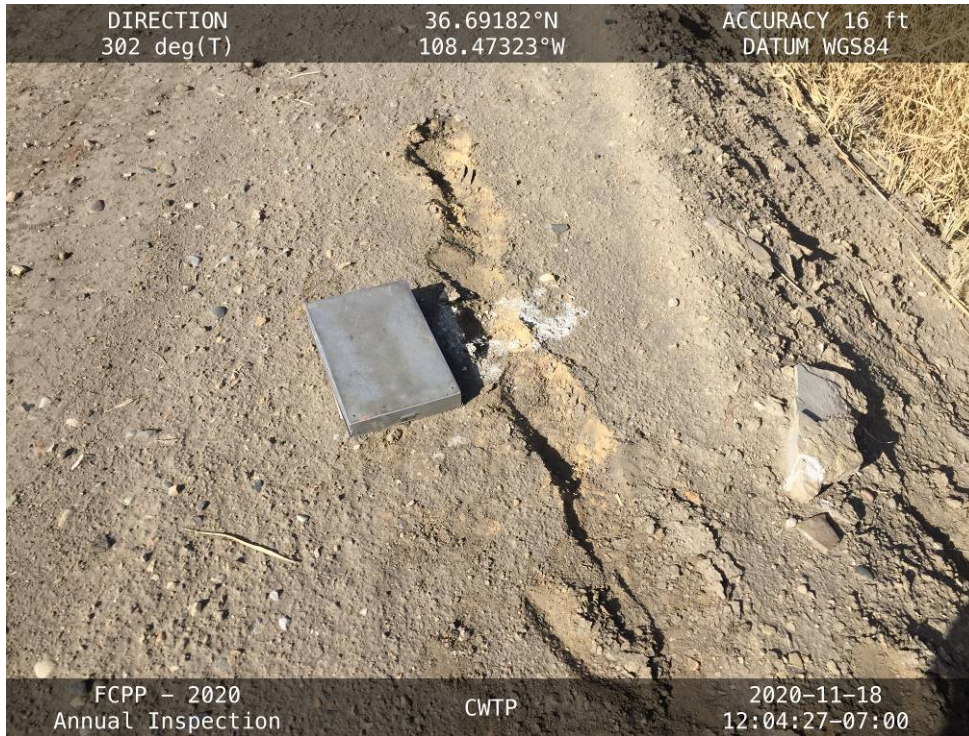
20201118 – IMG_3272

An 11.5-foot long tension crack forming on the downstream slope of the eastern part of the embankment. This is the same location observed in photo IMG_0933 during the 2018 inspection.
