# **Arizona Public Service Cholla Power Plant**

## **Fly Ash Pond**

### **Location Restrictions Demonstration Report**

AECOM Job No. 60587726  
October 8, 2018

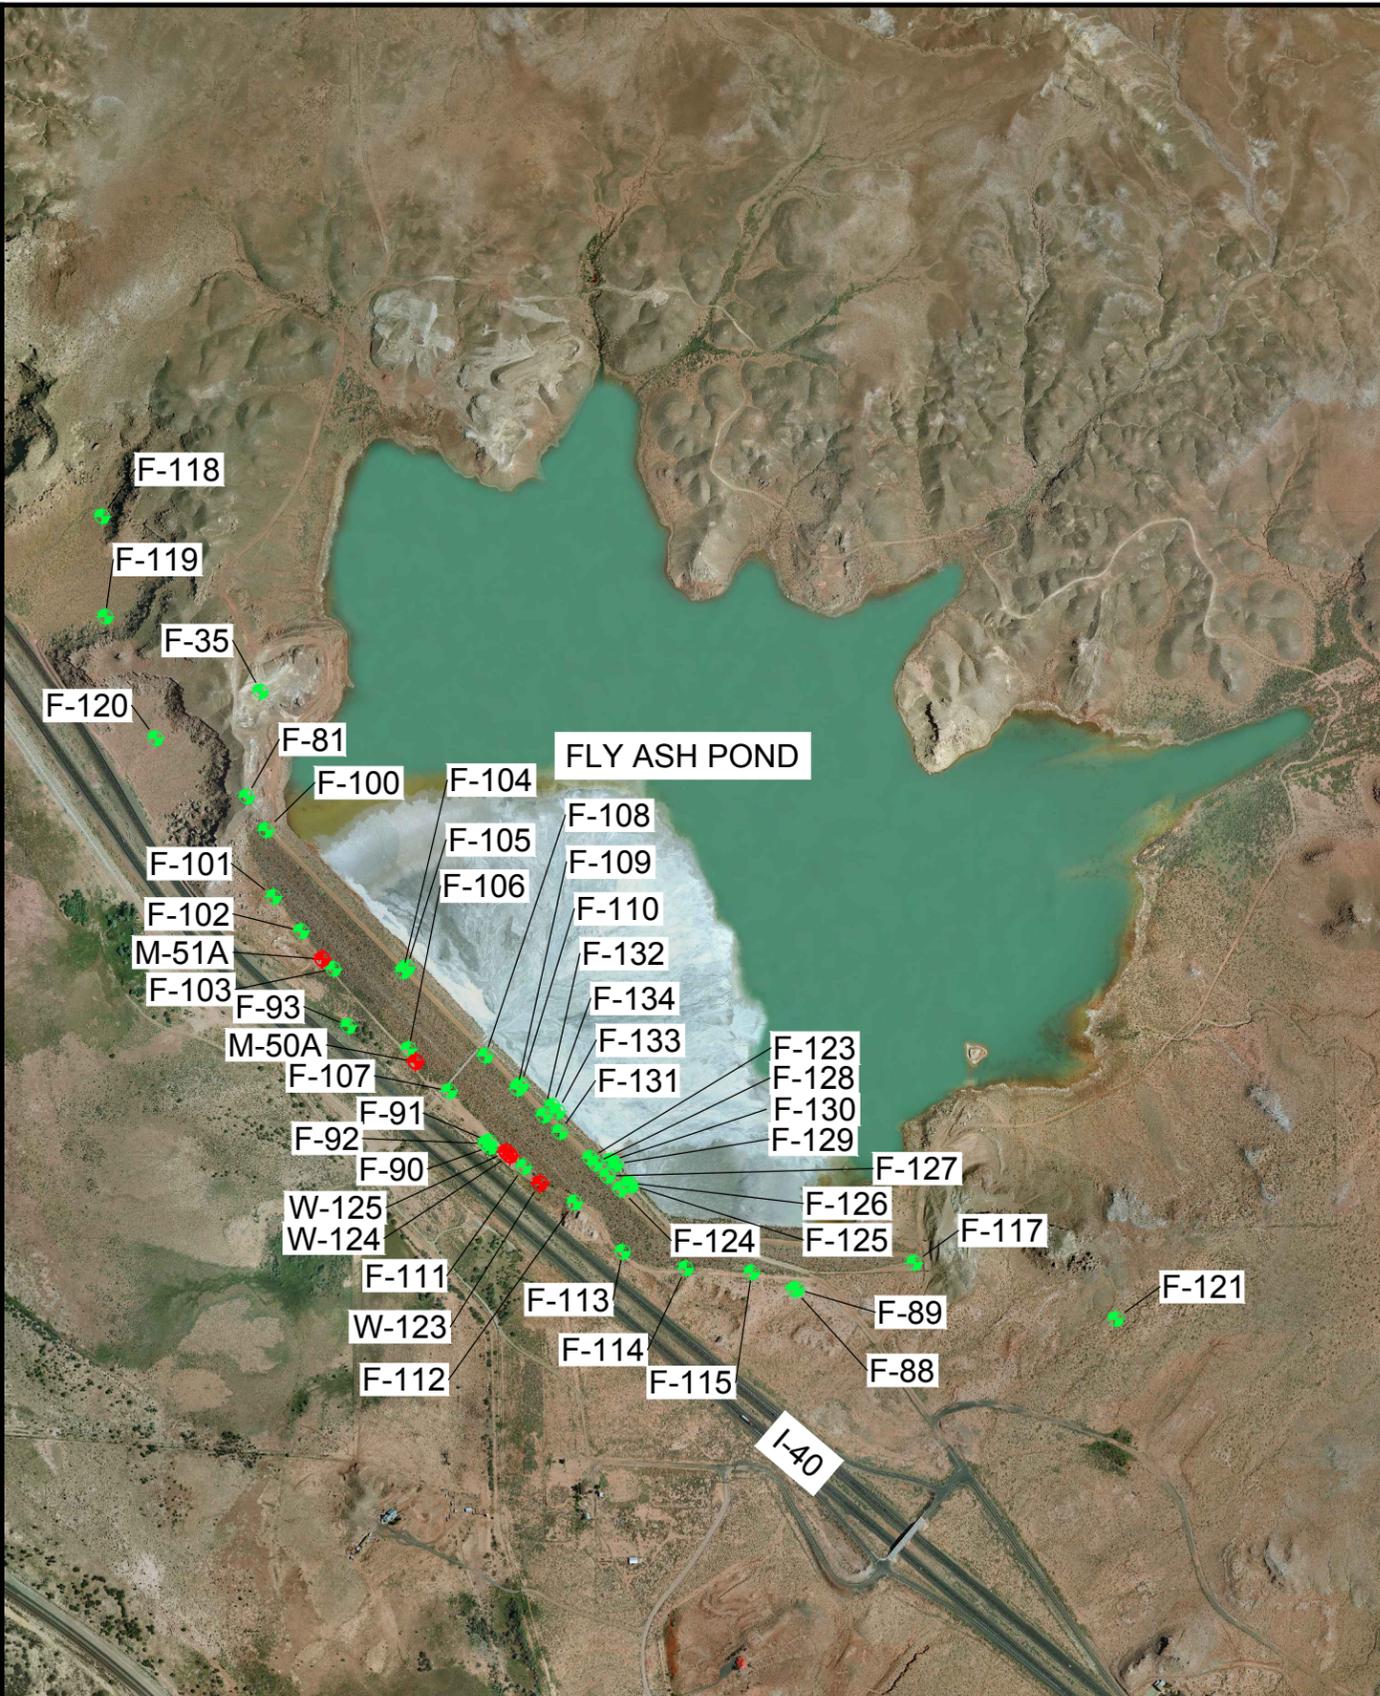
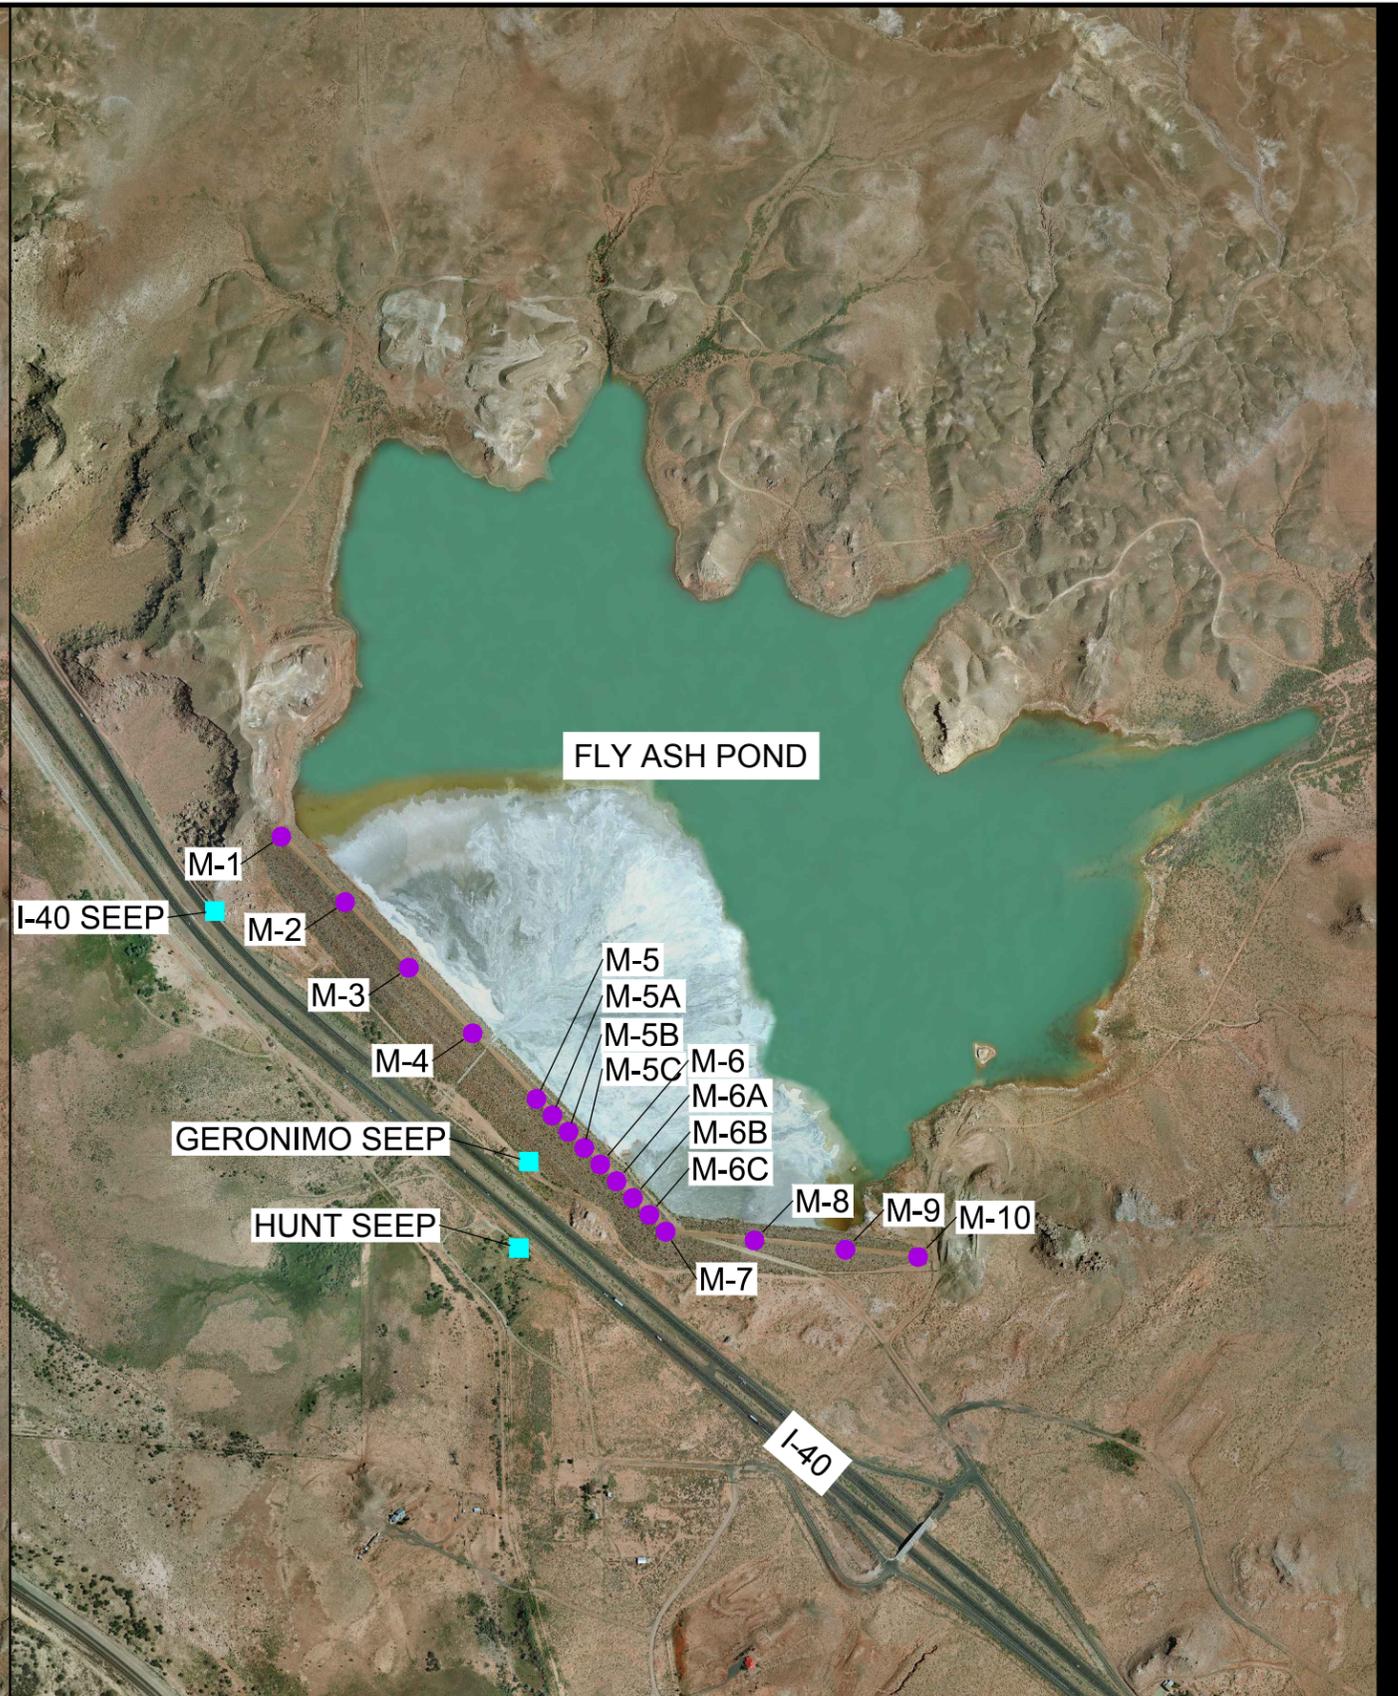
Figure 2-1: Monitored Instrumentation and Seep Location Map

**PIEZOMETERS AND WELLS**

- PIEZOMETER (F-###)
- WELL (M-## OR W-###)

**SETTLEMENT MONUMENTS AND SEEPS**

- SETTLEMENT MONUMENT (M-##)
- SEEPAGE LOCATION

The Fly Ash Dam is constructed on alluvium. Groundwater is present in the alluvium near the Fly Ash Pond and in the underlying bedrock aquifer. During original construction, APS installed a series of standpipe piezometers (F-104, F-105, F-108, F-109, and F-110; Figure 2-1) on the crest of the dam; these piezometers are monitored on a monthly basis. The maximum groundwater elevations for the open standpipe piezometers located in the Fly Ash Dam crest are included in the Annual CCR Impoundment and Landfill Inspection Report (APS and AECOM 2016, APS 2017, and APS 2018a) for data since 2014. The data associated with the piezometers are presented in Table 1.

Several seepage locations have been observed downstream of the dam since the Fly Ash Pond went into operation. These seeps are thought to occur due to a combination of normal flow through the embankment, discontinuities in the foundation near the groin of the abutment, and flow through gypsum seams in the Moenkopi Formation. An underground French drain system was installed at the toe of the Fly Ash Dam at the Geronimo Seep and further downstream at the Hunt Seep. The seepage intercept systems pump the water collected in the sumps back into the Fly Ash Pond. A third seep along Interstate 40 (I-40), known as the I-40 Seep, is an area of seepage observed along the shoulder of I-40 where the rock outcrop near the northwest abutment was cut as part of the road construction. The I-40 Seep does not normally result in ponded water along the road and is not connected to the seepage pumpback system. The locations of these three seeps are shown in Figure 1-2. APS monitors flows from the sumps installed at the Geronimo and Hunt Seeps on a regular basis. Flow rates at the Geronimo Seep typically range from 10 to 45 gallons per minute (gpm) and flow rates at the Hunt Seep typically range from 0 to 15 gpm. The turbidity of the seep water observed at the sumps is also low. Both the low flow rate and the lack of turbidity indicate a low potential of internal erosion of the dam embankment or foundation.

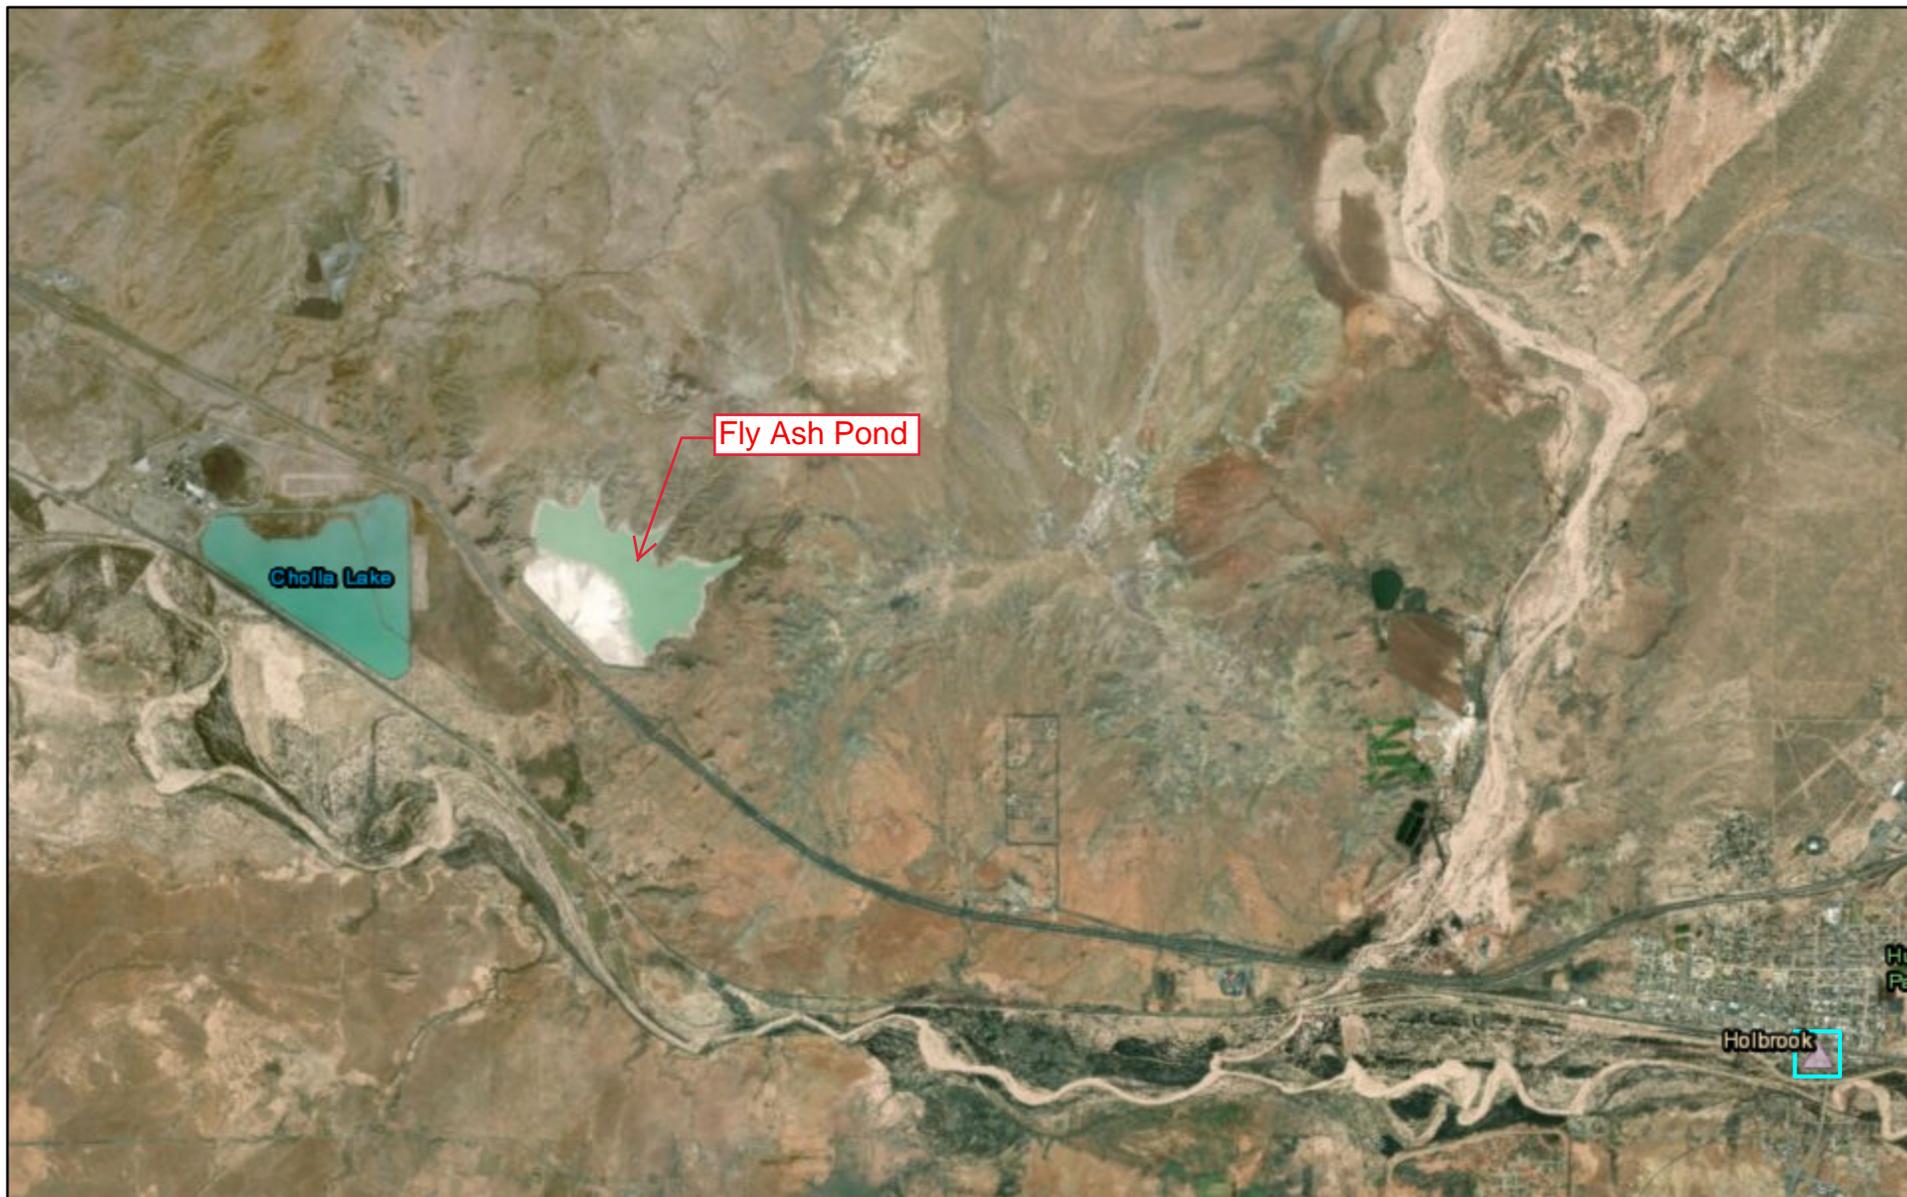
Earthquake Epicenters

The USGS Quaternary Faults and Folds Database of the United States did not contain any Class A or Class B faults in Navajo County. The AEIC catalog contained one earthquake within 10 miles of the Fly Ash Pond: a Modified Mercalli intensity VI earthquake occurred near Holbrook in 1921. The earthquake location is presented in Appendix D.

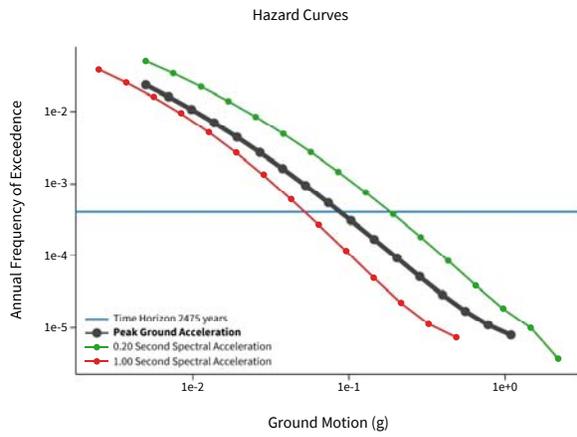
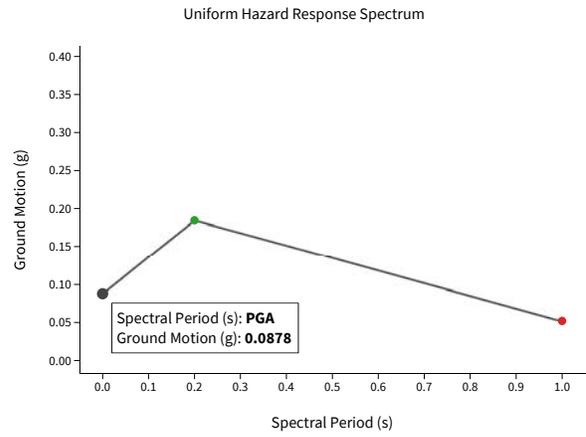
## ^ Hazard Curve

The USGS maintains the Unified Hazard Tool website to provide access to the source and attenuation models for locations within the United States. AECOM utilized version 4.0.x of the 2014 Unified Hazard Tool to calculate the peak horizontal ground acceleration (PGA) with a 2 percent probability of exceedance in 50 years (USGS 2018a) for the Fly Ash Pond location. The Unified Hazard Tool result is presented in Appendix E.

The PGA with a 2 percent probability of exceedance in 50 years for the Fly Ash Pond is 0.0878g. This value is less than the Rule-required maximum value of 0.10 g in 50 years.

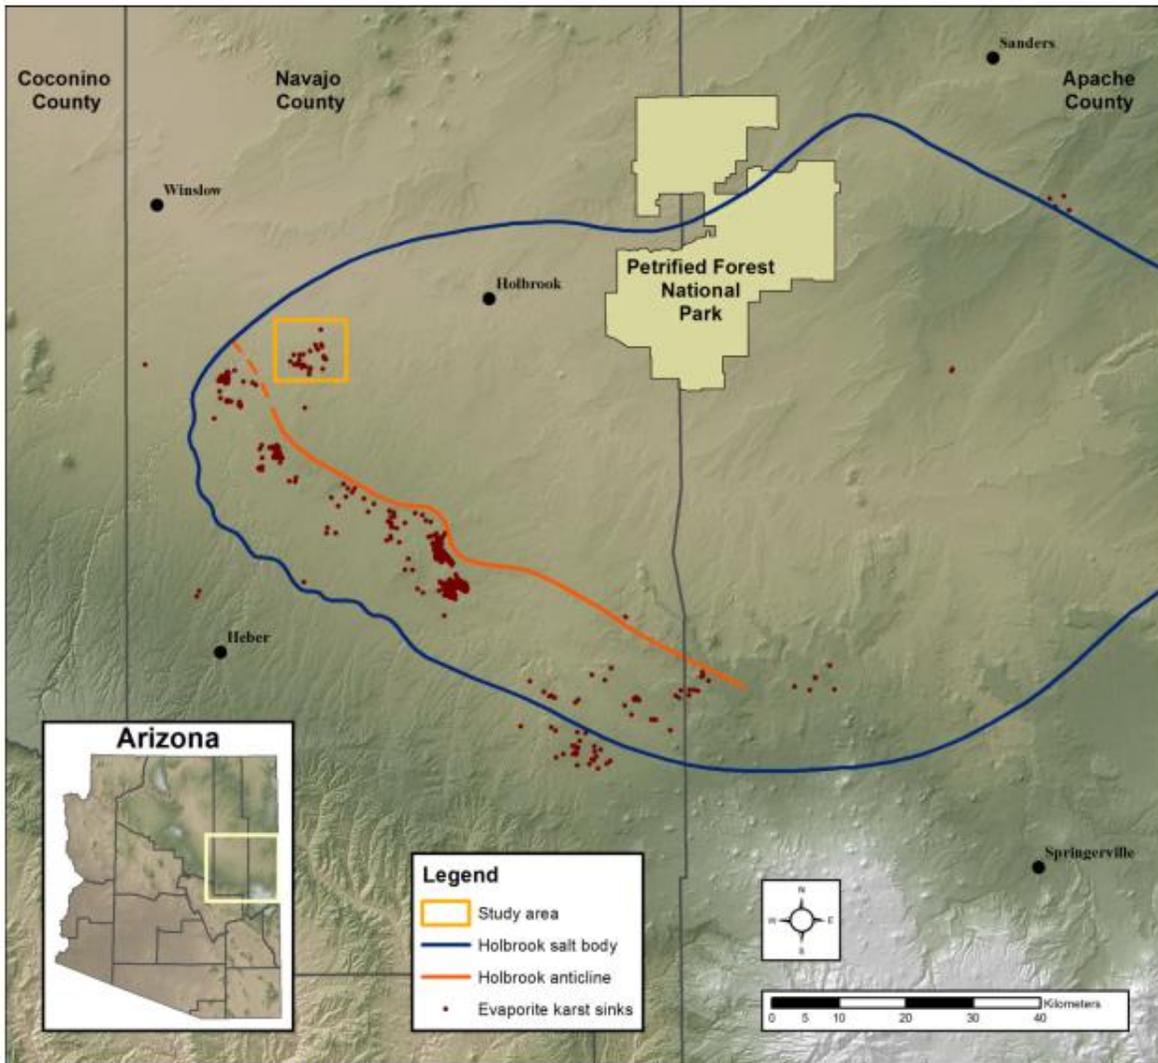
**Figure 1.** Location map of Holbrook Basin, study area extent, and distribution of existing evaporite karst sinks relative to the extent of the Holbrook salt body and anticline.

Collapse features (sinkholes, fissures, depressions, expanded bedrock joints and joint sets, compression ridges and buckles) associated with dissolution of evaporate deposits within the Permian-aged Supai Formation have been documented within the Holbrook Basin (see map in Appendix F). These features, collectively referred to as "salt karst," are concentrated along a roughly 60 mile long, northwest-southeast trending dissolution front near the southwestern margin of the Holbrook Basin, approximately 20 miles from the Cholla Power Plant.

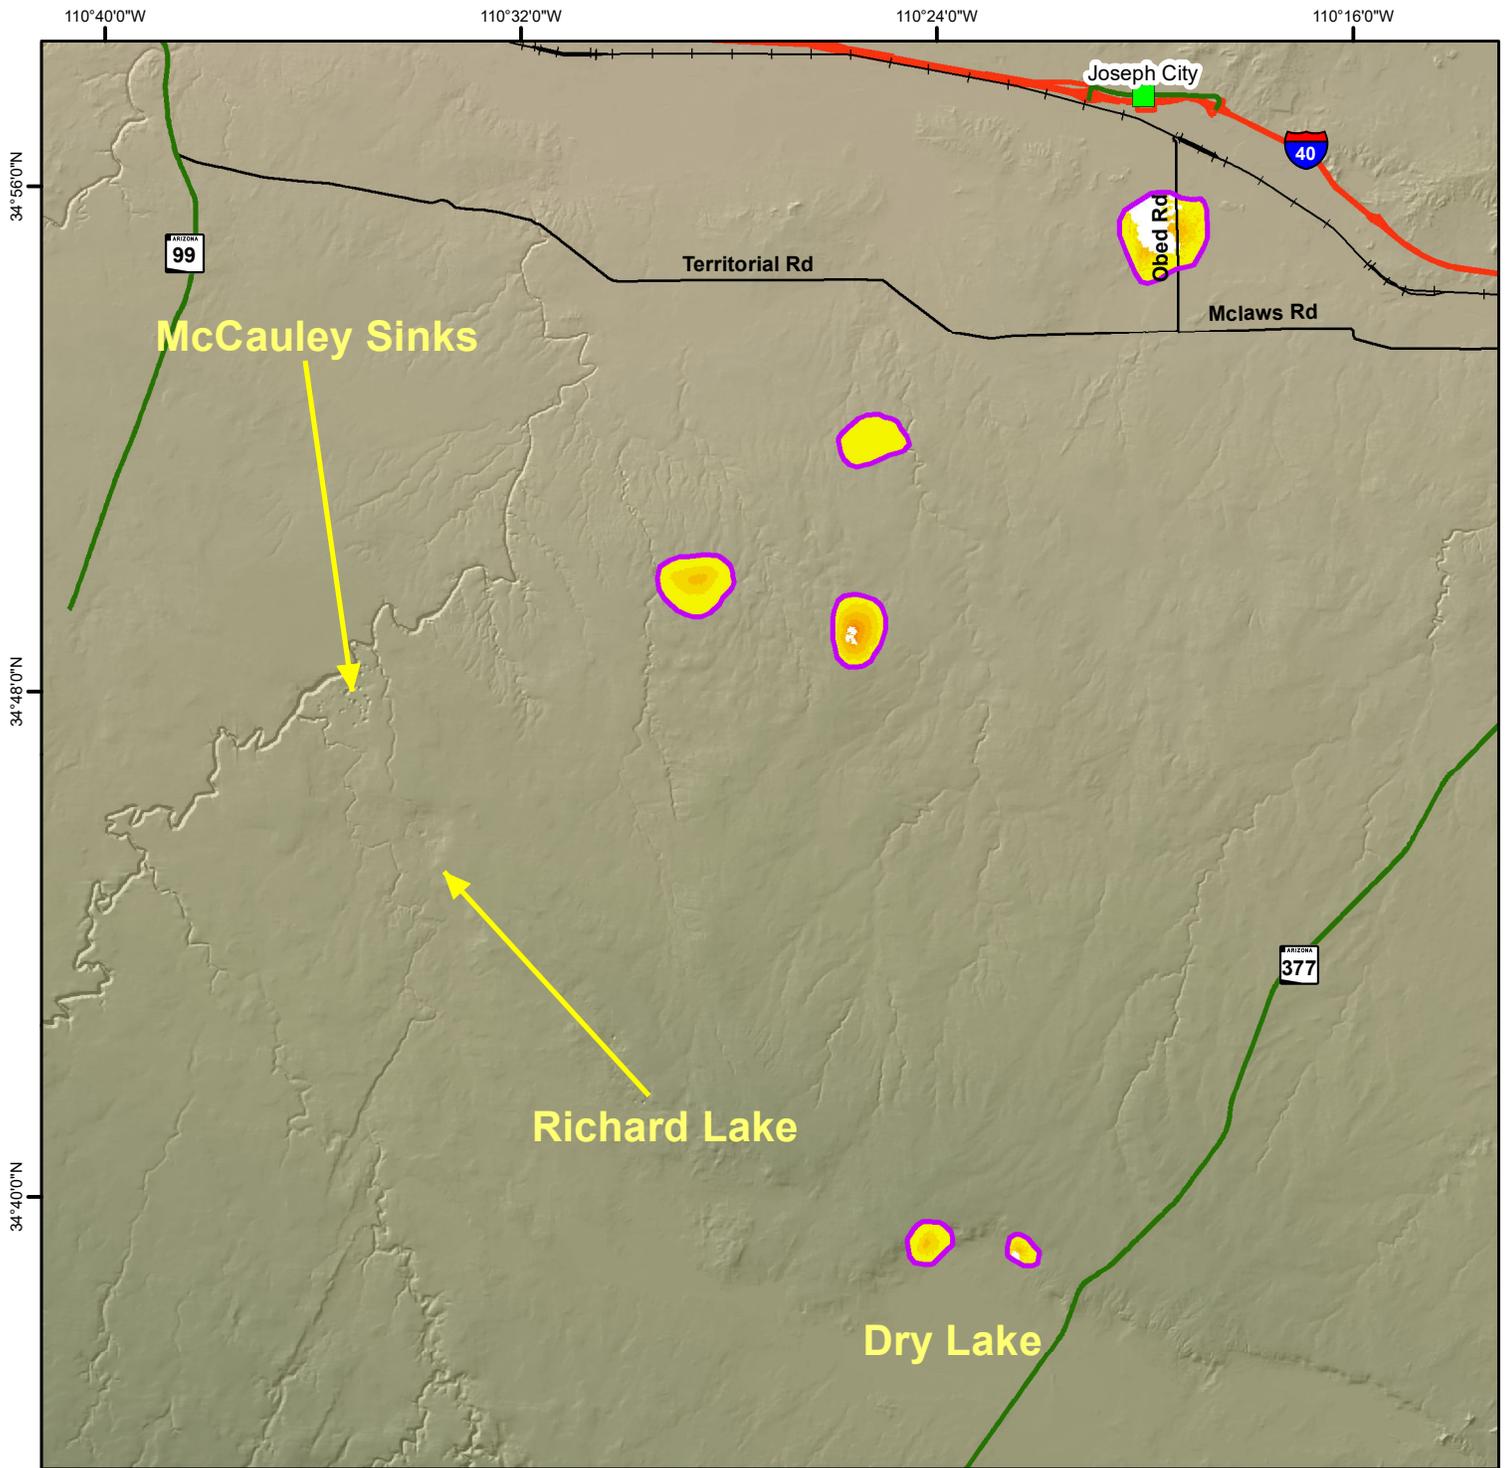
**Total Land Subsidence in the Holbrook Basin, Navajo County**  
 Based on Radarsat-2 Satellite Interferometric Synthetic Aperture Radar (InSAR) Data  
 Time Period of Analysis: 5.5 Years 09/22/2012 To 04/24/2018

The ADWR land subsidence maps suggest a cumulative subsidence of 3.9 to 5.9 inches between 2012 and 2018. The ground underlying the Fly Ash Pond is not considered to be susceptible to the formation of earth fissures based on the distance of the CCR unit from the area of identified subsidence and the relatively small indicated total settlement.

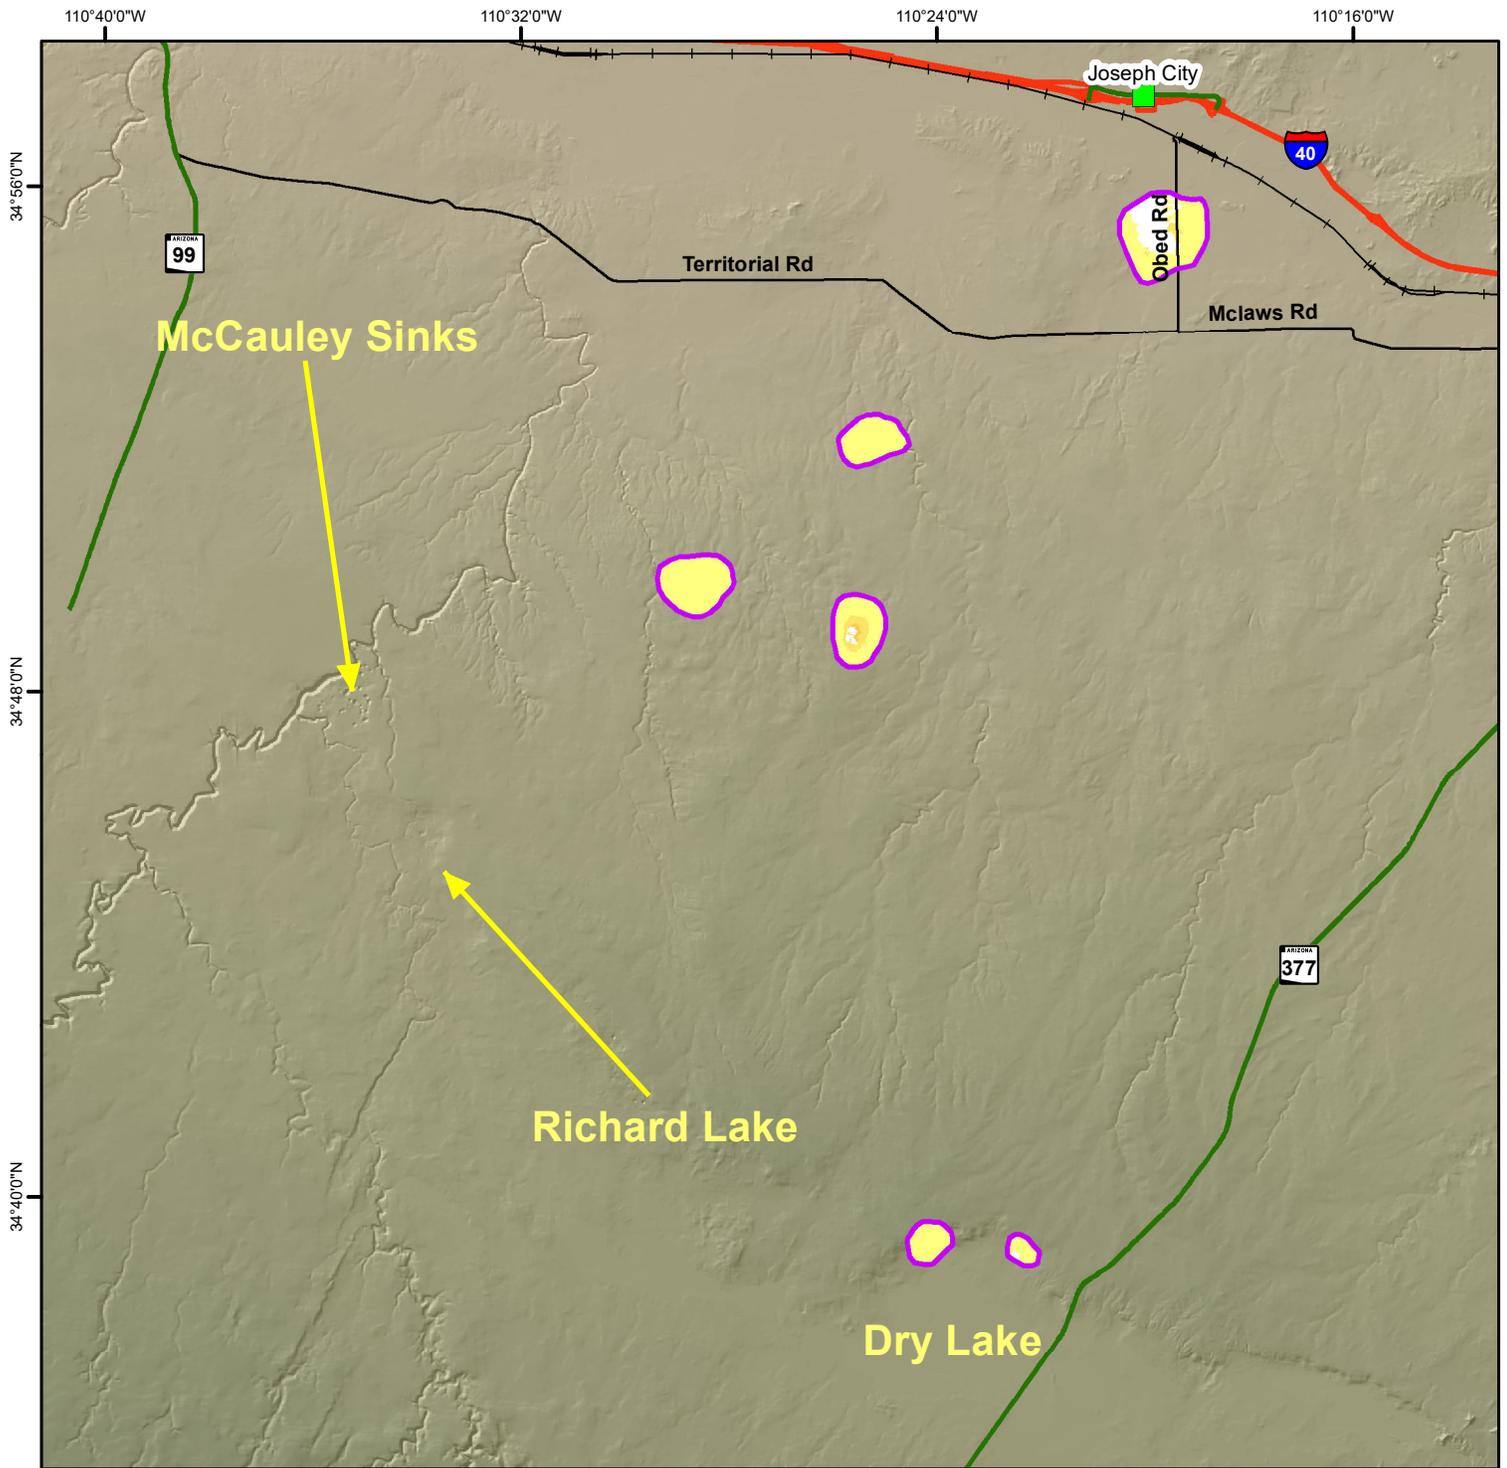
**Land Subsidence Rate in the Holbrook Basin, Navajo County**  
 Based on Radarsat-2 Satellite Interferometric Synthetic Aperture Radar (InSAR) Data  
**Time Period of Analysis: 5.5 Years 09/22/2012 To 04/24/2018**

The InSAR data suggest subsidence rates in the range of 0 to 1 centimeters per year (cm/yr) for the most recent six-year interval (2012-2018). APS operates a wellfield south and east of the Plant, east of the subsidence area indicated on the ADWR land subsidence maps (Appendix F). APS staff report that: 1) APS groundwater extraction from its wellfield has decreased by approximately one-third since the retirement of Unit 2 in 2014 and 2) the Coconino aquifer is highly productive and groundwater levels within the wellfield have been rising since the retirement of Unit 2 in 2014 (APS Internal Communication 2018b).
