FOUR CORNERS POWER PLANT
Lined Ash Impoundment,
Lined Decant Water Pond,
Combined Waste Treatment Pond,
Upper Retention Sump, and
Dry Fly Ash Disposal Area

Annual
CCR Impoundment and
Landfill Inspection Report

2017

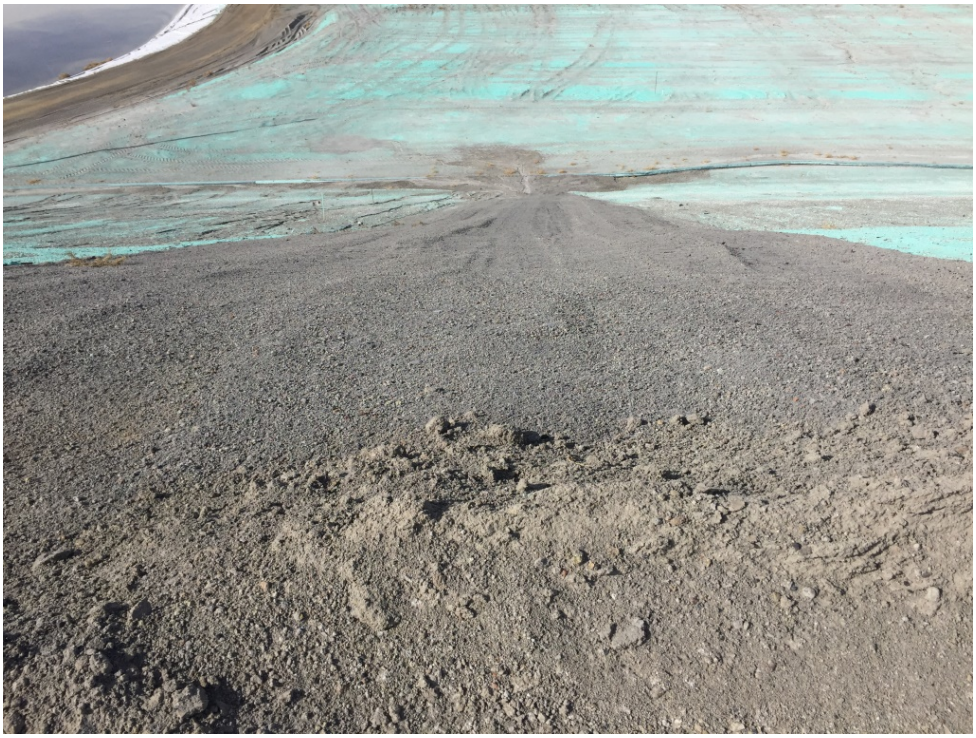
iv. The downstream slope of the West Embankment had recent erosion repairs (photo IMG_1886) and minor recent erosion rills. These local erosional features may require repair in the future (photos IMG_1884 and IMG_1887) and should be monitored.

20171113 – IMG_1884
Minor erosion rills along the downstream slope of the West Embankment.

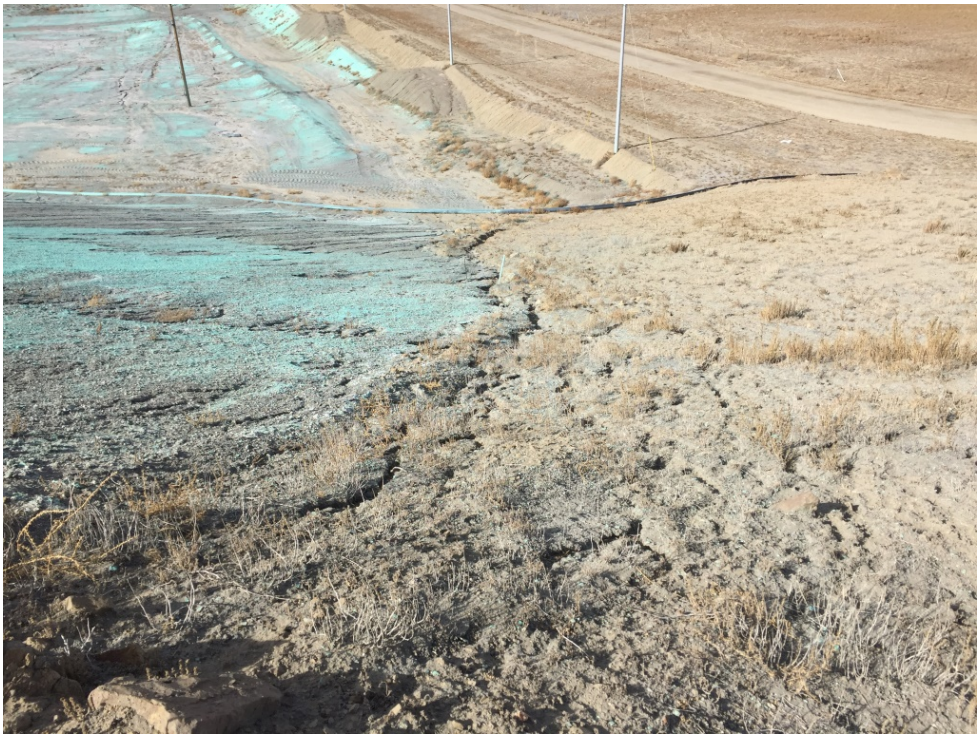
20171113 – IMG_1886
Area of repaired erosion along the downstream slope of the West Embankment.

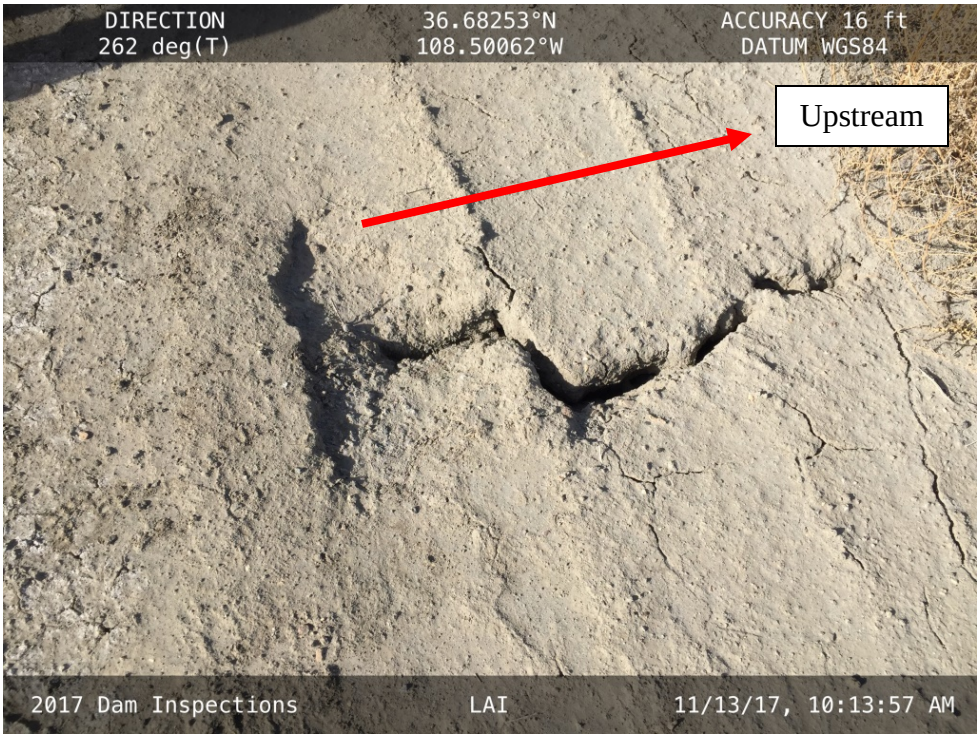
i. The transverse cracks observed in the anchor trench along the South Embankment (photo IMG_5190) did not appear to be widespread or indicative of adverse conditions along the crest. The area should be monitored and repaired if the cracks become more widespread.

20171113 – IMG_5190
A transverse crack on the crest of the South Embankment extending from the edge of the anchor trench to the upstream slope.

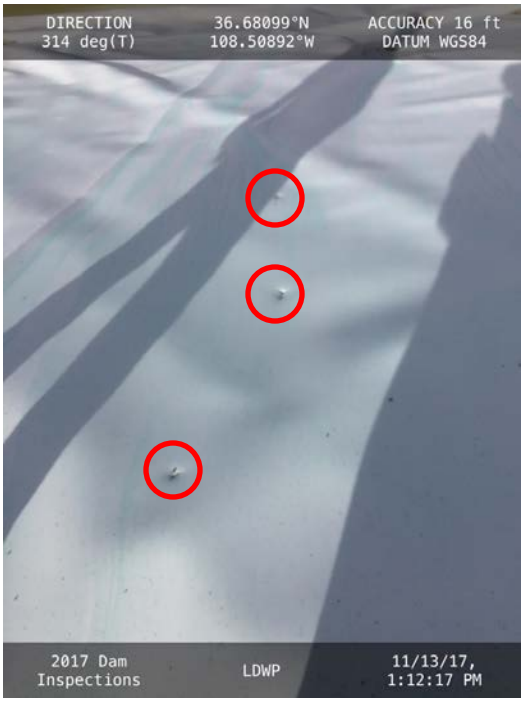
20171113 – IMG_5366
The East Embankment upstream slope, facing north.

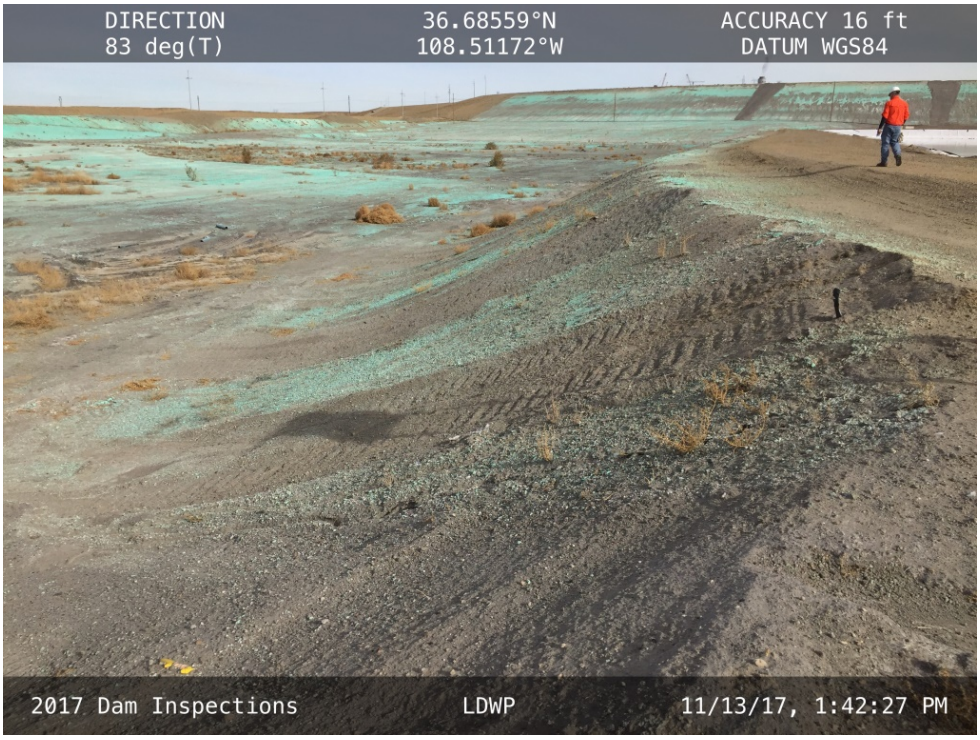
v. The liner was observed to be pulling out of the anchor trench in isolated areas along the West and East Embankments (photos IMG_5408 and IMG_5435). The area where the liner was observed pulling out of the anchor trench during the 2016 inspection has been repaired (photo IMG_5411).

20171113 – IMG_5408
The liner pulling out of the anchor trench in the northern portion of the West Embankment.

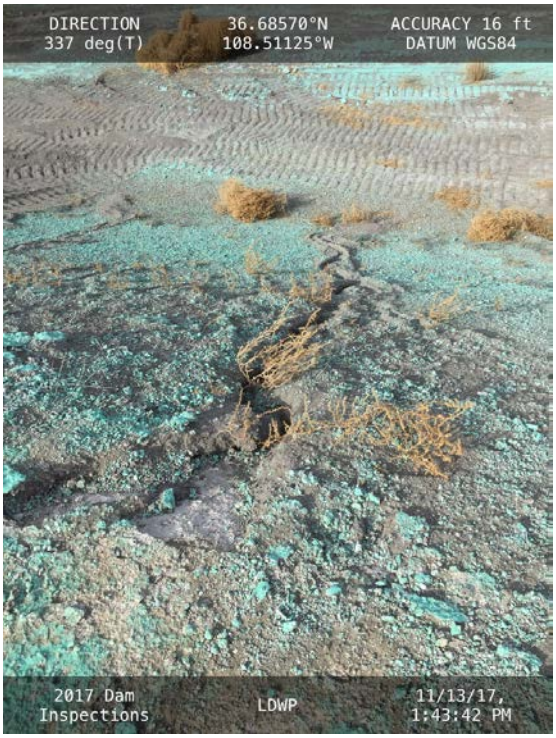
ii. The external slopes of the embankments show evidence of minor erosion rilling (photos IMG_5354, IMG_5361, and IMG_5425). APS has been maintaining the affected areas by regrading and recompacting eroded areas (photo IMG_5421). At the time of the inspection, several locations along the South, West, and North Embankments had recently been repaired. The current program appears to be sufficient and should be continued such that rills are repaired if the erosion depth exceeds one foot.

20171113 – IMG_5425
Erosion rill forming along the North Embankment downstream slope, facing toward the toe.

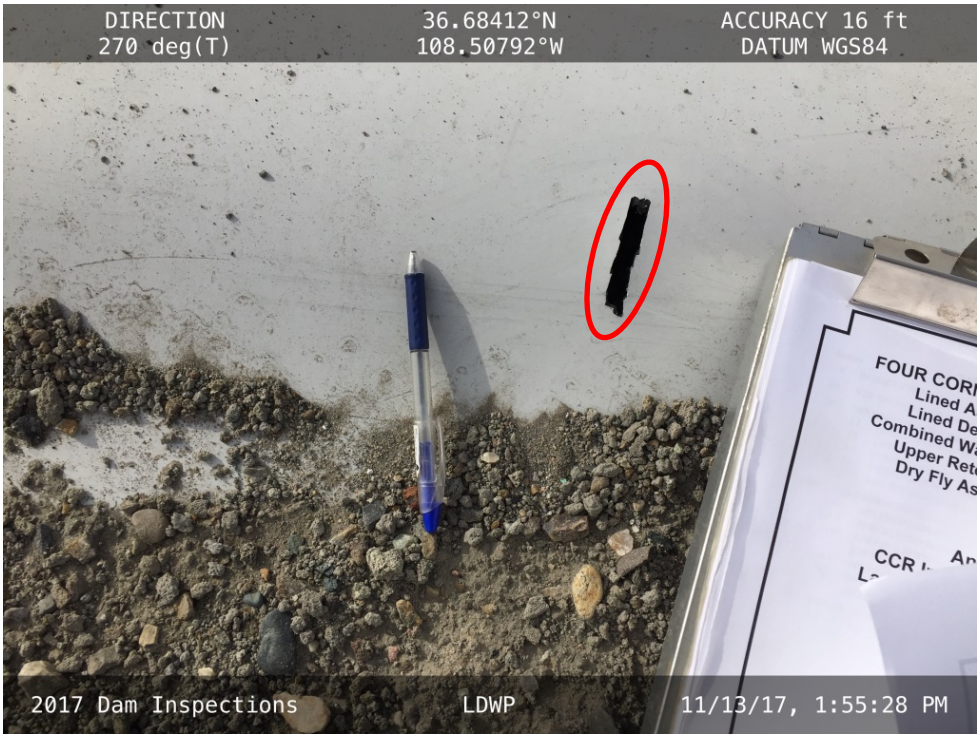
iv. There were several holes and tears in the liner along the South, North, and East Embankments (photos IMG_5382, IMG_5429, IMG_5438, and IMG_5442). FCPP personnel stated that they were aware of several existing tears and intend to repair them.

20171113 – IMG_5429
Tears in the liner along the North Embankment.
