CHOLLA POWER PLANT Fly Ash Dam, Bottom Ash Dam, and Bottom Ash Monofill

Annual CCR Impoundment and Landfill Inspection Report

2023

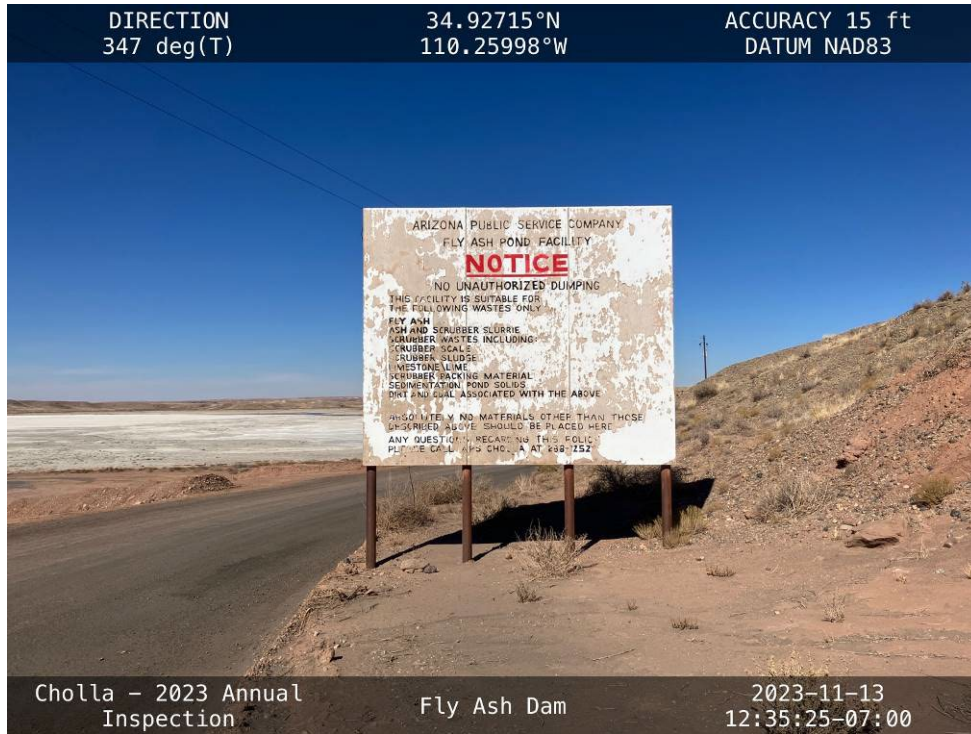
20231113 – IMG_1506
Sign identifying allowed and disallowed materials in the Fly Ash Pond.

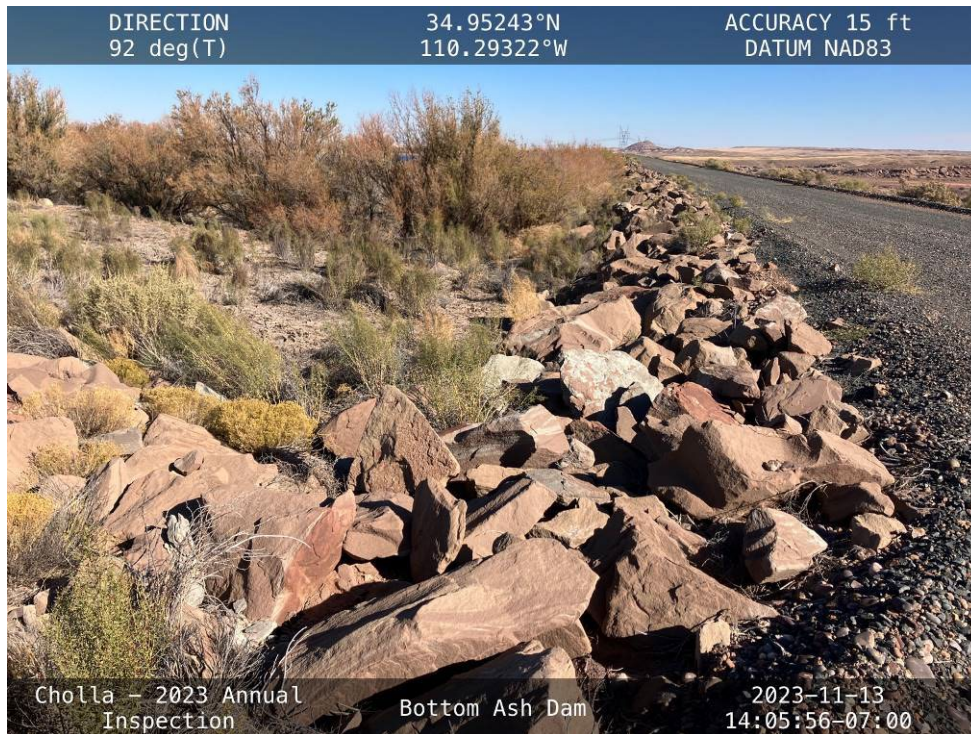
20231113 – IMG_1609
Trees and other woody vegetation to be removed from the South Embankment upstream slope.

9) Remove vegetation from the upstream slope at the Right Abutment.	Woody vegetation rooted in the embankment should be removed and the resulting disturbed area should be replaced with compacted material similar to the embankment material per NMOSE (2011).

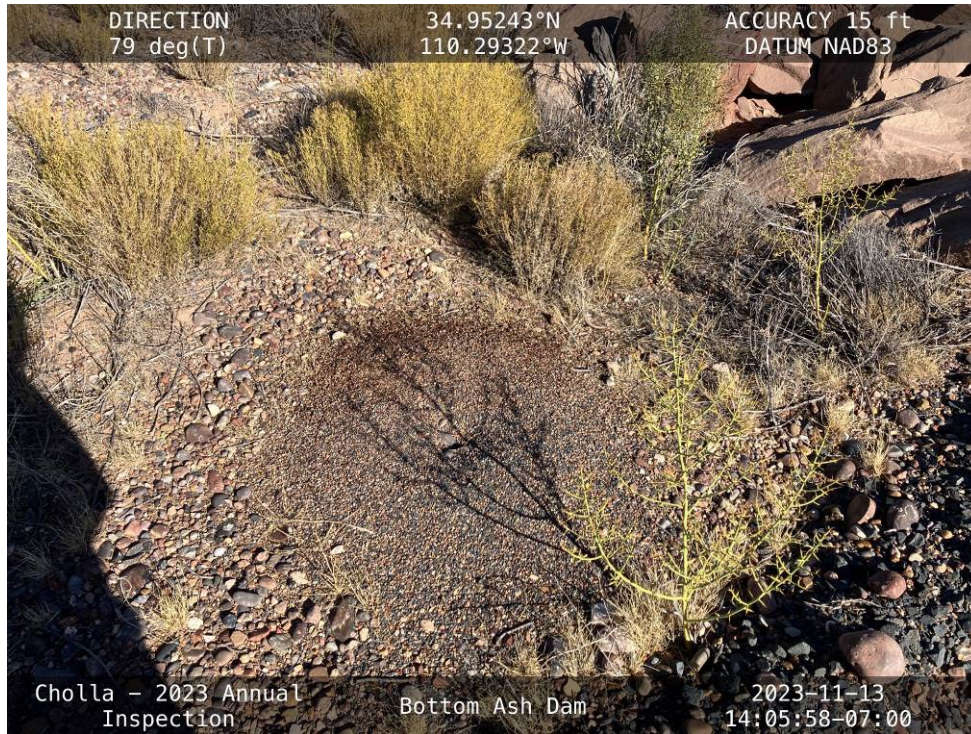
20231113 – IMG_1610
An ant hill on the upstream shoulder at the Right Abutment.

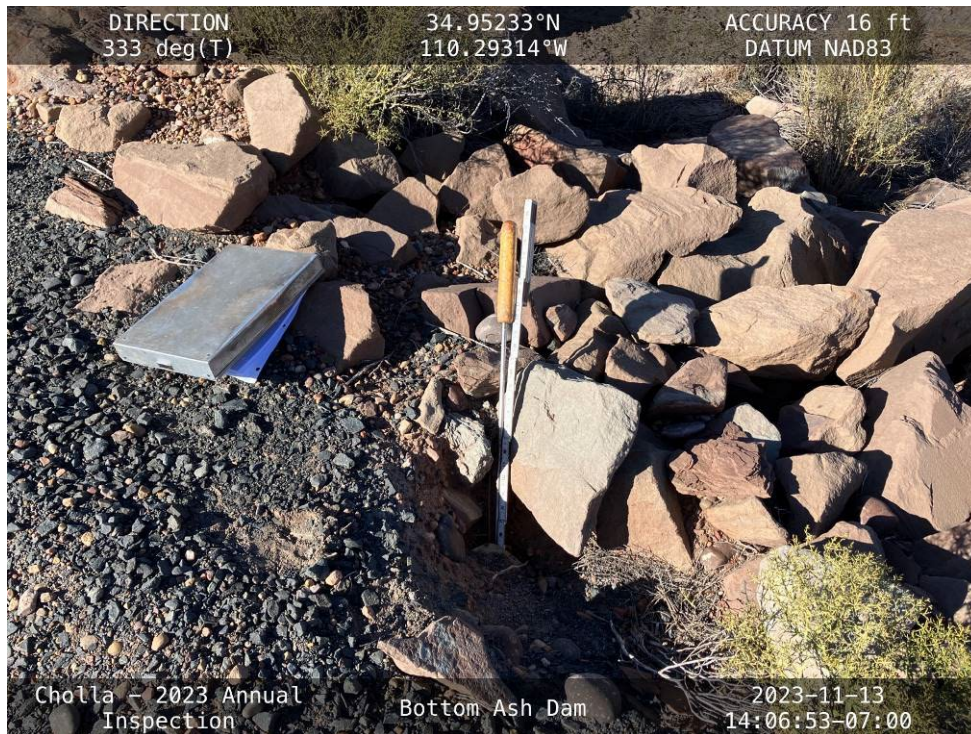
20231113 – IMG_1611
12 inches of erosion on the upstream side of the South Embankment shoulder.

10) Continue to monitor the erosion around the siphon line encasements and on the shoulder of the crest.	Repair erosion if the eroded depth exceeds 1 foot.

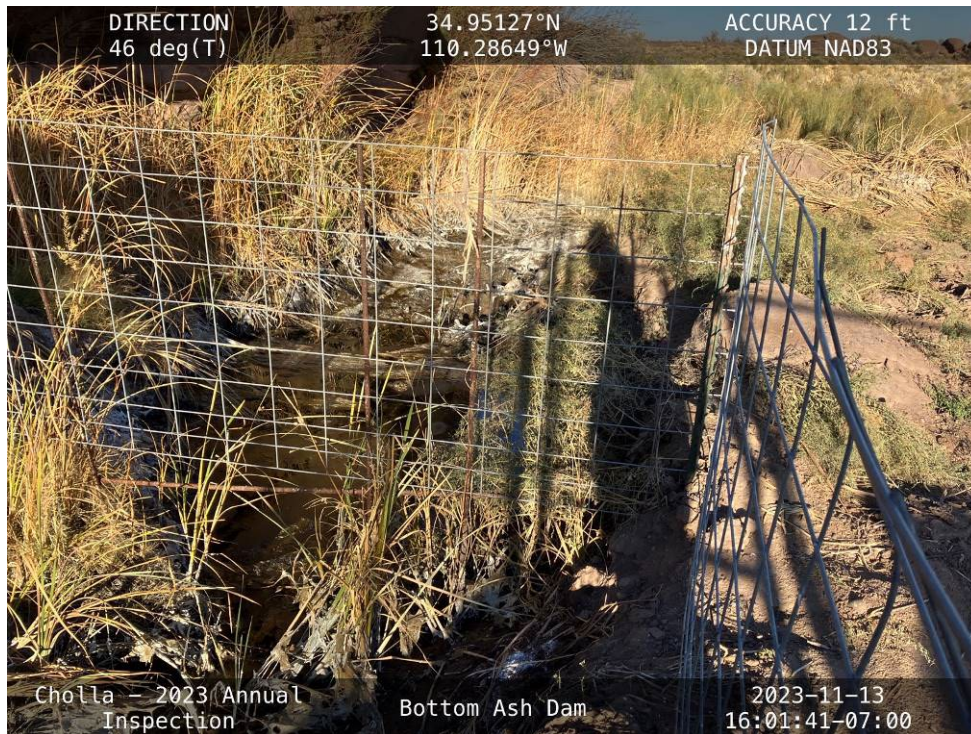
20231113 – IMG_1744
Ash and water being deposited into the Bottom Ash Pond.

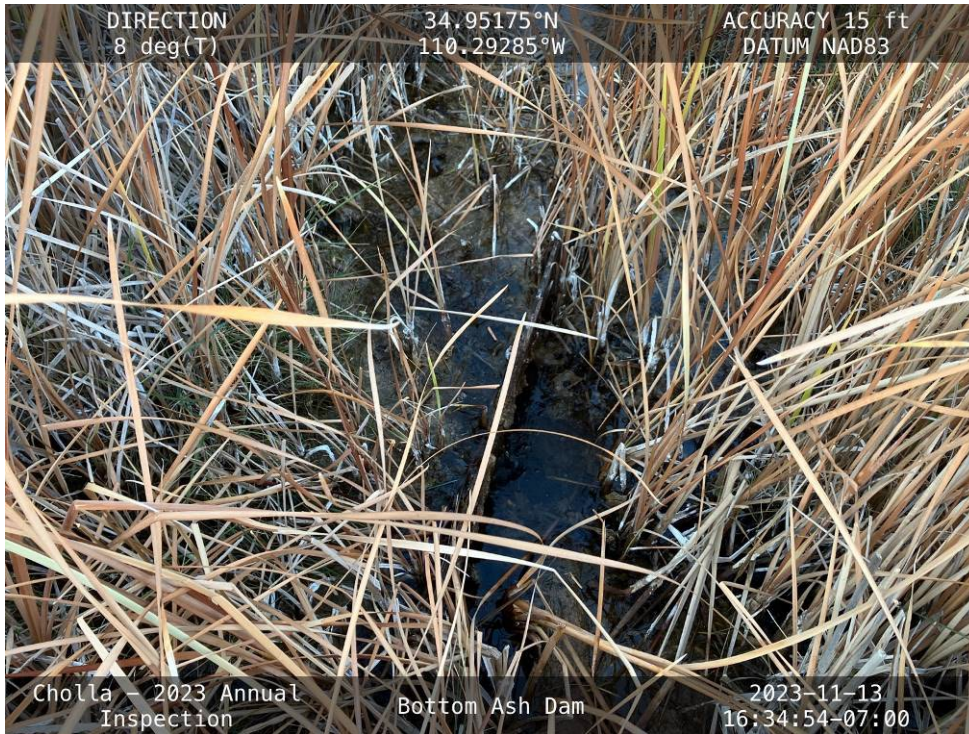
20231113 – IMG_1789

The downstream slope and toe of the Bottom Ash Dam, facing north near the central siphon lines.

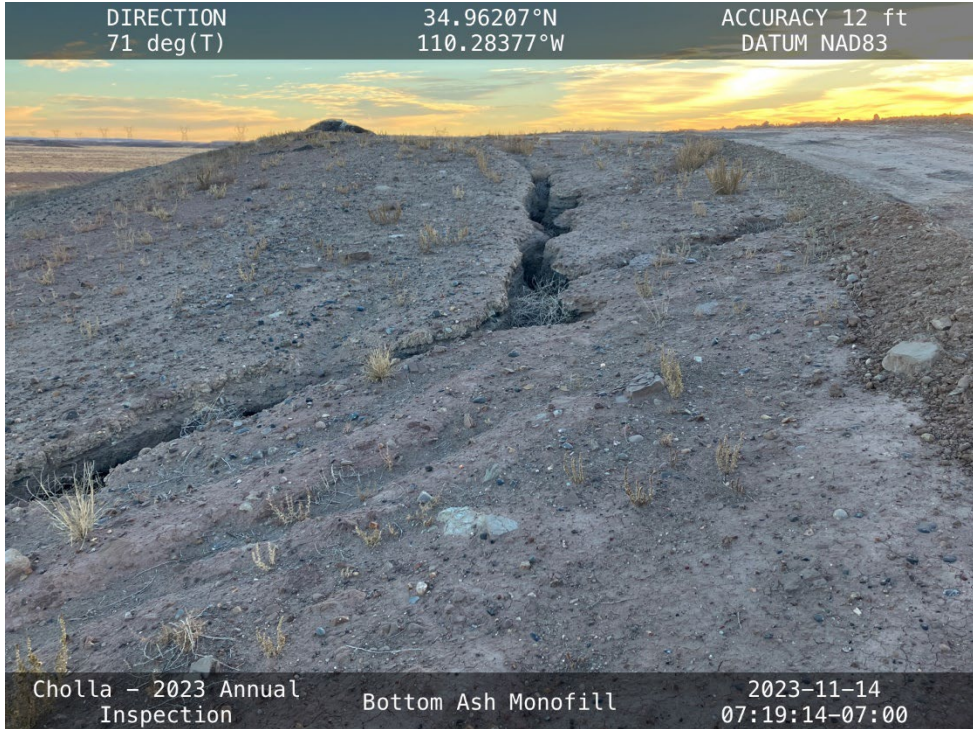
20231114 – IMG_1840
An erosion gully on north side of the BAM, facing south.

Action Item	Action Status
1) Erosion gullies several feet deep were observed at various locations at the CCR unit. Some erosion gullies extended into the ash underlying the soil cover.	Repair the erosion once it exceeds 1 foot in depth or reaches the underlying ash. NOTE: This will always be an ongoing maintenance activity.

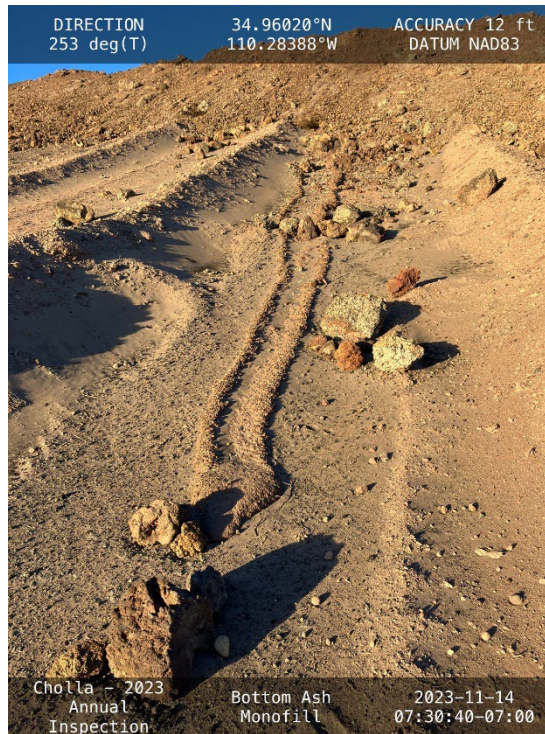
20231114 – IMG_1862
A streak of cemented ash along the downstream slope of the East Embankment.

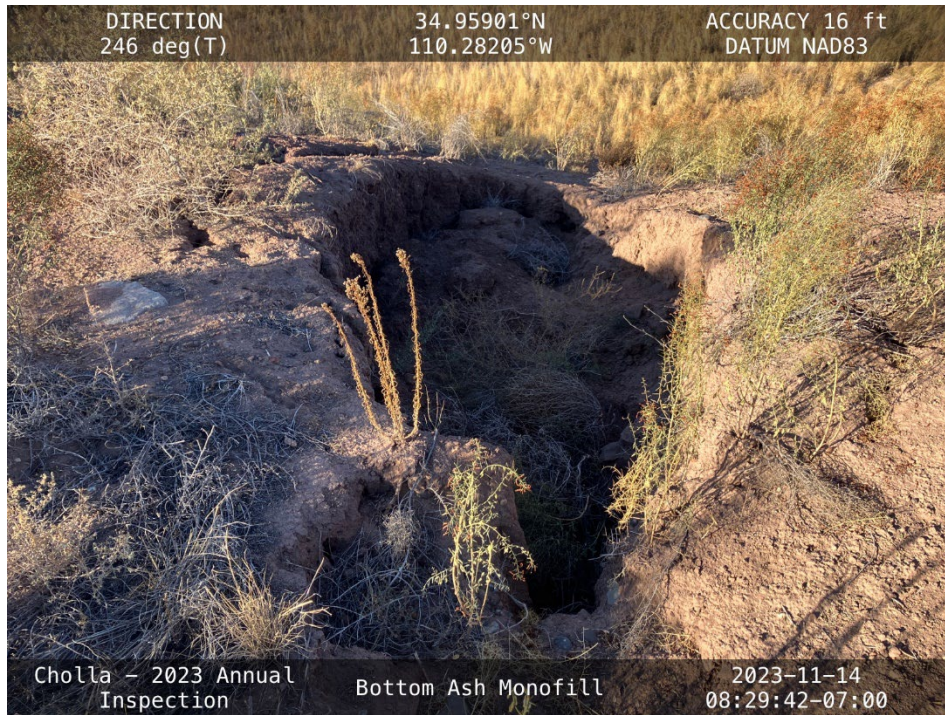
20231114 – IMG_1949
Erosion on the east side of the Stormwater Detention Basin.

7) Severe erosion around the Stormwater Detention Basin.	Repair the erosion. Assess the gradients entering the Basin and consider reducing the entrance slope or placing riprap along the slopes to reduce the erosive potential of the run-on.
