# CHOLLA POWER PLANT Fly Ash Dam, Bottom Ash Dam, Sedimentation Pond, and Bottom Ash Monofill

## Annual CCR Impoundment and Landfill Inspection Report

2020

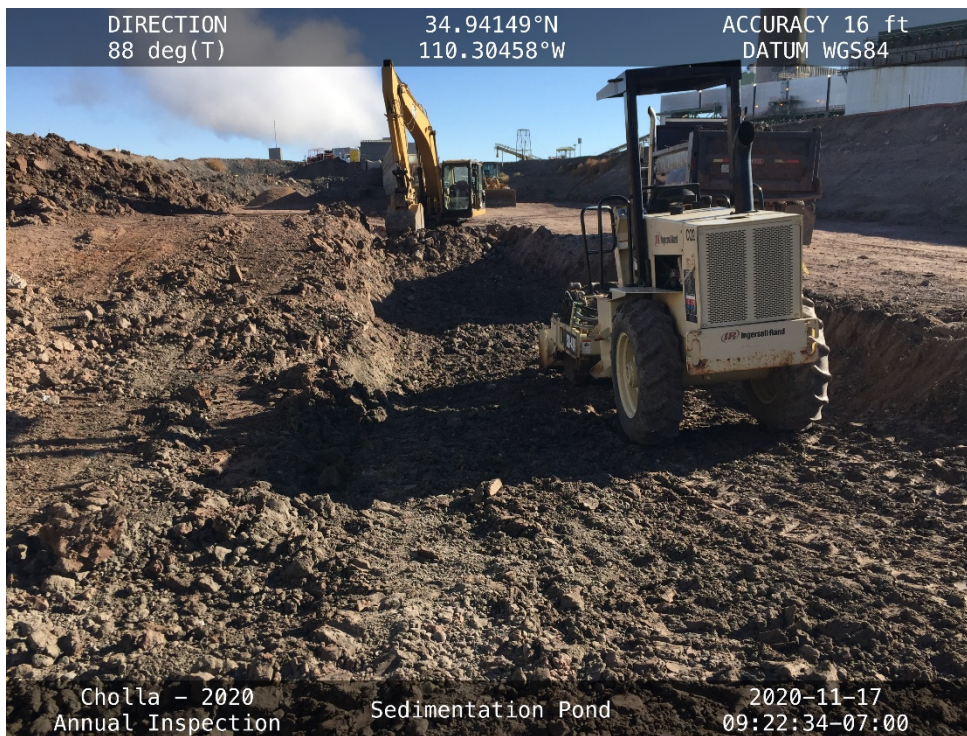
**20201117 – IMG\_2961**  
 The western end of the South Cell.

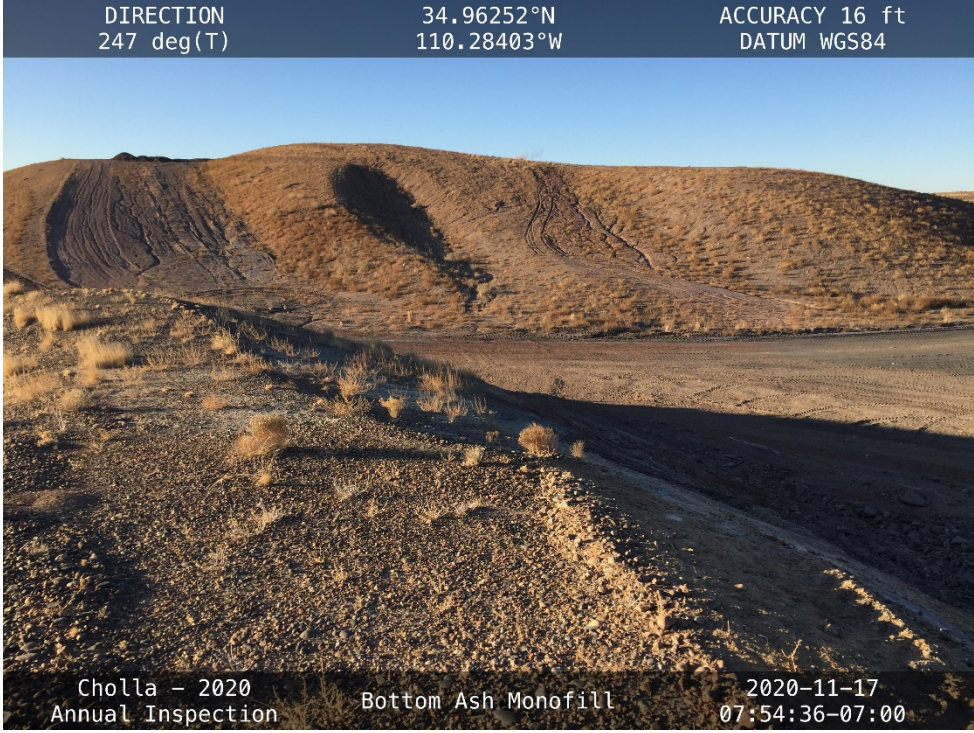
**20201117 - IMG\_2847**

A section through the eastern ramp showing the soil cap overlying the landfilled ash.
