CHOLLA POWER PLANT Fly Ash Dam, Bottom Ash Dam, and Bottom Ash Monofill

Annual CCR Impoundment and Landfill Inspection Report

2022

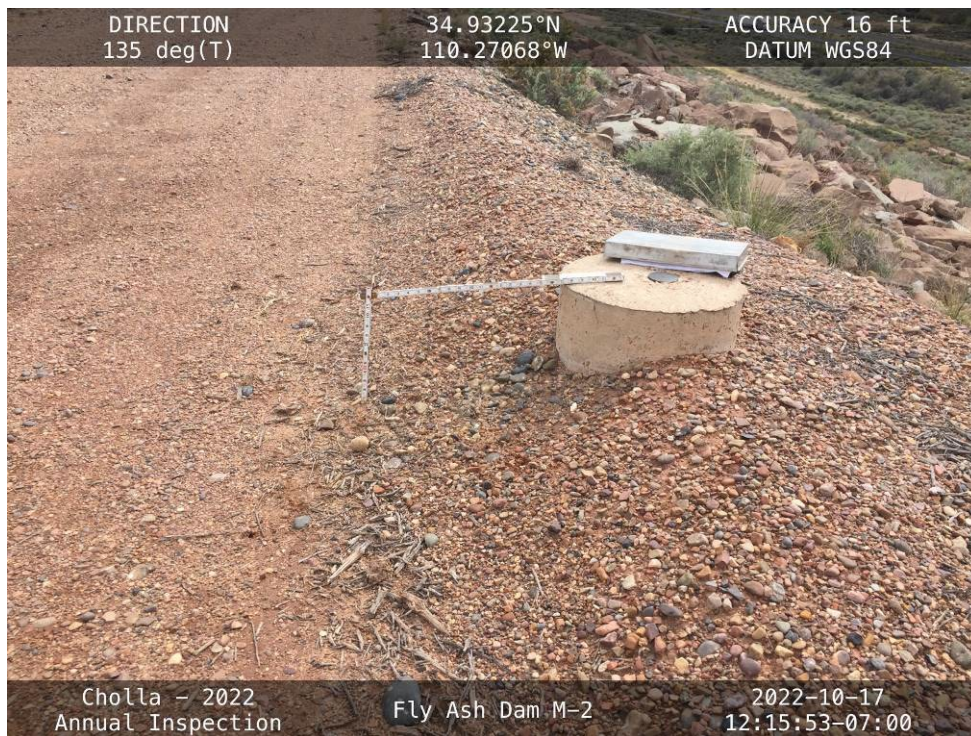
20221017 – IMG_3458
Settlement monument M-2 on the crest of the West Embankment.

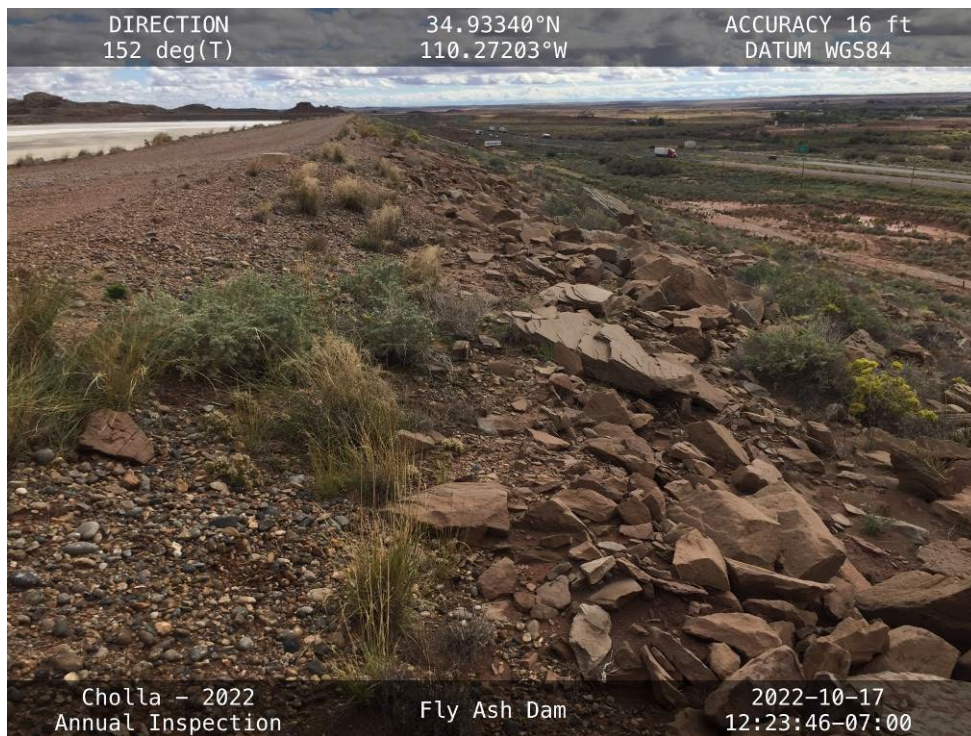
20221017 – IMG_3462
The downstream slope of the Fly Ash Dam, facing southeast from the Right Abutment.

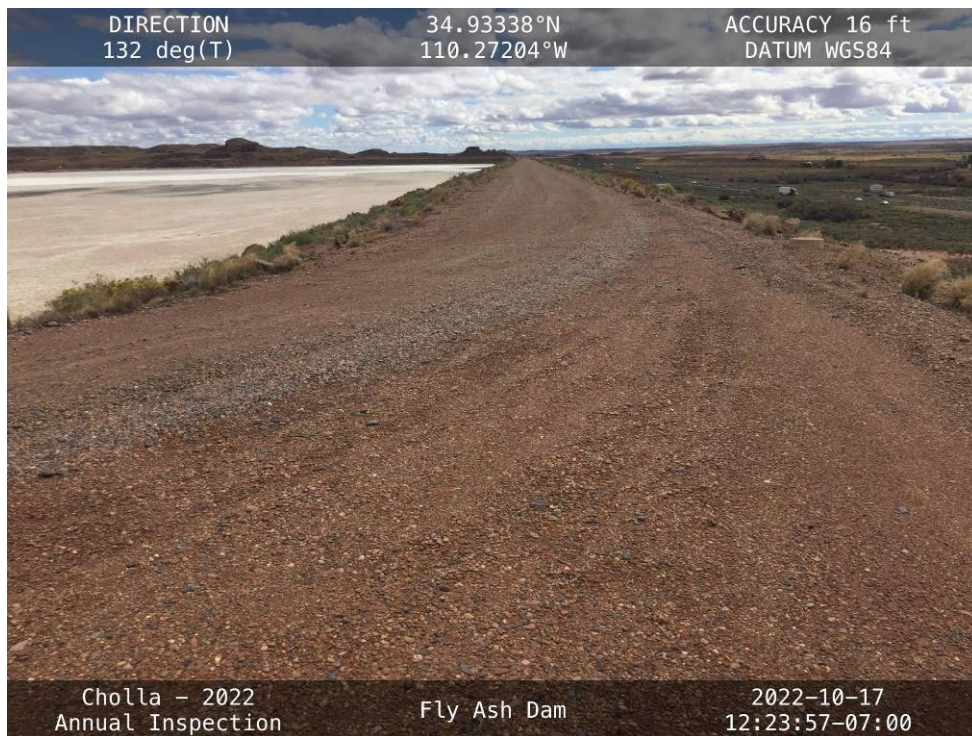
20221017 – IMG_3464
The crest of the Fly Ash Dam, facing southeast from the Right Abutment.
