# CHOLLA POWER PLANT Fly Ash Pond, Bottom Ash Pond, Sedimentation Pond and Bottom Ash Monofill

## Annual CCR Impoundment and Landfill Inspection Report

### 2015

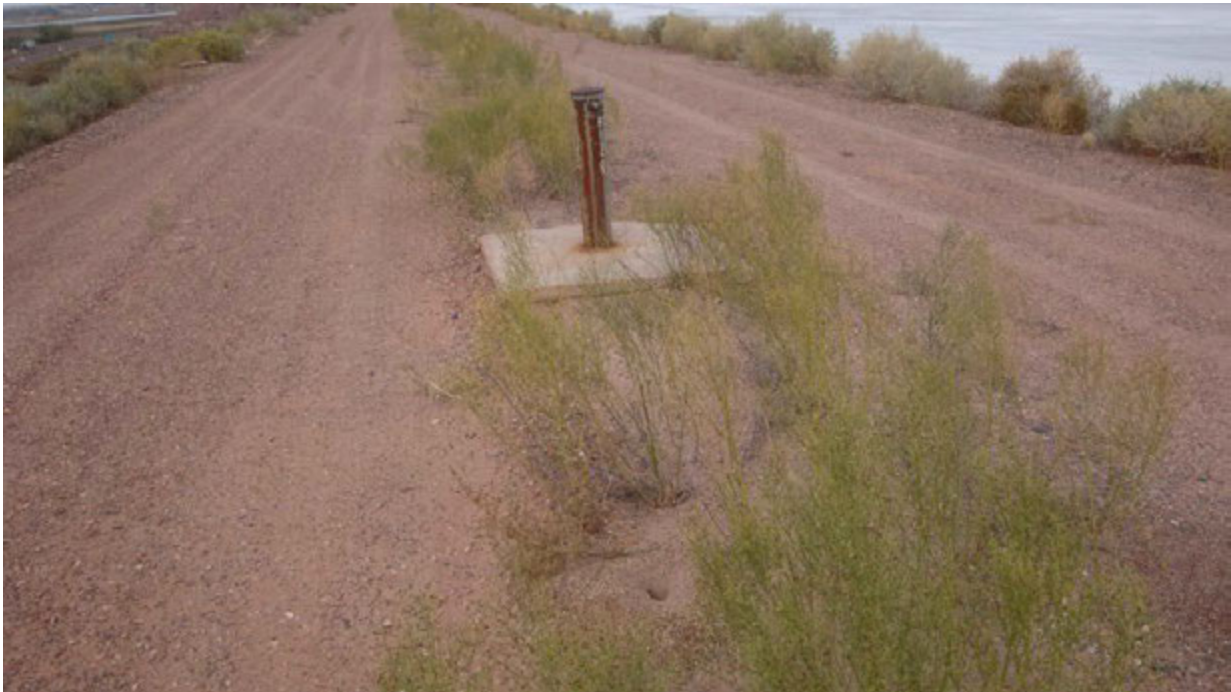
<b>DAM EMBANKMENT CHECKLIST</b>								
<b>3</b>	<b>DAM CREST</b>							
a	Settlements, slides, depressions?			X				
b	Misalignment?			X				
c	Longitudinal/Transverse cracking?			X				
d	Animal burrows? <b>Observed, but at low frequency. See Photos FAP 10, FAP 17, and IMG-2148. Continue to monitor and implement deterrent measures if frequency increases.</b>			X		X		
e	Adverse vegetation?			X				
f	Erosion?			X				
<b>4</b>	<b>UPSTREAM SLOPE</b>							
a	Erosion?			X				
b	Inadequate ground cover?			X				
c	Adverse vegetation? <b>Shrubs and other vegetation observed. See Photo FAP 16 and FAP 22.</b>				X	X		
d	Longitudinal/Transverse cracking?			X				
e	Inadequate riprap?			X				
f	Stone deterioration?			X				
g	Settlements, slides, depressions, bulges?			X

**20151016 – Photo 17**  
Crest. Apparent minor animal burrow.

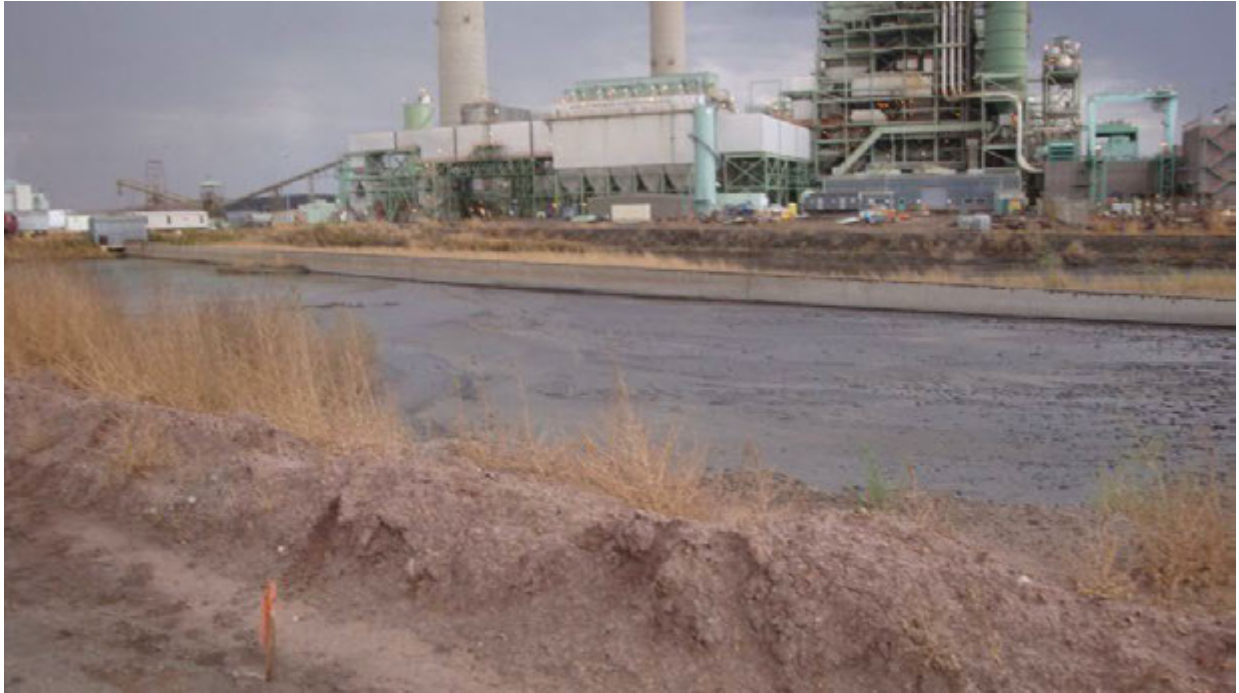
**20151016 – Photo 1**  
Sedimentation Pond. View across pond to northeast.

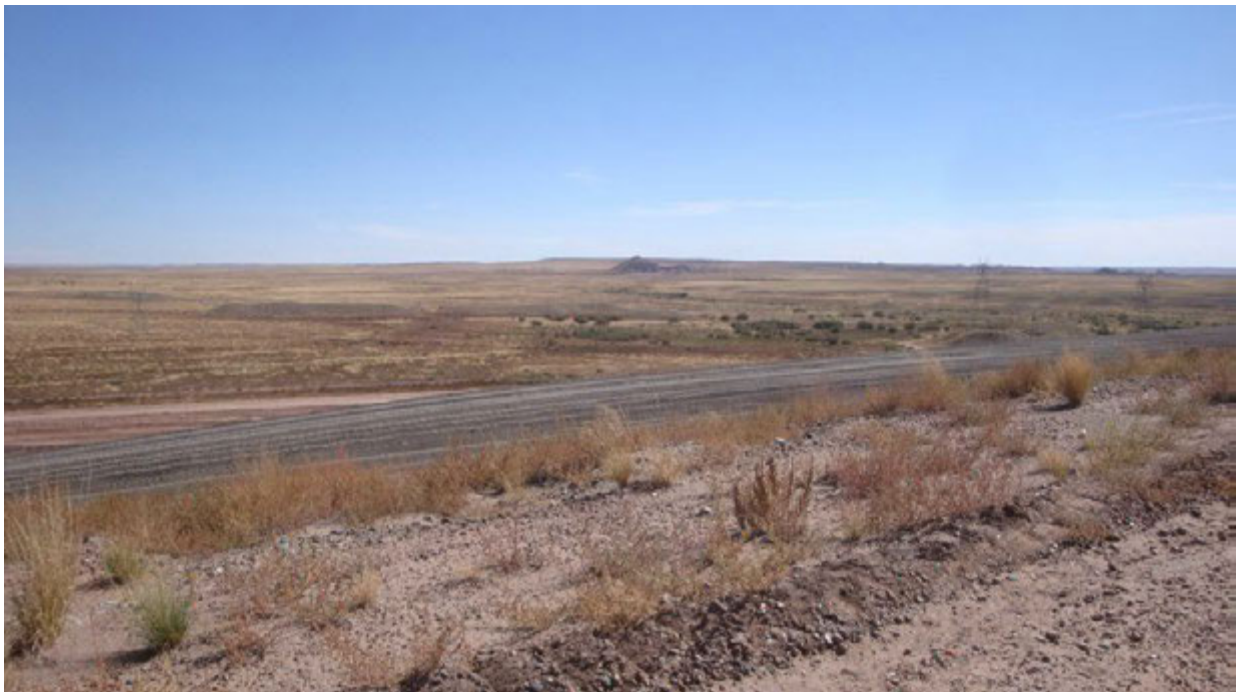
**20151016 – Photo 5**  
Fresh ash placement. View from crest of previously placed bottom ash cell.

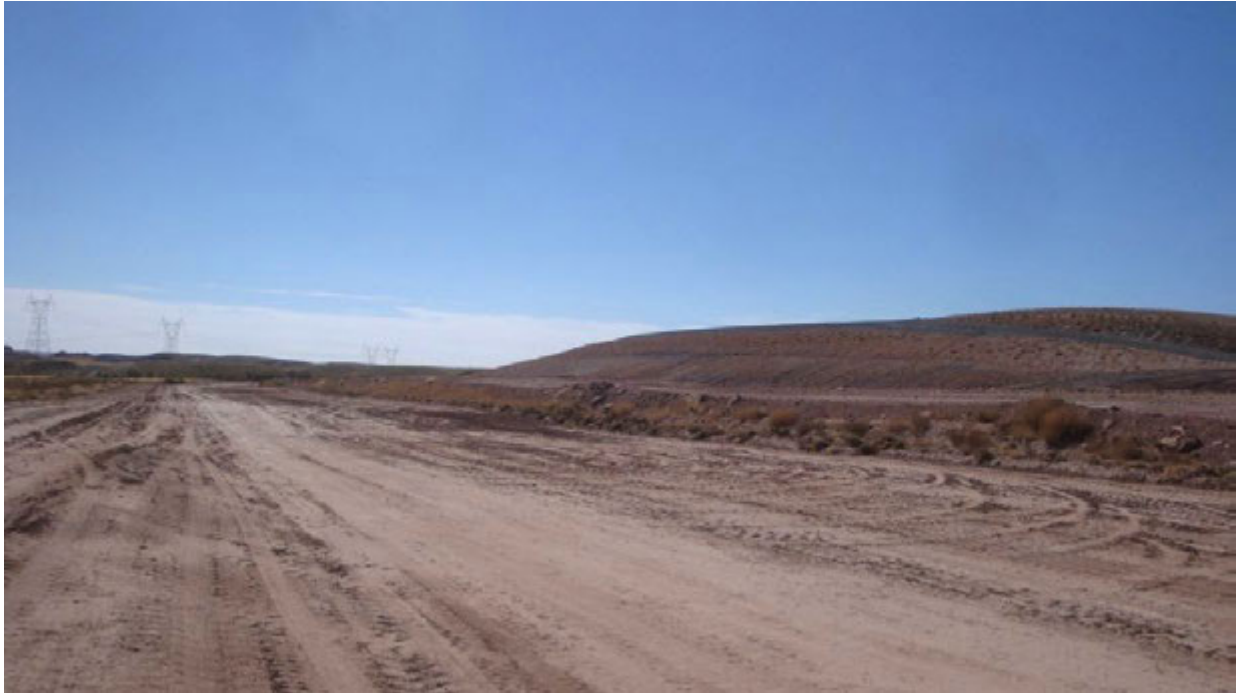
**20151016 – Photo 11**  
Lateral expansion finished grade. Ready to receive bottom ash.
