**FOUR CORNERS POWER PLANT
Lined Ash Impoundment,
Lined Decant Water Pond,
Combined Waste Treatment Pond,
Upper Retention Sump, and
Dry Fly Ash Disposal Area**

**Annual
CCR Impoundment and
Landfill Inspection Report
2018**

**GENERATION ENGINEERING
Design Engineering
P.O. BOX 53999
PHOENIX, ARIZONA 85072**

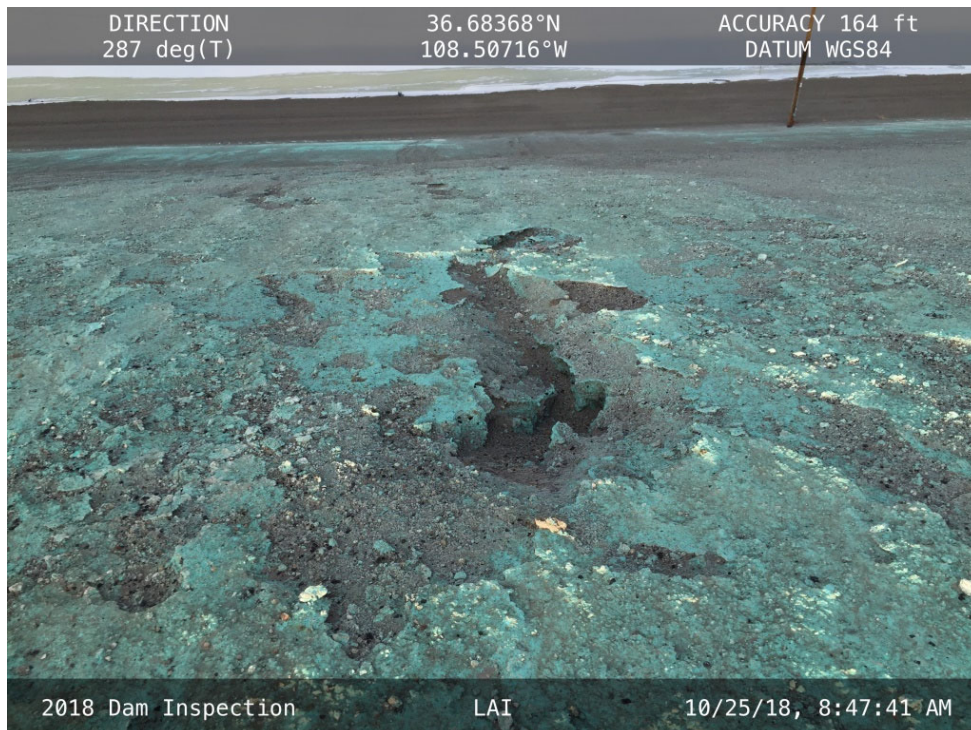
- iv. The downstream slopes of the West Embankment and the Northwest Embankment have minor erosion rills (Photos IMG_1269, IMG_1017, and IMG_1338). Continue monitoring erosion features and repair them if the erosion depth exceeds 1 foot.

20181025 – IMG_1269
Minor erosion on the downstream slope of the West Embankment.

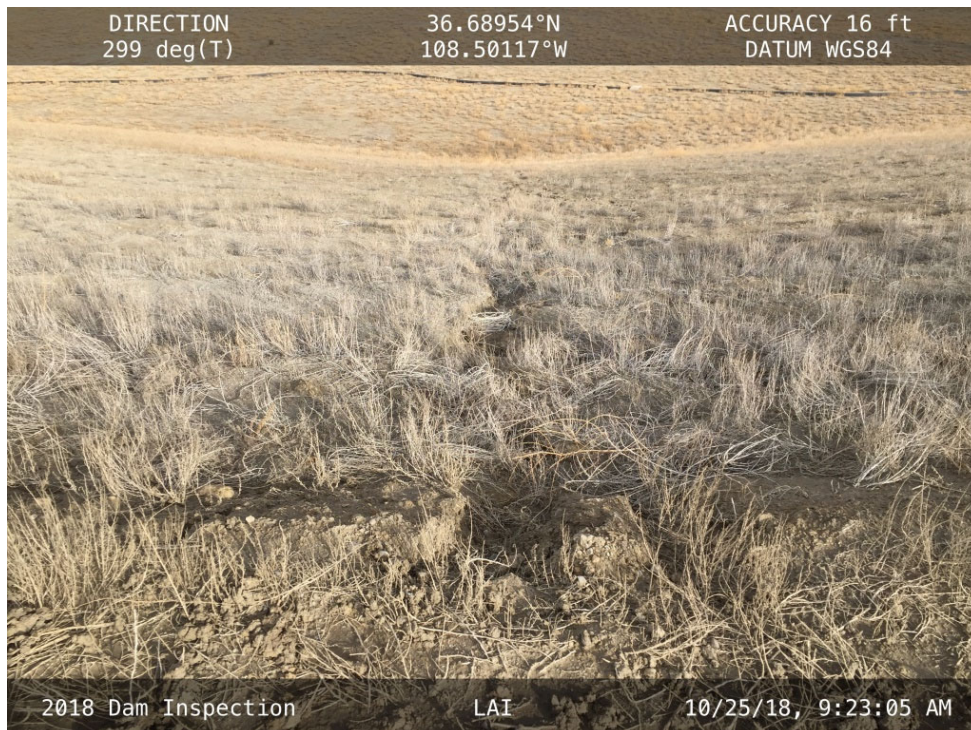
20181025 – IMG_1338
Shallow erosion rill in the groin of the Northwest Embankment along the north end of the LAI.

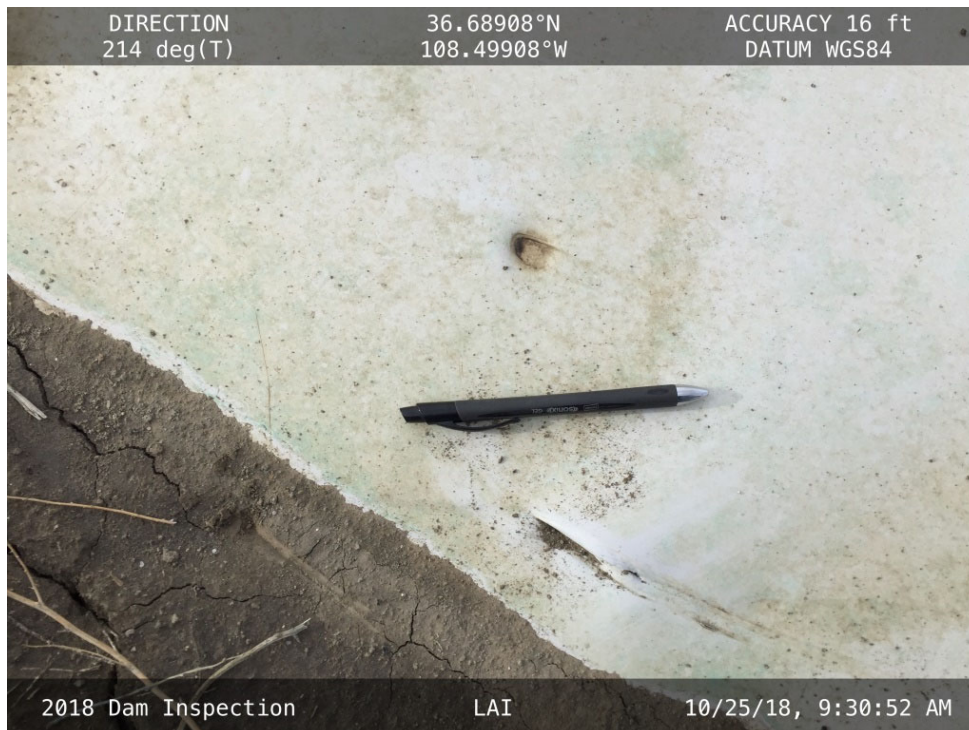
- v. There are small tears and holes in the liner along the crest of the East Embankment (Photos IMG_1358, IMG_1373, and IMG_1375). The tears should be repaired to prevent stormwater or other runoff from entering the space beneath the liner.

20181025 – IMG_1358
 A small scratch and indentation in the liner along the East Embankment.

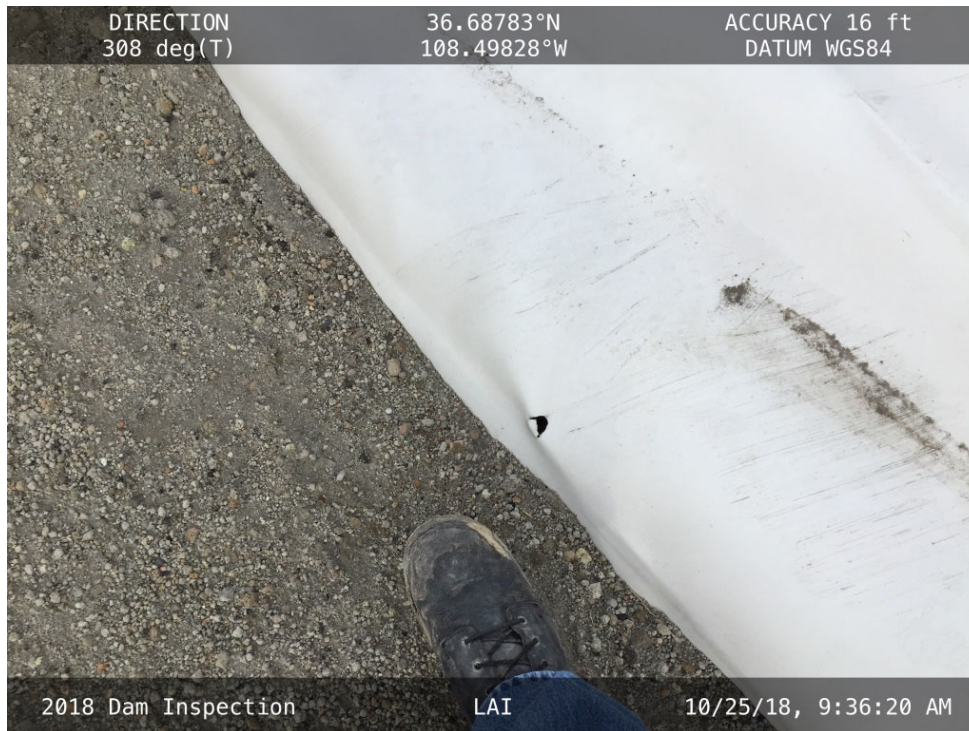
20181025 – IMG_1375
A small hole in the liner near the V-ditch at the East Embankment.

5) There are small tears and holes in the liner on the crest of the East Embankment.	Repair the tears.

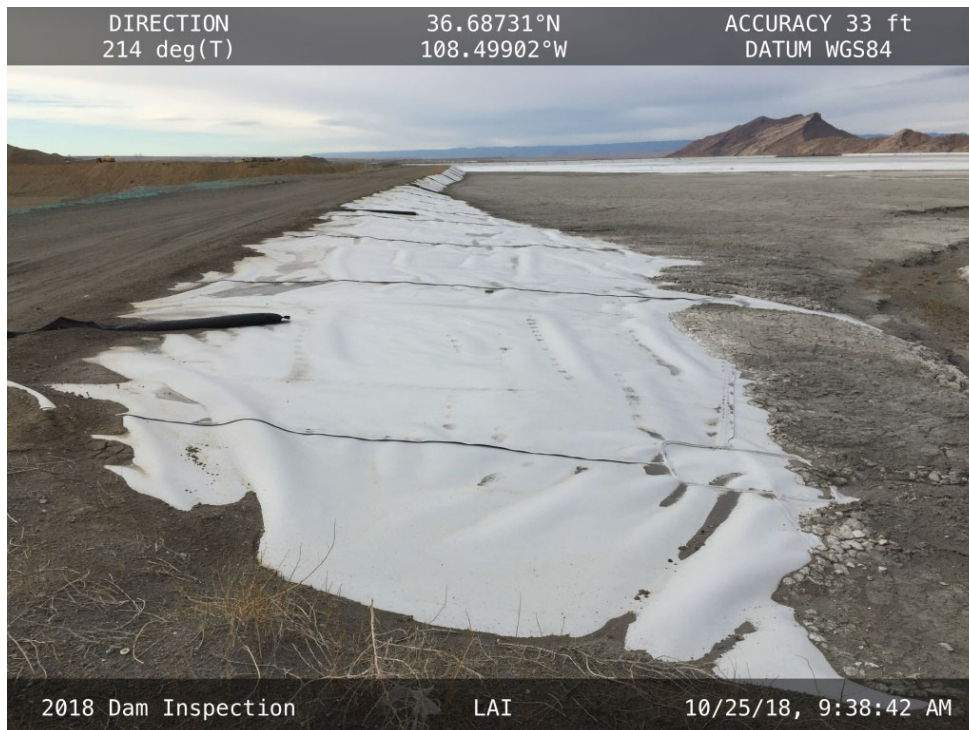
20181025 – IMG_1378
The upstream slope of the East Embankment near the abandoned V-ditch, facing southwest.

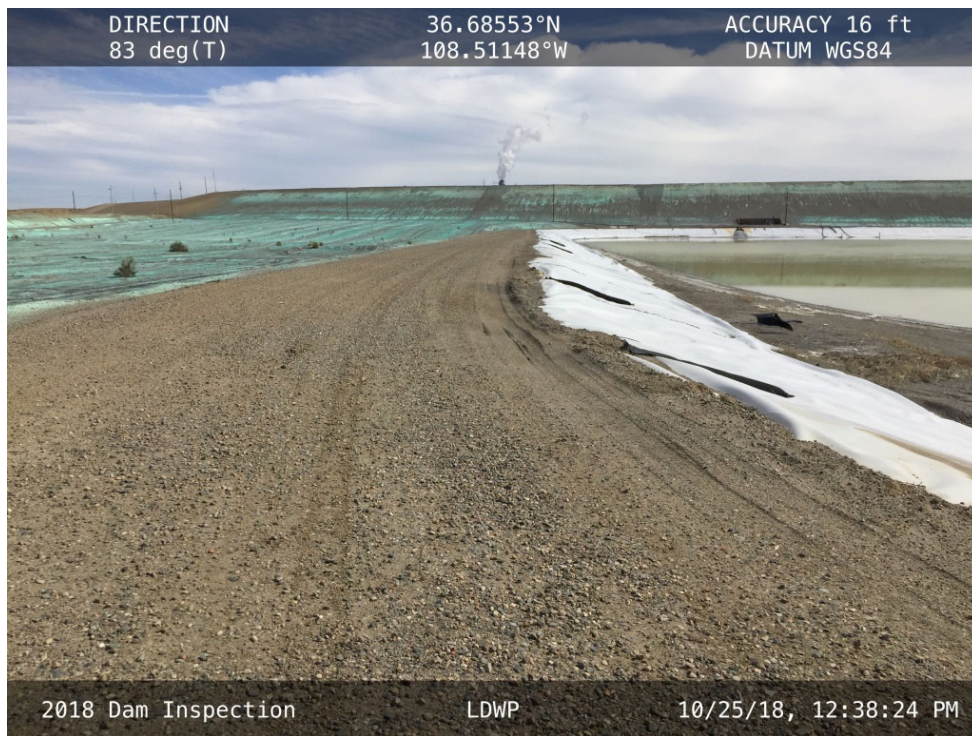
20181025 – IMG_1521
A shallow dent in the liner in the northwest corner of the LDWP.

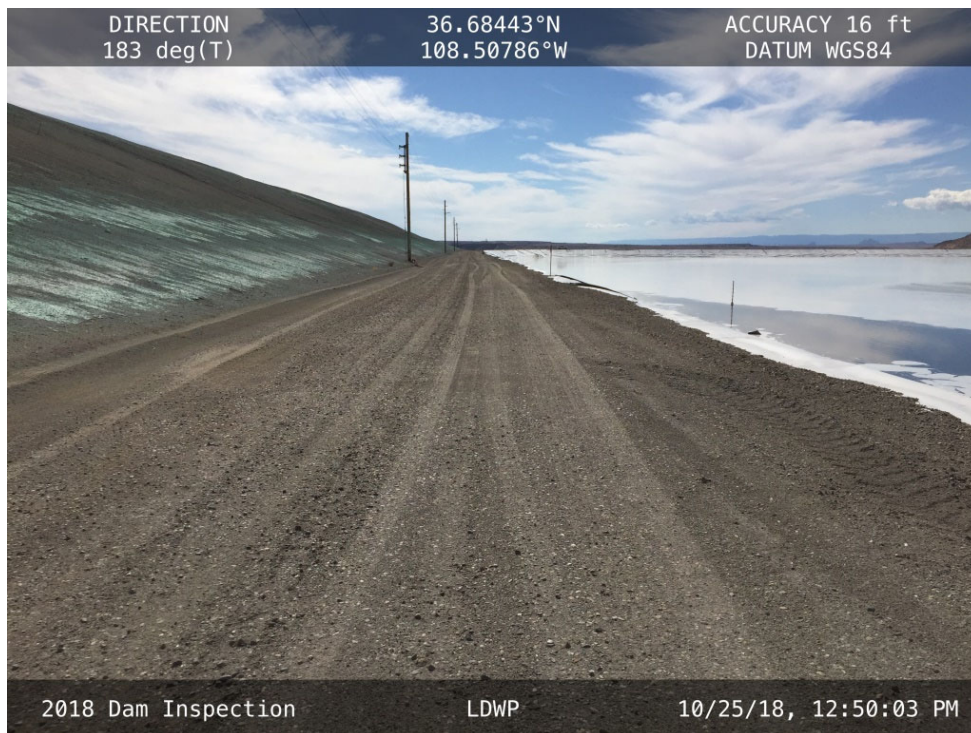
20181025 – IMG_1564
The liner pulling out of the anchor trench in the East Embankment.

Observed Condition	Action Item
1) Two sloughs were observed on the lowermost bench of the West Embankment.	Repair the areas and monitor the slope.
2) The liner in the anchor trench in the central portion of the West Embankment appeared to be pulling out of the trench.	Investigate the cause of the damage and repair the liner as necessary.
3) Minor erosion rilling was observed on the North and West downstream slopes of the LDWP at the time of the inspection.	Continue ongoing repair program for repairing rills if the erosion depth exceeds 1 foot.
4) There are small holes and tears in the liner along the North and East Embankments.	Repair the tears and holes.

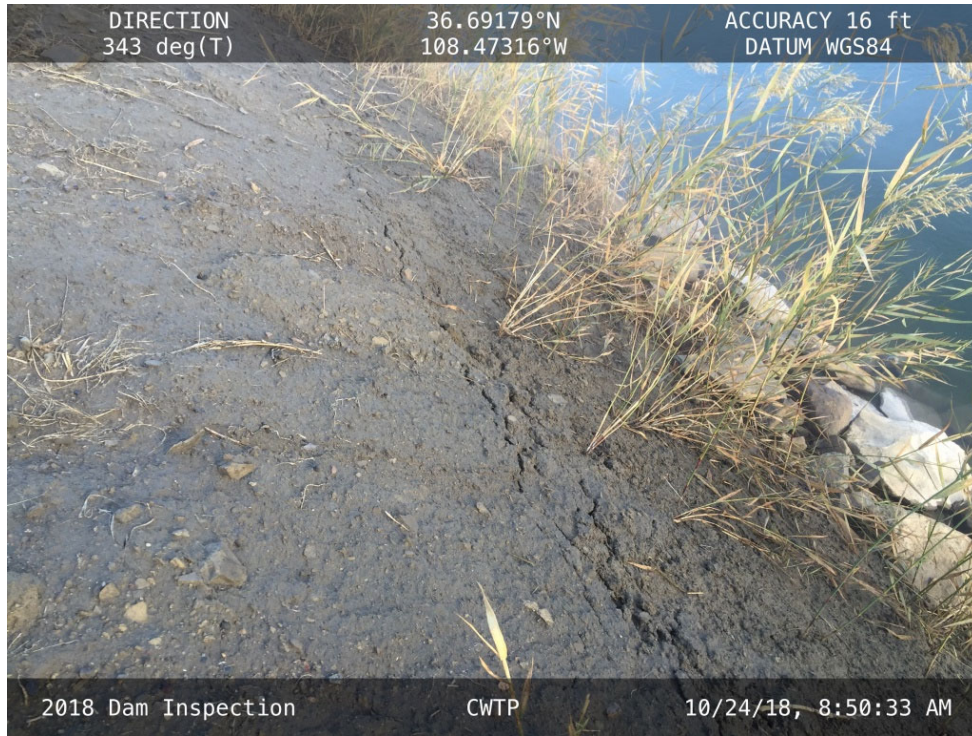
20181024 – IMG_0933
 Longitudinal cracks on the downstream slope of the CWTP embankment.

The inspection identified longitudinal cracks forming along the downstream slope of the eastern CWTP embankment above the water line. The area should be monitored and the cracks should be repaired to prevent a disruption to the normal operation of the CCR unit if they are observed to expand.

3) Longitudinal cracks along the downstream slope above the riprap.	Monitor the area and repair the slope if the cracks expand, deepen, or result in a slough/slide.

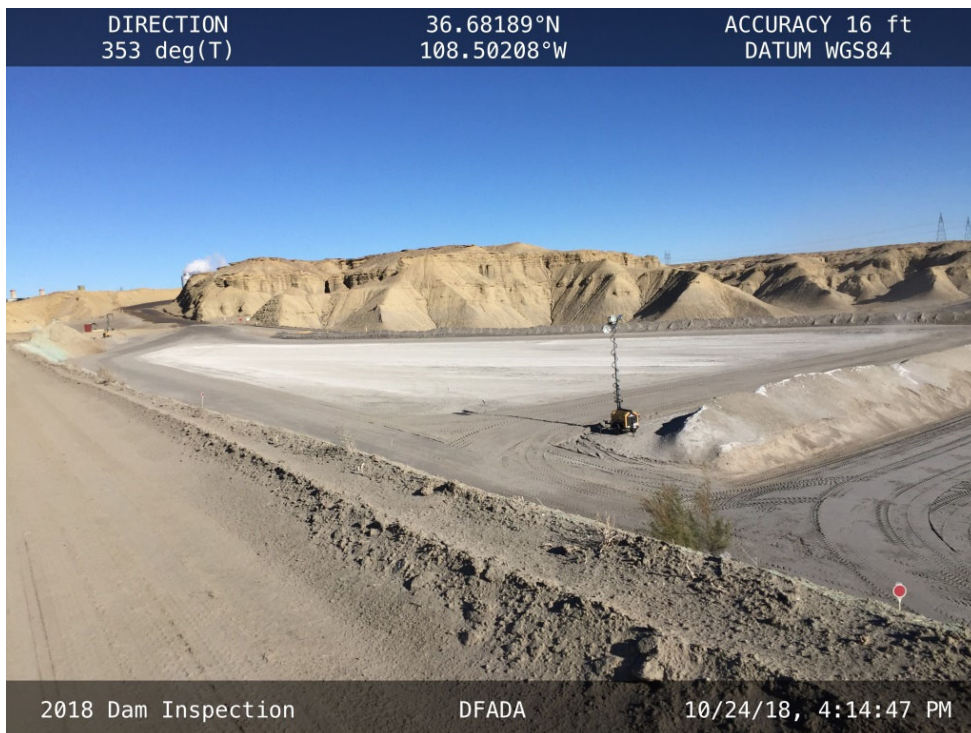
20181024 – IMG_1202
The easternmost portion of DFADA Cell 3, facing east from the South Embankment of the LAI.

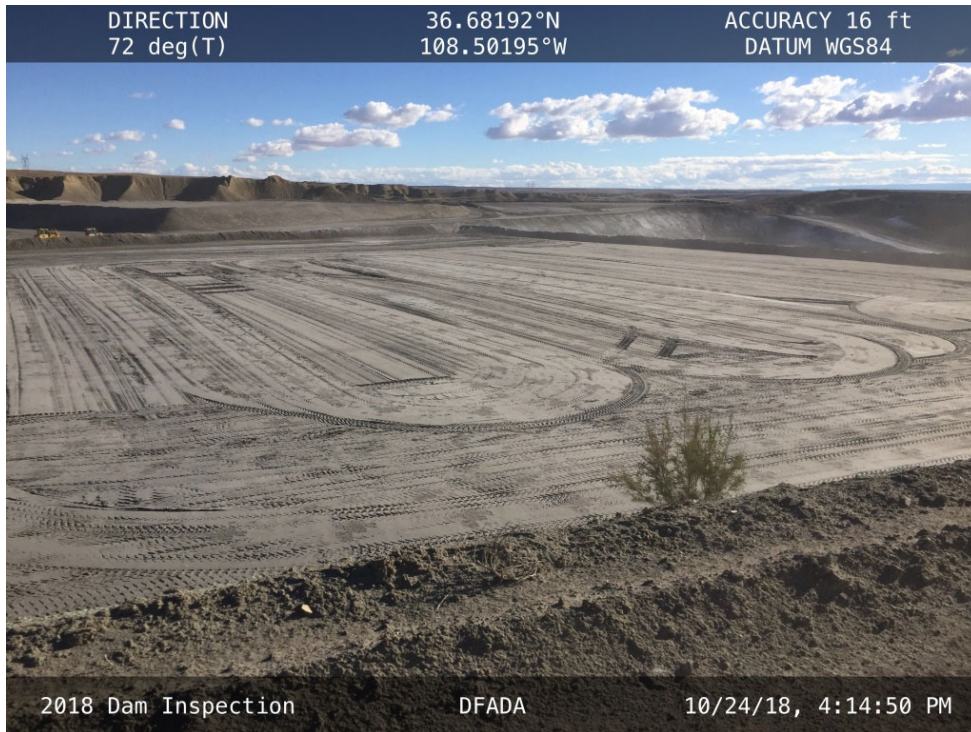
20181024 – IMG_1203
 DFADA Cell 2 (background) and the central portion of Cell 3 (foreground), facing south.

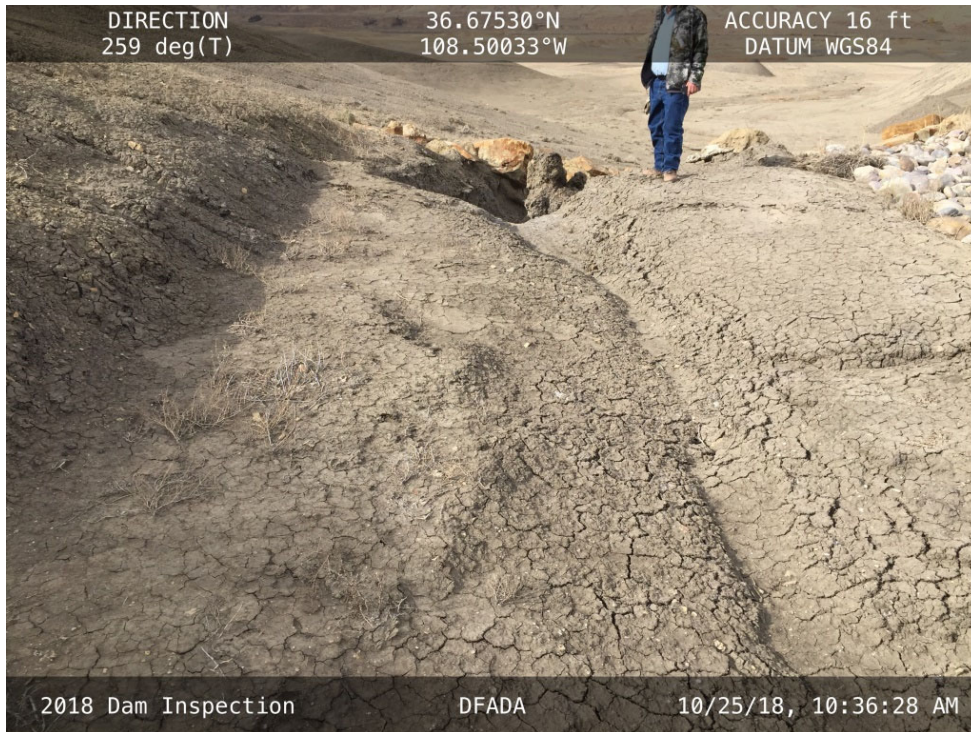
20181025 – IMG_1422
Erosion at the Stormwater Diversion Channel outlet, facing west.

Observed Condition	Action Item
1) There is erosion at the inlet and outlet of the Stormwater Diversion Channel.	With future expansion of the DFADA, perform an engineering re-evaluation to understand whether the run off pattern has changed or whether a different erosion control method should be applied. Monitor erosion and repair as required. Alternately, place additional sandstone riprap in the eroded area.
2) Several plants are growing through the Pyramat geosynthetic along the western toe of Cell 1.	Monitor the plant growth and remove the vegetation if it is determined to be damaging the primary geomembrane liner.
3) Vacuum truck operators were allowing ash to be blown across the site while it was being unloaded.	Monitor contractor activities and enforce dust control plan.

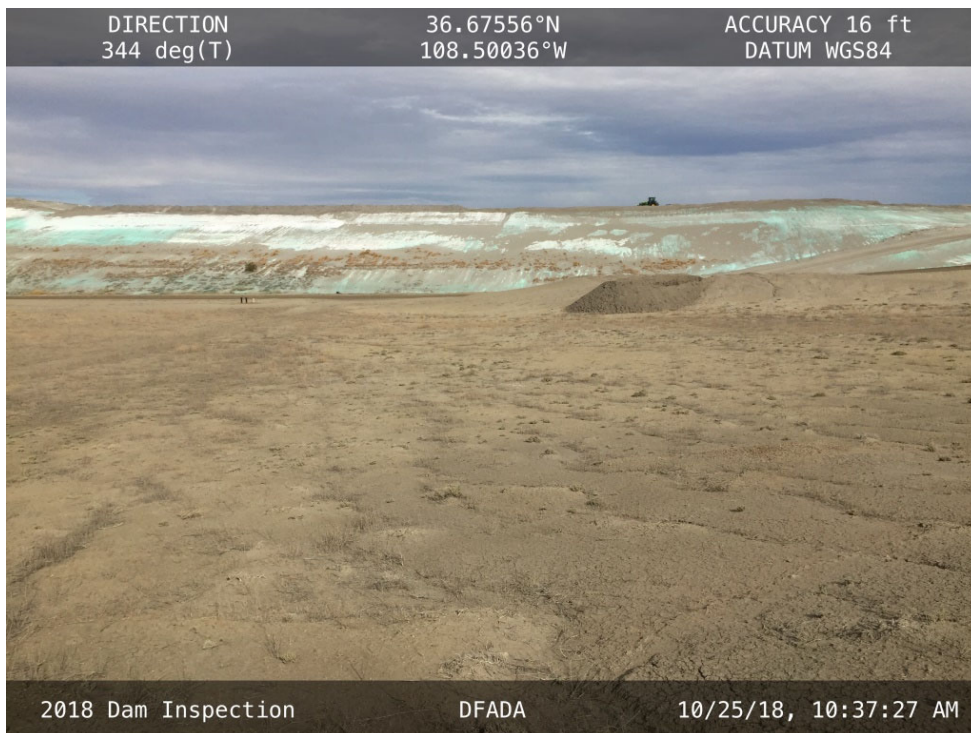
20181025 – IMG_1426
The south slope of DFADA Cells 1 and 2, facing north.
