**FOUR CORNERS POWER PLANT
Lined Ash Impoundment,
Lined Decant Water Pond,
Combined Waste Treatment Pond,
and Dry Fly Ash Disposal Area**

**Annual
CCR Impoundment and
Landfill Inspection Report
2019**

**GENERATION ENGINEERING
Design Engineering
P.O. BOX 53999
PHOENIX, ARIZONA 85072**

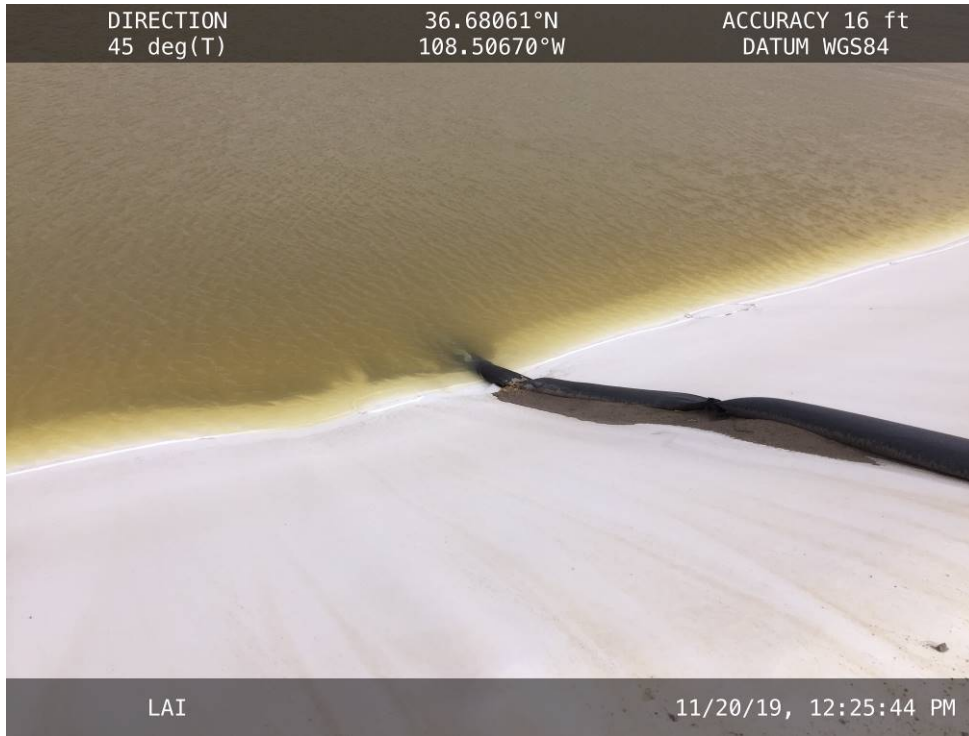
- ii. The geomembrane liner was observed to exhibit uneven depressions and bulges in the Southwest Corner (Photo IMG_6504). These depressions and bulges are in the vicinity of previously observed holes in the upstream liner. In addition, a new cut and a possible new hole in the geomembrane liner were observed during this inspection (Photo IMG_6506). The presence and identified causes of the depressions, bulges, and liner damage should be recorded and any tears should be repaired in accordance with the recommendation of the geotechnical engineer. Repair documentation should be maintained with the operating record.

20191120 – IMG_6504
 Uneven section of the upstream liner along the South Embankment.

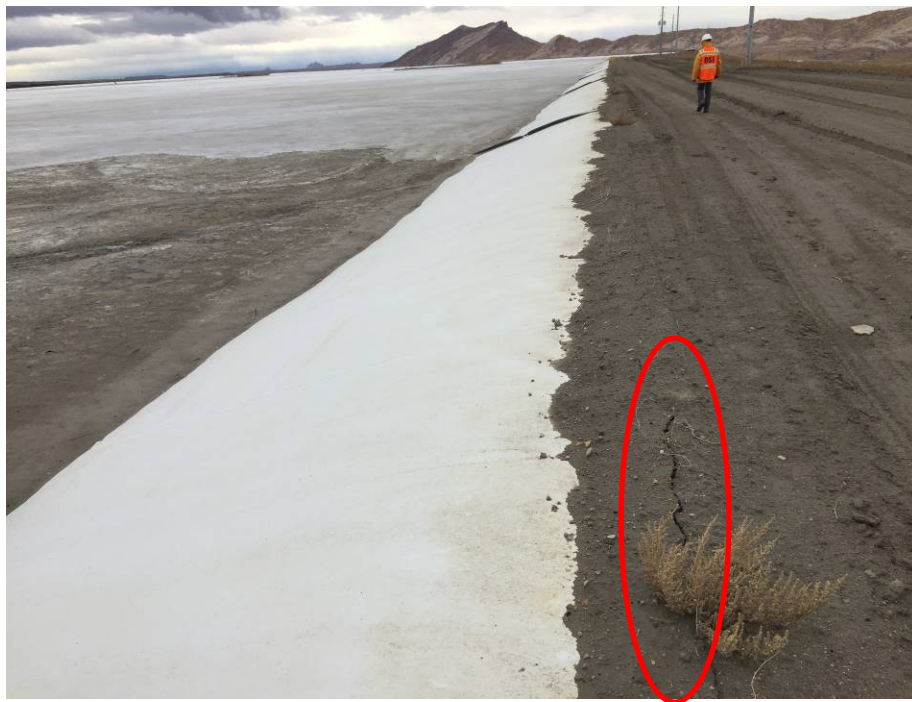
DAM EMBANKMENT CHECKLIST											
3	DAM CREST										
a	Settlements, slides, depressions?				X						
b	Misalignment?				X						
c	Longitudinal/Transverse cracking?	Cracks were observed along portions of the geomembrane liner anchor trench in the Northwest Embankment. See Photos IMG_6612 and IMG_6622.									
d	Animal burrows?				X						
e	Adverse vegetation?				X						
f	Erosion?				X

20191120 – IMG_6622
The upstream slope of the Northwest Embankment and a crack in the anchor trench, facing southwest.

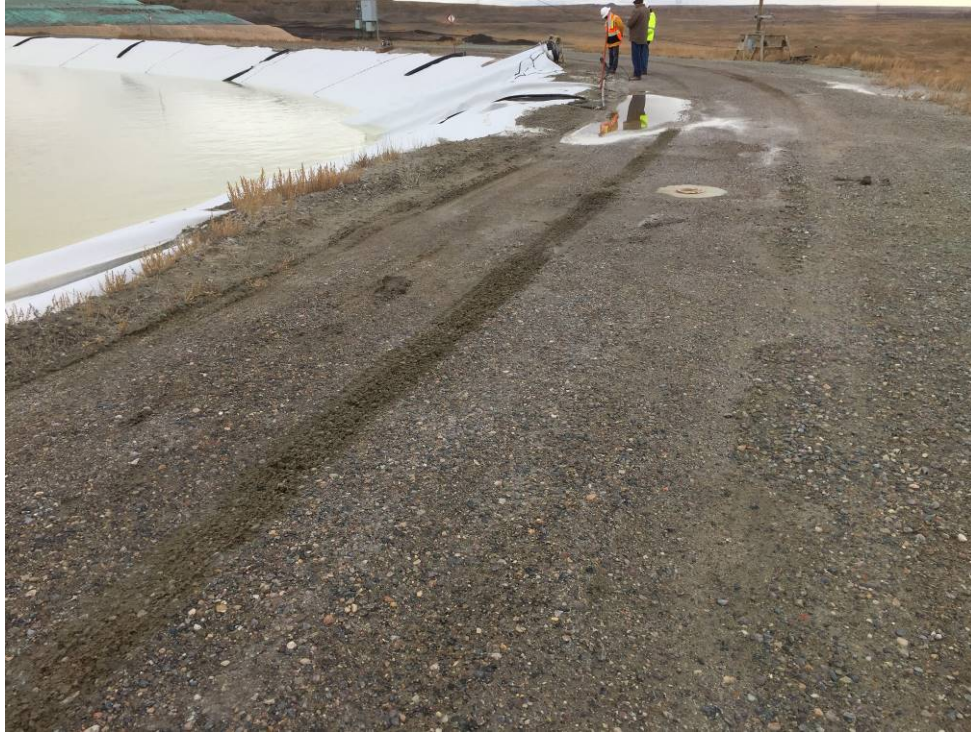
20191120 – IMG_6671
Water ponding on the crest near the Interstitial Evacuation Pump.

7) Poned rainwater was observed in the southwest corner near the Interstitial Evacuation Pump.	Monitor this area for signs of erosion and monitor the nearby piezometer (P-19) for water level increases.

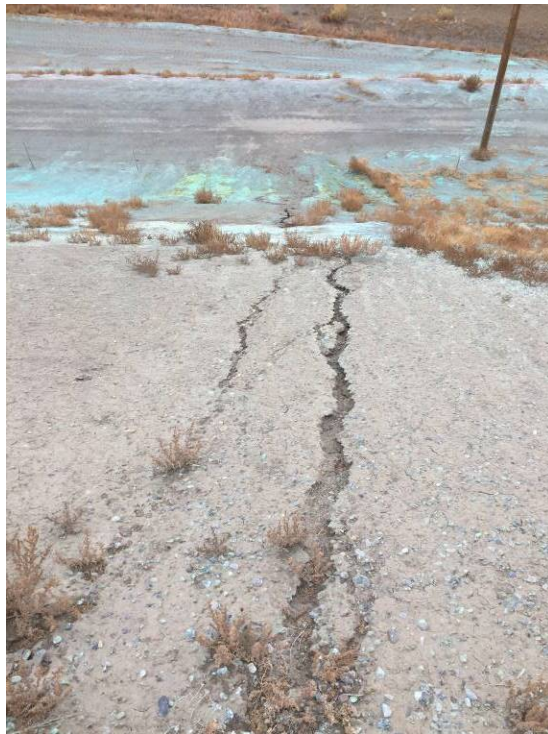
20191120 – IMG_6700
Erosion rills forming in an area of prior repair on the upper half of the South Embankment.

2) Minor erosion rilling was observed on the West and South downstream slopes of the LDWP at the time of the inspection.	Continue ongoing repair program for repairing rills if the erosion depth exceeds 1 foot.

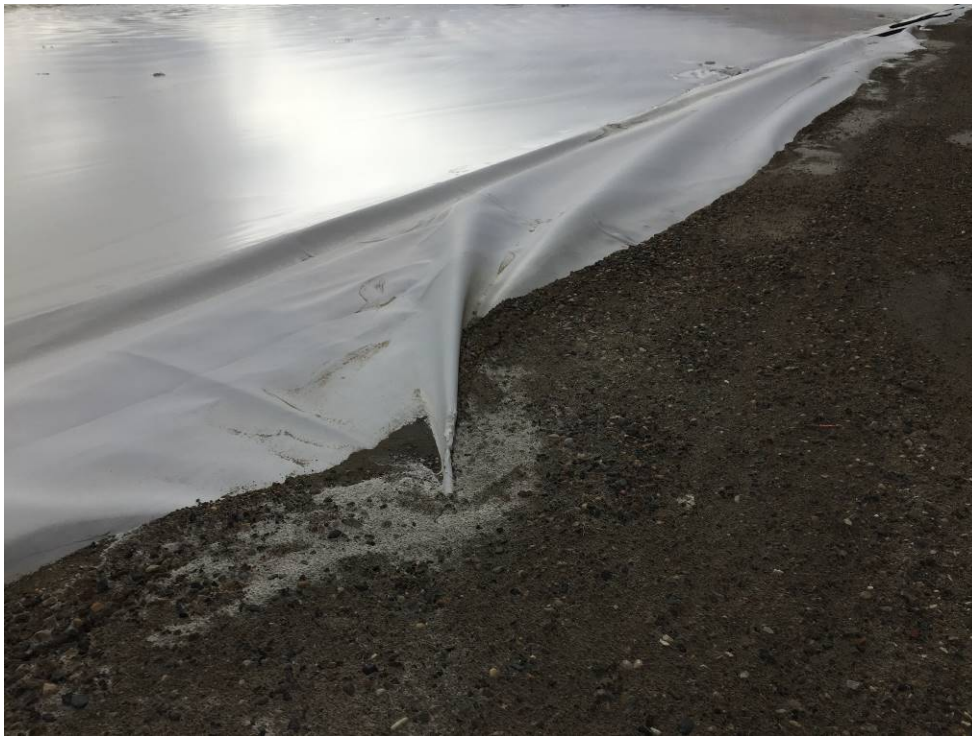
20191120 – IMG_6766
Small tears in the liner along the North Embankment repaired since the 2018 inspection.

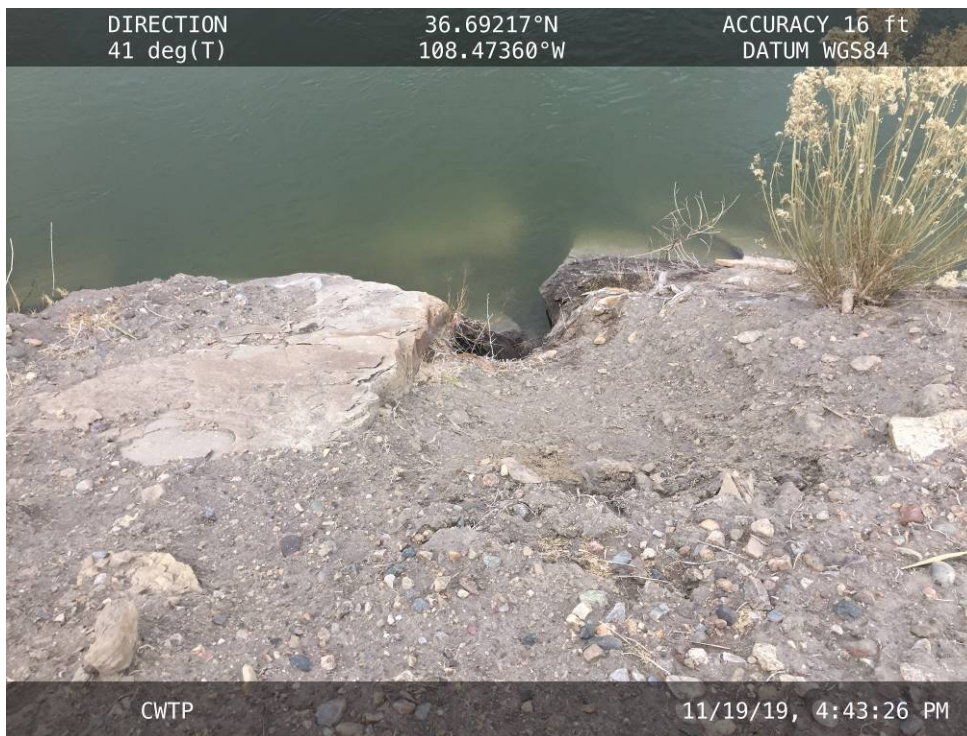
20191119 – IMG_6272
Erosion around the riprap on the downstream slope along the eastern portion of the embankment.

2) Instances of minor erosion were observed along the upstream and downstream slopes.	Continue to monitor these areas and repair erosion if it exceeds 1 foot in depth.

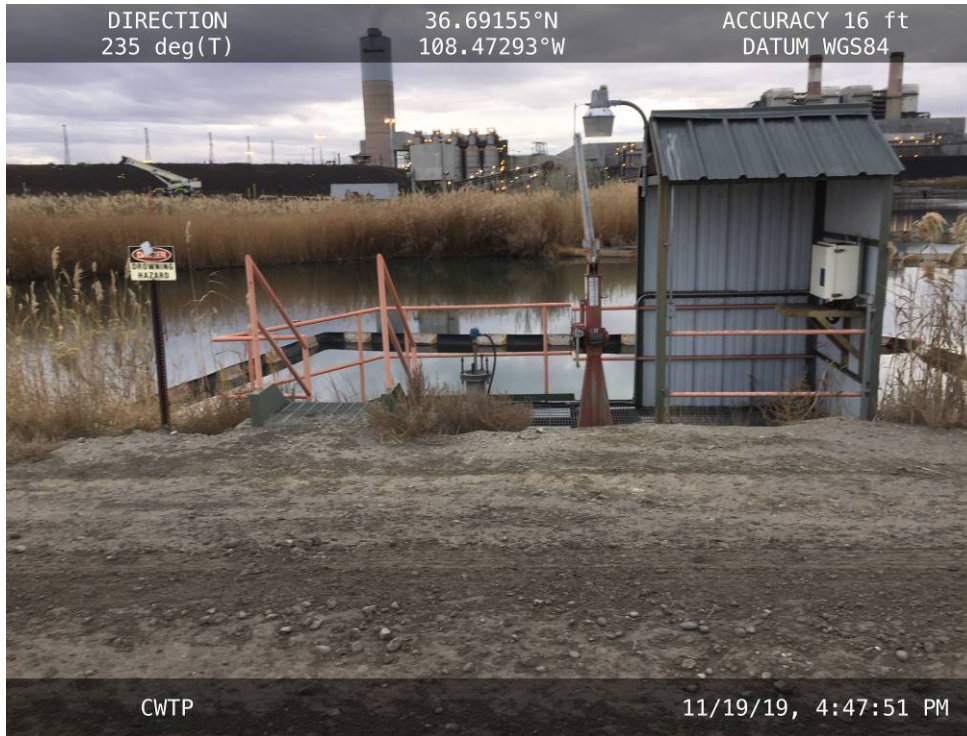
20191119 – IMG_6281

The downstream slope along the eastern portion of the embankment, facing southeast.

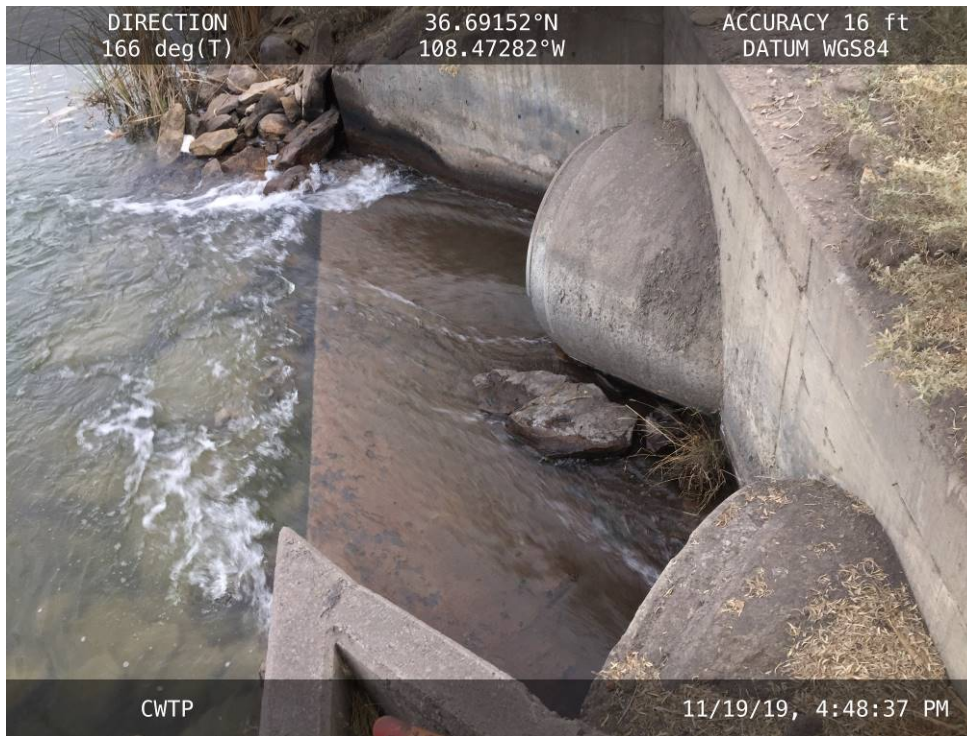
20191119 – IMG_6287
 The CWTP flow monitoring structure on the eastern portion of the embankment.

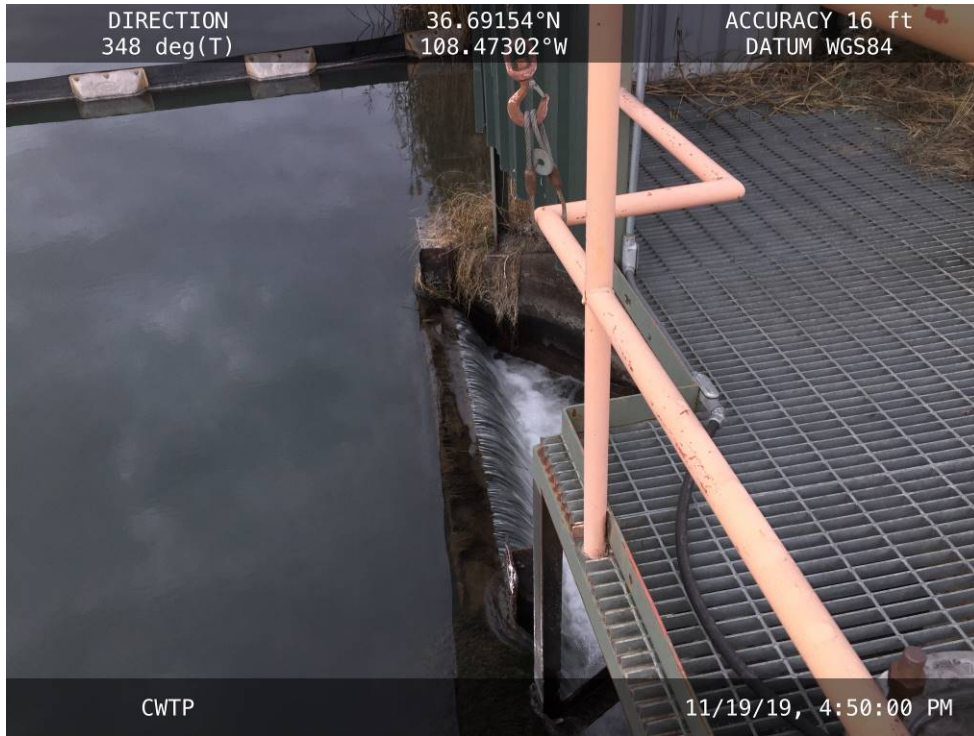
20191119 – IMG_6288
 The outfall from the CWTP to the discharge canal.

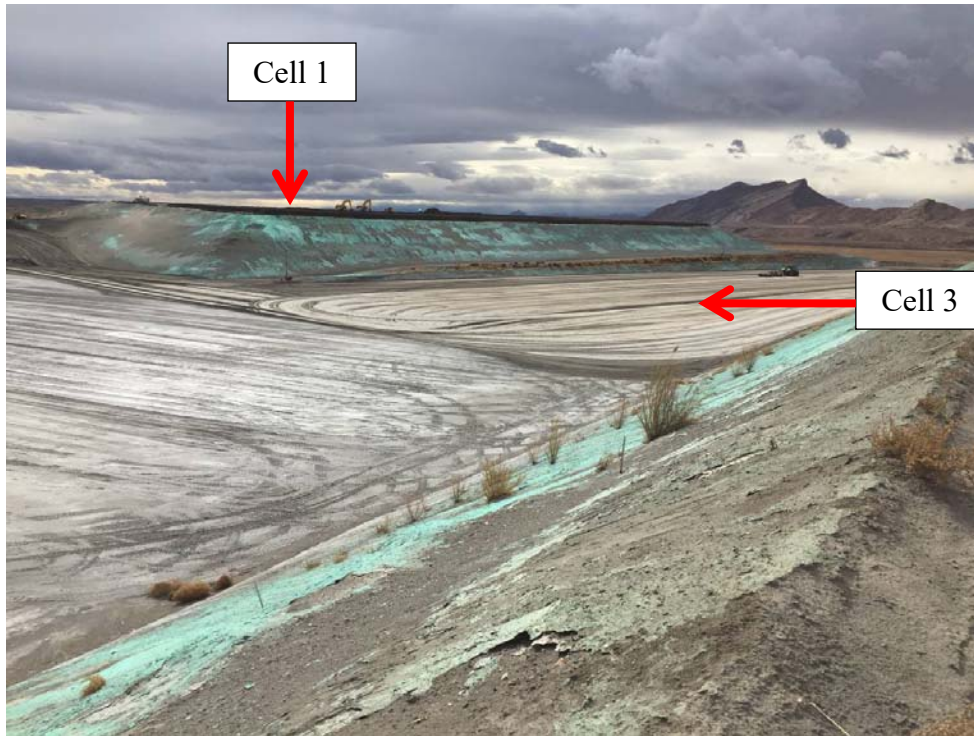
20191120 – IMG_6519

The western slope on the easternmost portion (the closure area) of Cell 3, facing south.

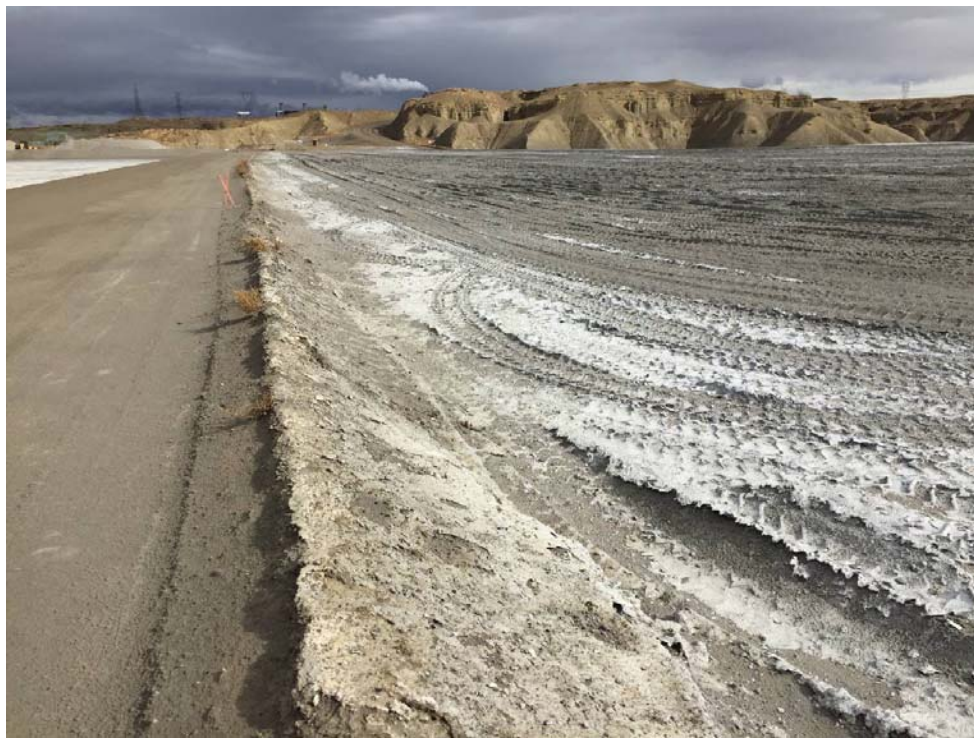
20191120 – IMG_6521
DFADA Cell 1 and the western portion of Cell 3, facing southwest.

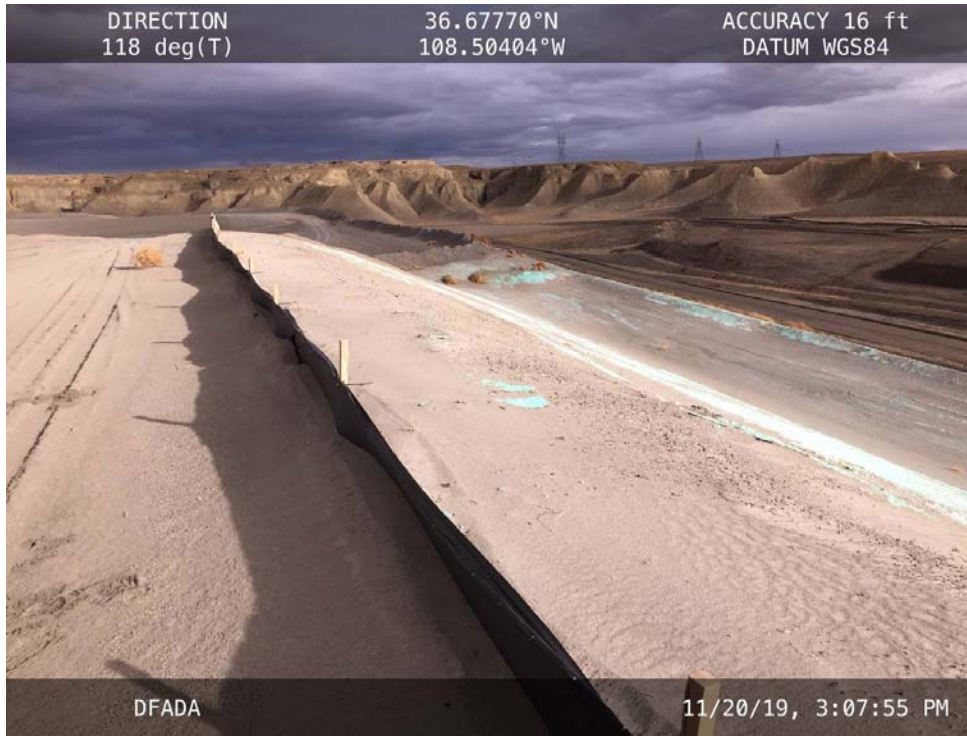
20191120 – IMG_6832

The southern slope of Cell 1, facing southwest from the top of the cell.

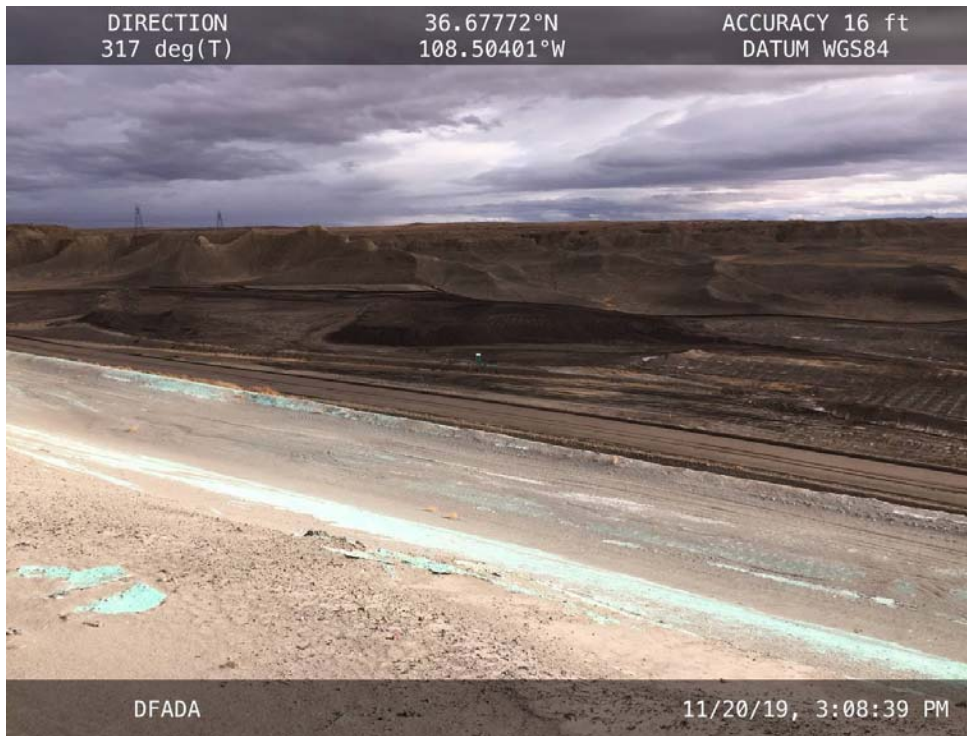
20191120 – IMG_6838
 The southern slope of Cells 1 and 2, facing east from the top of Cell 1.
