**FOUR CORNERS POWER PLANT
Lined Ash Impoundment,
Lined Decant Water Pond,
Combined Waste Treatment Pond,
Dry Fly Ash Disposal Area,
and Return Water Pond**

**Annual
CCR Impoundment and
Landfill Inspection Report
2021**

**GENERATION ENGINEERING
Design Engineering
P.O. BOX 53999
PHOENIX, ARIZONA 85072**

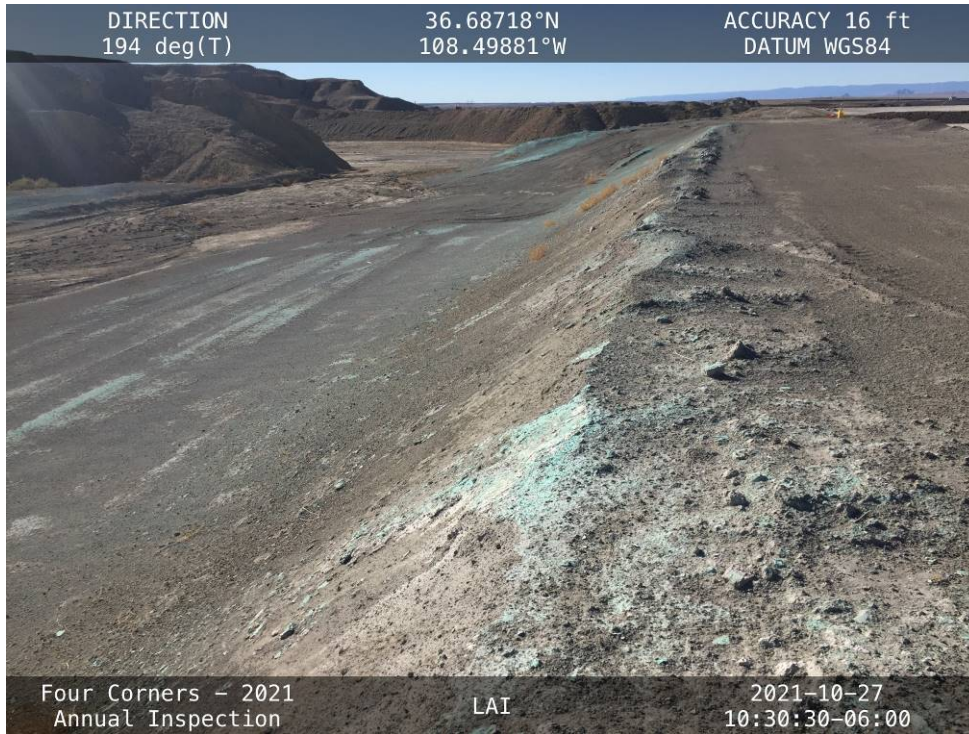
20211027-IMG_7642
Access ramp at old V ditch Northeast area of LAI.

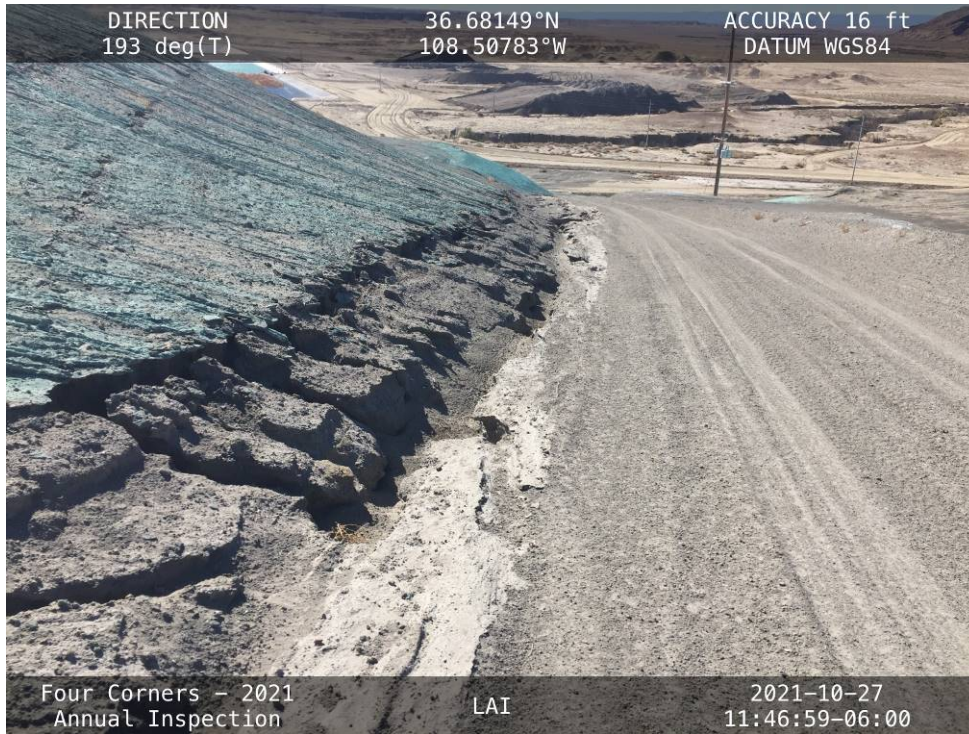
20211027-IMG_7753
Erosion on the LDWP access ramp, facing south.

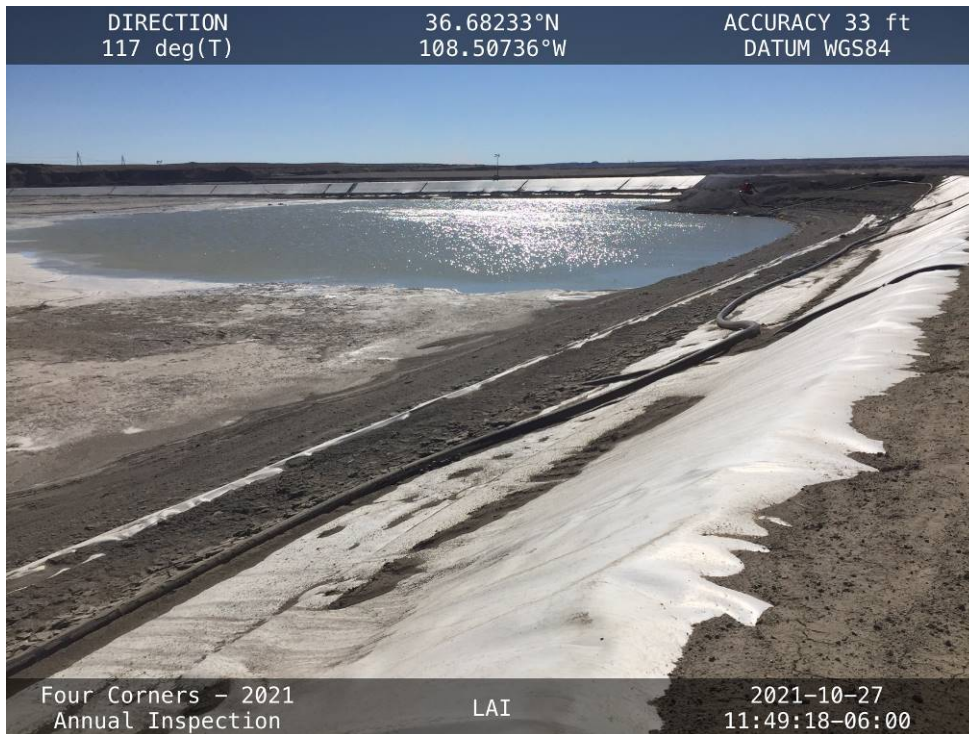
20211027-IMG_7755
The current extent of impounded water in the LAI, facing south from the West Embankment.

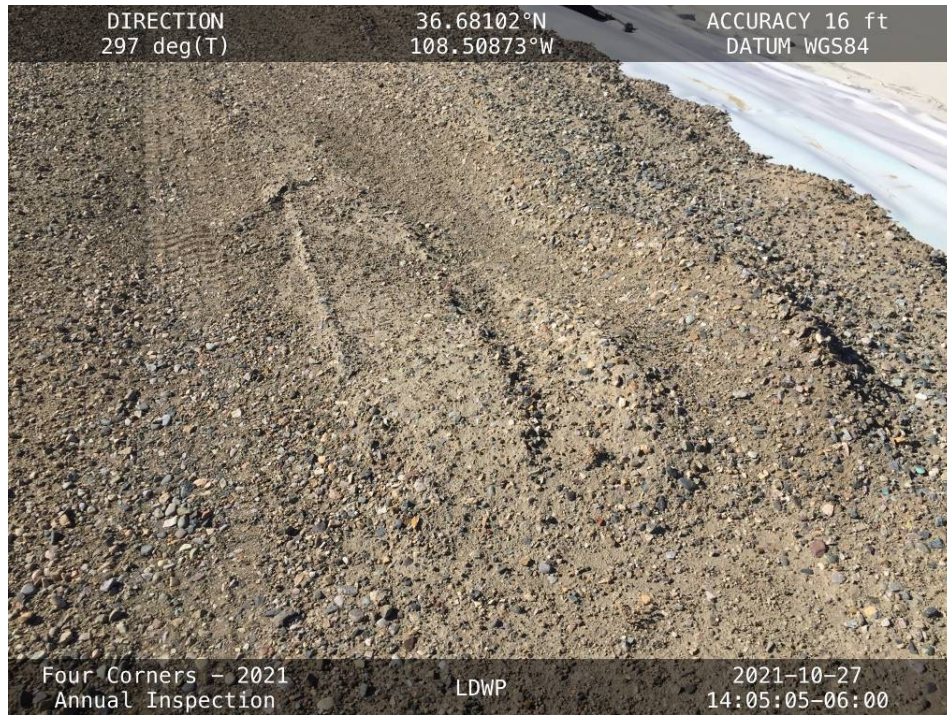
20211027 – IMG_7918
 A rut in the crest of the South Embankment.

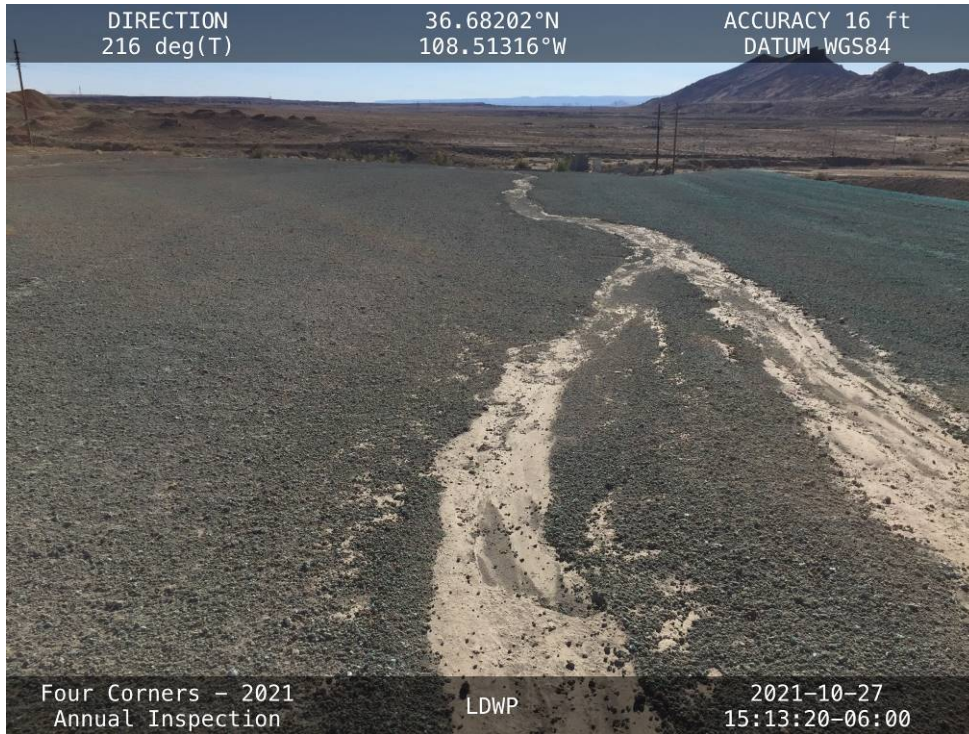
20211027-IMG_8018

Erosion rills and gullies on the upper section of the West Embankment.

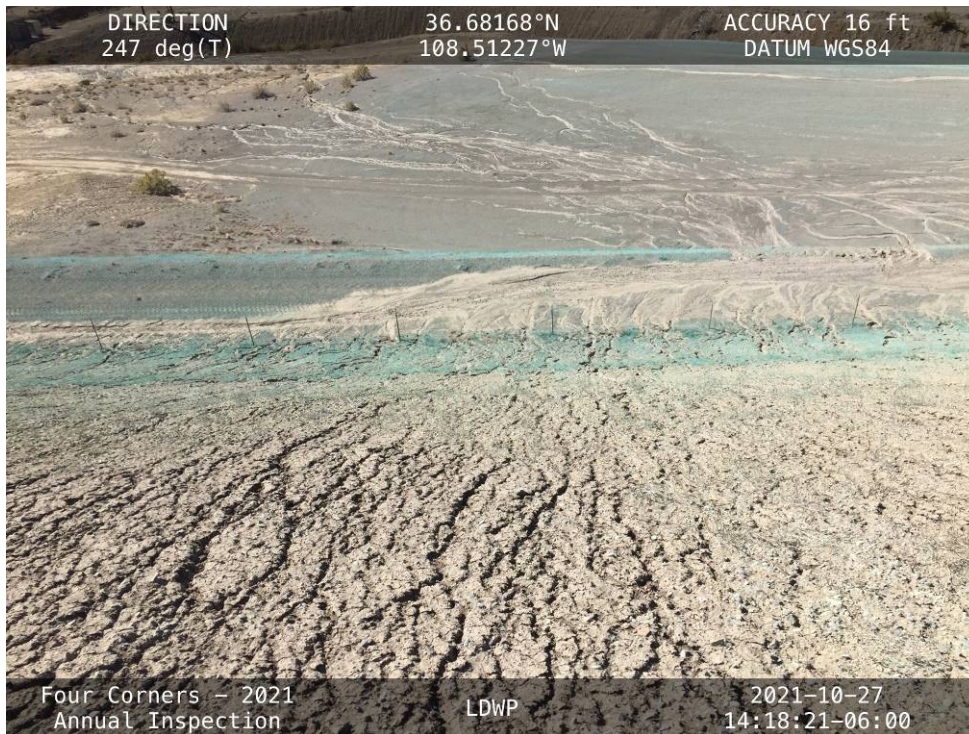
20211027-IMG_8017
 Runout channels from the erosion shown in IMG_8015 and IMG_8018.

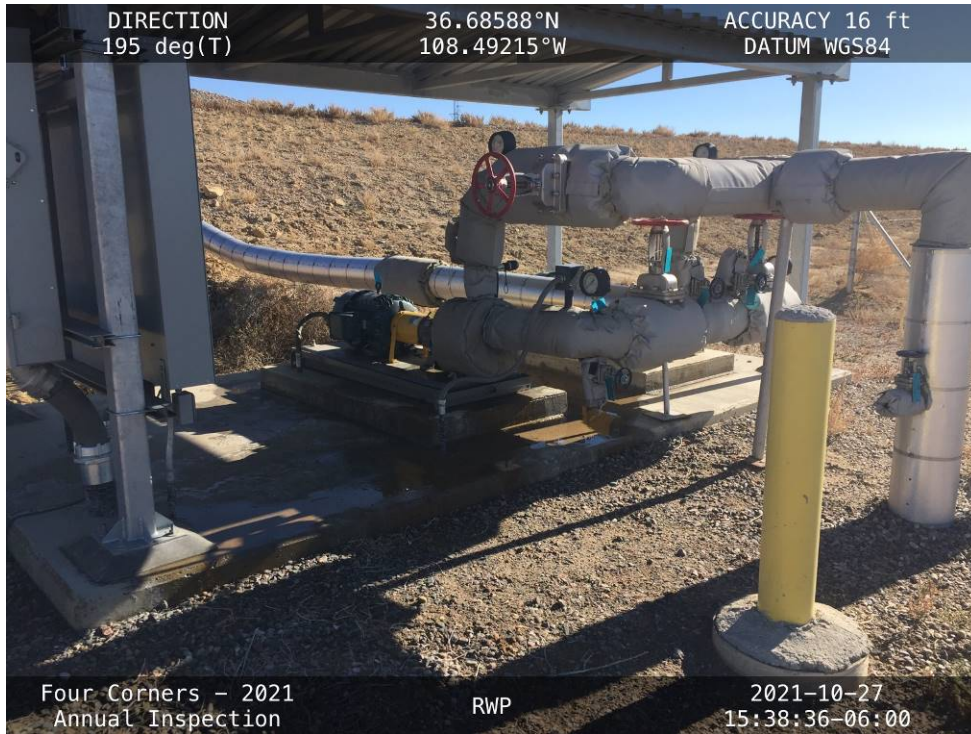
20211027-IMG_8022

A work request tag for the RWP Pump 002 (RWP-PMP-002), which has had low discharge pressure and cavitation.

5) The two Flowserve horizontal base-mounted pumps at the downstream toe of the Northwest Embankment were both subject to work requests at the time of the inspection.	Repair the pumps.

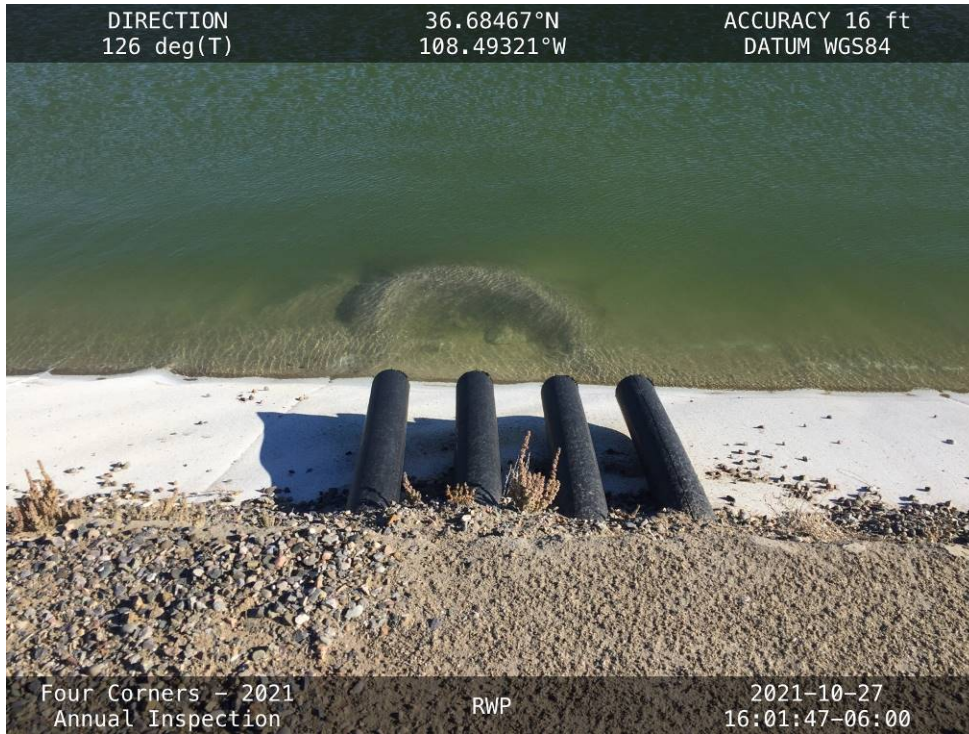
20211027-IMG_8083

The upstream slope of the FGD Pond cell Northwest Embankment, facing northeast.

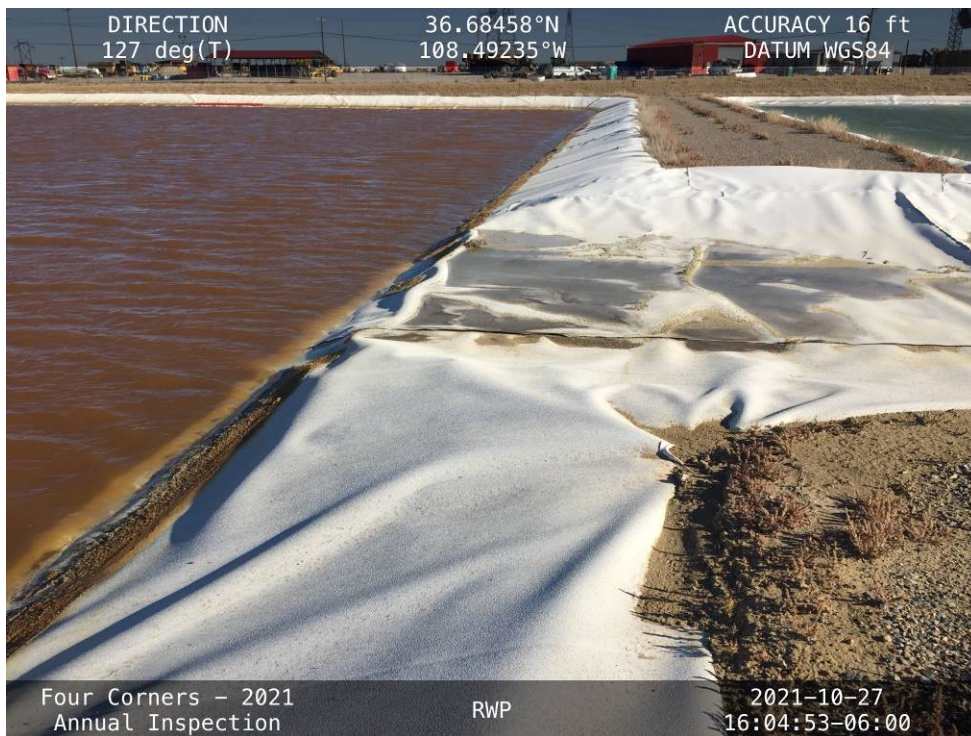
20211027-IMG_8099
The crest of the Internal Embankment, facing southeast.
