FOUR CORNERS POWER PLANT COMBINED WASTE TREATMENT POND – Periodic Structural Integrity Assessment

Periodic Hazard Potential Classification Periodic Structural Stability Assessment Periodic Safety Factor Assessment

October 2021 AECOM Project 60664563

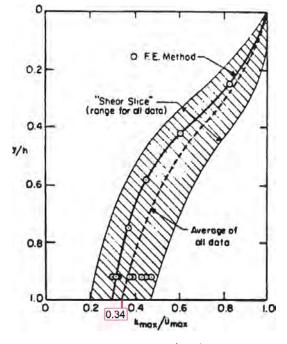
Figure 5 – Variation of "Maximum Acceleration Ratio" with depth of sliding mass after Makdisi and Seed (1977)

Finally, the PGA_{crest} was adjusted because the "maximum acceleration ratio" varies with the depth of the sliding mass relative to the embankment height (Makdisi and Seek, 1977). Figure G-4 (shown below) presents the relationship between maximum acceleration ratio (k_{max}/u_{max}) and depth of sliding mass (y/h). For deep-seated failure surfaces that involve the entire vertical profile of the dam slope and extend from the crest to the toe or

below the toe of the embankment into the foundation soils, the acceleration at the crest can be as low as approximately 34 percent of the maximum value:

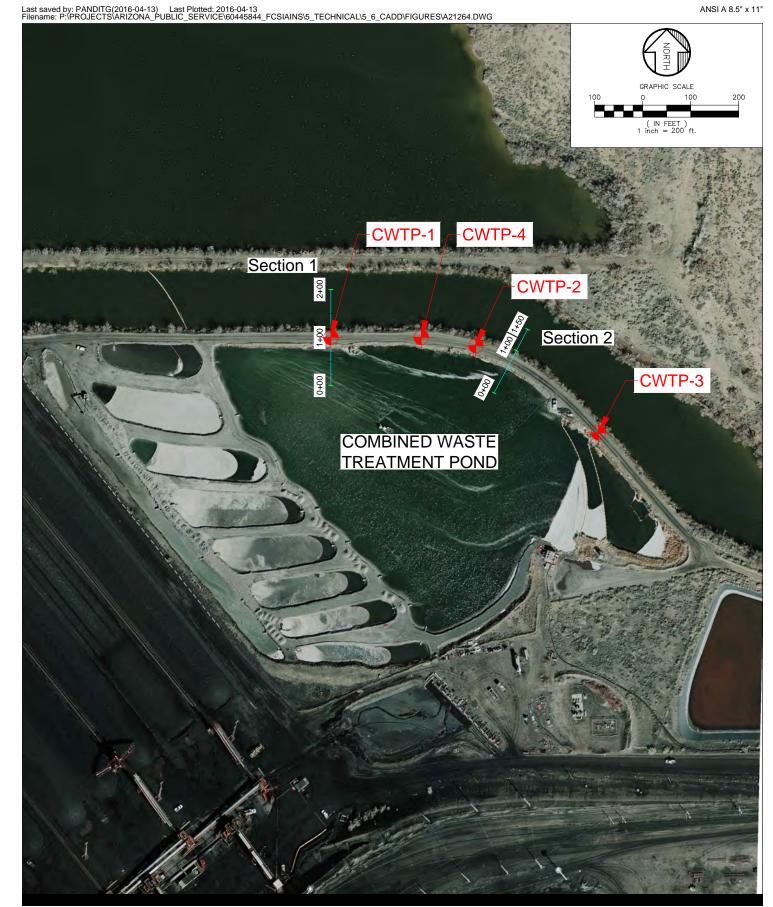
COMBINED WASTE TREATMENT POND (CWTP) FIGURE 1 WITH BORING AND SECTION LOCATIONS

Safety factors were calculated for two cross sections of the CWTP Embankment (shown on Figure 1, attached) selected to represent different embankment geometries, heights, and stratigraphic conditions to provide confidence that the critical cross section was analyzed. The critical cross section is the cross section that is anticipated to be most susceptible to structural failure for a given loading condition. The critical cross section thus represents a "most-severe" case. Section locations were selected based on variation in the embankment height, side slope configuration, pond and canal depths, and stratigraphic conditions. Subsurface soil profiles were developed using information from the borings presented in Section 2 of this report. The cross sections analyzed are:

CWTP Section 1: This cross section represents the maximum section in the western portion of the CWTP embankment where a layer of low blow-count bottom ash was encountered. The embankment is approximately 22 feet high, with a 1.4H:1V downstream slope and a 1.8H:1V upstream slope. The embankment fill consists of Sandy Lean Clay over approximately 14 feet of bottom ash with bedrock at 36 feet bgs. MCS penetration testing in the upper zone of the bottom ash at the CWTP-4 location resulted in an uncorrected N-value equal to 2 (indicating very loose soil). This condition was represented in the model using a 5-foot thick layer of "Upper Bottom Ash" having a strength lower than the underlying bottom ash (see discussion of material properties in Section 3.3).

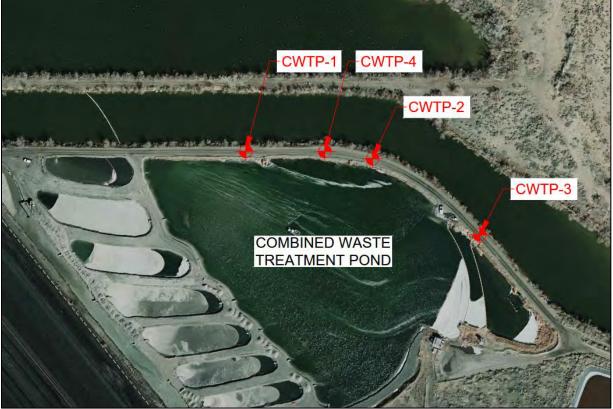
Figure 1. AECOM 2016 Geotechnical Exploration Boring Locations

Four profiles of liquefaction potential with depth were analyzed at the CWTP based on the four borings, CWTP-1 to CWTP-4, drilled at the site as presented in Figure 1. For each profile, a result figure was produced with the corrected SPT blowcounts, CRR, CSR, factor of safety against liquefaction (FS_{lig}), maximum shear strain (γ_{max}), and vertical reconsolidation strain (ε_v).

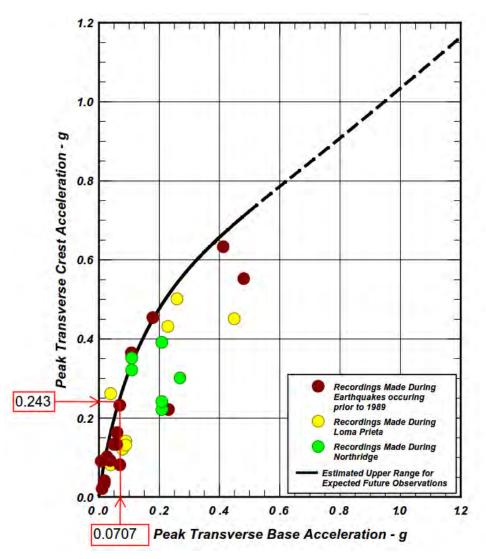
Figure 4. Variations of Peak Transverse Crest Acceleration v. Peak Transverse Base Acceleration Based on Holzer (1998)

The PGA at the ground surface for Site Class C (PGA_M) was then used to estimate the peak transverse acceleration at the crest of the embankment, $PGA_{crest} = 0.243g$, as shown on Figure 4 and based on variations in recorded peak crest accelerations versus those recorded at the base of earth and rock fill dams by Holzer (USGS, 1998).

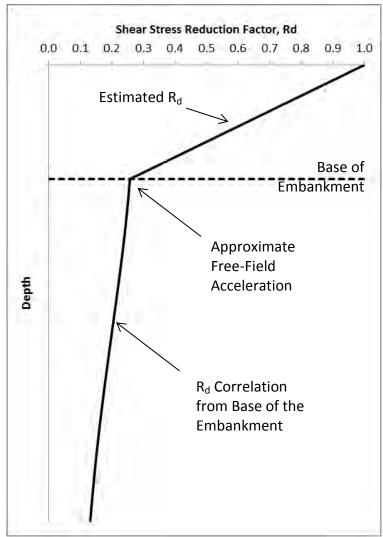
Figure 5. Estimated R_d Factor

First, based on past experience with 2-dimensional site-response analyses, the acceleration is generally less than or equal to the free-field (site-corrected) acceleration at the base of the embankment. Second, the amplification of the acceleration increases more rapidly as the height within the embankment increases to the maximum at the crest. Therefore, the acceleration for a given depth within the embankment was interpolated from these two boundary conditions. Below the embankment, R_d was assumed to behave similarly to that of the free-field conditions, which is probably conservative as a result of the overburden pressure and additional confinement beneath the embankment. The diagram in Figure 5 shows how R_d was modified for the analysis.
