**FOUR CORNERS POWER PLANT
Lined Ash Impoundment, Lined Decant
Water Pond, Combined Waste Treatment
Pond, Upper Retention Sump, and Dry
Fly Ash Disposal Area**

**Annual
CCR Impoundment and
Landfill Inspection Report
2015**

**AECOM
7720 North 16th Street,
Suite 100
PHOENIX, ARIZONA 85020**

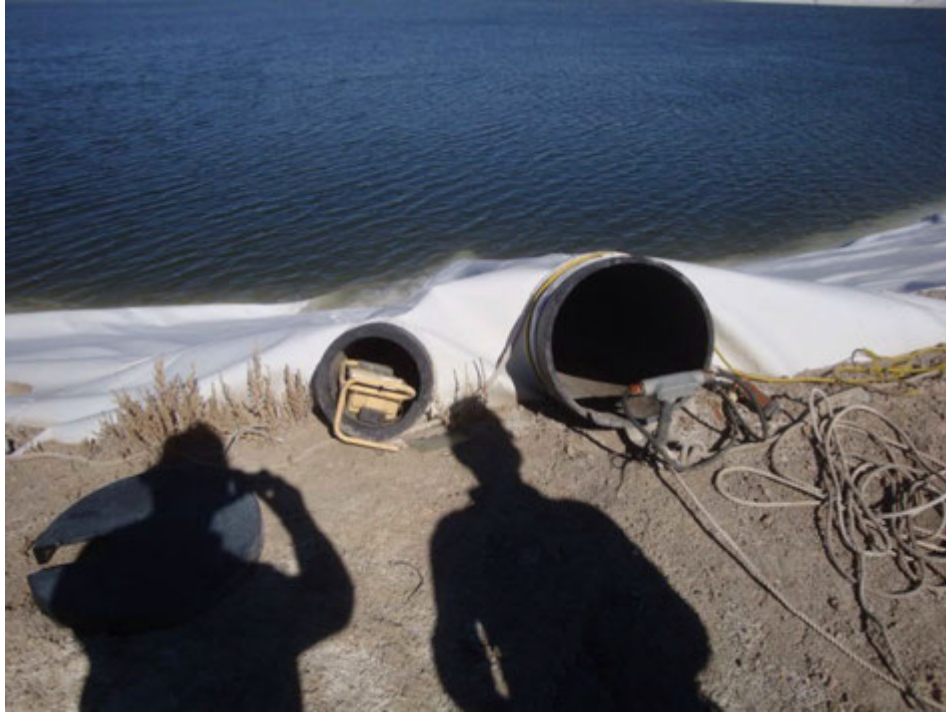
20151014 – Photo 11, Set 1

Crest, southwest corner. Double-liner interstitial pump-out system. Larger pipe abandoned due to subsurface collapse. No pump installed in smaller pipe.

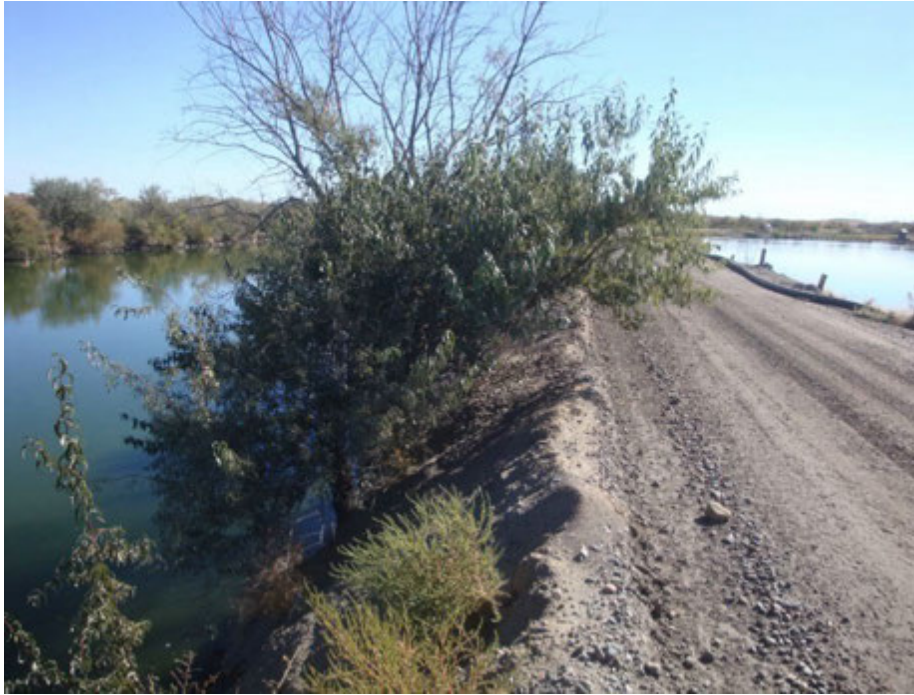
20151014 – Photo 14

Downstream slope of CWTP. Looking east. Note heavy vegetation, including trees, on downstream slope.

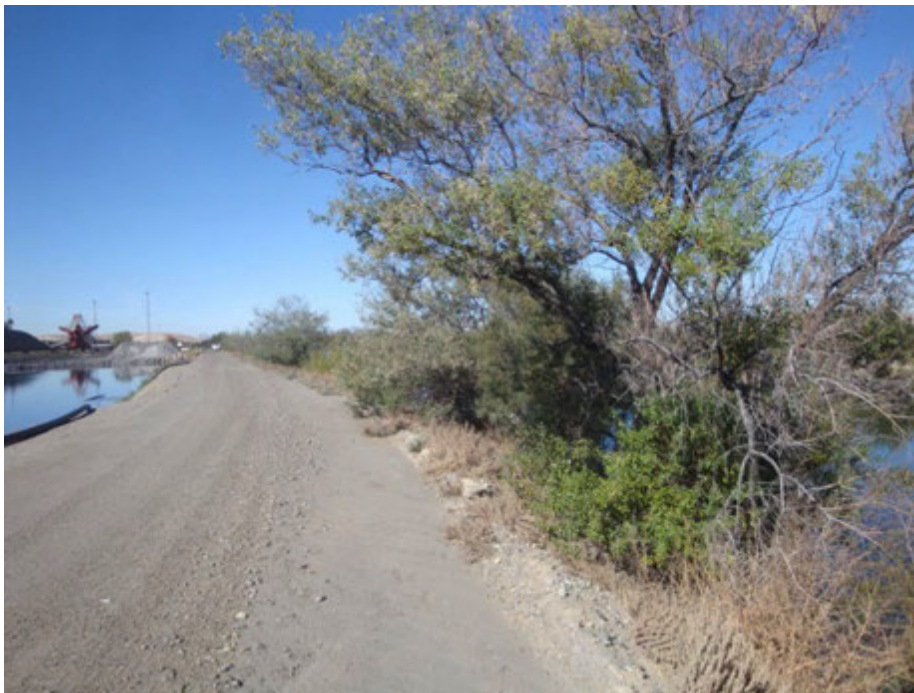
20151014 – Photo 19

Downstream slope of CWTP. Looking west. Note heavy vegetation, including trees, on downstream slope.

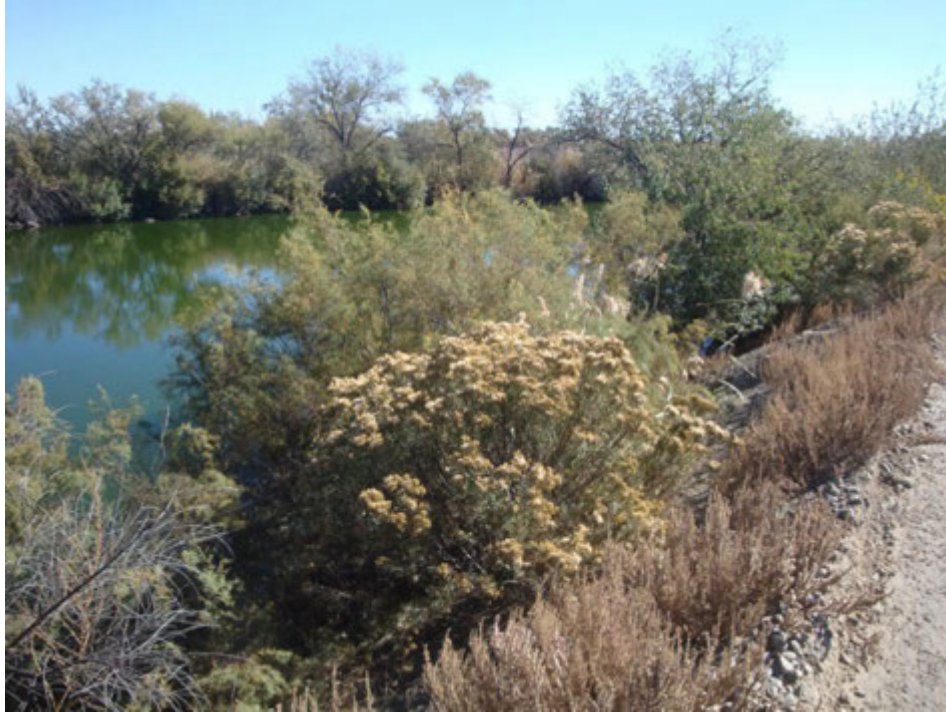
20151014 – Photo 20

Downstream slope of CWTP. Looking east. Note heavy vegetation, including trees, on downstream slope.

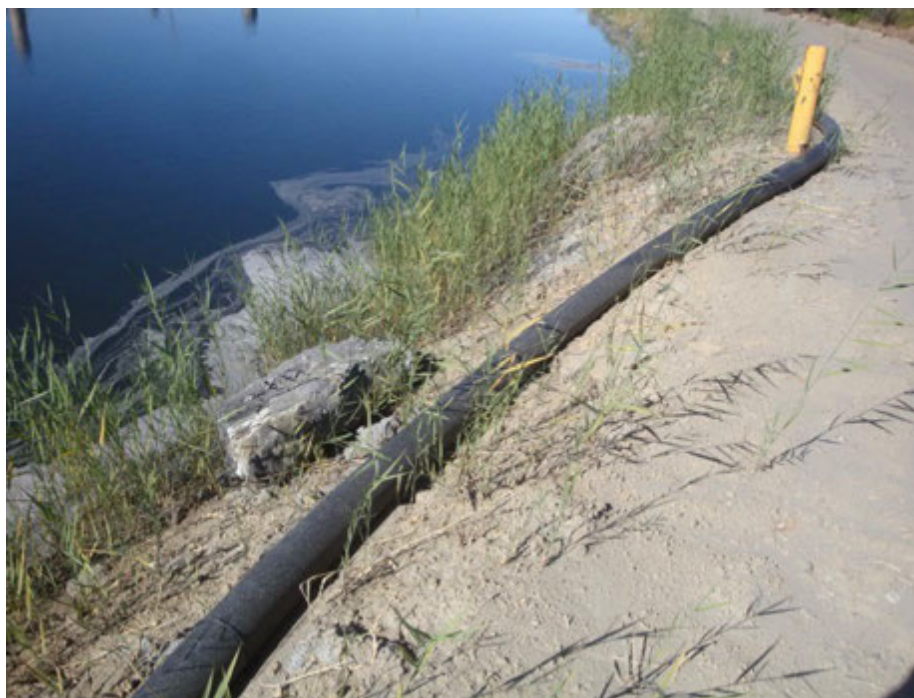
20151014 – Photo 22

Uneven crest elevation in location of yellow bollard. Evidenced by approximately 1 foot apparent reduction in depth to the CWTP water surface.

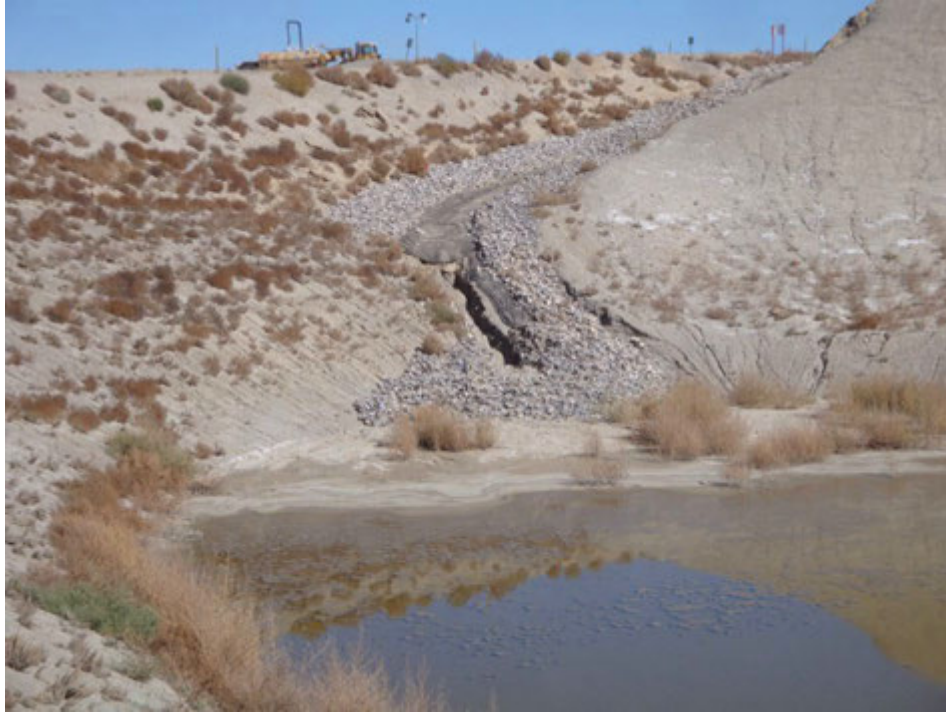
20151014 – Photo 2

Inlet to Storm Water Diversion Channel from ash haul cut. Note minor erosion on steep sections.

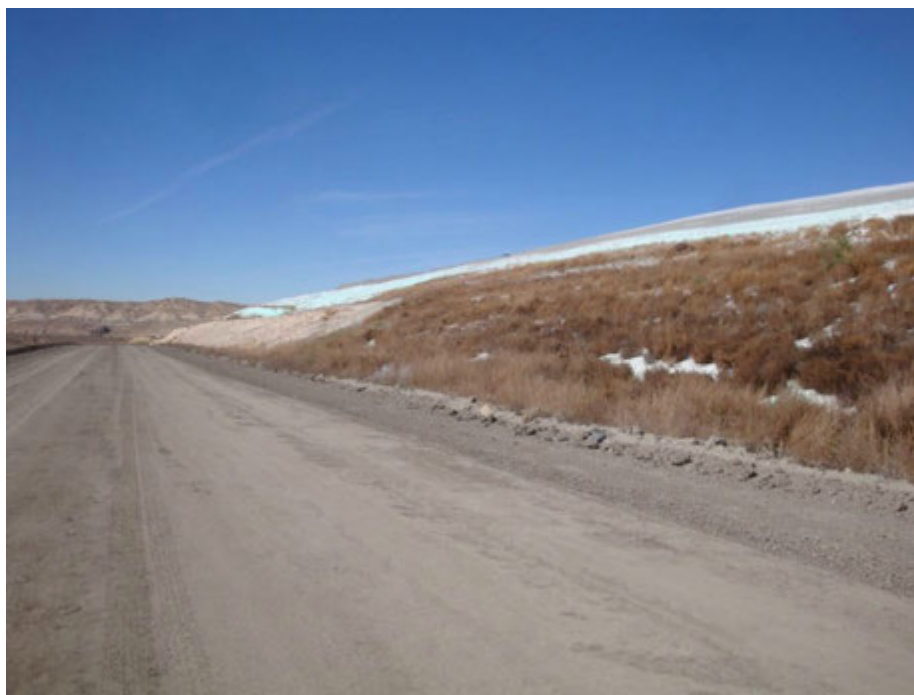
20151014 – Photo 34

South Slope of Units 1 and 2. Note sparse vegetation in foreground and Pyramat-covered slope in far ground.

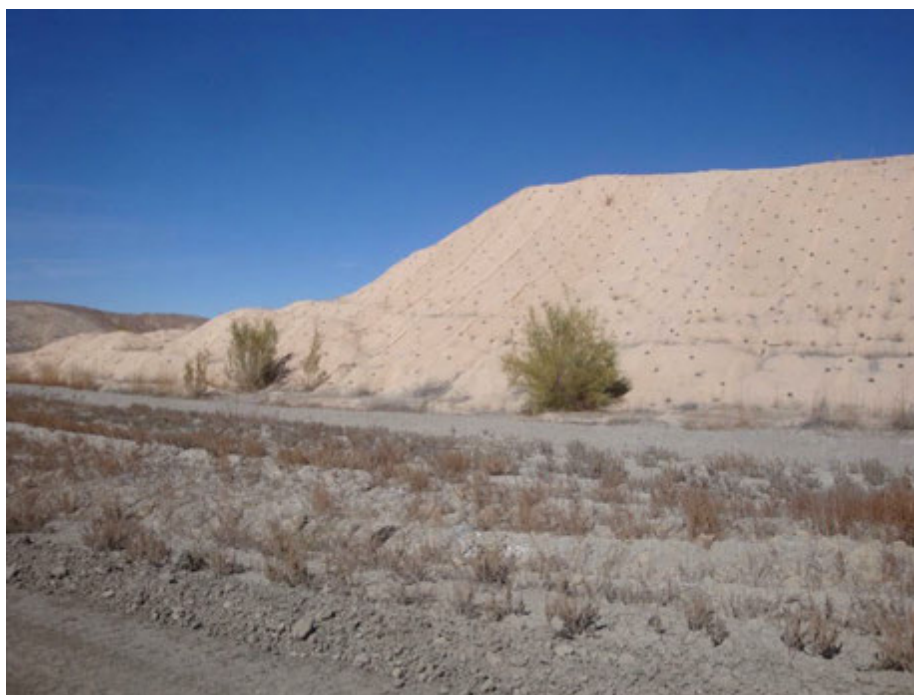
20151014 – Photo 38

Southwest corner of Unit 1. Slope covered with anchored geosynthetic and Pyramat to control dust generation.
