**FOUR CORNERS POWER PLANT
Lined Ash Impoundment,
Lined Decant Water Pond,
Combined Waste Treatment Pond,
Dry Fly Ash Disposal Area,
and Return Water Pond**

**Annual
CCR Impoundment and
Landfill Inspection Report
2022**

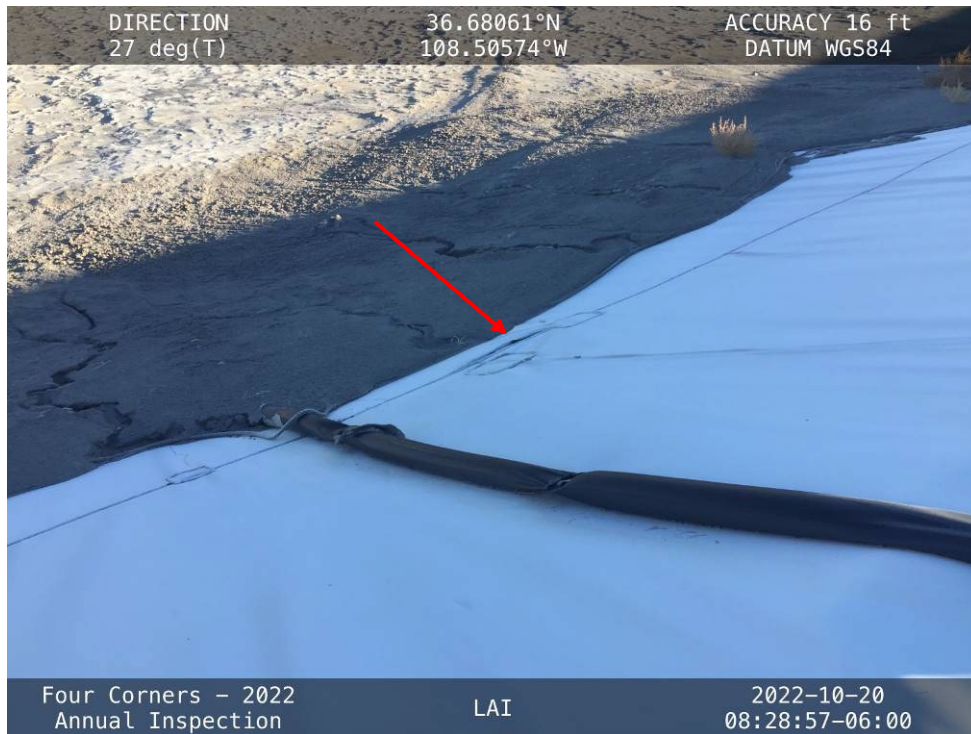
20221020 – IMG_4429
 A tear along the horizontal seam in the liner.

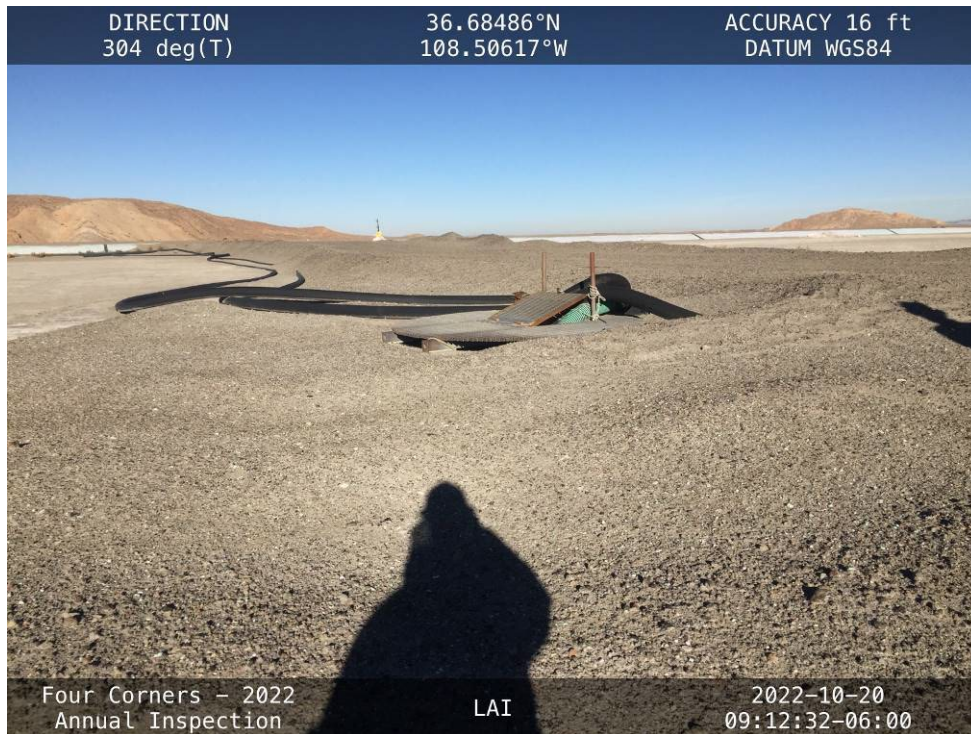
20221020 – IMG_4477
The Drop Inlet Structure, facing west from inside the LAI reservoir.

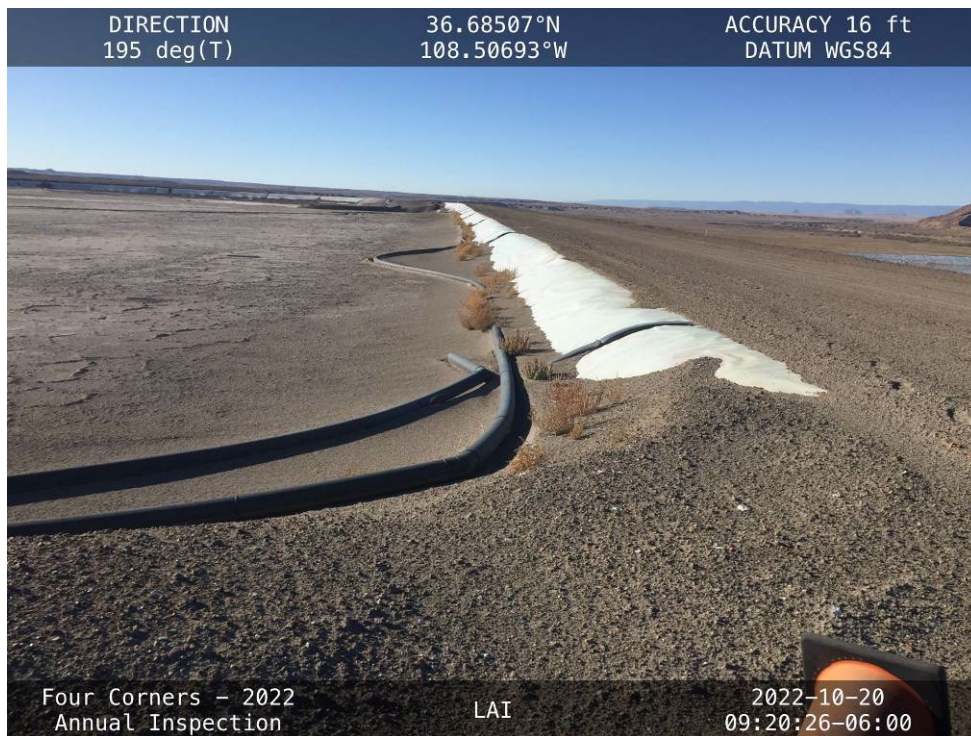
20221020 – IMG_4484
The upstream slope of the West Embankment, facing south from the Drop Inlet Structure ramp.

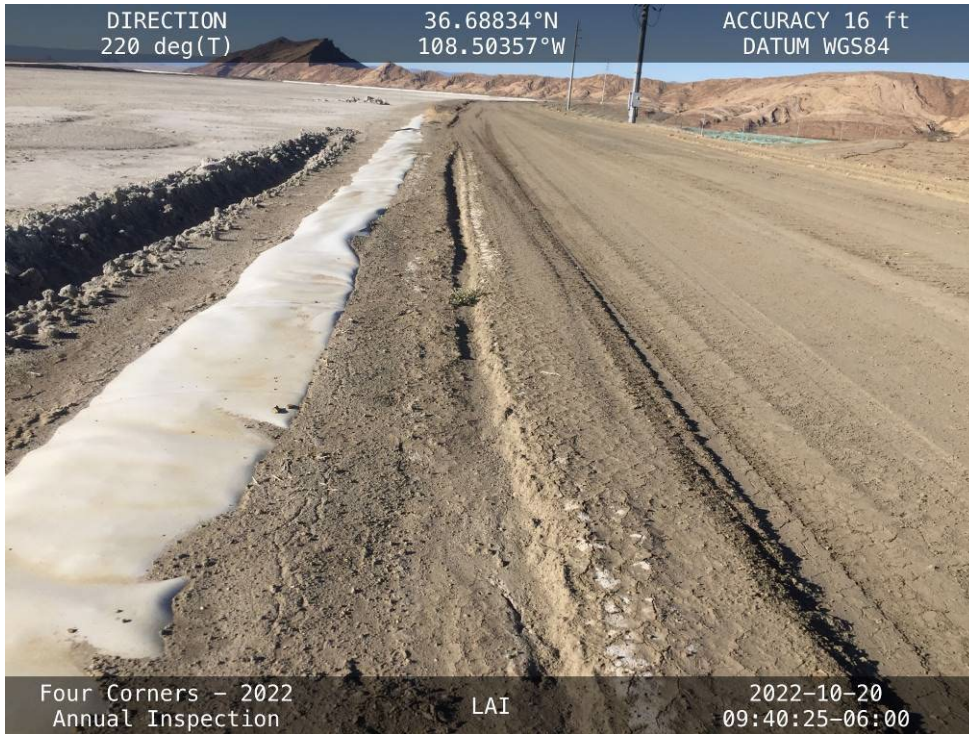
20221020 – IMG_4507
Ruts on the upstream side of the Northwest Embankment crest.

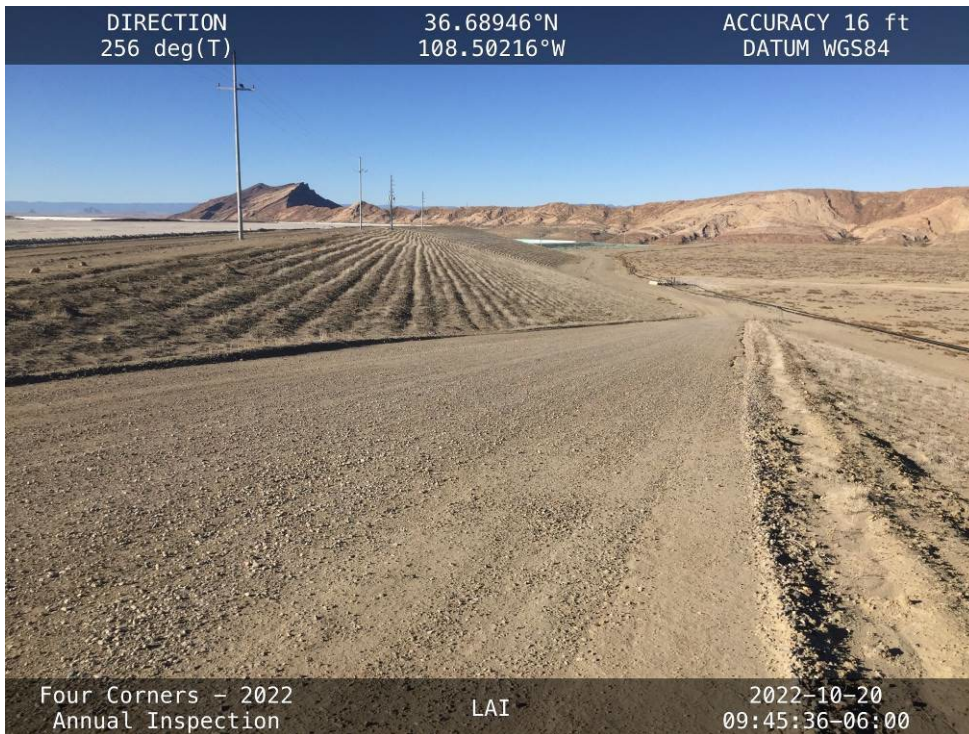
20221020 – IMG_4509
The downstream slope of the Northwest Embankment, facing west.

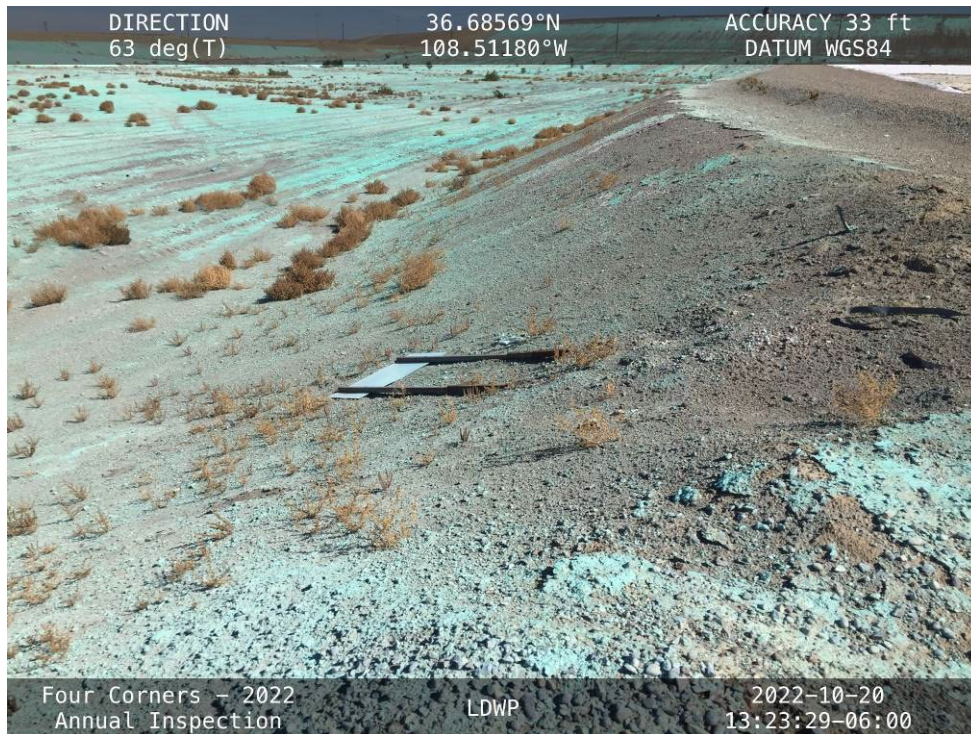
20221020 – IMG_4805
 The sign for the CCR unit, to be re-erected.

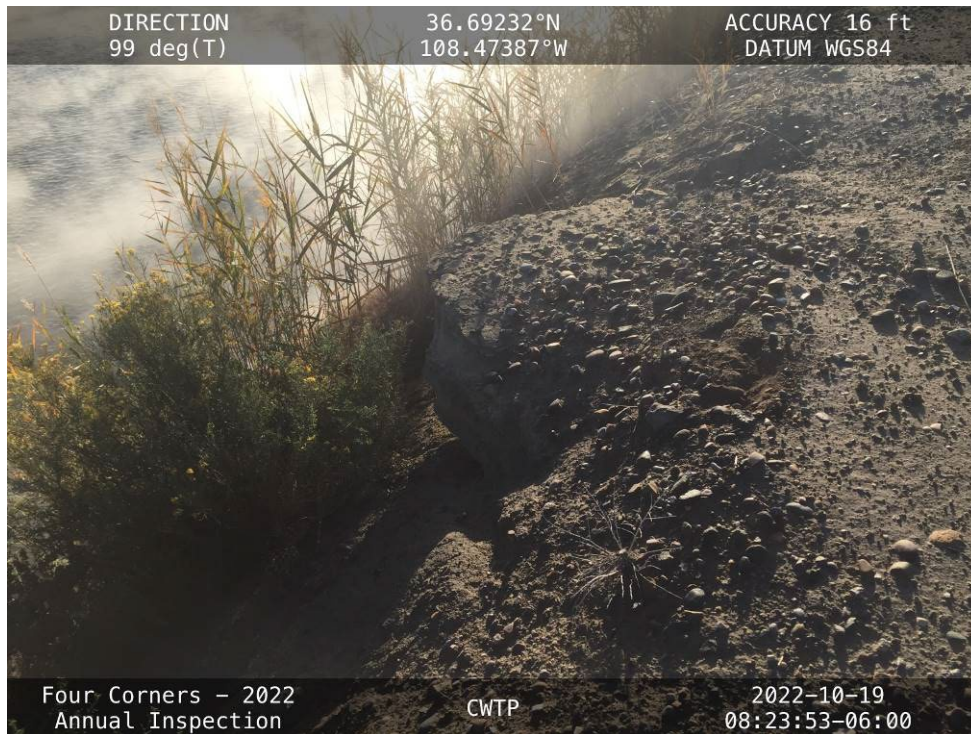
20221019 – IMG_4017
Erosion beneath a riprap boulder on the downstream slope.

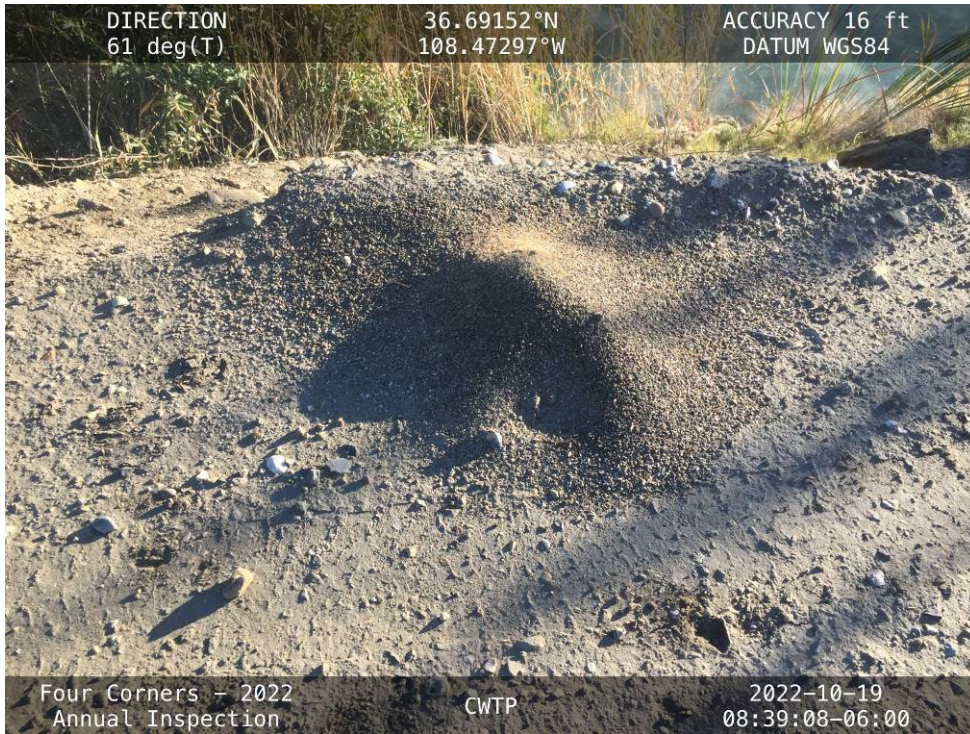
20221019 – IMG_4045
 An ant hill on the downstream shoulder of the embankment.

5) Ant hills were observed along the embankment crest and animals have been known to burrow in the area.	This is an ongoing maintenance requirement. Repair ant hills and animal burrows as needed.

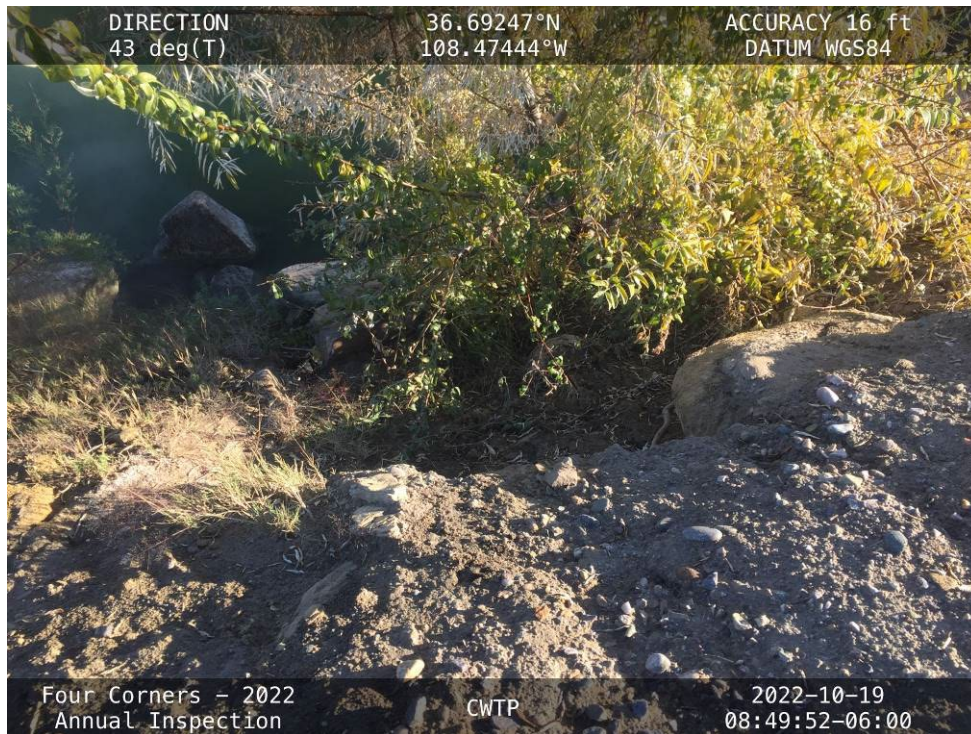
20221019 – IMG_4087
Erosion and vegetation to be removed from the downstream slope.

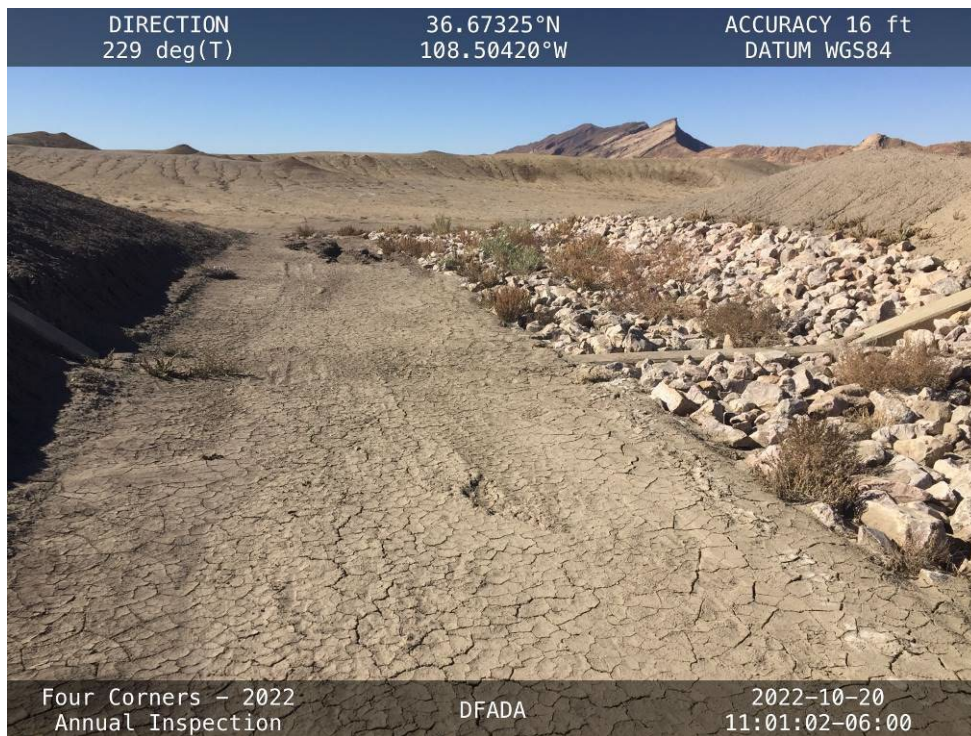
20221020 – IMG_4631

3.5 feet of erosion at the new outlet for the Stormwater Diversion Channel.

Action Item	Action Status
1) There is erosion at the Stormwater Diversion Channel inlet and outlet.	Monitor erosion and repair the area. Alternately, place additional sandstone riprap in the eroded area.

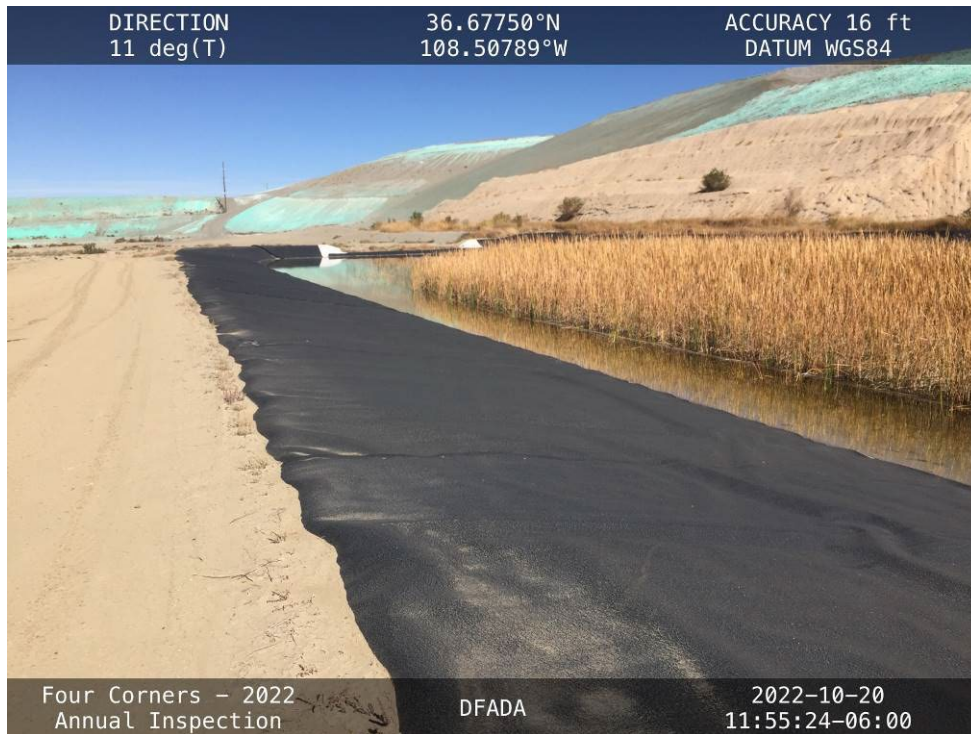
20221020 – IMG_4674

The drainage channel to the Cell 1 leachate collection pond, filled with sediment and grasses.

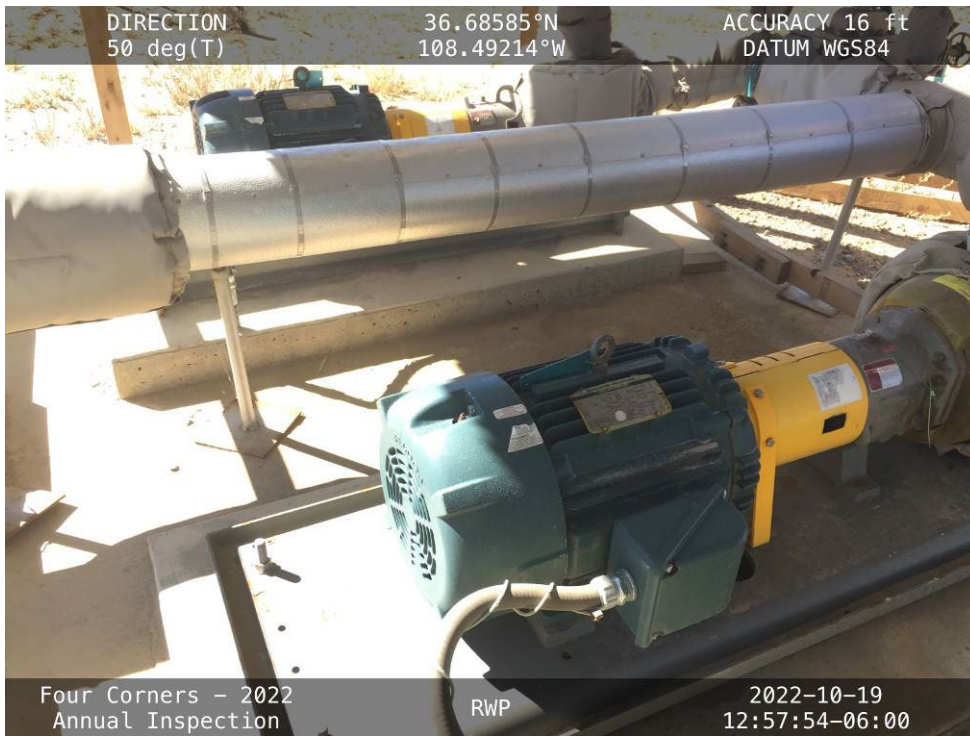
20221019 - IMG_4300
 The RWP pumps, no longer leaking.

Action Item	Action Status
1) The two Flowserve horizontal base-mounted pumps at the downstream toe of the Northwest Embankment were both subject to work requests at the time of the inspection (2021 inspection).	The pumps were repaired.
2) The hinge for the access gate at the southern entrance to the RWP is broken (2021 inspection).	The gate was repaired.
3) The FGD Pond was observed to be at “full capacity” during a series of weekly inspections in December 2020 and January 2021. In addition, the RWP and FGD cells were near full capacity during the 2021 inspection.	Both cells were several feet lower during the 2022 inspection.
