**FOUR CORNERS POWER PLANT  
Lined Ash Impoundment,  
Lined Decant Water Pond,  
Combined Waste Treatment Pond,  
Dry Fly Ash Disposal Area,  
and Return Water Pond**

**Annual  
CCR Impoundment and  
Landfill Inspection Report  
2023**

**GENERATION ENGINEERING  
Design Engineering  
P.O. BOX 53999  
PHOENIX, ARIZONA 85072**

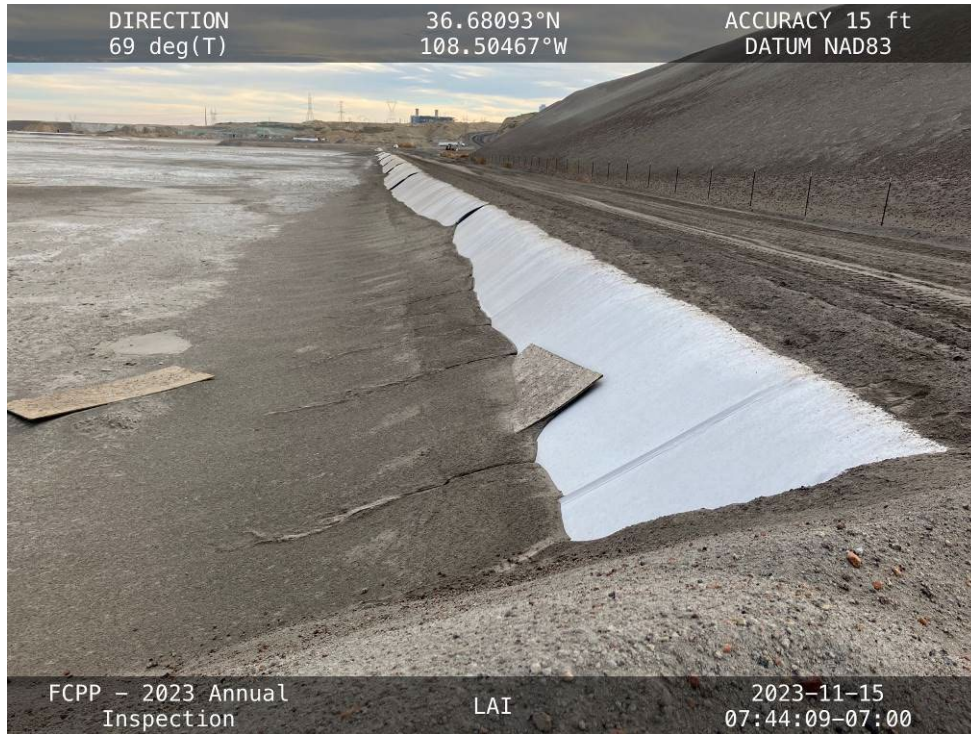
**20231115 – IMG\_2303**  
A piece of plywood along the liner, separated by a thin layer of ash.

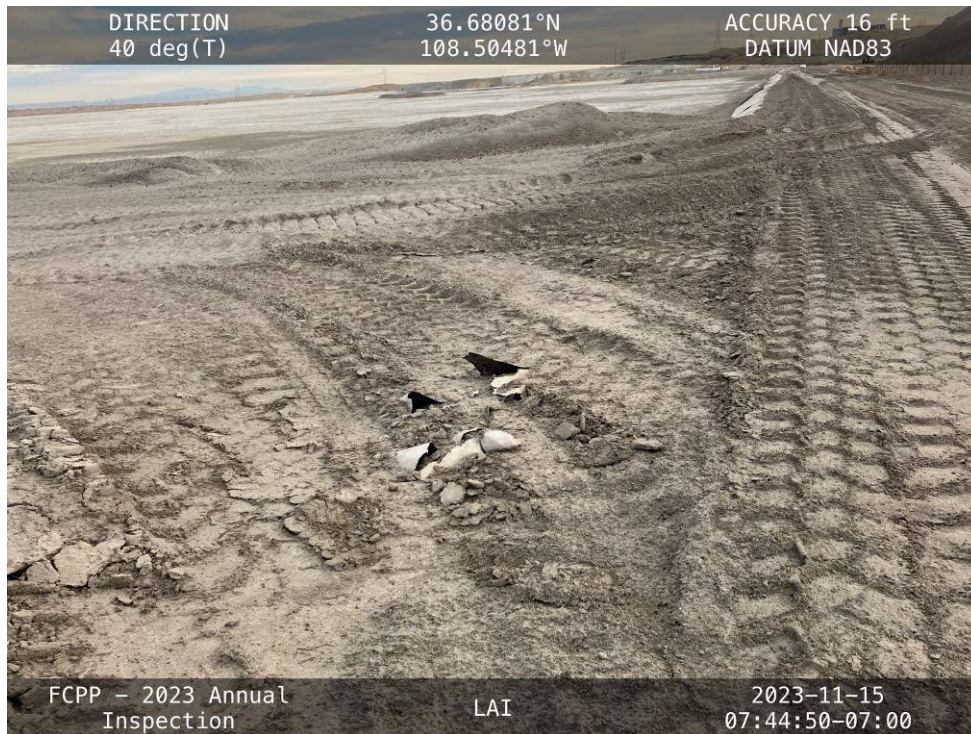
**20231115 – IMG\_2306**  
Liner tears at an access ramp into the reservoir.

- v. There are several tears, cuts, and torn seams in the liner along the upstream slope. Two tears and all of the torn seams are on the South Embankment near the Southwest Corner (Photos IMG\_2306, IMG\_2311, IMG\_2325, IMG\_2327) appear to be due to tension in the liner as they occur along the horizontal seams associated with the final embankment raise. Unlike the 2022 inspection, the torn seams were not leaking water; however, the liner on the South Embankment is very tight. The tension could be released by excavating the anchor trench, pulling extra liner out to provide slack, and backfilling the trench. Repair the tears to prevent water from infiltrating underneath the line.

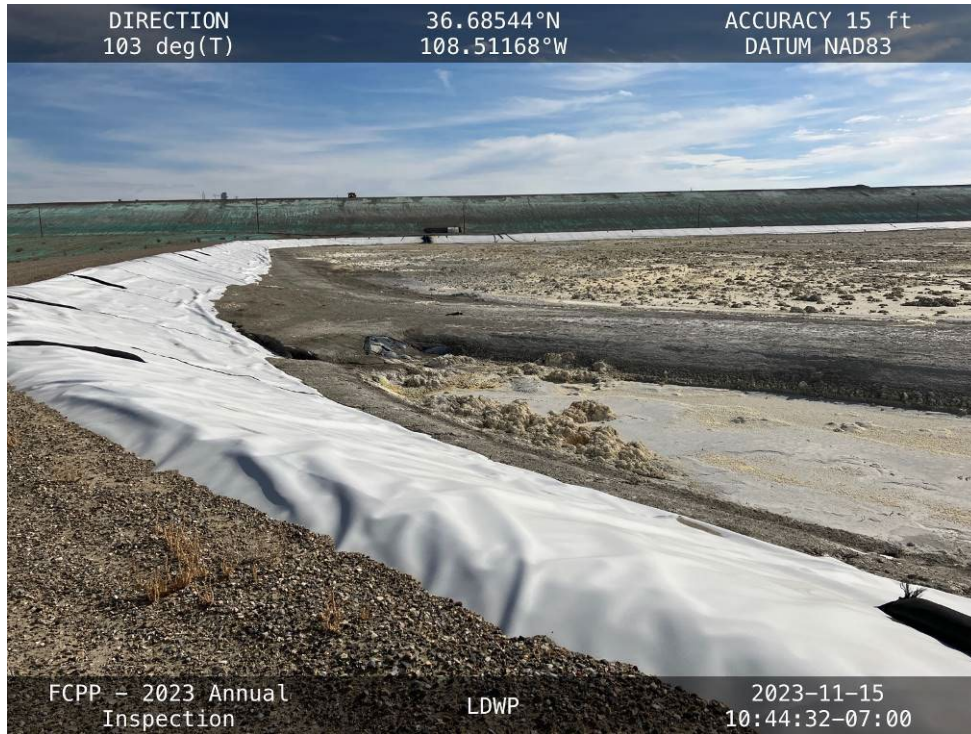
**20231115 – IMG\_2614**

The upstream slope of the West Embankment, facing south.

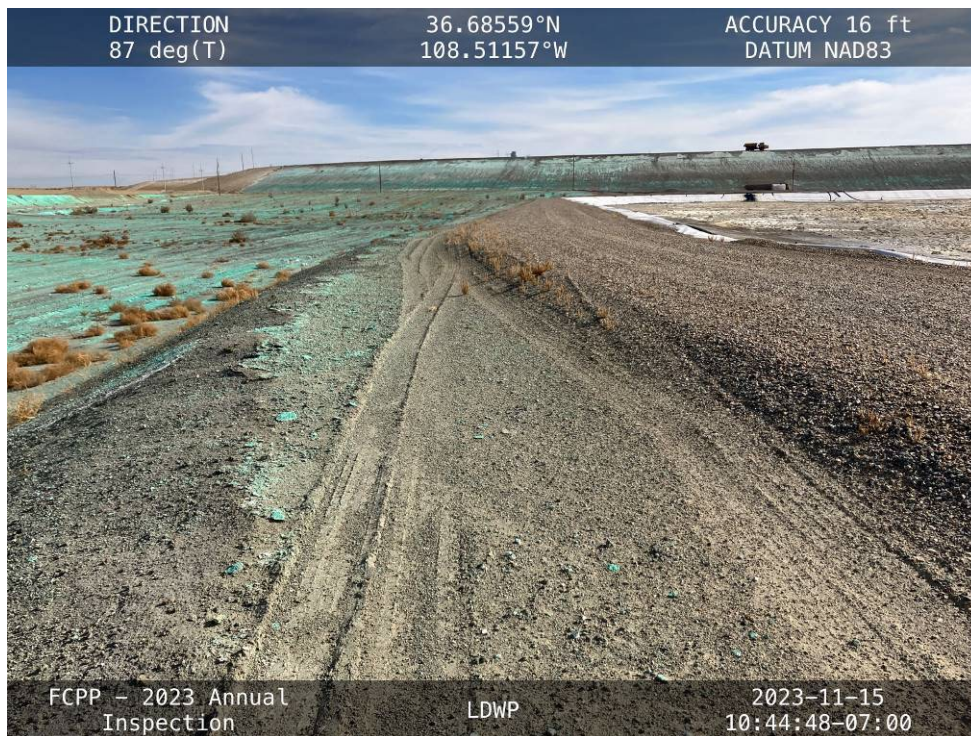
**20231115 – IMG\_2617**  
The upstream slope of the North Embankment, facing east.

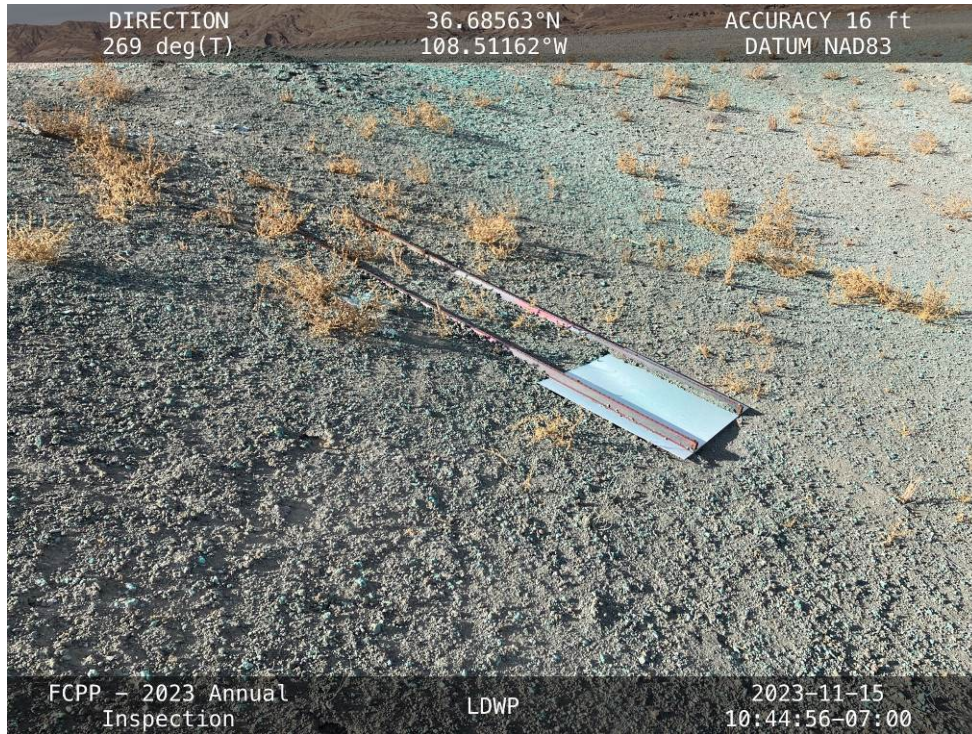
**20231115 – IMG\_2618**  
The crest of the North Embankment, facing east from the West Embankment.

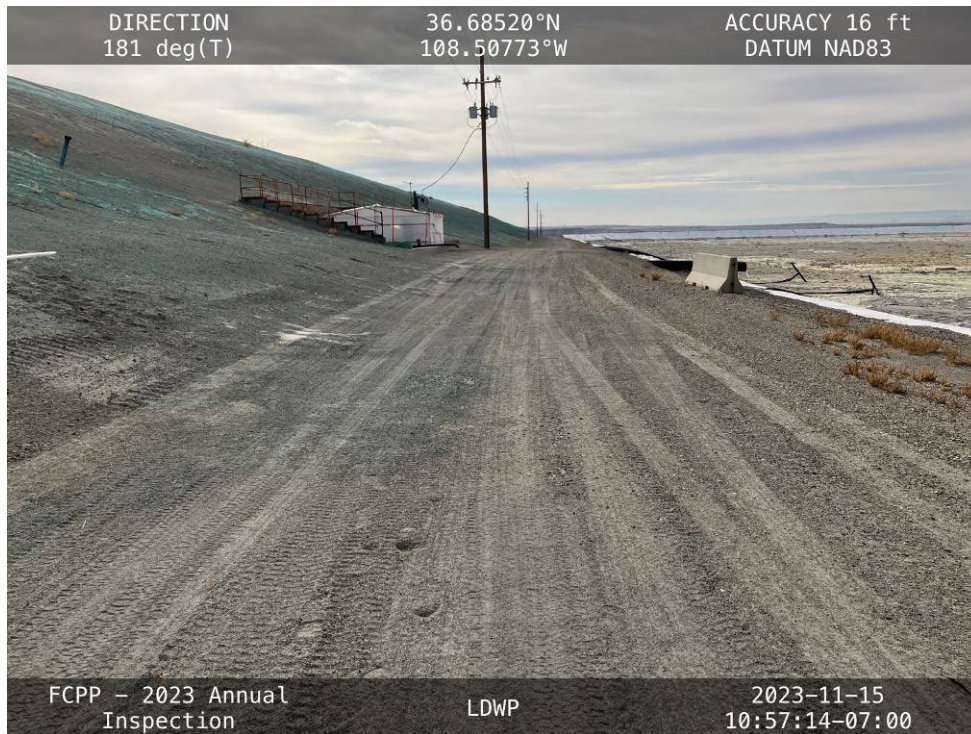
**20231115 – IMG\_2647**  
 The surface monuments for piezometers P-23, P-24, and P-25.

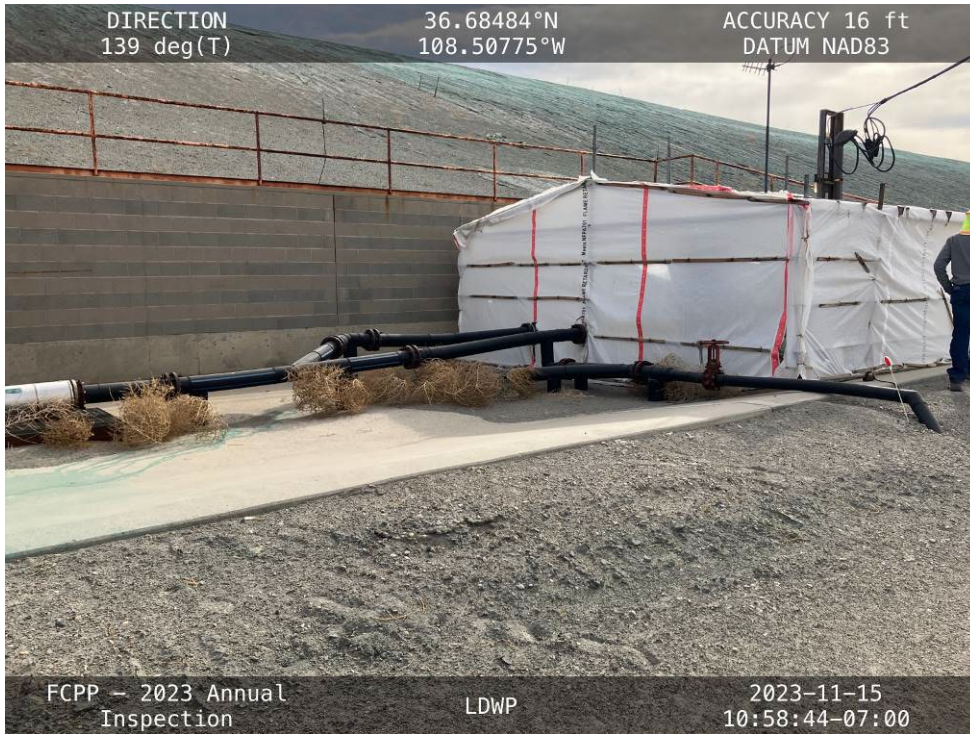
**20231115 – IMG\_2657**

The LAI/LDWP pump station.

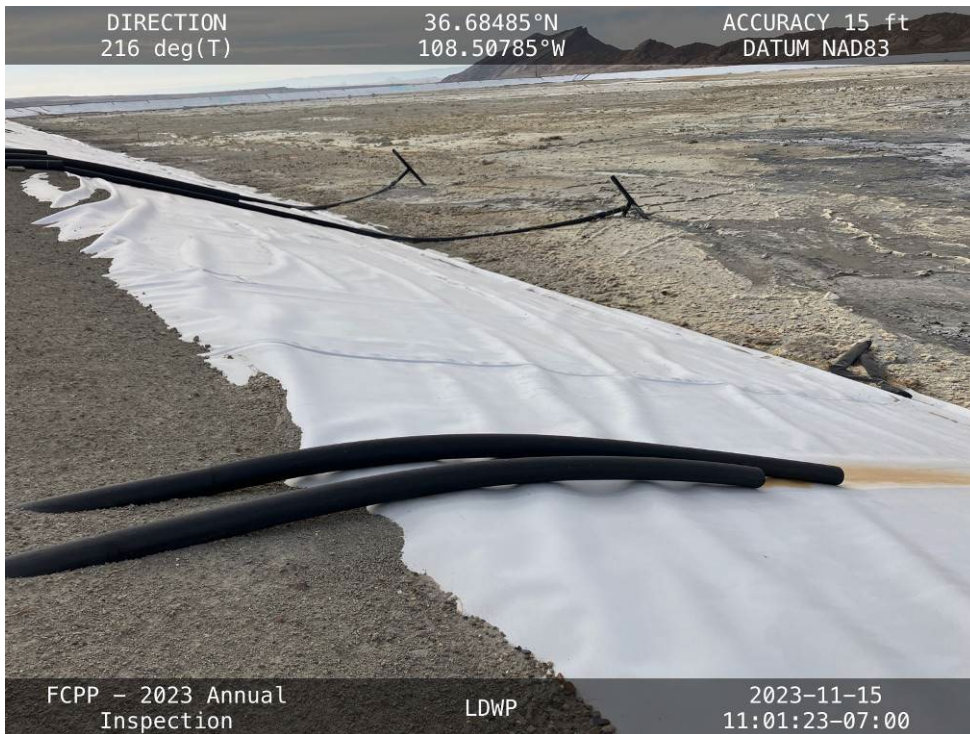
**20231115 – IMG\_2658**  
The LAI/LDWP pump station.

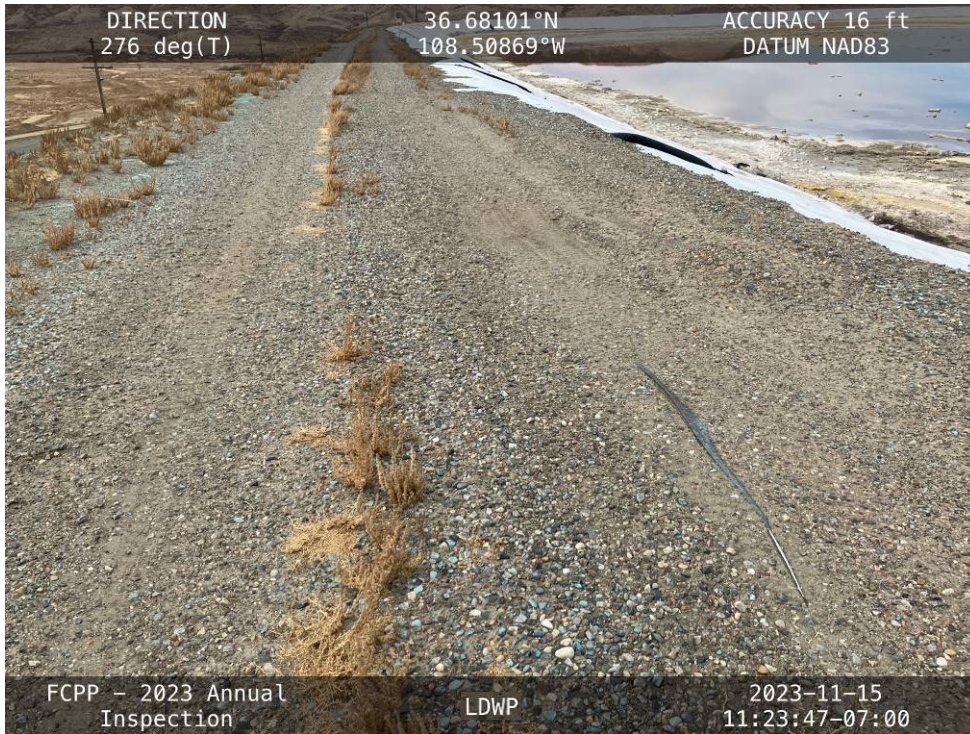
**20231115 – IMG\_2714**

The downstream slope of the South Embankment, facing west from the southeast corner.

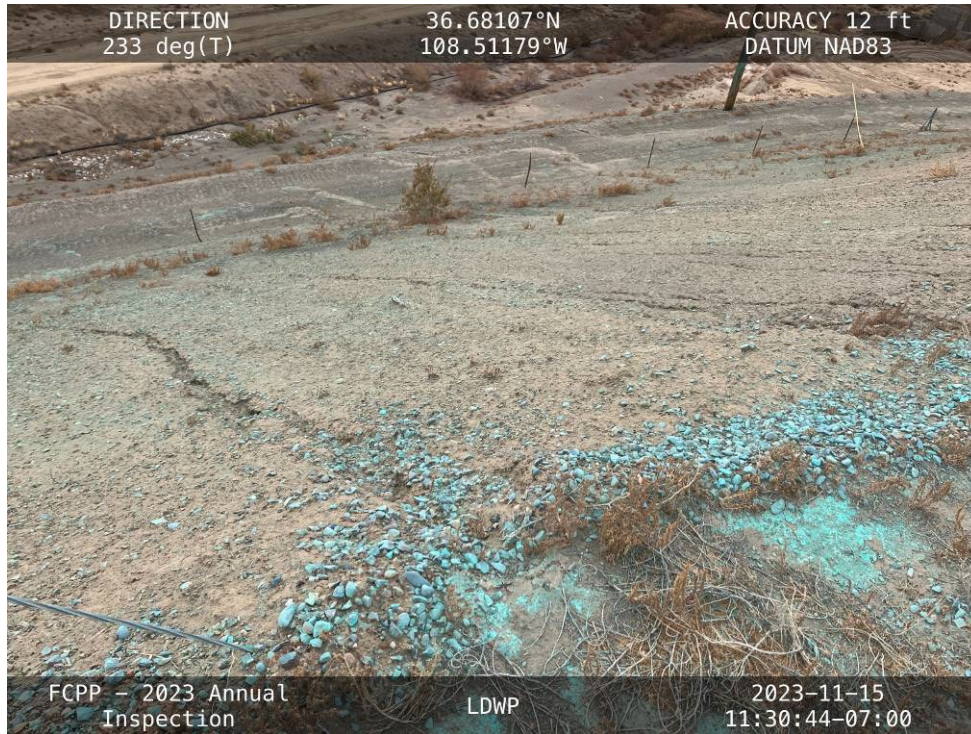
**20231115 – IMG\_2716**  
 An ant hill on the downstream shoulder of the South Embankment.

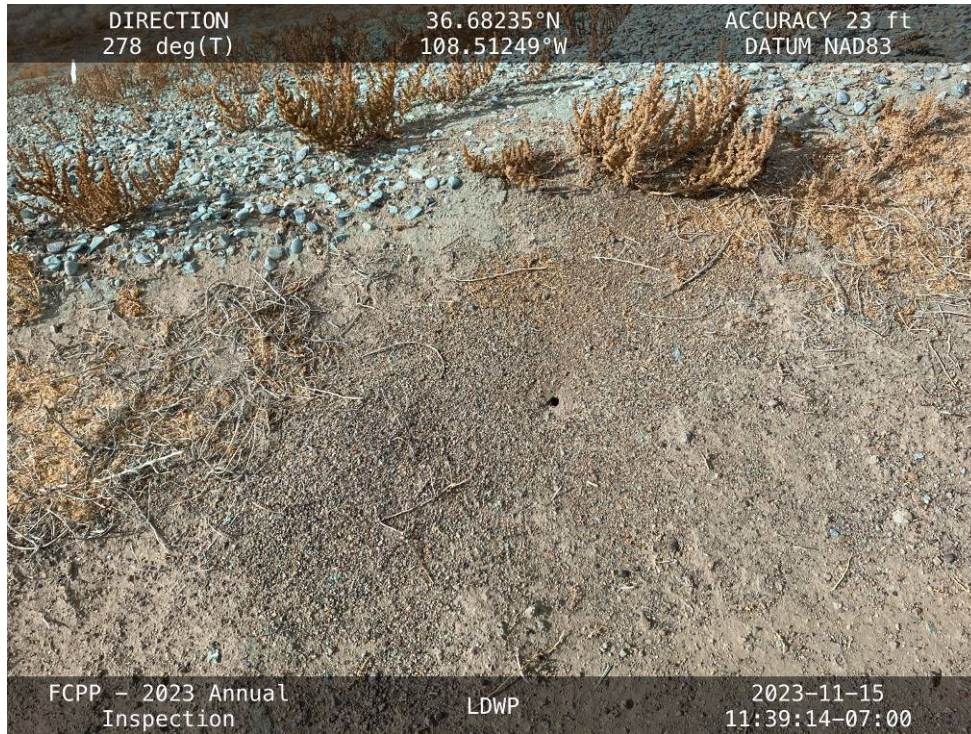
**20231115 – IMG\_2739**  
 An ant hill on the downstream shoulder of the West Embankment.

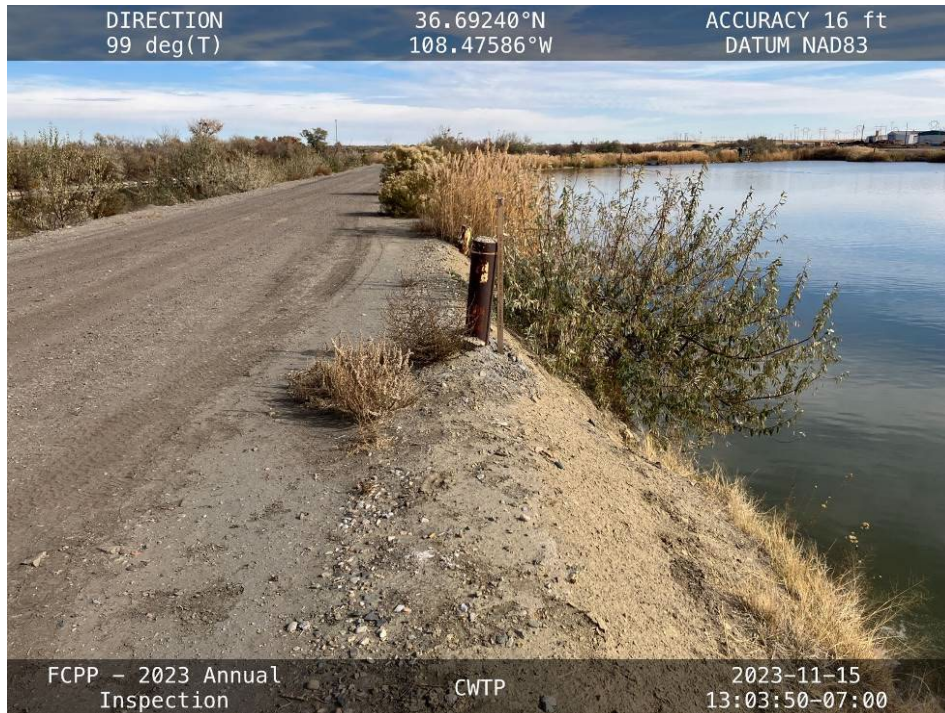
**20231115 – IMG\_2801**  
Vegetation to be removed from the upstream slope.

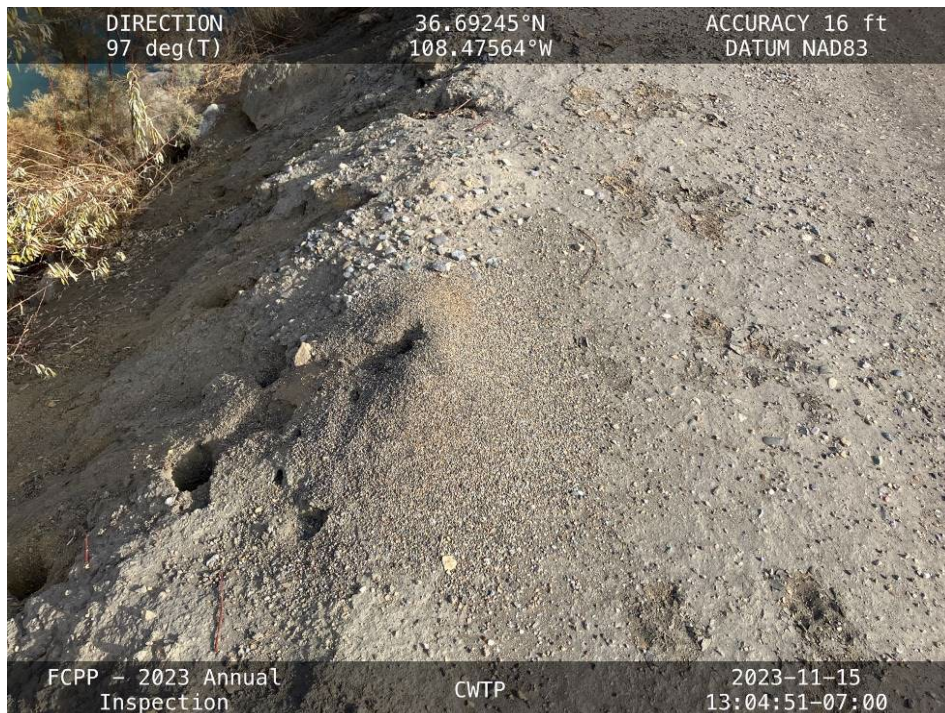
**20231115 – IMG\_2806**  
Shallow holes and an ant hill on the downstream shoulder of the North Embankment where there were depressions in 2021 and 2022 (2021 IMG\_8448, 2022 IMG\_3998).

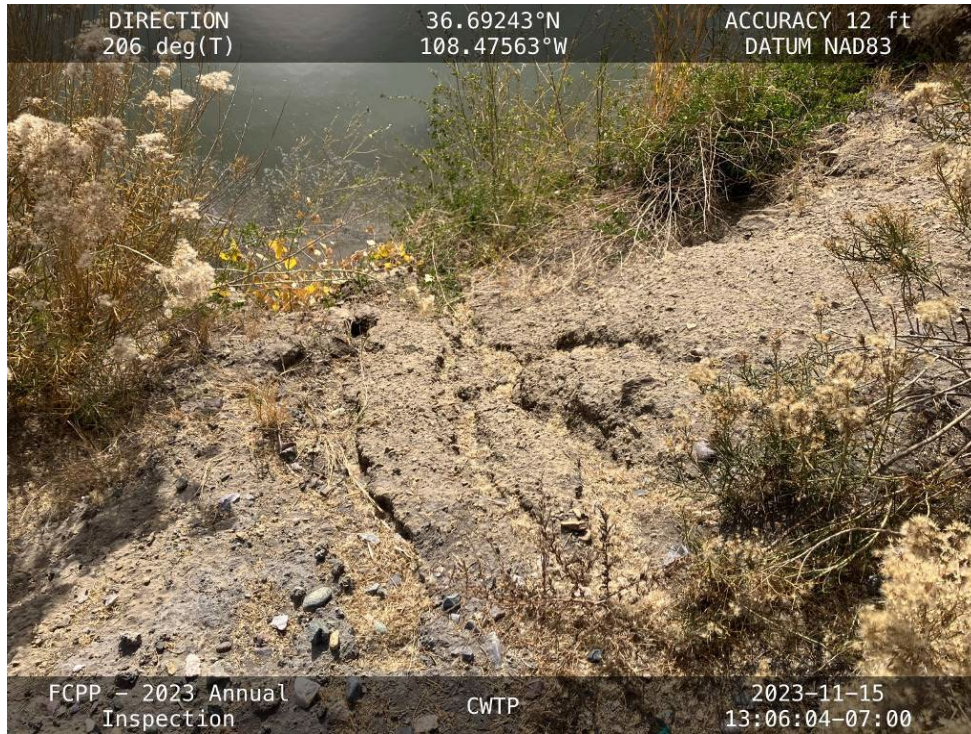
**20231115 – IMG\_2810**  
Erosion rills forming on the upstream slope.

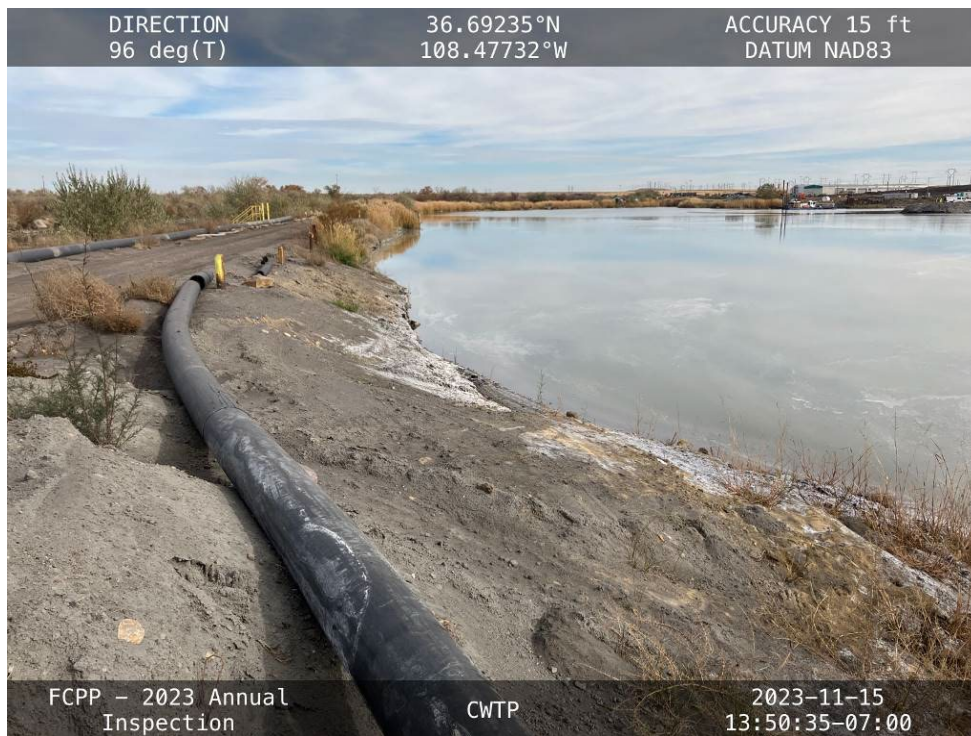
**20231115 – IMG\_2898**  
Erosion along the upstream slope of the North Embankment.

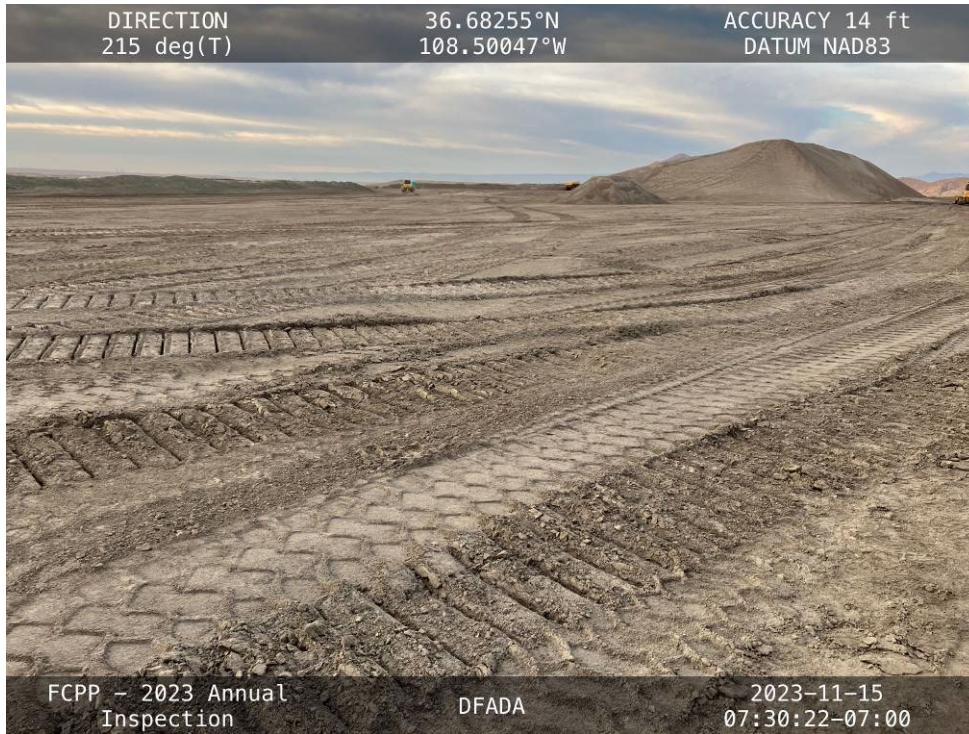
**20231115 – IMG\_2287**  
Cell 3, facing southwest from the South Embankment of the LAI.

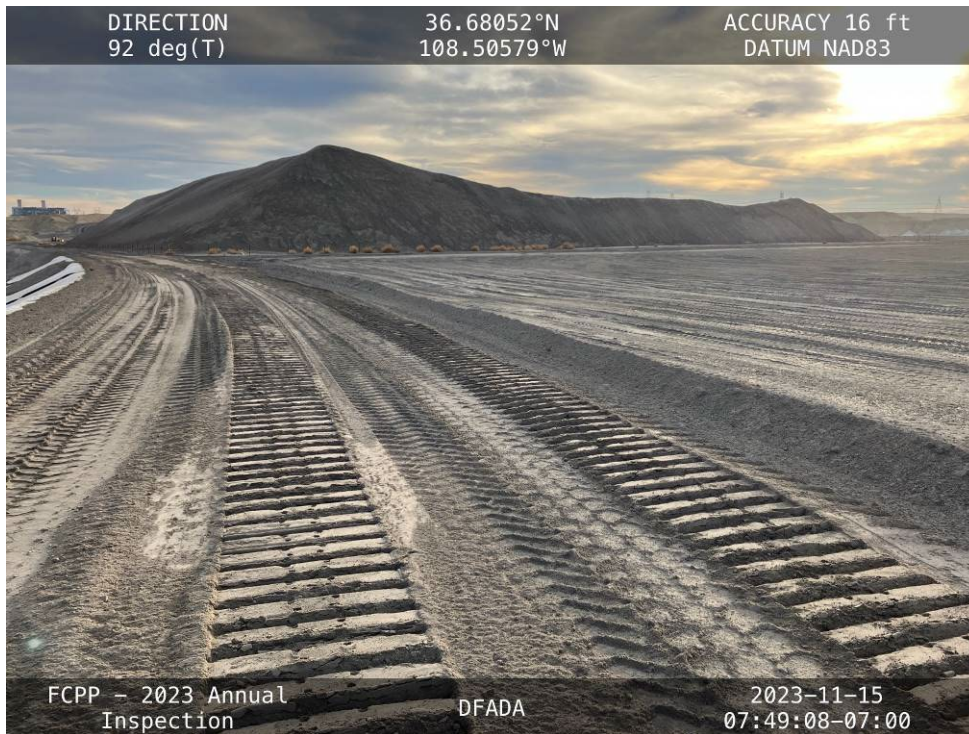
**20231115 – IMG\_2316**  
The top of Cell 3, facing east from the LAI crest.

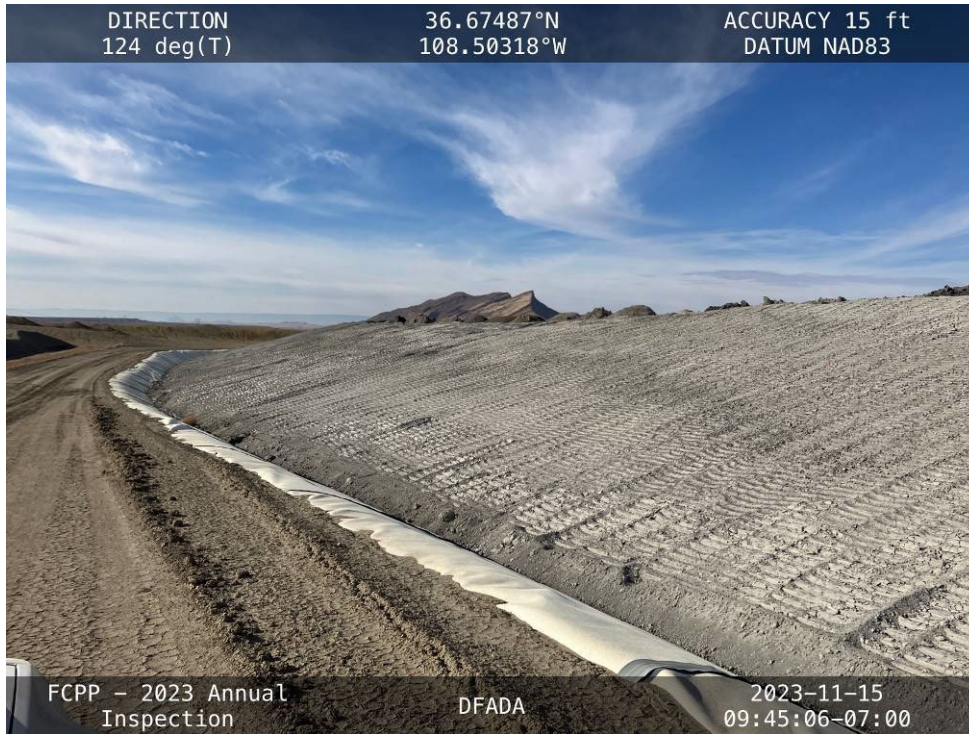
**20231115 – IMG\_2534**  
The downstream slope of Cell 4, facing southwest.

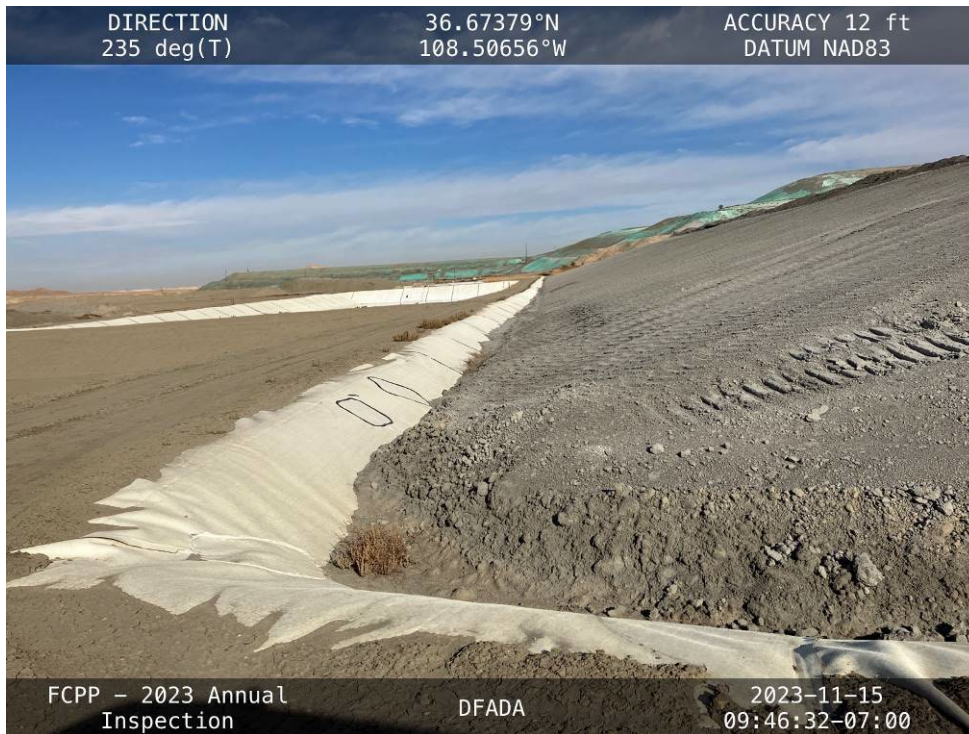
**20231115 – IMG\_2535**  
The western toe of Cell 4, facing north from the south end.

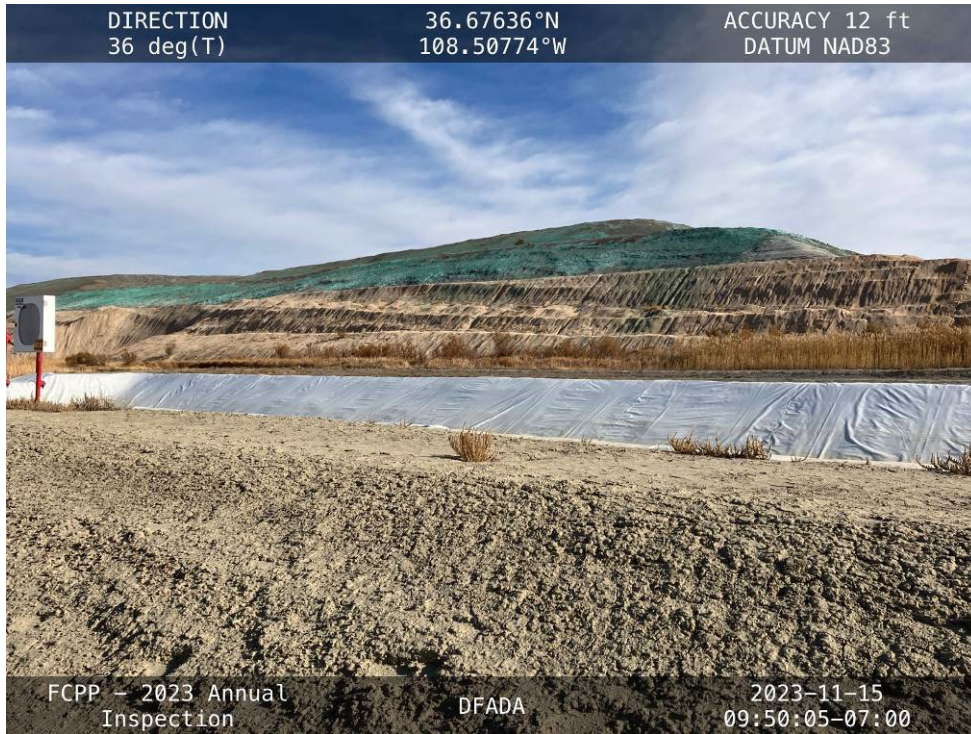
**20231115 – IMG\_2543**  
The western slope of Cell 1, facing east.

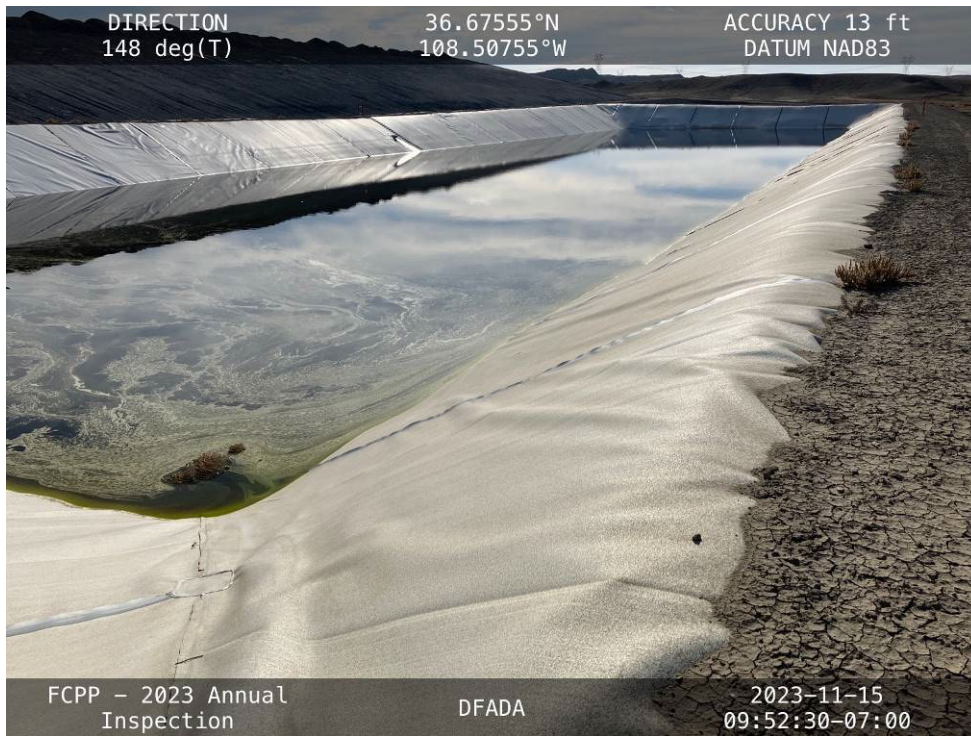
**20231115 – IMG\_2545**  
The Cell 4 leachate collection pond, as seen from its northwest corner.

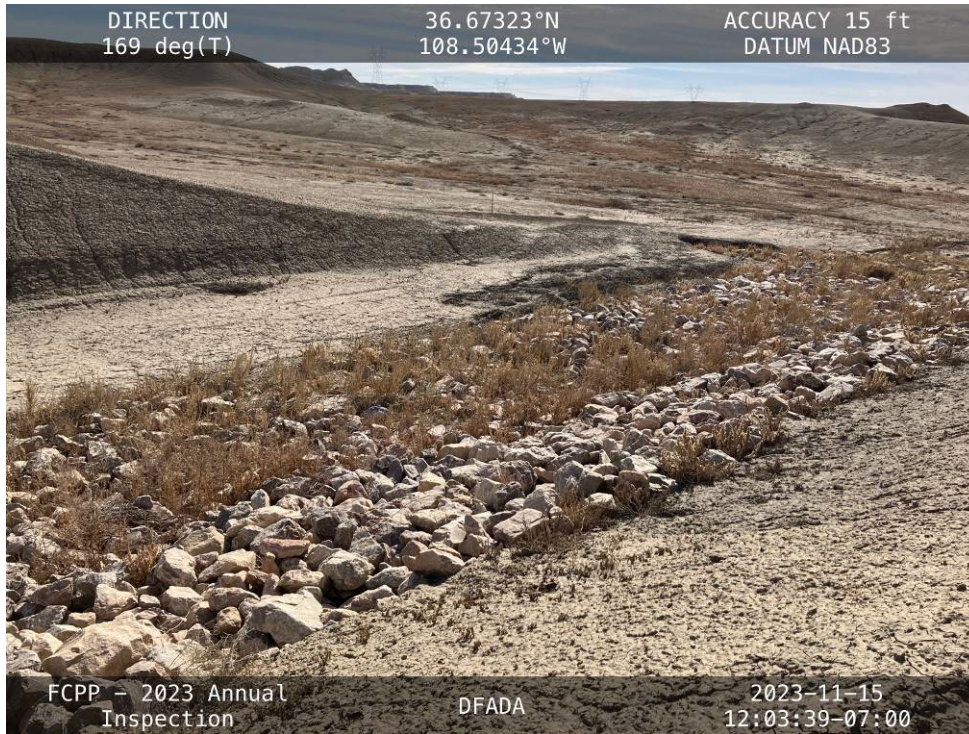
**20231115 – IMG\_2778**  
 The end of the Stormwater Diversion Channel, facing south.

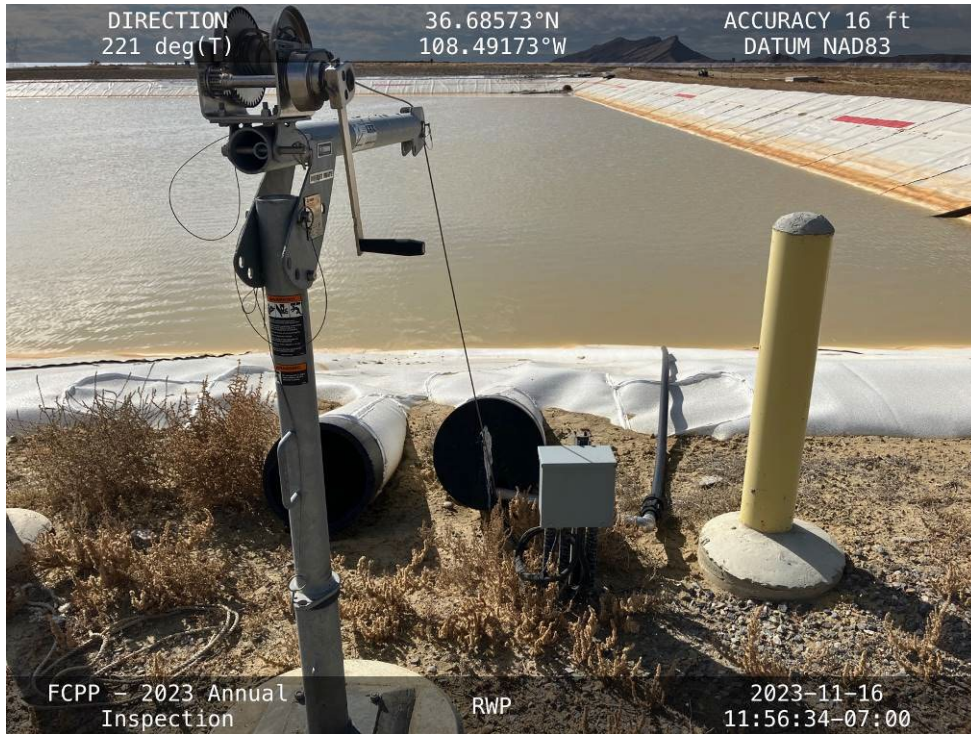
**20231116 – IMG\_3212**  
The LCRS riser pipes and crane on the north side of the RWP.

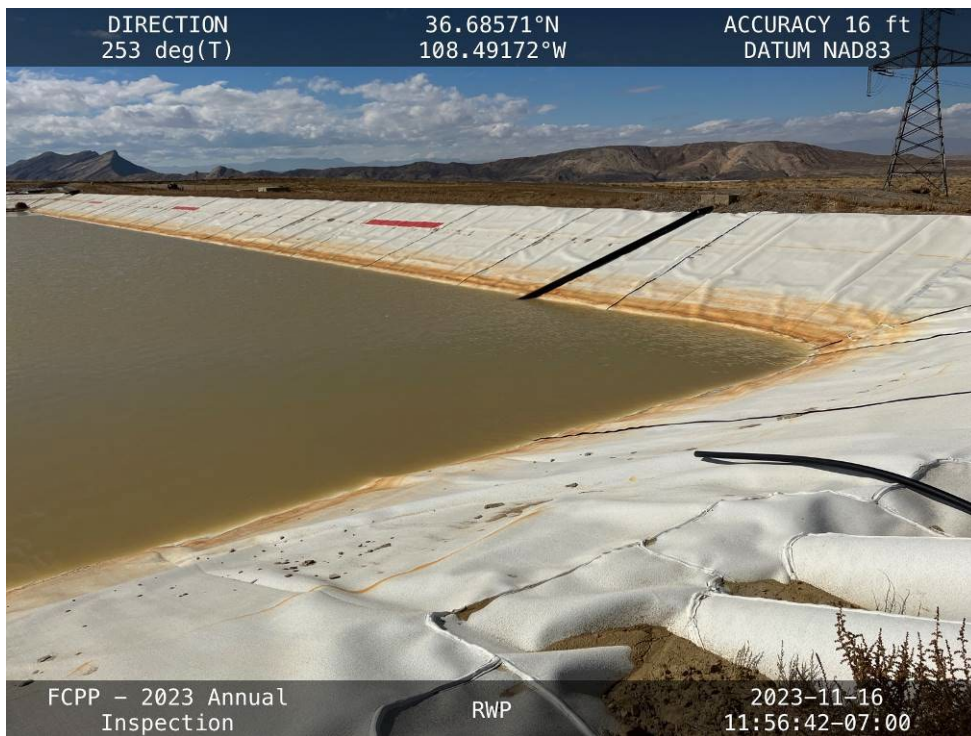
**20231116 – IMG\_3213**  
The upstream slope of the Northwest Embankment, facing southwest from the north corner.
