FOUR CORNERS POWER PLANT LINED DECANT WATER POND - Periodic Structural Integrity Assessment

Periodic Hazard Potential Classification
Periodic Structural Stability Assessment
Periodic Safety Factor Assessment

October 2021
AECOM Project 60664563

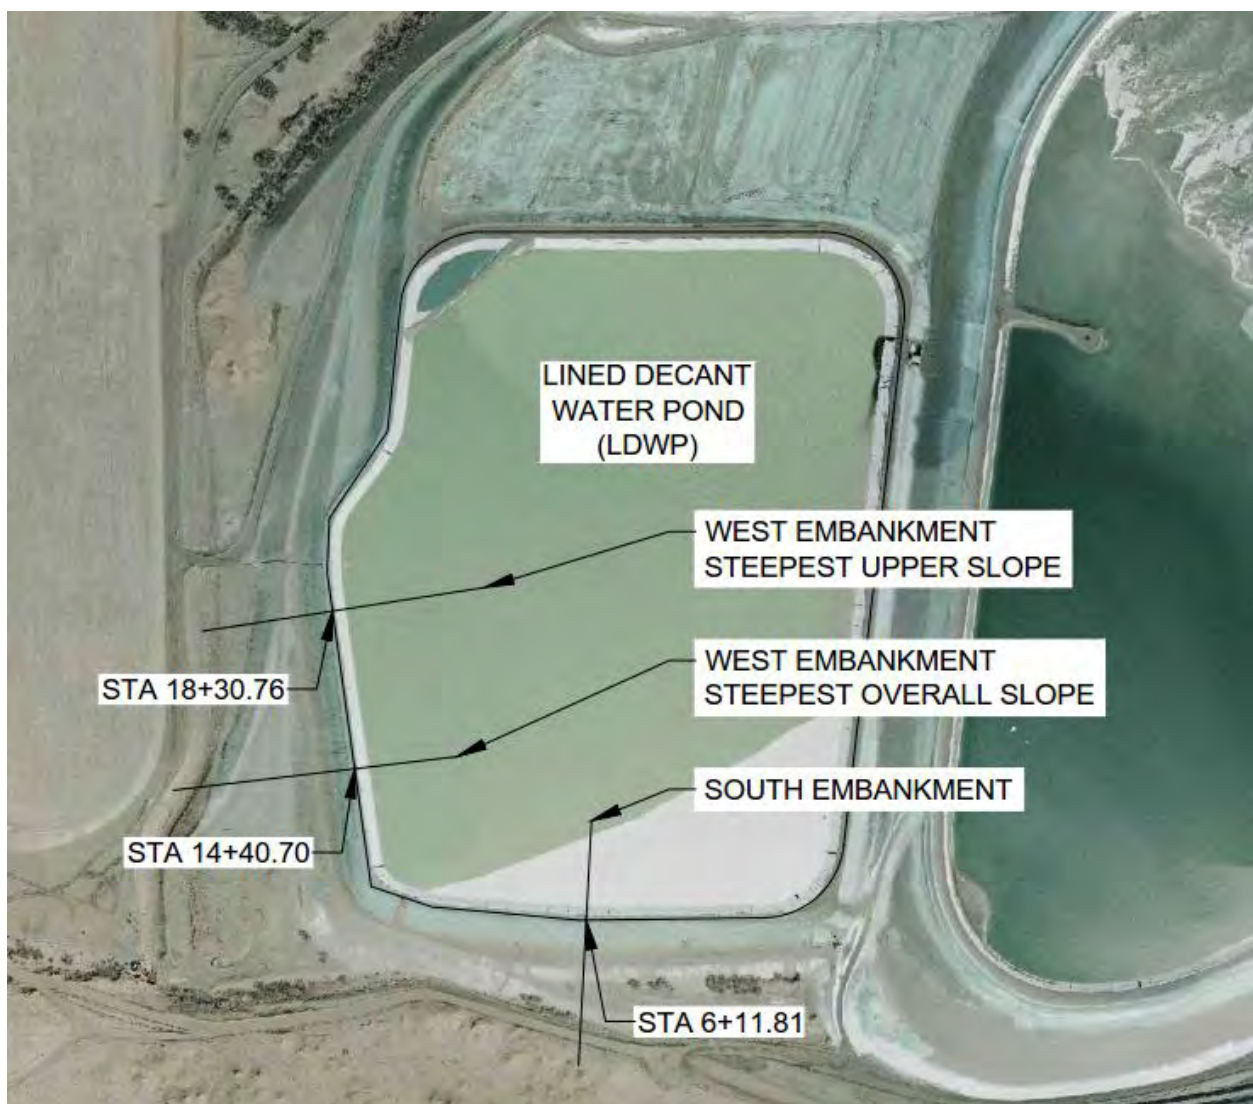
Figure 1 – Slope Stability Cross Section Locations Along the LDWP

West Embankment (Steepest Upper Slope): The location along the LDWP West Embankment with the steepest upper downstream slope is shown in Figure 1. The West Embankment of the LDWP is about 84 feet high and was constructed on native ground, which is composed of weathered shale. The downstream slope of the existing embankment is benched. The upper portion of the slope above the bench is inclined at an effective slope of about 1.5H:1V. The West Embankment of the LDWP includes a 15-foot wide compacted clay lining on the upstream slope and crest.

West Embankment (Steepest Overall Slope): The location along the LDWP West Embankment with the steepest overall downstream slope from crest to toe is shown in Figure 1. The downstream slope of the existing embankment is benched to provide an effective overall slope of about 1.9H:1V. The West Embankment of the LDWP includes a 15-foot wide compacted clay lining on the upstream slope and crest.

South Embankment: The section of the LDWP South Embankment with the steepest downstream slope is shown in Figure 1. The section was modeled from Section E of the Construction Drawings. The South Embankment of the LDWP is about 60 feet high and was constructed on native ground, which comprises weathered shale. The downstream slope of the existing embankment is benched to provide an effective slope of about 2.5H:1V. The South Embankment of the LDWP includes a 15-foot wide compacted clay lining on the upstream slope.
