**FOUR CORNERS POWER PLANT
Lined Ash Impoundment,
Lined Decant Water Pond,
Combined Waste Treatment Pond,
Dry Fly Ash Disposal Area,
and Return Water Pond**

**Annual
CCR Impoundment and
Landfill Inspection Report
2020**

**GENERATION ENGINEERING
Design Engineering
P.O. BOX 53999
PHOENIX, ARIZONA 85072**

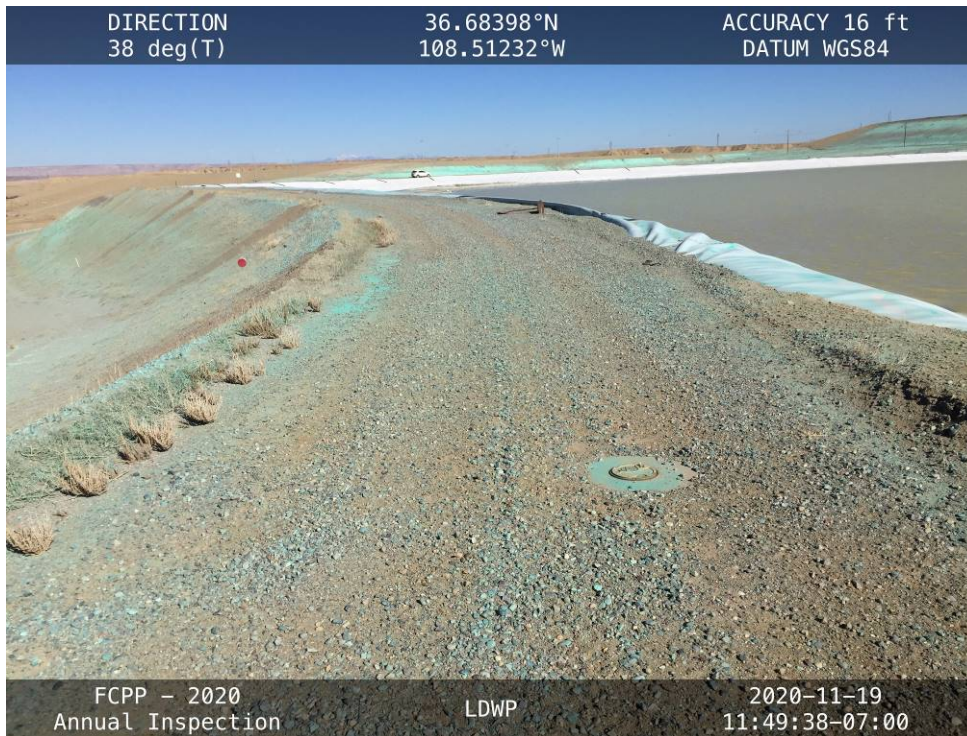
20201119 – IMG_3708
The liner pulling out of the anchor trench in the northern portion of the West Embankment.

Observed Condition	Action Item
1) The liner in the anchor trench in the central portion of the West Embankment appeared to be pulling out of the trench.	Continue to monitor the liner in the anchor trench. Re-anchor the liner if the liner continues to pull out of the trench.

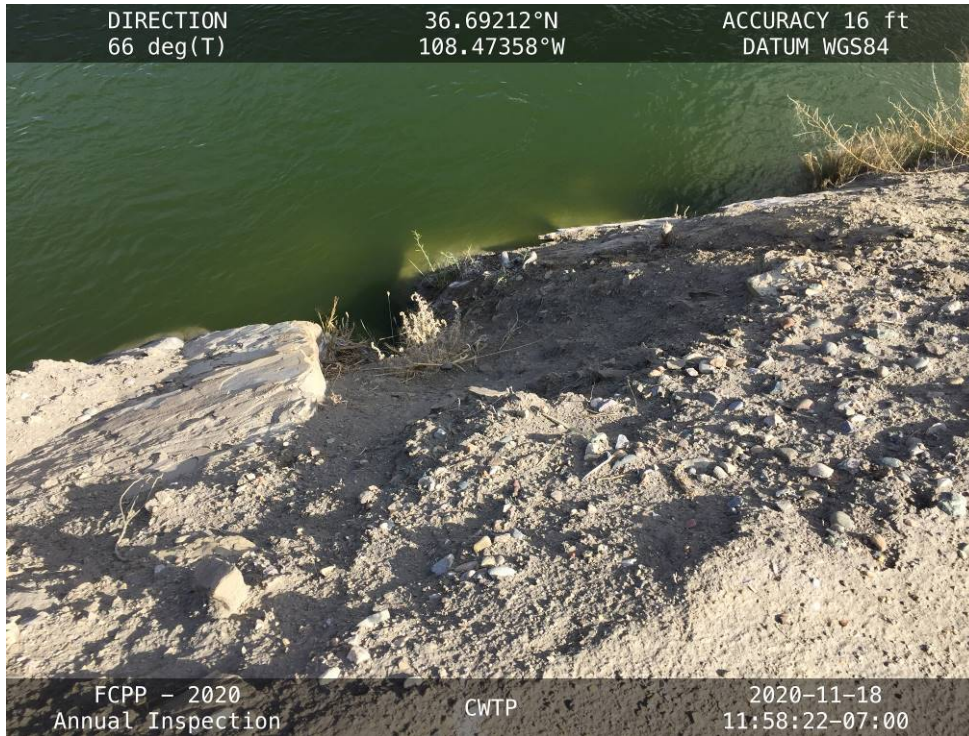
2) Instances of minor erosion were observed along the upstream and downstream slopes.	Continue to monitor these areas and repair erosion if it exceeds 1 foot in depth.

20201118 – IMG_3257
Erosion in a portion of the downstream slope without riprap.

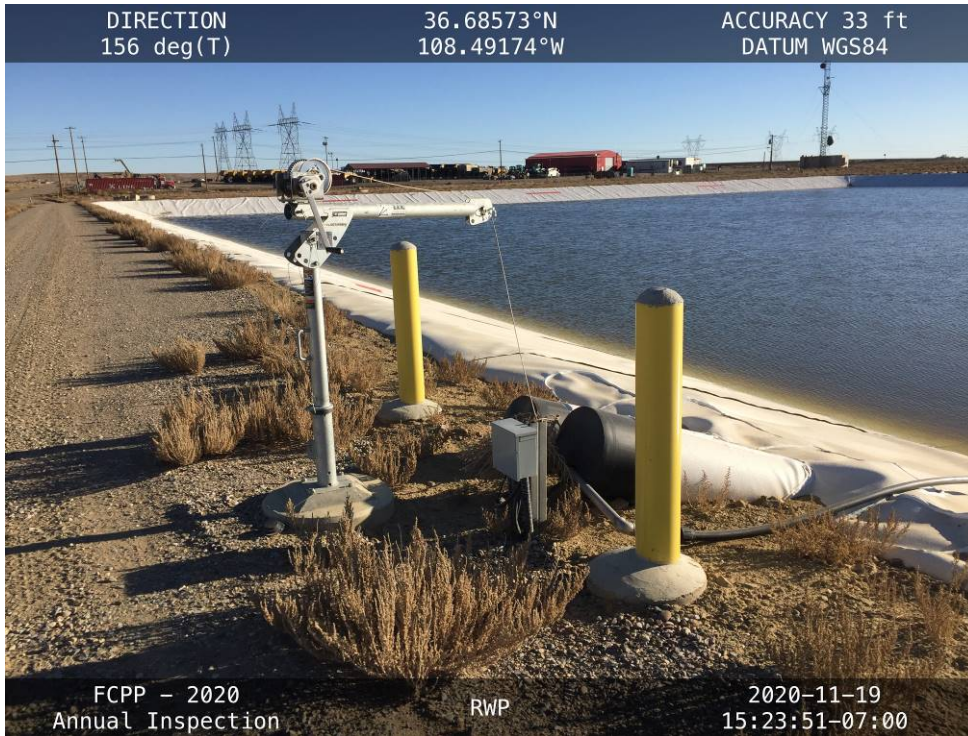
20201119 – IMG_3861

The LCRS pump control on the north side of the RWP.
