# CHOLLA POWER PLANT BOTTOM ASH POND – Periodic Structural Integrity Assessment

Periodic Hazard Potential Classification  
Periodic Structural Stability Assessment  
Periodic Safety Factor Assessment

October 2021  
AECOM Project 60664605

AECOM, 2016. *Final Summary Report, Structural Integrity Assessment: Bottom Ash Pond, Cholla Power Plant, Joseph City, Arizona*. Prepared for: Arizona Public Service, AECOM Job No. 60445840, August 26, 2016

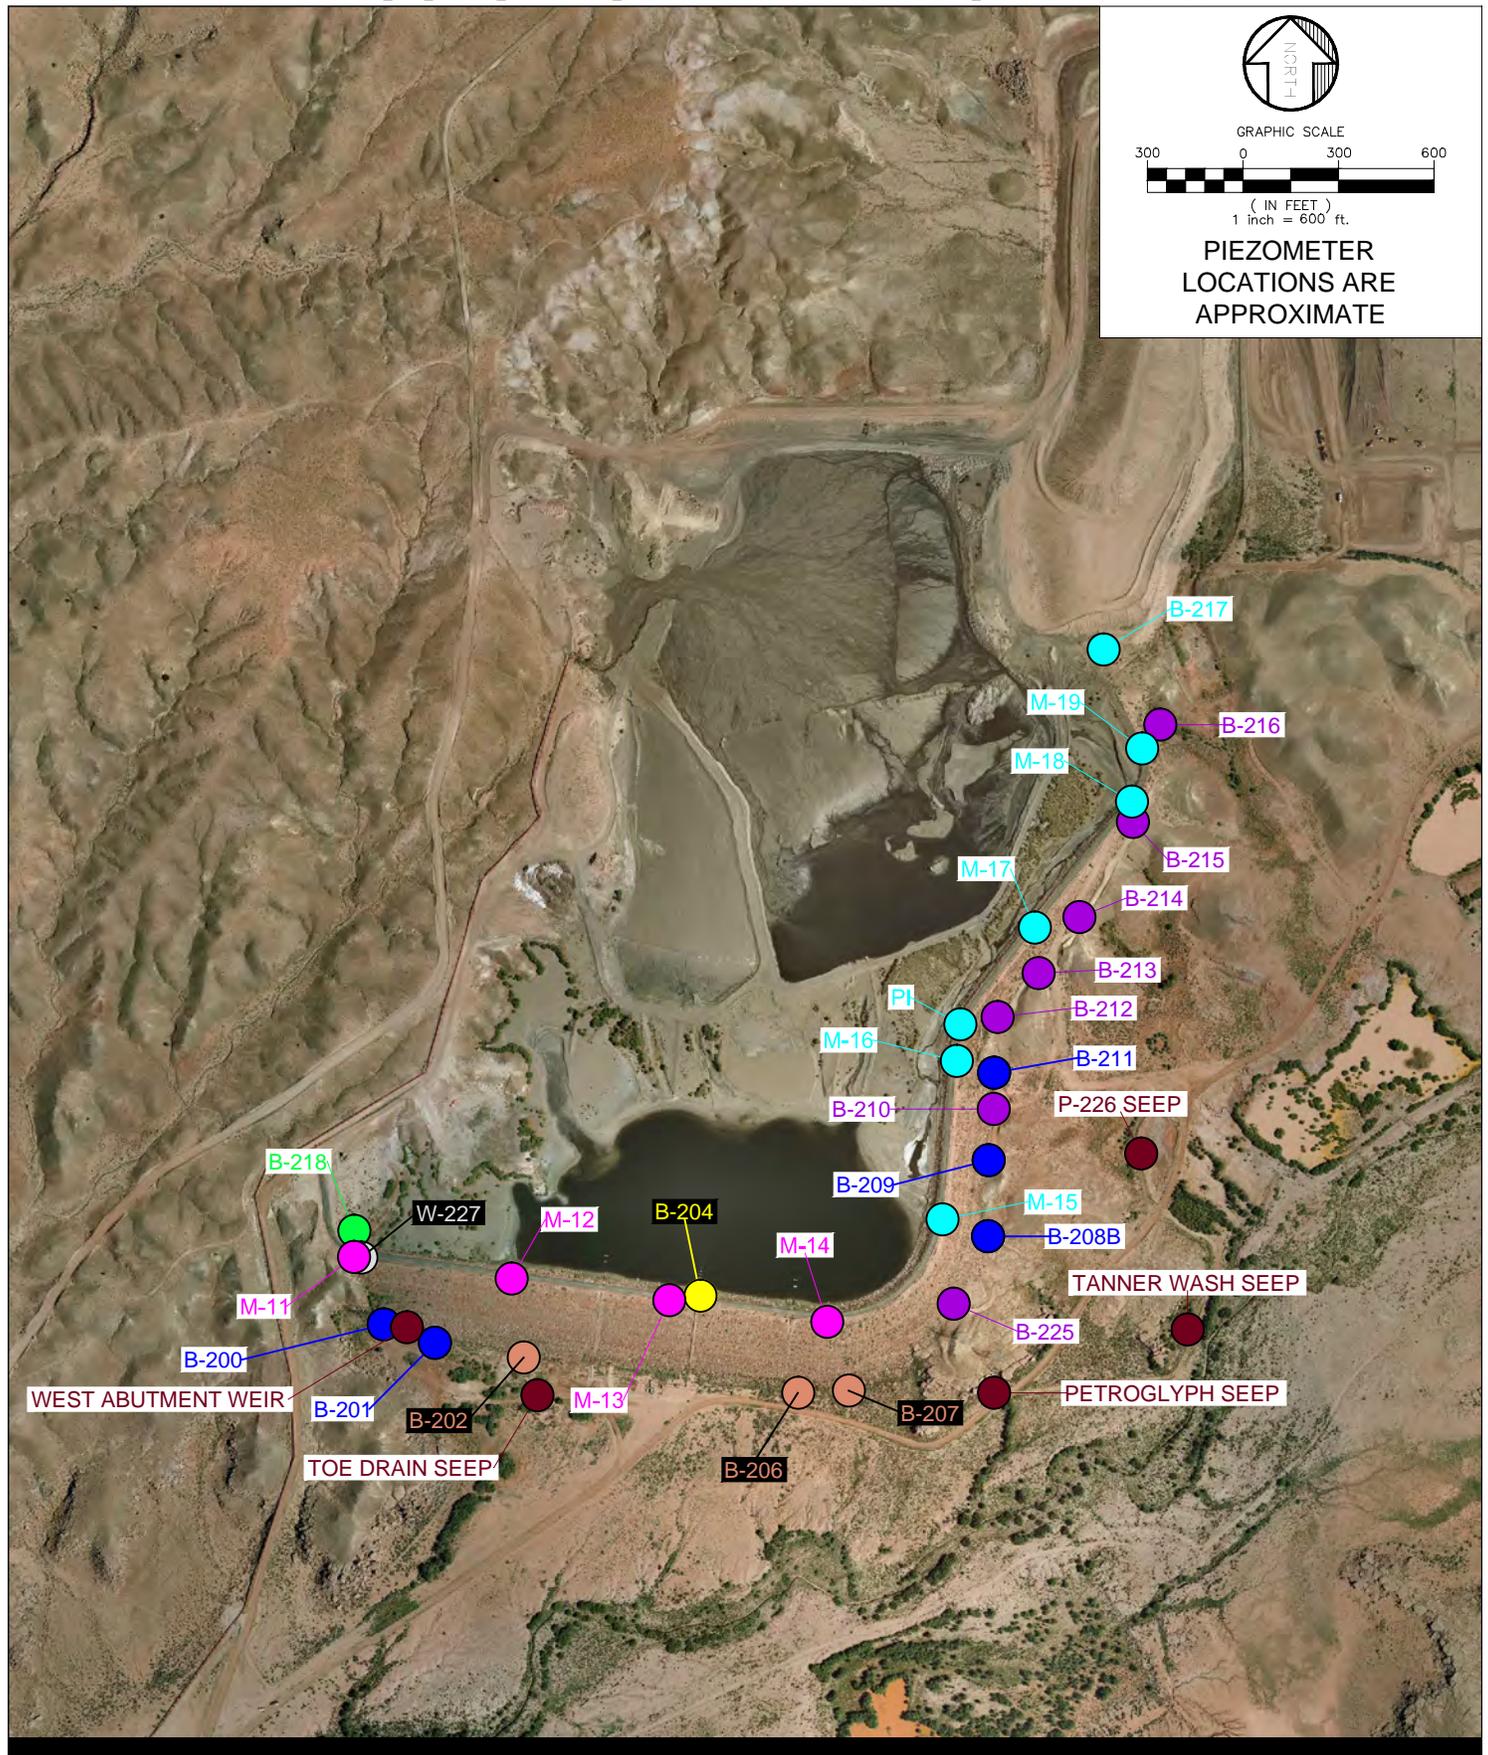
Last saved by: ALEISA KRUG(2016-06-16) Last Plotted: 2016-06-16  
Filename: P:\ARIZONA PUBLIC SERVICE\60445840\_APS\_CHOLLA\_STRUCTURAL\_INTEGRITY\CADD FILES\FIGURES\FIGURE 1-2\_INSTRUMENT LOCATIONS.DWG

( IN FEET )  
 1 inch = 600 ft.  
**PIEZOMETER  
 LOCATIONS ARE  
 APPROXIMATE**

Piezometers, settlement monuments, flow measurement devices, and water level gauges are installed at the Bottom Ash Pond to monitor the performance of the dam. Measurements from the monitoring instruments are reviewed by AECOM and documented annually in a data report. Starting on October 19, 2015, the piezometer, survey monuments, V-notch weirs, and sumps are read at intervals not exceeding 30 days per the requirements of 40 CFR § 257.83(a)(1)(iii). The locations of the piezometers, survey monuments, weir, and flow totalizers are shown on Figure 1-2.

Item	As-Constructed/ Current	Comments	Reference Document
Type and Purpose of Instrumentation	<ul style="list-style-type: none"> <li>• Open standpipe piezometers and wells for monitoring the phreatic levels in the embankment and foundation.</li> <li>• Settlement monuments for monitoring movement of the embankment.</li> <li>• Water level gauge for monitoring water level in reservoir.</li> <li>• V-notch weir and seepage monitoring systems for measuring seepage rates.</li> </ul>	---	Annual CCR Impoundment and Landfill Inspection Report 2015 (AECOM & APS, 2016)
Location of Instrumentation	<ul style="list-style-type: none"> <li>• Open standpipe piezometers and wells located in and around the embankment.</li> <li>• Movement monuments located along the embankment crest.</li> <li>• Water level gauge located in the reservoir.</li> <li>• V-notch weir and seepage monitoring systems located along the downstream toe.</li> </ul>	See Figure 1-2	Annual CCR Impoundment and Landfill Inspection Report 2015 (AECOM & APS, 2016)

Piezometer locations are shown on Figure 1-2. Piezometer data were used, along with pond water level under steady-state, maximum storage pool conditions (ADWR, 1986 and ADWR, 1998), and pond water levels under maximum surcharge pool conditions (Ebasco, 1975 and Dames & Moore, 1991) to estimate pore pressure distributions with the embankment sections. Piezometer data are presented in the calculation in Appendix B.

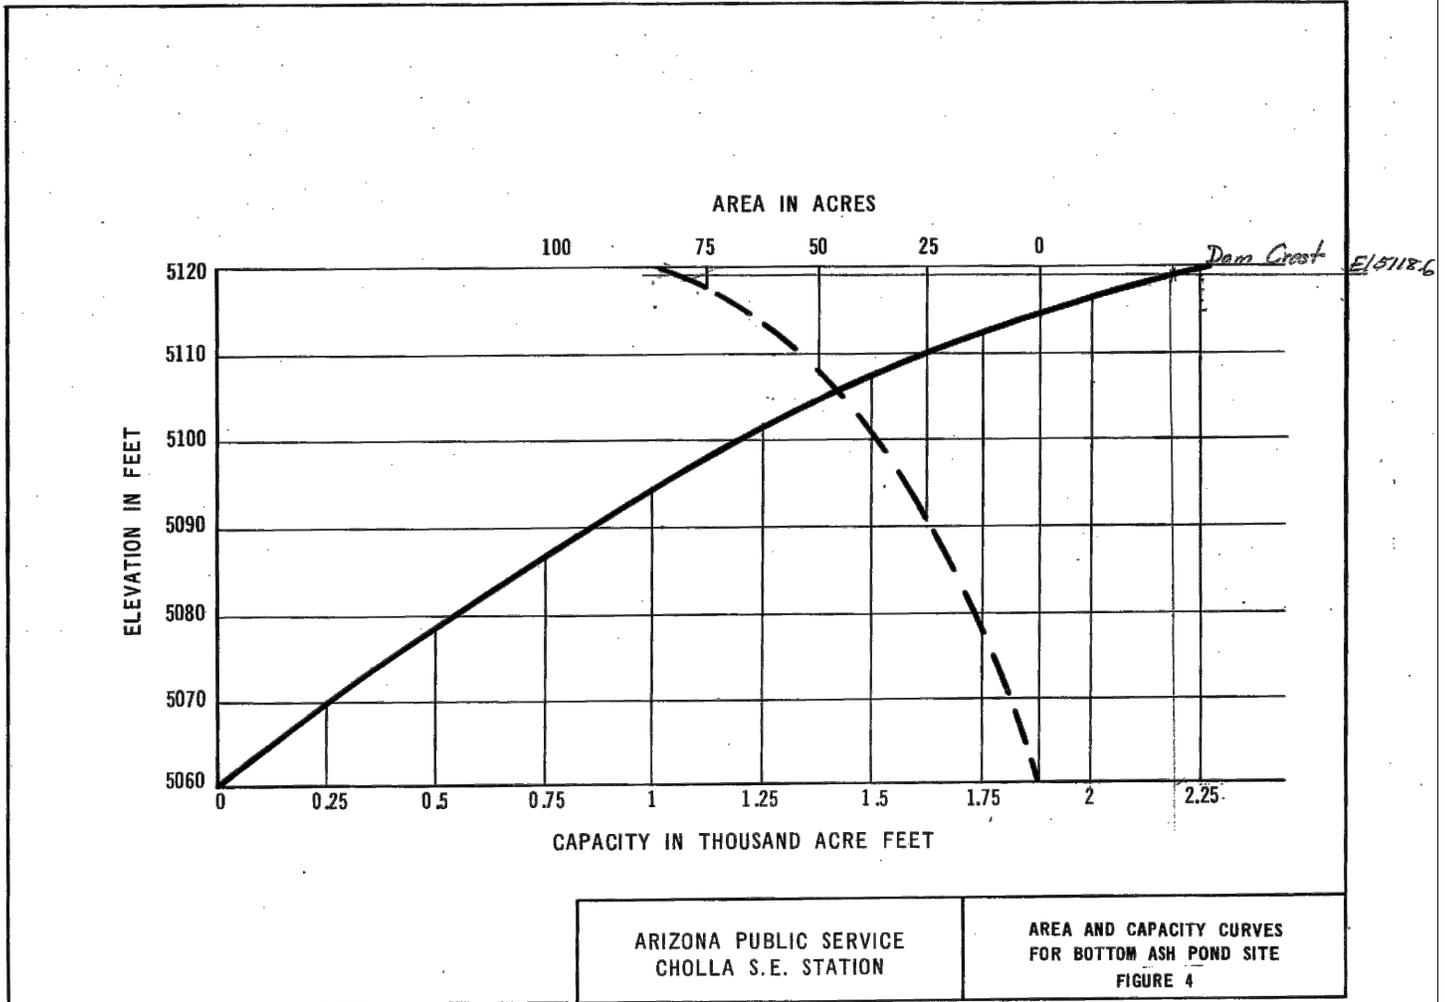
Last saved by: ALEISA KRUG(2016-06-16) Last Plotted: 2016-06-16  
Filename: P:\ARIZONA PUBLIC SERVICE\60445840\_APS\_CHOLLA\_STRUCTURAL\_INTEGRITY\CADD FILES\FIGURES\FIGURE 4-2\_AREA CAPACITY CURVE.DWG

ARIZONA PUBLIC SERVICE CHOLLA S.E. STATION	AREA AND CAPACITY CURVES FOR BOTTOM ASH POND SITE FIGURE 4
---	--

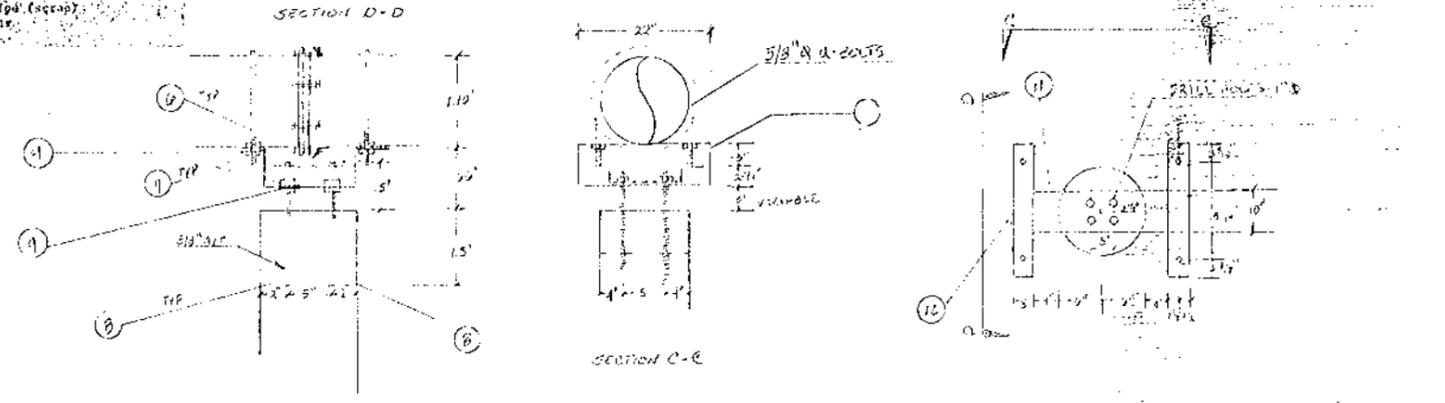
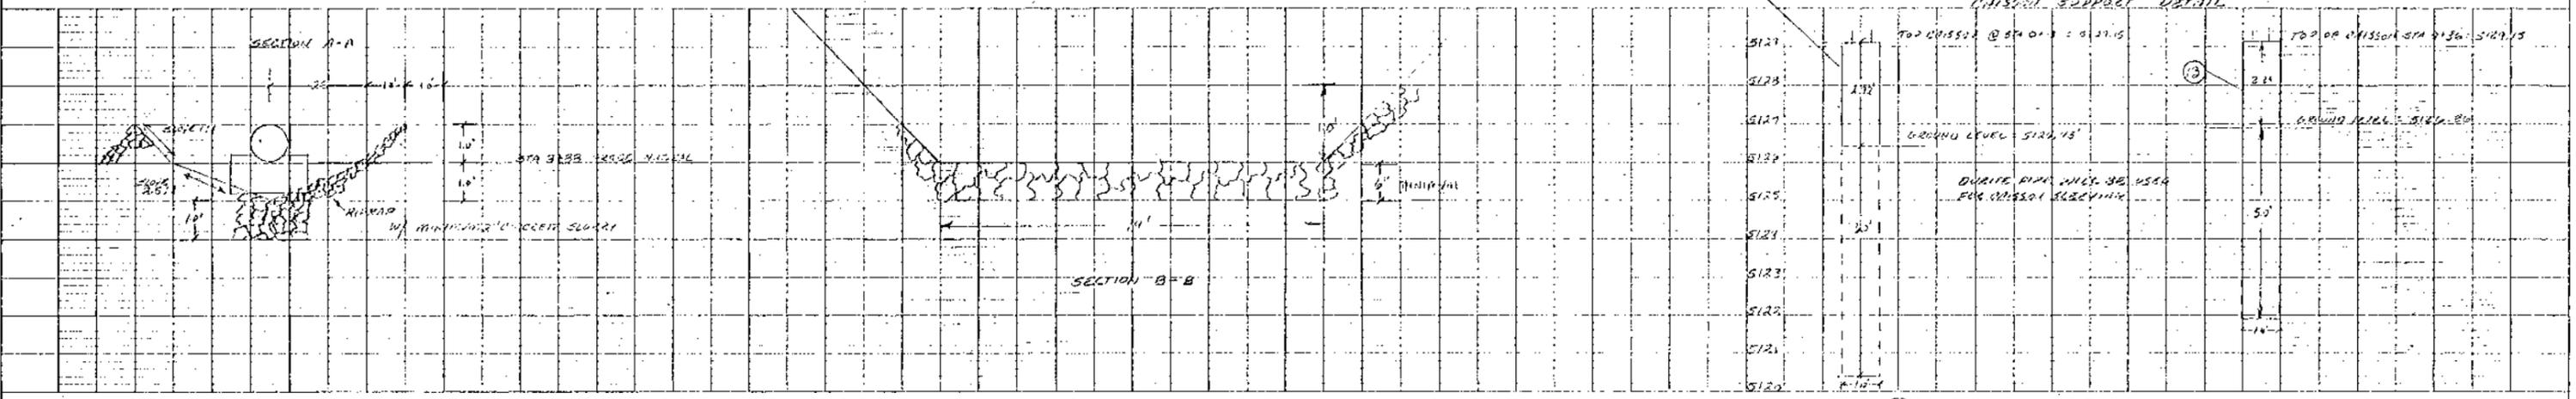
**PROFILE**

NOTE: SLOPE MAY CHANGE DEPENDING UPON CONDITIONS OF GROUND UPON EXCAVATION

**PLAN**

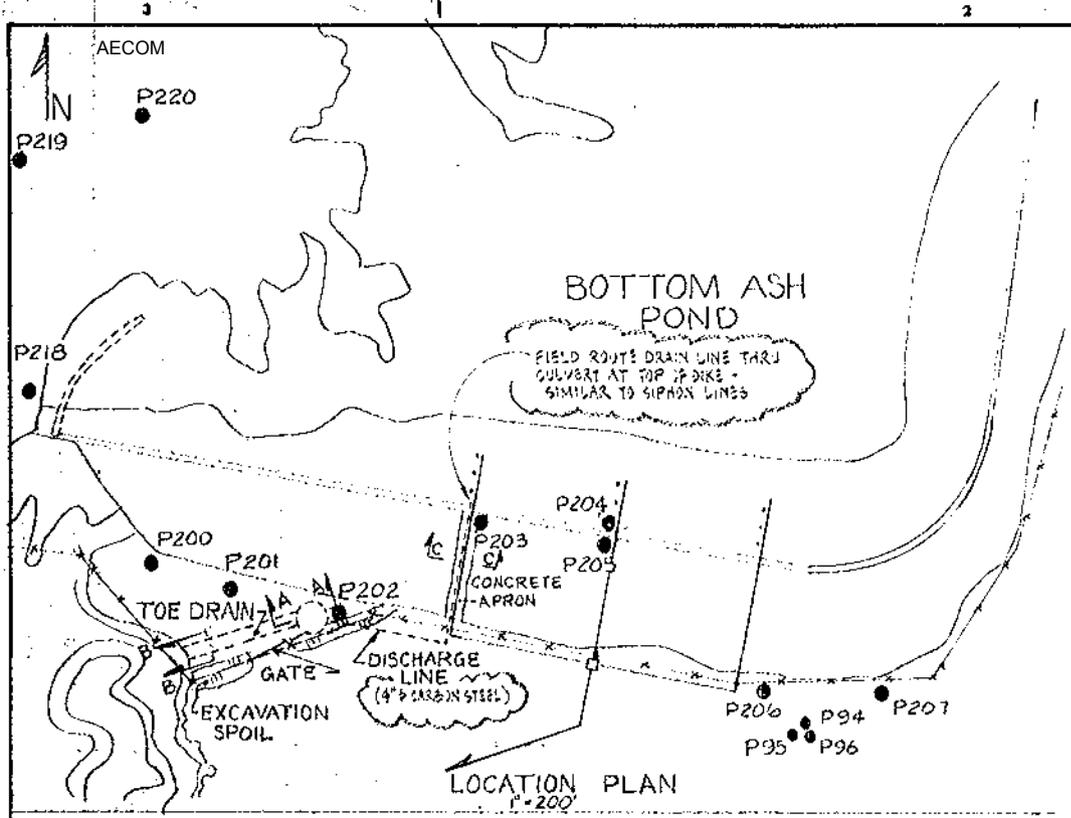
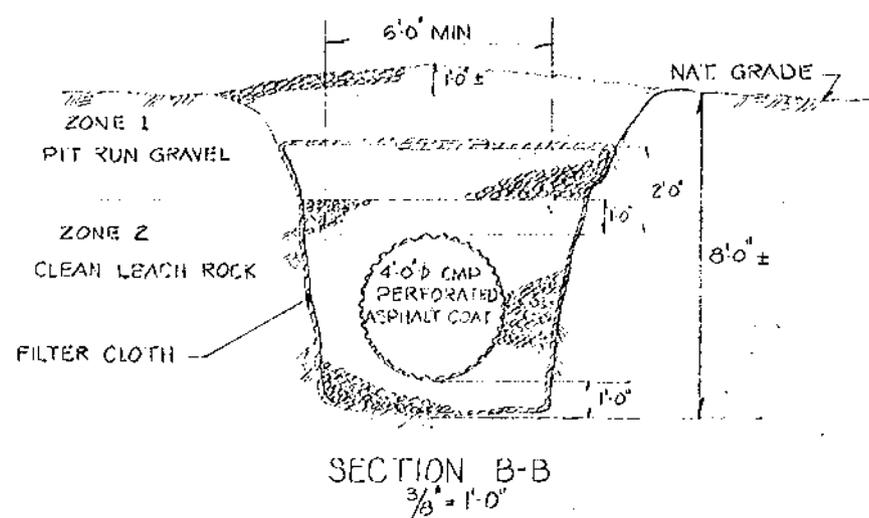
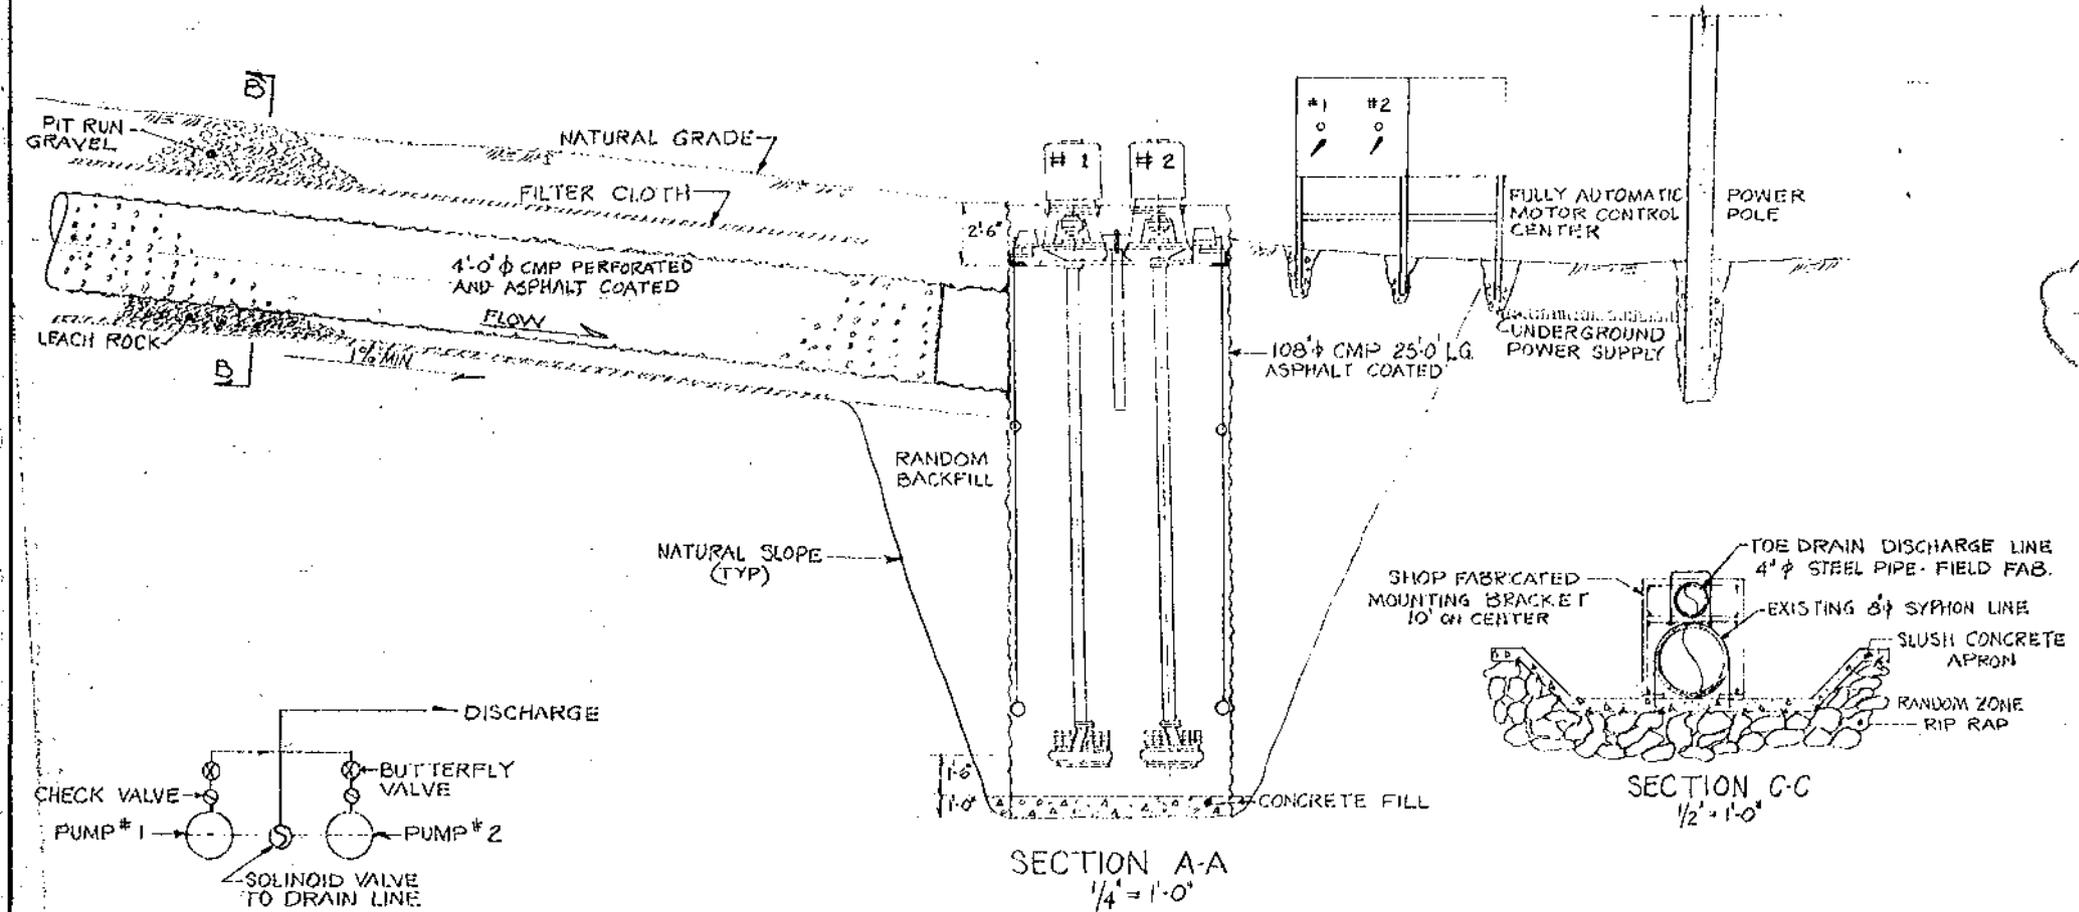
**TOE DRAIN SYSTEM**  
**(APS, Rev. 1991)**

TOE DRAIN SYSTEM TO BE CONSTRUCTED IN ACCORDANCE WITH THE DETAILS OF THIS DWG AND APS SPECIFICATION-CHOLLA PROJECT ENGINEERING-CPE NO. 1, TOE DRAIN INSTALLATION

EXACT DRAIN LOCATION BY FIELD

NO EXCAVATION WITHIN 20 FOOT OF THE EMBANKMENT TOE.

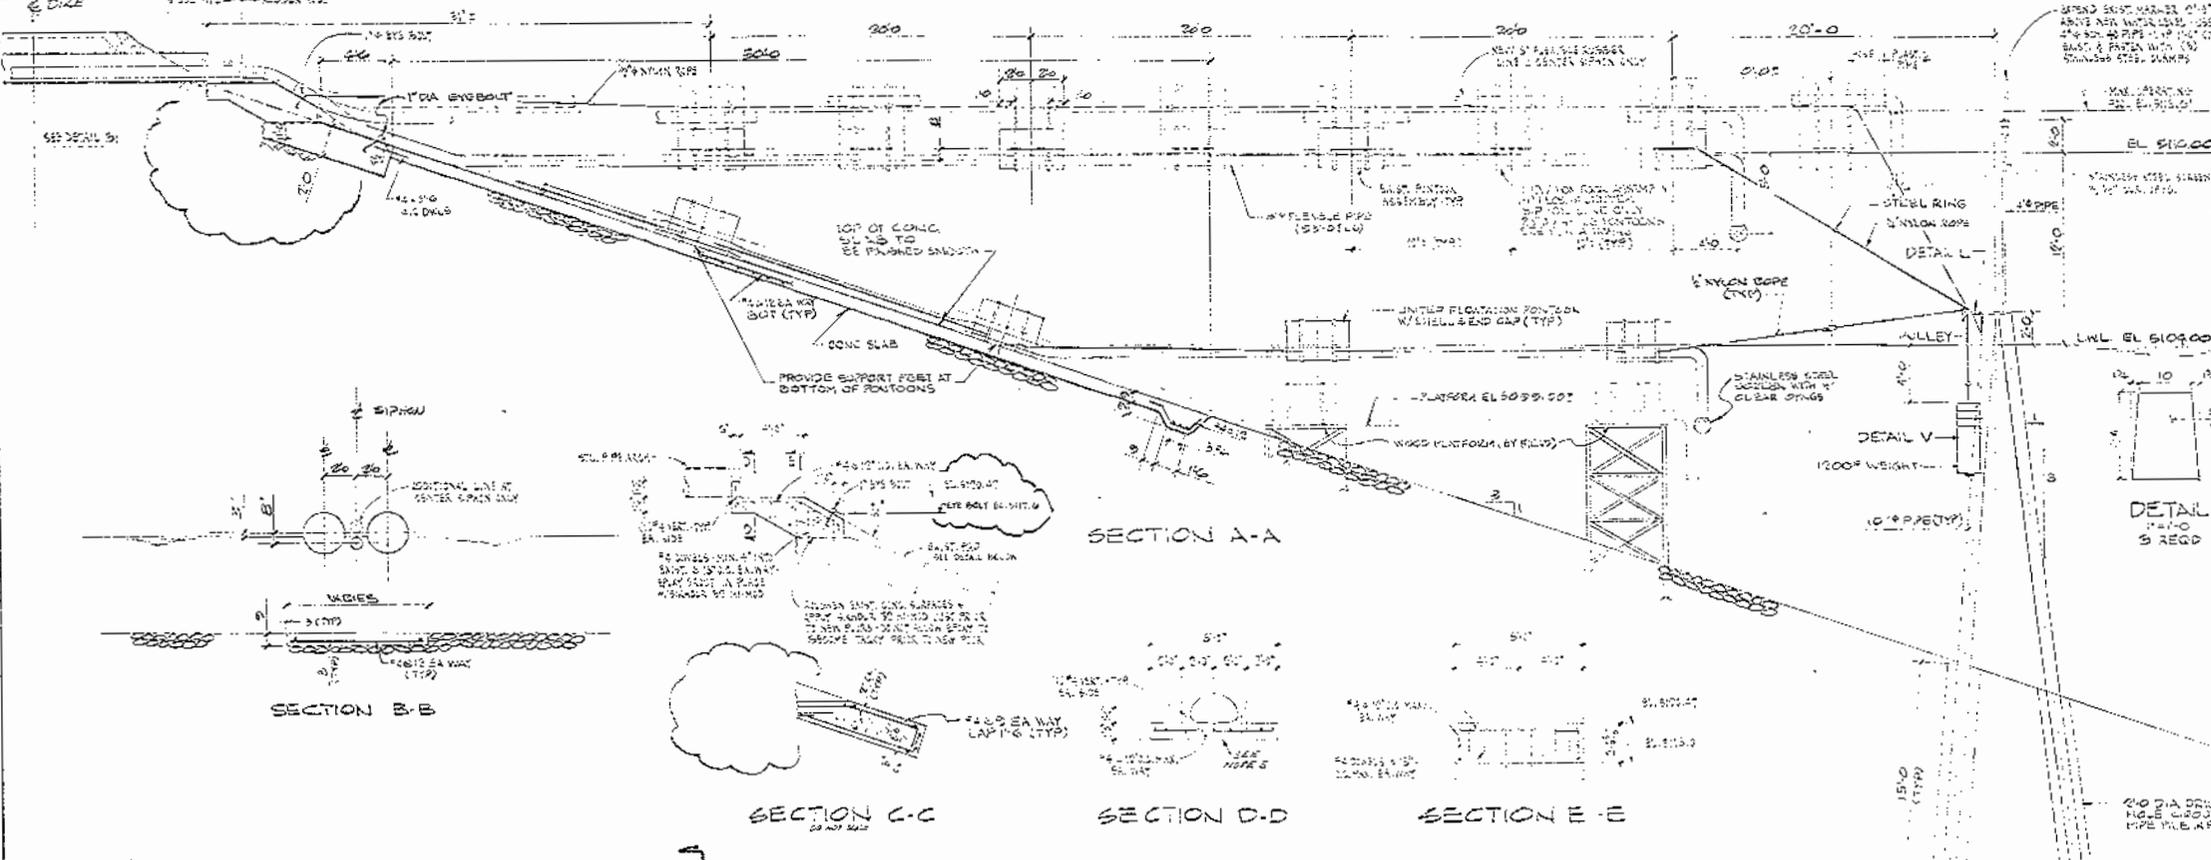
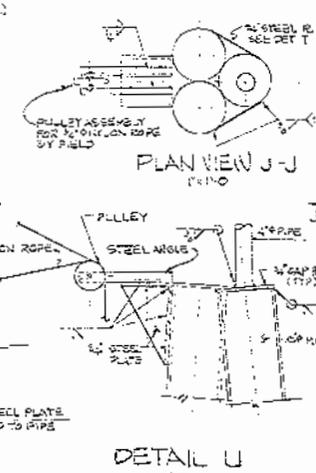
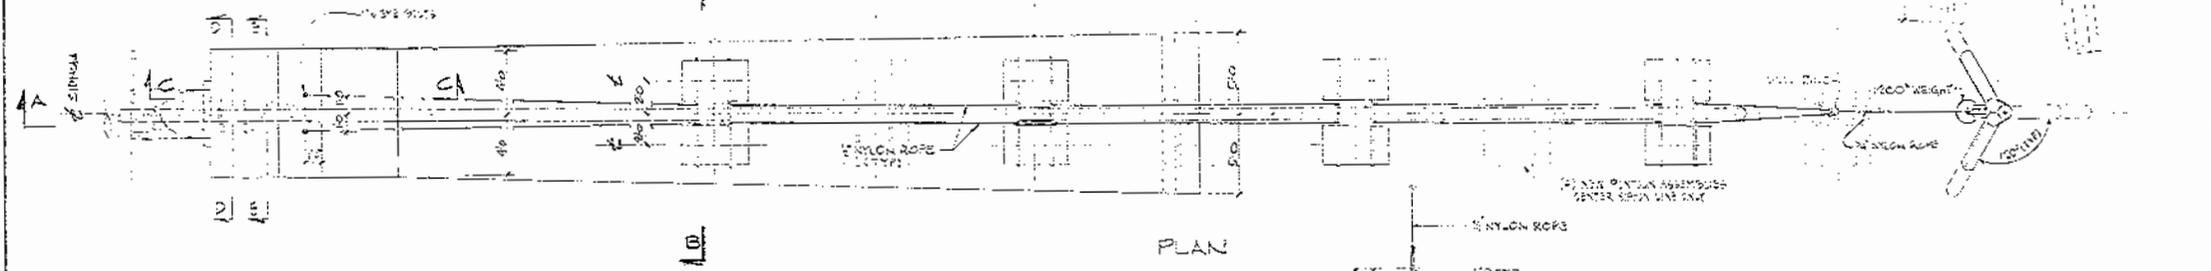
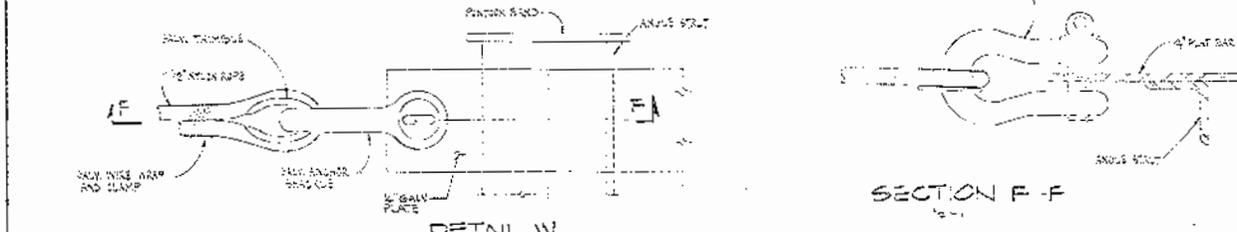
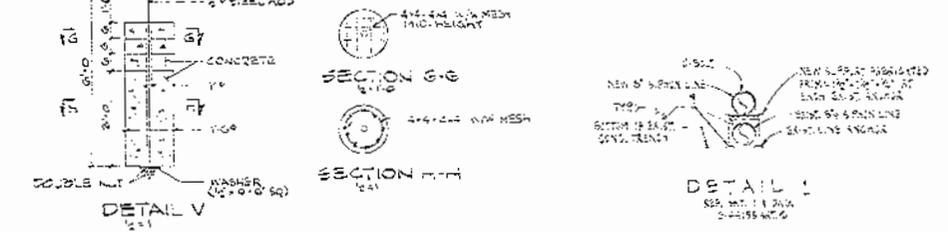
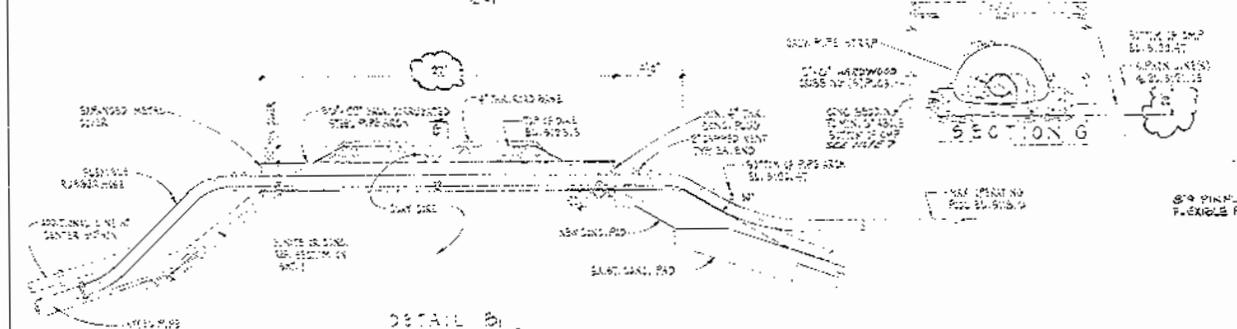
**AS-BUILT SIPHON SYSTEM & FLOATING PIPE**  
**(Ebasco, 1993)**

FLLOATING PONTON ASSEMBLY - BY LATERAL LOAD CAPACITY (CONCRETE)	28 LIN FT
CONCRETE (CLASS 3 3000 PSI)	23 SQ YD
4-4 #4 W/MESH	1500 LBS
GRADE 40 REINF STEEL (#3BARS)	1200 LBS
10" PIPE	12 LIN FT
4" PIPE	12 LIN FT
1/2" NYLON ROPE	100 LIN FT
1/4" NYLON ROPE	20 LIN FT
MULLY ASSEMBLY DESIGNED FOR 2000 LBS

ARIZONA PUBLIC SERVICE COMPANY  
 CHULA VIE STATION  
 277-250 NEW INSTALLATION - UNIT NO. 2  
 1976-250 MW EXTENSION - UNIT NO. 3  
 ASH DISPOSAL SYSTEM  
 BOTTOM POND  
 SIPHON SYSTEM & FLOATING PIPELINE

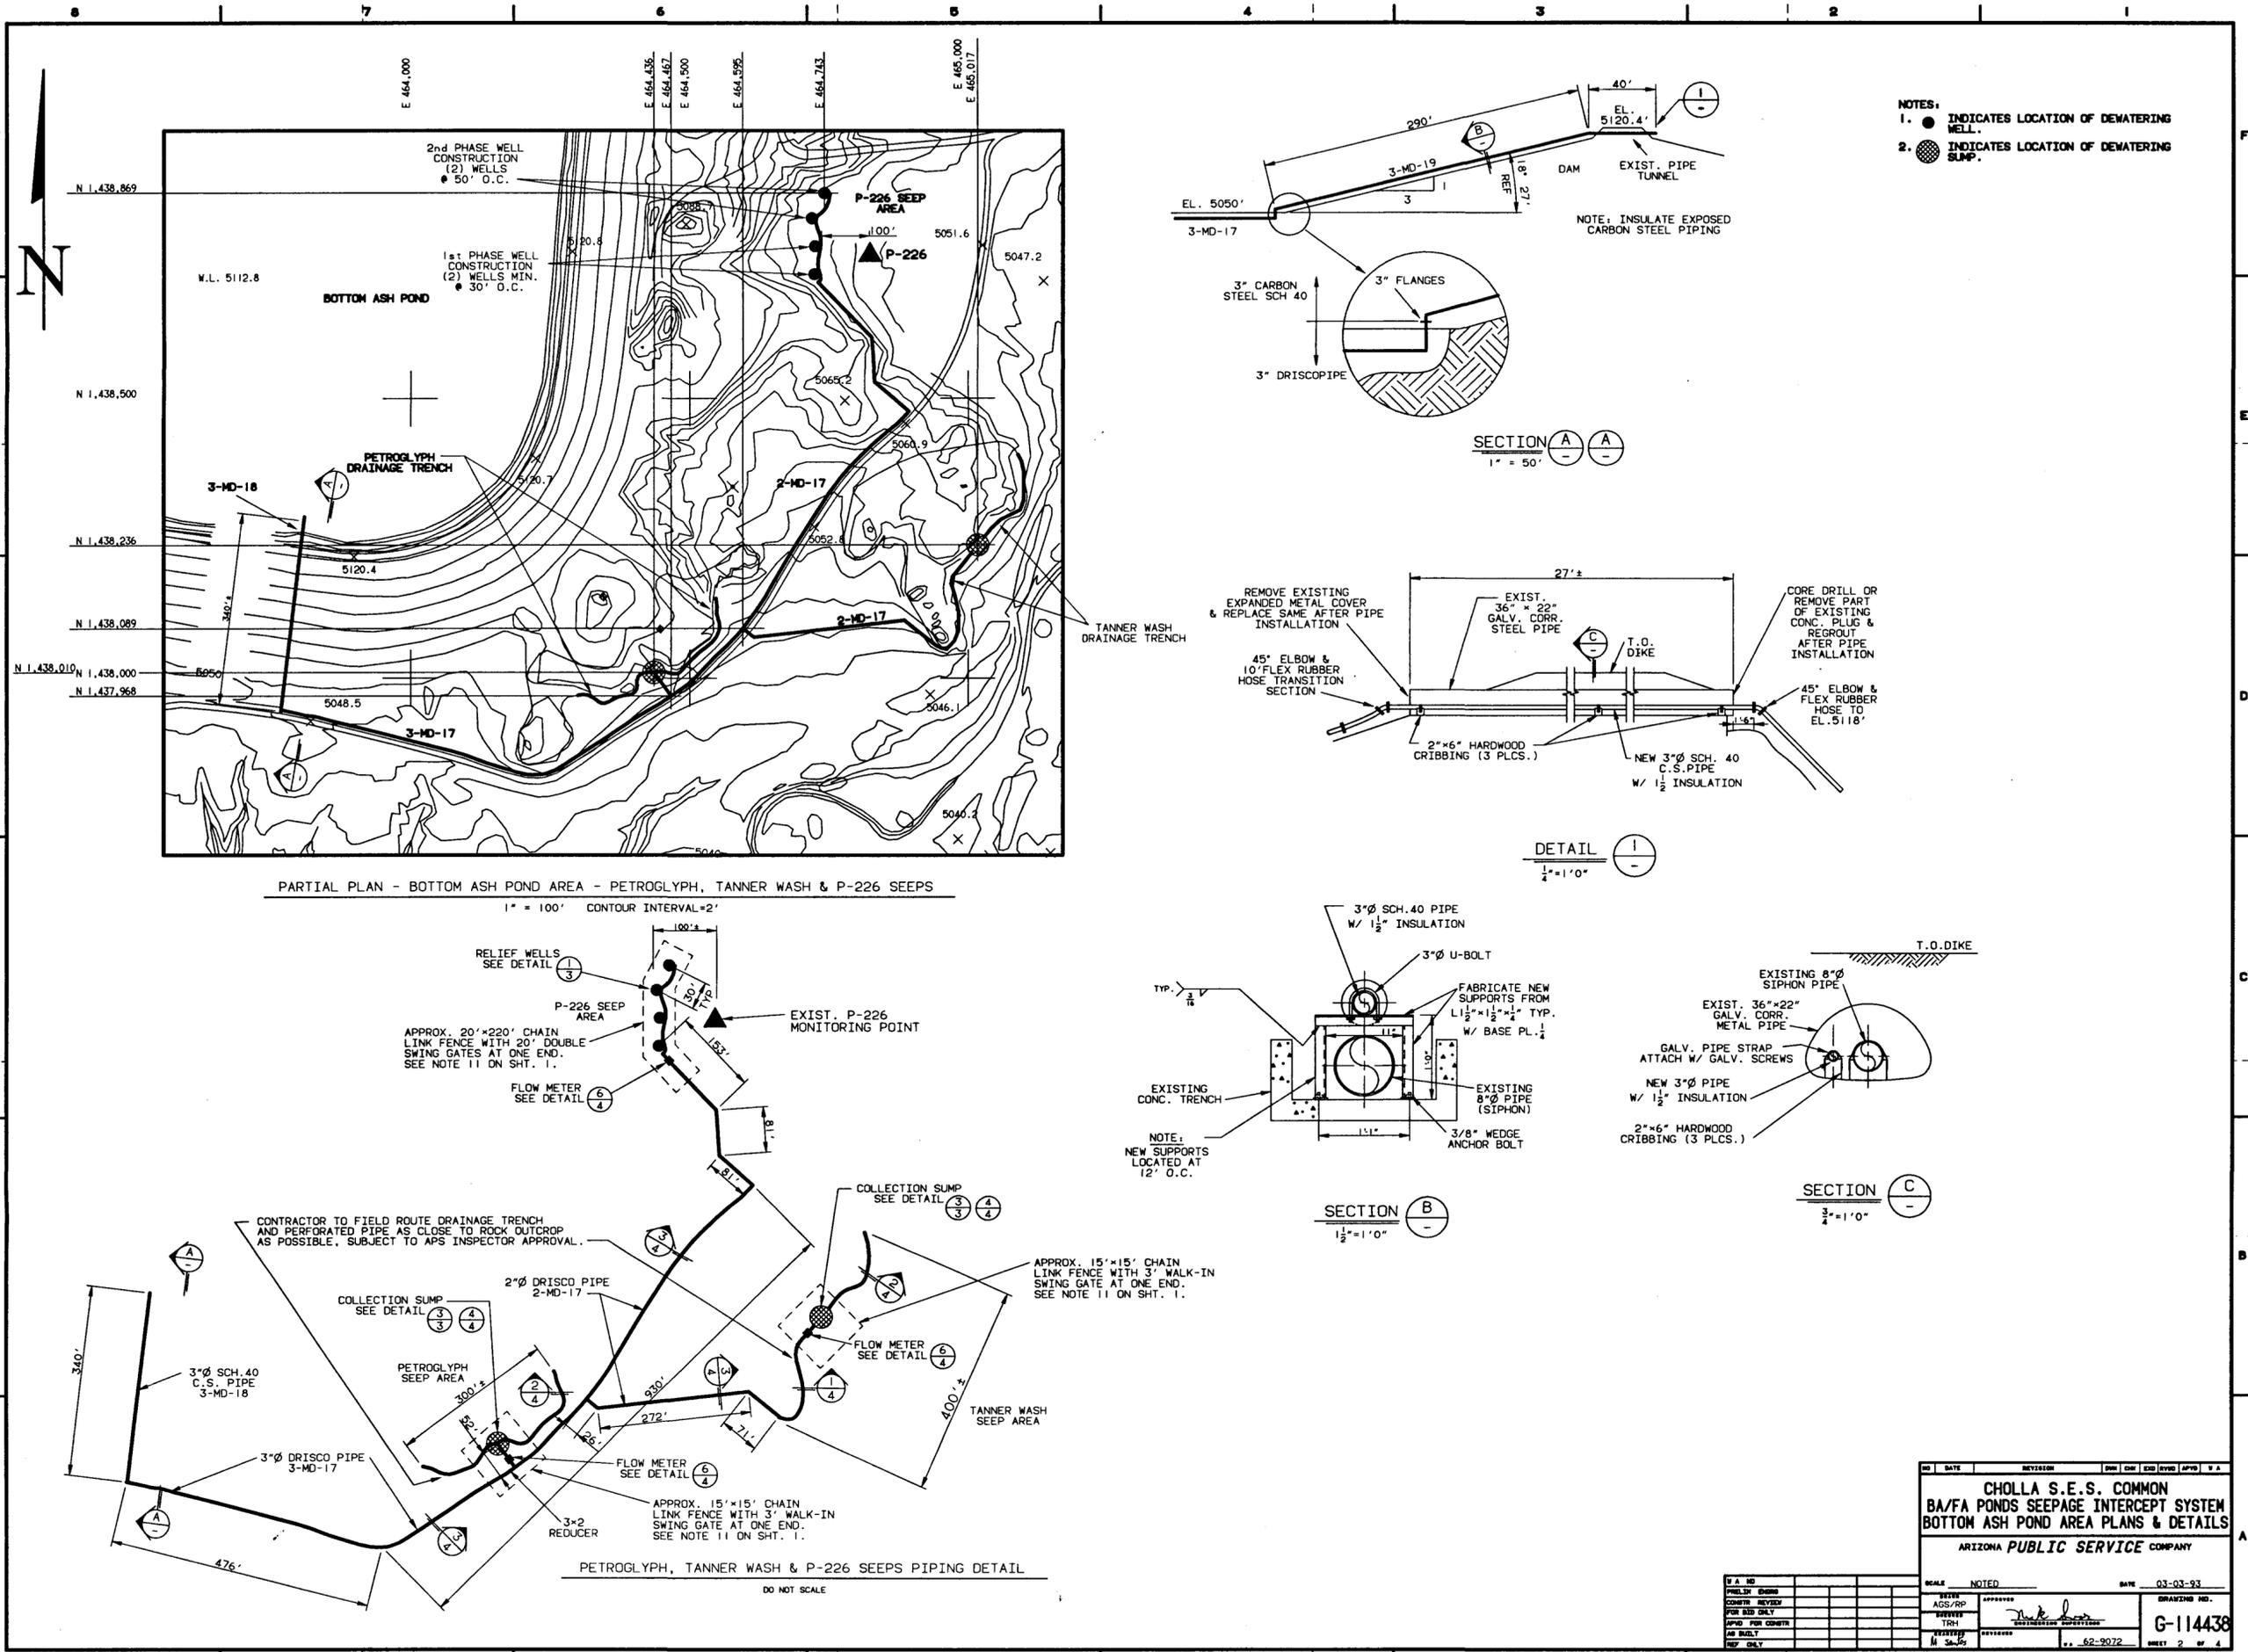
**SEEPAGE INTERCEPT SYSTEM DRAWINGS**  
**(APS, 1993)**

NO.	DATE	REVISION	BY	CHK	APP	DATE
<b>CHOLLA S.E.S. COMMON          BA/FA PONDS SEEPAGE INTERCEPT SYSTEM          BOTTOM ASH POND AREA PLANS &amp; DETAILS</b> ARIZONA PUBLIC SERVICE COMPANY						
P.A. NO. FIELD NO. COUNTY REVIEW FOR BID ONLY APNO FOR CONSTR. AS BUILT REV ONLY	SCALE AGS/RP TSH DATE 62-9072	NOTED DATE 03-03-93	DRAWING NO. <b>G-114438</b> SHEET 2 OF 4

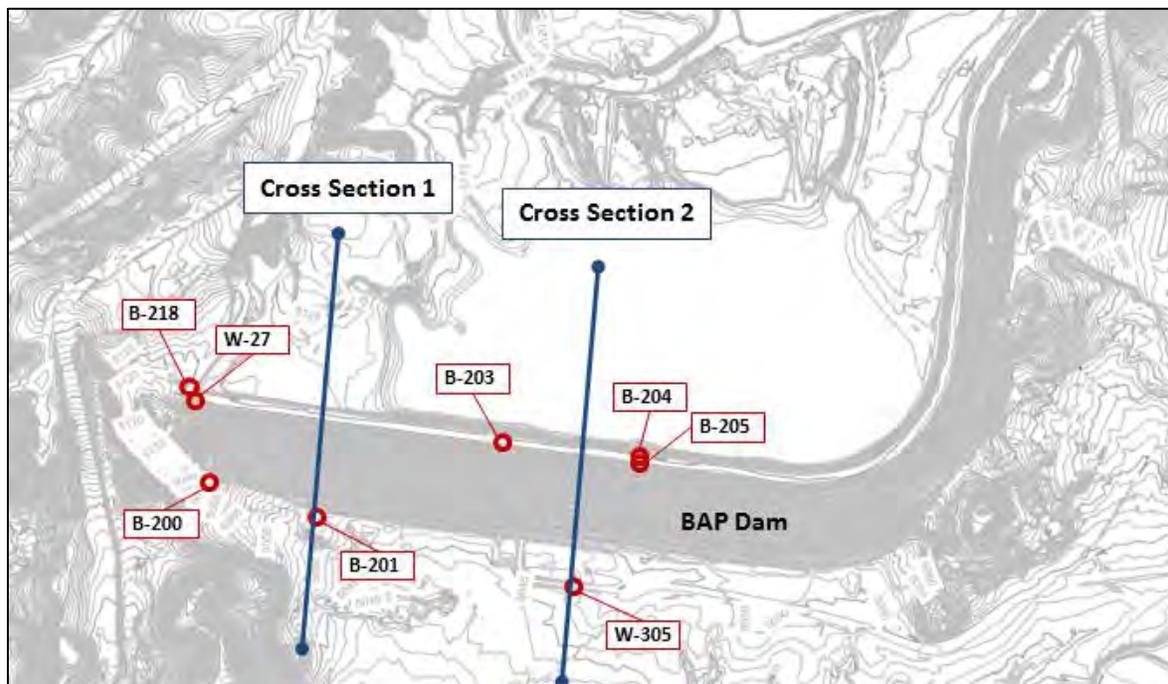
**Figure 1. Slope Stability Cross Section and Piezometer Locations Along the BAP Dam**

The safety factor assessments were performed for two cross-sections along the BAP Dam:

Based on guidance from the EPA Regulations (EPA 2015), pore-water pressures are estimated from the most reliable of the following: “1) *Field measurements of pore pressures in existing slopes*; 2) *past experience and judgment of the Engineer*; 3) *hydrostatic pressures calculated for the no-flow condition*; or 4) *steady-state seepage analysis using flow nets or finite element analyses*.” For the BAP Dam analysis, the pore pressure distribution was assigned using water level readings obtained from piezometers located near the stability cross sections (APS 2016). This distribution was adjusted based on engineering judgement to correspond with pond water level under steady-state, maximum storage pool conditions (ADWR 1998), and pond water level under maximum surcharge pool conditions (D&M 1991). The piezometers used to estimate the pore water pressure within the dam cross sections are shown in Figures 1.

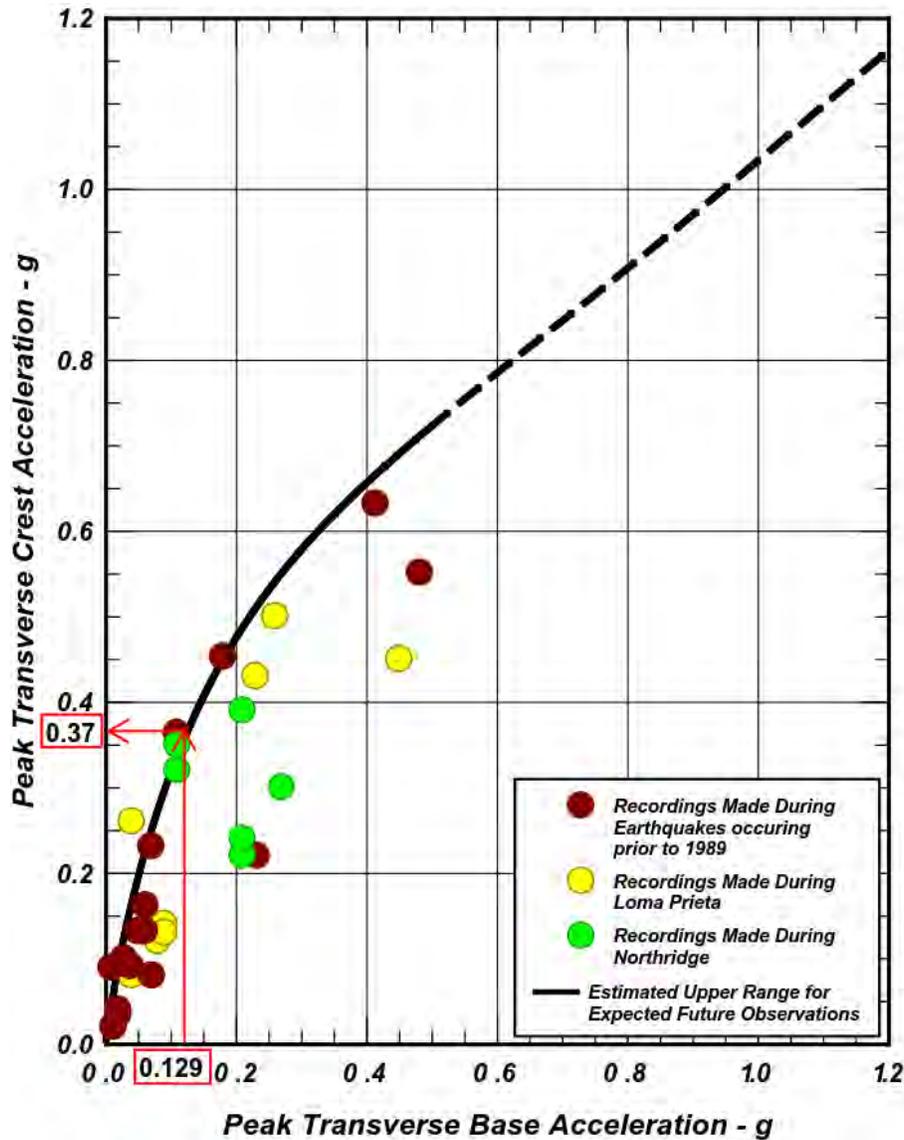
**Figure 4. Variations of Peak Transverse Crest Acceleration vs. Peak Transverse Base Acceleration Based on Holzer (1998)**

The PGA at the ground surface for Site Class D ( $PGA_M$ ) was then used to estimate the peak transverse acceleration at the crest of the embankment,  $PGA_{crest} = 0.307g$ , as shown on Figure 4 and based on variations in recorded peak crest accelerations versus those recorded at the base of earth and rock fill dams by Idriss (2015) and on recorded values for Loma Prieta, and other earthquakes, by Holzer (USGS, 1998).

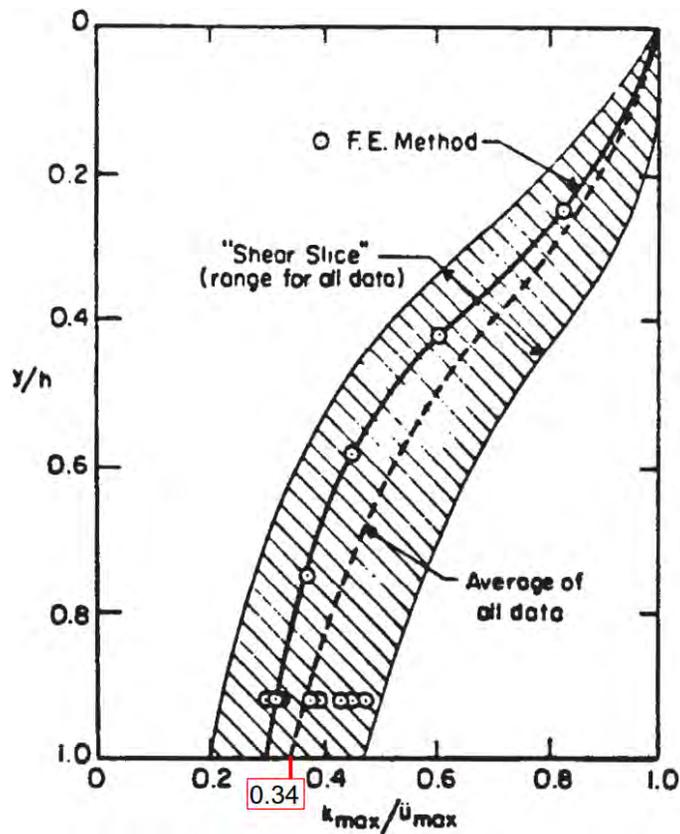
**Figure 5. Variation of "Maximum Acceleration Ratio" with  
Depth of Sliding Mass after Makdisi and Seed (1977)**

Makdisi and Seed (1977) notes that the “maximum acceleration ratio” varies with the depth of the sliding mass relative to the embankment height. Figure 5 (shown below) presents the relationship between maximum acceleration ratio ( $k_{max}/u_{max}$ ) and depth of sliding mass ( $y/h$ ). For deep-seated failure surfaces that involve the entire vertical profile of the dam slope and extend from the crest to the toe or below the toe of the embankment into the foundation soils, the acceleration at the crest can be as low as approximately 34 percent of the maximum value:

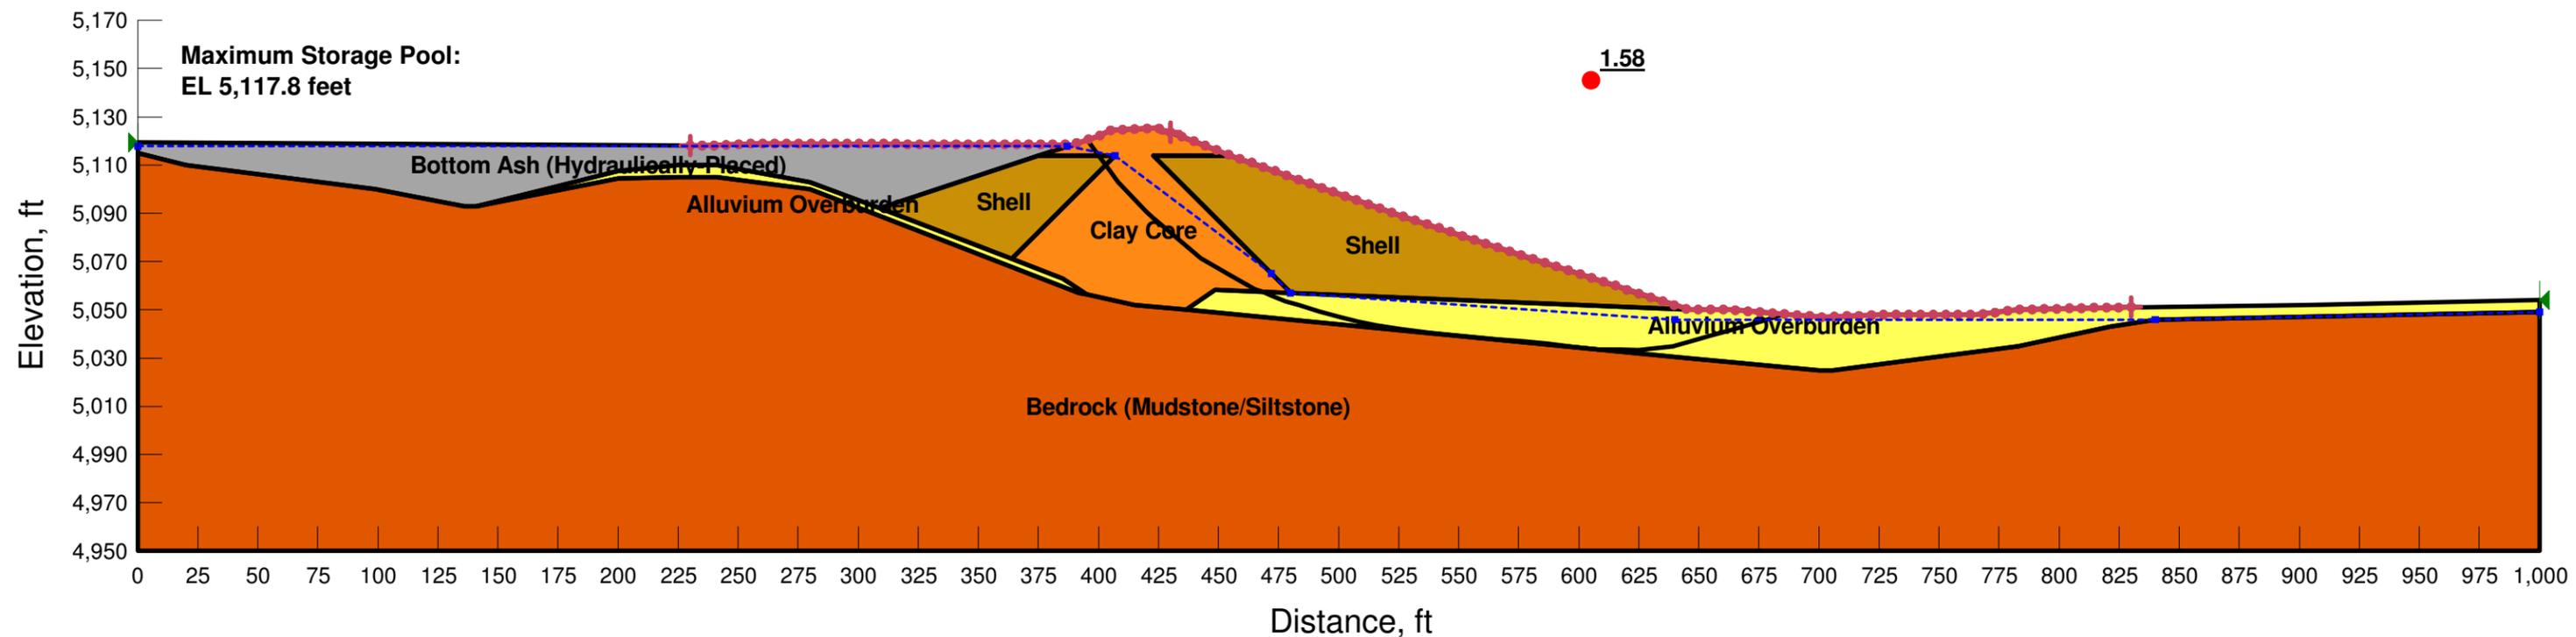
**Factor of Safety: 1.58**

Material Type:	Unit Weight Saturated:	Unit Weight Above Water:	Cohesion:	Friction Angle:
Clay Core	125 pcf	120 pcf	0 psf	28 °
Shell	130 pcf	125 pcf	0 psf	33 °
Alluvium Overburden	120 pcf	120 pcf	0 psf	26 °
Bedrock (Mudstone/Siltstone)	150 pcf	150 pcf	1,000 psf	65 °
Bottom Ash (Hydraulically-Placed)	75 pcf	75 pcf	0 psf	25 °

**Slope Stability Analysis  
Cross Section 1  
Bottom Ash Pond**

For this analysis, the long-term, maximum storage pool in the BAP was set at EL 5,117.8 ft. Since the piezometric conditions within the dam are at steady-state flow, drained material strengths were used in the analysis.
