# CHOLLA POWER PLANT BOTTOM ASH POND – Periodic Structural Integrity Assessment

Periodic Hazard Potential Classification  
Periodic Structural Stability Assessment  
Periodic Safety Factor Assessment

October 2021  
AECOM Project 60664605

AECOM, 2016. *Final Summary Report, Structural Integrity Assessment: Bottom Ash Pond, Cholla Power Plant, Joseph City, Arizona*. Prepared for: Arizona Public Service, AECOM Job No. 60445840, August 26, 2016

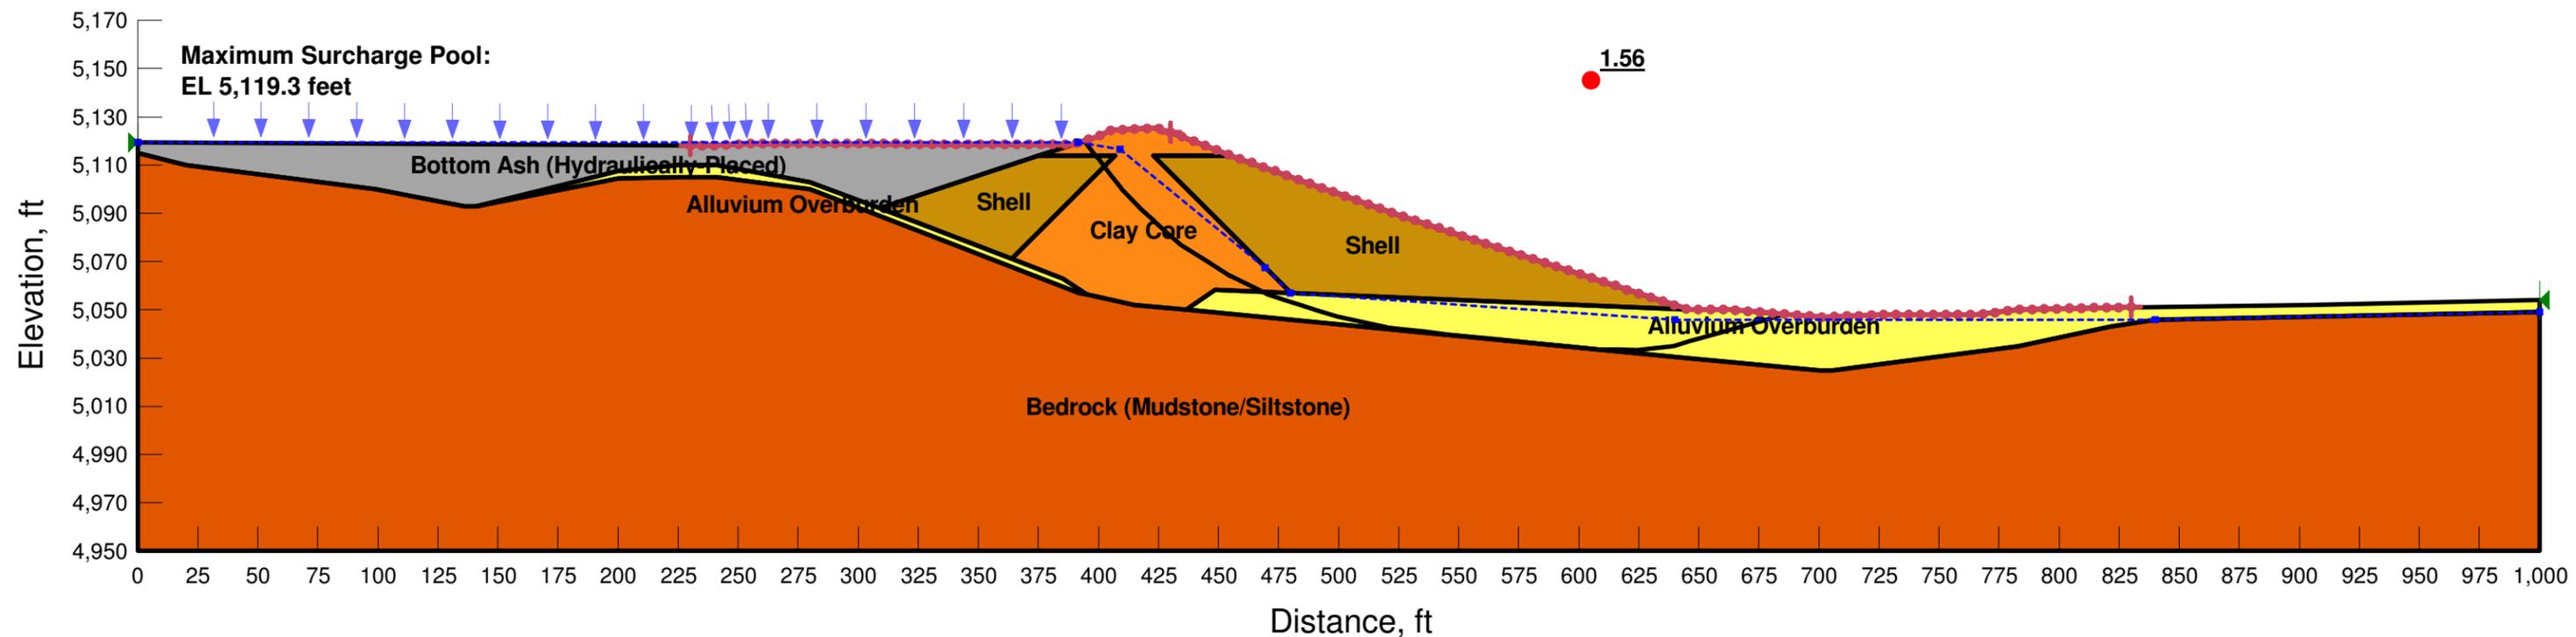
**Factor of Safety: 1.56**

Material Type:	Unit Weight Saturated:	Unit Weight Above Water:	Cohesion:	Friction Angle:
Clay Core	125 pcf	120 pcf	0 psf	28 °
Shell	130 pcf	125 pcf	0 psf	33 °
Alluvium Overburden	120 pcf	120 pcf	0 psf	26 °
Bedrock (Mudstone/Siltstone)	150 pcf	150 pcf	1,000 psf	65 °
Bottom Ash (Hydraulically-Placed)	75 pcf	75 pcf	0 psf	25 °

**Slope Stability Analysis  
Cross Section 1  
Bottom Ash Pond**

For this analysis, the maximum surcharge pool in the BAP was set at EL 5,119.3 ft. Since the piezometric conditions within the dam are at steady-state flow for this loading condition, drained material strengths were used in the analysis.

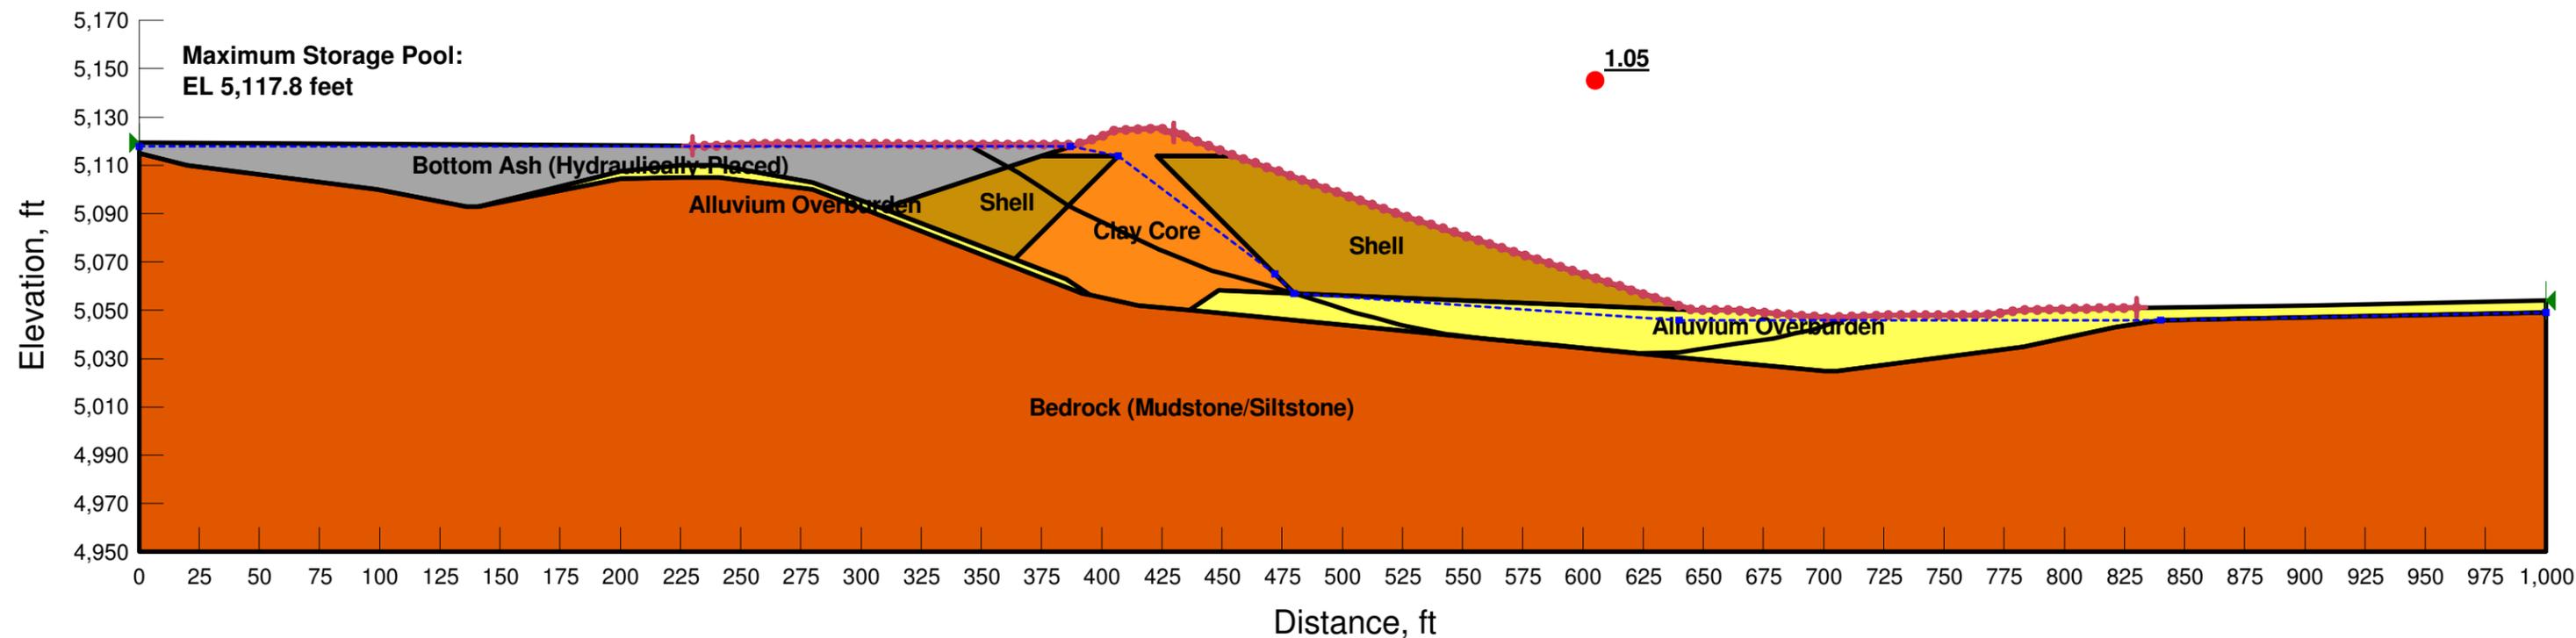
Material Type:	Unit Weight Saturated:	Unit Weight Above Water:	Cohesion:	Friction Angle:	Undrained Strength Ratio:
Clay Core	125 pcf	120 pcf	--	--	0.38
Shell	130 pcf	125 pcf	0 psf	33 °	--
Alluvium Overburden	120 pcf	120 pcf	0 psf	26 °	--
Bedrock (Mudstone/Siltstone)	150 pcf	150 pcf	1,000 psf	65 °	--
Bottom Ash (Hydraulically-Placed)	75 pcf	75 pcf	0 psf	25 °	--

Horz Seismic Coef.: 0.13

**Slope Stability Analysis  
Cross Section 2  
Bottom Ash Pond**

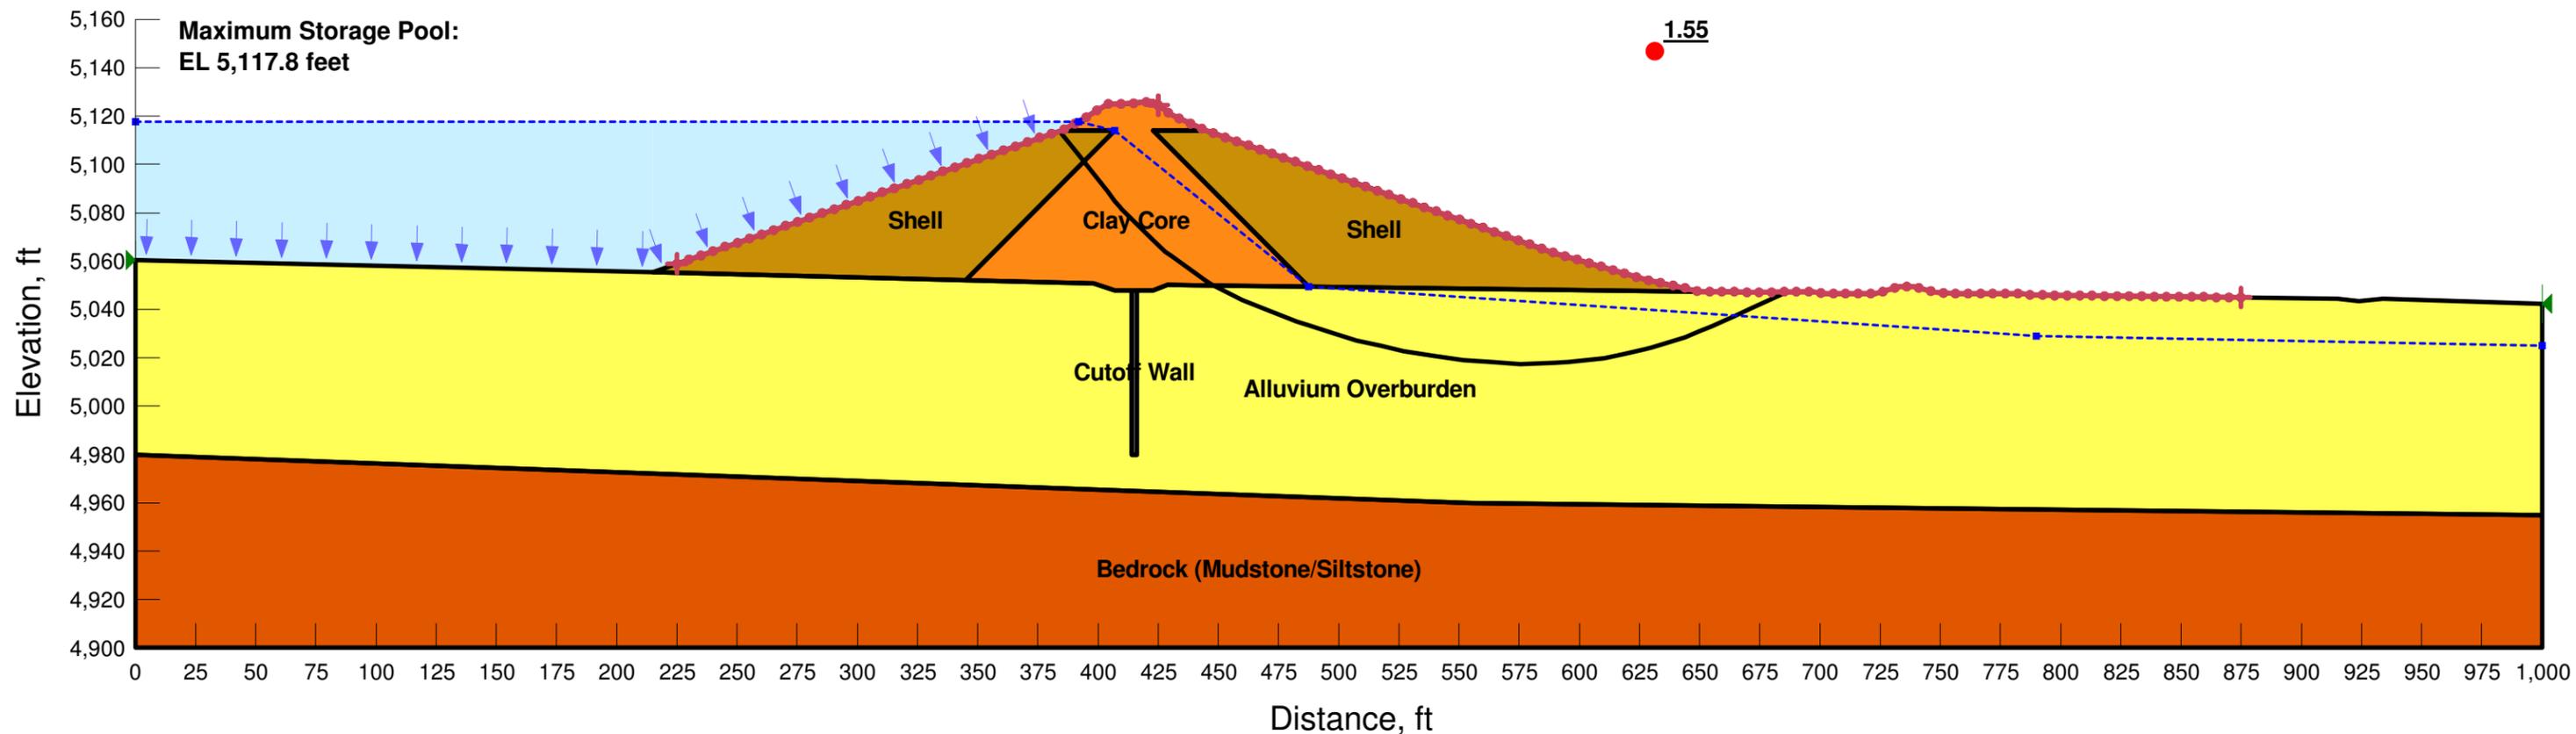
**Factor of Safety: 1.55**

Material Type:	Unit Weight Saturated:	Unit Weight Above Water:	Cohesion:	Friction Angle:
Clay Core	125 pcf	120 pcf	0 psf	28 °
Shell	130 pcf	125 pcf	0 psf	33 °
Alluvium Overburden	120 pcf	120 pcf	0 psf	26 °
Bedrock (Mudstone/Siltstone)	150 pcf	150 pcf	1,000 psf	65 °
Cutoff Wall	106 pcf	106 pcf	0 psf	28 °

**Slope Stability Analysis  
Cross Section 2  
Bottom Ash Pond**

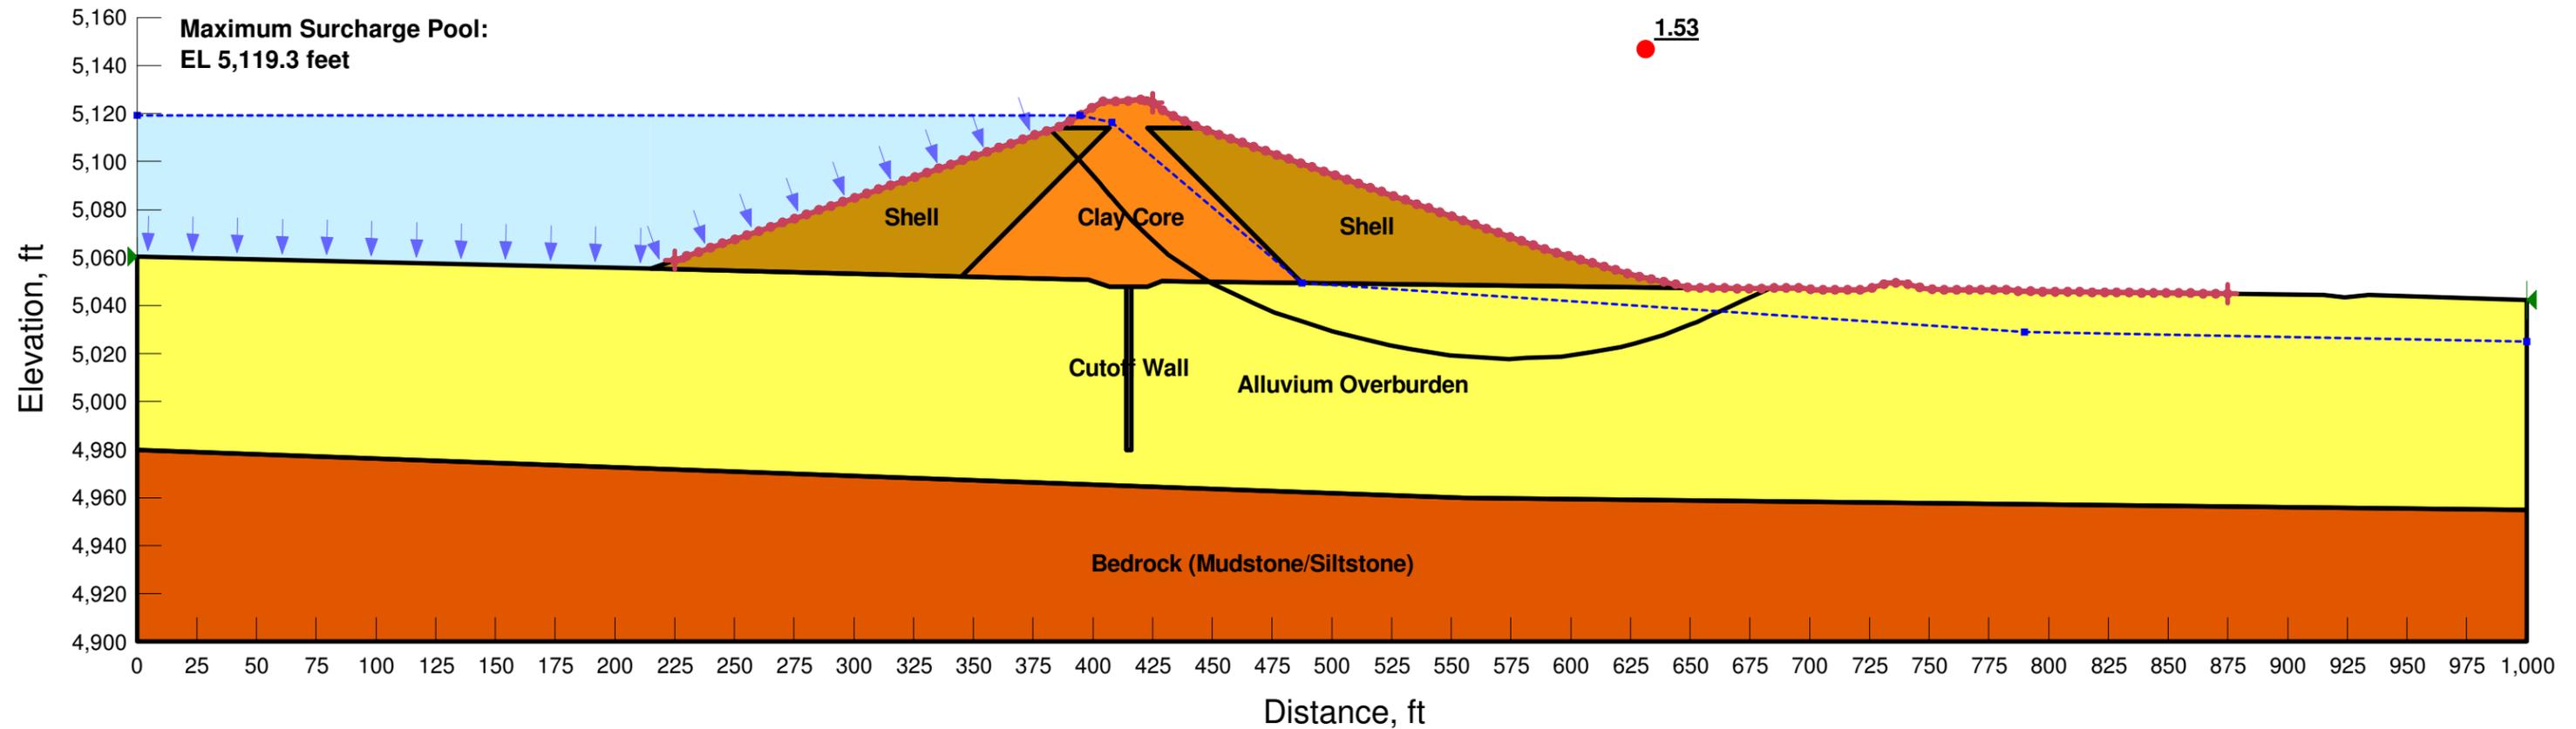
**Factor of Safety: 1.53**

Material Type	Unit Weight Saturated	Unit Weight Above Water	Cohesion	Friction Angle
Clay Core	125 pcf	120 pcf	0 psf	28 °
Shell	130 pcf	125 pcf	0 psf	33 °
Alluvium Overburden	120 pcf	120 pcf	0 psf	26 °
Bedrock (Mudstone/Siltstone)	150 pcf	150 pcf	1,000 psf	65 °
Cutoff Wall	106 pcf	106 pcf	0 psf	28 °

**Slope Stability Analysis  
Cross Section 2  
Bottom Ash Pond**

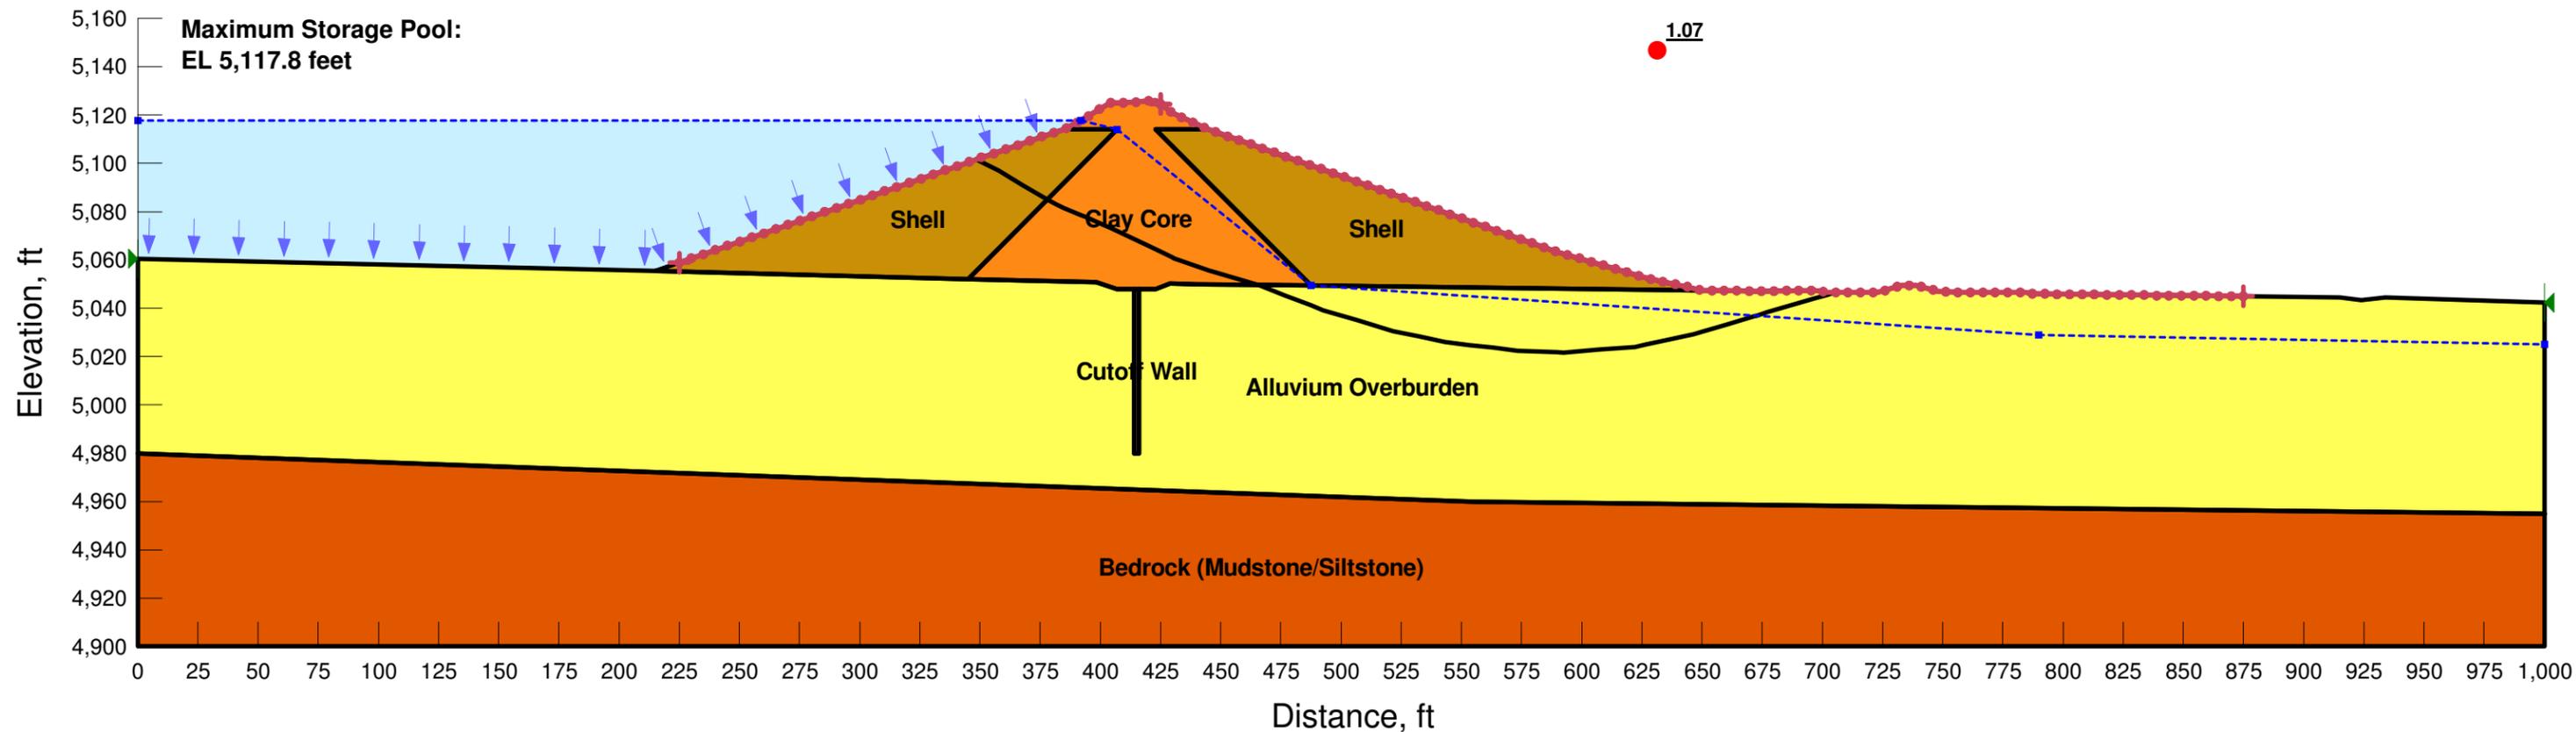
Material Type:	Unit Weight Saturated:	Unit Weight Above Water:	Cohesion:	Friction Angle:	Undrained Strength Ratio:
Clay Core	125 pcf	120 pcf	--	--	0.38
Shell	130 pcf	125 pcf	0 psf	33 °	--
Alluvium Overburden	120 pcf	120 pcf	0 psf	26 °	--
Bedrock (Mudstone/Siltstone)	150 pcf	150 pcf	1,000 psf	65 °	--
Cutoff Wall	106 pcf	106 pcf	10 psf	0 °	--

Horz Seismic Coef.: 0.13
