CHOLLA POWER PLANT FLY ASH POND – Periodic Structural Integrity Assessment

Periodic Hazard Potential Classification
Periodic Structural Stability Assessment
Periodic Safety Factor Assessment

October 2021
AECOM Project 60664605

Attachment A: AECOM, 2016. *Final Summary Report, Structural Integrity Assessment: Fly Ash Pond, Cholla Power Plant, Joseph City, Arizona*. Prepared for: Arizona Public Service, AECOM Job No. 60445840, August 26, 2016

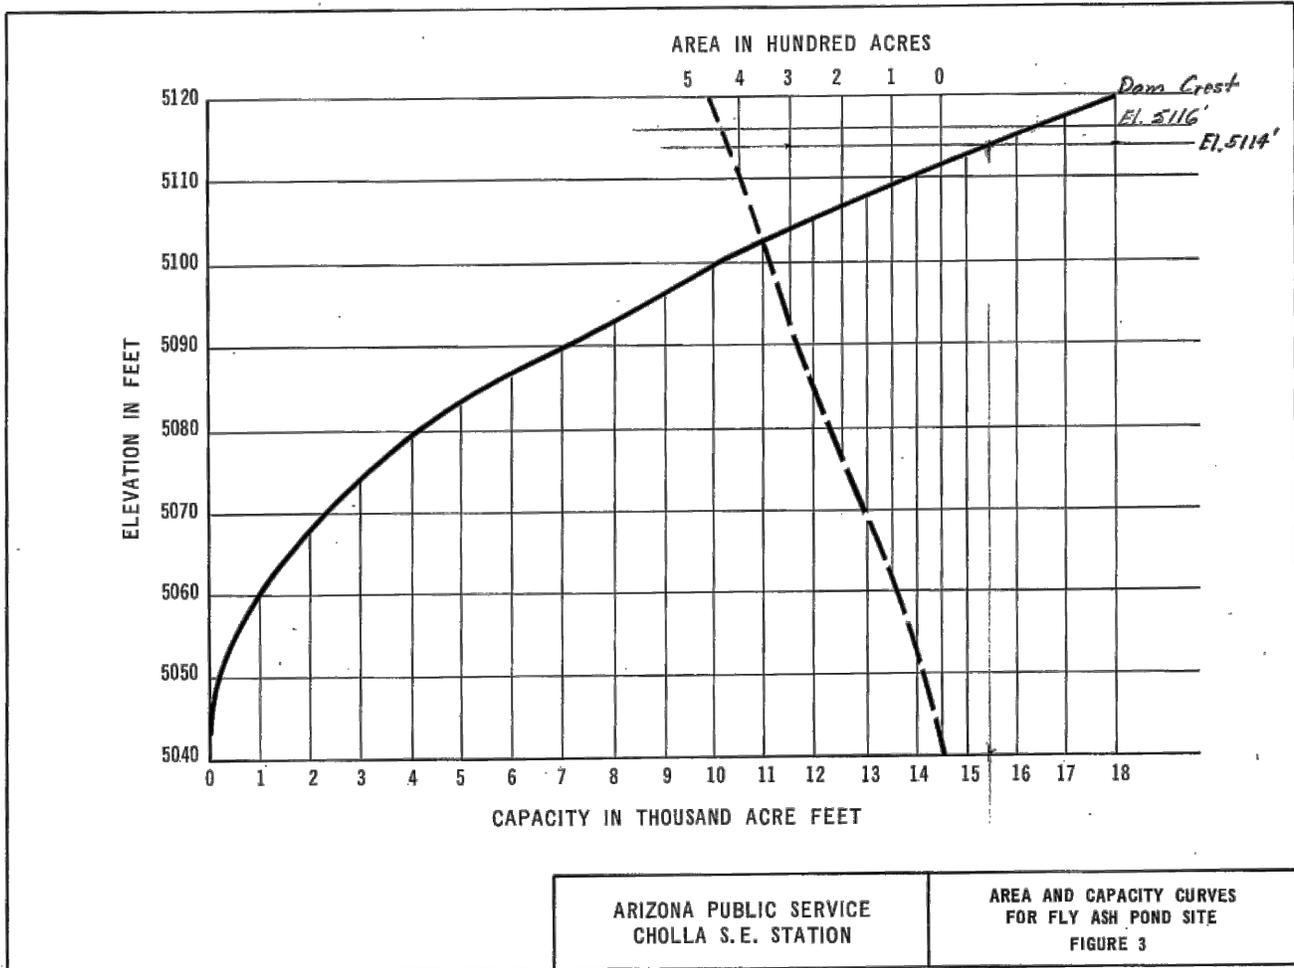
Last saved by: KING, JEREMY(2016-06-20) Last Plotted: 2016-06-20
Filename: P:\ARIZONA PUBLIC SERVICE\60445840_APS_CHOLLA_STRUCTURAL_INTEGRITY\CADD FILES\FIGURES\FIGURE 4-2_AREA CAPACITY CURVE_JSK.DWG

ARIZONA PUBLIC SERVICE CHOLLA S. E. STATION	AREA AND CAPACITY CURVES FOR FLY ASH POND SITE FIGURE 3
--	---

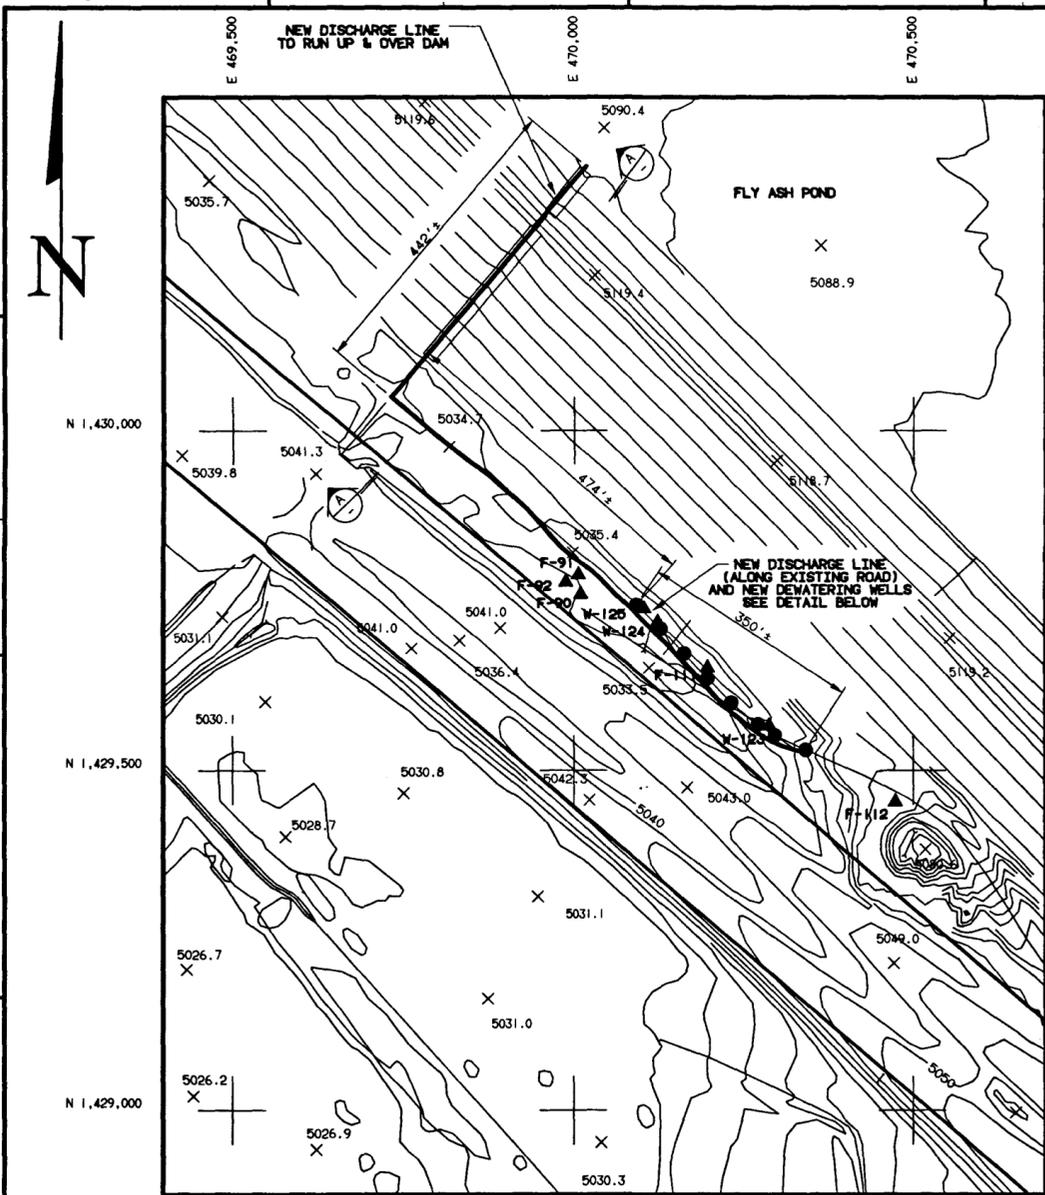
PARTIAL PLAN - FLY ASH POND AREA - GERONIMO SEEP

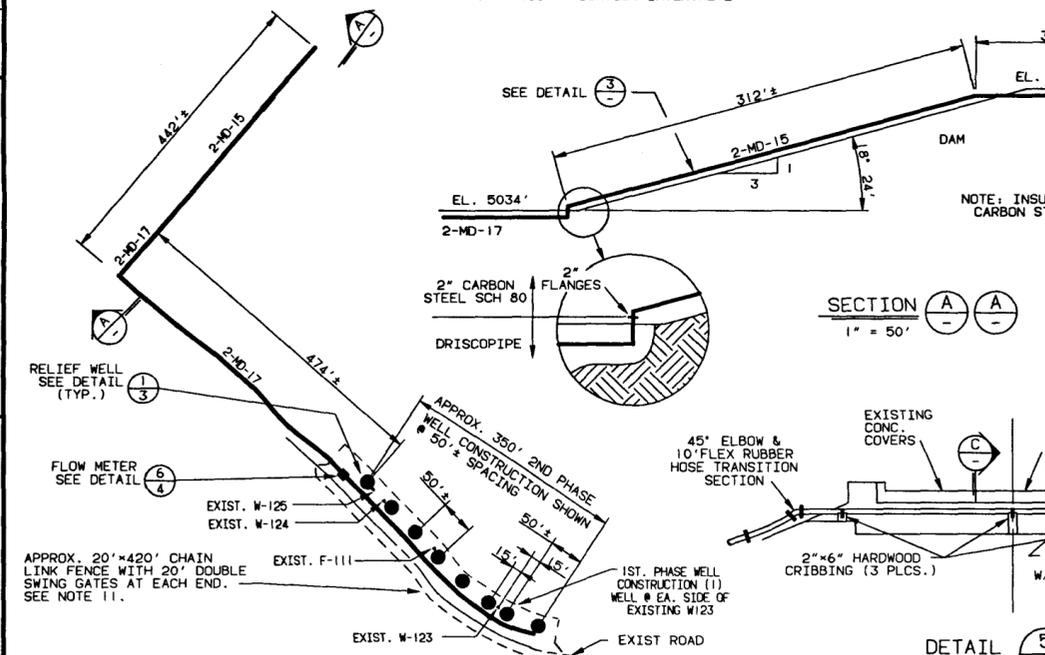
GERONIMO SEEP PIPING DETAIL

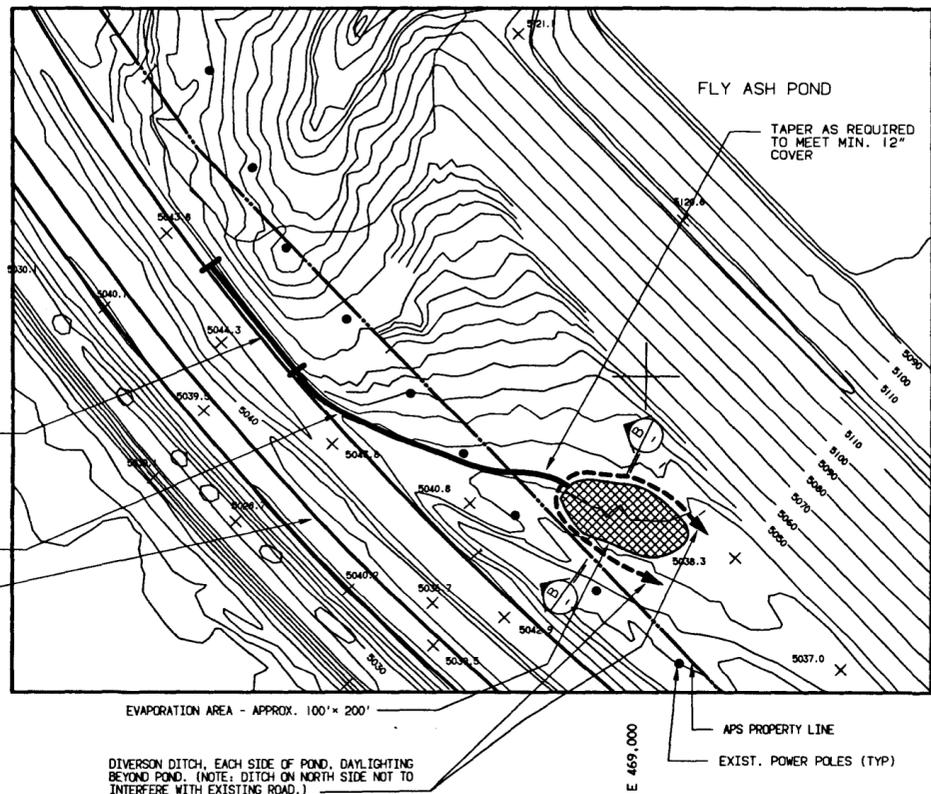
PARTIAL PLAN - FLY ASH POND - I-40 SEEP AREA

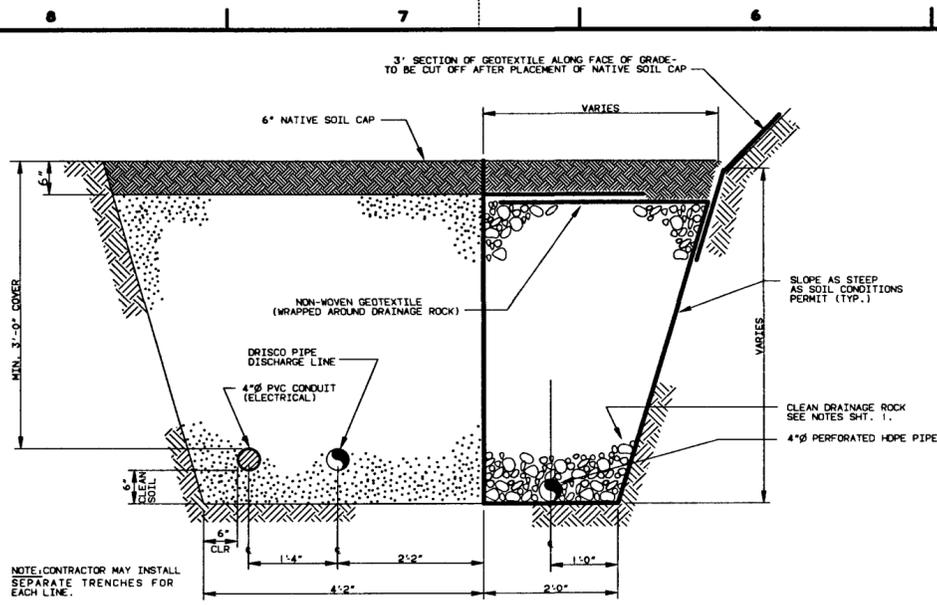
DETAIL 1 TYP. JOINT TRENCH
1"=1'-0"

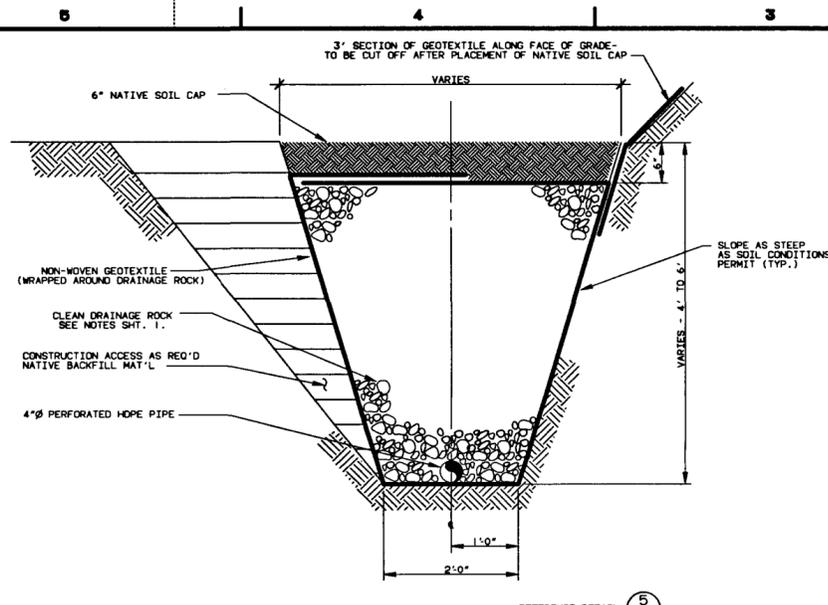
DETAIL 2 TYPICAL INTERCEPT TRENCH
1"=1'-0"

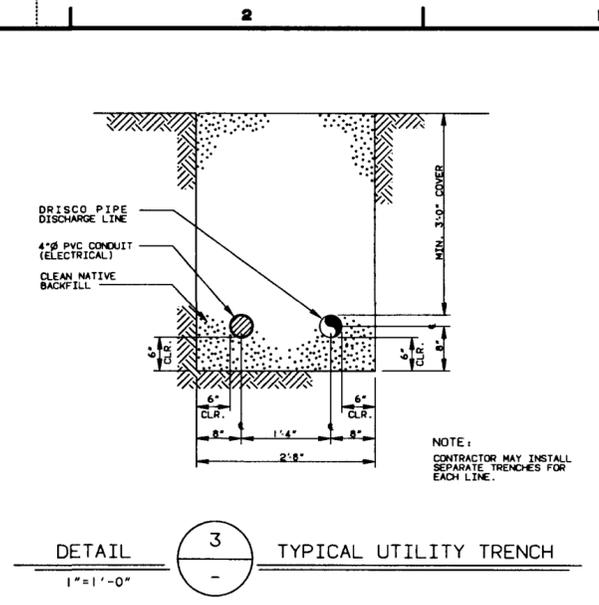
DETAIL 3 TYPICAL UTILITY TRENCH
1"=1'-0"

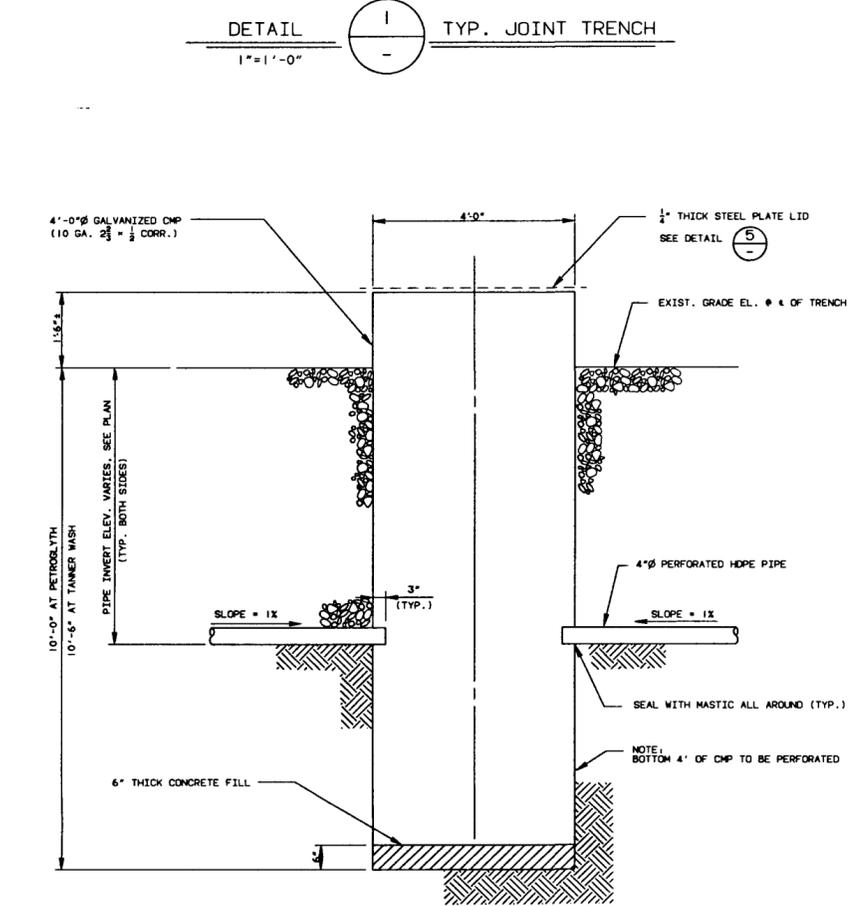
DETAIL 4 TYPICAL COLLECTION SUMP
3/4"=1'-0"

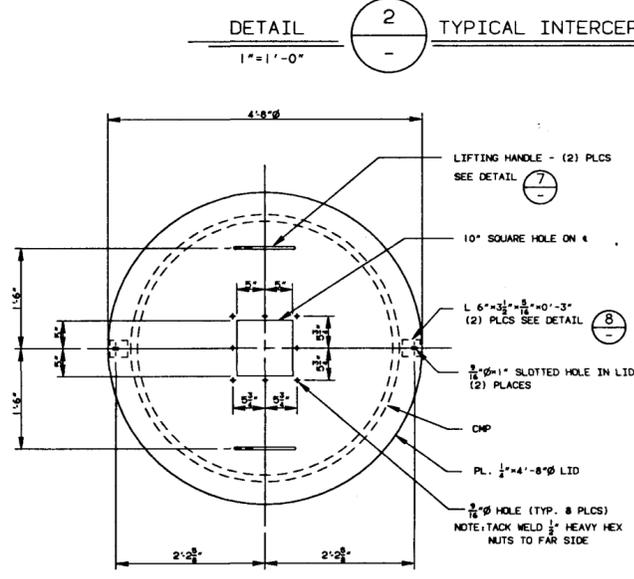
DETAIL 5 TYPICAL SUMP LID
1"=1'-0"

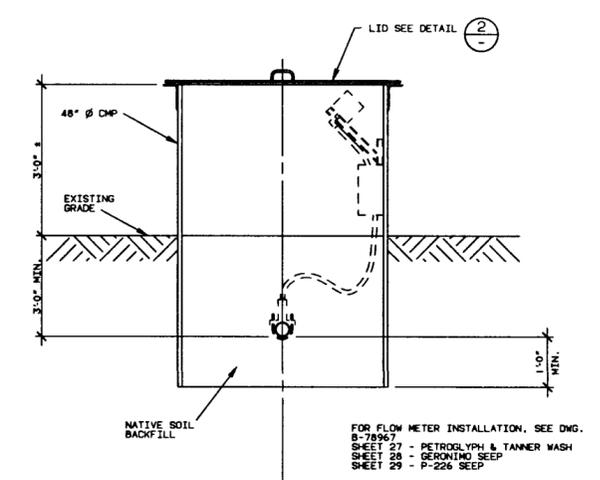
DETAIL 6 TYP. FLOW METER ENCLOSURE
3/4"=1'-0"

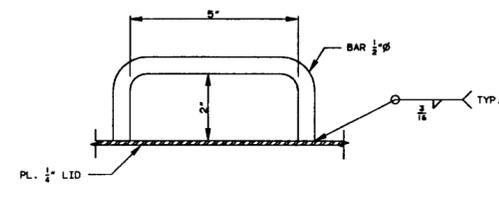
DETAIL 7 TYPICAL SUMP LID HANDLE
6"=1'-0"

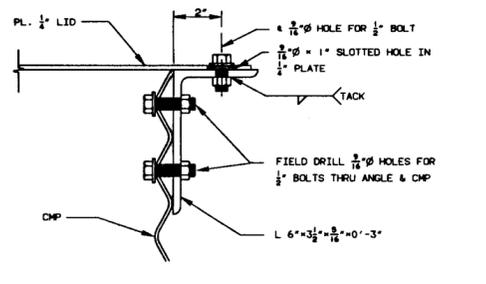
DETAIL 8 TYPICAL CMP LID ATTACHMENT
3"=1'-0"

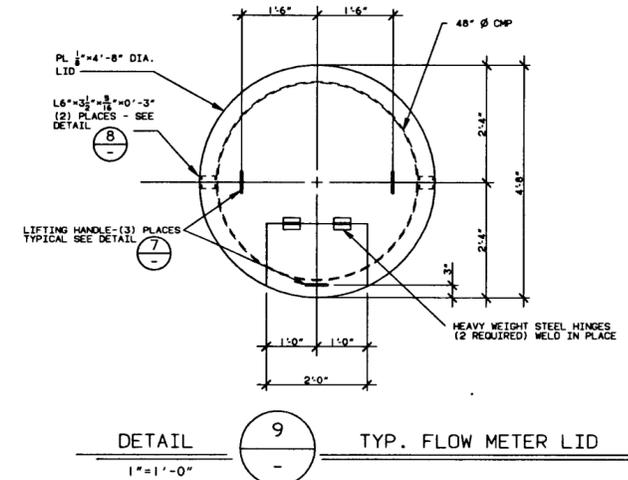
DETAIL 9 TYP. FLOW METER LID
1"=1'-0"

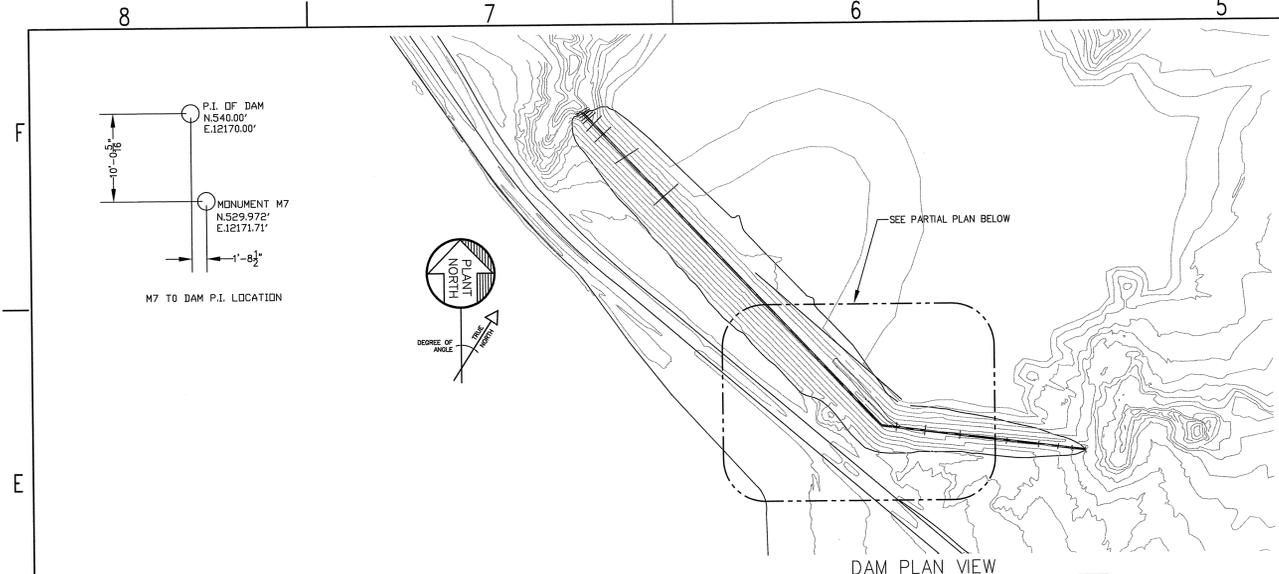
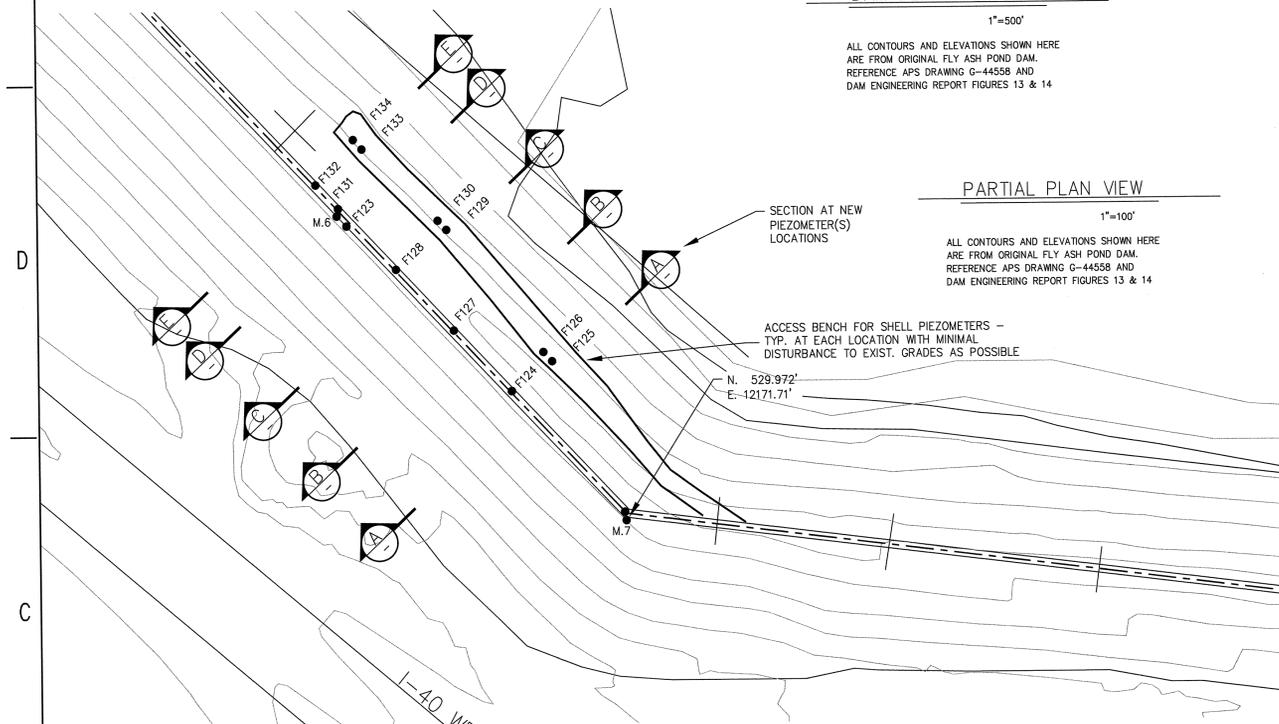
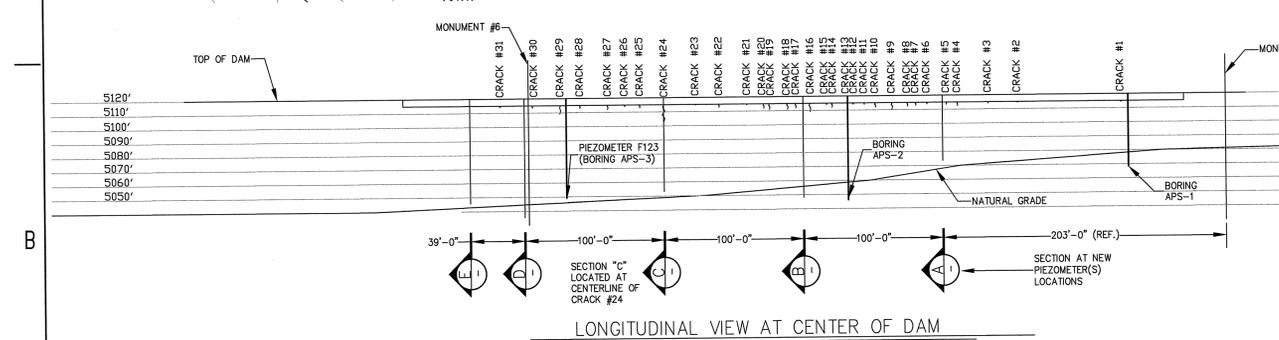
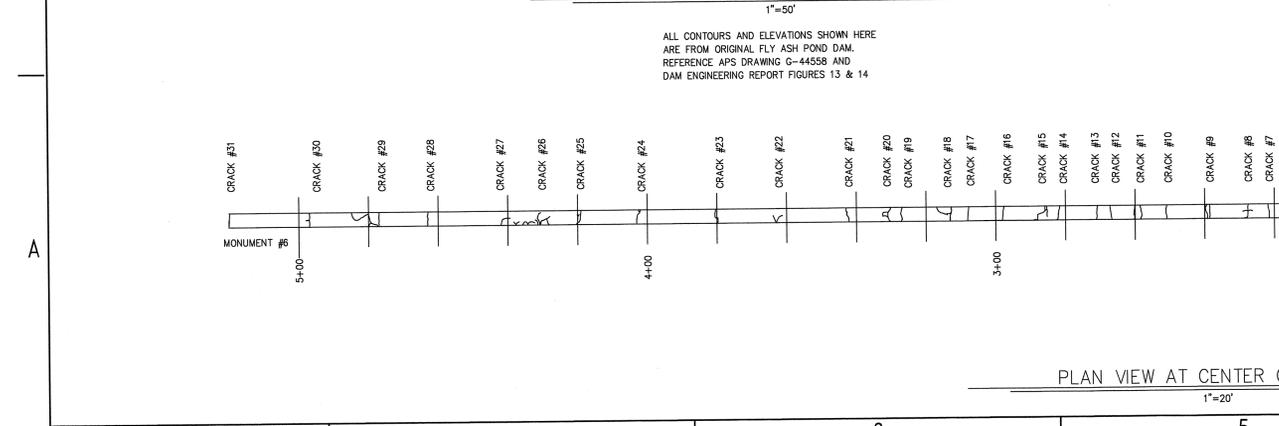
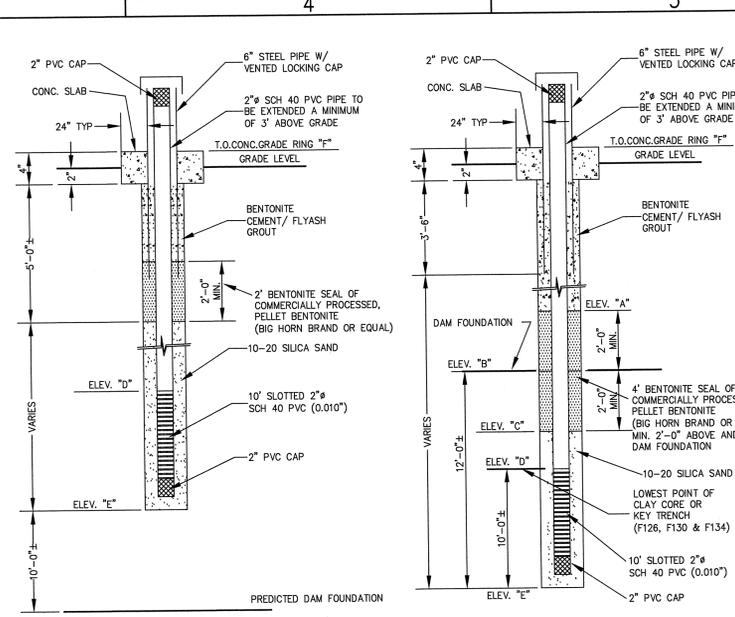
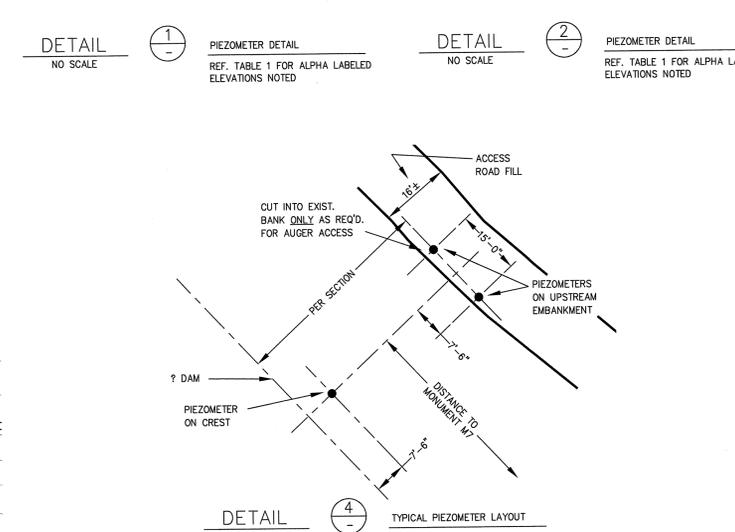
EMBANKMENT MONITORING
(APS, 1999)

TABLE 1
PIEZOMETER ELEVATIONS
REF. DETAILS 1 & 2

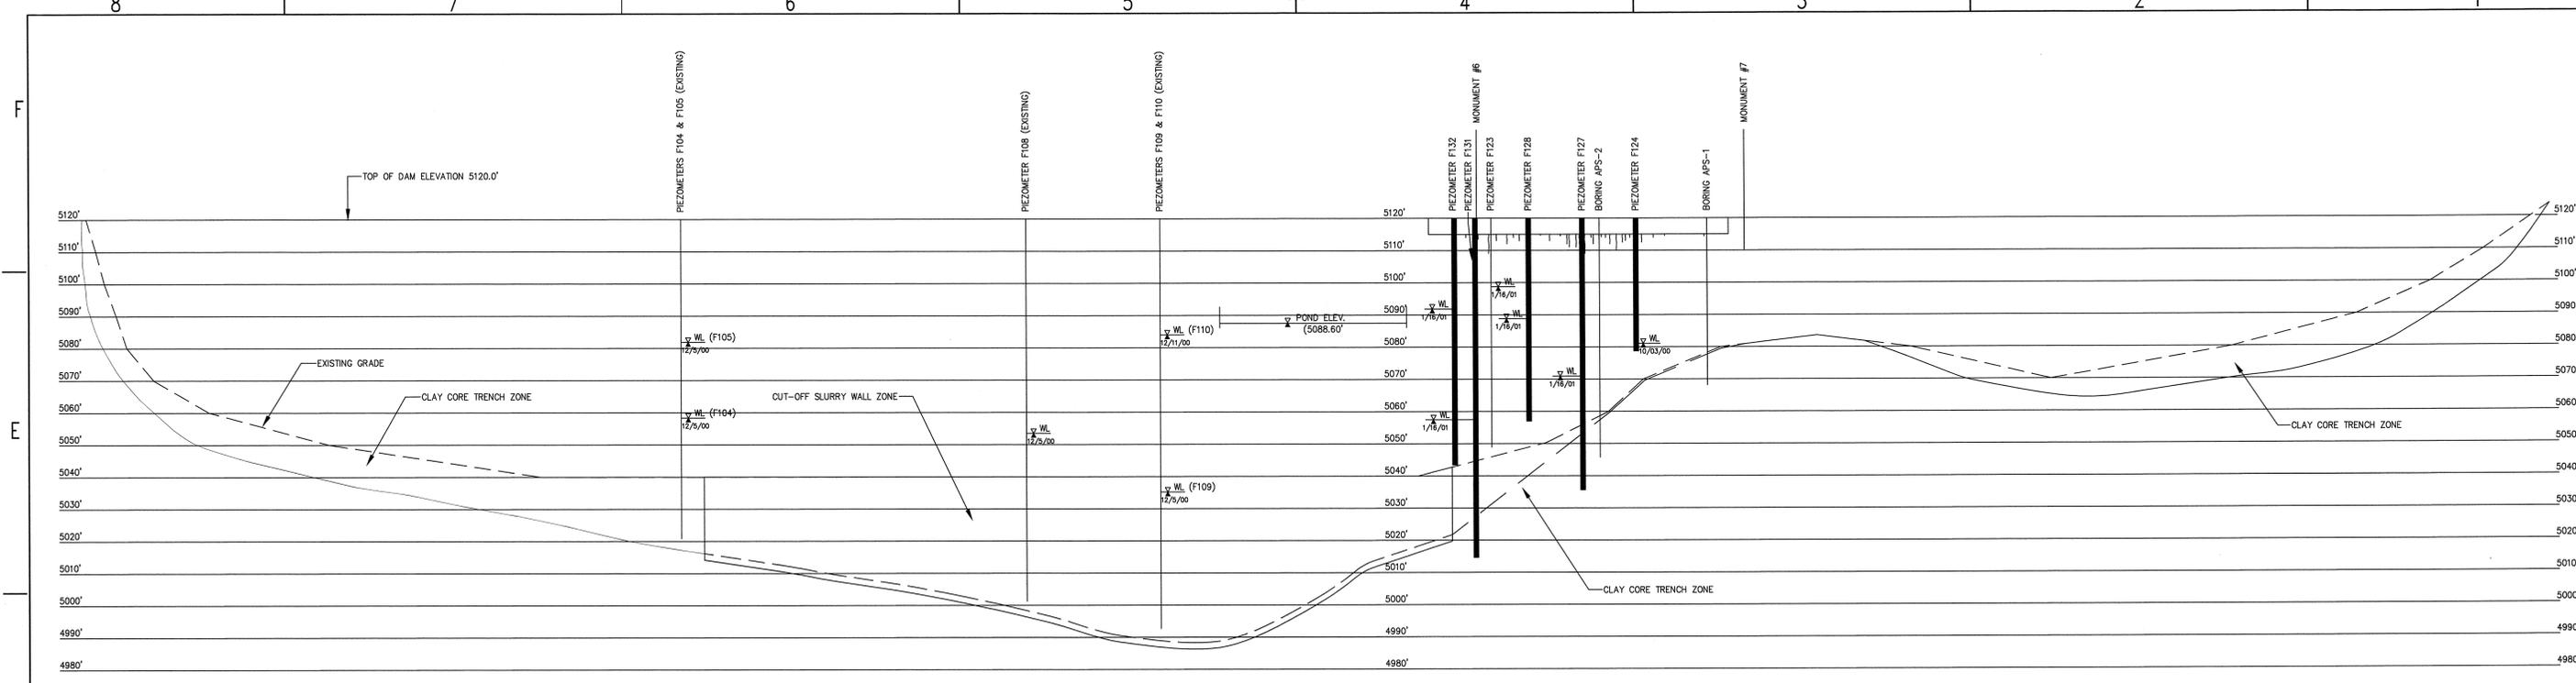
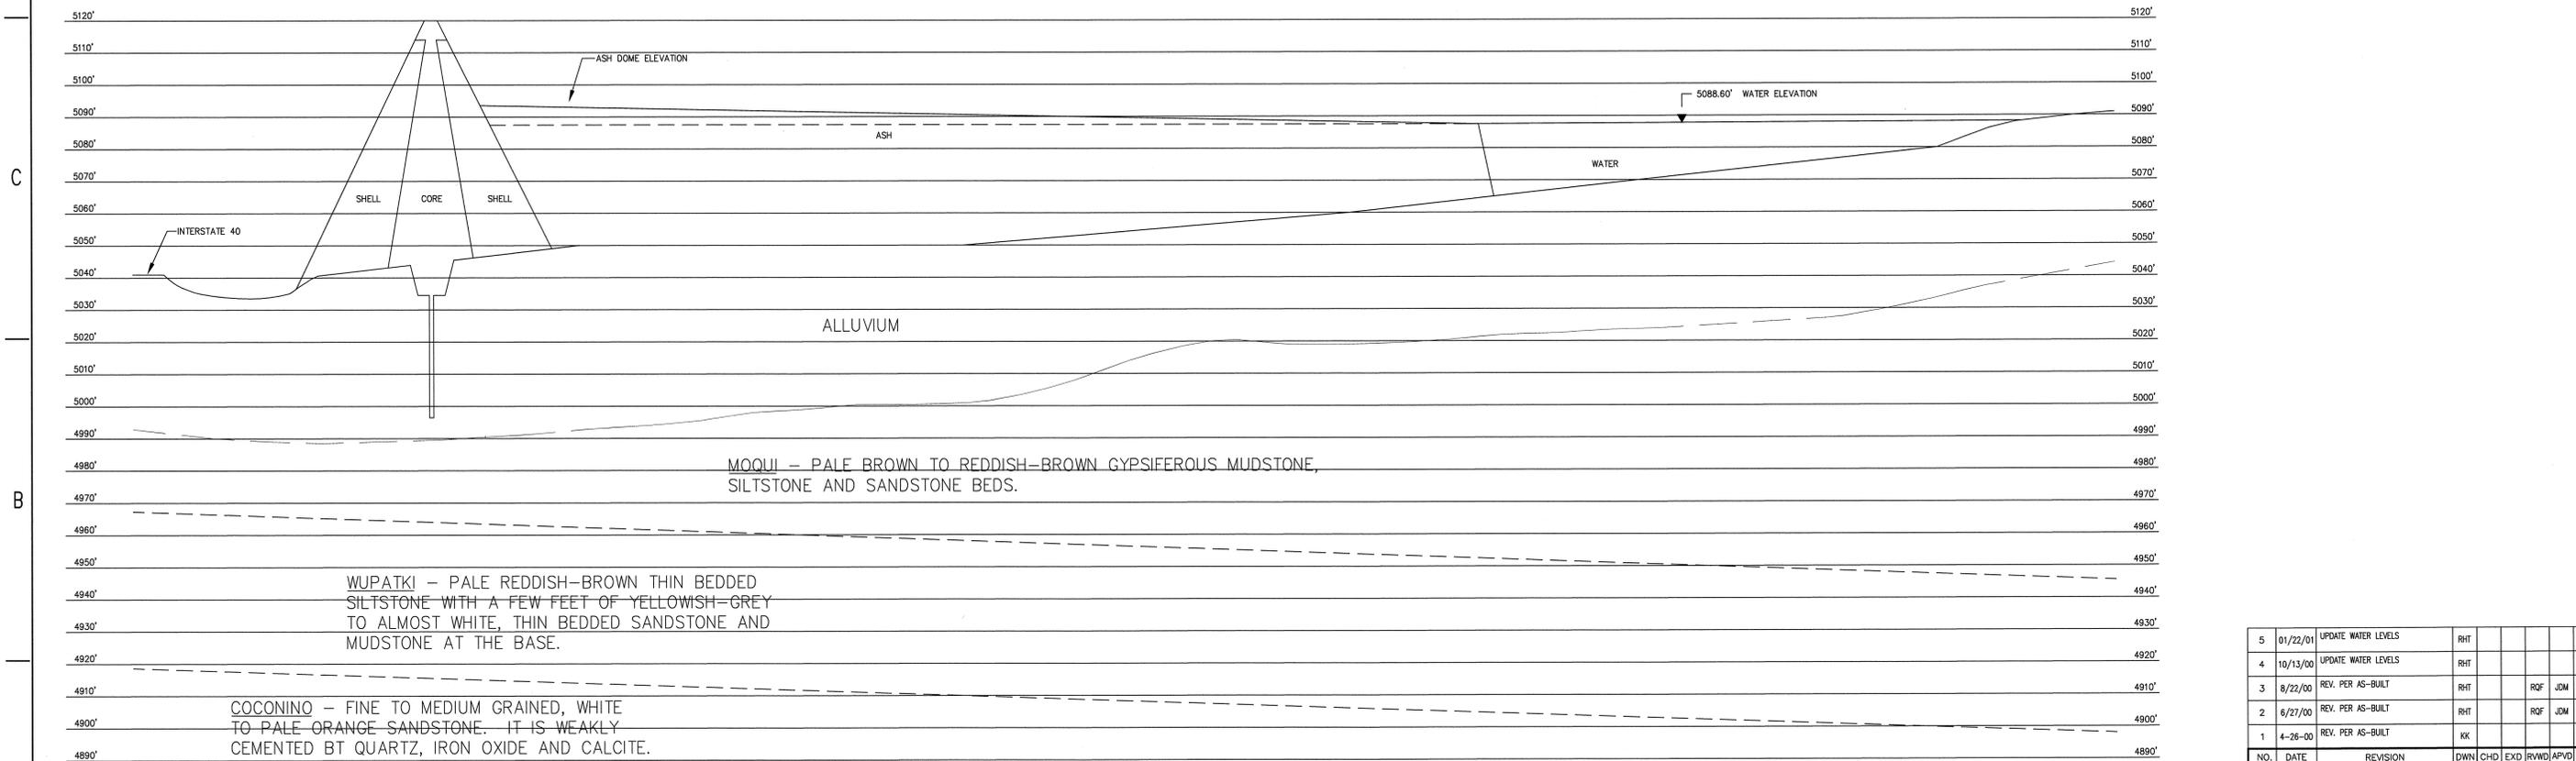
NO.	DATE	REVISION	DWN	CHD	EXD	RWD	APVD	W.A.
CHOLLA POWER PLANT FLY ASH POND EMBANKMENT MONITORING PROFILES								
VERT. 1"=20' SCALE HORIZ. 1"=120'								
								DATE 9-7-99
DWN	KK/MLD	APVD	JOHN D. MITCHELL ENGINEERING SUPERVISOR				DRAWING NO.	
CHD		RWD	W A				G-145746	
EXD	RQF		30-6923				SHEET 2 OF 2

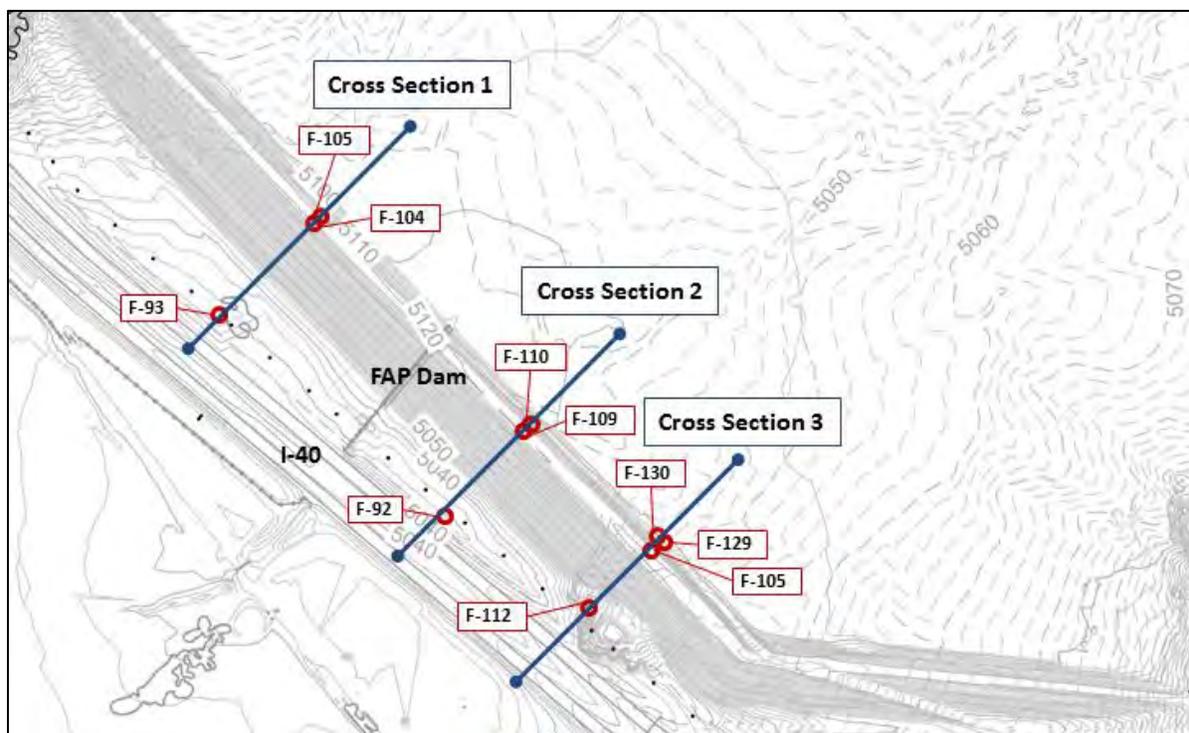
The safety factor assessments were performed for three cross-sections along the FAP Dam:

Figure 1. Slope Stability Cross Section and Piezometer Locations Along the FAP Dam

Factors of safety were calculated for critical cross-sections of the FAP Dam. The critical cross section is the cross section that is anticipated to be most susceptible to structural failure for a given loading condition. The critical cross section thus represents a “most-severe” case. Section locations were selected based on variation in the embankment height and stratigraphic conditions to represent the most-severe case.

Based on guidance from the EPA Regulations (EPA 2015), pore-water pressures are estimated from the most reliable of the following: “1) *Field measurements of pore pressures in existing slopes*; 2) *past experience and judgment of the Engineer*; 3) *hydrostatic pressures calculated for the no-flow condition*; or 4) *steady-state seepage analysis using flow nets or finite element analyses*.” For the FAP analysis, the pore pressure distribution was assigned using water level readings obtained from piezometers located near the stability cross sections (APS 2014). This distribution was adjusted based on engineering judgement to correspond with pond water level under steady-state, maximum storage pool conditions (ADWR 1986), and pond water levels under maximum surcharge pool conditions (Ebasco 1975). The piezometers used to estimate the pore water pressure within the dam cross sections are shown in Figures 1.

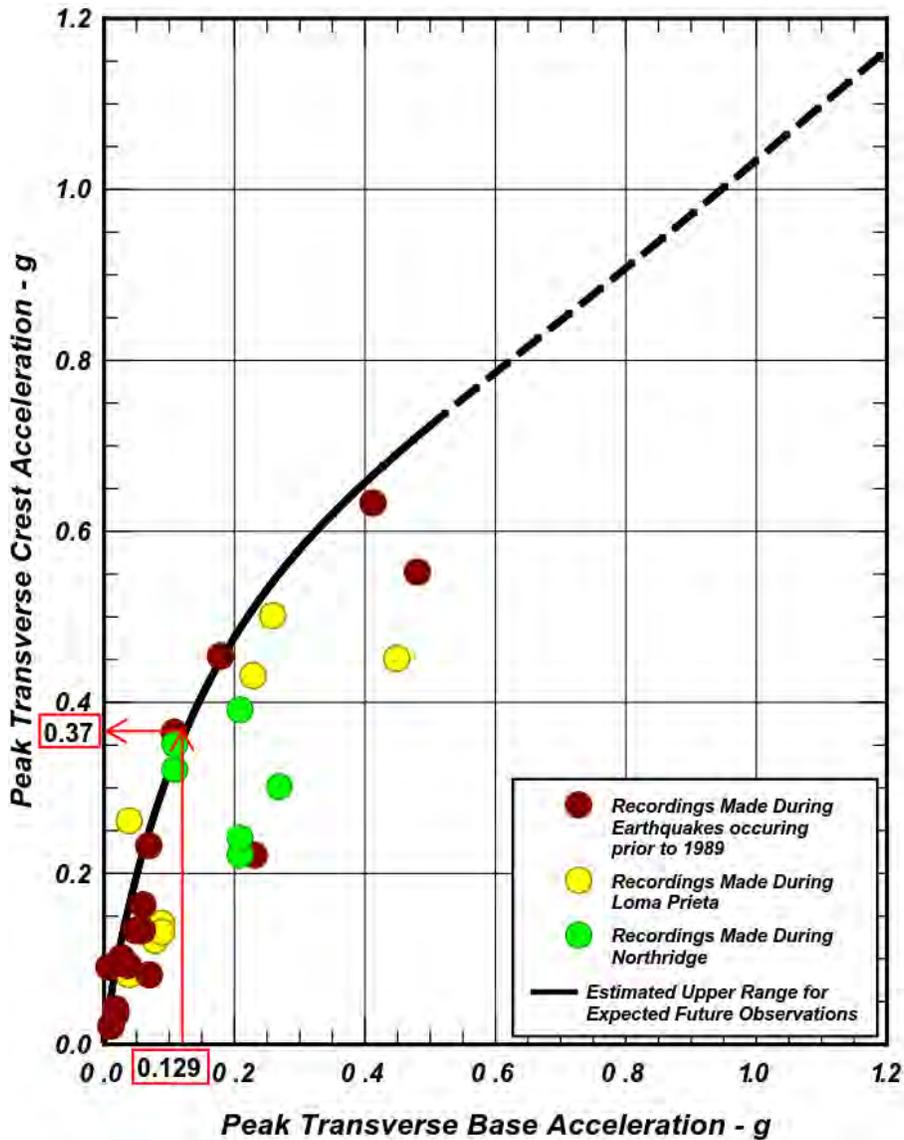
Figure 4. Variations of Peak Transverse Crest Acceleration vs. Peak Transverse Base Acceleration Based on Holzer (1998)

The PGA at the ground surface for Site Class D (PGA_M) was then used to estimate the peak transverse acceleration at the crest of the embankment, $PGA_{crest} = 0.307g$, as shown on Figure 4 and based on variations in recorded peak crest accelerations versus those recorded at the base of earth and rock fill dams by Idriss (2015) and on recorded values for Loma Prieta, and other earthquakes, by Holzer (USGS, 1998).

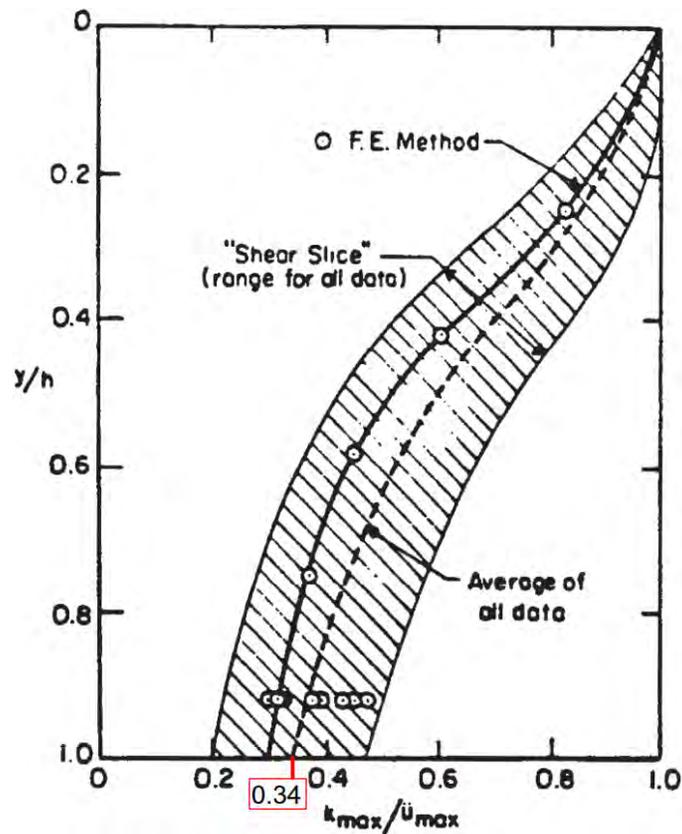
Makdisi and Seed (1977) notes that the “maximum acceleration ratio” varies with the depth of the sliding mass relative to the embankment height. Figure 5 (shown below) presents the relationship between maximum acceleration ratio (k_{max}/u_{max}) and depth of sliding mass (y/h). For deep-seated failure surfaces that involve the entire vertical profile of the dam slope and extend from the crest to the toe or below the toe of the embankment into the foundation soils, the acceleration at the crest can be as low as approximately 34 percent of the maximum value:

Figure 5. Variation of "Maximum Acceleration Ratio" with Depth of Sliding Mass after Makdisi and Seed (1977)

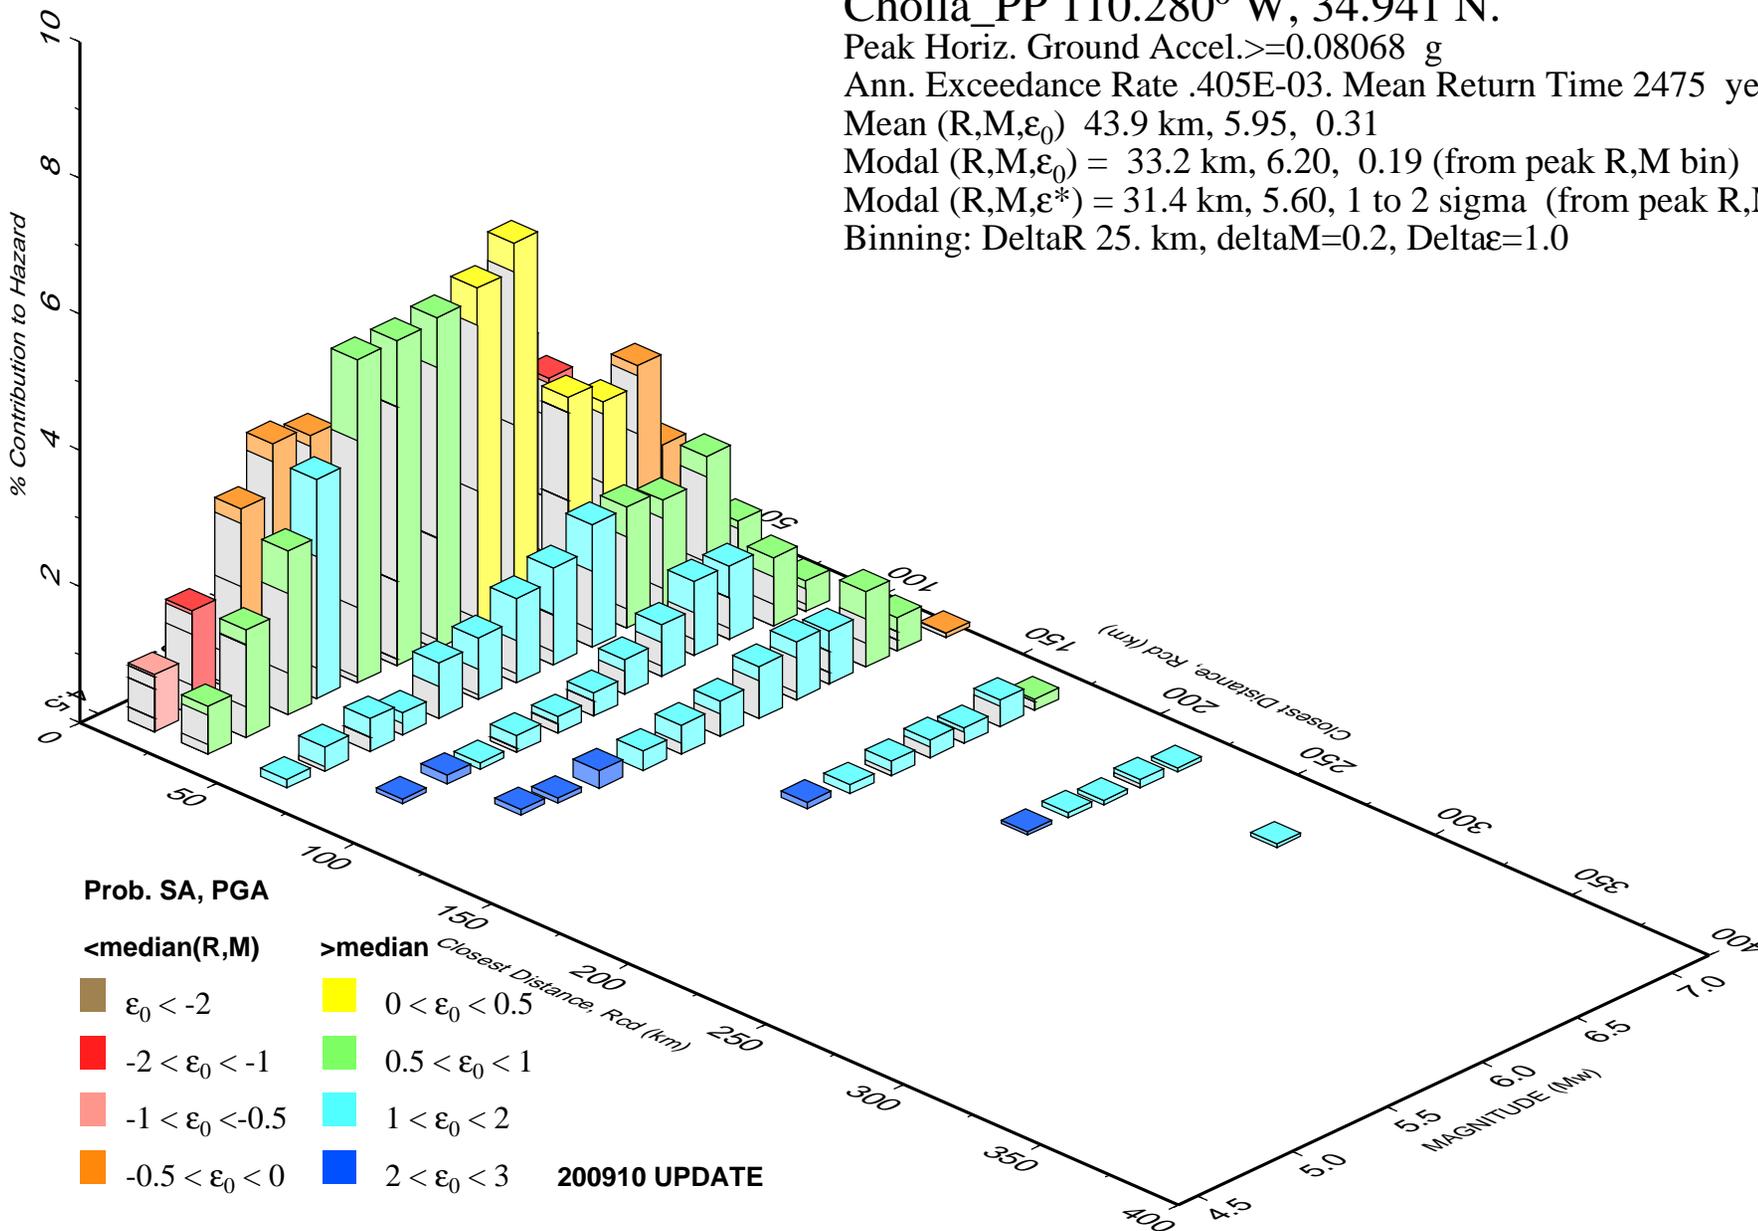
PSH Deaggregation on NEHRP BC rock Cholla_PP 110.280° W, 34.941 N.

Peak Horiz. Ground Accel. ≥ 0.08068 g
 Ann. Exceedance Rate .405E-03. Mean Return Time 2475 years
 Mean (R,M, ϵ_0) 43.9 km, 5.95, 0.31
 Modal (R,M, ϵ_0) = 33.2 km, 6.20, 0.19 (from peak R,M bin)
 Modal (R,M, ϵ^*) = 31.4 km, 5.60, 1 to 2 sigma (from peak R,M, ϵ bin)
 Binning: DeltaR 25. km, deltaM=0.2, Delta ϵ =1.0

The peak horizontal bedrock acceleration for a site classification of B "Rock" based on the USGS 2008 NEHRP seismic hazard map with a 2% probability of exceedance in 50 years is 0.0807g as presented in Attachment A (USGS 2008). Based on previous site explorations, a sit classification of D "Stiff Soil" was assigned to the site as illustrated in Table 1615.1.1 from the IBC (2003) shown in Figure 2.

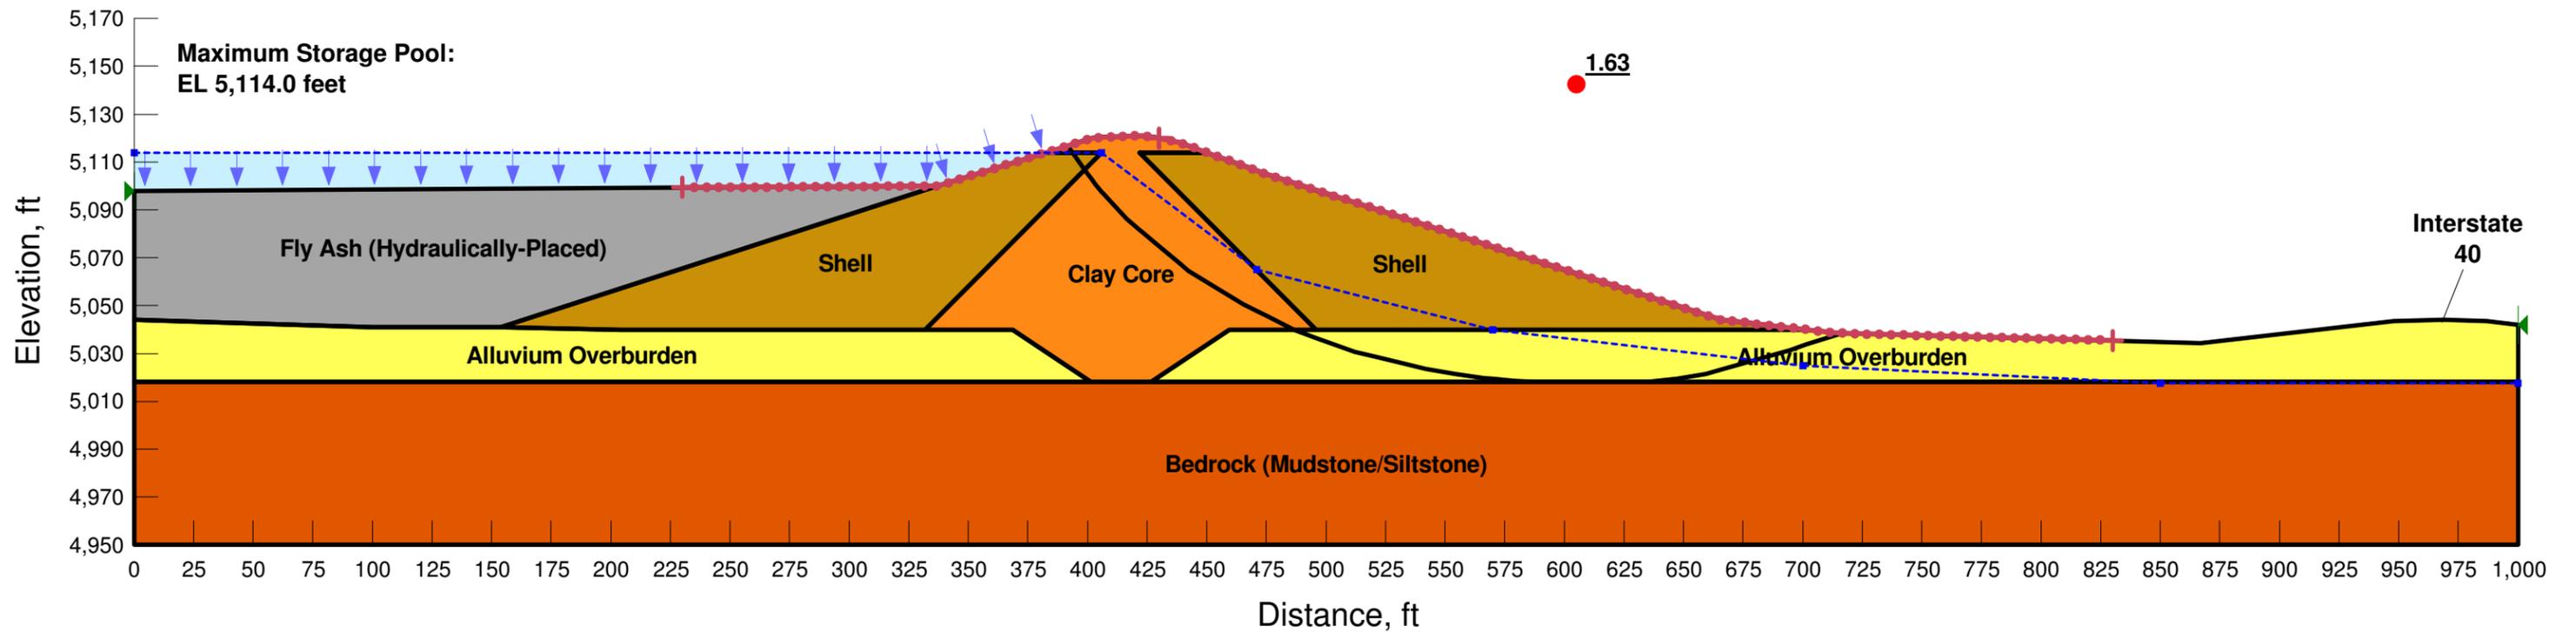
Factor of Safety: 1.63

Material Type:	Unit Weight Saturated:	Unit Weight Above Water:	Cohesion:	Friction Angle:
Clay Core	125 pcf	120 pcf	0 psf	28 °
Shell	130 pcf	125 pcf	0 psf	33 °
Alluvium Overburden	120 pcf	120 pcf	0 psf	26 °
Bedrock (Mudstone/Siltstone)	150 pcf	150 pcf	1,000 psf	65 °
Fly Ash (Hydraulically-Placed)	90 pcf	90 pcf	0 psf	0 °

**Slope Stability Analysis
Cross Section 1
Fly Ash Pond**

Loading Condition	Required Safety Factor	Calculated Minimum Safety Factor		
		Cross Section 1	Cross Section 2	Cross Section 3
Long-term, maximum storage pool	1.50	1.63	1.53	1.73
Maximum surcharge pool	1.40	1.61	1.52	1.70
Seismic (Pseudo-Static)	1.00	1.08	1.02	1.15
