CHOLLA POWER PLANT FLY ASH POND – Periodic Structural Integrity Assessment

Periodic Hazard Potential Classification
Periodic Structural Stability Assessment
Periodic Safety Factor Assessment

October 2021
AECOM Project 60664605

Attachment A: AECOM, 2016. *Final Summary Report, Structural Integrity Assessment: Fly Ash Pond, Cholla Power Plant, Joseph City, Arizona*. Prepared for: Arizona Public Service, AECOM Job No. 60445840, August 26, 2016

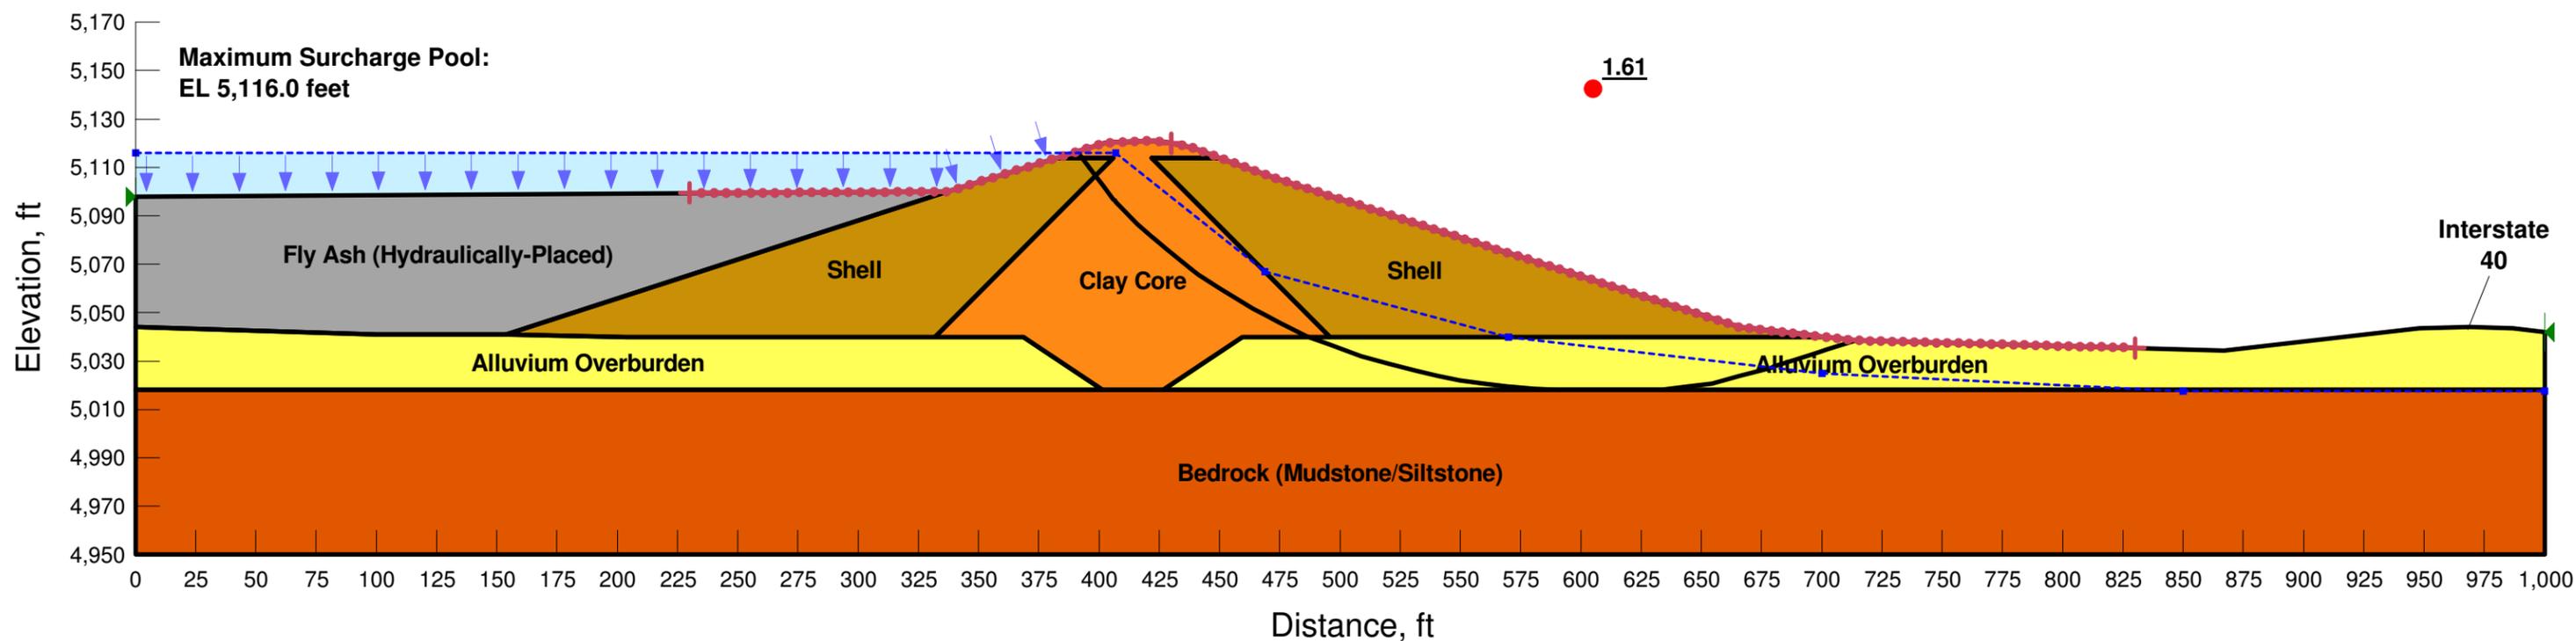
Factor of Safety: 1.61

Material Type:	Unit Weight Saturated:	Unit Weight Above Water:	Cohesion:	Friction Angle:
Clay Core	125 pcf	120 pcf	0 psf	28 °
Shell	130 pcf	125 pcf	0 psf	33 °
Alluvium Overburden	120 pcf	120 pcf	0 psf	26 °
Bedrock (Mudstone/Siltstone)	150 pcf	150 pcf	1,000 psf	65 °
Fly Ash (Hydraulically-Placed)	90 pcf	90 pcf	0 psf	0 °

**Slope Stability Analysis
Cross Section 1
Fly Ash Pond**

Loading Condition	Required Safety Factor	Calculated Minimum Safety Factor		
		Cross Section 1	Cross Section 2	Cross Section 3
Long-term, maximum storage pool	1.50	1.63	1.53	1.73
Maximum surcharge pool	1.40	1.61	1.52	1.70
Seismic (Pseudo-Static)	1.00	1.08	1.02	1.15

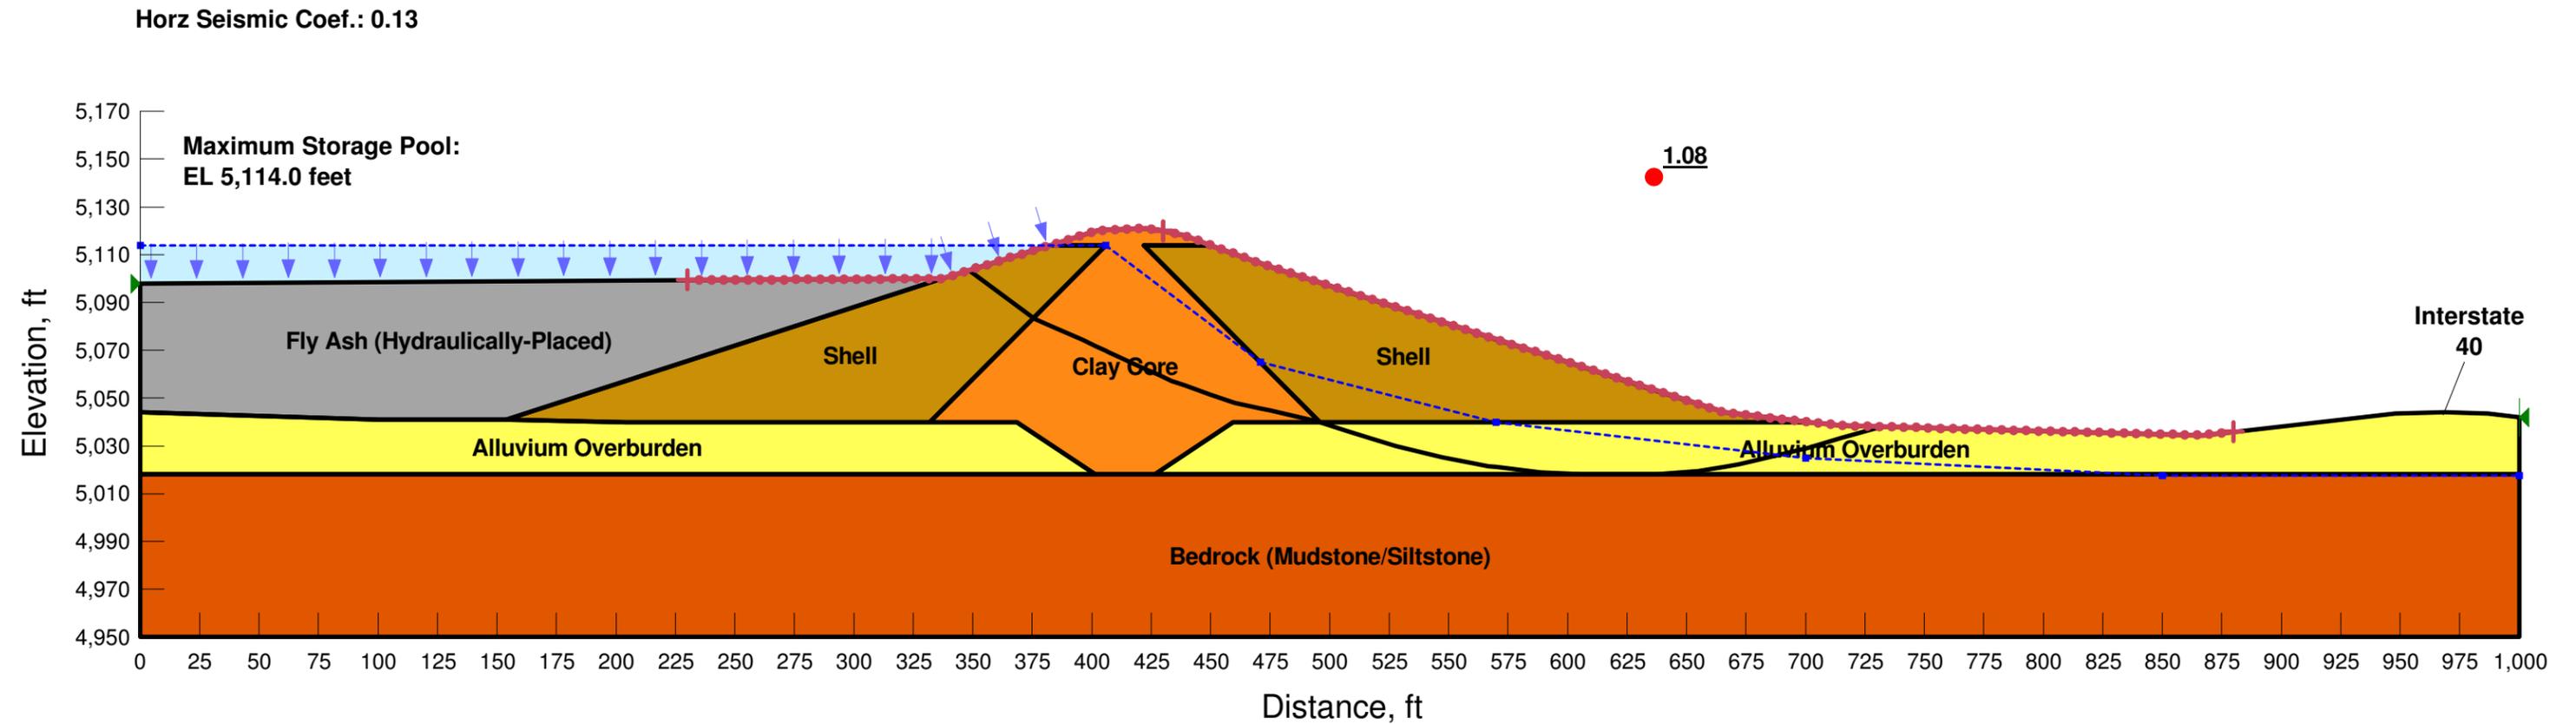
Factor of Safety: 1.08

Material Type:	Unit Weight Saturated:	Unit Weight Above Water:	Cohesion:	Friction Angle:	Undrained Strength Ratio:
Clay Core	125 pcf	120 pcf	--	--	0.38
Shell	130 pcf	125 pcf	0 psf	33 °	--
Alluvium Overburden	120 pcf	120 pcf	0 psf	26 °	--
Bedrock (Mudstone/Siltstone)	150 pcf	150 pcf	1,000 psf	65 °	--
Fly Ash (Hydraulically-Placed)	90 pcf	90 pcf	0 psf	0 °	--

**Slope Stability Analysis
Cross Section 2
Fly Ash Pond**

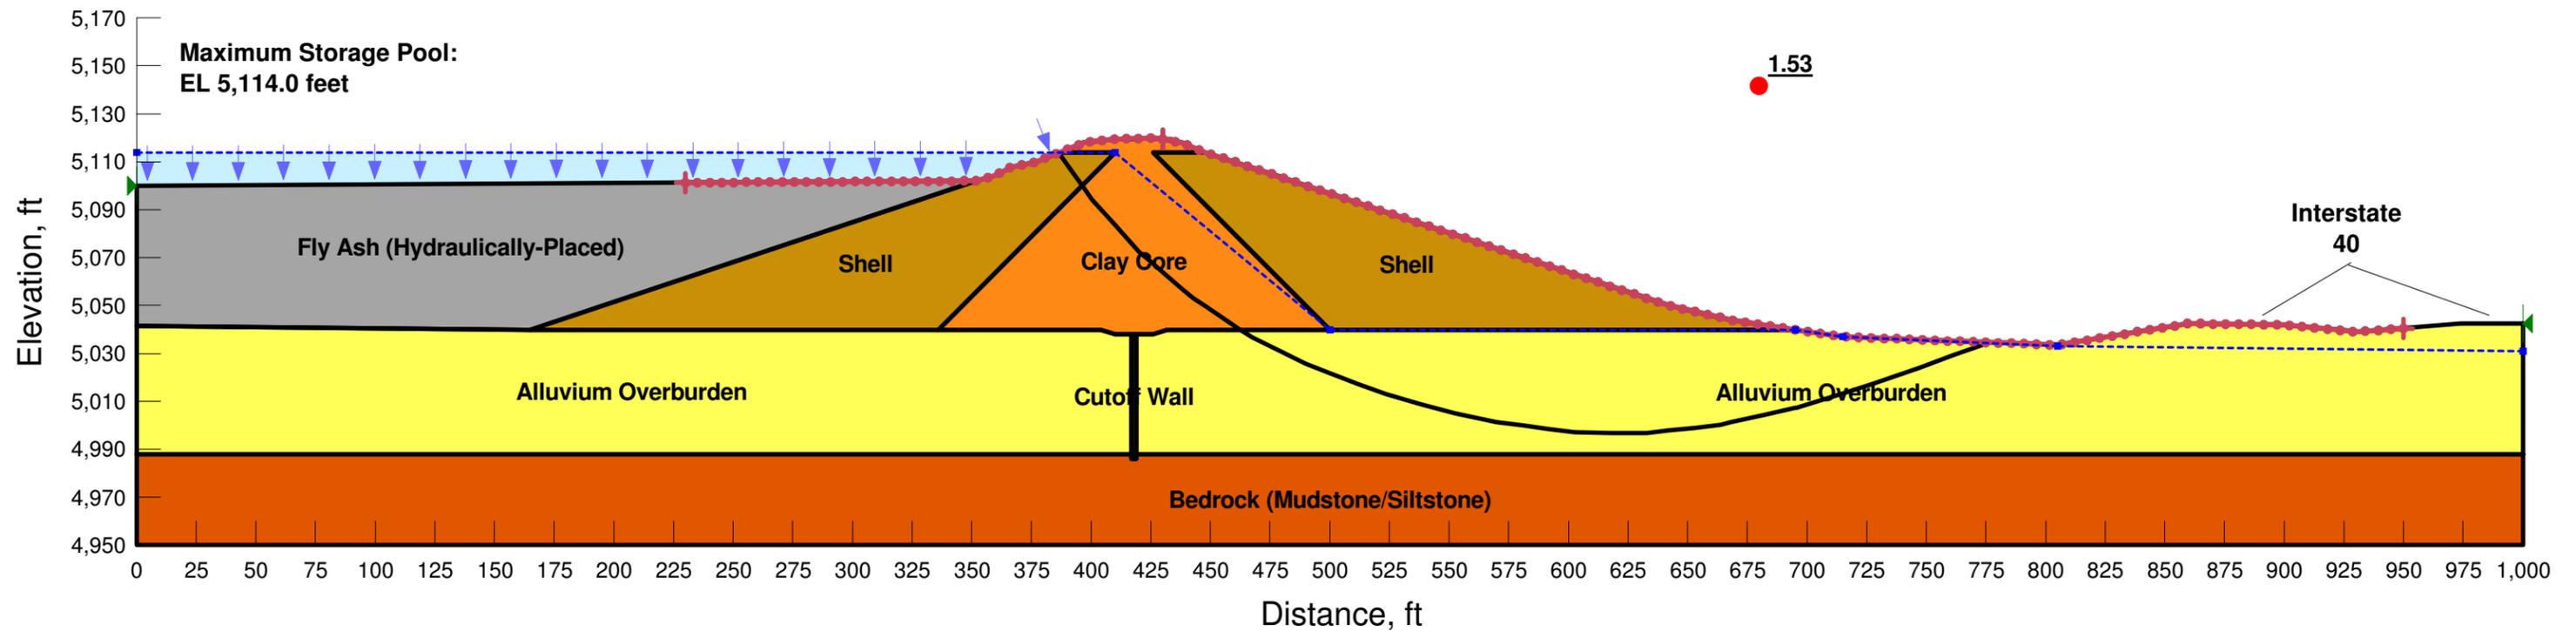
Factor of Safety: 1.53

Material Type:	Unit Weight Saturated:	Unit Weight Above Water:	Cohesion:	Friction Angle:
Clay Core	125 pcf	120 pcf	0 psf	28 °
Shell	130 pcf	125 pcf	0 psf	33 °
Alluvium Overburden	120 pcf	120 pcf	0 psf	26 °
Bedrock (Mudstone/Siltstone)	150 pcf	150 pcf	1,000 psf	65 °
Cutoff Wall	106 pcf	106 pcf	0 psf	28 °
Fly Ash (Hydraulically-Placed)	90 pcf	90 pcf	0 psf	0 °

**Slope Stability Analysis
Cross Section 2
Fly Ash Pond**

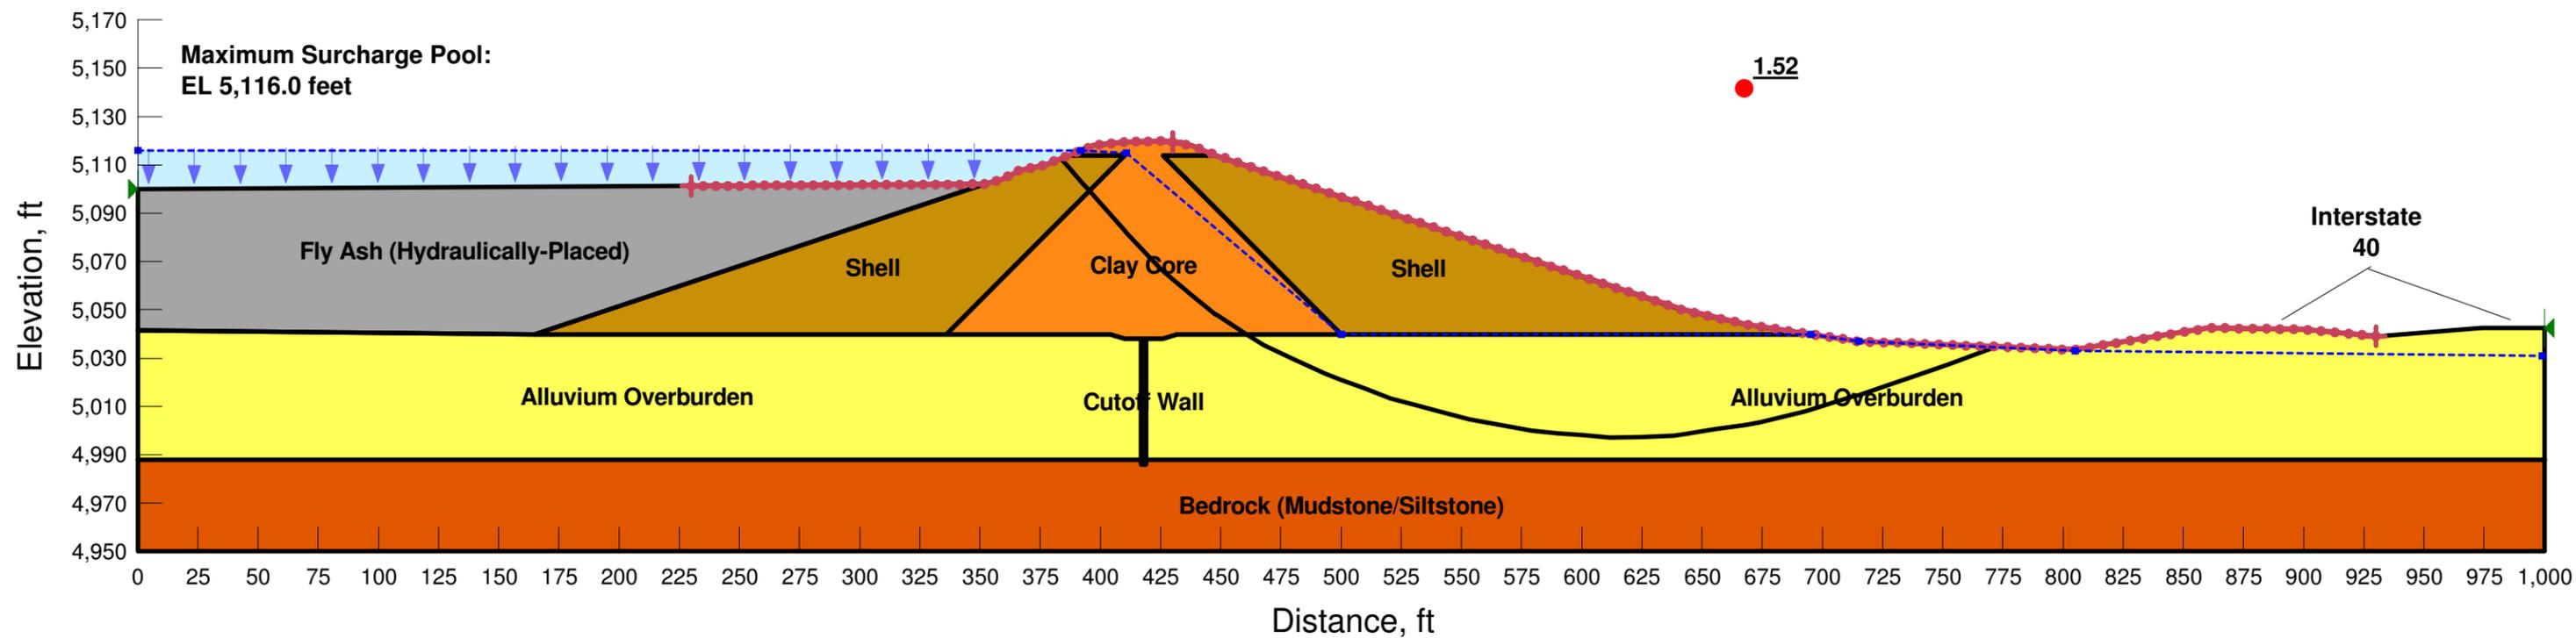
Factor of Safety: 1.52

Material Type:	Unit Weight Saturated:	Unit Weight Above Water:	Cohesion:	Friction Angle:
Clay Core	125 pcf	120 pcf	0 psf	28 °
Shell	130 pcf	125 pcf	0 psf	33 °
Alluvium Overburden	120 pcf	120 pcf	0 psf	26 °
Bedrock (Mudstone/Siltstone)	150 pcf	150 pcf	1,000 psf	65 °
Cutoff Wall	106 pcf	106 pcf	0 psf	28 °
Fly Ash (Hydraulically-Placed)	90 pcf	90 pcf	0 psf	0 °

**Slope Stability Analysis
Cross Section 2
Fly Ash Pond**

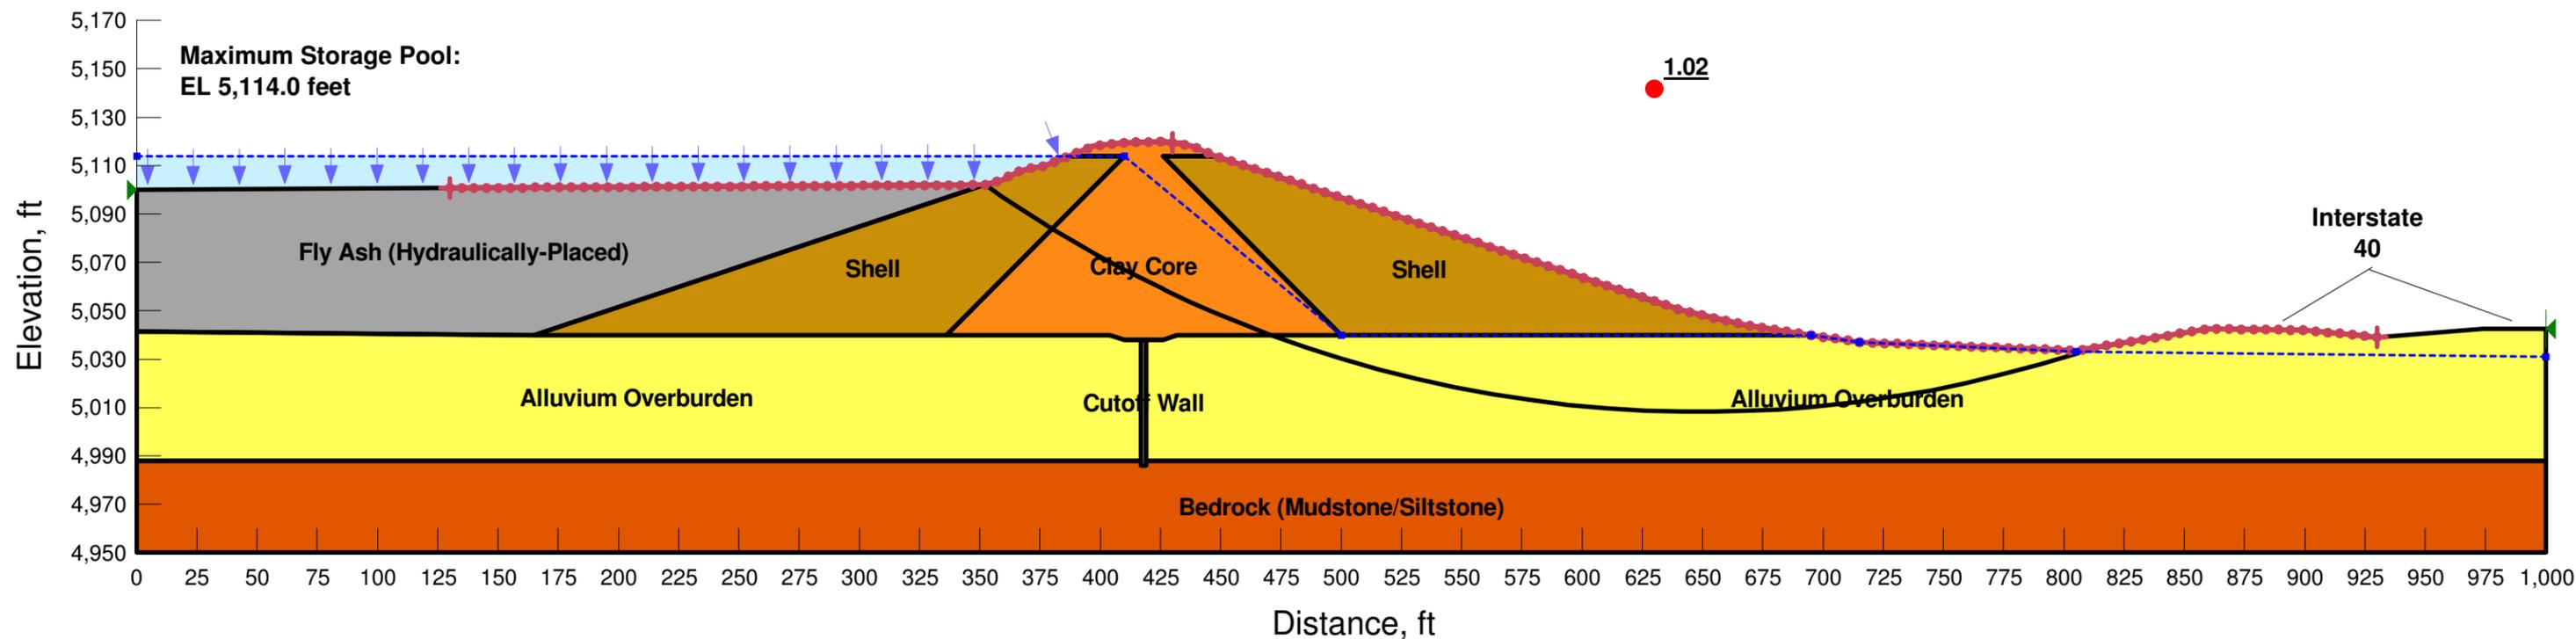
Material Type:	Unit Weight Saturated:	Unit Weight Above Water:	Cohesion:	Friction Angle:	Undrained Strength Ratio:
Clay Core	125 pcf	120 pcf	--	--	0.38
Shell	130 pcf	125 pcf	0 psf	33 °	--
Alluvium Overburden	120 pcf	120 pcf	0 psf	26 °	--
Bedrock (Mudstone/Siltstone)	150 pcf	150 pcf	1,000 psf	65 °	--
Cutoff Wall	106 pcf	106 pcf	10 psf	0 °	--
Fly Ash (Hydraulically-Placed)	90 pcf	90 pcf	0 psf	0 °	--

Horz Seismic Coef.: 0.13

**Slope Stability Analysis
Cross Section 3
Fly Ash Pond**

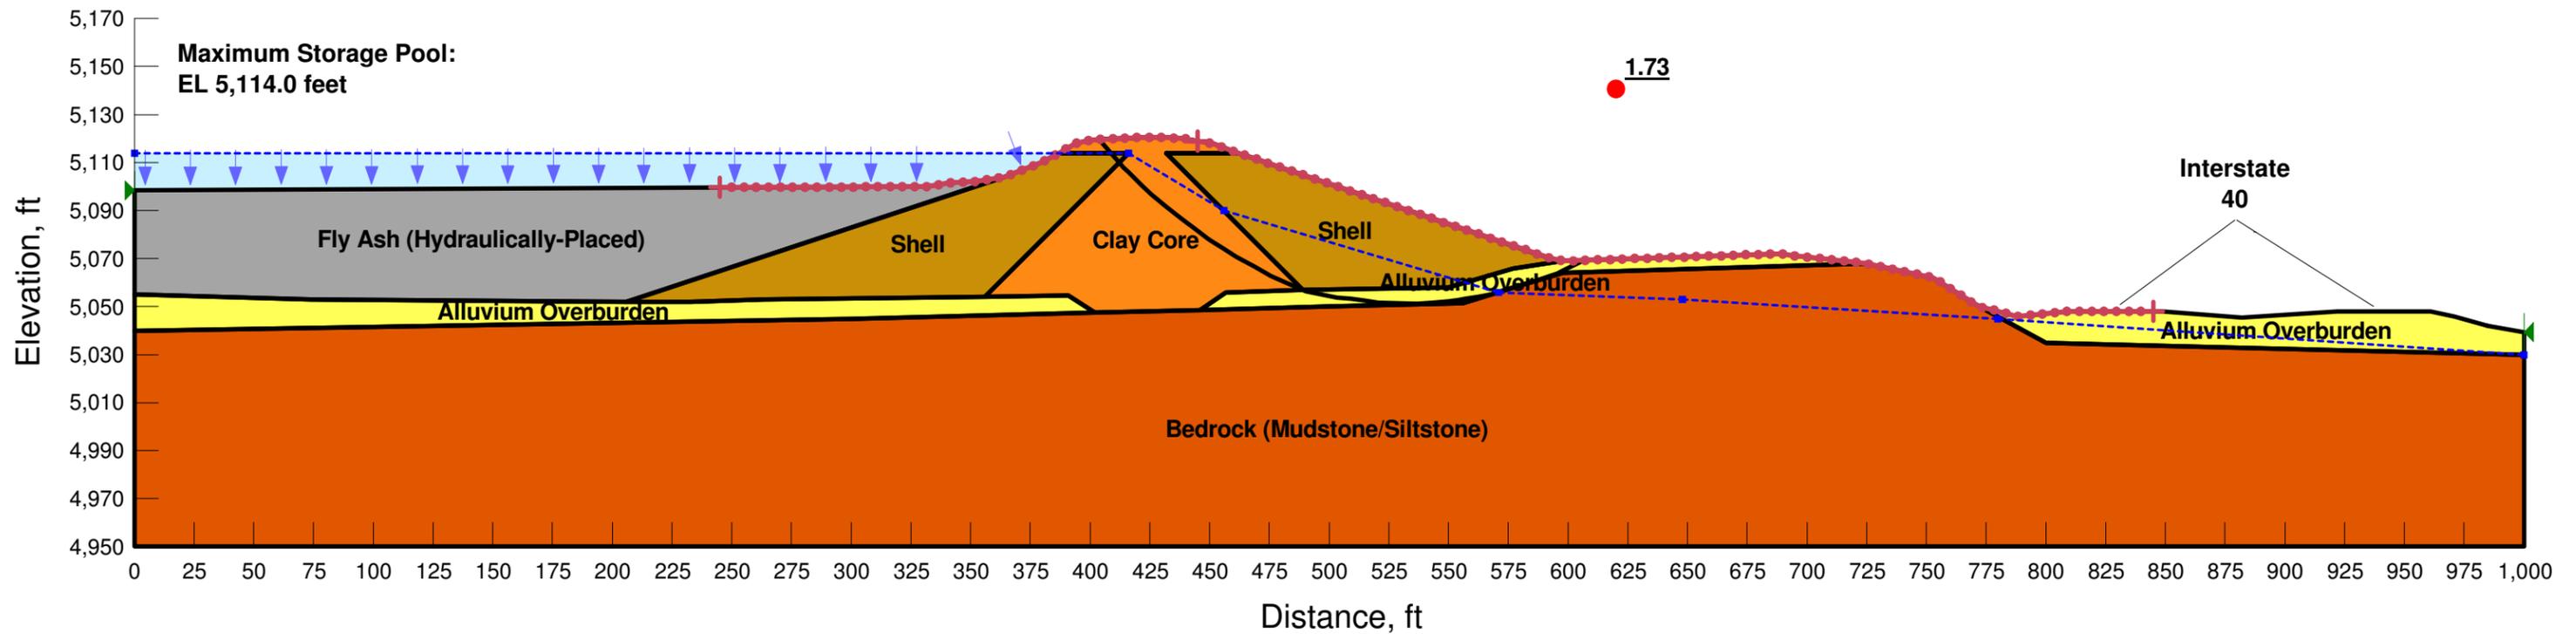
Factor of Safety: 1.73

Material Type:	Unit Weight Saturated:	Unit Weight Above Water:	Cohesion:	Friction Angle:
Clay Core	125 pcf	120 pcf	0 psf	28 °
Shell	130 pcf	125 pcf	0 psf	33 °
Alluvium Overburden	120 pcf	120 pcf	0 psf	26 °
Bedrock (Mudstone/Siltstone)	150 pcf	150 pcf	1,000 psf	65 °
Fly Ash (Hydraulically-Placed)	90 pcf	90 pcf	0 psf	0 °

**Slope Stability Analysis
Cross Section 3
Fly Ash Pond**

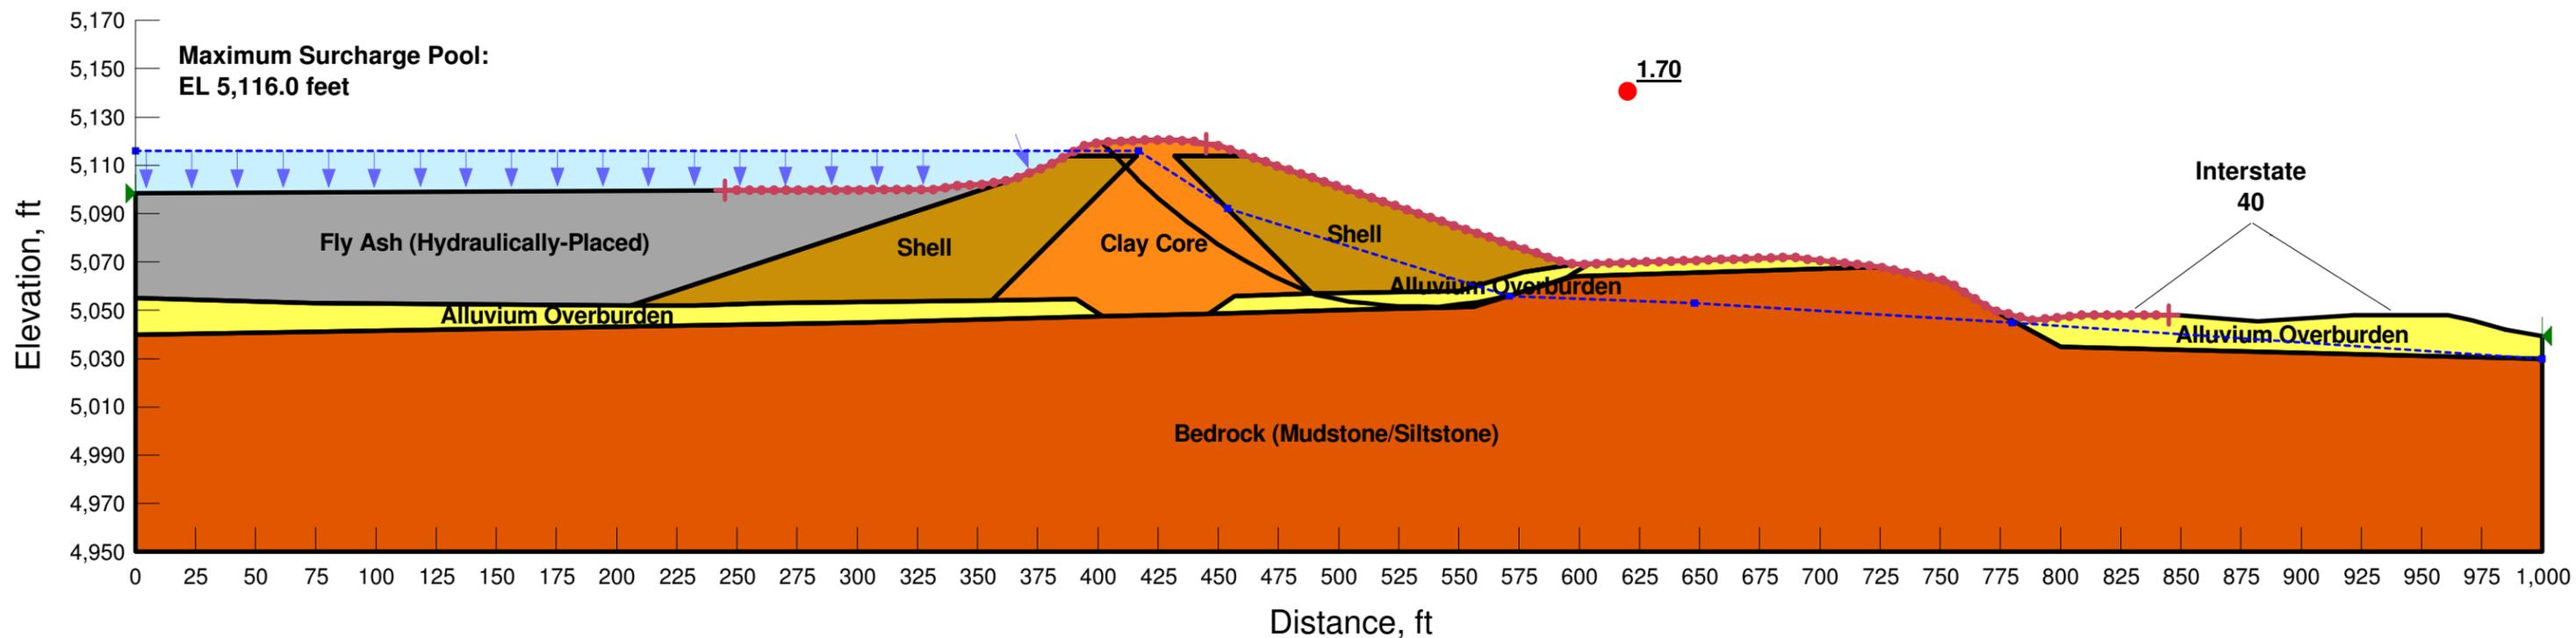
Factor of Safety: 1.70

Material Type:	Unit Weight Saturated:	Unit Weight Above Water:	Cohesion:	Friction Angle:
Clay Core	125 pcf	120 pcf	0 psf	28 °
Shell	130 pcf	125 pcf	0 psf	33 °
Alluvium Overburden	120 pcf	120 pcf	0 psf	26 °
Bedrock (Mudstone/Siltstone)	150 pcf	150 pcf	1,000 psf	65 °
Fly Ash (Hydraulically-Placed)	90 pcf	90 pcf	0 psf	0 °

**Slope Stability Analysis
Cross Section 3
Fly Ash Pond**

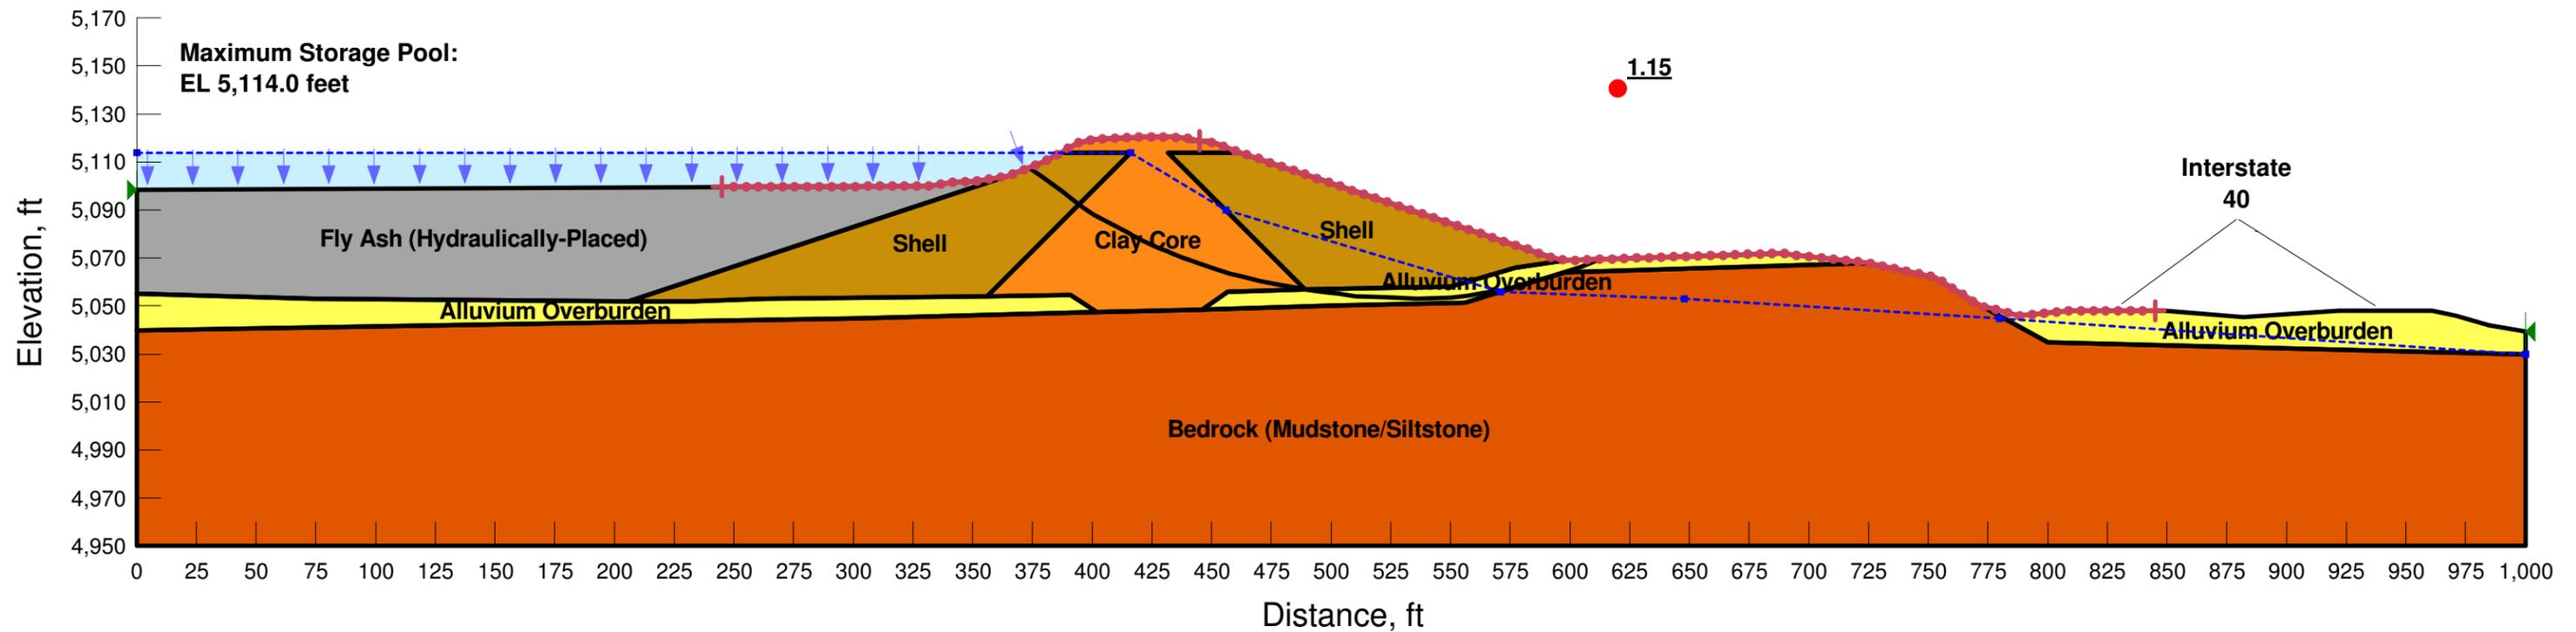
Material Type:	Unit Weight Saturated:	Unit Weight Above Water:	Cohesion:	Friction Angle:	Undrained Strength Ratio:
Clay Core	125 pcf	120 pcf	--	--	0.38
Shell	130 pcf	125 pcf	0 psf	33 °	--
Alluvium Overburden	120 pcf	120 pcf	0 psf	26 °	--
Bedrock (Mudstone/Siltstone)	150 pcf	150 pcf	1,000 psf	65 °	--
Fly Ash (Hydraulically-Placed)	90 pcf	90 pcf	0 psf	0 °	--

Horz Seismic Coef.: 0.13
