**EMERGENCY ACTION PLAN FOR
LINED ASH IMPOUNDMENT AND
LINED DECANT WATER POND
NMOSE FILE NOS. D-634 AND D-635
FOUR CORNERS POWER PLANT
SAN JUAN COUNTY, NEW MEXICO**

**Prepared for
ARIZONA PUBLIC SERVICE
COMPANY**

**Prepared by
AECOM
Revision 2: February 2017
Revision 3: January 2020**

**EMERGENCY ACTION PLAN
FOR
LINED ASH IMPOUNDMENT (LAI) AND
LINED DECANT WATER POND (LDWP)**

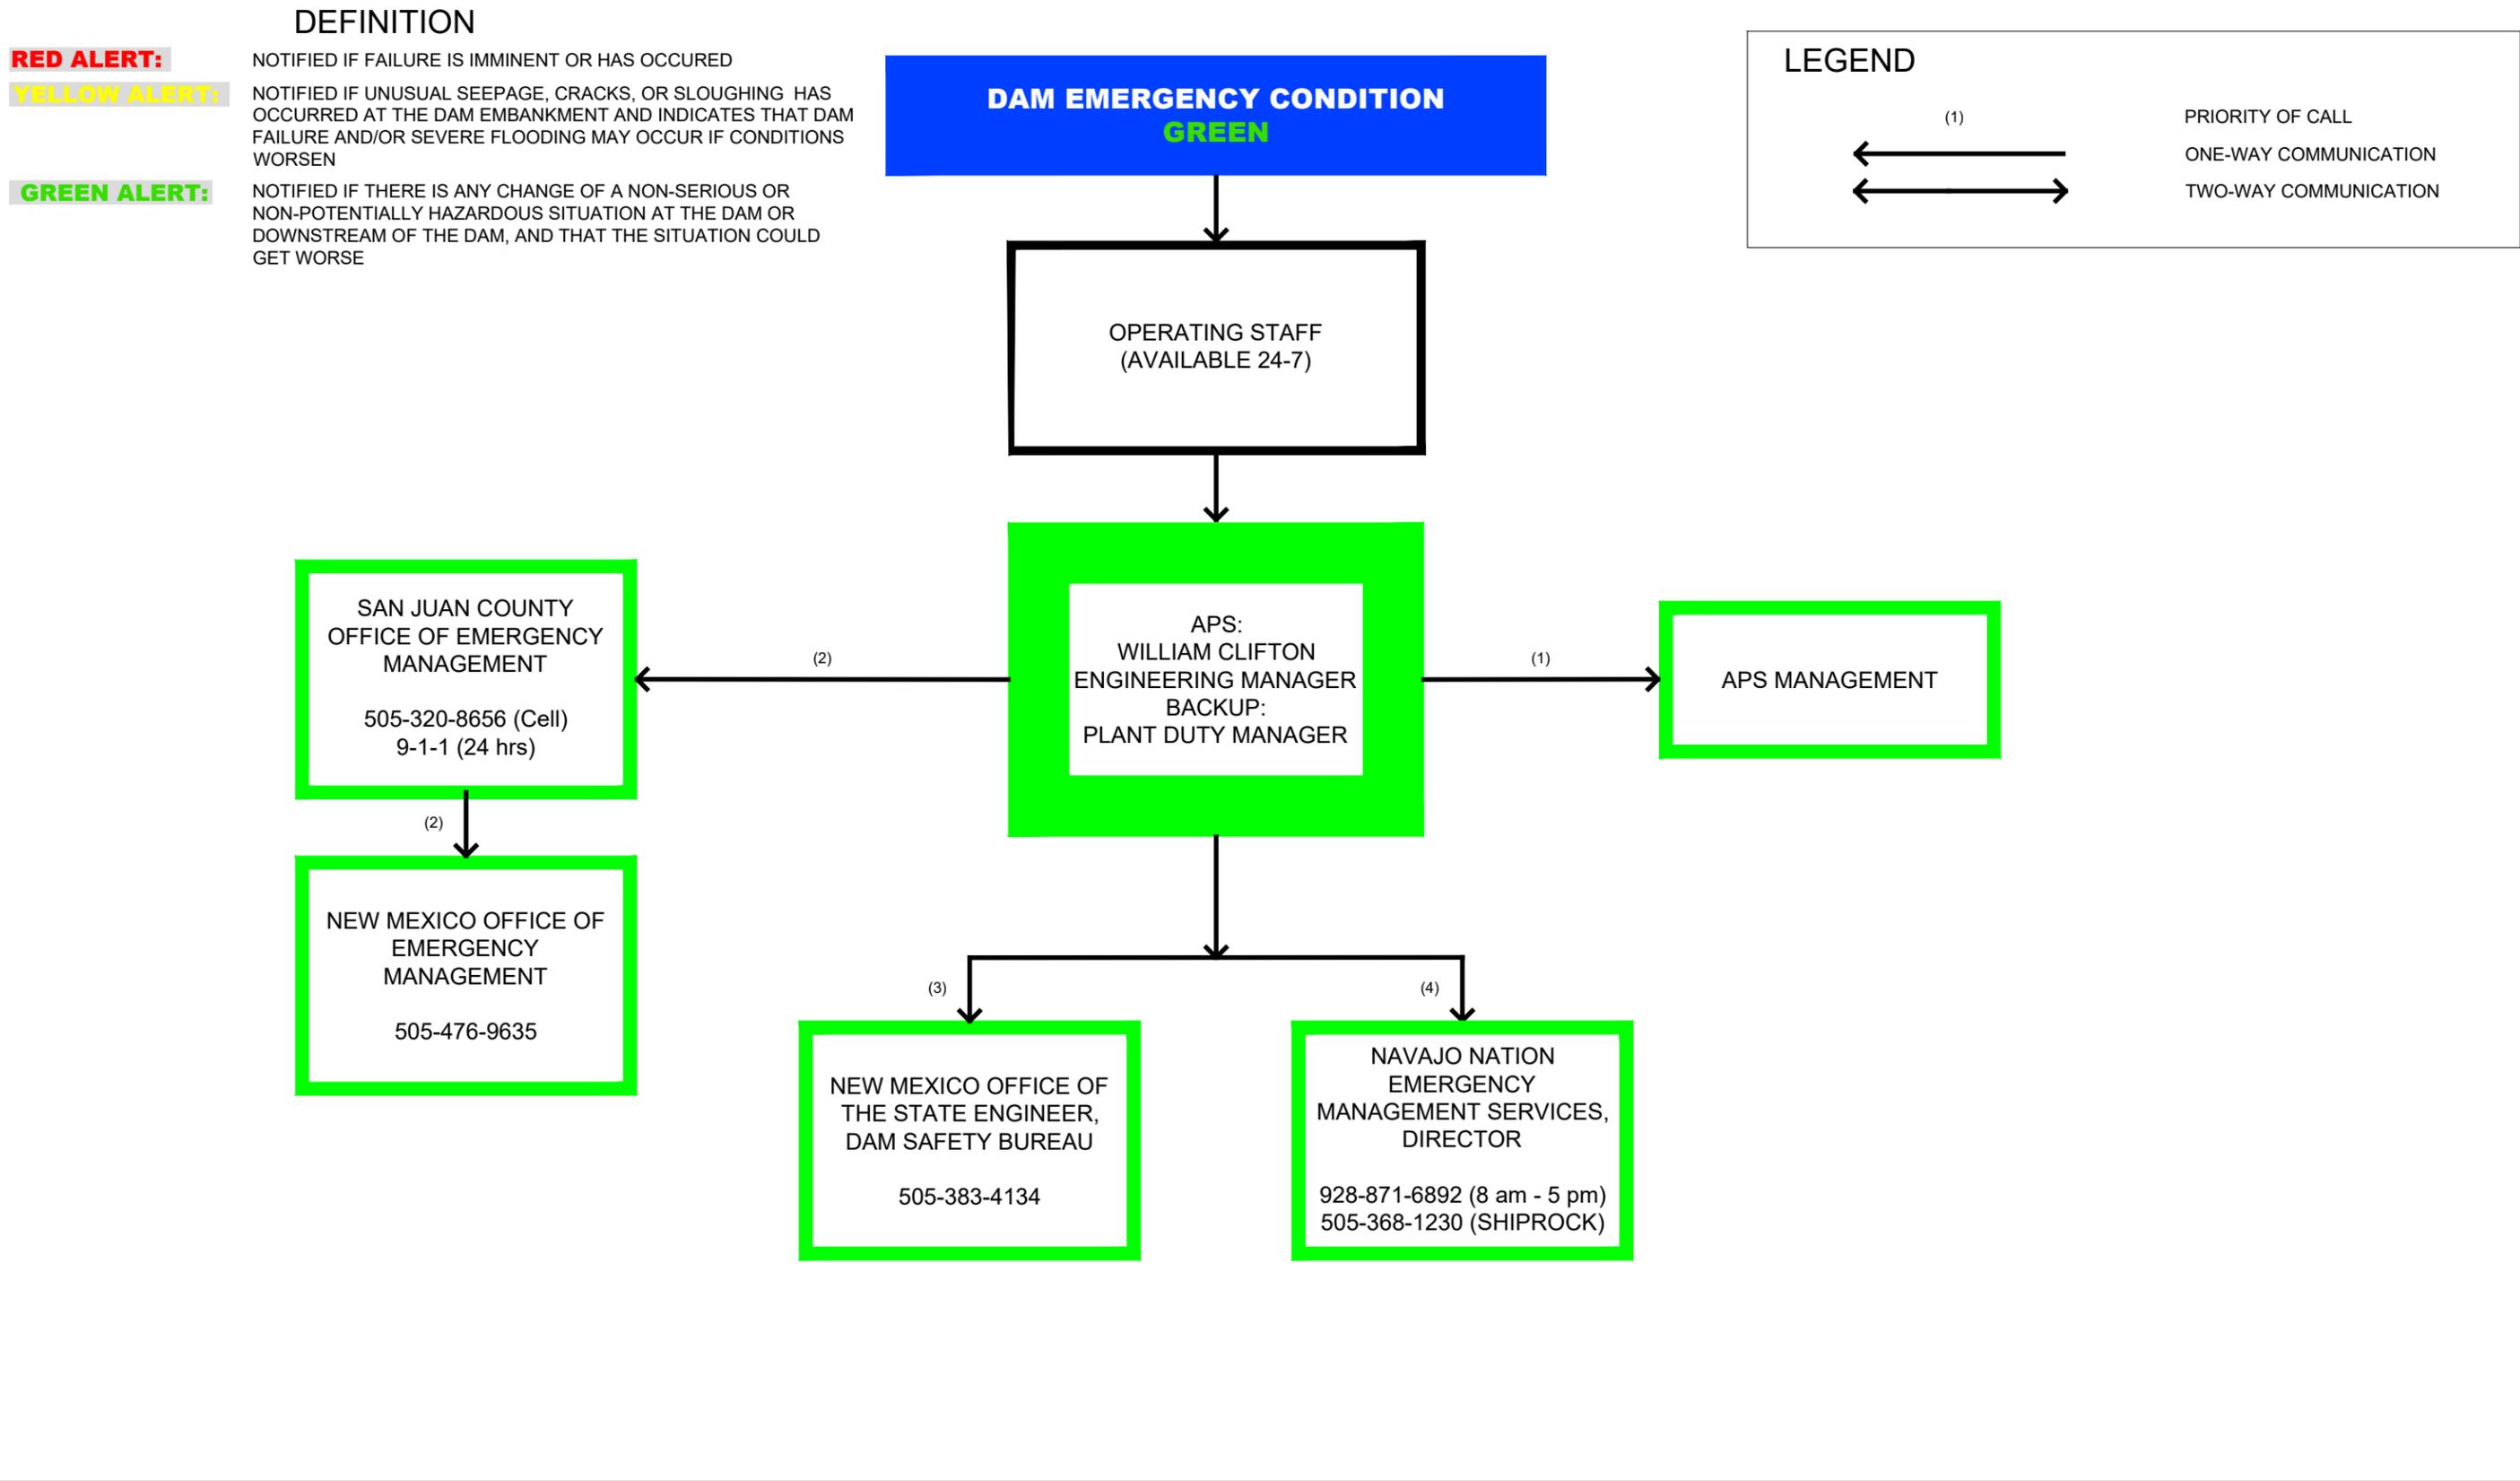
Figure 1-2A

Green Alert Notification Flowchart

- **SLOWLY DEVELOPING SITUATION**
- Something unusual is happening at the LAI and/or LDWP.
- There is the potential for impoundment breach.
- Current conditions are not serious, but could progress into a potential impoundment failure if it continues or intensifies.
- Initiate Level GREEN notifications (Flowchart: Fig 1-2A, GREEN phone list: p 3-3).

Determine if a situation is Developing or Imminent, then refer to the Notification Charts (Figures 1-2A, B & C)

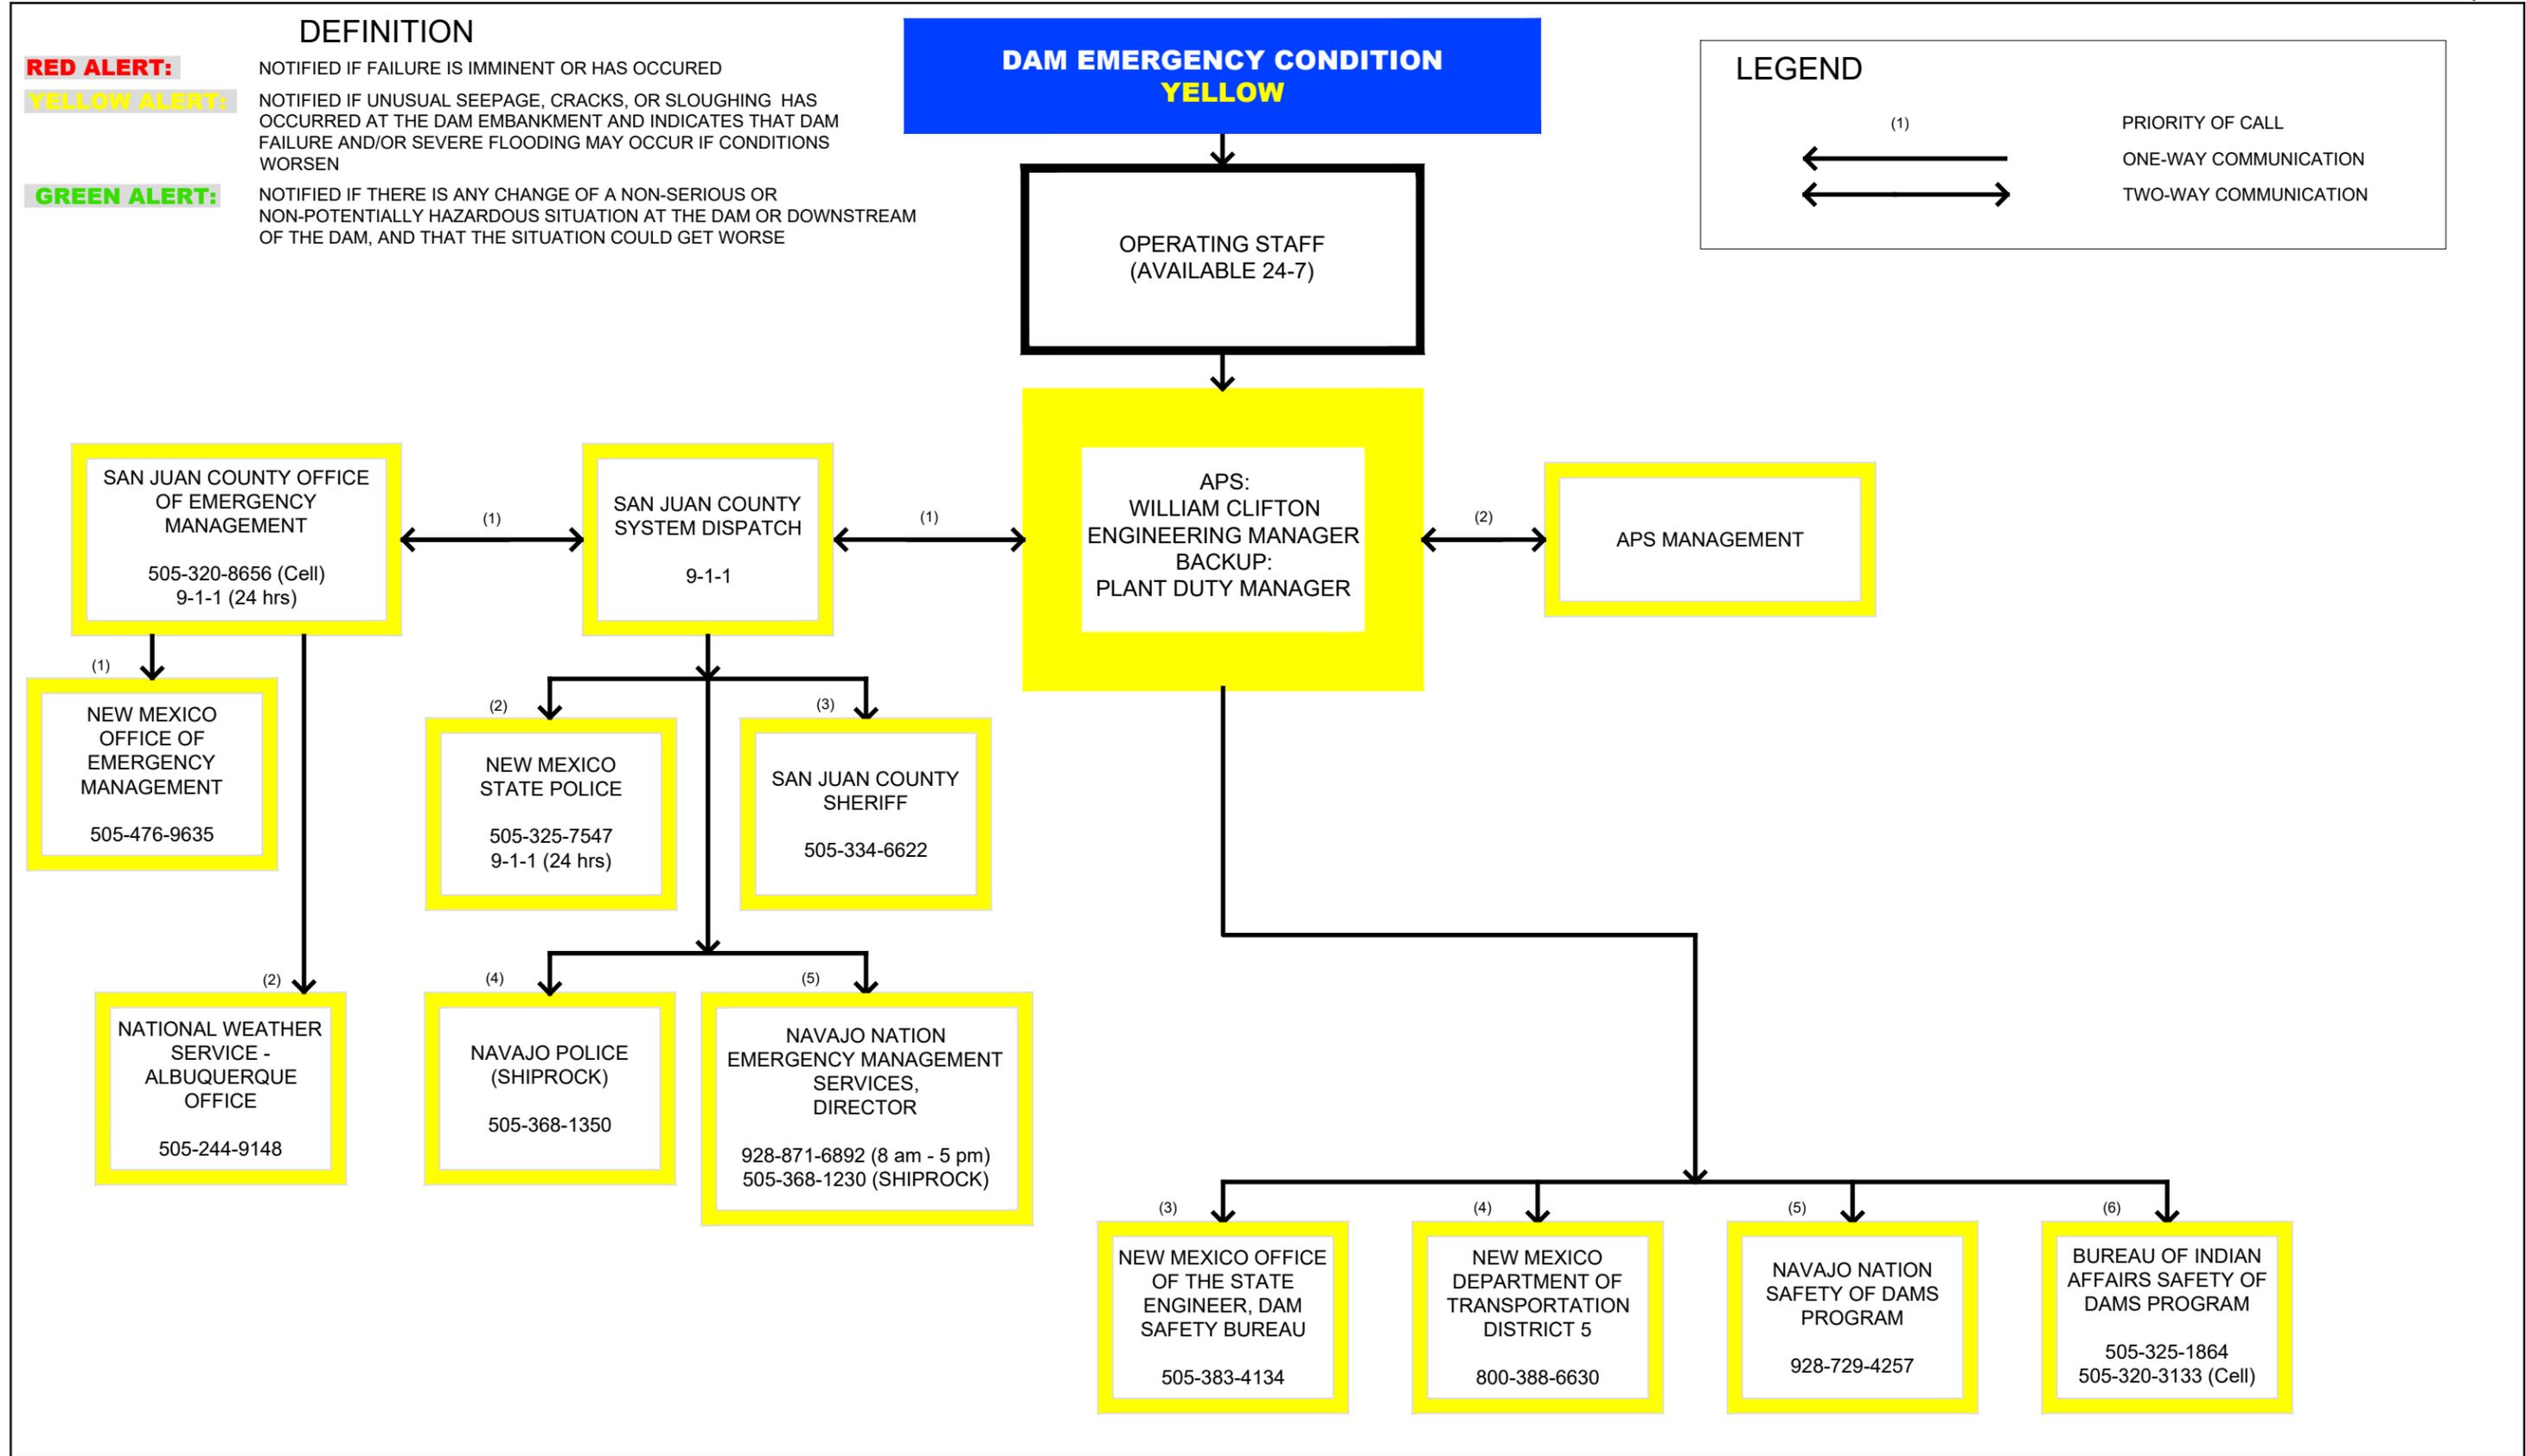
Figure 1-2B

Yellow Alert Notification Flowchart

- **RAPIDLY DEVELOPING SITUATION**
- Conditions are serious (more than a GREEN condition).
- Notify 24-hour operating staff (Refer to Notification Flowchart).
- The condition of the LAI and/or LDWP is becoming unstable.
- Initiate Level YELLOW notifications (Flowchart: Fig 1-2B, YELLOW phone list: p 3-4).
- Populations at risk SHOULD be notified to “standby”, prepare to leave, and await further instructions.
- Evacuations in low-lying areas may be required.

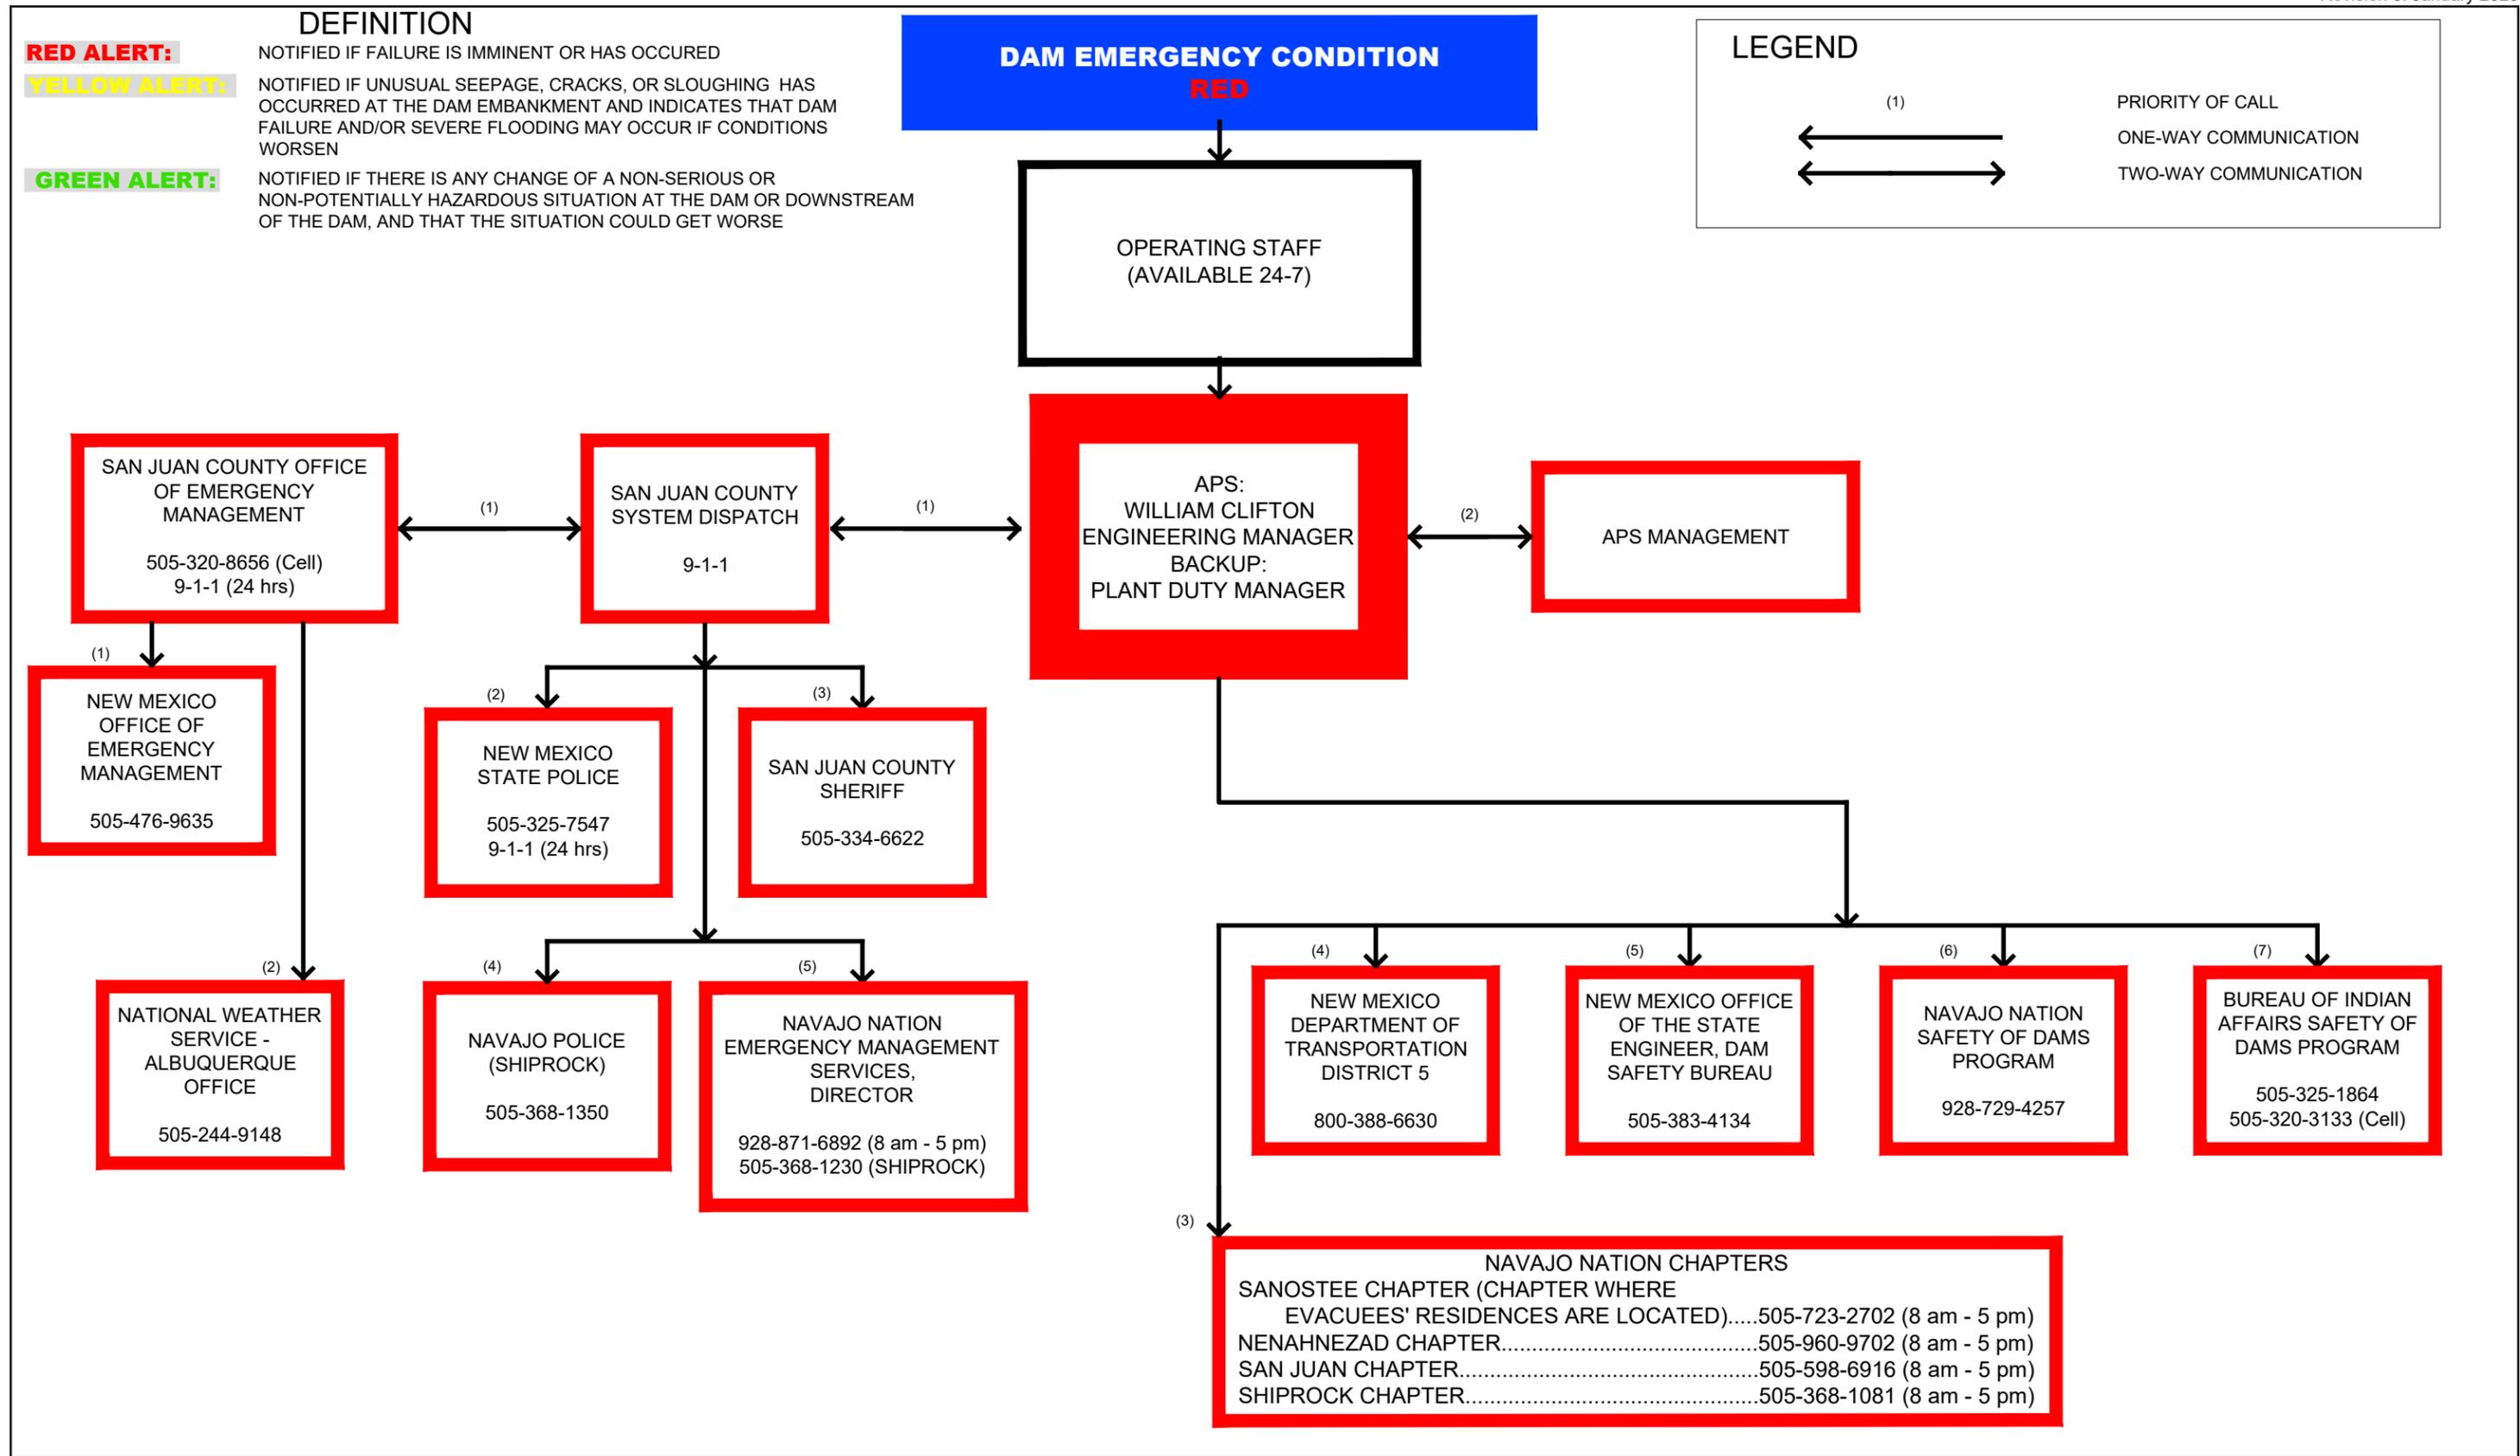
Figure 1-2C

Red Alert Notification Flowchart

- **FAILURE IS IMMINENT (it has been determined that the LAI and/or LDWP will fail), IS OCCURRING, OR HAS OCCURRED; LIFE THREATENING FLOOD WATERS ARE OR WILL BE RELEASED.**
- Life threatening releases will definitely affect populations at risk.
- Immediate evacuation of population at risk is necessary.
- Initiate Level RED notifications (Flowchart: Fig 1-2C, RED phone list: p 3-6).

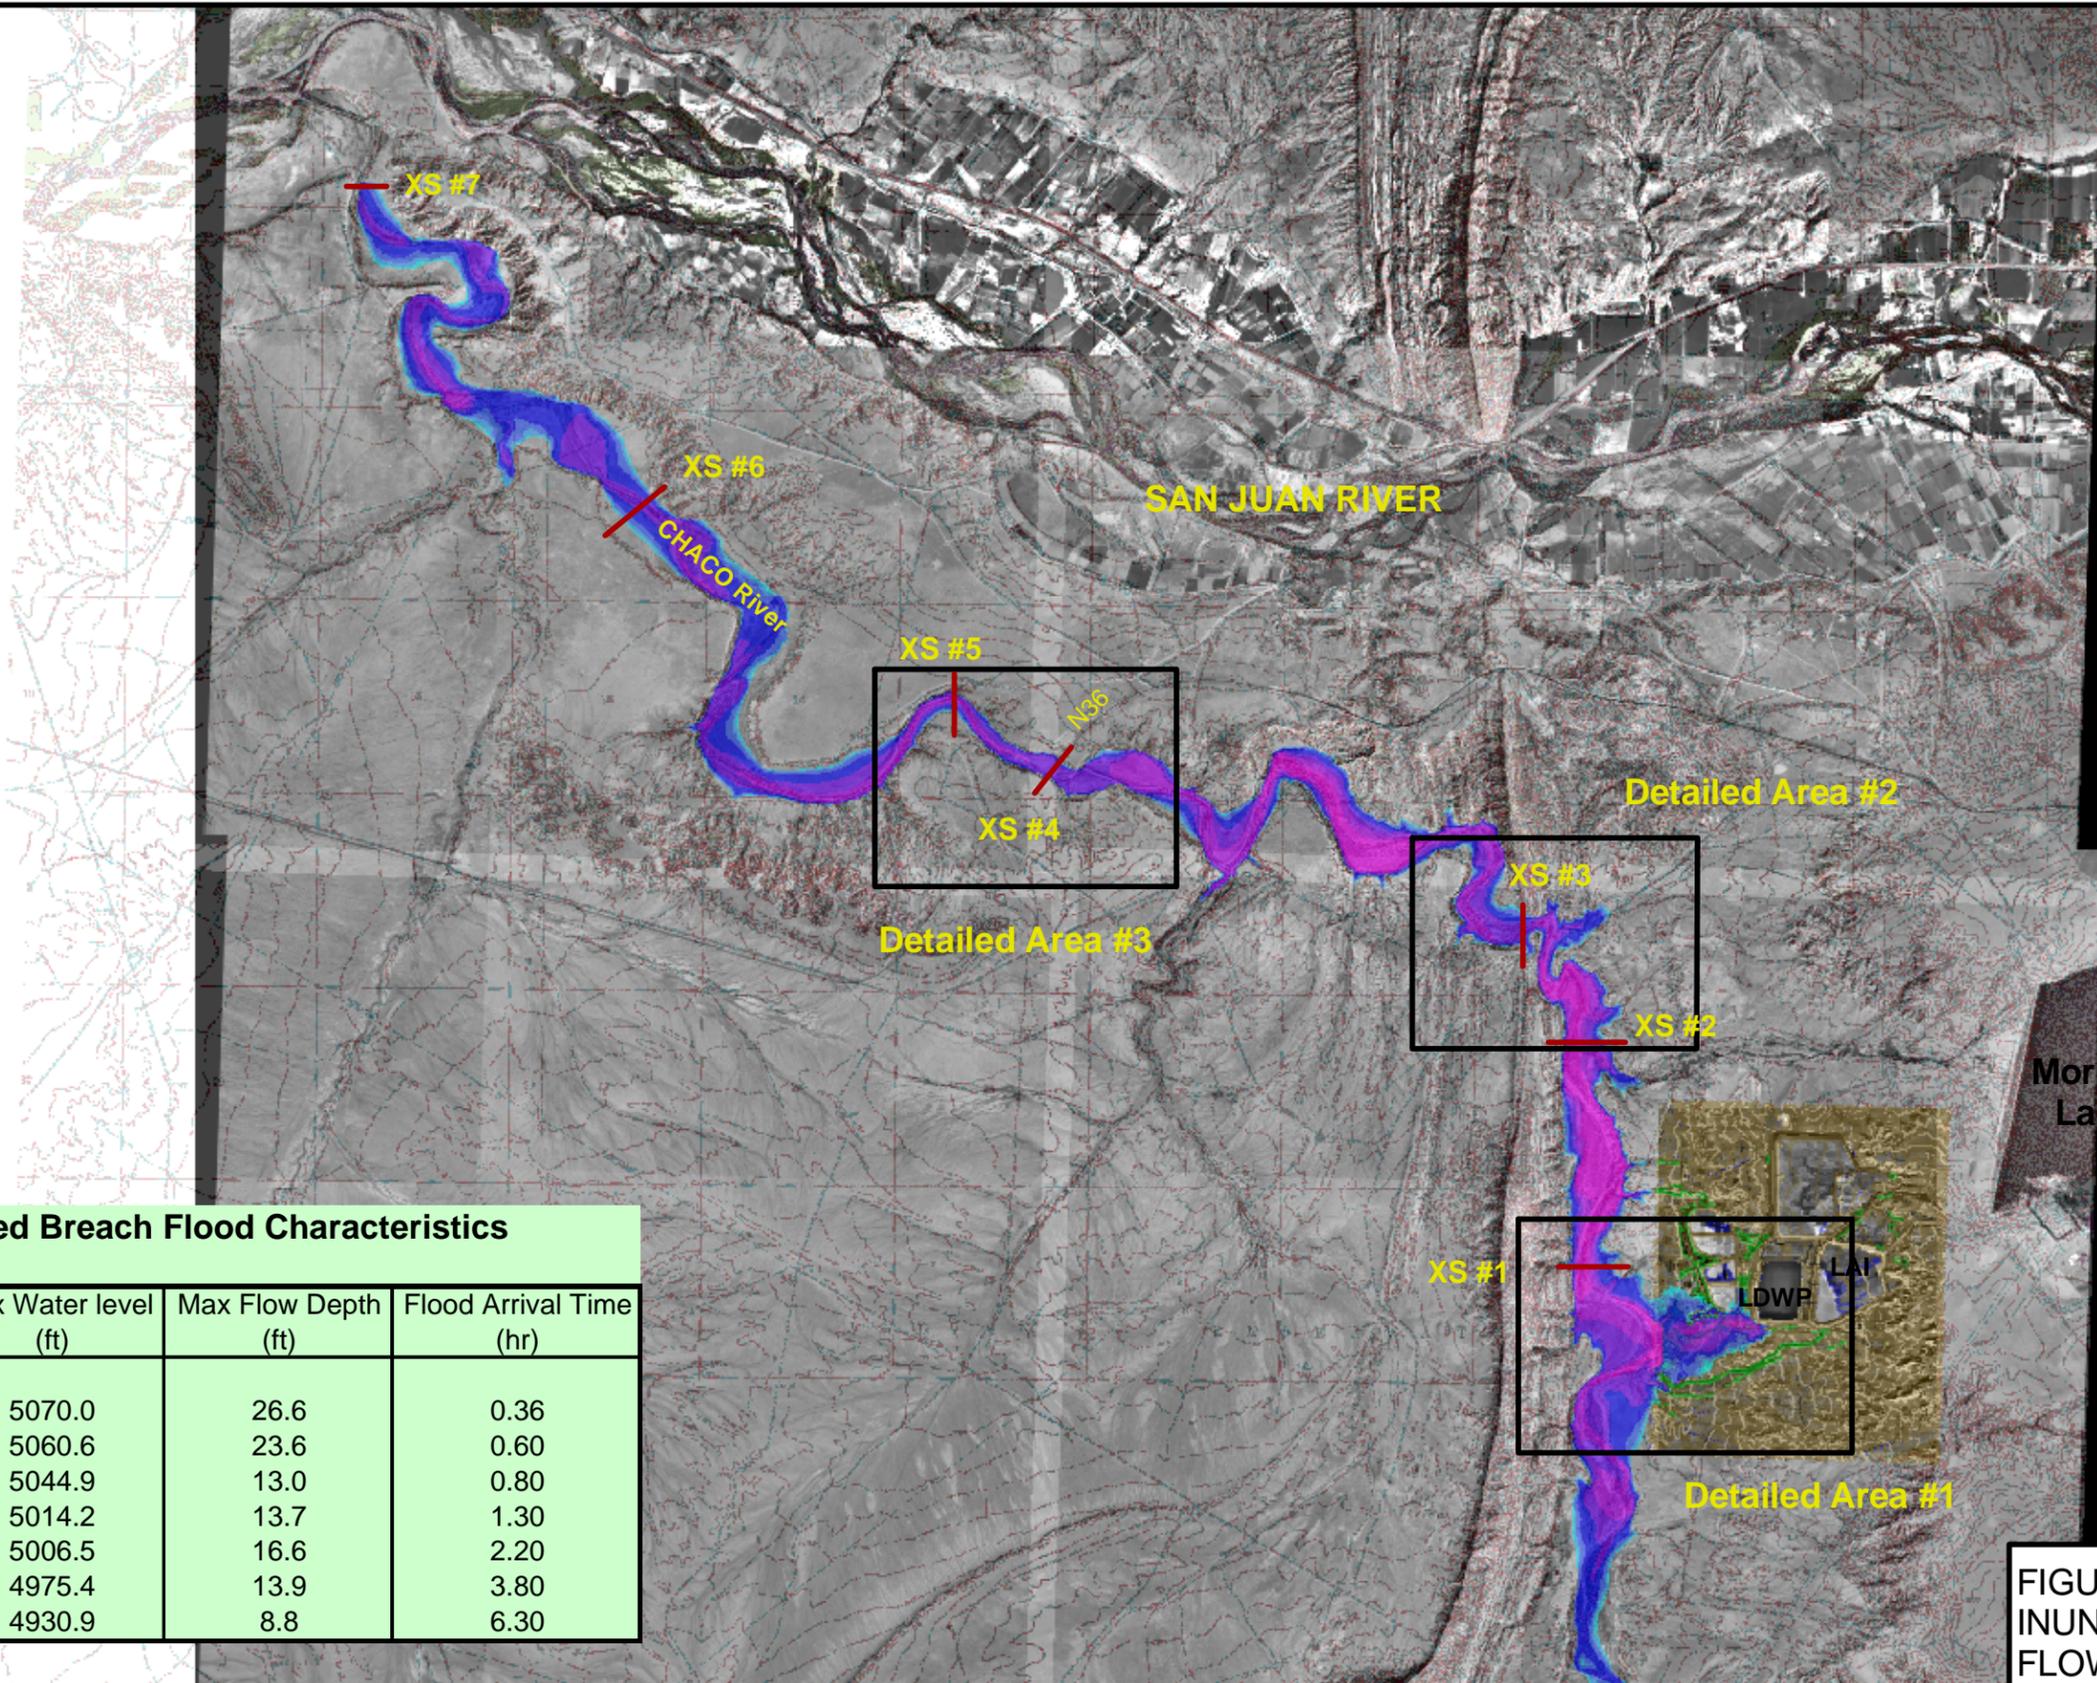
Predicted Breach Flood Characteristics

Cross Section XS #	Max Water level (ft)	Max Flow Depth (ft)	Flood Arrival Time (hr)
1	5070.0	26.6	0.36
2	5060.6	23.6	0.60
3	5044.9	13.0	0.80
4	5014.2	13.7	1.30
5	5006.5	16.6	2.20
6	4975.4	13.9	3.80
7	4930.9	8.8	6.30

FIGURE 3-4: SIMULATED FLOOD INUNDATION LIMITS AND MAXIMUM FLOW DEPTH FOR SCENARIO #1

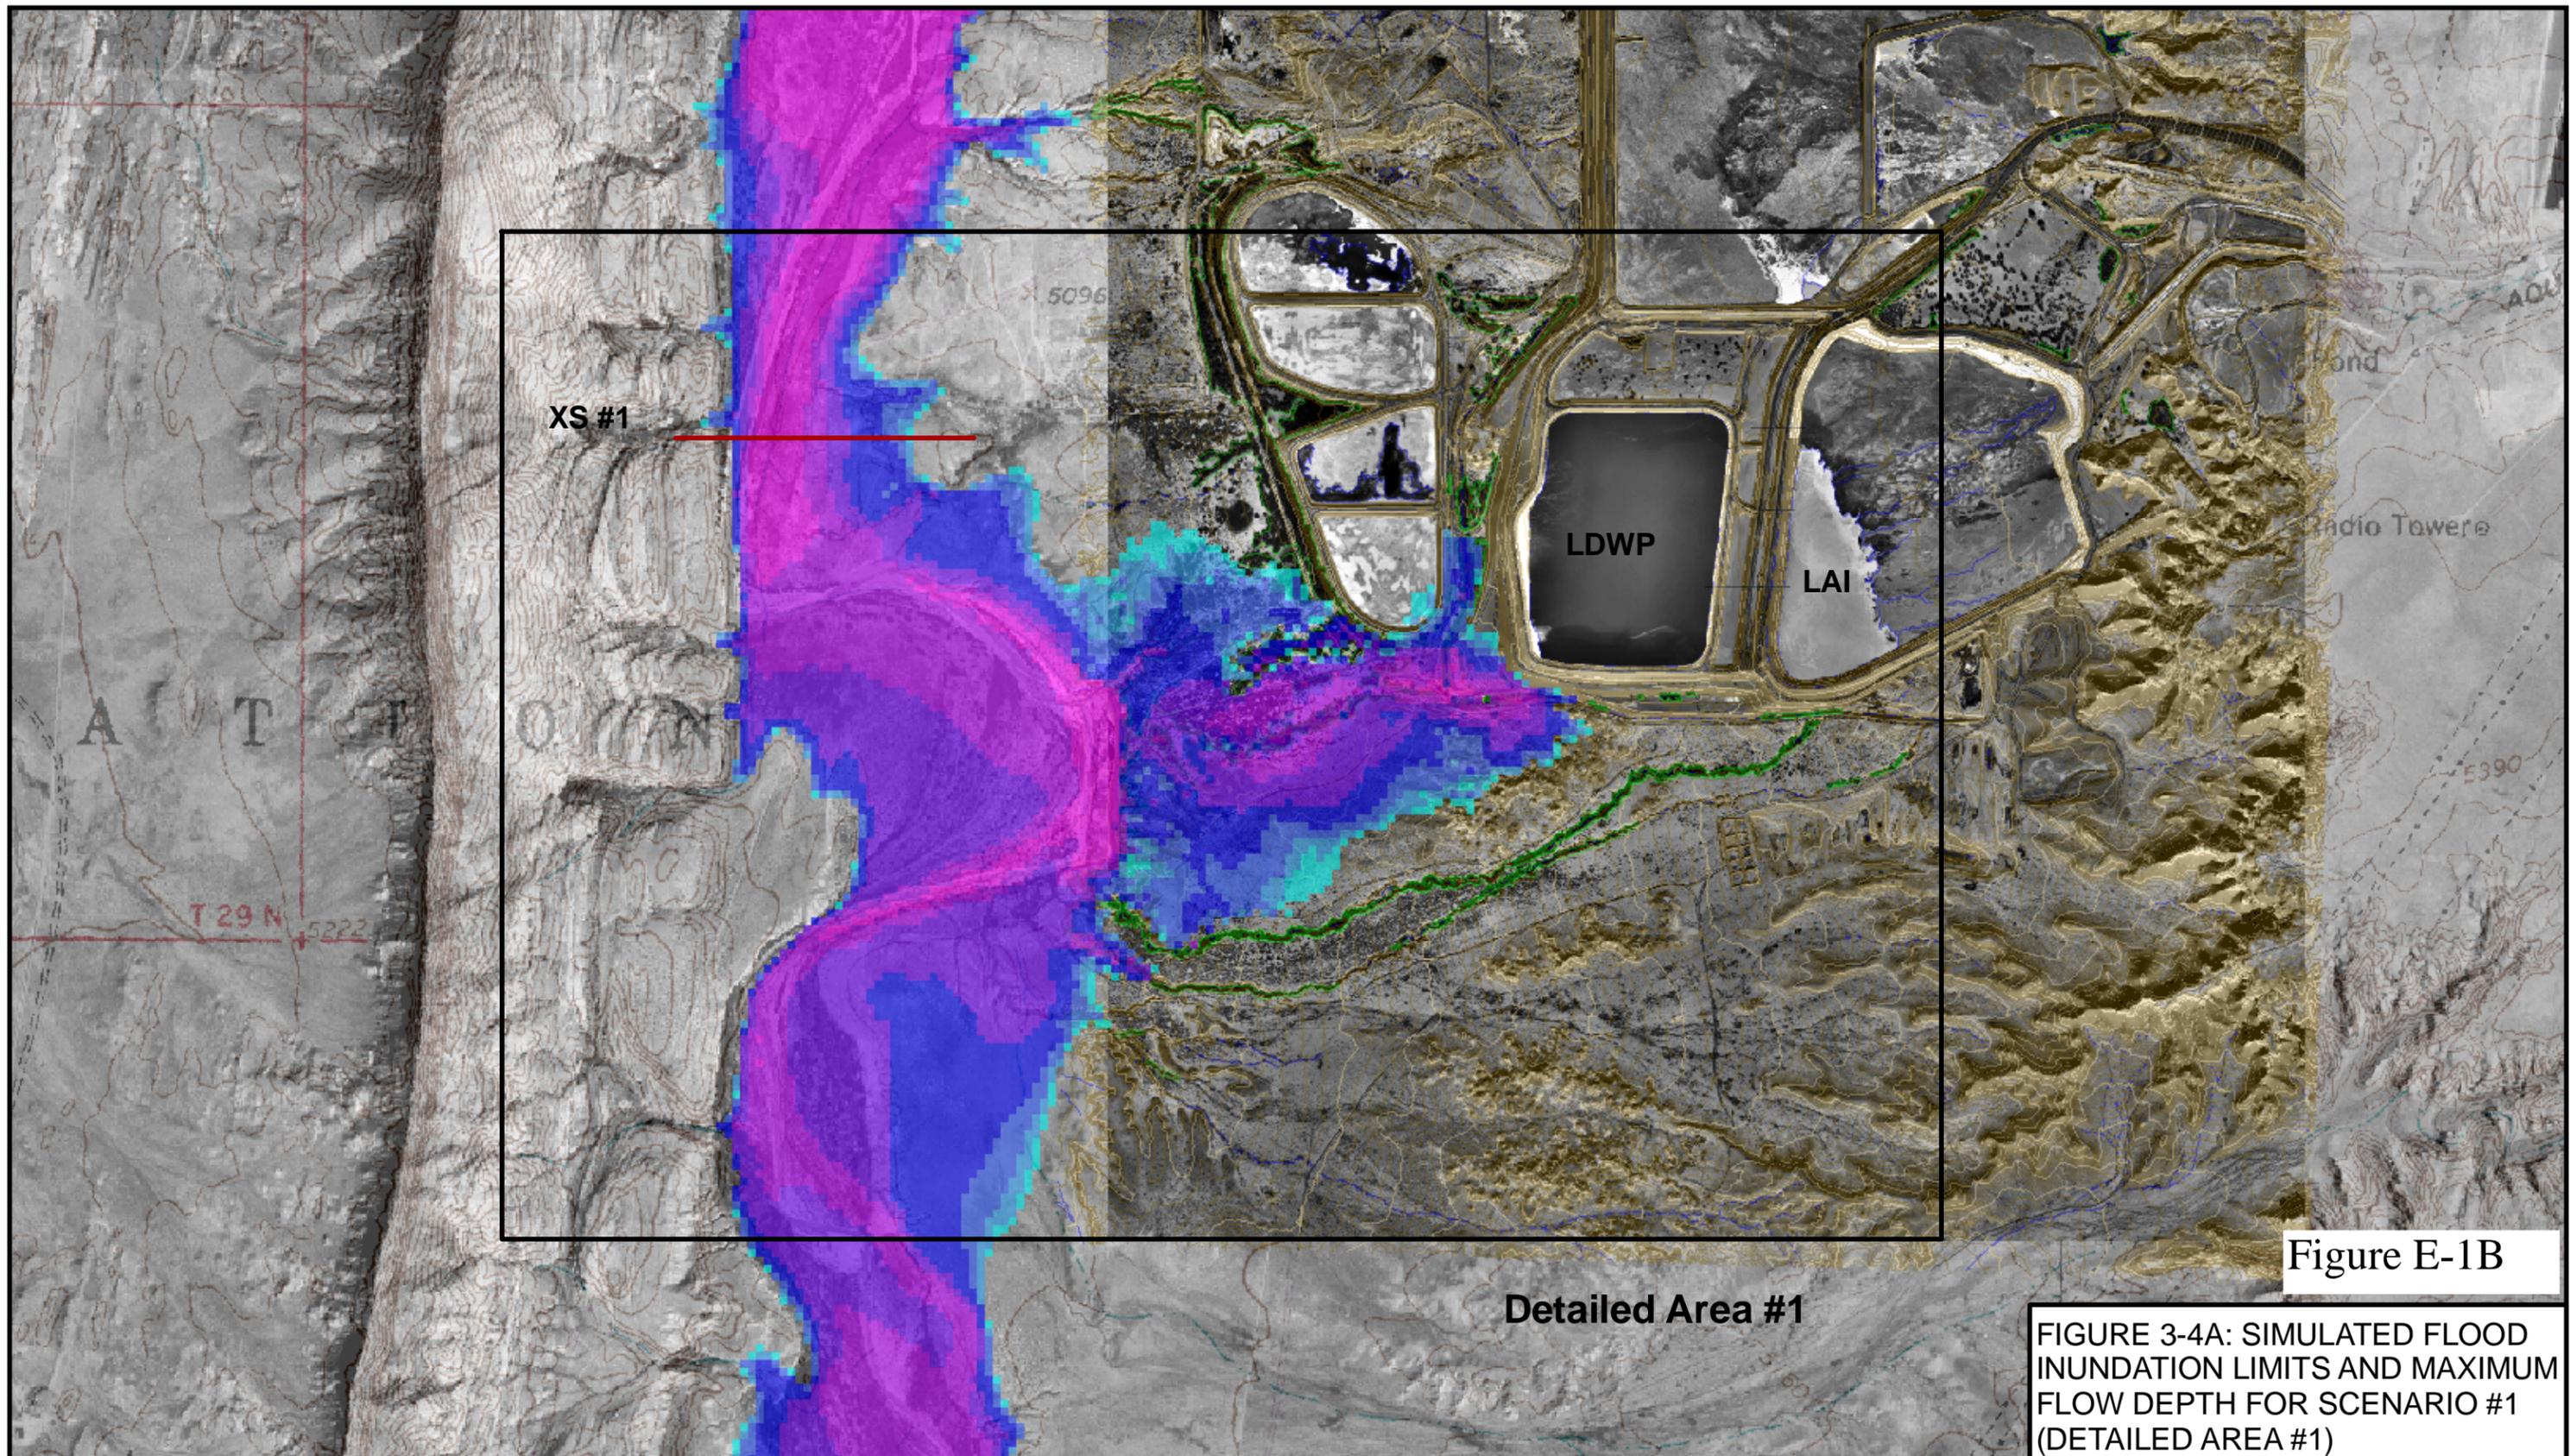
Figure E-1B

FIGURE 3-4A: SIMULATED FLOOD INUNDATION LIMITS AND MAXIMUM FLOW DEPTH FOR SCENARIO #1 (DETAILED AREA #1)

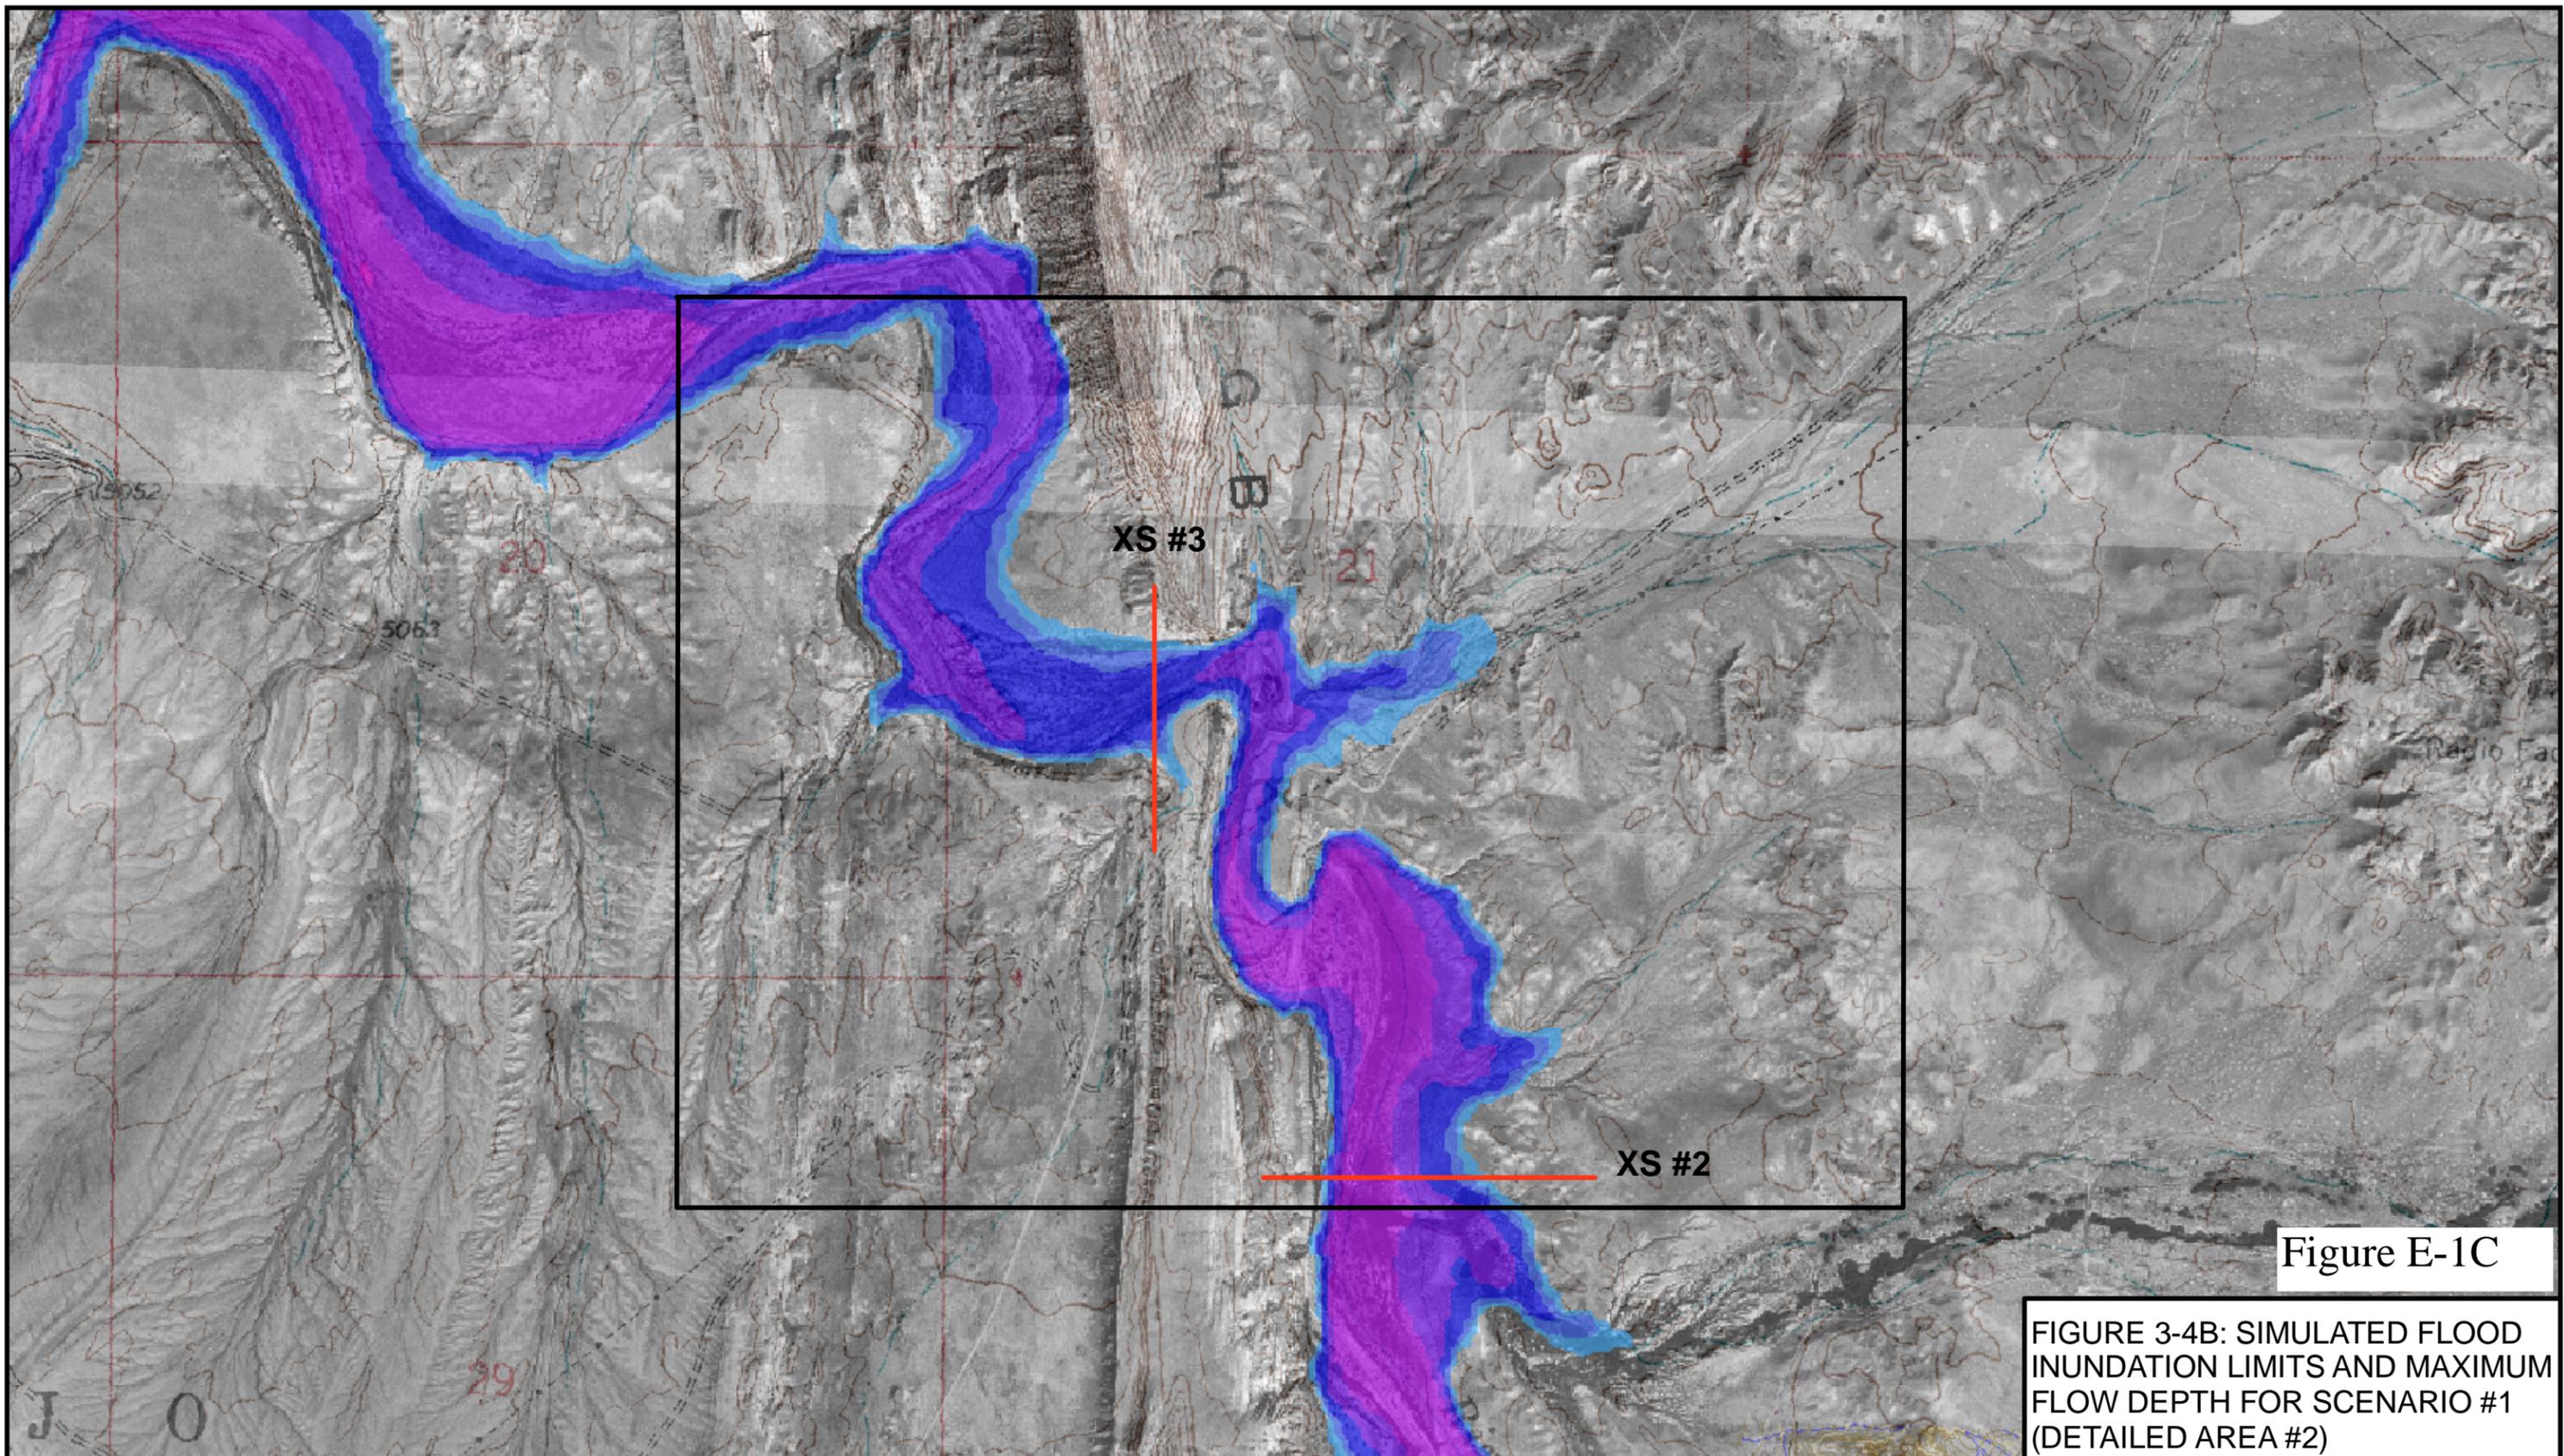
Figure E-1C

FIGURE 3-4B: SIMULATED FLOOD INUNDATION LIMITS AND MAXIMUM FLOW DEPTH FOR SCENARIO #1 (DETAILED AREA #2)
