**EMERGENCY ACTION PLAN FOR
LINED ASH IMPOUNDMENT AND
LINED DECANT WATER POND
NMOSE FILE NOS. D-634 AND D-635
FOUR CORNERS POWER PLANT
SAN JUAN COUNTY, NEW MEXICO**

**Prepared for
ARIZONA PUBLIC SERVICE
COMPANY**

**Prepared by
AECOM
Revision 2: February 2017
Revision 3: January 2020**

**EMERGENCY ACTION PLAN
FOR
LINED ASH IMPOUNDMENT (LAI) AND
LINED DECANT WATER POND (LDWP)**

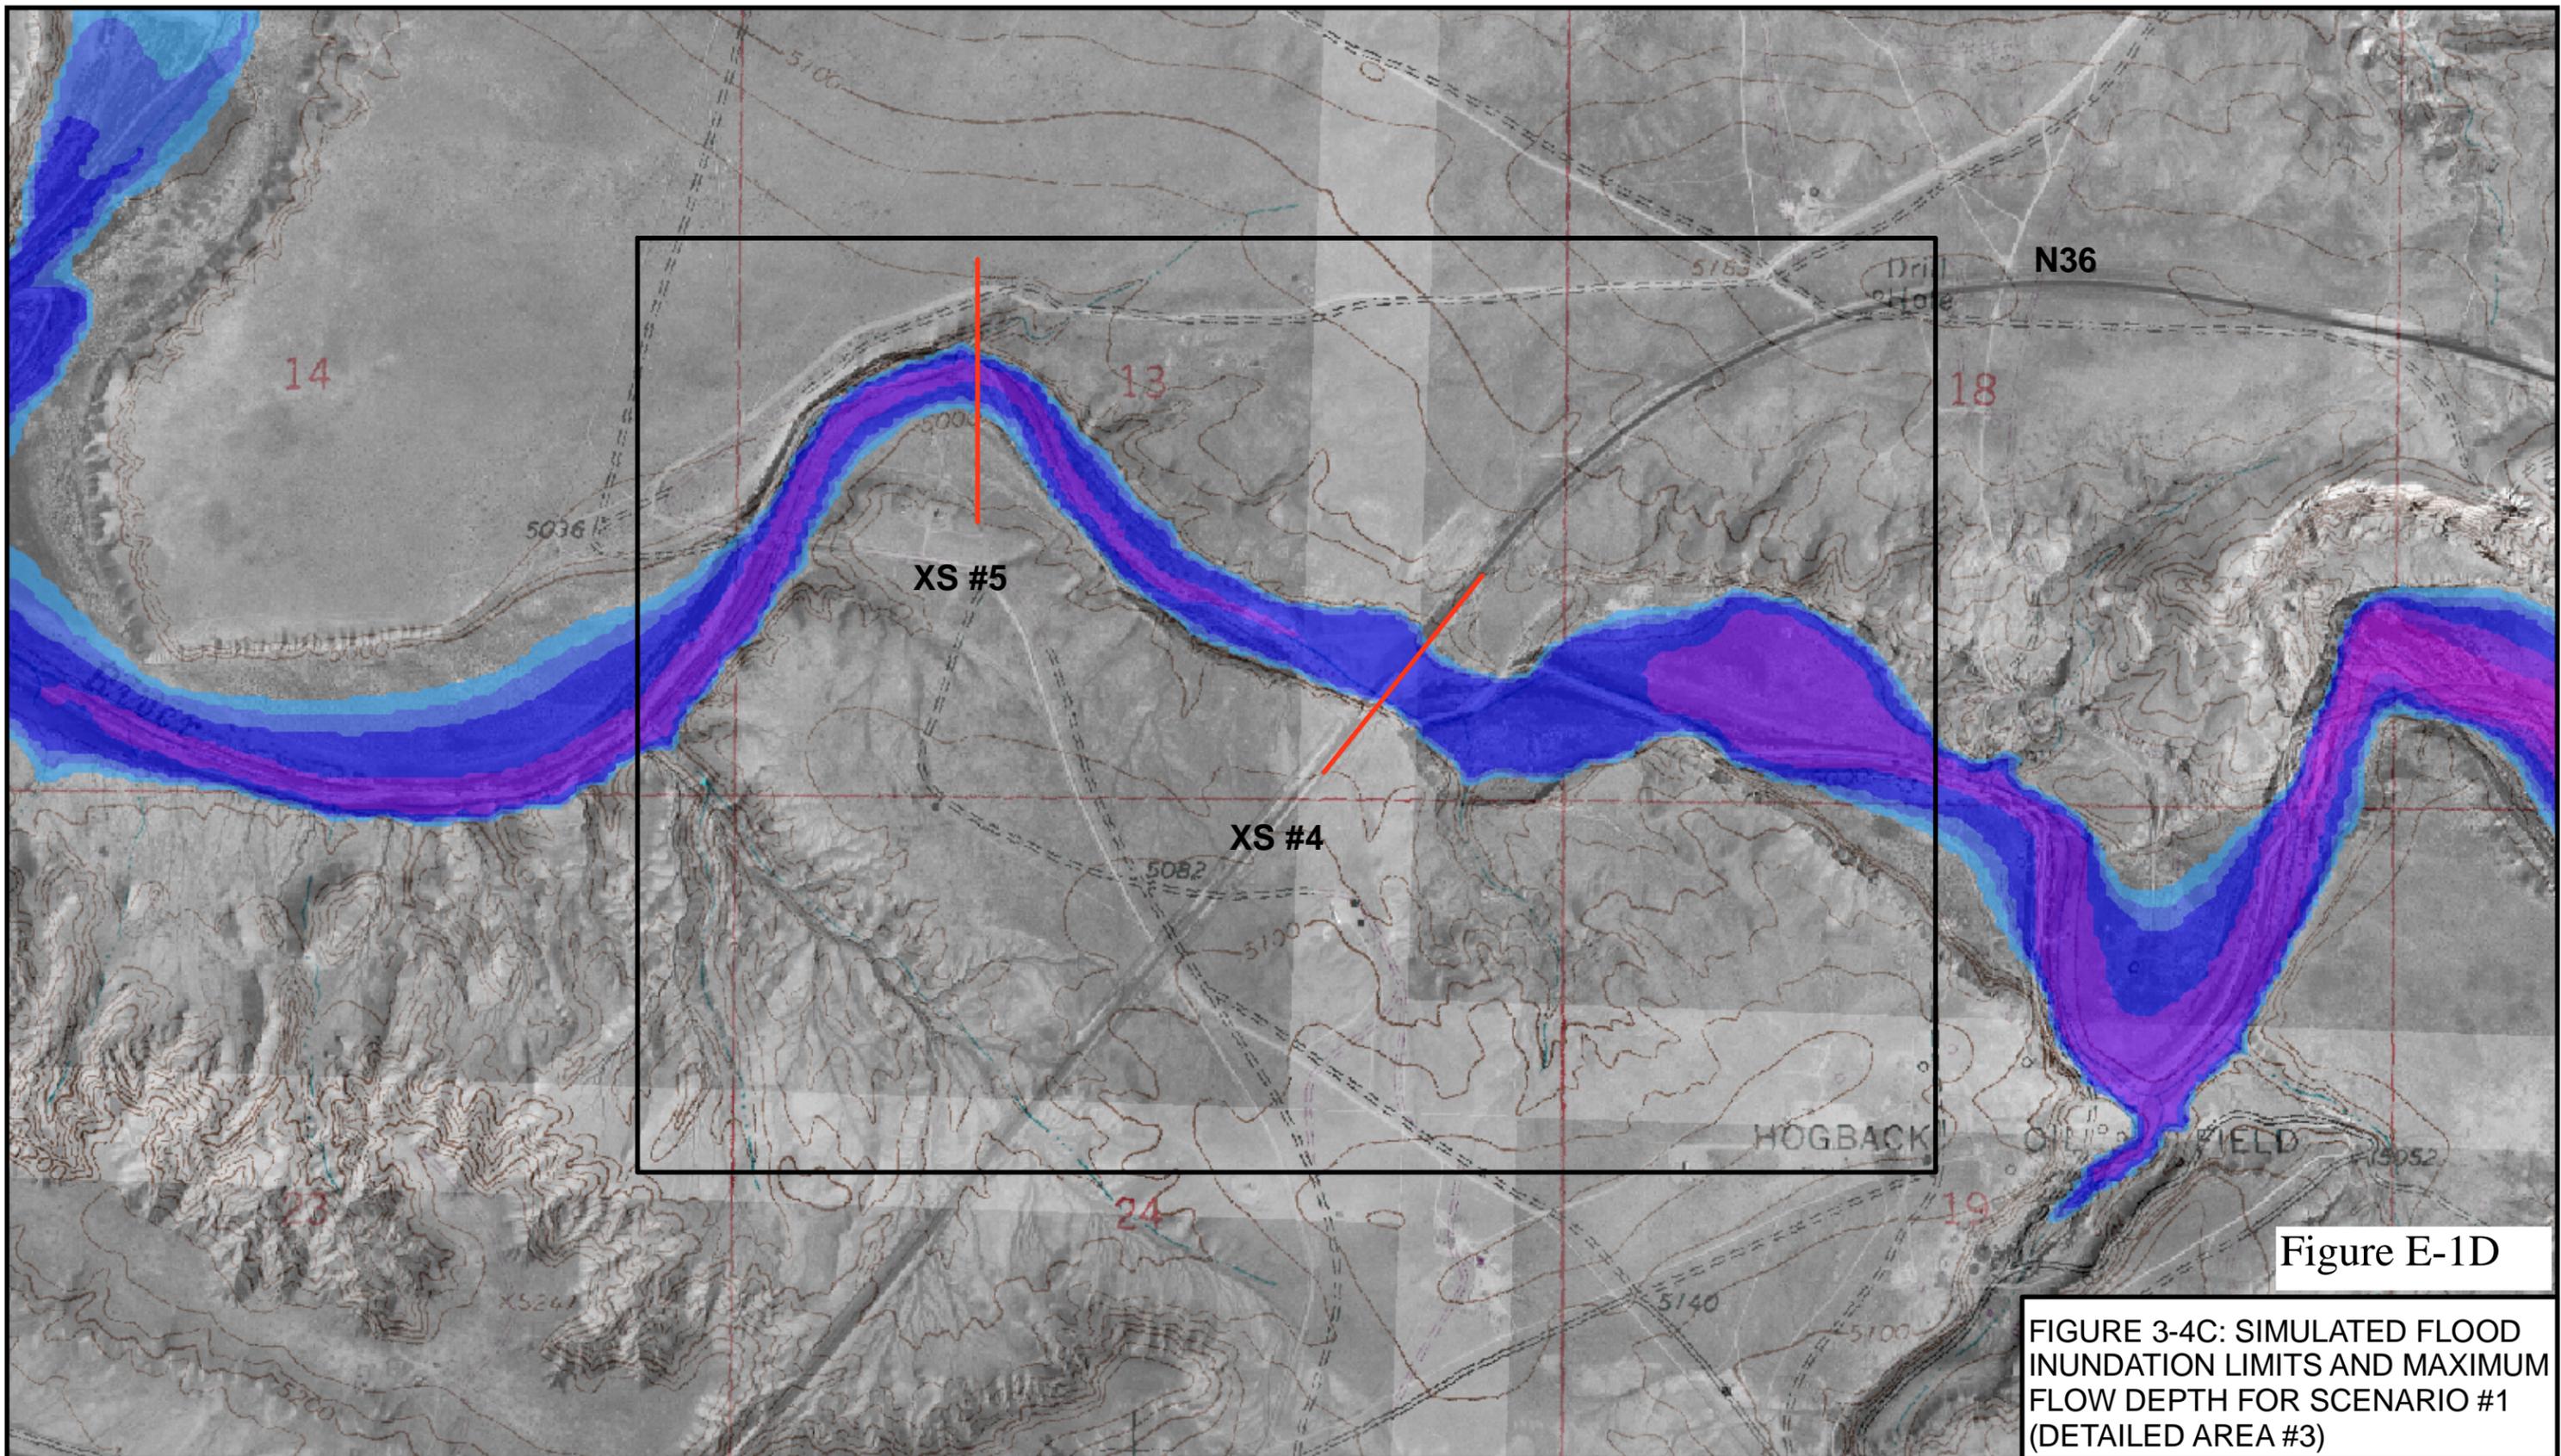
Figure E-1D

FIGURE 3-4C: SIMULATED FLOOD INUNDATION LIMITS AND MAXIMUM FLOW DEPTH FOR SCENARIO #1 (DETAILED AREA #3)

Note: Due to the method, procedures, and assumptions used to develop the flooded areas, the limits of the flooding shown and wave travel times are approximate and should be used only as a guideline for establishing evacuation zones. Actual areas inundated will depend on actual failure conditions and may differ from areas shown on map.

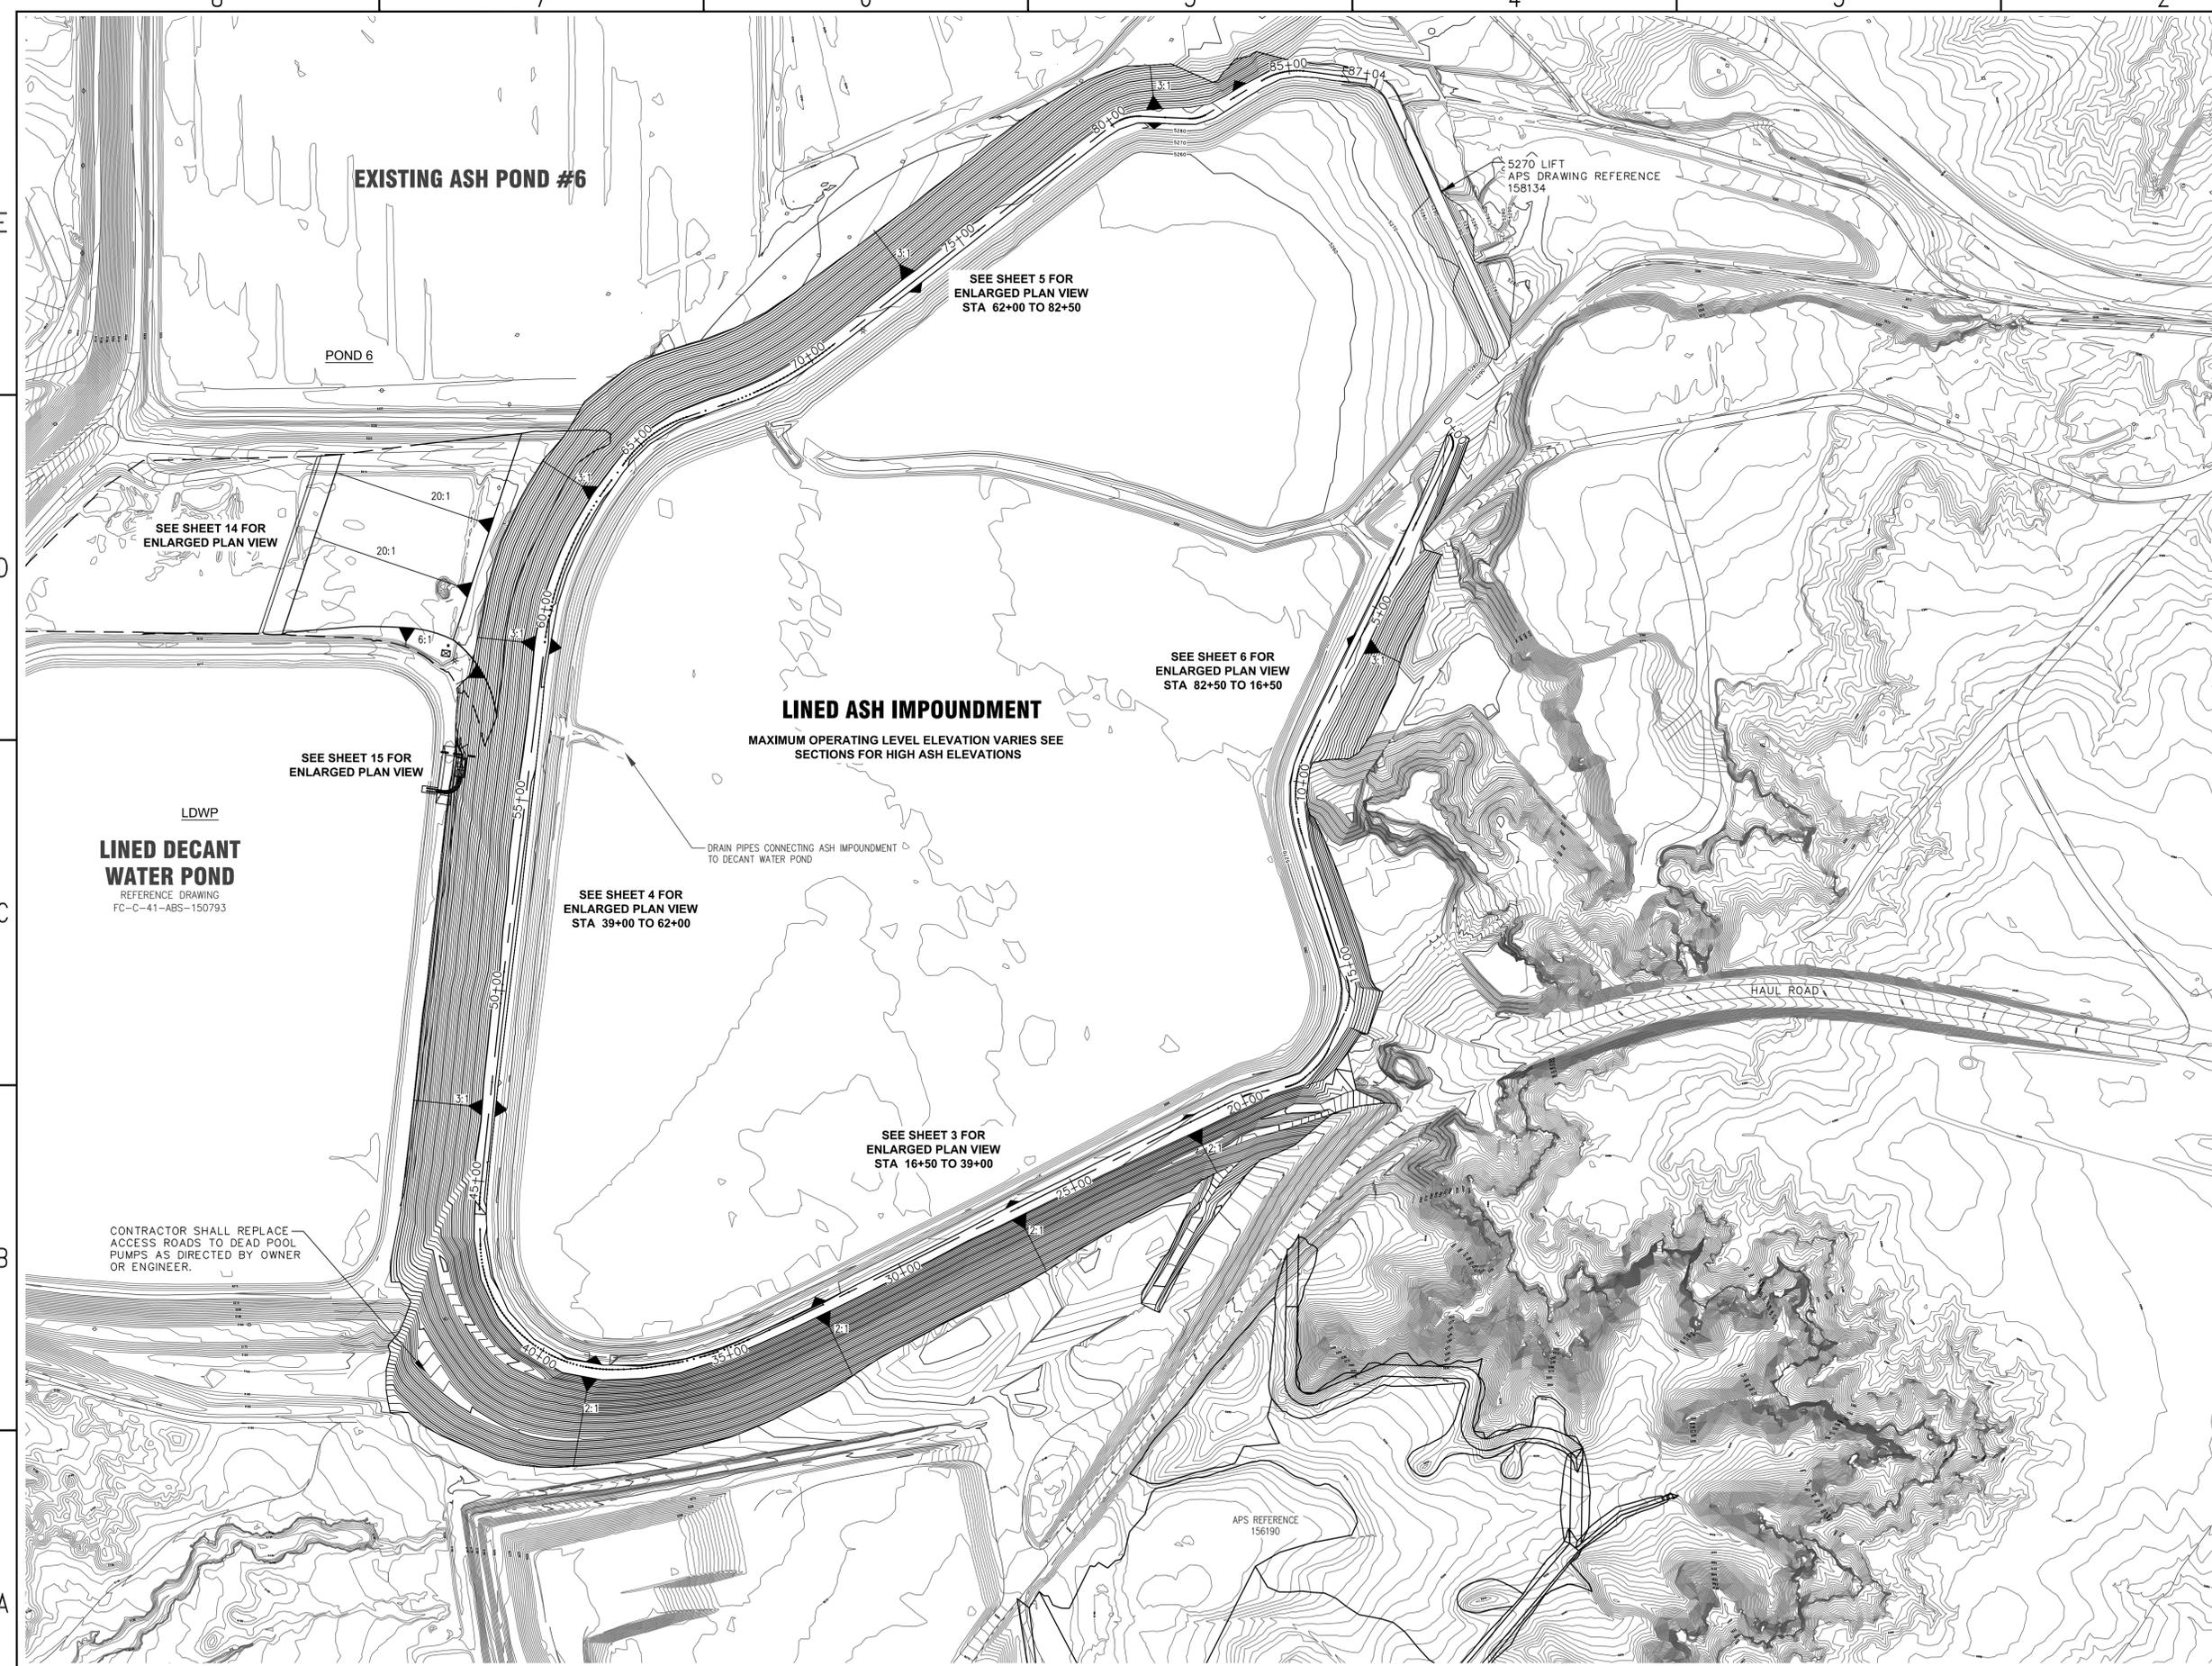
KEYMAP Figure E-2A

SITE PLAN
 SCALE: 1"=200'
 CONTOUR INTERVAL=2'

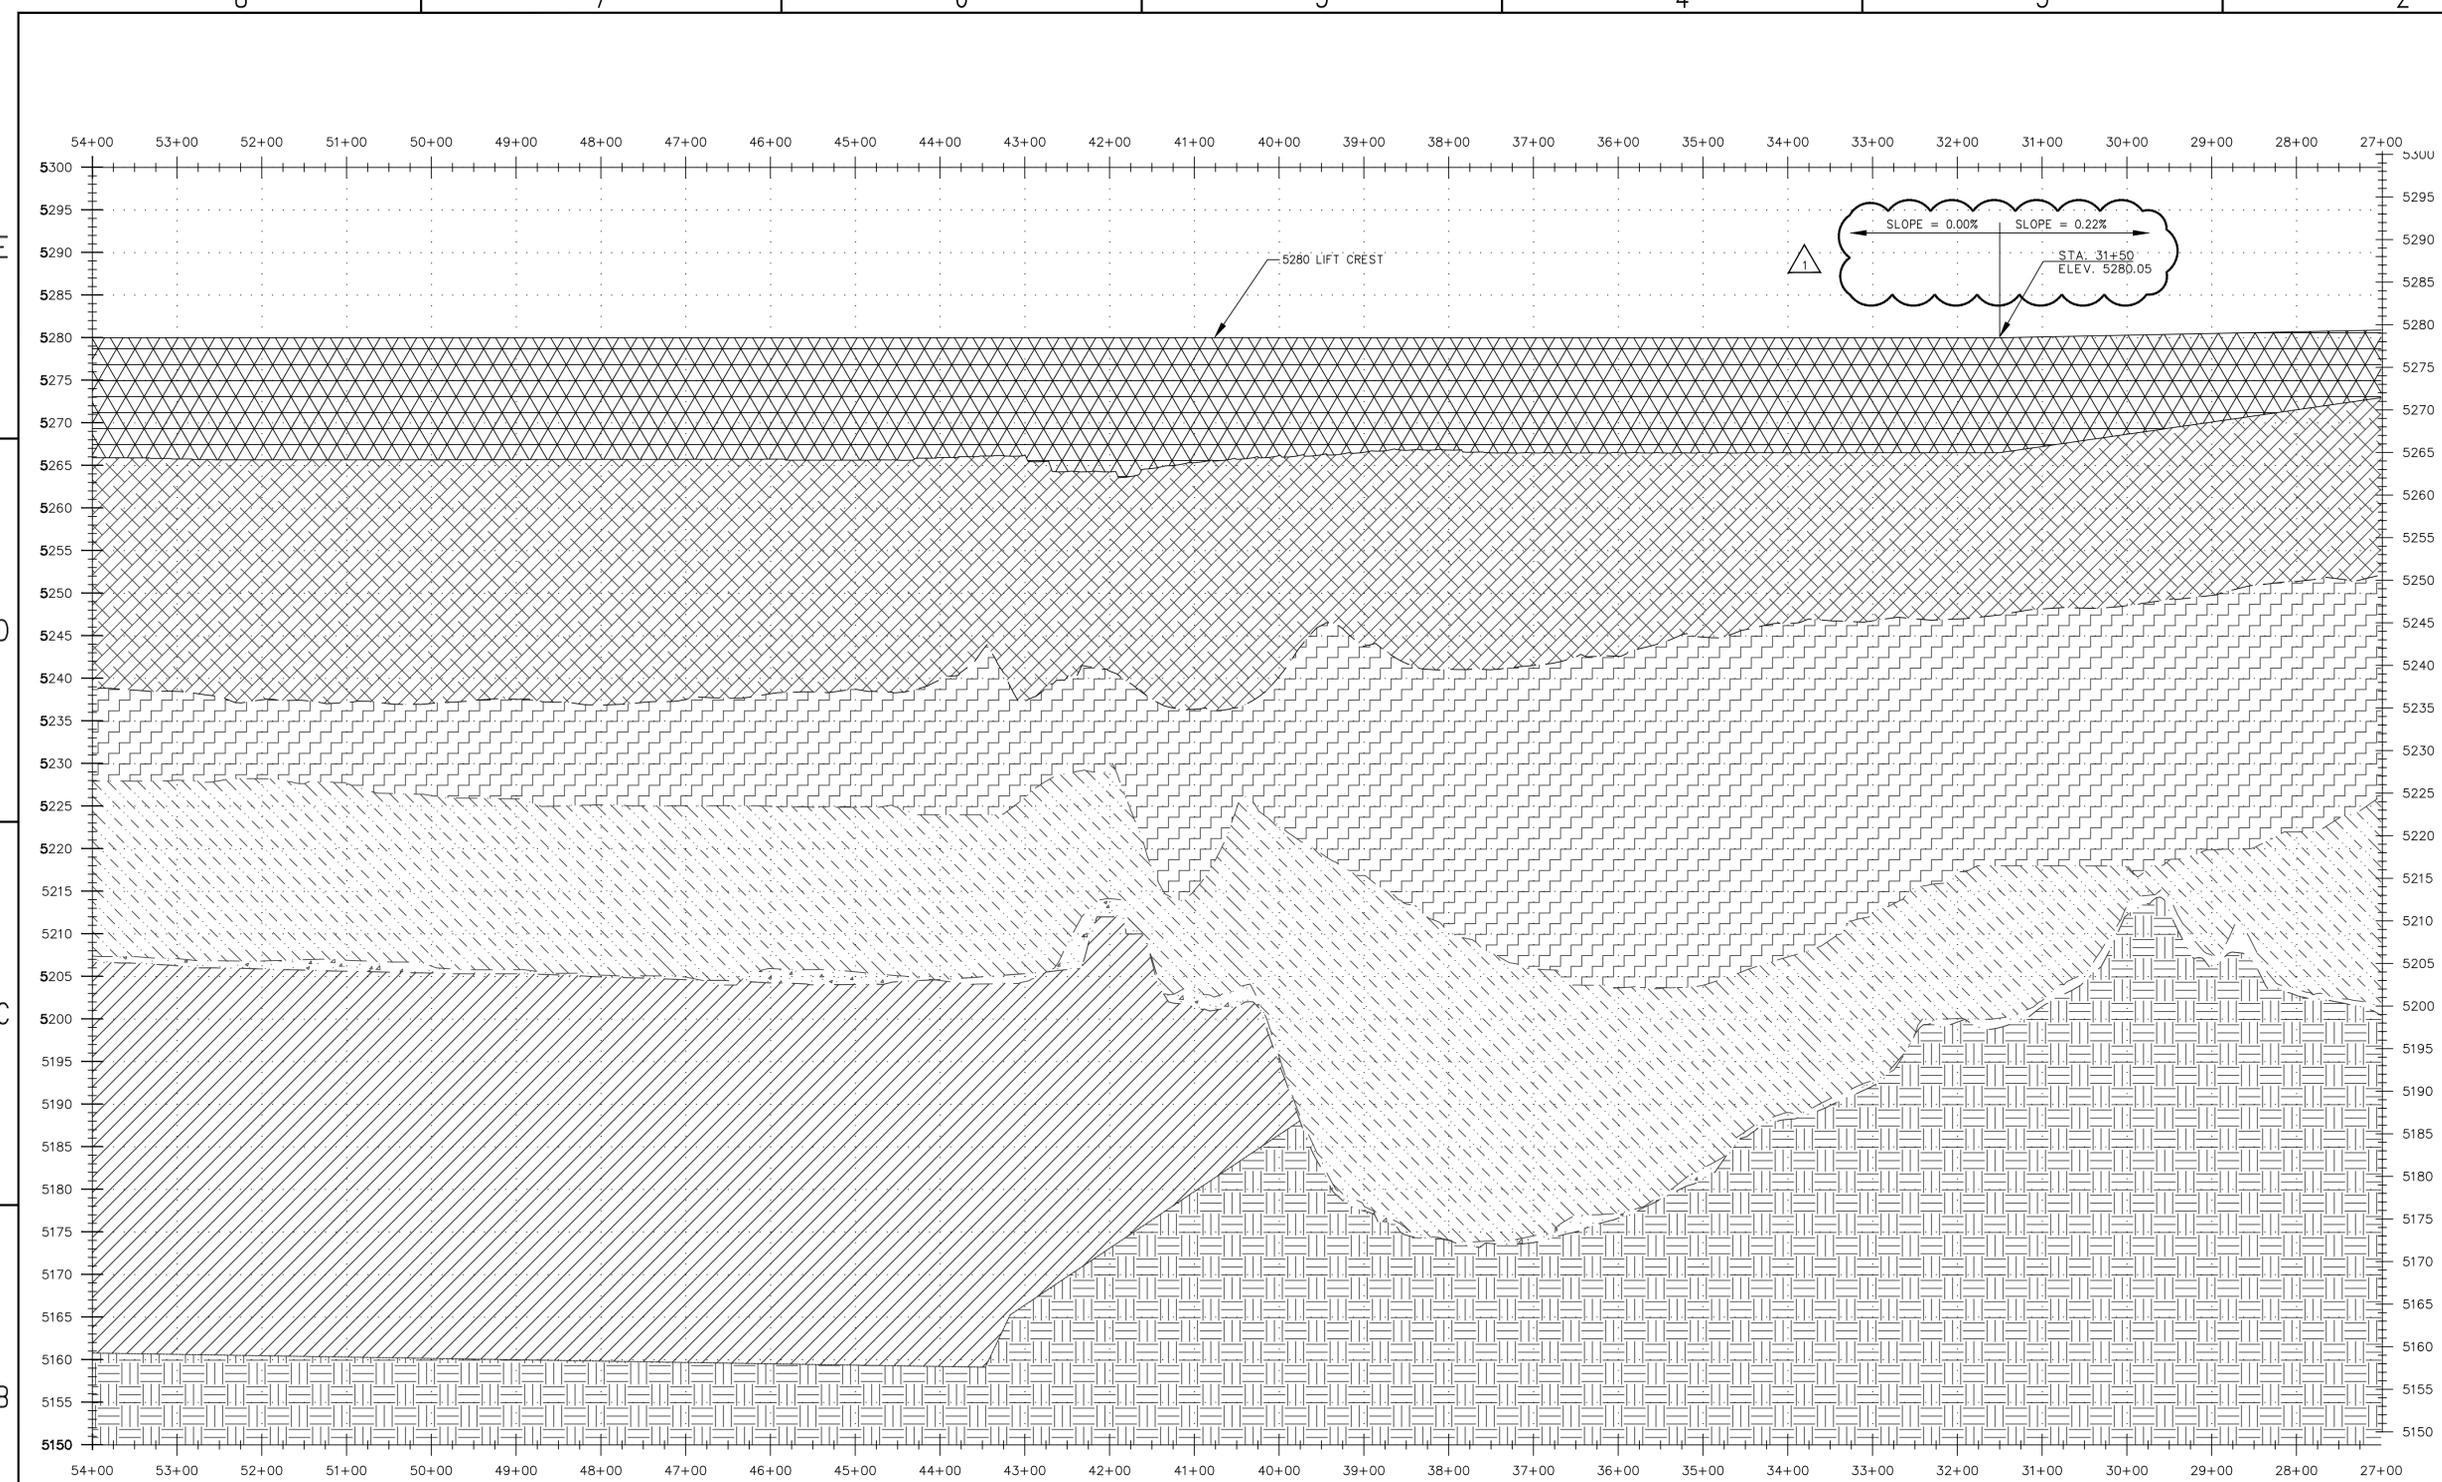
5280 LIFT LONG SECTION STA 27+00 TO STA 54+00

HORIZONTAL SCALE: 1"=100'
 VERTICAL SCALE: 1"=10'

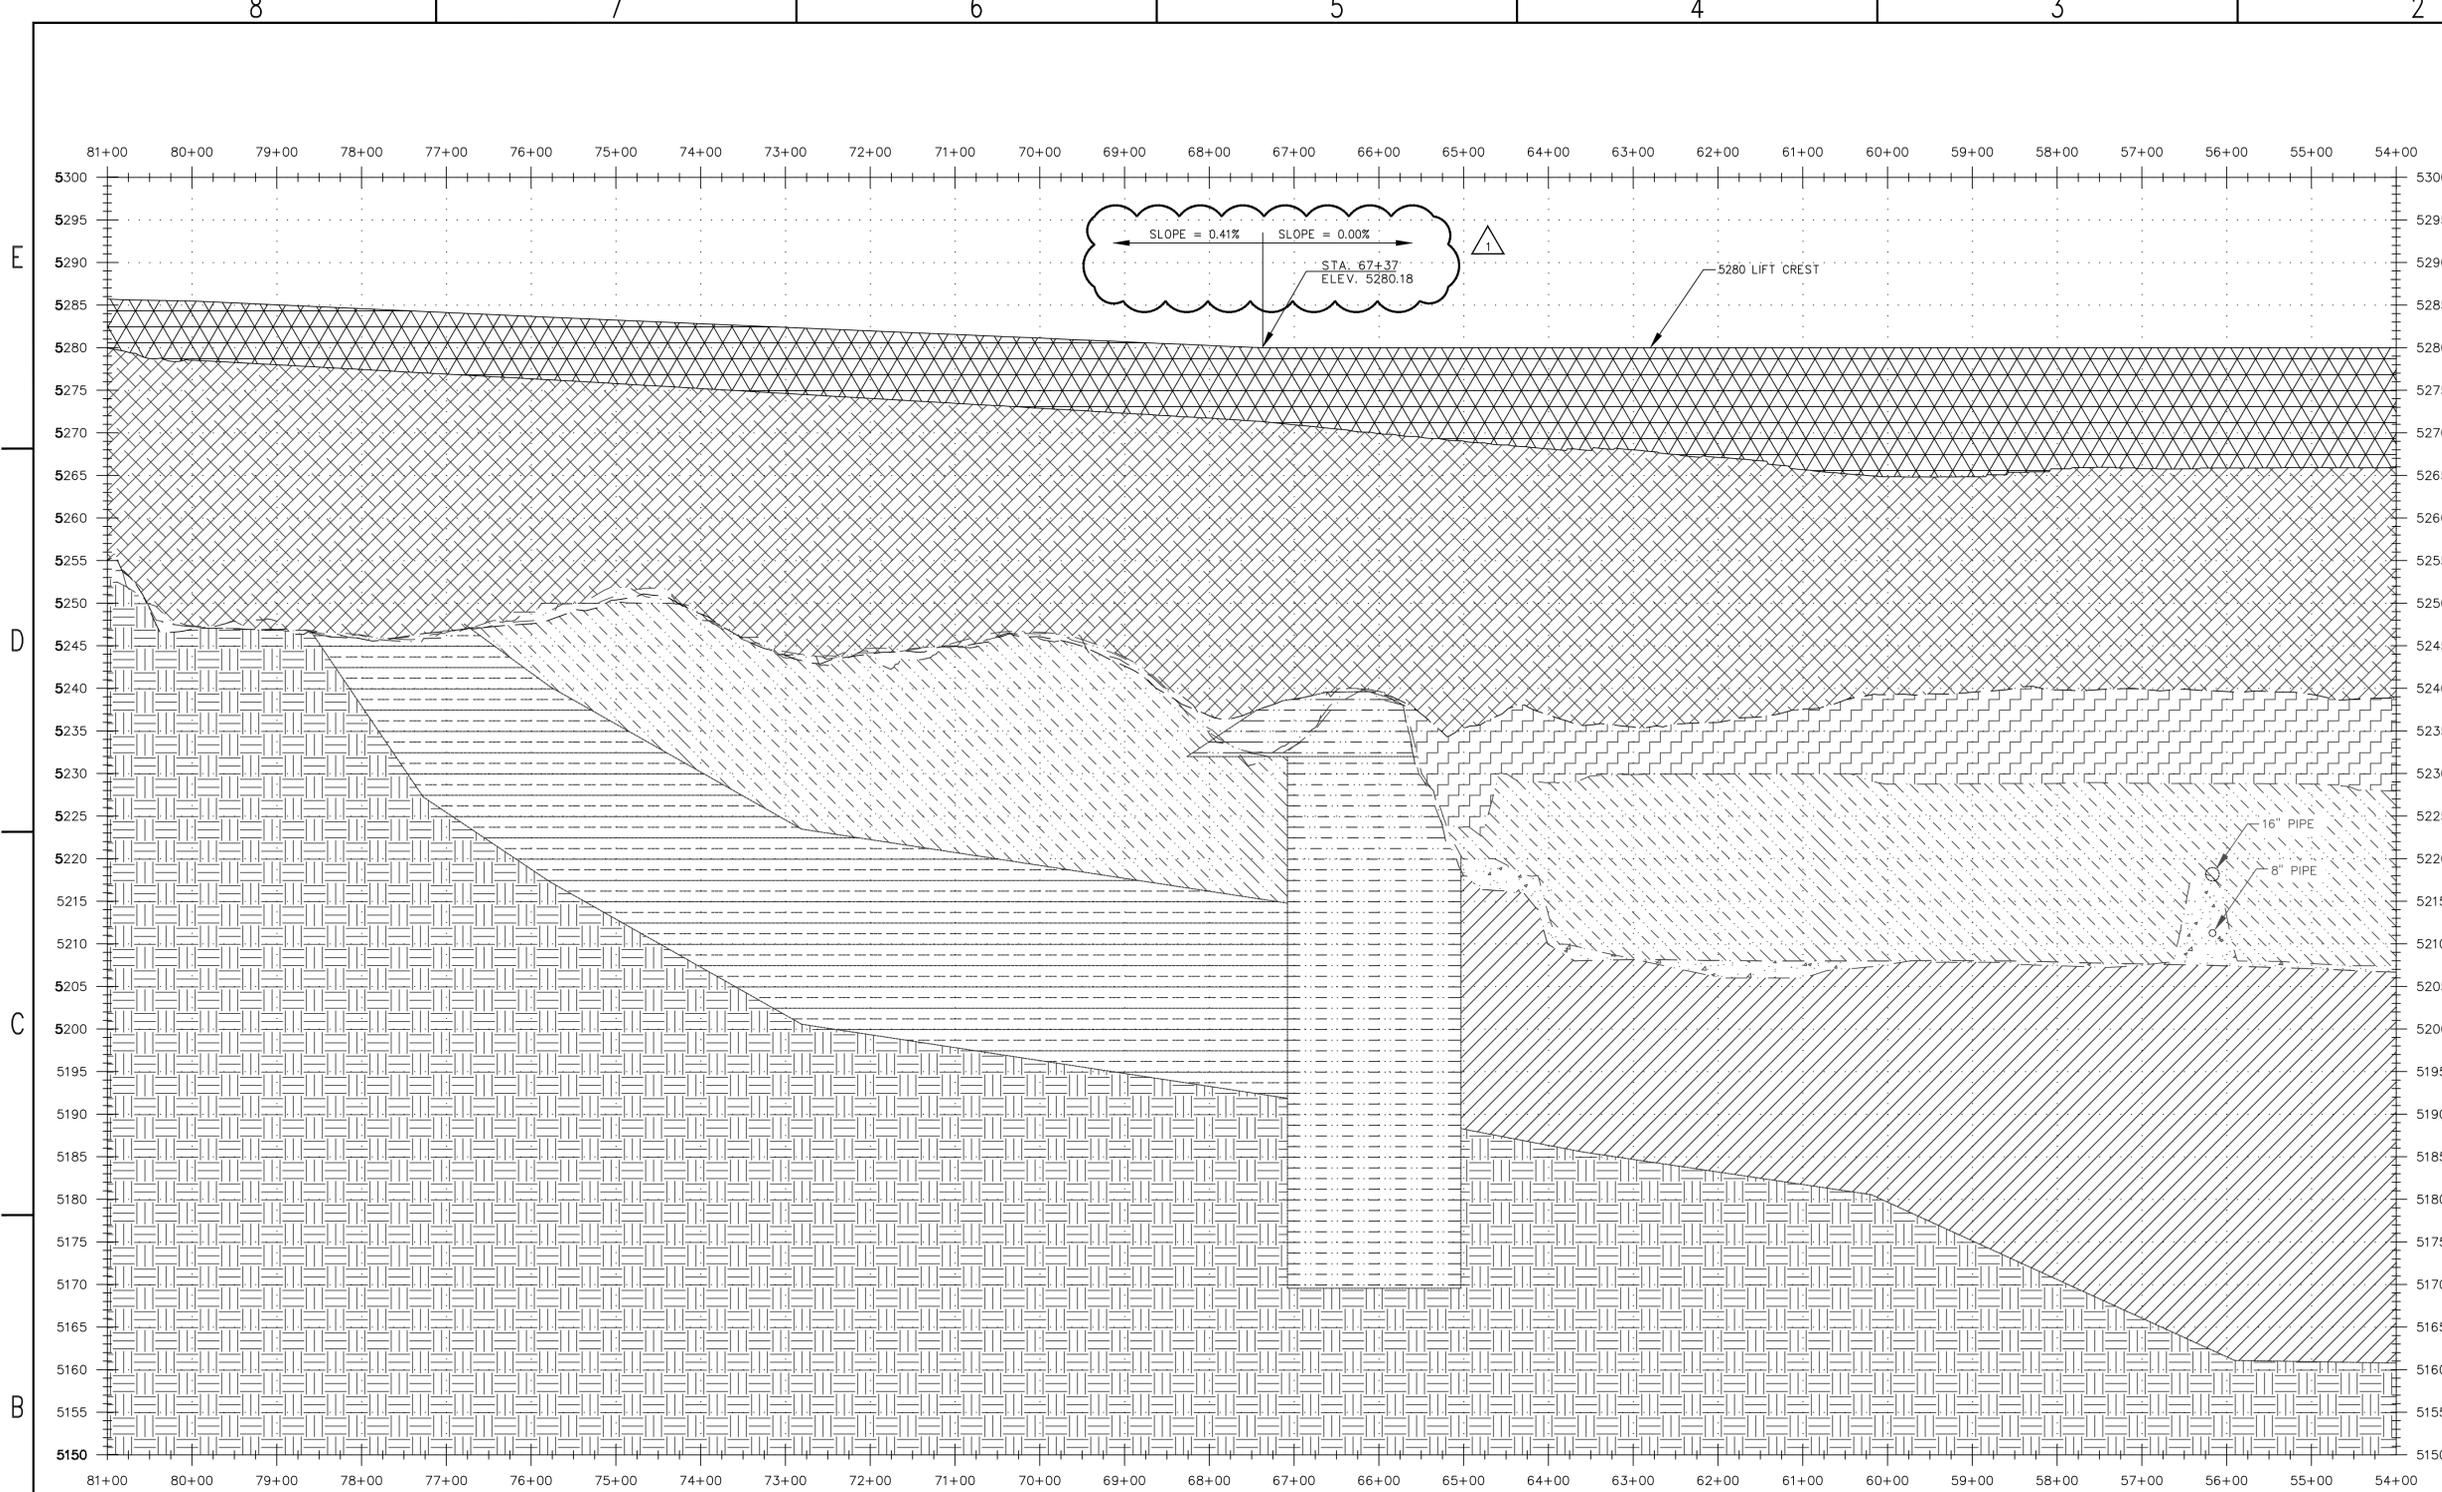
5280 LIFT LONG SECTION STA 54+00 TO STA 81+00

HORIZONTAL SCALE: 1"=100'
VERTICAL SCALE: 1"=10'

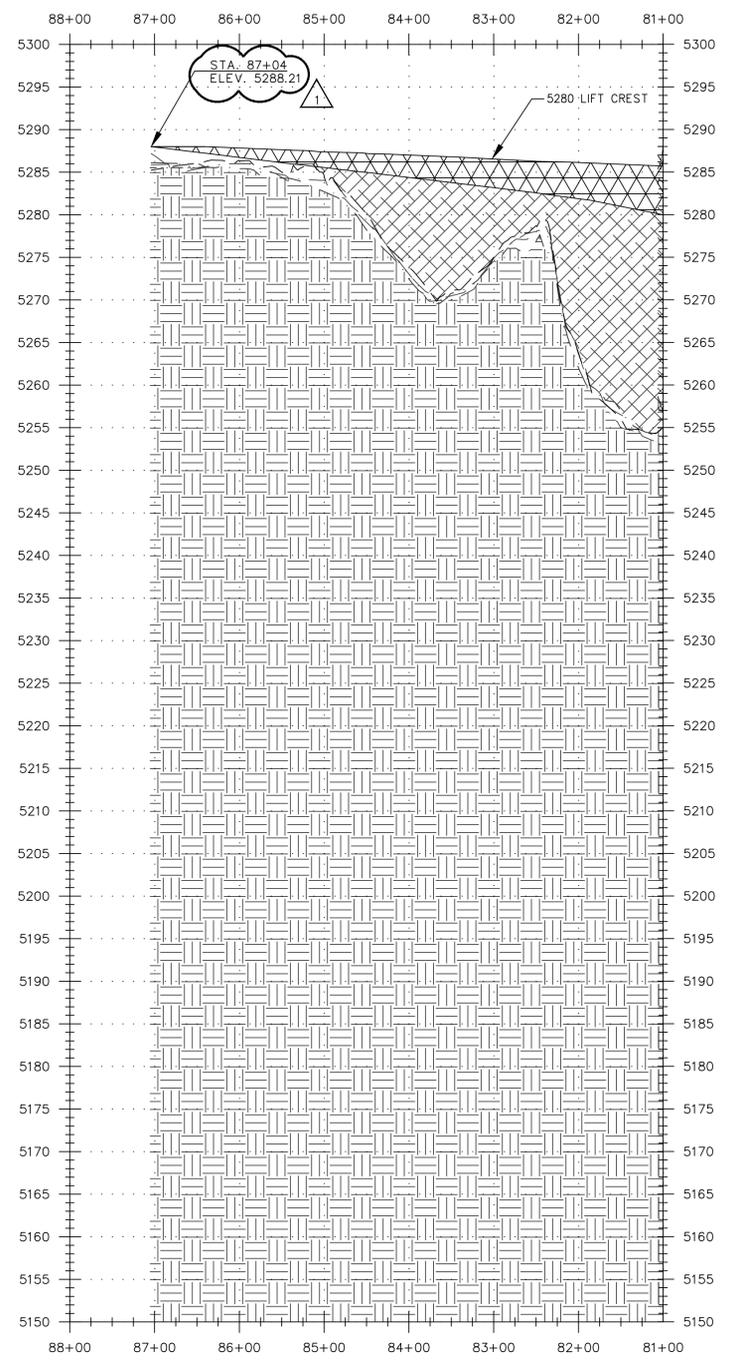
5280 LIFT LONG SECTION STA 81+00 TO STA 88+00
 HORIZONTAL SCALE: 1"=100'
 VERTICAL SCALE: 1"=10'

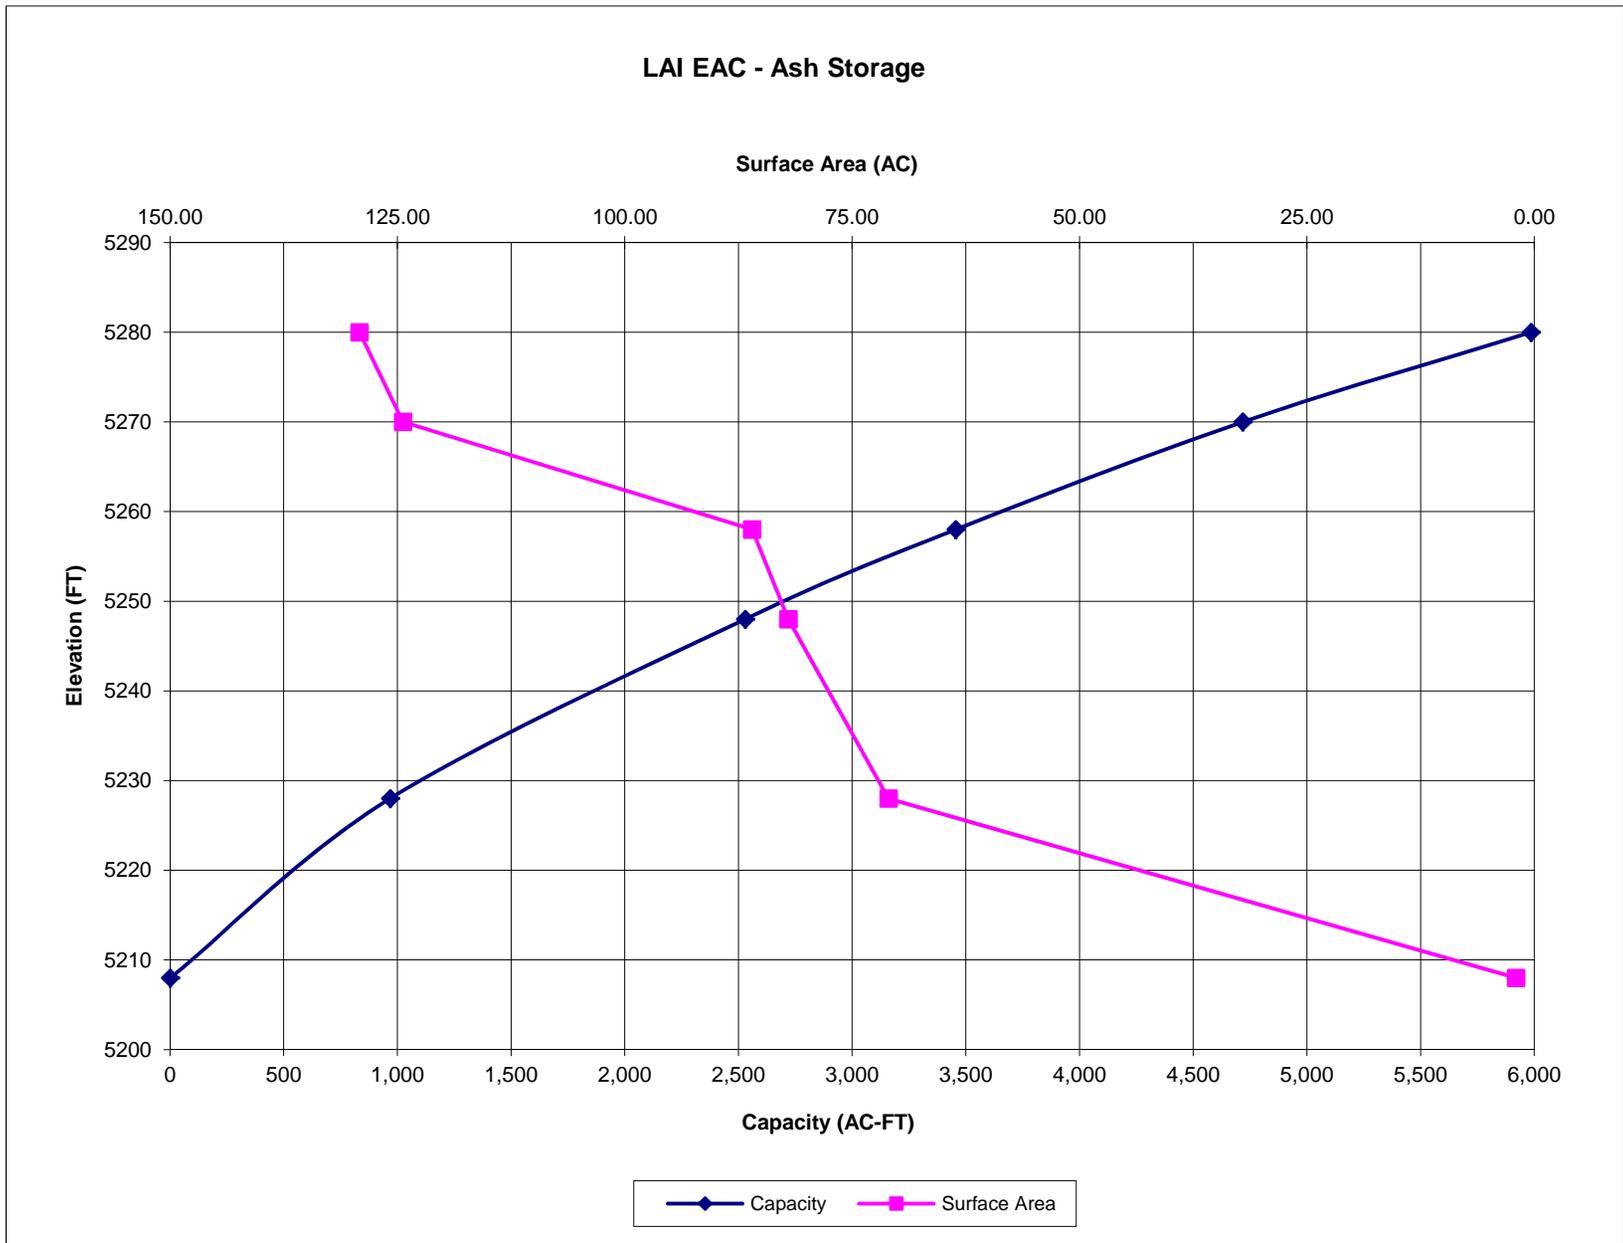
Figure E-3A

ELEVATION-AREA-CAPACITY CURVES

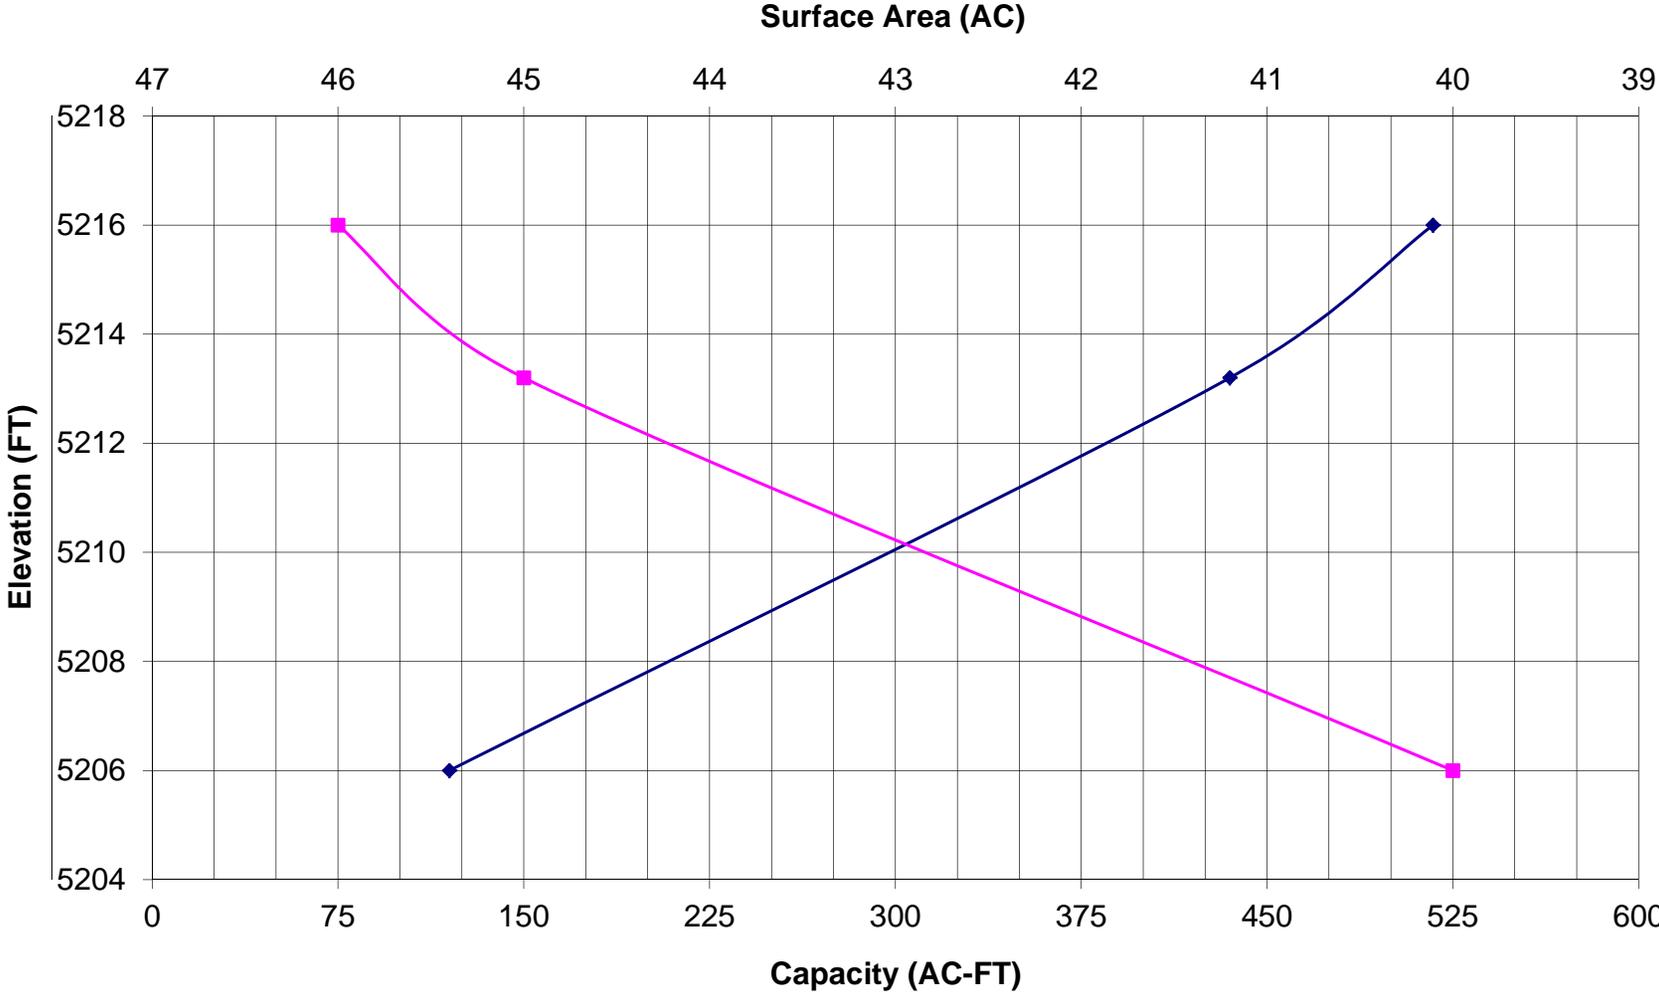
Figure E-3B

**Basin H (LDWP)
Elevation-Area-Capacity**
