CHOLLA POWER PLANT Fly Ash Dam, Bottom Ash Dam, Sedimentation Pond, and Bottom Ash Monofill

Annual CCR Impoundment and Landfill Inspection Report

2018

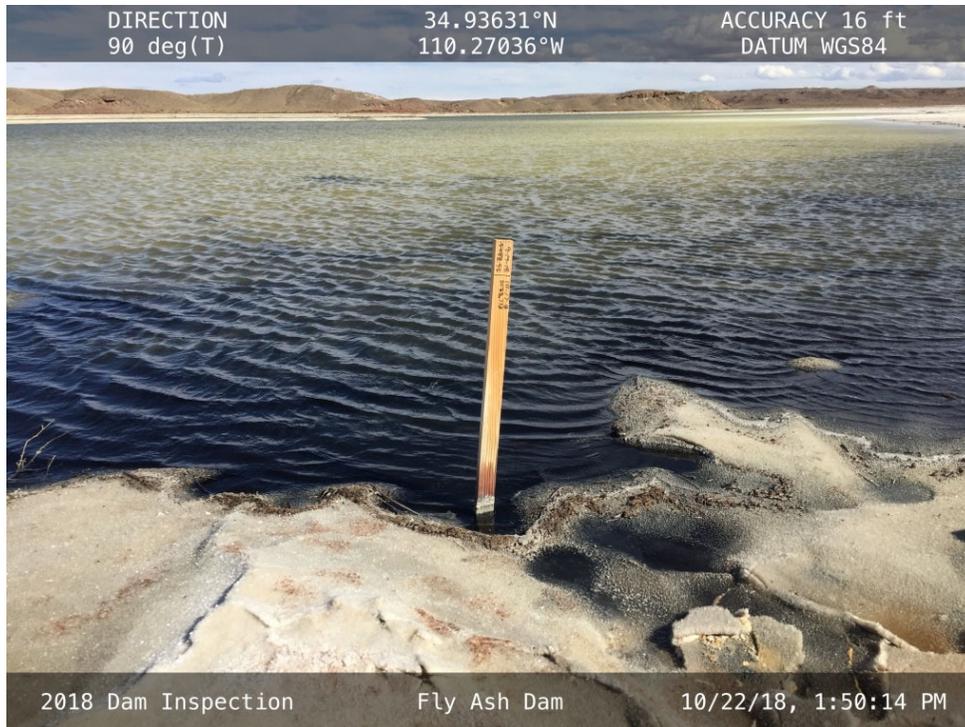
20181022 – IMG_0439

Lathe marking the location where the Fly Ash Pond elevation is measured.

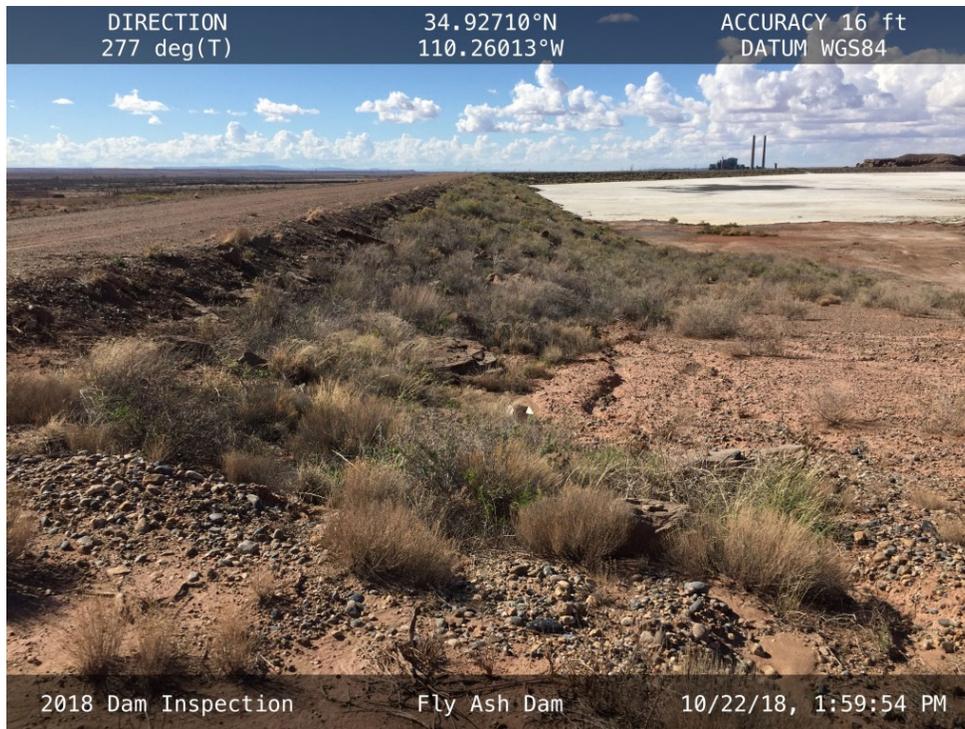
20181022 – IMG_0443

The upstream slope of the South Embankment, facing west from the East Abutment.

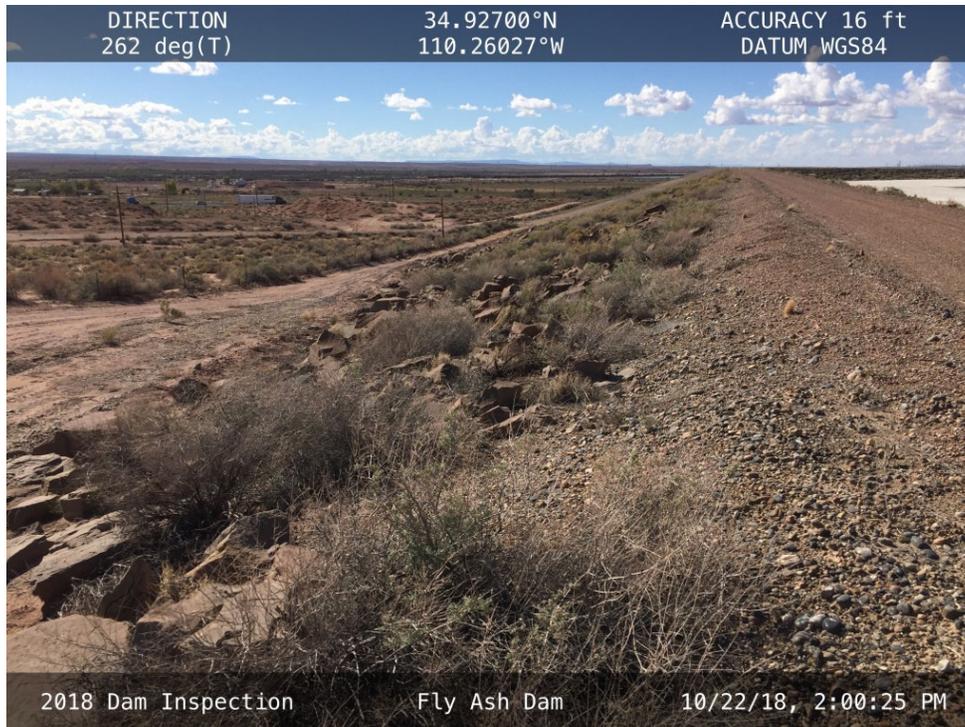
20181022 – IMG_0448

The downstream slope of the South Embankment, facing west from the East Abutment.

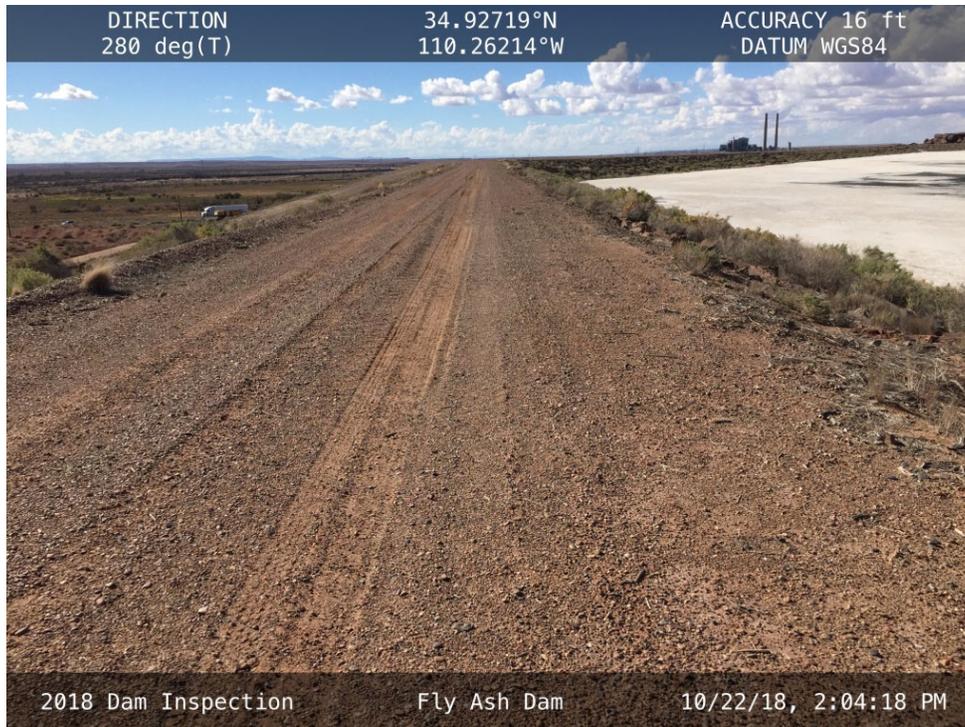
20181022 – IMG_0454
 The crest of the South Embankment, facing west.

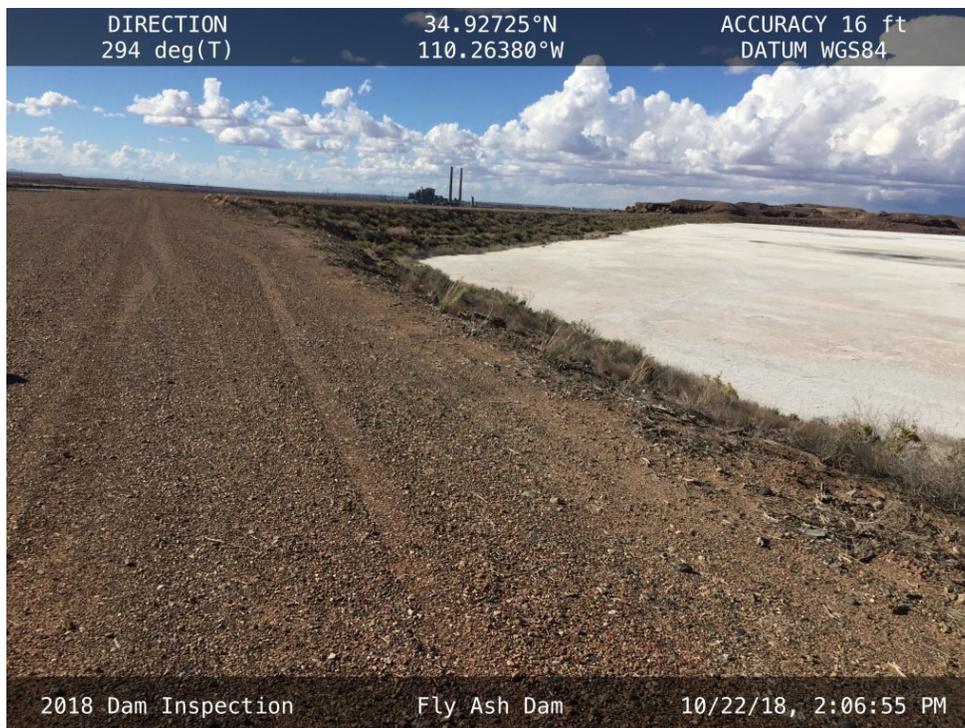
20181022 – IMG_0455
 The upstream slope of the West Embankment, facing northwest.

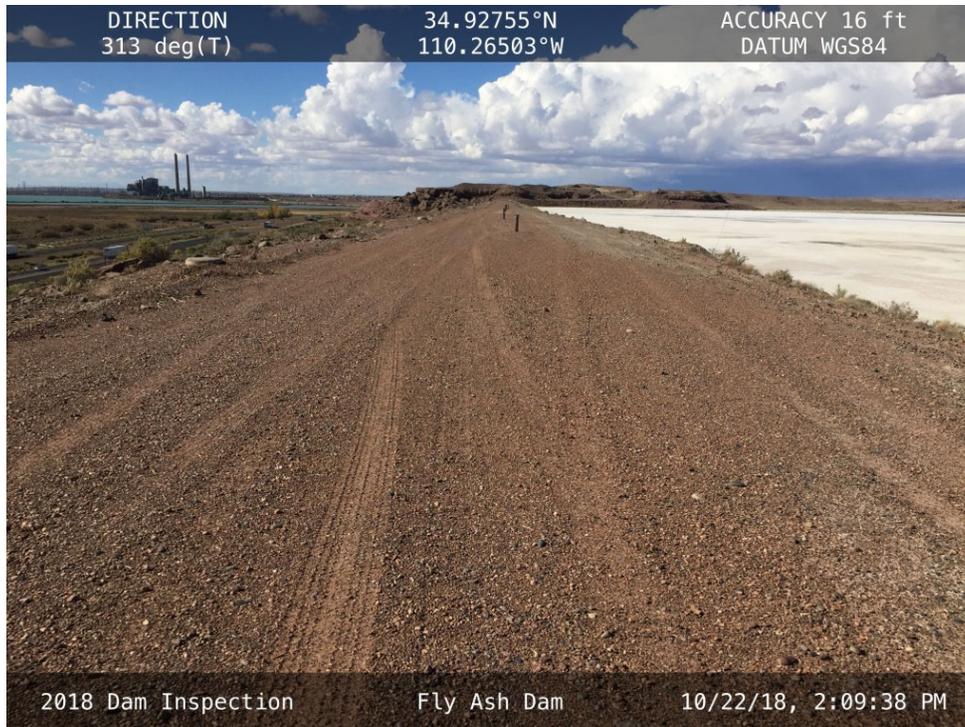
20181022 – IMG_0458
 The crest of the West Embankment, facing northwest.

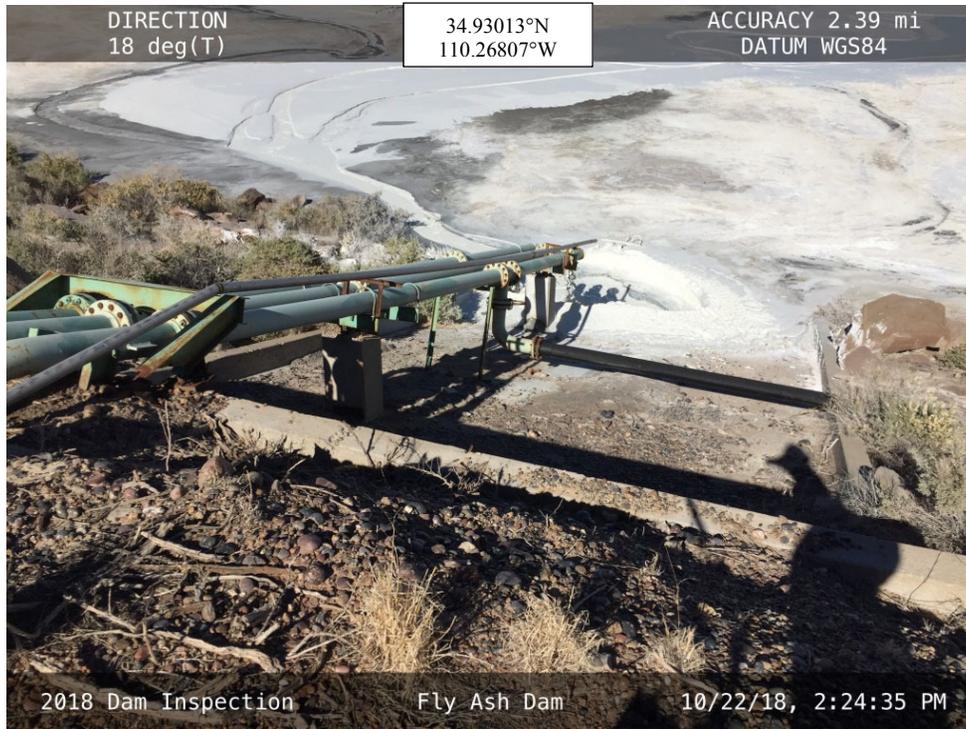
20181022 – IMG_0480
 The inlet pipe depositing CCR into the impoundment.

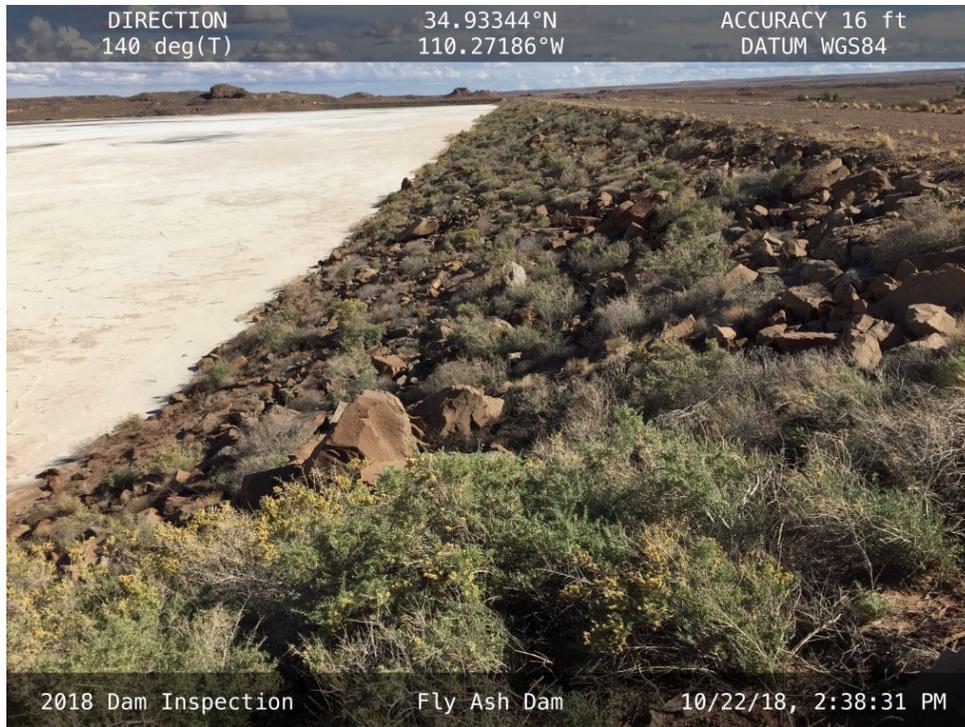
20181022 – IMG_0507
 The upstream slope of the West Embankment, facing southeast.

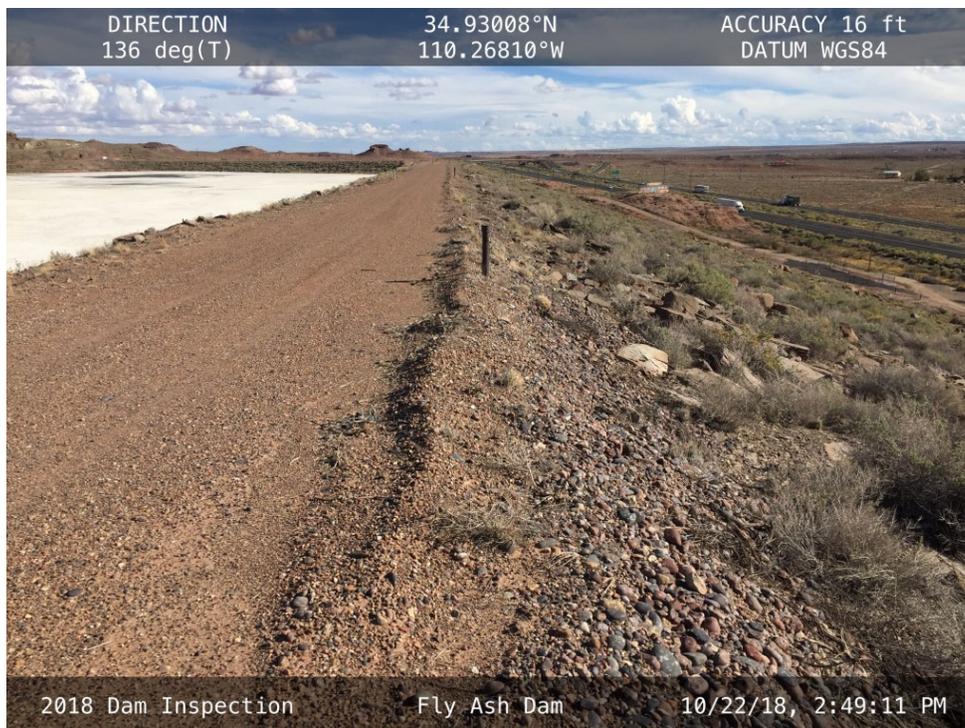
20181022 – IMG_0509
 The crest and downstream slope of the West Embankment, facing southeast.

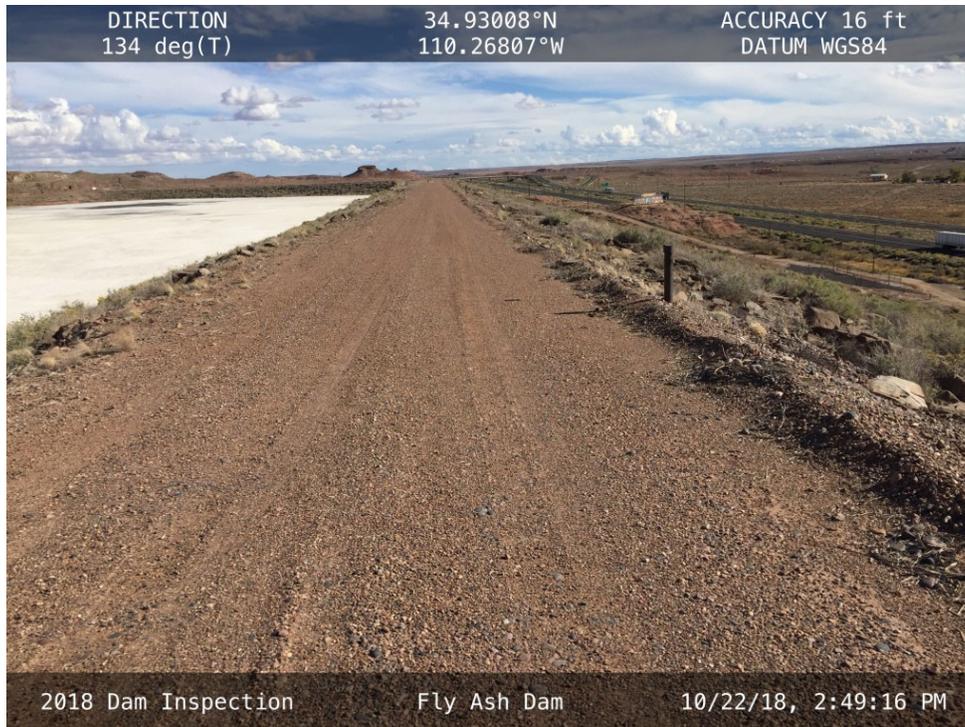
20181022 – IMG_0510
The crest of the West Embankment, facing southeast.

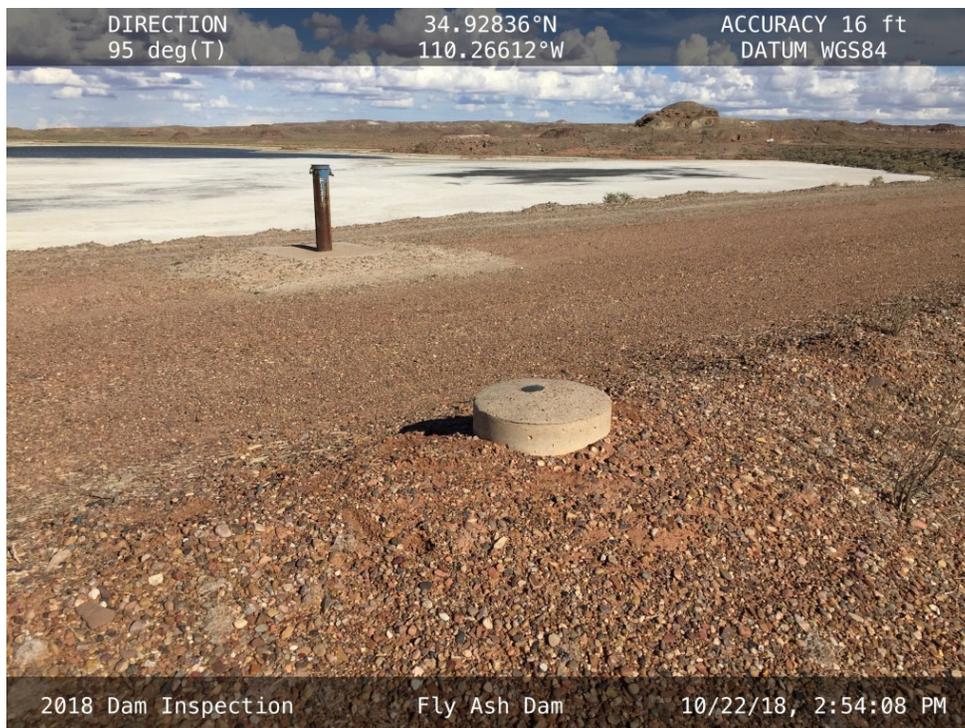
20181022 – IMG_0512
A piezometer and a settlement monument along the crest.

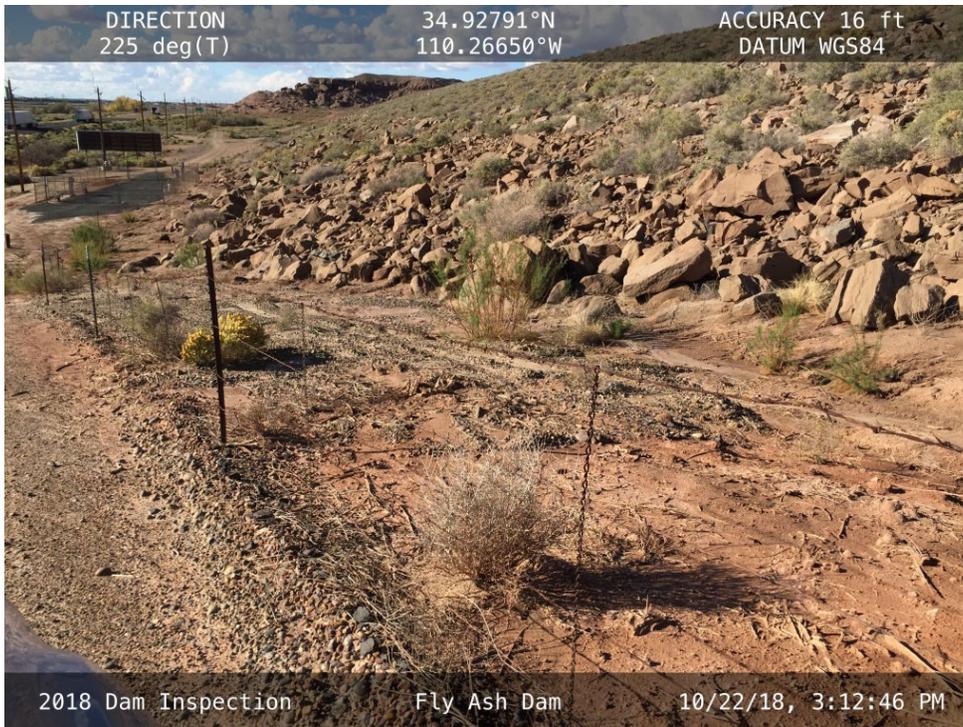
20181022 – IMG_0518

The downstream toe of the West Embankment where erosion has historically been observed.

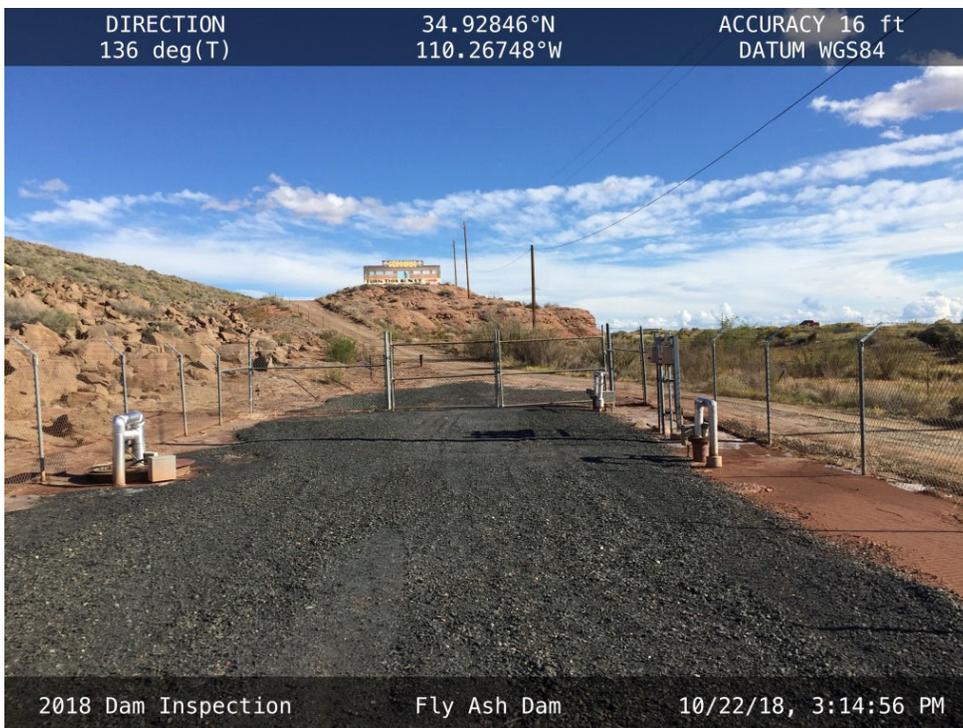
20181022 – IMG_0521

A portion of the Geronimo Sump.

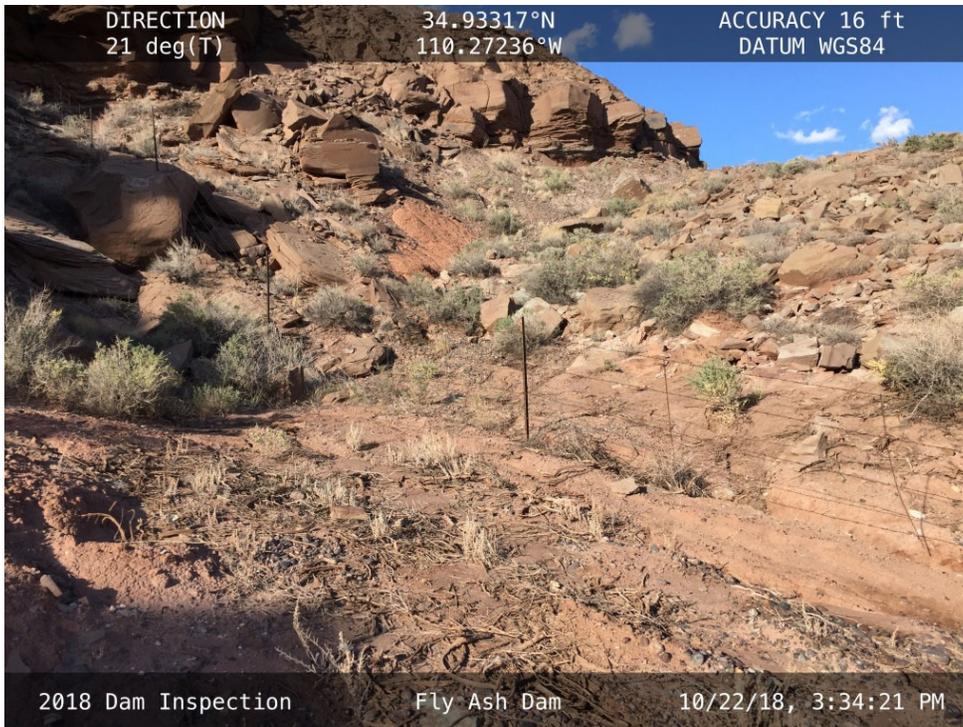
- iii. Minor stone deterioration was also observed during previous inspections.
- iv. Minor erosion was observed at the Northwest Abutment contact (Photos IMG_0502 and IMG_0542). The erosion should be monitored and repaired if the depth exceeds 1 foot.

20181022 – IMG_0542
 The Northwest Abutment, facing north from the downstream toe.

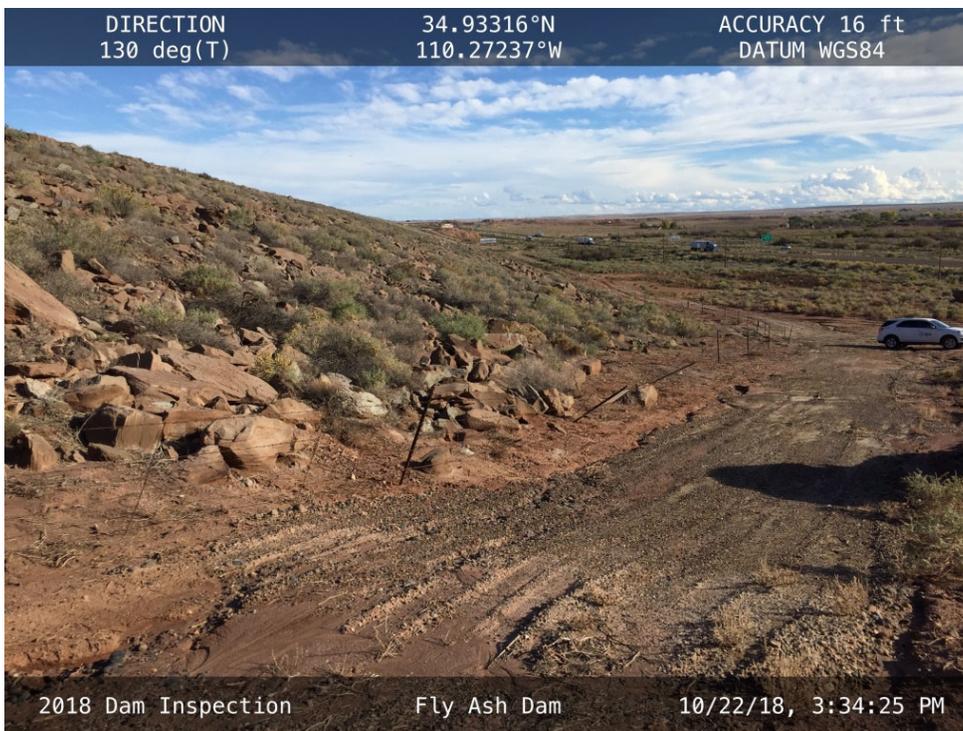
20181022 – IMG_0546
 The downstream slope in the north end of the West Embankment, facing southeast.

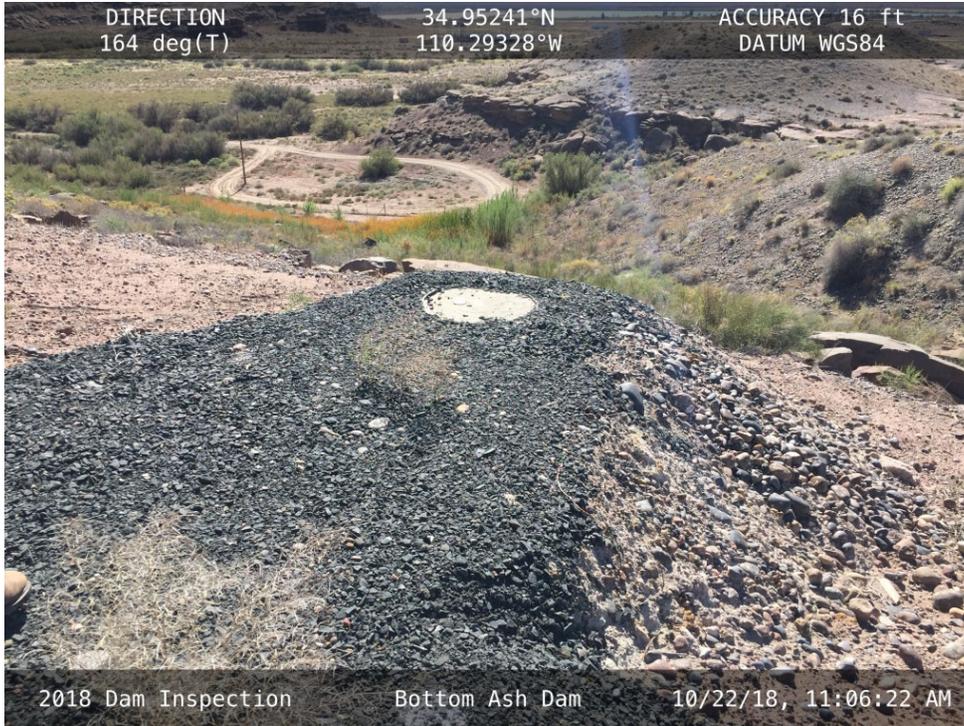
20181022 – IMG_0264

Settlement monument M-11 on the downstream side of the crest near the West Abutment.

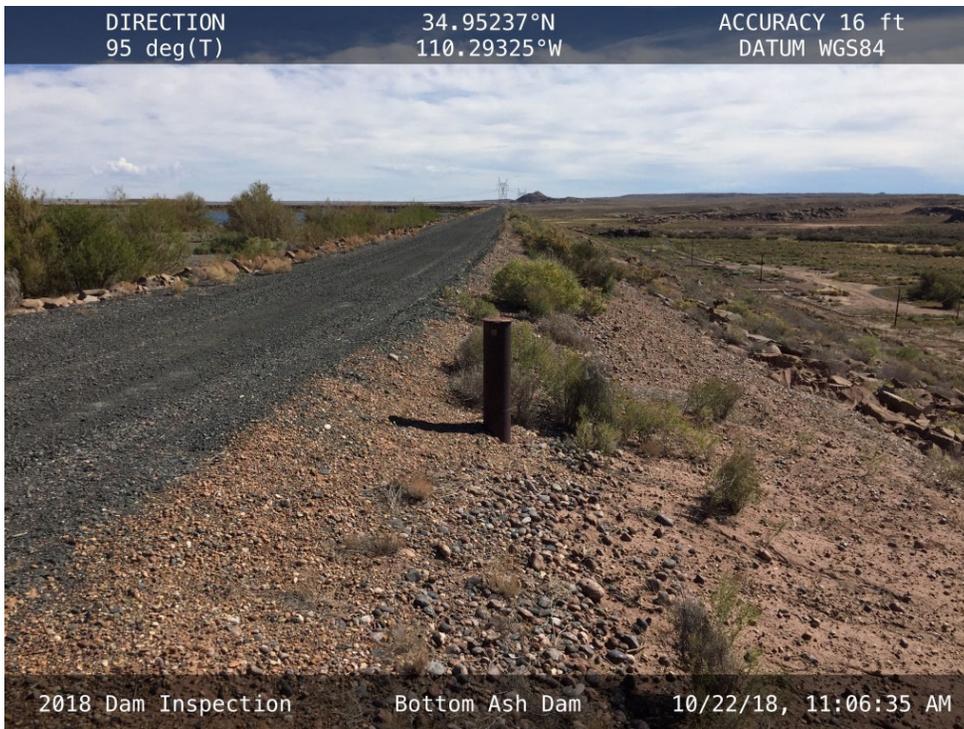
20181022 – IMG_0267

The downstream slope of the South Embankment, facing east from the West Abutment.

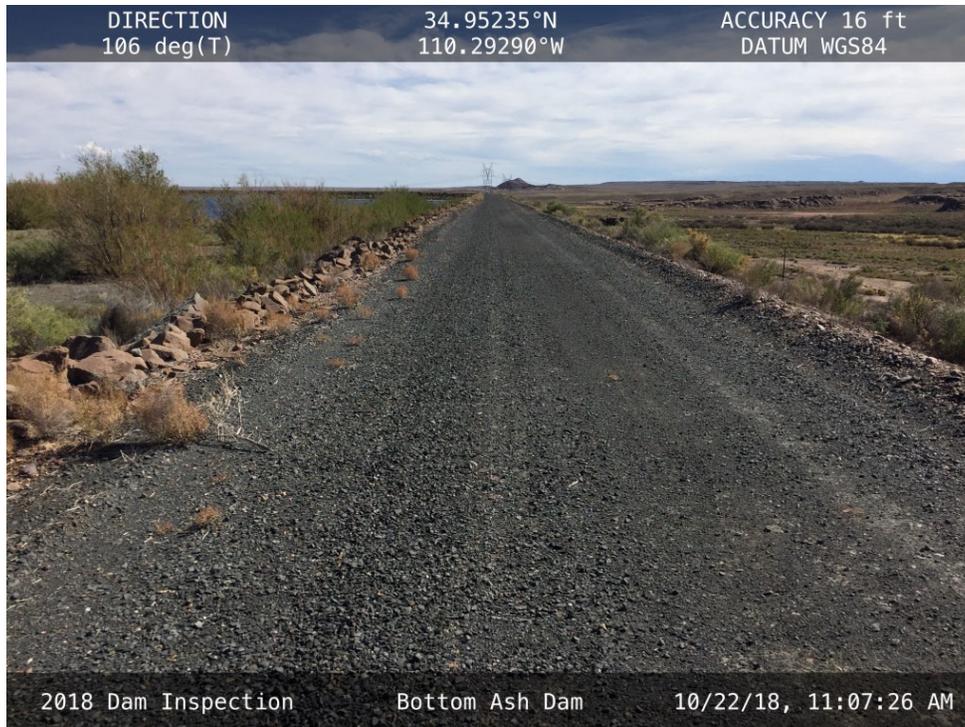
20181022 – IMG_0270
 The South Embankment crest, facing east from the West Abutment.

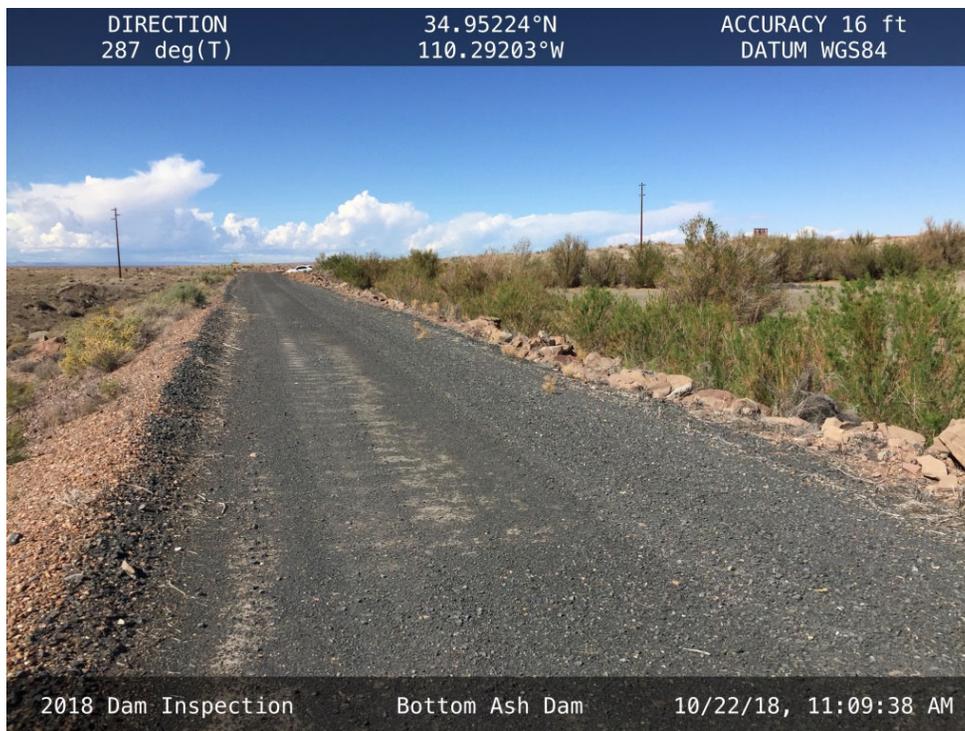
20181022 – IMG_0275
 The South Embankment crest and vegetation near the West Abutment, facing west.

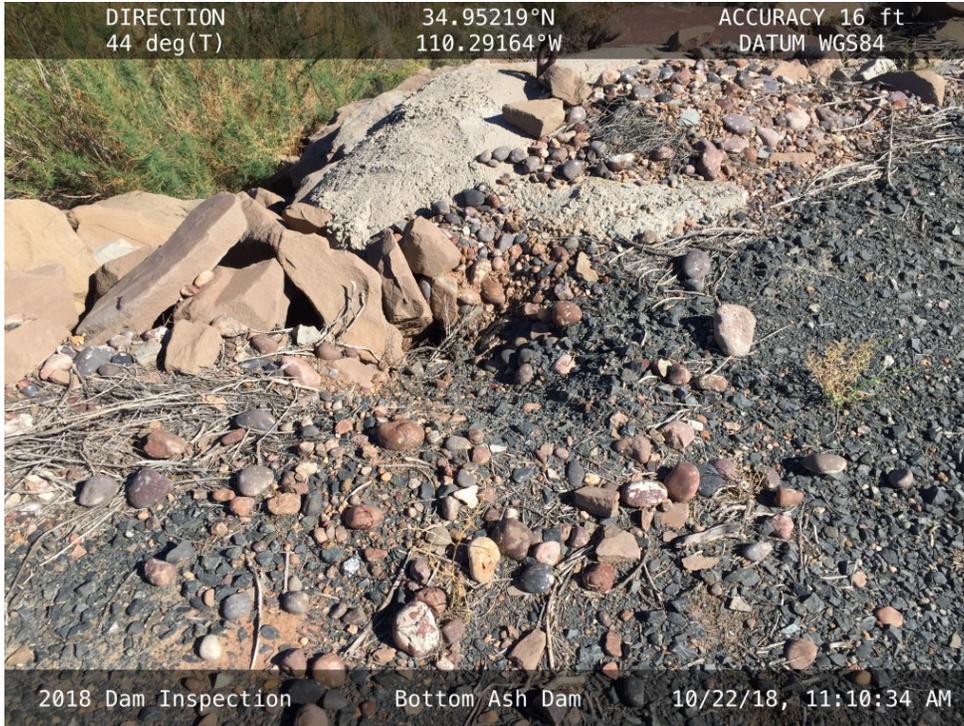
20181022 – IMG_0280

Incipient erosion rill on the upstream side of the South Embankment crest.

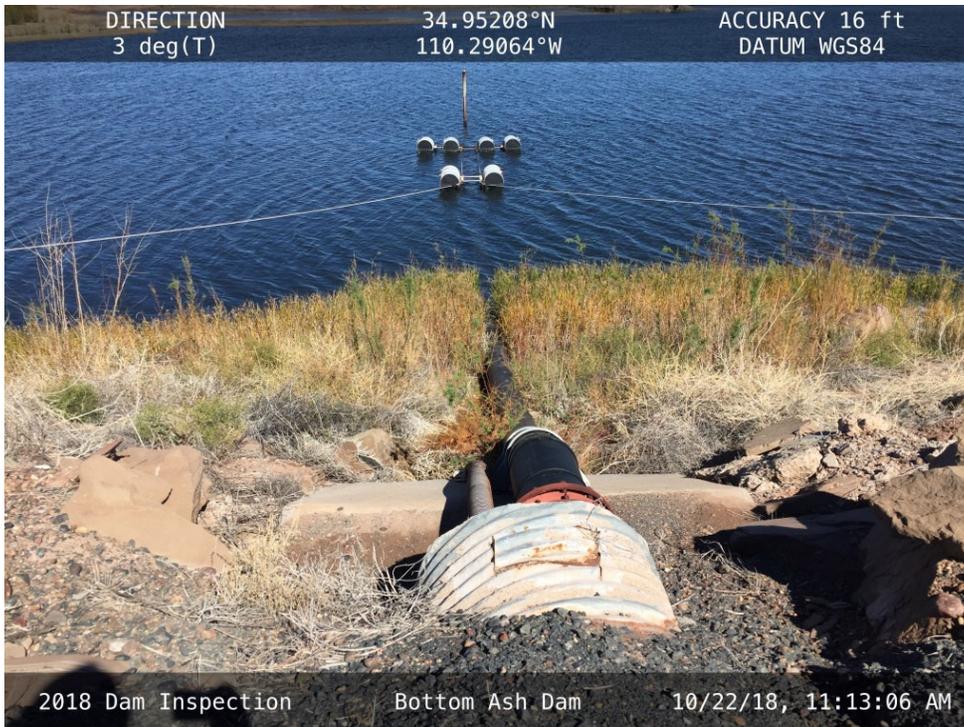
20181022 – IMG_0282

The western siphon line in the Bottom Ash Pond, facing upstream (north).

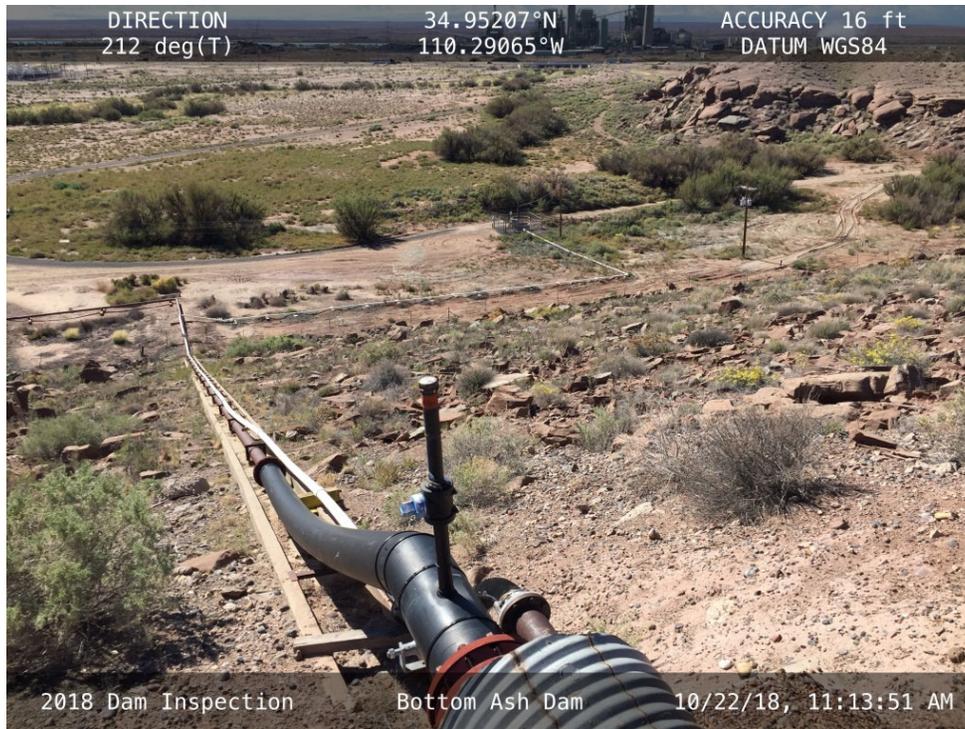
20181022 – IMG_0290

The western siphon line at the Bottom Ash Dam, facing downstream (south).

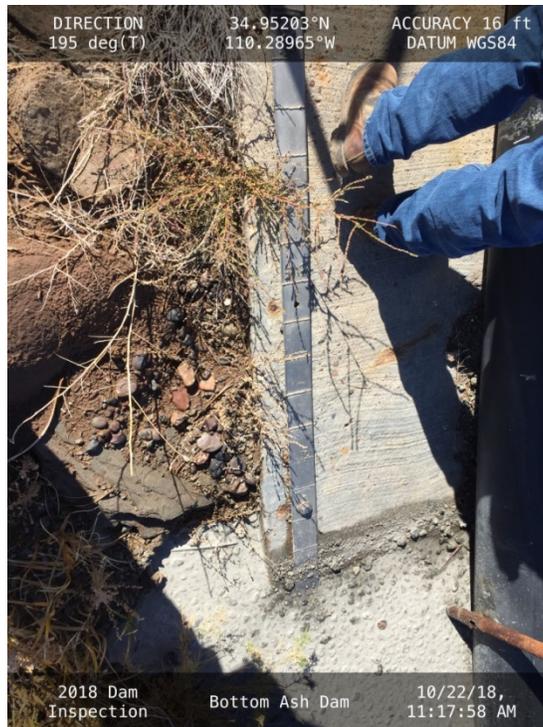
20181022 – IMG_0302
 The water level staff gage adjacent to the central siphon lines.

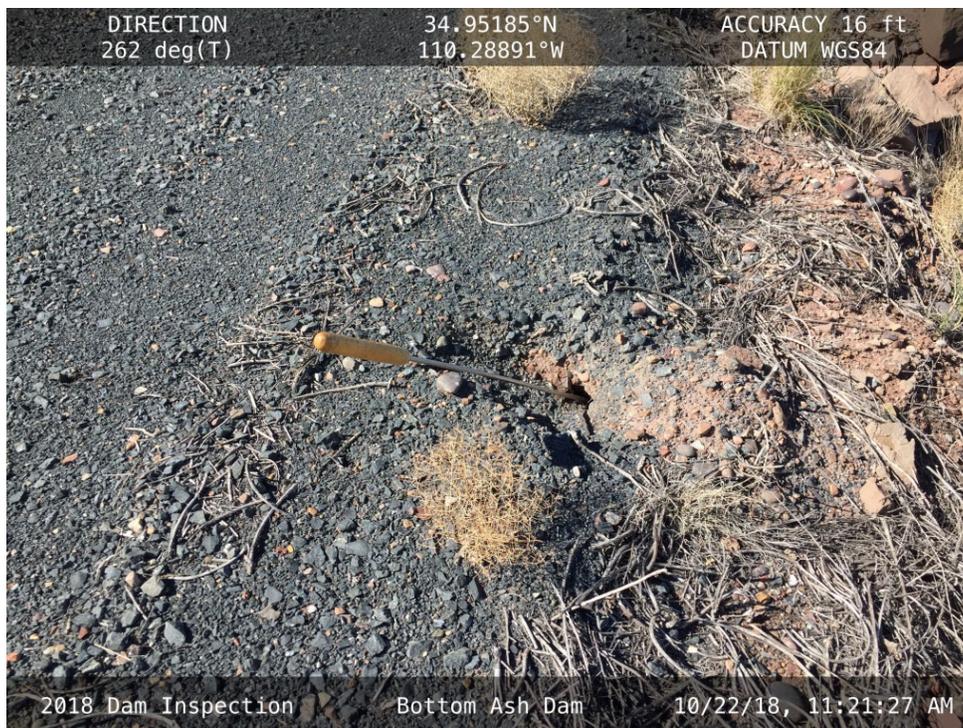
20181022 – IMG_0304
 Minor erosion hole on the downstream side of the South Embankment crest.

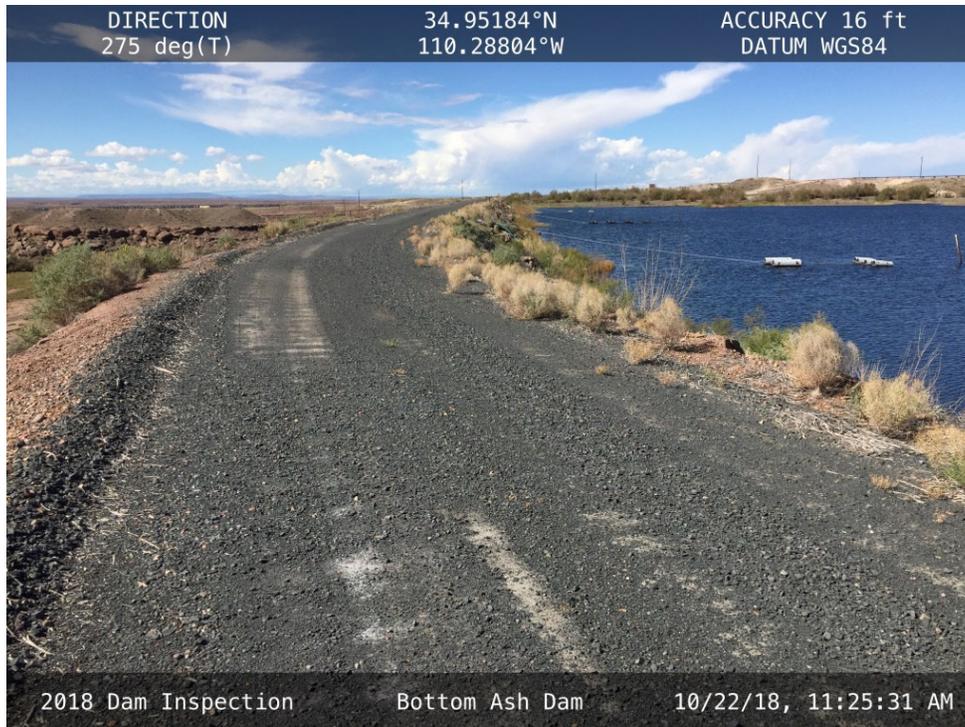
20181022 – IMG_0314

The crest and upstream slope of the South Embankment, facing west.

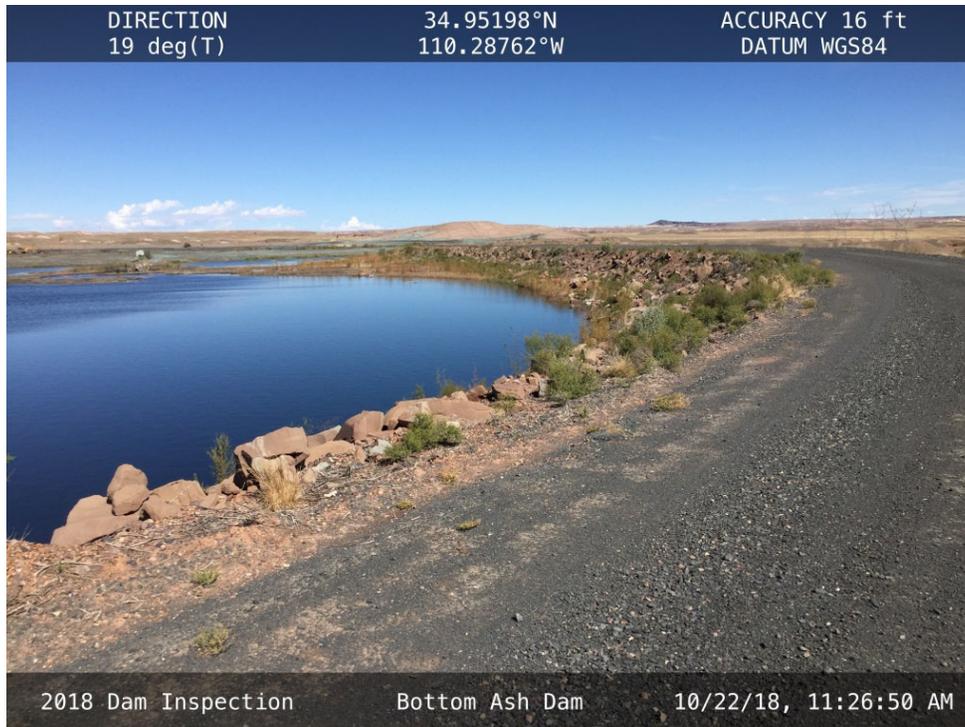
20181022 – IMG_0323

The upstream slope of the East Embankment, facing north from the South Embankment.

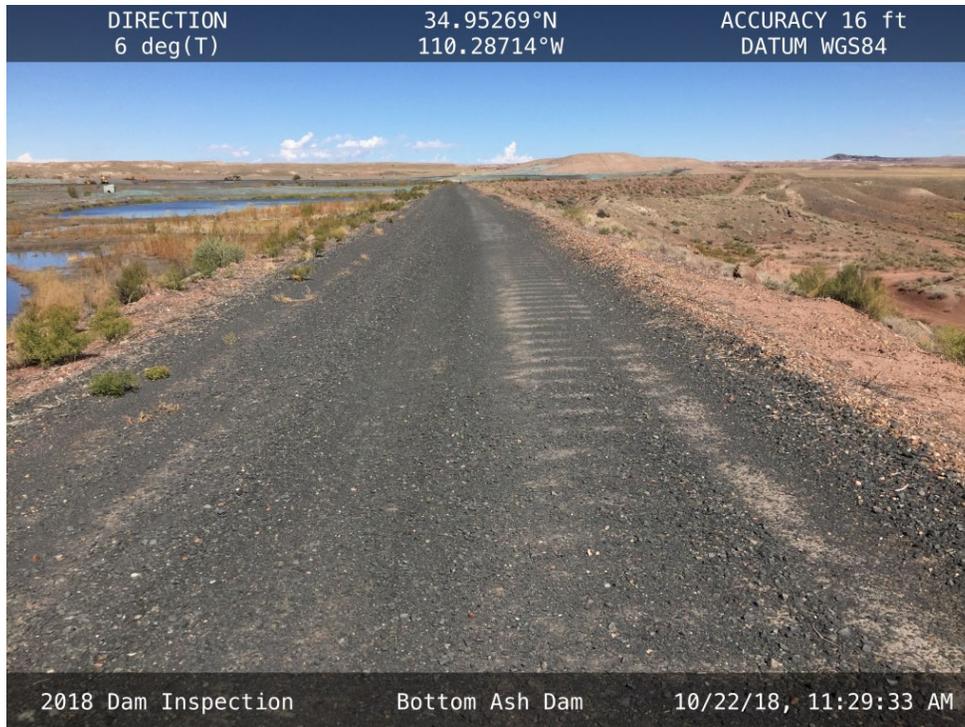
20181022 – IMG_0332
 The southern half of the East Embankment crest, facing north.

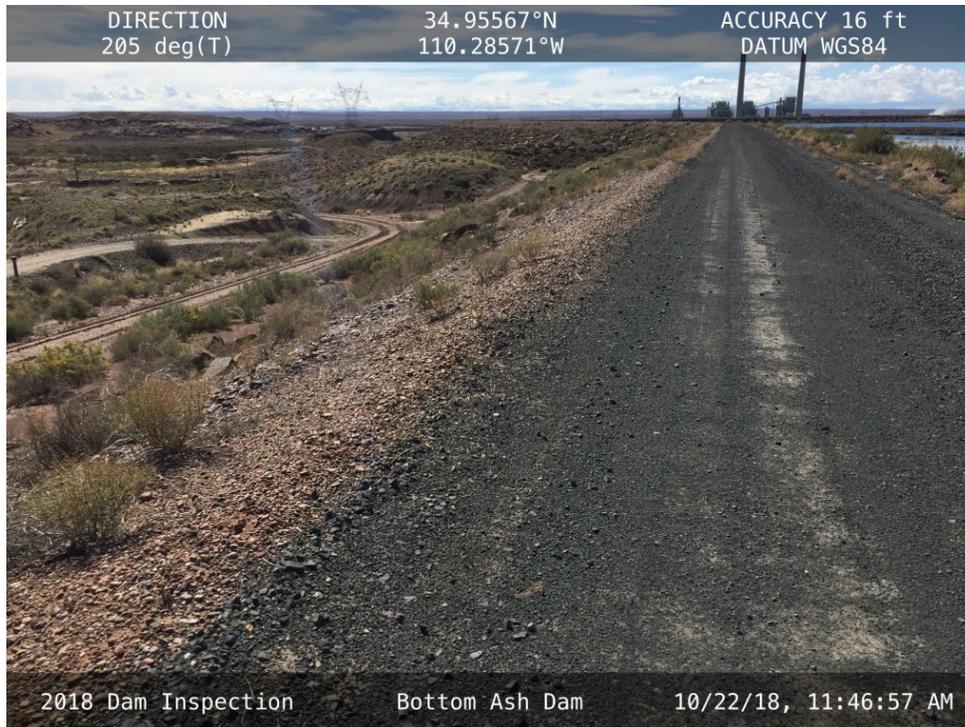
20181022 – IMG_0364

The East Embankment crest and downstream slope, facing south from the North Abutment.

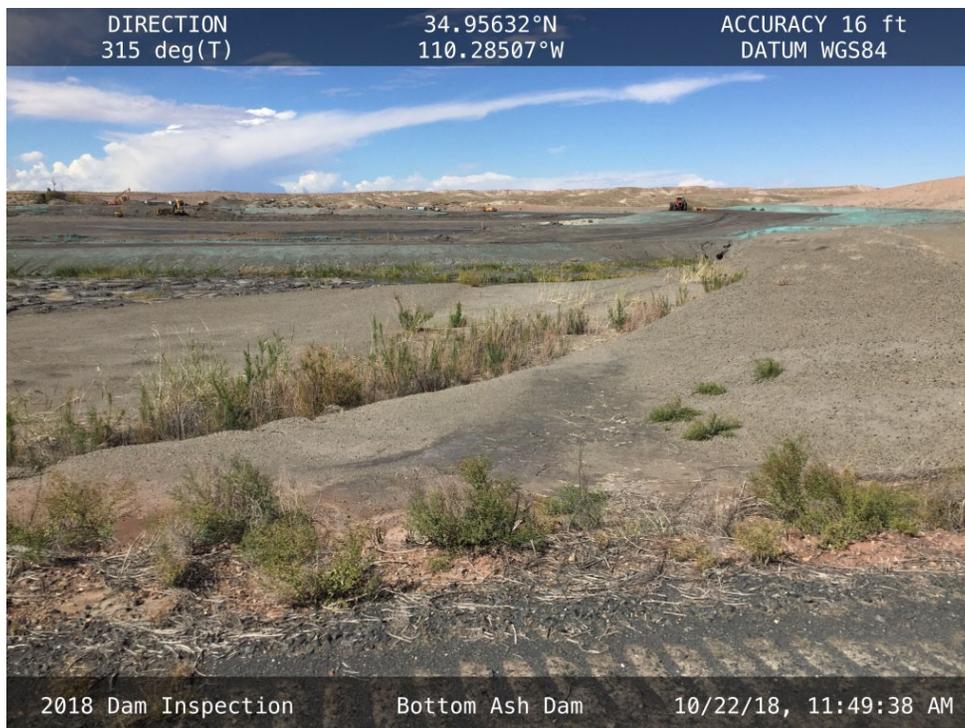
20181022 – IMG_0369

Ash removal activities in the west basin of the Bottom Ash Pond.

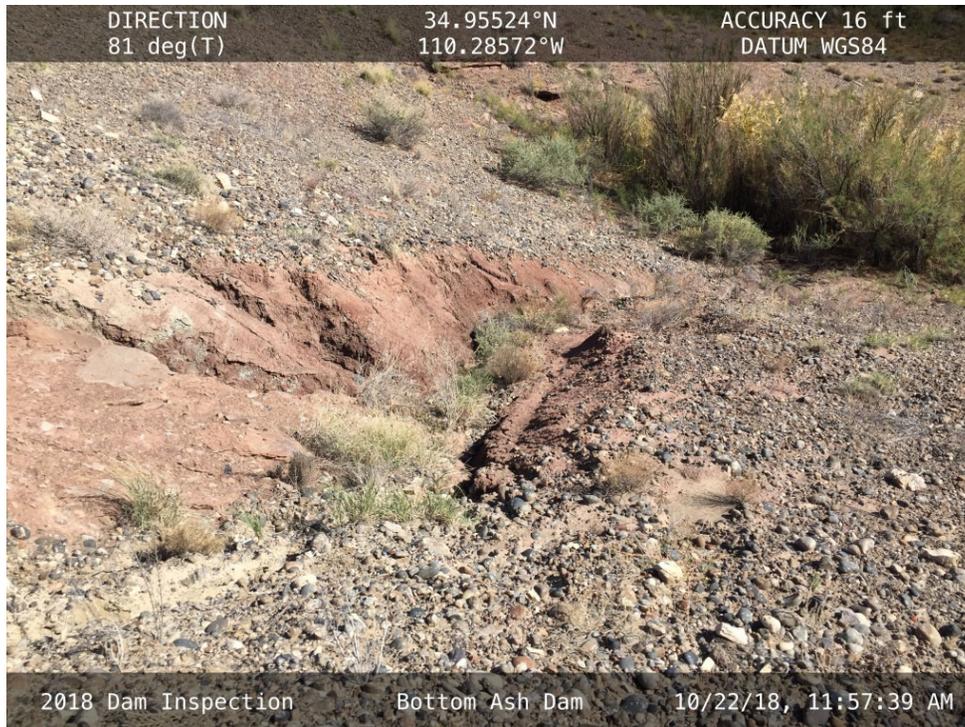
20181022 – IMG_0381

A second erosion gully on the downstream slope of the East Embankment.

2) Monitor the erosion gullies on the downstream slope of the East Embankment.	Repair as needed.
3) Monitor soil wasting along the downstream slope of the East Embankment near the access road.	Investigate the source of the soil wasting.

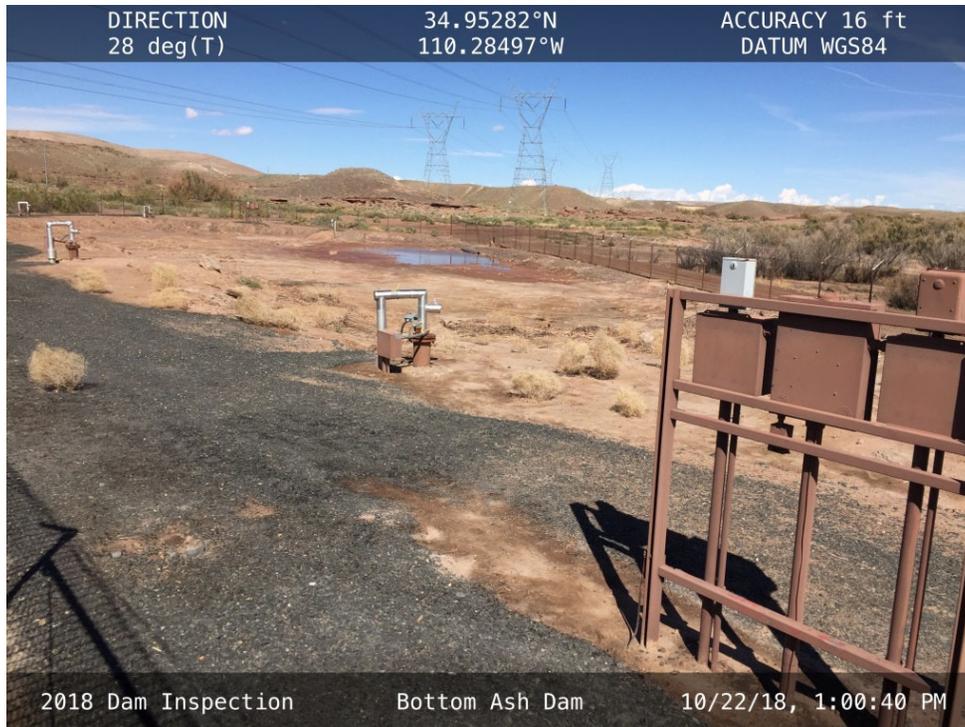
20181022 – IMG_0424

The P-232 seepage intercept area, facing north from the south end.

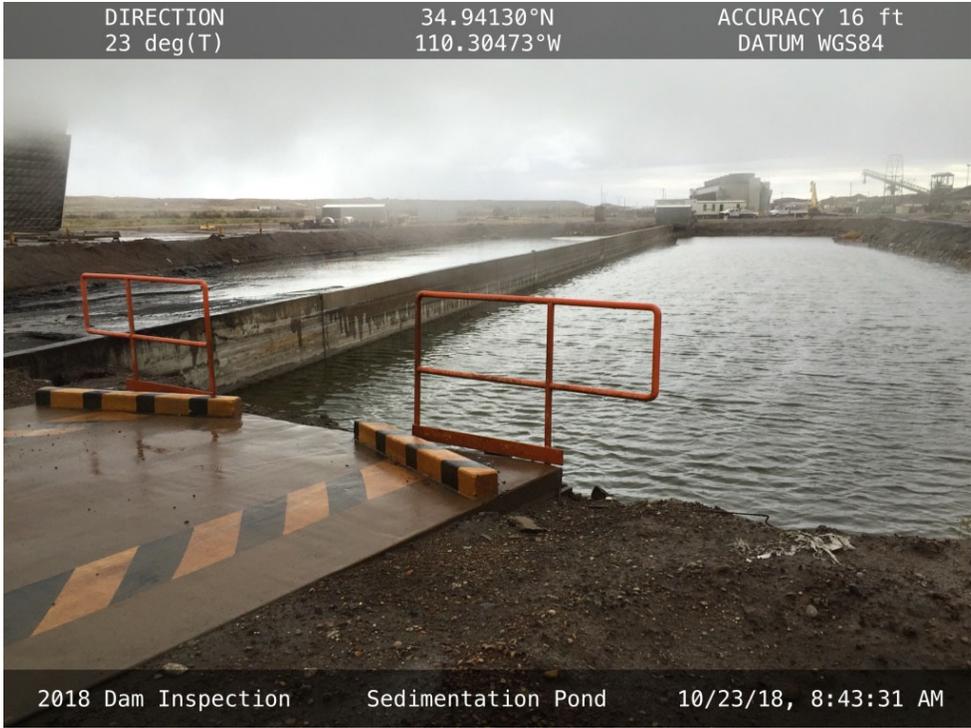
20181023 – IMG_0631

The divider wall in the Sedimentation Pond, facing northeast.
