CHOLLA POWER PLANT Fly Ash Dam, Bottom Ash Dam, Sedimentation Pond, and Bottom Ash Monofill

Annual CCR Impoundment and Landfill Inspection Report

2018

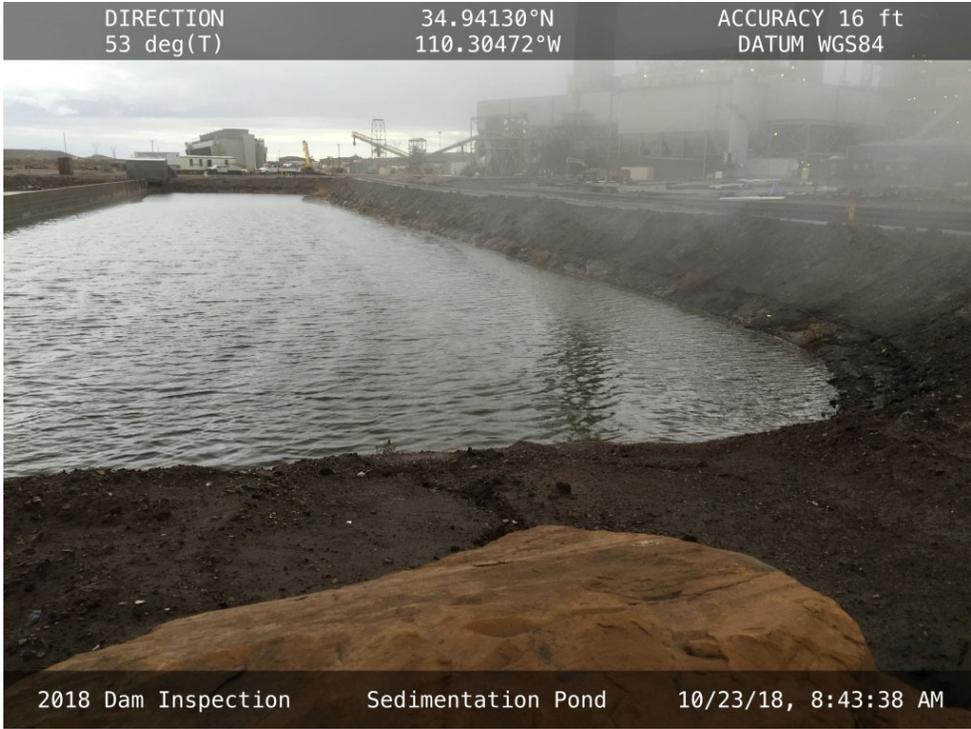
20181023 – IMG_0632

The upstream slope on the south side of the southern cell, facing northeast.

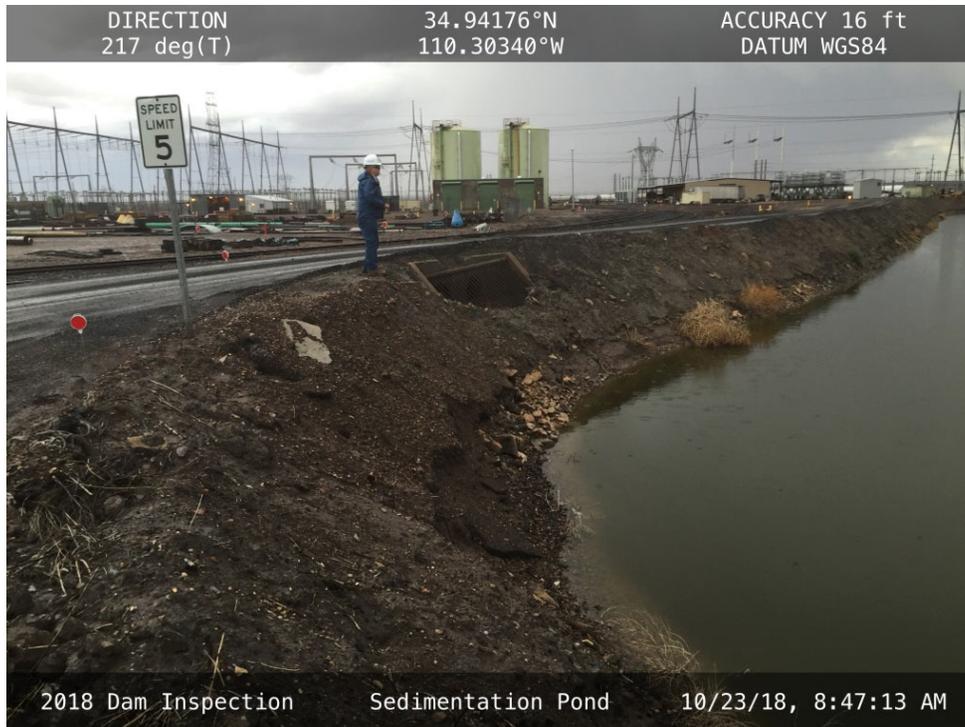
20181023 – IMG_0638

The spillway along the southern cell of the Sedimentation Pond, facing southwest.

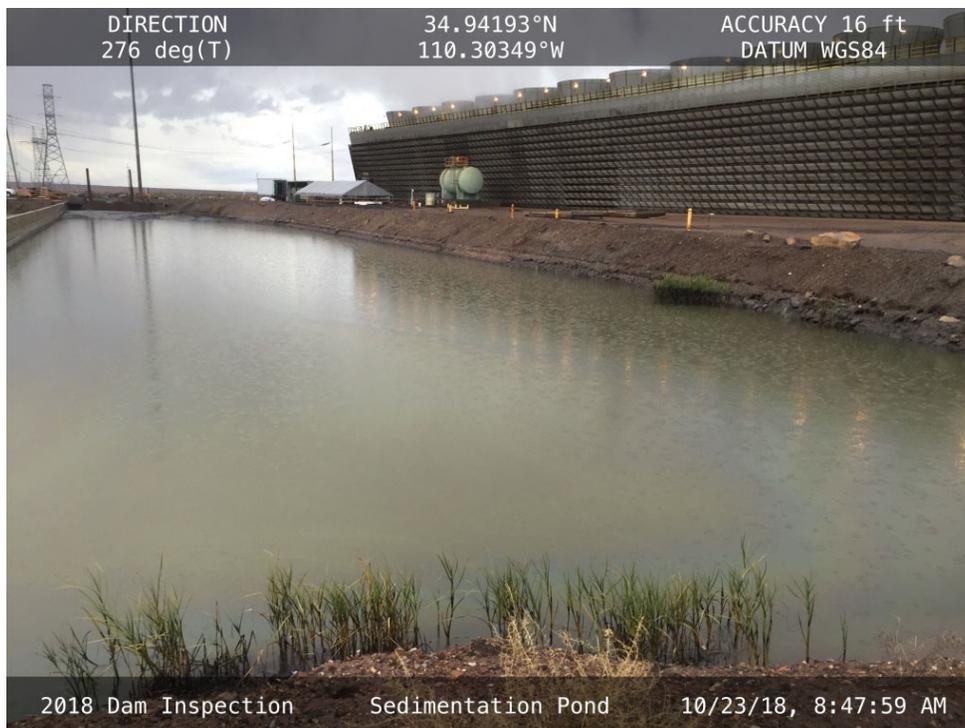
20181023 – IMG_0641

The upstream slope on the north side of the northern cell, facing west.

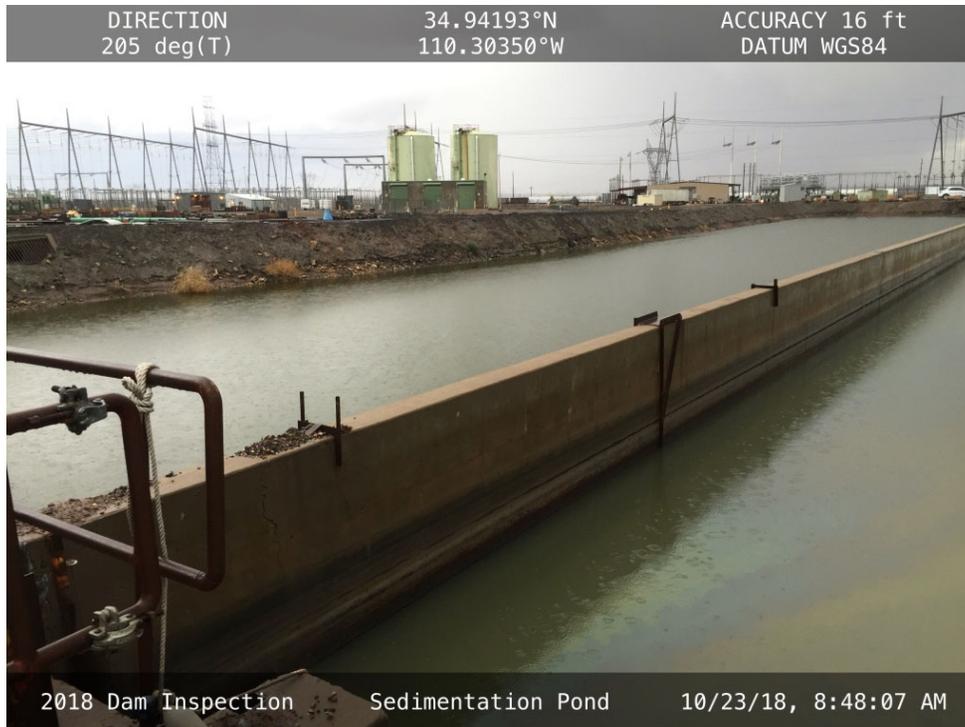
20181023 – IMG_0644

The divider wall and southern cell, facing southwest from the east embankment.

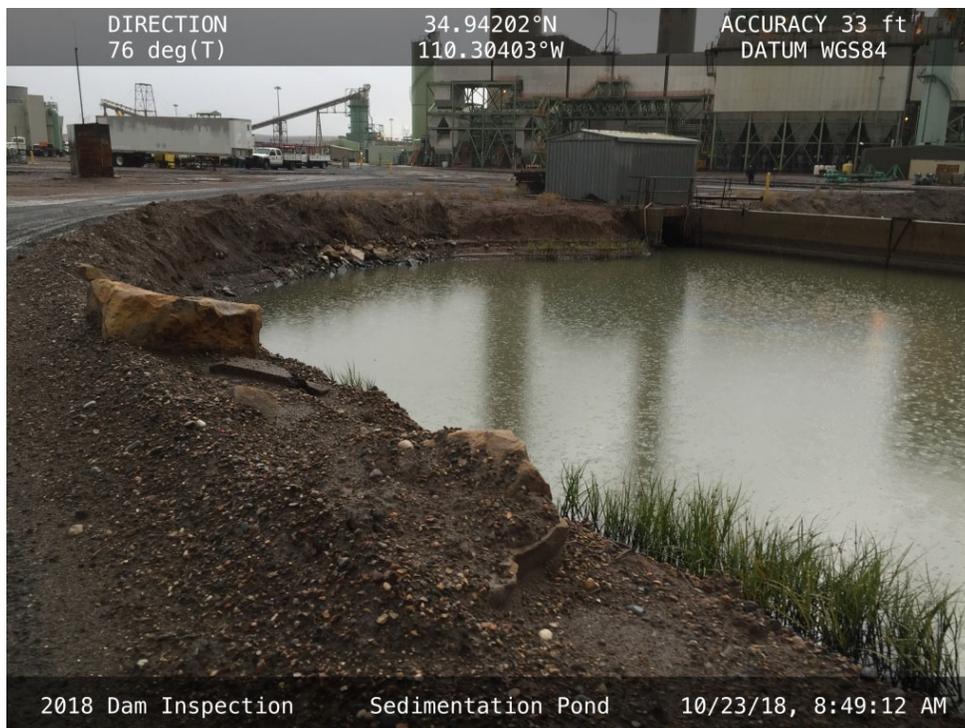
20181023 – IMG_0645

The upstream slope on the east side of the northern cell, facing east.

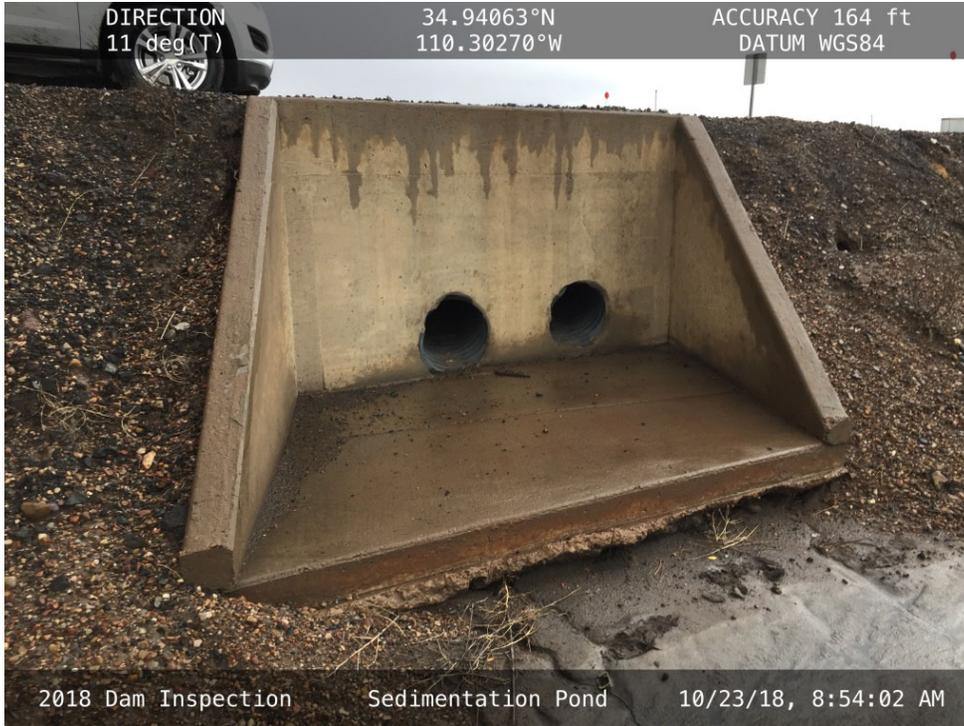
20181023 – IMG_0656

The concrete spillway on the downstream side of the south embankment.

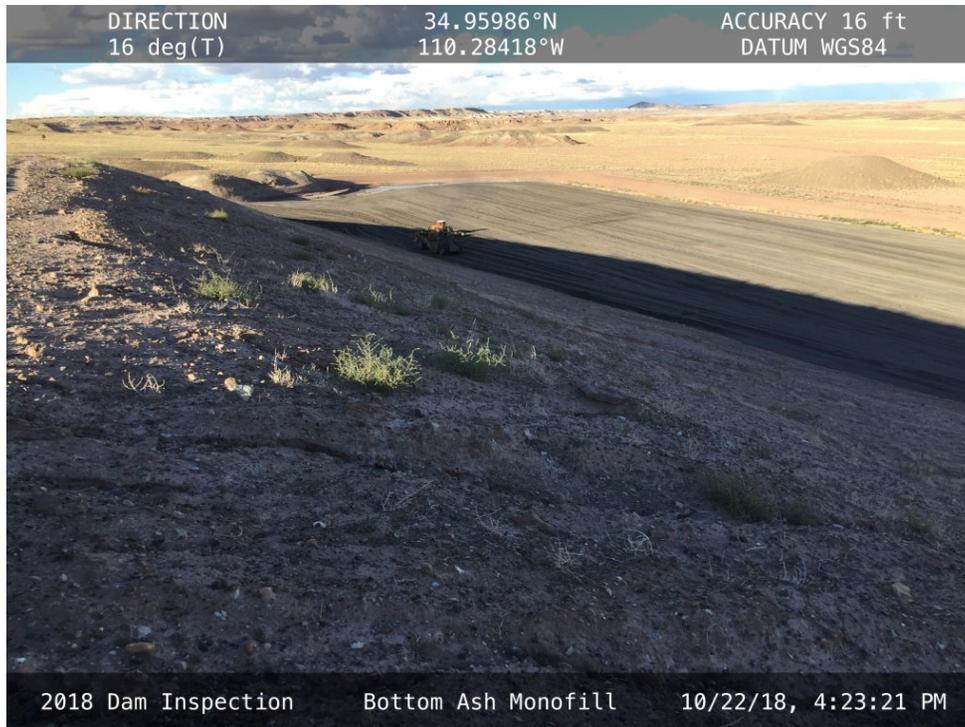
20181022 – IMG_0561

Bottom ash being placed in the Bottom Ash Monofill, facing north from the top of the Monofill.

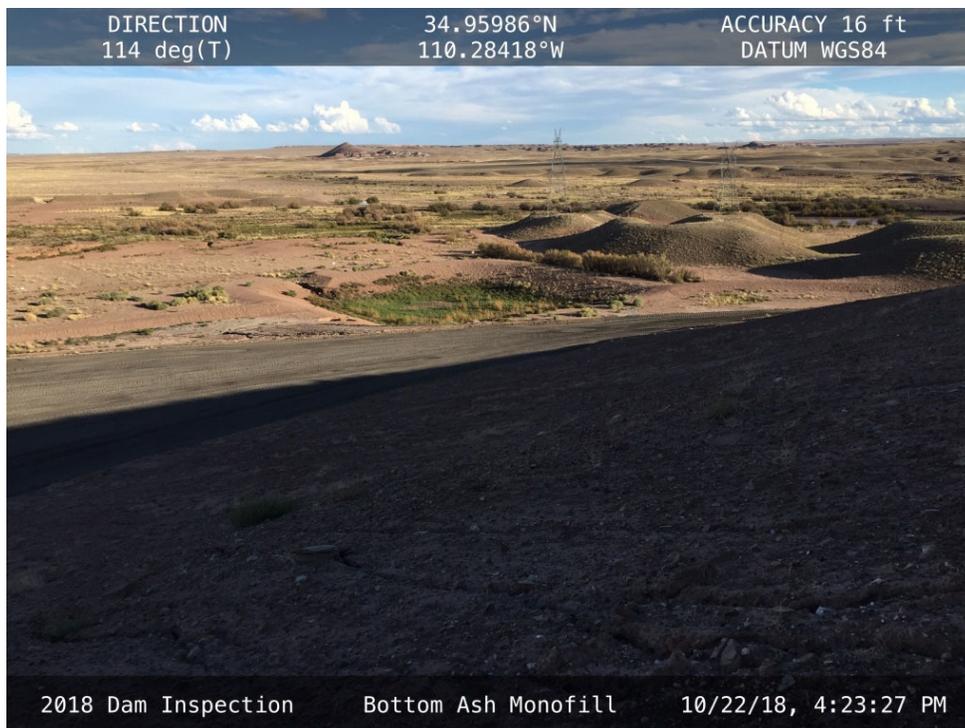
20181022 – IMG_0562

The Stormwater Detention Basin, facing southeast from the top of the Monofill.

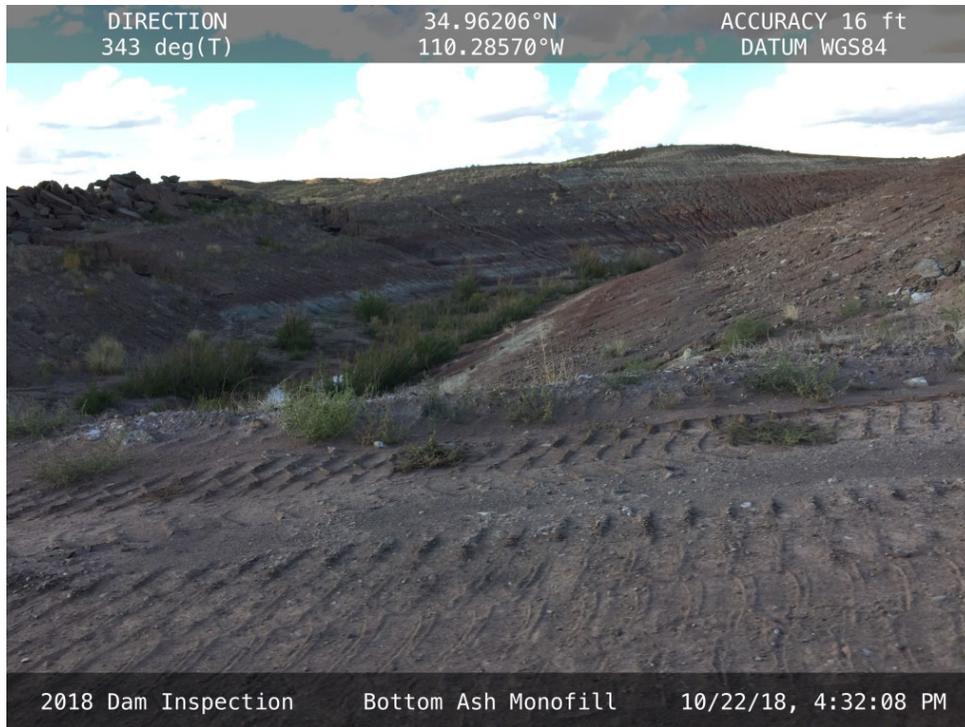
20181022 – IMG_0593

The Stormwater Diversion Channel along the north side of the Bottom Ash Monofill.

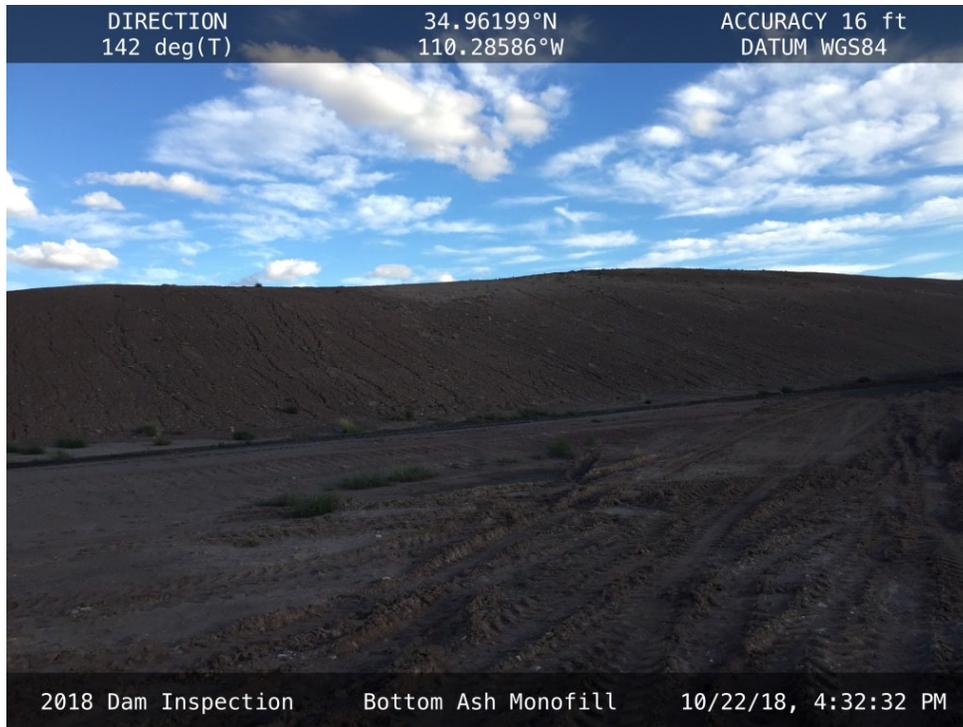
20181022 – IMG_0596

The western slope of the Bottom Ash Monofill, facing southeast.

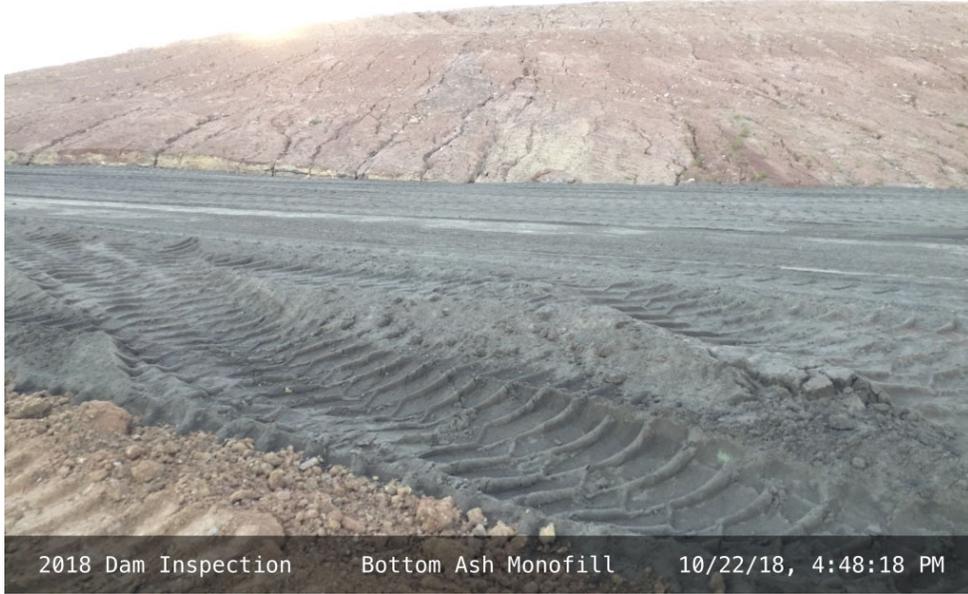
20181022 – IMG_0628

The erosion observed on the eastern side of the top of the Bottom Ash Monofill extended through the soil cover and into the underlying bottom ash. The erosion is localized and does not appear to affect the stability of the CCR unit at this time; however, if the erosion becomes more widespread, it could have the potential to disrupt the operation of the CCR unit. No other conditions that are or could be disruptive to the operation and safety of the CCR unit and appurtenant structures were identified during the field inspection.

Minor erosion rills along the eastern side of the Bottom Ash Monofill, facing west.

Action Item	Action Status
1) Monitor the erosion around the outfall structure and the surface of the CCR unit.	Repair as needed.
