CHOLLA POWER PLANT Fly Ash Dam, Bottom Ash Dam, and Bottom Ash Monofill

Annual CCR Impoundment and Landfill Inspection Report 2021

GENERATION ENGINEERING
Design Engineering
P.O. BOX 53999
PHOENIX, ARIZONA 85072

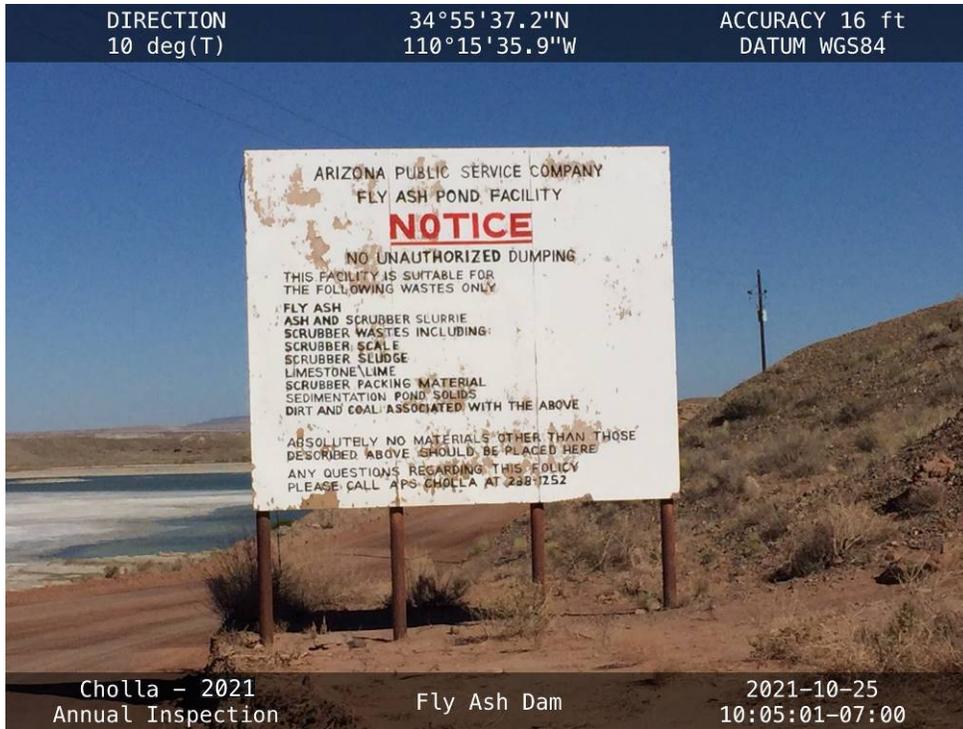
20211025-IMG_6757

Sign identifying allowed and disallowed materials in the Fly Ash Pond.

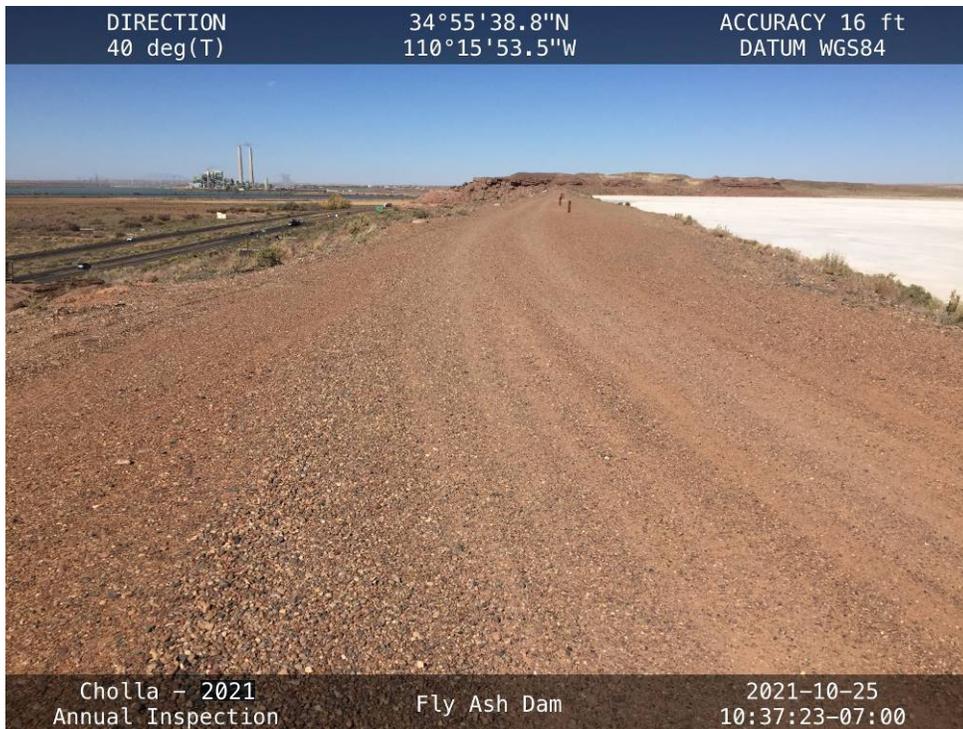
20211025-IMG_6765

The crest of the Fly Ash Dam, facing northwest from the South Embankment.

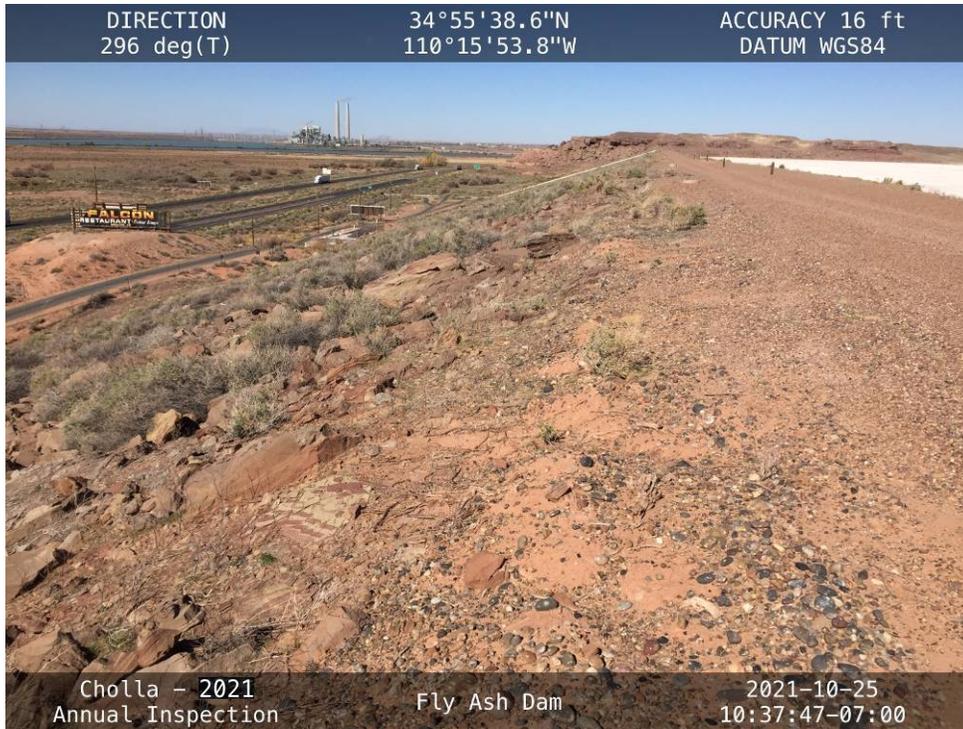
20211025-IMG_6772

The downstream slope of the Fly Ash Dam, facing northwest from the South Embankment.

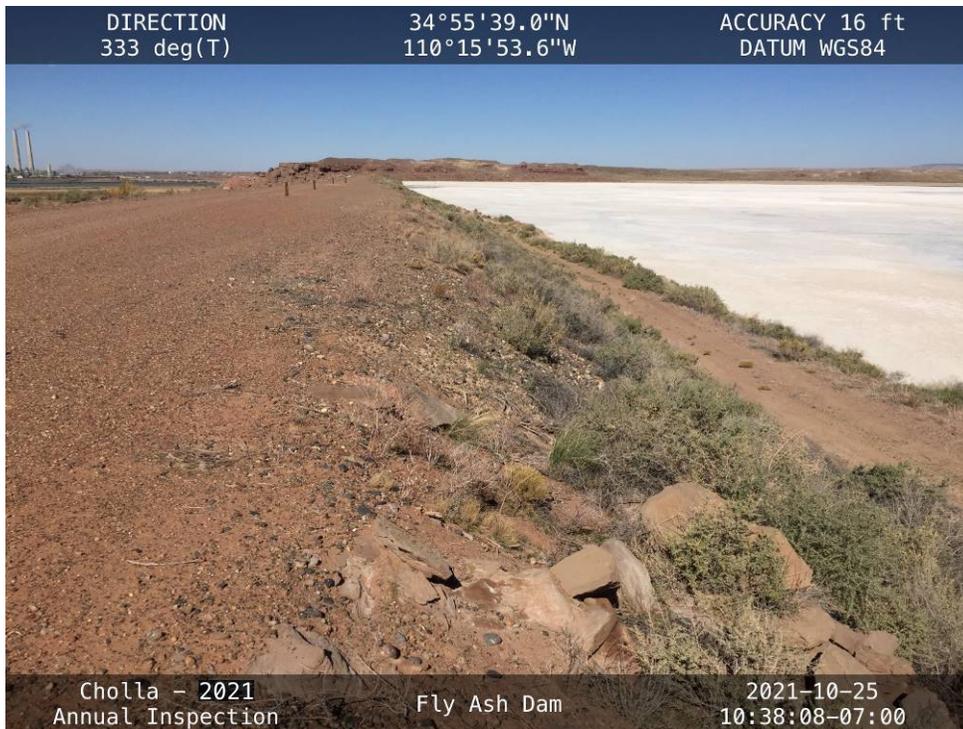
20211025-IMG_6773

The upstream slope of the Fly Ash Dam, facing northwest from the South Embankment.

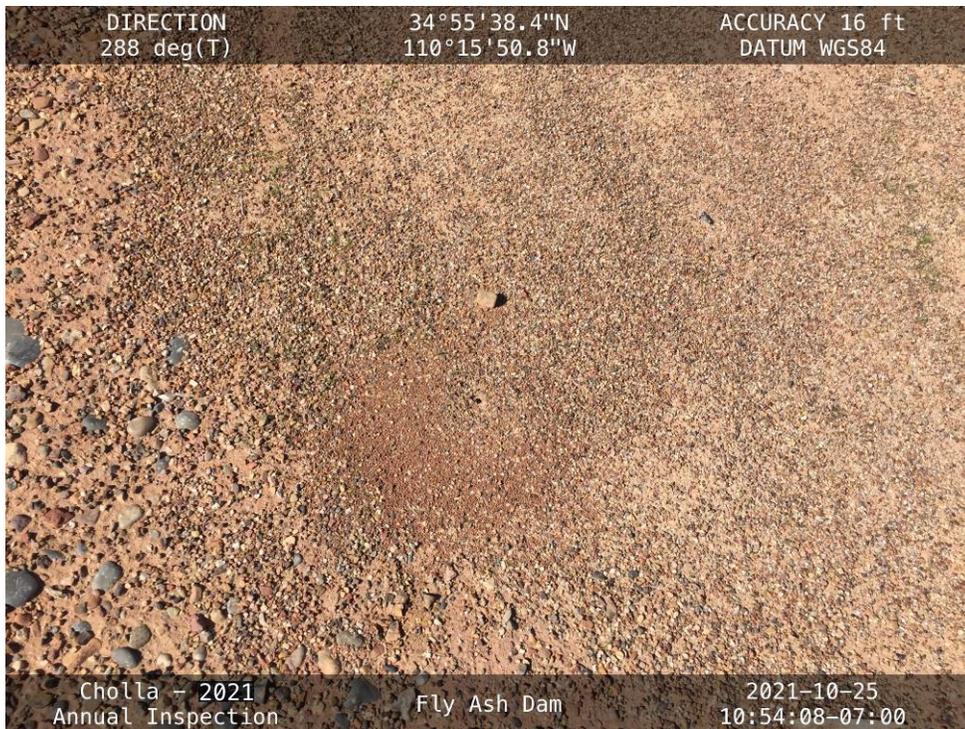
20211025-IMG_6783

DAM EMBANKMENT CHECKLIST								
3	DAM CREST							
a	Settlements, slides, depressions?							
b	Misalignment?							
c	Longitudinal/Transverse cracking? None observed. See comment ii.			X		X		
d	Animal burrows? Ant hills were observed at various locations across the crest (Photos IMG_6783 and IMG_6815).				X	X		
e	Adverse vegetation?							
f	Erosion?							
4	UPSTREAM SLOPE							
a	Erosion? Minor erosion and soil wasting observed along the upstream slope. See comment iii.				X	X		
b	Inadequate ground cover?							
c	Adverse vegetation? None observed. Continue to monitor vegetation.			X		X		
d	Longitudinal/Transverse cracking?							
e	Inadequate riprap?							
f	Stone deterioration? Minor deterioration observed. See comment iv.				X	X		
g	Settlements, slides, depressions, bulges?							
h	Animal burrows? None observed. Continue to monitor.			X		X

An ant hill on the crest of the South Embankment.

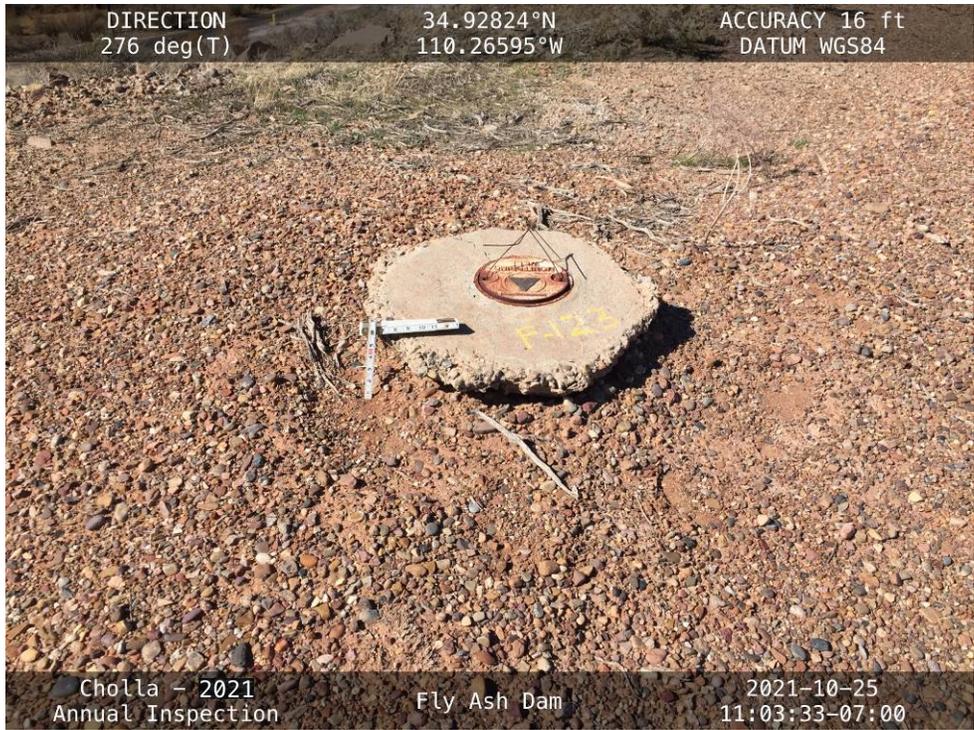
20211025-IMG_6792

Erosion around piezometer F-123 on the downstream shoulder of the West Embankment crest.

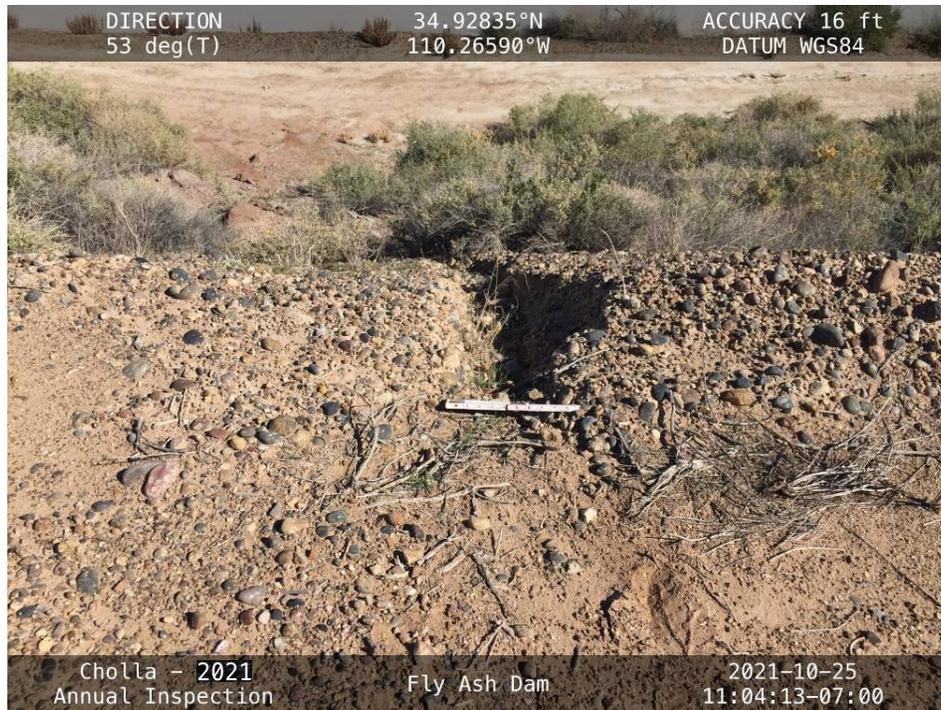
20211025 – IMG_6793

- iii. Minor erosion was observed along the upstream slope near the piezometers screened in the dam core (Photos IMG_6786, IMG_6787, IMG_6793, and IMG_6794). The eroded portion was observed to be slightly wider during this inspection compared to the 2020 inspection (comparing 2020 Photo IMG_2344 with 2021 Photo IMG_6793) and the erosion locations appeared more numerous compared to the 2020 inspection. The affected portion of the upstream slope is part of the dam crest widening constructed in early 2000 to accommodate piezometer installation activities. The crest is approximately 40 feet wide in this area (compared to the design crest width of 24 feet). The erosion appears to be in the extended portion and is not affecting the original crest.

Minor erosion on the upstream side of the crest in an area where the crest is wider (compare to 2020 Photo IMG_2344).

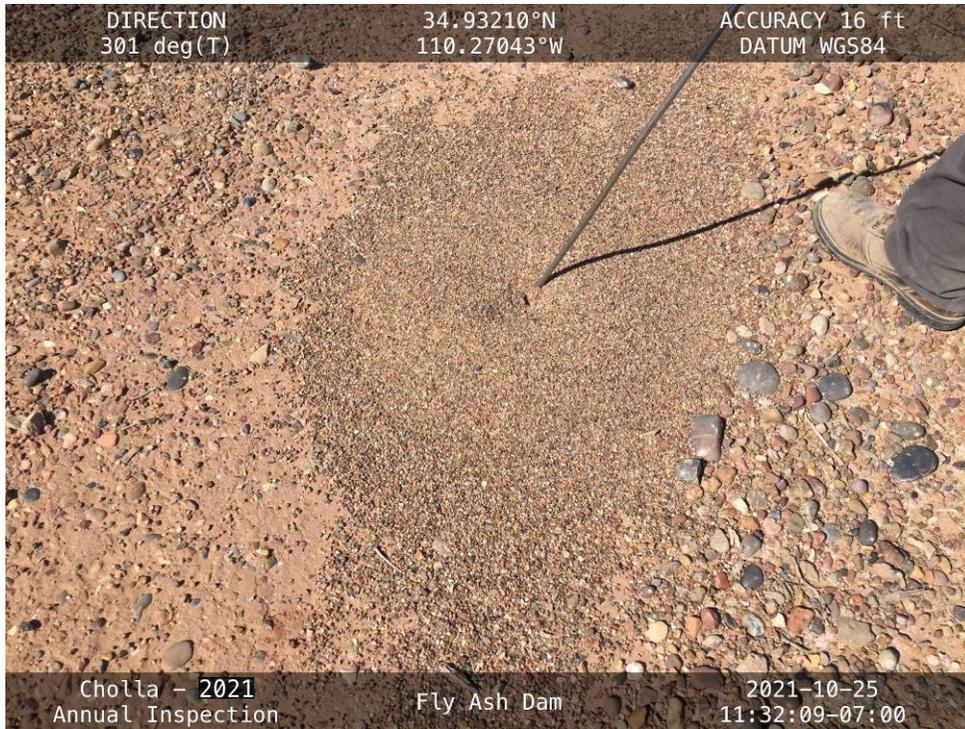
20211025-IMG_6815
An ant hill on the crest of the West Embankment.

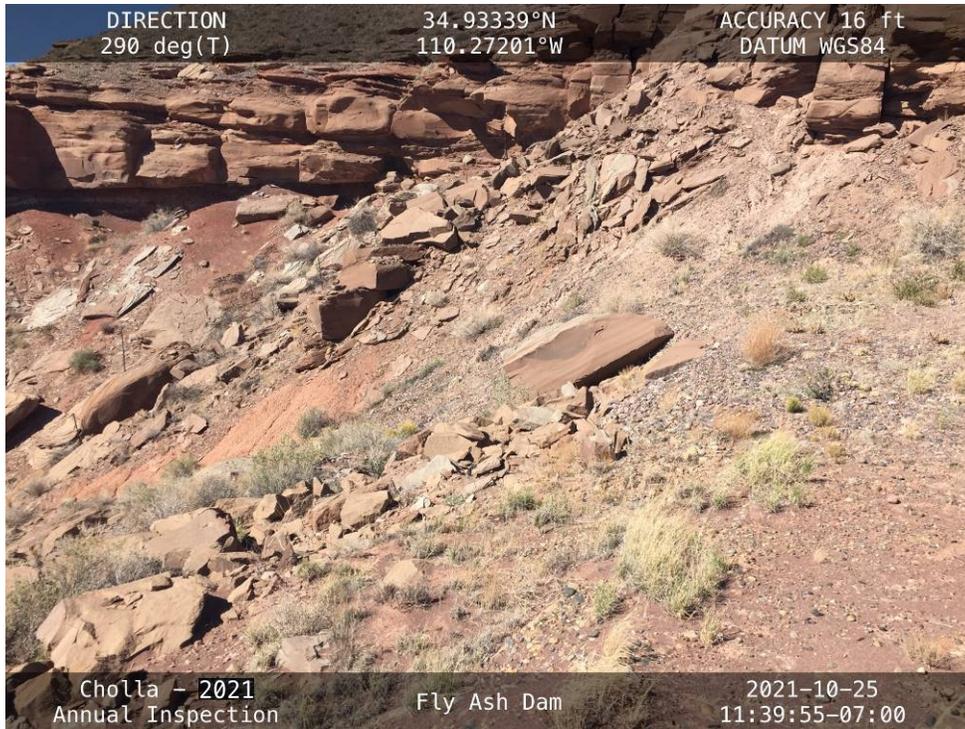
b	Differential movement?			X							
c	Cracks?			X							
d	Settlements, slides, depressions, bulges?			X							
e	Seepage?	Historic seepage has been observed downstream of the Right Abutment during previous inspections. The areas were observed to be dry during this inspection.		X			X				
f	Animal burrows?	None observed. Continue to monitor.		X			X				
7	<i>SEEPAGE/PIPING CONTROL DESIGN FEATURE(S)</i>										
a	Describe:	1) The Geronimo and Hunt seepage collection and pump back systems are located downstream of the dam near I-40 for fluid interception. See comment v. 2) Discharge from the crest side of the reservoir creates a beach to prevent water from being stored against the upstream face.									
b	Internal drains flowing?					X	X				
c	Seepage at or beyond toe?	See comment v.				X	X				
d	If so, does seepage contain fines?	Sumps C and D were inspected and the water appeared clear. Sumps A and B were not running at the time of the inspection.		X

20211025 – IMG_6824
The downstream side of the Right Abutment contact.

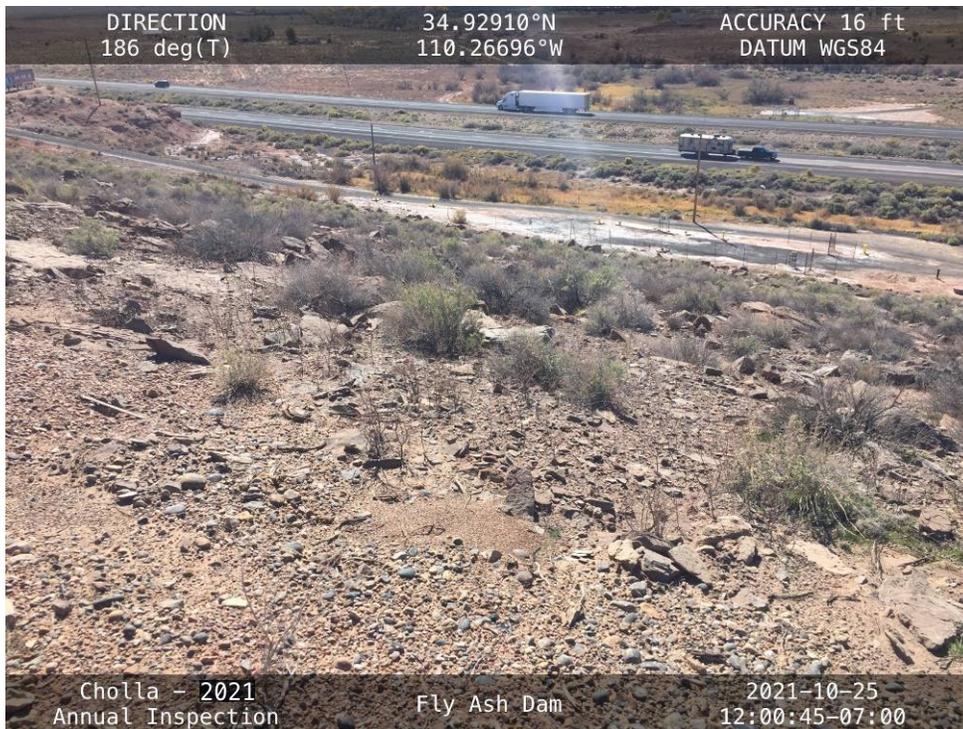
20211025 – IMG_6853

- iv. Minor stone deterioration was also observed during previous inspections. Continue to monitor.
- v. Seepage has historically been observed at the Geronimo Seep, the Hunt seep, the I-40 seep, and in areas of relatively lower elevation along the downstream toe. The Geronimo and Hunt sumps were active during the inspection while areas downstream of the West Embankment were dry. APS replaced Geronimo Seep well pumps A and B (GSX-1 and GSX-2) after observing they were operating inconsistently, had relatively low extraction rates, and erratic water levels (Wood 2021) (Photo IMG_6882). The well pump replacement coincided with the abandonment and replacement of the piezometers and wells described in comment i.

The downstream slope of the Fly Ash Dam, facing south toward the Geronimo Seep.

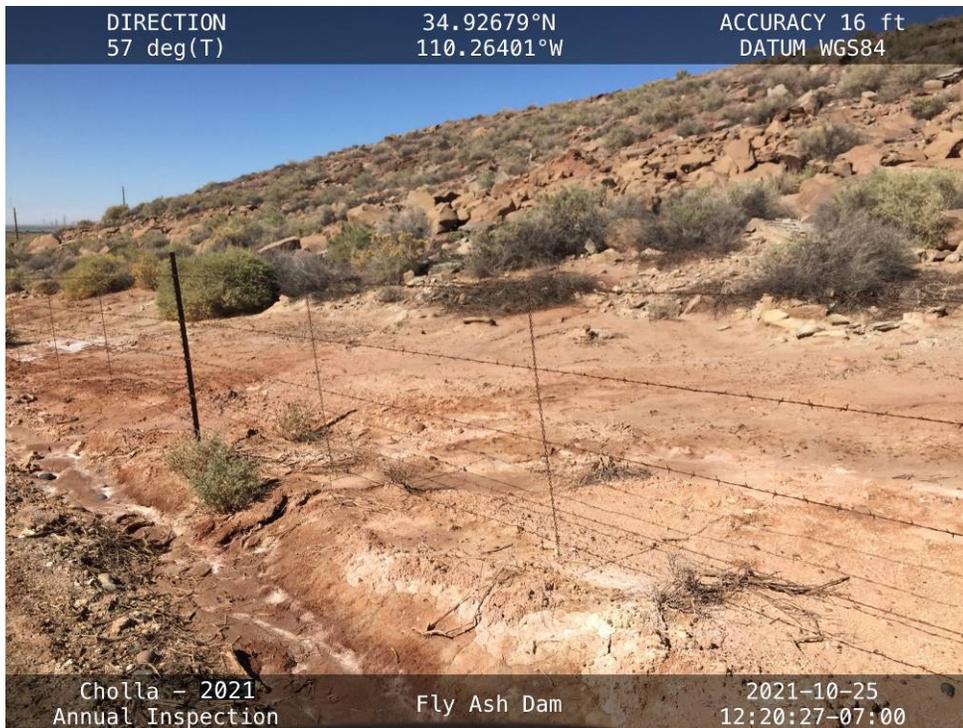
20211025-IMG_6869

The downstream slope and toe of the South Embankment.

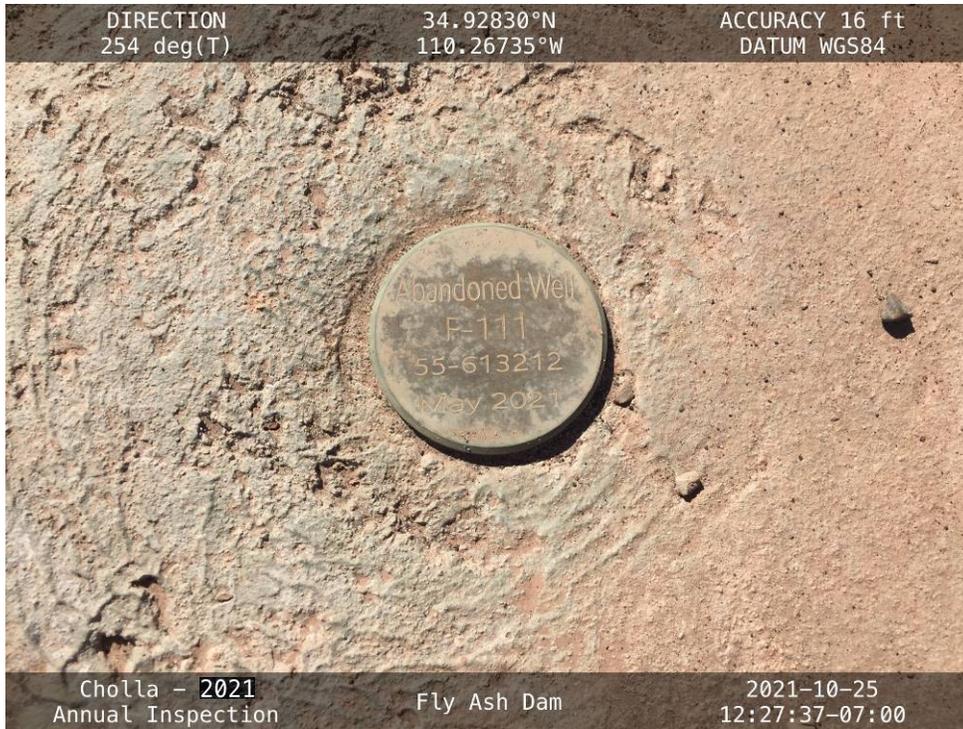
20211025-IMG_6885

The well abandonment marker for piezometer F-111 set in May 2021.

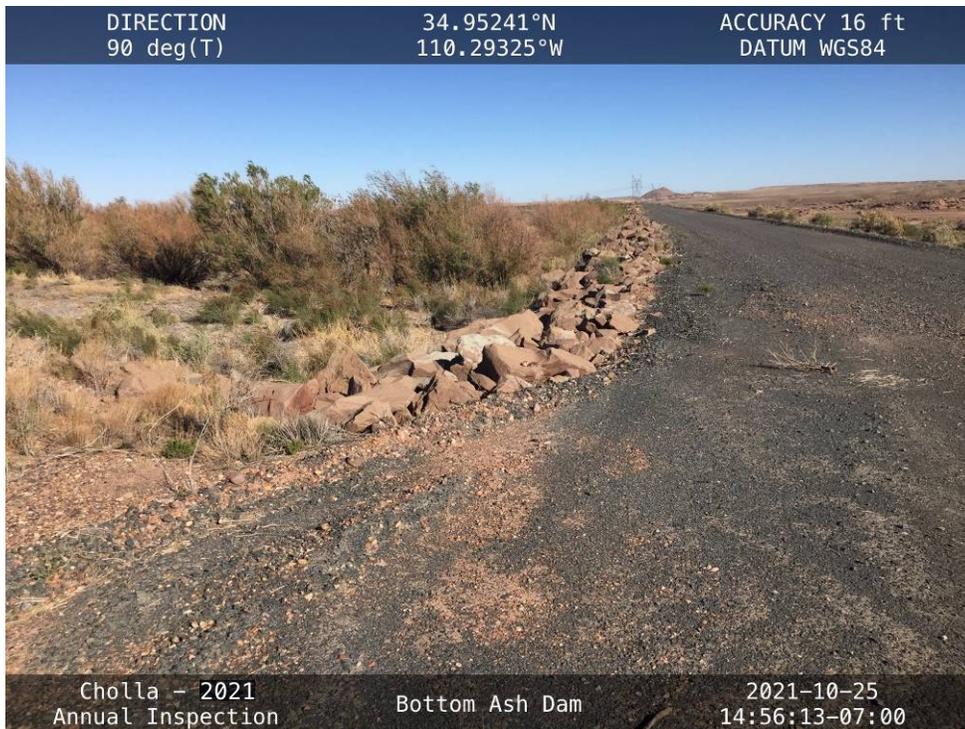
20211025-IMG_6976

Trees and other woody vegetation to be removed from the South Embankment upstream slope.

9) Remove vegetation from the upstream slope at the Right Abutment.	Woody vegetation rooted in the embankment should be removed and the resulting disturbed area should be replaced with compacted material similar to the embankment material per NMOSE (2011).

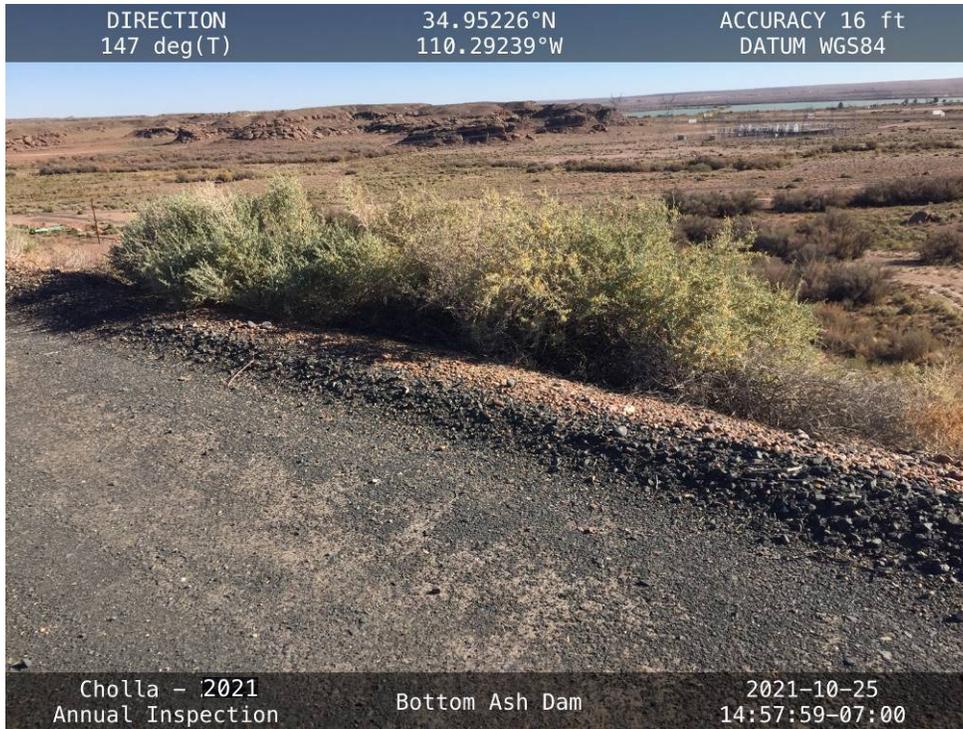
20211025-IMG_6981

Vegetation growing on the downstream slope of the South Embankment.

7) The pumpback flowmeter at the eastern siphon line is broken.	Replace the pumpback flowmeter at the eastern siphon line
8) Continue to monitor seepage areas for excessive vegetation.	Woody vegetation rooted in the embankment should be removed and the resulting disturbed area should be replaced with compacted material similar to the embankment material per NMOSE (2011).

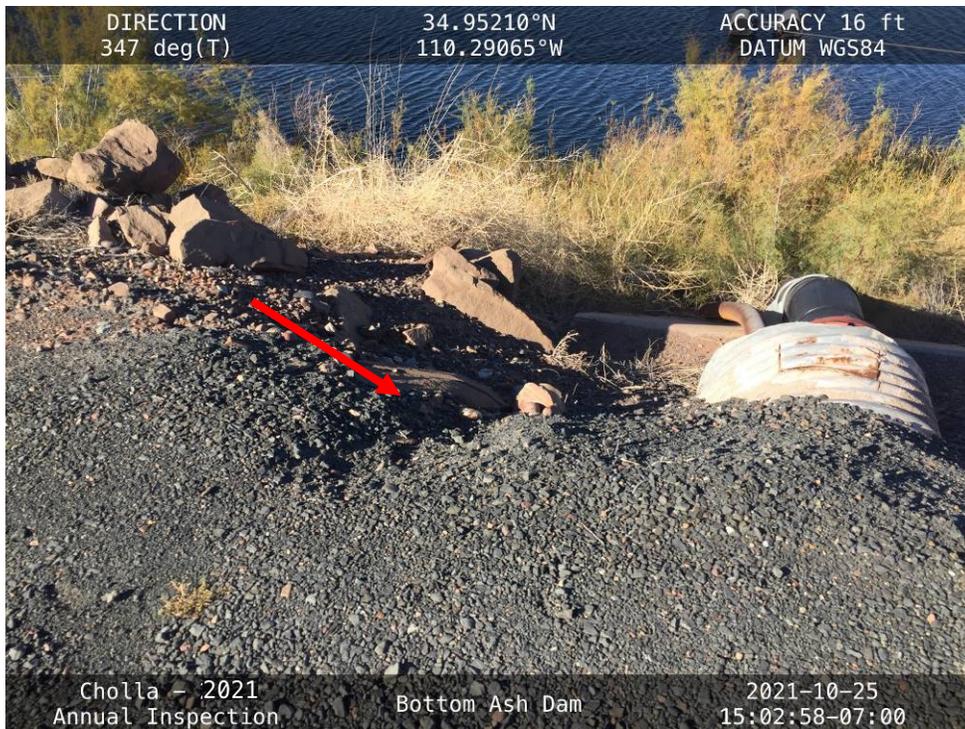
20211025-IMG_6998

Minor erosion around the concrete encasement for the western siphon line, facing upstream.

10) Continue to monitor the erosion around the siphon line encasements and on the shoulder of the crest.	Repair erosion if the eroded depth exceeds 1 foot.

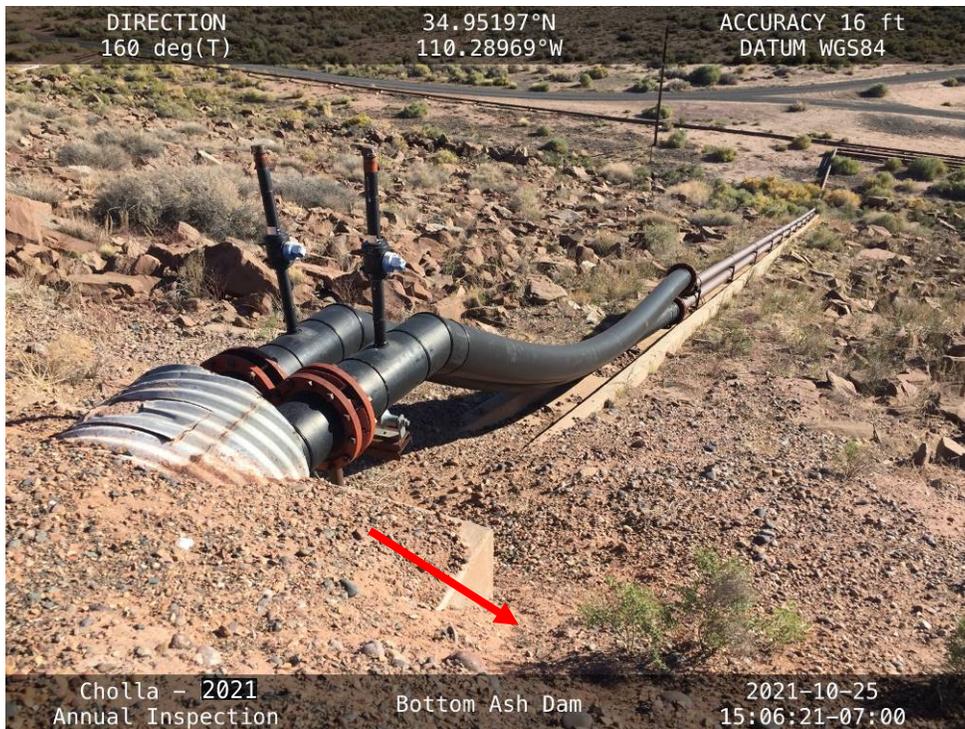
20211025-IMG_7010

Minor erosion around the concrete encasement for the central siphon lines.

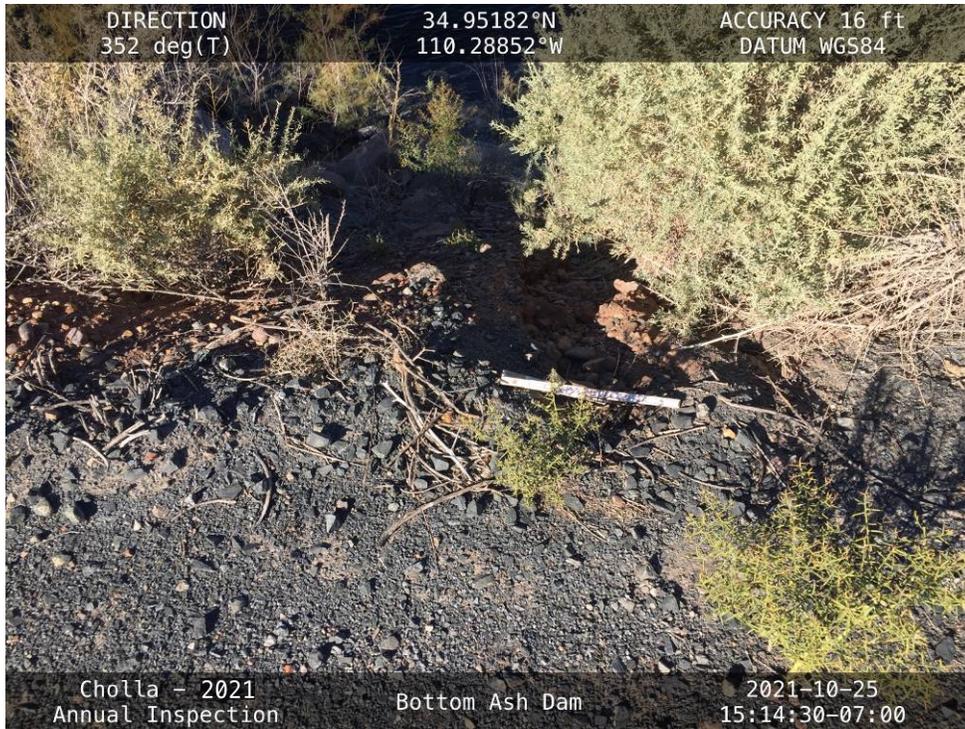
20211025-IMG_7036

Minor erosion rill forming on the upstream shoulder of the South Embankment (1 foot across).

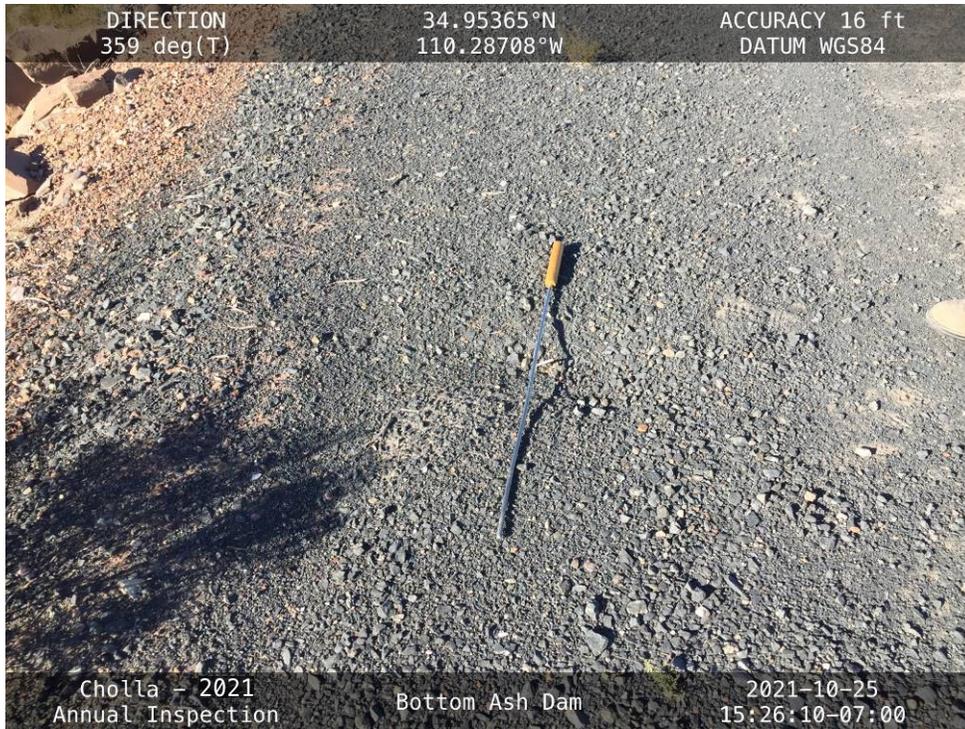
20211025-IMG_7052

A 2.5-inch-deep depression along the upstream shoulder of the East Embankment.

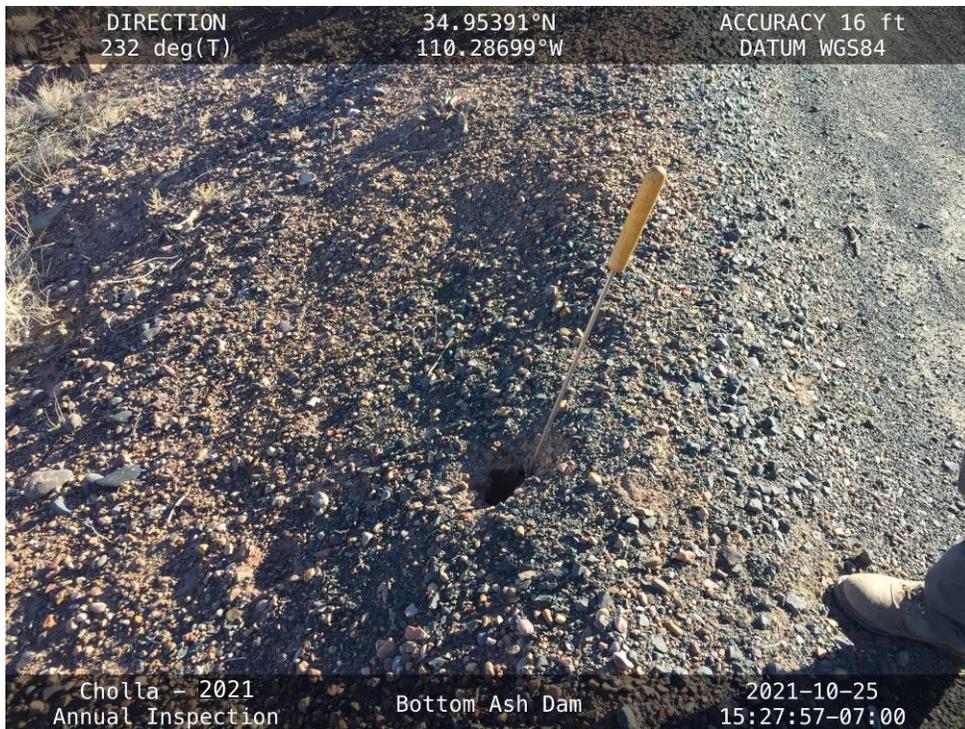
20211025-IMG_7053

A hole on the downstream shoulder of the East Embankment crest.

2) Monitor the erosion gullies at the downstream slope of the East Embankment.	Repair erosion since it has exceeded 1 foot in depth.
3) Continue identifying and remediating scattered animal burrows and ant hills.	1) Mark ant hills and animal burrows identified during weekly inspections. 2) Continue remediating identified ant hills and animal burrows. NOTE: This will always be an ongoing maintenance activity.

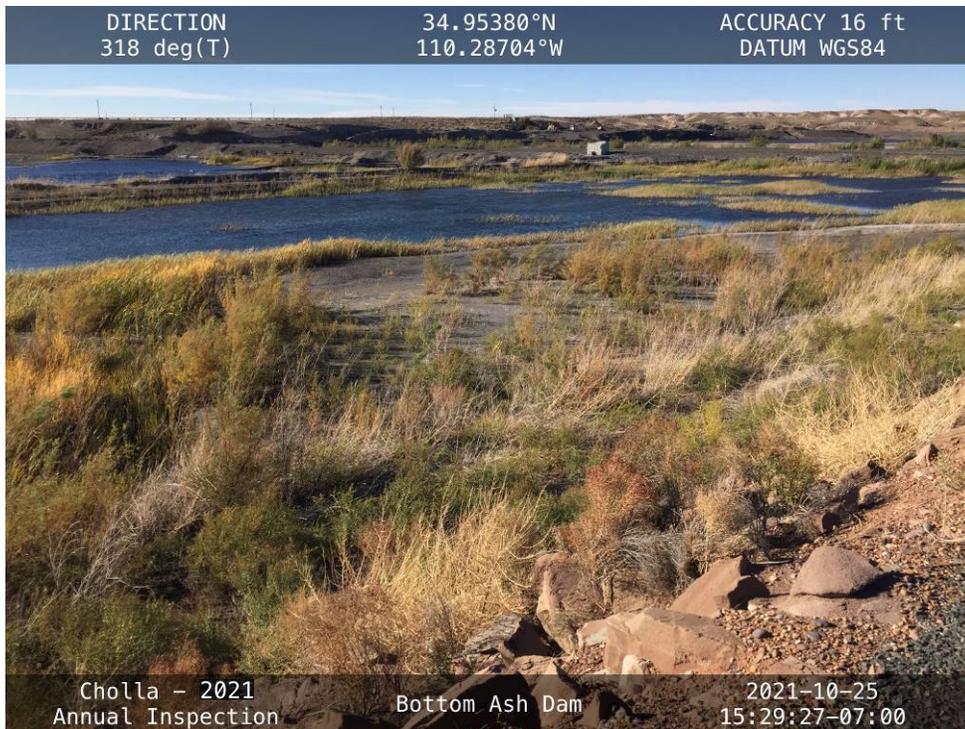
20211025-IMG_7056

The Divider Dike in the reservoir and vegetation on the upstream side of the East Embankment.

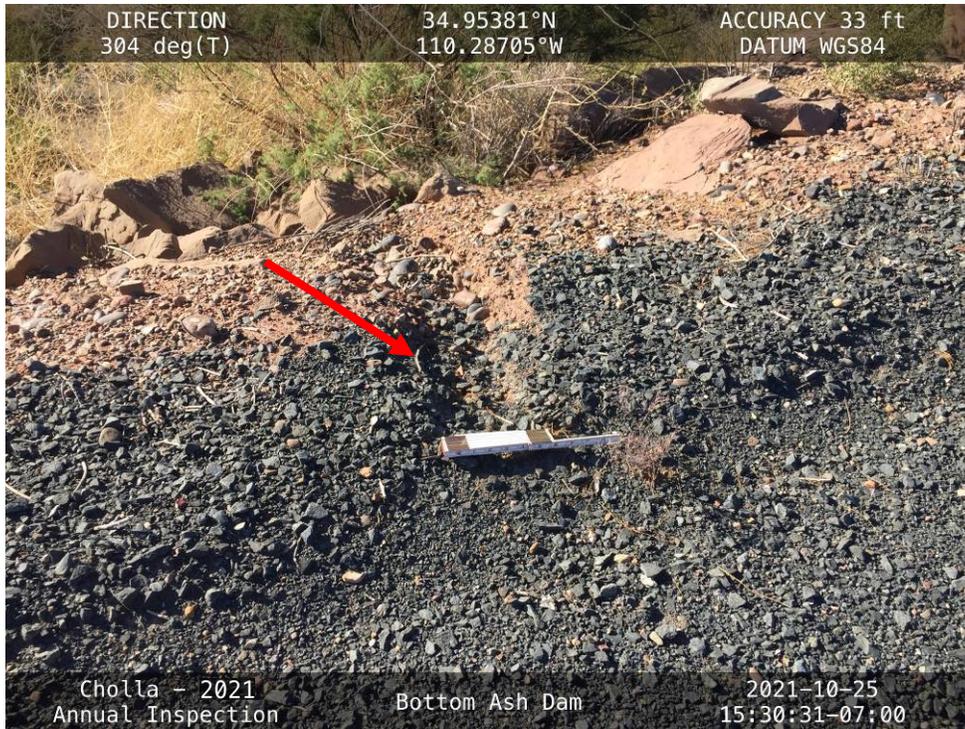
20211025-IMG_7060

Minor erosion rill forming on the upstream shoulder of the East Embankment (7 inches across).

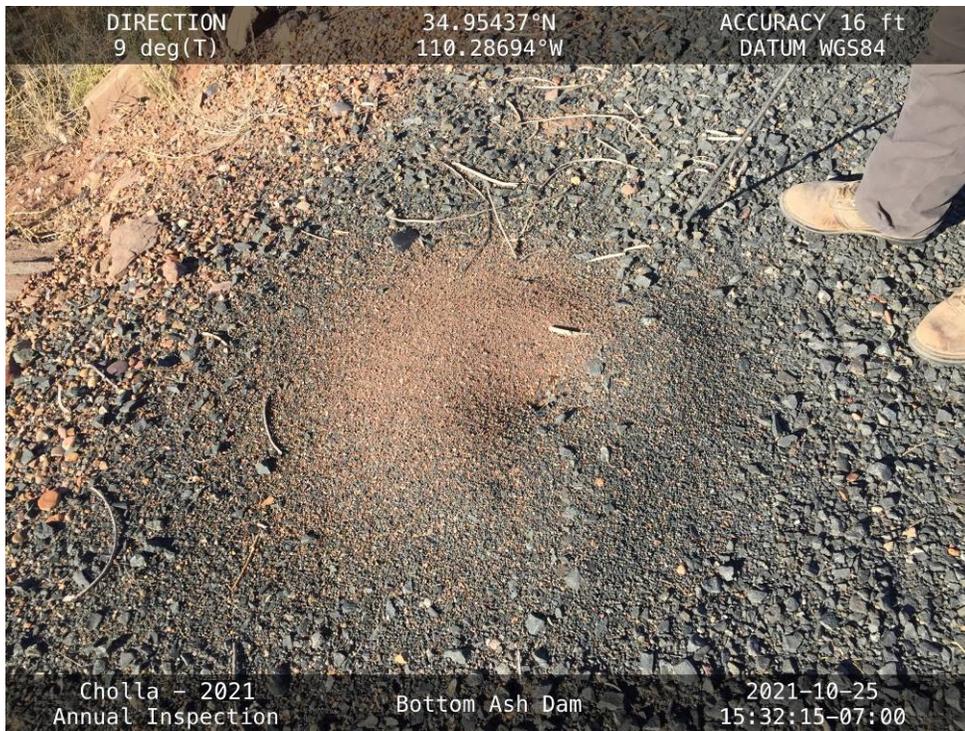
20211025-IMG_7062

An ant hill on the upstream shoulder of the East Embankment crest.

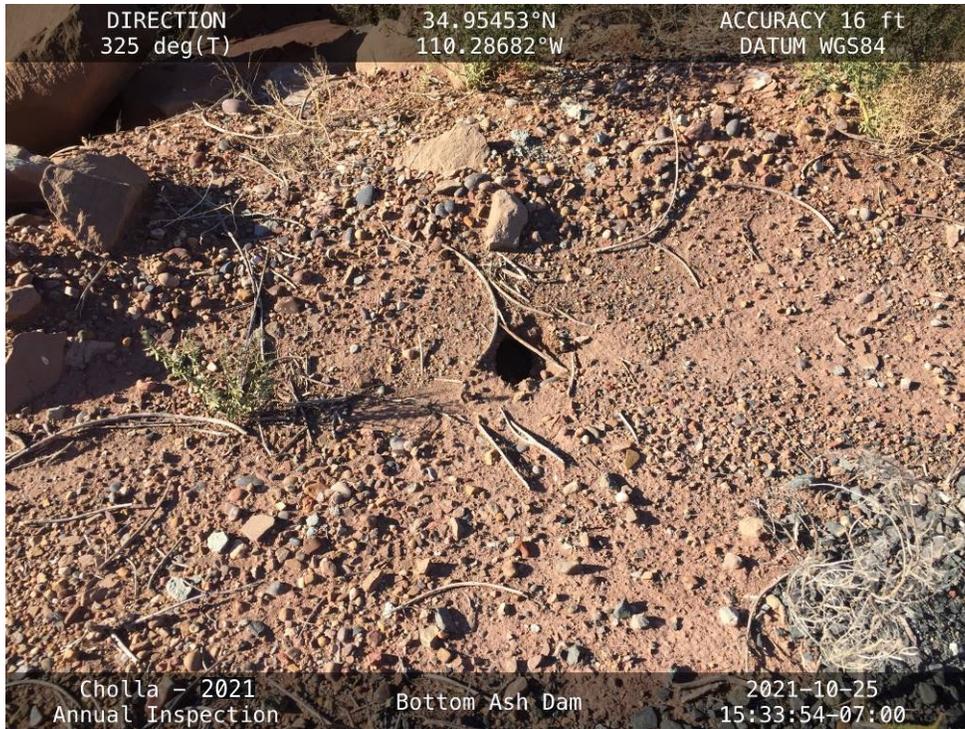
20211025-IMG_7064

A hole on the upstream shoulder of the East Embankment.

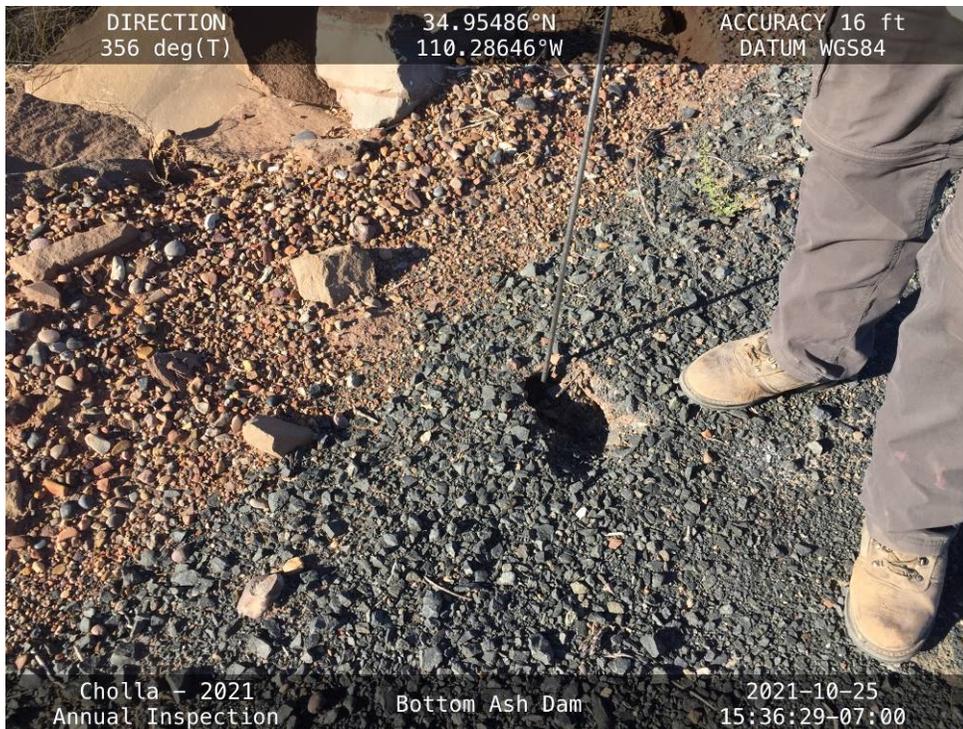
20211025-IMG_7074

The crest of the East Embankment, facing northeast from the middle of the embankment.

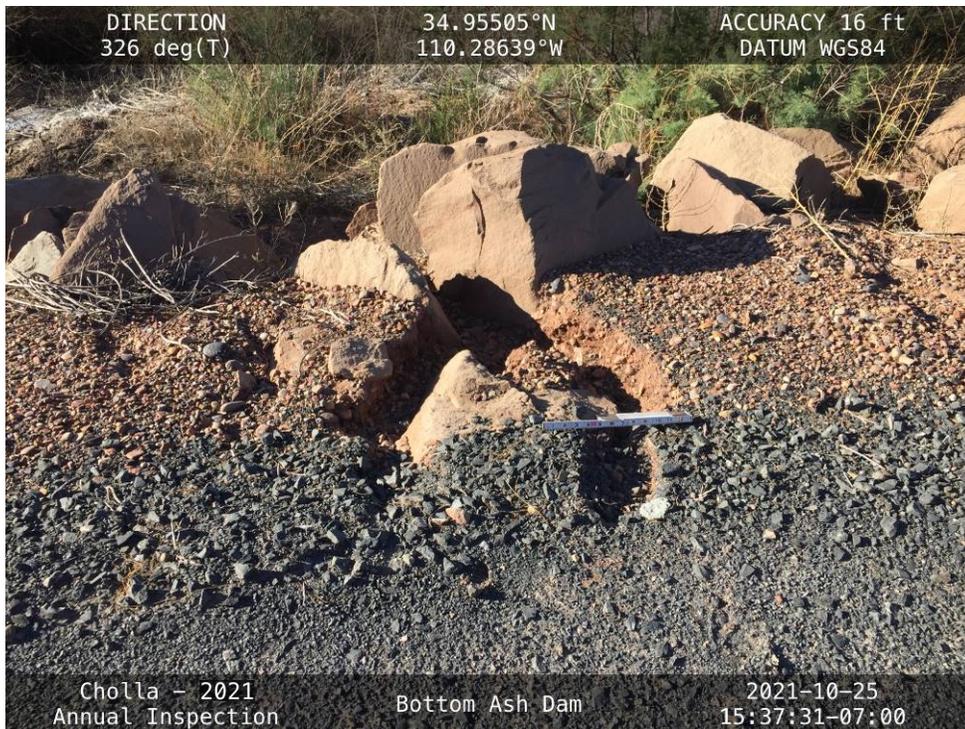
20211025-IMG_7082

A hole on the upstream half of the East Embankment crest.

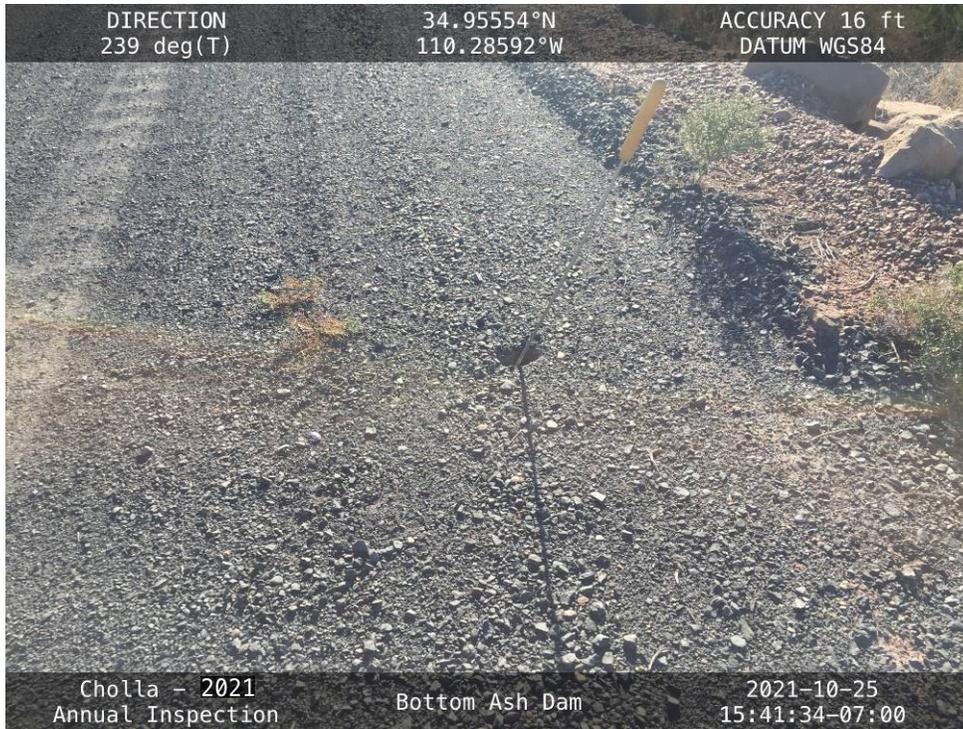
Repaired area where a series of holes was observed during the 2020 inspection (IMG_2700).

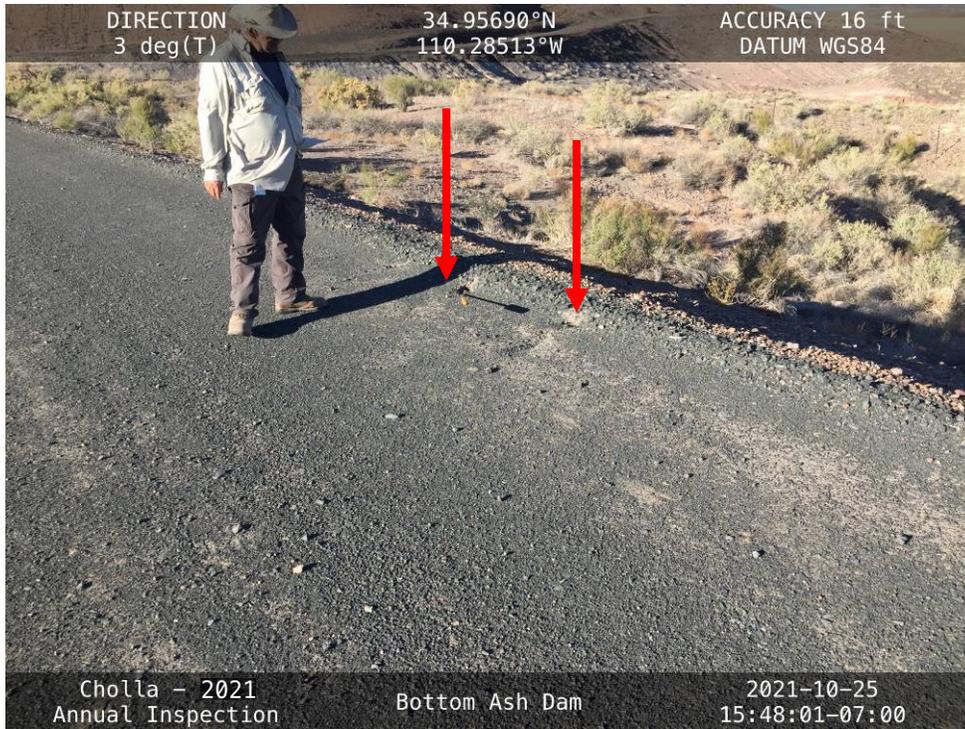
20211025-IMG_7097

A set of holes on the downstream shoulder in the northern portion of the East Embankment.

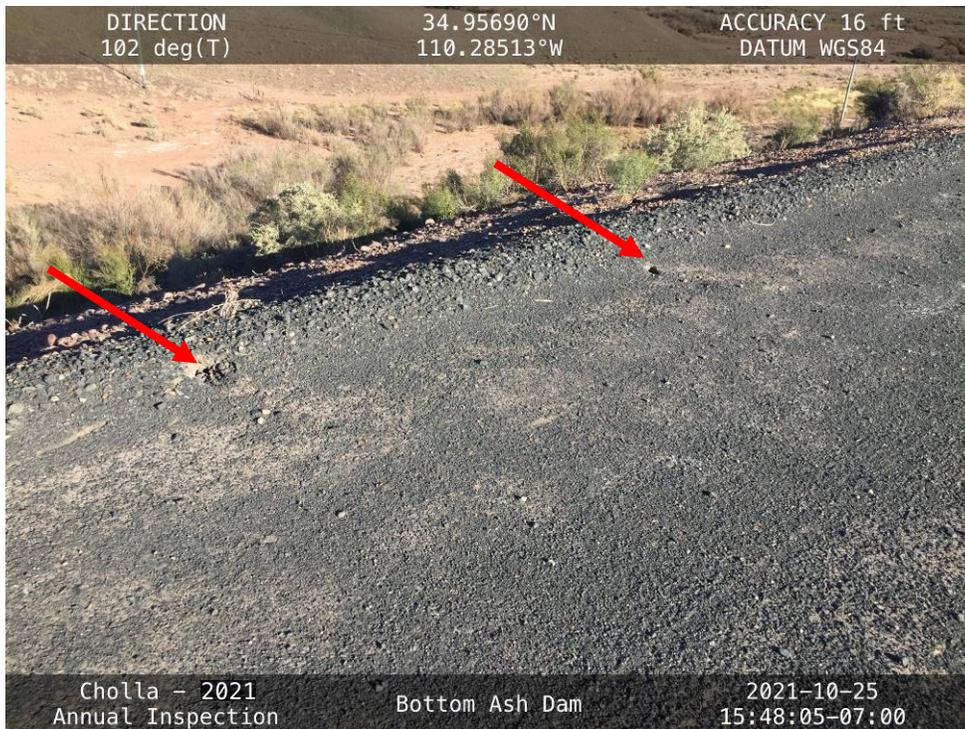
20211025-IMG_7098

A set of holes on the downstream shoulder in the northern portion of the East Embankment.

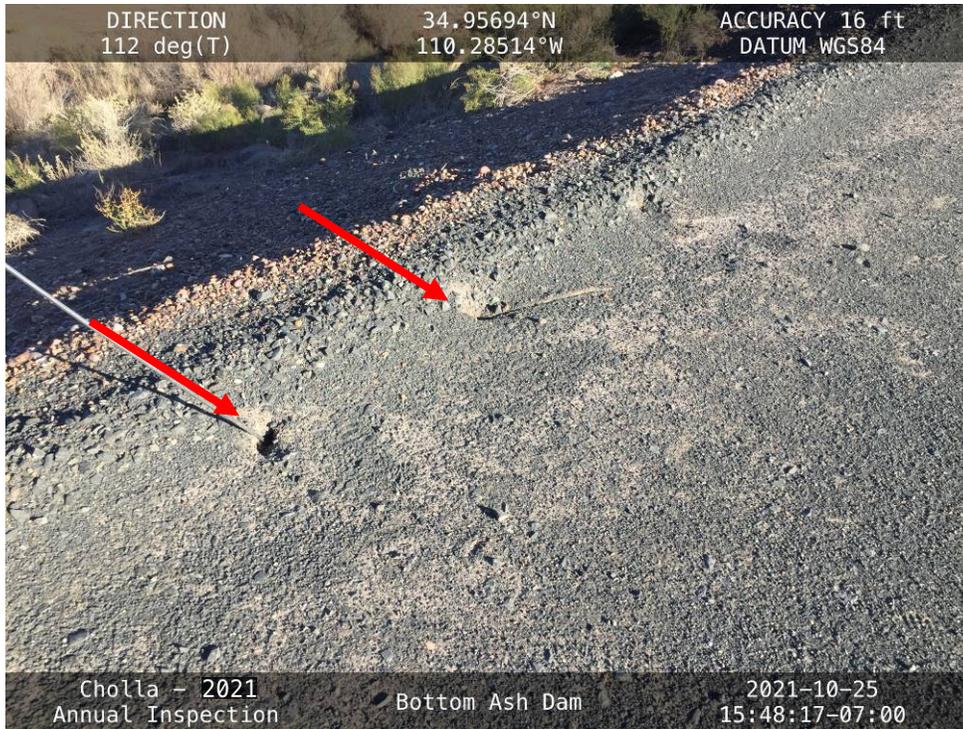
20211025-IMG_7099

A set of holes on the downstream shoulder in the northern portion of the East Embankment.
